# Brewster River River Corridor Plan

July 31, 2015

Fitzgerald Environmental Associates, LLC.  
18 Severance Green, Suite 203  
Colchester, VT 05446

**Lamoille County Planning Commission**  
PO Box 1637  
52 Portland Street, Second Floor  
Morrisville, VT 05661

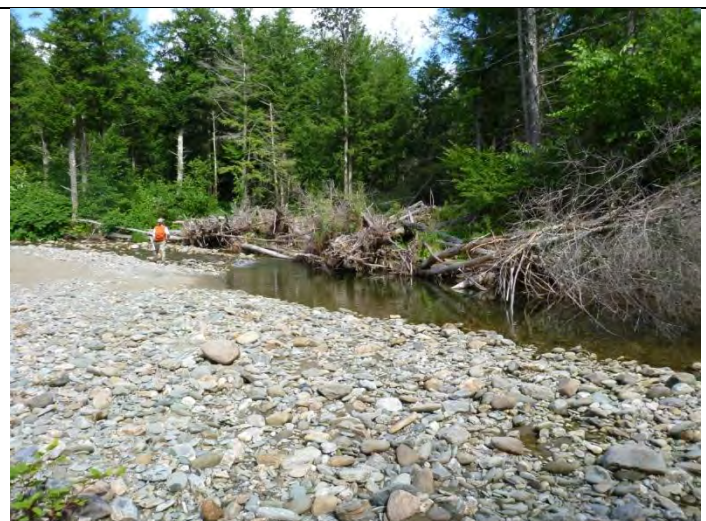
Major LWD deposits along the entrance to a large forested floodplain on the left bank

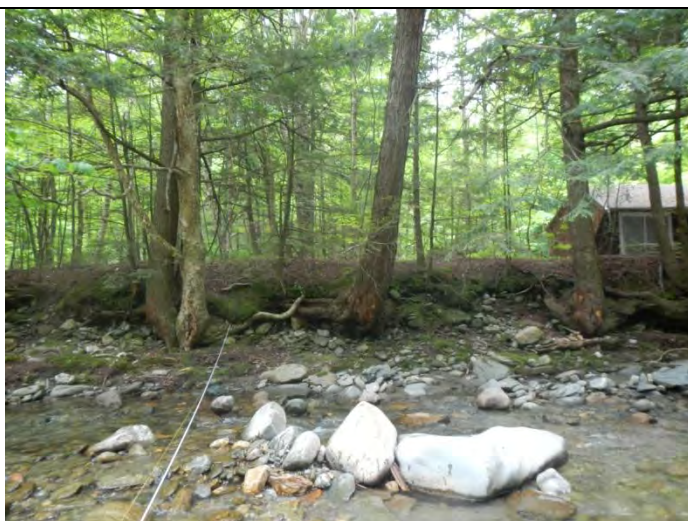
Recent bank scour along the campground property

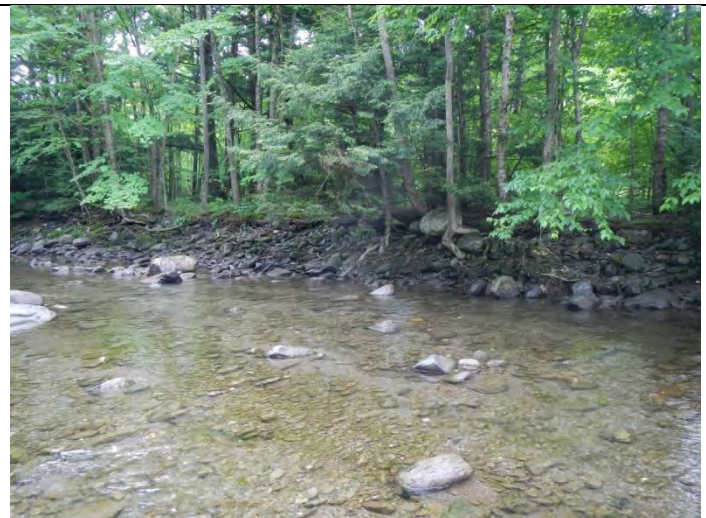
Near continuous heavy bank scour throughout reach

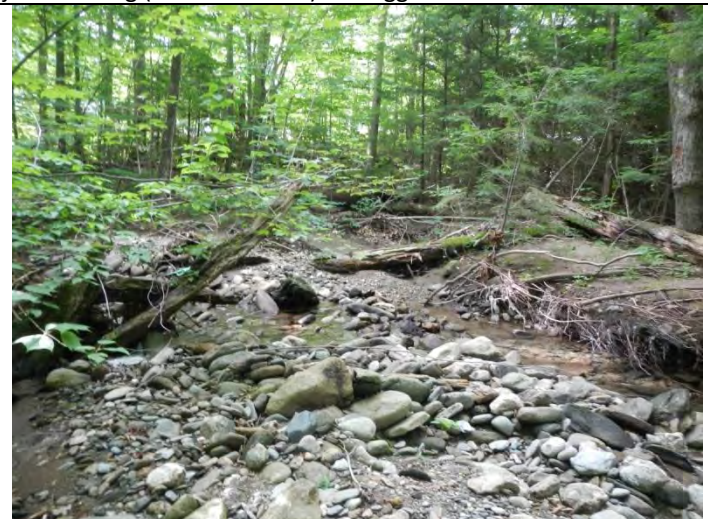
Multiple large flood chutes throughout reach

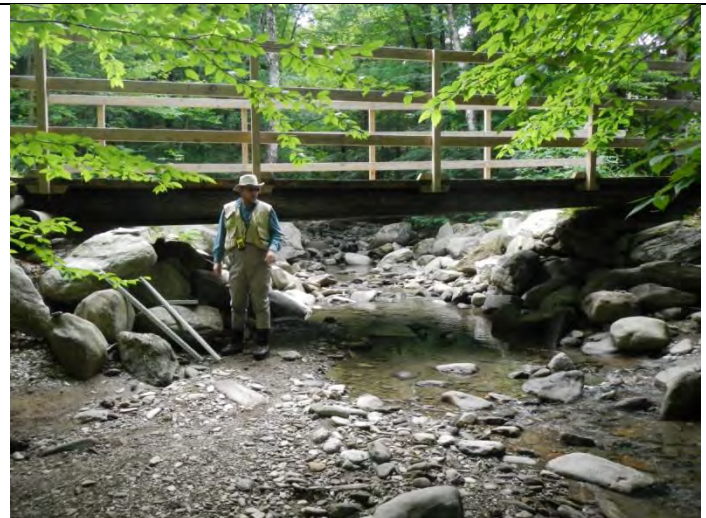
Major constriction from bridge abutments at upper footbridge

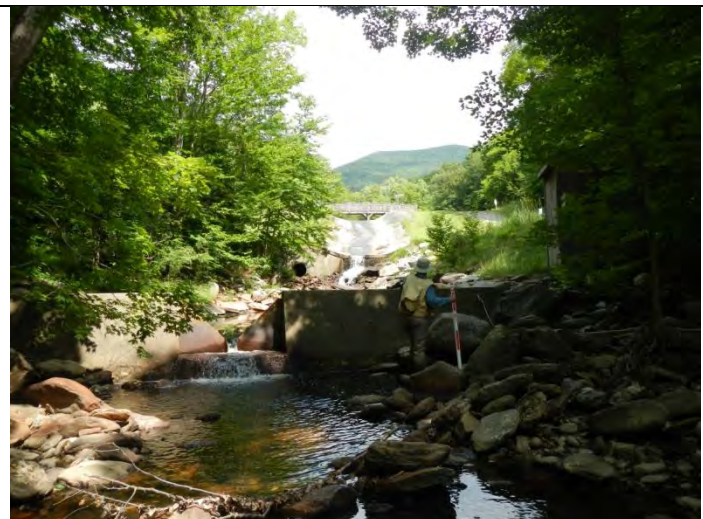
Large dam at the top of reach

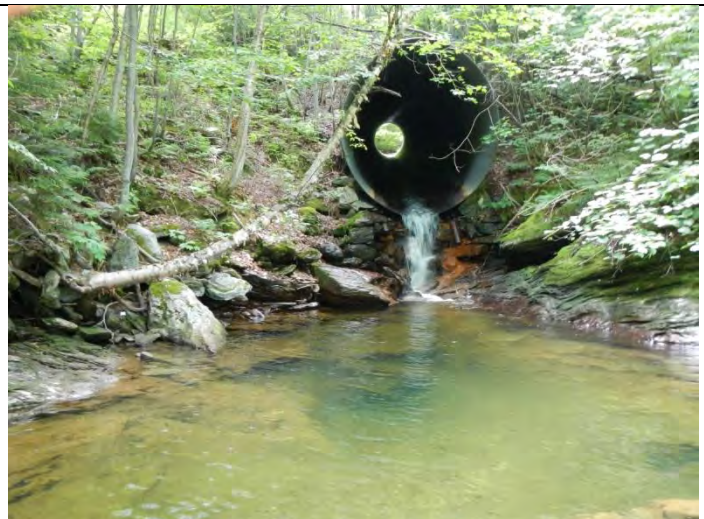
Large culvert under 108

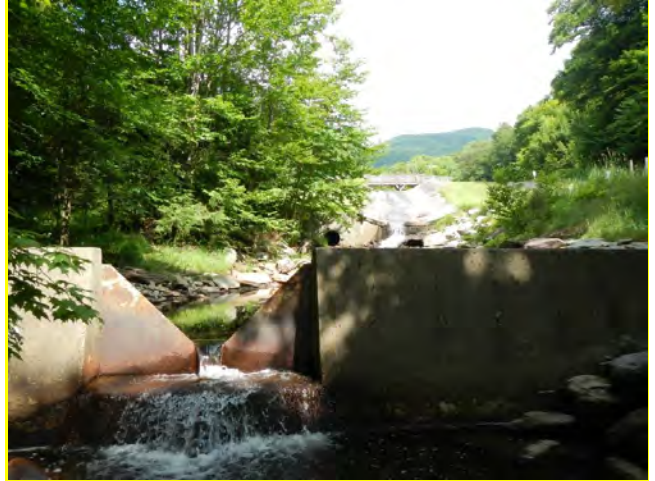
- Areas of small grade controls on segments M14 and T7.01
- Large and near continuous grade controls on segments M07.A, T7S4.03, and T7S4.02.01 (Figure 6)
- On-stream dams located on segments M14 (Figure 7) and T7S1.01
- Weirs on segments M14, T7S1.02, T7S4.03, and T7S4.02.01
- Partially breached timber crib dam on segment T7.01
- Extensive bank armoring on segments M14, T7S1.01 (Figure 8), and T7.S1.02

**Figure 7:** Weir and large dam on reach M14.

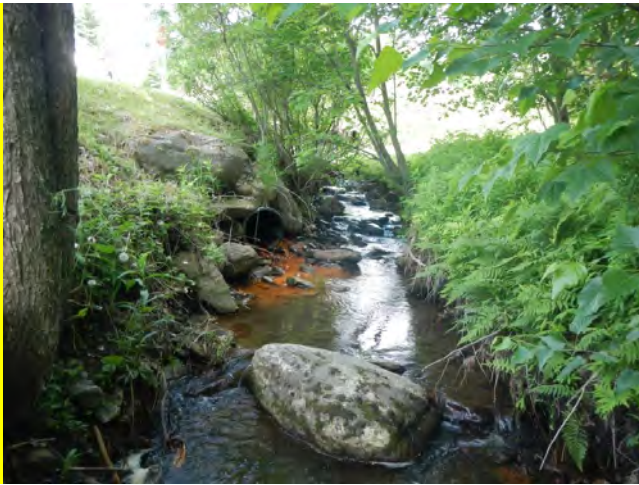
**Figure 8:** Bank armoring along road on reach T7S1.01

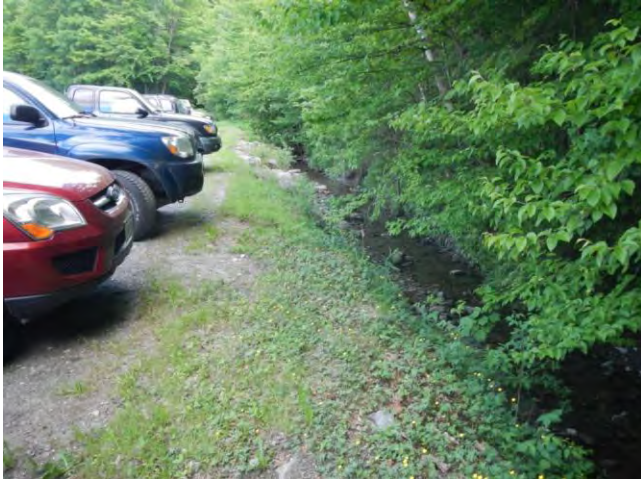
- Extreme channel straightening in reach: T7S1.01 (Figure 12)
- Moderate straightening in reach: T7.01
- Extensive corridor encroachments from berms and adjacent roadways and embankments in segments: M10, M11, M12.B, M13, M14, T7.01, T7S1.01, and T7S1.02 (Figures 13 and 14)
- Dredging in segments: M13, T7S1.01

**Figure 12:** Extreme straightening along a road and water park parking area on reach T7S1.01

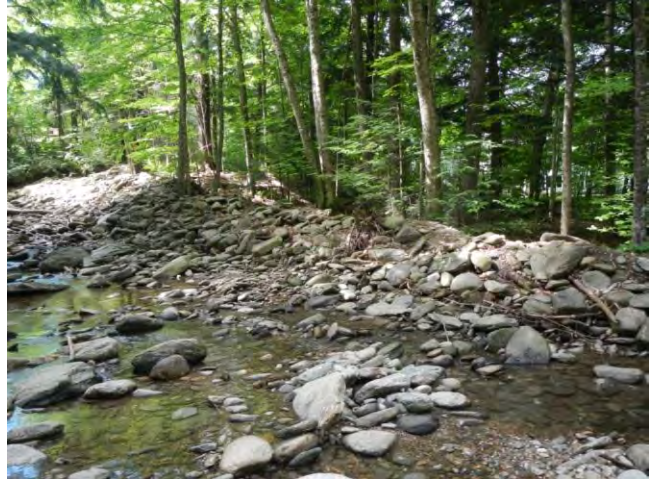
**Figure 13:** Recently constructed cobble berm blocking access to the left floodplain along reach M13.

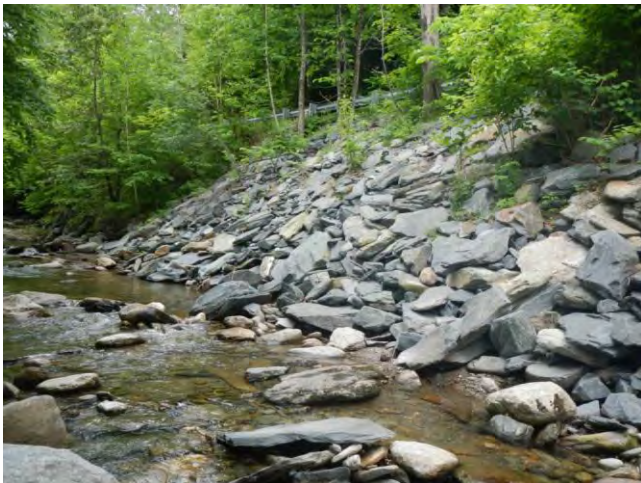
**Figure 14:** Encroachment from Desjardins Rd on T7.01.

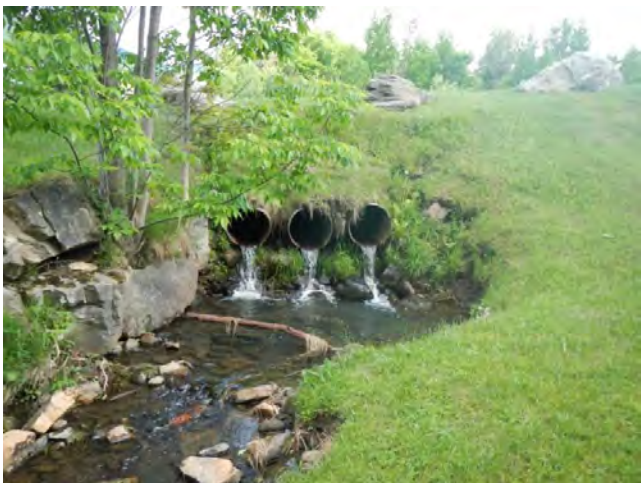
- Segments with numerous or large natural grade controls: M07.A, T7S4.03, and T7S4.02.01
- Segments with man-made grade controls:
  - Weirs: M14, T7S1.02, T7S4.03, and T7S4.02.01
  - Dam: M14, T7.01, and T7.S1.01 (Figures 15 and 16)

**Figure 16:** Three culverts at the outlet of the trout pond created by a small dam on reach T7S1.01.

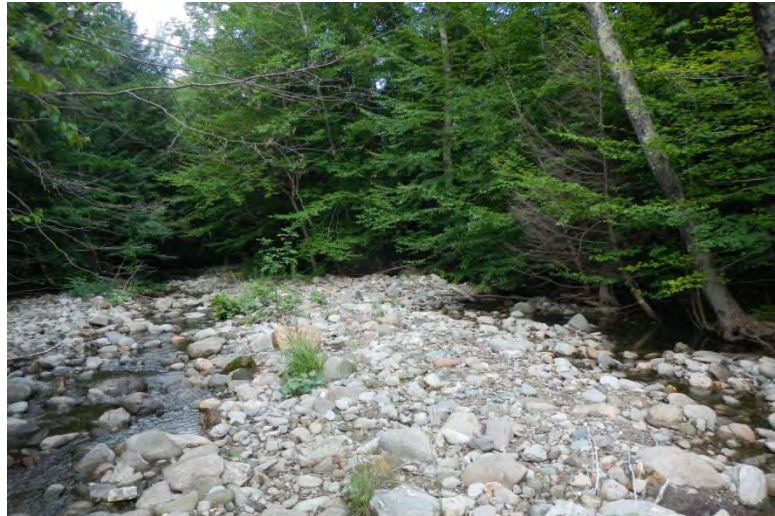
Four (4) of the extreme sensitivity segments were due to channel incision resulting from encroachment, armoring, or straightening. The remaining two (2) extreme sensitivity segments were due to major aggradation and widening in locations where flood sediments were deposited during and following the 2011 events (Figure 24).

**Figure 24:** Major deposition in segment M12.A causing a departure from C to D type and an extreme sensitivity rating.

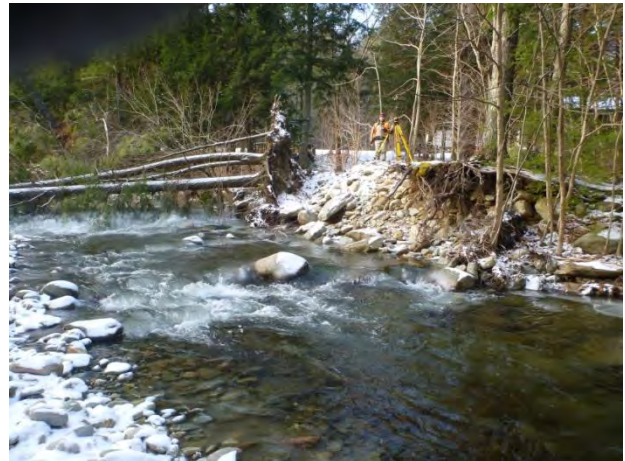
**Figure 2:** Major bank erosion towards the well head and undermining of large trees.

During spring flooding and Tropical Storm Irene in 2011, large volumes of coarse sediment were carried from upstream reaches and deposited throughout the middle and lower reaches of the Brewster River. These large volumes of sediment, coupled with high flows, caused the channel to over-widen up to four times the reference bankfull width. Cobble deposits filled the channel leading to numerous flood chutes and a large channel avulsion. Following the storms, the channel is adjusting planform within these widened areas and building large point and side bars (Figure 1). The project area is located at one of the planform adjustment sites. A large bar building along the right bank is pushing the thalweg into the Austin property. A bank several feet tall eroded and collapsed into the stream, taking with it numerous large hemlock and white pine trees (Figure 2). Many of the existing trees are completely undermined and will likely fall into the channel during successive events. A concrete well head for the Austin property is located approximately 20 feet from the eroding bank.

As described above, the thalweg is pushing against the left bank along the project area causing erosion and the loss of several large trees (Figure 3). This will likely progress as the channel adjusts planform and continues to build cobble bars along the right margin. The erosion is threatening a well head for the Austin property and contributing large volumes of sediment to the channel. Below is a summary of the recommended project approach to stabilize and protect the left bank along the Austin property.

A short section of armor slope (1V:2H) for approximately 50 linear feet along the downstream end of the project area would limit the progression of erosion towards the well head. A proposed sketch of this cross-section and armor slope is provided in Figure 5. Based on the estimated velocity during larger floods, Type III stone (median diameter of 16 inches) would be required, with a thickness of approximately 3 feet. The armor slope would be keyed into the channel bed 2 feet below the thalweg to prevent the slope from being undermined by scour. The top of the bank would be sloped back to 1V:3H and seeded with a conservation mix, mulched, and planted with willow stakes and/or fascines.

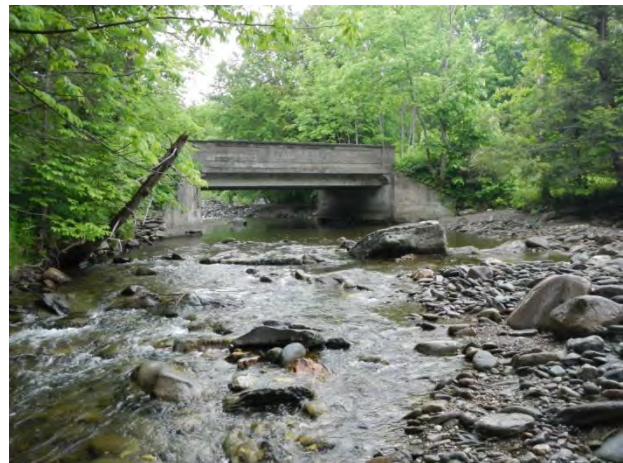
**Figure 8:** Bankfull constriction and downstream deposition

Based on these characteristics, and the evidence of severe channel adjustments upstream and downstream of the reach due to the bridge constriction, we recommend a bridge span with a minimum of width of 1.2 times the bankfull channel width, or 41 feet. Ideally, the structure span would be in the 50 to 60 foot range to accommodate the reach sediment regime, but a benefit-cost analysis can determine the most cost-effective size. As part of the design, hydraulic and sediment transport modeling and scour analysis will be required to comprehensively evaluate the reach and determine the appropriate bridge span and alignment.

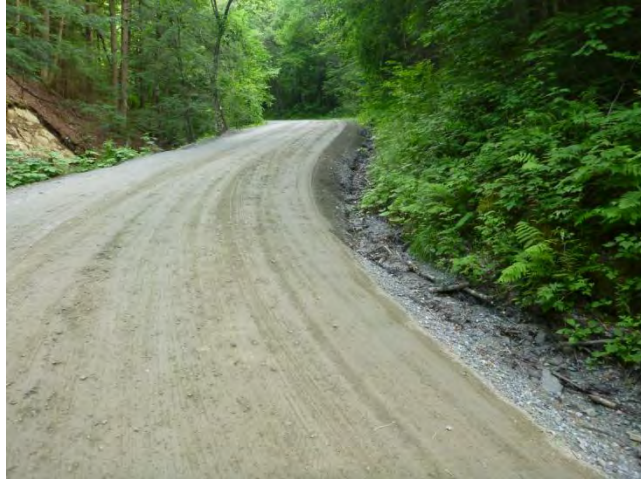
- The first area, ditch #1 shown on Figure 25, is located immediately up from the first road bend on the west side of the road (Figure 18). The road and ditch are very steep (approx. 10%) and the ditch is narrow (4-5ft) with steep side slopes and no rock armor protection. Approximately 150 feet of ditch would benefit from stabilization, with approximately 10 check dams required. Currently the ditch receives significant stormwater runoff from the road and carries a large amount of sand and fine gravel down to a natural sump prior to crossing the road to the stream through an old stone culvert.

**Figure 18:** Unstable ditch #1 just uphill from first bend in Canyon Road

There are two areas of unstable ditches (see Figure 25 map) that were previously identified by LCPC and another consultant in 2013. In 2014 we followed up on these areas to provide more specific guidance and locations for stabilization. In both cases, at a minimum we recommend the ditches be stabilized with stone check dams following the specifications shown in Figure 17. One of the two sites would also benefit from a sedimentation basin, which is described on the following page.

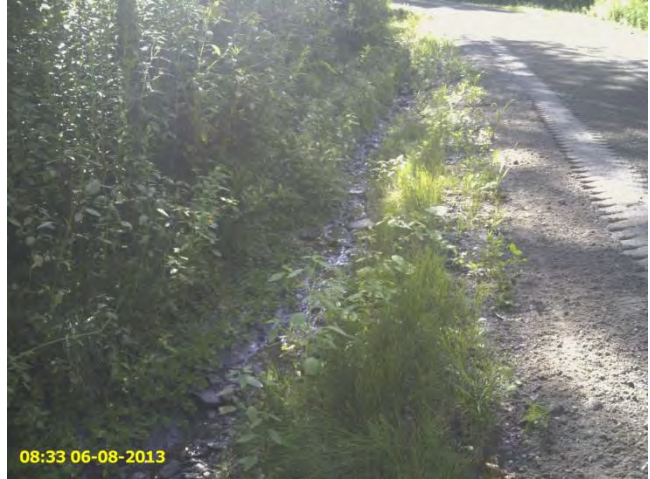
- Ditch #2 is located just west of the intersection with Robtoy Road (Figure 19). The road and ditch grade are less than 5%, but the ditch is narrow (4-5ft) with steep side slopes and conveys runoff from a longer stretch of the road. The ditch outlets to the stream through an 18 inch culvert. Approximately 300 feet of ditch would benefit from stabilization, but the most important area would be towards the downstream end before the culvert inlet. Approximately 10 check dams would be required.

**Figure 19:** Unstable ditch #2 west of intersection with Robtoy Road (photo by LCPC)

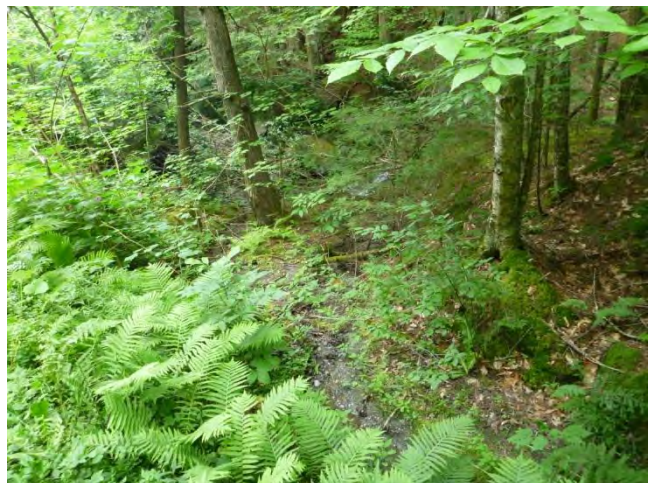
**Figure 21:** Outlet of an 18" culvert to the north side of Canyon Road just west of waterfall.

- Sediment basin #1: A sump on the south side of the first bend in Canyon Road (Figure 20) collects stormwater and sediment from ditch #1. Sediment trapping could be enhanced with a baffled stormwater basin. Plants may volunteer over time but the conditions are harsh.
- Sediment basin #2: A low point on the north side of the second bend in Canyon Road receives stormwater and sediment from an 18" diameter culvert draining a ditch (Figure 21). This area is much smaller than the footprint for basin #1; a similar but smaller baffled stormwater basin could be installed to trap sediment if room allows. Alternatively, a series of horseshoe shaped check dams could be installed at the outlet to slow velocity, trap sediment, and prevent scour in the small downstream channel leading to the stream.

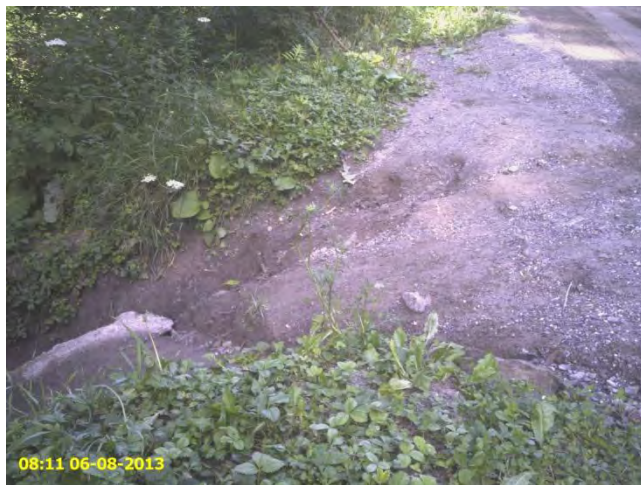
The entrance to the Brewster River from Canyon Road (Figure 23) is eroding, and the steeper section of the trail leading down to the river is gullying and eroding (Figure 24). Runoff from uphill sections of Canyon Road appears to funnel into the trail entrance. Some potential remediation ideas are listed on the following page.

**Figure 23:** Entrance to Brewster River Trail from Canyon Road (photo by LCPC)

- The first priority solution would be for the Town to regrade Canyon Road to the east leading up to the trail entrance to encourage runoff to shed off the road shoulder in more of a dispersed manner.
- A series of stairs down through the steeper section of the trail would slow the velocity of runoff going down the trail. These stairs could be constructed out of pressure treated lumber and stone, with water bars as needed to shed water to the edges. A larger gravel pad at the entrance of the trail (i.e., a landing step at or just below road grade) would help to disperse runoff off the sides of the trail.

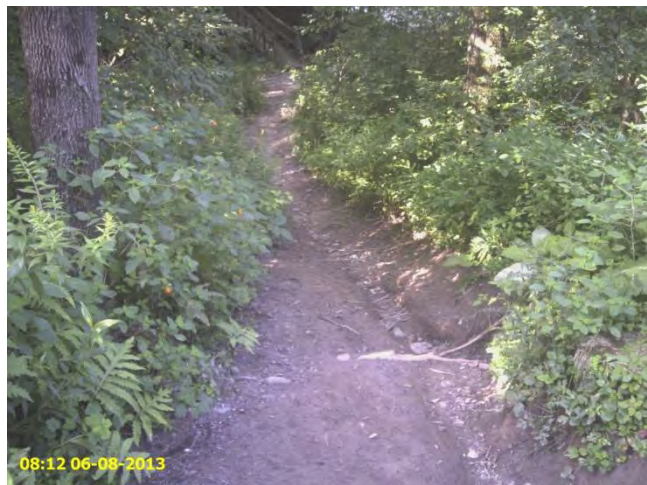
**Figure 24:** Erosion along steeper section of Brewster River Trail (photo by LCPC)
