# River Corridor Plan for Mill Brook in Windsor, West Windsor, and Reading, Vermont

May 29, 2015

**Fitzgerald Environmental Associates, LLC.**

**Southern Windsor County Regional Planning  
Commission**

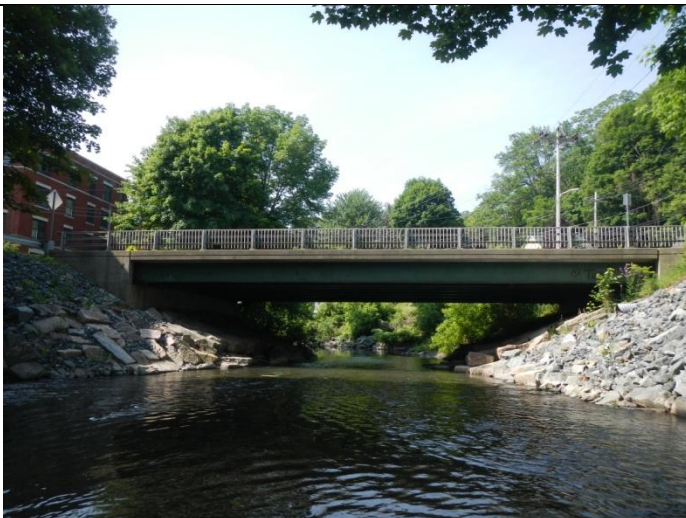
**Reach Highlights:** This reach was highly impacted from historic straightening and encroachment as it flows through the center of Windsor. Incision was variable but always F-type. Several grade controls reduced incision leading to widening and some deposition and gravel bar formation. The large dam and impoundment upstream is a major interruption to sediment supply, however the upper reach was bedrock controlled and did not indicate increased scour.

Bridge and armoring in the lower reach

- **Project WI 1:** Utility Conduit - A steel conduit with concrete piers constricts the channel causing bed scour, and is a major debris/ice jam risk.

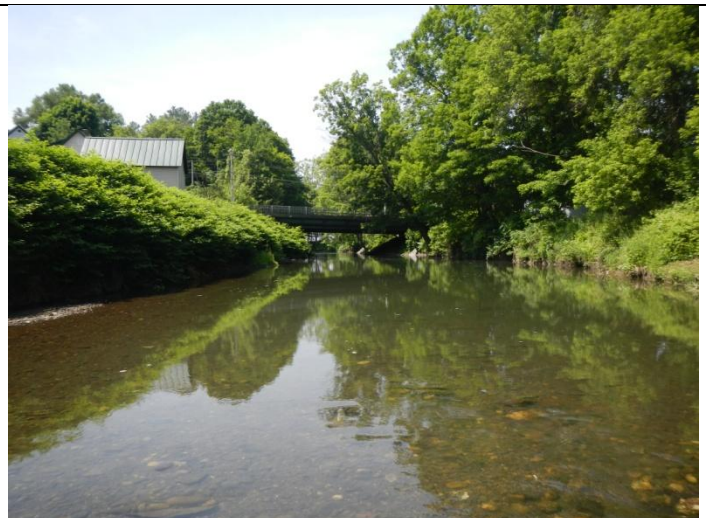
Straightening and buffer impacts in the upper reach

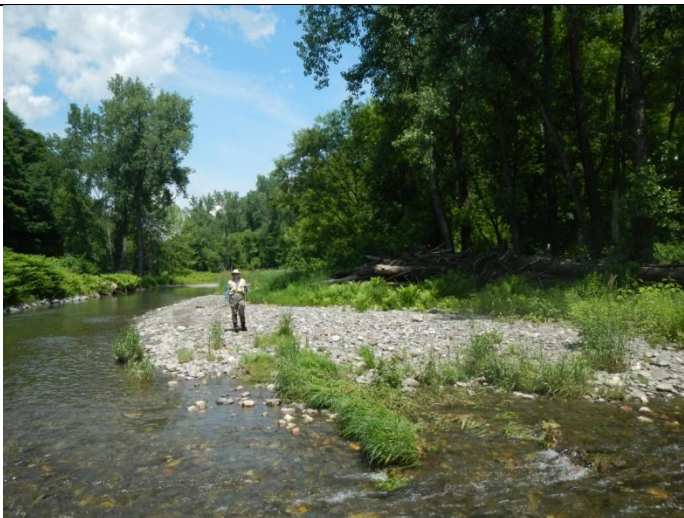
**Reach Highlights:** The channel is actively aggrading with sand and gravel from upstream mass failures and erosion. Extensive bank armoring and road encroachment are limiting planform adjustment, however the failure of historic armoring on the left bank throughout the lower reach is allowing for channel widening (note: armor failure was accounted for in RGA scoring for widening and planform). Some floodplain was accessible throughout the reach, likely a result of recent channel aggradation. This reach is transitioning from stage II to III.

Widening and aggradation in the lower reach with nice floodplain access

- **Project WI 2:** Conservation - "The Narrows" is a large forested floodplain area that provides valuable sediment and floodwater attenuation upstream of Mill Pond.
- **Project WI 3:** Corridor Protection - Small forested floodplain area

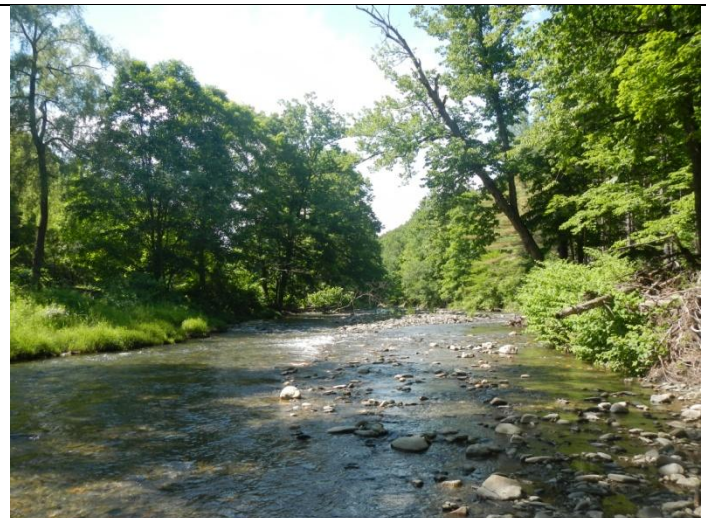
Widening and poor bedform in the upper reach

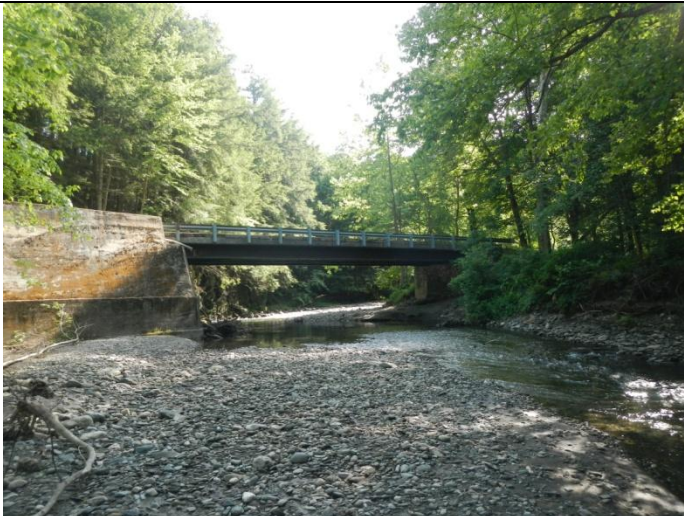
**Reach Highlights:** This segment and M05-B were similarly scoured and widened during T.S. Irene. Segment B has remained plane-bed and is relatively featureless. Segment A has redeveloped some riffle-pool sequences and has some planform development. We assessed this reach as stage III due to the widened state and the large volume of flood sediments that will continue to work through the reach. Major bed aggradation in portions of the lower segment has created small areas of accessible floodplain. The reach will slowly transition to stage IV if this process continues. Evaluation of some characteristics of confined river valleys in the RGA form are not entirely applicable to this Bc stream type setting (i.e., step-pool systems).

Aggradation at the lower Brook Rd bridge

- **Project WI 3b:** Corridor Protection - Several small floodplain areas
- **Project WI 4:** Floodplain Cleanup - Property on left floodplain has a large amount of debris/junk at risk of entering channel
- **Project WI 5:** Bank Stabilization - Eroding bank and no buffer vegetation along Merrell Property
- **Projects WI 6 + 8:** Bridge Replacement - Hewett Road bridge is high priority as an important transportation connector

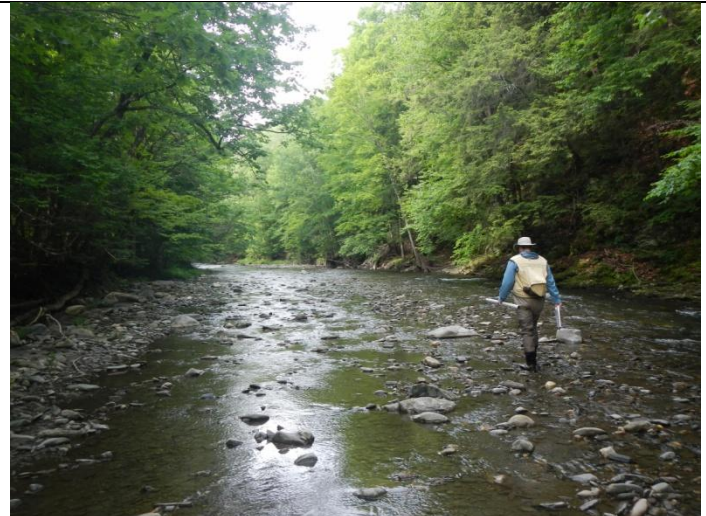
Widening and poor bedform in the upper segment

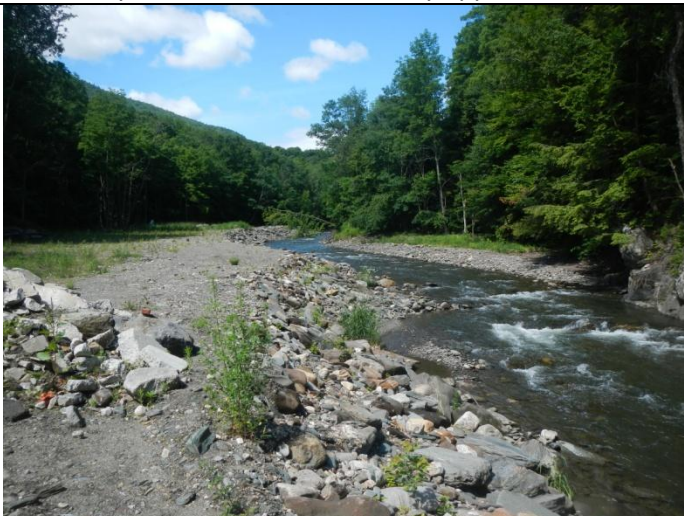
**Reach Highlights:** This reach scoured and widened considerably during T.S. Irene. The channel scoured out the entire valley in several stretches and huge mass failures, bank erosion, and heavy bank scour were observed throughout the reach. Brook Road closely followed the right valley through most of the reach and was completely washed out in numerous locations. This reach widened during TSI and is continuing to widen to accommodate the large volume of flood sediments working through. Historic floodplain terraces were observed through much of the reach; however these are elevated and were only partially accessed during T.S. Irene. Evaluation of some characteristics of confined river valleys in RGA form not entirely applicable to this Bc stream type setting (i.e., step-pool systems).

Channel and floodplain reconstructed in lower segment

- **Project WI 8:** Channel and Floodplain Restoration - Post-T.S. Irene repairs upstream of the Hewett Road crossing on a private lot have created a narrow and incised channel, restore floodplain access and plant buffer while protecting house.
- **Project WI 9:** Conservation - Over one mile of river valley is now inaccessible and is highly active.

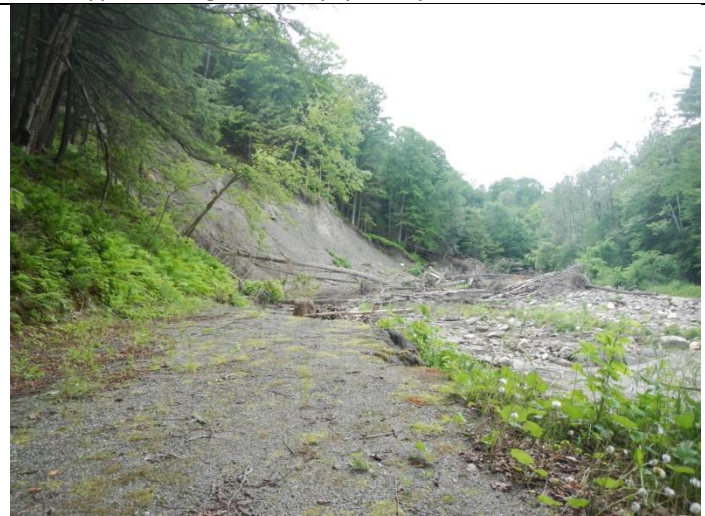
Major widening, mass failure, and Brook Road washout

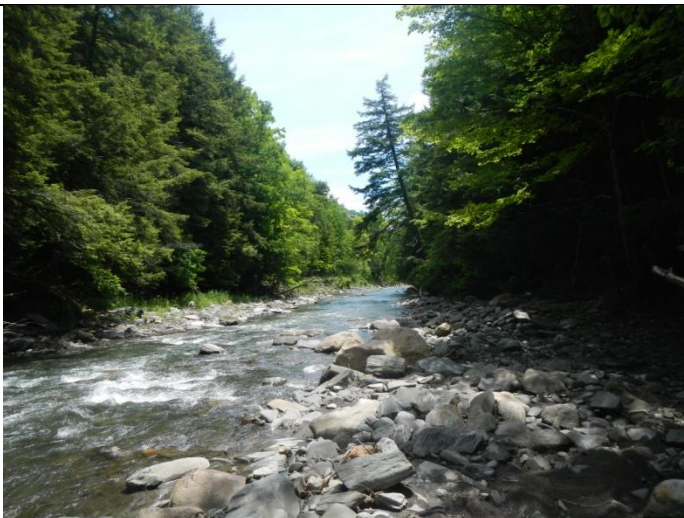
**Reach Highlights:** The bottom 600 feet of the segment are located in a bedrock gorge. Above the series of grade controls the channel is encroached by a heavily armored stretch of Brook Road along the left bank, but the right bank spills on to an accessible forested floodplain. The downstream bedrock and ledge along much of the banks has likely locked the bed in place through this segment. Minor incision led us to assess the segment as stage II CEM.

Minor scour and widening in lower segment, some floodplain access

- **Project WI 10:** Bridge Removal - Brook Road bridge is washed out and destroyed, remove abutments and deck which present a flood hazard risk.
- **Project WI 3c:** Corridor Protection - A small forested floodplain is low and accessible during all flood events

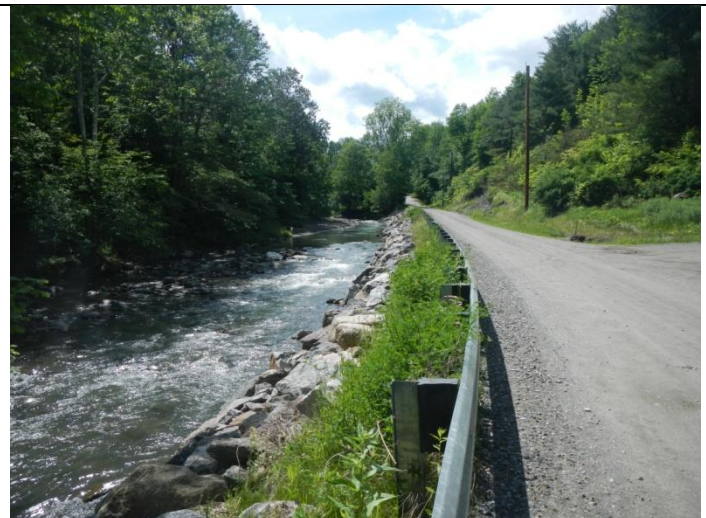
Accessible forested right floodplain and armoring along Brook Rd on left bank

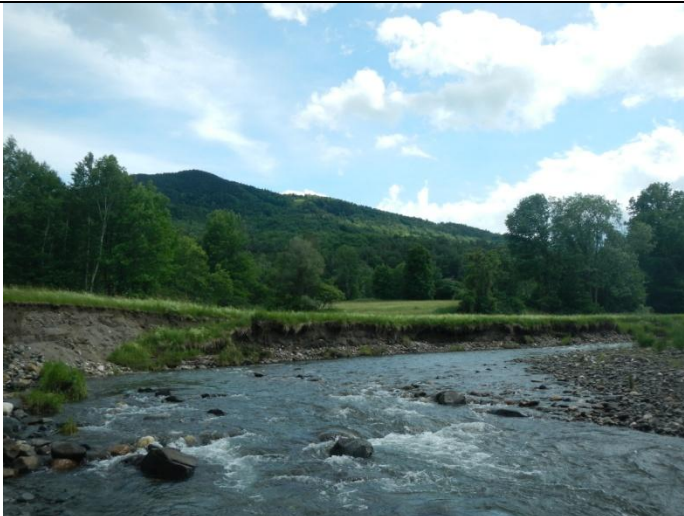
**Reach Highlights:** Moderately accessible floodplain was present on at least one bank for most of this reach. The floodplain was elevated as indicated by the high incision ratio, but still accessible during larger events. Some planform adjustment was observed in the lower portion, however the banks appeared relatively stable for most of the reach and widening was minimal. This reach is likely still affected by historic straightening which has restricted widening and planform adjustment, leading to ongoing incision; we assessed this reach as stage II. Aggradation processes may be initiating after TS Irene flood and stage III adjustment processes will likely begin soon.

Planform adjustment and major bank erosion along hayfield

- **Project WW 1:** Eroded Bank - Approximately 750' of major bank erosion along a hayfield with minimal buffer vegetation.
- **Project WW 2a:** Corridor Protection and Buffer Planting - Accessible floodplain area with minimal buffer vegetation.
- **Project WW 3:** Dam Removal/Retrofit - A former snow making withdrawal dam and current dry hydrant for WWVFD is in disrepair and at risk of being outflanked along the right bank. The impoundment behind the dam is completely filled in with gravel and causing fine deposition throughout the upstream segment.

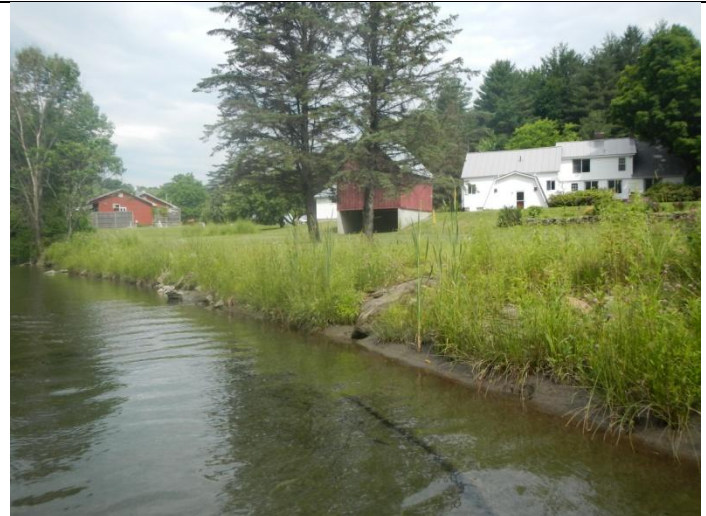
Corridor development and buffer impacts in upper reach

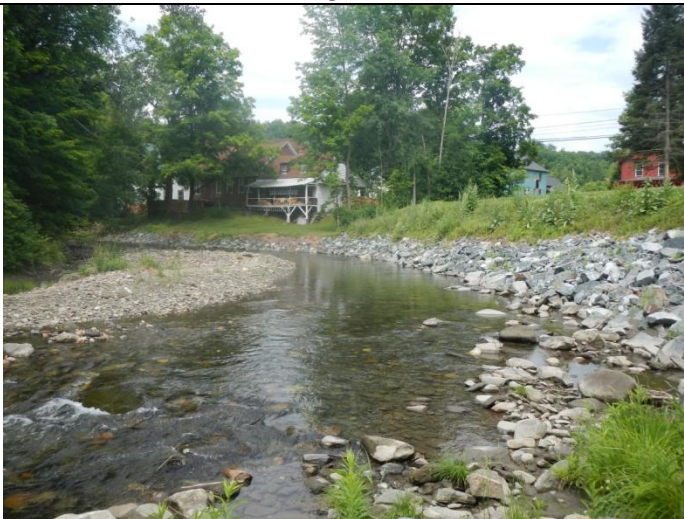
**Reach Highlights:** The left bank is encroached by development or Route 44 and armored for most of the segment. The right bank has a low and accessible wide floodplain with relatively stable banks. Sand and gravel deposition throughout the segment indicates that the downstream dam causes enough gradient change to increase fine deposition throughout the segment. This is likely controlling incision and maintaining floodplain access. We assessed the reach as stage II due to limited opportunity for widening or planform adjustment with the high degree of encroachment and armoring. The channel could incise if the dam failed or was removed.

Development, armoring, and aggradation

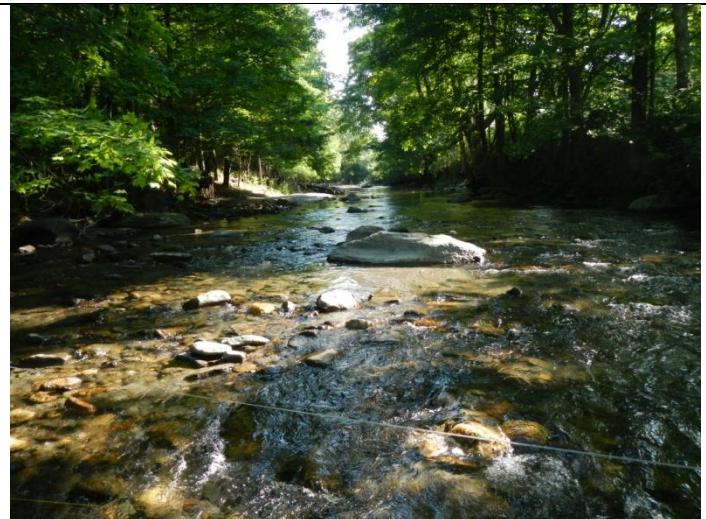
Accessible left floodplain and some planform adjustment in the upper segment

- **Project WW2b:** Corridor Protection - Small forested floodplain on the right bank

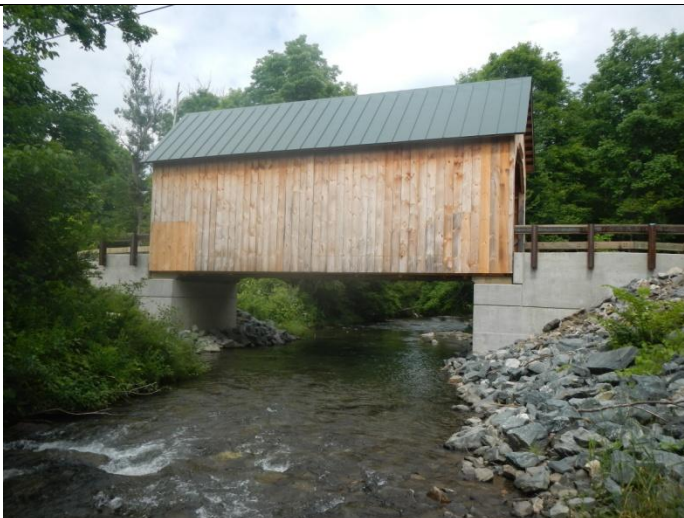
Major constriction at the Bible Hill Rd bridge

- **Project WW 4: Dam Removal** - A partially breached historic dam is an ice/debris jam hazard and should be fully removed.
- **Projects WW2c - e: Corridor Protection and Buffer Planting** - Three small floodplain areas with reduced bank and buffer vegetation
- **Project WW 5: Bridge Replacement** - The Bible Hill covered bridge is a major channel constriction and caused flooding problems during T.S. Irene

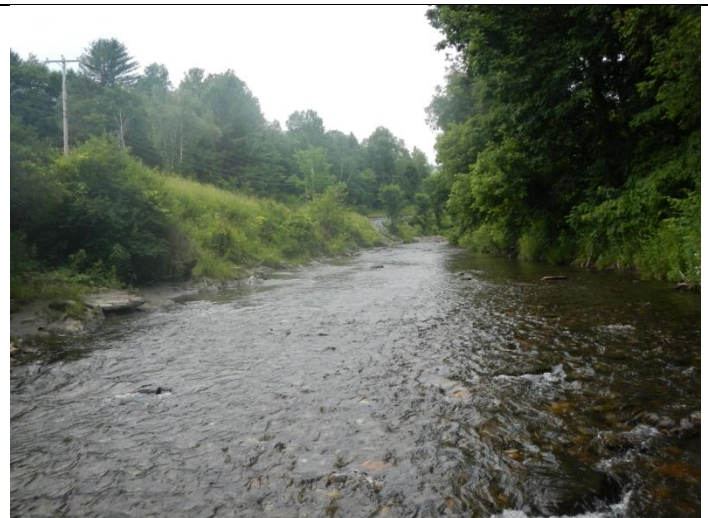
**Reach Highlights:** This segment was deeply incised and narrow throughout. The only accessible floodplain was located in the lower portion of the segment immediately upstream of a large grade control with a breached concrete dam. Bank erosion and scour were minimal indicating no recent widening or planform adjustment. T.S. Irene caused major flood damage to adjacent properties, however no major channel adjustments are apparent. This segment was assessed as stage II.

Encroachment and deep incision

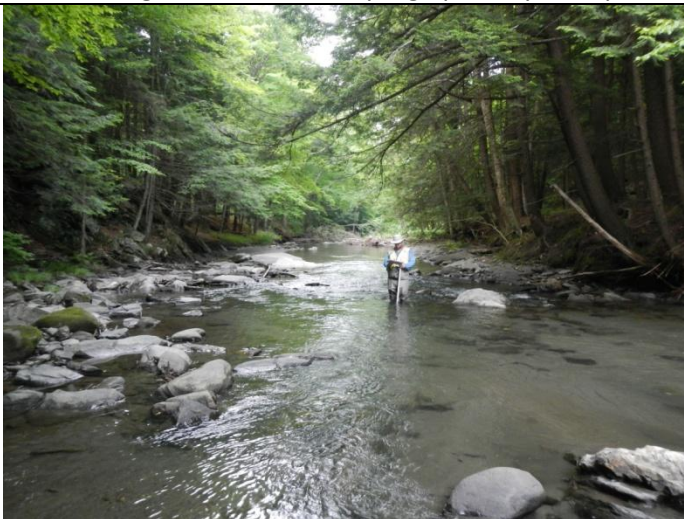
Semi-confined valley with large channel substrate

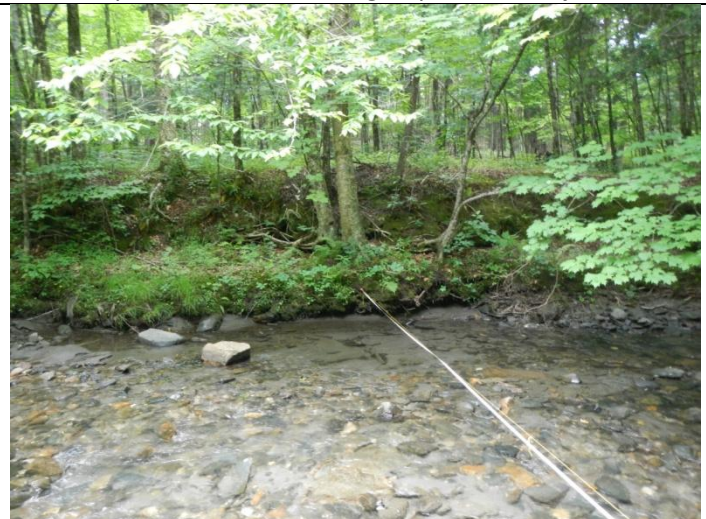
**Reach Highlights:** This reach scoured down during T.S. Irene in the upper reach and widened in the lower reach where multiple grade controls limited incision. Floodplain access is very limited throughout the reach and large mass failures were observed in the areas of widening. The upper half of the reach is naturally confined and is incised. A small ~5ft wide bench is the only accessible floodplain except during the largest events. Heavy bank scour was observed through most of the reach but widening is limited by stony soils, ledge, and dense roots. We assessed the reach as stage II due to the very high primary floodplain and the low potential for widening or planform adjustment.

Small floodplain bench and inaccessible main floodplain

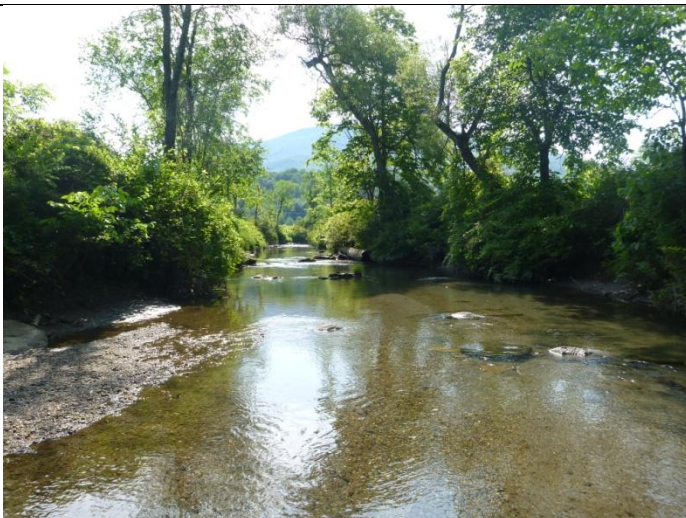
**Reach Highlights:** Extensive historic straightening and some armoring in upper segment near Route 44. Channel incised and stuck in Stage II of channel evolution. Signs of bed fining from recent floods, but no evidence of a transition to aggradation process. Minimal floodplain access during T.S. Irene.

Deeply entrenched and incised segment

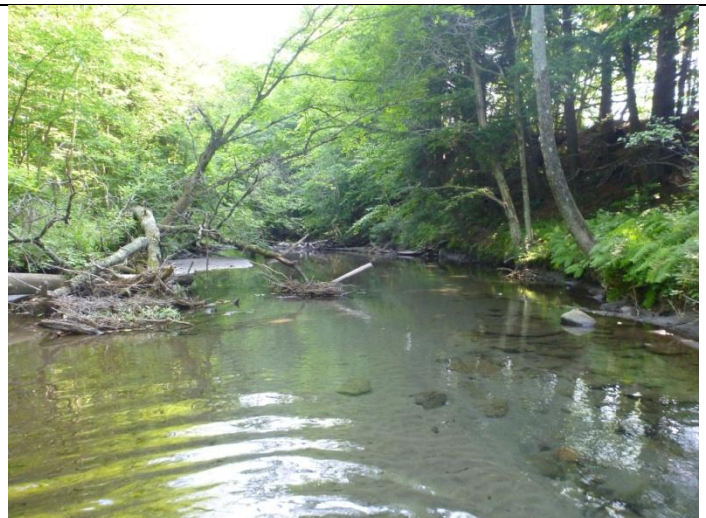
LWD in lower segment

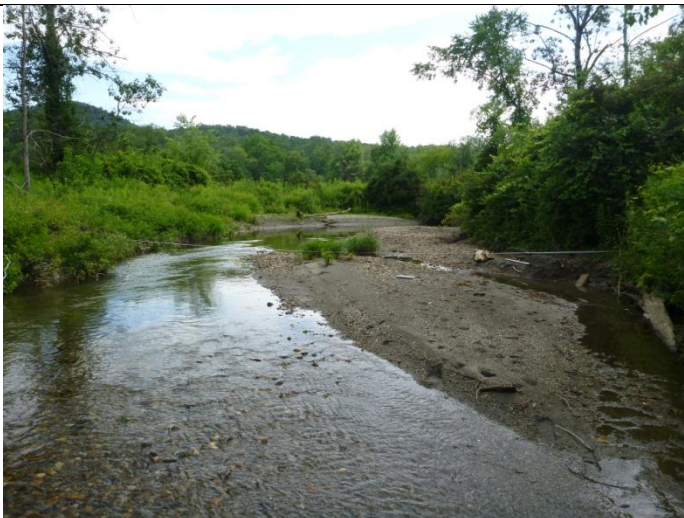
**Reach Highlights:** Significant historical straightening throughout segment. Majority of reach was likely armored historically. Erosion is now occurring post-T.S. Irene where armor failed. Bed aggradation has likely been occurring in recent decades and lateral channel migration is beginning. Stage III channel evolution will transition into stage IV in near future in the absence of channel management.

Deposition and widening

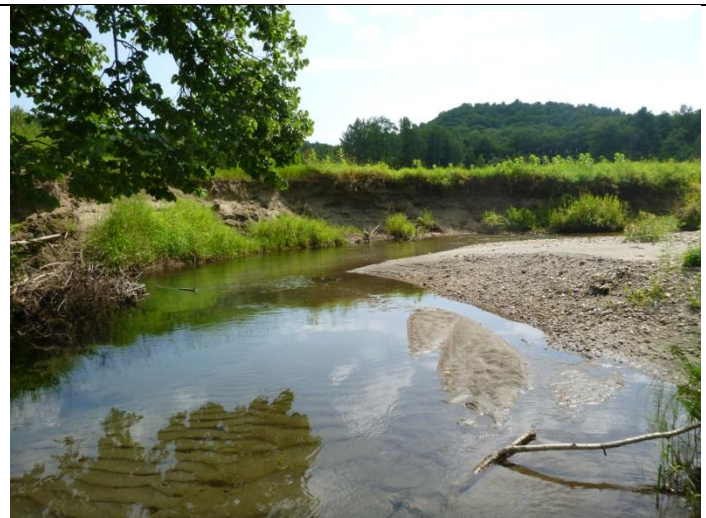
Bank erosion from planform adjustment and widening

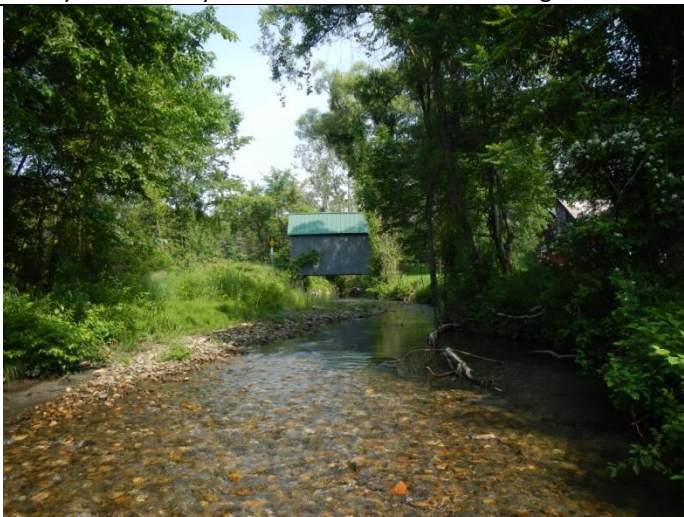
Churchill Rd bridge and accessible floodplain bench

- **Project WW 2h:** Corridor Protection - The right bank upstream of Churchill Rd has a nice floodplain hayfield that appears to have been abandoned following T.S. Irene. Protecting this floodplain from future development is important for reducing downstream flooding risk.
- **Project WW 7:** Bridge Replacement - The Churchill Road bridge is undersized and increased major overbank flooding during T.S. Irene. Replace with an appropriately sized structure to decrease flooding and reduce the risk of roadway and property damage.

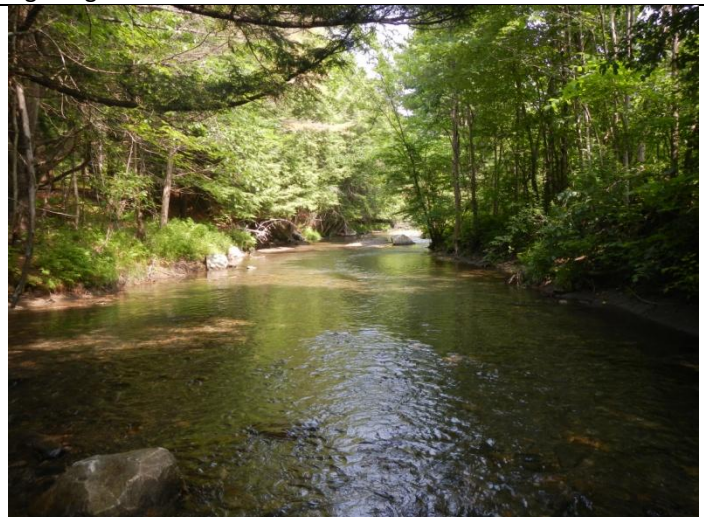
Stable channel in upper reach with some floodplain

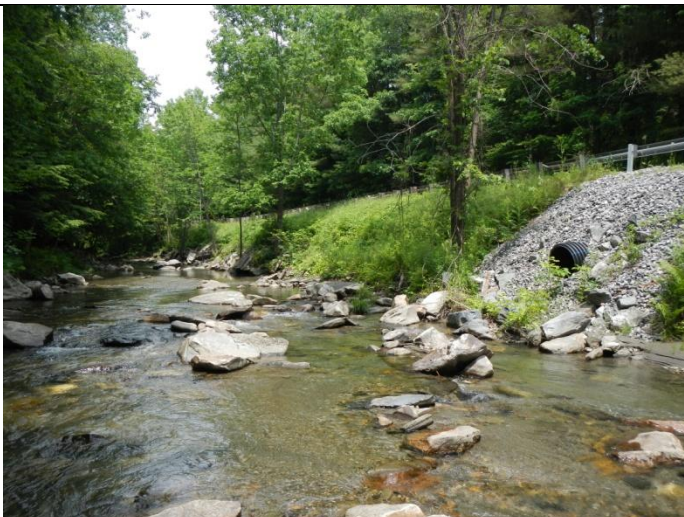
**Reach Highlights:** Floodplain access was extremely limited in this reach which is continuously encroached by Rt 44 and/or development between the road and the channel. An elevated historic terrace was observed along portions of the reach, but was typically 3x bankfull height and is only accessible during the largest events. Incision appears to be historic as the substrate is very large and resistant to further scour. The reach appears to have widened during TS Irene, scouring away lower benches. This caused a lower entrenchment ratio and departure from B to F.

Encroachment and armoring along Rt 44

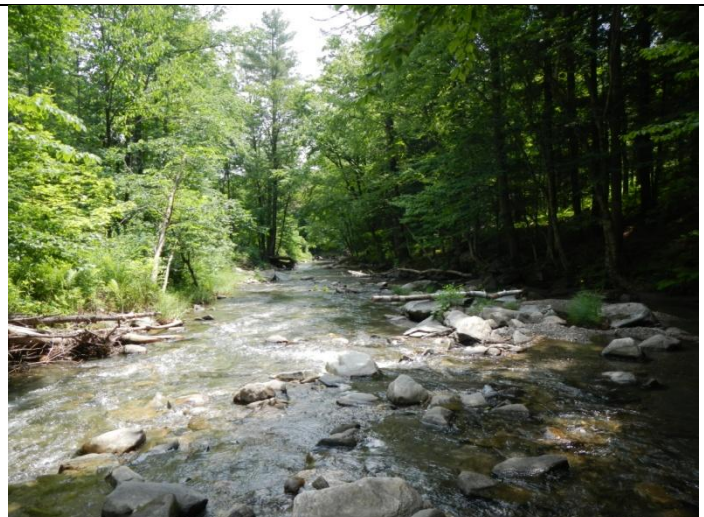
Semi-confined valley with lower benches scoured away

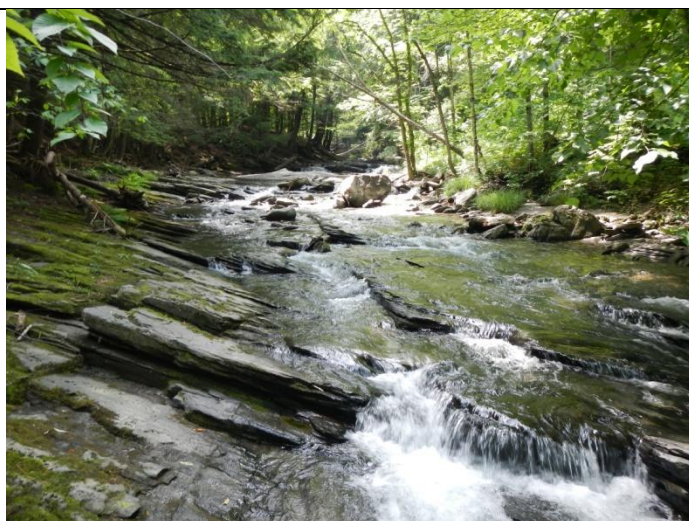
Bedrock gorge setting through most of segment

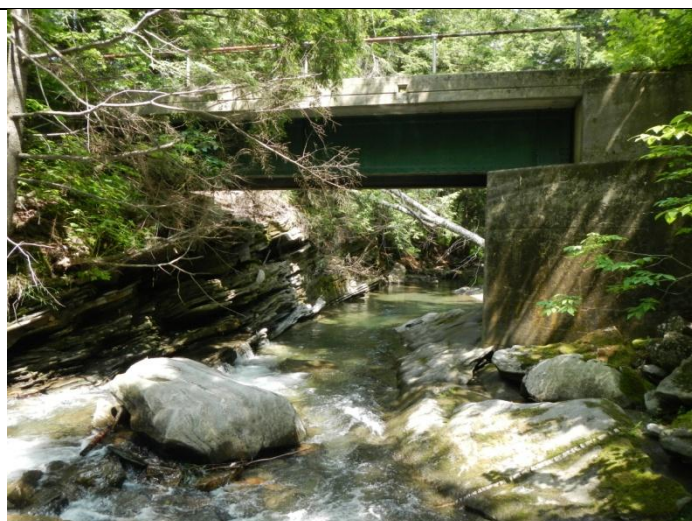
**Reach Highlights:** Segment was not assessed due to a gorge setting. An access road bridge at the top of the segment is a major bankfull constriction and likely caused the very high debris lines we observed in the field (10-12' above bankfull).

Major constriction at top of segment

- **Project WW 11:** Bridge Replacement/Removal - The abutments for a mine access bridge are a major channel constriction and likely plugged with debris during T.S. Irene causing major upstream flood elevation increases.

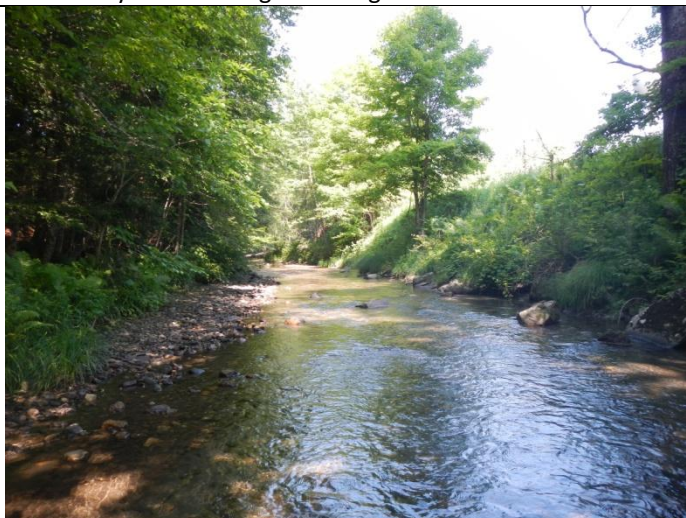
**Reach Highlights:** This segment is very incised and entrenched throughout. The segment likely incised further during TS Irene and is now aggrading with large volumes of sand and gravel, especially in the lower portion. Very tall banks along the talc mine property restrict access to the floodplain even during the largest events. This section is historically straightened and was likely dredged. Banks are lower in the upper portion of the segment; however floodplain access remains minimal causing a departure from C to F. Entrenchment ratios vary from approx. 1.2 in the lower reach to 1.6 in upper reach where cross section was taken. Reach likely transitioning from stage II to III channel evolution.

Straightening and incision along the talc mine property

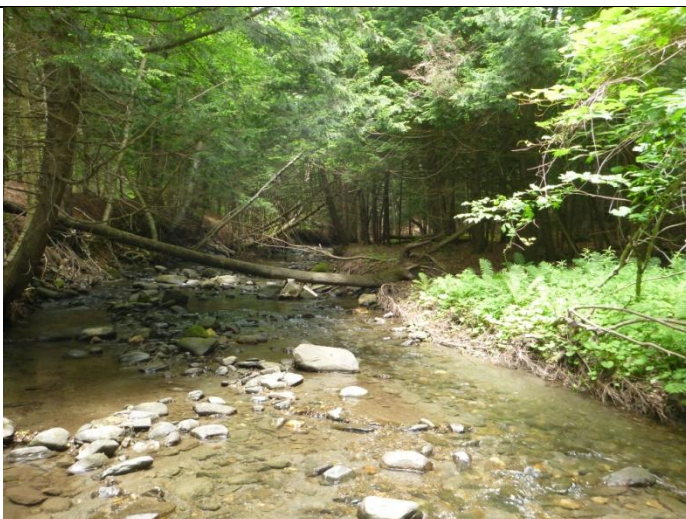
Accessible flood bench in upper reach

- Project WW 12: Corridor Protection - Accessible and undeveloped floodplain for most of the reach

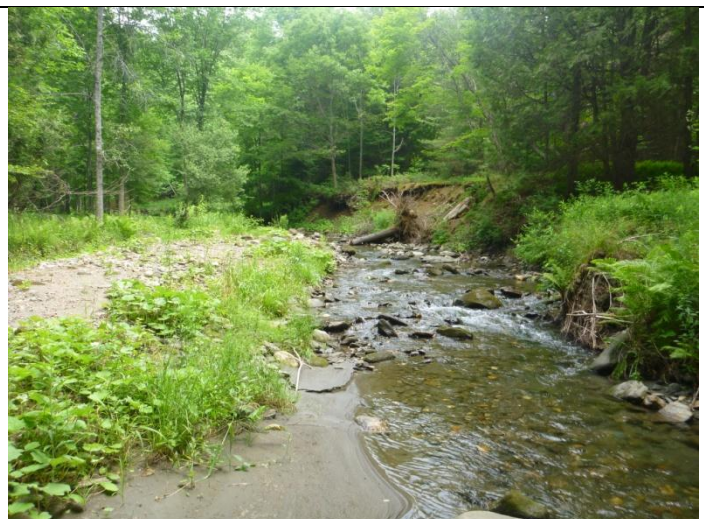
**Reach Highlights:** Channel appears to have incised moderately in the past but currently is in equilibrium. Bed does not appear to be vertically unstable at present and we observed minimal widening or planform adjustment. We assessed the reach as Stage II due to incision, however it is stable and could transition to Stage V over time. Areas of riparian impact and lateral instability are concentrated in the lower reach near the school, West Windsor Town Hall, and Route 44 crossing.

Moderate incision and bank erosion

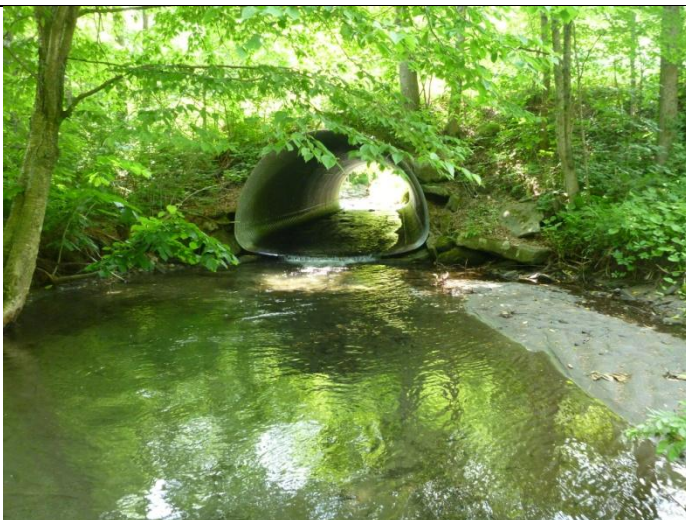
Coon Club Road culvert

- **Project WW 13:** Culvert Replacement/Retrofit: Coon Club Road culvert is undersized and perched. Culvert could be replaced with a larger structure to reduce flood risk, and/or AOP could be improved with tailwater control or similar structure.
- **Project WW 14a + b:** Buffer Planting - Two small floodplain areas with reduced bank and buffer vegetation. Fence cattle away from buffer at site a.
- **Project WW 15:** Culvert Replacement - Brownsville-Hartland Road culvert is undersized and a moderate AOP barrier.

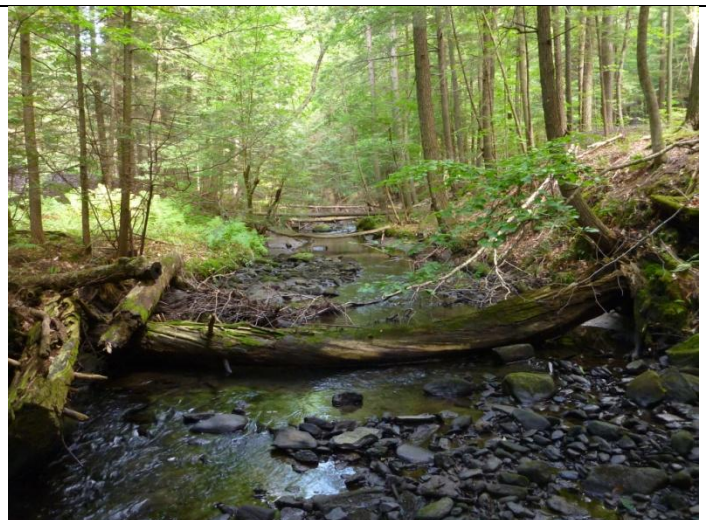
**Reach Highlights:** Minor incision and some bank/valley erosion noted throughout reach. Incision may be historic, but some current day encroachments in lower and upper segment may be contributing to ongoing instability. Given grade controls and natural vegetation in corridor and LWD in channel, segment does not appear susceptible to significant instability in the near future. Entrenchment varied throughout segment with some areas of Bc geometry.

Moderate incision in the upper segment

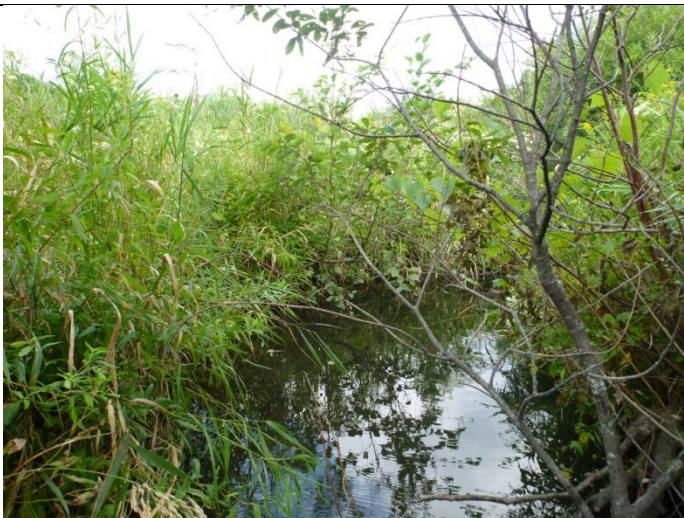
**Reach Highlights:** No evidence of channel instability; however beaver ponding made channel observations challenging in segment. Historic straightening likely given hay fields in corridor and obvious straightening in upstream segment.

Beaver ponding in upper segment

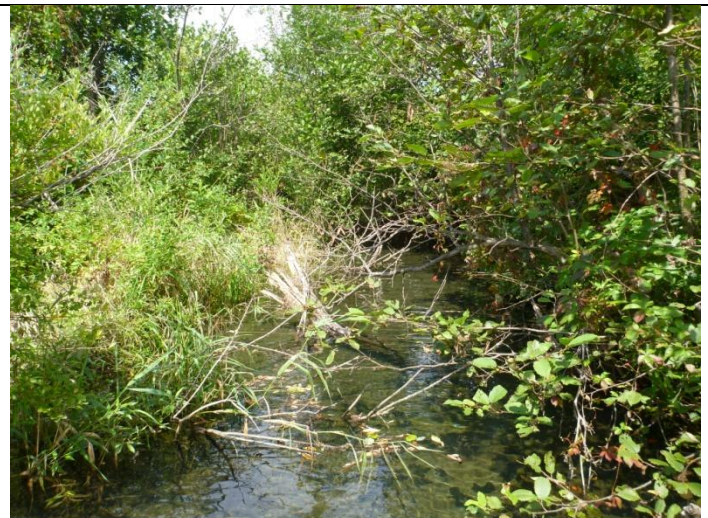
Dense alders along banks

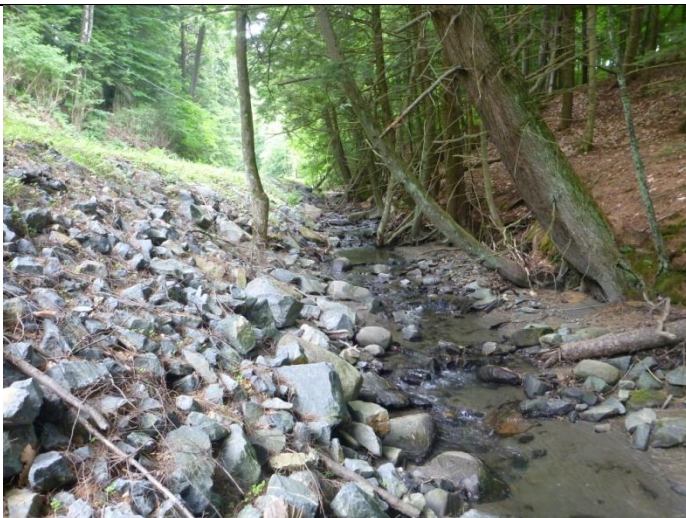
**Reach Highlights:** Channel is affected by encroachment and buffer impacts from Sheddsville Road for most of the segment. Significant channel erosion and roadway damage occurred during T.S. Irene in 2011. Mass failures along bank opposite road will likely worsen over time given the extensive hard bank armoring.

Highly encroached along Sheddsville Rd

- Project WW 16:** Bank Stabilization - Road embankment along Sheddsville Road has undersized armor and is vulnerable to erosion.

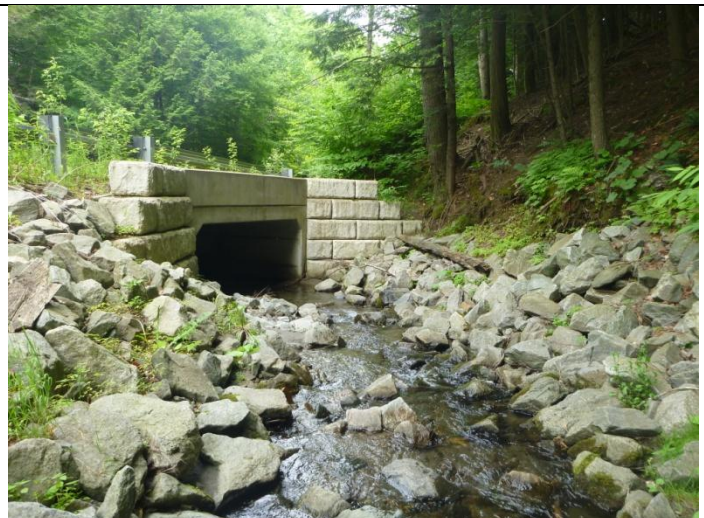
New box culvert under Sheddsville Rd

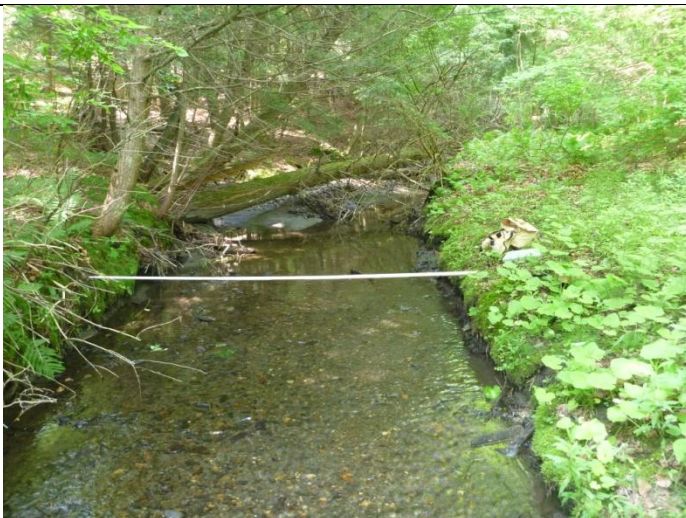
**Reach Highlights:** Channel morphology has not departed significantly from reference, but sinuosity is low due to historical straightening. Channel likely aggraded coarse material during T.S. Irene in 2011. Aggradation and widening may occur in near future. Unless channel is armored or managed in future, natural planform may begin to redevelop upstream of the Sheddsville Road crossing. A severely undersized culvert is located on a private driveway mid-segment.

Moderately incised C-type geometry at the cross-section

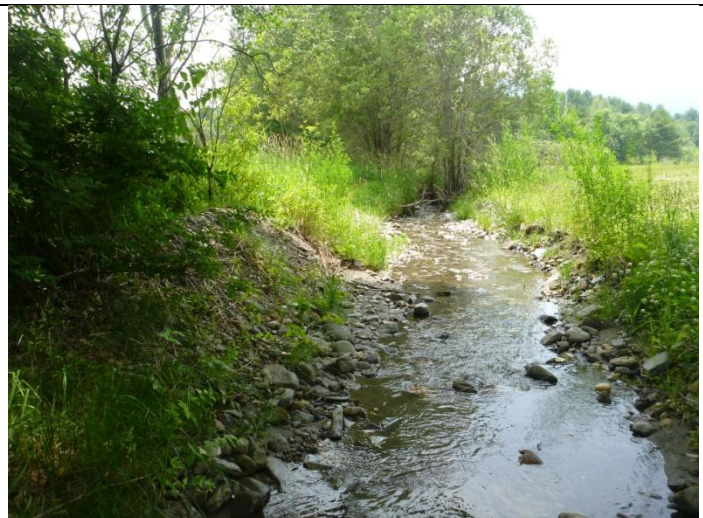
Bank and buffer impacts through most of reach

- **Project WW 17:** Buffer Planting - A large horse pasture follows most of the segment and has reduced buffer vegetation.
- **Project WW 18:** Culvert Replacement - A culvert under a private road is a major constriction and caused significant increased flooding during T.S. Irene.

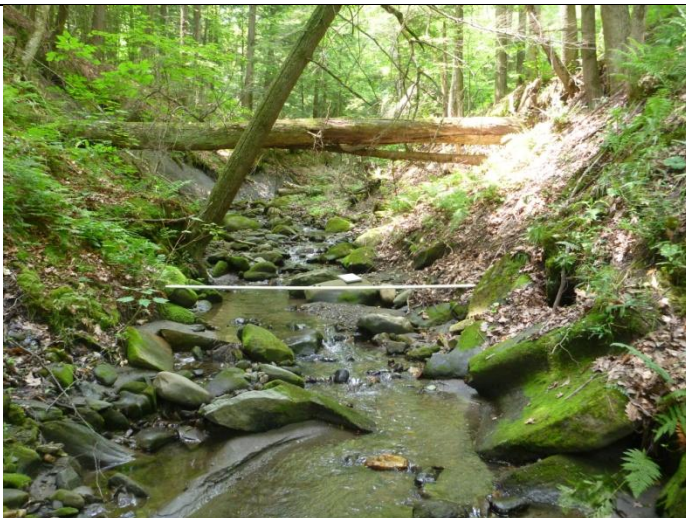
**Reach Highlights:** Channel is encroached by Sheddsville Road for over half the segment length. Some areas of road armor (i.e., rip rap) have constricted the channel by ~30%. Although no incision is reported (no natural floodplain for A-type channel), stage II CEM was selected to characterize the roadway impacts. Channel may incise in the future as there are no grade controls.

Typical cross-section with increased gravel

- **Project WW 19:** Bank Stabilization: Road embankment armoring is undersized and road is at risk of erosion damage.

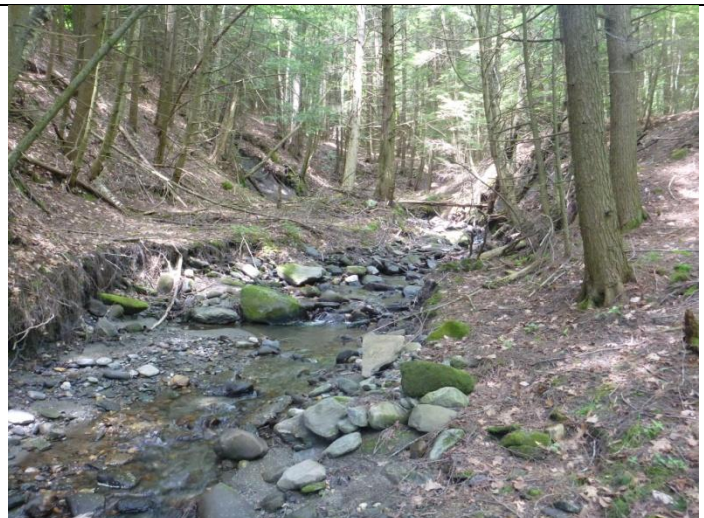
Typical geometry through segment

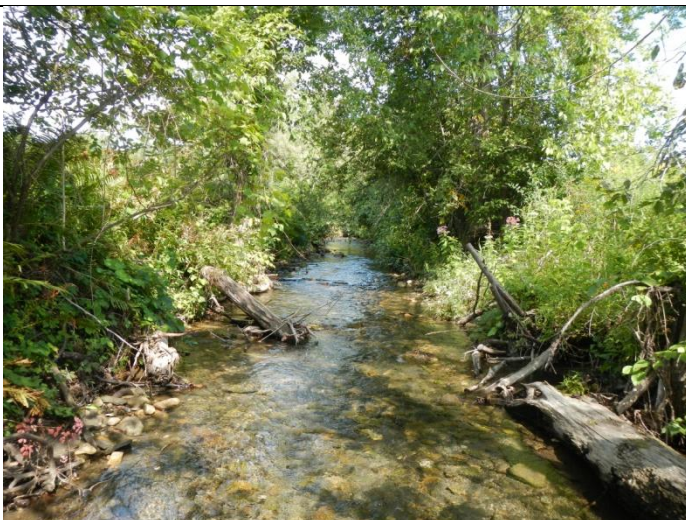
**Reach Highlights:** This segment is straightened through most of the horse pasture and as a result is narrow and deeply incised. The reach is either a very incised and narrow C-type or a highly straightened E-type by reference. Based on channel slope and the lack of obvious historic channel indicators in the meadow, we selected a C to F departure. The entrenchment ratio is slightly above the range for F-type; however this segment is approximately 30% under curve width. This segment is stuck in stage II with minimal access to the large floodplain except during larger events.

Straightening and incision through horse pasture

- **Project WW 20:** Replace Bridge: The Route 44 bridge is a moderate channel constriction based on the observed channel width. The bridge is in poor condition and should be considered for a large structure when up for replacement.
- **Project WW 21:** Bank Stabilization - Small area of bank erosion with undersized rip-rap may threaten the Route 44 embankment.
- **Project WW 22a:** Buffer Planting & Corridor Protection - Large hayfield along most of the segment is lacking sufficient woody vegetation.

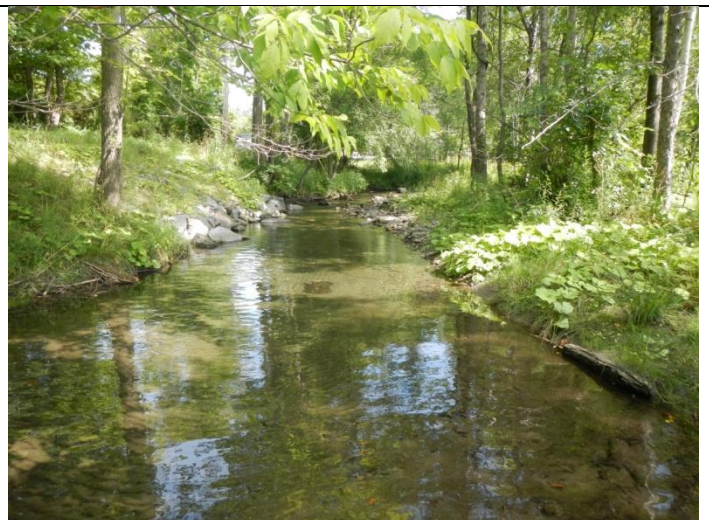
Encroachment from Rush Meadow Road

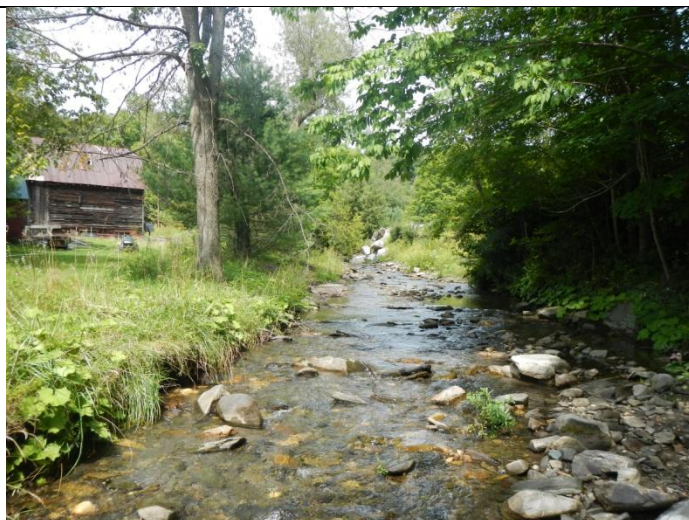
**Reach Highlights:** This segment had moderate floodplain access throughout and appeared to be fairly stable. We assessed the reach as stage IV as there was no evidence of ongoing incision or widening, and aggrading materials were causing some planform adjustments in the middle and lower portion of the segment.

Straightening and low floodplain

- **Project WW 22b:** Buffer Planting & Corridor Protection - Several sections of the segment have reduced woody buffer vegetation and should be protected from future development.

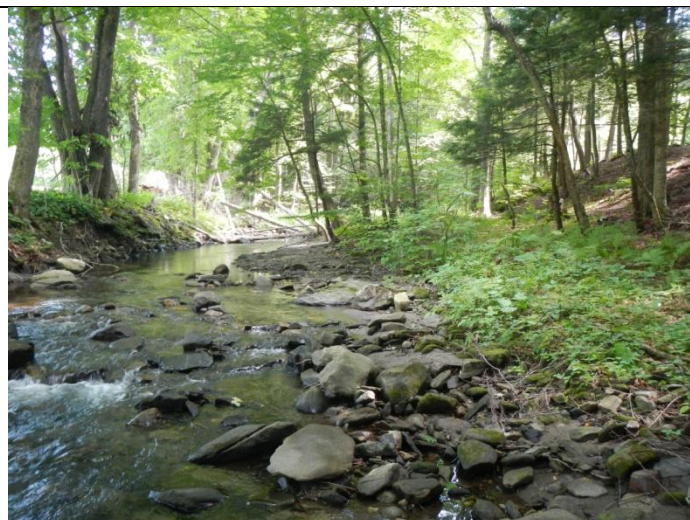
Accessible floodplain benches in lower segment

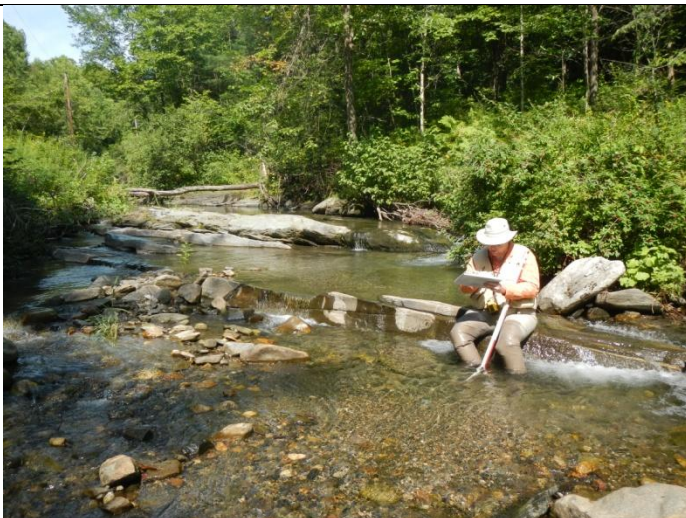
**Reach Highlights:** This reach widened during TS Irene scouring away low banks and then aggraded with larger cobbles and boulders. Currently the channel is continuing to aggrade with finer material and is beginning to adjust planform through the recent deposits. We observed evidence of continued widening and assessed the reach as stage III, likely to transition to stage IV in the future. Numerous grade controls limit incision and floodplain access was moderate throughout the reach.

Numerous grade controls limit incision through reach

- **Project WW 23:** Utility Repairs - A utility pole on the left floodplain is at risk during storm events.
- **Project WW 24:** Replace Culvert - An undersized driveway culvert is a major constriction and an AOP barrier.
- **Project WW 22c:** Corridor Protection: Small forested floodplain area on the left bank.

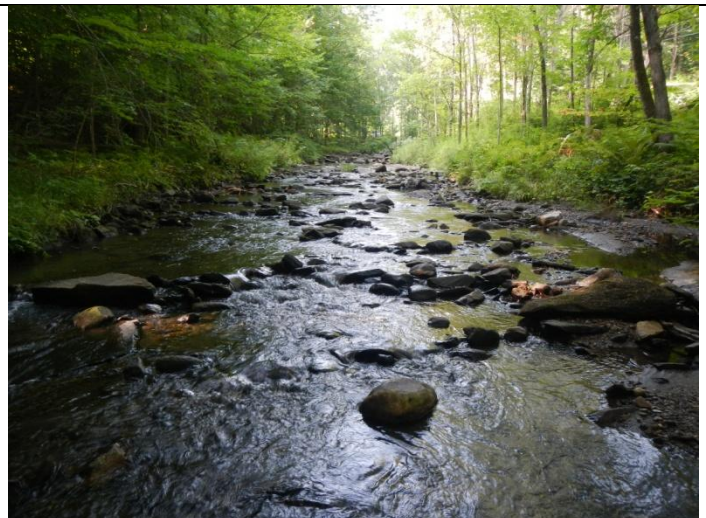
Typical widened channel
