# River Corridor Plan for Mill Brook in Windsor, West Windsor, and Reading, Vermont

May 29, 2015

**Fitzgerald Environmental Associates, LLC.**

**Southern Windsor County Regional Planning  
Commission**

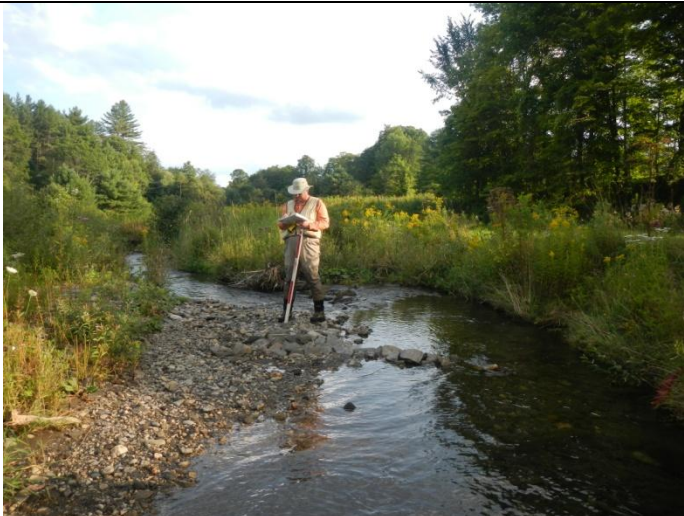
**Reach Highlights:** The first 1000ft of segment A were very similar to T2.02 (widening and aggrading B-type) and should be considered a part of that reach. The portion of segment A represented by our cross-section begins immediately downstream of the Rush Meadow bridge and continues upstream to the segment break. This E-type segment had an active beaver dam impounding the upper half. Moderate/high incision was observed below the beaver dam. Slumping banks and point bar development indicate that planform is slowly adjusting. We assessed the reach as stage II but transitioning towards aggradation and planform adjustment. The stream bottom was primarily cobble and was stable.

Typical incised E-type

- **Project WW 22d:** Buffer Planting - The hayfield along right floodplain has limited woody vegetation.

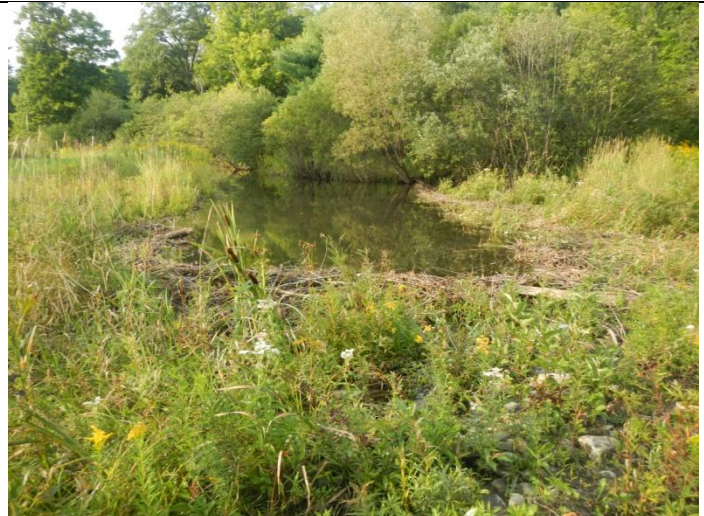
Beaver dam in upper segment

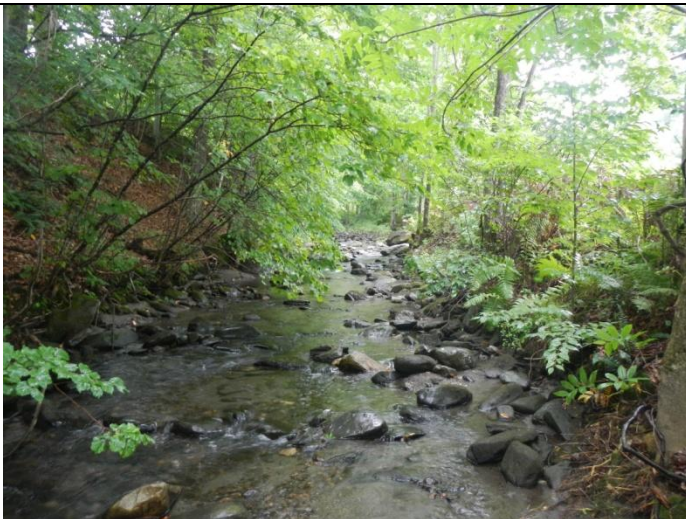
**Reach Highlights:** Width and slope were variable through this segment, incision and entrenchment were consistently high. The lower segment was impacted by armoring on one or both banks, the upper segment typically had ledge along the left bank and tall bank armoring to Rush Meadow Road on the right bank. A large flood chute mid-segment in an area with less entrenchment could lead to a channel avulsion. Overall this reach is stuck in stage II and due to natural or man-made hard banks it will likely remain there.

Typical incised F-type channel along Rush Meadow Ln

- **Project WW 25:** Replace Bridge: An undersized driveway bridge is a major constriction and in poor condition.
- **Projects WW 22e + f:** Buffer Planting & Corridor Protection: Several small floodplain areas have reduced woody vegetation and should be protected from future development.
- **Project WW 26:** Replace Culvert: The Rush Meadow Rd culvert at the top of the reach is a major constriction and a minor AOP barrier.

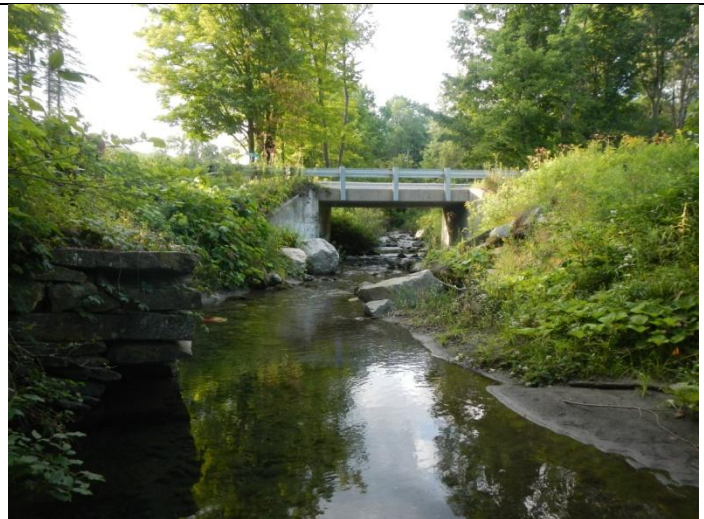
Several bridges and other constrictions increased incision

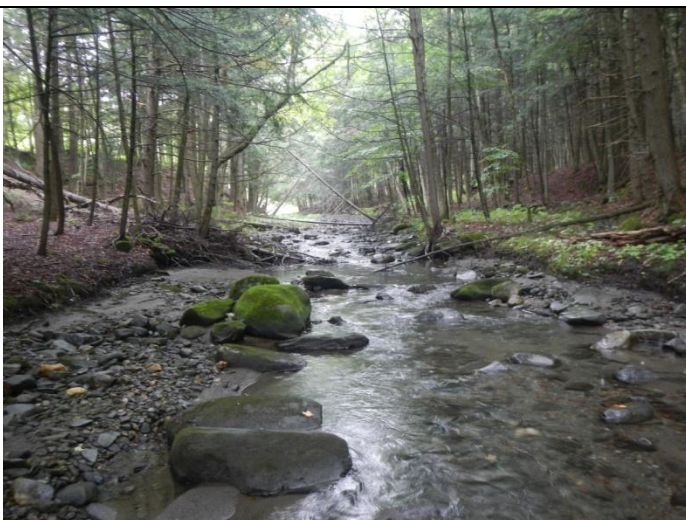
**Reach Highlights:** This reach was heavily scoured and widened during TS Irene. A low and accessible forested floodplain was present along one bank for most of the reach and was heavily accessed during TSI and other recent high flows. Numerous areas of floodplain access and deposition and a recent channel avulsion were also observed. The channel is currently aggrading and adjusting planform.

Typical geometry with accessible flood benches

- **Project WW 22g:** Reduced bank and buffer vegetation along both floodplains
- **Project WW 27:** Conservation - Most of the reach is a highly active depositional/planform area with accessible forested floodplain.
- **Project WW 28:** Bank Stabilization - A 20' tall mass failure is close to threatening Rush Meadow Rd and should be assessed for potential stabilization efforts
- **Project WW 29:** Bank Stabilization - A 25' tall mass failure is threatening a house

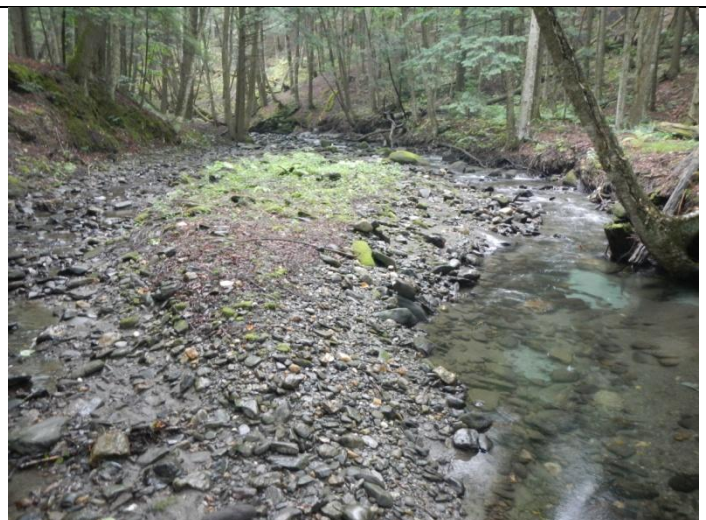
Widening and planform adjustment

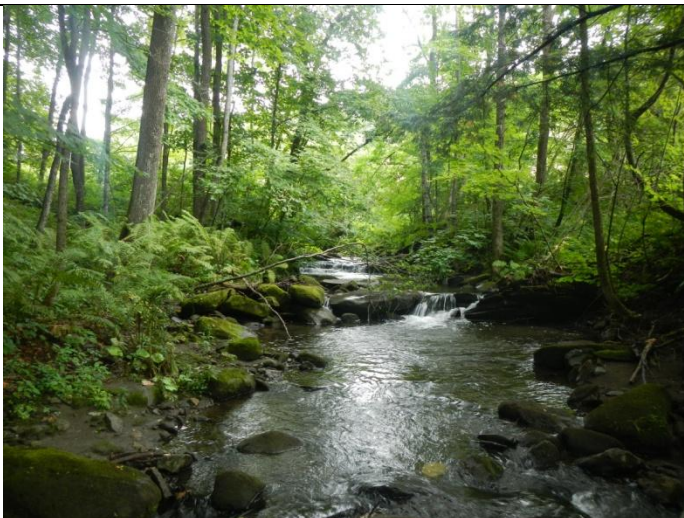
**Reach Highlights:** This short segment had numerous bedrock grade controls and the majority of the bed was underlain with ledge. The segment widened in several locations during TS Irene leading to some erosion and a large mass failure at the bottom of the segment. The channel has since filled back in with developing side bars and appears to be slowly adjusting planform in areas with less bedrock. We assessed this reach as stage IIb due to some widening and planform adjustments and limited incision due to numerous grade controls.

Near continuous grade control for most of segment

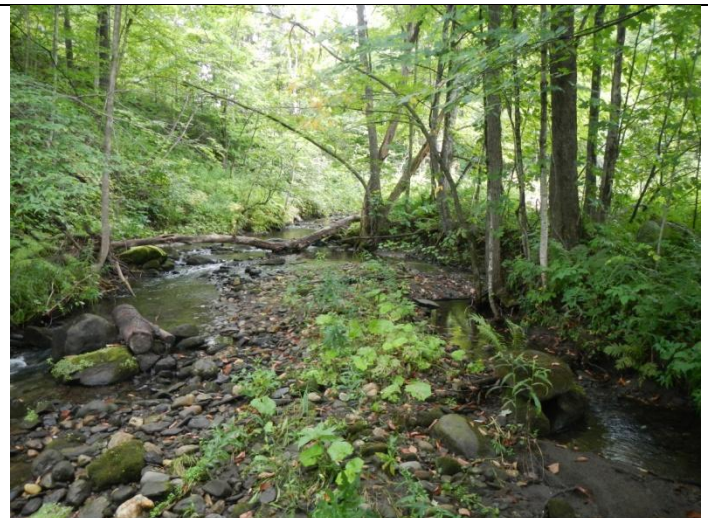
Aggradation and some widening

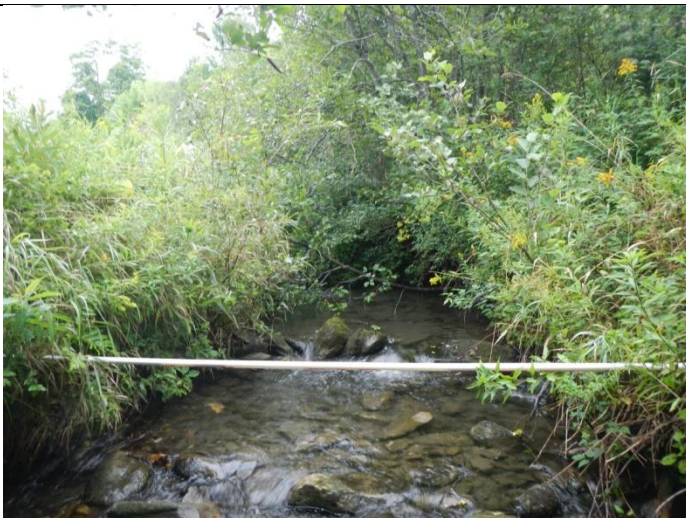
**Reach Highlights:** This short segment is E-type by reference and had moderate incision. We did not observe any evidence of widening or planform adjustment; therefore we assessed this segment as Stage II. The short stretch upstream of the Rush Meadow bridge is highly encroached by the road and is departed to F-type.

Moderately incised E-type at cross-section

- **Project WW 22h:** Buffer Planting & Corridor Protection - A hayfield along the right floodplain is lacking woody vegetation.

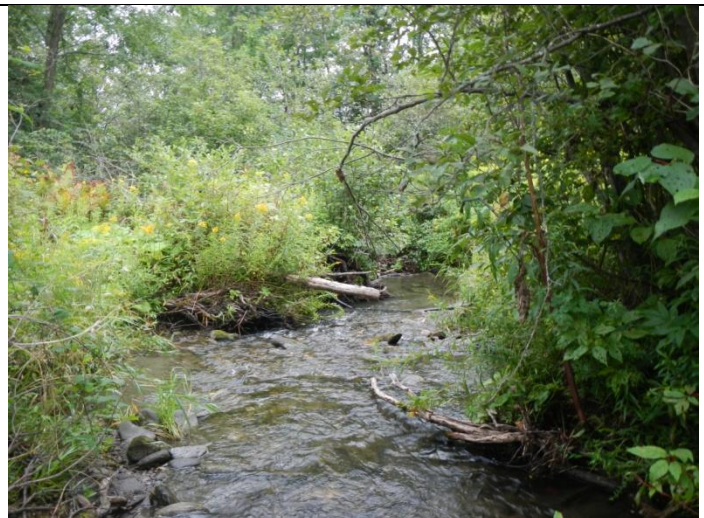
Moderately incised E-type

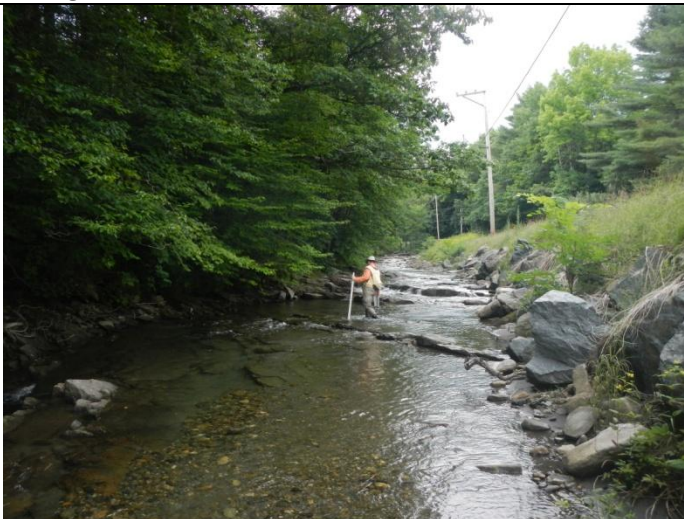
**Reach Highlights:** Most of this reach is highly encroached by Rt 106. This encroachment and heavy bank armoring has locked the channel in place leading to historic incision. We observed moderate scour along the right banks from TS Irene through most of the reach, but widening was limited by stony soils and dense roots along the bank. Side bars have formed along most of these scoured banks, indicating that aggradation is an ongoing process. Minimal floodplain access led to a stream type departure from Bc to F. We assessed the reach as stage II transitioning slowly to stage III.

Incision and encroachment along Rt 106

- **Project RE 1b:** Buffer Planting - A recently armored and straightened section below the private covered bridge has no woody vegetation shading the channel.
- **Project RE 2:** Gully Stabilization - A small but active gully is eroding a footpath to a former swimming area.

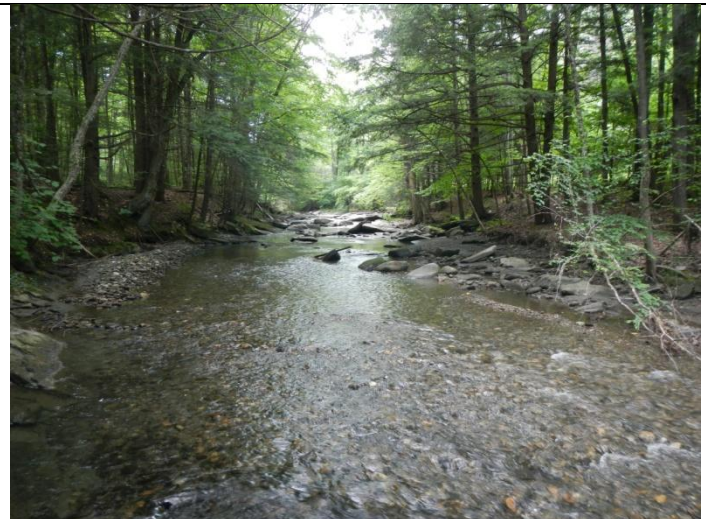
Evidence of bank scour and recent incision

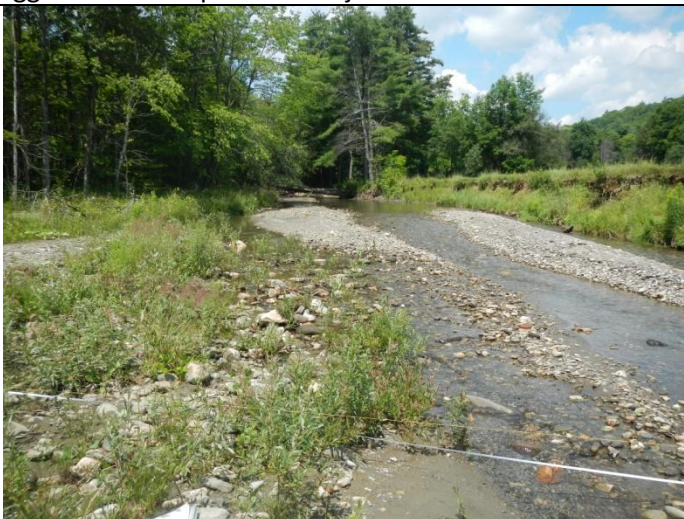
**Reach Highlights:** This segment was highly active during TS Irene with major access to both floodplains, planform adjustments, and huge volumes of gravel/sand deposition. A large volume of floodwater spilled on the left floodplain upstream of the undersized Agony Hill Rd arch damaging adjacent properties and structures. The channel widened considerably and is currently aggrading and adjusting planform to accommodate the large volume of gravel and sand working through the reach. We assessed this segment as somewhere between stage III and IV due to ongoing aggradation and planform adjustments.

Widening and major deposition at the cross-section

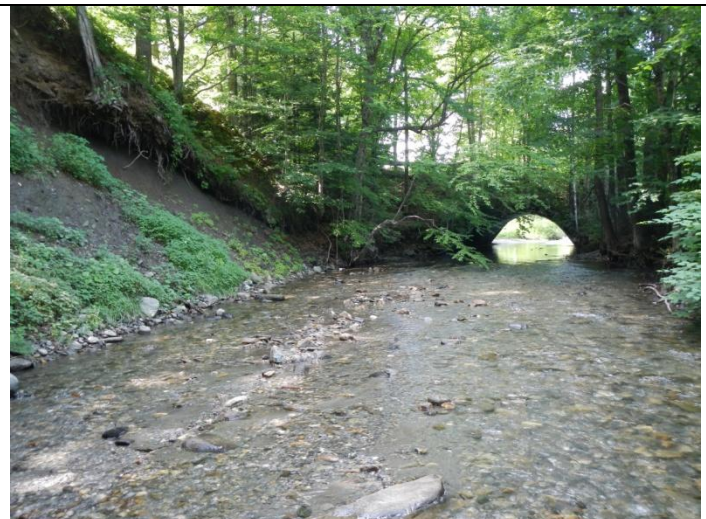
Undersized arch and downstream mass failure

- **Project RE 3:** Arch Replacement - Agony Hill Road arch is undersized and causing major sediment accumulation upstream and exacerbated flooding and road damage during T.S. Irene.
- **Project RE 4:** Conservation - Valuable forested floodplain on the right bank
- **Project RE 1 c+d:** Corridor Protection and Buffer Planting - Two large areas along the left bank have minimal woody vegetation and should be protected from future development.

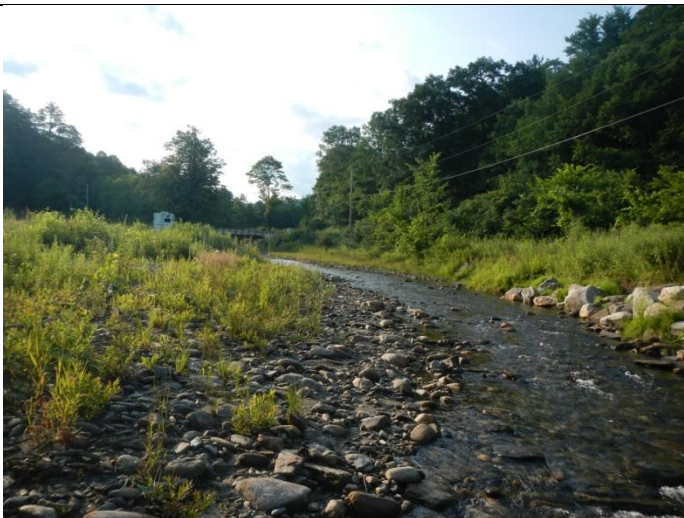
**Reach Highlights:** This segment has departed from C to F due to incision. The entrenchment ratio is close to B, however the bankfull width is well under curve width and the W/D is very low, further indicating a high degree of incision. Historic armoring and straightening have locked the channel in place and reduced floodplain access compared with segment A.

Straightening and encroachment along Bailey's Mills Rd

- **Project RE 5:** Farmer Outreach - A dairy barn on the floodplain is potentially contributing nutrients to the channel.
- **Project RE 1e:** Buffer Planting - Channel was straightened and armored following T.S. Irene and is lacking woody bank vegetation.
- **Project RE 6:** Remove House - An abandoned house on the right valley wall is falling in to the stream and should be removed.

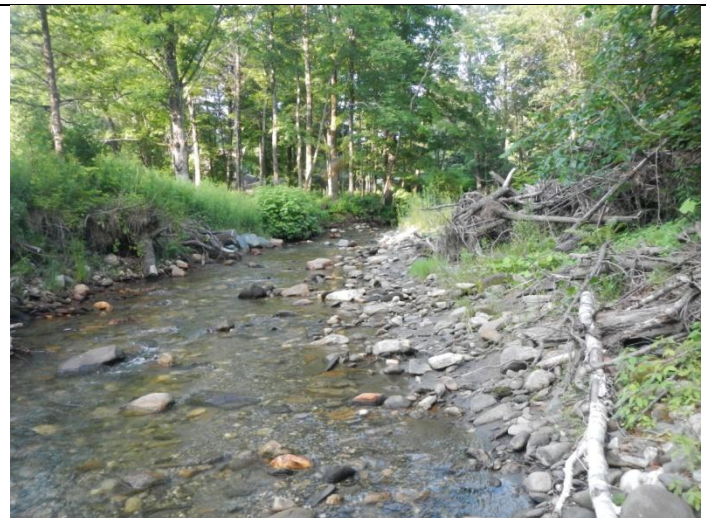
Incision mid segment

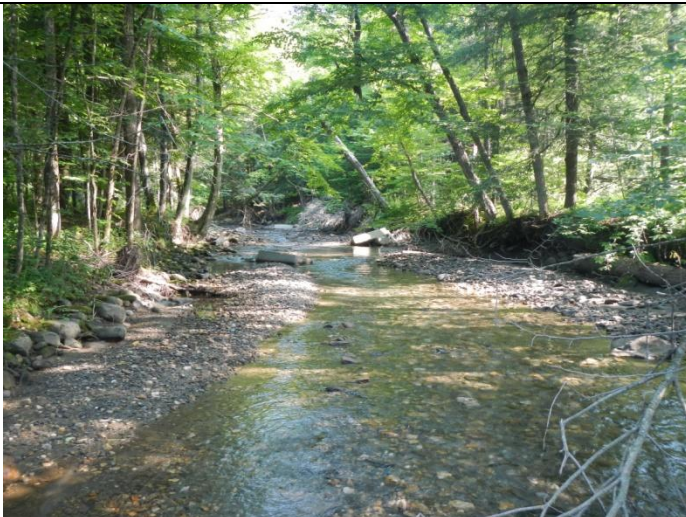
**Reach Highlights:** This segment had moderate to high incision throughout and had access to floodplain of variable width for most of the reach for the largest events (i.e., T.S. Irene). Some areas had access to a 60-80ft wide forested floodplain, other areas were a 5-10 ft herbaceous bench. Our cross-selection represents an average floodplain width and height and results in a departure from C to B. The reach scoured and widened during TS Irene and currently appears to be aggrading and widening. Huge volumes of sediment are stored in the channel through T4, and will likely continue to work through this segment for a long time. We assessed the reach as stage III possibly transitioning to stage IV in the near future.

Widening and moderate incision

- **Project RE 1f:** Corridor Protection - Several areas of highly active channel and floodplain should be protected from future development.
- **Project RE 7:** Abutment Removal - Concrete blocks from a snowmobile bridge were damaged during T.S. Irene and are a moderate constriction leading to sediment deposition and bed scour.

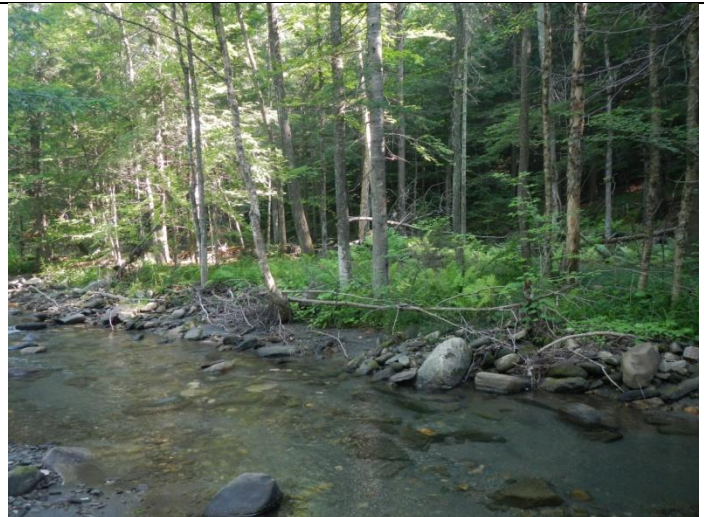
Aggradation and accessible narrow floodplain

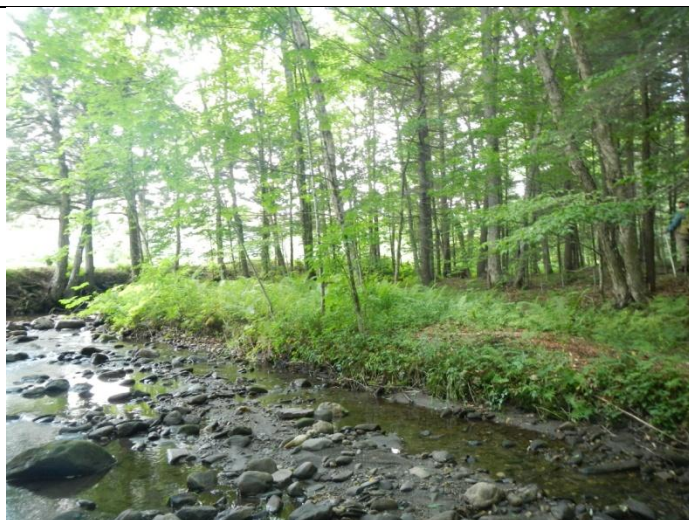
**Reach Highlights:** This short segment flows through a nice forested floodplain with low/moderate incision. The large right floodplain is elevated and only accessible during the largest events - difficult to tell whether this is an old abandoned floodplain or a glacial-era feature. The channel has carved out several meanders with nice riffle pool sequences. We assessed this as stage V based on the assumption that the channel was likely manipulated historically given the agricultural setting in the valley.

Accessible forested floodplain

- **Project RE 1g:** Corridor Protection - An accessible forested floodplain is located along the left bank throughout the segment.

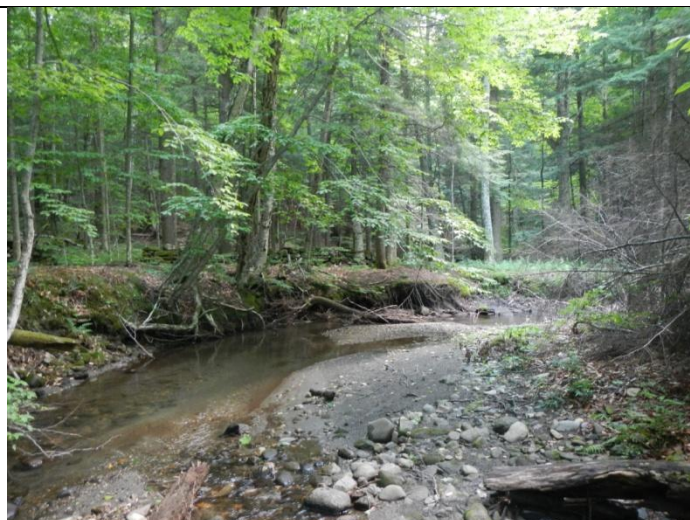
Stable banks and sinuous channel

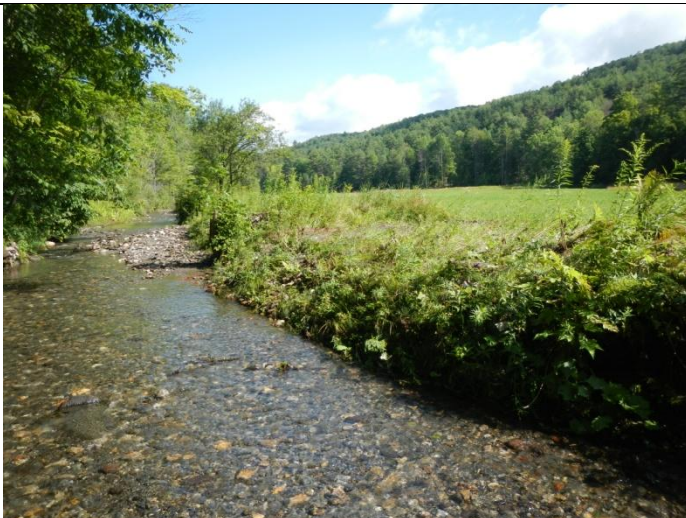
**Reach Highlights:** This segment is historically incised due to channel straightening and armoring. The channel is currently aggrading material as seen through numerous bars, and has regained access to the previously disconnected floodplain in several locations, however access to the large floodplain remains limited. Because of the moderate incision and reduced access to the large floodplain we assessed this reach as having recently transitioned to stage III.

Straightening and elevated floodplain hayfield

- **Projects RE 1h+i:** Buffer Planting & Corridor Protection - Several areas along the left floodplain area lacking woody vegetation, increasing bank erosion.
- **Project RE 8:** Culvert Replacement - A pair of very undersized culverts under a farm access road are highly susceptible to flood damage and are interrupting sediment transport through the segment.
- **Project RE 9:** Bank Stabilization and Swale - A swale receiving hayfield runoff is causing bank erosion, stabilize and plant.

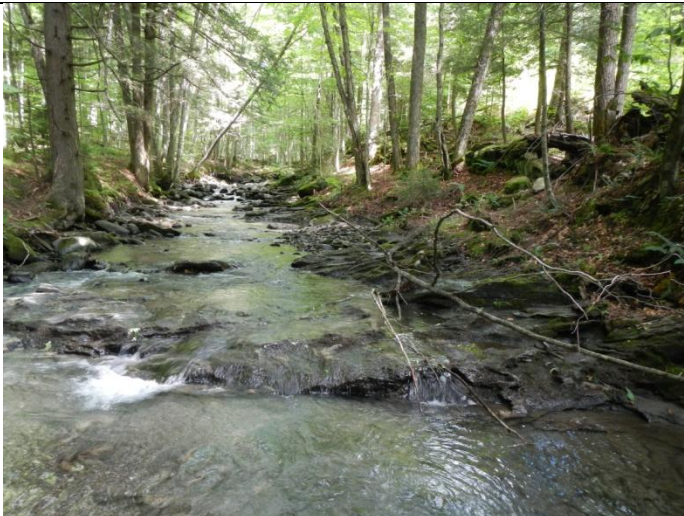
**Reach Highlights:** This segment widened during TS Irene and is currently aggrading as flood sediments work through the channel. Moderate to high bank scour was observed along all banks that were not ledge. Numerous grade controls restrict incision and several created large areas of widening with mass failure and debris jams upstream. A small to moderate floodplain bench was accessible during moderate to large events for most of the reach. A larger glacial terrace was present for most of the reach, however it is well above even the largest flood elevations.

Accessible floodplain benches and grade control

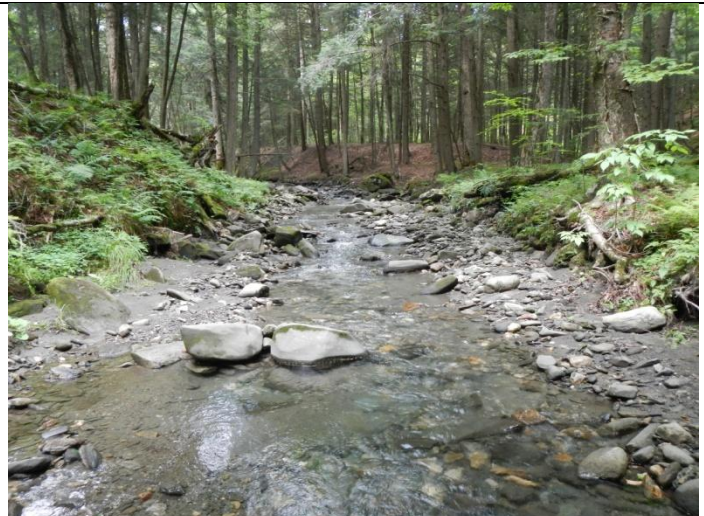
Evidence of recent widening

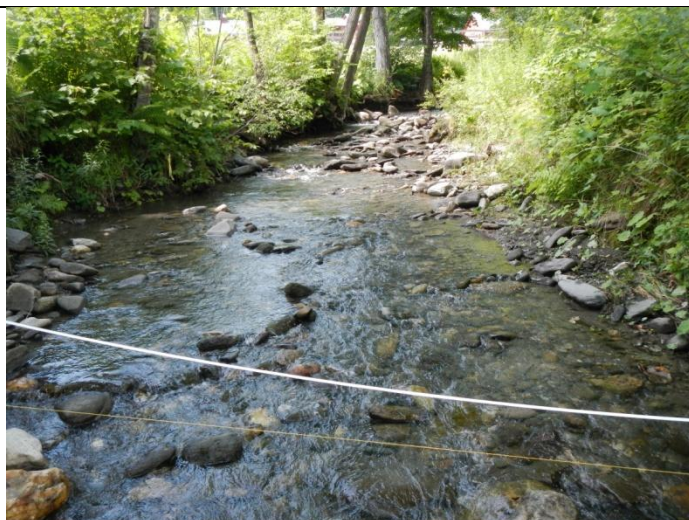
**Reach Highlights:** The channel bed of this segment was scoured during TS Irene, removing lower benches. Subsequent coarse deposition has lined much of the lower banks and has filled in the widened channel. The stream is currently cutting down and further incising. The upper portion of the segment is generating large volumes of sediment where coarse deposition is pushing the channel into the opposite bank causing erosion and mass failure.

Incision through historic straightening

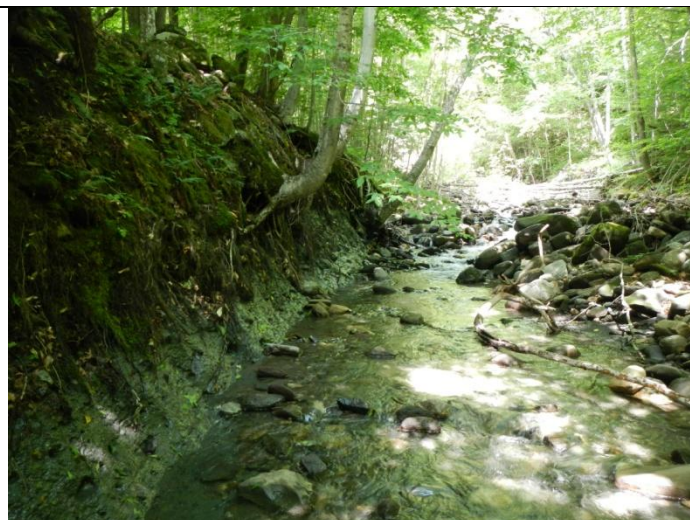
Active incision in the upper segment

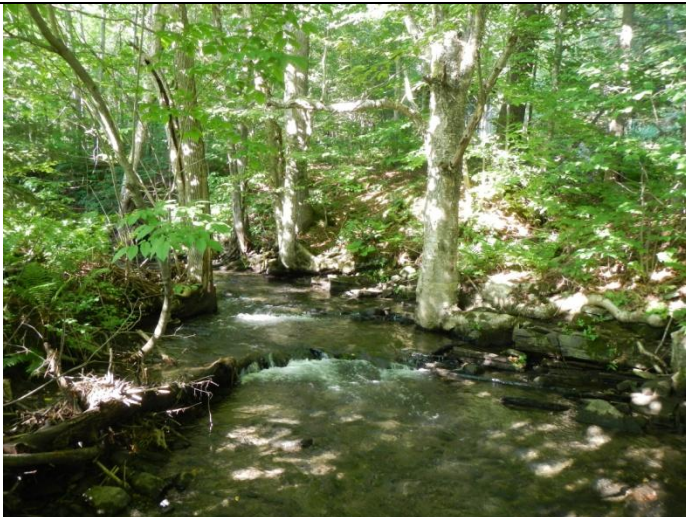
**Reach Highlights:** This segment had a unique bedform and channel characteristics. It is E-type currently and likely also by reference. We observed numerous grade controls that represented most of the vertical drop within the reach. Riffles below the grade controls were very clean cobble substrate, the remainder of the reach consisted of deep runs and pools. Encroachment from Rt 106 decreased the floodplain throughout, especially in the upper reach where the road was immediately adjacent to the channel. Most of the reach was likely historically straightened, however the grade controls limited incision decreasing the impact. We assessed the reach as stage IIc with some observed aggradation and planform changes.

E-type with numerous bedrock grade controls

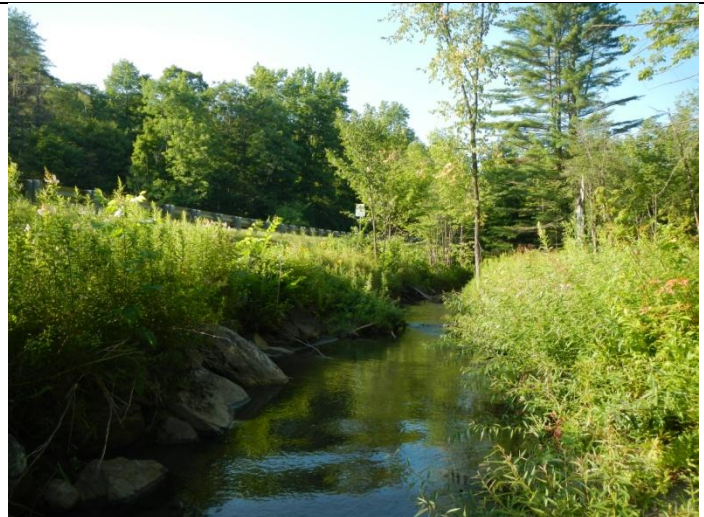
Moderately incised E-type encroached by Rt 106

- **Project RE 12:** Bank Stabilization - Undersized armor along Route 106 is an erosion risk.

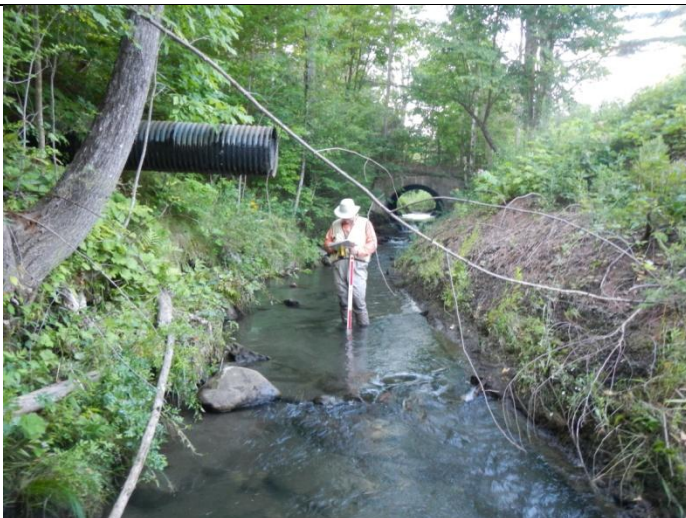
**Reach Highlights:** The entire reach was moved to a new location in a blasted bedrock channel. Bedrock is present along both banks and under the channel throughout. A poured concrete slope occupies most of the left bank in the lower segment. An area of mass failure at the bottom of the reach is threatening to breach the storage pond embankment, potentially causing major flooding. Recent survey markers indicate that this is known and being addressed. We did not fully assess the reach due to the gorge-like conditions and property access concerns.

Straightened channel with ledge along right bank and poured concrete along left bank

- Project RE 13:** Bank Stabilization – Moderate bank erosion is found along the embankment for the talc mine pond. The landowner is aware of the erosion. A geotechnical engineer is developing recommendations to address the erosion.

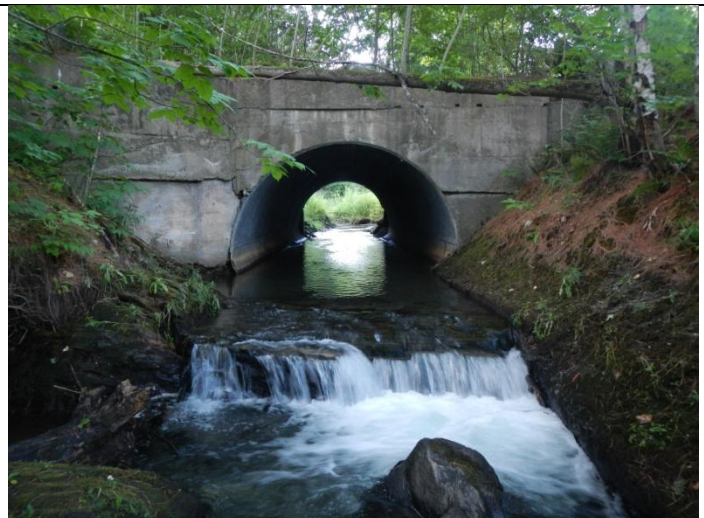
Ledge and mine access culvert

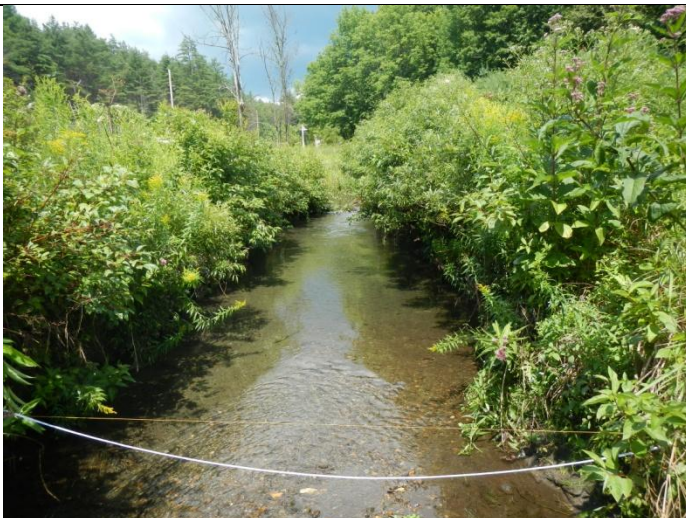
**Reach Highlights:** This E-type reach has some areas of historic straightening that remain straightened. The remainder of the reach is adjusting planform and we observed several potential neck cutoffs and a few active cutoffs and flood chutes. Many beaver dams were recently mechanically removed from the segment, leading to some areas of temporary erosion as the bed adjusts slope.

Straightened along Rt 106

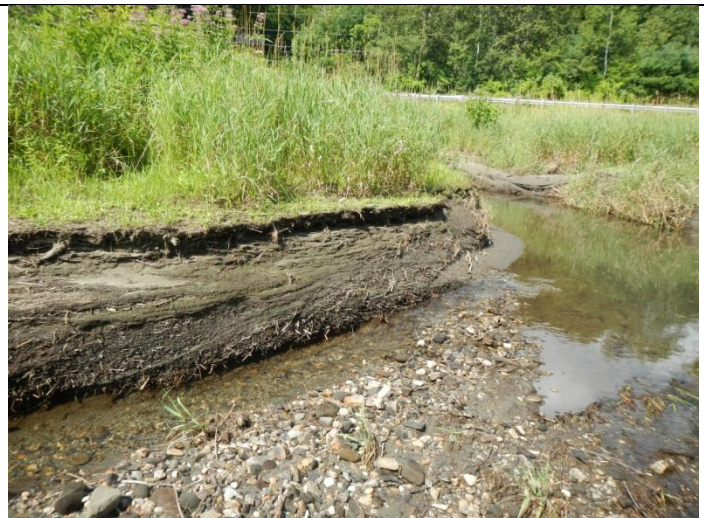
Evidence of numerous recently removed beaver dams

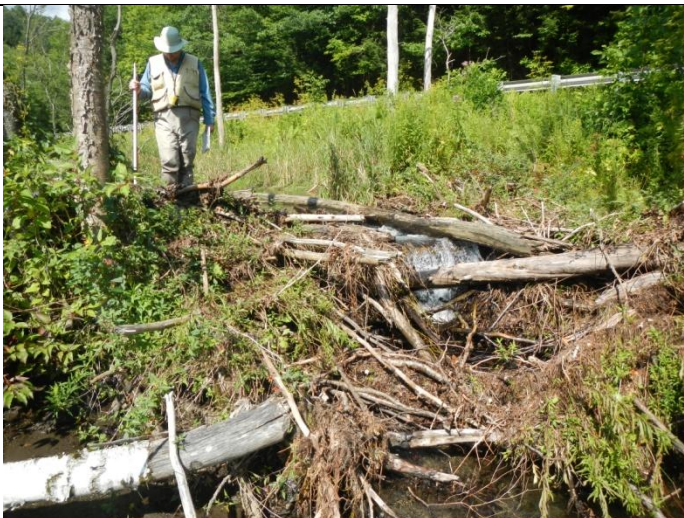
**Reach Highlights:** The lower portion of the reach has one recently removed beaver dam and alternates between reference C and reference E. Above the Whitmore Circle culvert the reach flows through an active beaver meadow. Much of this portion is highly impacted by beaver dams with multiple channels and deep deposition. The cross-section was collected near the top of the reach where the channel returns to a single thread and is E-type.

Large beaver dam in upper reach

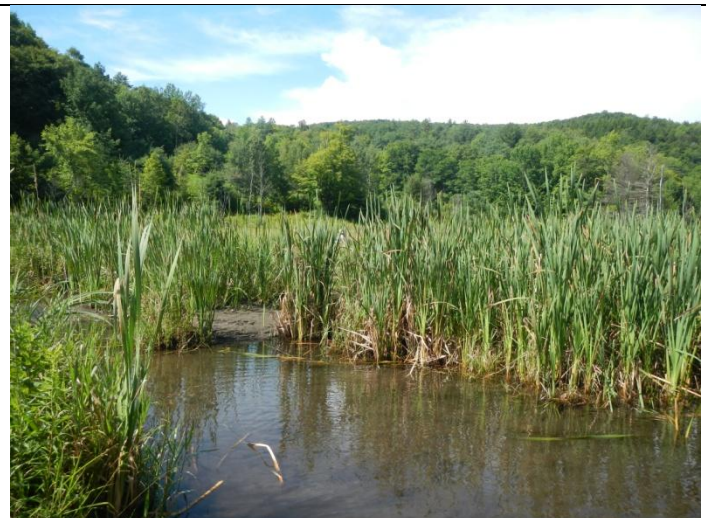
Multi-thread channel through a beaver meadow

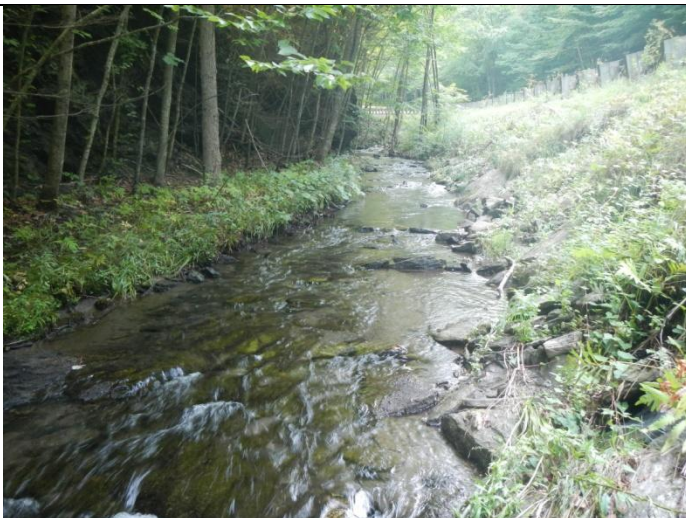
**Reach Highlights:** The lowest portion of the reach transitions from a B-type with a small low floodplain and some planform adjustments to a narrowly confined reference B or A<sub>b</sub> reach that is highly encroached by Rt 106. This encroachment likely pushed the stream against the valley walls and has removed all floodplain resulting in a departure to F. The stream bed and banks are primarily bedrock or heavy rip-rap along the embankment, leaving little to no opportunity for channel adjustment vertically or laterally.

Encroachment from Route 106 throughout reach

- **Project RE 16:** Embankment Stabilization - A small erosional rill is cutting in to the Route 106 embankment.
- **Project RE 17:** Culvert Replacement - The culvert under Route 106 is at a sharp angle and undersized, major damage to the road is possible in a large event of if the culvert plugs with debris.
- **Project RE 18:** Bank Stabilization - A mass failure may eventually threaten Route 106.

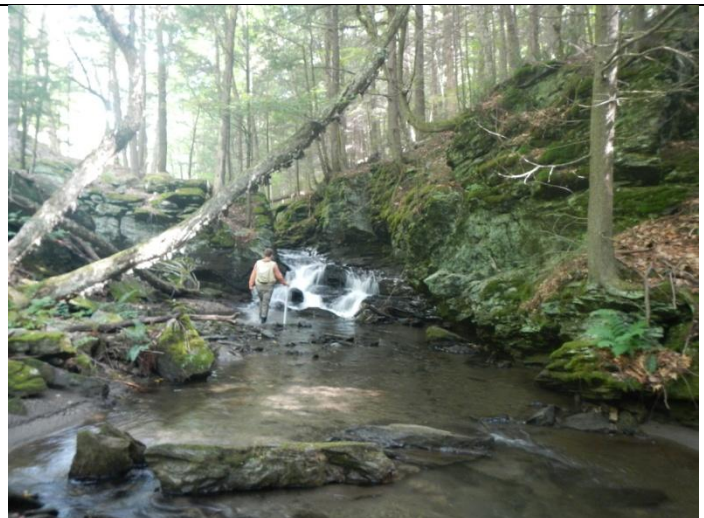
Near continuous grade control

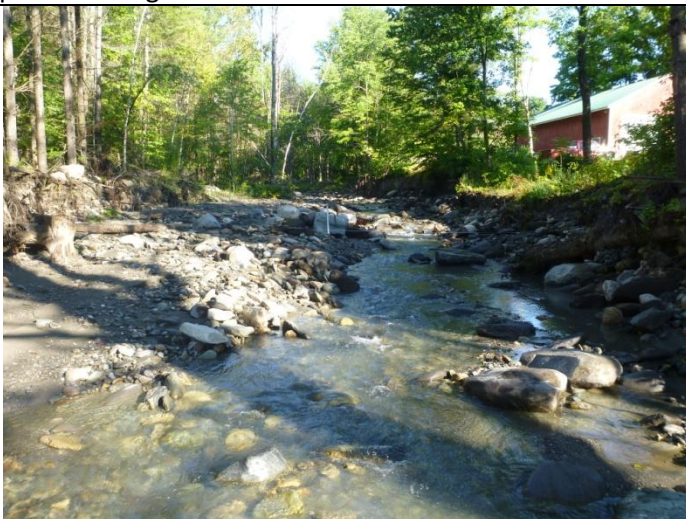
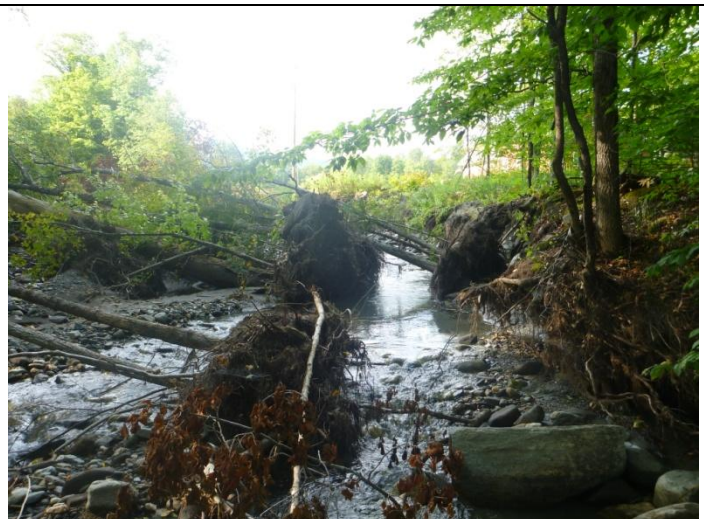
**Reach Highlights:** Severe vertical and lateral adjustments throughout reach due to alluvial fan setting, undersized crossing, and post-flood recovery work that left channel prone to ongoing erosion. In lower segment below Bailey's Mills Road, entrenchment ratios are <2.0 due to severe channel widening. Upstream of Bailey's Mills Road, some berms left from flood recovery work are confining flood flows. Stream type departure varies between C->D and C->F depending on limits of berming. D-type departure chosen due to severe aggradation and braiding throughout, and presence of grade controls.

Widening, deposition, and severe erosion

- **Project RE 19:** Bank Stabilization - Two areas of major bank erosion are threatening the Smith property driveway and potentially utilities.
- **Project RE 20:** Arch Replacement - The Baileys Mills Road arch is undersized and increased deposition and scour during T.S. Irene.
- **Project RE 21:** Channel and Floodplain Restoration - The floodplain and channel upstream of the arch were buried in sediment and debris during T.S. Irene, floodplain is now largely inaccessible.

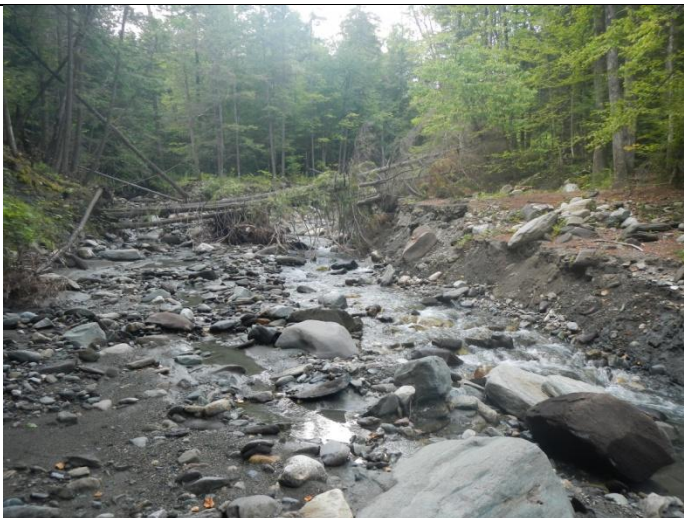
**Reach Highlights:** This segment was massively scoured during TSI and typically widened to 50-80 feet. The scoured channel was then buried in 4-8ft of gravel/cobble. The stream is currently cutting down through these deposits and was observed to be well below the pre-Irene bed elevation in several areas. Floodplain access was non-existent and only minimal storage was possible on top of flood sediments in areas where the channel was wider. This reach is actively cutting down and is deeply incised, assessed as a B to F departure and stage II.

Channel is cutting down through huge flood deposits

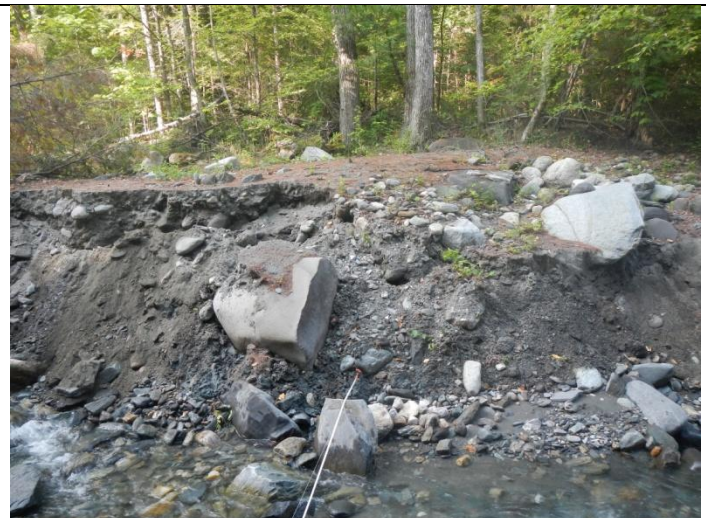
8' tall gravel deposits along channel margins

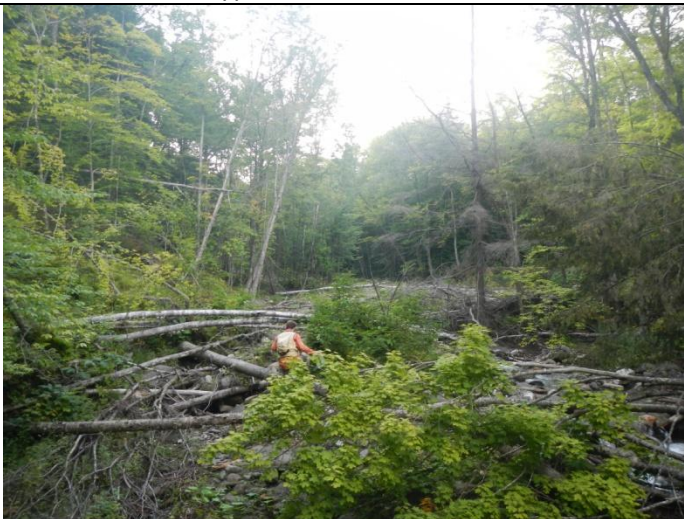
**Reach Highlights:** This reach also massively widened during TSI, scouring from valley wall to valley wall throughout. Huge volumes of cobbles and gravels were deposited and continue to work through the reach. This segment is very different from T4.01B. However, the ongoing deposition is filling the channel leading to floodplain access and planform adjustment. Some grade control was observed and huge debris jams were also helping to hold the bed in place and allow for aggradation. This widening, aggradation, and planform adjustment led to a B to D departure and an assessment at type IIc.

LWD and huge gravel deposits

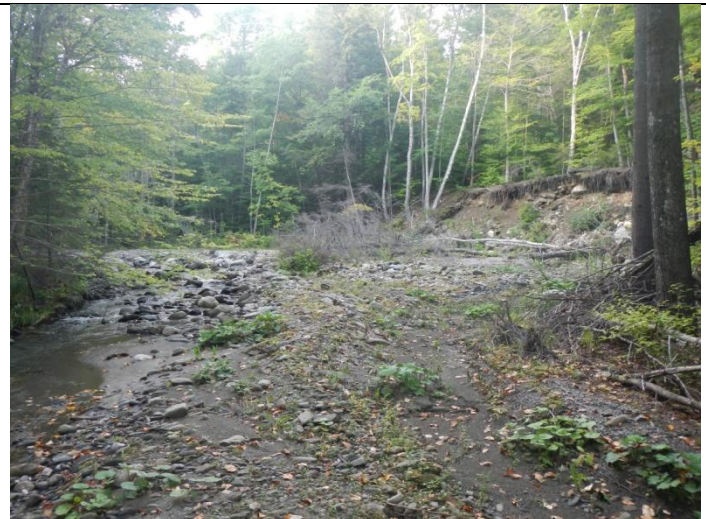
Ongoing widening and erosion/mass failure

- **Project RE 24:** Buffer Planting - A large mass failure is carving into a hayfield along Kittridge Pasture Rd. Buffer plantings may help slow this process and reduce sediment inputs to the channel.
- **Project RE 25:** Road Stabilization - A large mass failure is potentially threatening Kittridge Pasture Rd. and should be assessed and monitored.

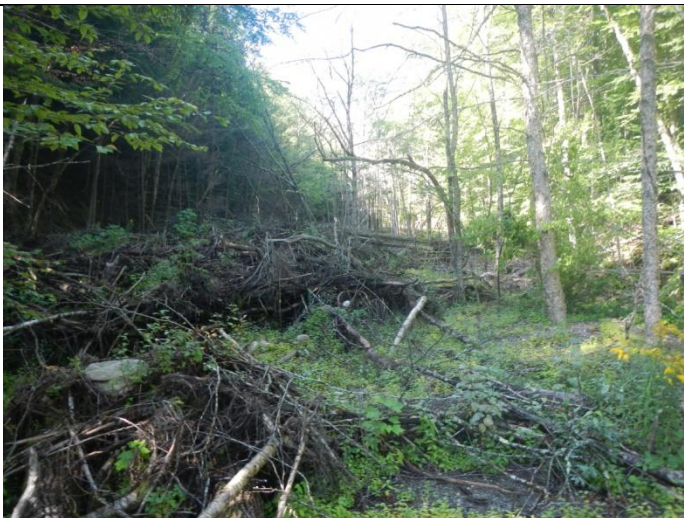
**Reach Highlights:** Similar to T4.01.C, this segment scoured the entire valley during TSI and filled in with 6-8ft of cobble and gravel deposition. The channel is now carving through these deposits and adjusting planform. We assessed the CEM stage for this segment as Ild due to the areas of braiding and increased planform adjustment. Bankfull width and W/D were also lower and we assessed the segment as a departure from B to C.

LWD and huge gravel deposits

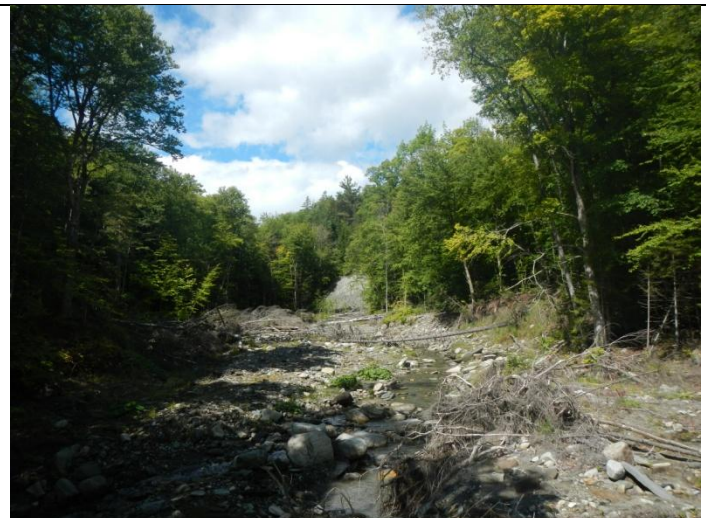
Braiding as the channel carves through flood deposits

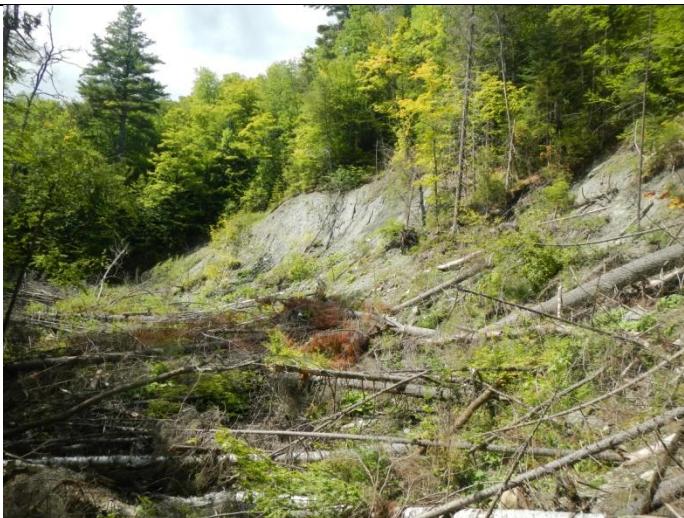
**Reach Highlights:** Similar to T4.01C and T4.02A, this segment scoured the entire valley during TSI and filled in with approximately 2ft of cobble and gravel deposition. The channel is now carving through these deposits and adjusting planform. We assessed the segment as IID due to the areas of braiding and increased planform adjustment. Bankfull dimensions were relatively close to reference width and with only moderate incision. Most of the reach is lined with eroding banks and mass failures and it will remain highly active for a long time.

LWD and large mass failures

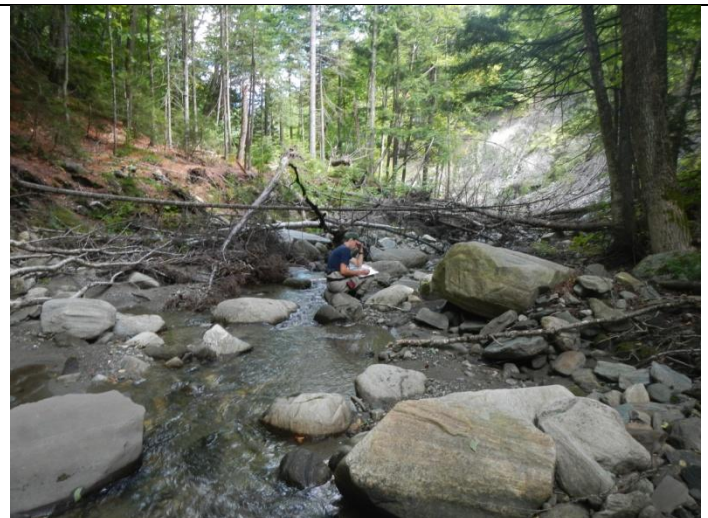
Widened channel adjusting planform

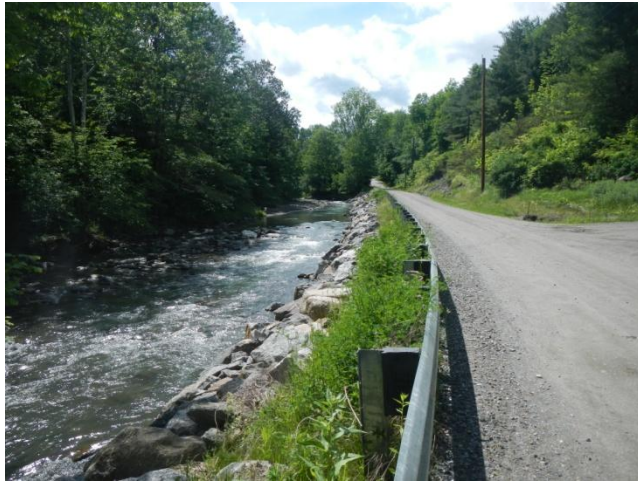
**Figure 4.10:** Extensive bank armoring along Brook Road on segment M05.C.

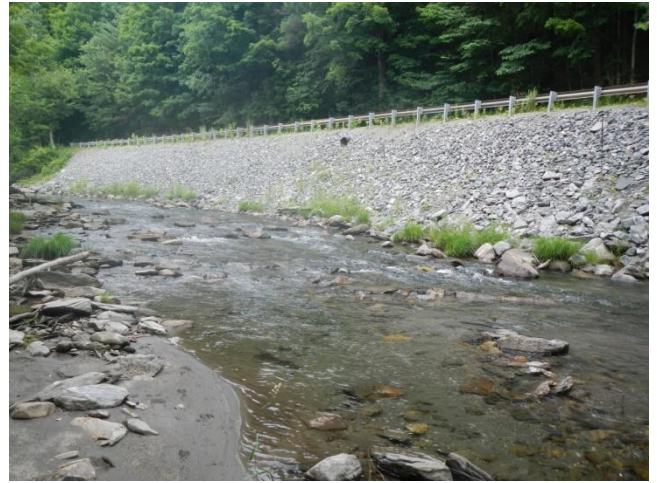
**Figure 4.11:** Harrington Road bank armoring in segment M07.B.

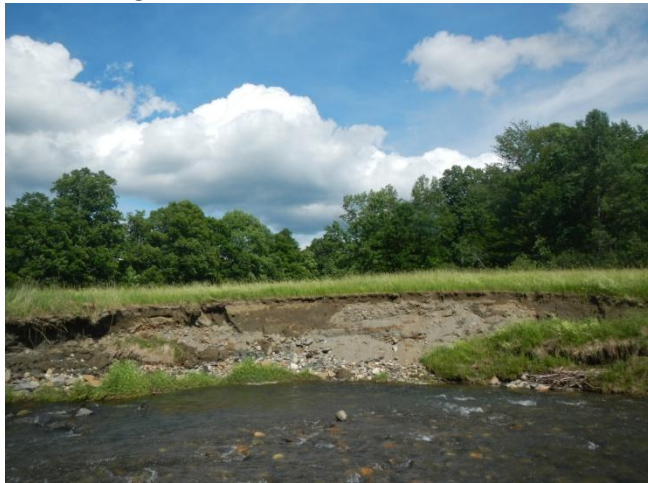
**Figure 4.12:** Major bank erosion and buffer impacts in reach M06.

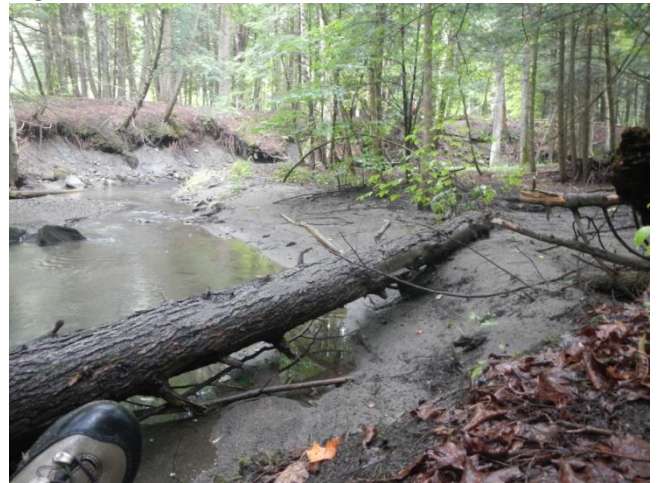
**Figure 4.13:** Extensive bank erosion in a natural corridor on reach T2.04.
