# River Corridor Plan for Mill Brook in Windsor, West Windsor, and Reading, Vermont

May 29, 2015

**Fitzgerald Environmental Associates, LLC.**

**Southern Windsor County Regional Planning  
Commission**

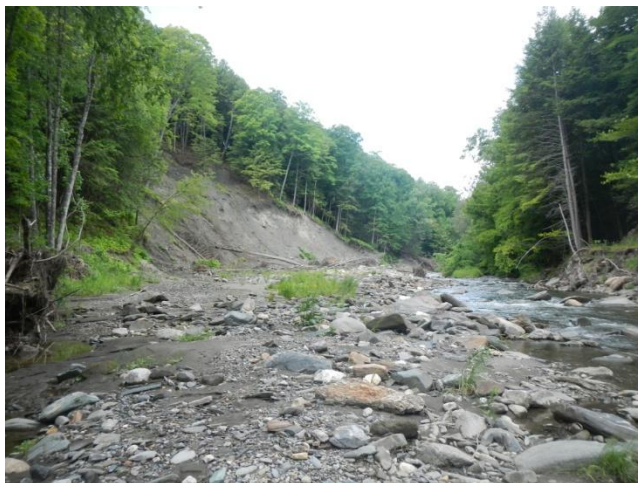
**Figure 4.14:** Huge mass failure on segment M05.B.

| Phase 2<br>Segment ID | Reference Sediment<br>Regime | Existing Sediment Regime | Cause of Departure |
|---|---|---|---|
| M05.B | Transport | Confined Source and<br>Transport | Recent widening with major bank erosion and mass<br>failure |

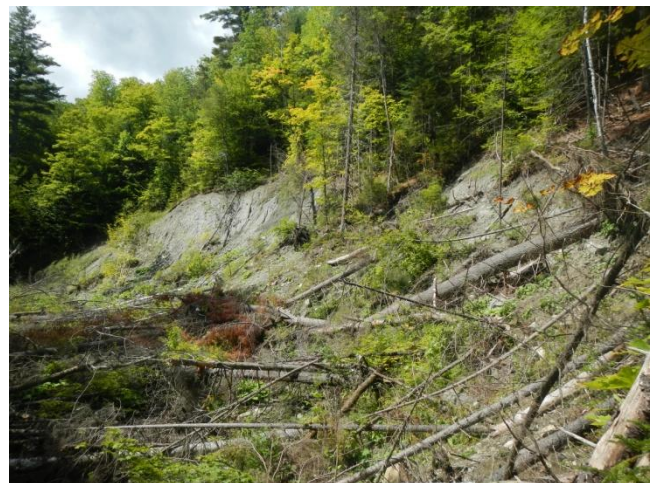
**Figure 4.15:** Near continuous mass failure along segment T4.02.B.

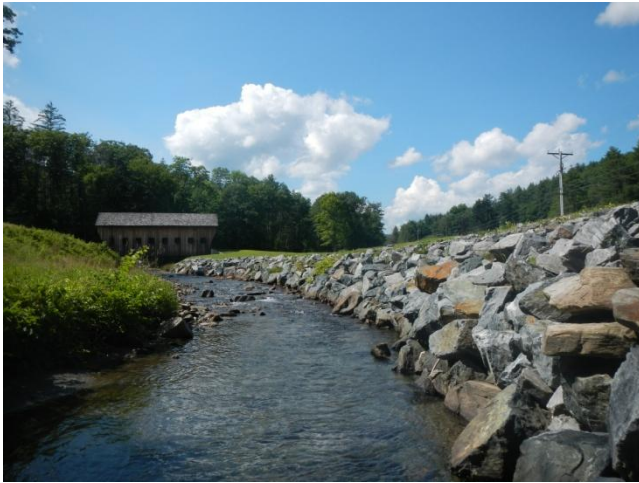
**Figure 4.17:** Recently straightened channel along reach M13.

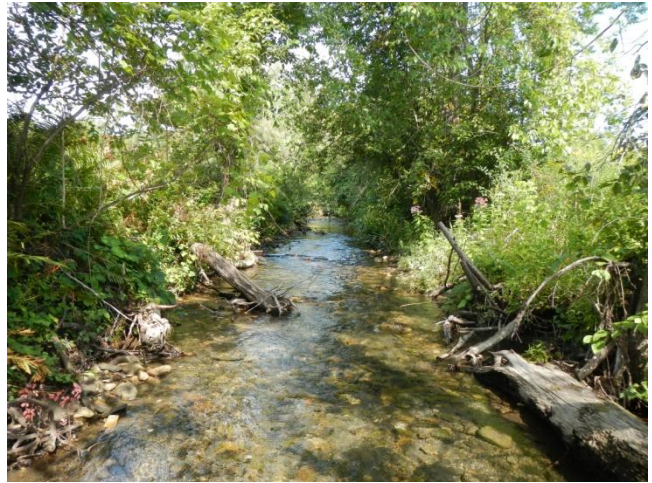
**Figure 4.18:** Extreme straightening through hayfields on segment T2.01.A.

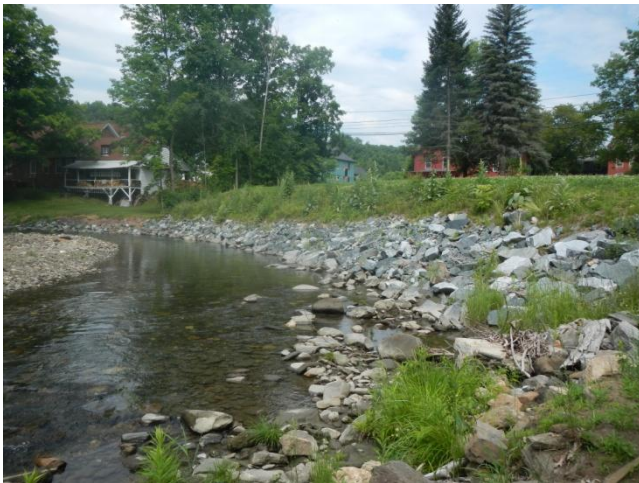
**Figure 4.19:** Encroachment from development in Brownsville on segment M07.A.

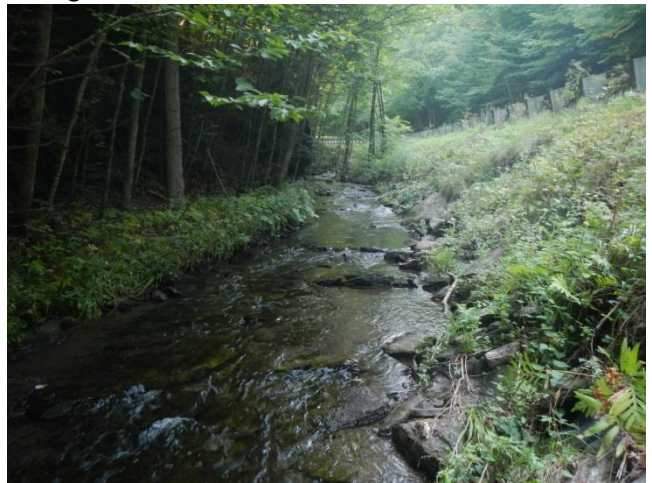
**Figure 4.20:** Extreme encroachment along Route 106 on reach T3.04.

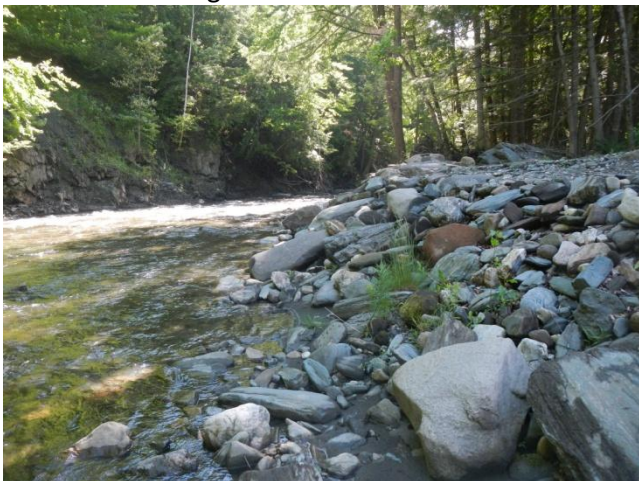
**Figure 4.21:** Dredged material blocking off a flood chute entrance on segment M05.B.

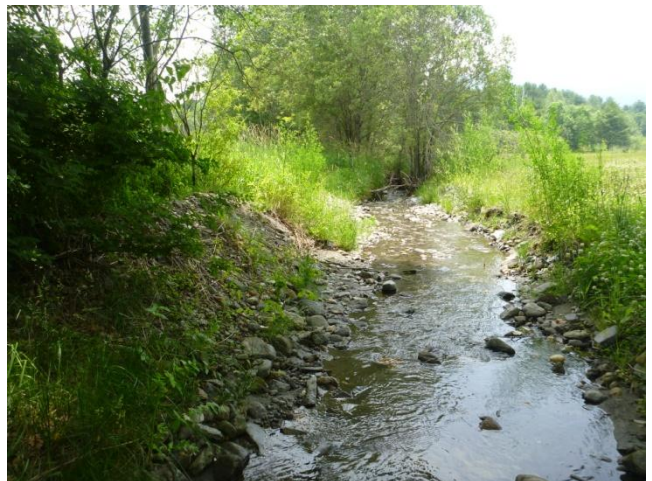
**Figure 4.22:** Dredged material along the banks of segment T1.01.S4.01.B.

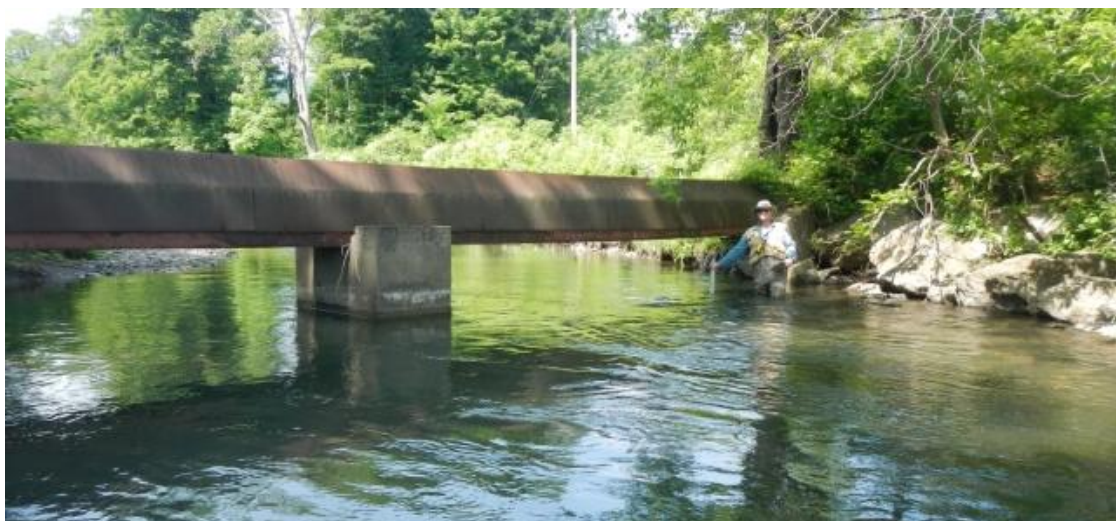
events. This obstruction has caused the channel bed to scour, potentially undermining the center pier. The sewer line was not damaged during T.S. Irene, however this is likely only due to peak flow and woody debris attenuation in Mill Pond. Debris catchment on the sewer line could increase flood elevations and impact upstream houses. Damage to the sewer line in a future storm event would interrupt sewer service to the High School and cause major water quality impacts to Mill Brook and the Connecticut River.

We recommend an alternatives analysis to assess options to re-route the sewer line or replace the existing structure to improve flood capacity and reduce the risk of debris jamming. We discussed this site with Mike Reynolds, an operator at the Windsor Sewer Plant, and they are aware of the issues and concerned about flooding risks. Potential project partners and funding sources for this project include the Town of Windsor and FEMA.

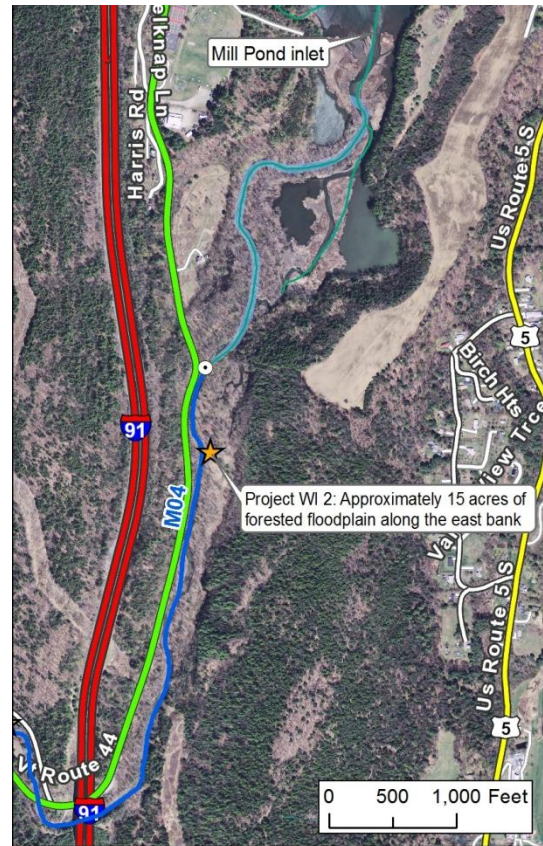
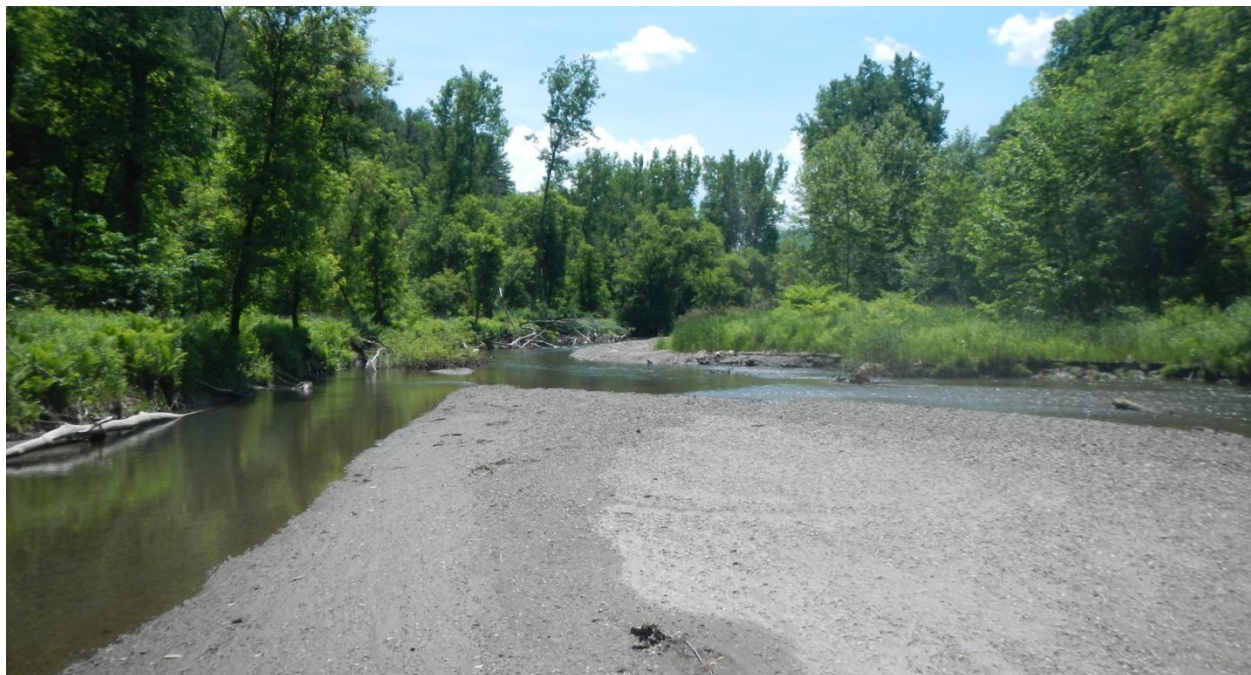
### Project WI 2 - Floodplain Conservation along the "Narrows"

The confined valley running along Route 44 from the Mill Pond inlet to the Interstate 91 bridges is referred to as the "Narrows". This valley was described in a previous Phase 2 SGA study that assessed sediment sources to Mill Pond (SWCRPC, 2003). SWCRPC assessed the reach as highly impacted by road encroachment and armoring with some floodplain access along a partially abandoned hayfield. Based on our observations in 2014, the reach appears to be aggrading and developing a meandering planform. The hayfield along the right floodplain is fully abandoned and is filling in with shrubs and small trees. A narrow band of large trees lines most of the right bank and historic armoring along this bank is failing as the channel widens and builds a meander sequence. Large sand and gravel bars within the channel and thick sand/silt deposits on the floodplain indicate that this area is storing large volumes of T.S. Irene related sediments and reducing sedimentation of Mill Pond.

There are currently no improved structures or active agricultural practices within this floodplain area. We recommend long-term protection of this valuable floodplain through a conservation easement with VLT and/or through VTANR ERP. The landowner has not yet been identified or contacted.

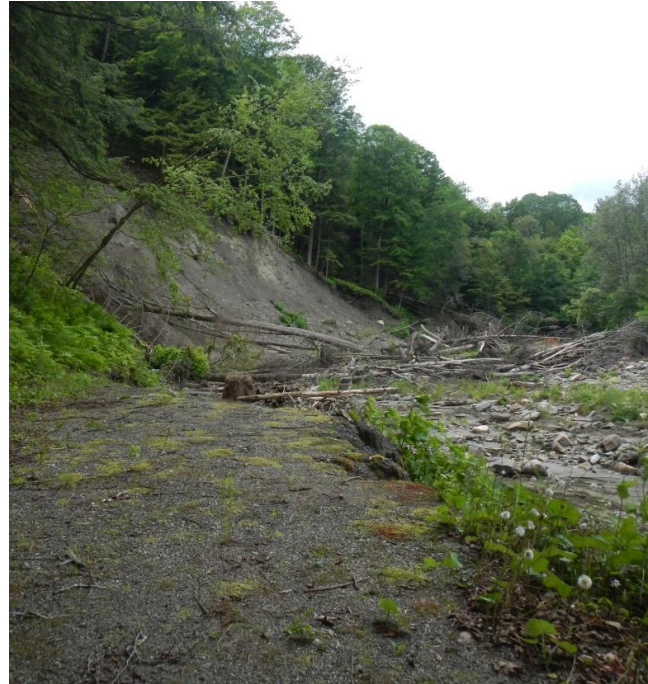
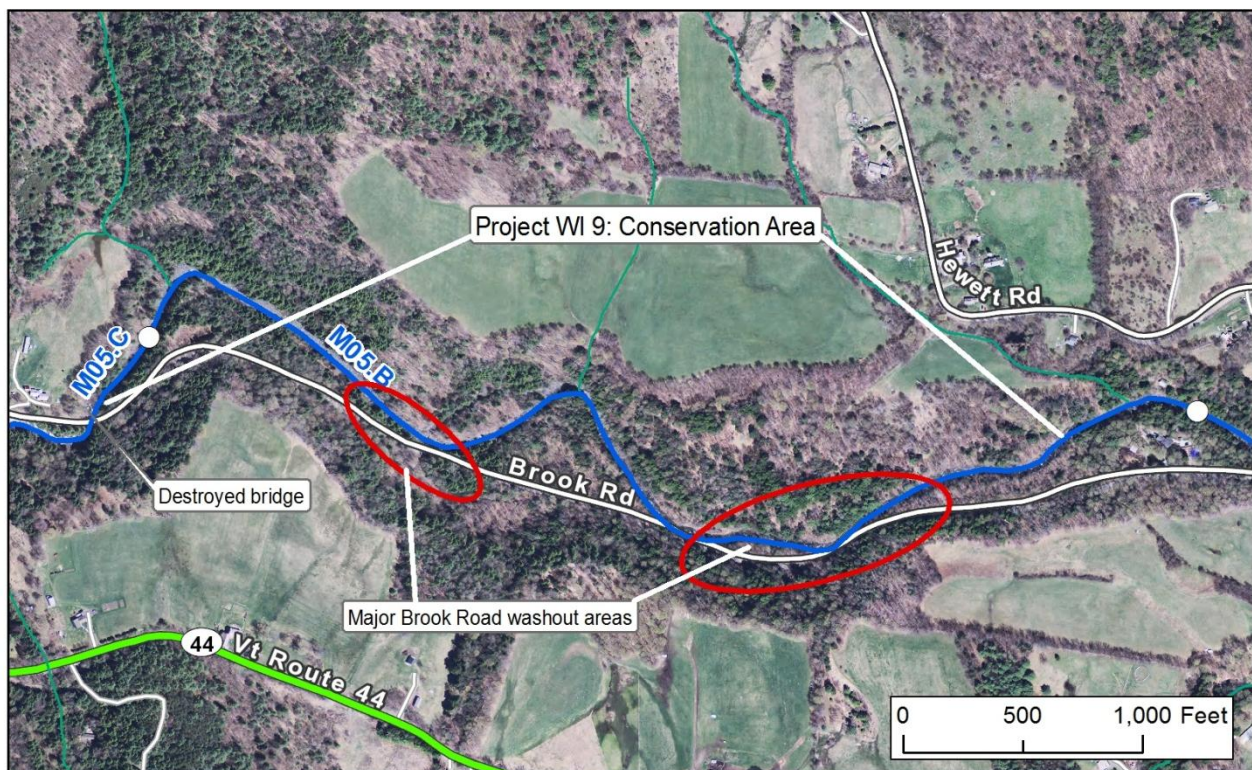
### Project WI 9 - Brook Road Conservation Area

The river valley along most of Segment M05.B to the destroyed Brook Road bridge in M05.C is incredibly active and is generating and storing huge volumes of sediment and debris. Brook Road is completely washed out in several locations and is not feasible to repair. The channel severely widening during T.S. Irene, triggering large mass failures, most of which remain active. Following the flood, the channel is continuing to widen and aggrading gravel and sand as flood sediments work through the reach. Larger forested floodplain areas were only partially accessed during T.S. Irene, therefore most of the floodwater and sediment storage will continue to occur within the widened channel.

The washed out Brook Road bridge is the only improved structure within this area and the remaining portions of Brook Road along the right valley are slowly revegetating. We recommend long-term protection of this highly active valley through a conservation easement with VLT and/or through VTANR ERP. The landowners have not yet been identified or contacted.

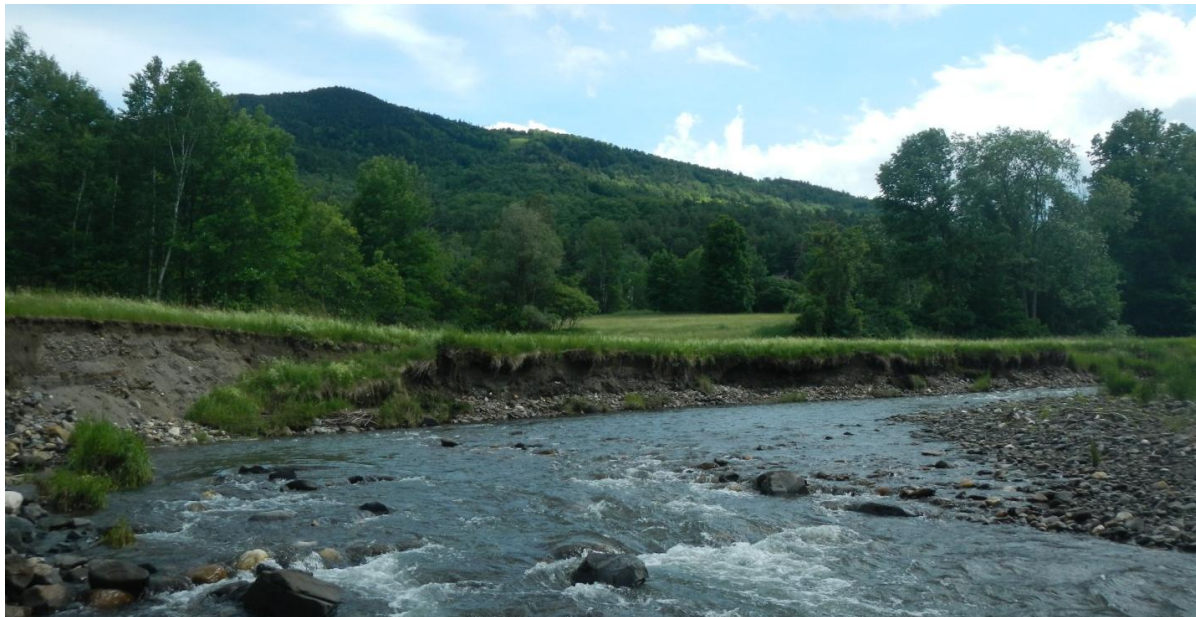
### Project WW 1 - Bank Erosion along Hayfield

A large bank erosion site is located in Reach M06 where the right bank is carving into a hayfield with minimal woody bank/buffer vegetation. This reach was likely straightened historically causing the channel to incise and limit floodplain access. Tropical Storm Irene triggered some widening and planform adjustment leading to bank erosion in areas with reduced stabilization from bank and buffer vegetation. Project WW 1 is a 750 foot long eroding bank that is typically 7 feet high.

Based on pre-Irene aerial imagery, the channel has migrated approximately 70 feet to the southeast over the last five years. This erosion will continue to contribute large volumes of sediment to the Brook, and may accelerate with ongoing planform adjustments. A utility pole is located near the middle of the project area and is currently 25 feet from the top of the eroding bank.

We recommend an alternatives analysis to determine the feasibility of re-grading and stabilizing the bank. A "do nothing" approach may be appropriate to allow the channel to develop a meander sequence and build an accessible floodplain area. Bank and buffer plantings should also be considered and could be paired with stabilization using rock or wood along the toe of the bank. The utility pole should be moved or monitored for stability. VTANR ERP, private landowner, VLT, and ONRCD Trees for Streams are all potential project partners.

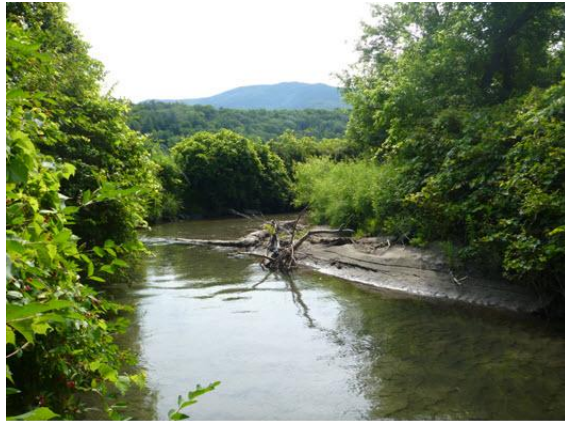
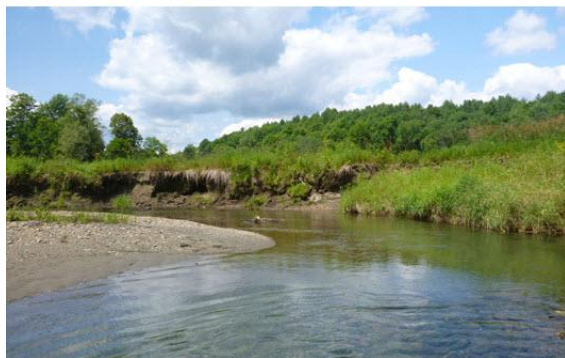
### Projects WW 2f and WW 2g – Buffer Plantings and Corridor Protection in Reach M09

In the upper reach (Segment M09.B) there was a significant amount of coarse and fine sediment deposited during T.S. Irene, which led to channel widening and severe bank erosion. The segment was historically straightened but is now redeveloping meanders through the valley. Corridor protection in the upper segment is a high priority given the floodplain's capacity to absorb flood flow and sediment from unstable reaches of Mill Brook and Willow Brook upstream, thereby taking pressure off the villages and infrastructure downstream. There is a narrow strip of woody vegetation along most of M09.B, but given the tendency for the reach to continue widening and migrating, we recommend that targeted buffer plantings along the segment take into account the future meander belt width. The lower segment (M09.A) is deeply incised; only minimal areas of the adjacent floodplain were accessed during T.S. Irene. The meander scars in the valley suggest that the river used to occupy a much wider corridor. There is a narrow strip of woody vegetation (many invasives) along M09.A. The buffer could be substantially improved in targeted areas, taking into account

channel stability (existing erosion and armoring) along the river, with appropriate setbacks of larger planting stock in areas expected to migrate. Corridor protection in M09.A is a medium to high priority given the incised state of the channel, with potential for the floodplain to function better in the long term. A VLT agricultural easement covers the middle portion of the reach. VLT, VTANR, and the Vermont River Conservancy (VRC) are potential partners for river corridor easements.

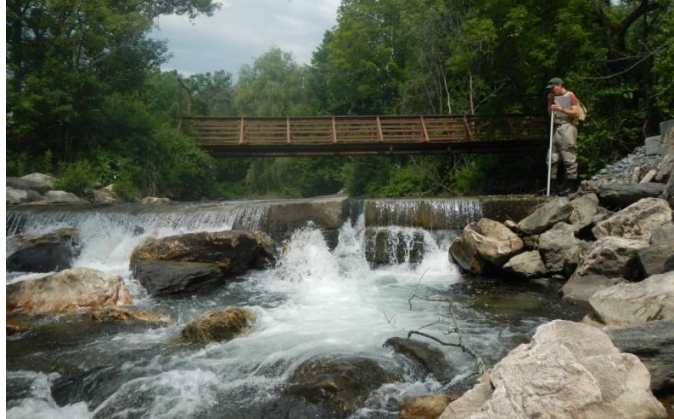
### Project WW 3 – Brownsville Dam Removal or Retrofit

A former snowmaking withdrawal site for Ascutney Mountain Resort has a 6-foot tall concrete block dam. The West Windsor Fire Department currently maintains the structure as a water source for fighting fires in the village. The small impoundment behind the dam is completely filled in with sediment. The channel is eroding around the right (south) side of the dam, potentially destabilizing the structure. The dam is likely a barrier to upstream migration of fish and other aquatic organisms. The upstream river segment (M07.B) is storing a large volume of gravel and sand, which exacerbates flooding upstream and increases erosion downstream.

As a long-term solution to address the negative effects of the dam on the river and flooding/erosion, we recommend that the Town pursue dam removal or retrofit, while developing an alternative water withdrawal configuration to address critical public safety concerns in the village with respect to fire fighting. Potential partners and funding include VTANR, USFWS, and other stakeholder groups in the Connecticut River watershed. Apart from the social and legal aspects of current dam ownership and liability, a pre-design feasibility assessment of structure removal/retrofit should include the following components:

- Detailed survey of channel upstream and downstream of dam to determine depth of sediment deposits and potential vertical adjustments in the bed following dam removal;
- Evaluation of bank stability and risk to adjacent properties upstream as there are homes and other infrastructure (i.e., septic systems) in close proximity to the channel;
- Evaluation of sediment management options and restoration plan to reform channel bedform features and potentially provide grade control to prevent channel downcutting.

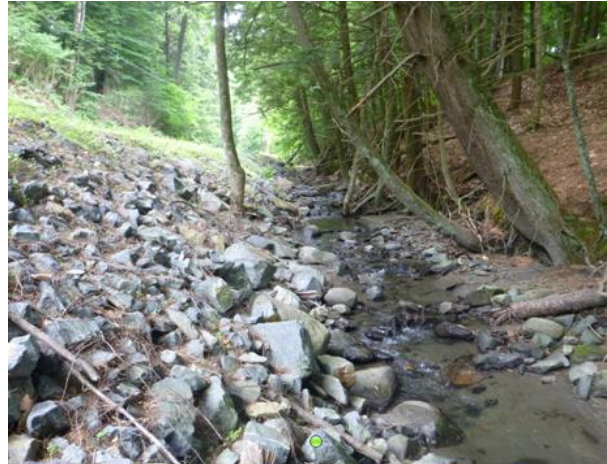
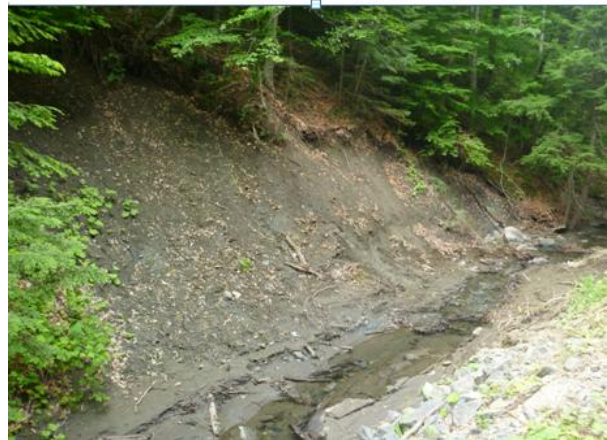
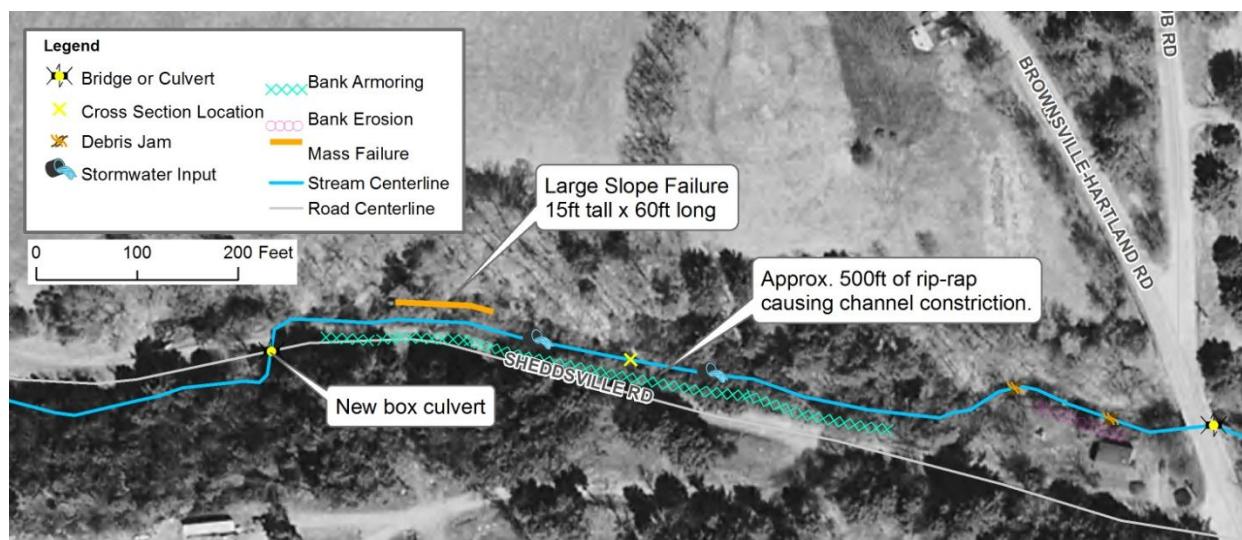
### Project RE 3 - Agony Hill Road Arch

The steel arch under Agony Hill Road is a channel constriction (70% of bankfull width), poorly aligned, deformed, and filling in with sediment. The arch is located near the middle of segment M14.A which was likely historically straightened and incised. During T.S. Irene the channel widened dramatically and began to redevelop some meander bends. Overbank flooding deposited large volumes of sand and gravel over the forested right floodplain areas (orange areas in map to right) and buried three properties along the left bank. A low section of road bed along Agony Hill Rd served as a valuable flood relief area and likely reduced damage to the upstream properties. The channel remains highly active and continues to widen and adjust planform. Huge volumes of flood sediments are working through the segment, creating large bar features.

We recommend replacing the arch with a larger structure to better accommodate the large volumes of sediment working through the reach. A structure larger than the predicted bankfull channel width (36 feet) should be considered based on channel adjustment processes (Schiff *et al.*, 2014). The floodplain spillway over the road should be stabilized but not elevated. Additional projects to protect floodplain (RE 4) and stabilize and plant an eroding bank (RE 1d) should be considered for implementation before or during any structure replacement. VTrans and the Town of Reading are potential partners for this project.

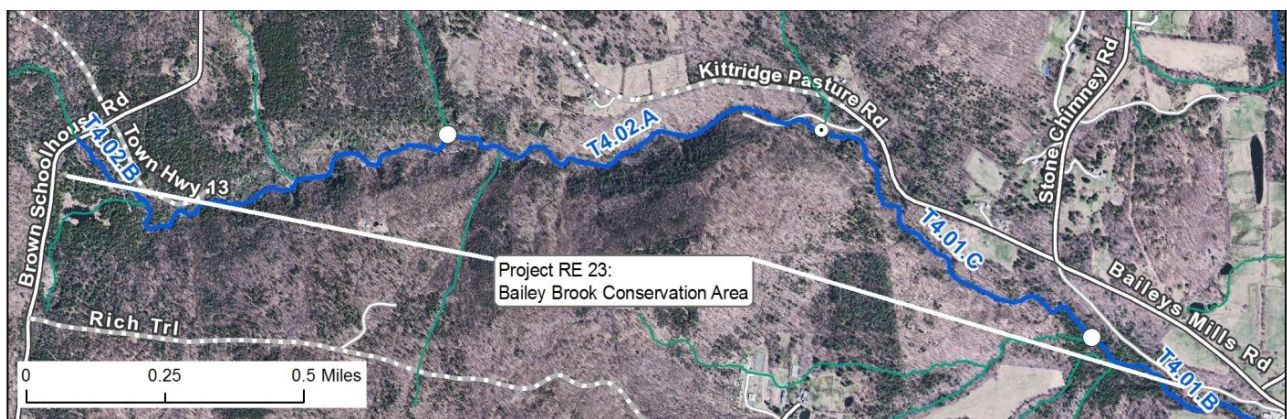
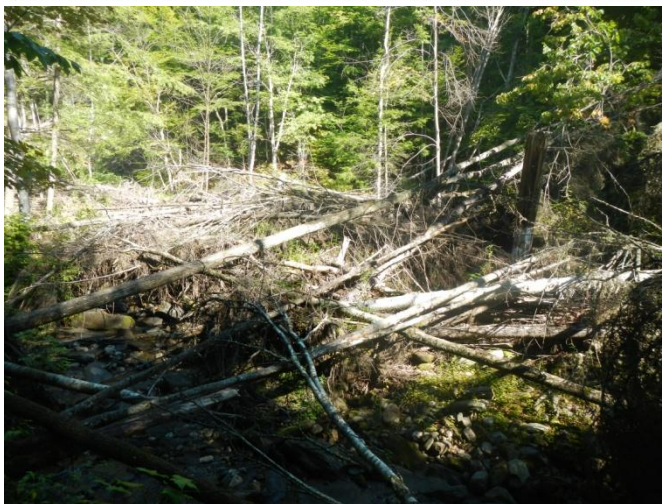
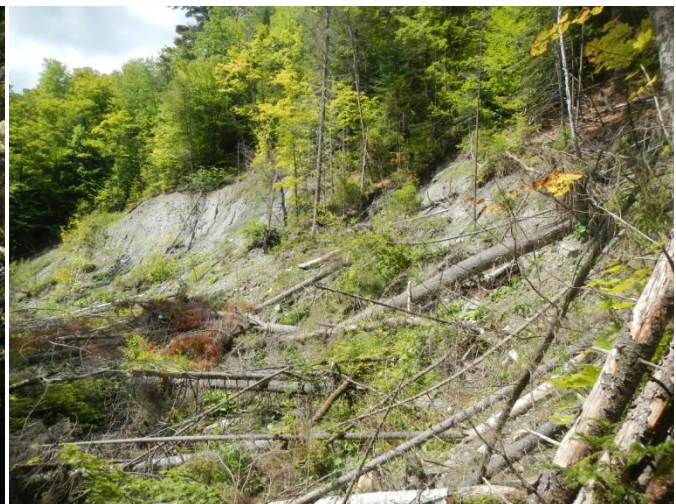
### Project RE 23 - Bailey Brook Conservation Area

The portion of Baileys Brook from the Baileys Mills Bed & Breakfast upstream to Browns Schoolhouse Road flows through a forested valley with minimal impacts from Kittridge Pasture Road and a small adjoining hayfield. This watershed was incredibly active during T.S. Irene as the floodwaters carved into the valley walls triggering huge landslides. The debris from these bank failures filled the valley in several locations which subsequently trapped huge volumes of woody debris, gravel, and sand. The channel is now braiding through these deep flood deposits in the upper segments (T4.01.C - T4.02.B), and carving down into the stream bed causing deep incision in the lower segment (T4.01.B). The sediment flushed out of this stream continues to have major impacts on Mill Brook that were visible for miles downstream. Many of the mass failures remain active and will likely continue to generate sediment and woody debris for a long time. The debris jams throughout the valley are critical for retaining sediment and re-establishing floodplain areas. Any clearing of these debris jams could release huge volumes of sediment and increase downstream flood risks.

We are recommending long-term protection for the entire valley from Baileys Mills B&B upstream to Browns Schoolhouse Road. A conservation easement through VLT and/or VTANR ERP would protect this area from management or clearing and allow for natural channel adjustment and sediment storage processes. The Green Mountain Horse Association maintains numerous trails through the area and may be an additional project partner. The landowners have not yet been identified or contacted.
