**Phase 2 Stream Geomorphic Assessment
Upper Otter Creek Watershed**

**Reaches: M22 – M26
Rutland & Clarendon, Rutland County, Vermont**

February 2006

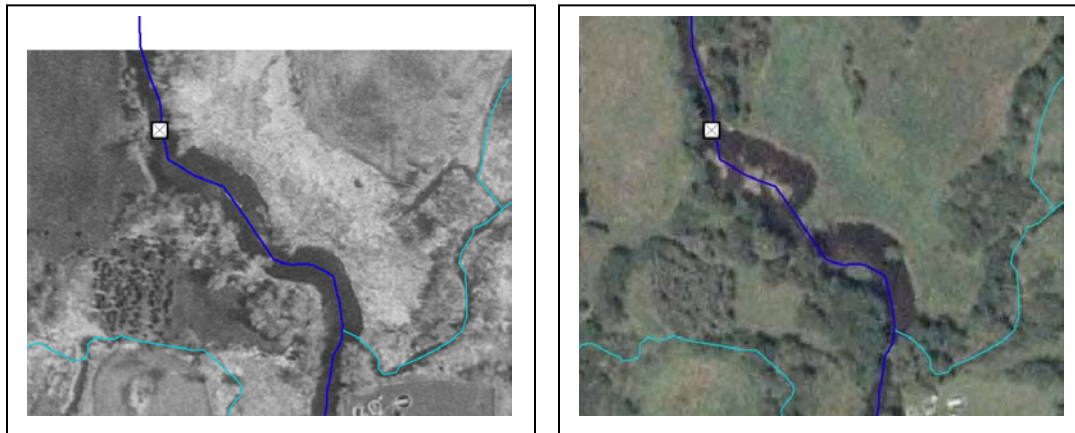
(a) 1994

(b) 2003

Accelerated meander extension was noted at several locations along the Upper Otter Creek valley, coincident with gaps in the woody riparian buffer. Occasionally, a meander will grow and move until the bend becomes too tortuous for the river to pass through, and the neck of the meander will be cut off in the next flood event (or a series of flood events). Comparison of the 1994 orthophotos with 2003 aerial imagery revealed a few examples of recent and pending neck cutoffs in the study area (see Figure 9). Where possible, these gaps in the buffer can be filled in by tree and shrub plantings. As the shrubs and trees establish themselves, the root systems will hold the erodible alluvial soils along the channel margins and offer roughness elements to slow the erosive power of the river; streambank erosion will be reduced and nutrient and sediment loading to the river will be reduced over the long term.

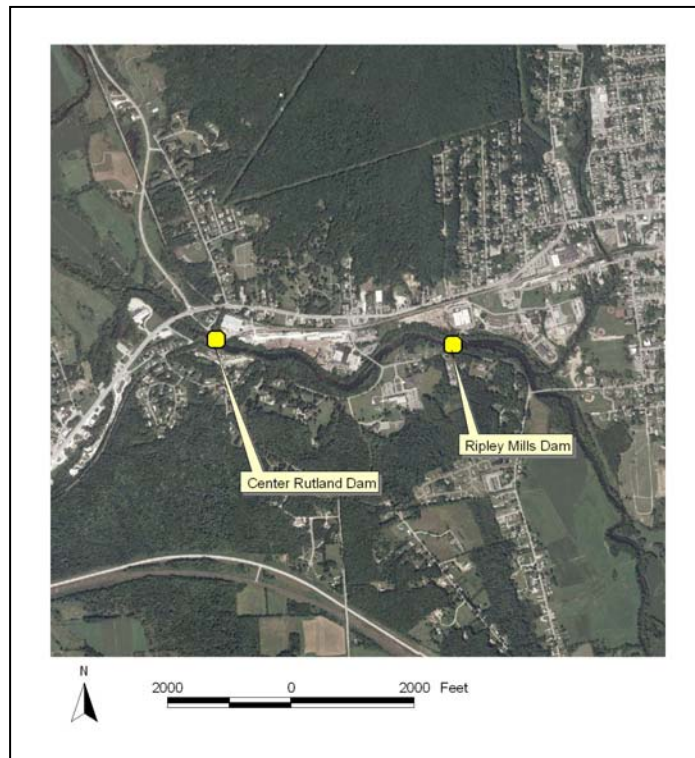
*Figure C.11
Location of dams on
Otter Creek near
Rutland City,
Reach M21.*

Very little information was available for the Ripley Mills Dam. This dam appears intact on 1995 orthophotos and 2003 NAIP aerial imagery. The Vermont Dam Inventory available from Vermont Center for Geographic Information indicates that this dam is 100 feet long and 5 feet high. Therefore, it could be considered a low-head dam with minimal impounding effects. If so, this dam would have minimal backwater effects upstream in the Otter Creek.

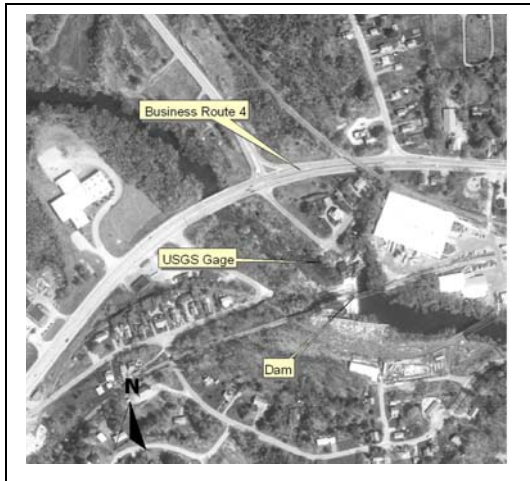
The Center Rutland Dam is approximately 190 feet long positioned at an angle across the Otter Creek channel. There is a 174-foot long spillway. The crest of the spillway is at 504.8 feet elevation, while 2.3 feet of wooden flashboards (top elevation of 507.1) are in place year-round under normal operations (VT Water Resources Board, 1992).

The Center Rutland Dam was constructed about 1898. Since 1992, the dam has operated as a run-of-river dam, meaning that the amount of water leaving the dam area is equal to the amount of water entering the impoundment above the dam. To maintain the run-of-river operations water surface elevation in the impounded area behind the dam is maintained at approximately 0.25 feet above the top of the flashboards, or 507.4 feet elevation (VT Water Resources Board, 1992).

The impounded area above the Center Rutland dam is minor – approximately 13 acres in area, 140 feet in width (perpendicular to the channel), storing approximately 30 acre-feet of water. Maximum backwater effects in the Otter Creek channel are reported to extend approximately 4000 feet upstream, or to a point a few hundred feet downstream of the Ripley Mills dam (VT Water Resources Board, 1992).

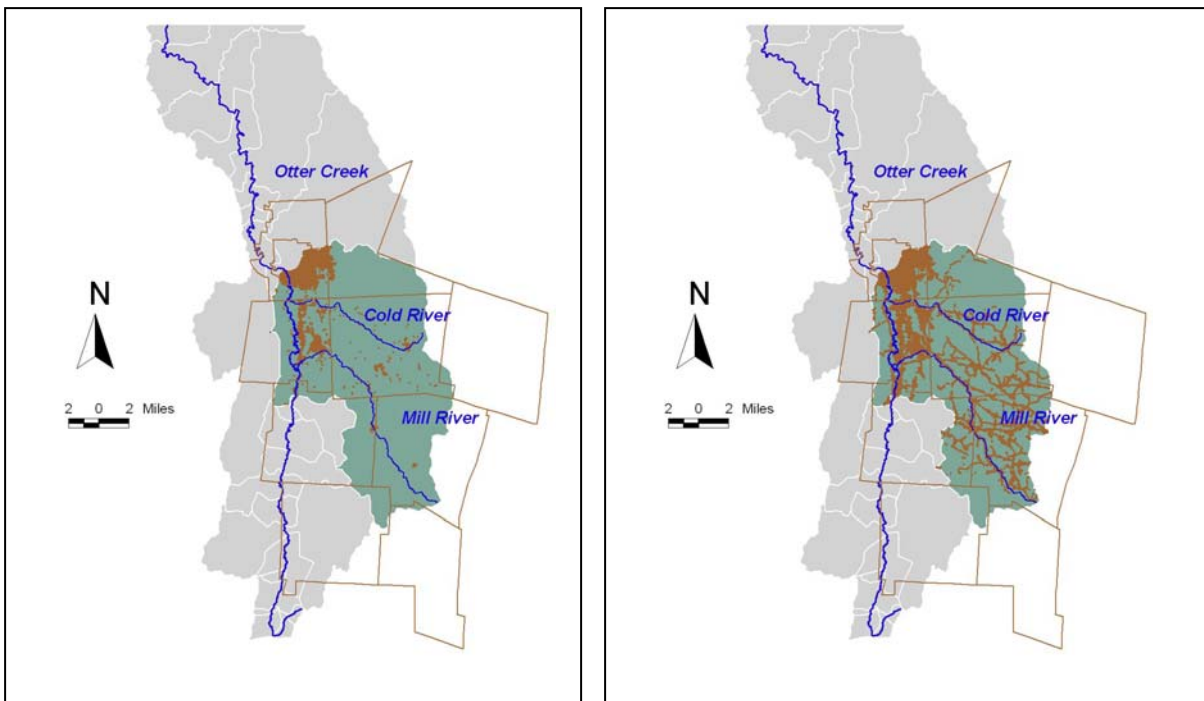
Figure D.2 (a) Developed land area as represented in 1993 LcLu data set;
(b) Developed land area as represented in 2002 LcLu data set.

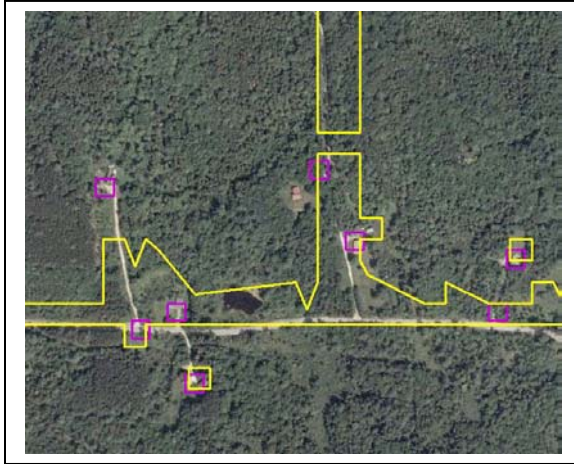
However, upon closer review (Figures D.3 and D.4), it was determined that the two data sets from 1993 and 2002 can not be directly compared. The methods used to delineate "developed" areas under each of the LcLu data sets (1993, 2002) appear to be quite different. As a result, the increase in development suggested in Table D.2 and Figure D.2 is misleading, and the actual change in developed land area in the watershed can not be determined from a comparison of these data sets.

Particularly in the rural settings, the methods used to develop the 2002 LcLu data set, by far, overestimate the actual developed land areas as compared to the methods used to develop the 1993 LcLu data set. Even in areas where there has been no appreciable change in development on the ground between 1993 and 2002, the two methods do not similarly represent the extent of developed land areas (see Figure D.3 and D.4).

Figure D.3. Delineation of “developed” land cover / land use, near North Shrewsbury, VT. Yellow line surrounds “developed” lands on 2002 LcLu data set. Purple line surrounds “developed” lands on 1993 LcLu data set. Base map is 2003 aerial photography.

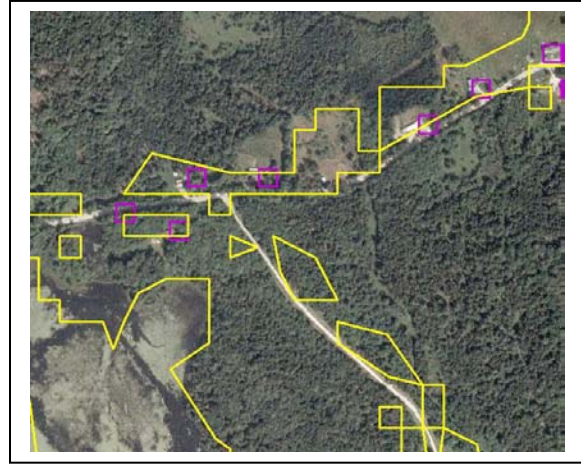
Figure D.4. Another area near North Shrewsbury where 2002 LcLu delineation (yellow) overestimates area of “developed” lands as compared to the 1993 LcLu delineation (purple). 2002 delineation includes areas of forested land along the road at the center of the image, and areas of wetlands at the bottom left of the image. Base map is 2003 aerial photography.

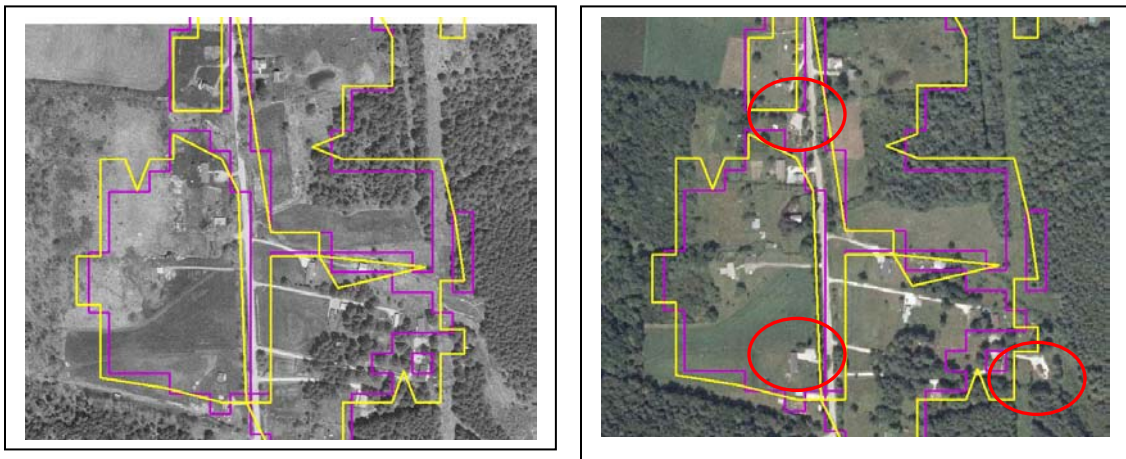
In areas where new structures have been built, comparison of 1995 orthophotos to 2003 aerial imagery reveals that the LcLu delineation methods are of insufficient accuracy and resolution to capture these incremental increases in numbers of structures (see Figure D.5).
