Upper Otter Creek

Phase 2 Geomorphic Assessment & Preliminary Restoration Project Identification

Rutland County, Vermont

January 21, 2009

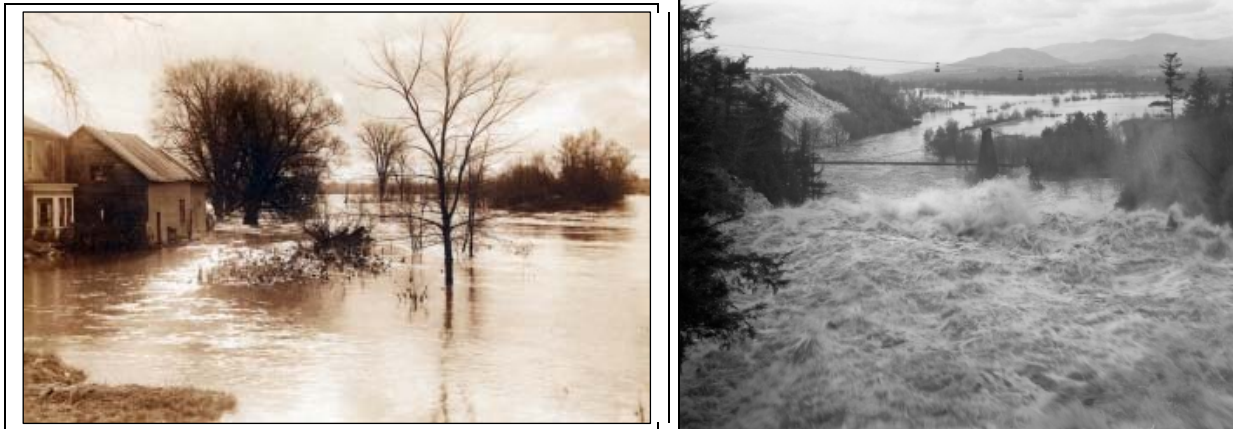
the period of 1995-1998 alone, flood losses in Vermont totaled almost \$57 Million. Of particular concern for towns and properties near streams, it notes that, “While some flood losses are caused by inundation (i.e. waters rise, fill, and damage low-lying structures), most flood losses in Vermont are caused by “fluvial erosion”. Fluvial erosion is erosion caused by moving water and can range from gradual streambank erosion to catastrophic changes in river channel location and dimension during flood events (Figure 7).”

Figure 7: These images show the Otter Creek during the 1927 flood. Left image is from an unknown location. Right image is of the Sutherland Falls in Proctor (reach M19-A).

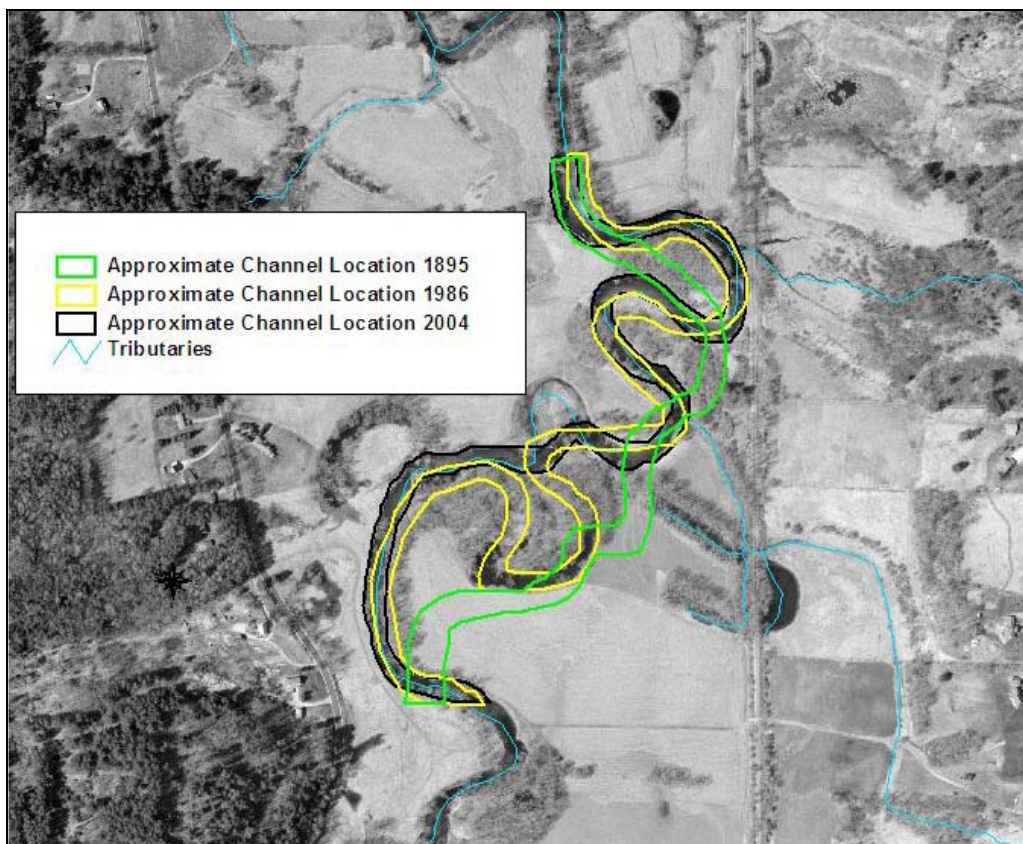
It is important to note that channel evolution processes may take decades to play out and may not only affect areas immediately adjacent to evolving channels. Even landowners that have maintained forests along their stream and riverbanks may experience eroding banks, sedimentation, and migrating channels, as the river responds to alterations up or downstream (Figure 22).

Figure 22: Meander patterns in the Upper Otter Creek in Clarendon.

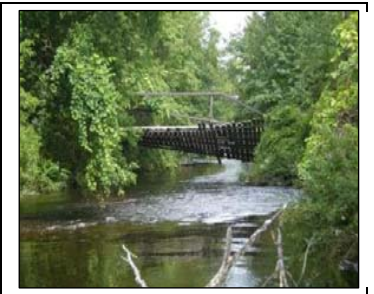
REACH NUMBER	METHOD	BENEFIT	DESCRIPTION	FEASIBILITY/ CONSTRAINTS	COST	LANDUSE CONVERSION	PARTNERS
M31

Protect River Corridor	Sediment Attenuation Area (Conserve and Enhance)	This fairly undeveloped reach is already attenuating floodwaters and sediment. Long term river corridor protection would reduce future conflict and ensure these functions are served for future generations.	No major structures along river	Unk.	Open land and forest remains structure free	Town, RRPC, VTANR
	Restore Riparian Buffer	Long term stability	Buffer removal on the left bank has made this reach vulnerable in the long-term.	No major structures along river. River may remain stable for years to come and allow trees to grow.	Unk.	Agriculture and Residential Land to Forest	UOCWC, RNRCD, FWS
	Remove or Replace Structures	Allow River to Adjust, Reduce Flooding	Several abandoned bridge abutments constrain the river.	Low cost to remove. Stone may be reused.	Low	Stone and old road bed converted to forest.	VTANR, Town, FWS

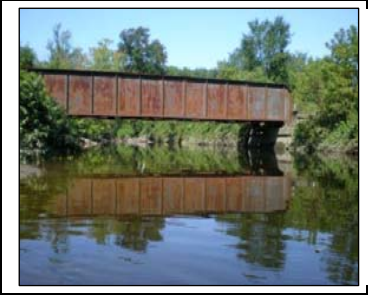
REACH NUMBER	METHOD	BENEFIT	DESCRIPTION	FEASIBILITY/CONSTRAINTS	COST	LANDUSE CONVERSION	PARTNERS
M29

Protect River Corridor	Sediment Attenuation Area (Conserve and Enhance)	This fairly undeveloped reach is already attenuating floodwaters and sediment. Long term river corridor protection would reduce future conflict and ensure these functions are served for future generations.	No structures near the river.	Unk.	None, remains forest	Town, RRPC, VTANR
	Remove or Replace Structures	Allow River to Adjust, Reduce Flooding	Several abandoned bridge abutments constrain the river.	Low cost to remove. Stone may be reused.	Low	Stone and old road bed converted to forest.	VTANR, Town, FWS
	Restore Riparian Buffer	Long term stability	Buffer removal on both banks has made this reach vulnerable in the long-term.	Only a few major structures along river. River fairly stable	Unk.	Agriculture and Residential Land to Forest	UOCWC, RNRCD, FWS

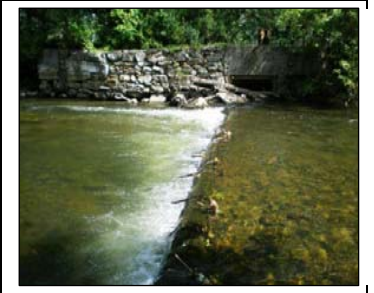
REACH NUMBER	METHOD	BENEFIT	DESCRIPTION	FEASIBILITY/ CONSTRAINTS	COST	LANDUSE CONVERSION	PARTNERS
M27

Remove or Replace Structures	Improve sediment and flood water flow through the village.	Remove old dam remnants in channel. Replace Creek Road Bridge.	Dam removal would be easy, low cost. Creek Road Bridge is a major project.	High	None	Town, VTANR, VTFWS, VTRANS, Landowners
	Restore Riparian Buffer	Long term stability	Replace buffer on the west side of the river to reduce sediment and other impacts from the quarry.	River may remain stable for years to come and allow trees to grow.	Unk.	Industrial land to Forest	Quarry, RNRCD, FWS
M21-D

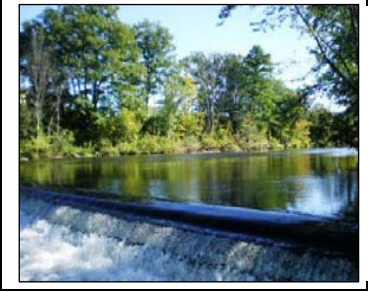
Remove or Replace Structures	Improve sediment flows through Rutland City. Improve fish passage.	Remove old concrete dam.	Extensive study and permitting. River may breach dam someday on its own.	High	Dam to free flowing river.	VTANR, ACOE, Landowners

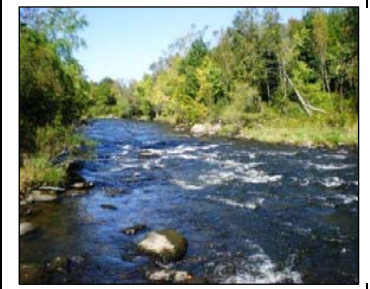
REACH NUMBER	METHOD	BENEFIT	DESCRIPTION	FEASIBILITY/ CONSTRAINTS	COST	LANDUSE CONVERSION	PARTNERS
M21-C

Remove or Replace Structures	Improve flow through developed area	Replace Ripley Road Bridge	May already been in the works.	High	None	VTRANS, Town, VTANR, Landowners
	Restore Riparian Buffer	Improve shade, stability of river, habitat	Buffer has been removed along a good portion of left (south) bank near residences.	Very little room for reforestation	Low	Lawn to forest	VTANR, RNRCD
M21-B

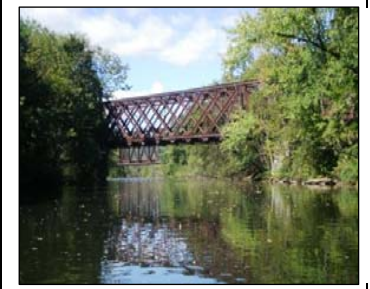
Restore Riparian Buffer	Improve shade, water quality and habitat	Buffer has been removed along both banks due to industrial development	Industries must be willing to sacrifice land.	Low	Impervious surface to forest	VTANR, RNRCD

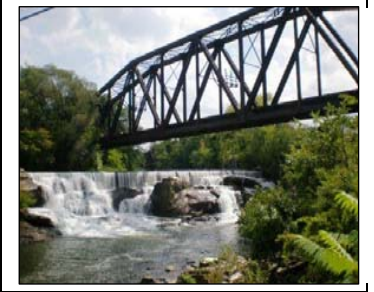
REACH NUMBER	METHOD	BENEFIT	DESCRIPTION	FEASIBILITY/ CONSTRAINTS	COST	LANDUSE CONVERSION	PARTNERS
M21-A

Remove or Replace Structures	Improve flow through developed area	Replace Route 4 A Bridge	Not likely until it is in disrepair.	High	None	VTRANS, Town, VTANR, Landowners
	M20

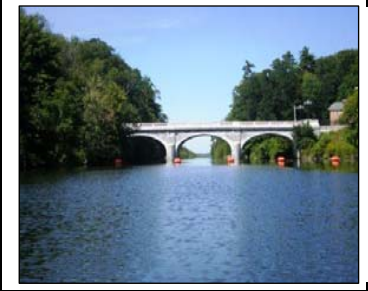
REACH NUMBER	METHOD	BENEFIT	DESCRIPTION	FEASIBILITY/ CONSTRAINTS	COST	LANDUSE CONVERSION	PARTNERS
M19-B

Protect River Corridor	Sediment Attenuation Area (Conserve and Enhance)	This fairly undeveloped reach is already attenuating floodwaters and sediment. Long term river corridor protection would reduce future conflict and ensure these functions are served for future generations.	No major structures along river	Unk.	Open land and forest remains structure free	Town, RRPC, VTANR
	Restore Riparian Buffer	Improve shade, stability of river, habitat	Buffer has been removed along a good portion of right bank due to armoring along the road.	Very little room for reforestation	Low	Barren to forest	VTANR, RNRCD
M19-A

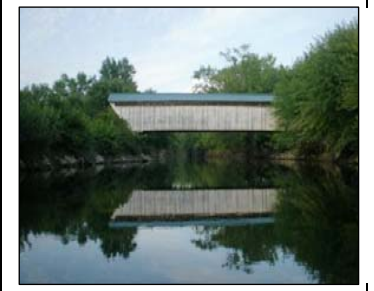
REACH NUMBER	METHOD	BENEFIT	DESCRIPTION	FEASIBILITY/ CONSTRAINTS	COST	LANDUSE CONVERSION	PARTNERS
M18

Protect River Corridor	Sediment Attenuation Area (Conserve and Enhance)	This fairly undeveloped reach is already attenuating floodwaters and sediment. Long term river corridor protection would reduce future conflict and ensure these functions are served for future generations.	No major structures along river	Unk.	Open land and forest remains structure free	Town, RRPC, VTANR
	Restore Riparian Buffer	Improve shade, stability of river, habitat	Short corner of field is lacking adequate buffer.	None.	Low	Bare to forest	VTANR, RNRCD, CREP

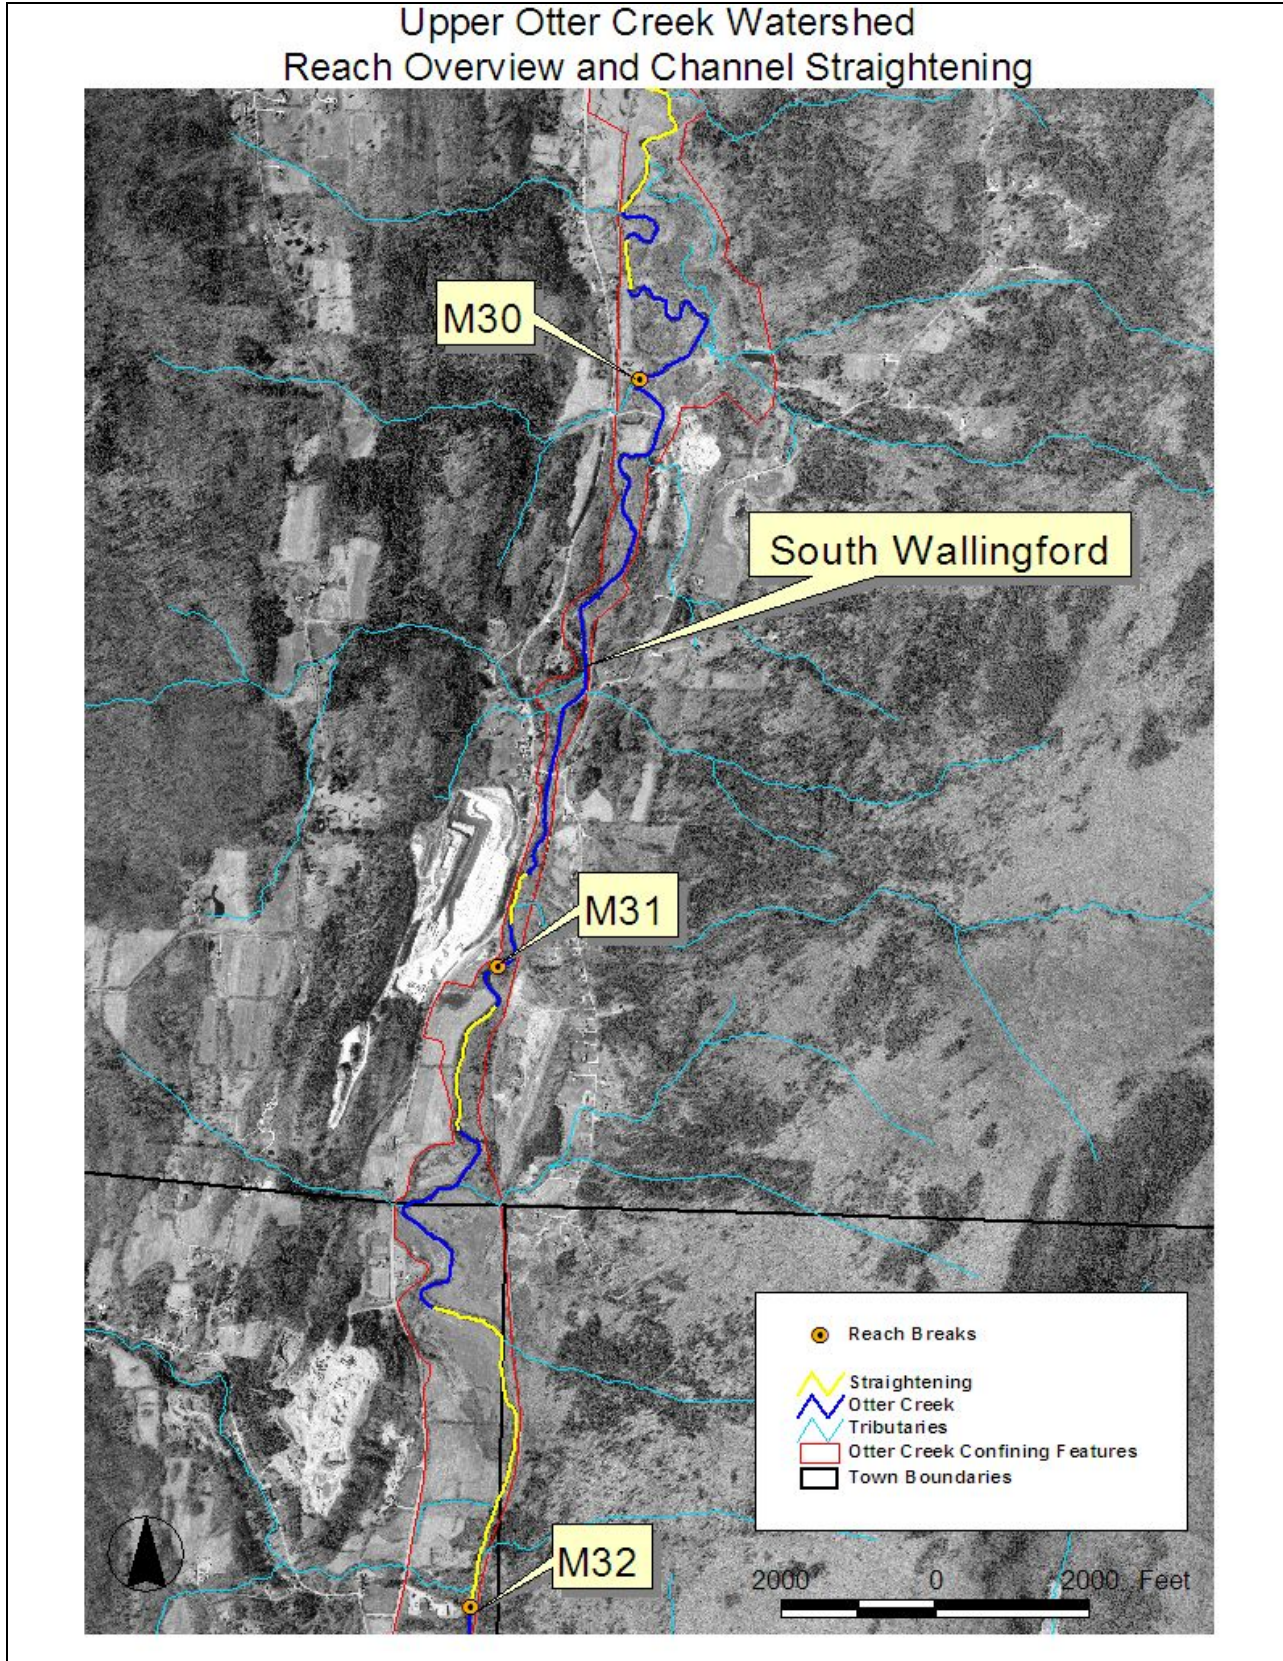
Figure 1: Overview of reaches M31 through M30 and channel straightening.

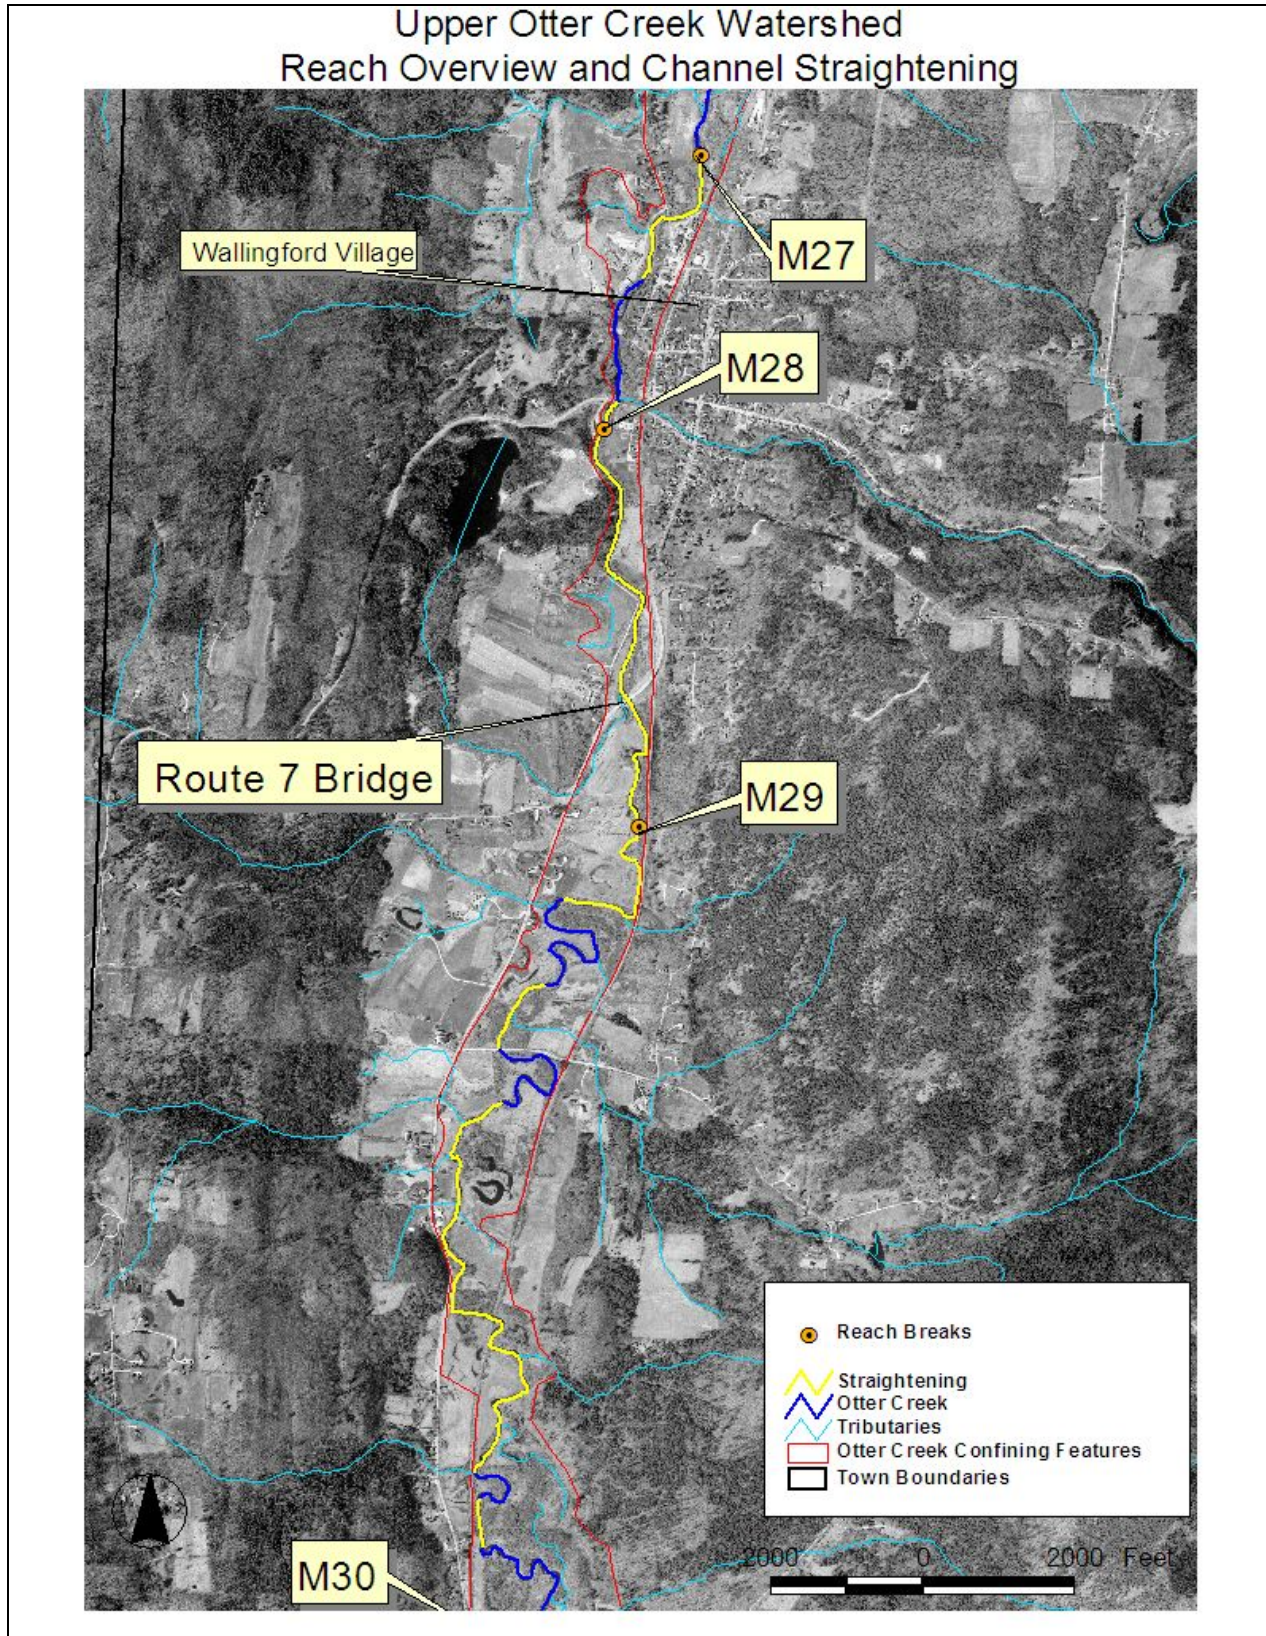
Figure 2: Overview of reaches M29 through M27 and channel straightening.

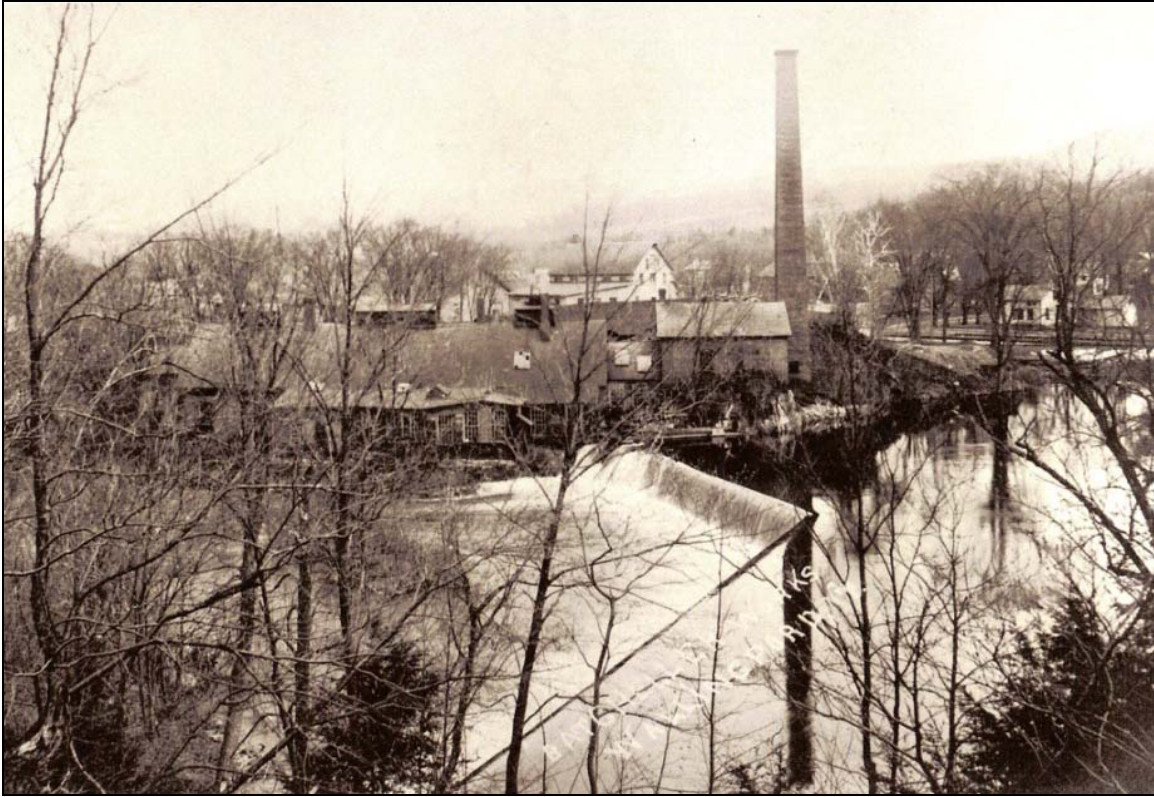
This reach has been significantly altered by the history of village industry and damming (evident in the historic diversion ditches and abutment remnants visible in the channel) (Figures 7 and 8). Extensive straightening, riprap, and bridge crossings also control and hinder the river (Figure 9). Despite these alterations, no incision was observed.

Figure 7. Historic photograph of a dam that existed in reach M27, Wallingford Village.

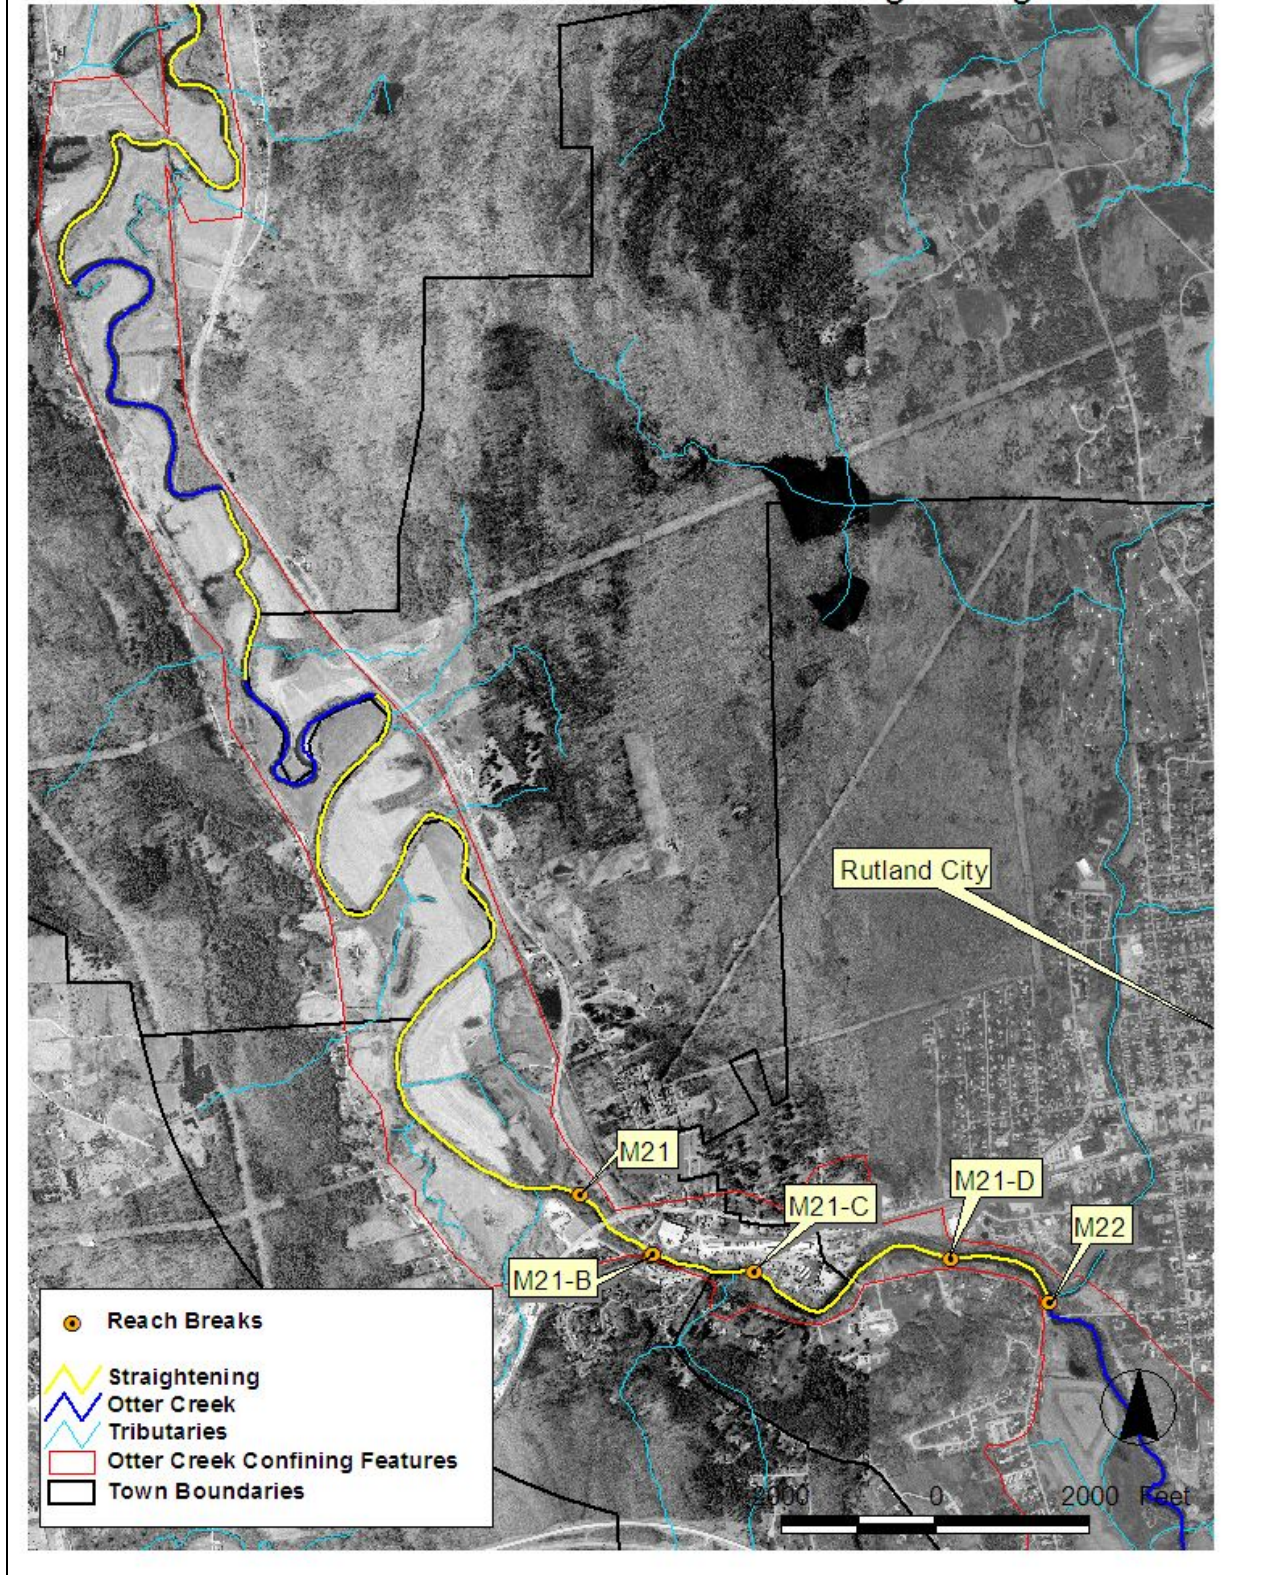
Figure 10: Overview of reaches M21 through M20 and channel straightening.

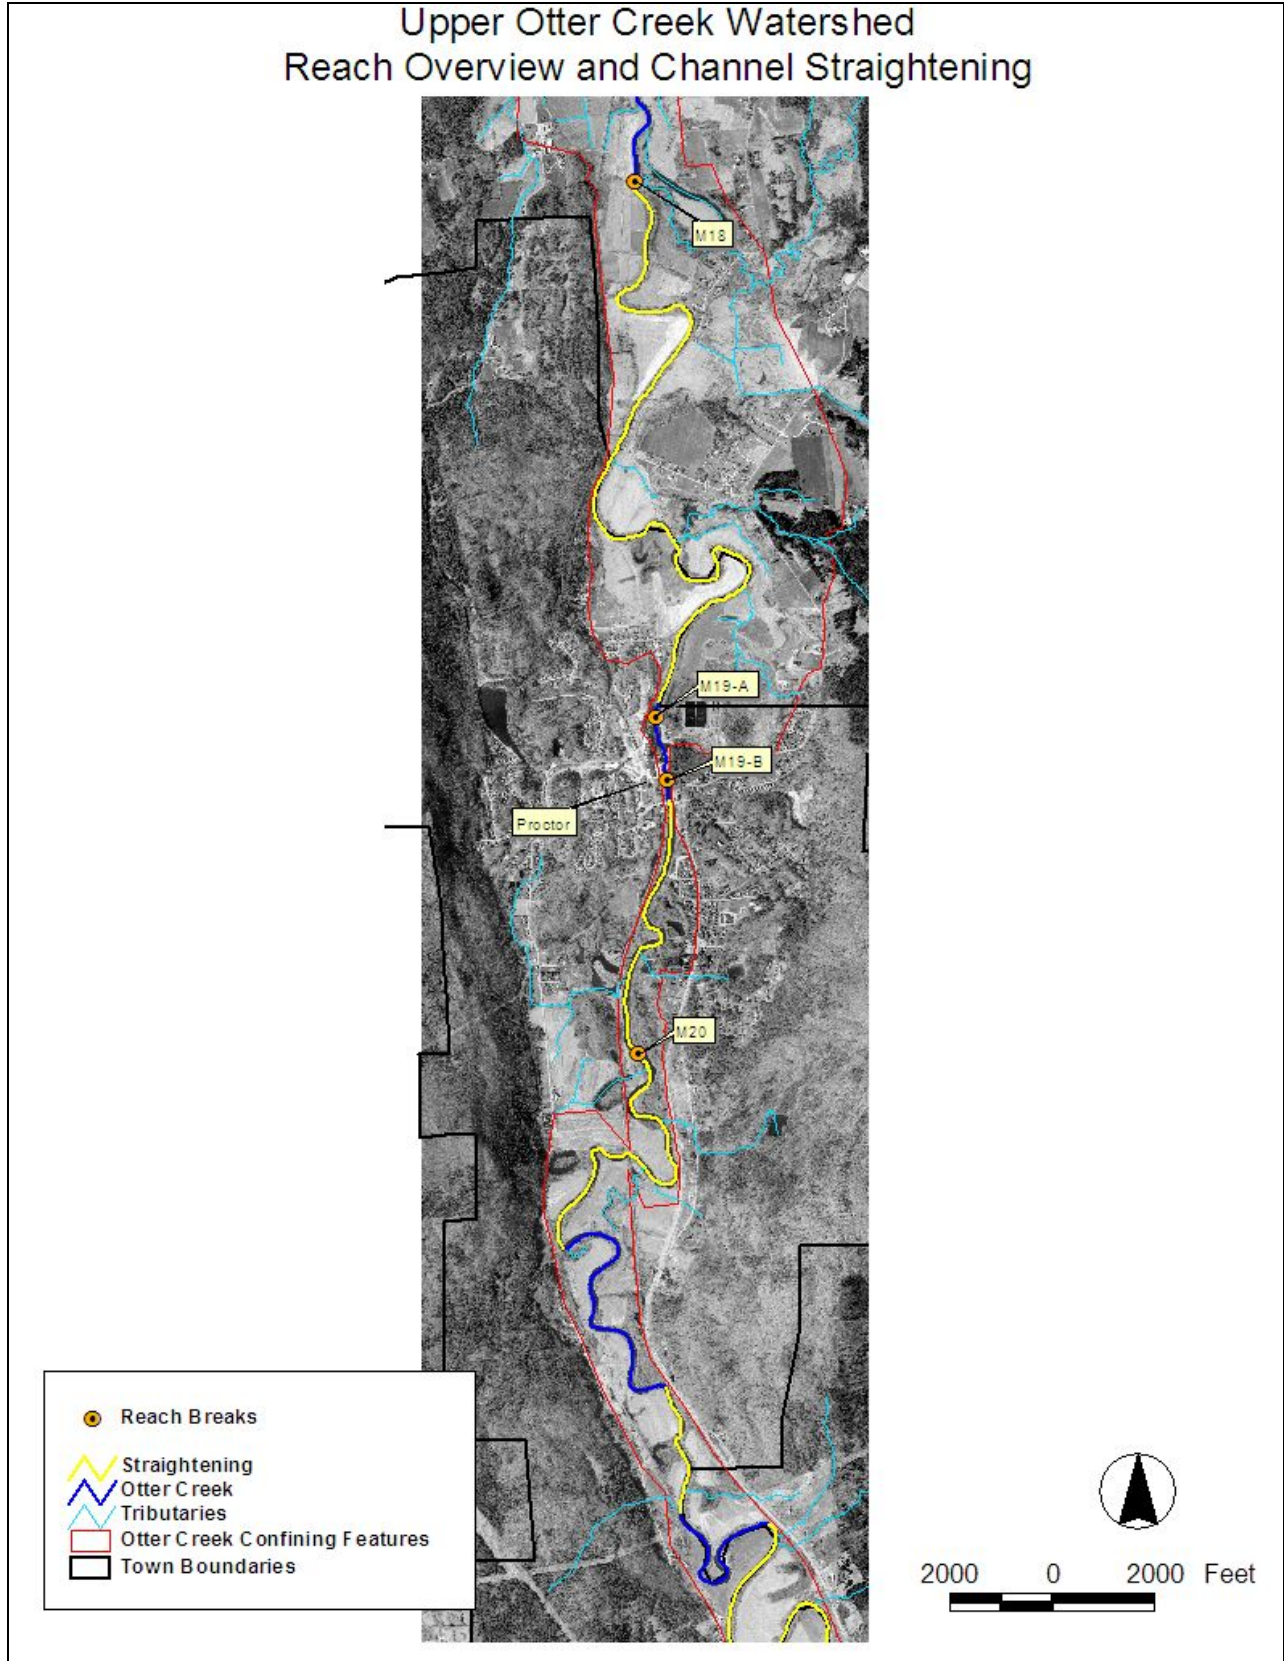
Figure 11: Overview of reaches M20 through M18 and channel straightening.

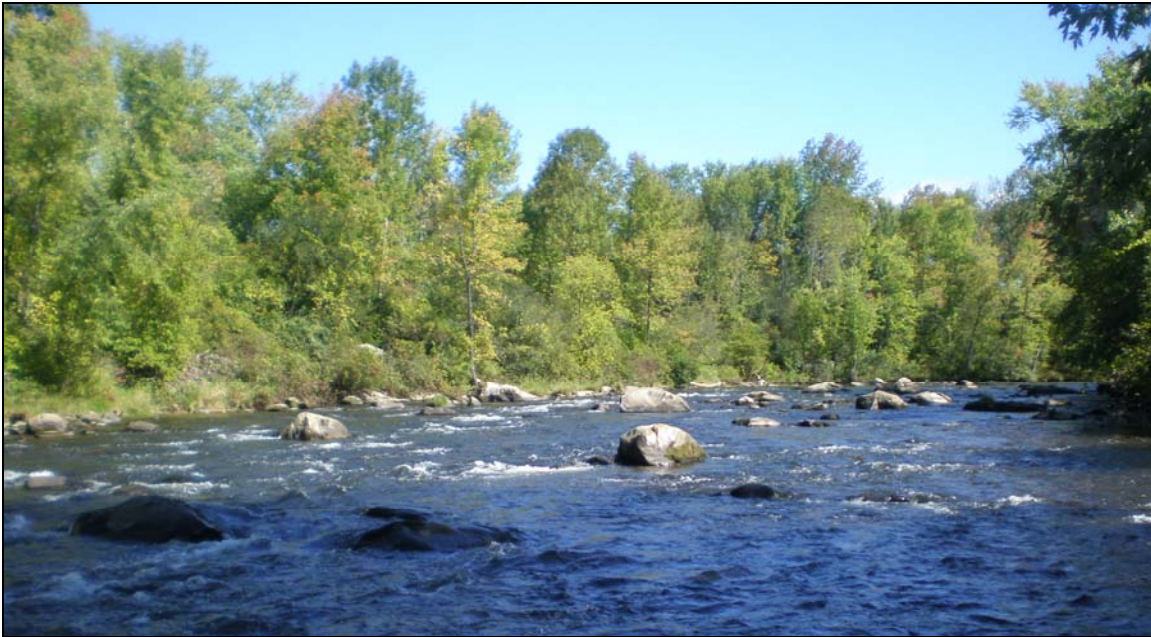
Upper Otter Creek segment M21-C is a broad section of riffle-dominated water (Figure 13). The segment begins at the Ripley Mills Dam and continues downstream for over 3000 feet ending where the stream flow is altered by the Mead Falls and Omya Hydropower dam. The channel is incised very slightly due to historic straightening and floodplain fill. Channel widening and planform adjustment appear to be limited due to streambank materials (armoring and trees). By reference this section is likely a “C” type channel dominated by gravel. Channel straightening and floodplain encroachment appear to have caused some loss of bedform and increased transport power so that

cobble is now the dominant bed substrate. Overall the stream does not appear to be undergoing significant adjustments within this section.

Figure 13. Segment M21-C is a broad riffle-filled stretch of the Upper Otter Creek.

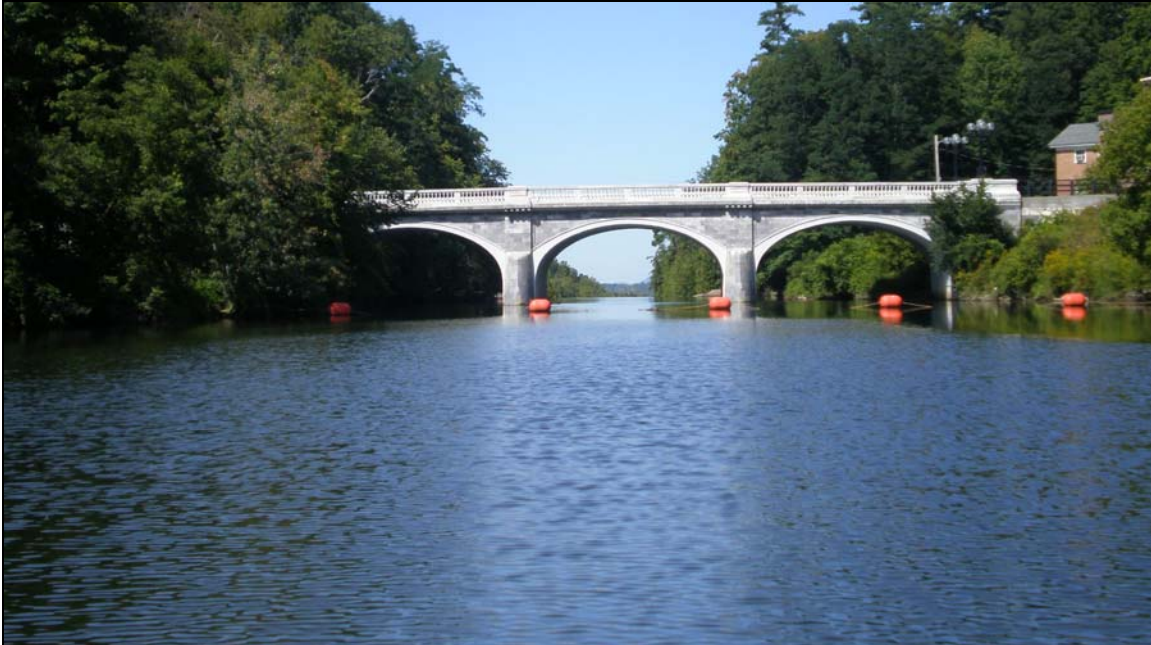
Otter Creek segment M19-B encompasses the area upstream of the Sutherland (Great) Falls and Omya hydroelectric dam in Proctor (Figure 17). It is an area of impounded water and in following with the VTANR protocol was not included for a full geomorphic assessment. The slope and valley width of the stream upstream of the falls indicate that the river would likely be an “E” type channel without the impoundment. The railroad bed has severed at least one historic oxbow in this reach. Bank armoring, floodplain encroachment, and riparian vegetation removal are all impacts that are prevalent in this reach as a result of the railroad and development in Proctor Village.

Figure 17. Otter Creek segment M19-B looking downstream to the Marble Bridge in Proctor and the Omya dam (at the horizon).

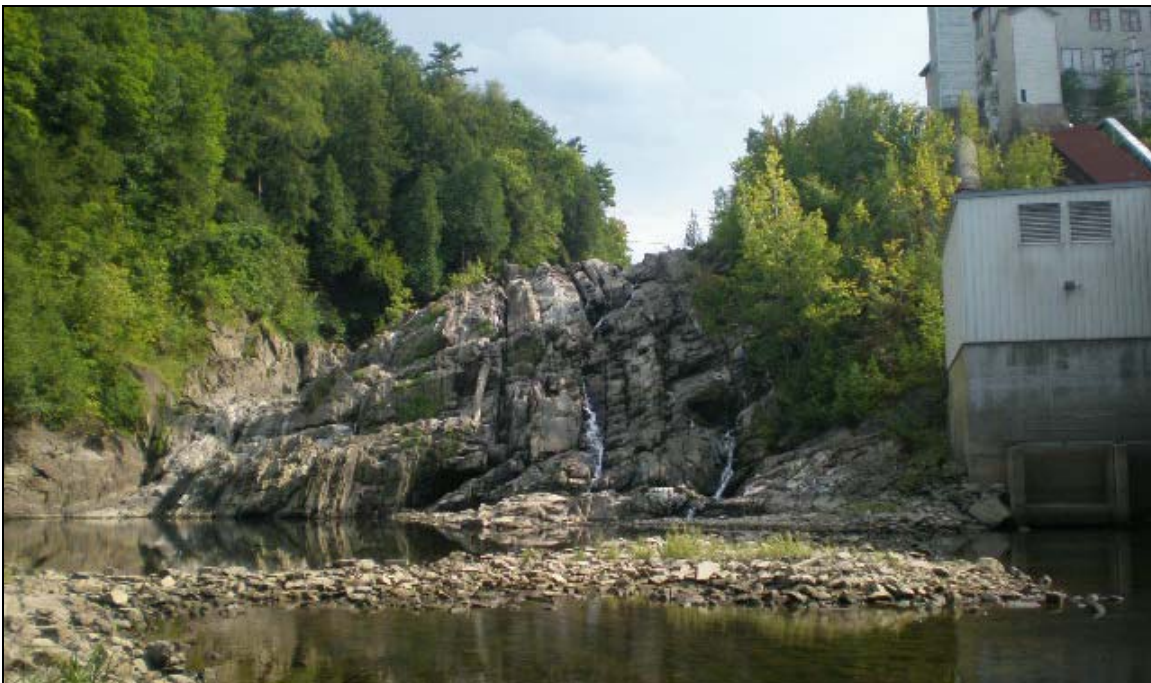
Upper Otter Creek segment M19-A is dominated by the Sutherland (Great) Falls and the hydroelectric dam for the Proctor Omya quarry downstream to the start of the next reach (Figure 18). The segment consists mostly of a large bedrock waterfall (F1 stream), and therefore in accordance with the VTANR protocol only a partial Phase 2 assessment was conducted.

Figure 18. M19-A is a very short reach dominated by the bedrock of Sutherland Falls.

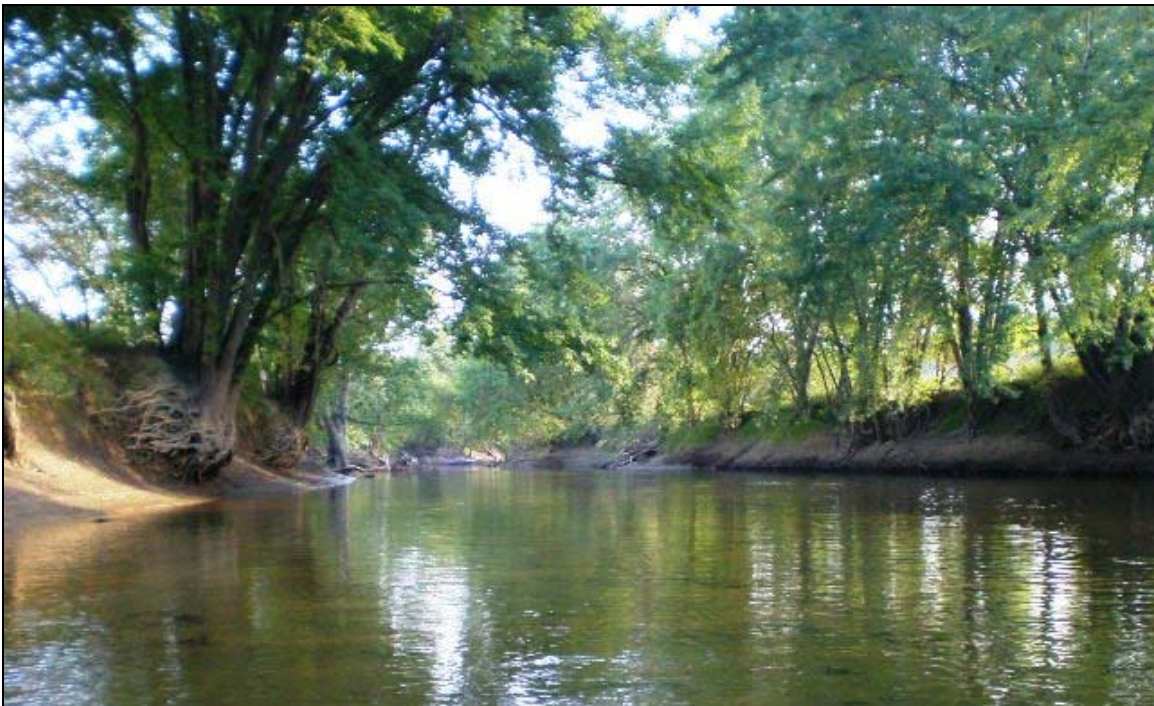
Reach M18 of the Upper Otter Creek begins just downstream of the Sutherland Falls in Proctor and flows northerly through agricultural and residential lands eventually meeting the mouth of the Furnace Brook in Pittsford (~3 miles downstream). This is an “E” type stream channel dominated by sand substrates and a ripple-dune bedform. The reach has excellent floodplain access and similar to M20 great silver maples line much of the banks (Figure 19).

The greatest impacts to this reach have been the removal of riparian vegetation for agriculture, the draining of fields and wetlands, and historic channel straightening. Field observations indicate that M18 is exhibiting evidence of planform adjustment, minor widening, and aggradation and may be expected to continue to adjust in the future.

Figure 19. M18 is an “E” channel with sand substrates and silver maples providing stability to the banks.

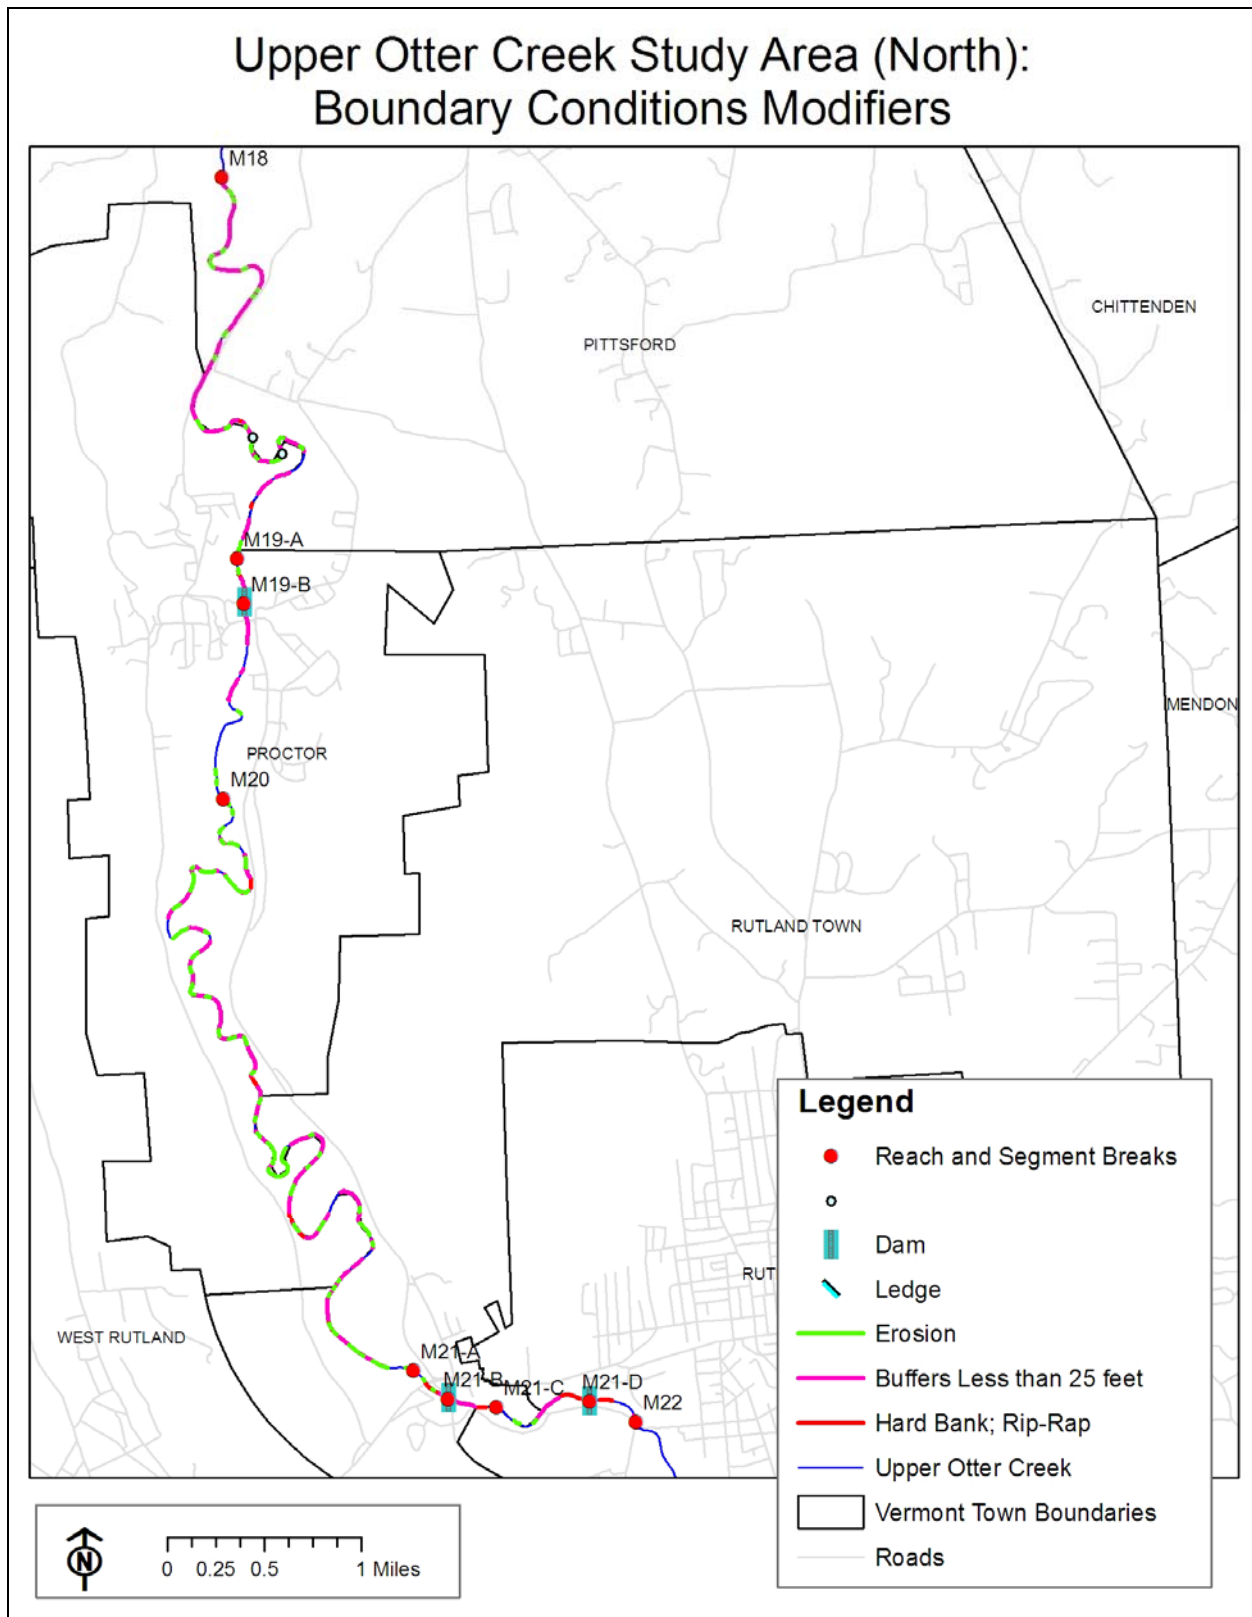
Figure 10: Boundary Condition Alterations: North Section of Upper Otter Creek (M22-M18)

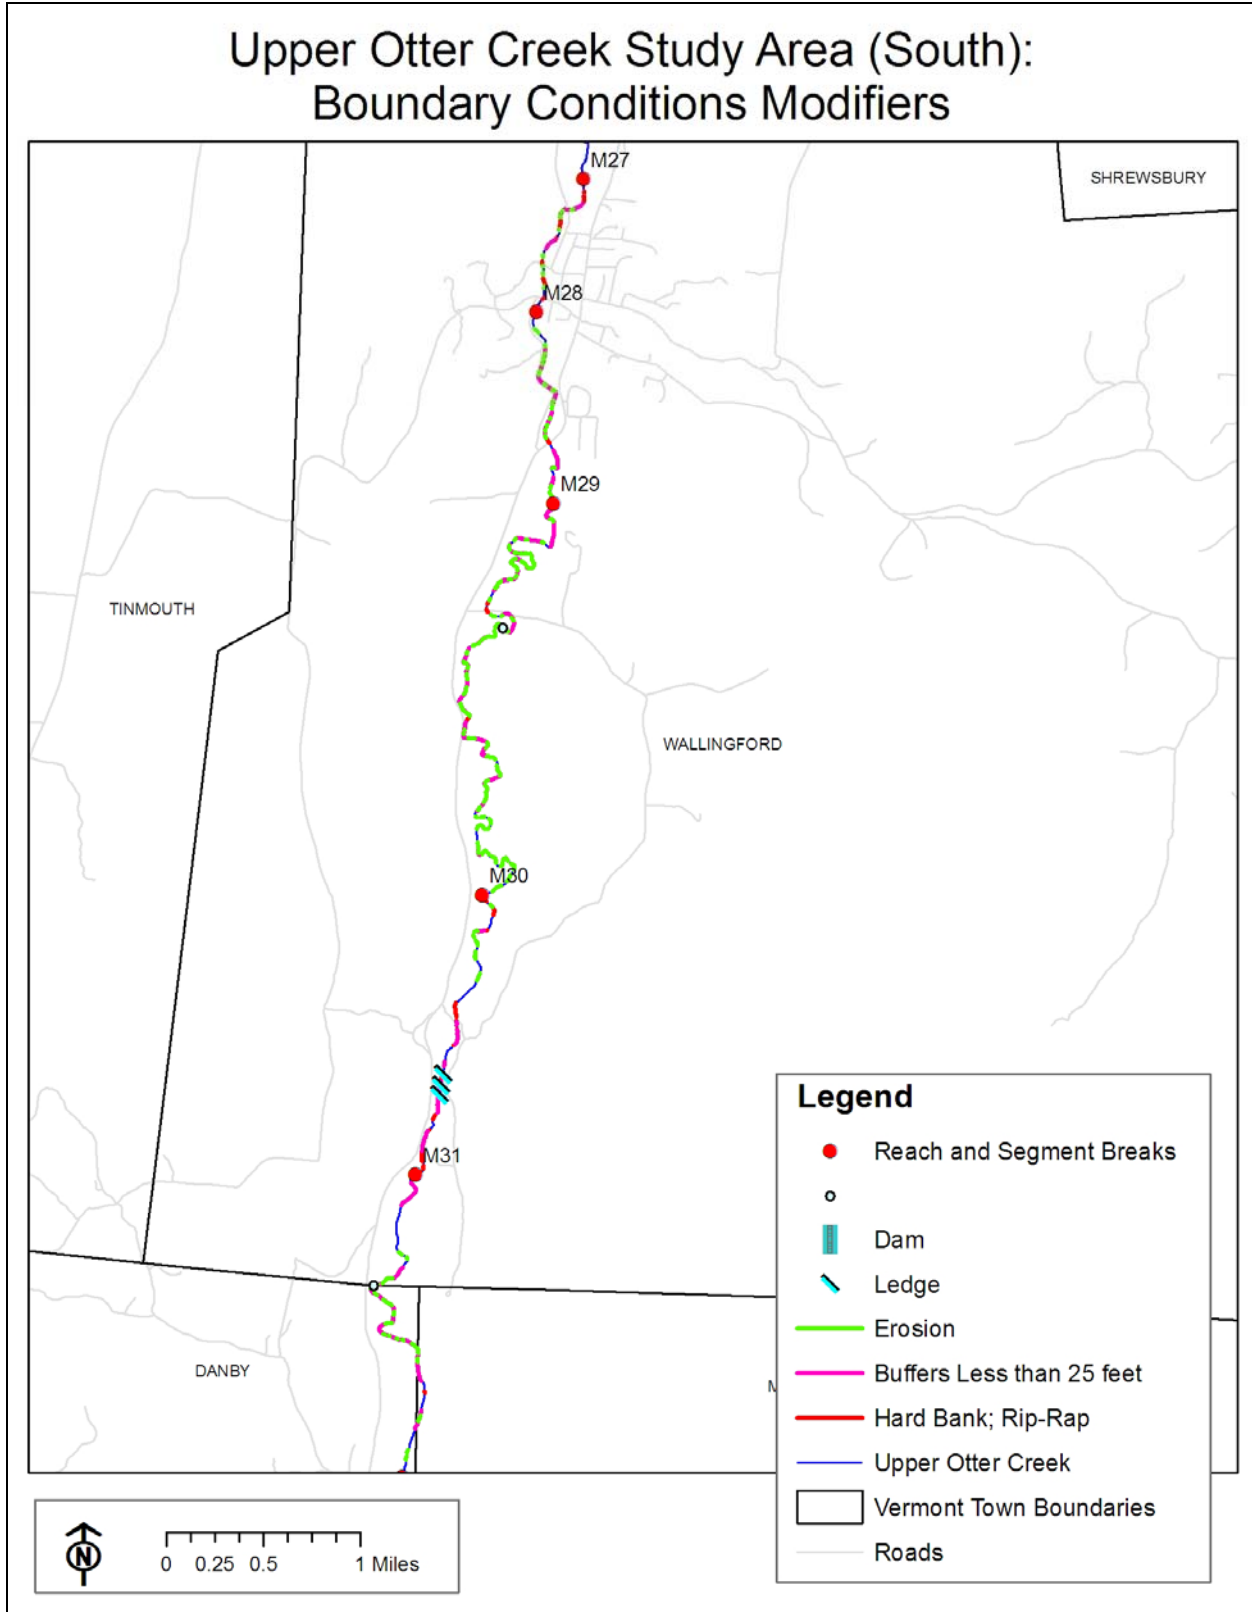
Figure 11: Boundary Condition Alterations: South Section of Upper Otter Creek (M31-M27)
