# Cambridge, Vermont Seymour River Corridor Plan

May 31, 2018

Prepared by:  
Bear Creek Environmental, LLC  
149 State Street, Suite 3  
Montpelier, Vermont 05602

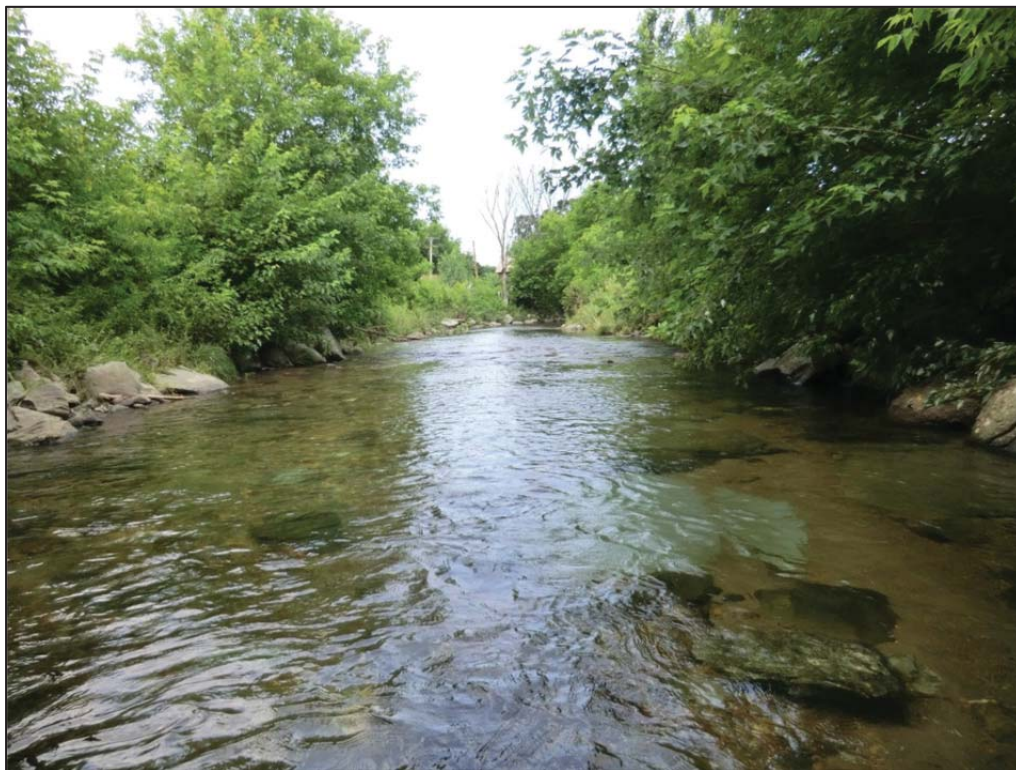
The upstream segment on reach M01 of the Seymour River is nearly 2,200 feet in length, spanning the distance from the Gates Covered Bridge at the downstream end to just above the Mansfield Avenue bridge at the upstream end. Access to this segment was denied by the landowner, so M01-B could not be fully assessed. Limited observations were recorded about the segment from the downstream segment and the Mansfield Avenue bridge. Lands to the east of the river in this section are primarily agricultural, while to the west is both agricultural and residential development in Cambridge Village. Based on limited observations of this segment, it appears that major historic incision has likely occurred here, resulting in a likely stream type departure and loss of floodplain access. Riparian buffer vegetation appears to be lacking for about half of the segment. This segment was given an administrative judgment of “fair” condition.

**Figure 5.2.** M01-B from the Mansfield Avenue bridge looking downstream.

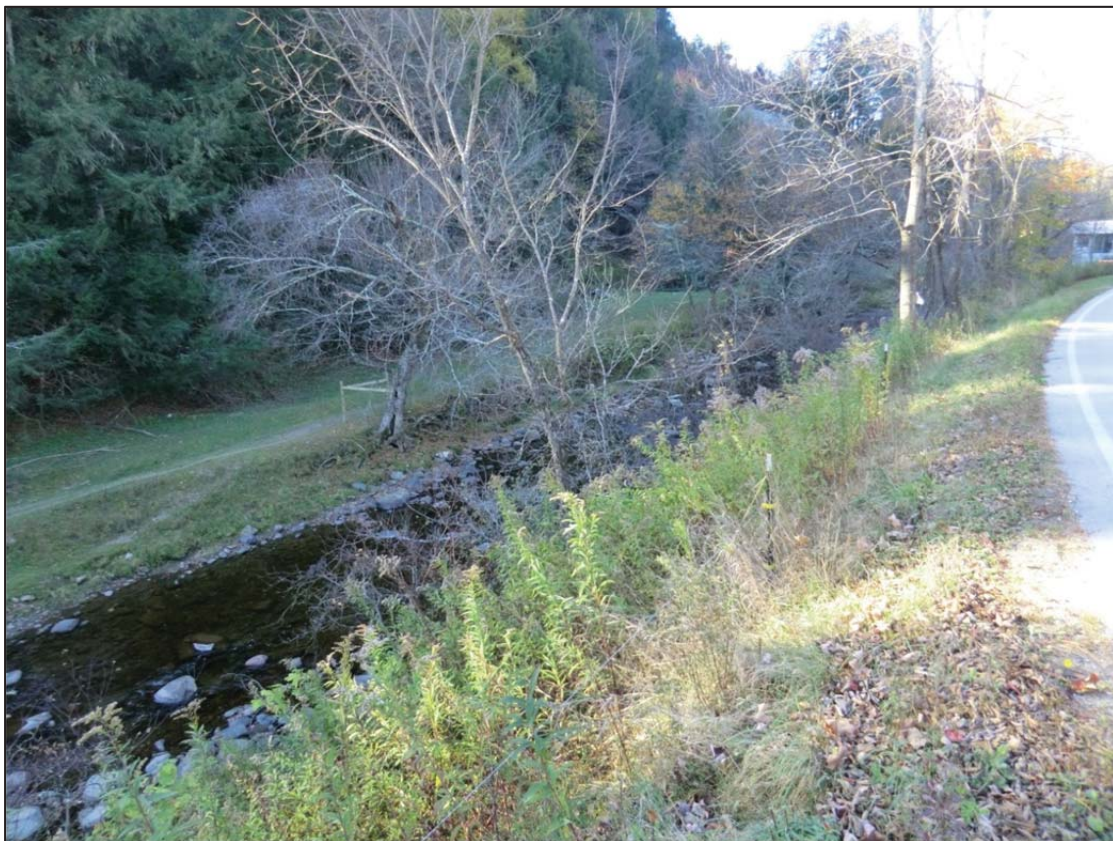
The second reach on the Seymour River is nearly 950 feet in length, extending from just above the Mansfield Avenue bridge downstream to upstream where the river valley opens up near the intersection of Lower Pleasant Valley Road and Bryce Road. Similarly to downstream, access to this reach was denied by the landowner, so a full Phase 2 assessment could not be completed. Observations were recorded from Lower Pleasant Valley Road to characterize the reach to the extent feasible. The river valley is naturally much narrower in this reach than it is above and below, and the river channel appears to be naturally straight as a result. Based on limited observations from the road, M02 appeared to be in a fairly stable state with minimal impacts (lacking riparian buffer vegetation and possible bank armoring) and did not appear to be undergoing major adjustments. The reach was given an administrative judgment of “good” condition.

**Figure 5.3.** View of reach M02 from Lower Pleasant Valley Road.

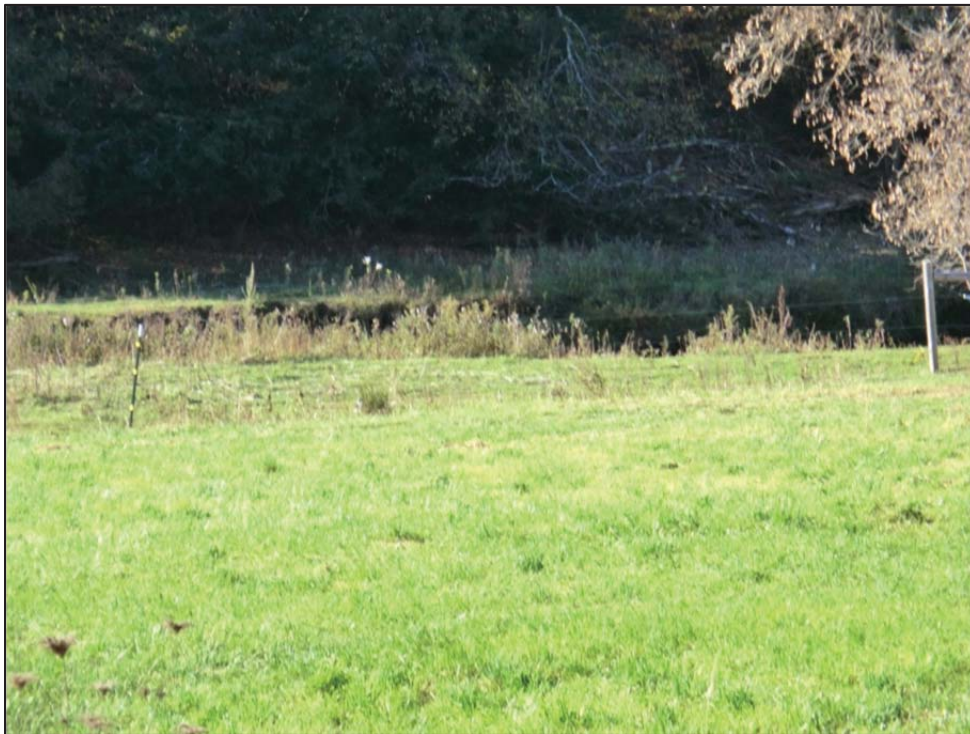
Reach M03 on the Seymour River flows through a very broad valley that is bisected by Lower Pleasant Valley Road on the east, reducing the functional width of the river valley to broad. Access to this reach was denied by the landowner, and, similarly to the downstream reaches, a full Phase 2 assessment could not be completed on M03. Limited data were collected from one observation point on Lower Pleasant Valley Road and through remote sensing analysis. Lands to the west of the river in this reach are primarily forested with possible pastureland at the downstream end. On the east, adjacent lands are primarily pasture, with a small section of forest at the upstream end of the reach. It appears that most of the reach may have been historically straightened as a result of adjacent land uses. Large bar features and lateral bank erosion were observed from the road, which suggests that the river may be in the process of widening with planform change. Riparian buffer vegetation is lacking in this reach, especially along the pasture on the eastern side of the river. These factors resulted in an administrative judgement of “fair” condition.

Figure 5.4. Looking west across the river from Lower Pleasant Valley Road.

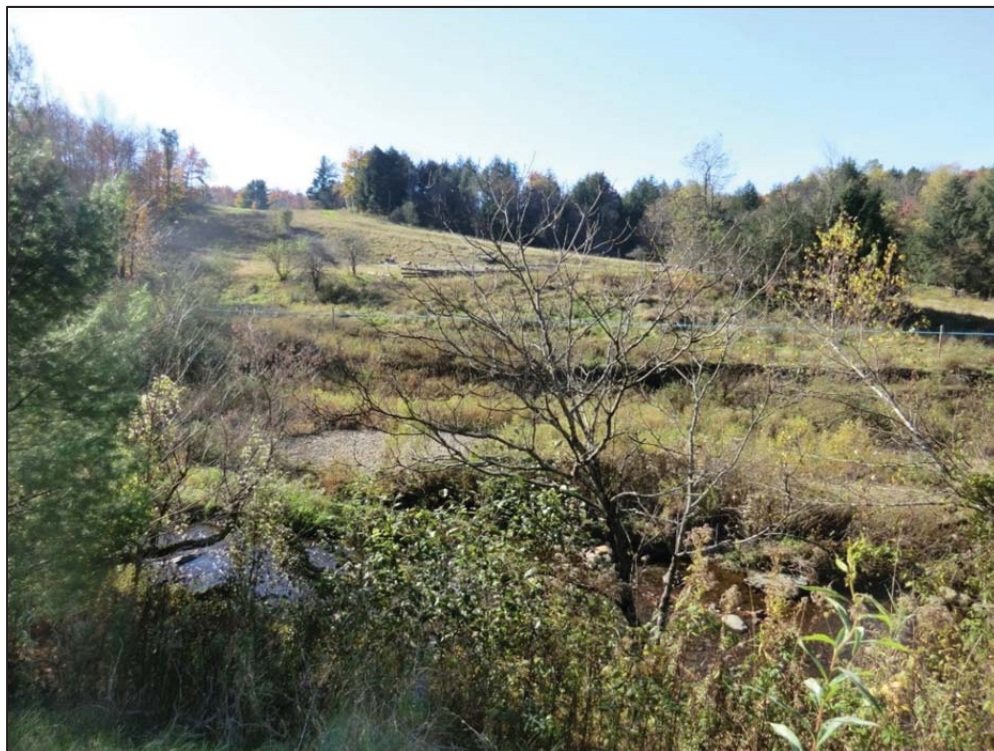
Reach M04 is nearly 1,500 feet in length, beginning in the vicinity of 611 Lower Pleasant Valley Road downstream and extending upstream to near 811 Lower Pleasant Valley Road. Access to conduct a Phase 2 assessment on this reach was denied by the landowner, so limited data were collected from an observation point on Lower Pleasant Valley Road and through remote sensing. The Seymour River flows through a broad valley in this reach and a mix of forested and pastured land. This reach appears to have been historically straightened for much of its length due to the presence of Lower Pleasant Valley Road on the eastern bank and pastureland on the west. Extensive bank erosion was observed from the road, which suggests that the river is undergoing widening in this reach, likely in response to historic incision. It is possible that a stream type departure has occurred within this reach due to historic incision, leading to loss of some floodplain access. Riparian buffer vegetation is lacking due to the adjacent pastureland. Taking into account the extensive bank erosion and the lack of vegetation along the channel, this reach was given an administrative judgment of “fair” condition.

Figure 5.5. View across Seymour River valley in reach M04 (looking east to west).

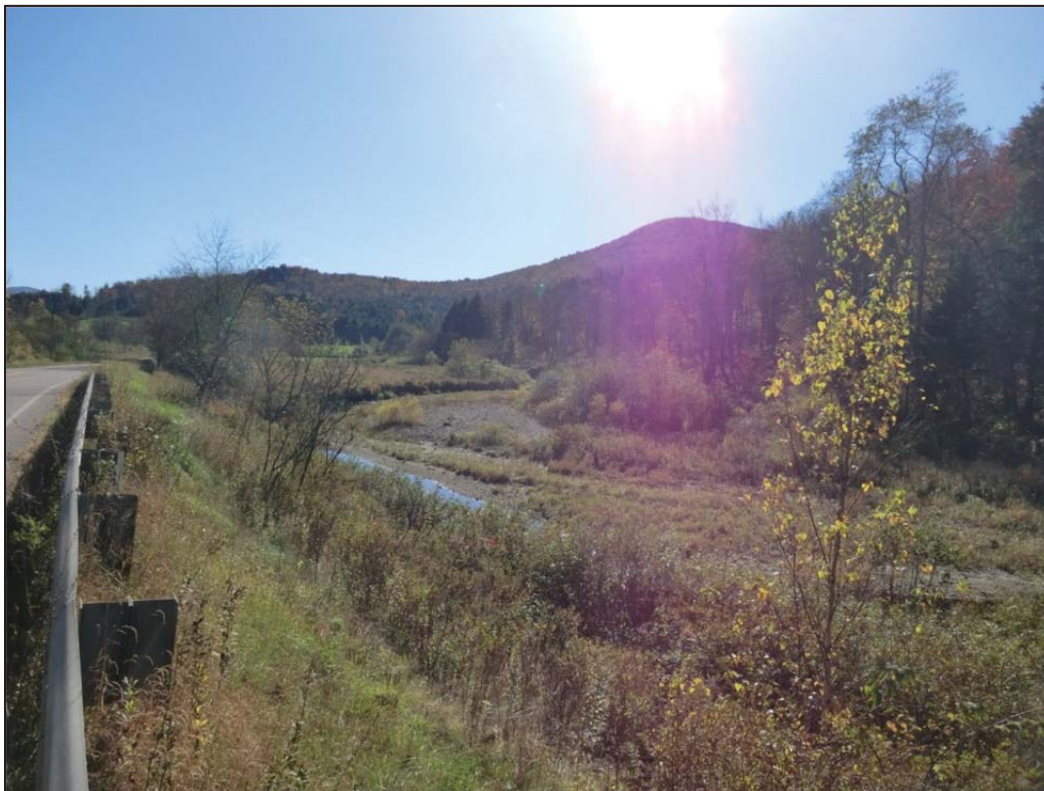
Reach five on the Seymour River is nearly 2,400 feet in length and extends from near 811 Lower Pleasant Valley Road downstream to roughly 600 feet below the first bridge on Lower Pleasant Valley Road upstream. This reach could not be fully assessed because the landowner denied access to the river on his property. Limited observations were collected from a vantage point on Lower Pleasant Valley Road, as well as through remote sensing. The river flows along agricultural land toward the upstream end of the reach and along Lower Pleasant Valley Road on the east and forested land along the west for the remainder for the reach. The upstream half of the reach has a more sinuous planform than the downstream half, which is fairly straight. Where the river meanders, there are large depositional features and the river banks are low. Both the channel and valley are narrower in the downstream half of the reach than upstream. Riparian buffer vegetation is lacking for some sections of this reach. This reach was given an administrative judgment of “fair” condition.

Figure 5.6. Reach M05 looking southwest from Lower Pleasant Valley Road.

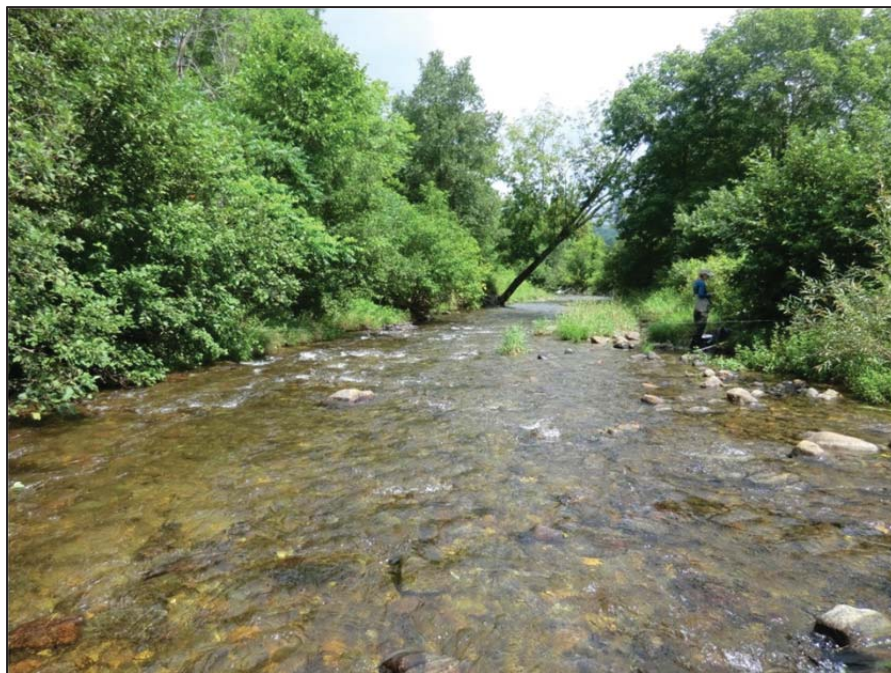
The downstream segment in reach M07 is just over 1,700 feet in length, extending from 1867 Lower Pleasant Valley Road downstream to where the valley narrows significantly upstream. The river valley is broad in this segment and surrounding lands are agricultural and residential. Roughly one third of this segment appears to have been historically straightened due to adjacent land uses. Three ledge grade controls were documented in this segment, which afford the river vertical stability. Moderate historic incision was measured within this segment. It is likely that the channel incised down to bedrock, however, future incision is limited due to the presence of this bedrock. No major adjustment processes were notes for M07-A, and as such, it was placed in **good** geomorphic condition. The segment was placed in **fair** habitat condition as a result of lacking large woody debris in the channel, as well as reduced bank and buffer vegetation.

Figure 5.9. Looking downstream at cross section in M07-A.

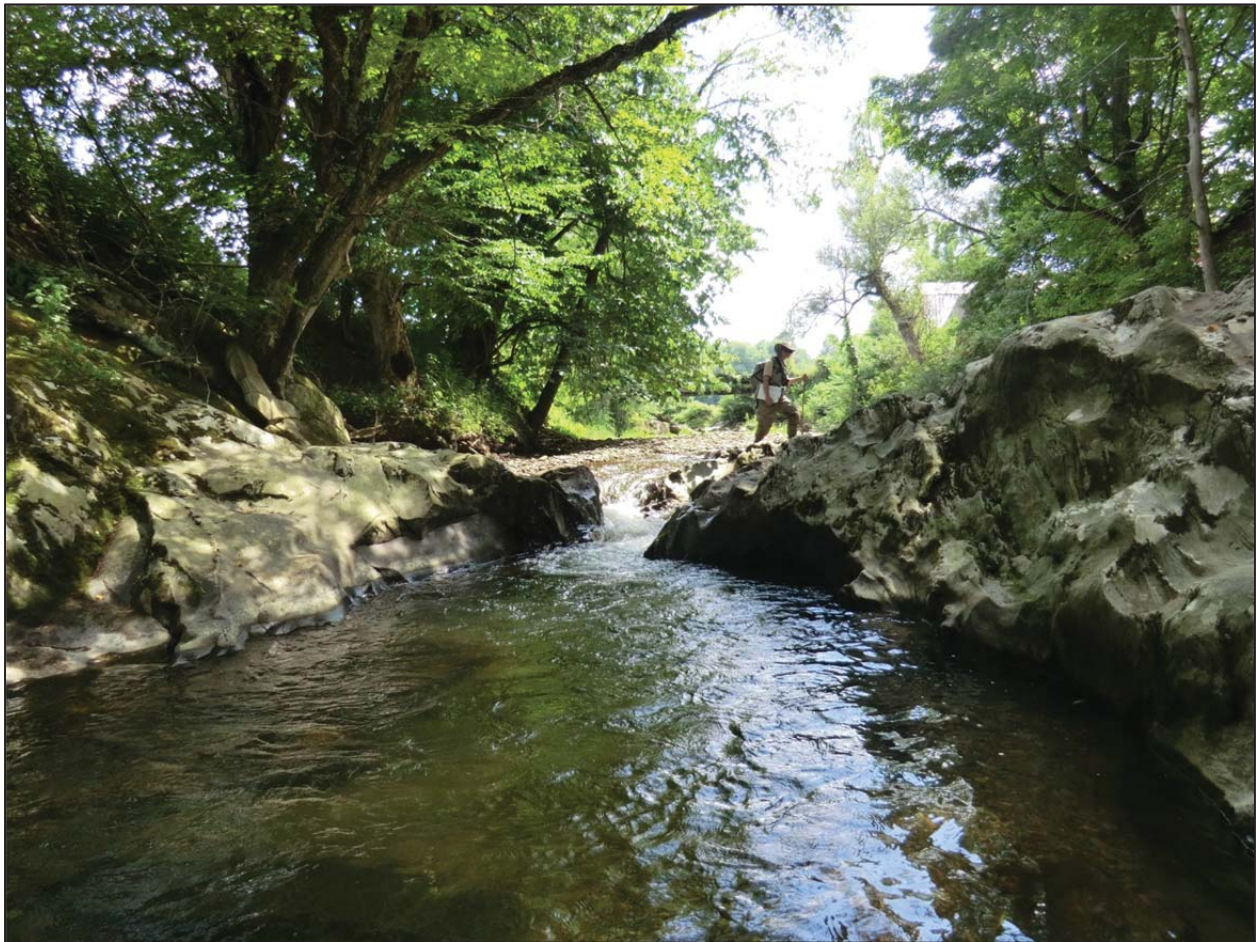
The upstream segment on reach M07 of the Seymour River is nearly 800 feet in length. The river flows through a bedrock gorge in this segment and, for this reason, could not be fully assessed. The river valley is semi-confined in this segment and bedrock grade controls are common. Impacts within this segment are minimal, but include areas where riparian buffer vegetation is lacking. Overall, this segment is very stable as a result of its narrow valley and bedrock-dominant substrate.

**Figure 5.10.** Bedrock grade control in M07-B.

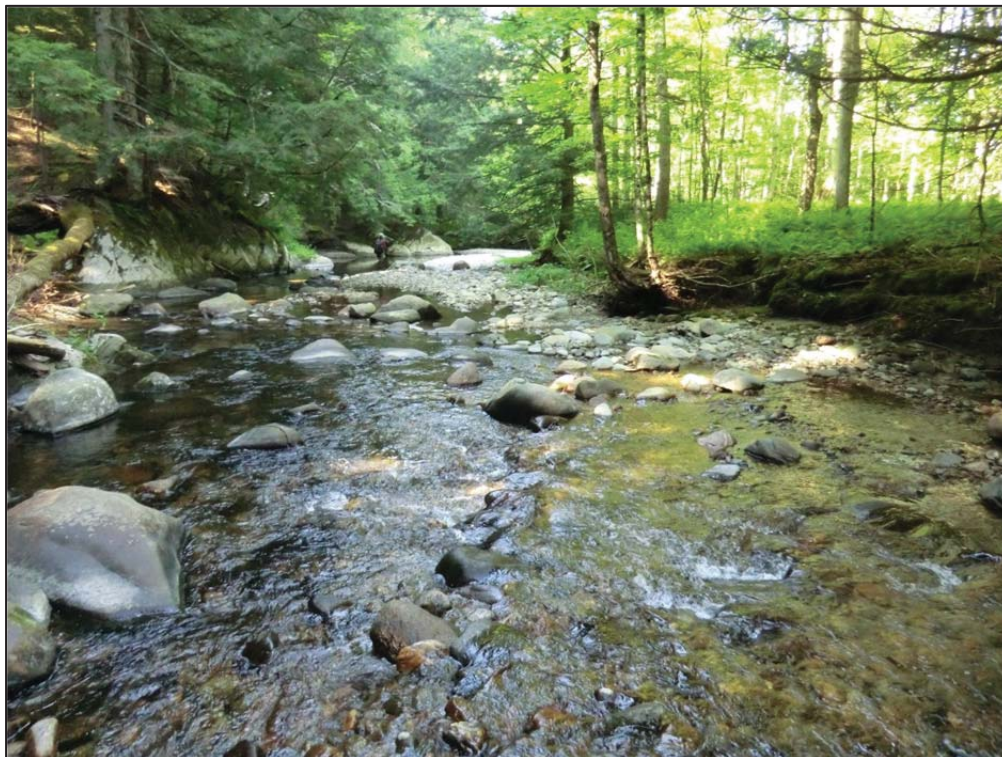
The upstream segment on reach M08 is characterized by having a relatively natural planform. The river flows through the woods in the vicinity of West Hill View Drive for just over 1,200 feet in this segment. Very few impacts were recorded in this segment. Moderate historic incision was measured at the cross section. The river is fairly depositional and has a wide channel for most of this segment. The river valley is wide for the upper portion of the segment, but pinches in dramatically at the downstream end for a very short lived narrow bedrock section. Immediately below this bedrock area, the valley opens back up again in the next segment downstream. Some planform change was noted within this segment, primarily as flood chutes on bars. M08-B was placed in **fair** geomorphic condition as a result of active adjustments occurring. The river has an abundance of woody debris, instream cover for fish, good floodplain connectivity, and well forested banks and buffers in this segment. For these reasons, M08-B is in **good** habitat condition.

**Figure 5.12.** The Seymour River flows through a well forested area with minimal impacts in M08-B.

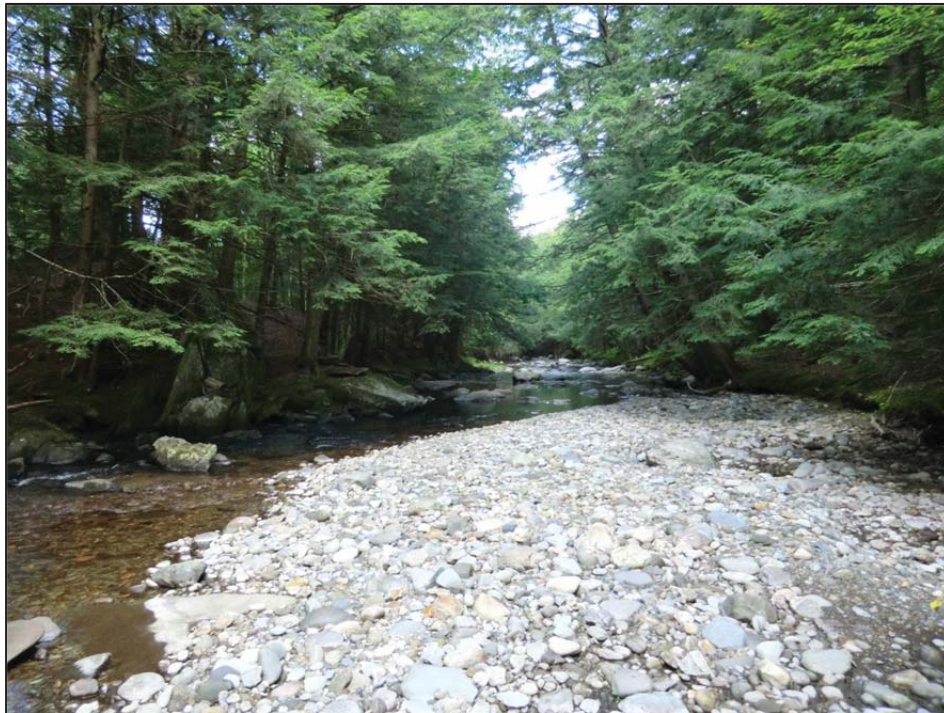
Reach nine on the Seymour River is nearly 3,200 feet in length and flows through a broad valley in the vicinity of Hidden Valley Drive and West Hill View Drive in Cambridge. Adjacent lands to the river in this reach are primarily forested and minimal human impacts to the river and river corridor were recorded. There is one house on the western bank of the river toward the upstream end of this reach where bank armoring and an impacted riparian buffer were observed. Overall, this reach is very stable. It is located immediately downstream of a bedrock gorge and upstream of a bedrock grade control in M08-A, both of which afford the river vertical stability in this reach. Natural entrenchment was measured at the cross section for M09 and a higher terrace exists along one side of the river for much of this reach. Active adjustments were not documented during the Phase 2 assessment of M09. For this reason and its apparent stability, the reach was placed in **good** geomorphic condition. Additionally, this reach provides high quality habitat for aquatic organisms, including ample large woody debris, a diversity of bed features, and well forested banks and buffers. For these reasons, M09 is also in **good** habitat condition.

**Figure 5.13.** M09-A flows through the woods largely away from human impacts.

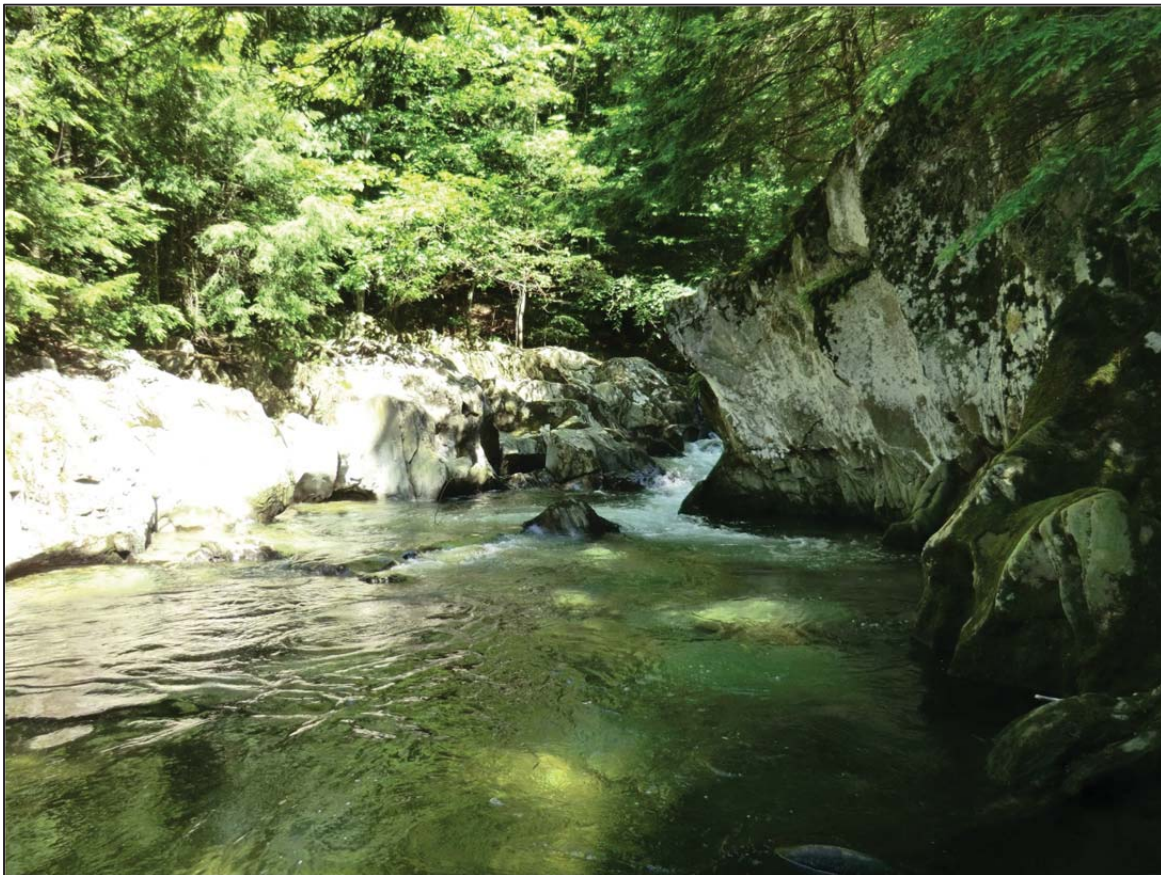
The downstream segment on reach M10 is very short, only 360 feet in length. This segment is a bedrock gorge. The river flows through a semi-confined valley in this segment, and bedrock cascades are the dominant bedform. The abundant bedrock on the streambed and banks makes this segment extremely stable. An administrative judgement for geomorphic condition of **reference** was assigned to this segment.

**Figure 5.14.** M10-A is a bedrock gorge and is very stable.

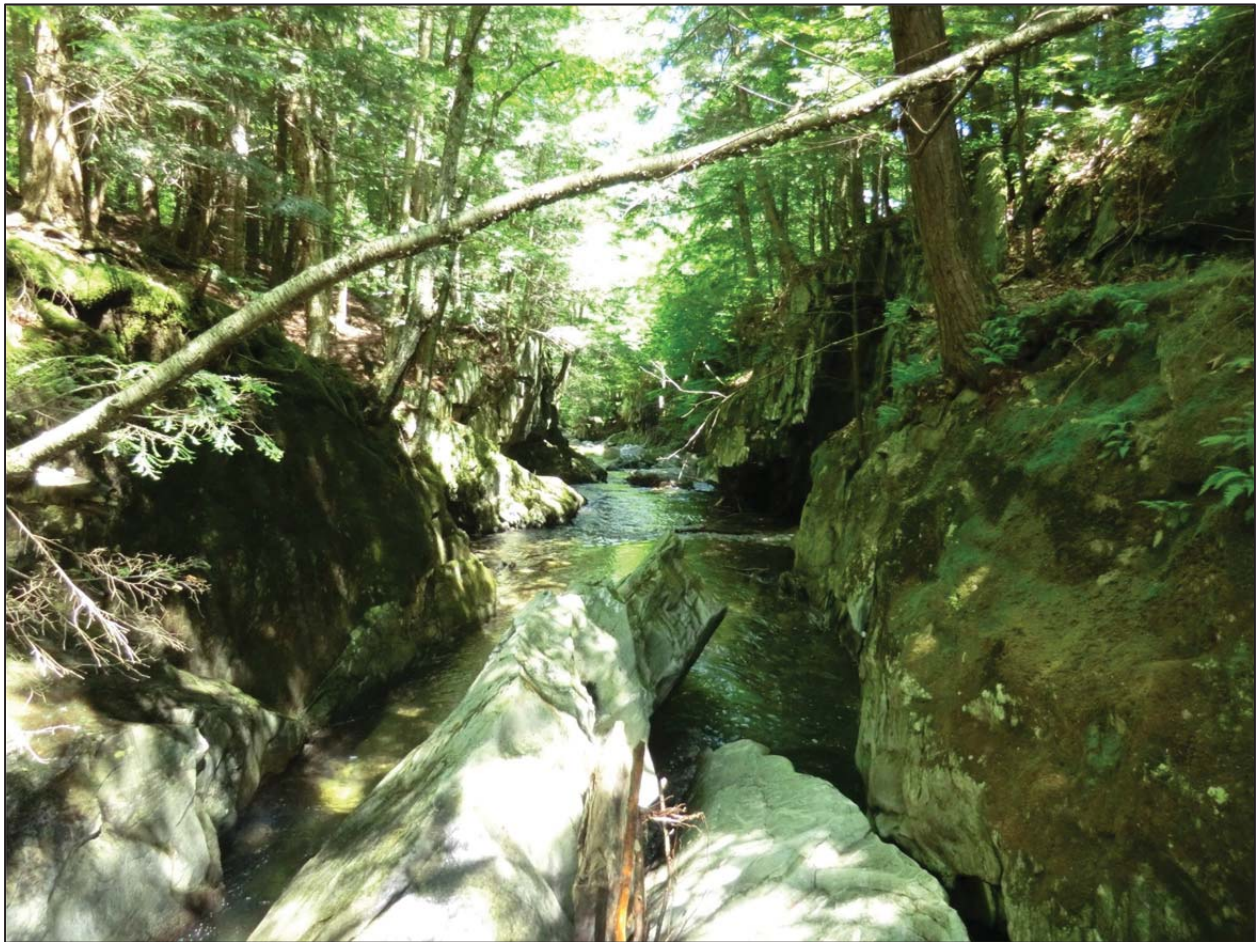
Reach 11 on the Seymour River is a bedrock gorge, and thus was not fully assessed. The river flows for just under 1,000 feet through the woods from just below the Lower Pleasant Valley Road bridge downstream and the intersection of Lower and Upper Pleasant Valley Road upstream. The river flows through a semi-confined valley in this reach and has a dominant bedform of bedrock cascades. Although it was not assessed, an administrative judgement geomorphic condition of **reference** was assigned to M11 due to its extremely stable nature.

Figure 5.16. M11 is a bedrock gorge.

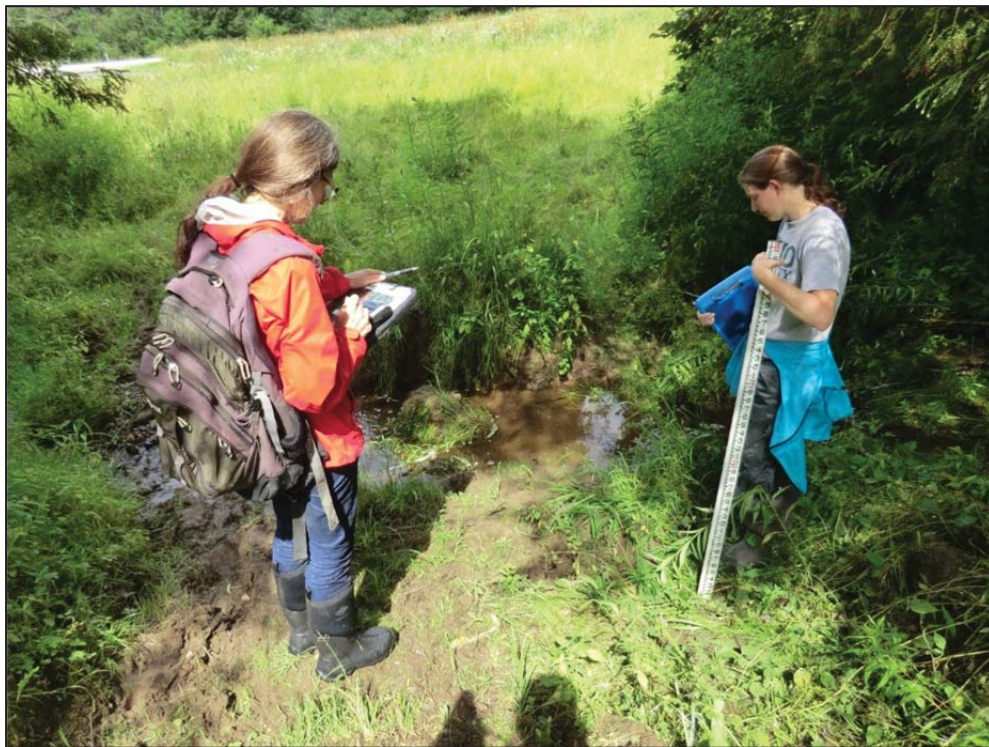
Reach one on this unnamed tributary is located about 0.45 miles south of the junction of Bryce Road and Lower Pleasant Valley Road at the base of the subwatershed. The reach is only 375 feet in length, flowing through mostly residential and agricultural lands in the vicinity of 611 Lower Pleasant Valley Road. The last 100 feet of this 375 foot long reach could not be assessed due to lack of landowner permission. In general, this very small channel had a buffer of less than 25 feet on the north side for most of its length and for a short stretch on the south as well. This segment could be enhanced by widening the buffer where it is lacking on one or both sides of the channel. An animal crossing was observed at the upstream end of this reach.

**Figure 5.21.** Animal crossing at upstream end of M04S1.01.

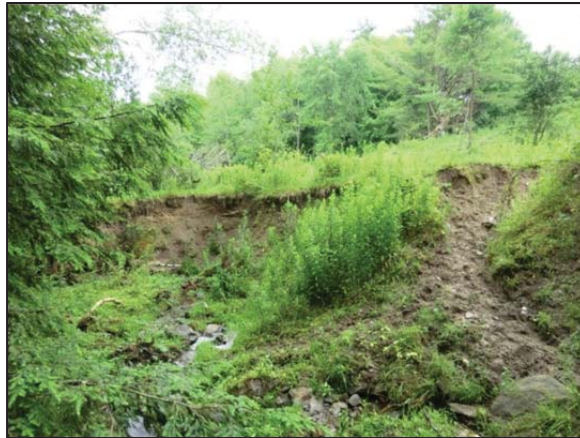
The middle segment on reach M04S1.02 is just over 500 feet in length and flows through a pastured and wooded area between Bryce Road and Lower Pleasant Valley Road. This segment has a considerable amount of erosion along the stream banks. Approximately 50 percent of the south bank is eroded, while 80 percent of the north bank is eroded. The dominant corridor land use is pasture along each side of the channel. There are a couple of measures that would improve channel and bank stability in this segment. First, livestock exclusion would allow the buffer to rejuvenate; thereby, improving channel and bank stability. Stream crossings could be eliminated or improved. In particular, the tractor crossing could be stabilized to reduce erosion and sedimentation. A gully on the north side of the channel that appears to originate at Bryce Road should be investigated.

**Figure 5.23.** Severe bank erosion was documented along both banks in M04S1.02-B.

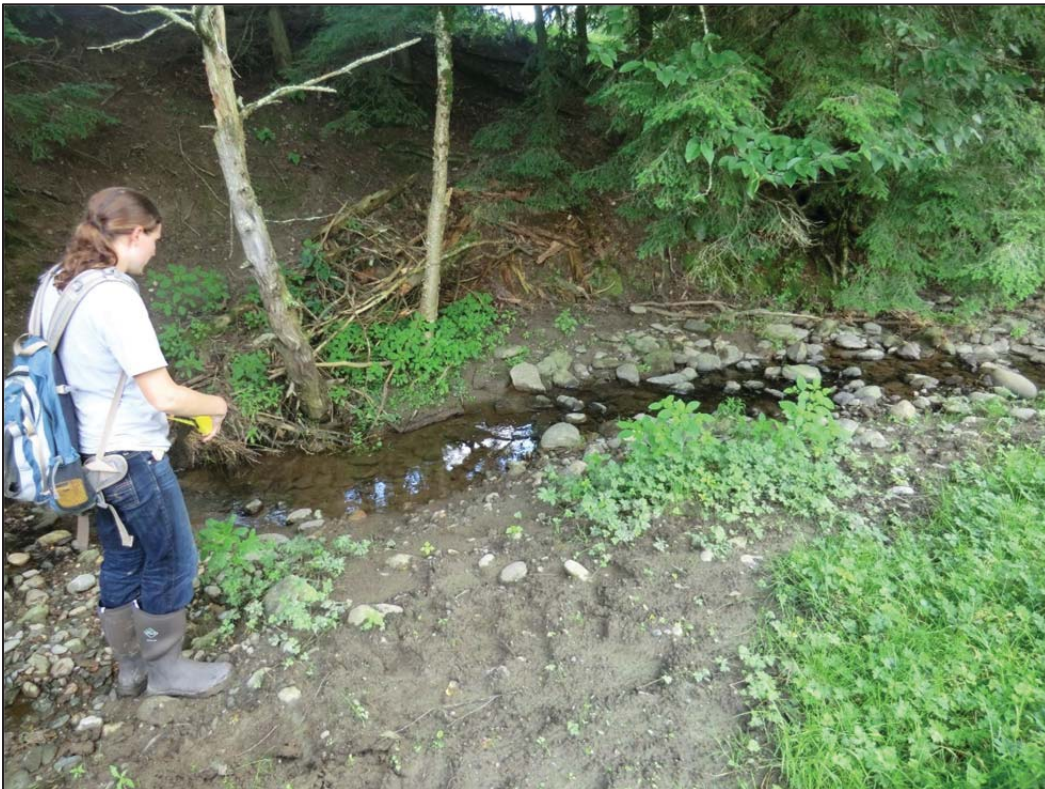
Reach one on tributary 1 to M06 is just over 400 feet in length and flows through primarily pastured land. Impacts noted in this short reach were minimal, but included some channel straightening and lacking riparian buffers due to adjacent land uses. Opportunities for improvement in this reach include planting native trees and shrubs in the riparian buffer zone on the north side of the stream where vegetation is currently lacking.

**Figure 5.25.** Small stream channel in M06S1.01.

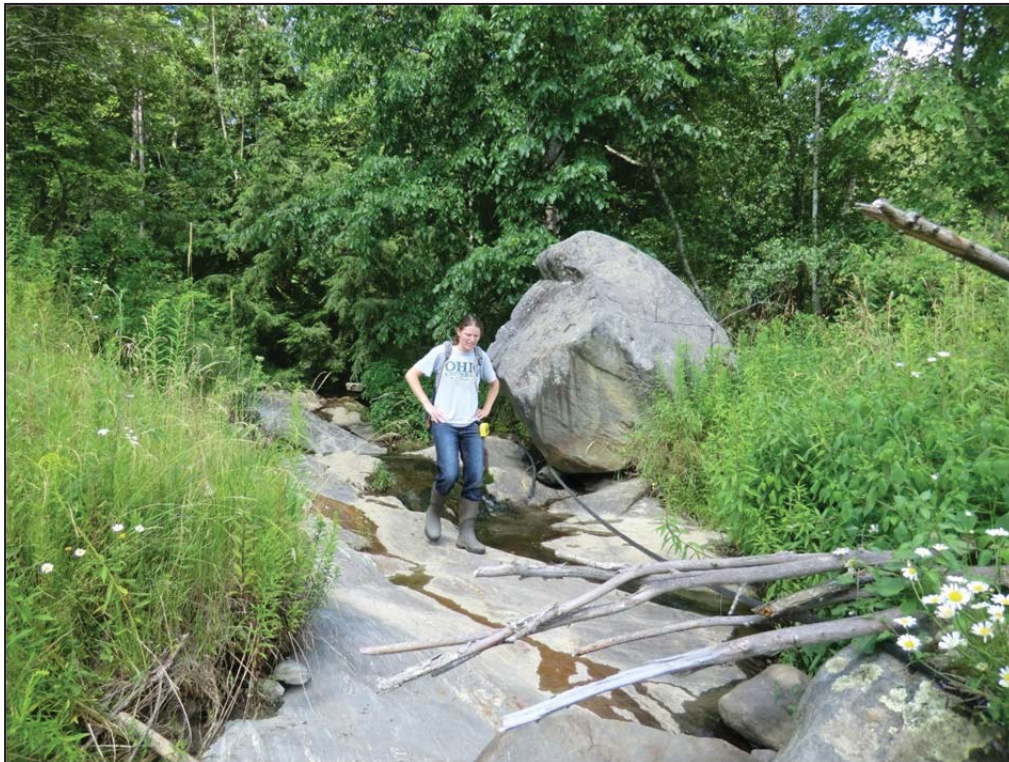
The downstream most segment on M06S1.02 is nearly 600 feet long and flows through primarily agricultural land (pasture and hay). The upper end of this segment is located approximately 1,300 feet downstream of Bryce Road. Clay substrate was observed in areas of bank erosion during the walkover. There is a large bedrock grade control (estimated 100 feet long) at the upstream end of the segment offering some vertical stability to the channel in and above this segment. At the downstream end of the segment, an active headcut was observed just downstream of a stream ford. Opportunities for improvement in this segment include investigating methods for arresting the active headcut and planting vegetation in areas where the riparian buffers are lacking.

**Figure 5.26.** Bedrock grade control at upstream end of M06S1.02-A.

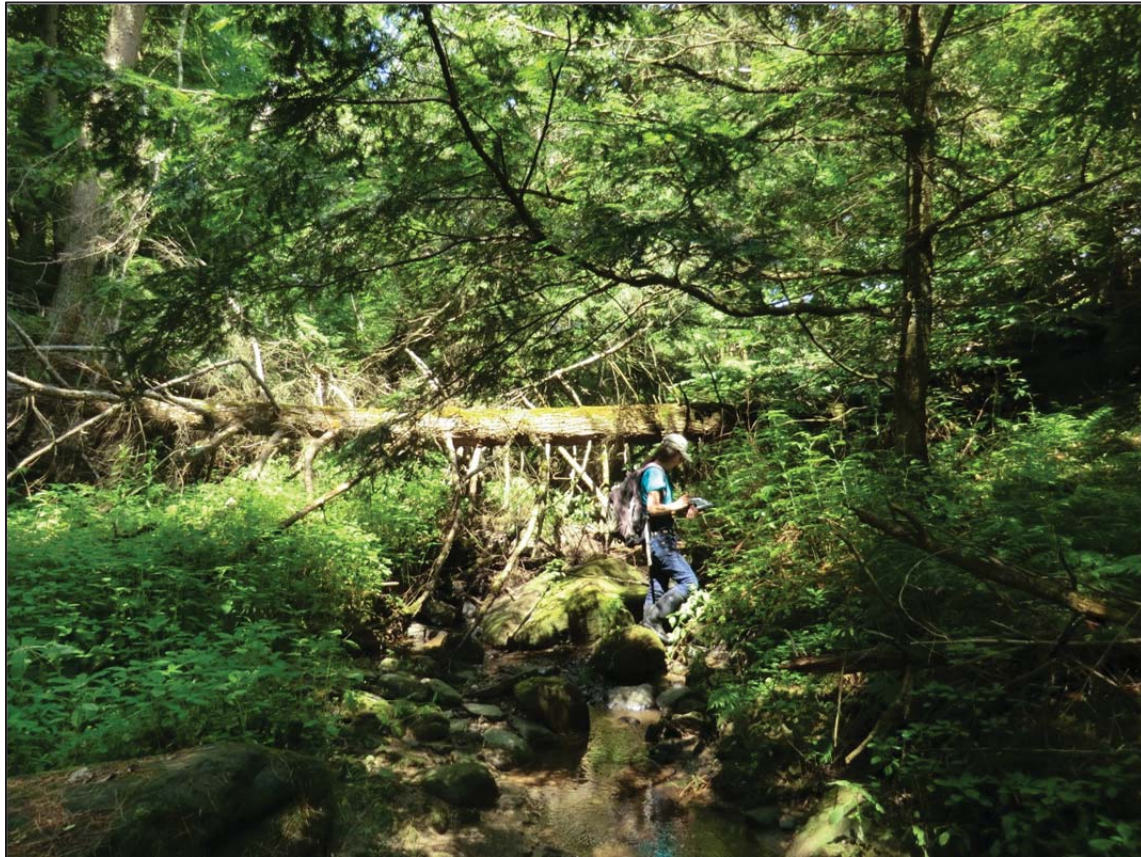
The second segment on reach two of unnamed tributary 1 to M06 is just over 550 feet long and flows through a wooded section between Bryce Road and Lower Pleasant Valley Road. Few impacts were documented in this segment during the stream walkover. Three small mass failures as well as some minor bank erosion were observed in this segment. Two debris jams create nice habitat and well forested buffers shade the stream channel.

**Figure 5.27.** M06S1.02-B has well forested buffers and debris jams.

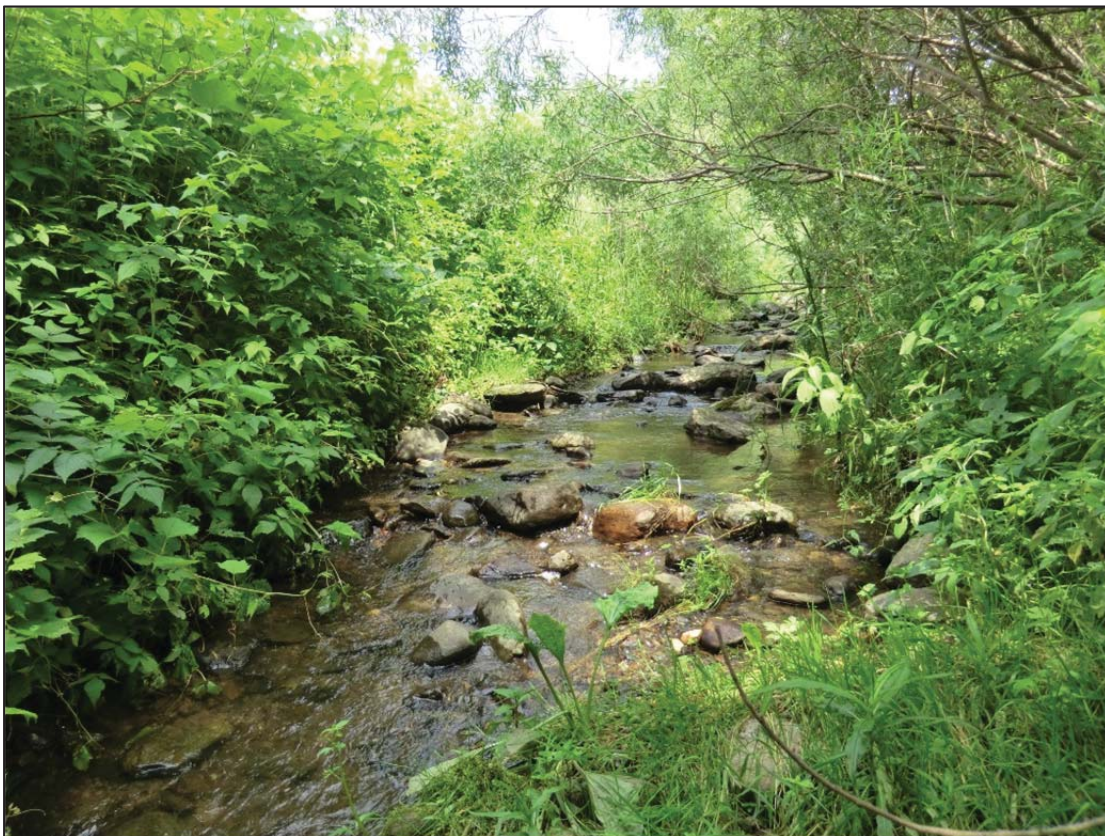
Reach one on tributary 2 to M06 flows for approximately 650 feet through agricultural land before meeting the Seymour River. This reach appears to have been historically straightened for its entire length due to adjacent land uses. A stream ford for vehicles and an animal stream crossing were observed at the upstream end of this reach. Riparian buffers are lacking on both banks for about half of the reach. The reach would benefit from establishing a “no mow” zone in the adjacent pastures to allow the riparian buffer to regenerate where it is currently lacking.

**Figure 5.30.** View looking upstream in M06S2.01.

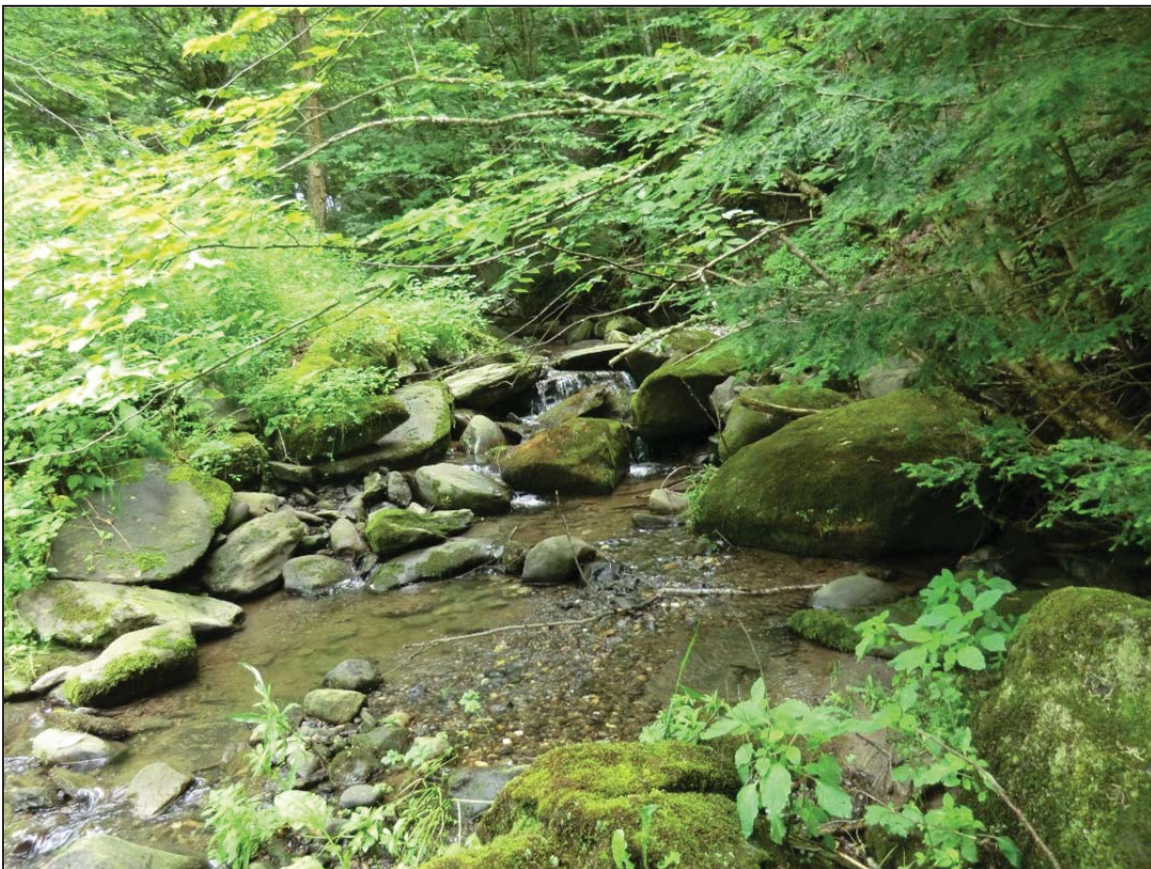
The downstream most segment on reach two is just over 700 feet long and flows through a wooded section. This segment has a steeper slope and narrower valley than the upstream segments. The stream banks are very steep and erosion is common along the north bank. There is one mass failure on the south bank in this segment. A gully exists coming off of the north bank that is likely a source of sediment to the stream.

**Figure 5.31.** The channel is steeper and has larger substrate in M06S2.02-A than surrounding segments.

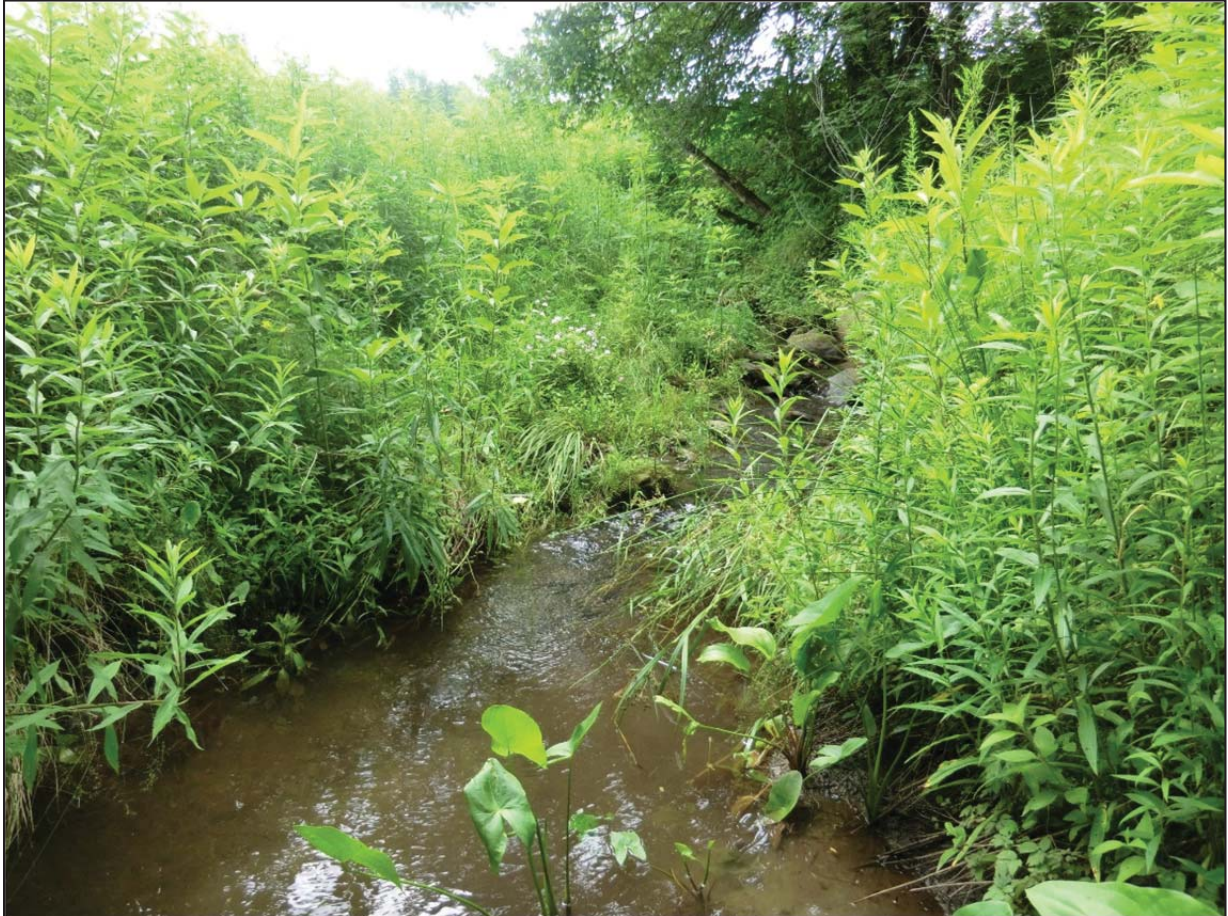
Reach three on tributary 2 to M06 is nearly 2,300 feet long and was not segmented during the stream walkover. It begins downstream just below the Bryce Road culvert and extends upstream to just above the Pratt Road culvert. For most of the length of this segment, the stream flows through a wetland channel. Other than lacking buffer vegetation, few impacts were noted to this segment. Most of the lacking buffer is due to Upper Pleasant Valley Road running along the stream in this reach.

**Figure 5.34.** There are extensive adjacent wetlands along M06S2.03.

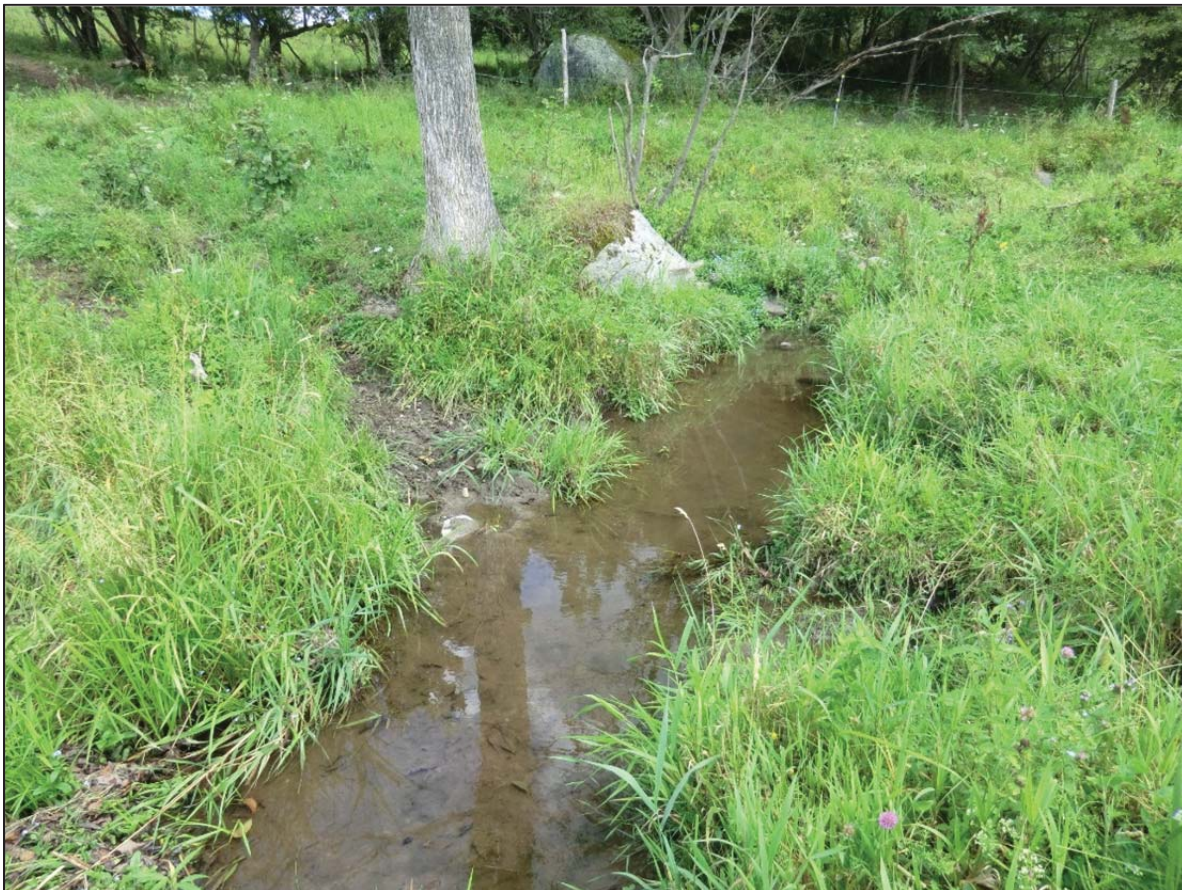
The downstream segment on reach M06S3.01 is nearly 900 feet long and flows through agricultural land. The brook in this segment appears to have been extensively historically straightened and is lacking riparian buffers on both banks for its entire length. Four animal stream crossings are present at the upstream end of the segment and are contributing to instability of the streambanks in this location. Toward the lower end of the segment, the channel becomes a grassed ditch.

**Figure 5.35.** One of four animal stream crossings in M06S3.01-A.
