# Cambridge, Vermont Seymour River Corridor Plan

May 31, 2018

Prepared by:  
Bear Creek Environmental, LLC  
149 State Street, Suite 3  
Montpelier, Vermont 05602

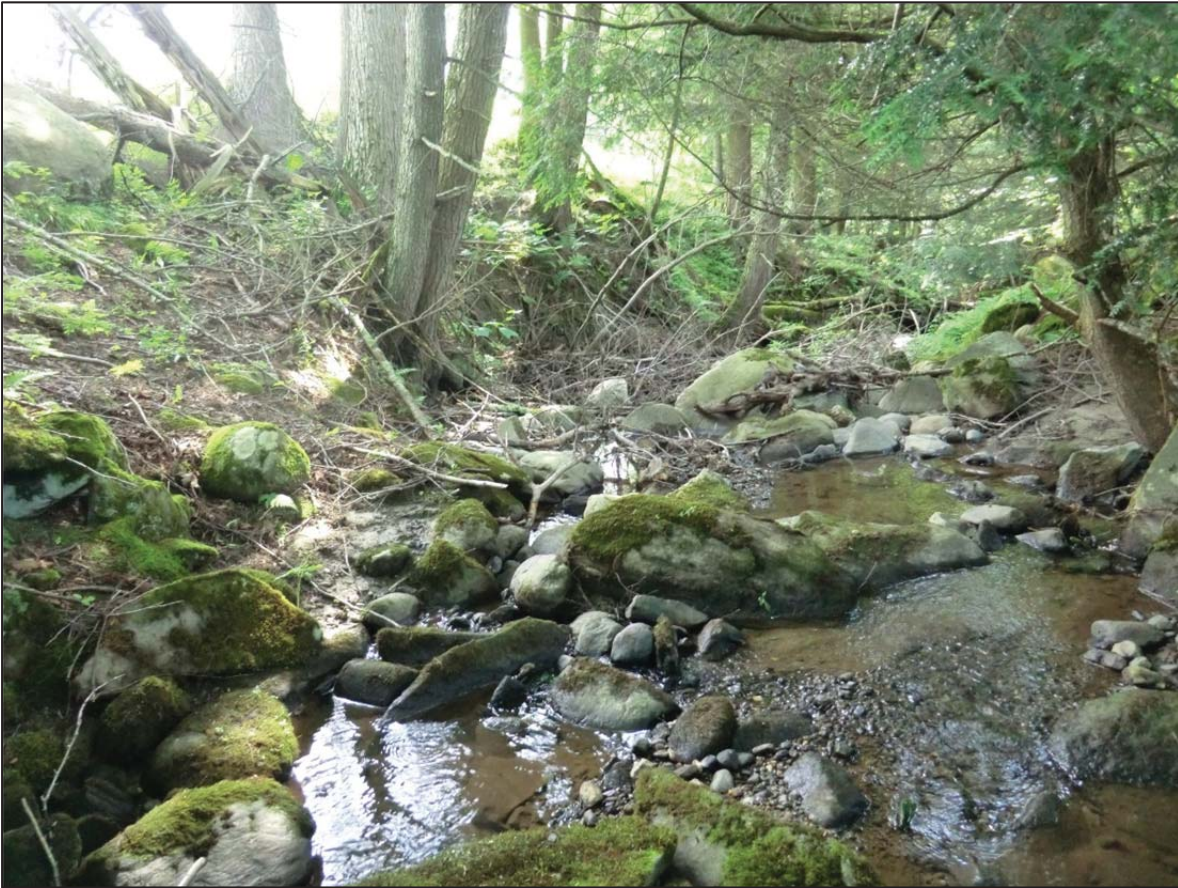
The second segment on tributary 3 to M06 is 375 feet long and flows through a small section of woods within pastured land. Bank erosion is common in this segment, especially on the south bank, and one mass failure was observed during the stream walkover. One animal stream crossing was documented at the downstream end of the segment and is contributing to localized instability there. Overall, buffers are forested in this segment though there are short sections of lacking buffer at the upstream and downstream ends of the segment.

**Figure 5.36.** Downstream channel photo in M06S3.01-B.

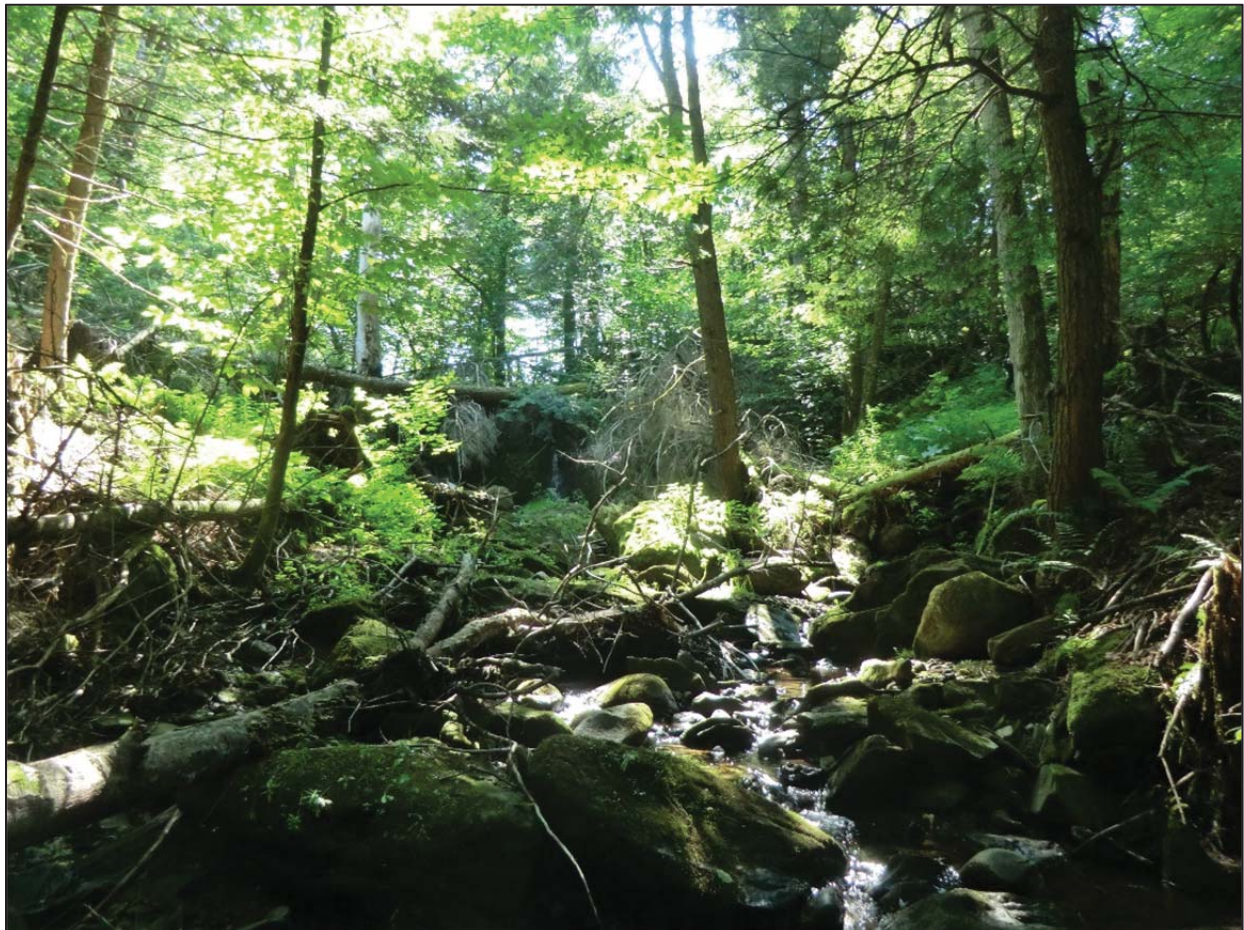
The downstream segment on this reach is nearly 800 feet in length, flows through forested land, and is naturally entrenched. Two bedrock grade controls were observed within this segment during the field work.

**Figure 5.38.** M07S1.03-A flows through the woods and is naturally entrenched.

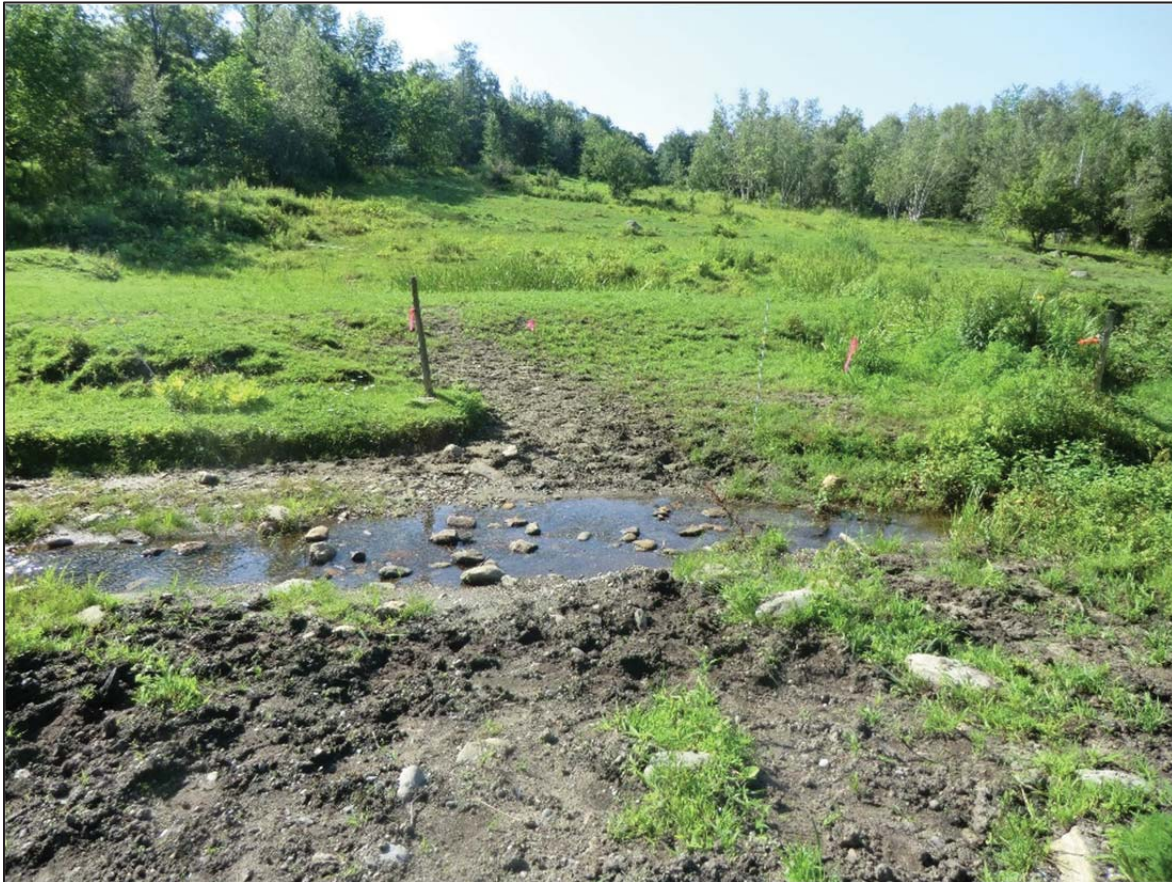
The upstream segment on this reach has a flatter slope and narrow channel. It flows for nearly 500 feet through agricultural land and appears to have been historically straightened for most of its length. Bank erosion was nearly continuous along both banks in this segment at the time of the stream walkover. This erosion appears to be related to lacking riparian vegetation and grazing activities along the banks of the stream. Two animal stream crossings are contributing to instability in this segment.

**Figure 5.39.** One of two animal stream crossings present in M07S1.03-B.

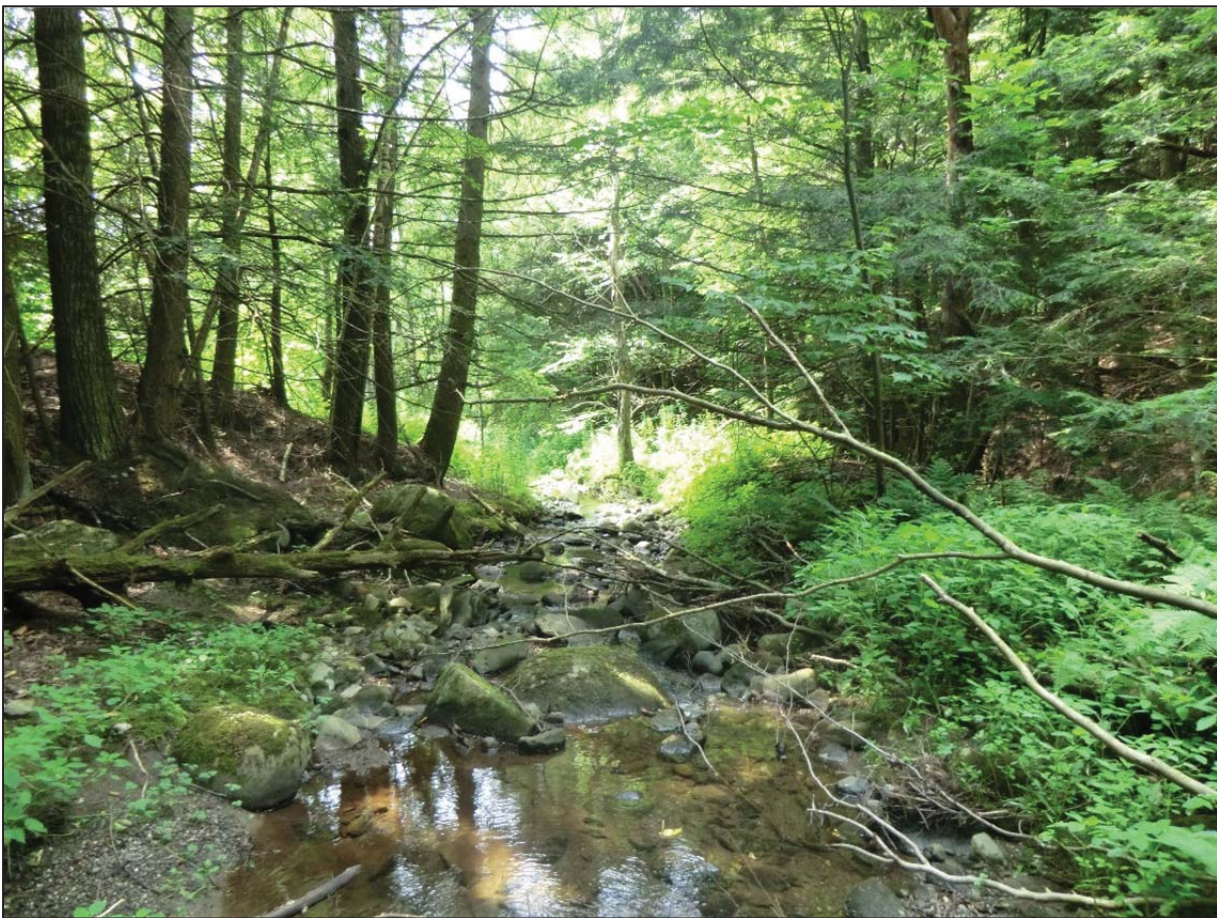
Reach one on this tributary is nearly 800 feet in length and flows through the woods to the Seymour River. Overall, the stream channel is stable in this segment and riparian buffers are well forested. Very few impacts were observed during the stream walkover.

**Figure 5.40.** M10S1.01 is stable and has well forested banks and buffers.

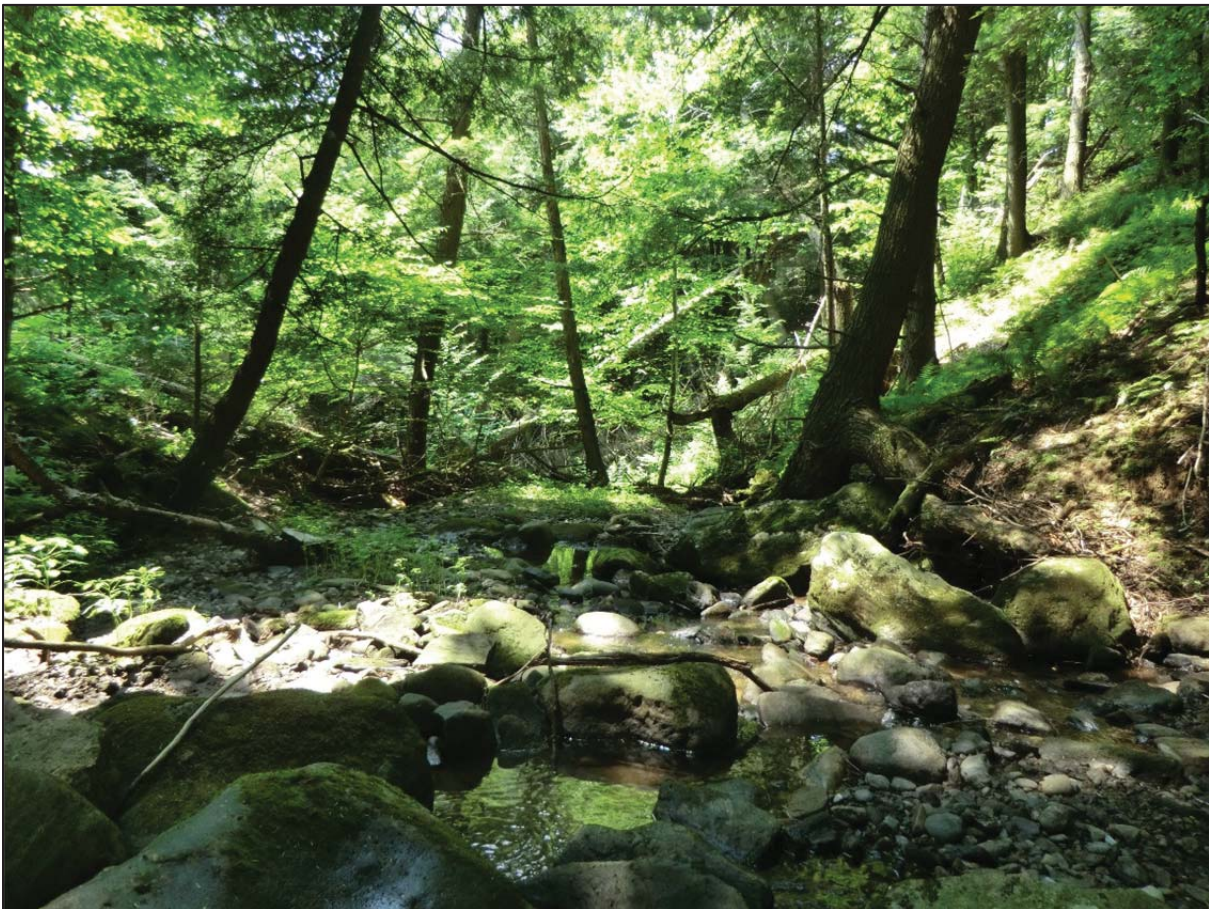
The downstream segment on reach two of trib 1 to M10 is roughly 1,500 feet long. It flows through the woods and has a narrower valley width than the surrounding segments. In general, this segment is very stable and minimal impacts were observed. Some minor bank erosion was noted that may be related to grazing activities on adjacent pasture land to the south of the stream. Riparian buffers in this segment are well forested, though a short section of lacking buffer is present on the south side where the pastureland exists.

**Figure 5.41.** M10S1.02-A is stable and has well forested banks and buffers.

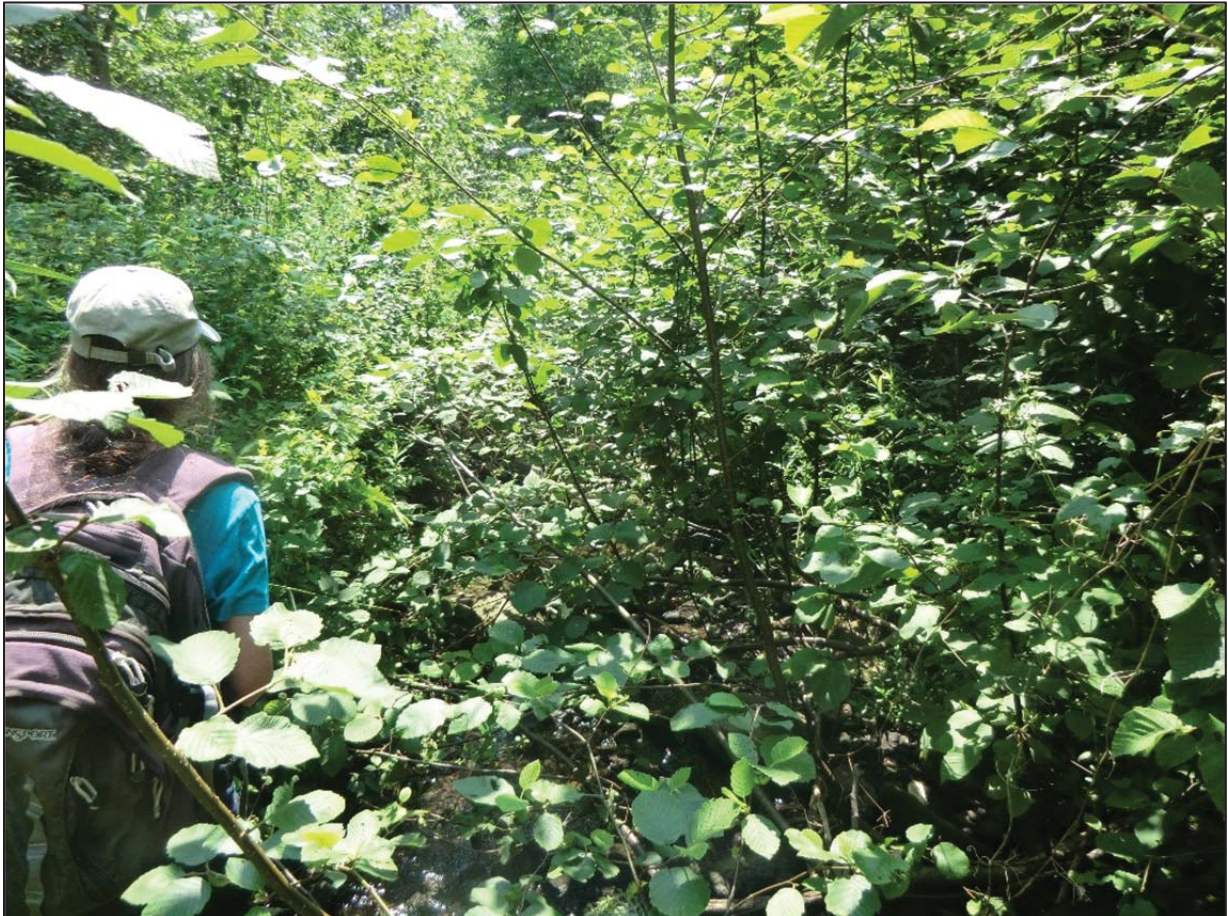
The upstream segment on this reach is nearly 1,000 feet long and has a flatter slope and wider valley than the segment below. Adjacent lands are covered by shrub/sapling vegetation, with an intact riparian buffer on the south side of the channel and a regenerating buffer on the north. Overall, the stream was noted to be stable and no bank erosion was observed. Two culverts are present within this segment and both are significantly undersized and likely pose barriers to aquatic organism passage.

**Figure 5.42.** Dense shrub/sapling vegetation covers the banks for much of M10S1.02-B.

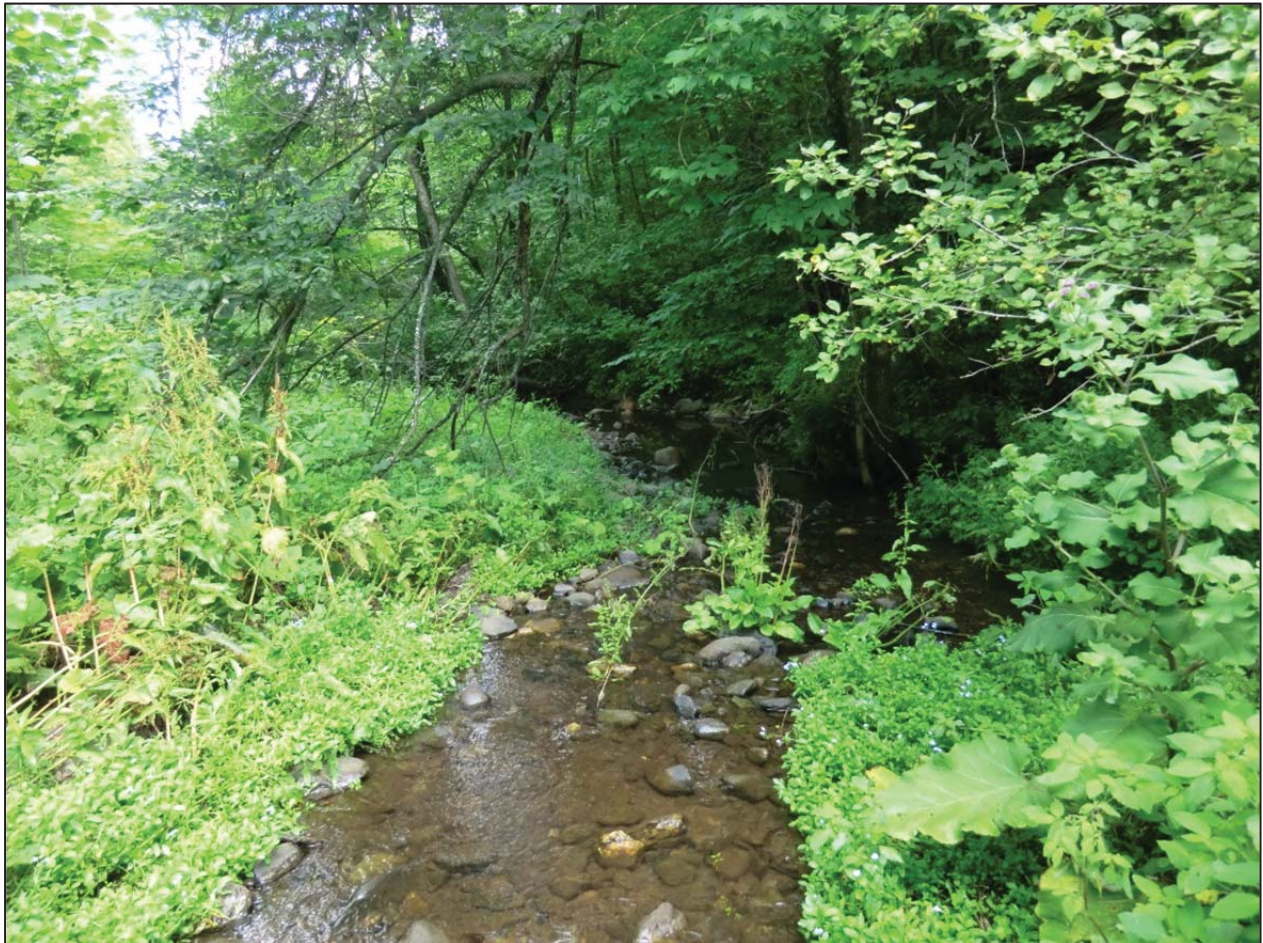
The downstream segment on this reach is nearly 500 feet long and has a wider valley than the upstream segment. It flows through a section of woods and into the Seymour River. Generally, this segment appears to be stable and has well forested banks and buffers. There is some lateral bank erosion occurring as the sinuosity of this short segment changes over time.

**Figure 5.43.** Upstream channel photo in M10S2.01-A.

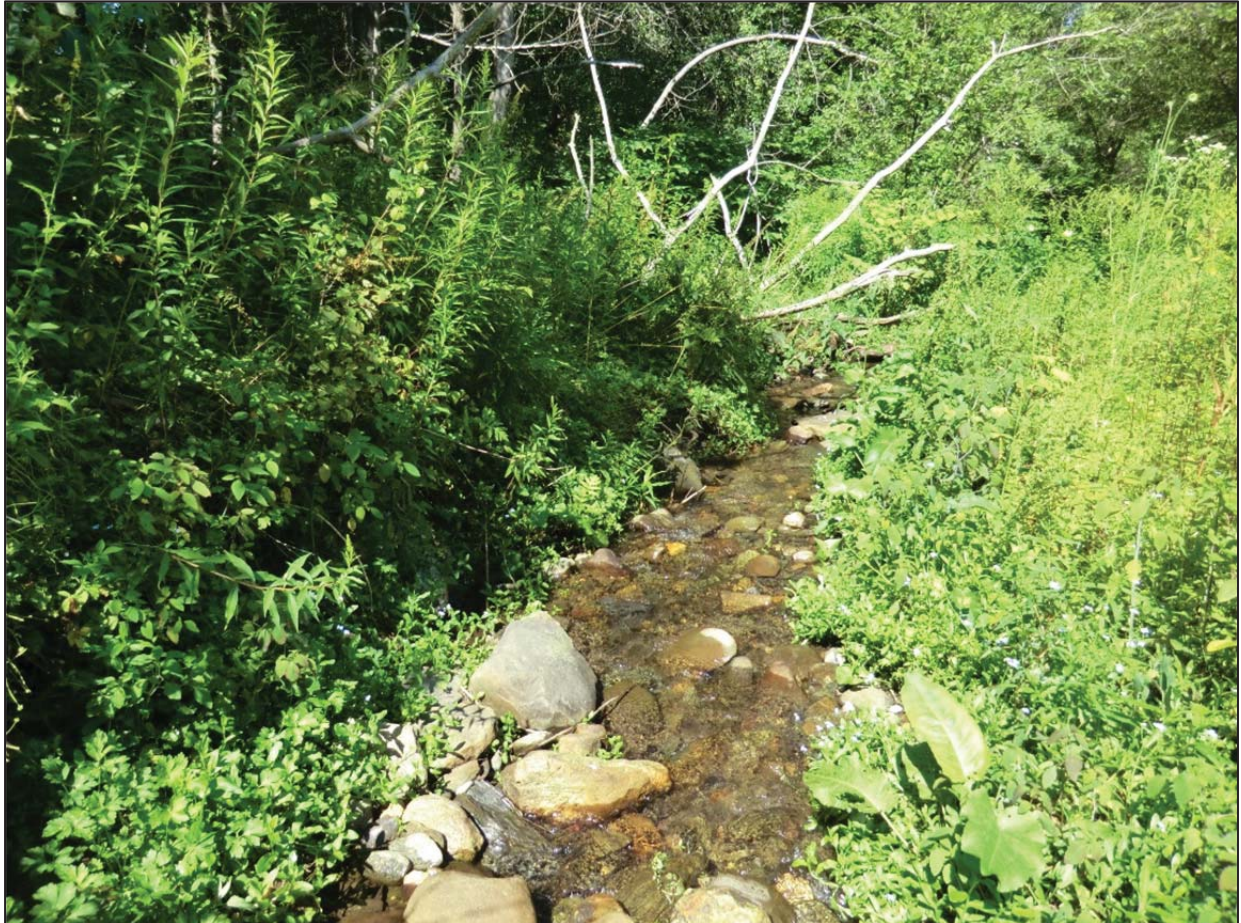
The second segment on reach one of trib 2 to M10 is slightly longer – almost 600 feet and has a narrower valley than the downstream segment. No impacts to this segment were noted in the field and it is characterized as being very stable.

**Figure 5.44.** M10S2.01-B looking downstream.

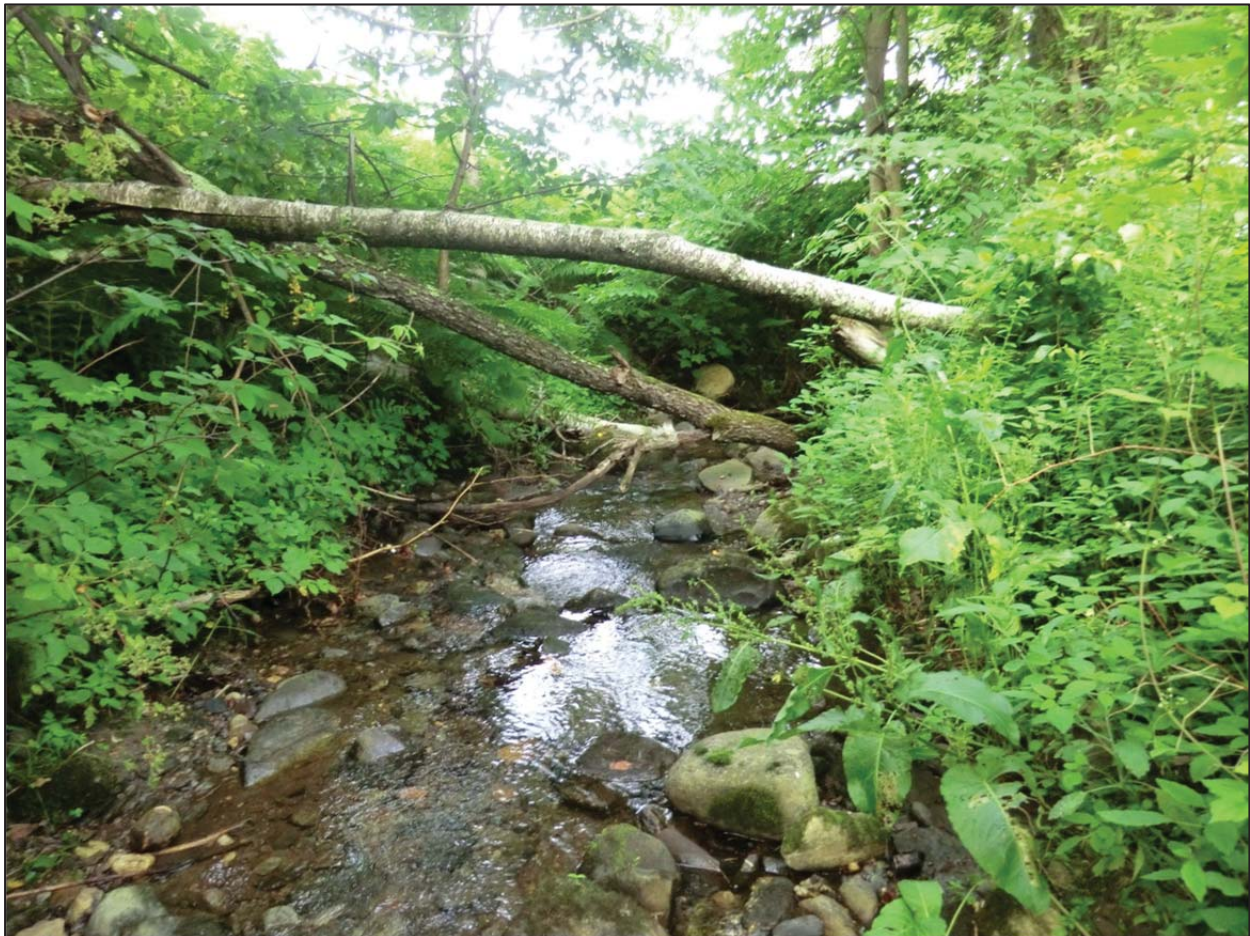
The first segment on this reach is approximately 2,000 feet long and flows primarily through forested land with some agricultural land. Minimal impacts to this segment were recorded during the stream walkover. Riparian buffers are lacking in a couple areas but overall are intact. Some planform adjustment via flood chutes was noted. There is an undersized culvert at Lower Pleasant Valley Road in this segment that is in poor condition and is perched.

**Figure 5.45.** Downstream channel photo in M10S2.02-A.

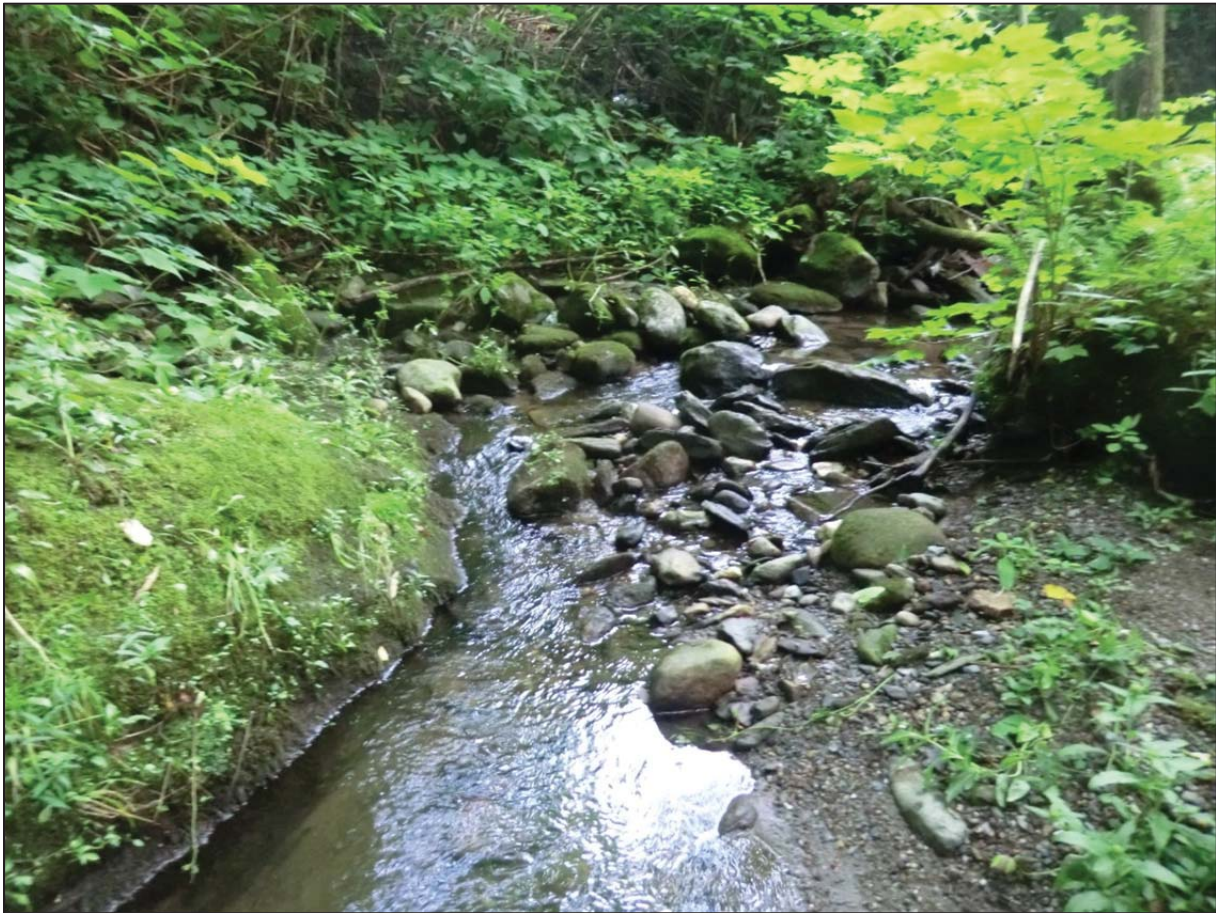
The upper segment on this reach that was included in the stream walkover is shorter – just over 400 feet long. The segment begins at the Westman Road culvert and continues downstream from there. This segment is characterized as having an entrenched channel and forested banks and buffers. Bedform is primarily step pool with a steeper slope than the downstream segment. Observed impacts were minimal but included abundant trash along the banks. The culvert at Westman Road at the upstream end of this segment is significantly undersized and may have reduced aquatic organism passage.

**Figure 5.46.** Stable stream channel in M10S2.02-B.
