# Phase 2 Stream Geomorphic Assessment Castleton River Watershed – Town of Castleton Rutland County, Vermont

March 2007 (Revised April 2008)

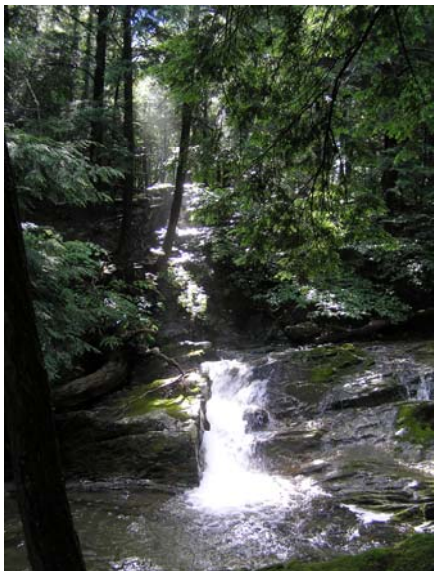
Figure 3. Bedrock gorge west of Birdseye Road on Gully Brook. (T02.11-s1.04)

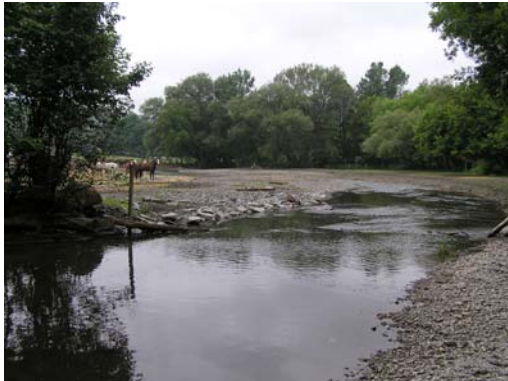
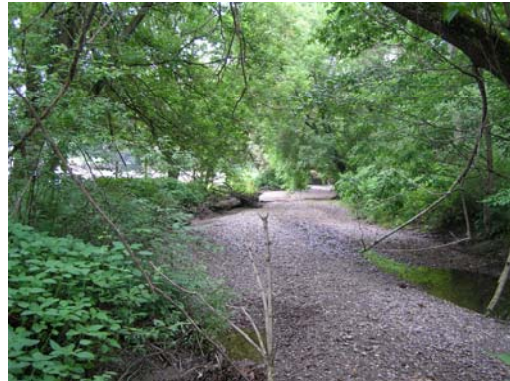
Downstream of Route 4A, at the downstream extent of Segment B near the horse stables, a recent channel avulsion is apparent. The Castleton River has abandoned a meander approximately 600 feet in length to flow approximately 400 feet through active horse pasture (see Figures 9 and 10).

Figure 10. (a) View downstream (to the west) of avulsed channel through horse pasture. (b) View downstream (to the west) of abandoned channel. Castleton River main stem, 30 June 2005.

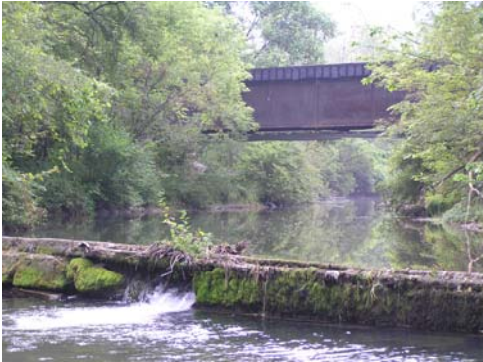
reach. The Castleton River is crossed by the railroad, Mill Street, and North Street within the reach. A low-head dam is located near the upstream end of the reach (Figure 12). This run-of-river dam serves as a vertical grade control, and appears to have a small impounding effect.

Figure 12. Low-head dam in reach T02.09, located just downstream of the confluence of North Bretton Brook, approximately 350 feet downstream of the Route 4A crossing, and 110 feet downstream of the railroad crossing. (View upstream on 11 August 2005).

A limited survey on foot along the left bank of the river at the dam, revealed what appeared to be a former sluiceway channel (now heavily overgrown) leading to the west toward the former mill buildings along the south bank of the Castleton River in the vicinity of the Mill Street bridge crossing. The sluiceway channel was marked by a terrace on its left bank, and an earthen berm on its right bank. The berm may be coincident with the grade for the former electric trolley that connected West Rutland to Hydeville and Fair Haven. Given the relative elevations of this sluiceway channel and the impoundment behind the dam, it is possible that this sluiceway functions as an overflow channel for the river (flood chute) during very high water events.

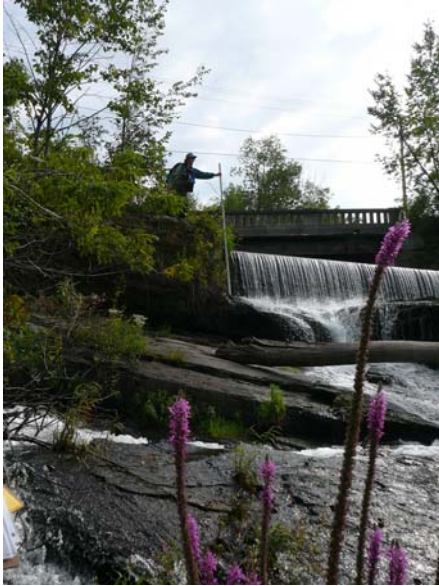
- Upstream Dam 3 (Water Street Dam) is located approximately 50 feet downstream of the Depot Street (formerly Water Street) bridge crossing (Figure 16). Dam 3 is a "... run of the river dam, approximately 50 feet long and 7 feet wide at the crest. The height varies due to the bedrock in the streambed but it is estimated at 5 to 10 feet. There is a separate sluiceway portion separated from the main dam by a small island of bedrock. The sluiceway weir is approximately 20 feet long, with an upper plywood gate and an integral wooden gate in the weir." (Bushman, 2004).

Figure 16. Dam 3 – Water Street Dam –  
Castleton River reach T02.03.  
(a) view upstream from bedrock falls; Depot  
Street crossing in the background; 23 August  
2006. (b) view of the dam and right-bank  
sluiceway from top of left bank; 25 April 2005.  
Moderate to low flow conditions, each date.

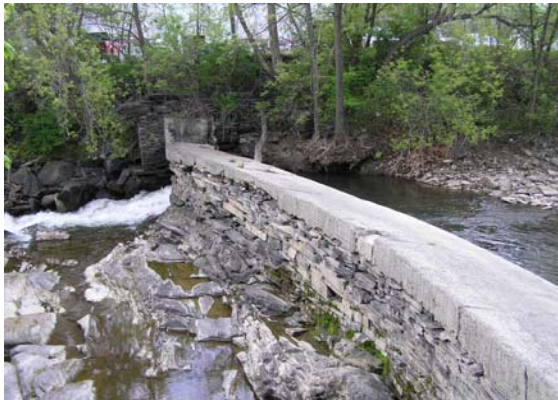
Figure 17a. Dam 2 – Structural Slate Dam, view to north from southern end of dam. Breach evident at north end. 18 May 2005, during moderate to low flows.

breach of the Structural Slate Dam was reported to the VT Dam Safety Section by the Town of Fair Haven in February of 2004. The dam apparently breached at the location of a former sluice gate at the right abutment (facing downstream). During low water conditions, flow in the Castleton River is directed solely through the breached sluiceway (see Figure 17a). The left sluice gate was intact on the inspection date by the VTDEC Dam Safety Section (10 August 2004) but demonstrated signs of significant erosion and deterioration (Bushman, 2004).

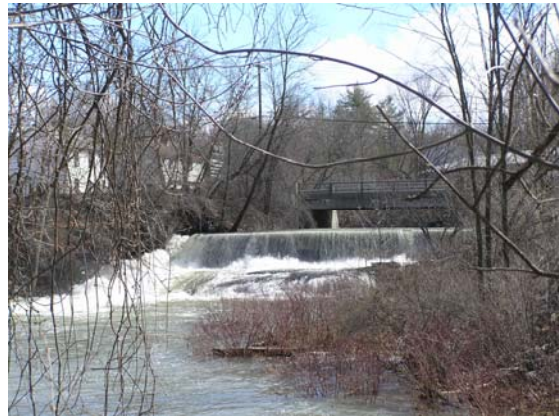
Dam 2 is a "... run of the river dam, approximately 75 feet long and 7 feet wide at the crest. The height varies due to the bedrock in the streambed but it is estimated at 7 to 10 feet." Construction of the dam is "slate core, with a concrete cap on the crest and upstream face" (Bushman, 2004).

Figure 17b. Dam 2 – Structural Slate Dam, view upstream from vicinity of Adams Street. 5 April 2006 high water conditions.

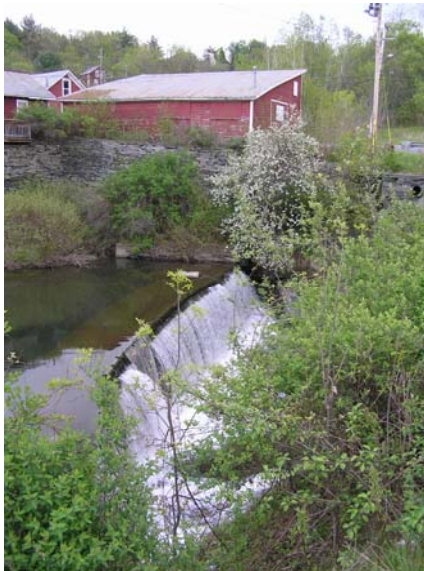
The Shirt Factory Dam is a "... run of the river dam, approximately 75 feet long and 7 feet wide at the crest. The height varies due to the bedrock in the streambed but it is estimated at 7 to 10 feet." (Bushman, 2004).

Figure 19. Dam 1 - Shirt Factory Dam  
(a) view to southeast from Adams Street bridge crossing, 18 May 2005, low to moderate flows. (b) view upstream from right bank abutment under Adams Street bridge, 13 July 2006, moderate to high flows.

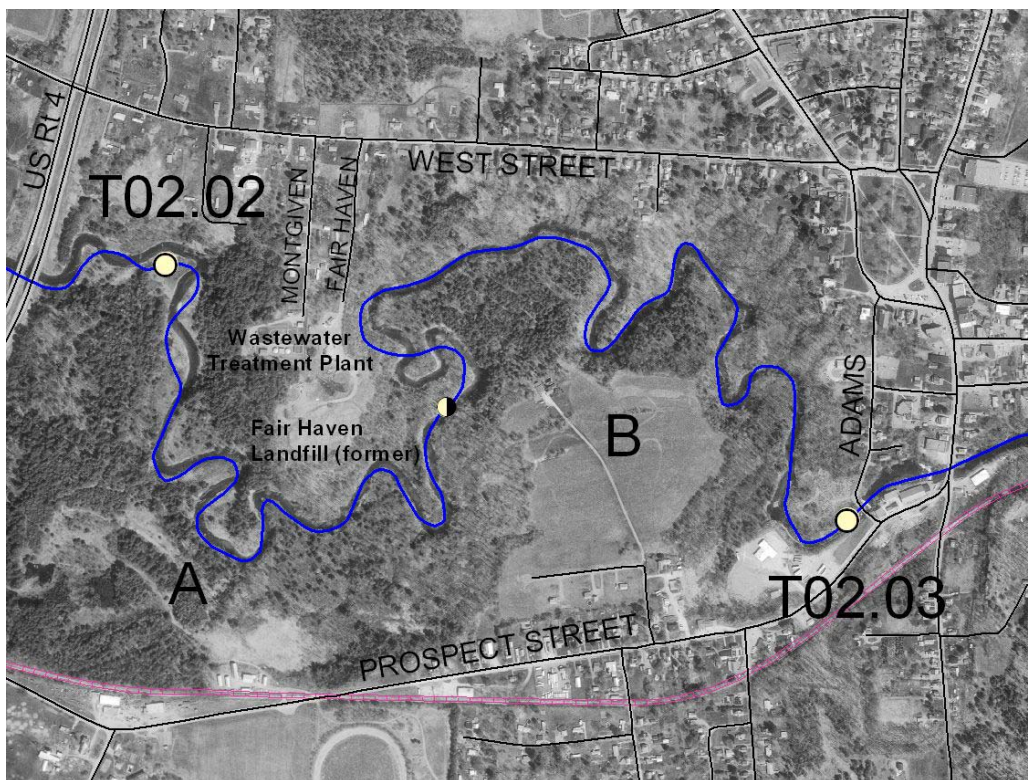
Figure 20. Segmentation of reach T02.02. Base map: 1994 orthophotograph. Flow is from east (picture right) to west (picture left).

At present, the valley setting for reach T02.02 in the upper 2/3 of the reach is narrowly confined between steep valley walls. Valley widths are between 1.5 and 2 times the bankfull width. Near the upstream end of the reach, valley confinement may have been increased marginally by the placement of slate and other fill materials along the tops of the valley walls. Height of the valley walls ranges from 20 to 80 feet above the channel. In the downstream 1/3 of reach T02.02, the valley opens up slightly to a width of 2 to 4 times the bankfull width. The height of the valley walls is somewhat reduced, typically ranging from 12 to 30 feet high. This change in valley setting compelled a segment break, due to the different reference stream types ("confined" versus "unconfined"). The segment position indicated in Figure 20 is approximate only; the transition from narrowly-confined to semi-confined occurs gradually.

The channel is highly sinuous (ratio of 1.9) in reach T02.02, exhibiting an irregular meander pattern which includes some tortuous meanders. Near the segment break and at the downstream end of the reach, the current planform, as depicted on 2003 and 1994 aerial photography, is substantially different than the planform indicated by the VHD (blue line in Figure 20), which itself appears coincident with the planform depicted on the 1972 USGS topographic map. These observations suggest historic planform adjustments occurring between 1972 and 1994. Anecdotal accounts of increased mass failure activity in the last two or three years suggest recent, active meander migration (Lobdell, 2006).

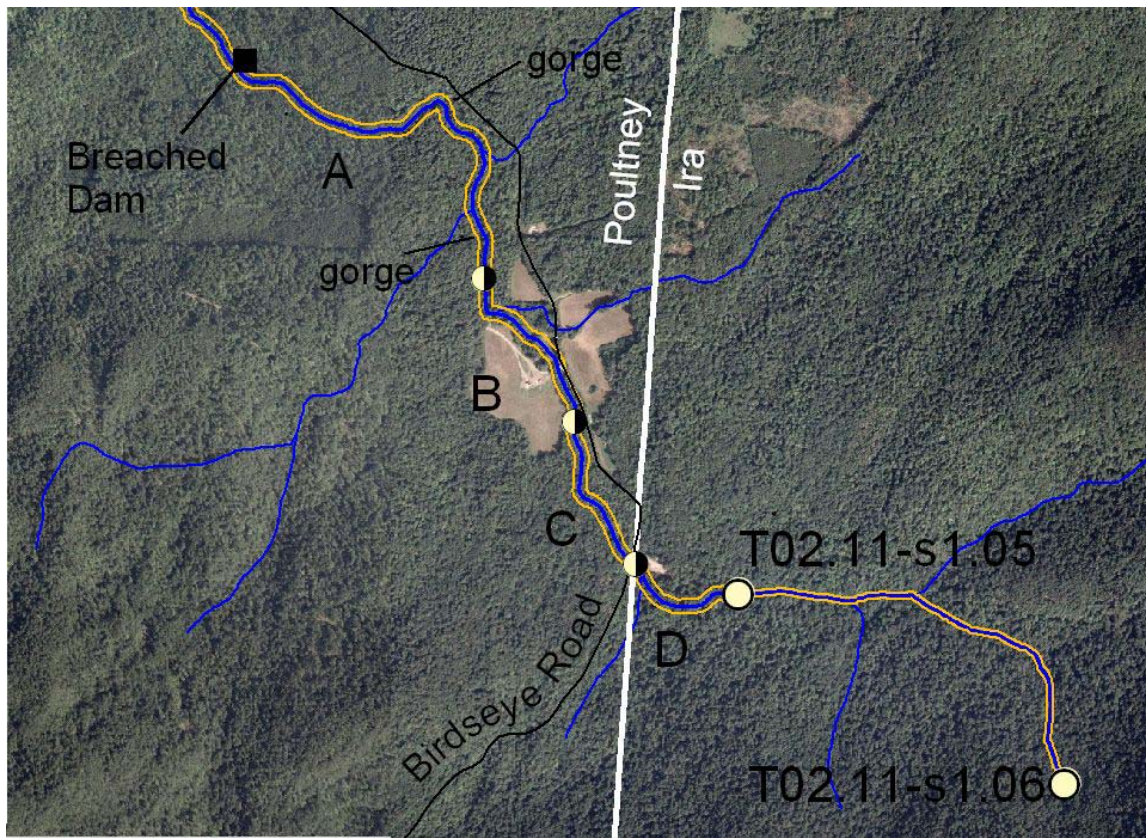
Figure 24. Segmentation of reach T02.11-s1.04, Gully Brook, Castleton River Watershed.

While the overall channel slope and valley confinement of reach T02.11-s1.04 suggest a B-step/pool reference stream type, there is considerable variation of valley confinement, slope, channel bedform and geomorphic condition along the length, compelling the following segmentation (see Figure 24):

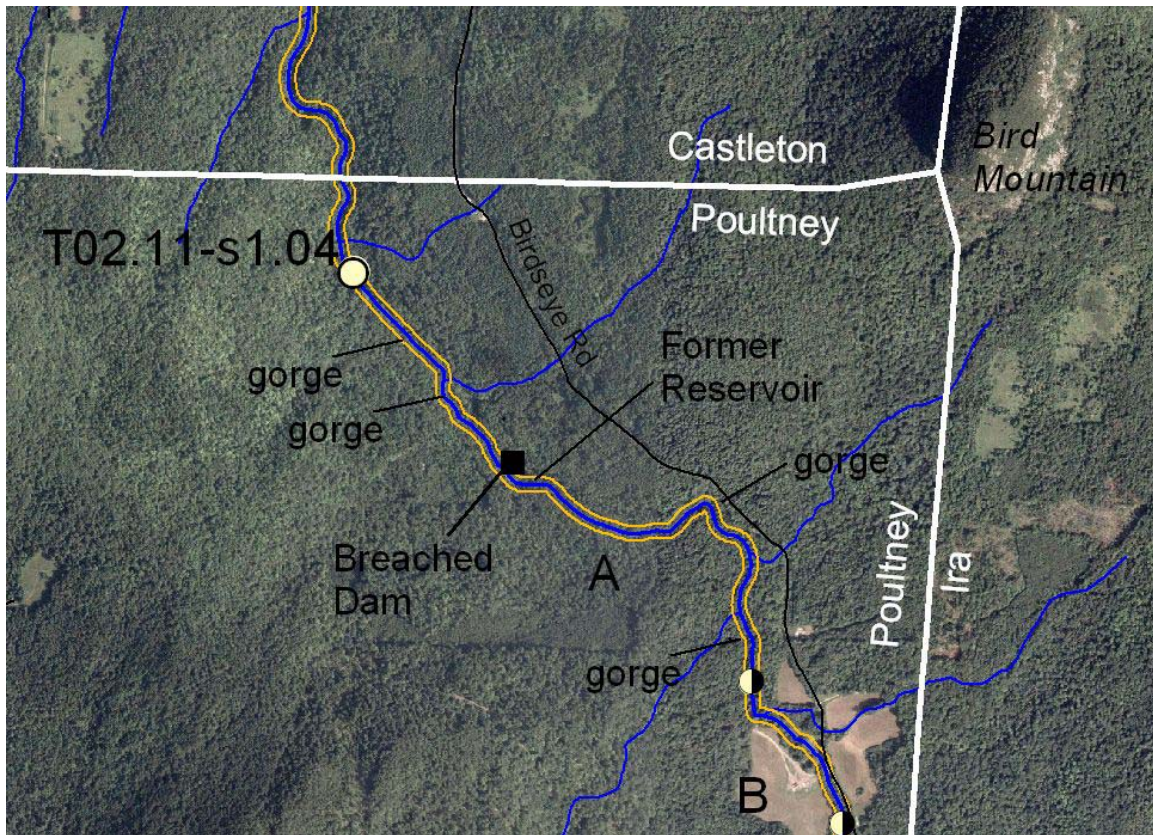
Figure 25. Downstream end of Reach T02.11-s1.04, Gully Brook, Castleton River Watershed.

Overall, Segment A of T02.11-s1.04 is in fairly stable condition. Much of the segment is flowing directly on channel-spanning bedrock. Channel planform is controlled largely by structural features of the bedrock. Two brief sections of channel showed signs of moderate incision and loss of connection to the adjacent flood plain: a 50-foot length downstream of the breached dam on approach to the bridge crossing, and a 500-foot length upstream of the dam. Possible tributary rejuvenation was evident in a left bank tributary and a right bank tributary immediately upstream of the bridge. The very limited degree of streambank erosion within the segment (up to 7 and 8 feet in height) was localized to 600 feet of channel upstream of the former dam and reservoir site. Along a majority of the segment, however, the main Gully Brook channel did not show evidence of active or historic incision.

adjustments occurring in response to historic impoundment and subsequent breaching of the dam, Segment A is generally in very stable condition. Extensive lateral and vertical controls offered by the bedrock exposures, and maintenance of well-forested wide buffers along the channel margins have contributed to the overall stability of Segment A. A "Very Low" sensitivity was assigned to the segment.

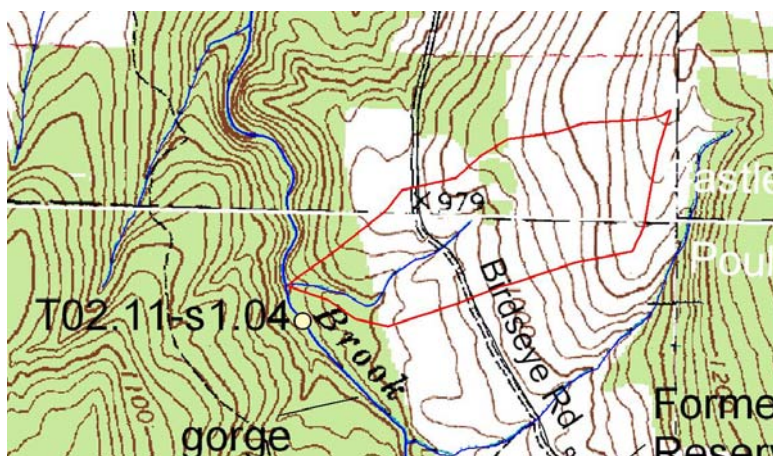
Several of the tributary reaches to T02.11-s1.03 were observed to be incised and overwidened. One tributary was viewed while walking out to Birdseye Road from the downstream end of T02.11-s1.04 (see Figure 27). Based on the drainage area for this tributary (approximately 0.07 square mile), a bankfull width of 4 feet and a maximum depth of 0.5 foot would be expected (VT Regional Hydraulic Geometry Curves; VTDEC WQD, 2006). The present channel is 8 to 12 feet wide and 1 to 2 feet deep.

(b) Based on the drainage area for this tributary (in red below: approximately 0.07 square mile), a bankfull width of 4 feet and a maximum depth of 0.5 foot would be expected. The present channel is 8 to 12 feet wide and 1 to 2 feet deep.

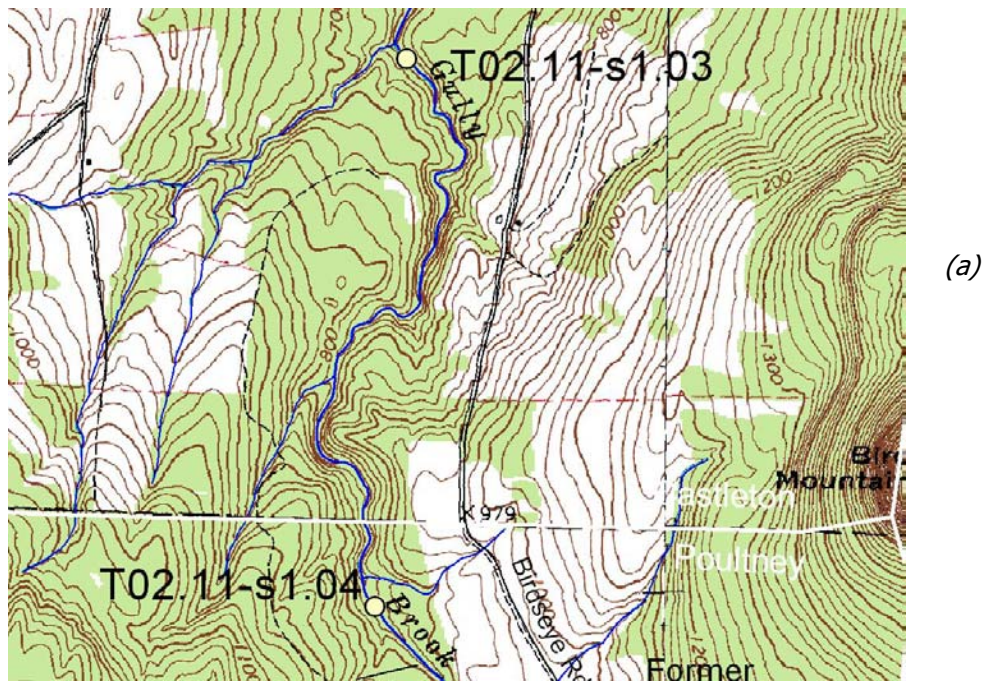
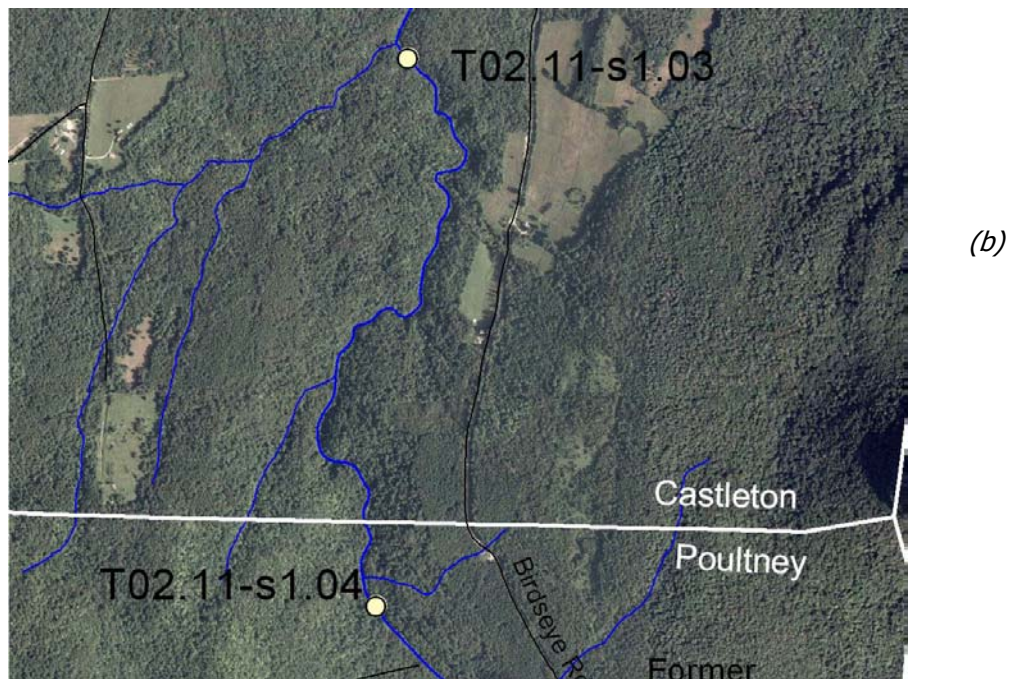
Also, an ongoing history of logging in the watershed may have contributed to channel incision and widening in tributaries to T02.11-s1.03. The USGS topographic map (dated 1964, photorevised 1972) indicates most of the eastern catchment to be cleared (Figure 28a). Removal of trees along the channel margins would be expected to lead to channel instability. Moreover, precipitation and snowmelt would run off more quickly and in higher volumes in a nonforested catchment. Higher peaks and magnitudes of flow could lead to channel incision and widening.

A 1994 orthophoto indicates very young forest growth in these previously cleared areas; by 2003 the forest is revegetating (see Figure 28b).

Figure 28. Revegetation of forest land cover in eastern catchment of Gully Brook reach T02.11-s1.03 along Birdseye Road in Castleton, VT. (a) 1964 USGS topographic map (photorevised 1972); (b) 2003 aerial photograph

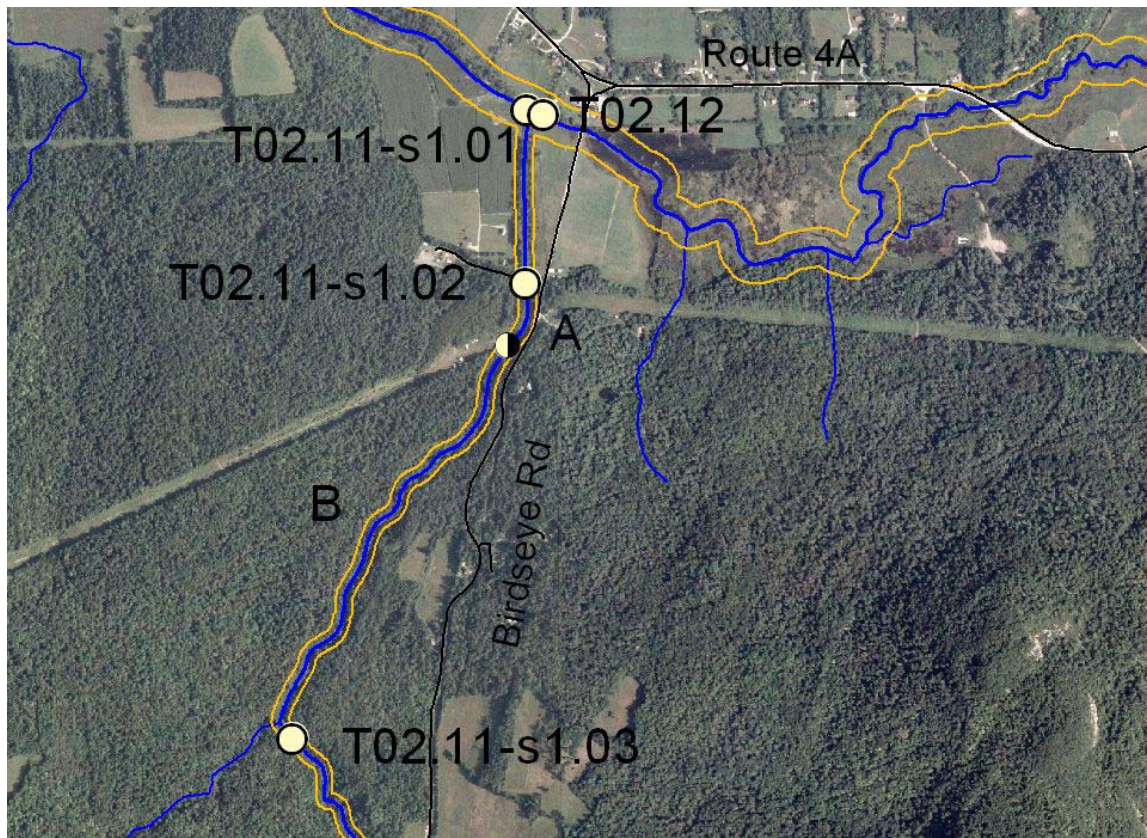
Figure 29. Downstream reaches of Gully Brook (T02.11-s1.02, T02.11-s1.01), town of Castleton, Castleton River watershed. Orange line depicts Phase 2 belt-width-derived corridor.

The majority of this reach flows through a steep, narrowly-confined, bedrock-controlled valley. A small section of the reach at the base of Bird Mountain was segmented where the Gully Brook transitions out into the broad valley of the Castleton River main stem, due to the change in slope and reference stream type (see Figure 29).

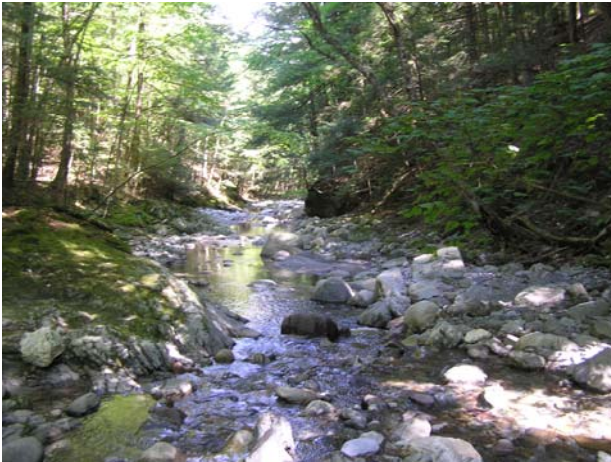
Segment B is approximately 3,746 feet in length and flows through a narrowly-confined forested bedrock valley (see Figure 30). This valley setting, and an estimated slope of 3.2% suggest a B-step/pool reference stream type. Current encroachments within the segment are essentially non-existent. The Birdseye Road parallels the channel for a length of approximately 170 feet within the Phase 2 belt-width-derived corridor near the downstream end of the segment. However, the road is elevated well above the floodprone width elevation of the channel.

*Figure 30. Segment T02.11-s1.02-B is a gravel and cobble step/pool channel flowing through a forested, narrowly-confined, bedrock-controlled valley of moderate to steep gradient.*

Overall, Segment B of T02.11-s1.02 was rated in “Good” condition following the RGA, and a “Moderate” sensitivity was assigned. Extensive lateral and vertical controls offered by the bedrock exposures, and maintenance of well-forested wide buffers along the channel margins have contributed to the overall stability of Segment B. Overall, Segment B is operating as a transport reach, although there are

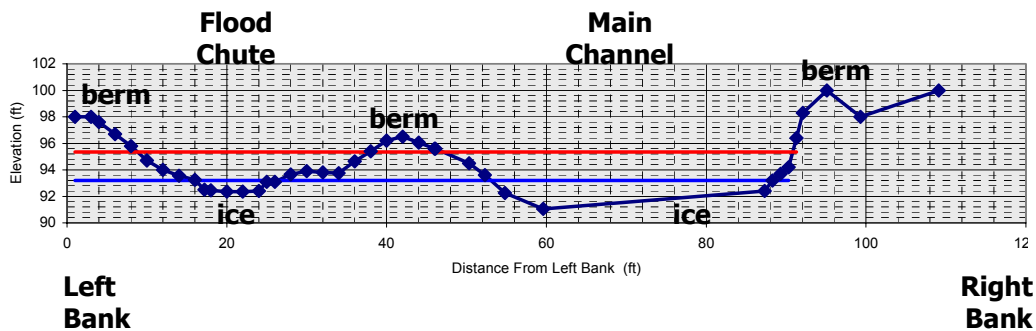
The cross section completed in this segment indicates an F4c-plane bed stream type (IR >2; ER of 1.26). The current channel has a linear planform and appears to be developing a slight secondary sinuosity and riffle-pool form. The channel is incised below the adjacent left bank floodplain; entrenchment is also exacerbated by the presence of berms along both left and right banks. A two to five-foot high gravel and cobble berm is present along the right top of bank from a point where the channel leaves the right valley wall downstream to the Woodbury Bridge crossing. On the left bank, there are two parallel gravel and cobble berms, one along the left top of bank, and a second berm within one bankfull width of the channel. The closer berm terminates at the channel half-way to the Woodbury Road crossing. The second berm is present along the full length of the segment. An active flood chute separates from the channel at the upstream end of these berms and flows between the berms to rejoin the channel (see Figure 31). Mature trees rooted in each of these berms suggest their age to be between 20 and 50 years.

Signs of active incision were not observed within the segment. Channel-spanning bedrock is exposed just upstream of the upstream end of the segment, which would serve as a grade control for potential headward migration of headcuts. The present degree of incision appears to be historic in nature, related to channelization and dredging, and exacerbated by the placement of high berms along both left and right bank (see Figure 31).

Figure 31. Gravel and cobble berm along left bank of Gully Brook upstream of Woodbury Road bridge crossing. Berm height ranges from 4 to 9 feet above channel thalweg.

(below) Cross section completed 24 January 2007. View downstream. Red line indicates Flood Prone Width elevation (10- to 50-year storm). Blue solid line indicates Bankfull elevation (annual high flow).

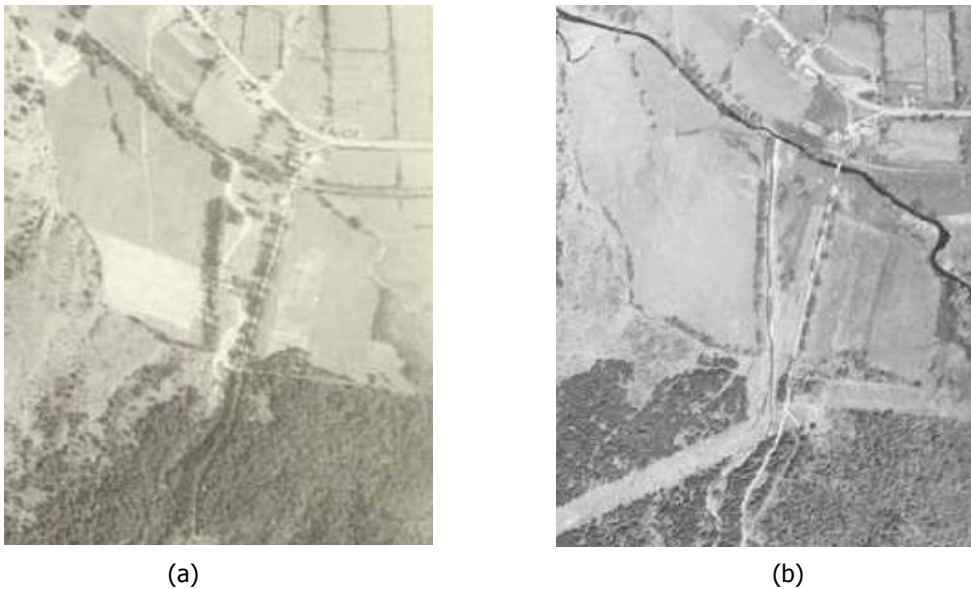
The Gully Brook is prone to very dynamic lateral and vertical adjustments within this reach due to the natural reduction in sediment transport capacity. Over recent decades, the sensitivity of this reach has apparently been enhanced by increases in sediment delivery to this point from upstream reaches and tributaries, by the partial removal of forested buffers, and by the gradual encroachment of road networks, residential and agricultural land uses. In an attempt to protect the investments of the Woodbury Road bridge crossing, Birdseye Road, residential development, and agricultural lands along this highly dynamic section of the river, there has been a history of channelization, windrowing, and berming of the Gully Brook as well as repeated gravel extraction from the Gully Brook and from the Castleton River in the vicinity of the confluence. The previously sinuous channel now has a very linear planform (Figure 32).

Figure 32. T02.11-s1.01. Gully Brook upstream from the confluence with Castleton River main stem. The brook was channelized between 1942 and 1962. (a) 1942 aerial photograph; (b) 1962 aerial photograph.

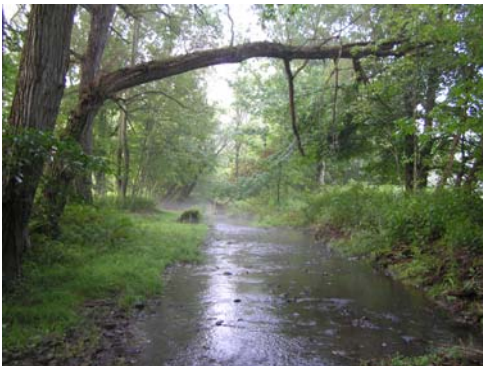
The upstream extent of the reach exhibits a linear planform for a distance greater than 20 times the channel width; this planform, coincident with closely-encroaching agricultural fields on both banks, suggests historic channelization. A plane-bed channel form is present (see Figure 35).

*Figure 35. Plane-bed channel form at upstream extent of T02.09-s1.05.*

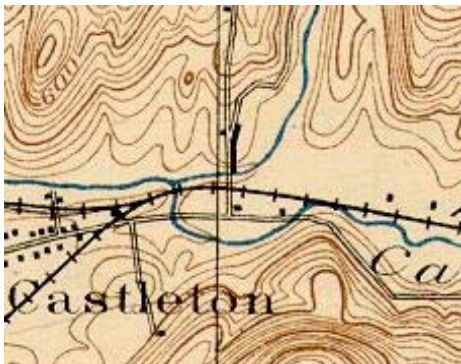
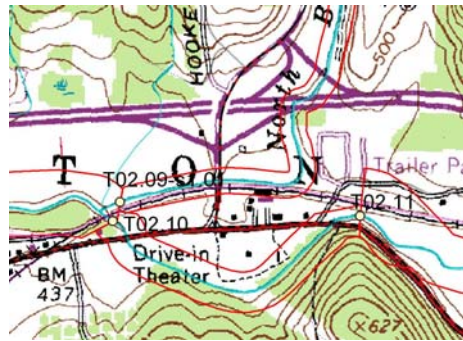
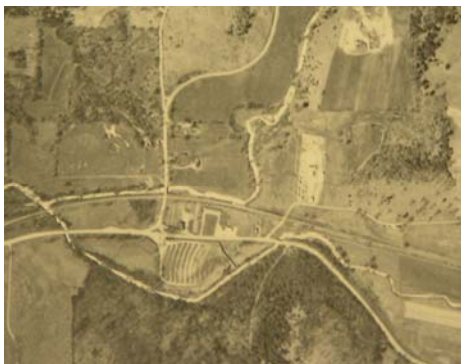
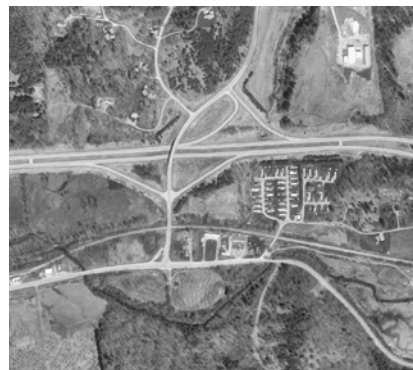
downstream of the reach break between T02.10 and T02.09. Based on review of historical resources (Smith & Rann, 1886; Castleton Historical Society, 1998), it is apparent that this confluence was moved in 1850 to accommodate the Rutland and Washington Railroad (later Delaware & Hudson Railroad, now Clarendon-Pittsford Railroad) (Figure 39.a). "On the north side of the railroad, and parallel with it, a new channel was cut by the company, at the same time, and Hubbardton Brook [North Bretton Brook] was turned into it, which saved building a railroad bridge across the old channel, ..." (Smith & Rann, 1886). The railroad grade is presently 10 to 15 feet in elevation above the North Bretton Brook and forms the left valley wall of the lower 1700 feet of Segment A. Substantial portions of the natural plateau formed by an alluvial fan from the North Bretton Brook were also excavated during construction of the railroad (Smith & Rann, 1886).

Figure 39. Planform of North Bretton Brook near confluence with Castleton River main stem. (a) 1897 Castleton 15-Min. USGS topographic map; (b) 1972 Poultney 7.5-Min. USGS topographic map; (c) 1962 aerial photograph; (d) 1994 orthophotograph.

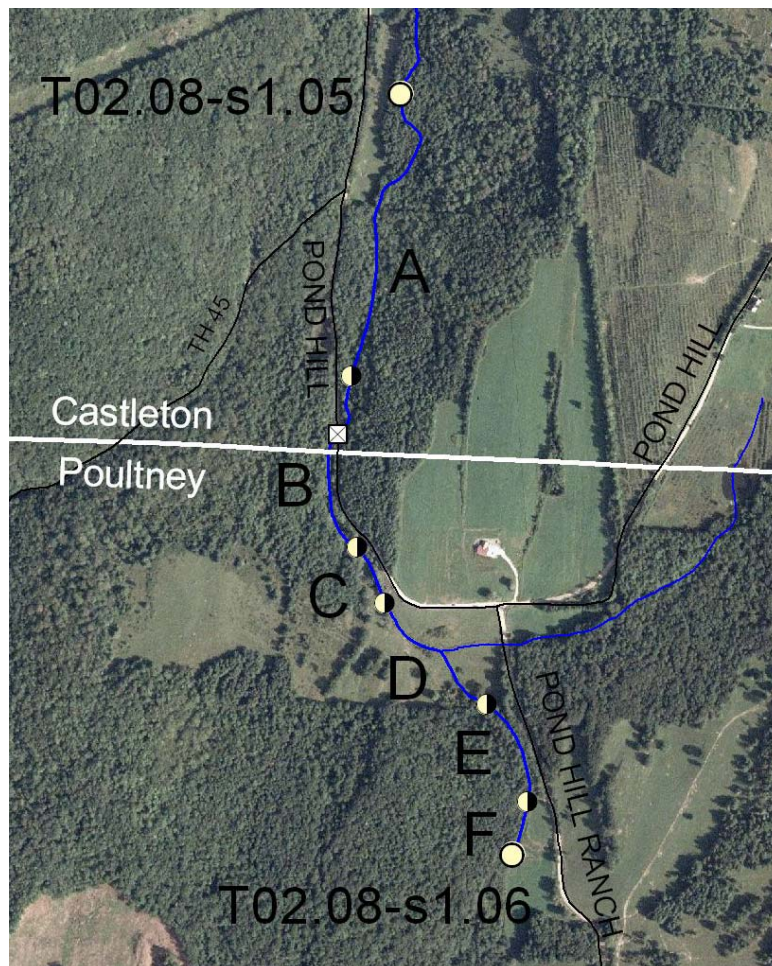
Figure 42. Segmentation of reach T02.08-s1.05.

The upstream-most delineated reach of Pond Hill Brook begins along Pond Hill Ranch Road, approximately 500 feet downstream from a wetland noted on the USGS topographic map. Generally, the reach flows through a narrowly-confined to semi-confined, steep valley in forest cover. For a majority of its length through reach T02.08-s1.05, Pond Hill Brook was observed to be flowing directly on bedrock ledge or cascading over bedrock waterfalls. In some discrete sections of the reach, channel gradients were less than 4% (but still greater than 2%), and valley widths were a bit more relaxed (semi-confined). This variability of valley confinement and gradient along with land use conditions led to segmentation of the reach in accordance with protocols (see Figure 42).

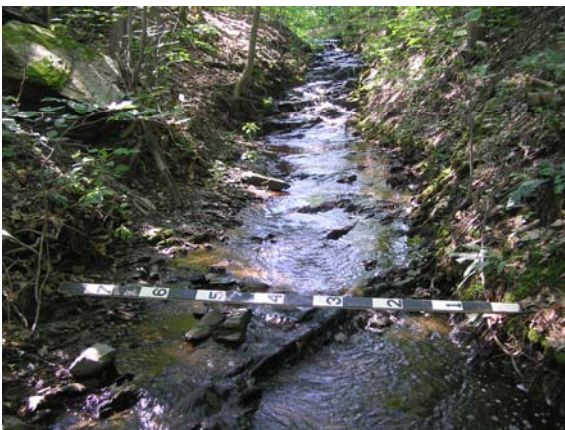
Proceeding downstream, the channel gradient picks up substantially, as Pond Hill Brook flows over bedrock ledge and waterfalls through hemlock forest to the west of Pond Hill Ranch Road. The topography and valley setting indicate a reference A1-cascade stream type.

*Figure 43. T02.08-s1.05-E  
A1-cascade bedrock channel flows  
through a deciduous forest to the  
west of Pond Hill Ranch Road.  
View upstream, 25 July 2006. River  
staff is at approximate bankfull  
elevation.*

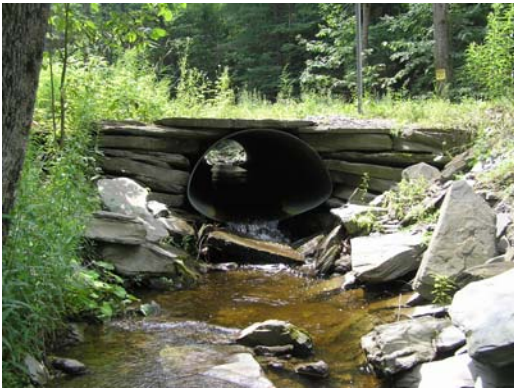
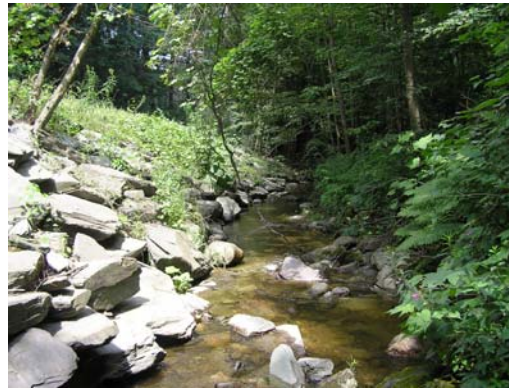
activities upstream and downstream of the crossing indicate past erosion issues associated with this crossing. A gravel and cobble berm of angular slate is present for 70 feet along the right top of bank leading to the culvert inlet, which pins the channel between the berm and the bedrock-controlled left valley wall. Slate rip-rap is also present along the left bank upstream of the culvert and along both banks downstream of the culvert. A drop of 1.7 feet from culvert inlet to the bed of the channel on the downstream side indicates possible vertical scour of the channel (or elevated culvert installation). An approximate 150-foot length of the Pond Hill Brook downstream of the crossing appears to have been channelized and shifted westward to flow directly alongside the road. The left bank of this channelized section has been heavily armored and the road surface is elevated well above the flood-prone-width elevation. Through this section, the channel appears somewhat entrenched below the surface of a right-bank floodplain terrace. Channel-spanning bedrock is exposed in the downstream portion of this channelized section, as the brook transitions to a downstream bedrock gorge (Segment A).

Figure 45. T02.08-s1.05-B. Pond Hill Road crossing of Pond Hill Brook. (a) View upstream to the culvert outlet – rip-rap present on both banks; distance of 1.7 feet from culvert invert to channel bed. (b) View downstream from culvert along recently channelized and armored section parallel to Pond Hill Road..

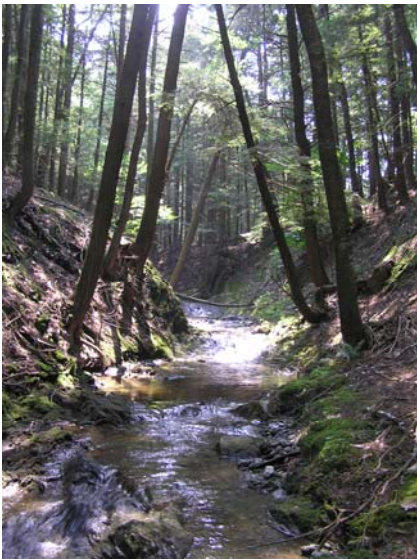
Cross section data from Segment E could be applied to Segment A, given the similarity in gradient, valley setting and channel characteristics. Since this segment was characterized as a “gorge” by protocols, a RGA and RHA were not completed, and a “Low” sensitivity was assigned.

The considerable slope of Segment A and the narrowly-confined valley suggest that this section of Pond Hill Brook is transport-dominated, with a high sediment transport capacity.

*Figure 46. T02.08-s1.05-A  
A1-cascade bedrock channel flows through  
a coniferous and hemlock deciduous forest  
east of Pond Hill Road.  
View upstream, 25 July 2006.*

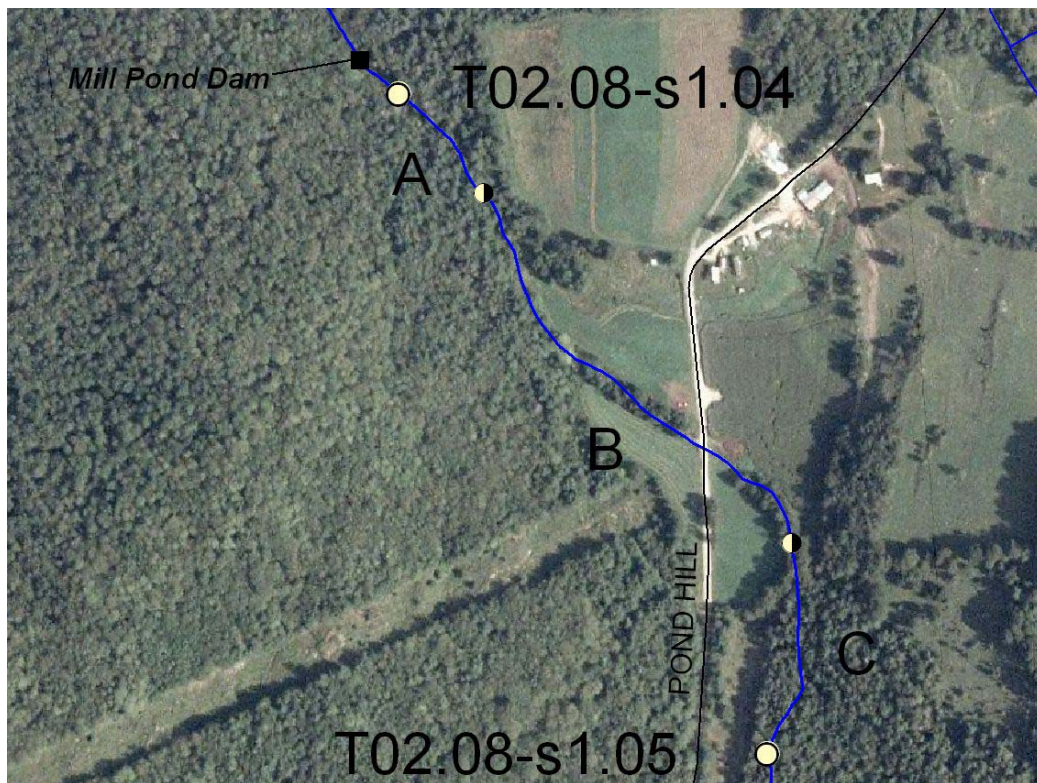
Figure 47. Segmentation of reach T02.08-s1.04, Pond Hill Brook, Castleton, VT. Flow is from south (bottom) to north (top).

Given the limited resolution of the topographic coverage (20-foot contours), the reach delineation established during the Phase 1 Stream Geomorphic Assessment, inadvertently encompassed short sections of alternate stream type (bedrock gorge) at the upstream and downstream ends of the reach. Segmentation was required to delineate these subreaches (see Figure 47).

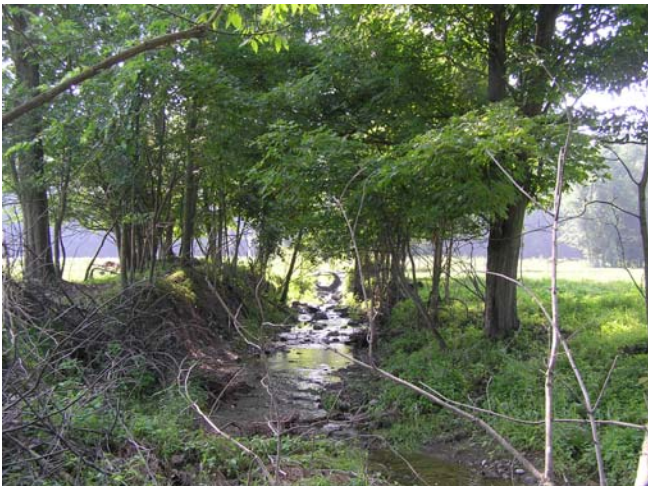
*Figure 48. T02.08-s1.04-B.*

*Pond Hill Brook has been historically channelized and bermed through farm fields in an unconfined valley setting between bedrock gorges.*

Clearance and span of the Pond Hill Road culvert were measured as 4.5 feet and 5.9 feet, respectively. Comparison of these dimensions to the measured bankfull width of 22.5 feet at the segment cross section, indicated this culvert crossing to be a constrictor of bankfull and flood flows. Cobble and boulder-sized rip-rap was observed along both banks at the culvert inlet and outlet, along both banks downstream of the culvert, and along right bank near the downstream end of the segment.

Signs of active incision were not observed along the segment, which is bounded by extensive bedrock vertical grade controls at both upstream and downstream ends. A moderate degree of aggradation was indicated by the presence of multiple, enlarged point and side bars, as well as mid-channel and transverse bars. Evidence of moderate planform adjustments, particularly in the downstream half of the segment, included active flood chutes, meander migration in the form of erosion along the outside of incipient meander bends, and an apparent neck cutoff near the downstream end of the segment. A wider-than-regime bankfull width of 22.5 feet, and a somewhat elevated width/depth ratio suggest widening within the segment. However, signs of active widening were minor (e.g., failing banks, leaning trees, exposed roots along both channel banks through a riffle section). This segment appears to be rebuilding an incipient floodplain at a lower elevation through aggradational processes and planform adjustments in response to historic degradation from channelization and berming (i.e., late stage III or early stage IV of an F-stage channel evolution model). A geomorphic score of "Fair" was assigned following the RGA. The stream type departure from Cb to F dictated an "Extreme" sensitivity rating.

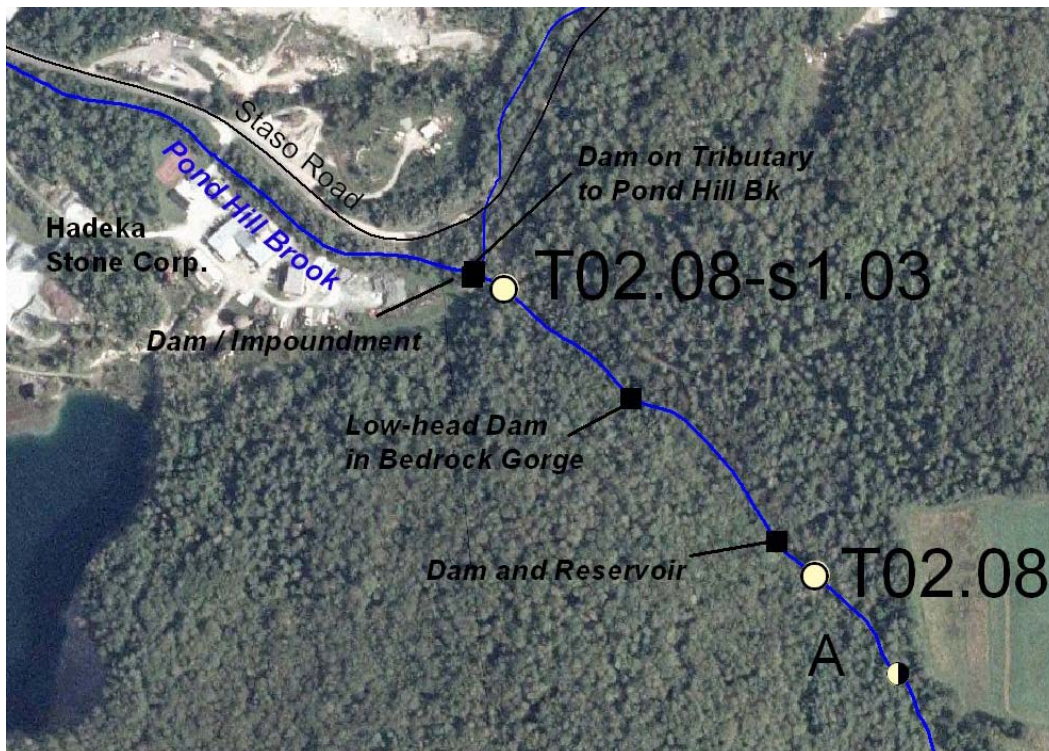
*Figure 50. A former reservoir and dam and a small low-head dam were observed in reach T02.08-s1.03. Two additional dams were noted in the next downstream reach: one elongate concrete structure impounds the Pond Hill Brook and a tributary brook just upstream of their confluence. Flow in Pond Hill Brook is from lower right to upper left.*

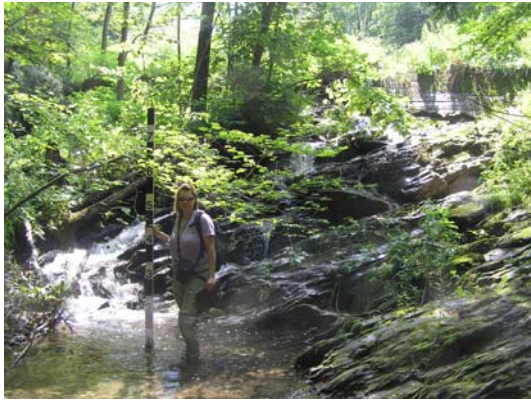
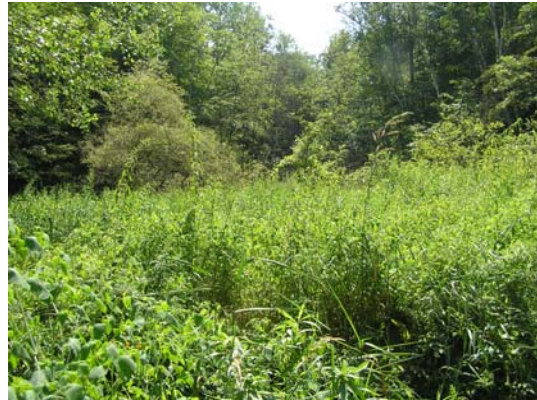
The former upstream reservoir (now filled with sediment) was approximately 300 feet long and a maximum of 90 feet wide (based on USGS topographic map depiction). The Phase 1 reach break between T02.08-s1.03 and the next upstream reach falls mid-way along this former pond. The upstream 150 feet of channel in reach T02.08-s1.02, flowing in the former

reservoir area, exhibits a C-riffle/pool, gravel bed stream type. The channel meanders along the southern periphery of the former pond, and substantial aggradation is evident in the form of point bars greater than half bankfull height, mid-channel bars, transverse bars and side bars. Sediments in this brief section of channel were very loose under foot.

*Figure 51. Former dam and reservoir on Pond Hill Brook at the upstream end of reach T02.08-s1.03. (a) view upstream from beneath the dam, average dam height of 3 feet from top of dam to bedrock foundation near spillway; (b) view upstream from dam into former reservoir now filled with sediment and re-vegetating.*

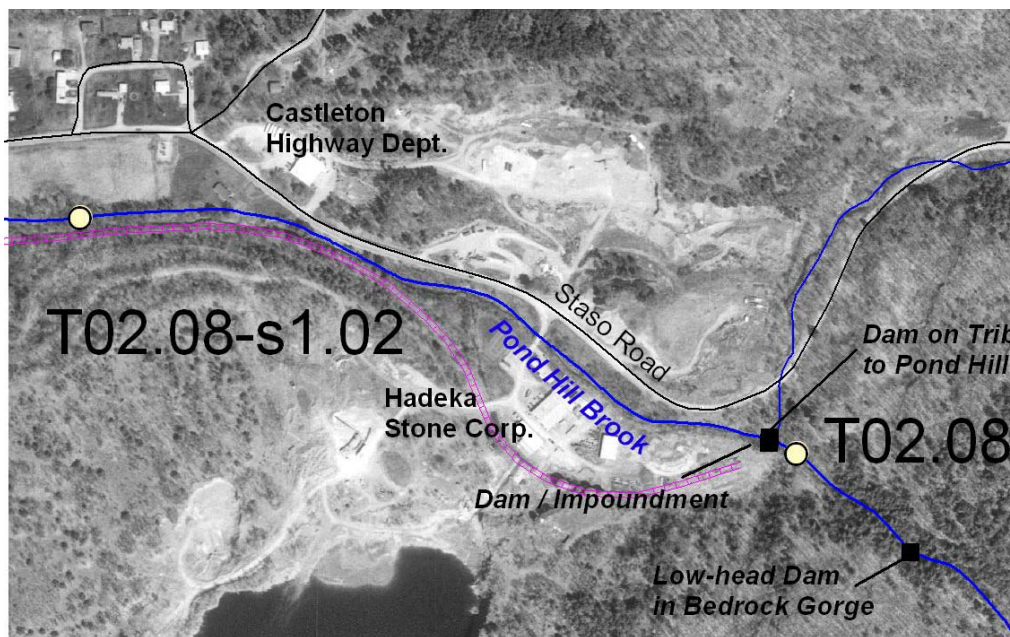
Figure 53. Reach T02.08-s1.02 of Pond Hill Brook flowing between Staso Road to the north and the slate quarry to the south, now occupied by Hadeka Stone Corporation. Flow is from lower right to upper left. Approximate location of historic railroad spur indicated in purple.

Rip-rap is present along right bank for approximately 400 feet. Nearly the entire length of the left bank is armored by rip-rap, fill material comprised of slate quarrying waste, or the railroad grade in the downstream half of the reach. Just downstream of the dams near the upstream end of the reach, massive rip-rap on both banks creates a constriction narrower than the bankfull width. Sediment is aggraded upstream of this area, and scour holes between large boulders of failed rip-rap are evident downstream.

The Pond Hill Brook is entrenched well below the surrounding floodplain, to depths ranging from approximately 5 to perhaps 12 feet. The degree of channel degradation in this reach may be related, in part, to incision on a geologic scale several thousands of years ago, where the Pond Hill incised into underlying erodible gravels and cobbles of glacial kame terrace origin. However, the current degree of entrenchment is very likely a result of historic dredging, straightening, and armoring, as well as fill associated with the adjacent quarrying operations, maintenance of the Staso Road, and construction and maintenance of the railroad spur(s). It is also possible that impoundment of sediments in the upstream dams, particularly at the former reservoir in reach T02.08-s1.03, historically may have caused a condition of “hungry water”, contributing to incision through downstream reach s1.02 below the bedrock channel.

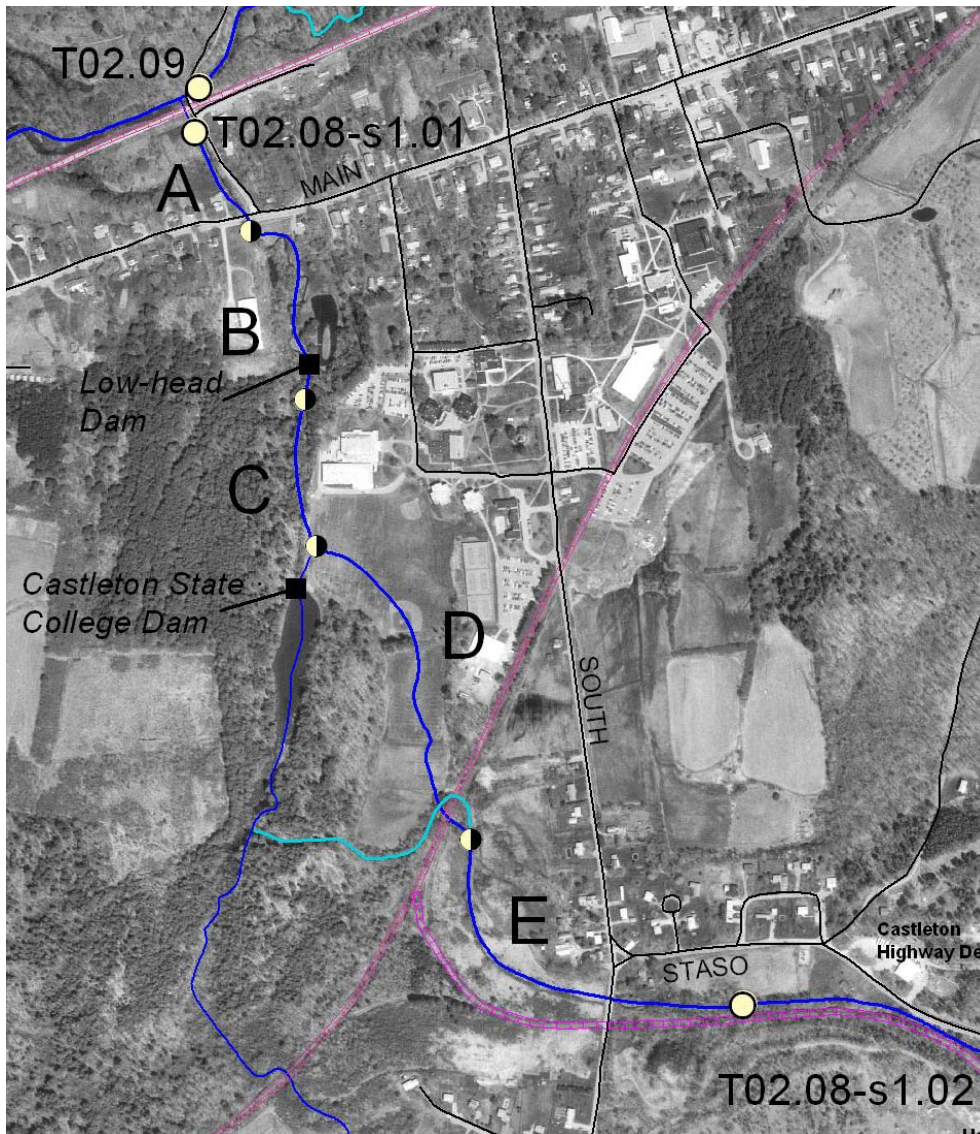
Figure 56. Segmentation of reach T02.08-s1.01 of Pond Hill Brook. Flow is from lower right to upper left. Light blue line depicts current planform of Segment D.
