# Phase 2 Stream Geomorphic Assessment Castleton River Watershed – Town of Castleton Rutland County, Vermont

March 2007 (Revised April 2008)

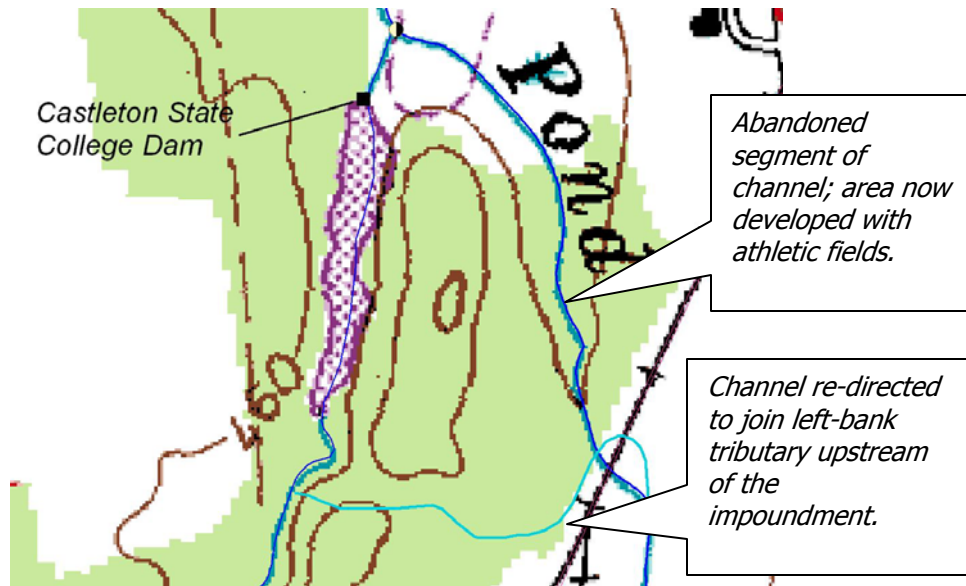
The exact date of diversion of the Pond Hill Brook is not known. According to the database of Vermont dams (EmergencyOther\_Dams), the Castleton State College dam was constructed circa 1967 and designed by NRCS. Consistent with this record, the impoundment and a nearby running track are depicted in purple coloring on the USGS 7.5-Minute topographic map (Figure 57), which indicates they were features identified in the 1972 photo-revision of this 1964 map. The Pond Hill Brook is depicted in its pre-diverted planform on this 1964 / 1972 topographic map, which might suggest that re-channelization of the Pond Hill Brook took place after 1972. However, the 1962 and 1968 aerial photographs reviewed at the Rutland County NRCS field office indicate a different timeline. In 1962 the area of the athletic fields is forested, and no pond appears in the present location of the impoundment. The 1968 photograph (although of limited resolution) shows the area of the athletic fields to be cleared; a portion of the re-channelized planform of the Pond Hill Brook is somewhat visible in the same approximate planform as present. A reflective white area is present in the approximate position of the impoundment. Thus, it would appear that channel redirection and impoundment occurred nearly at the same time, and coincident with the development of the athletic fields, on or around 1968.

Figure 57. Portion of reach T02.08-s1.01 on Pond Hill Brook redirected to west to a constructed impoundment in the mid- to late-1960s. Base map is 1964 USGS 7.5-Minute topographic map (photoinspected 1972).

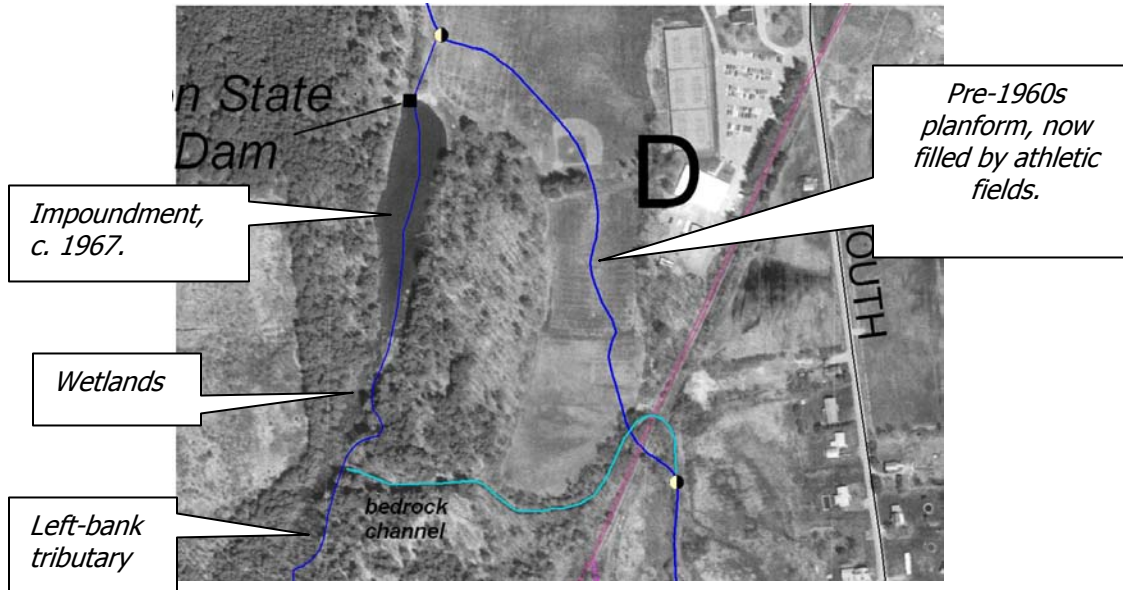
Approximately 120 feet downstream (south) of this crossing is an apparent former railroad crossing visible along left bank in the approximate position of the pre-channelized planform. The former crossing also consists of two concrete culverts located approximately 1 foot apart. Backwater was observed flowing from the main channel into these culverts. The eastern side (former inlet) of these culverts was not visible from the channel upstream. It appears that this area of the former channel planform is inundated at higher water stage, and may represent a potential channel avulsion site.

Figure 59. Variable stream types are present along the portion of Pond Hill Brook redirected to a constructed impoundment west of Castleton State College athletic fields in the mid- to late-1960s. Reach T02.08-s1.01. Base map is 1994 orthophotograph.

A cross section completed nearly 200 feet downstream of the railroad crossing confirmed a C4-riffle/pool stream type. The riffle/pool form is not well developed. Pools are absent and runs dominate the channel between short riffles. The measured channel cross section appears somewhat undersized, based on comparison to expected width, depth, and width/depth ratio for a reference C stream type with a drainage area of approximately 2 square miles (VT RHGC data, VTDEC, 2006). The measured bankfull width of 13.5 feet is significantly less than predicted (17.2 to 19.5 feet) and less than measured in upstream segments (18.5 feet in Segment E; 17.0 feet in reach T02.08-s1.02). The width/depth ratio of 9.9 is very low, more characteristic of an E stream type, but permissible for classification of a C stream type with consideration of the (+/- 2 units) permitted under protocols. It appears dredging to create this channel diversion resulted in a channel cross section which is somewhat undersized. The short berm and rip-rap near the upstream end of the segment suggest that channel avulsions may have been an issue in recent years.

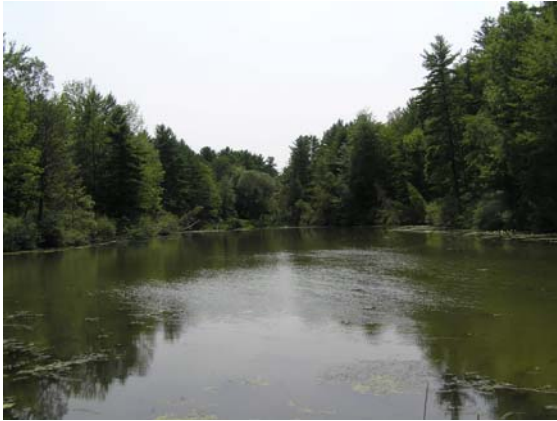
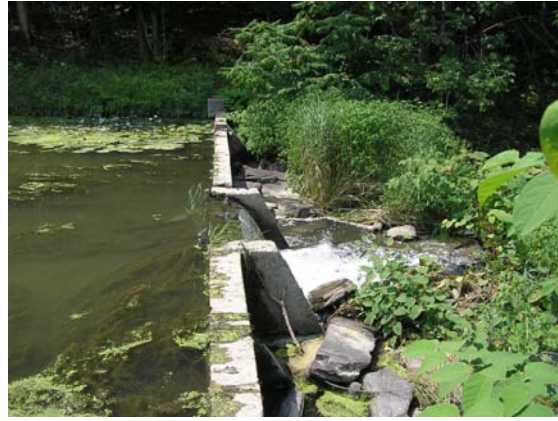
narrowly-confined bedrock gorge (estimated B1-cascade). Flows then merged with a left-bank tributary in a wetland complex west of a north-south trending bedrock knoll. The wetland subsequently flows into the 2-acre (+/-) impoundment behind the Castleton State College dam (Figure 60). Vermont Dam Inventory records (VCGI, 2005) indicate this dam to be 290 feet long and approximately 10 feet high.

Figure 60. Impoundment (approximately 2 acres) behind Castleton State College dam constructed circa 1967 – 1968. (Segment D of reach T02.08-s1.01). (a) view upstream (south) from dam; (b) view toward left bank, along dam. Viewed 31 July 2006.

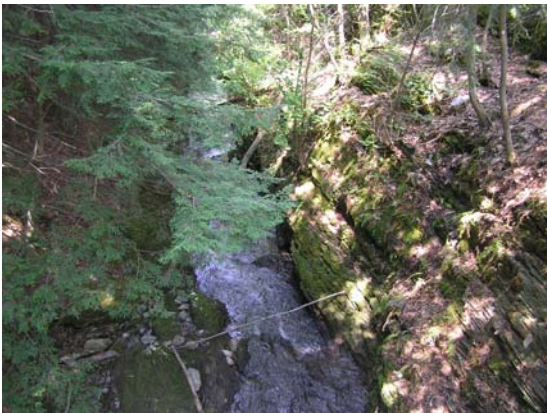
Bedrock walls of the channel create a semi-confined to narrowly-confined valley setting. Bedrock ("ledge", by protocols) is exposed in the channel bed for a majority of the length, with locally steeper sections of cascade bedform over bedrock waterfalls. Since this segment was characterized as a "gorge", a RGA and RHA were not completed, and a "Low" sensitivity was assigned (by protocols). The considerable slope of Segment C and the narrowly-confined valley suggest that this section of Pond Hill Brook is sediment-supply limited, with a high sediment transport capacity.

Figure 61.  
Bedrock gorge (Segment C) of  
reach T02.08-s1.01.

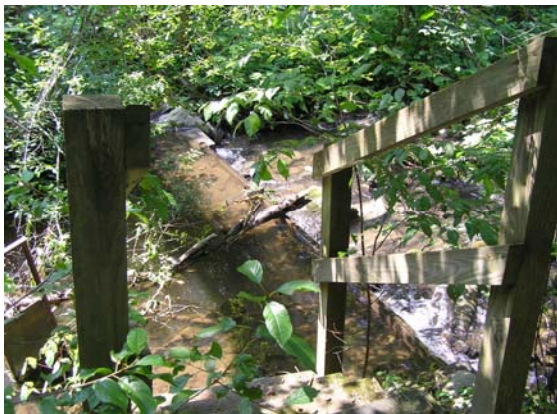
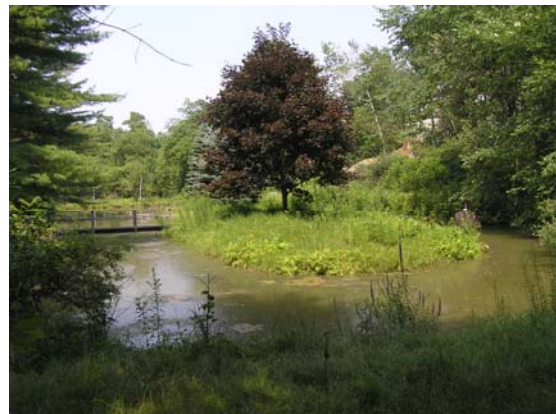
A constructed pond with island in the middle is present along the right bank corridor. As discussed in earlier sections, this pond appears to have been constructed between 1972 and before 1994. A small portion of flow in Pond Hill Brook is diverted to this pond from a small impoundment behind a low-head dam (Figures 62 and 56). Water is returned from the pond to the channel via a corrugated steel culvert protruding from right bank, located approximately 400 feet downstream of the withdrawal site. It is unknown whether this constructed pond (by design) receives stormwater runoff from adjacent residential / commercial properties. New buildings were in the process of being constructed along the east side of this pond on the assessment date (31 July 2006). The pond does represent a local drainage "sink" for precipitation and runoff; therefore, the culvert draining the pond to Pond Hill Brook was identified as a stormwater input during the assessment.

Figure 62. Water from Pond Hill Brook (Segment B) is diverted from a small impoundment behind a low-head dam and piped to a constructed pond along right bank, downstream of the Castleton State College campus and upstream of the Route 4A (Main Street) crossing. (a) view from right bank of low-head dam and pipe inlet accessed by wooden stairs; (b) view to north of constructed pond with island accessed by wooden footbridge. 31 July 2006.

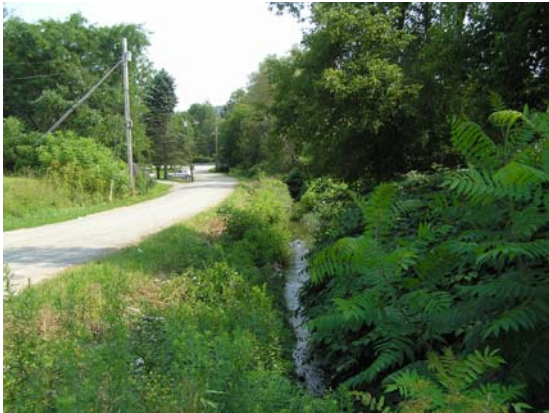
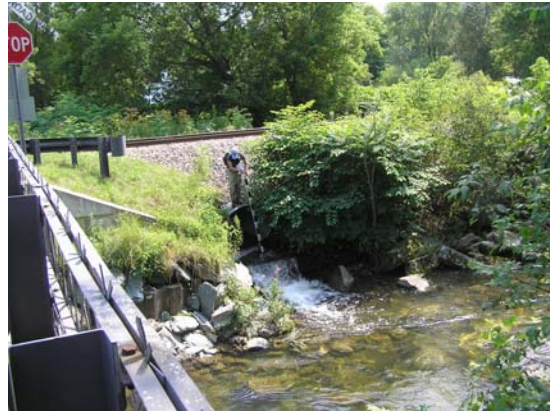
Segment A is the downgradient-most section of the reach from the Route 4A (Main Street) crossing downstream to the Castleton River. Based on review of historic maps, this section of the reach appears to have been channelized some time after 1897 and before 1964, to follow Cemetery Drive and join the Castleton River at a point 800 feet upstream of its former confluence (Figure 63a). While this modified planform would have shortened the segment length, it may not have substantially increased the channel gradient, since the Pond Hill Brook falls approximately 3 feet from an instream culvert under the railroad grade to join the Castleton River (Figure 63b).

*Figure 63. In its last 500 feet downstream of the Main Street crossing, Pond Hill Brook is channelized along Cemetery Drive and flows under the Delaware & Hudson Railroad through an instream culvert to cascade into the Castleton River. (a) view upstream (south) from railroad crossing; (b) view to southwest from Cemetery Drive crossing of the Castleton River toward confluence of Pond Hill Brook. 31 July 2006.*

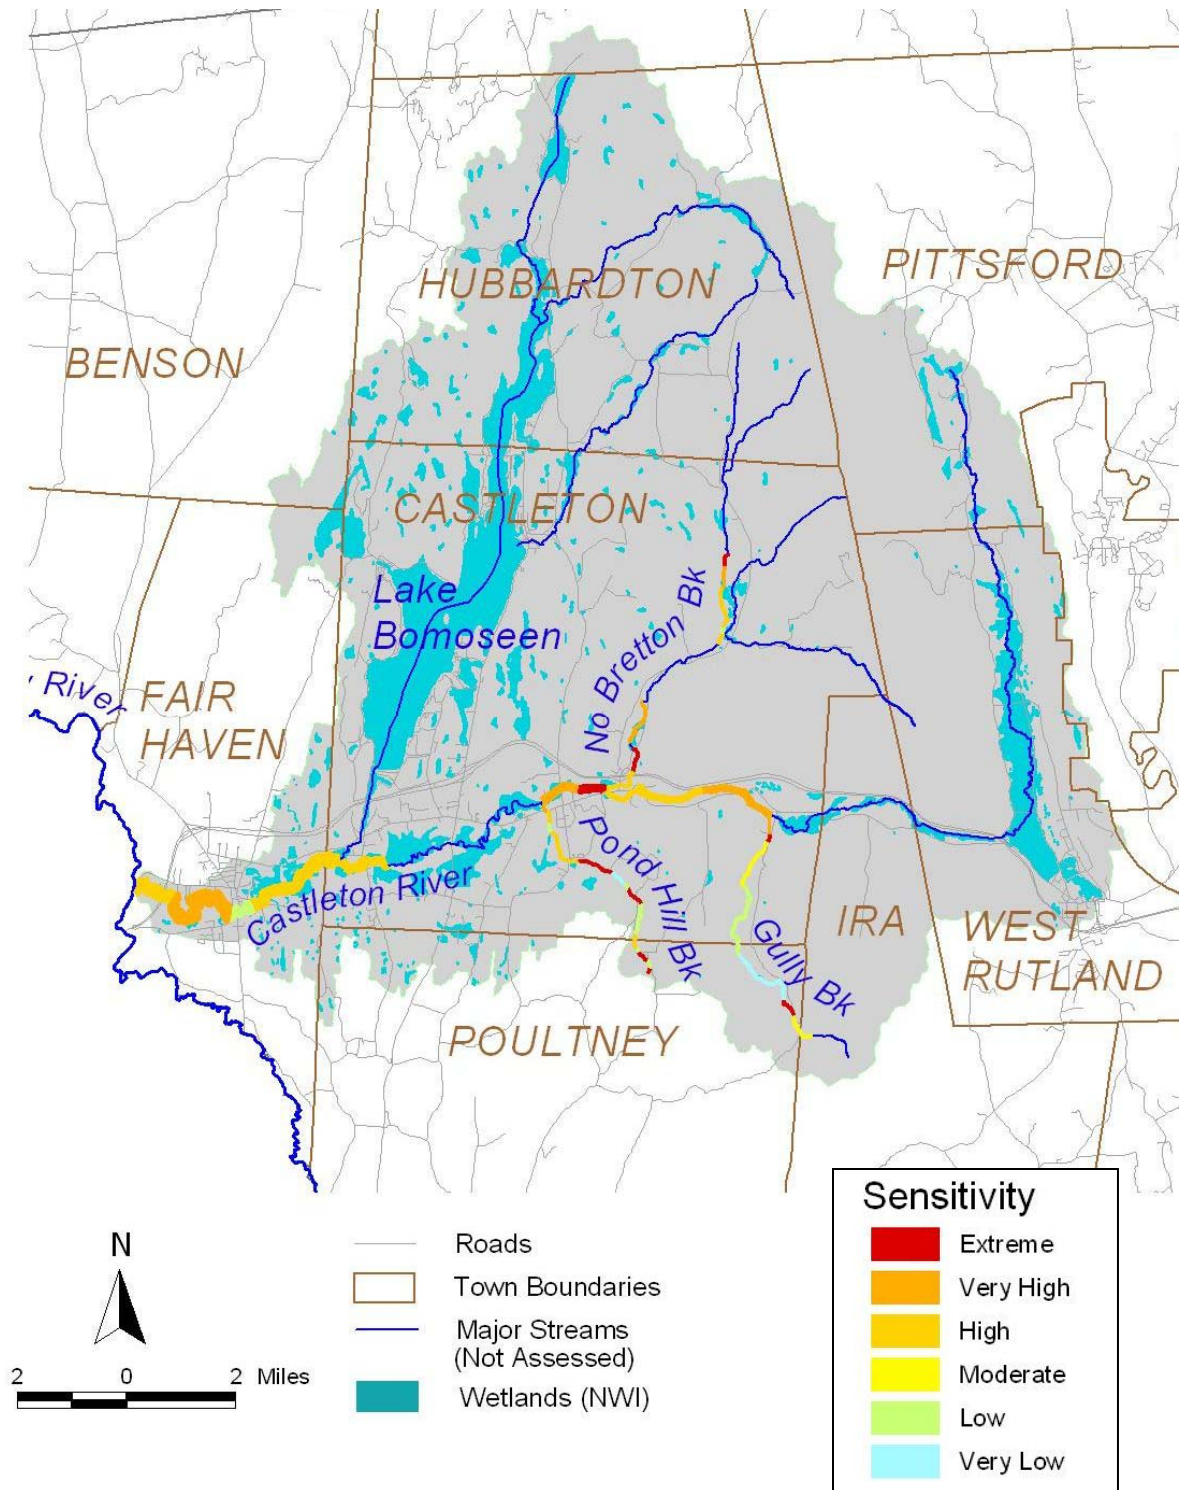
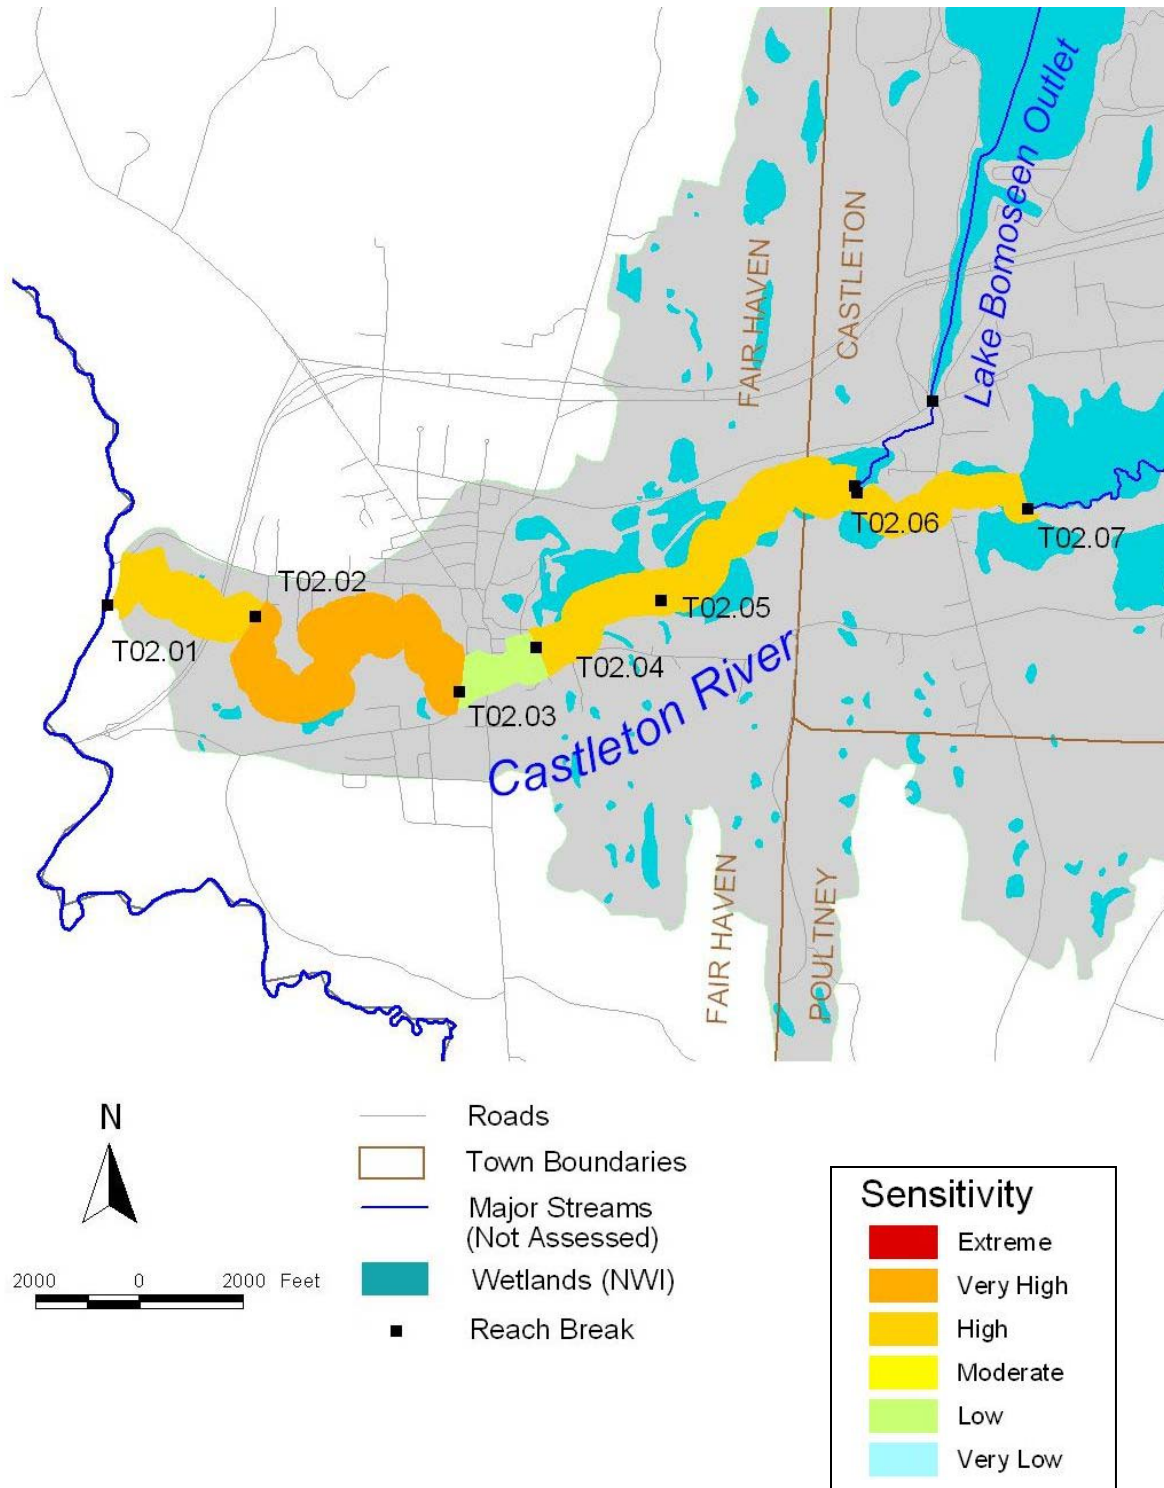
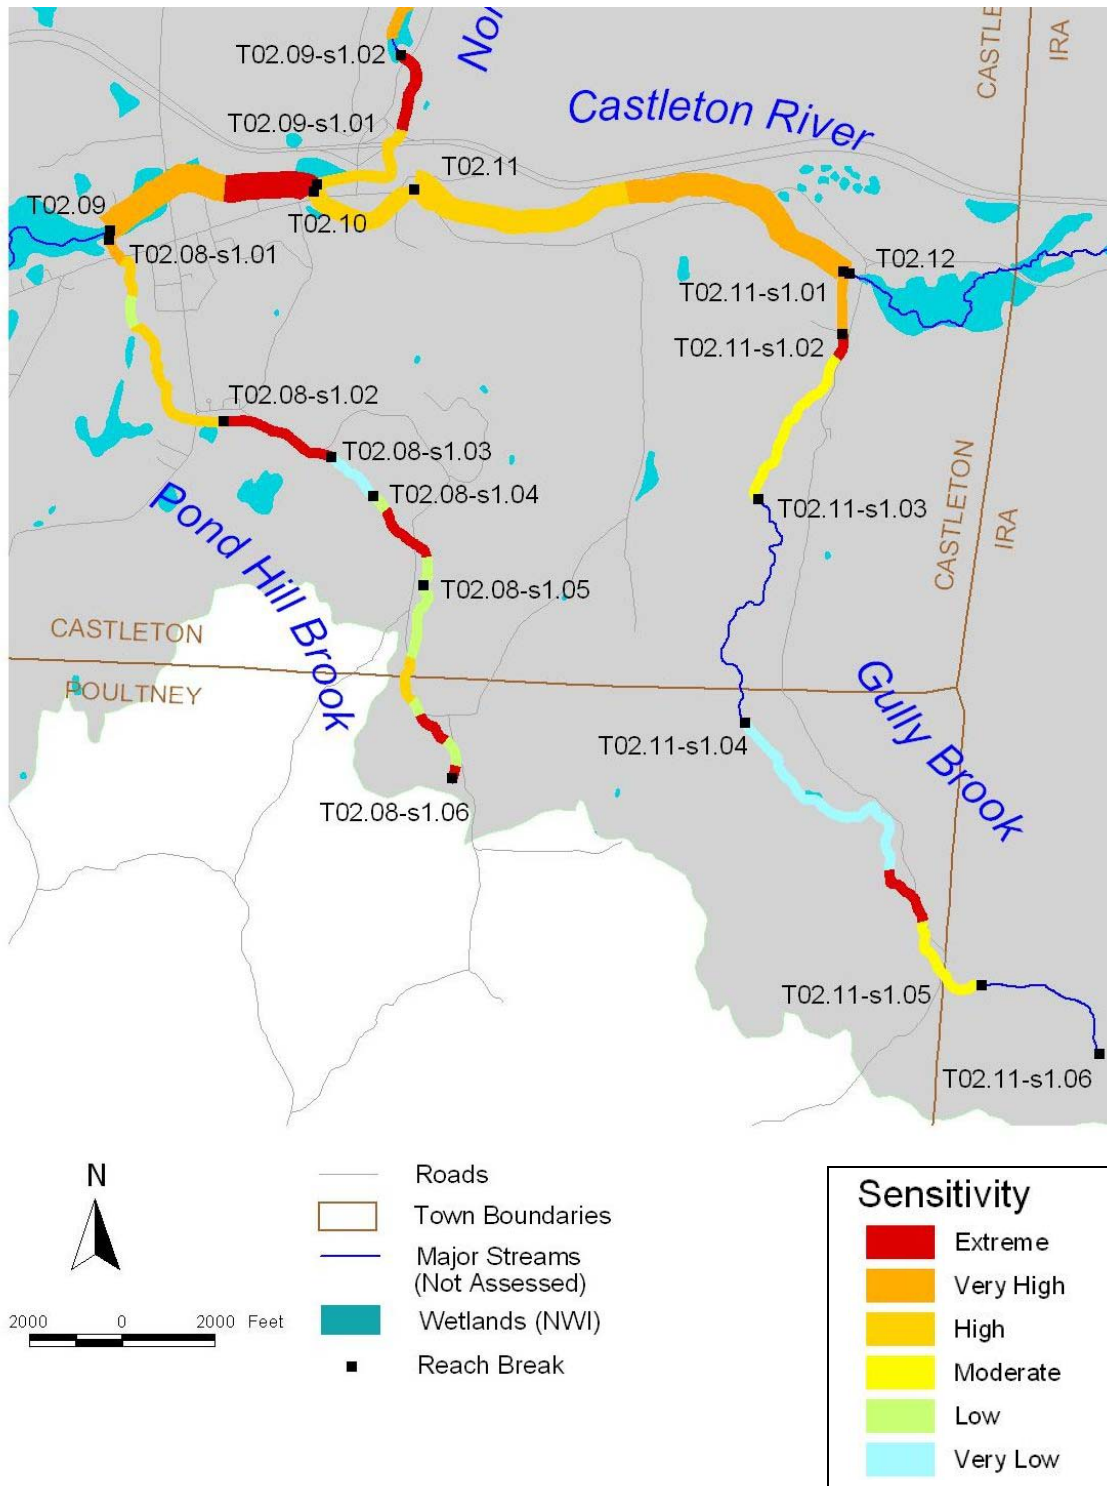
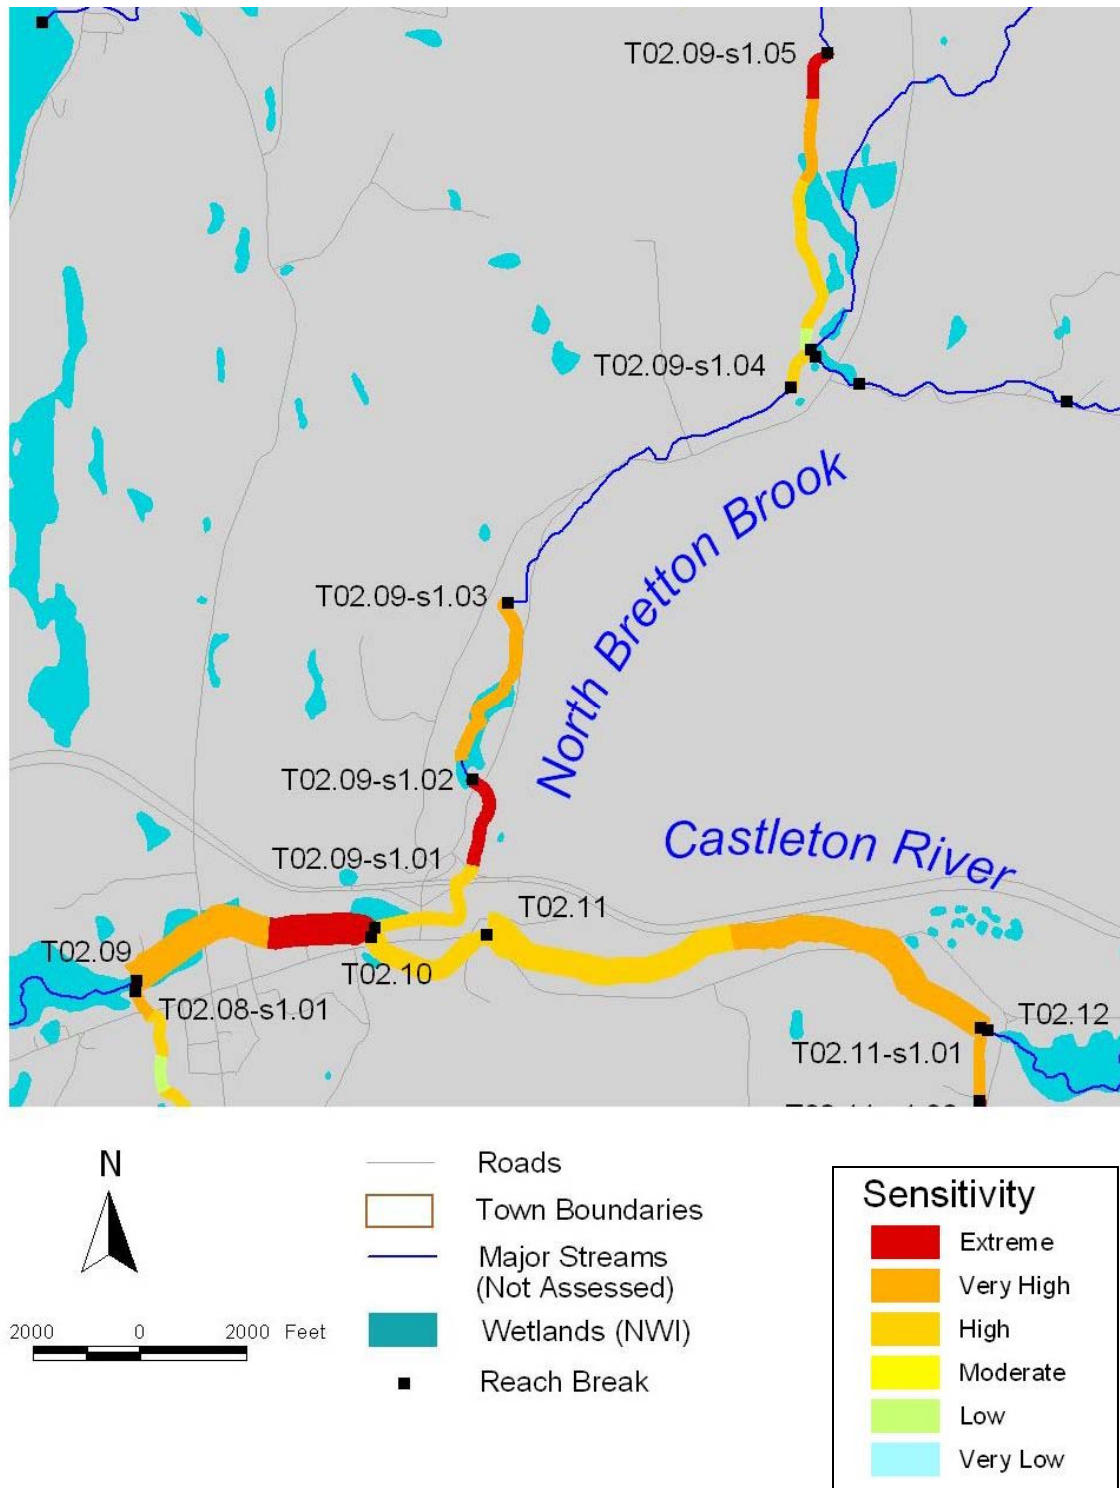
Sensitivities of the study area reaches/segments as defined in VTANR protocols (2006) are presented in Figures 64 through 67. In general, this Phase 2 assessment purposely targeted lower-gradient, (reference C or E-stream-type) reaches that would be expected to exhibit higher sensitivity, and which have current constraints within the river corridor (and elevated impact ratings in the Phase 1; RRPC, 2005). Therefore, it is not unexpected that many of the study area reaches were defined as having sensitivities at the high end of the scale.

- main stem reach, T02.03 - the bedrock-controlled, relatively steep-gradient (2.4%) channel with three historic dams located in Fair Haven village (Low sensitivity) (Figure 65);
- a narrowly-confined, steep gradient (4.6%), bedrock segment of Gully Brook - T02.11-s1.04-A (Very Low sensitivity) (Figure 66);
- narrowly-confined to semi-confined, steeper-gradient (3.2 to 5.5%), cobble- to coarse-gravel-dominated segments of Gully Brook – T02.11-s1.04-D and -C, and T02.11-s1.02-B (Moderate sensitivity) (Figure 66);
- a short, semi-confined, steep-gradient (2.9%), bedrock-dominated segment B of North Bretton Brook reach T02.09-s1.04 (Low sensitivity) Figure 67); and
- narrowly-confined to semi-confined, steep gradient (3.7% to 11.4%), bedrock segments of Pond Hill Brook - T02.08-s1.05-E, C, and A; T02.08-s1.04-C and A; T02.08-s1.03; T02.08-s1.01-C (Low to Very Low sensitivities) (Figure 66);

In contrast, segments exhibiting a pervasive stream type departure (as compared to reference stream type) were assigned an **Extreme** sensitivity. Typically, these reaches/segments have lost access to their floodplains becoming entrenched within their banks, as a result of historic channelization and/or dredging. Occasionally, entrenchment has been exacerbated by road or railroad encroachments or sediment berms close to the channel. Dominant adjustment processes observed in these reaches were planform adjustment, aggradation and widening; none of the segments exhibited signs of system-wide active incision. Generally, these moderate- to lower-gradient (< 4%), cobble, gravel and sand channels showed stream type departures from C (or C<sub>b</sub>) reference stream type to an entrenched F stream type (there was also one example each of a D to F departure and a C<sub>b</sub> to B departure).
