Phase 2 Geomorphic Assessment of the Batten Kill, Vermont

Prepared by:
John J. Field
Field Geology Services
Farmington, ME

December 2005

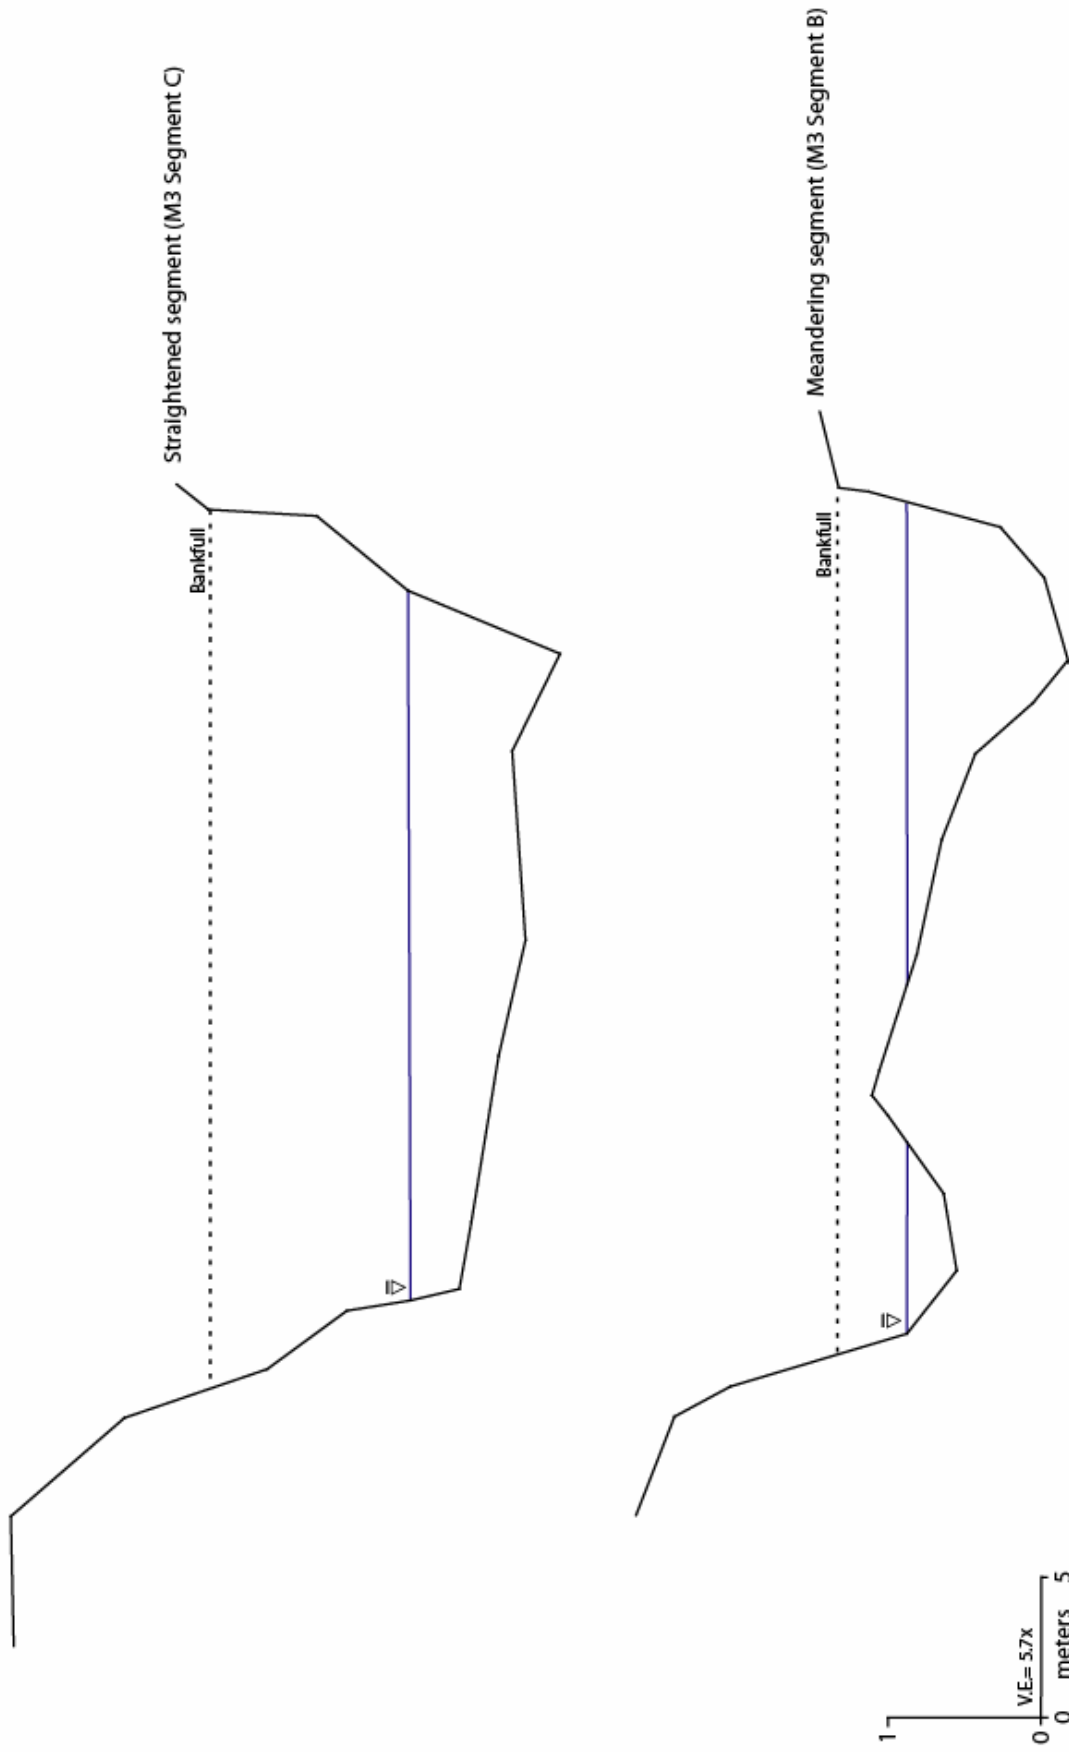
Comparison of Straightened and Meandering Channel Bankfull Widths

reveal that the well developed riffle-pool bed morphology in meandering areas is replaced by shallower and less numerous pools in straightened segments (Figure 11). These channel adjustments have resulted in degraded habitat conditions in the straightened segments with poorer pool development and less velocity-depth flow complexity. Sand substrate predominates in all segments of Reach M5 so particle size distribution is not altered by straightening.

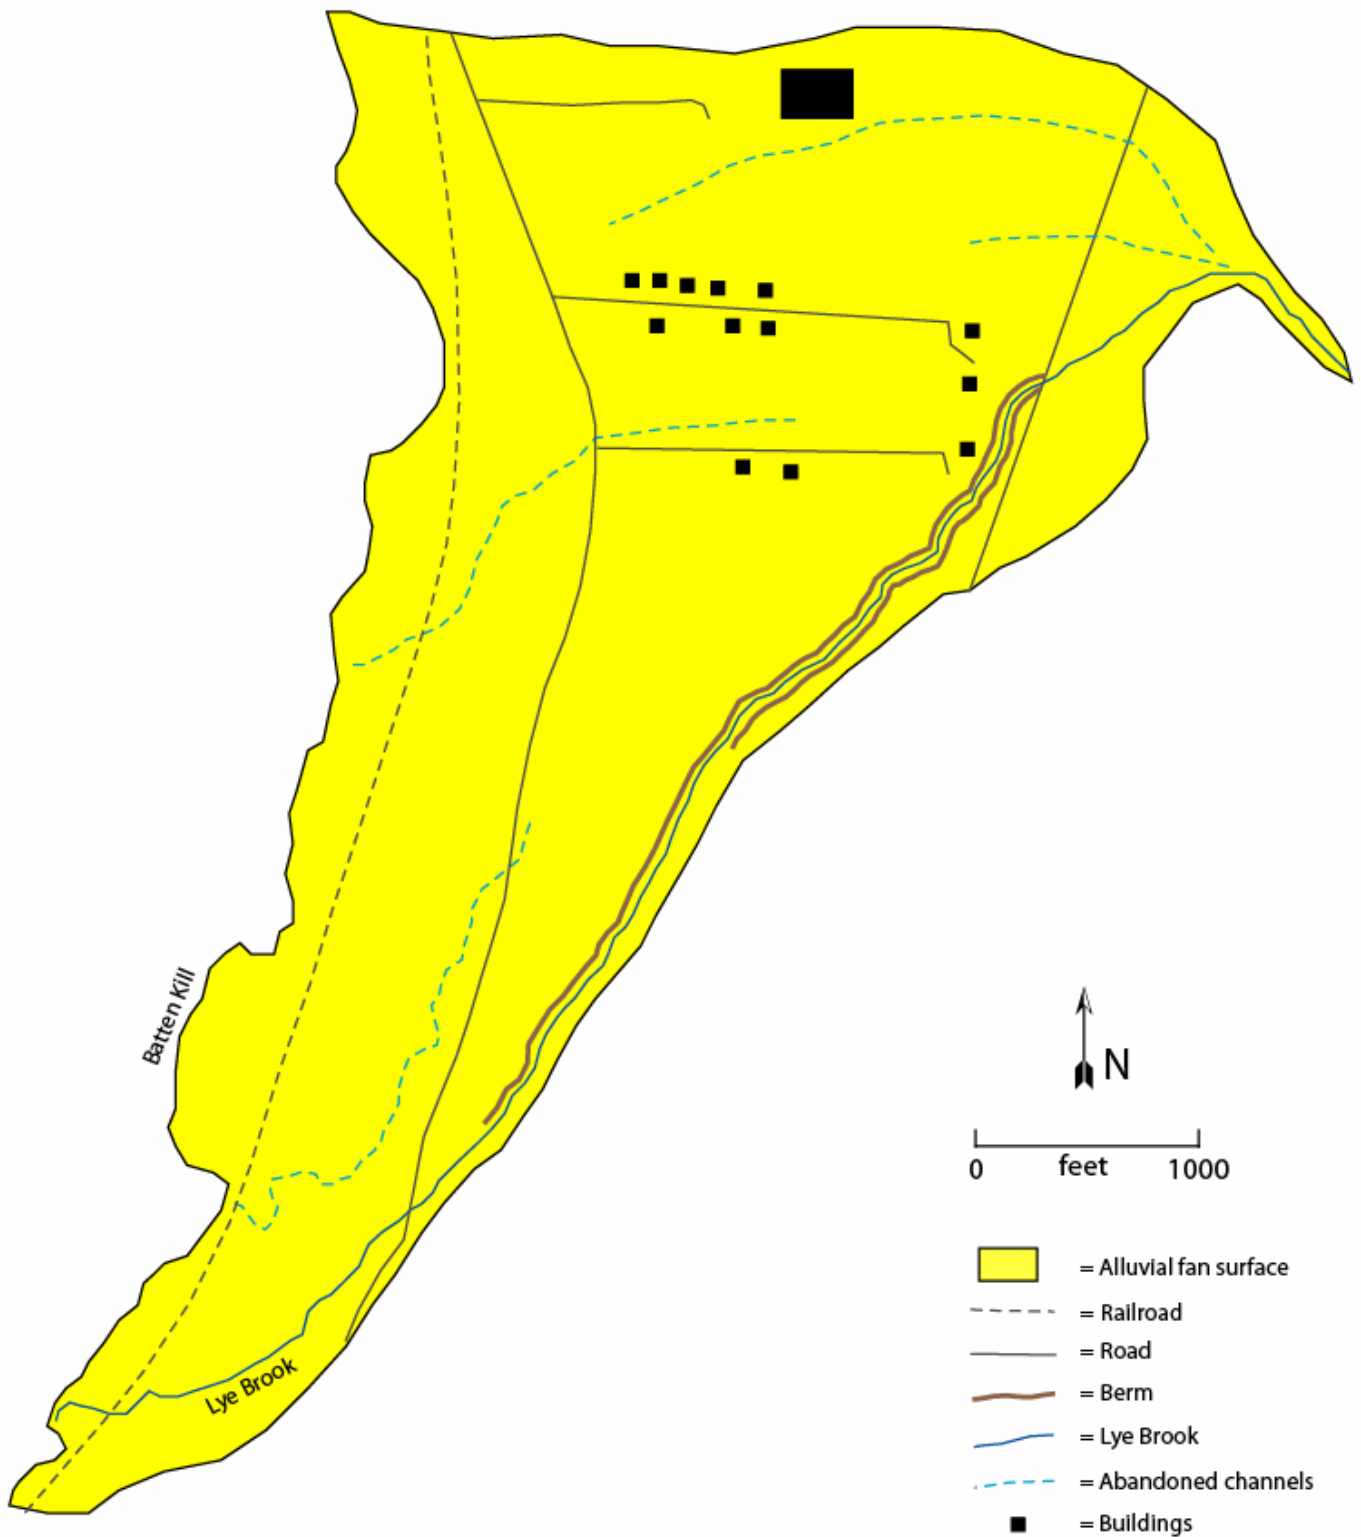
Lye Brook Alluvial Fan

Note: Batten Kill mainstem flows along western edge of alluvial fan surface

flow crosses the alluvial fan surfaces found at the lower ends of the Green Mountain tributaries. Although removing berms in many localities would put property at greater risk, opportunities should be sought, far from any developments, where berm removal would allow flow to escape onto the alluvial fan surface. Restoration such as this would have several advantages: 1) create side channel habitat on the alluvial fans; 2) reduce peak flow velocities within the formerly confined tributary, thereby permitting revegetation of gravel bars; 3) reduce the risk of berms catastrophically failing in other areas where property might be damaged; 4) allow the stream to expend additional energy before entering the mainstem; and 5) return the stream to a more natural flow regime. The implementation of restoration strategies on the tributaries and mainstem that run counter to traditional river management techniques will require a concerted education effort throughout the watershed that increases public understanding and support for restoration plans that can potentially improve fish habitat, reduce risks to human infrastructure, and return streams to a natural equilibrium condition by hastening the natural channel evolutionary process.
