**FLUVIAL GEOMORPHOLOGY ASSESSMENT:
MIDDLEBURY RIVER WATERSHED
ADDISON COUNTY, VERMONT**

August 2003

Kristen L. Underwood, P.G.

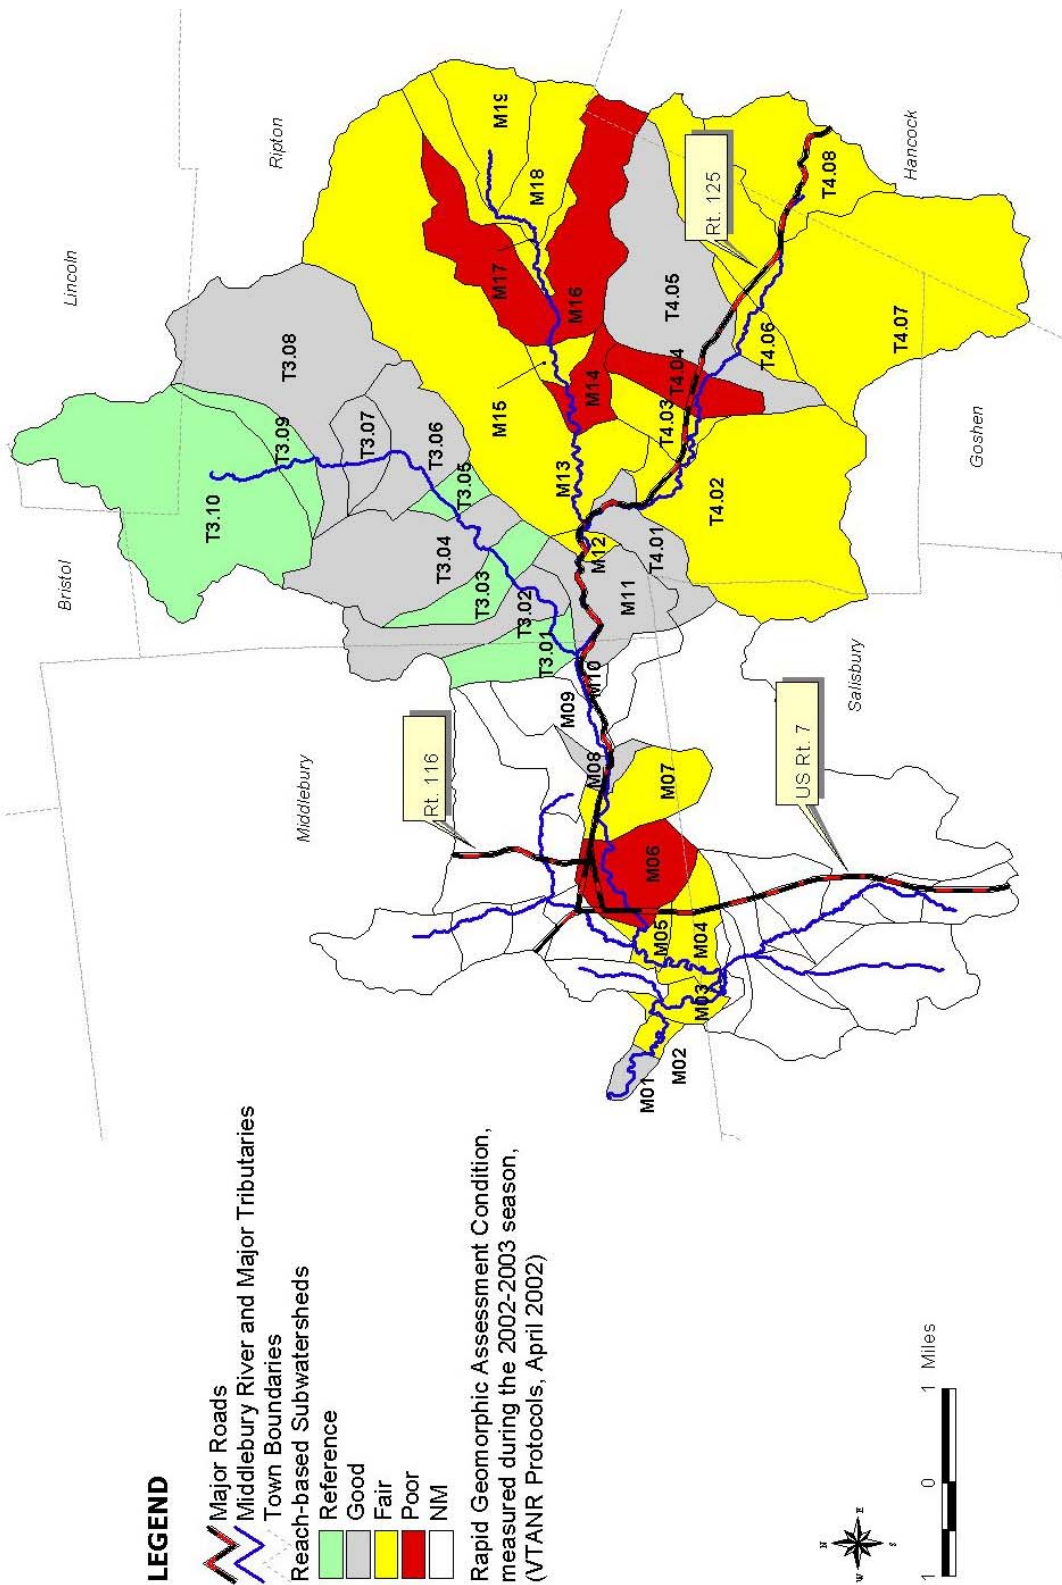
Figure 14. Reach-based Geomorphic Condition Phase 2 Stream Geomorphic Assessment Results, 2002-2003, Middlebury River Watershed

Geomorphic conditions within the Middlebury River watershed are summarized in Figure 14. Generally, North Branch reaches appear to be in good condition, with several reaches suitable for conservation. The steepness of gradient, frequency of bedrock and boulder grade controls, as well as the relative lack of stressors from floodplain encroachment and channel management activities (see Table 9) have likely contributed to stable conditions in this upper tributary watershed.

South and Middle Branch reaches have experienced more regional and local stressors from deforestation in the mid-1800s, with active farming and lack of buffers persisting in the riparian corridor through at least the early 1960s. These upland tributaries have also been subject to floodplain encroachment by residential development and roads. Fewer locations of stabilizing bedrock or boulder grade controls exist in these tributary watersheds (see Figure 15). Also, anecdotal accounts suggest that the 2000 flood was concentrated on the southeastern portion of the watershed, more than over the North Branch portion of the watershed. The majority of reaches in the Middle and South Branches were rated in Fair to Poor geomorphic condition.

Downstream of the Transport Reaches which were in Good condition, the majority of the Lower Watershed channel was in Fair to Poor geomorphic condition. Stressors in the Lower Watershed contributing to channel disequilibrium likely include channel management activities (channelization, dredging and berming, armoring, etc.) particularly through East Middlebury reaches M06, M07, and M08, undersized bridges (see Figure 16, Appendix G), lack of riparian buffers, and localized floodplain encroachment by roads (Table 9).

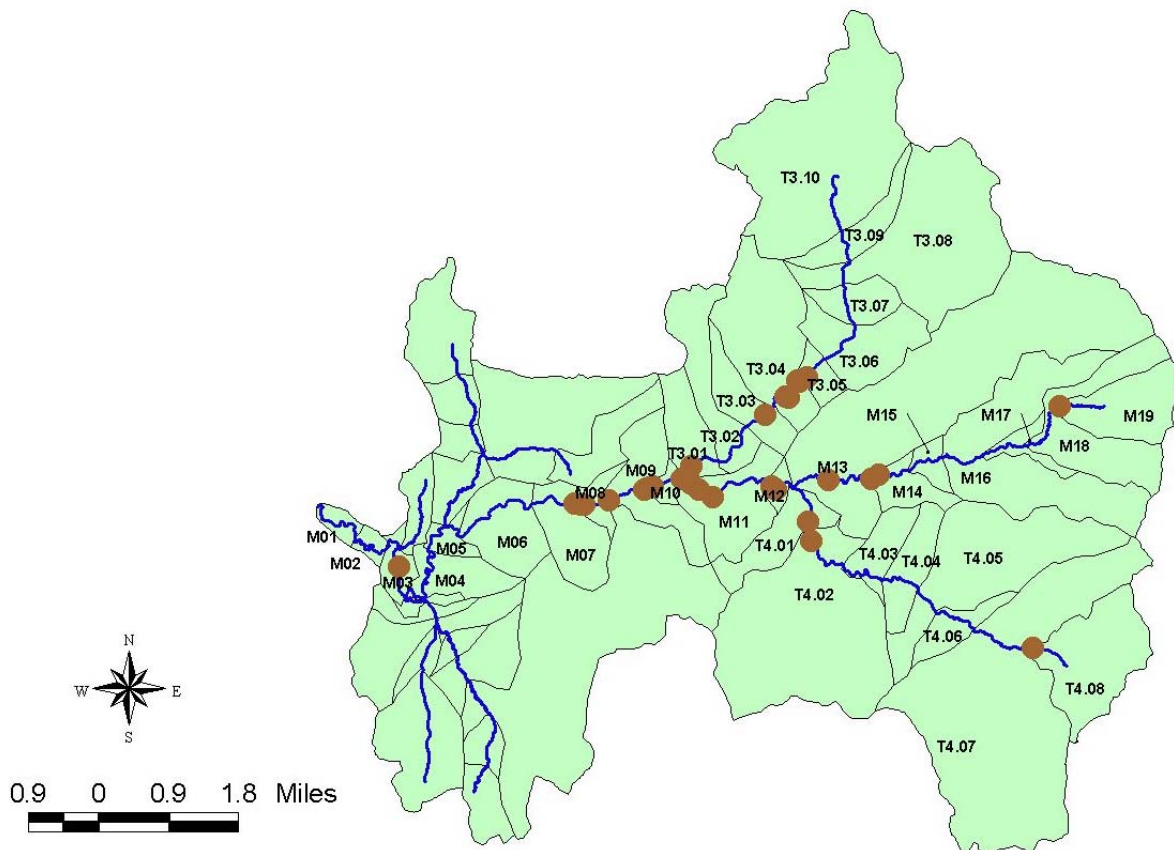
Figure 15. Location of boulder, bedrock and structural grade controls in the Middlebury River watershed.

Good frequency of vertical grade control is offered in the downstream half of the North Branch by channel-spanning bedrock (and in a few possible instances, by channel-spanning boulder lines). (see Field Notes in Appendix F and Figure 15).

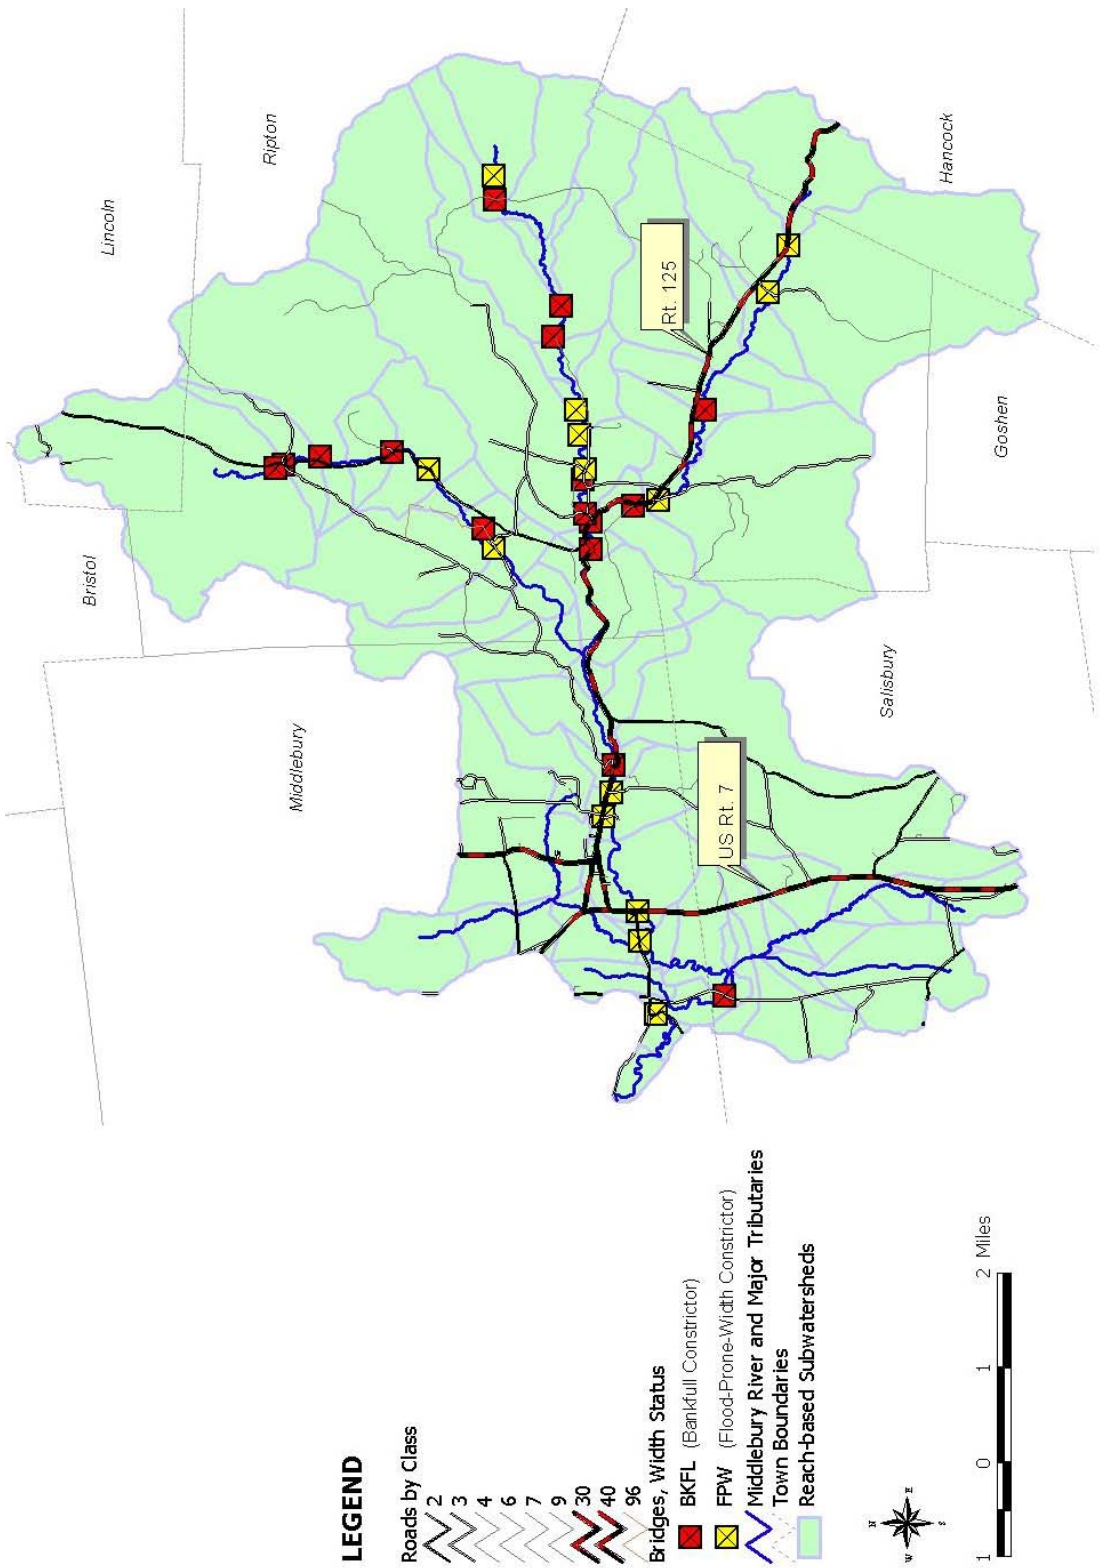
Figure 16. Bridge and in-stream culvert crossings: Middlebury River main stem and Middle, North and South Branches.

Note: Yellow symbol indicates bridge undersized with respect to the Flood Prone Width (Q10 to Q50 storm). Red indicates bridge undersized with respect to the Bankfull Width (Q1.5 storm).

Many bridges and in-stream culverts providing road crossings to the Middlebury River main stem and tributaries were determined to be undersized with respect to the bankfull flow (see Figure 16). All crossing structures were undersized when compared to flood prone widths (i.e., corresponding to the ten-year to fifty-year storm). Undersized structures can lead to channel aggradation upstream of the structure and vertical and lateral scour on the downstream side of the channel. Such conditions can, in turn, lead to destabilization of the fill and armoring material supporting the bridge and to undermining of footings or other structural components. In addition to locally constricting channels, undersized bridges and culverts can be a source for flood hazards to neighboring properties, serving as the location of debris jams or ice jams during spring runoff events or larger magnitude floods. Particularly, those bridges / culverts noted in red on Figure 16 are points to watch in future flooding conditions, as these are structures undersized with respect to the bankfull width.

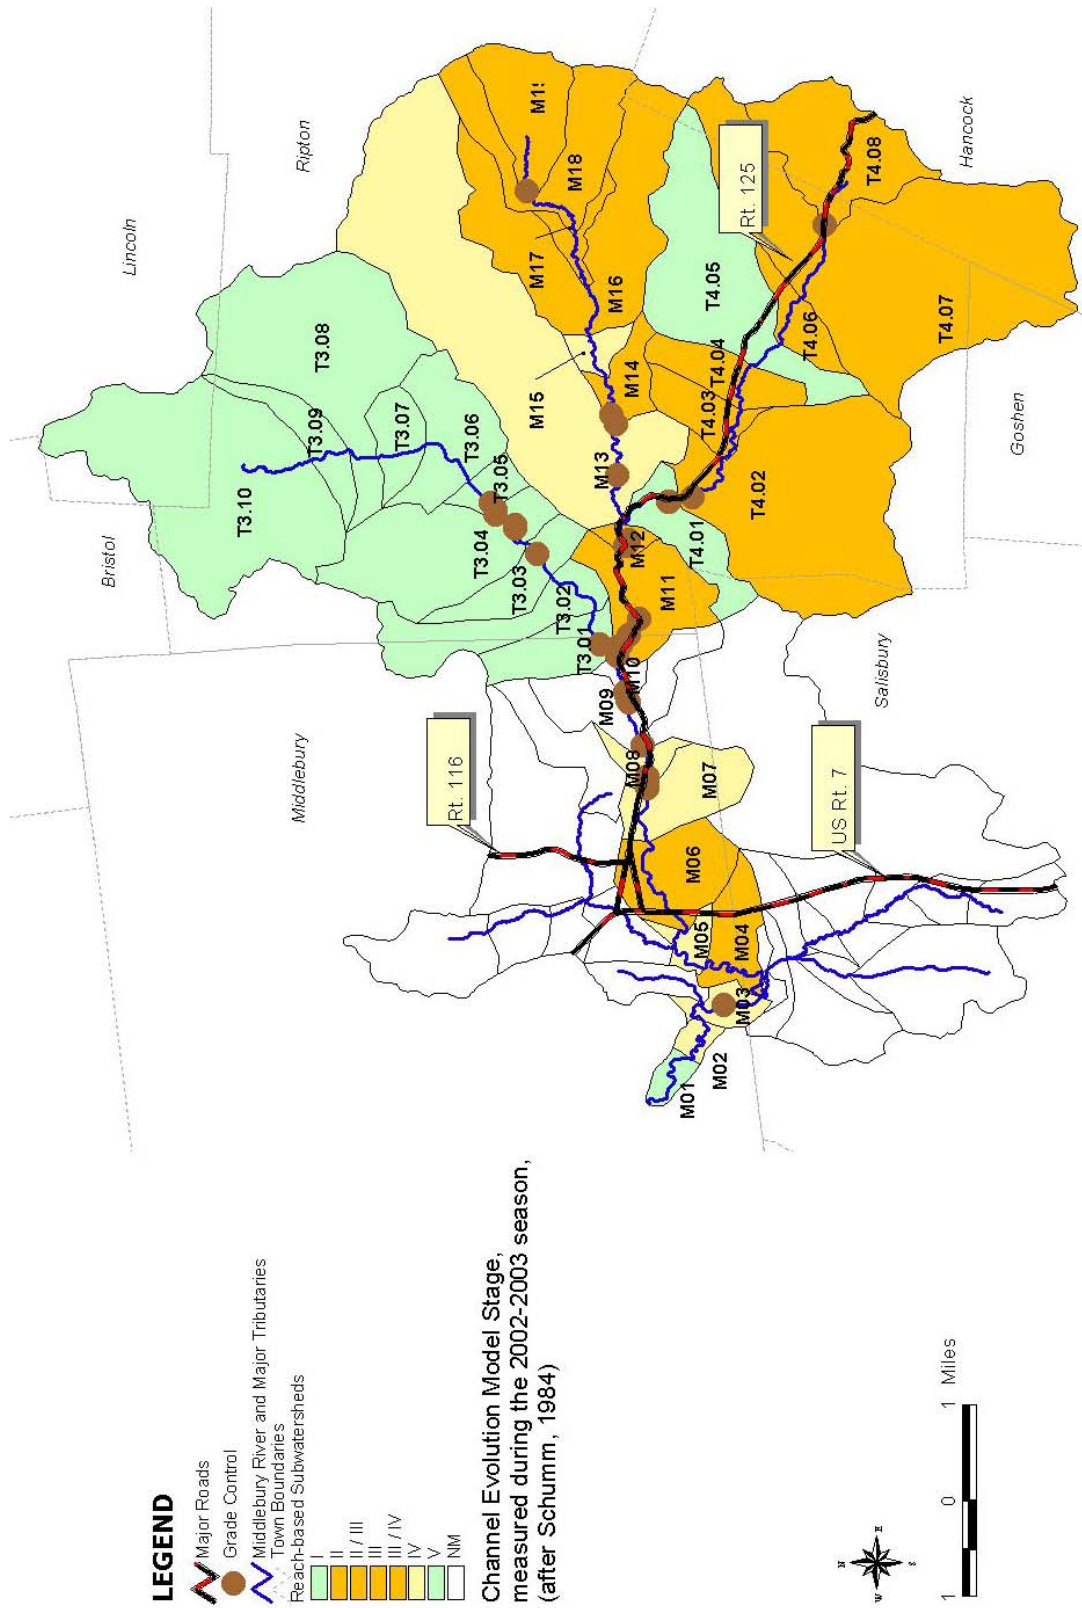
Figure 17. Reach-based Channel Evolution Model Stage Phase 2 Stream Geomorphic Assessment Results, 2002-2003, Middlebury River Watershed

Middlebury River reaches which were assessed to be in a Stage II or III condition are noted in orange on Figure 17. These include the majority of reaches in the Middle and South Branches and Lower Watershed reaches, M06 and M04. Stage II and III reaches which are especially susceptible to future adjustments are those containing no grade controls, those in lower gradient settings with smaller grain sizes (sands and gravels) dominating the stream bed, and those with absent or minimal forested riparian buffers:

- Lower Watershed – M04 and M06
- South Branch – T3.03, T3.04, T4.06, and T4.07

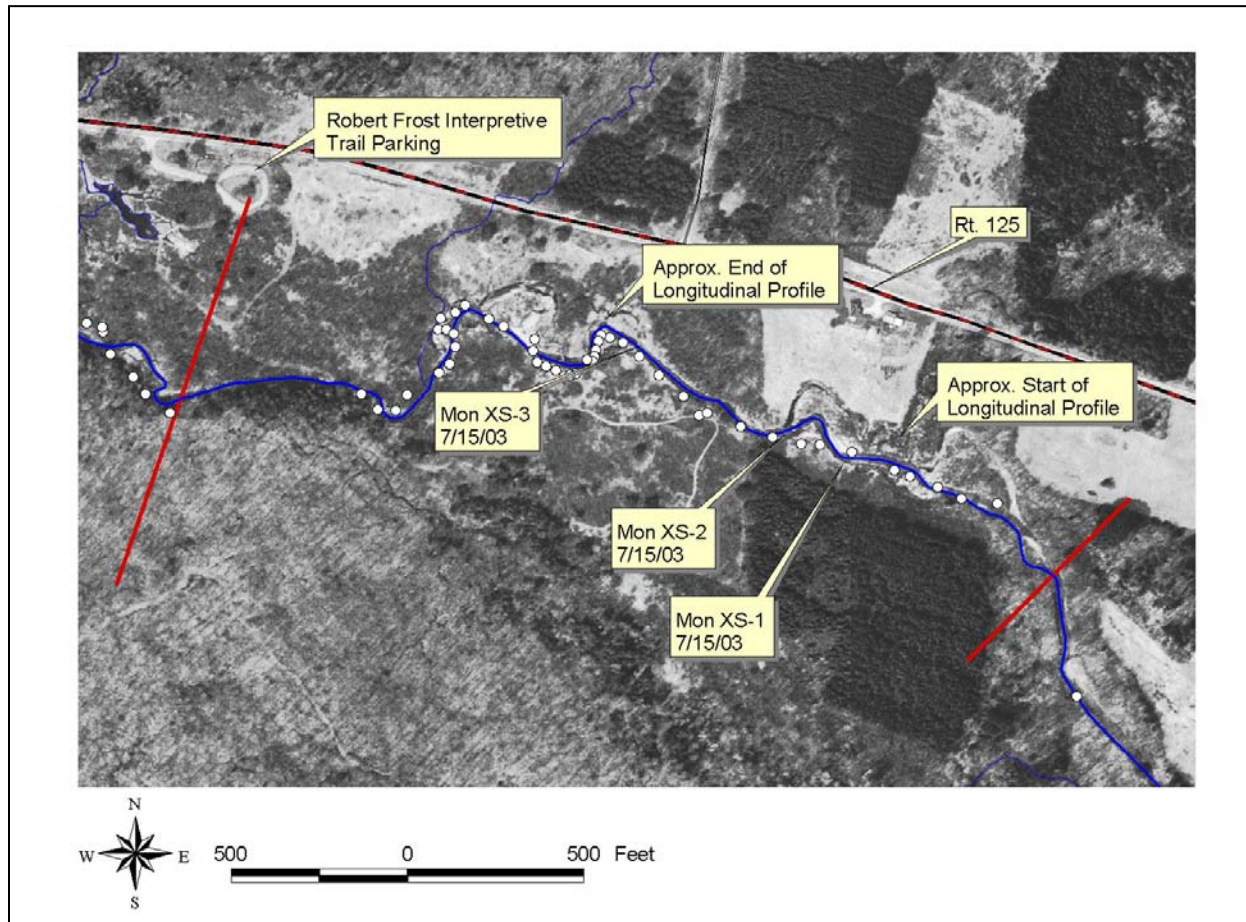
Results of the detailed cross sections generally confirm findings of the Phase 2 assessment of this reach. Downstream monumented cross section XS-3 is similar in geometry to the Phase 2 cross section conducted further downstream in June of 2003 (see Appendix F). These cross
