**Phase 2 Stream Geomorphic Assessment
New Haven River Watershed
Addison County, Vermont**

September 2004

South Mountain Research & Consulting

Addison County Regional
Planning Commission
79 Court Street
Middlebury, VT 05753
802-388-3141

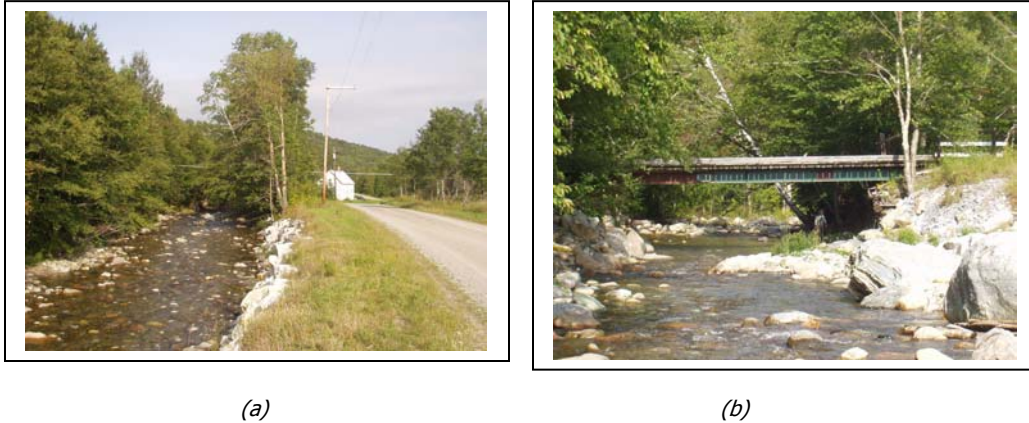
Figure 11. Channel encroachments along reach M26, South Lincoln, VT. (a) Armoring, South Lincoln Road, and residential development along right bank. (b) Private bridge near downstream reach break with span (40.6 ft) less than measured bankfull width (49.1 ft).

The cross section measured in M26 was in a locally widened area just downstream of a length of right bank armoring (background of Figure 11a). Floodplain access was available at the cross section site on the left bank, but incision has disconnected the channel from its floodplain in all but the higher magnitude flows (IR = 1.9). The reach was classified as a C3b-Step/Pool stream type, as it was felt that this stream type is characteristic of a little more than half of the reach. However, locally, the reach exhibits more confinement (approaching stream type departure to an F) between the armored / bermed right bank and the steep, bedrock-controlled left valley wall. Channel degradation leading to abandoned terraces along the right bank appears historic in nature, and may contribute in part to the incision ratio noted in the reach. However, locally, there were noted steep riffles and steps, and scour along both banks with leaning trees, suggesting active incision. SMRC conducted a windshield survey following the August 2004 flood. From observations of matted vegetation and debris traces clinging to trees and shrubs, SMRC noted that the river had not come up over the rip-rap or berms along the South Lincoln Road along this reach, but only accessed the local pockets of floodplain along the left valley wall.

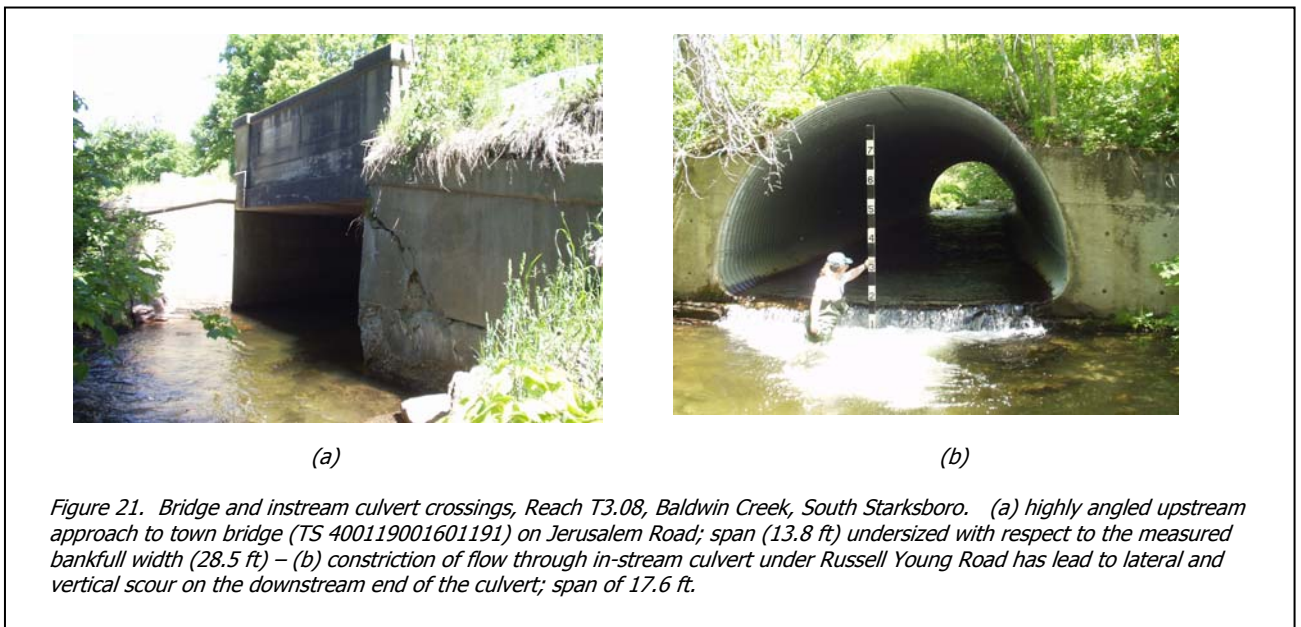
Commercial and residential development has encroached on the floodplain through the upstream portion of reach T3.08. The river passes under one private driveway bridge, under two town bridges (Jerusalem Road), and through one in-stream culvert under Russell Young Road. The span of each of these structures was measured to be less than the bankfull width at the reach cross section. Approach angles of the river to the two town bridges are highly angled (Figure 21a), and substantial armoring is present on both banks. The 83-foot long in-stream culvert under Russell Young Road has developed a large scour pool at the downstream end (Figure 21b).

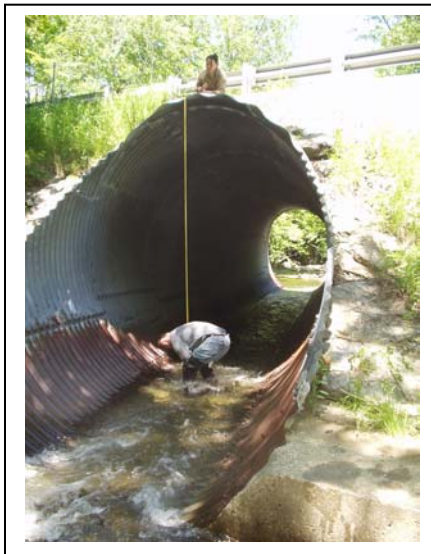
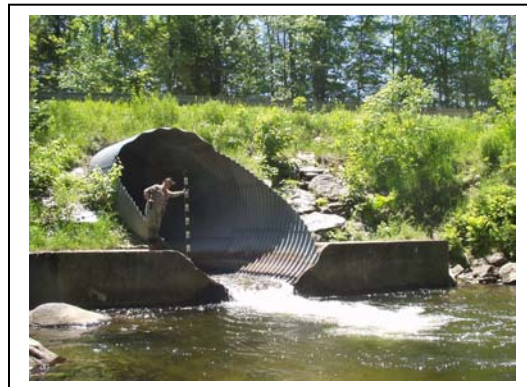
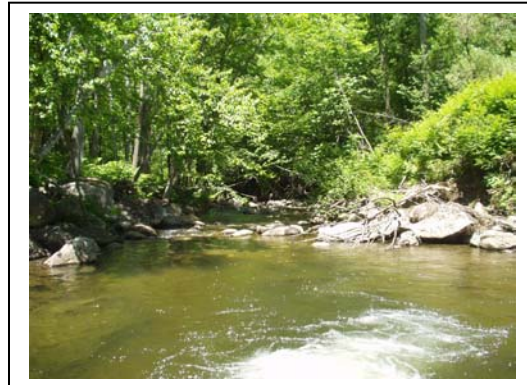
development and encroachment by roads are limited through the downstream half of reach T3.07 and the next reach, T3.06. The geomorphic condition in these reaches is fairly stable. Some localized instability was noted, however, at the Route 17 crossing. Baldwin Creek crosses under Route 17 through an 88-foot long culvert that is taller in dimension than it is wide (see Figure 22a). The span of this culvert (11.2 feet) is far undersized with respect to the bankfull widths measured in reaches T3.07 and T3.06 (31.4 ft and 34.8 ft, respectively). Excessive vertical and lateral scour were noted at the downstream end of this structure (see Figures 22b and 22c).

Figure 22. Instream culvert under Route 17 (Appalachian Gap Rd), reach T3.07, Baldwin Creek, South Starksboro, VT.
(a) approach end, view downstream;
(b) outlet, view upstream from scour pool;
(c) scour pool, view downstream from culvert

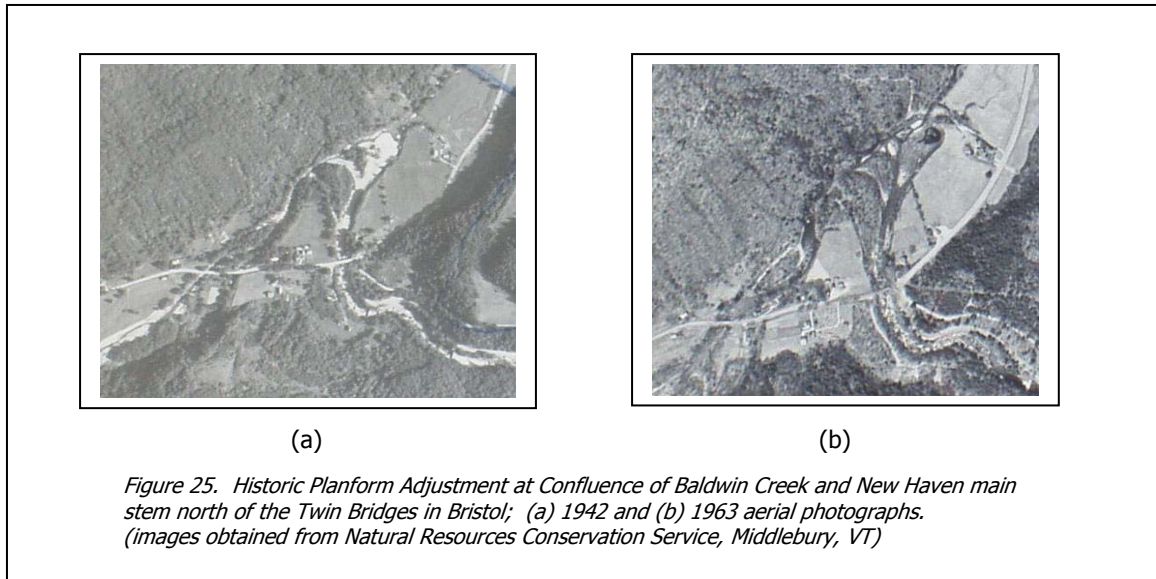
The downstream-most section of M16 was designated as a subreach, as it demonstrates a different reference stream type than the majority of the reach (as it is positioned within the Champlain Valley province). The 750 feet of channel downstream of the easternmost twin bridge along Route 17 / 116 has a significantly lesser gradient than the rest of the reach, and demonstrates channel braiding typical of a D-stream. Substantial sediment loads are delivered to this location in the watershed, particularly during higher magnitude flood events. During Phase 2 assessments on 5 July 2004 (see Appendix E), at least four distinct channels were identified. The easternmost sub-channel actually flows nearly 900 feet to the northeast to join Baldwin Creek (T3) 500 feet upstream of its principal confluence with the main stem. Based on review of historic aerial photographs, this channel has shifted laterally over time (Figure 25).

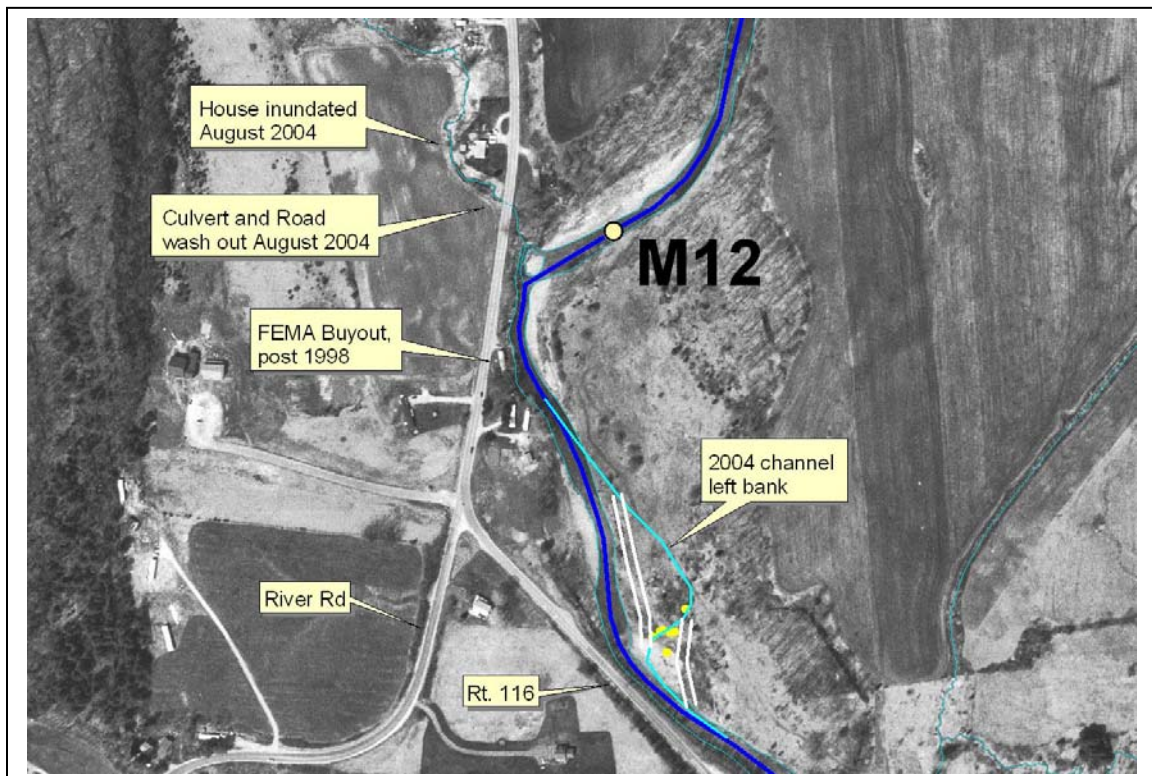
Reach M11, Segment B is something of a response reach, accepting excess sediments which have their source both in the reach itself (active lateral bank erosion on the left bank) and from the extensive lateral erosion and planform adjustments in upstream reaches, M12 and M13. Progressive streambank erosion along the left bank has resulted in a broad, enlarged point bar on the right bank. Mid-channel bars and aggradational steep riffles are present immediately upstream of the Segment break, as the channel makes two sharp turns heading into a somewhat constricted section between a high terrace on the left bank and an armored right bank along Route 116. Until August 2004, stream flow had been directed perpendicular to the armored right bank at Route 116. Flood chutes developed along the left bank were observed to take much of the flow at high river stage, relieving pressure on the right bank (Underwood, personal observations, 1998 – 2004). As a result of the August 2004 flows, this area has widened more, eroding the sharp angle along left bank.

Figure 29. New Haven River main stem, Reach M11 - Segment B.

Figure 29 compares the GPS'd June 2004 left bank to the 1995 left bank position. The channel has eroded up to 170 feet laterally into the fallow field along left bank in the nine years since 1995, equating to an average lateral migration rate of 19 feet per year. The June 2004 position of the top of left bank indicates that approximately 1.4 acres of woody riparian buffer and fallow field have eroded during the elapsed nine years. A conservative estimate of the volume of sediment mobilized from this site since 1995 is 6,600 cubic yards, assuming an average vertical thickness of 3 feet of sediment across the 1.4-acre area.

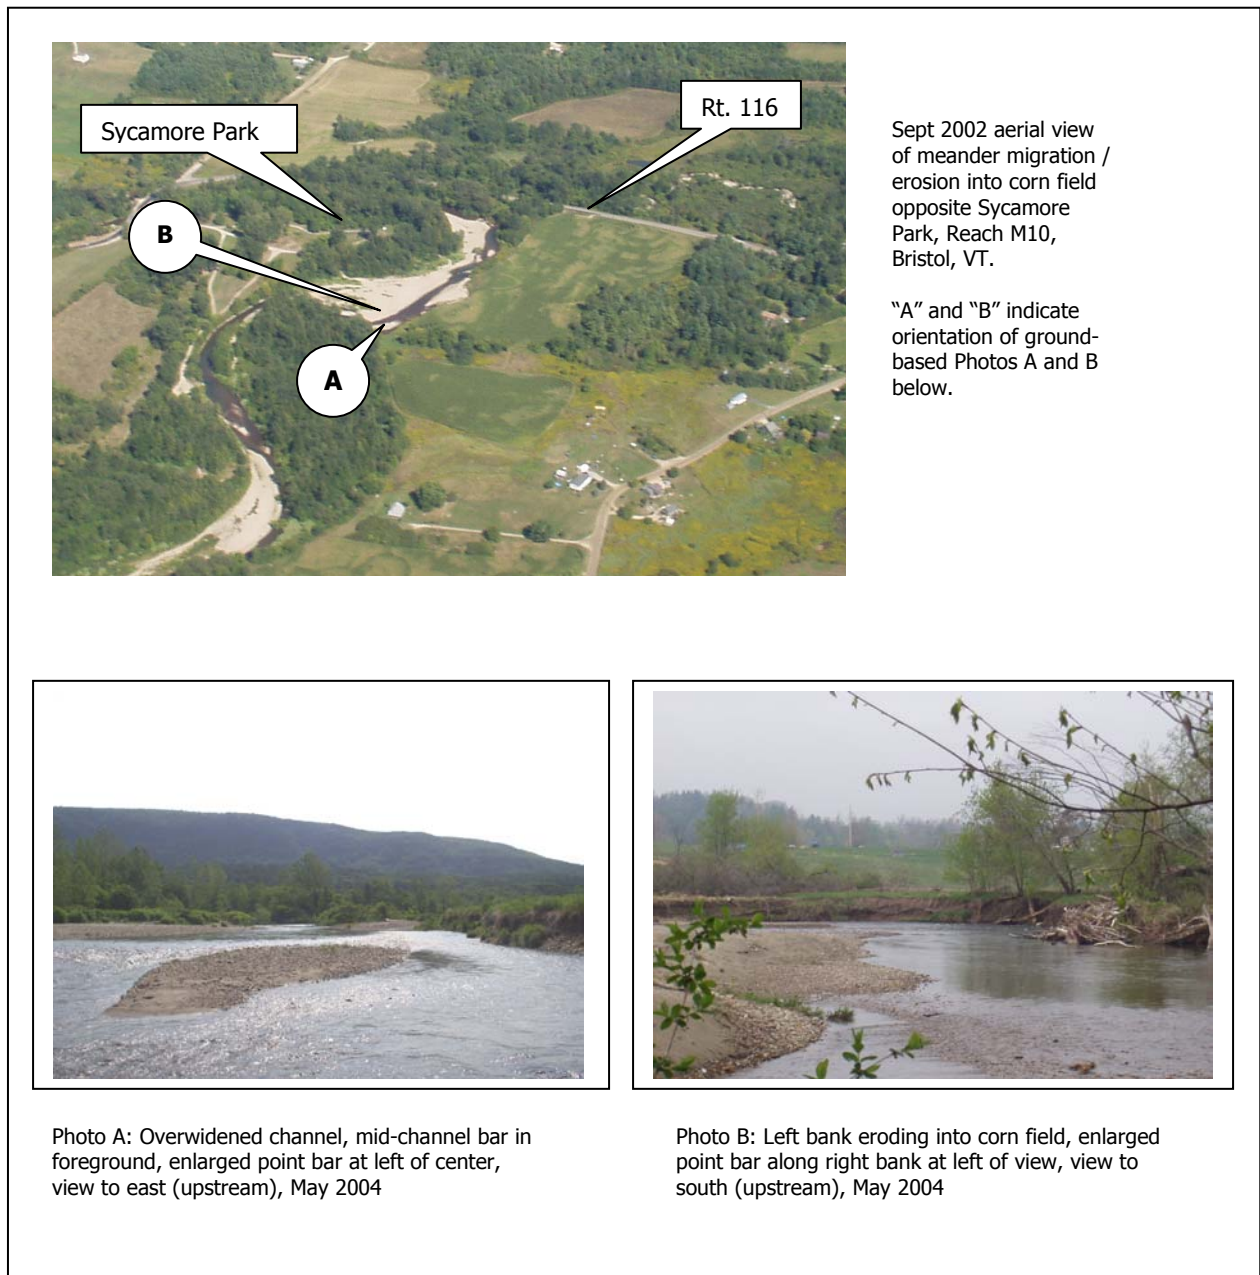
bank in the upstream $\frac{1}{4}$ of the reach) and from extensive lateral erosion and planform adjustments in upstream reaches, M11 through M13. An enlarged point bar has built up in recent years along the right bank at the head of the reach across from Sycamore Park (see Figure 30). A mid-channel bar and aggradational steep riffles are present immediately downstream of this location as the channel currently makes two sharp 90 degree turns heading into a somewhat constricted section between a high terrace on the left bank and an armored right bank. Locally, the thalweg was observed to be out of alignment with planform. This area receives intense ATV and vehicle use at certain times of the year; multiple trails are present on the point bar and vehicle fords cross shallower sections of the channel.

Figure 30. New Haven River main stem reach M10, Bristol, Vermont.

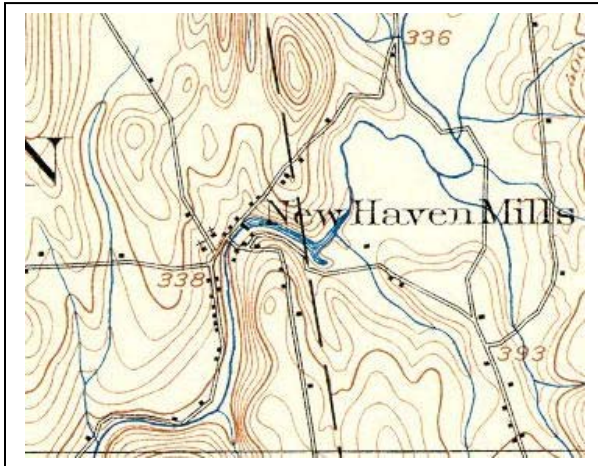
break (Beers, 1871). These commercial and manufacturing interests incurred damage in floods of the 1800s and were not rebuilt following severe damage in the flood of 1927 (Farnsworth, 1984). From the late 1790s until it was breached in the 1927 flood, a dam was present just upstream of the Munger Street crossing. The dam formed a narrow mill pond extending upstream east of the New Haven / Bristol line (see Figure 33).

Figure 33. Location of former mill dam at New Haven Mills, Reach M09. USGS 15-minute topo quad, Middlebury, 1905, surveyed 1903.

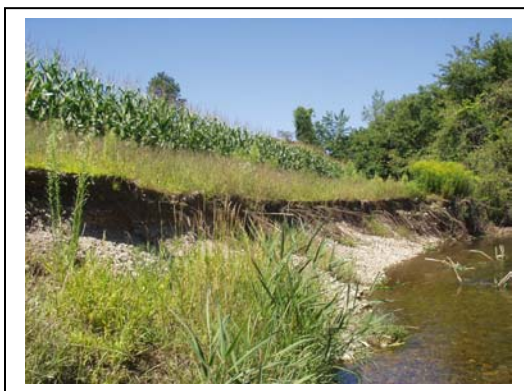
Reach M07 has experienced some planform adjustments over recorded history as apparent from review of historic aerial photographs (see Figure 34). A channel migration zone ranging from 250 to 400 feet wide is indicated by past channel positions. Within the last 6 years since the 1998 flood, there has been accumulation of sediment on point bars and substantial filling of pools in the reach (Manley, 2004). Meander migration in the downstream half of the reach has created a narrow meander with high potential for neck cutoff. The upstream meander bend has migrated southward into an adjacent corn field (see Figure 34) eroding approximately 1.1 acres of land. The downstream meander has eroded northward into the tributary channel that enters the main stem along right bend into a position similar to the channel

Figure 35. Reach M07, New Haven River main stem, New Haven. (a) Recent (post-1995) meander migration into corn fields; (b) overwidened channel with enlarged point bars of steep faces, multiple flood chutes, and large woody debris.

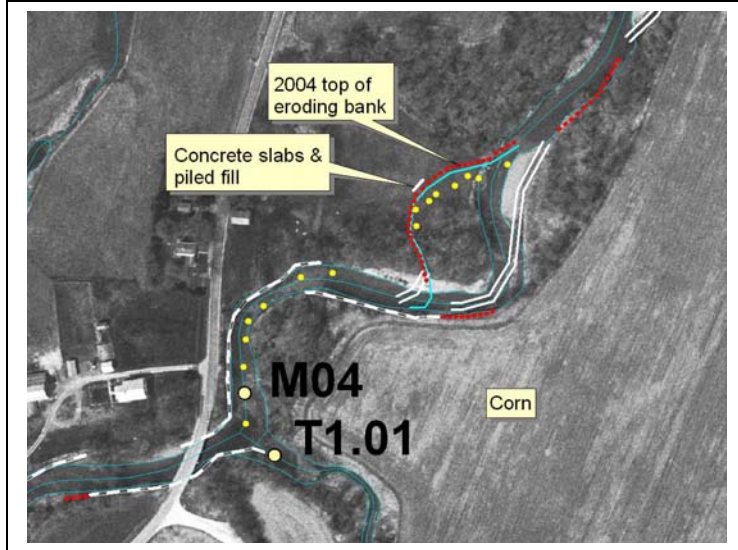
At the downstream end of reach M04 in vicinity of the old Nash Farm, there is active planform adjustment and associated localized aggradation just upstream of channel constriction by past channelization and armoring (see Figure 36). An estimated 6,700 cubic yards of sediment have mobilized from this site since 1995, assuming an average vertical thickness of 5 feet of sediment across the approximately 0.8-acre area. An average lateral migration rate of the channel is estimated as 17 feet per year (150 feet in 9 years). This downstream portion of reach M04 has considerable floodplain access. Floodwaters (e.g., 1998, 2004) regularly inundate the River Road upstream of the bridge over the main stem (Underwood, personal observations).

Figure 36. Recent (post-1995) planform adjustments in reach M04. Yellow dots represent mid-channel position recorded with GPS, 9 August 2004.

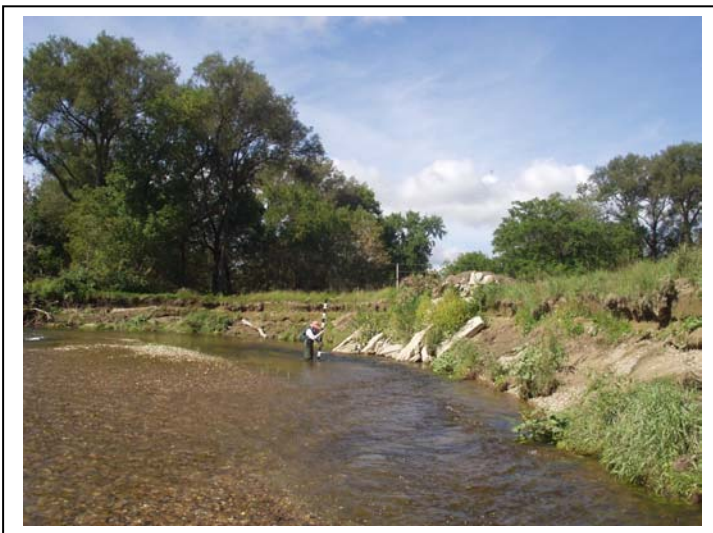
Figure 37. Less than 5-foot riparian buffer along an eroding meander in reach M04. Buffer in this location is dominated by grasses which provide little root-binding capacity to streambank soils and negligible shade to the river channel.

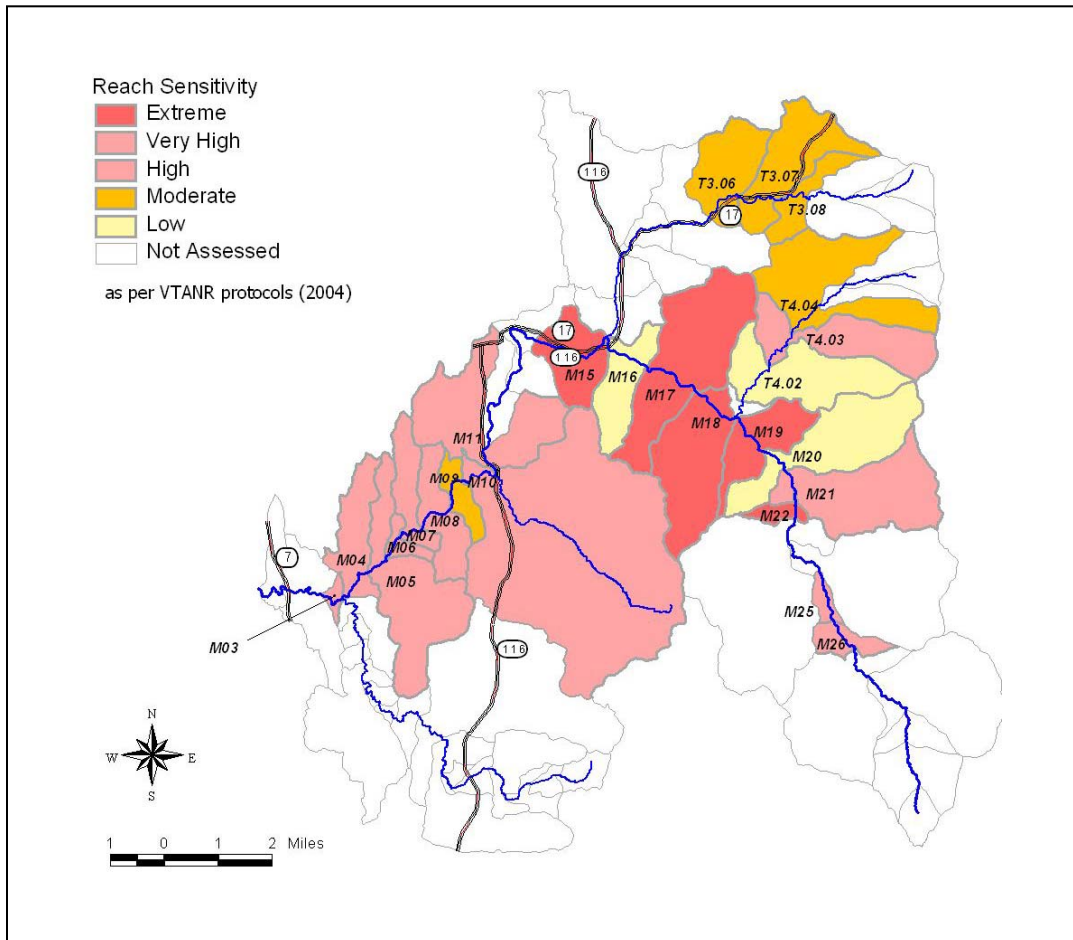
Dominant adjustment processes and sensitivity for the targeted reaches within the New Haven River watershed are summarized in Figure 39. The present stage of channel adjustment for a given reach or sub-reach can be classified by reference to a channel evolution model (CEM) after Schumm (1984). The reader is referred to the VTANR stream geomorphic assessment protocols for more details (VTANR, 2004). In brief, a reach which is evidenced to be in an equilibrium state, able to effectively mobilize its water and sediment loads, is either in Stage I (pre-disturbance equilibrium) or State V (post-disturbance equilibrium, following adjustment through the intermediate phases). Adjusting reaches, in Stage II, III, or IV, are those which are actively degrading, widening, or aggrading, respectively. These channels are not effectively transporting their water and sediment loads, and may be associated with substantial streambank and streambed erosion. Particularly, reaches in Stage II or III (actively deepening and widening) should be further evaluated through detailed survey work and more in-depth historic assessments prior to consideration of labor- and resource- intensive restoration options (Simon, et al, 2001). For example, a well-intentioned streambank armoring project may be washed downstream in the next Spring runoff or minor flood event, when a Stage II channel continues to drop its bed and stabilization structures are undermined and collapse into the channel.

Figure 39. Reach-based channel-evolution-model stage and sensitivity (VTANR, 2004)
New Haven River watershed, 2004 Phase 2 assessment results.

Reaches were classified in terms of their sensitivity to future stressors after VTANR protocols (see Figure 39). High to extreme sensitivity reaches are those which are especially susceptible to future adjustments due to a combination of factors which can include:

As displayed on Figure 39, those reaches exhibiting extreme sensitivity tend to be those reaches at the transition from steeper slopes to shallower slopes (reference Figure 3 in Section 2.3). They are also coincident with some of the higher concentrations of floodplain development: M15 through Bristol village and Rockydale; M17 – M19 through West Lincoln and Lincoln villages and M22 through South Lincoln. Also, the lower 750-foot subreach of M16 east of Bristol Village is assigned an Extreme sensitivity due to its position on an alluvial fan at the transition between bedrock-controlled slopes upstream and the more broad alluvial valley downstream. The relatively low sensitivity rankings of reaches T4.02, M20 and M16 are due to the substantial bedrock controls through these reaches.

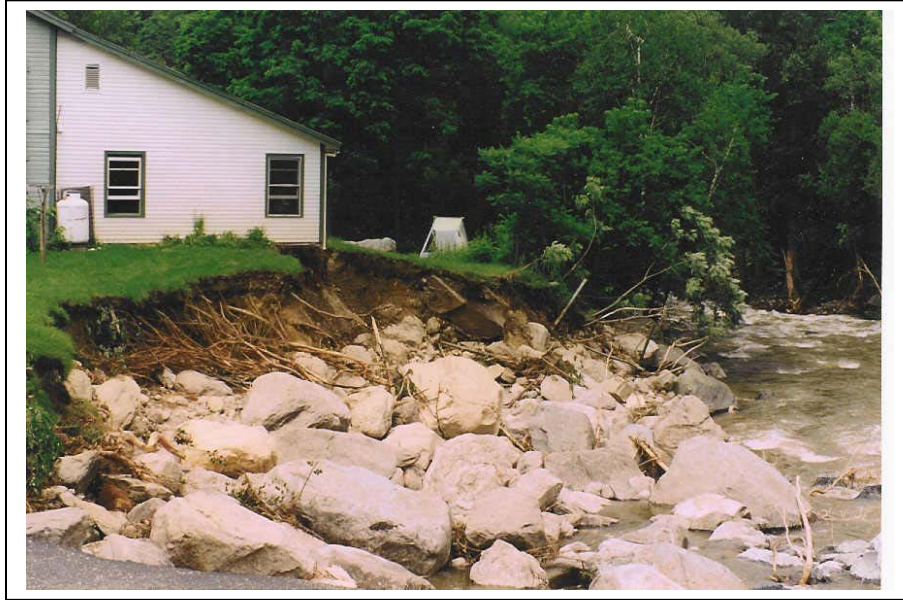
Photo 11. Streambank erosion and undermining of residence, immediately downstream of South Street Bridge, 1998 flood. *K. Underwood collection.*

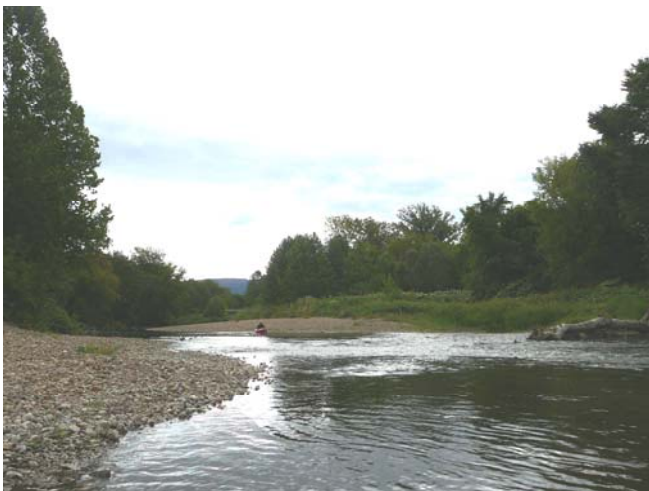
Depositional bars (point bars, side bars, mid-channel bars, transverse bars) are frequent within the reach; some pools are relatively shallow and bar heights are occasionally greater than the one-half bankfull height. Active recruitment of large woody debris (LWD = 65) is generating local scour holes, providing variability in velocity/depth patterns and contributing to morphological diversity. At the low to moderate flow stage of the assessment date (9/12/2007), many of the riffle substrates were exposed. Forested buffer widths are moderate to occasionally absent; this fact combined with the large size of the channel and its open canopy result in limited shading for the river. Moderate streambank erosion was noted, related to active meander extension and a recent (post-1995, pre-2003) neck cut-off. Active recruitment of large woody debris and detritus is occurring, providing epifaunal substrates and organic matter for instream habitats. Overall, a "Good" habitat condition rating (0.65) was assigned following the RHA (on the cusp with a "Fair" rating).

Figure 6.
Transverse depositional bars
and point bars are frequent
along Reach M02.

(View upstream,
12 September 2007).
