**Phase 2 Stream Geomorphic Assessment
New Haven River Watershed – Addendum
Reaches M01, M02
Town of New Haven, Addison County, Vermont
January 2008 (DRAFT)**

South Mountain Research & Consulting
2852 South 116 Road, Bristol, VT 05443
802-453-3076

Addison County
Regional Planning Commission
14 Seminary Street
Middlebury, VT 05753

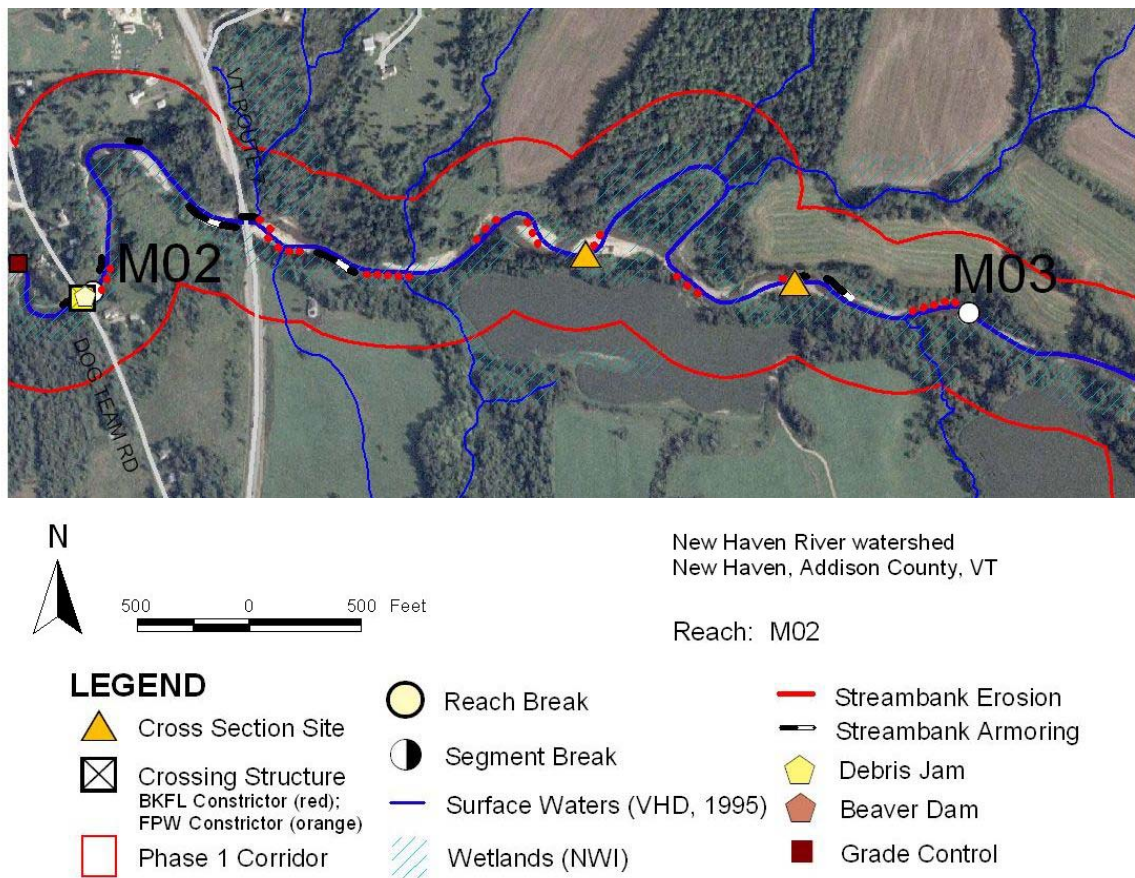
Figure 5. Reach M02 (flow is from picture right to picture left).
 (Red boundary indicates Phase 1 corridor [SGAT version 2; SMRC, 2004b]).

Two cross sections were completed in reach M02 and confirmed a gravel-dominated C-riffle/pool stream type. The river has access to a wide floodplain. A minor degree of historic incision is indicated by the measured incision ratios of 1.18 and 1.22; no indications of active incision were noted in the reach (e.g., headcuts, coincident undercut banks on both LB and RB). Historic incision may be related to inferred channelization near the VT Route 7 bridge (circa 1960s). Perhaps, historic breaching of a dam(s) at Brooksville, which operated in downstream reach M01 from the 1700s through the early 1900s may have

Minimal indications of widening were noted. One of the cross section sites had an estimated width/depth ratio of 46.7; however, this ratio appears to be more related to aggradation and planform adjustment processes than active channel widening. (The second cross section site had a measured W/D ratio of 21). While undercut banks, exposed root systems, and leaning trees were evident along the channel, these features tended to be located along either bank (not both banks in one location) and were associated with meander extension (planform adjustment processes). Moderate aggradation and planform adjustment were indicated by the prevalence of depositional bars, meander migration sites, the recent neck cut-off, as well as several bankfull-elevation flood chutes. The channel has a different planform at present than is represented by the 1995 VHD. The blue line in Figure 5 represents the approximately 1995 channel position (VHD), superimposed on the 2003 aerial photograph.

The geomorphic condition of reach M02 was rated as "Fair" following the RGA (score of 0.60). Overall, this reach appears to be operating as a deposition-dominated reach. A reduced sediment transport capacity is inferred, due to increased sediment and debris from in-reach and upstream sources. It is likely that flood sediments associated with the 1998 flood event are still working their way through the river network; this was an estimated 500-year flood event (Olson, 2002). Also, streambank erosion is prevalent in upstream reaches (e.g., M03 through M08), due to ongoing channel adjustments, and areas of absent forest buffers in erodible soils (SMRC, 2004a). A channel evolution stage of "IV (F)" and a "Very High" sensitivity rating were assigned to reach M02 following guidance presented in the geomorphic assessment protocols (VTANR, 2007).

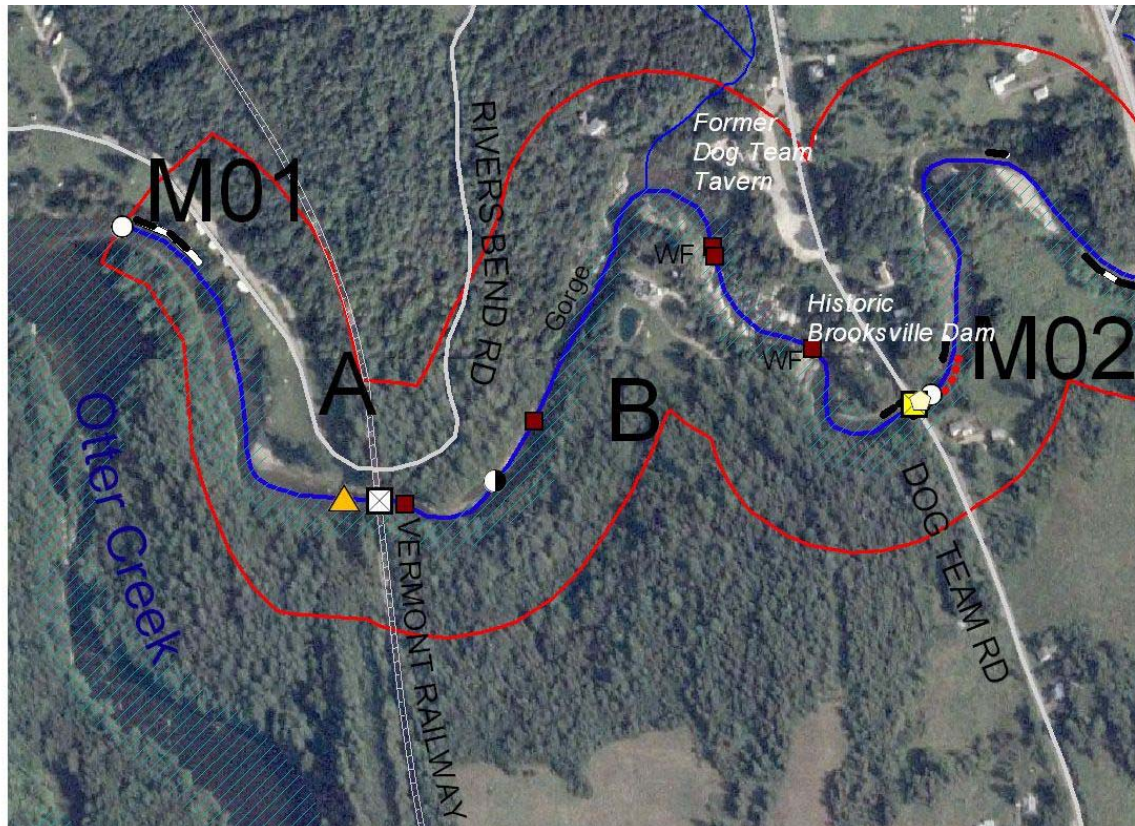
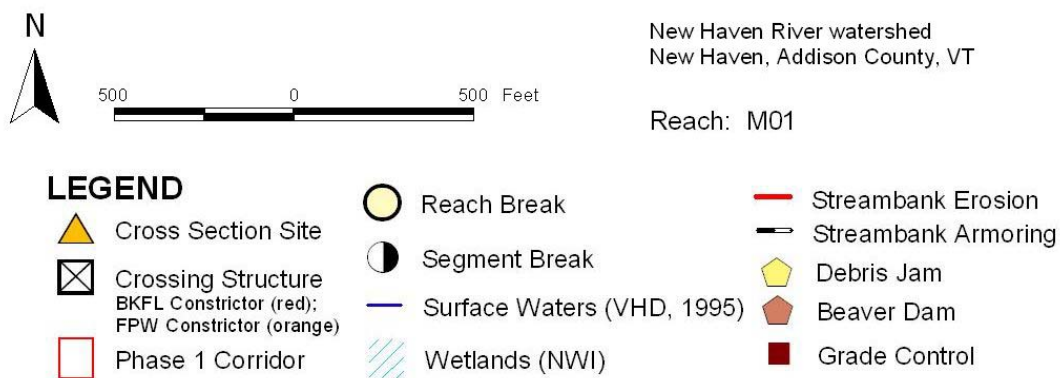
Reach M01 is approximately $\frac{3}{4}$ of a mile in length (3,753 feet) and continues from the Dog Team Road crossing, over the falls at Brooksville and on to join the Otter Creek at Rivers Bend campground. Within reach M01, the New Haven River crosses north-south strike of limestone and dolomite formations; bedrock provides both lateral and vertical grade controls to the New Haven River channel. Bedrock falls are also located along the Otter Creek within close proximity to the New Haven River confluence (e.g., Huntington Falls, Beldens Falls). Reach M01 was segmented to capture a subreach of bedrock-controlled channel in the upstream 2/3 of the reach (see Figure 7): Segment B = 2,173 feet, 0.7% gradient; Segment A = 1,580 feet, 0.1% gradient.

Figure 7. Segmentation and Phase 2 results for reach M01 (flow is from picture right to left). Red line represents Phase 1 corridor (SGAT v.2; SMRC, 2004b). WF = waterfall, as defined in VTANR protocols, 2007.

Segment B of reach M01 is a 2,173-foot section of channel where bedrock dominates the channel margins. In the upstream end of the segment, cascade and step/pool bedforms dominate the channel which is flanked by moderately-sloped bedrock banks. The upstream end of this section is marked by a waterfall (at the historic site of mill operations and the Brooksville dam; Figure 8), followed by several shallower bedrock steps and a second waterfall across from the former Dog Team Tavern. In this section, an approximate drop of 13 feet occurs over a length of 450 feet (equivalent to a 3% slope). The channel then turns abruptly to the southwest and enters a short gorge with near-vertical bedrock walls (see Figures 7 and 9). Although submerged bedrock ledge forms the channel bottom in this section, the vertical drop of the channel is not as pronounced as in the upstream section (subcategory "c" slope). While individual sections of Segment B have more pronounced gradient, the overall estimated segment slope is 0.7%.

No signs of active channel incision were observed within Segment M01-A. It is likely that bedrock grade controls within the reach and in the nearby Otter Creek have limited vertical and lateral channel adjustments. A high terrace approximately 2 to 2.6 times bankfull height is present along the RB corridor within one bankfull width of the channel. VTANR protocols state that higher terraces “that were active flood plains before historic times [greater than 200 years ago]” should be avoided in the identification of the Recently Abandoned Floodplain for measurement of Incision Ratio in Phase 2 Step 2.5 (page 27 of VTANR protocols, May 2007 version). Protocols suggest avoiding terraces that are greater than 3 times the bankfull height. While this terrace is somewhat lower than 3 times the bankfull height, USDA NRCS mapping suggests that the parent materials for soils comprising this terrace have a glaciofluvial origin (thousands of years before present), rather than a more recent alluvial origin. On the other hand, available surficial geologic mapping (Calkin, no date; Stewart & MacClintock, 1969) suggests that sediments comprising this terrace are bouldery clays of glacio-lacustrine origin. No more detailed (or more recent) surficial geologic mapping was noted for this study area in Vermont Geological Survey records. More intensive surficial geologic mapping and analysis would be required to determine with greater certainty the age of these terrace sediments and the processes which created this terrace; such analysis was beyond the scope of work for this geomorphic study. Thus, best professional judgment was applied to infer that the origin of this terrace was the result of processes occurring greater than 200 years before present. The current degree of vertical separation of the channel bed (thalweg) from the terrace surface is not believed to represent a process of incision occurring within the last 200 years.
