Phase 2 Assessment of the Hungerford Brook Watershed, Franklin County, Vermont 2006

Carmi Consulting

1.0 Summary

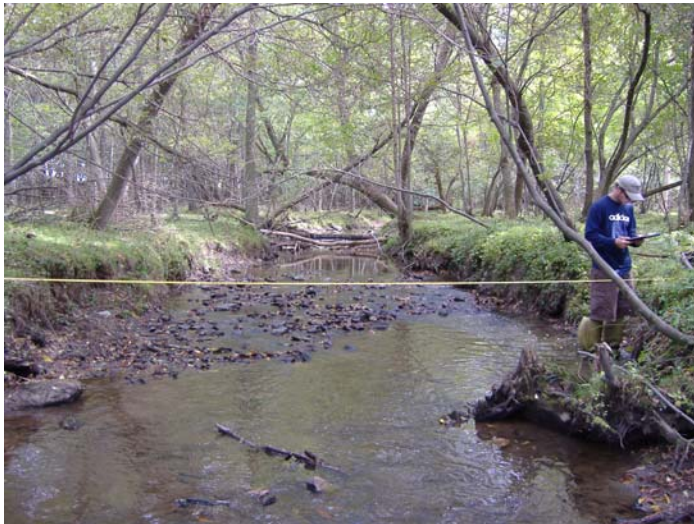
Close to Woods Hill Road cattle have access to the brook and much erosion was observed. Before the brook crosses the road it enters a barnyard and loses all buffer and is extremely eroded.

Old feed is dumped into the corridor leaching nutrients directly into the brook. Woody buffer is lost in this short area along Woods Hill Road.

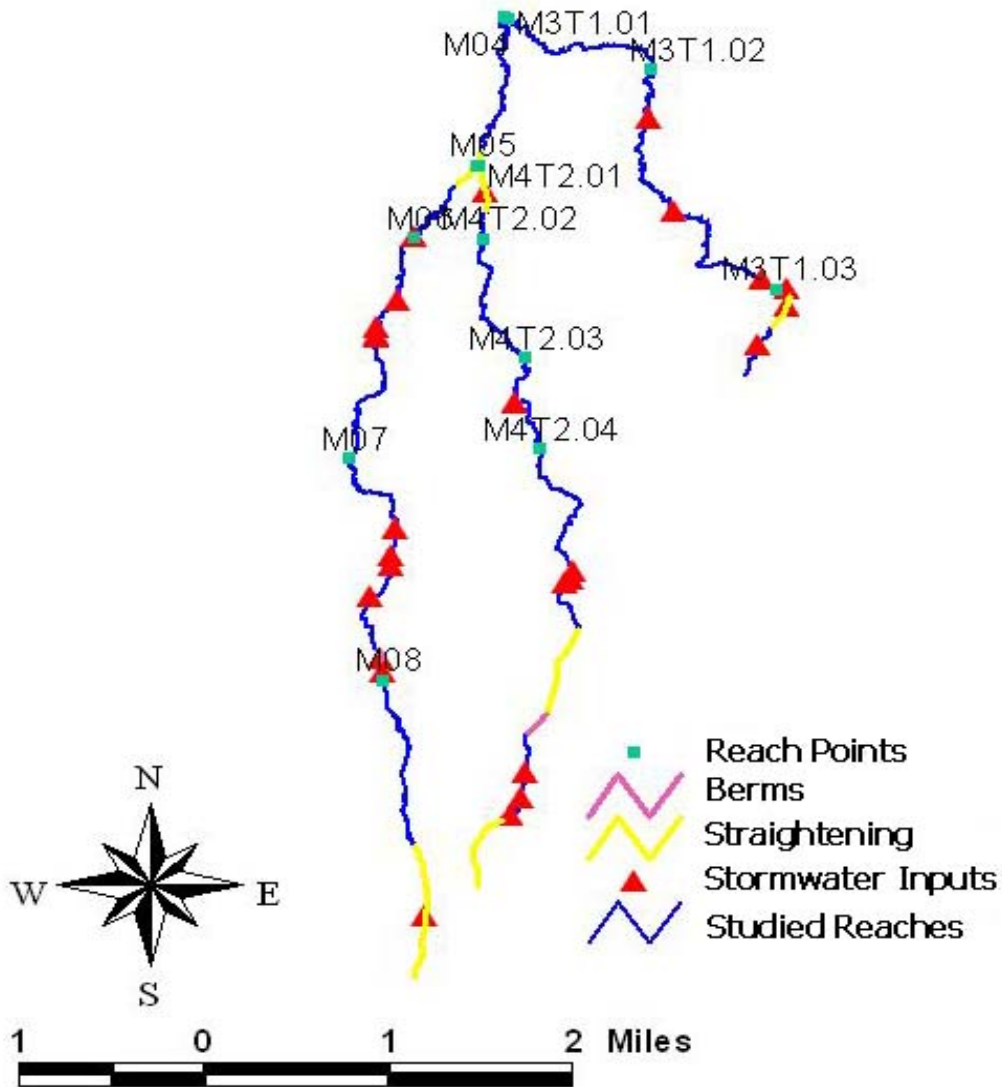
Figure 25 Sediment Transfer Zones

Five of the eleven reaches studied in The Hungerford Brook Watershed had an incision ratio of greater than 1.4 (See table 4.) Out of the five incised reaches three have been straightened. The following figure, Figure 25, shows reaches that have been bermed, straightened, and/or have storm water inputs. These factors can aid in sediment transfer causing the stream to lose its equilibrium.

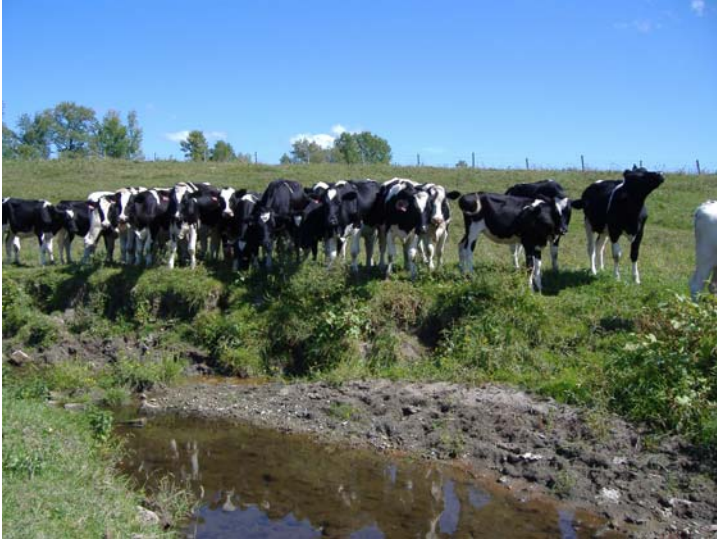
Figure 26 M06 Very High Sensitivity Rating with Multiple Channel Stressors

know the sensitivity so one may prioritize. The Hungerford Brook and its tributaries had three reaches that were in the moderate category for stream sensitivity: M07A, M4T2.02 and M4T2.03. All other reaches and segments were either in the high or very high categories. Passive rather active restoration techniques work best for sensitive streams due to the multiple stressors.

Passive restoration techniques include establishment of corridor areas with improved woody buffers, adoption of agronomic and soil conservation practices or easements to prevent future development of infrastructure in the erosion hazard risk zone. Active restoration techniques include repair and resizing of culverts, stabilization of eroding stream banks, restoration of floodplain access and in-stream wetland creation/restoration. Active restoration techniques are often costlier with unsure certainty for long-term success without an integrated “watershed” approach.

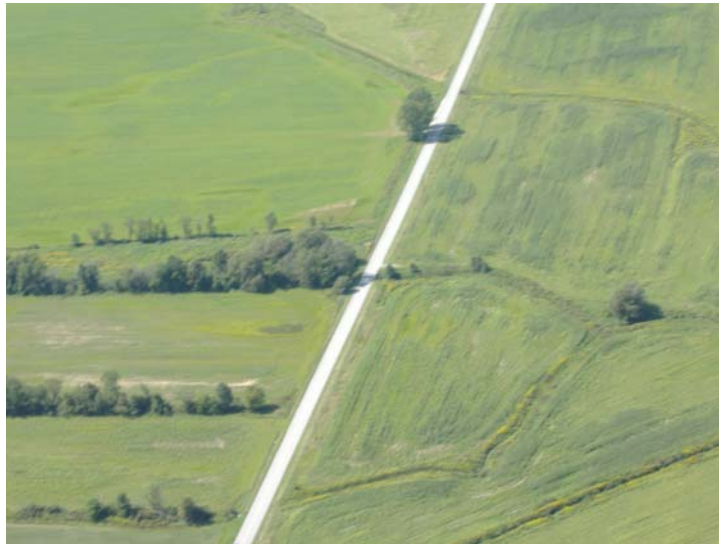
*Figure 27 Woods Hill Road
M05 and M4T2.01*

The downstream portions of both reaches M4T2.01 and M05 have undergone major channel alterations. The brooks corridor is encroached by crop land and there is little to no woody buffer. The culvert under the Woods Hill Road on M4T2.01 serves as a transient grade control that could wash out in a high water event. M05 however flows under a bridge constricted by boulders. Upstream of these boulders, depths of water in the

channel ranged from 4.0' to 6.0'. Data shows access to flood plain is lost upstream of Woods Hill Road due to increased degradation caused by increased hydrologic pressure.
