# Upper Winooski River: Plainfield to Montpelier

## River Corridor Management Plan

### Washington County, Vermont

MARCH 31, 2010

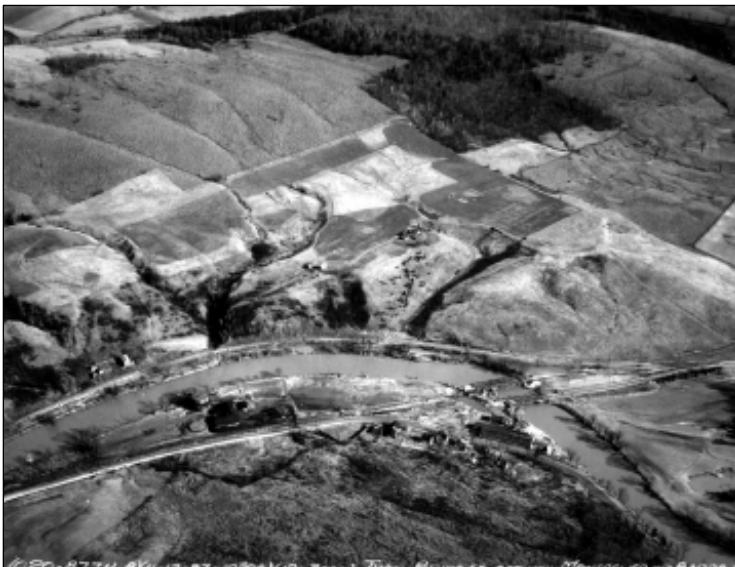
**Figure 4: Winooski River between Montpelier and Barre following the 1927 flood. Extensive deforestation of surrounding hillsides is seen in the photograph (courtesy: UVM Landscape Change Program).**

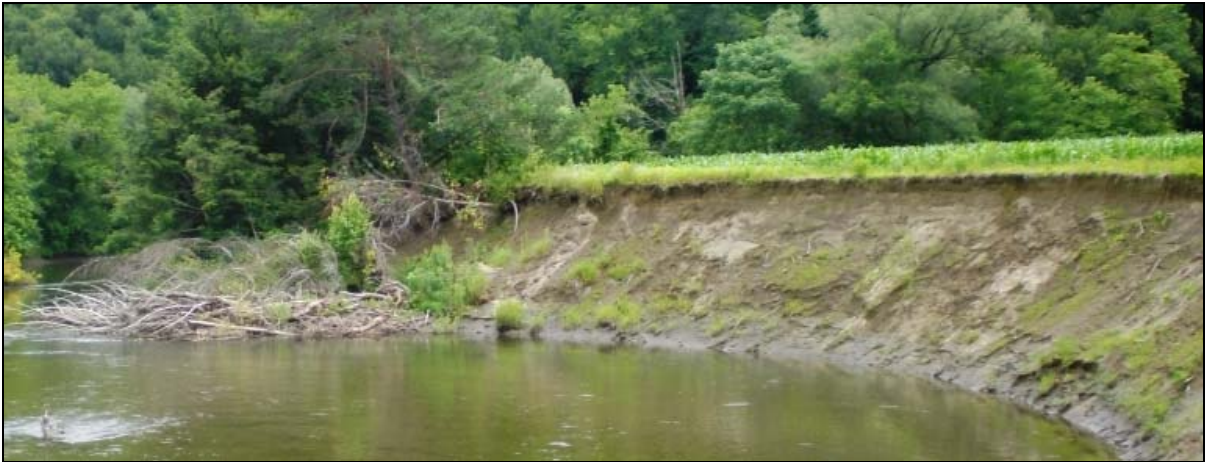
**Figure 10:** Reaches such as R23 are susceptible to thermal pollution due to lack of shading on some of the banks.

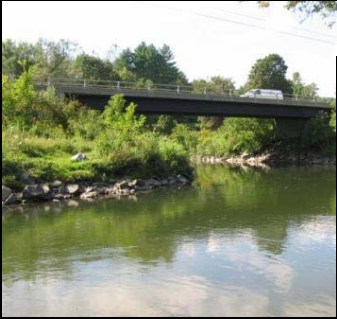
REACH NUMBER	METHOD	BENEFIT	DESCRIPTION	FEASIBILITY/ CONSTRAINTS	COST	LANDUSE CONVERSION	PARTNERS	PRIOR-ITY
<b>R22-A</b>

Replace Undersized Structure	Open the river channel to allow for sediment transport, channel migration, and riparian habitat connectivity.	Replace highly undersized Route 2 bridge which is currently creating instability upstream.	Project will need to ensure protection of houses upstream and downstream.	High	Remains a bridge crossing, opens up for sediment transport.	Landowners VTRANS, Town, VTANR	High
	Restore Riparian Buffer	Long term channel stability, reduce flood velocities, nutrient uptake, habitat and other ecosystem services.	This is an incised and historically straightened reach. The left bank is predominately a road (Route 2), and the right bank has had significant riparian deforestation. Efforts to improve the riparian forest on the right bank may help improve instream channel condition and habitat along this reach. As well as provide long term ecosystem services for the community.	Few major structures along reach. River stability is good overall which will allow trees to grow.	Low	Pasture land to forest. Productivity shift to other economic, ecologic, and social gains.	Landowners FWR, WNRCD, FWS	Low

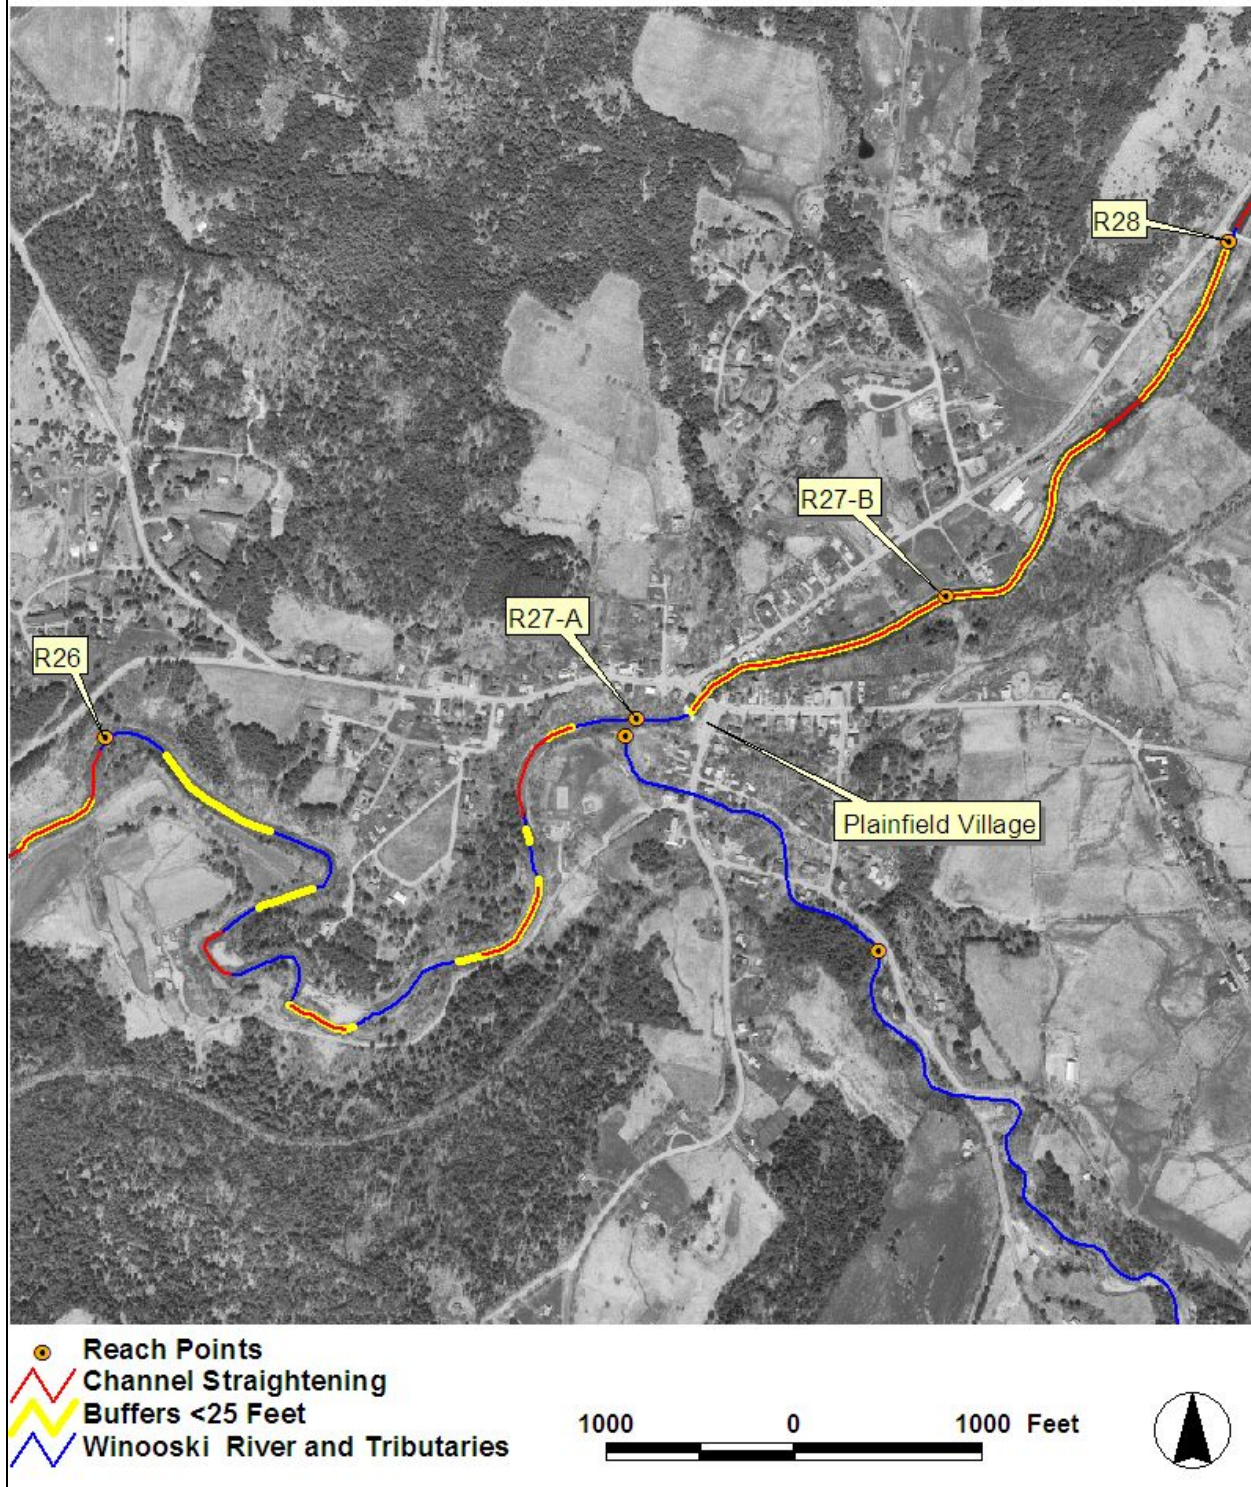
Figure 1: Reaches R27 through R26 with channel straightening and riparian buffers <25 feet wide.

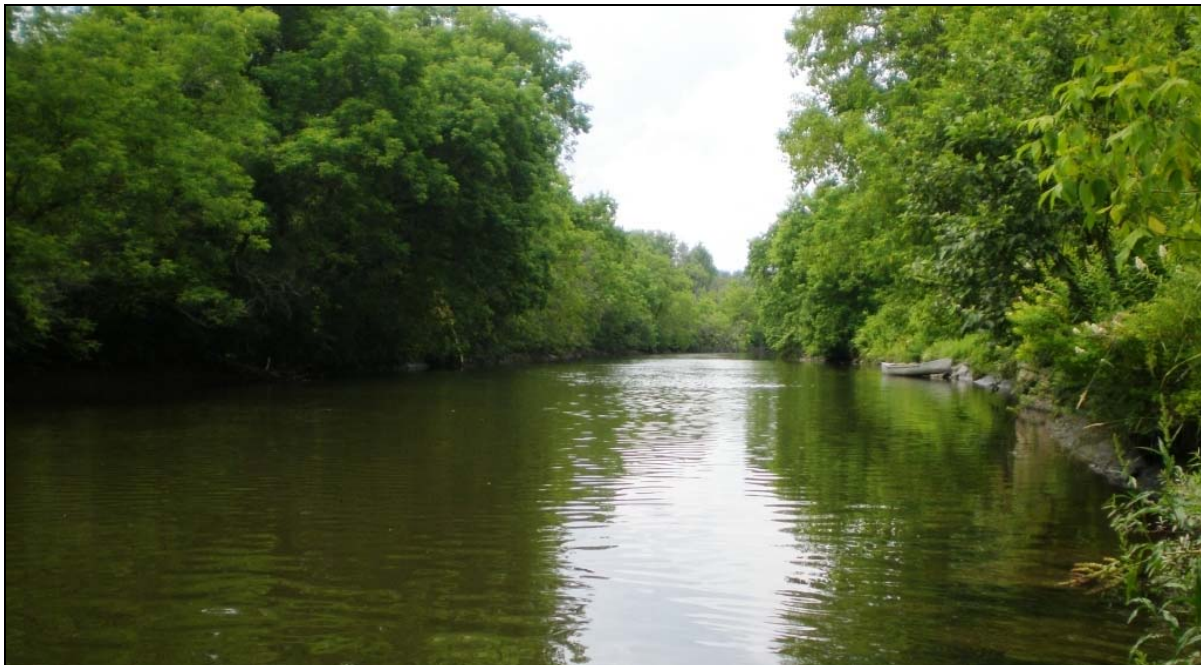
Upper Winooski segment R27-B begins at the John Fowler Bridge and flows downstream to approximately 1500 feet upstream of the Plainfield dam. The reach is characterized by a very straight E-type stream channel dominated by a ripple-dune sand bottom. The channel appears straight due to historic manipulation. This straightened channel has widened and there is evidence of some minor planform adjustment as the river attempts to erode an outside bank. Lack of significant adjustment may be attributed to the low slope and excellent floodplain access and a moderately healthy riparian buffer (see Figure 2). The straightening and widening have, however, greatly reduced instream habitat quality. Forest clearing for residential and recreational use has significantly impacted the right bank as well as a portion of the left riparian area which has been cleared for agriculture. Route 2, several residences, and a commercial operation impede on the right corridor while the left corridor has no significant development.

Figure 2: Typical perspective of segment R27-B, a ripple-dune channel with a very low slope.

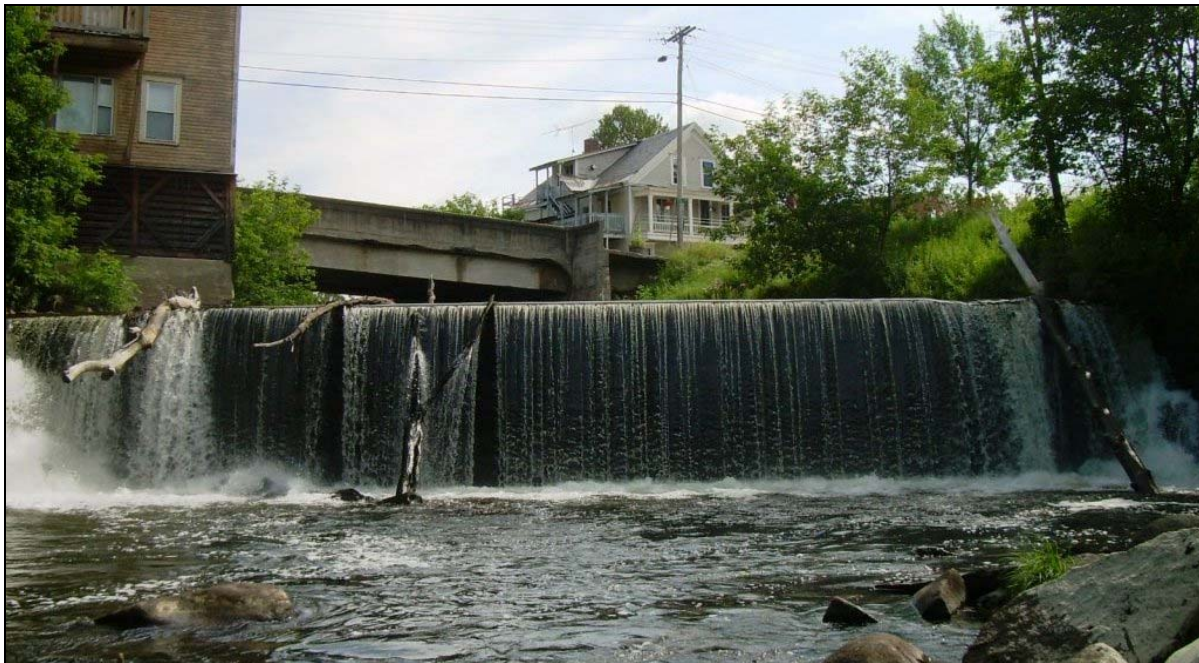
The Plainfield Dam is owned by the Town of Plainfield and has recently been considered for hydropower development (Figure 3).

**Figure 3: Dam in Plainfield Village on Reach R27-A.**

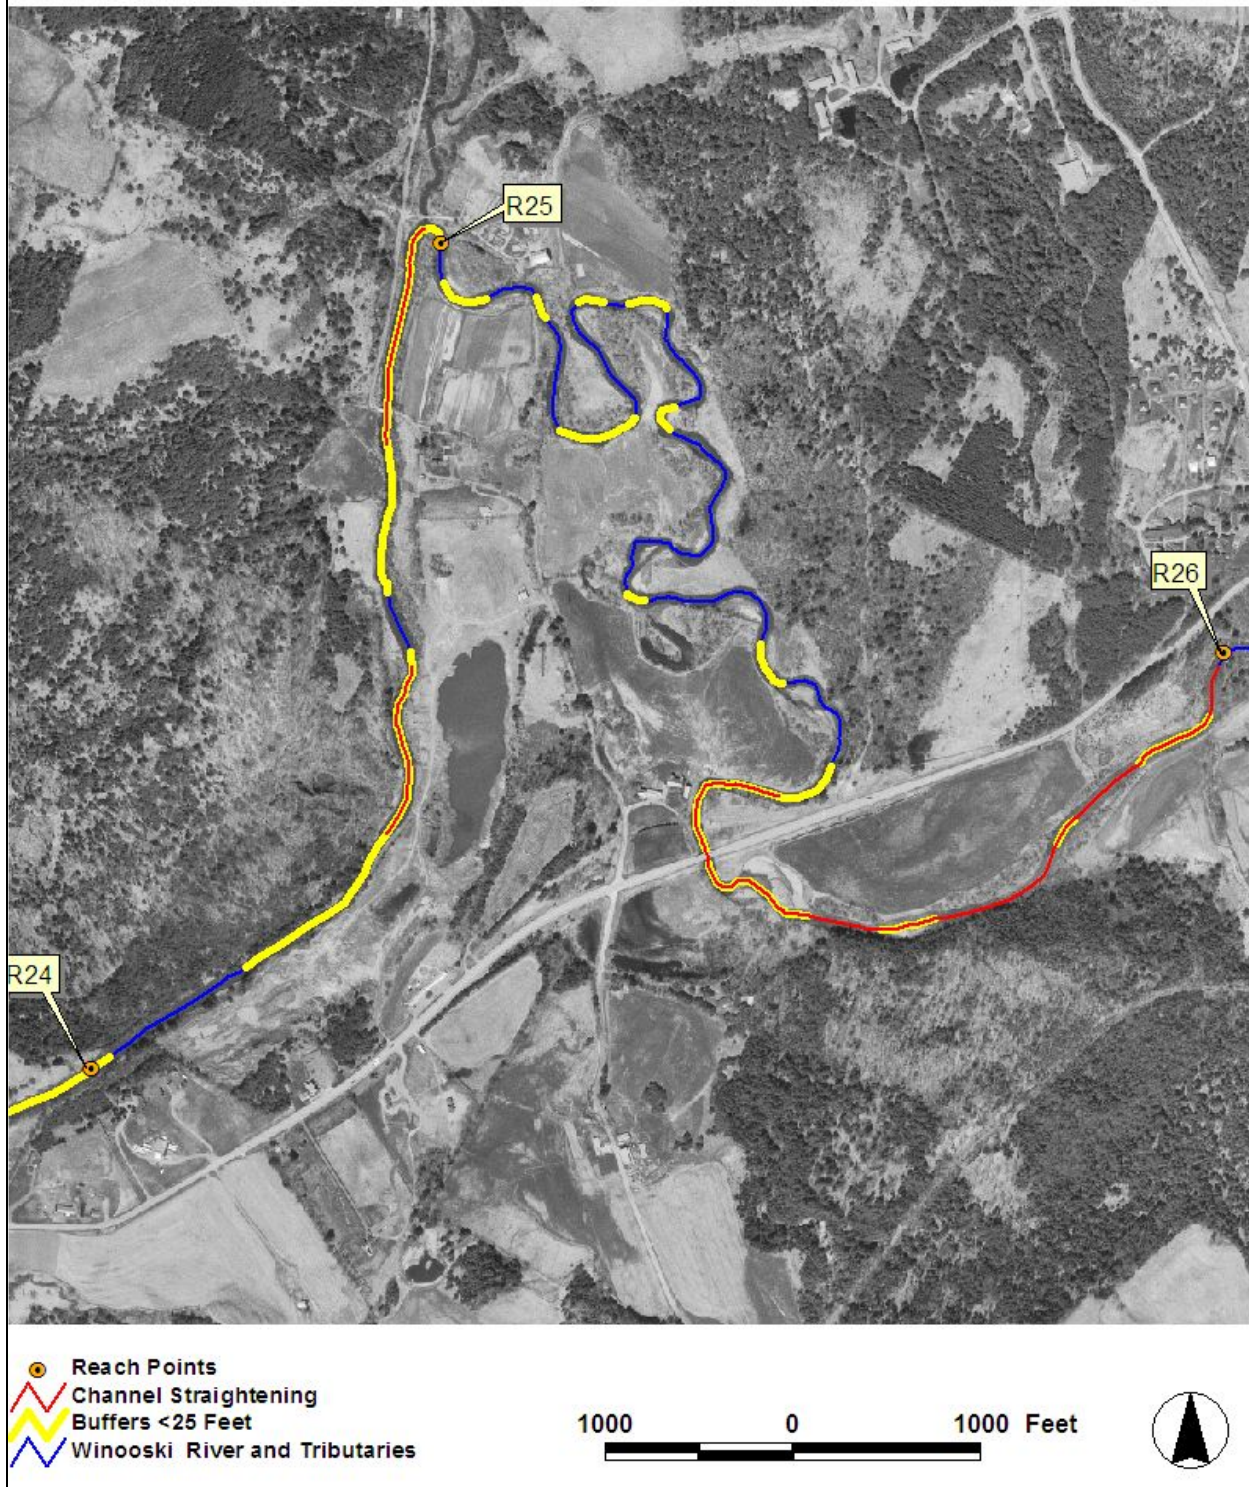
Figure 5: Reaches R25 through R24 with channel straightening and riparian buffers <25 feet wide.

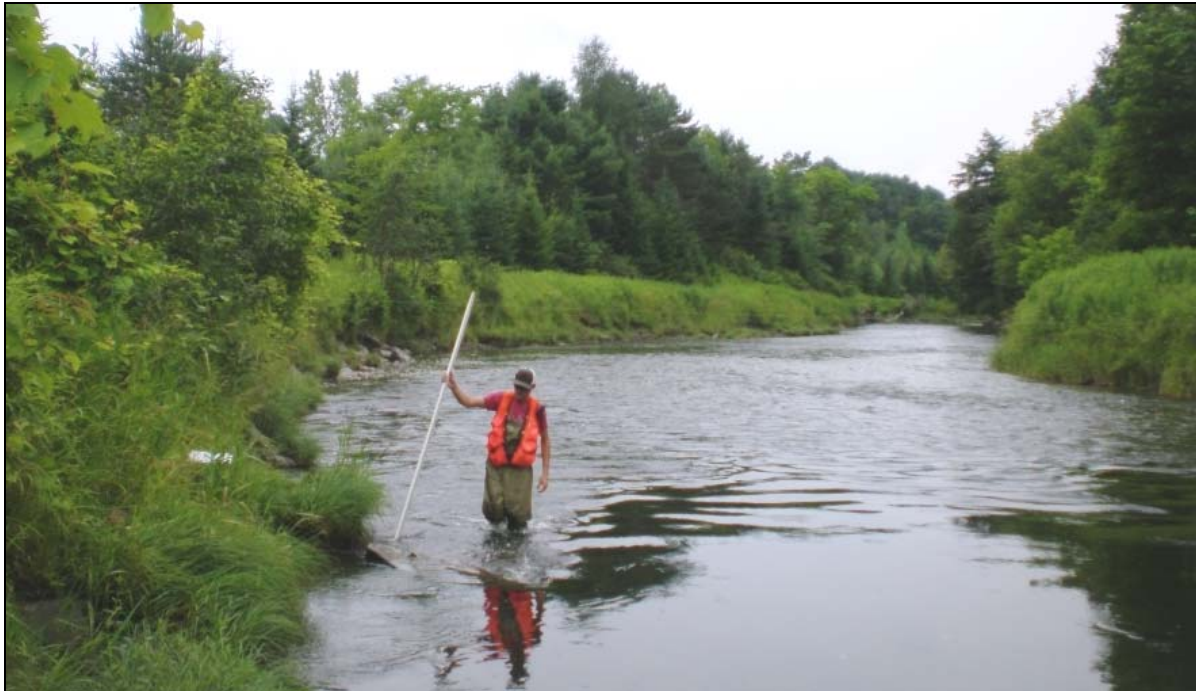
R24 is slightly incised. Excessive energy in the channel may have caused a large mass failure on the right bank as well as other intermittent erosion patches that exist commonly on both the right and left banks. It also may have reduced the habitat complexity which is dominated by a plane bed bottom and only two riffles over the course of the mile long reach (sediment contributions from R25 and the Kingsbury branch may also have filled in some of the bottom topography) (see Figure 7).

**Figure 7: Measuring channel incision along reach R24.**

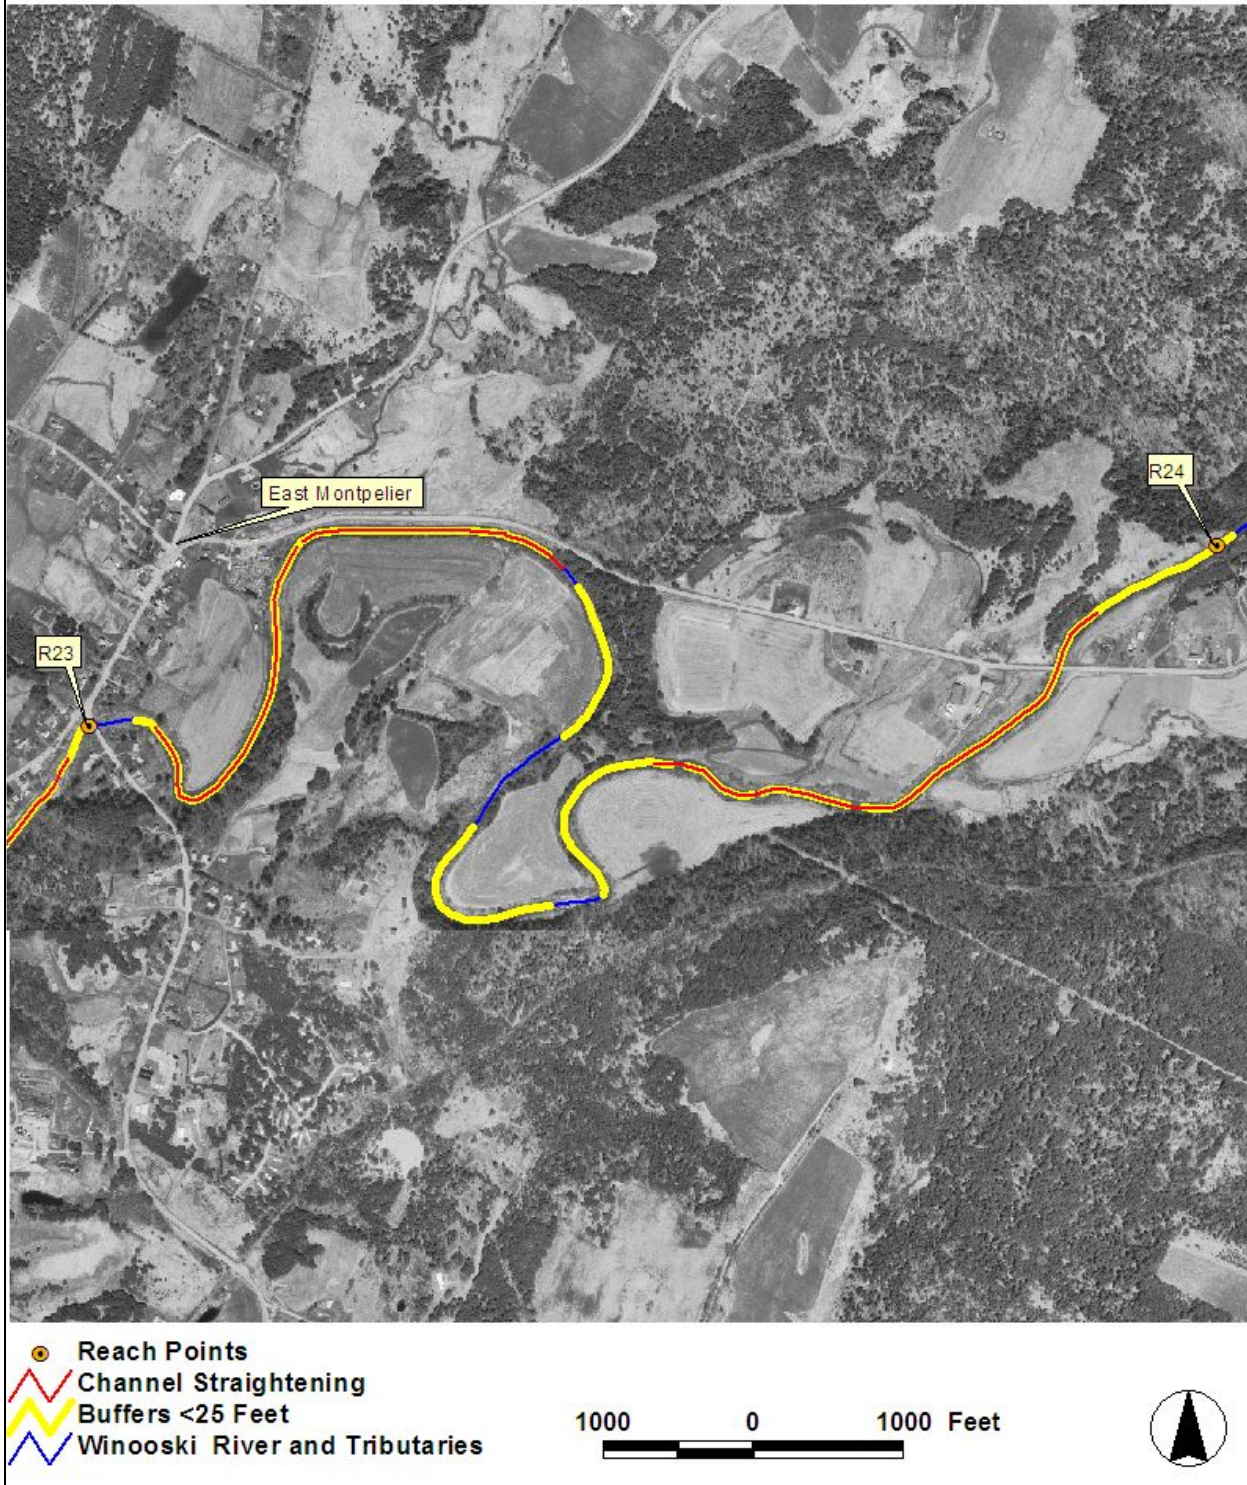
Figure 8: Reach R23 with channel straightening and riparian buffers <25 feet wide.

R23 is an “E” type channel by reference and should by nature be sinuous, narrow, and deep with excellent floodplain access. The reach is, however, severely incised. Excess erosive energy is widening the stream channel and exacerbating planform adjustment. These processes may have contributed to triggering several mass failures which are found in the lower part of the reach. Incision is so excessive that the entrenchment of the channel has been reduced and the channel is now best described as a “B” type channel having departed from reference channel conditions. As the stream widens and adjusts laterally it is already building new floodplain benches on the inside of some meander bends. These floodplain benches will colonize with vegetation and may, over time, become part of the functioning floodplain for the Winooski. The geomorphic adjustment processes are, however, causing excessive streambank erosion along much of the reach and sending these sediments downstream into other reaches reducing stream bottom habitat and transporting nutrients towards Lake Champlain.

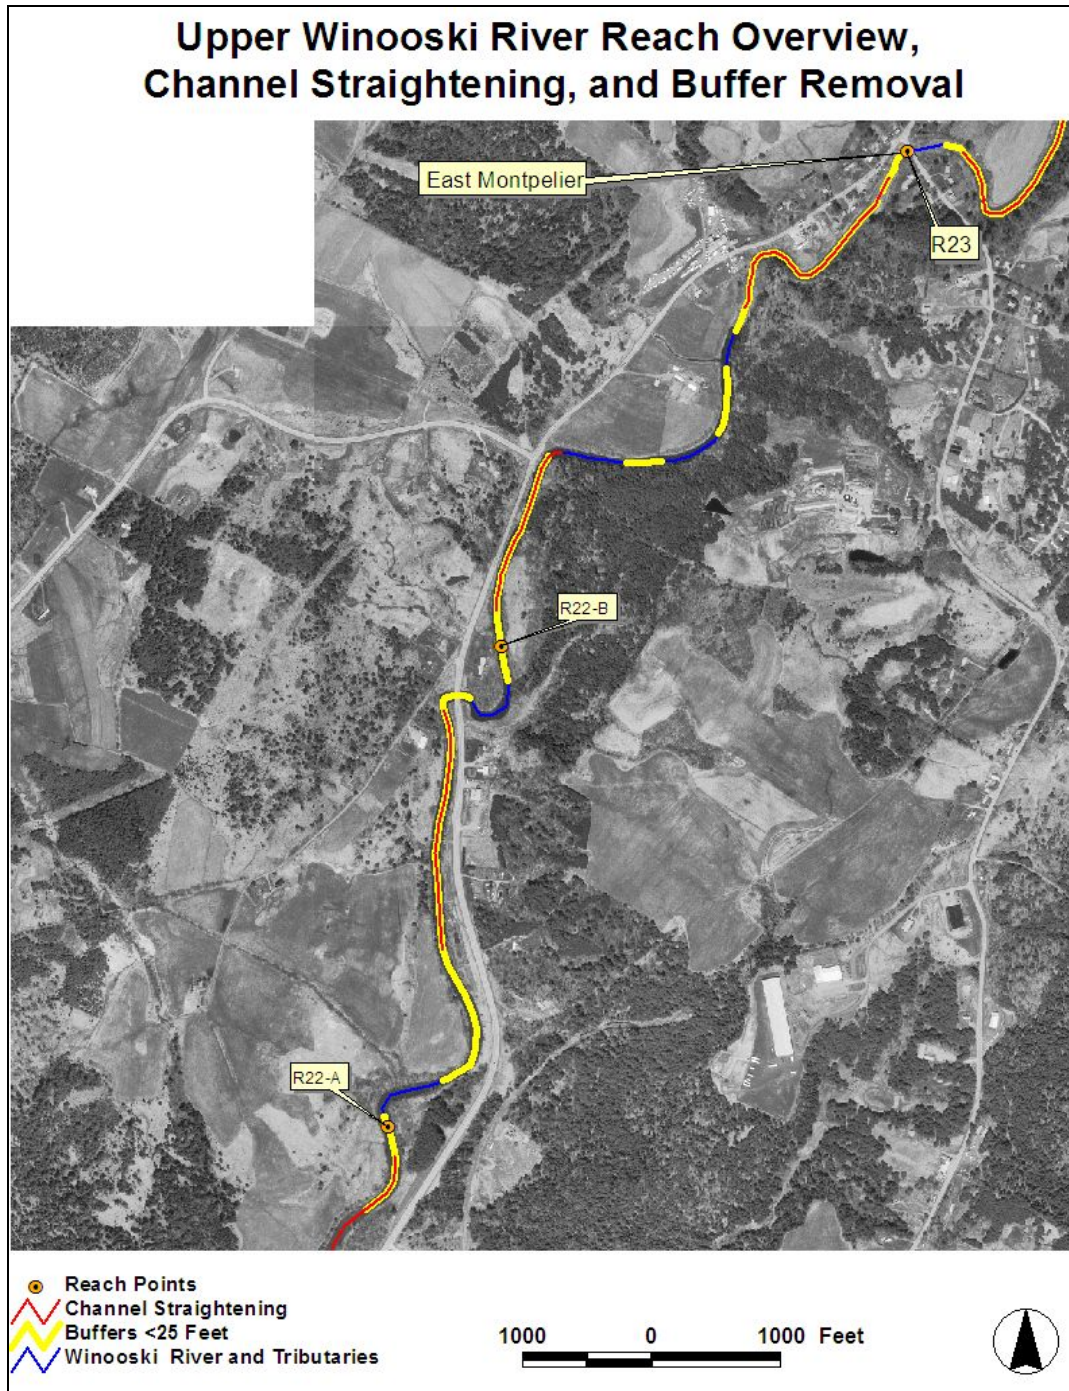
Figure 10: Reach R22 with channel straightening and riparian buffers <25 feet wide.

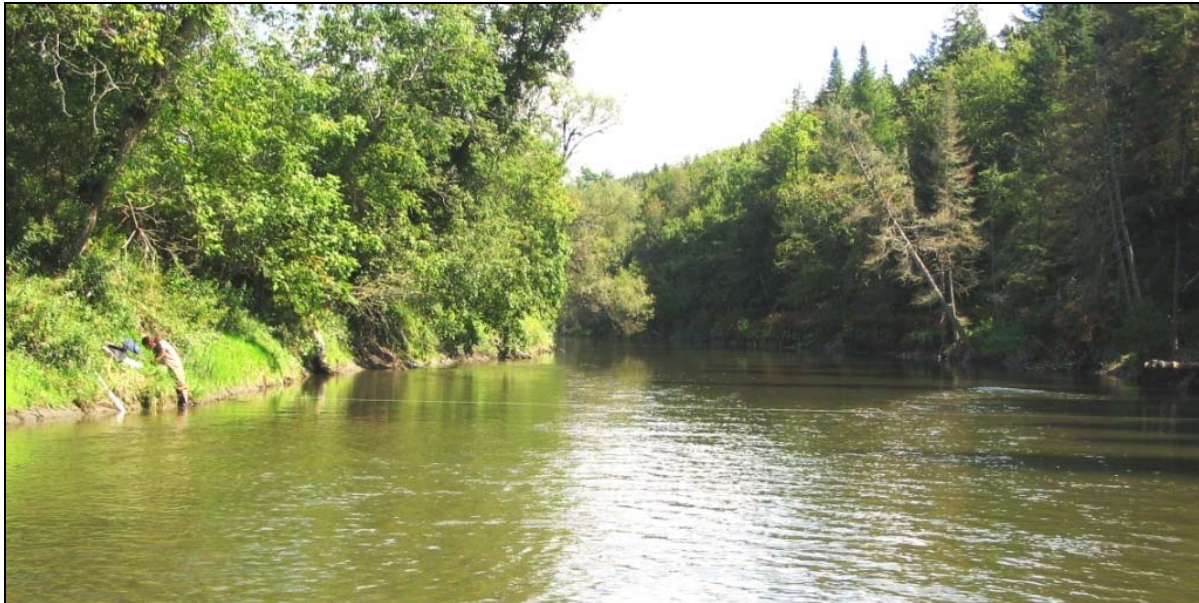
“R22B also may have also been straightened in the past because of development in East Montpelier. The geomorphic and habitat assessment scores were 0.45 and 0.43 respectively, both “fair” conditions. The segment was found to be in Stage III of evolution and has lost access to its historic floodplain. The dominant adjustment processes are widening and historic degradation. Active channel migration evidenced by flute chutes was observed. There is aggradation at the mouth of the tributary, Mallory Brook, as is evident by depositional features such as delta, side, point and mid-channel bars. The right riparian corridor was dominated by a hay field on the right, and had a narrow buffer of less than 5 feet. The left riparian corridor consisted of forest with a buffer of more than 100 feet.”

Figure 11: Cross section on reach R22-B. Photo credit: Johnson Company

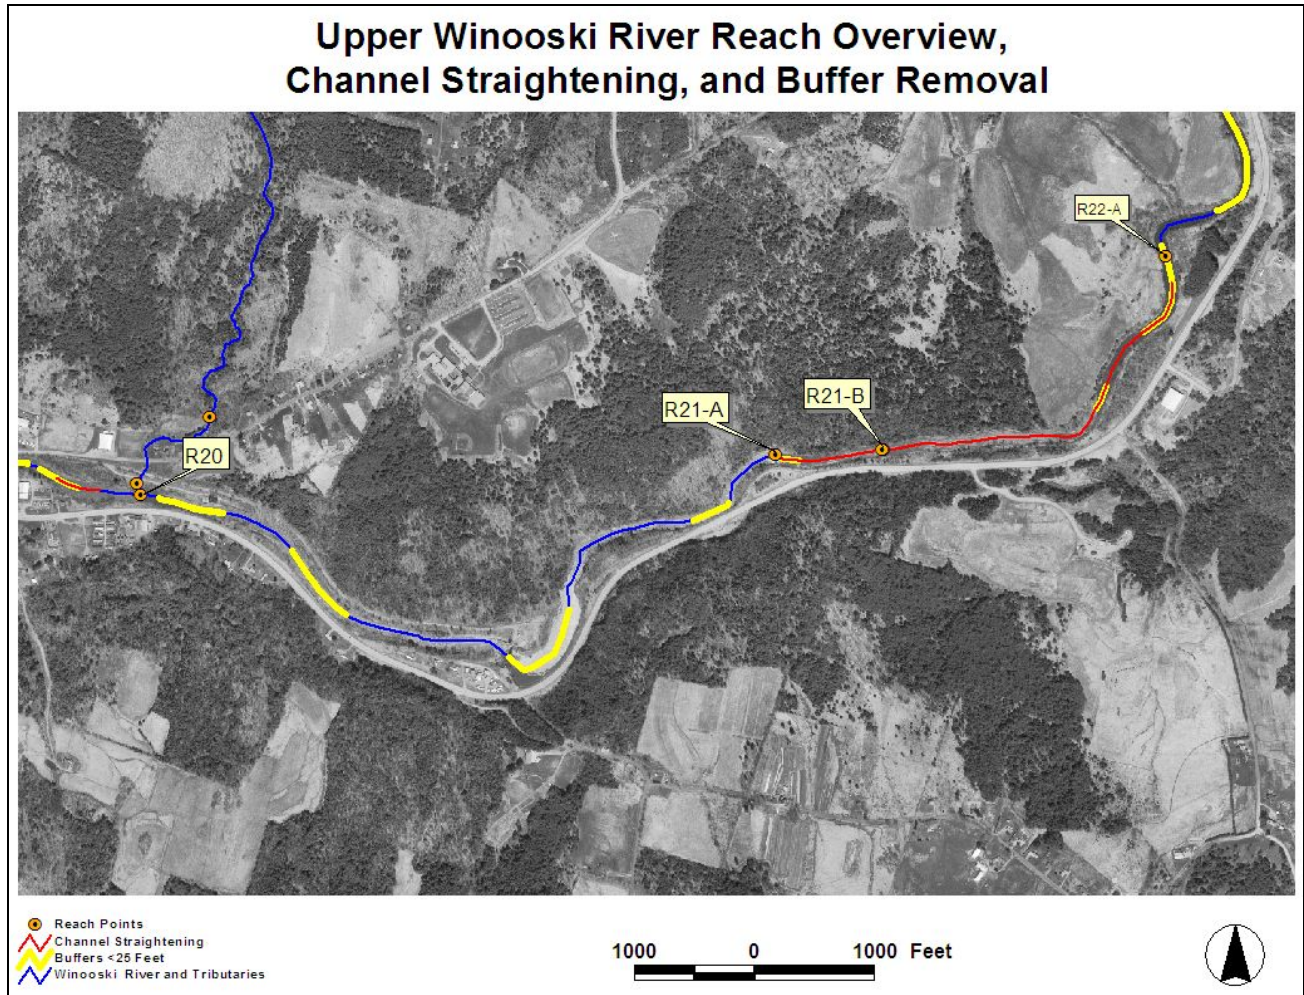
**Figure 13: Reaches R21 and R20 with channel straightening and riparian buffers <25 feet wide.**

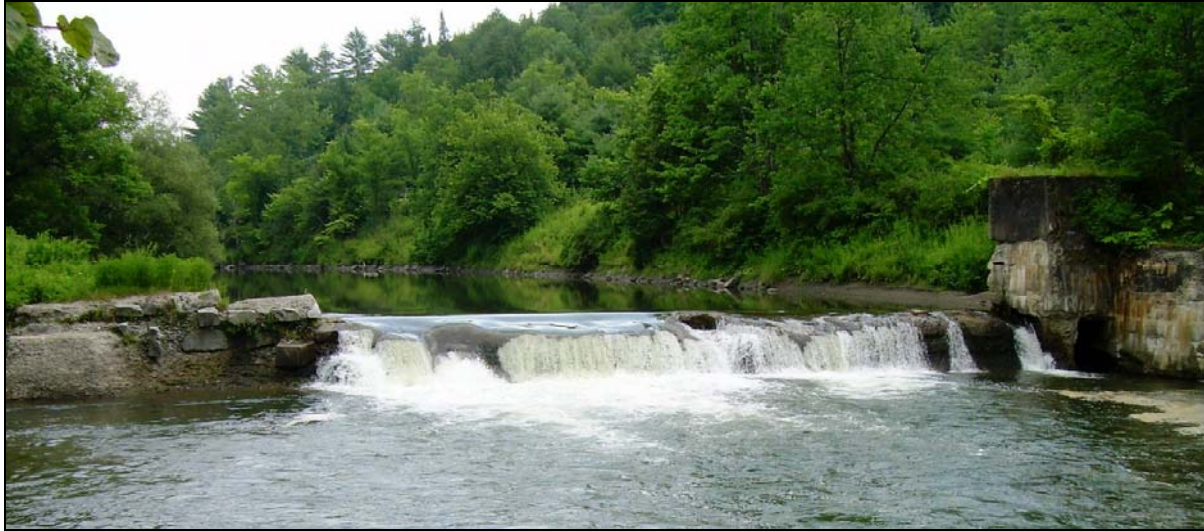
Winooski River segment R21-A was only partially assessed due to the impact of the concrete dam that exists at its lower end (Figure 15). The dam reduces water surface slope and changes the channel bottom from cobble/gravel to sand/silt. The dam is no longer in use but still impacts the channel. Just on the downstream side of the old dam a large alluvial fan has developed where a tributary affected from upstream disturbance is carrying a significant amount of sediment towards the river.

**Figure 15: An old concrete dam disrupts water and sediment transport at reach R21-A (looking upstream).**

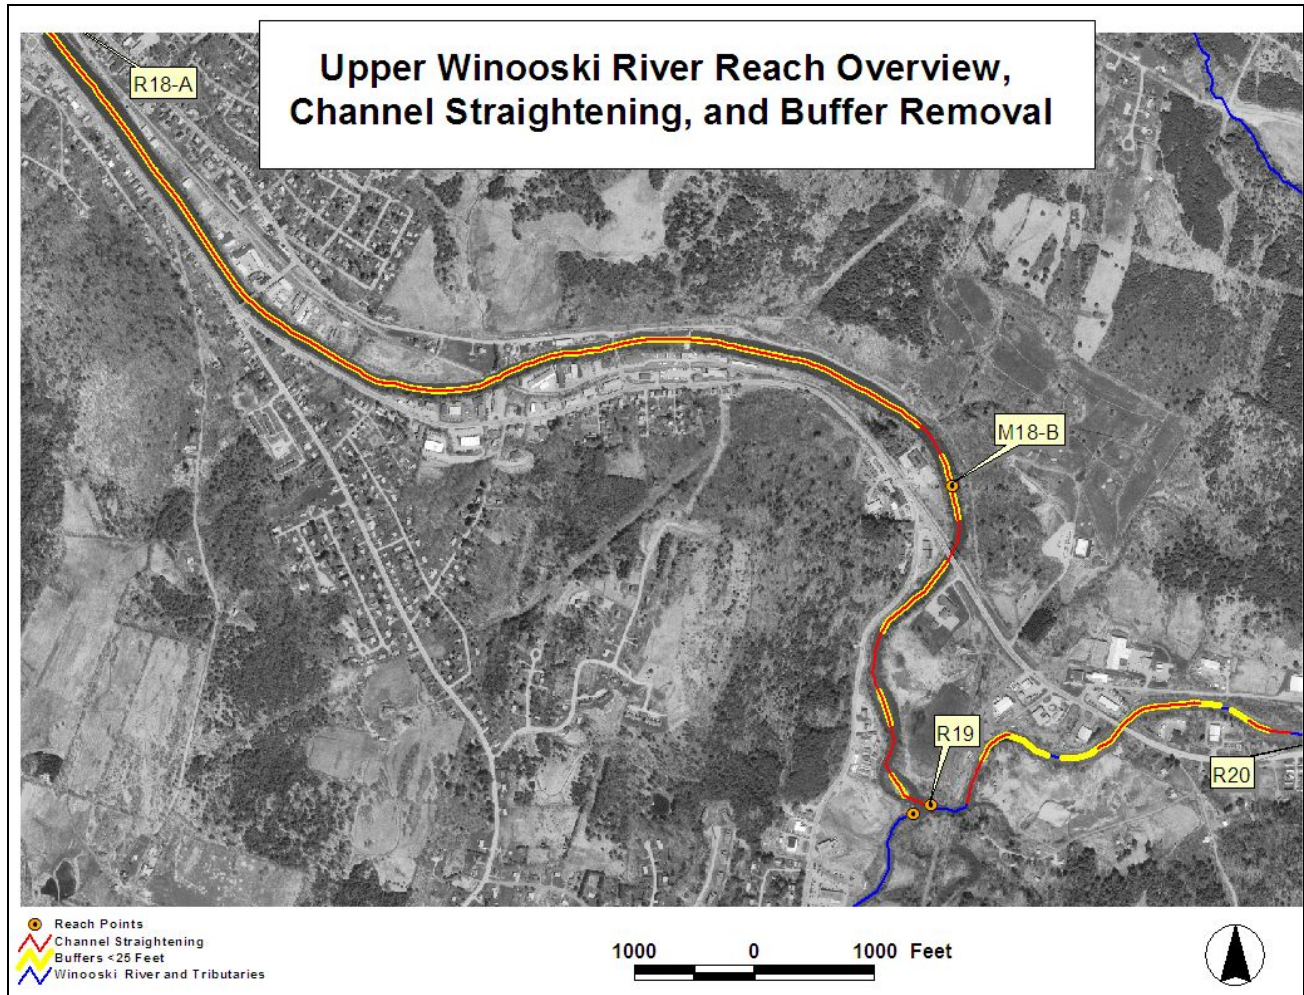
Figure 16 Reaches R20, R19, and R18 with channel straightening and riparian buffers <25 feet wide.

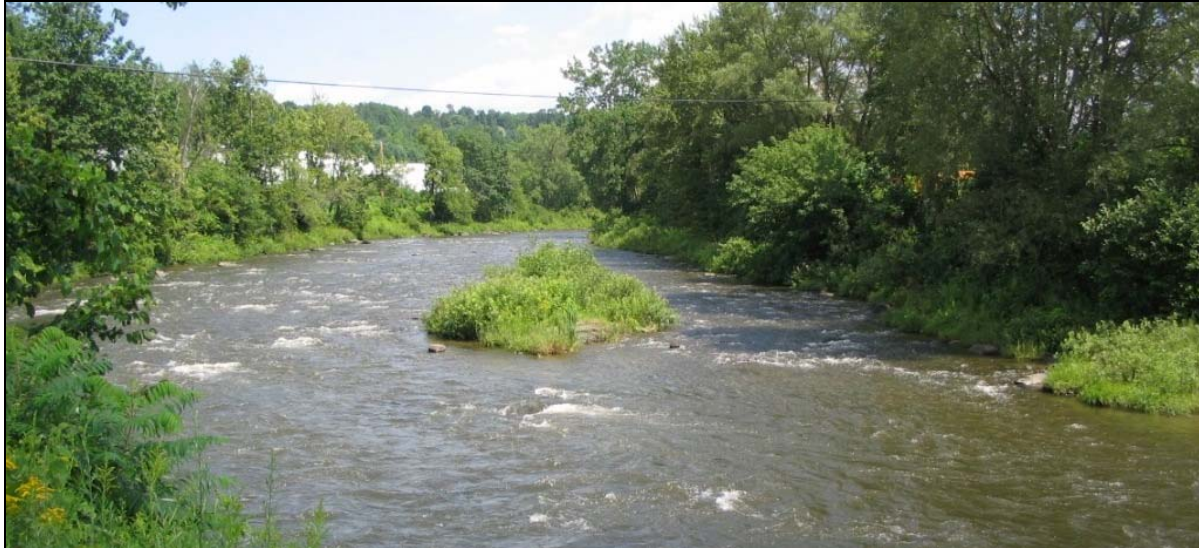
“It was found to be an F boulder stream, which was a stream type departure from the Phase 1 reference C stream type. The stream type departure is due to historic degradation and the commercial and industrial development along Route 2. These stressors have lowered the entrenchment to 1.5 and increased the incision ratio to 1.4. The major active adjustment process is widening, as evidenced by rip-rap failure of approximately 160 feet long located upstream from the railroad bridge on the left bank. The two bridges are channel constrictions. Although bank instability was clear near the two bridges, no active head cuts were documented. The reach was found to be in Stage III of evolution. Historically, the reach has been straightened. The habitat score was 0.48, or “fair,” and geomorphic score 0.34 or in “poor” condition. Relatively minor bank erosion was noted along both the right and left bank with a total length of 185 feet and an average height of 10 feet. The right bank erosion is located upstream from the bridge on Route 2 and adjacent to a parking lot. The left bank erosion is located downstream and adjacent to the

railroad bridge. The erosion is related to constriction by the bridge. The riparian corridor was dominated by development. Buffers ranged from <5 to 25 feet along the left and <5 feet along the right. This reach may be affected by the water release coming from the Levesque Station-Montpelier Hydroelectric Dam #4. The lower portion of the reach is connected to the mouth of the Steven Branch and the Food Works site described above.”

Figure 17: Typical channel conditions along reach R19. Photo credit: Johnson Company

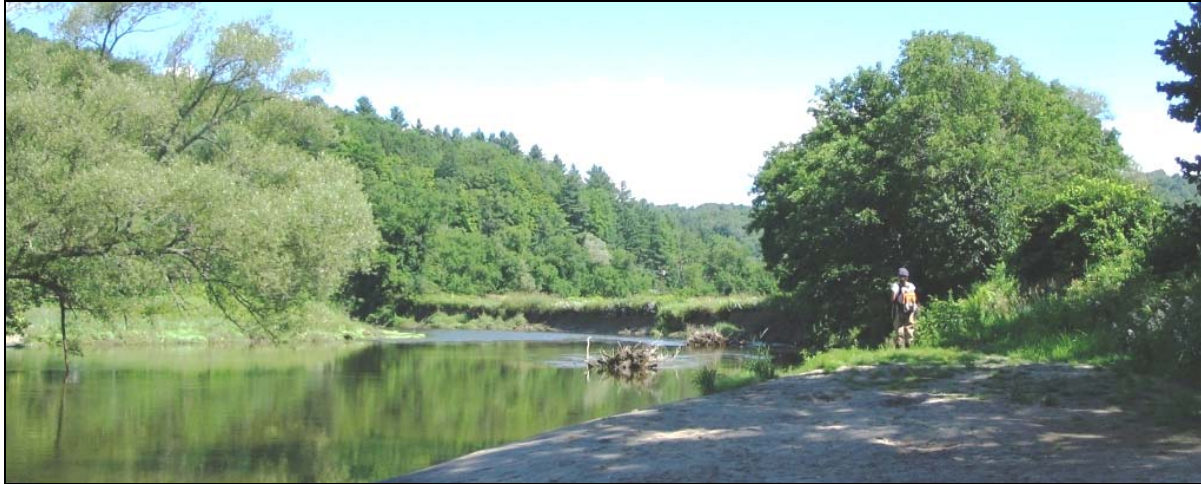
“R18-B may have also been straightened in the past. The geomorphic and habitat assessment scores were 0.33 and 0.34 respectively, both “poor” conditions. The dominant adjustment process was [historic] degradation and widening (see Figure 18), with an incision ratio of 1.9 and enrichment ratio of 1.6. The segment was found to be in Stage III of evolution and has lost access to its historic floodplain. Evidence of channel avulsion was found on the upper portion of the segment near the confluence with the Stevens Branch. The right riparian corridor was dominated by agricultural crops managed by the Food Works project, and had a buffer from 5-25 feet. An eroding bank approximately 10 feet high and 320 feet long exists on this property. The left riparian corridor consisted of a narrow wooded buffer of <5 to 25 feet. A mobile home sales business is located on the top of the left bank. A river meander is cutting the bottom of the left bank creating some serious instability on the steep slope of the bank.”

**Figure 18: Typical channel conditions along reach R18-B. Photo credit: Johnson Company**

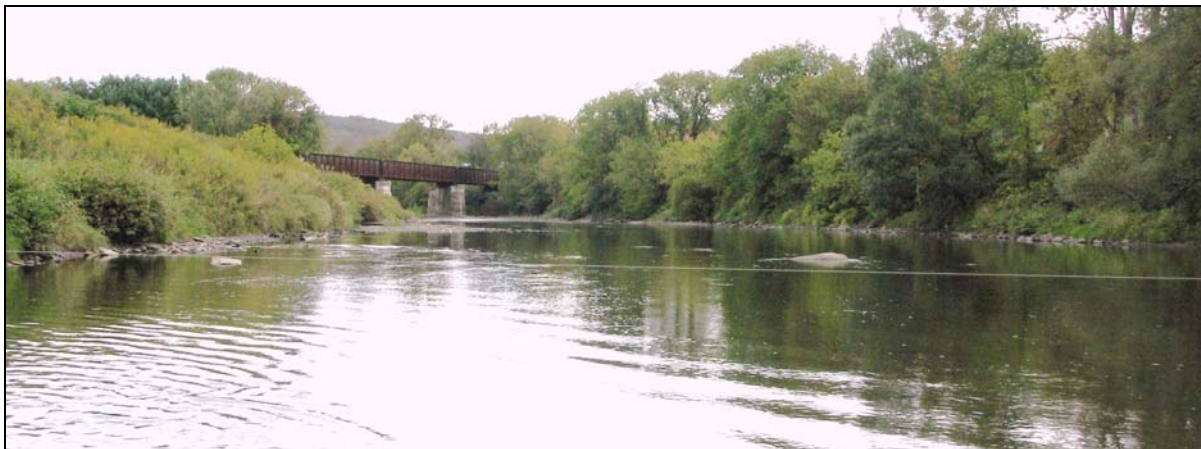
“R18-A had undergone a stream type departure from its reference C type stream to the current F type due to historic degradation and the development of Montpelier within the historic river corridor, which has lowered the entrenchment to 1.2 and increased the incision ratio to 1.5. The actual conditions show a highly entrenched stream with a moderate incision ratio (Figure 19). The segment no longer has access to its original floodplain and was found to be in evolution stage II. Historically, it has been channelized as a flood control measure for the City of Montpelier. R18A had a habitat score of 0.44 “fair” and a geomorphic assessment score of 0.30 “poor”. Despite the incision, there was relatively no erosion noted in the segment due to the significant amount of rip-rap. The riparian corridor was dominated by commercial development on both sides with a very narrow buffer of < 5 feet on both sides. An old dam located at the upper portion of the segment on a bedrock constriction serves as a grade control. The dam was found to be partially breached and does not impound much more water than the naturally occurring bedrock grade control upon which it is constructed.”

**Figure 19: Typical channel conditions along reach R18-A. Photo credit: Johnson Company**

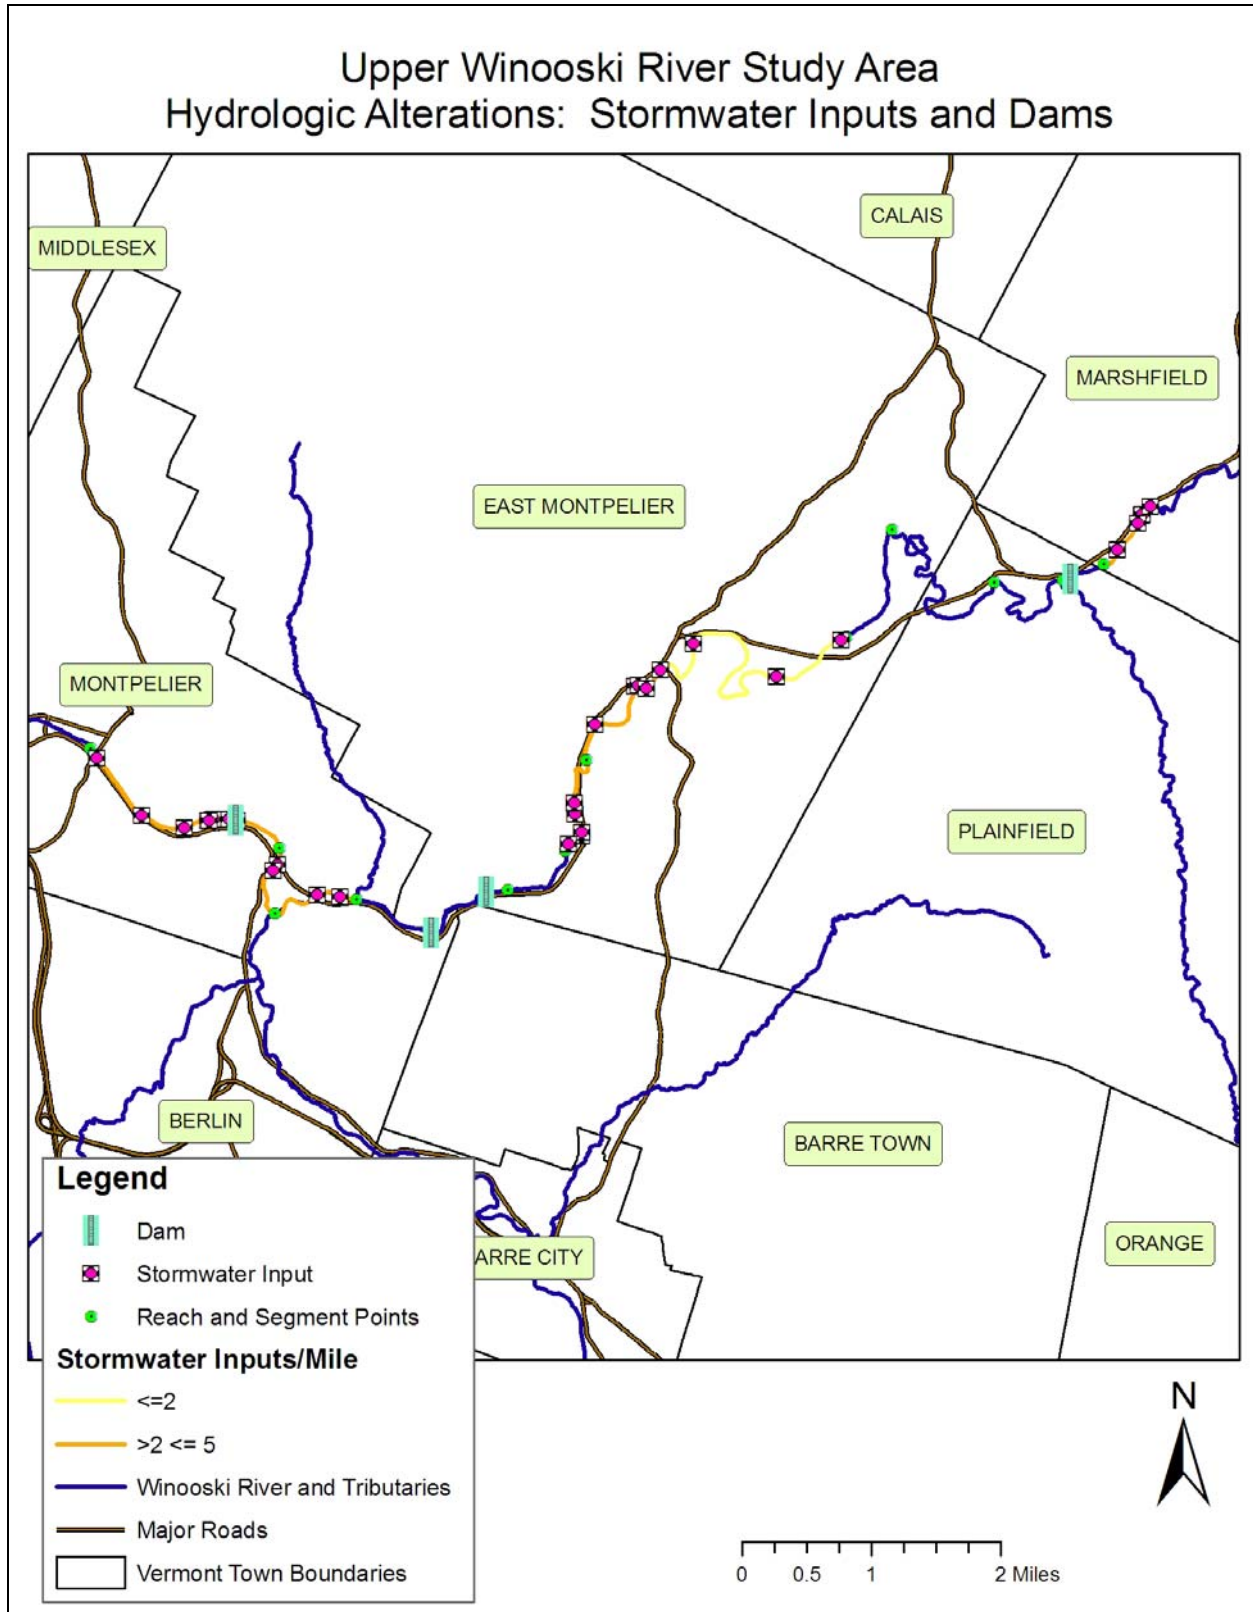
Figure 1: Stormwater Inputs and Dam Location: Upper Winooski River Study Area (M18-M27)

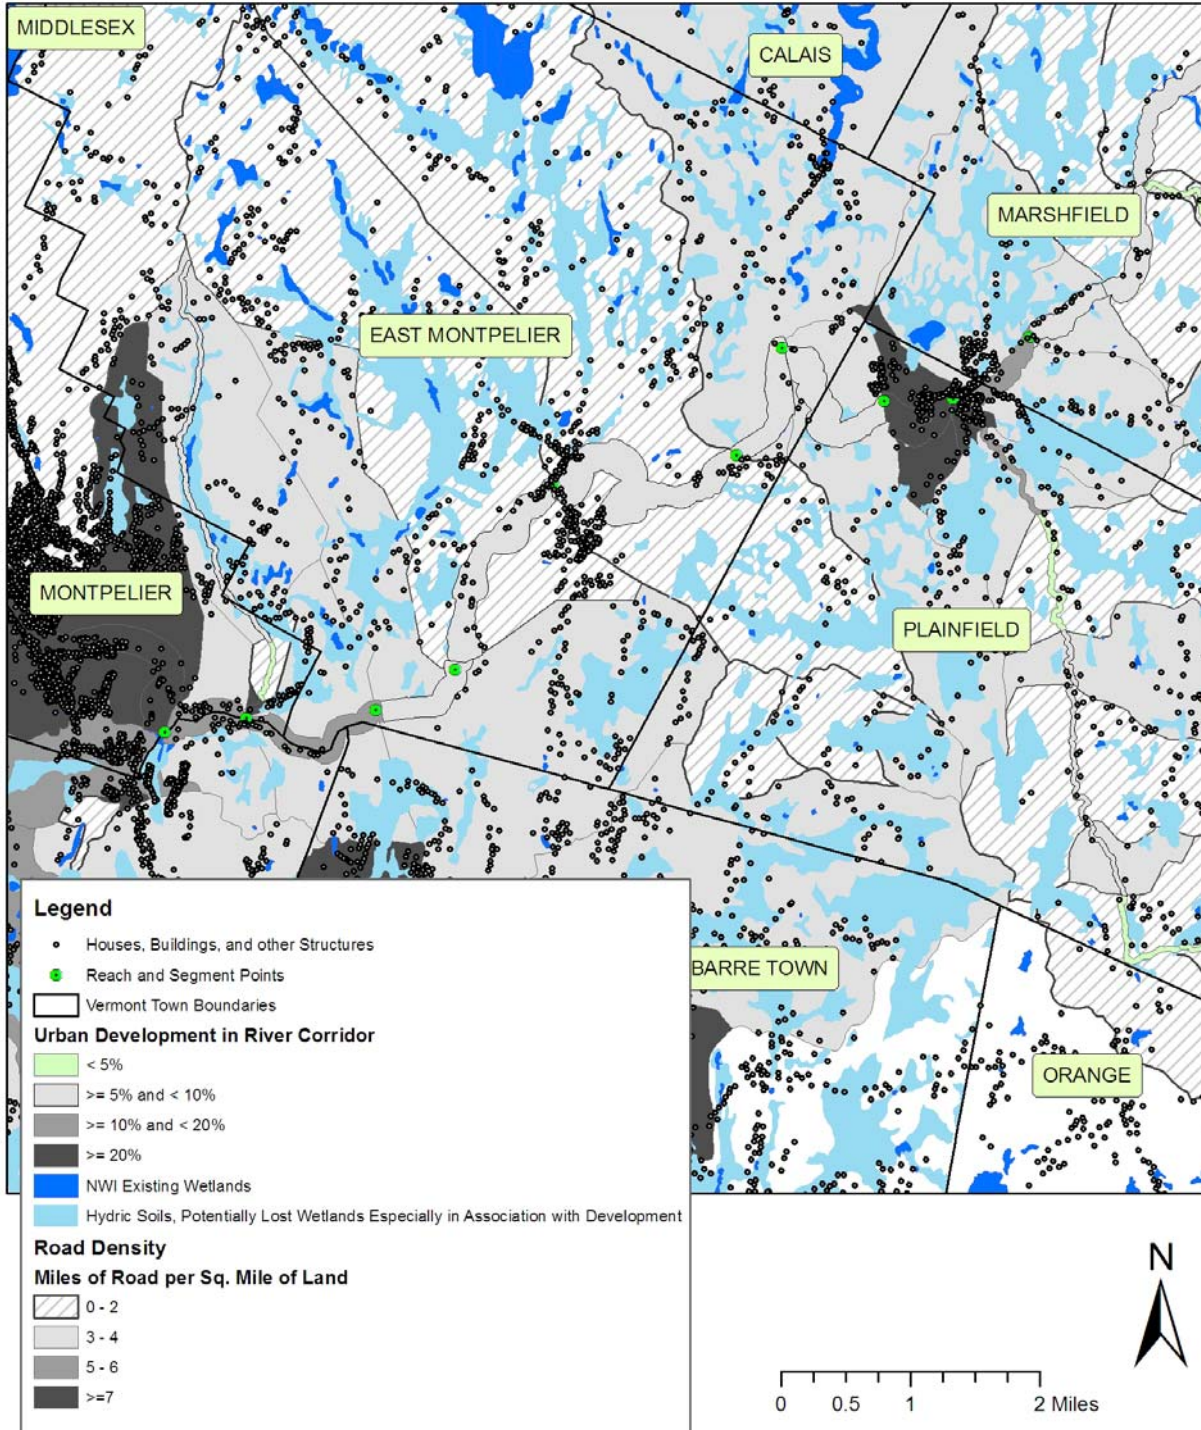
Figure 2: Potential Wetland Loss, Density of Roads and Urban Development: Upper Winooski River Study Area (M18-M27)
