# Upper Winooski River: Plainfield to Montpelier

## River Corridor Management Plan

### Washington County, Vermont

MARCH 31, 2010

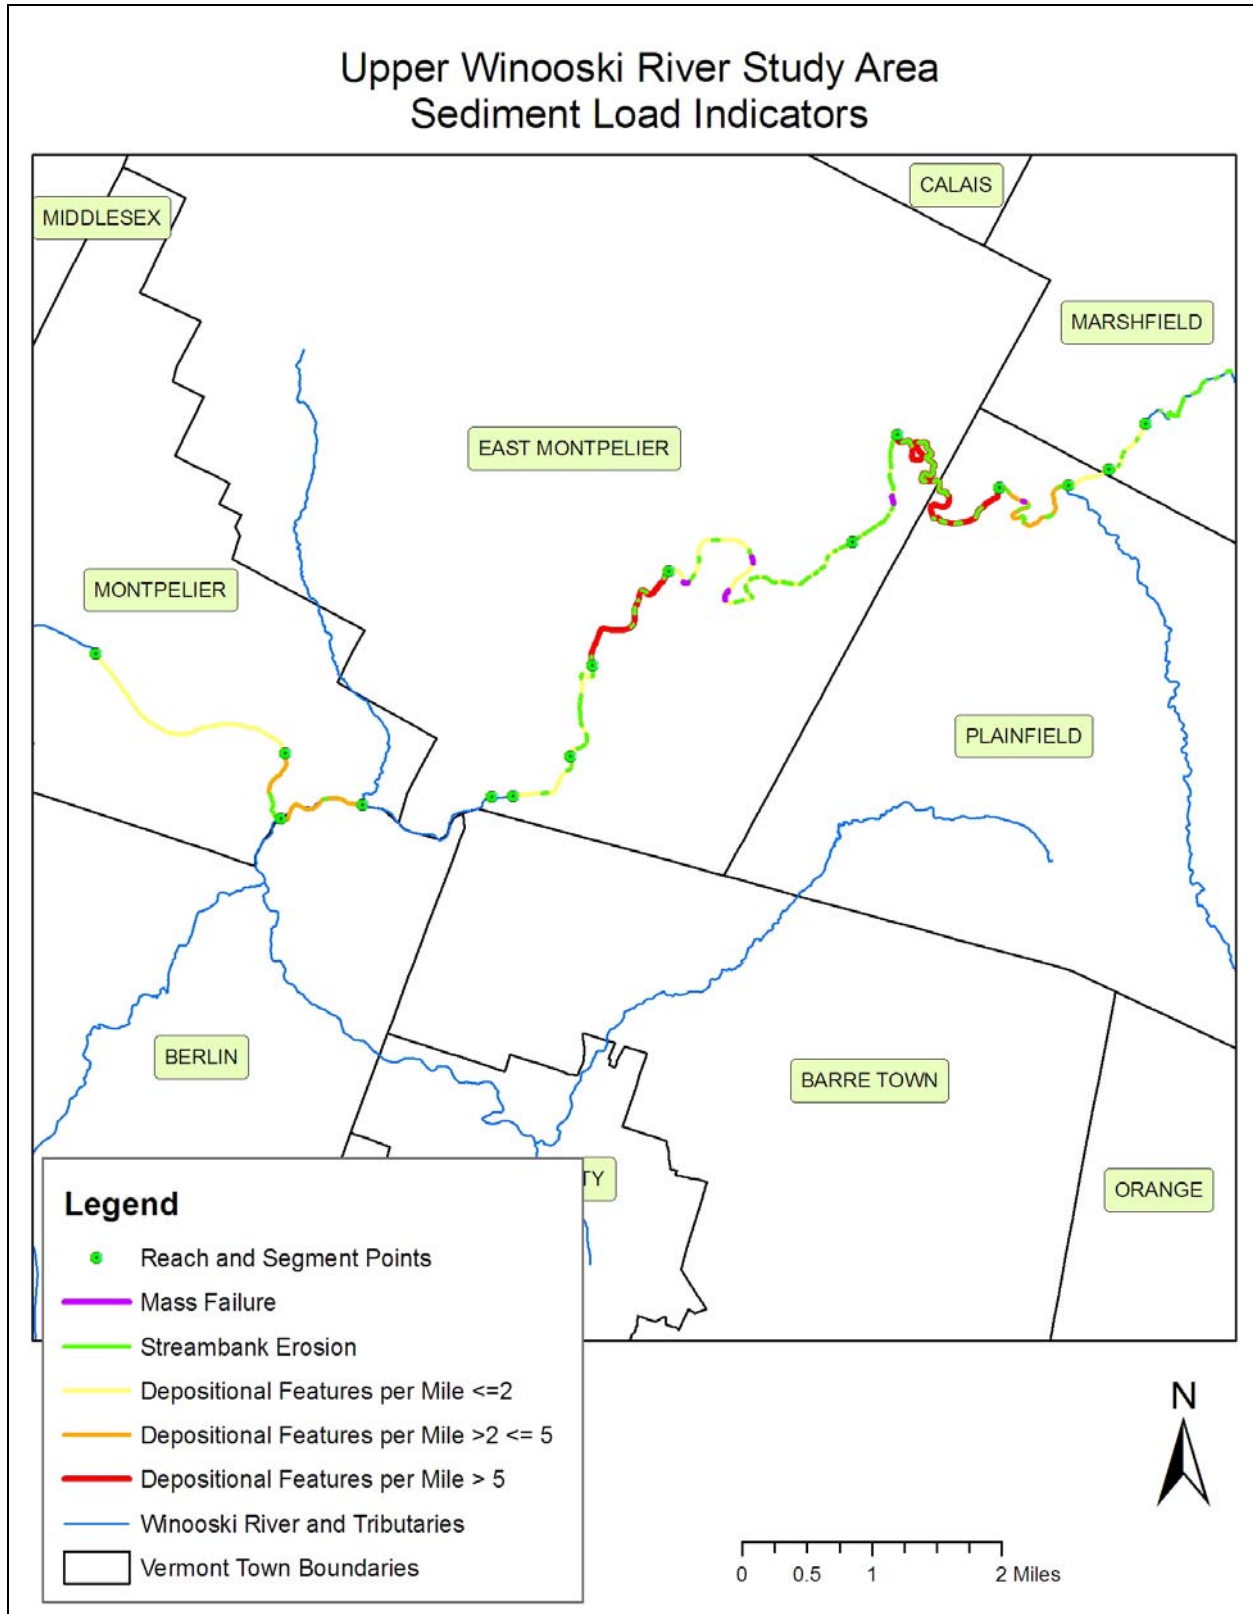
Figure 3: Sediment Inputs to the Upper Winooski River Study Area (M18-M27)

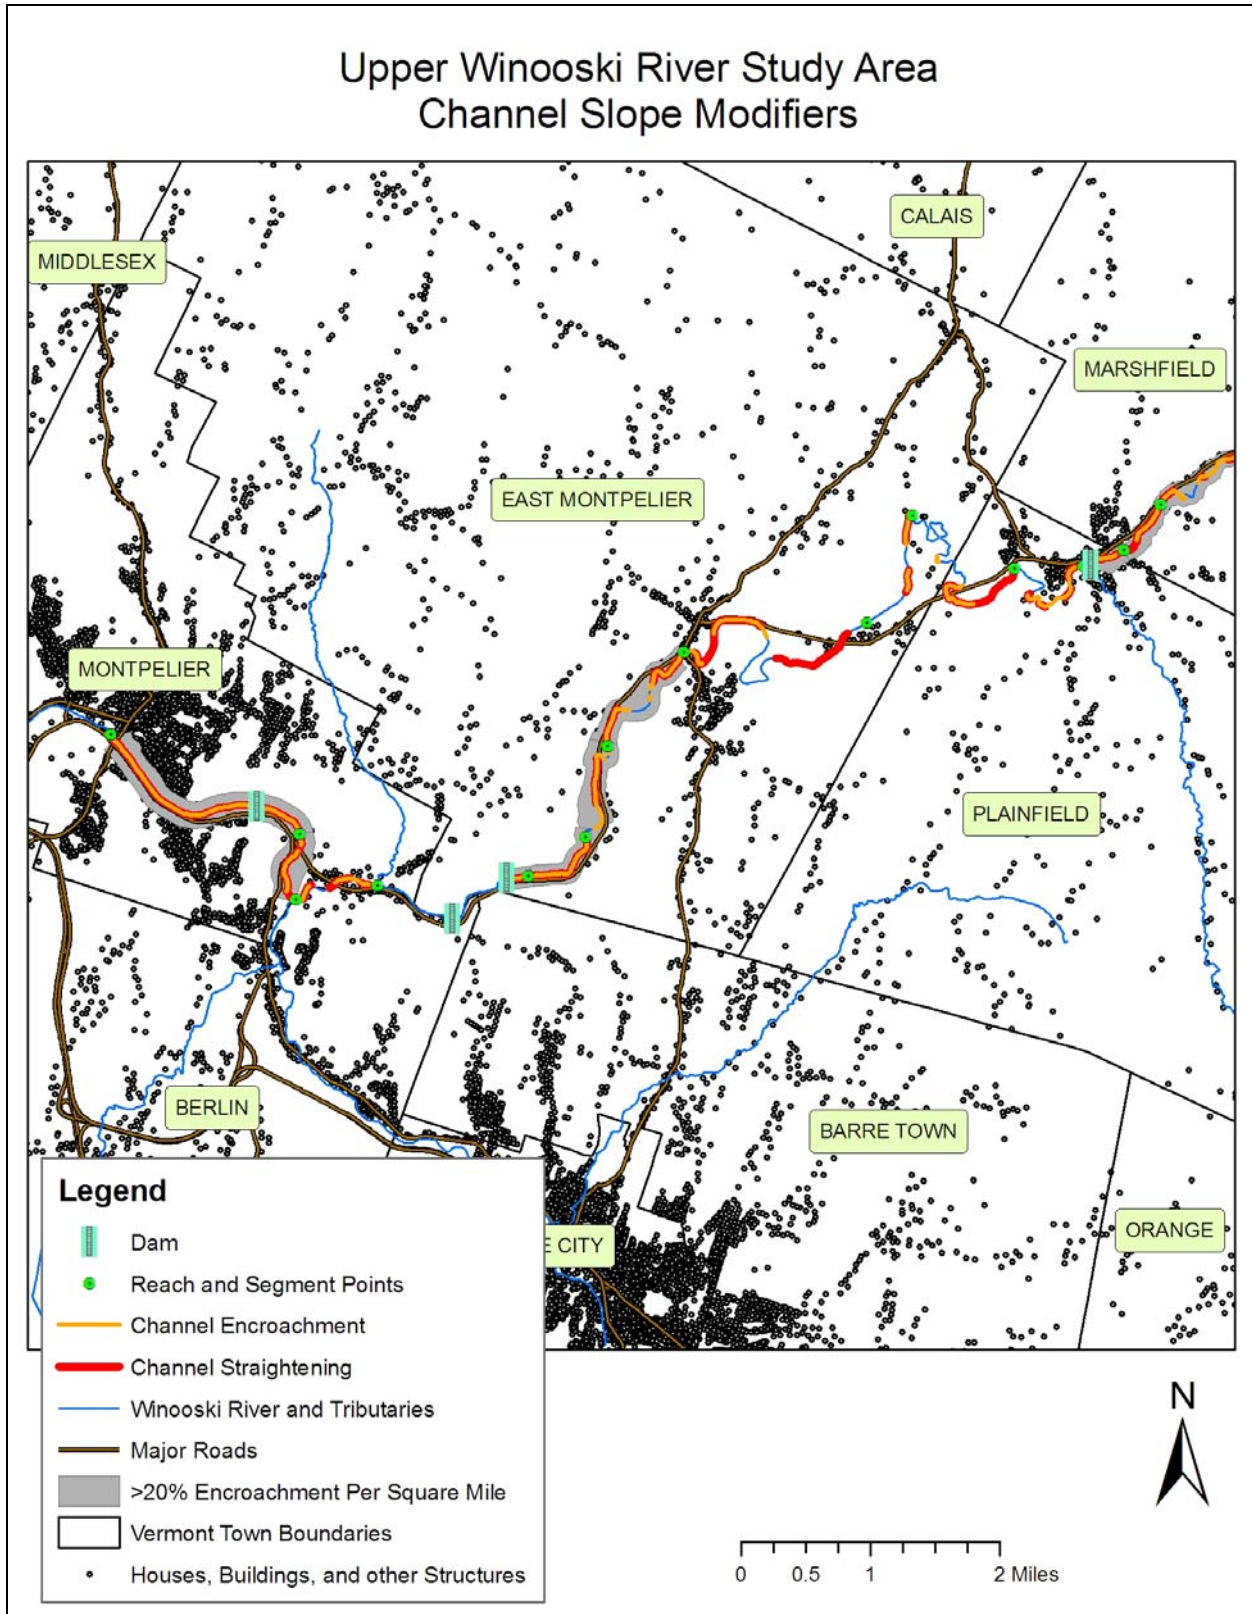
Figure 4: Channel Slope Modifiers of the Upper Winooski River Study Area (M18-M27)

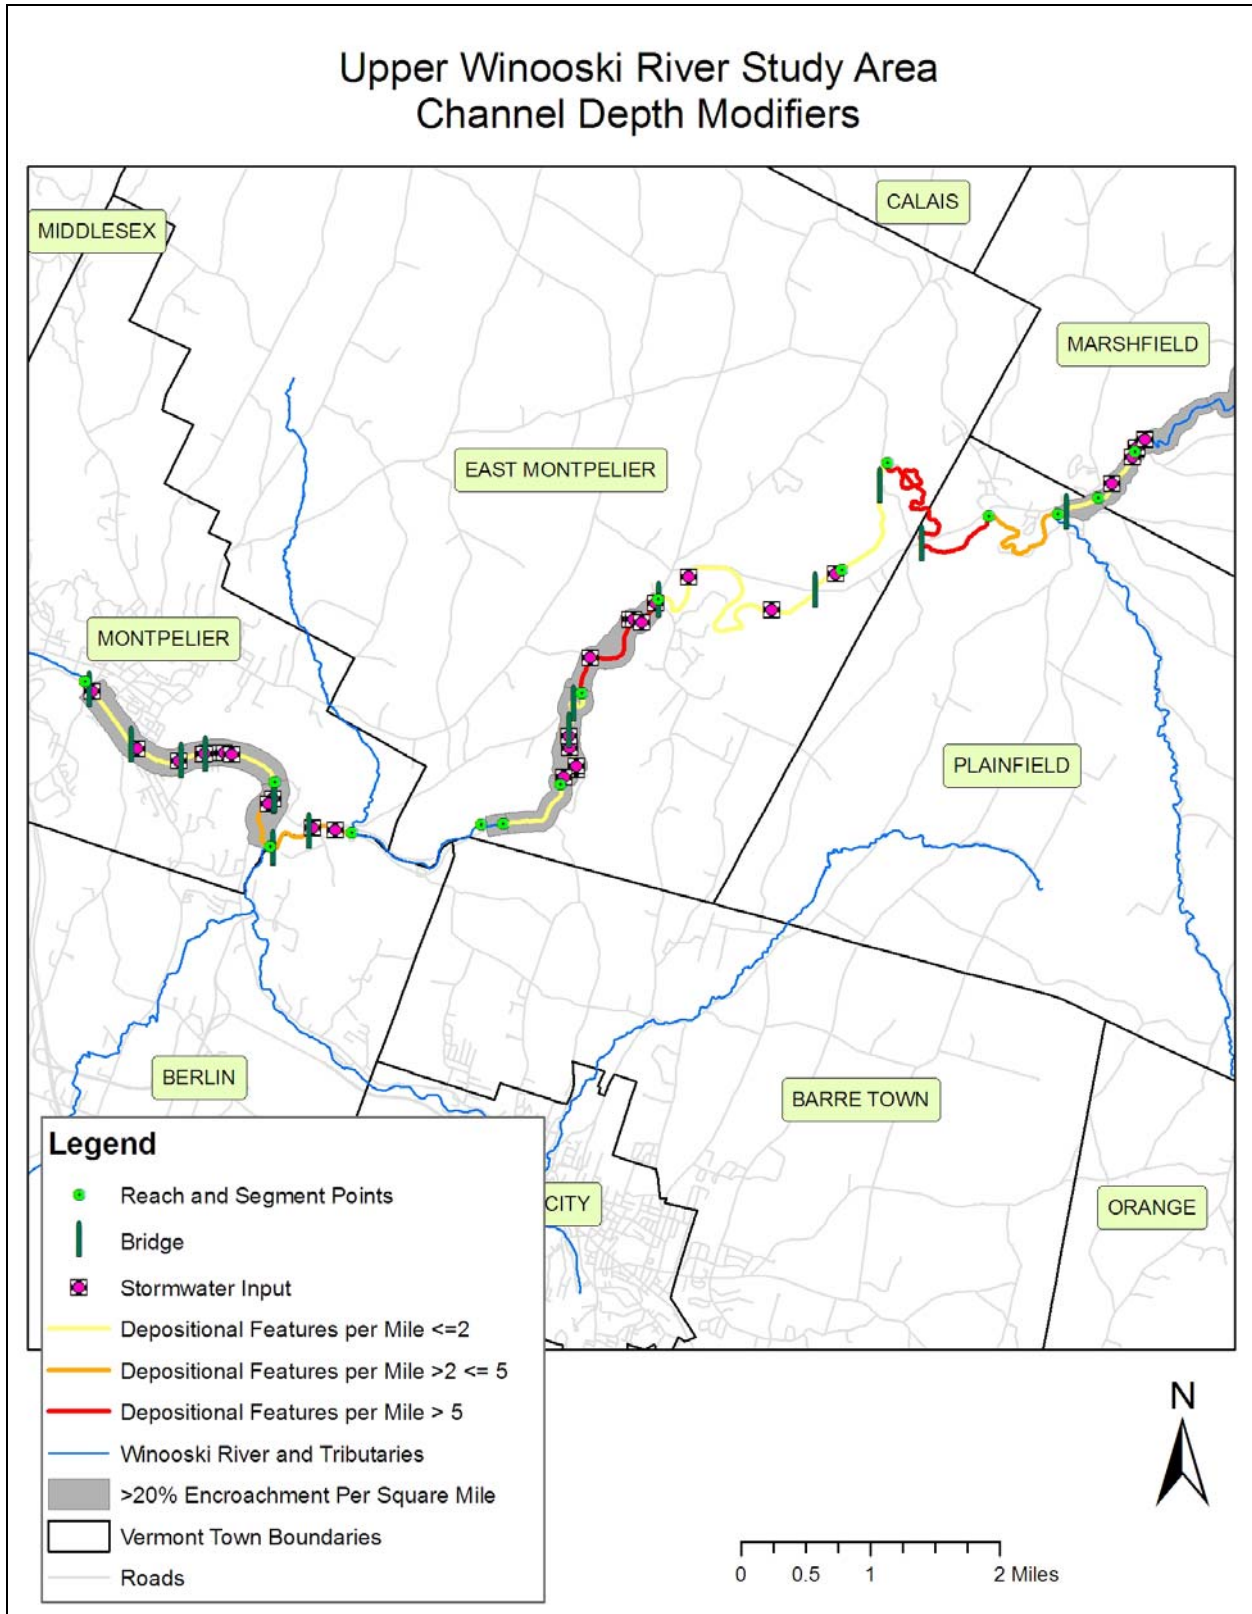
Figure 5: Channel Depth Modifiers of the Upper Winooski River Study Area (M18-M27)

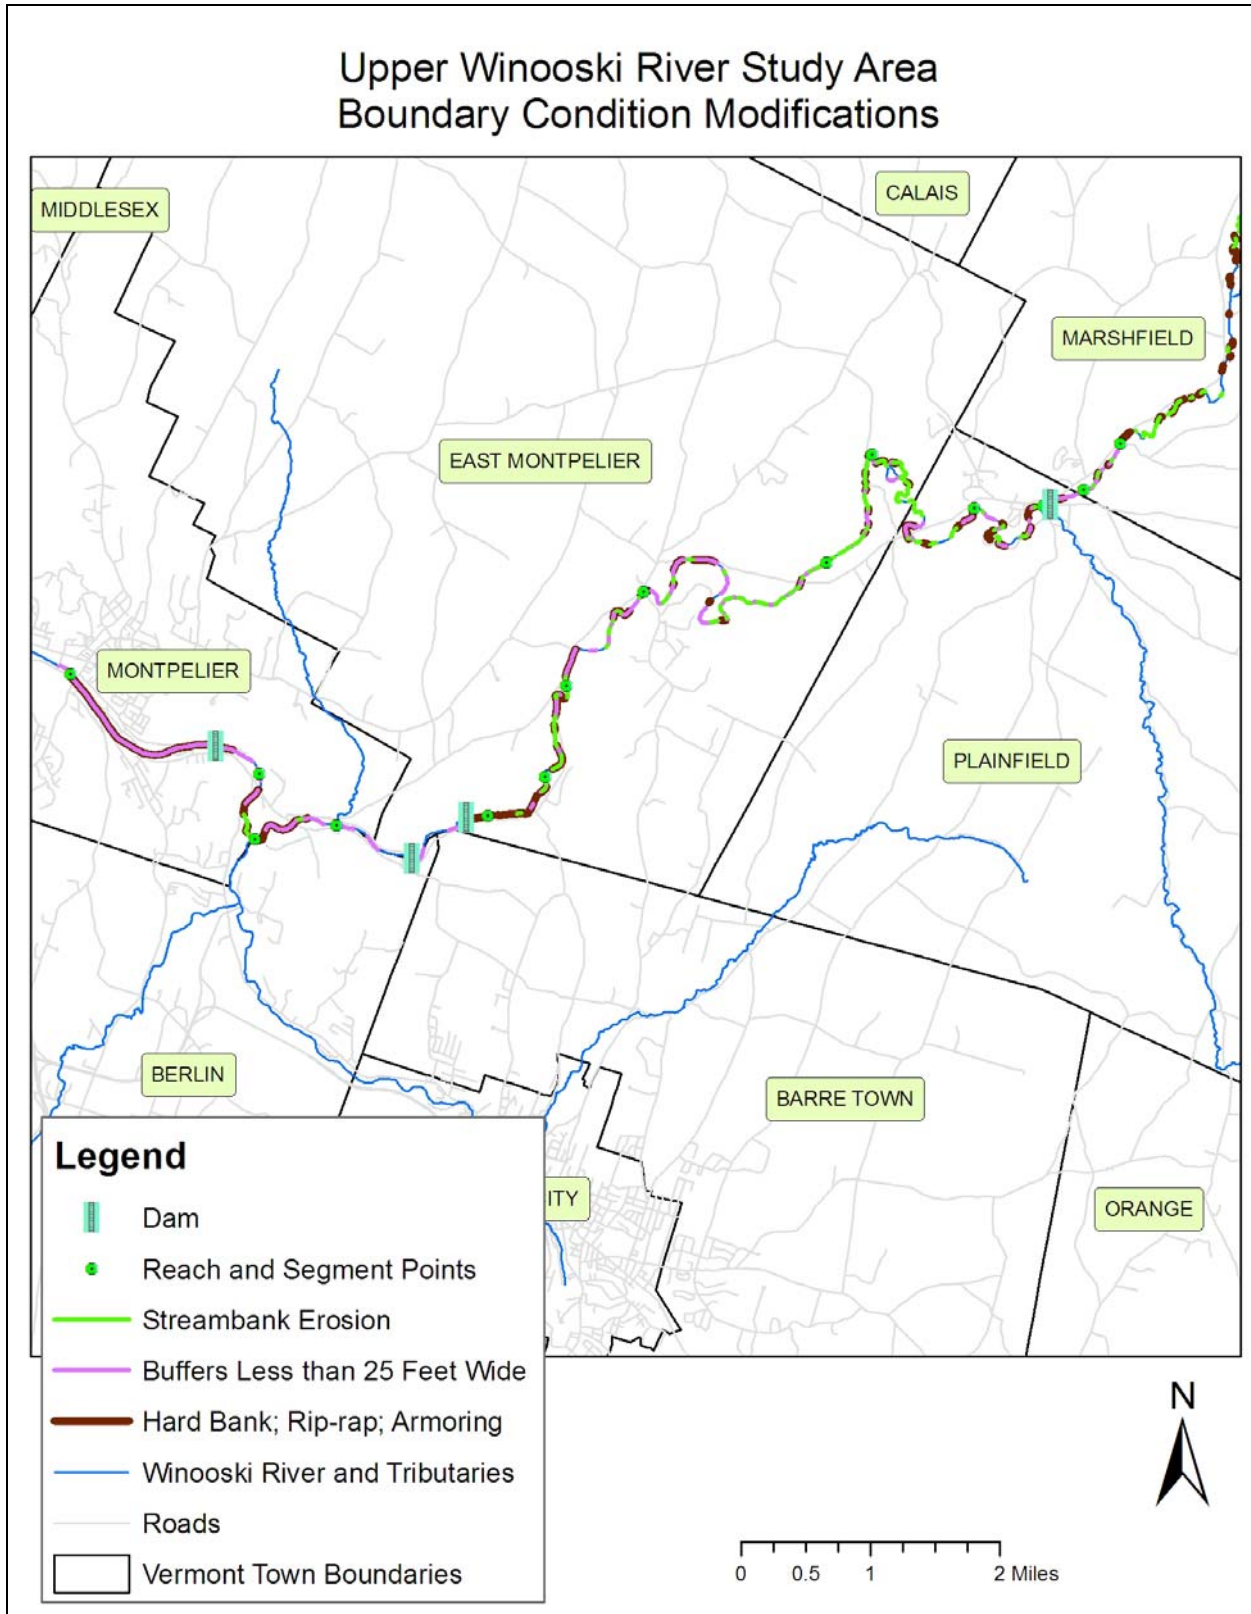
Figure 6: Boundary Condition Modifiers of the Upper Winooski River Study Area (M18-M27)

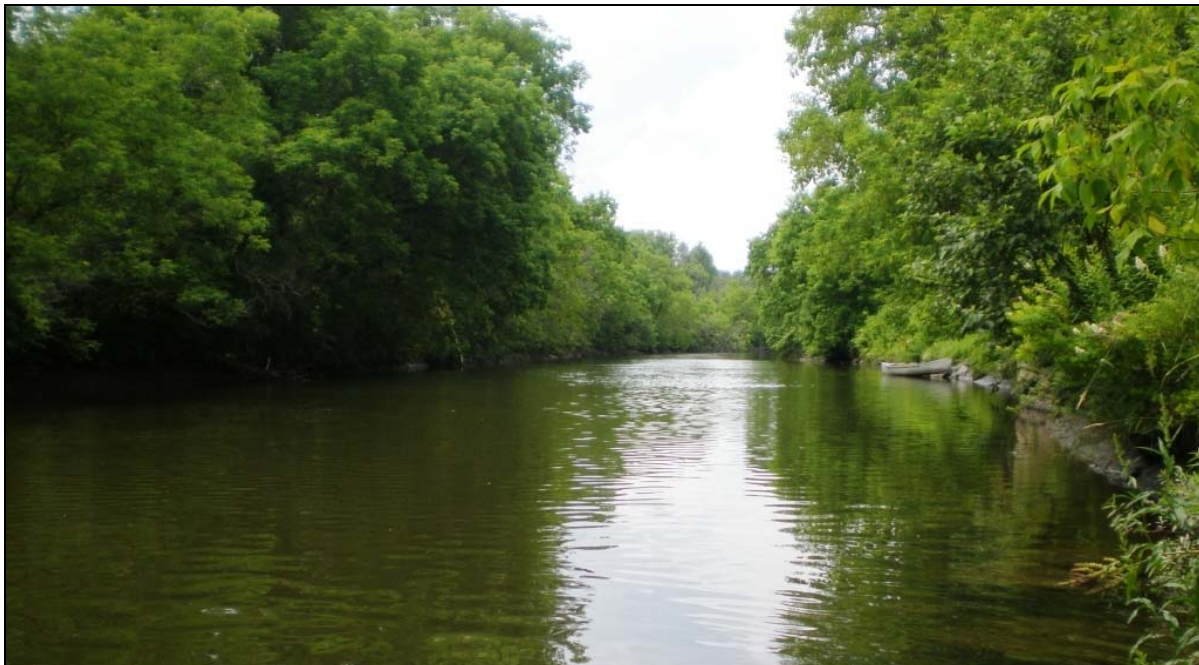
Upper Winooski segment R27-B begins at the John Fowler Bridge and flows downstream to approximately 1500 feet upstream of the Plainfield dam. The reach is characterized by a very straight E-type stream channel dominated by a ripple-dune sand bottom. The channel appears straight due to historic manipulation. This straightened channel has widened and there is evidence of some minor planform adjustment as the river attempts to erode an outside bank. Lack of significant adjustment may be attributed to the low slope and excellent floodplain access and a moderately healthy riparian buffer (see Figure 2). The straightening and widening have, however, greatly reduced instream habitat quality. Forest clearing for residential and recreational use has significantly impacted the right bank as well as a portion of the left riparian area which has been cleared for agriculture. Route 2, several residences, and a commercial operation impede on the right corridor while the left corridor has no significant development.

Figure 2: Typical perspective of segment R27-B, a ripple-dune channel with a very low slope.

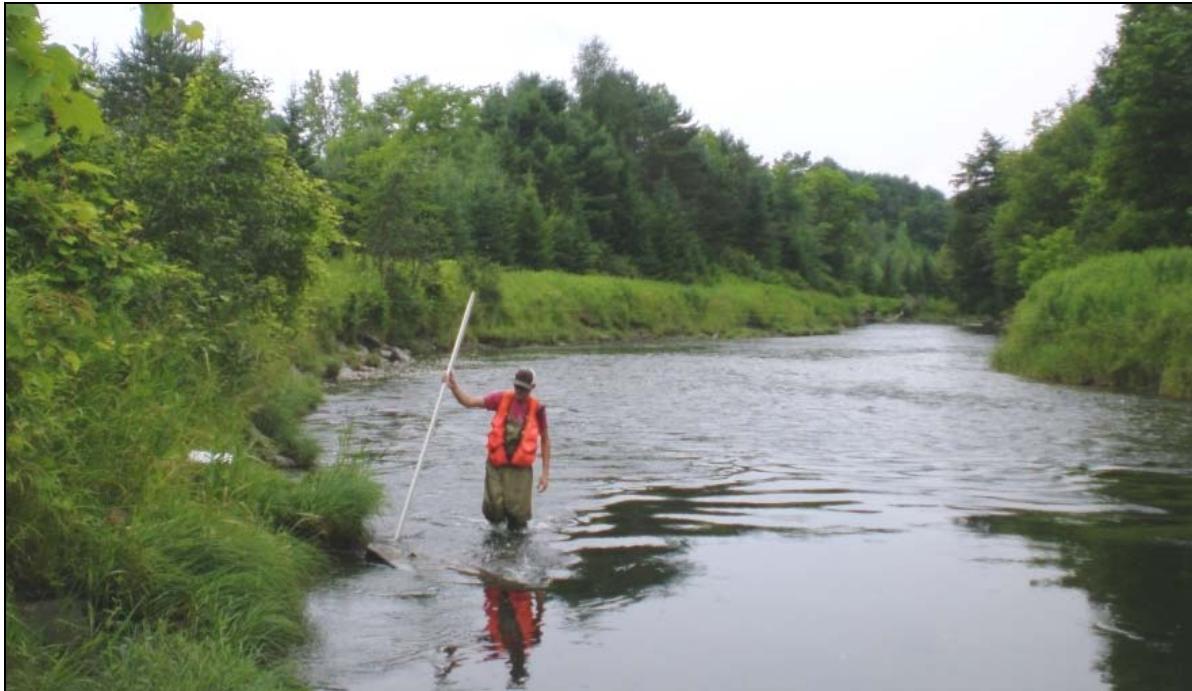
R24 is slightly incised. Excessive energy in the channel may have caused a large mass failure on the right bank as well as other intermittent erosion patches that exist commonly on both the right and left banks. It also may have reduced the habitat complexity which is dominated by a plane bed bottom and only two riffles over the course of the mile long reach (sediment contributions from R25 and the Kingsbury branch may also have filled in some of the bottom topography) (see Figure 7).

**Figure 7: Measuring channel incision along reach R24.**

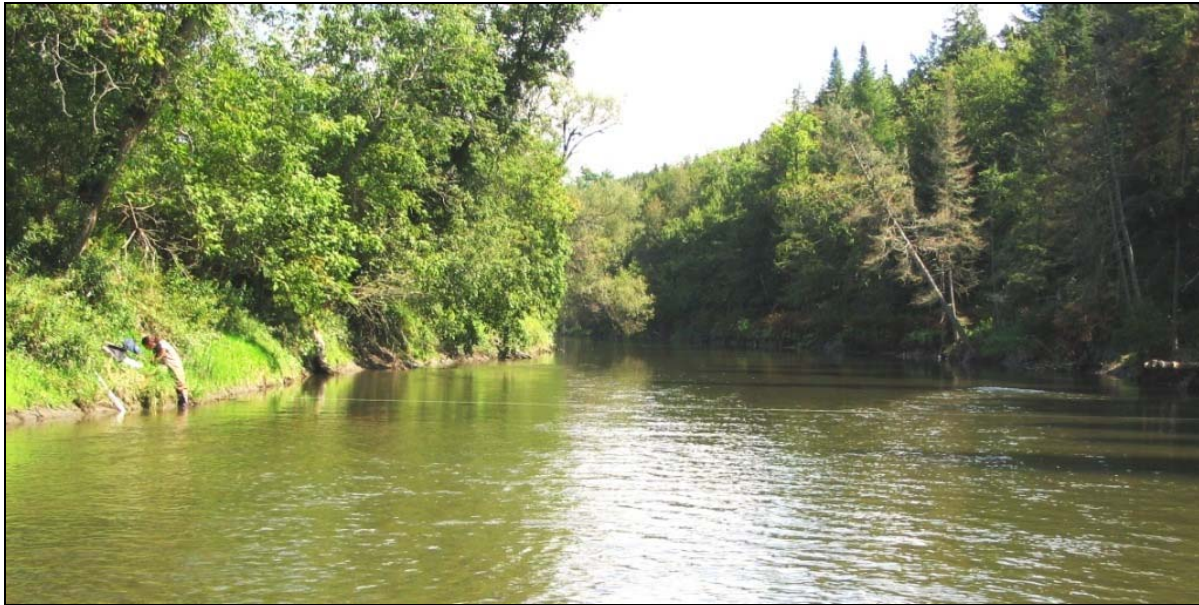
“R22B also may have also been straightened in the past because of development in East Montpelier. The geomorphic and habitat assessment scores were 0.45 and 0.43 respectively, both “fair” conditions. The segment was found to be in Stage III of evolution and has lost access to its historic floodplain. The dominant adjustment processes are widening and historic degradation. Active channel migration evidenced by flute chutes was observed. There is aggradation at the mouth of the tributary, Mallory Brook, as is evident by depositional features such as delta, side, point and mid-channel bars. The right riparian corridor was dominated by a hay field on the right, and had a narrow buffer of less than 5 feet. The left riparian corridor consisted of forest with a buffer of more than 100 feet.”

**Figure 11: Cross section on reach R22-B. Photo credit: Johnson Company**

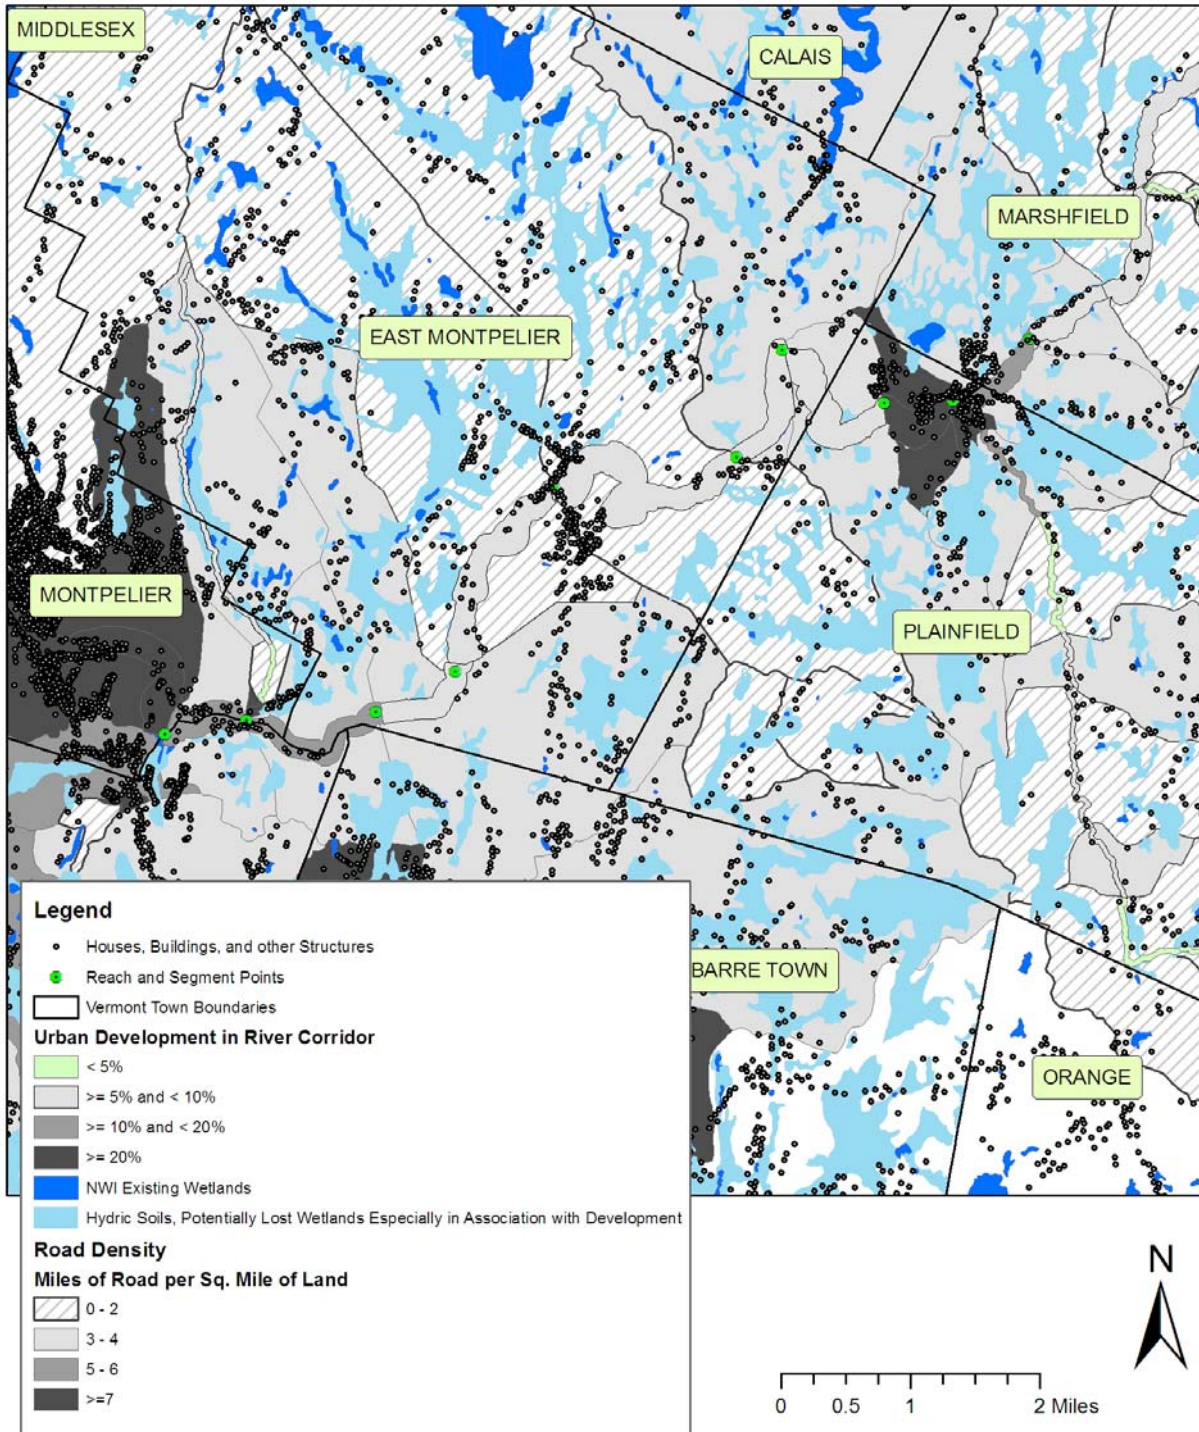
Figure 2: Potential Wetland Loss, Density of Roads and Urban Development: Upper Winooski River Study Area (M18-M27)

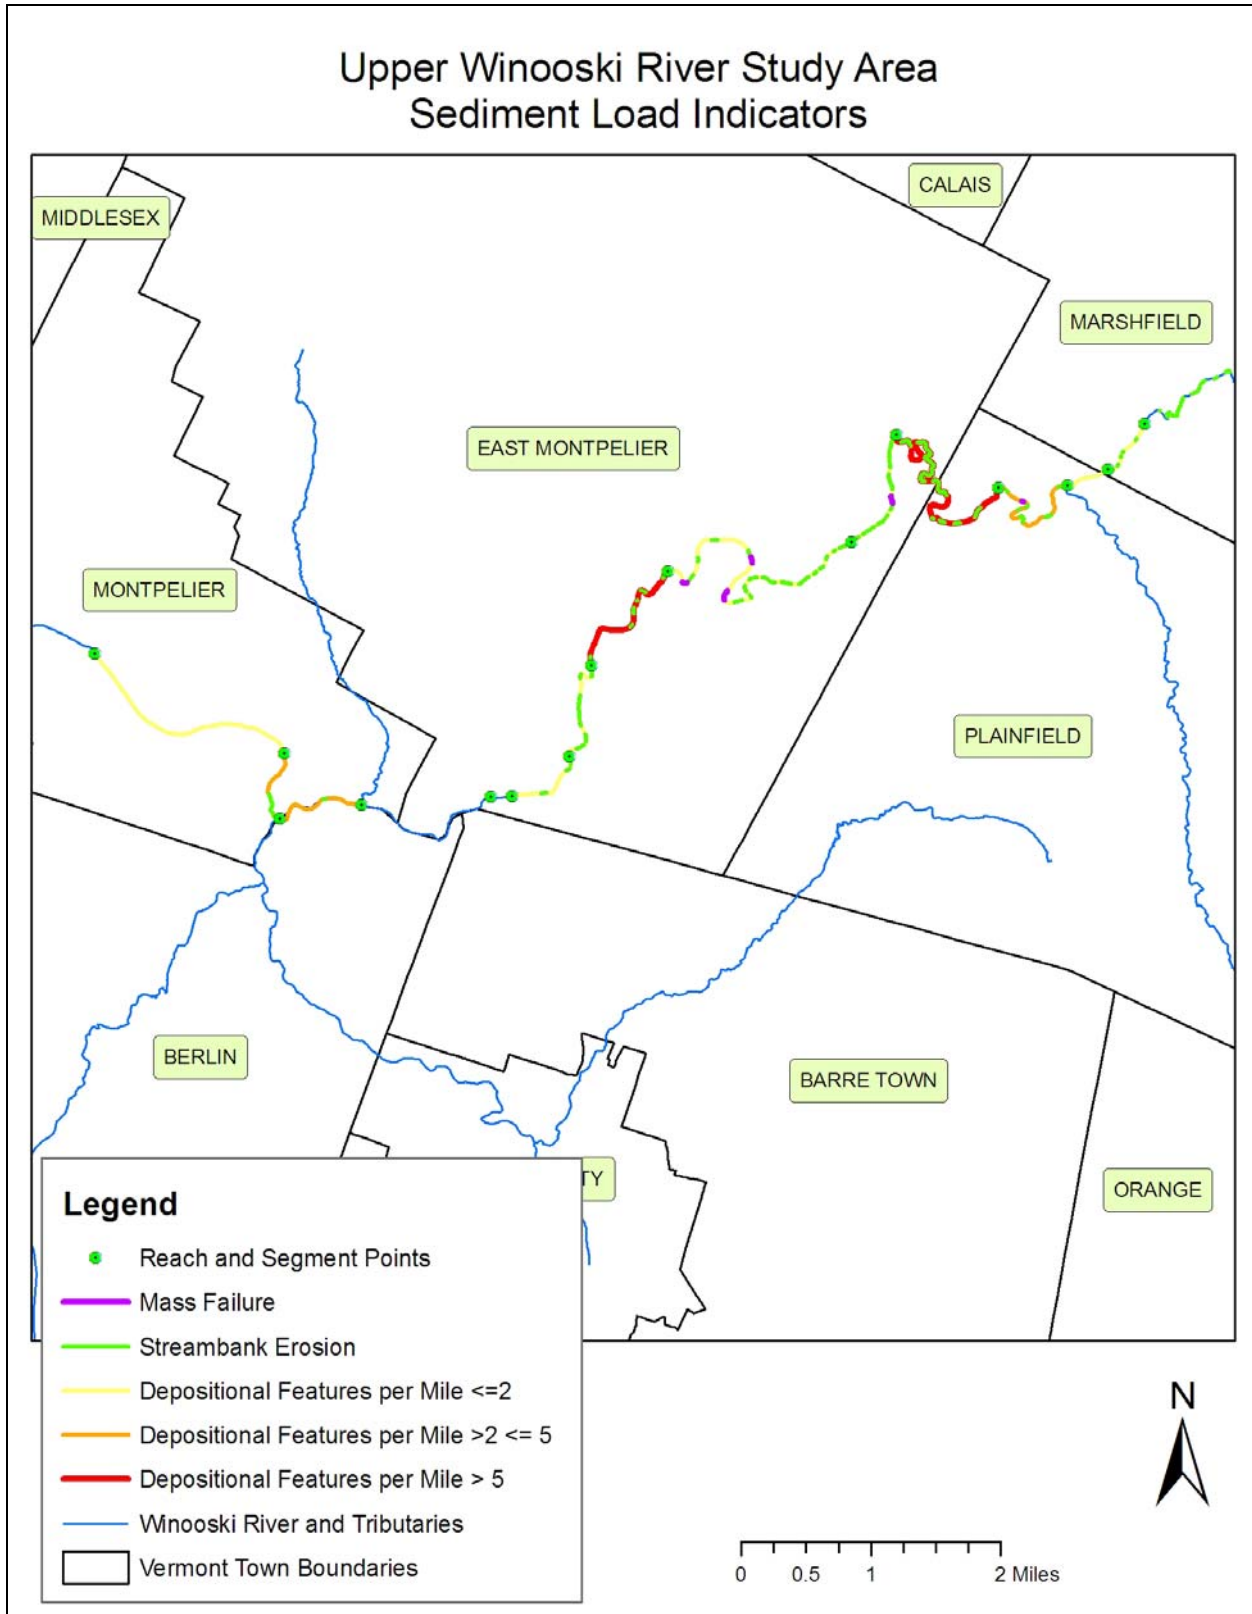
Figure 3: Sediment Inputs to the Upper Winooski River Study Area (M18-M27)
