Moretown, Vermont Phase 2 Stream Geomorphic Assessment & River Corridor Plan

April 20, 2018

Prepared by:
Bear Creek Environmental, LLC
149 State Street, Suite 3
Montpelier, Vermont 05602

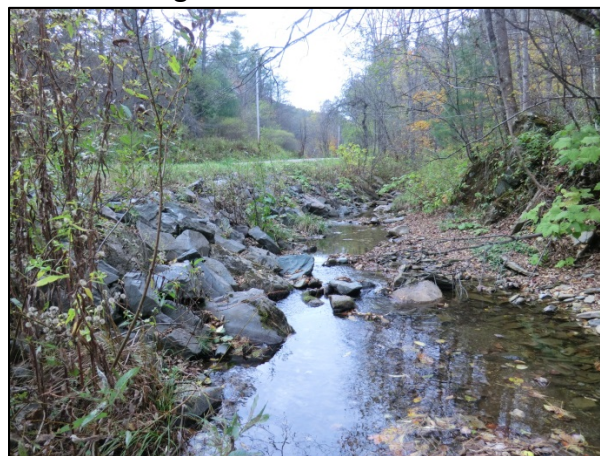
The downstream segment on reach one of Kelley Brook is characterized by a broad valley and moderate channel slope. Bedrock grade controls are common throughout this segment. Ward Brook Road is a corridor encroachment for nearly the entire length of the segment (Appendix C, Map 8). Almost all of R16.S2.02-S1.01-A has been historically straightened due to the placement of Ward Brook Road and houses along it. Additionally, there is extensive bank armoring, especially in areas where the brook is directly adjacent to the road. Channel straightening and bank armoring have led the brook to undergo major historic incision in this segment, resulting in a loss of floodplain access and a stream type departure. Channel widening is prevented by bank armoring on one side of the channel and the location of the valley wall on the other side for much of the segment; however, bank erosion is common where armoring is not present. Segment A was placed in **fair** geomorphic condition for these reasons. Habitat condition is also **fair** due to the altered channel planform, as well as lacking large woody debris, pool features, and bank and buffer vegetation.

Figure 5.25. R16.S2.02-S1.01-A flows directly along Ward Brook Road for much of the segment.

R16.S2.02-S1.01-A Data Summary		Reference	Existing
Length:	3,425ft	Confinement	Broad
Drainage Area:	2.1 sq. mi.	Stream Type	C _b
Evolution Stage:	F-II	Entrenchment Ratio	> 2.2
Sensitivity:	Very High	Incision Ratio	< 1.2
		Dominant Bed Material	Cobble
		Dominant Bedform	Riffle-Pool
Major Stressors:	Channel straightening, encroachment, lacking buffers, bank armoring, stormwater inputs

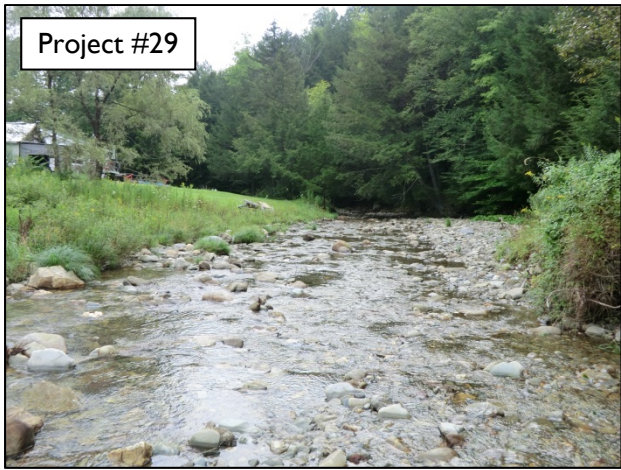
Project #29

29	7	Buffer planting in R16.S2.03-C	Plant native trees and shrubs along ~1000 feet of the western bank of the brook in the vicinity of 1789 & 1927 Jones Brook Road where buffer vegetation is lacking due to lawns.	River - Planting	5	R16.S2.03-C	44.246944	-72.657331	Site would benefit from establishment of a "no mow" zone at a minimum.	Moretown	Tributaries to Upper Mid-Winooski	Moderate	Winooski Natural Resources Conservation District, Friends of the Winooski River, Landowner(s)
30	8	Culvert replacement - Kelley Brook crossing on Jones Brook Road	Replace undersized culvert with properly sized structure.	Floodplain/Stream Restoration - Preliminary Design	6	R16.S2.02-S1.01-A	44.250609	-72.653232	Culvert appears to be in good condition structurally, but is significantly undersized.	Moretown	Tributaries to Upper Mid-Winooski	Low	Town of Moretown, Central Vermont Regional Planning Commission
31	8	Buffer planting in R16.S2.02-S1.01-A	Plant native trees and shrubs along ~600 feet of the western bank of the brook in the vicinity of 122 Ward Brook Road where buffer vegetation is lacking due to lawn.	River - Planting	5	R16.S2.02-S1.01-A	44.252741	-72.655145	Landowner indicated tentative interest in planting.	Moretown	Tributaries to Upper Mid-Winooski	Moderate	Winooski Natural Resources Conservation District, Friends of the Winooski River, Landowner(s)

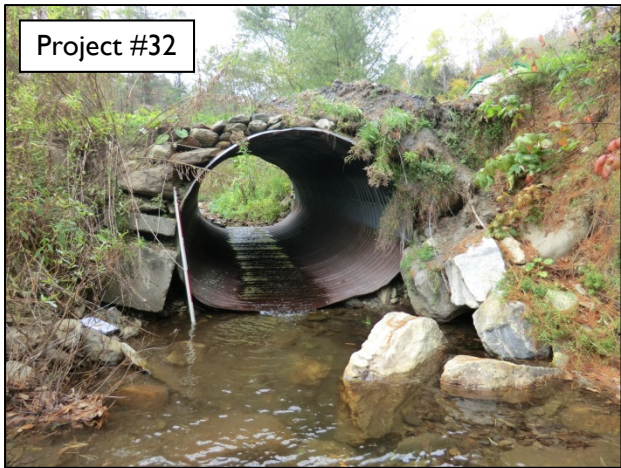
Project #32

32	8	Culvert replacement - driveway culvert in R16.S2.02-S1.01-A	Replace undersized culvert with properly sized structure.	Floodplain/Stream Restoration - Preliminary Design	6	R16.S2.02-S1.01-A	44.254147	-72.65779	Culvert is undersized and armoring around structure is failing.	Moretown	Tributaries to Upper Mid-Winooski	Moderate	Landowner(s), Central Vermont Regional Planning Commission
33	8	Buffer planting in R16.S2.02-S1.01-B	Plant native trees and shrubs along ~400 feet of the northern bank of the brook where buffer vegetation is lacking due to lawn/garden area.	River - Planting	5	R16.S2.02-S1.01-B	44.25825	-72.668052		Moretown	Tributaries to Upper Mid-Winooski	Low	Winooski Natural Resources Conservation District, Friends of the Winooski River, Landowner(s)
34	8	Culvert replacement - Ward Brook Road near 990 Ward Brook Road	Culvert is undersized, rusting, and an AOP issue.	Floodplain/Stream Restoration - Preliminary Design	6	R16.S2.02-S1.01-B	44.259042	-72.66896	Significantly undersized, major scour at outlet, free fall outlet.	Moretown	Tributaries to Upper Mid-Winooski	High	Town of Moretown, Central Vermont Regional Planning Commission
