Indian Brook Watershed Departure Analysis and Project Identification Summary

April 14, 2008

Fitzgerald Environmental Associates, LLC.

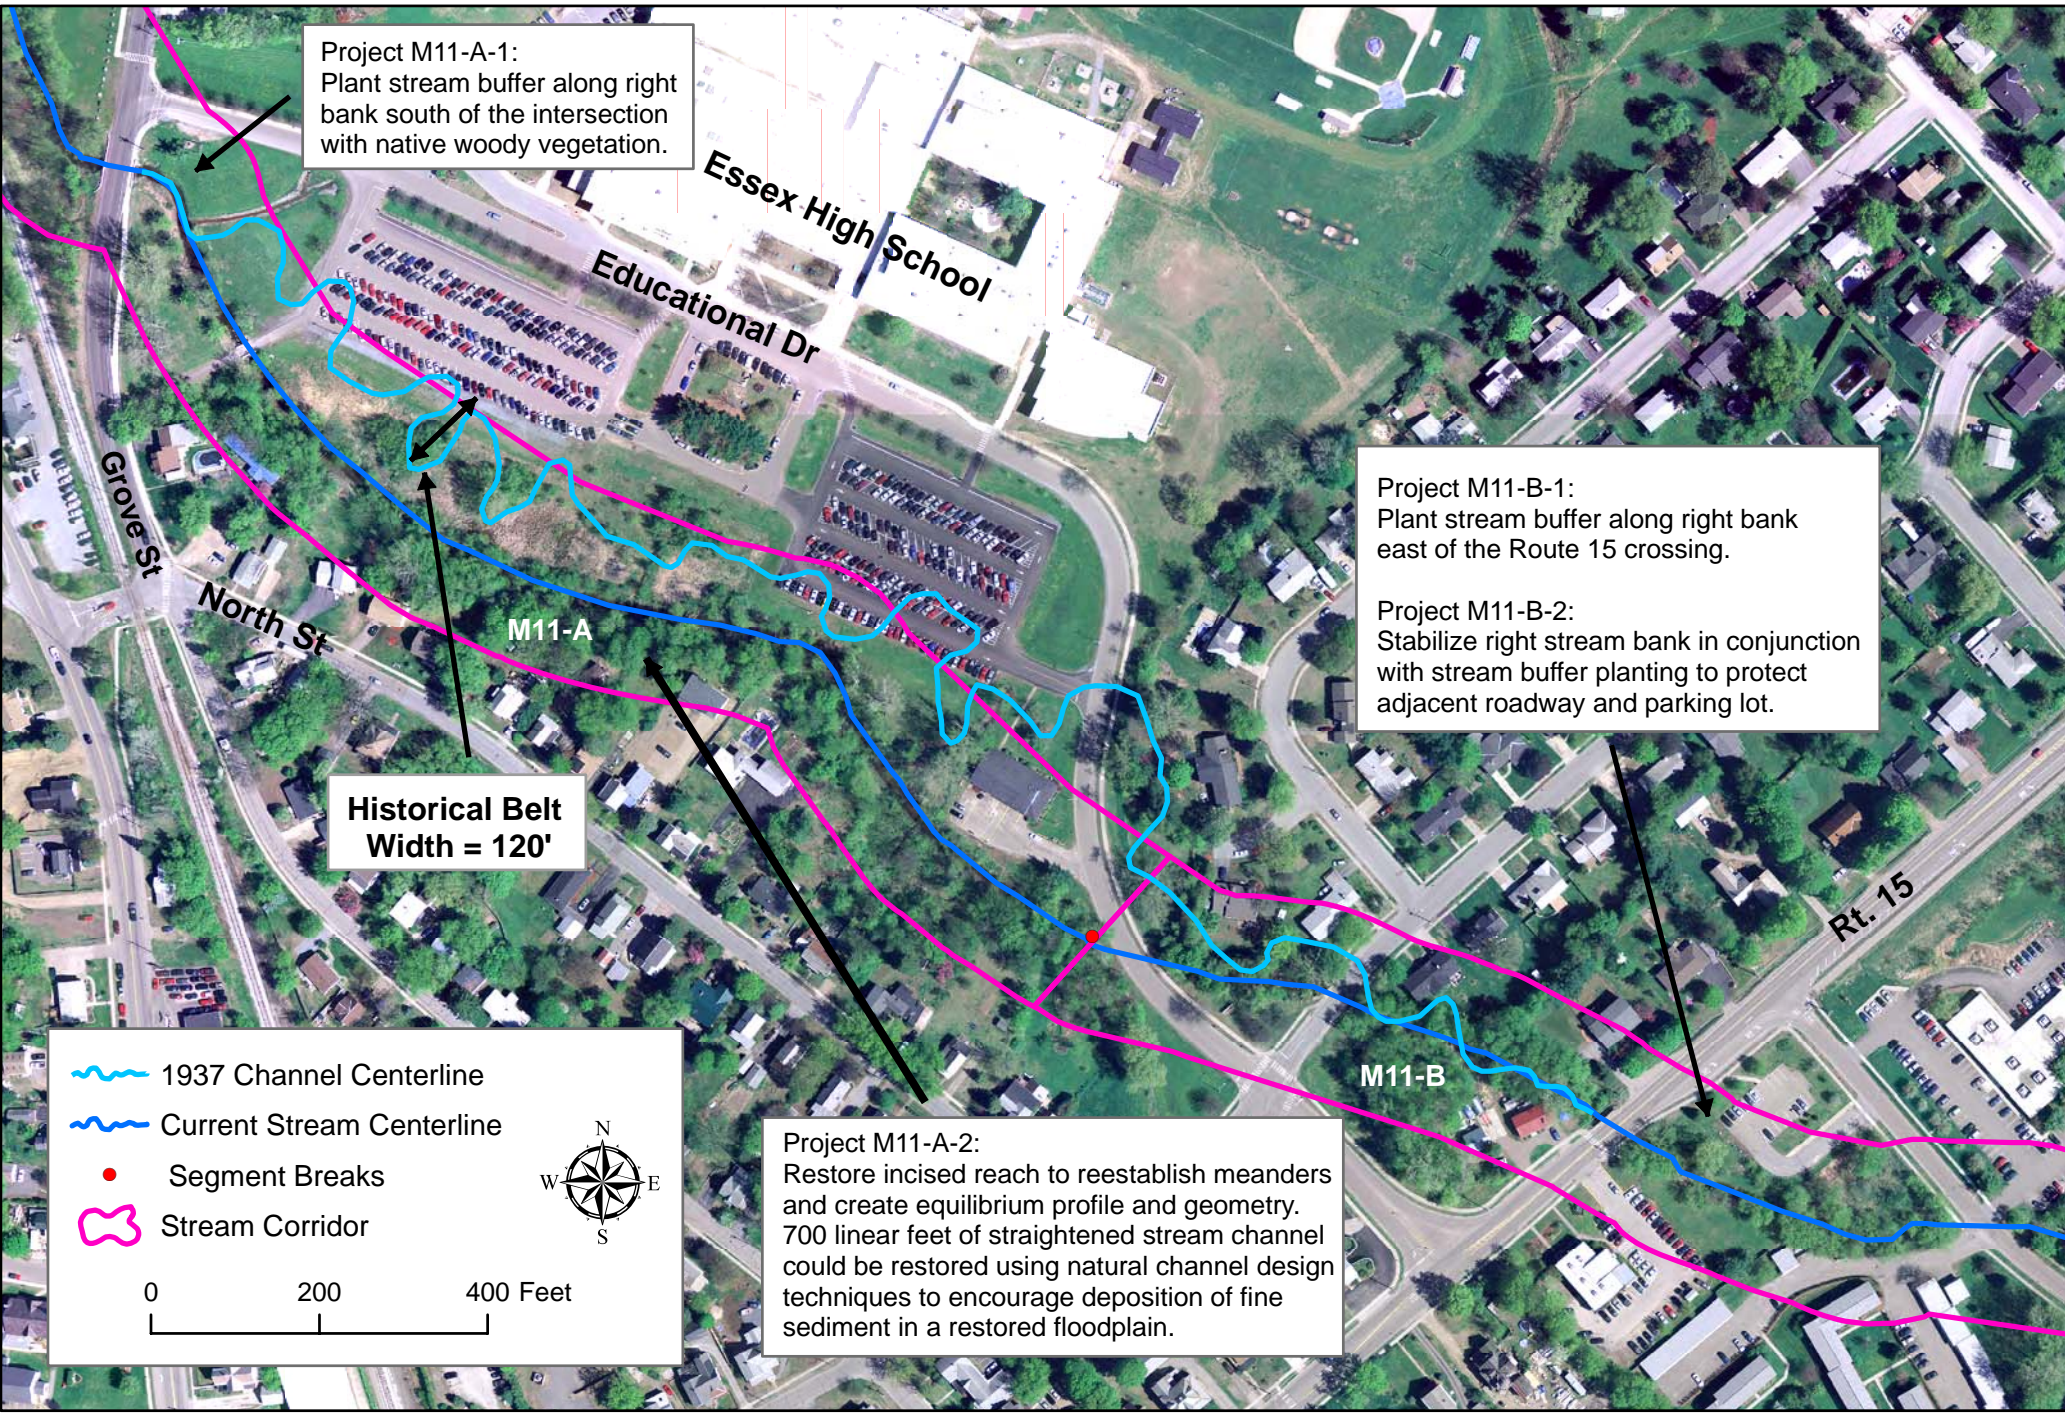
Figure 13
Project Locations for Segments M11-A & M11-B

M11-A-2, E, II, Fair/Poor	See above segment description. Greater than 75% of reach length has been historically straightened, leading to an incised channel with limited floodplain access. See Figure 13 for site and project details. Historical channel (1930's) was highly sinuous, and likely a sand-bottomed, E-type channel with wide floodplain and good floodplain access.	Restore incised reach (32) to reestablish meanders and create equilibrium profile and geometry along section adjacent to school. 700 linear feet of straightened stream channel south of Essex High School parking lots could be restored using natural channel design techniques to encourage	Segment is located downstream of transport segments (M11-B, M11-C, M12), making it a high priority floodplain restoration location. Feasibility depends on: 1) Town/School willingness to cooperate, and 2) compatibility with DEC approach to the mitigation of the overall hydrologic regime (i.e., TMDL permitting). Active restoration costs typically very high. Risk of short-term failure of restored reach	Attenuation of fine sediment will further protect WQ in Lake Champlain. Improved biotic habitat. Potential for educational program for post-restoration monitoring.	Town of Essex; VTDEC

M11-B-2, C, IV, Fair/Fair	See above segment description. Stream banks are unstable due to lack of woody vegetation for ~150' upstream of Route 15 crossing. Roadway and paved parking lot are within 50' of eroding banks.	Stabilize right stream bank (10) in conjunction with stream buffer planting (described above) to protect adjacent roadway and parking lot. See Figure 13 for site details.	This area of reach is less incised than lower section (stage IV CEM), and has encroachment along both banks. High priority project to protect narrow strip of adjacent land that could be established as a buffer in the future.	Protection of Route 15 roadway and parking lot from ongoing bank erosion.	Town of Essex; VTDEC
M11-C-1, C, IV, Good/Good	Segment less affected by historical straightening than downstream segments. Channel is readjusting to equilibrium profile (no incision), with plane bed features and good floodplain connectivity. Small section of	High priority stream corridor protection (3). Only small area of segment corridor is developed, with potential to protect entire corridor in upper segment	Due to high degree of urbanization in the area, with limited opportunities for corridor protection (and high development pressure), this segment has a high priority for corridor protection. 3 parcels occupy corridor, with 2 parcels appearing to have common	Attenuation of fine sediment will further protect WQ in Lake Champlain. Recreational opportunities for surrounding	Town of Essex; VLT; Adjacent Home-owners Assoc.

3. M11-A-1: Plant stream buffer along right bank south of the intersection with Grove St. and Educational Drive. See Figure 13 for a site map of the project area (high priority).

5. M11-B-1: Plant stream buffer along right bank east of the Route 15 crossing. See Figure 13 for a site map of the project area (high priority).
6. M11-B-2: Stabilize right stream bank in conjunction with stream buffer planting (project M11-B-1, see below) to protect adjacent roadway and parking lot. See Figure 13 for a site map of the project area (high priority).
