**Phase 2 Stream Geomorphic Assessment
Rock River Watershed
Highgate and Franklin, Franklin County, Vermont
December 2006 (Revised January 2007)**

South Mountain Research & Consulting
2852 South 116 Road
Bristol, VT 05443

Town of Highgate
2996 VT Rte 78, PO Box 67
Highgate Center, VT 05459

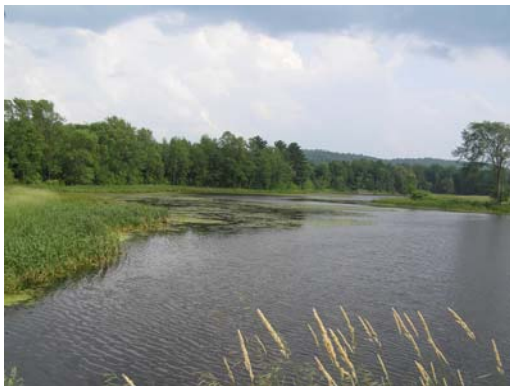
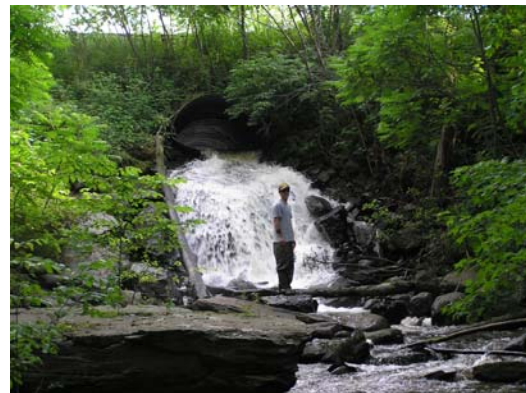
Floods in January of 1996 reportedly exposed the original mill dam under the Browns Corner Road. The present culvert was installed in 1997 to replace a culvert blown out during flooding. The elevation of the culvert was reportedly lowered during this most recent replacement, leading to a reduced elevation of the water surface in Bullis Pond (Fiske, 2006; Kempton, 2006).

Figure 14. M08. (a) Bullis Pond upstream of Browns Corner Road. (b) Rock River flows through a squash-bottom culvert under Browns Corner Road; water free falls, dropping approximately 8 feet to a cobble-dominated riffle-pool channel.

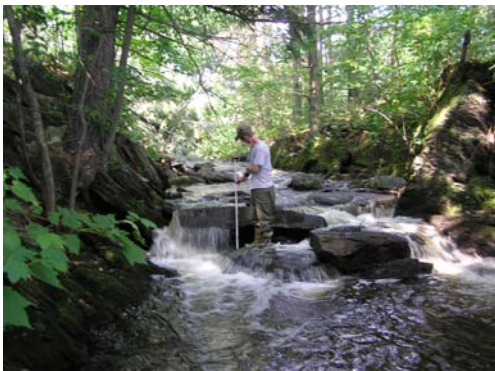
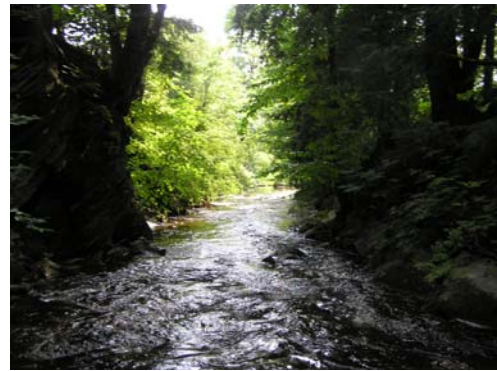
Figure 15. Boulder step/pool channel location at the mid-point of Segment M07-B. 29 June 2006. (a) view upstream to waterfall (b) view downstream.

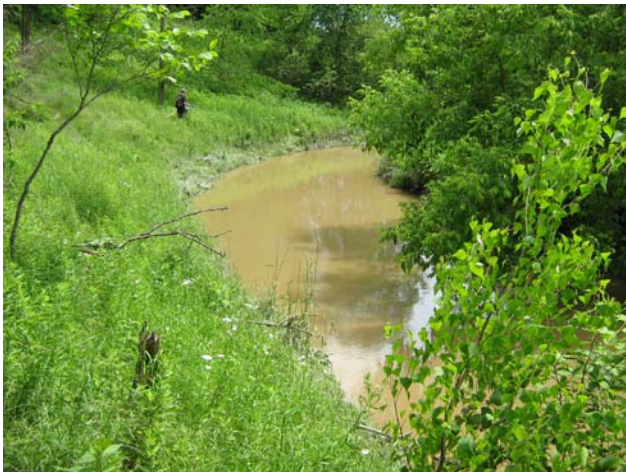
Figure 19. Reach M05 flows through a narrow to semi-confined valley.

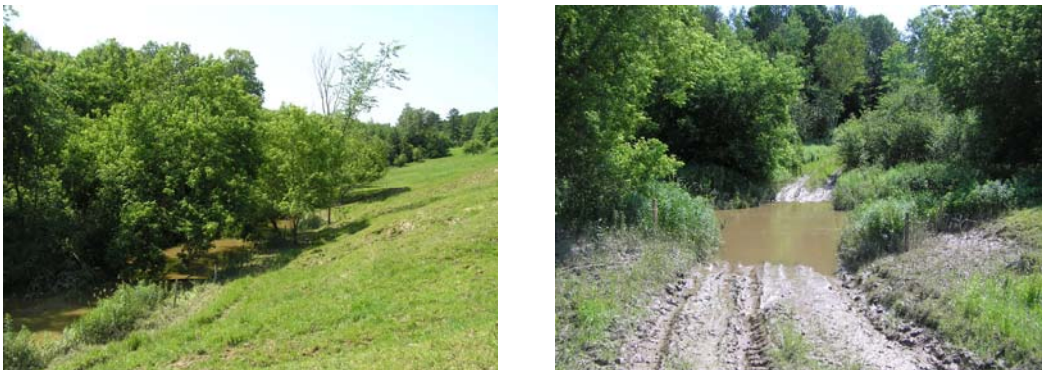
The RB corridor is mostly forested, with occasional crop fields; buffer widths are greater than 100 feet. The LB corridor is occasionally forested, but predominantly active dairy pasture (Figure 21a). Buffer widths are often 5 to 25 feet in width, but sometimes absent. High streambank erosion is evident at these gaps in the woody buffer along LB. Several sections of pasture fencing were observed leaning into (or collapsed into) the river channel from the left top of bank.

Figure 21. Reach M04. (a) View upstream (to south) from LB pasture accessed along Rollo Road. (b) equipment ford leading from LB pasture. 3 July 2006.

Other than pasture along the LB, encroachments along reach M04 are relatively minor. Old laid-up stone abutments are present near the upstream end of the reach, coincident with a historic road crossing indicated on the 1987 USGS 7.5-minute topographic map. Further downstream, there are two equipment fords which permit access to agricultural fields to the east of the river. One is located mid-pasture (Figure 21b); the second is located further downstream north of the adjacent Rollo Road farmstead. The relatively coarser sediments comprising the second equipment ford form a local nick point with a control height of approximately 2 feet. A large lateral and vertical scour pool has developed downstream of this ford. Based on comparison of 1995 photographs to 2006 GPS points, this ford appears to have been in the same location for at least the previous 10 years.

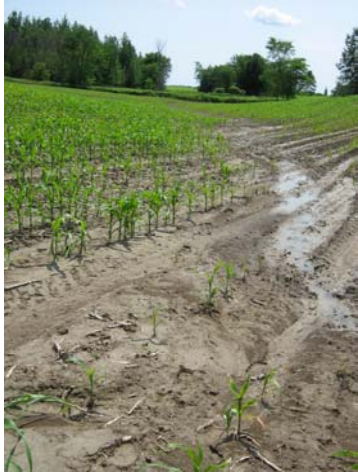
M6S1.01 just upstream of its confluence with the Rock River. Reach M6S1.1S1.01 was segmented to separate the upstream third of the channel, exhibiting intermittent flows (Segment B), from the remainder of the channel (Segment A) (see Figure 23).

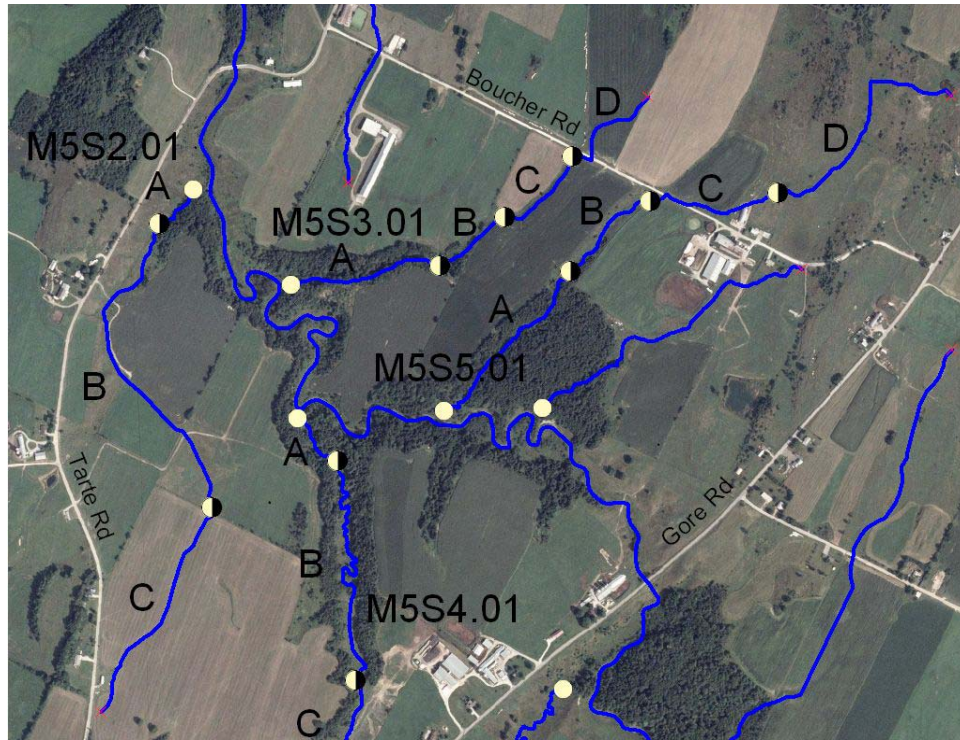
Figure 29. Location of assessed tributaries to M05, Rock River, Highgate, Vermont.

Several small tributaries drain directly to reach M05 of the main stem between the Cassidy Road crossing and the Tarte Road crossing in the town of Highgate. Four of these unnamed tributaries were assessed. Each of them originates in cultivated fields or pasture up on the broad plains and eventually cut through several tens of feet of sediments to meet the Rock River down in its forested valley (see Section 2.2, Figure 4). The four tributaries have drainage areas ranging from 0.2 to 1.0 square mile.

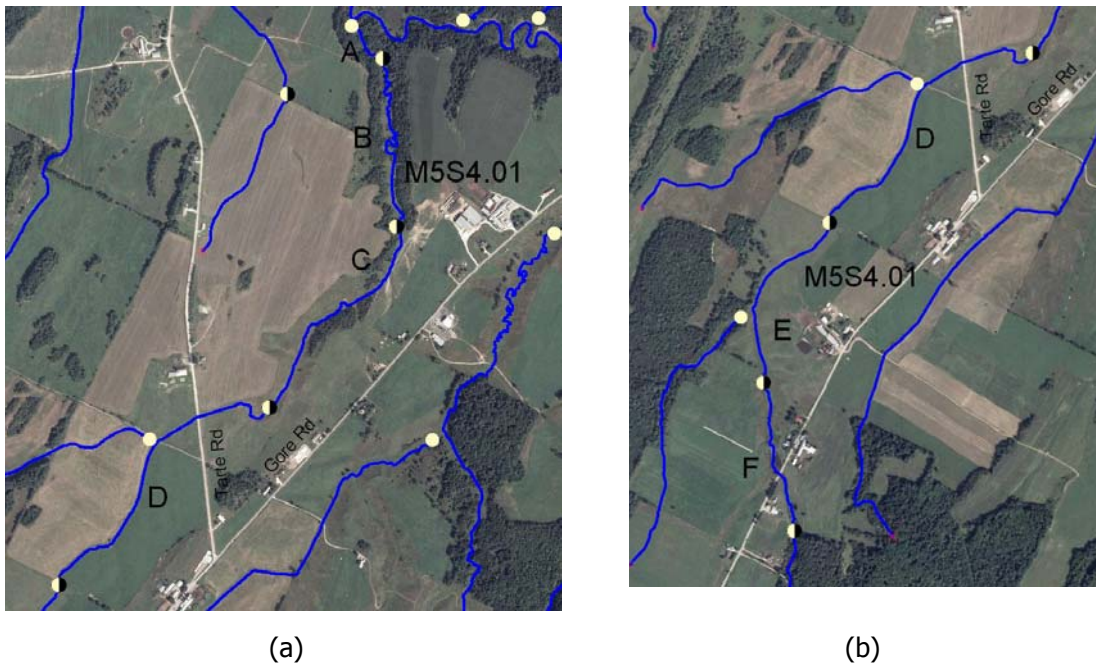
Figure 30. Segment delineation in tributary reach M5S4.01, Rock River, Highgate, Vermont.

This 2.7-mile reach flows to the north from the vicinity of Highgate Springs, along Gore Road and Tarte Road to join the Rock River approximately 4,100 feet upstream of the Tarte Road crossing. This tributary drains residential and agricultural lands in a 1.0-square mile watershed. Reach M5S4.01 was segmented to distinguish a section of intermittent flow (G), a section of wetlands (F), two sections exhibiting stream type departure (E and D), and a subreach of alternate stream type (A), from two sections of Ec reference stream type (C, B) with differing land uses. Segment delineations are illustrated in Figures 30a (downstream) and 30b (upstream).

Segment M5S4.01-G is a section of intermittent flow at the upstream, forested extent of the reach - approximately 2,395 feet in length (not pictured in Figure 30b). A Rapid Geomorphic Assessment was not completed in this segment, given its ephemeral nature.

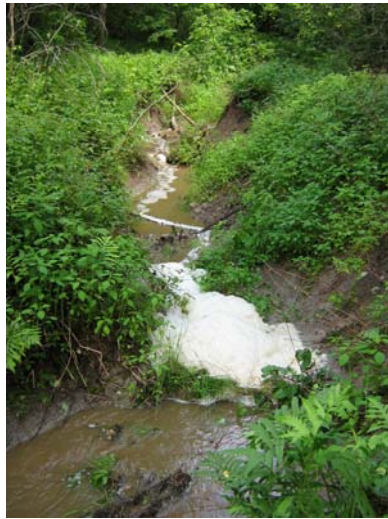
(a)

There is no apparent evidence of direct channel management (e.g., dredging, channelization) within Segment M5S3.01-A. However, indirect sources of hydrologic stressors were noted. First, the undersized instream culvert crossing at the upstream end of the segment is a significant constrictor of flows, and has contributed to channel scouring. Second, gullies were noted along the left and right valley walls of the segment near the top of the forested valley side slopes. Agricultural tiles drain the adjacent fields and terminate at the tops of the side slopes. Installation of drainage tiles in adjacent fields has improved field drainage, but as a consequence, delivers groundwater and surface water runoff to the tributary valley in greater volumes over shorter time periods. These effects have likely increased the peak and magnitude of flows in the tributary during storm events. Flows velocities may now exceed thresholds for erosion of the channel bed and bank materials with greater frequency, contributing to channel incision and widening. No energy dissipation mechanisms are in place at tile outlets. In at least three cases, gullies have developed at the tile outlets, resulting in sediment erosion down the side slopes into the tributary valley below (Figure 37). These gully locations are local points of lower elevation, and saturation excess overland flow (surface runoff) was observed draining to these gully locations on the date of assessment (20 June 2006).

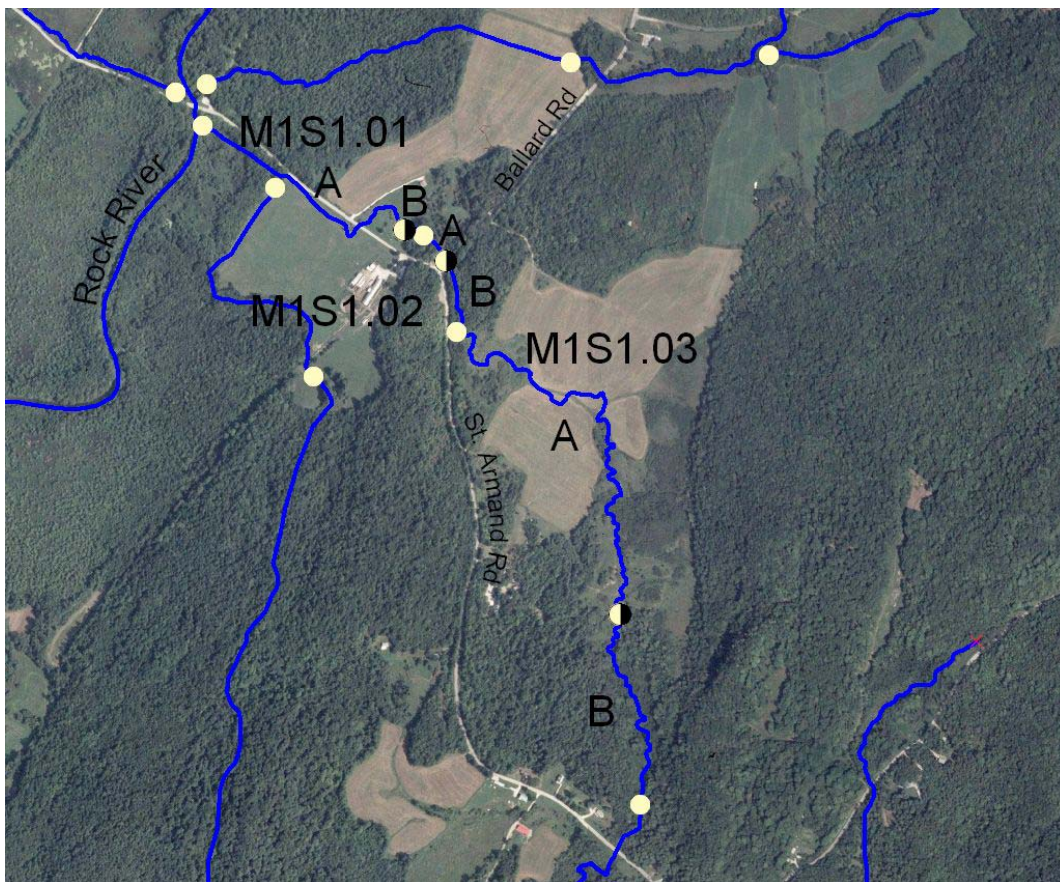
Figure 41. Location of Saxe Brook reaches / segments assessed in 2006, Rock River, Highgate, Vermont..

The Saxe Brook tributary drains a 2.9-square mile area in the northwest portion of the watershed. This tributary joins the Rock River main stem (reach M01) immediately downstream of the St. Armand Road crossing of the Rock River near the Wildlife Management Area access (Figure 41). Three reaches comprising the downstream 1.5 miles of this tributary were assessed in 2006.

Phase 2 assessments revealed greater variation in channel profile along this lower portion of the Saxe Brook than was apparent at the remote-sensing scale of Phase 1 assessments. The lower two reaches were each segmented to capture the change in gradient (and reference stream type) along the profile of this tributary. The uppermost assessed reach (M1S1.03) was also segmented to capture changes in channel management and land use.

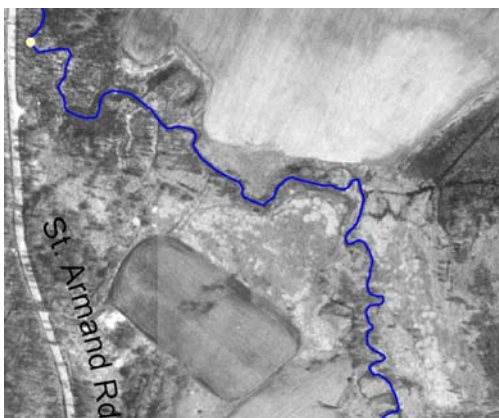
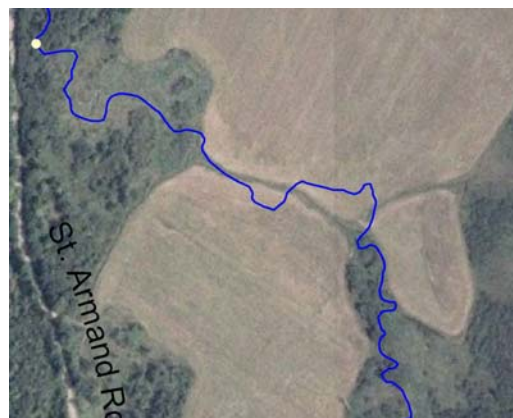
In the downstream half of the segment, channelization of the Saxe Brook appears more recent. Based on a comparison of historic air photos, the Saxe Brook was channelized between 1995 and 2003 to facilitate cropping on either side of the channel. More than 800 feet of sinuous planform has been reduced to approximately 600 feet of straightened channel. Shrub and tree buffers are nearly absent. Near bank areas are covered by grasses of moderate height, where recent dredging activities have not stripped the vegetation. A freshly tilled crop field was noted along the left bank, while fields along the right bank were in hay on the observation date (6 June 2006). At least five drainage tiles lead from the LB corn field and terminate in the Saxe Brook; one tile was observed leading from the hay field along the RB.

Figure 43. Saxe Brook segment M1S1.03-A. Channelization of Saxe Brook has occurred between 1995 and 2003 based on review of aerial photographs. (a) 1995 digital orthophotographs – Vermont Mapping Program (b) 2003 aerial imagery [NAIP, 2003]).

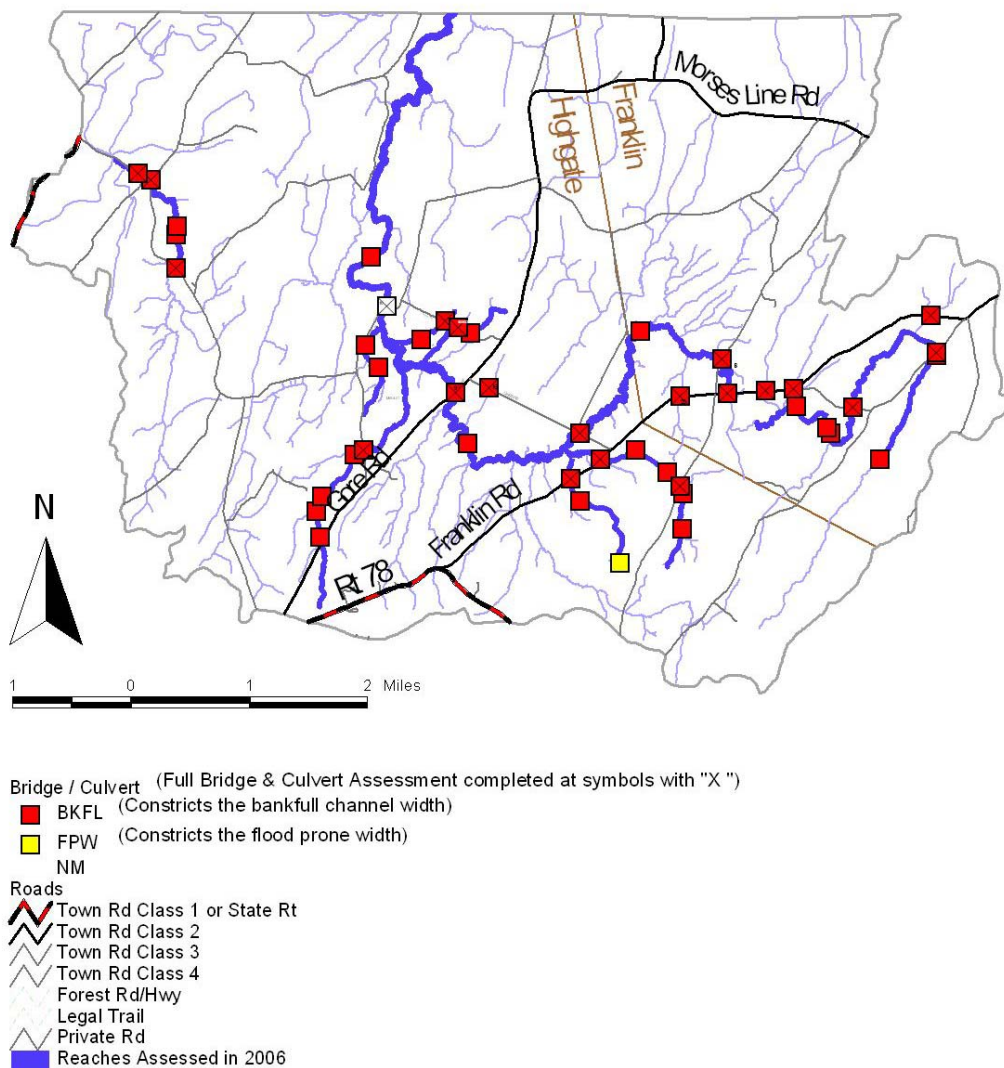
Figure 45. Constriction Status of Bridge and Culvert Crossings Encountered during Phase 2 Stream Geomorphic Assessments, Rock River watershed, 2006.

A database summary report for each of the 22 bridge and culvert crossings assessed following Appendix G of the VTANR protocols is contained in Attachment D to this report. The constriction status of assessed crossing structures, including the additional 23 minor structures encountered, is depicted graphically in Figure 45. All but two of the 45 structures encountered had spans which were undersized with respect to the width of the bankfull stage (and therefore were also constricting of the flood prone width). Only the Tarte Road bridge crossing of the main stem, which is elevated well above the bedrock channel, was found not to be constricting to the channel. Span data for each of the structures assessed (41 culverts and 4 bridges) can be reviewed in the Data Management System (Phase 2 Step 4.8).

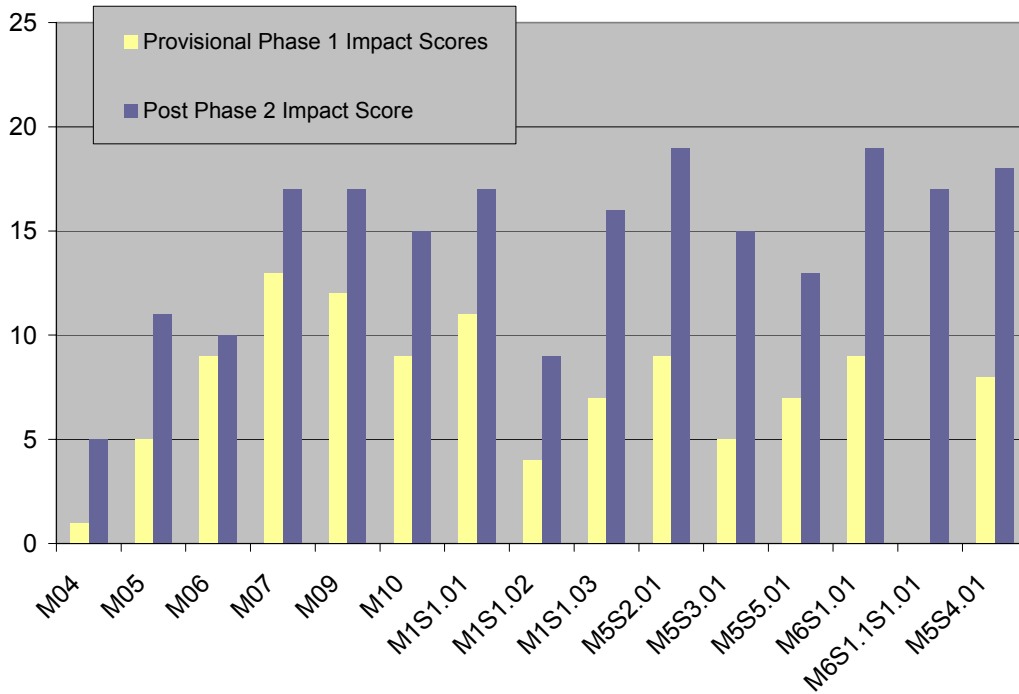
Figure 46. Comparison of Phase 1 Impact Scores before and after updating with field-based Phase 2 Data.

Figure 46 summarizes how the total impact rating for each of the Phase 2 assessed reaches changed; in each case, the total impacts increased. Note that tributary reach M6S1.1S1.01 was not selected for complete evaluation in Phase 1 (including Steps 4 through 7 which enable calculation of the impact score); therefore, an original Phase 1 impact score for this reach is not available for comparison to the post-Phase-2 impact score.

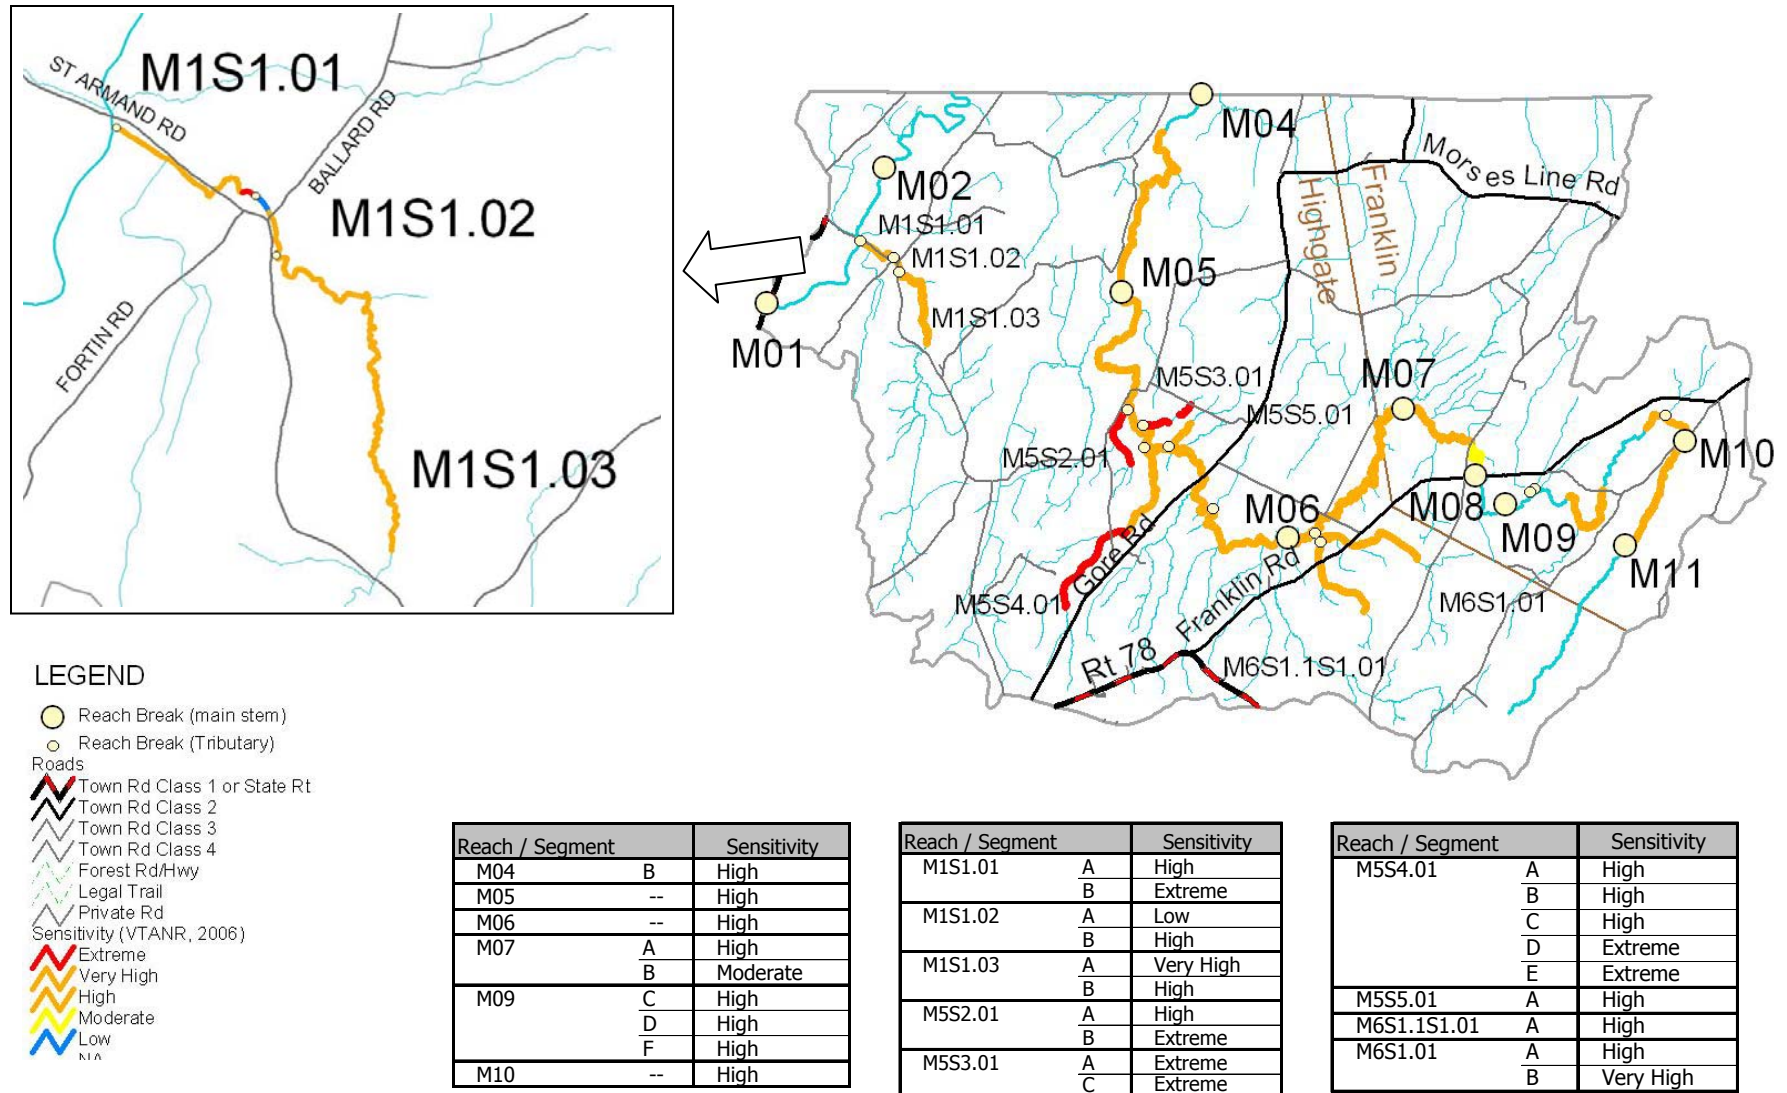
Figure 47. Reach / Segment Sensitivity, Rock River Watershed, 2006 Stream Geomorphic Assessments.

Sensitivities of the study area reaches/segments as defined in VTANR protocols (2006) are presented in Figure 47. For the most part, this Phase 2 purposely targeted lower-gradient, (reference C or E-stream-type) reaches that would be expected to exhibit higher sensitivity, and which have current constraints within the river corridor (and elevated impact ratings in the Phase 1; NWRPC/SMRC, 2006). Therefore, it is not unexpected that most of the study area reaches were defined as having sensitivities at the high end of the scale. Exceptions to this generalization were:

A sixth segment, located on Saxe Brook downstream of the Ballard Road crossing and upstream of the St. Armand Road crossing, was conservatively assigned an Extreme sensitivity, although assessments did not reveal either a Poor condition or Stream Type Departure (see Figure 47). M1S1.01-B is a short, alluvial fan segment, exhibiting lateral adjustments, aggradation and widening. These processes in this setting of substantial slope reduction are natural, and not the result of any apparent human stressor(s). Thus the condition rating was noted as Good, with no apparent departure from reference condition. However, sensitivity of this segment to future adjustments is considered Extreme given the alluvial fan setting.
