**Phase 2 Stream Geomorphic Assessment
Rock River Watershed
Highgate and Franklin, Franklin County, Vermont
December 2006 (Revised January 2007)**

Prepared by

South Mountain Research & Consulting
2852 South 116 Road
Bristol, VT 05443

Town of Highgate
2996 VT Rte 78, PO Box 67
Highgate Center, VT 05459

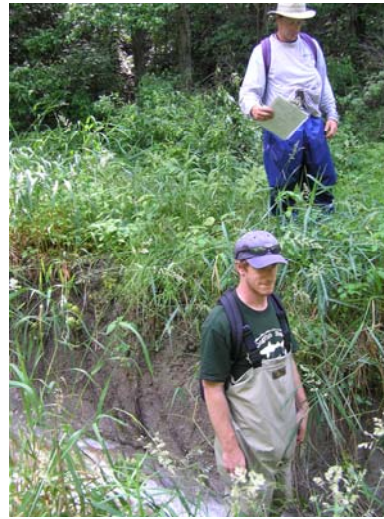
Segment M5S3.01-A begins immediately downstream of the farm road culvert crossing and extends 1,169 feet downstream to the confluence with Rock River. The majority of Segment A is actively incising and widening into cohesive silts and clays (Figure 36). Several nick points in the cohesive bed materials were noted, and the relief of the current bed elevation compared to the recently abandoned floodplain suggests an incision ratio over 4. This segment is located in a forested, narrow valley approximately ¼ mile upstream from the Rock River main stem.

There is no apparent evidence of direct channel management (e.g., dredging, channelization) within Segment M5S3.01-A. However, indirect sources of hydrologic stressors were noted. First, the undersized instream culvert crossing at the upstream end of the segment is a significant constrictor of flows, and has contributed to channel scouring. Second, gullies were noted along the left and right valley walls of the segment near the top of the forested valley side slopes. Agricultural tiles drain the adjacent fields and terminate at the tops of the side slopes. Installation of drainage tiles in adjacent fields has improved field drainage, but as a consequence, delivers groundwater and surface water runoff to the tributary valley in greater volumes over shorter time periods. These effects have likely increased the peak and magnitude of flows in the tributary during storm events. Flows velocities may now exceed thresholds for erosion of the channel bed and bank materials with greater frequency, contributing to channel incision and widening. No energy dissipation mechanisms are in place at tile outlets. In at least three cases, gullies have developed at the tile outlets, resulting in sediment erosion down the side slopes into the tributary valley below (Figure 37). These gully locations are local points of lower elevation, and saturation excess overland flow (surface runoff) was observed draining to these gully locations on the date of assessment (20 June 2006).

Figure 36. M5S3.01-A. Segment is actively incising, and widening to expose bare clay and silt soils in the channel bed and near bank areas.
