**Rock River Watershed  
Stream Geomorphic Assessment  
Phase 2 Report  
May, 2007**

**Prepared by:**

**Landslide Natural Resource Planning**  
P O Box 311  
East Middlebury, VT 05740

Windham County Natural Resources Conservation District  
28 Vernon Street  
Brattleboro, VT 05301

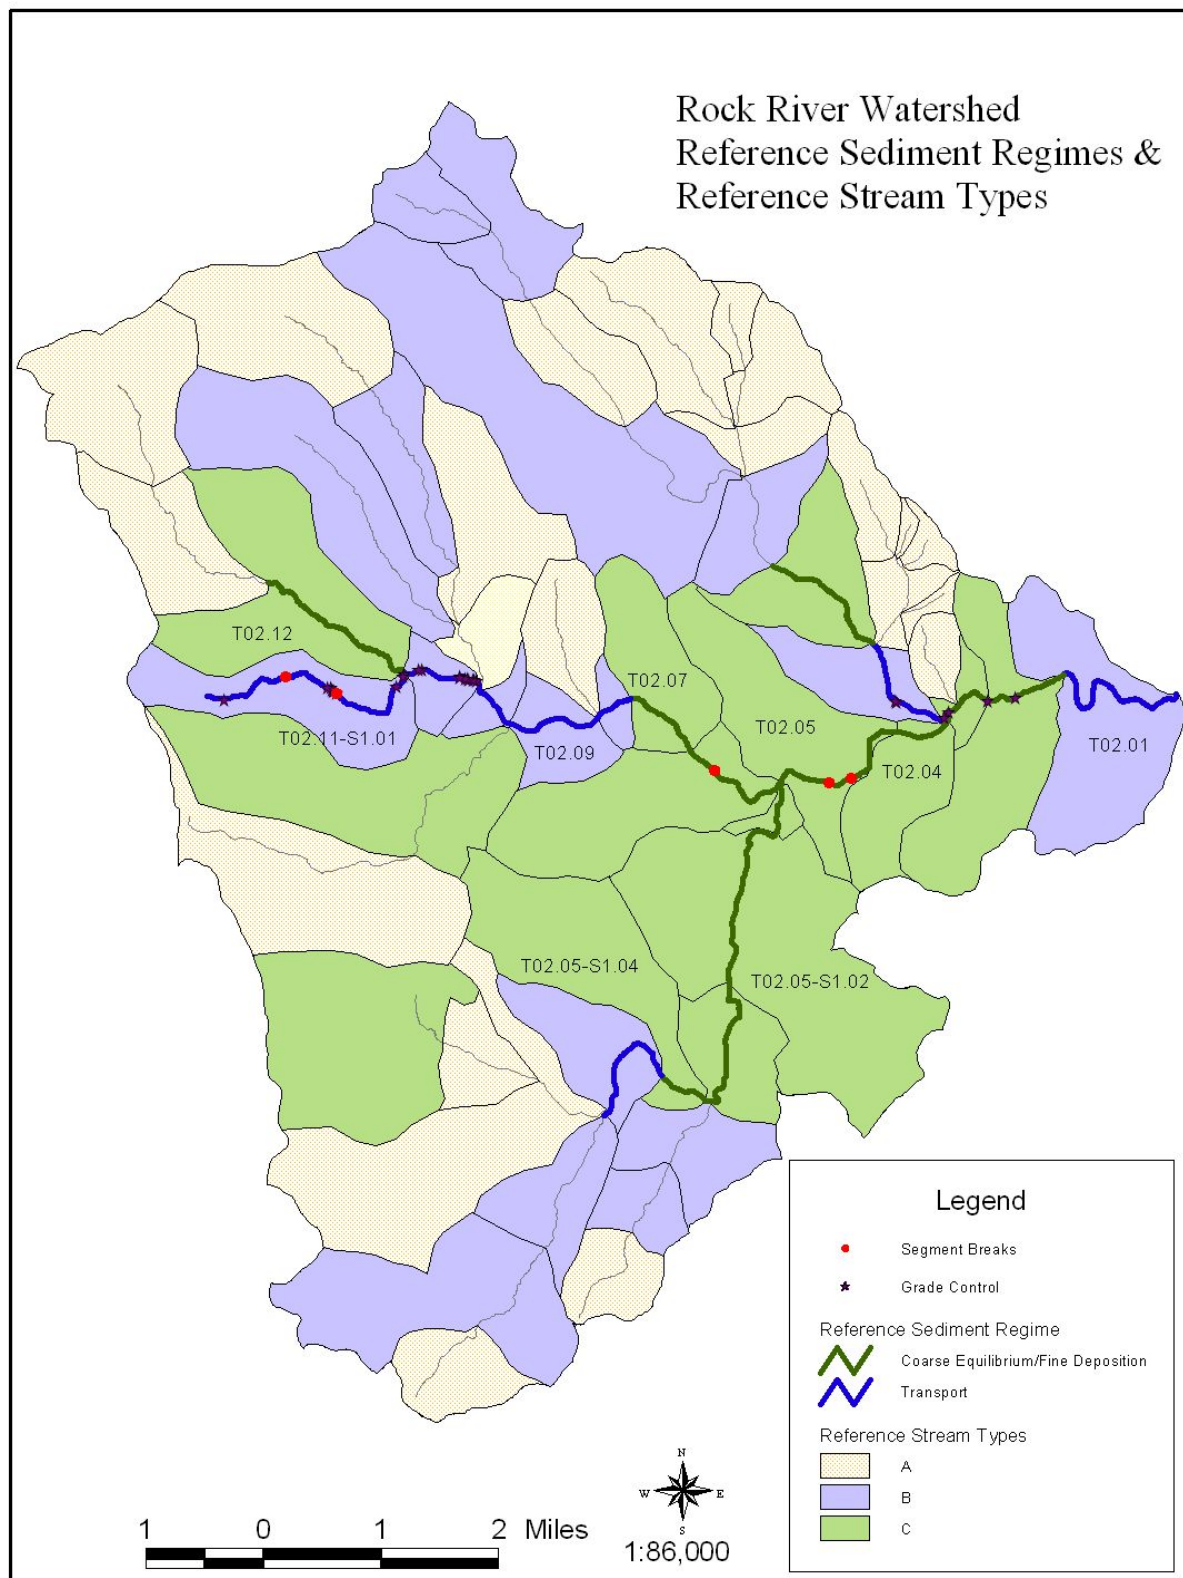
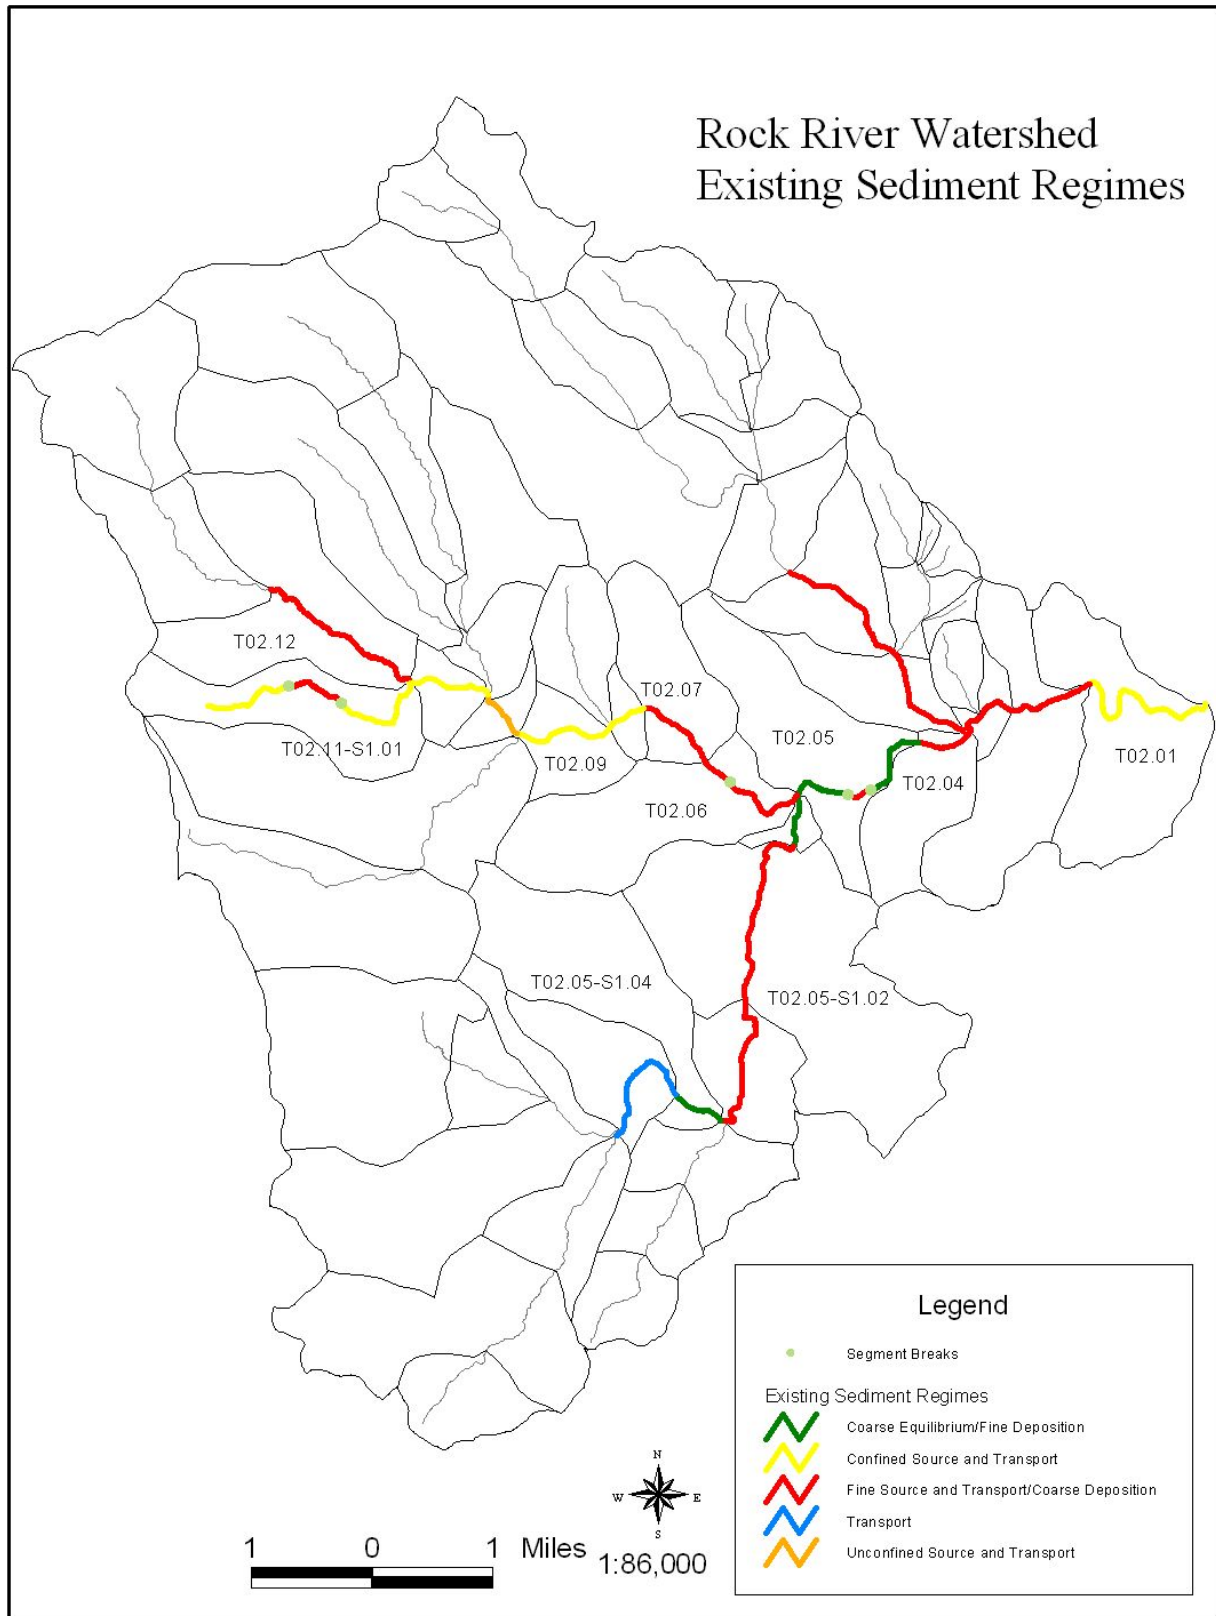
Streams that have been converted from Coarse Equilibrium/Fine Deposition to transport reduce sediment and flood attenuation capacity on that reach as well as watershed wide. This increases flood and erosion hazards downstream. Of the 25 segments assessed, 11 are transport (B type) streams by reference. There are 9 segments that have been converted to transport. Three of these converted streams have the potential to be restored to Coarse Equilibrium/Fine Deposition type streams. The following two maps represent reference and current sediment regimes in the Rock River Watershed.

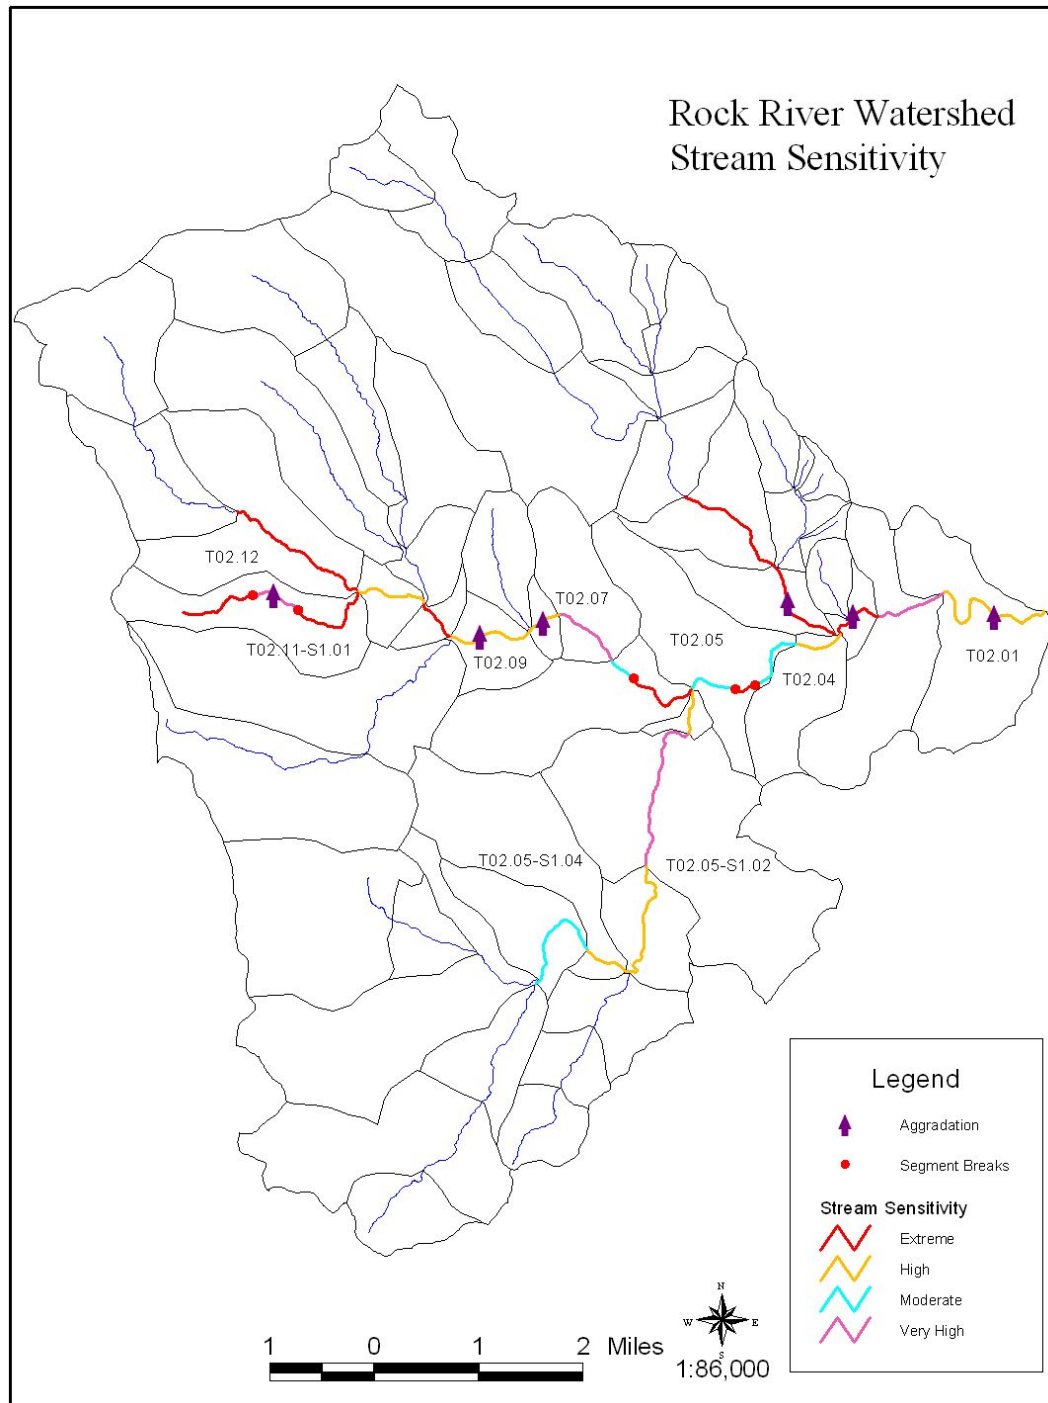
### 6.1.7 Sensitivity Analysis

The Vermont DEC River management Section has developed a five level sensitivity rating for streams based on current stream type and geomorphic condition. The rating scale is low, moderate, high, very high, and extreme. Sensitivity ratings are based on how rapidly a given stream type is expected to adjust (move laterally or horizontally) given its current geomorphic condition. The following map represents sensitivity ratings throughout the watershed.

Sensitivity ratings assist in restoration project selection by identifying areas where rapid channel planform adjustment may occur in the presence of valuable human-built infrastructure. The following table prioritizes reaches for restoration based on sensitivity, current adjustment and potential threats to infrastructure. The results were incorporated into project identification tables in the next section.
