TYLER BRANCH WATERSHED

PHASE 2 STREAM GEOMORPHIC ASSESSMENT

June 2, 2009

Prepared by:
Daniel Ruddell, Elisabeth McLane,
Staff Scientists, and
Ben Machin, Principal
Redstart Consulting

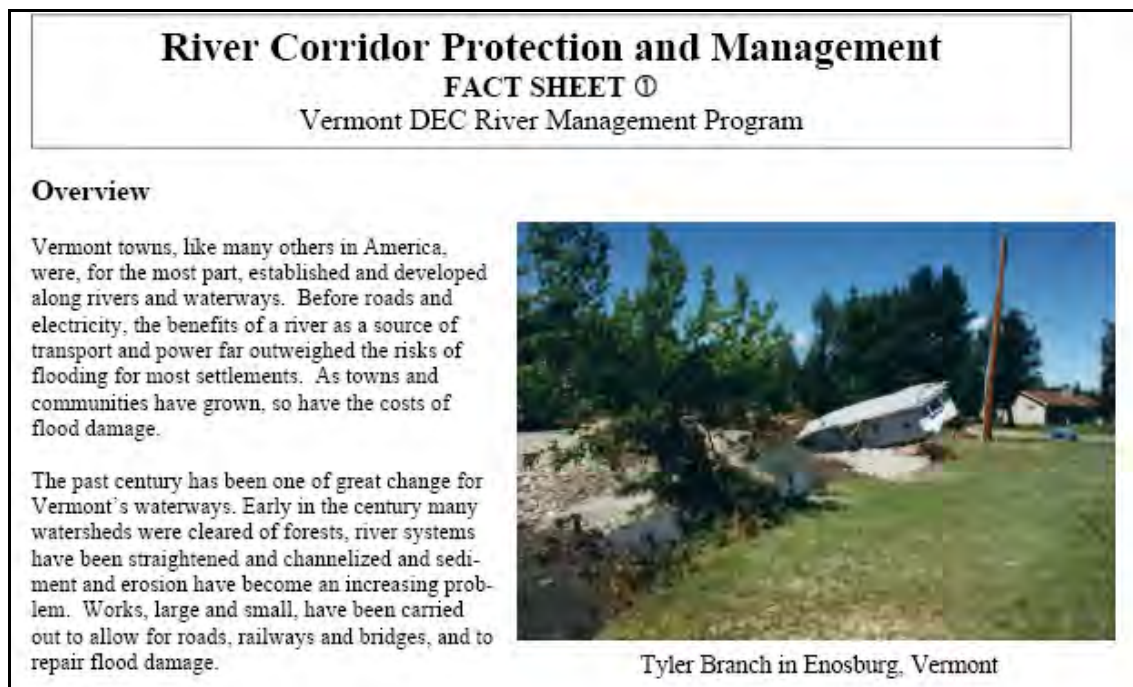
Figure 1. Excerpt from a VT River Management Program fact sheet features a location in the Tyler Branch watershed illustrating the type of catastrophic changes that can occur during flooding on an out-of-balance stream.

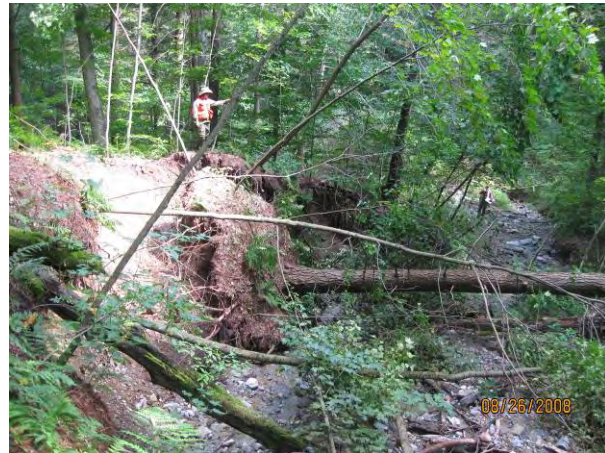
Figure 5. This classic gully, ~200 feet in length, opened in unconsolidated geologic materials along a valley wall of reach M14 on the Tyler Branch during an intense storm in a very wet summer 2008.

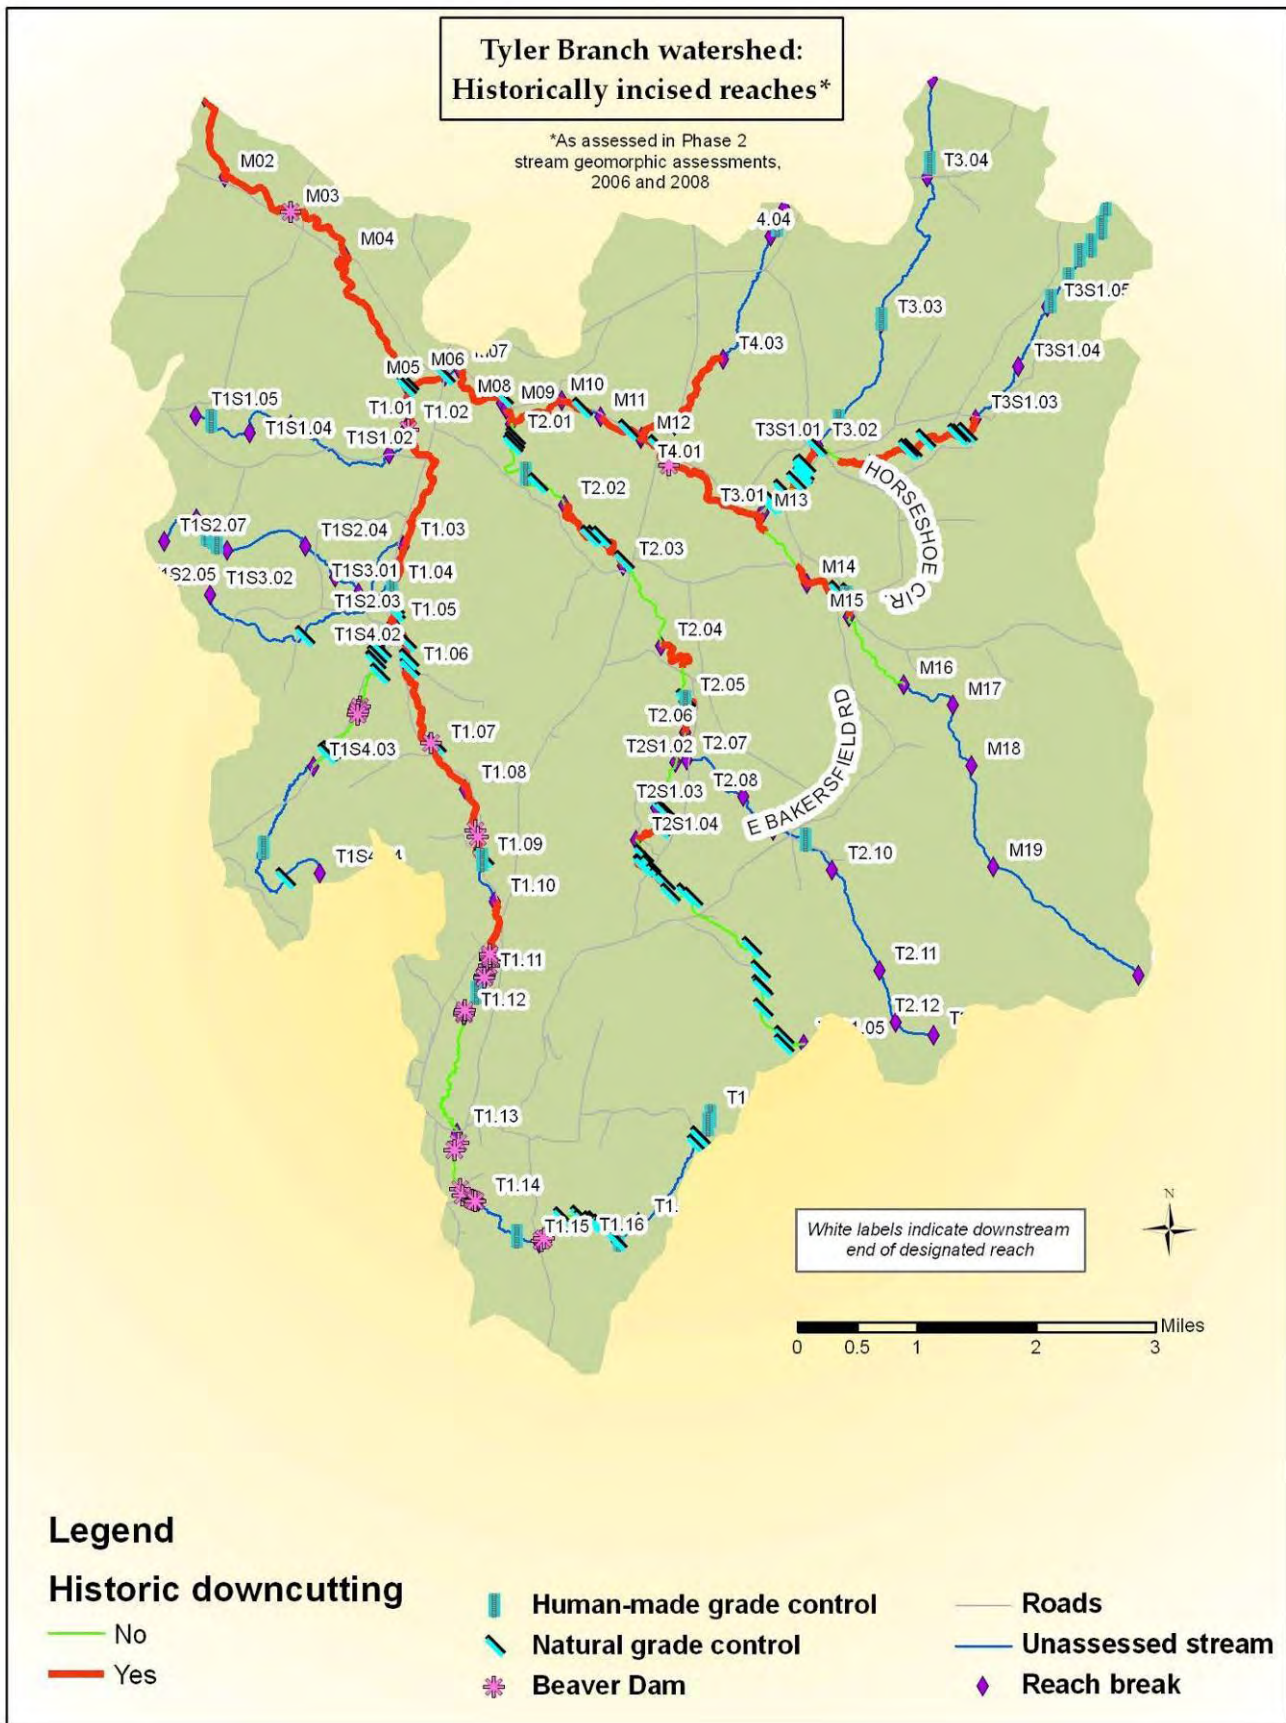
Figure 13. Phase 2 assessments in 2006 and 2008 indicated historical downcutting (incision) in numerous downstream reaches of the Tyler Branch watershed.

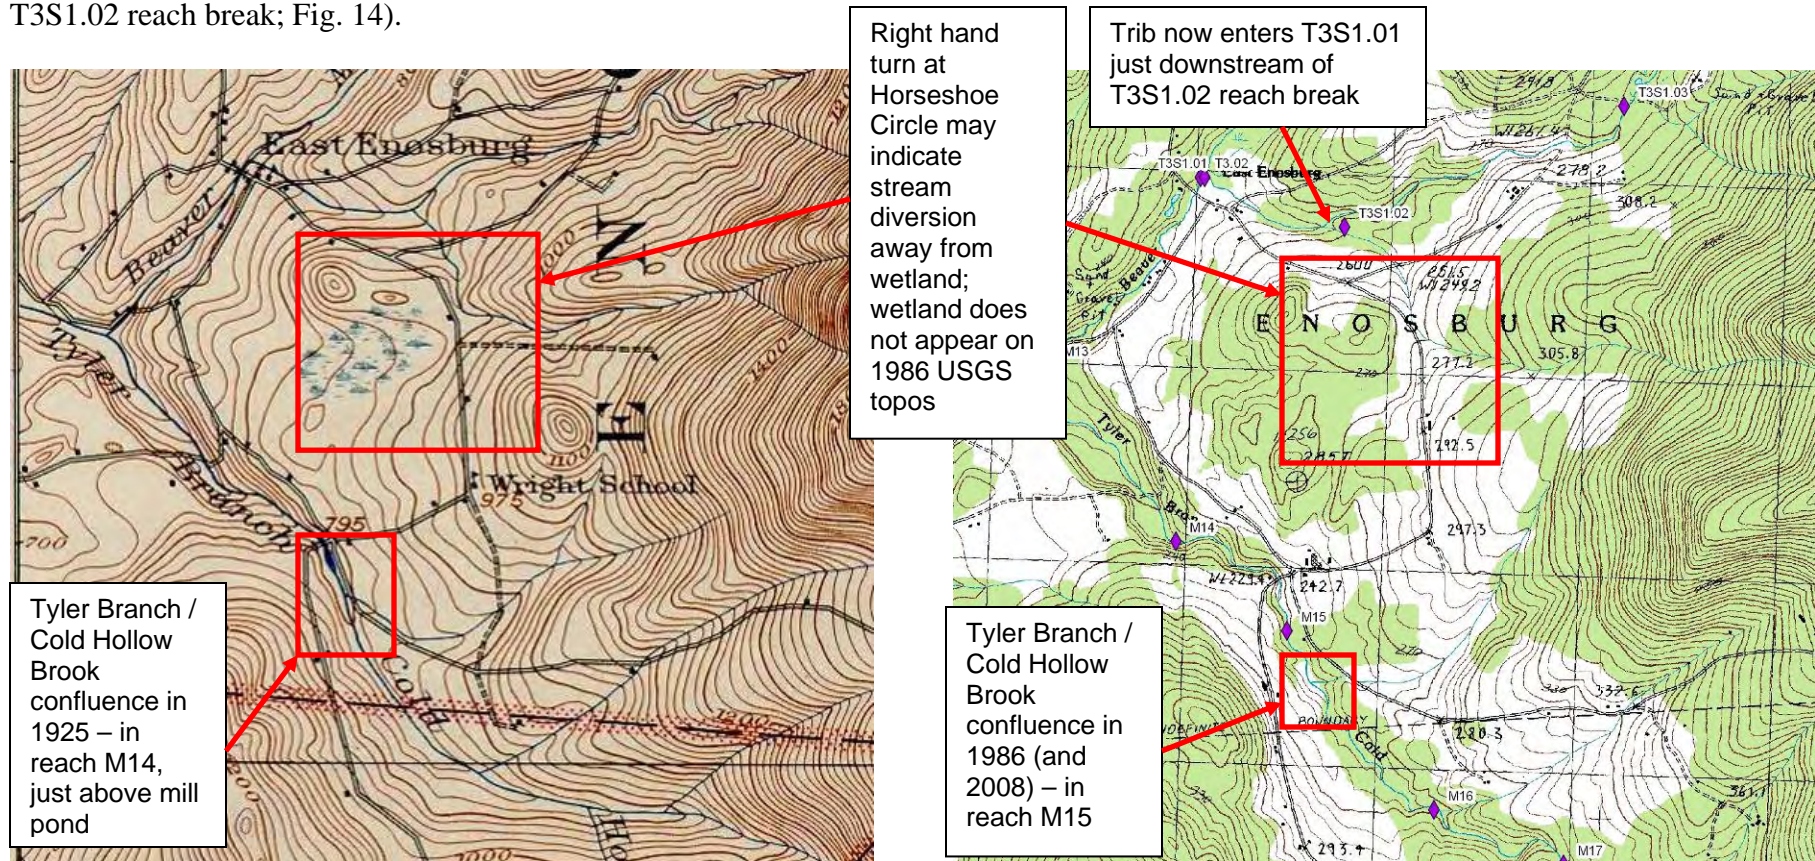
In 1925, the confluence of the Tyler Branch mainstem and Cold Hollow Brook was indicated a short distance upstream of an old mill pond at the East Bakersfield Rd. bridge, west of the Wright School, in what was assessed in 2008 as reach M14 (Fig. 14, smaller red rectangles). This confluence is indicated in the same place on a 1953 topographic map, but in 2008 was field-located in reach M15 (where it also appears on 1986 USGS topographic maps, Fig. 14; see also the more recent aerial photography in Fig. 32). This diversion would have meant that water did not flow through the area of an alluvial fan in reach M15.

The larger red rectangle indicates a significant wetland in a saddle between two hills just downstream of a tributary that eventually flows into Beaver Meadow Brook at East Enosburgh. The topography at the right hand turn of this stream when it reaches Horseshoe Circle, midway between East Enosburgh and the Wright School, and the fact that the wetland does not appear on 1986 USGS topographic maps (though it does appear on Vermont Significant Wetland Inventory maps), indicate possible diversion of the stream at this point. Fieldwork during 2008 indicated that this stream has cut down significantly through the erodible sideslopes approaching the tributary of Beaver Meadow Brook that it now flows into (reach T3S1.01 near the T3S1.02 reach break; Fig. 14).

Figure 14. Topographic maps from 1925 (left) and 1986 (right) indicates possible stream diversions in eastern portions of the Tyler Branch watershed, which may have contributed to channel incision through more direct flows into the stream in a shorter period of time.

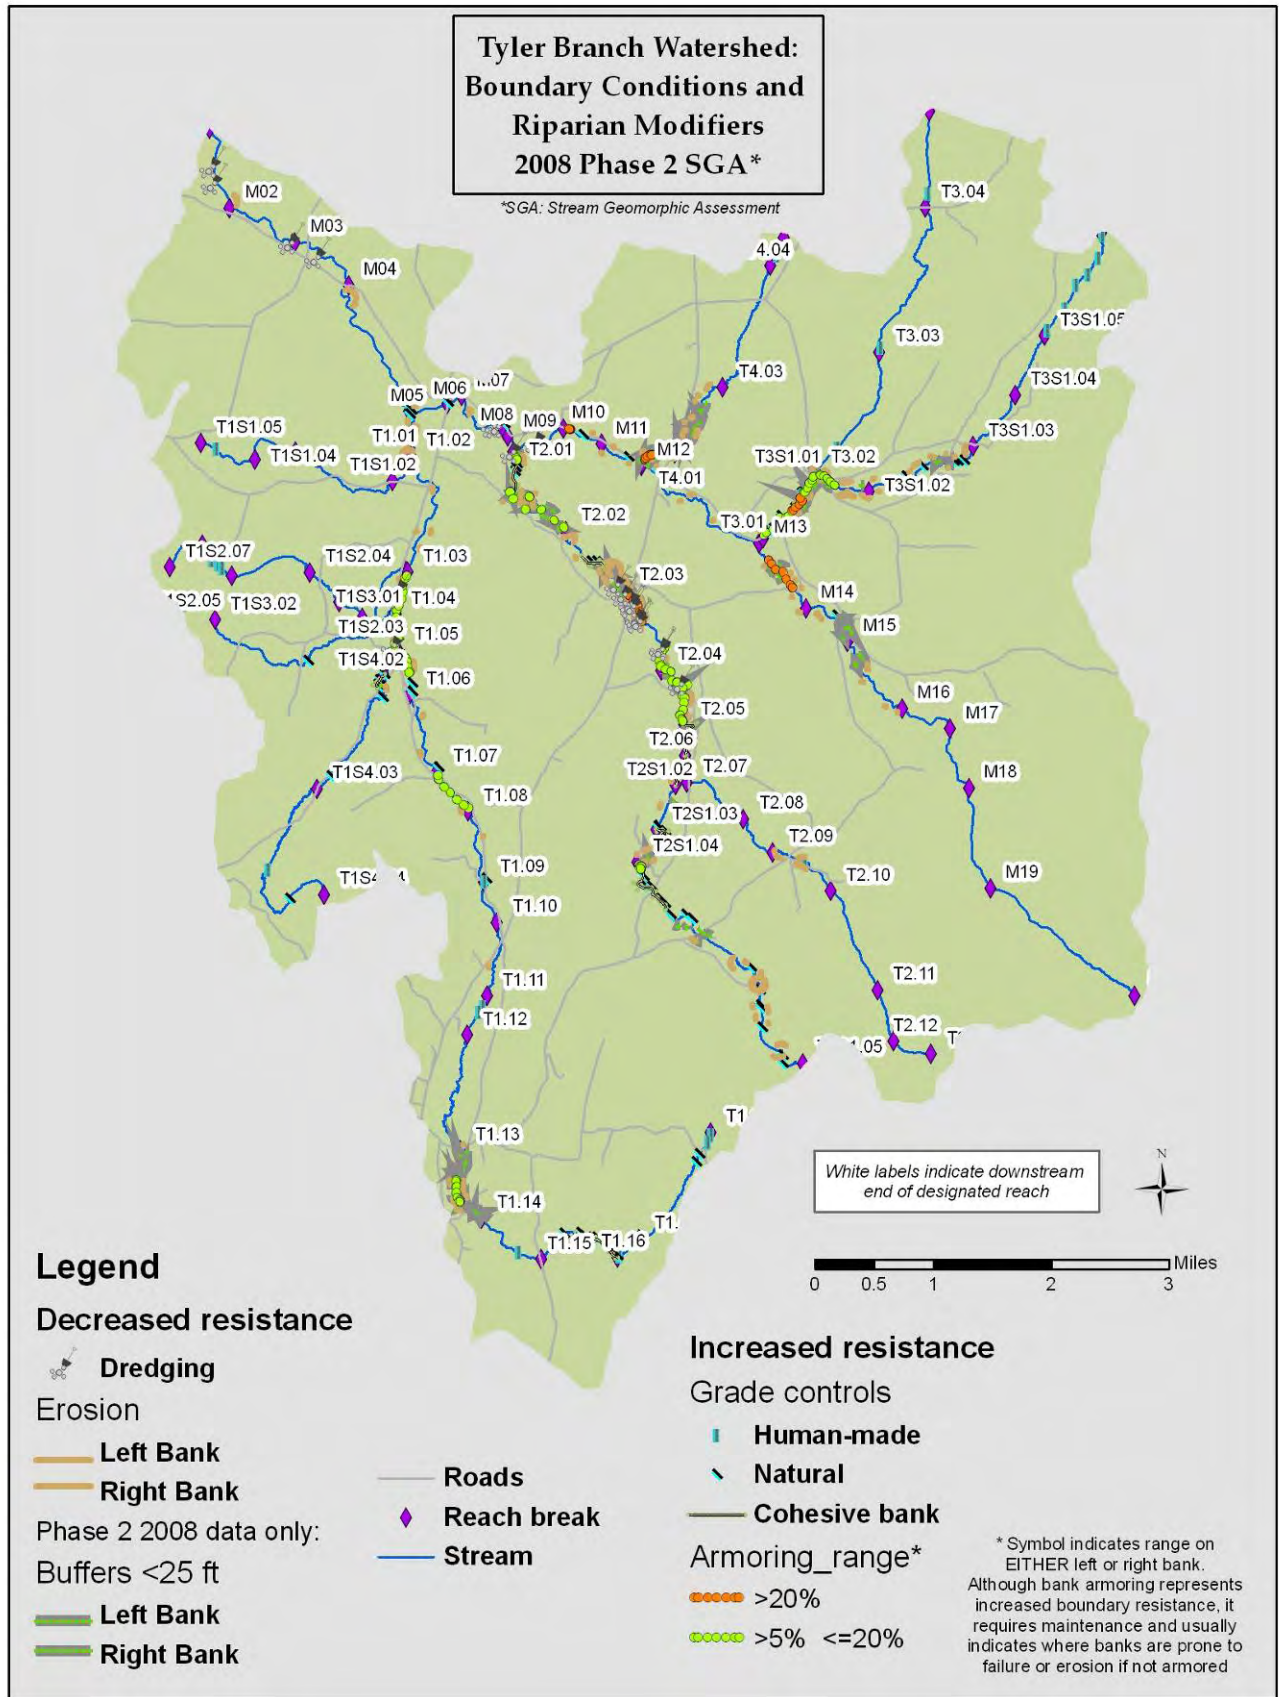
Figure 20. Reach-scale stressors: Boundary condition and riparian modifiers map for the Tyler Branch watershed.

Although data collection under protocols in place in 2006 did not denote the locations of areas with vegetated buffers of less than 25 feet, there is a clear overlap between elevated levels of erosion and bank armoring and areas lacking buffers along the reaches assessed in 2008 (Fig. 20). In addition, the propensity of streams to avulse and undergo rapid lateral migrations, in eastern portions of the watershed in particular, reinforce the importance of wooded buffers for diffusing stream power, mitigating flood damage, and stabilizing soils outside of the current stream channel as well. The flash flooding that occurred in the watershed in 2008 indicated a number of places, where channels had relocated, that would have lost a great deal more soil if the area had not been wooded. The trees that toppled into the streams in these areas were doing a great deal of work in slowing the movement of sediments downstream as well.

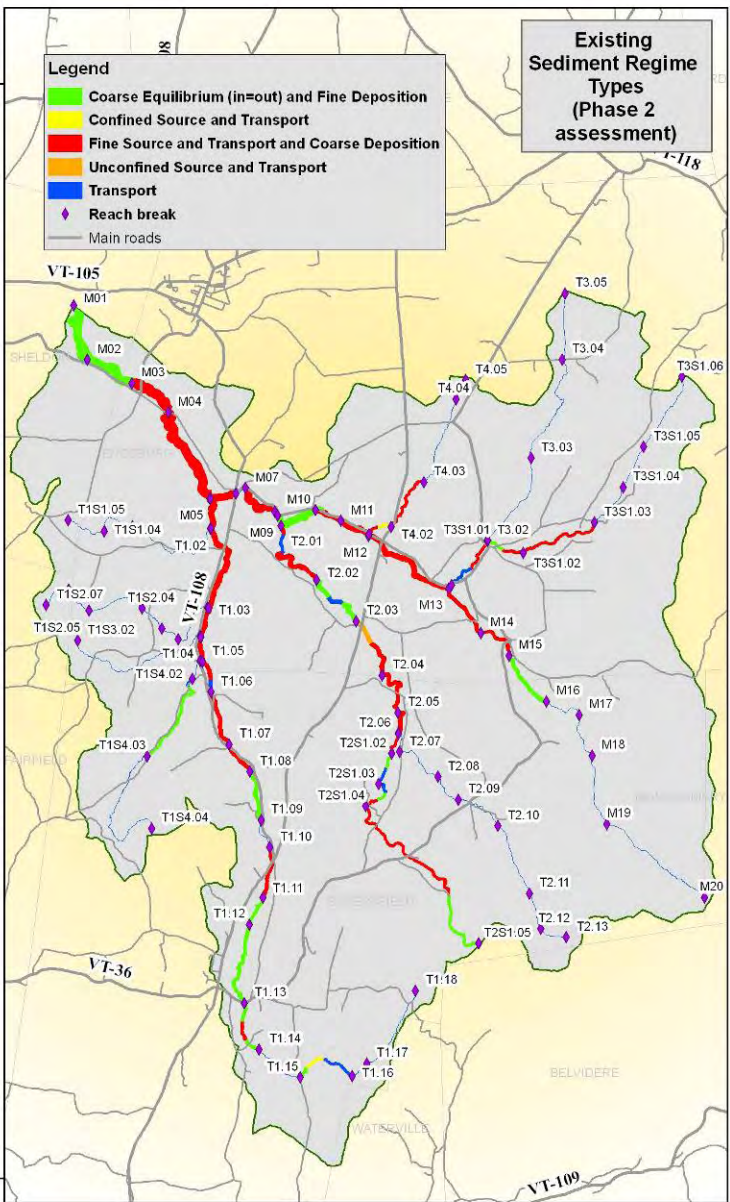
Although important ledge grade controls have limited downcutting in both downstream and upstream portions of the watershed, high flows have combined with "sediment starving" at dams to increase stream power and fine sediment transport through the watershed.

Figure 22. Sediment regime departure in the Tyler Branch watershed.

Due to coarse substrates present in many of the upstream portions of the watershed in particular, stream power is frequently diffused through lateral migration and extensive meanders, with old channel remains visible to the extent of both valley walls in many of the narrower valleys. Corridor protection to allow for full development of these patterns can do much to maintain the role of vital attenuation assets in the Tyler Branch watershed and reduce stream power and flood impacts.

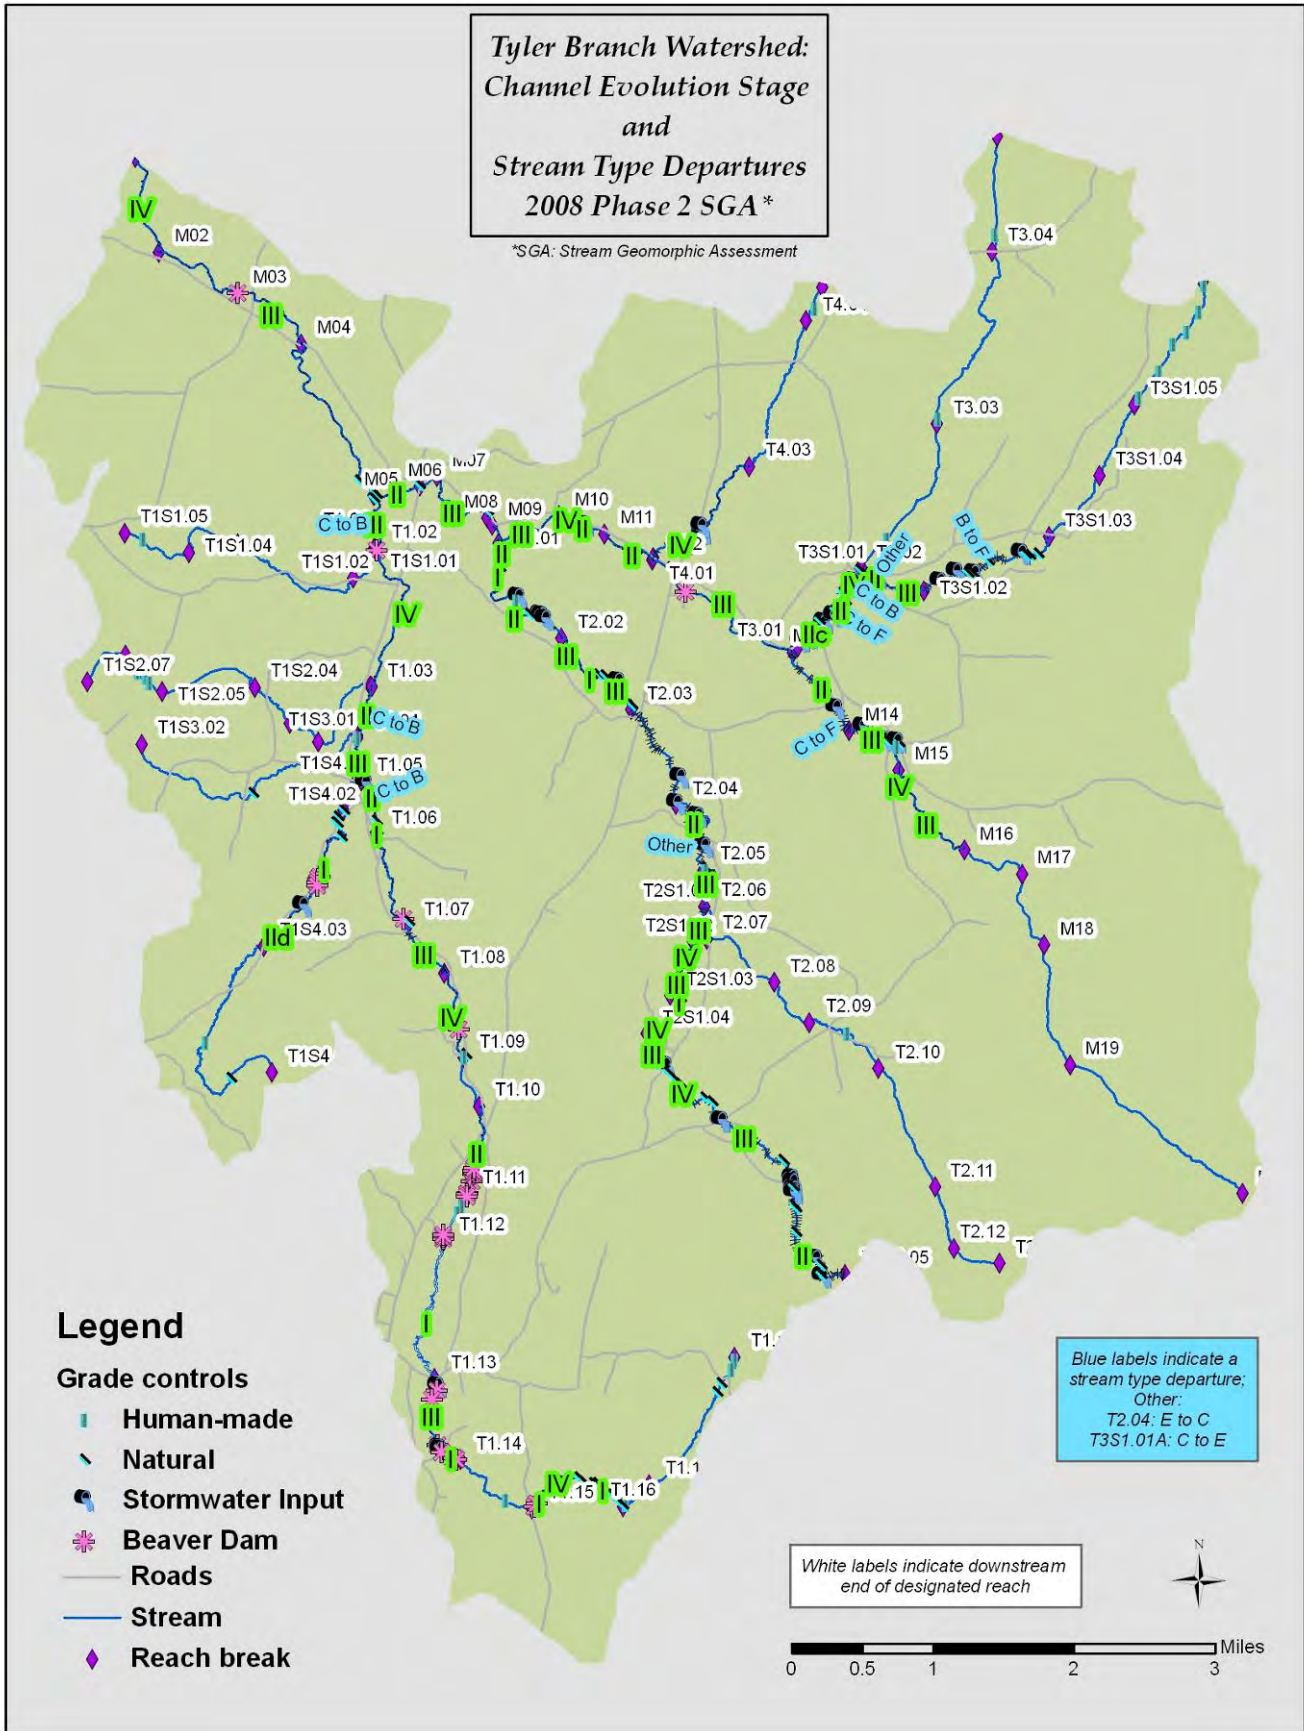
Figure 24. Channel evolution stage and stream type departures map for Phase 2 assessed reaches in the Tyler Branch watershed corridor planning area.

conjunction with “sediment starving” and localized heightened hydrologic impacts below dams) to observed adjustments, including stream type departures, occurring along The Branch downstream of Bakersfield village (Fig. 24). Historic bed degradation may have been further enhanced by historic stream diversion into Beaver Meadow Brook and its tributary in East Enosburgh (see discussion in Sec. 3.1.1, Watershed-scale hydrologic changes). Channel adjustments due to increased flows can be difficult to remediate in downstream reaches (Booth and Jackson 1997), potentially prolonging the stages of disequilibrium in these streams and leaving them open to heightened flood impacts in future events. This places a premium on attenuation of high flows in upstream reaches in particular, and increases the importance of:

“Other” stream type departures (Fig. 24) in reaches T2.04 and T3S1.01 were primarily due to planform changes related to hydrologic impacts as well. In reach T2.04, extensive straightening and a recent channel avulsion have dramatically reduced the sinuosity of an E-type stream, as well as increasing the width to depth ratio (to the cusp of C/E type delineations based on this parameter). Current sediment deposition in point bars appears to be part of this stream channel’s evolution back toward a narrower channel and more sinuous planform. In contrast, Segment T3S1.01A in East Enosburgh is a C-type reference stream that currently has a much lower E-type width to depth ratio (although sinuosity is also low and not characteristic of an E stream) due to sediment windrowing and berming in the vicinity of an undersized bridge following flood impacts in 1997 or 1998. The coarse materials used in the windrow and berm are likely to curtail the rate of channel evolution and exacerbate the impacts of increased stream power.

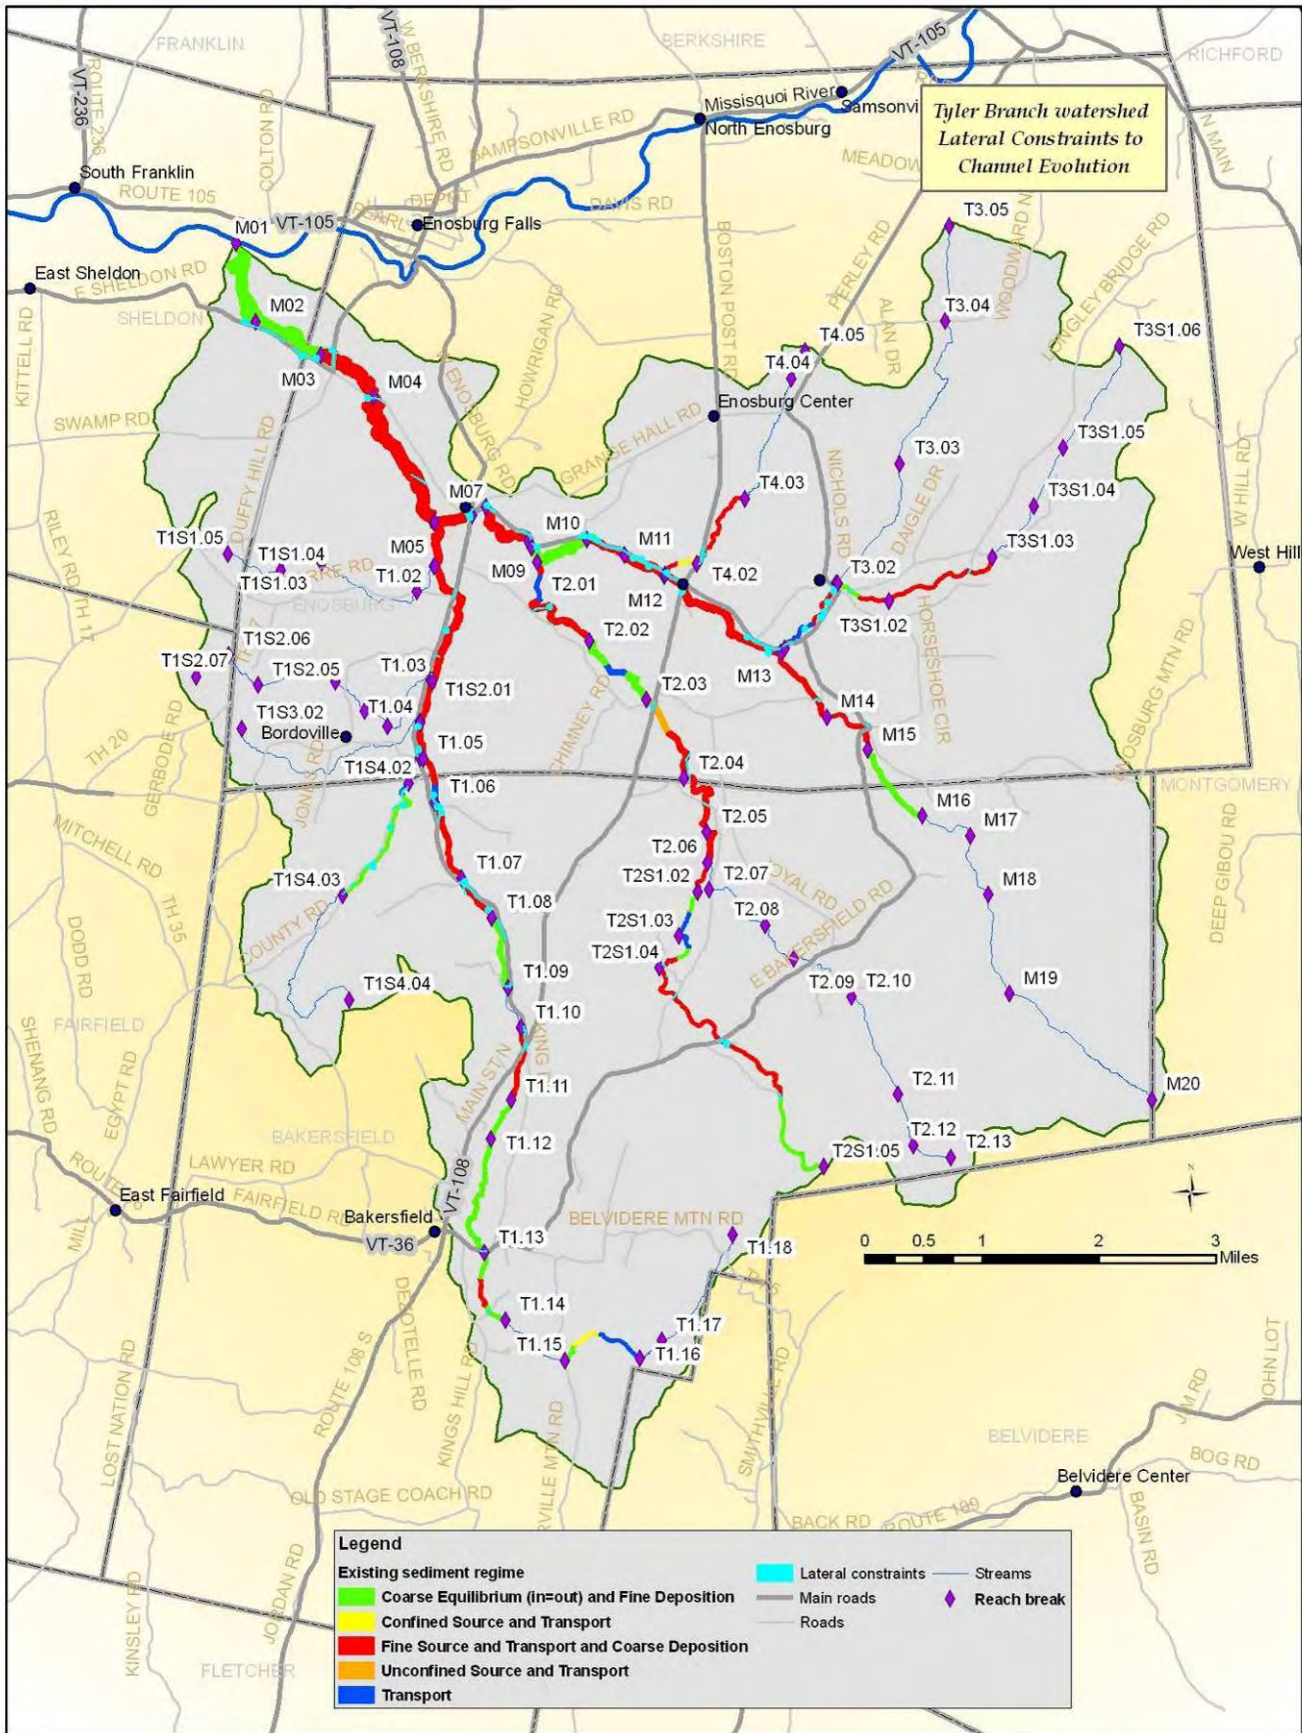
Branch Rd. between West Enosburgh and Gilbert's Tannery (Tyler Branch reaches M07 – M11), around East Enosburgh (upstream half of reach Tyler Branch reach M12 up to the M13 reach break and continuing up Beaver Meadow Brook reach T3.01), along Rte. 108 downstream of Bakersfield village to the Enosburgh town line (The Branch reaches T1.04 – T1.08), along Beaver Meadow Brook in Bakersfield (reach T1S2.04), and along the East Sheldon Rd. (Tyler Branch reach M.02)(Fig. 25).

Given the significant number and degree of lateral constraints along the Tyler Branch Rd., protection of attenuation assets at upstream tributary confluences in the eastern portion of the watershed will play an important role in mitigating flood impacts on downstream reaches and reducing the distance that fine washload sediments are transported through (and out of) the watershed (Fig. 25). Key assets include:

Figure 25. Map of existing sediment regime in conjunction with vertical and lateral constraints to channel evolution in the Tyler Branch watershed corridor planning Project area.

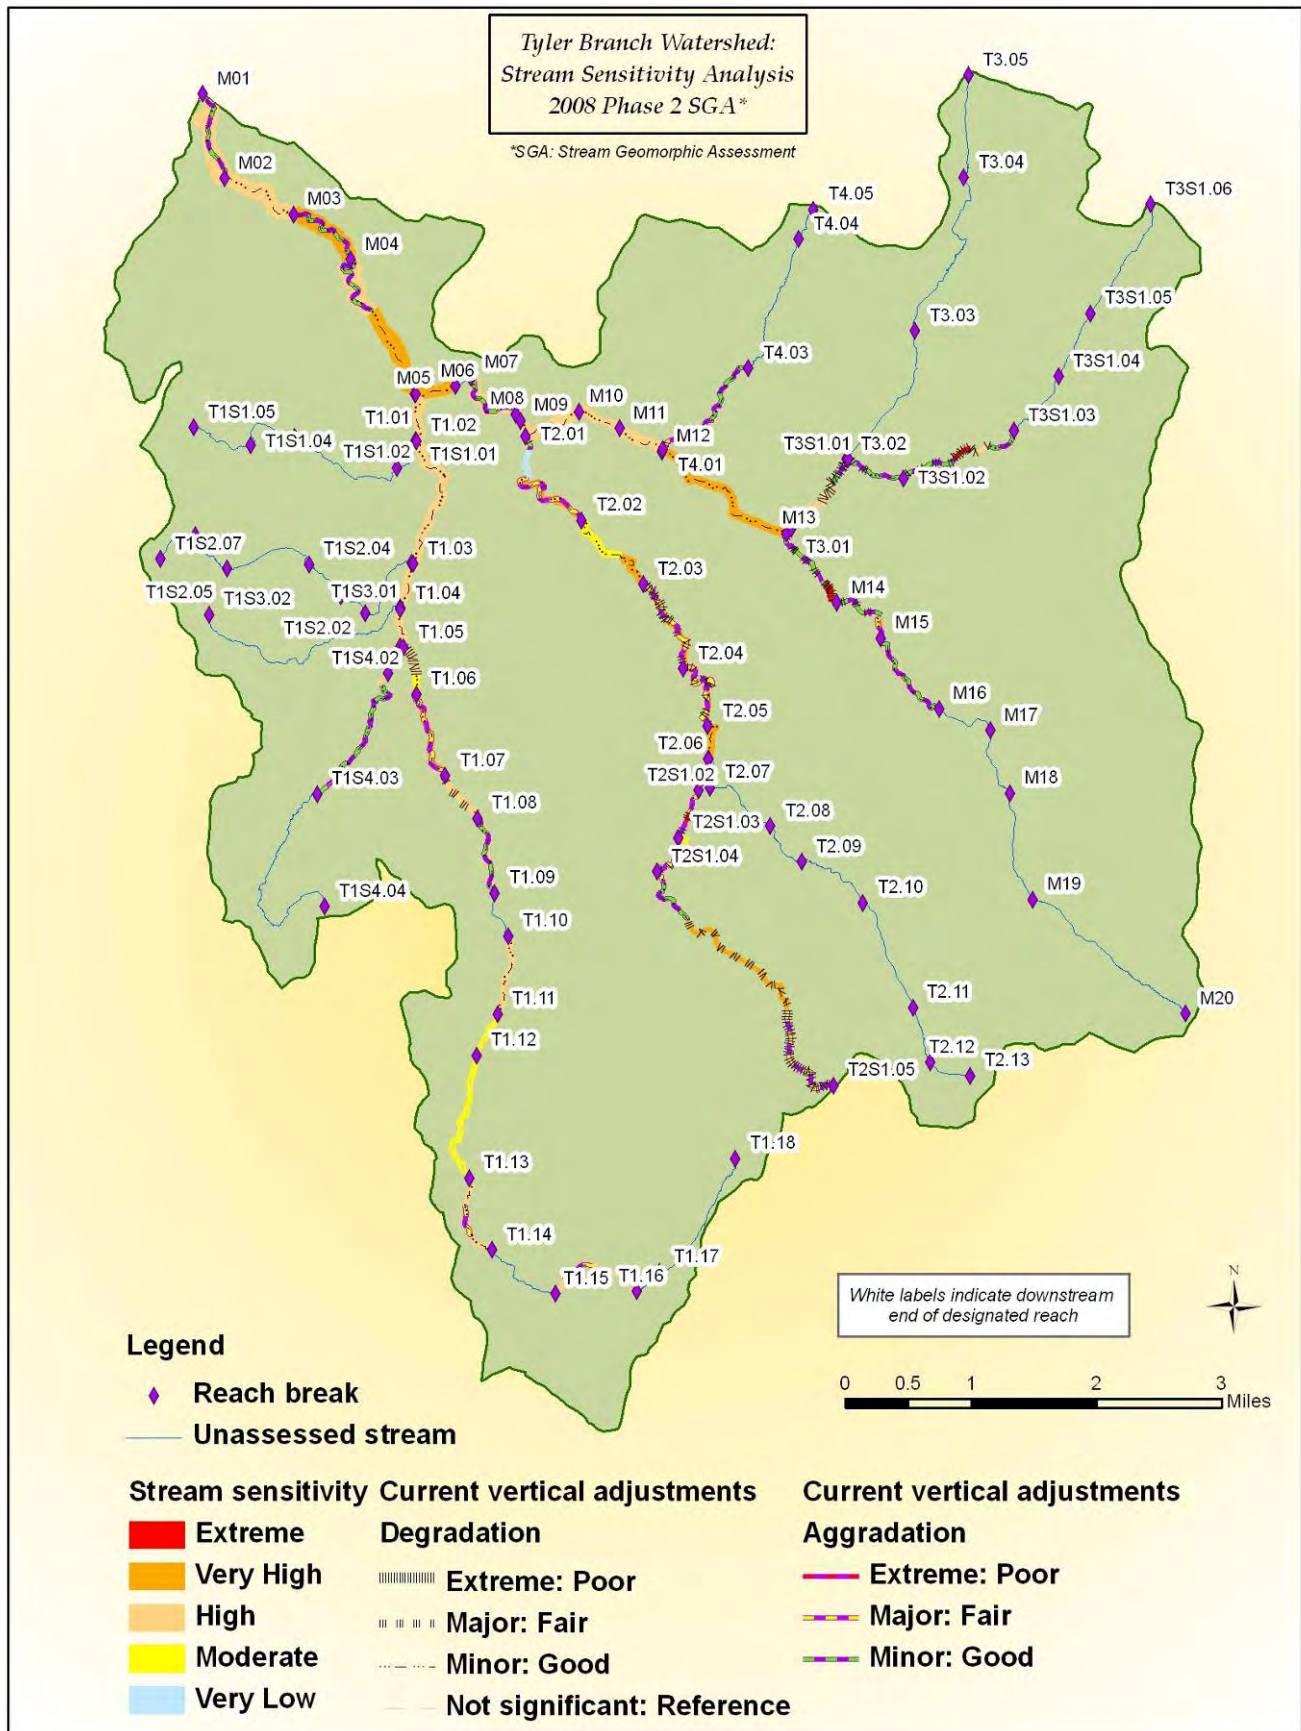
conditions) if stressors are addressed (Fig. 26). This is in part due to the selection of mostly C-type streams for assessment, which are by nature relatively sensitive and capable of recovery to equilibrium conditions in response to restoration efforts (Rosgen 1994). Most reaches along The Branch are Highly sensitive (but in Good or Reference geomorphic condition), with a small number of beaver-impacted and bedrock-controlled portions (in Reference or Good condition) rating Moderate sensitivity (Fig. 26). Reaches in the eastern portion of the watershed tend to be even more sensitive, with ratings predominantly in the Very High category and geomorphic condition predominantly in the Fair range; two segments exhibiting stream type departures due to loss of access to floodplain (T3S1.02B and M13C) are Extremely sensitive (and Poor to Fair condition).

Only segment T2.01B, a bedrock-controlled area in Reference condition at the base of Bogue Branch, was classed with Very Low sensitivity (Fig. 26). A closer look at the distribution of moderately sensitive reaches in this portion of the watershed (Fig. 27) indicates that half of reach T2.02 upstream of this area is moderately sensitive. The lower level of sensitivity in portions of these reaches, in conjunction with limited spatial extent and current land use constraints on functionality as an attenuation asset in reach T2.01 at the confluence of Bogue Branch and Tyler Branch (see discussion in Sec. 5.1.4 above in regards to attenuation assets and lateral constraints) indicates that channel evolution in this area may be slow. Moderately sensitive reaches are also located on both up and downstream ends of the high deposition zone at the confluence of Ross Brook and Bogue Branch (Fig. 27). Prioritization of restoration efforts on upstream reaches is recommended as the most effective restoration strategy on Bogue Branch, from a watershed view, due to expectations of a slower rate of channel evolution in these areas.

Figure 26. Sensitivity analysis: Stream sensitivity and current adjustment map for the Tyler Branch watershed corridor planning area.

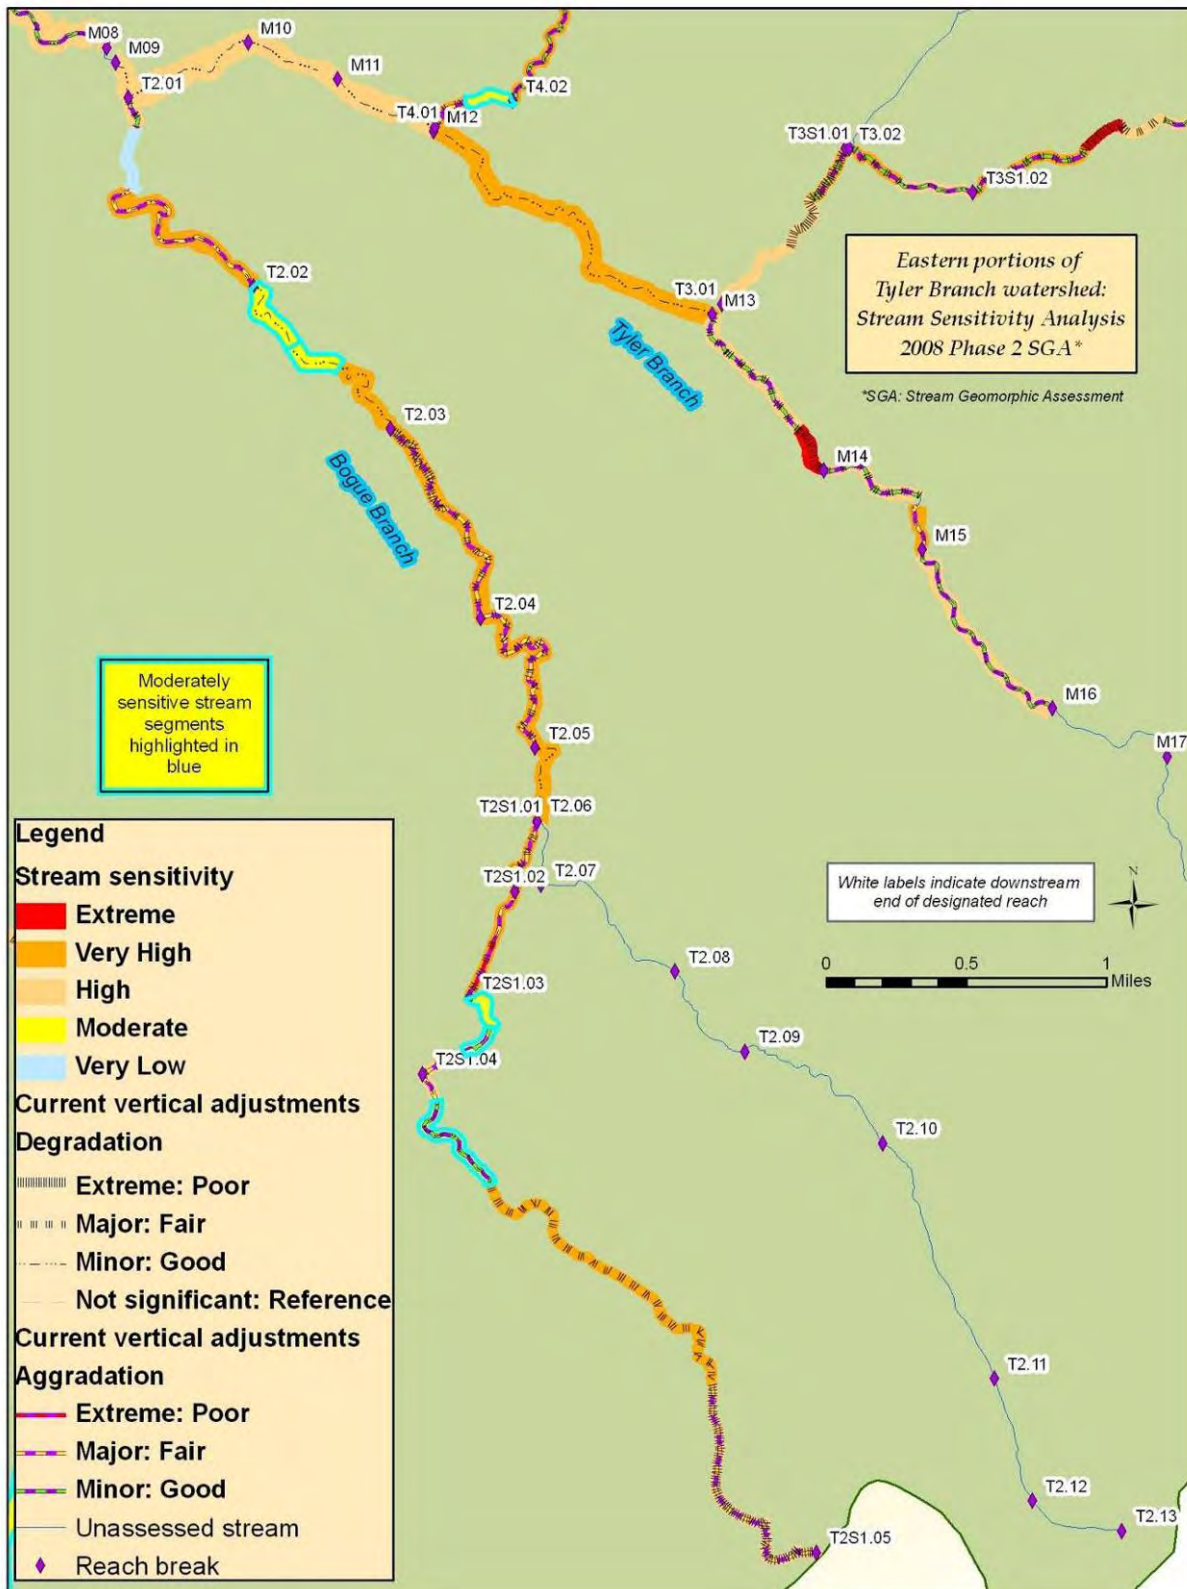
Figure 27. Distribution of moderately sensitive reaches in eastern portions of the Tyler Branch watershed indicates that channel evolution may be slower in key areas along Bogue Branch, suggesting that watershed strategies might achieve better results by focusing on restoration of upstream reaches first. Moderate sensitivity in segment Tyler Branch tributary segment T4.01B increases the importance of T4.01A as an attenuation asset.

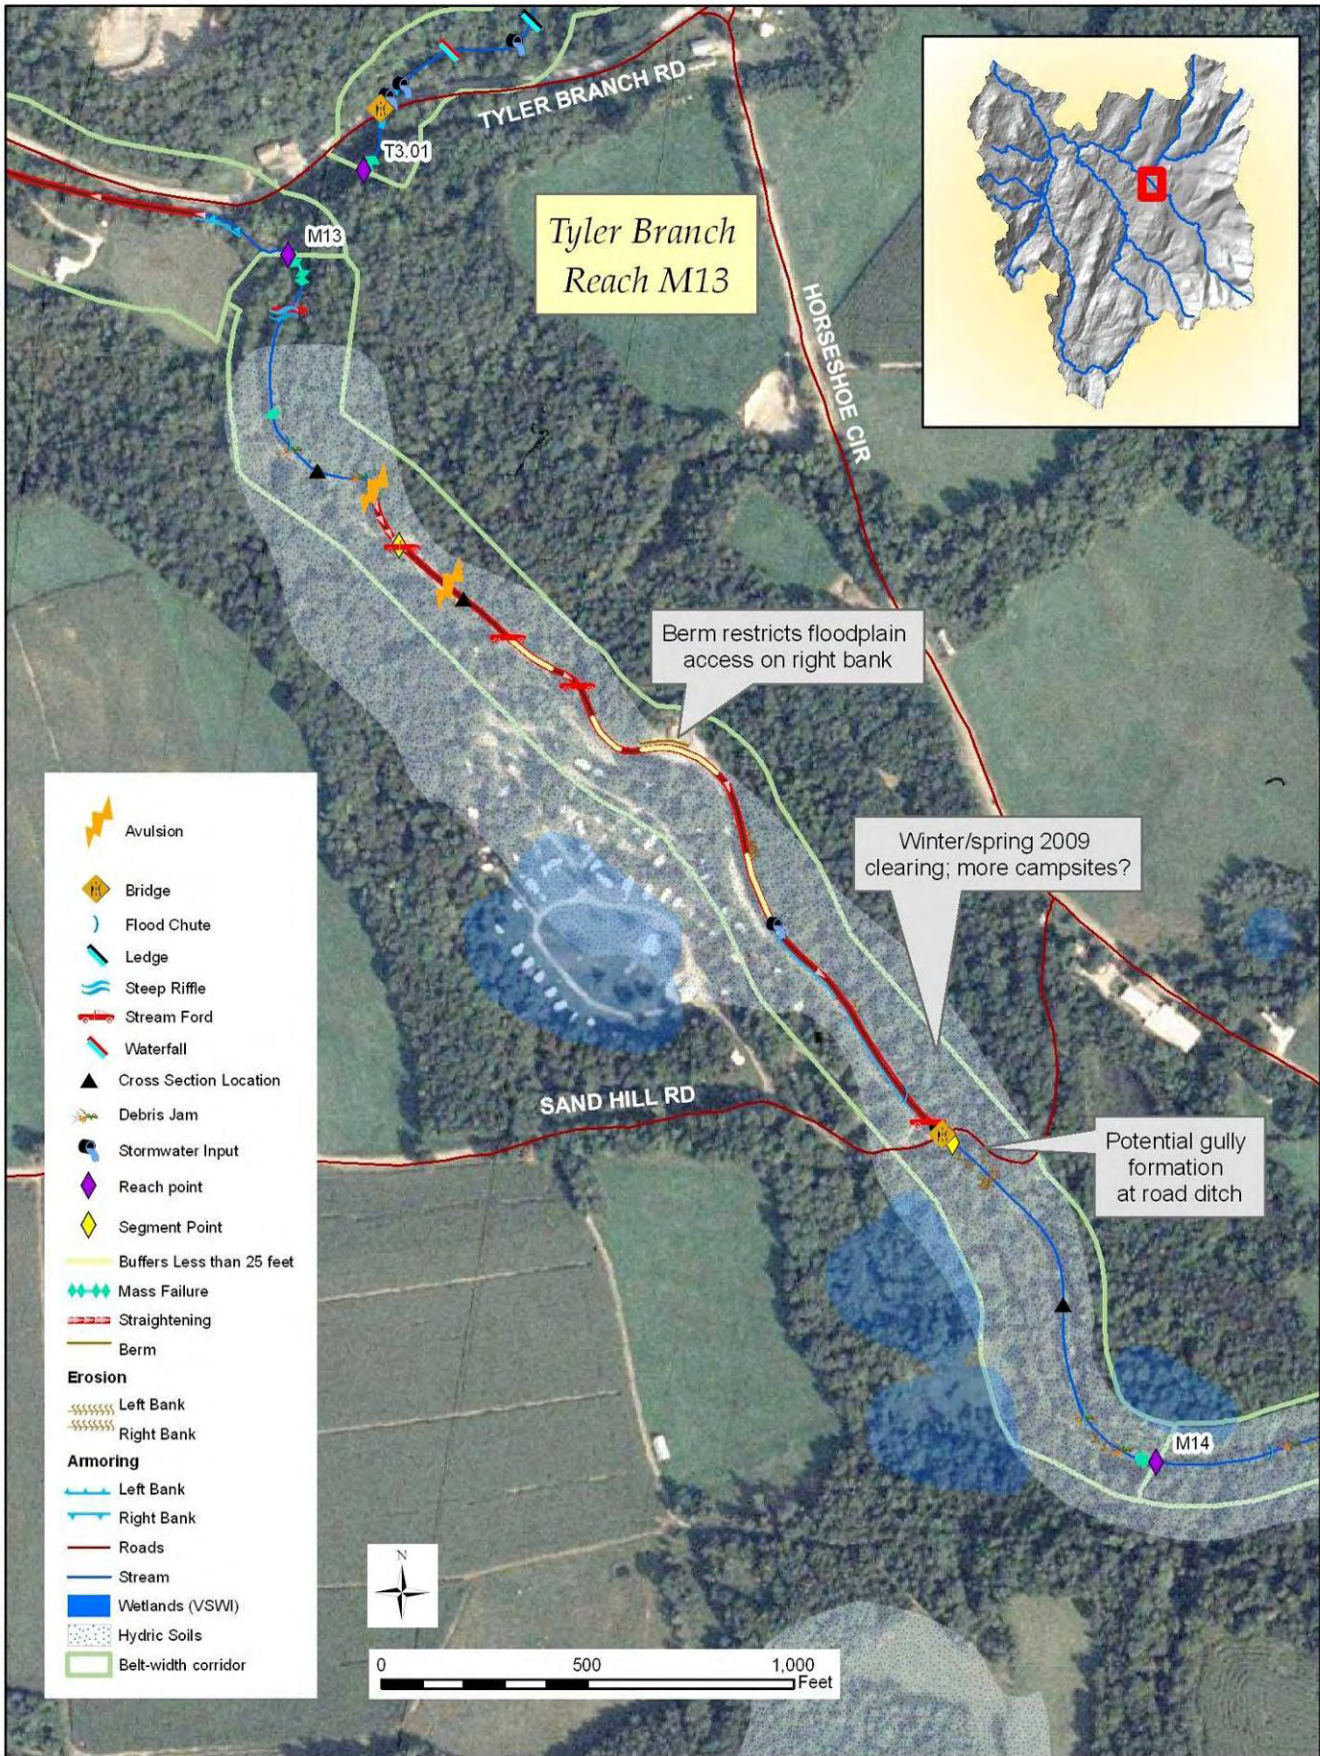
Figure 28: Tyler Branch Reach M13

Segment M13A retains a fairly undisturbed setting but appears to be quite dynamic. Channel planform adjustment indicators are common. Key features include:

- There is no armoring on this segment.
- There are 2 mass failures at the lower end of the segment.
- Dominant buffer on both banks is >100 ft.
- Cobble substrate appears to somewhat inhibit incision.
- Old channel beds in the valley indicate past channel movements through avulsion.
- The stream is in stage III, showing some historical incision but with widening, aggradation, and planform change dominating the active processes.
- Substrate is cobble and sensitivity rating is High, and geomorphic rating is Fair
