TYLER BRANCH WATERSHED

PHASE 2 STREAM GEOMORPHIC ASSESSMENT

June 2, 2009

Prepared by:
Daniel Ruddell, Elisabeth McLane,
Staff Scientists, and
Ben Machin, Principal
Redstart Consulting

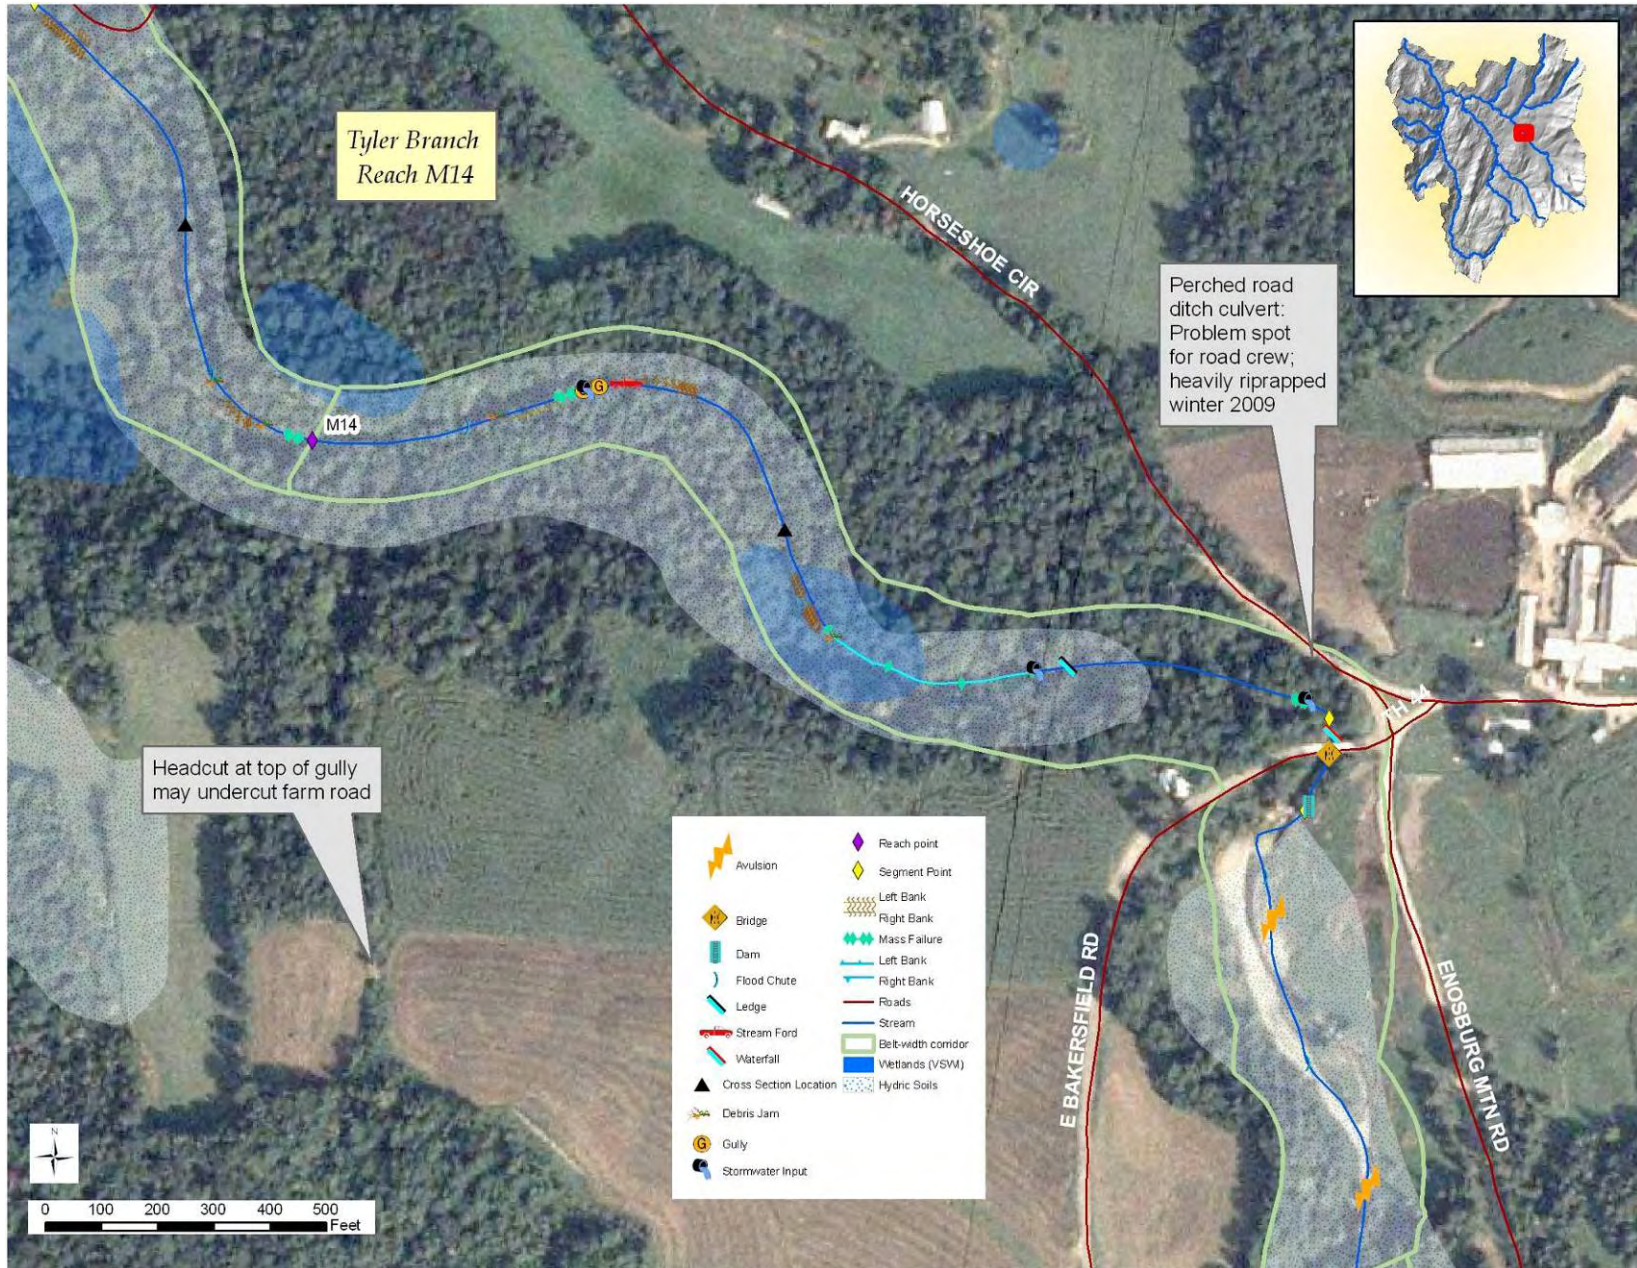
Figure 30. Tyler Branch mainstem reach M14 map

Reach M14 comprises roughly 3645 feet of the Tyler Branch mainstem extending from approximately 1000 feet upstream of the Sand Hill Rd. bridge to an open pasture upstream of the East Bakersfield Rd. bridge, near the junction of that road with the Enosburgh Mtn. Rd. and Horseshoe Circle (Fig. 30).

Reach M14 was assessed as 3 segments of roughly 2136 feet, 177 feet, and 936 feet in length. The short section in segment M14B comprises a 50 foot waterfall and a 10 foot dam located in a bedrock gorge. With much of the elevational gradient of the overall reach accounted in the waterfall and dam of segment M14B, both M14A and M14C were classified as C type streams, although both segments were just above the lower limit of a ‘b’ subslope (2-4% slope).

gully opened beneath a small red maple/hemlock forested wetland, cutting through highly erodible unsorted (ice-contact) substrates, even though the extremely steep valley wall was well forested with mature trees. A headcut at the top of the hill has the potential to undercut a farm road that crosses from corn and hayfields accessed off the East Bakersfield Rd. toward a smaller hayfield to the west (Wright farm; Fig. 30)

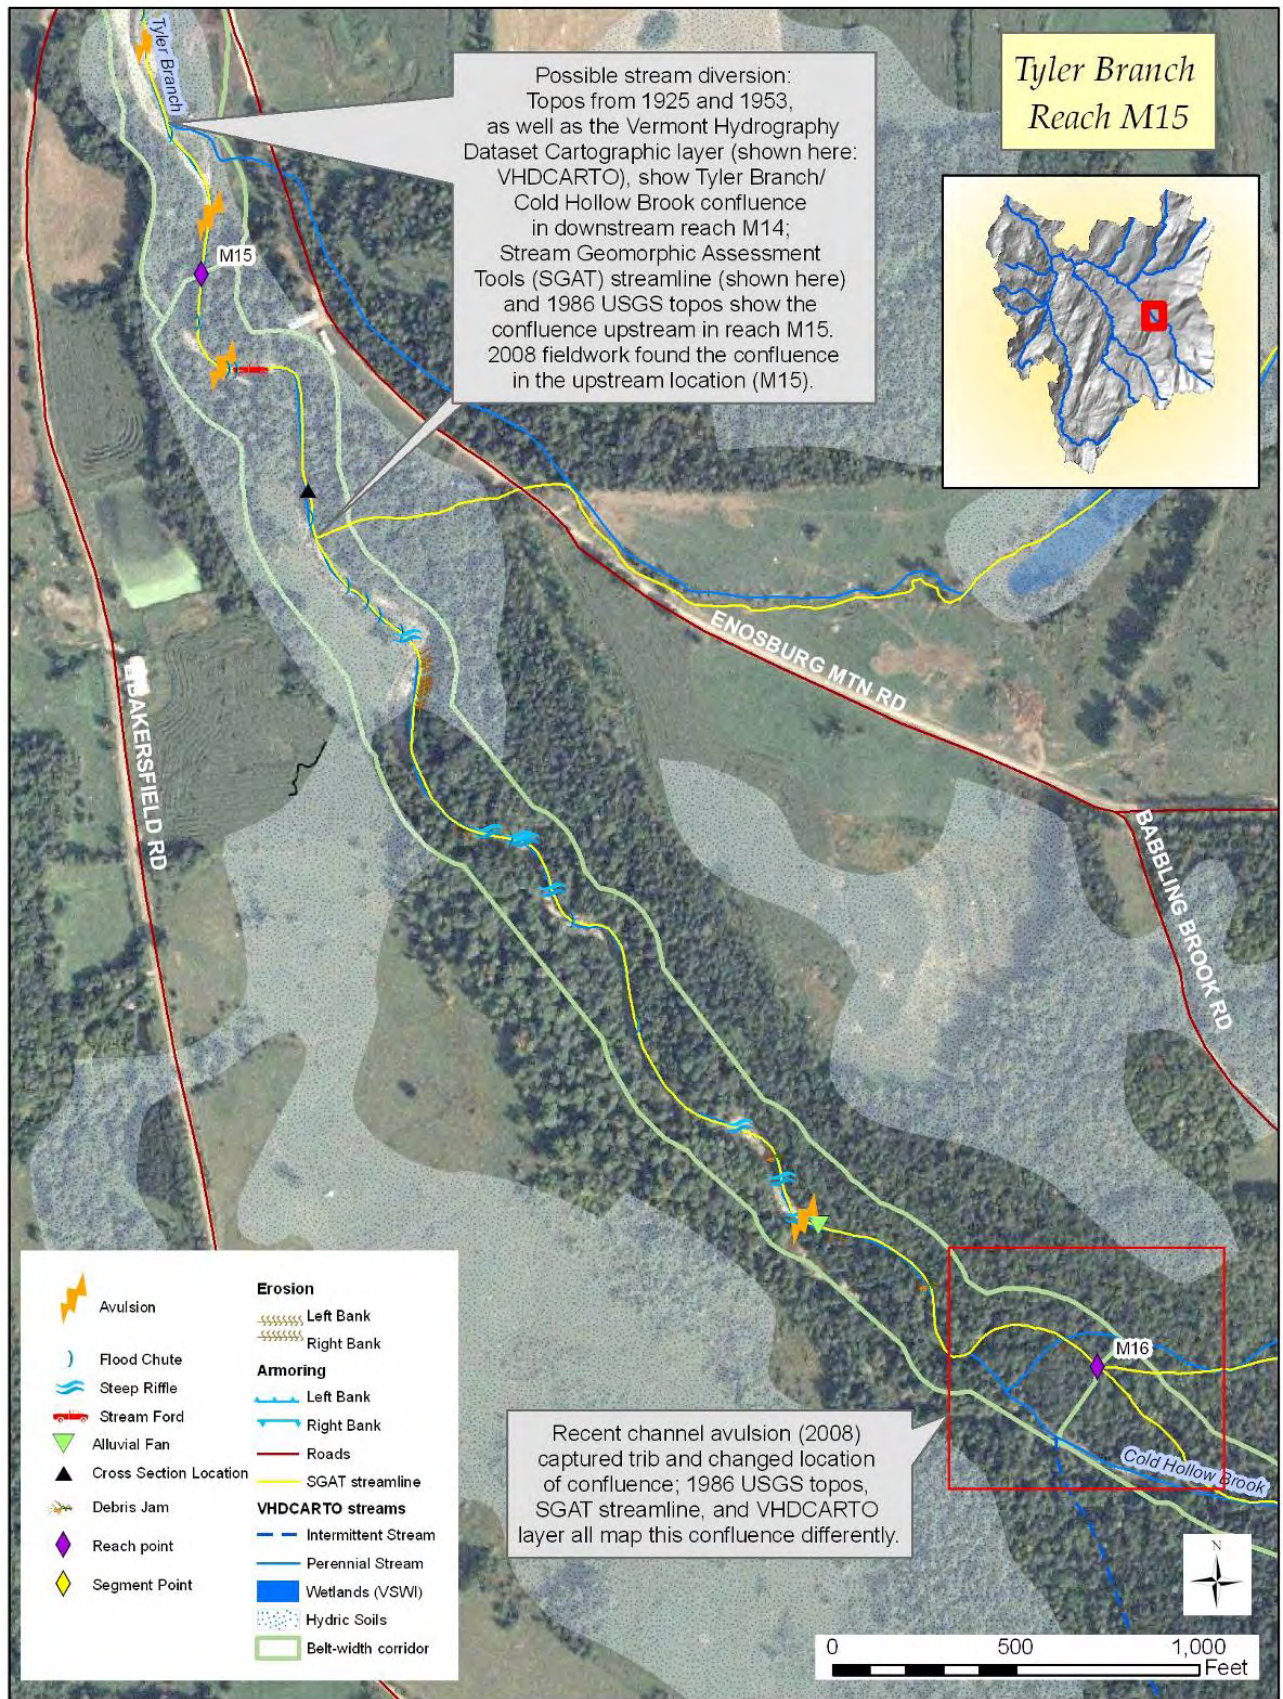
Figure 34. Tyler Branch mainstem/ Cold Hollow Brook reach M15 map.

In contrast, USGS topographic maps from 1986 and the Vermont Hydrography dataset, used for 2003 Phase 1 assessment of the Tyler Branch watershed, indicate the confluence of the Tyler Branch and Cold Hollow Brook in similar locations further upstream in reach M15 (Fig. 34, next page), confirmed as the present location during 2008 fieldwork. If the stream was indeed diverted (possibly to supply the mill pond), this may have increased flow inputs to the stream without the full attenuation of flow and sediments that would have occurred further upstream on the alluvial fan, where the stream course appears to migrate frequently through accumulated sediments, diffusing stream power both through frequent planform and meander pattern changes as well as the work of moving these accumulated sediments.

Maps from different eras indicate changes in the upstream portion of the reach near the M16 reach break as well (Fig. 34), likely related to the type of rapid lateral migrations and channel avulsions that were observed during 2008 fieldwork. Fieldwork found a very recent change in the confluence of the tributary near the M16 reach break due to the mainstem avulsing and the tributary using the avulsed channel as its own channel (Fig. 33); other portions of this reach showed multiple location/ planform changes as well. With coarse substrates currently limiting planform adjustments and widening, indications are that the stream will utilize much of the valley over time, especially when a flood chute or tributary is captured. This appears to happen primarily in large flood events, with the stream potentially occupying its new location for decades before a similar event occurs.

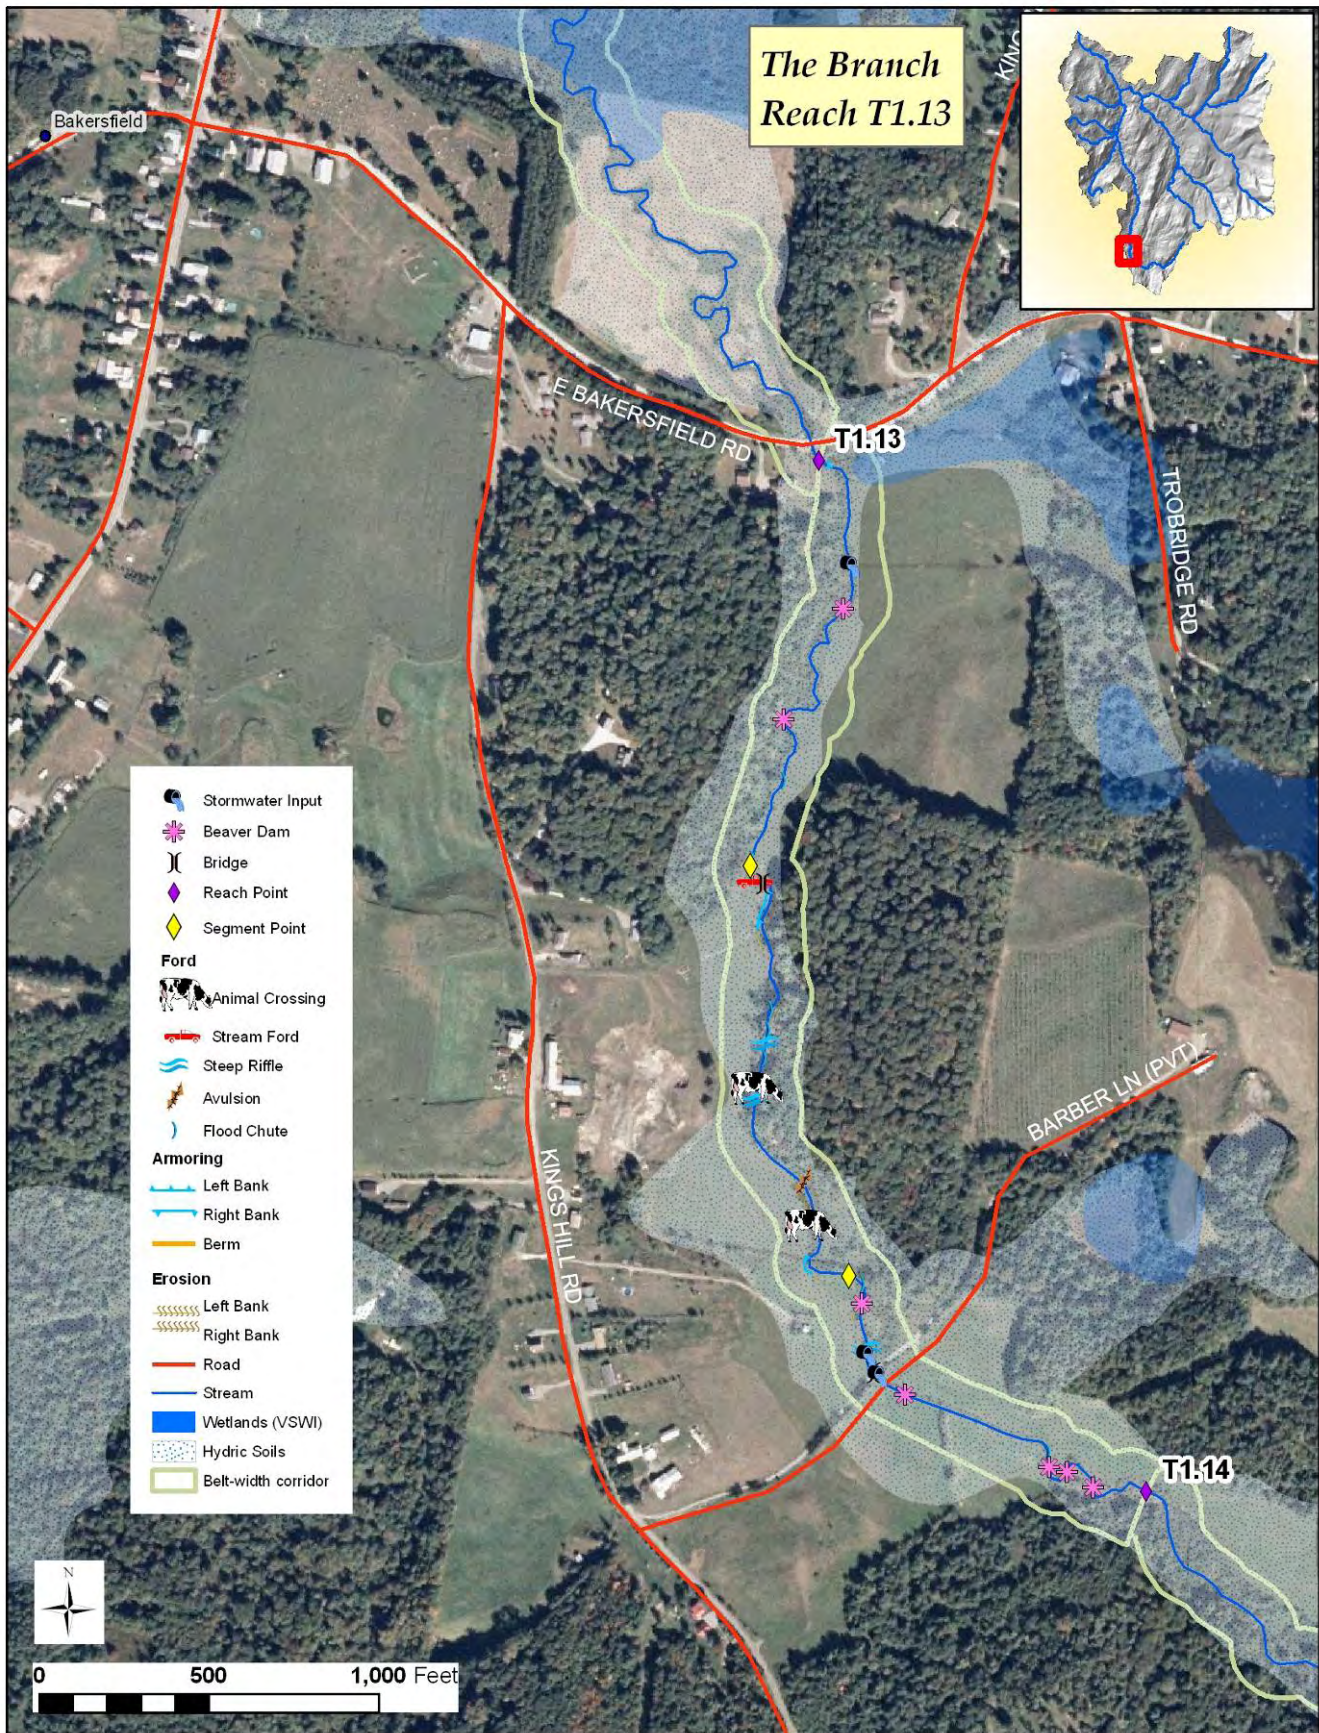
Figure 36: The Branch reach T1.13 map.

Reach T1.13 is 4,317 feet long and was segmented for Phase 2 assessment. Segments A, B and C are 1453, 1471, and 1392 feet long, respectively. Phase 1 characterized this reach as having a Very Broad valley and an E-type stream with a riffle-pool bedform and a sand substrate. All three segments fit this initial description, although segment B has widened almost to the point of a stream type departure to a C-type stream. Segment B also has a gravel, rather than a sand, bed. Soil maps show that the greater part of this very broad valley is underlain by hydric soils (Fig. 36, next page). This reach provides important attenuation assets. Agricultural use, both for pasture and crop land, dominates the stream valley.

T1.13B (1,471 ft) is a more impacted section of stream where pastured animals have been allowed access to the stream channel (Fig. 35). Key features include:

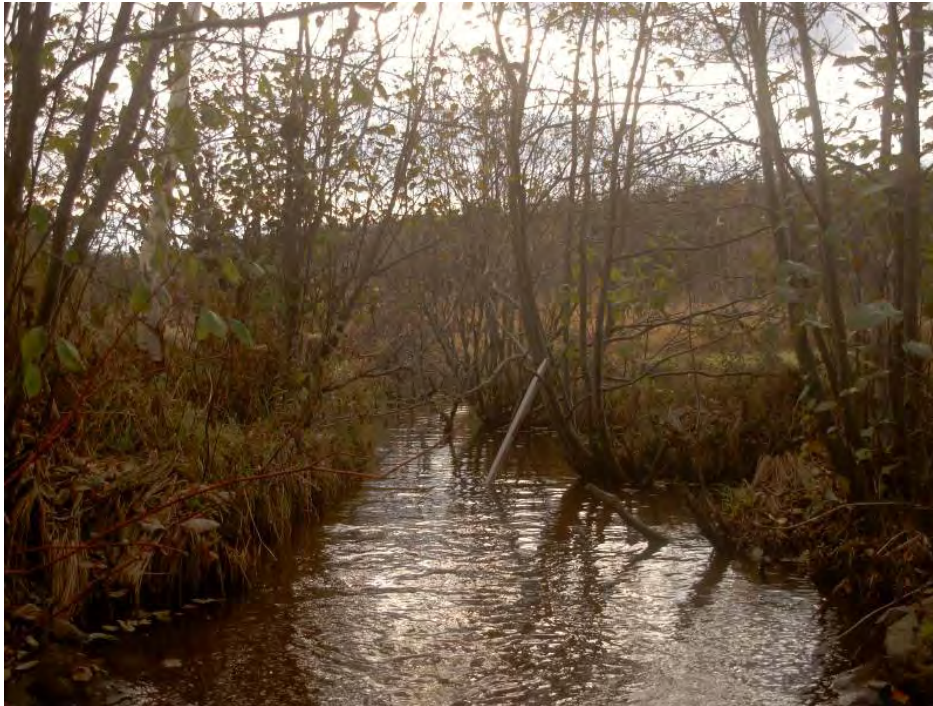
Segment T1.13C (1,392 ft) is a mixture of sinuous, beaver impacted stream (upper and lower portion) and a section of straightened stream mid-segment. Adjacent fields on the left bank have the appearance of having been used for agricultural but are now abandoned for that use. The right bank still has active agriculture. Key features include:

- Dominant buffer vegetation on the right bank is 0-25 ft with more than 50% having a buffer less than 25 ft.
- Straightening has impacted >40% of the segment.
- There is almost no development or encroachment on this segment.
- There is a moderate amount of aggradation in this segment, with 5 mid-channel bars, 3 side bars, and 1 steep riffle mapped.
- There is a bridge in this segment that is a channel constriction.
- The stream is in stage I. Flood plain access is still available and there was only very limited evidence of incision. Moderate planform adjustments are related to beaver damming activity.
- Substrate is sand, sensitivity rating is High, and geomorphic rating is Good

Figure 37: Segment T1.13C has been straightened in this mid-section of the segment. The narrow alder buffer is common along this segment and along the entire reach.

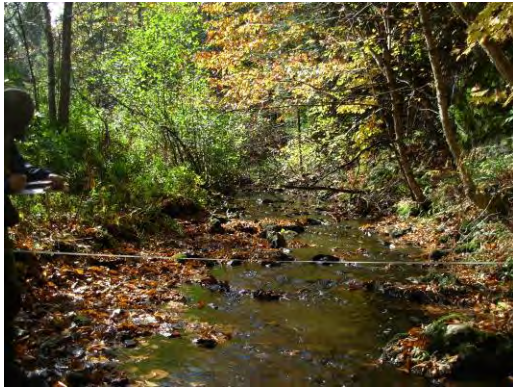
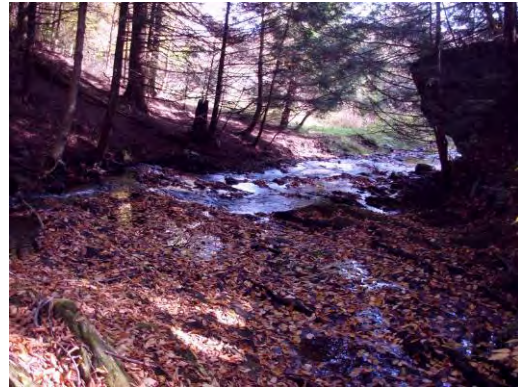
T1S4.02A (723 ft) is a stable section of stream dominated by bedrock grade controls in a narrowly confined valley. Sensitivity rating is High due to the fact that dominant substrate is cobble. The segment is somewhat variable, with the upper section, where the cross-section was taken, being of lower slope, wider valley, and smaller substrate. Key features include:

Figure 42: Beaver Meadow Brook (Bakersfield), reach T1S4.02. Upper segment somewhat wider and shallower slope (left) compared to lower segment dominated by bedrock grade controls (right).

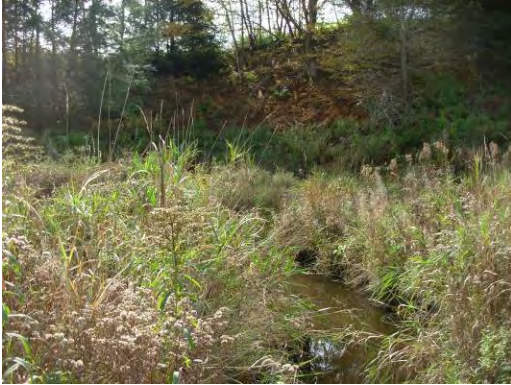
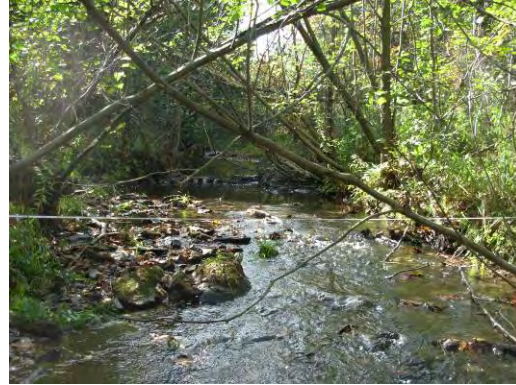
T1S4.02B (5,248 ft) comprises the majority of this reach. It is dominated by wetland that alternates between alder swamp and abandoned beaver meadow. Evidence of beaver activity is common. Key features include:

Figure 43: Beaver Meadow Brook (Bakersfield) segment T1S4.02B alternates between old beaver meadow (left) and alder swamp (right).

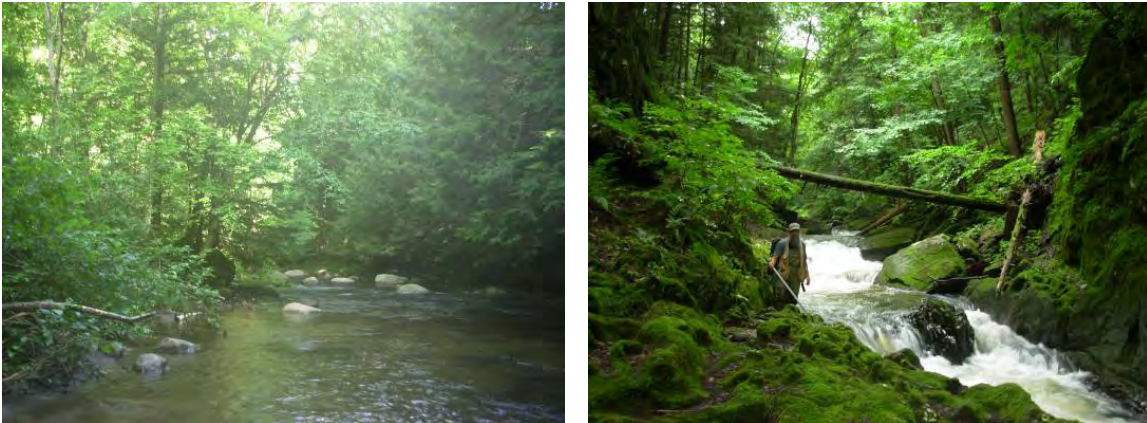
T2.01B (1,264 ft) is a section of stream dominated by a forested buffer, narrowly confined valley, and several ledge grade controls. The stream type varied between F and A types. Steep bedrock cascade sections are more A-like, but in between ledges widening has occurred and the segment was classified overall as an F-type stream. Key features for this segment include:

Figure 46: Bogue Branch reach T2.01segment B has both F-type (left) and A-type stream.

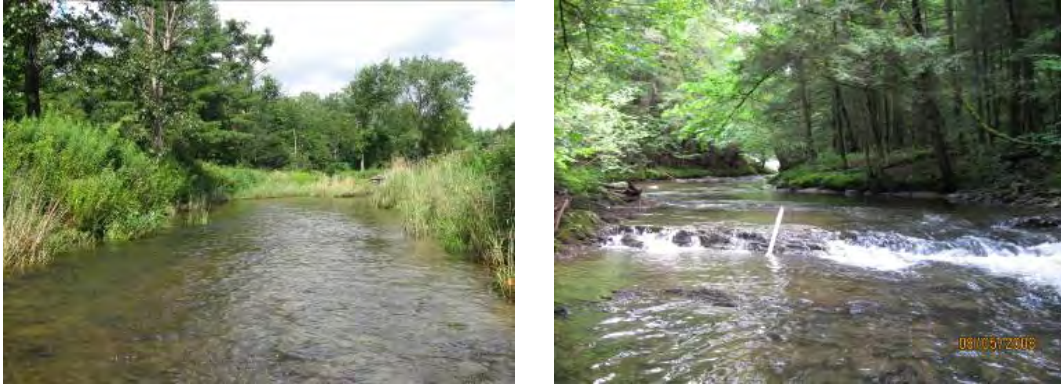
Figure 49. Bogue Branch T2.02A (left) is buffered by forested wetland, shrub/sapling and herbaceous vegetation. T2.02B (right) is a bedrock-controlled, B-type planebed section of the stream.

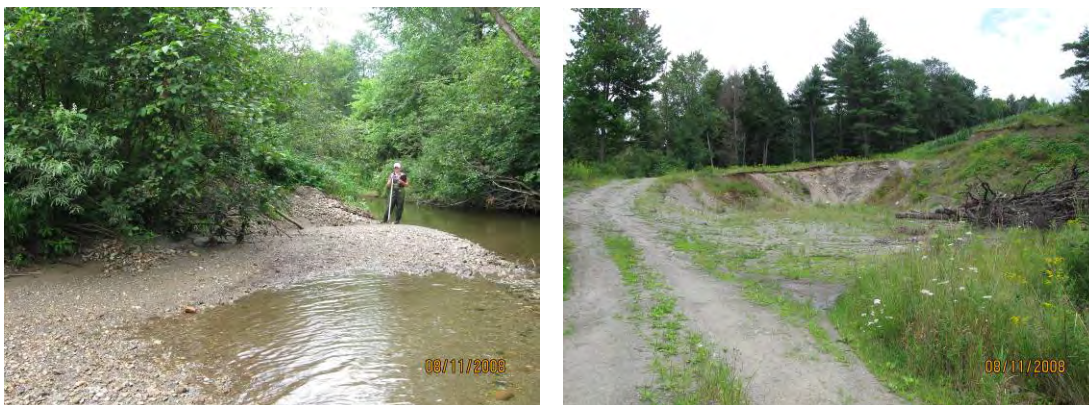
- Recent small scale gravel removal on downstream end, possibly used for farm road maintenance. Farm road off right bank was significantly extended/improved between time of 1998 orthos and 2003 NAIP aerial photography, and a small sand/gravel pit appears to have been opened off the downstream right bank of this segment to provide construction material (Fig. 53); not clear if or how much material was obtained from the stream for this effort. Bedrock outcrops in upper portion of the segment would likely hamper gravel removal in the upstream area.

Figure 53. Recent gravel removal at downstream end of segment T2.03C (left) is very close to a pit (right) that appears to have been opened sometime between 1995 and 2003, and was likely used to significantly upgrade the road that runs along the right bank of segment T2.03C.

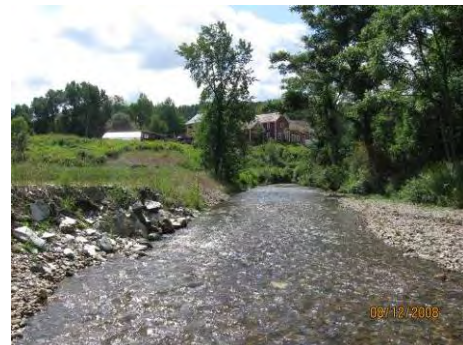
Figure 54. FEMA helped fund riprapping of the left bank in segment T2.04A beneath the Lopes' home and barns at Witchcat garlic farm, which has been augmented by windrowing and berm construction upstream.

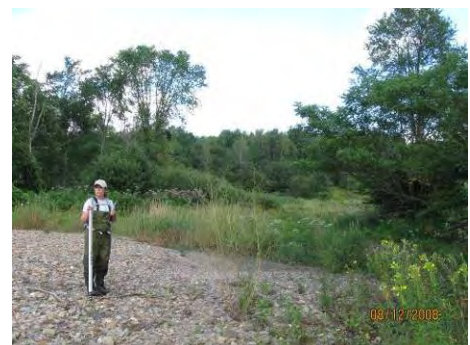
A short distance upstream of the riprap and berm a mass failure has occurred on the right bank, and upstream of that there is a large sediment plug that has closed the mouth of a former large meander in a wetland area off the right bank (Fig. 55), contributing to a channel avulsion that has significantly shortened the channel length (and thus increased the slope, since the stream no longer crosses the slope gradient through the meander). A pond further east in the valley off the right bank is visible in 2003 color aerial photos, but 1995 black and white orthophotography indicates a meandering stream in this area (Fig. 56).

Figure 55. A large sediment plug has closed the mouth of a former meander through a wetland area in T2.04A, contributing to a channel avulsion that has significantly shortened the channel.

aerial photography from the 2008 flyover. An active restoration project to remove gravel from the mouth of the meander might be valuable to restore the attenuation functions of the wetland, but may not be necessary if the stream can accomplish this on its own. An active restoration would also be at high risk for failure if more flooding were to occur before new meanders and buffers were established and stabilized, and project design would need to be based on expected sediment and flow discharges from upstream. These discharges are currently undergoing adjustments themselves, as discussed in the reach descriptions for reaches T2S1.01 – T2S1.04 in Section 6.1 of this report. Higher priority would thus be given to addressing upstream impacts first, but buffer establishment, augmentation and maintenance would greatly benefit this reach and could be completed independently.

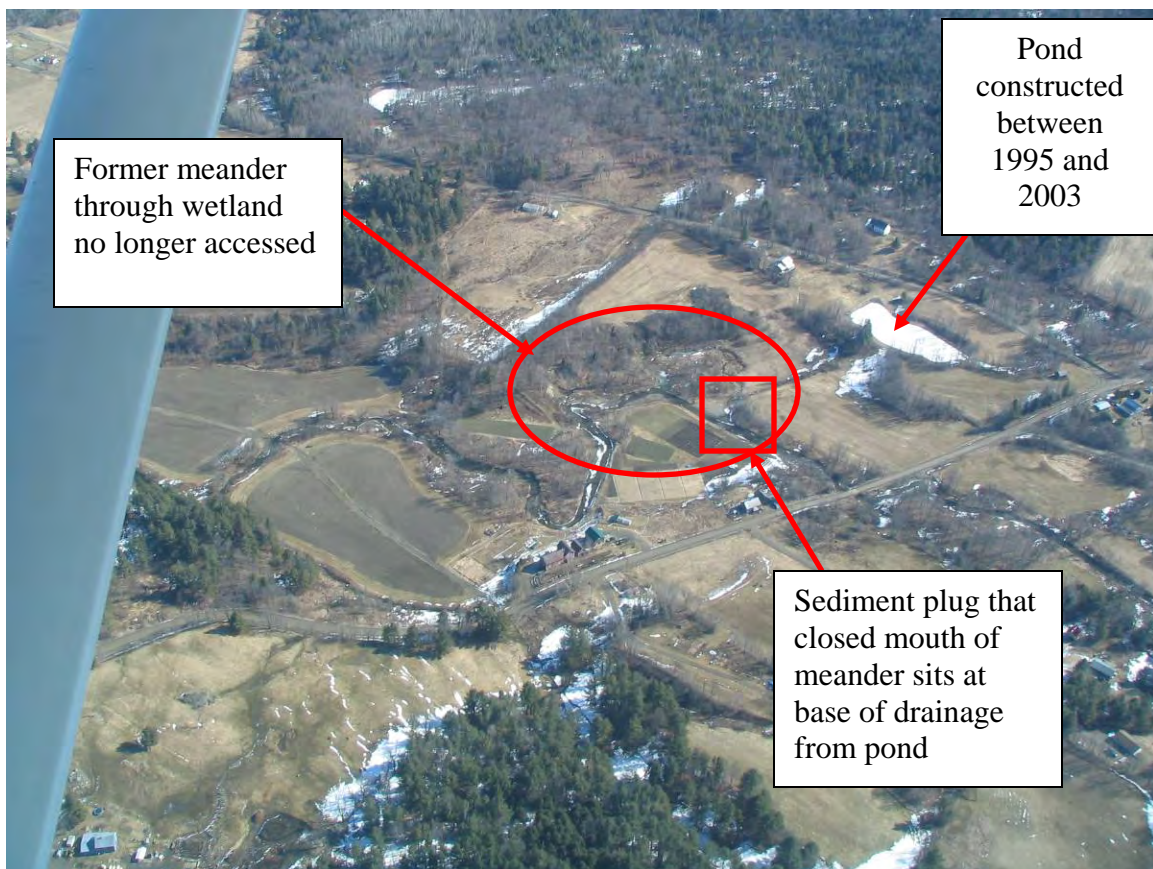
While it is not known exactly when the pond was constructed, it does appear that the sediment plug that closed the top of the meander is located at the downstream end of a drainage flowing away from what is now the pond site, giving rise to questions concerning the impacts of the floods on water and sediment discharges arising from the area of the pond. Given the highly sinuous nature of the stream visible in the 1995 orthophotography it is likely that sediments in this area would be very fine, while the gravels that plugged the meander mouth are coarser. A high flow discharge to the point of the meander plug, however, may have contributed to formation of a delta deposit accruing sediments from Bogue Branch as the floodwaters receded. This area was photographed during a flyover in 2009 (pers. comm., VT-RMP River Scientist Staci Pomeroy and NRPC Land Use Planner Deb Perry), and the disconnected meander as well as the drainage from the pond area leading to the sediment plug are clearly visible in one of the photos (Fig. 57).

Figure 57. Aerial photo from 2009 flyover at the site of a channel avulsion in segment T2.04A indicates that the sediment plug that closed the mouth of the former meander during a 1997 flood sits at the downstream end of a drainage coming from a pond to the east that was built sometime between 1995 and 2003.

The wetland meander in this area played a valuable role in diffusing stream power in particular, and the shortened, steeper channel now flowing by the garlic farm is likely to be further energized. Sensitivity analysis indicated Very High sensitivity for the stream in this area, indicating good chances for the channel to evolve using its own resources to establish new meanders, and significant deposits are already visible in the channel in

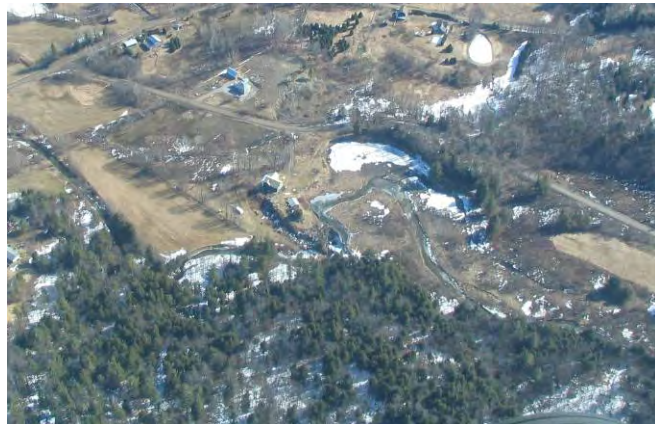
A large impoundment shows up above the dam on 1924 topographic maps (<http://docs.unh.edu/VT/enos24se.jpg>), and is still relatively large in 1995 orthophotos taken during leaf-off conditions. During 2008 assessments, the stream was flowing in a mostly single-thread channel (with some braiding in localized areas) in the interior of the old impoundment, surrounded by an extensive herbaceous wetland (Fig. 60). The old pond appears to function as an oxbow wetland in wet conditions at least, and may remain wet even during the summer (Fig. 61). This area provides some value as an attenuation asset for high flows and sediment, but likely is a break in coarse sediment transport to downstream reaches that may have contributed to “sediment starving” and bed downcutting. While removal might aid channel evolution in downstream reaches, it would be costly and would need more in-depth assessment of the impacts of sediment discharges and possible headcutting upstream (the next grade controls are nearly a mile upstream, though bedrock 0.75 mi upstream is likely close to grade). The dam is located on bedrock, so removal may or may not have aquatic organism passage benefits.

Figure 60. The old mill pond above the Johnson mill dam in Bogue Branch reach T2.05 is now reduced to a mostly single-thread channel, with portions of the old pond (covered in snow here) functioning as an oxbow wetland (2009 aerial photo).

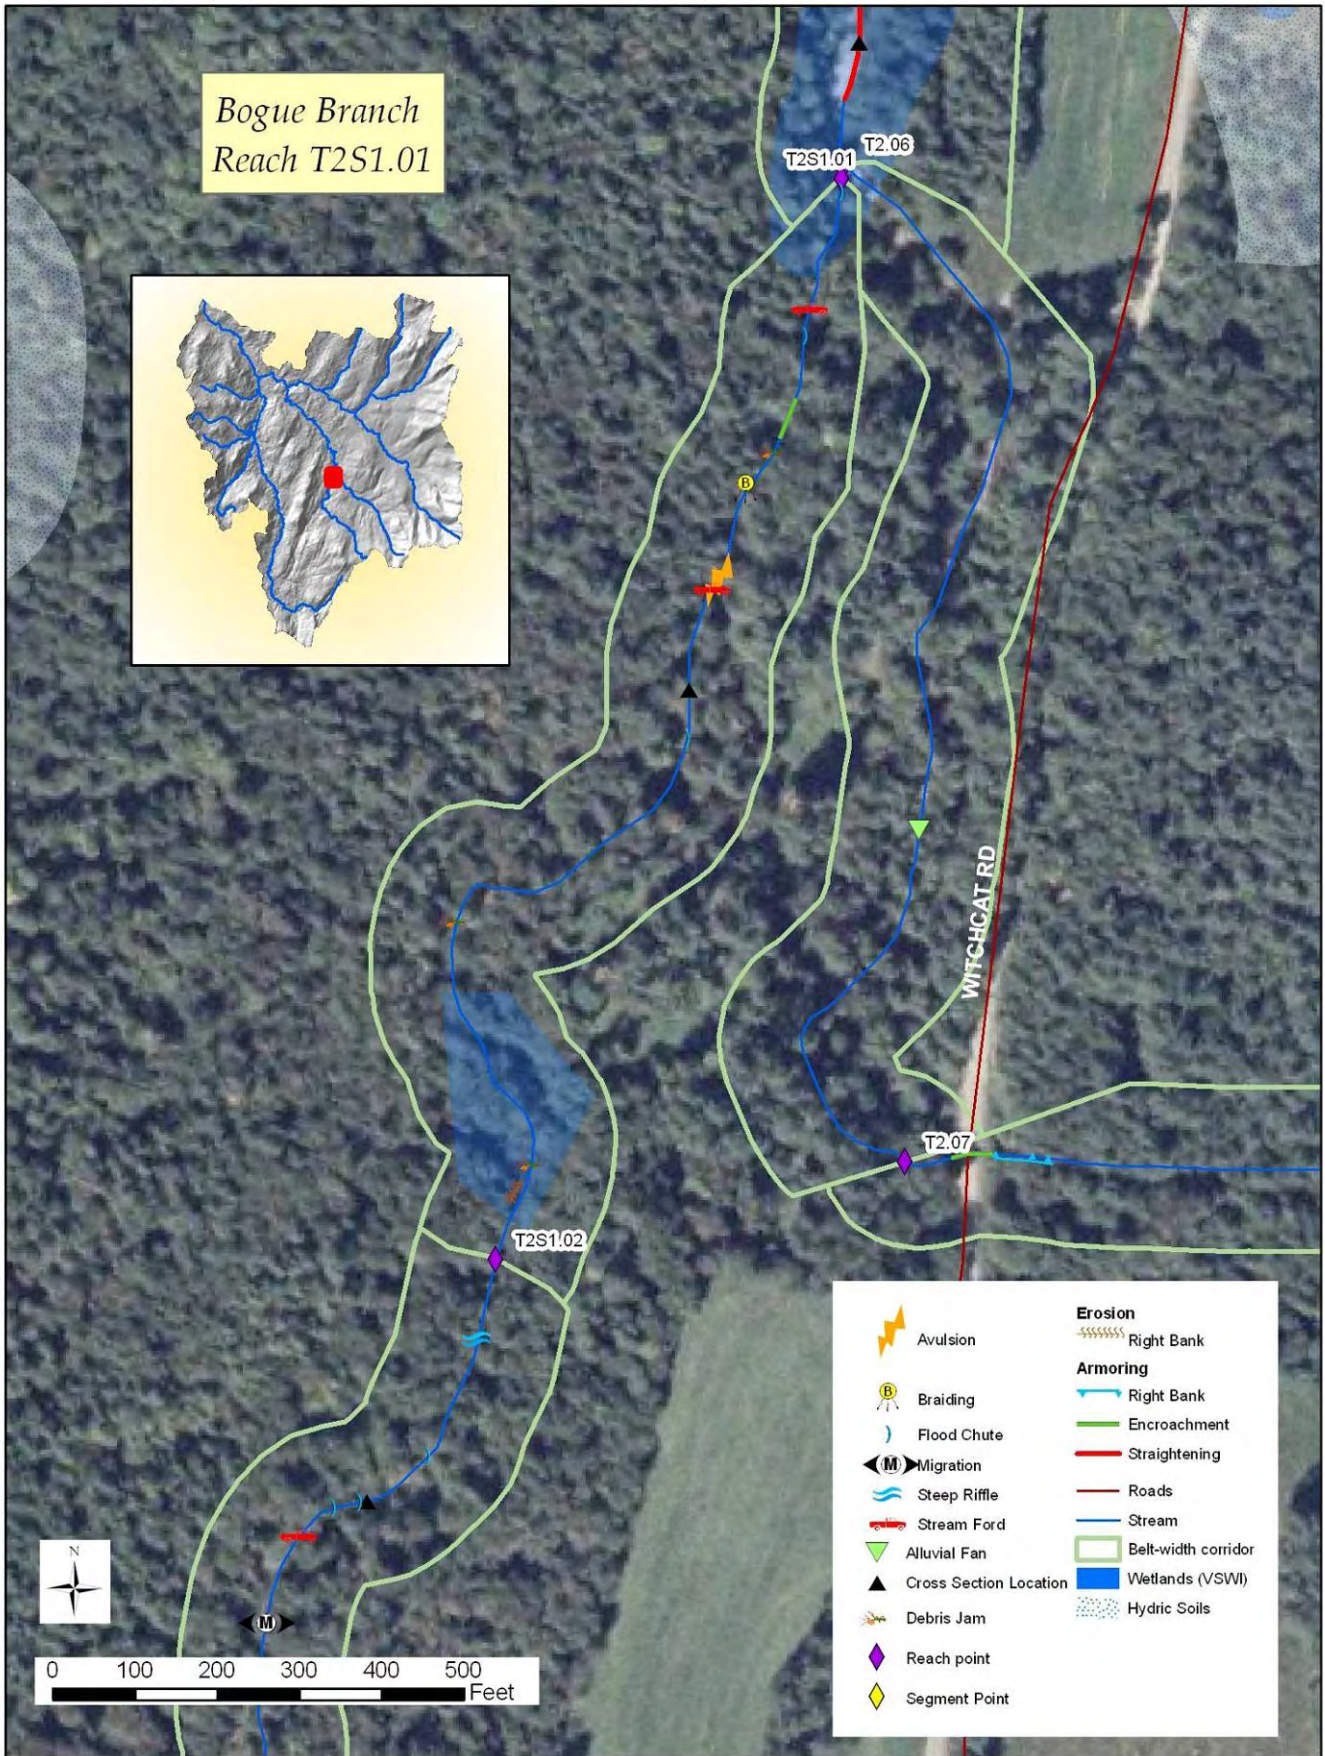
Figure 62. Bogue Branch reach T2S1.01 reach map.

An incision ratio of 1.8 in reach T2S1.01 indicates some loss of floodplain functionality in this area, but not complete loss of access at flood flows. Bedrock outcrops on the left bank at the upstream end of the reach close the valley wall tight on that side but do not form constrictions, and ledge outcrops in the streambed in this area are not channel spanning but are significant. These would be likely to limit further bed downcutting in this area (upstream migration of headcuts may be conceivable if the dam downstream in reach T2.05 is ever removed or largely breached).

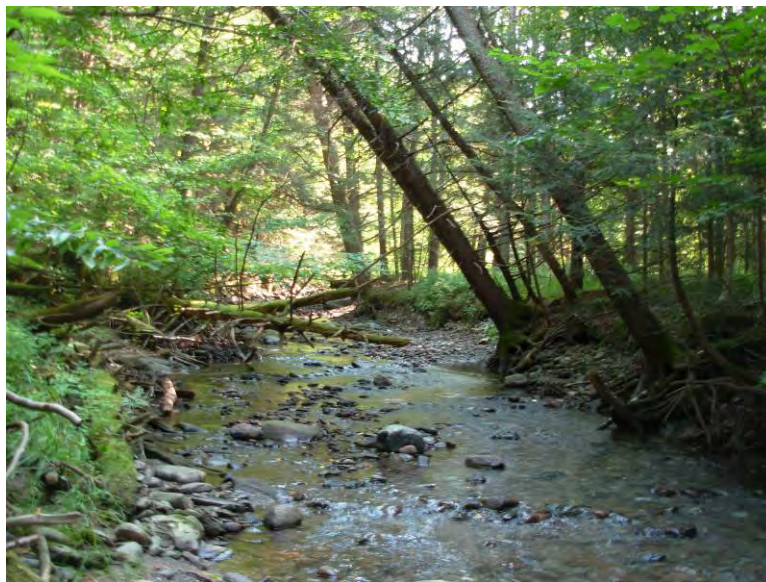
- Dominant buffer on both banks is >100 ft.
- There is a small clearing and cabin along the right bank in mid-segment.
- There is no encroachment on this segment.
- There is a moderate amount of aggradation; with 1 mid-channel bar, 11 side bars, 2 diagonal bars, and 3 steep riffles being mapped.
- Flood chutes are fairly common and appear to be historic channels indicating past stream avulsions. Four flood chutes were mapped.
- There are two fords in this segment.
- The stream is in stage IV. There is some incision and widening appears to be a moderately active process in some parts of the segment. Overall, aggradation is dominant, however. New flood plain benches are being built and the stream appears to be stabilizing.
- Substrate is gravel, sensitivity rating is Very High, and geomorphic rating is Fair.

Figure 63. Bogue Branch reach T2S1.02 segment A: bank erosion where widening is occurring is also causing trees to fall into stream.

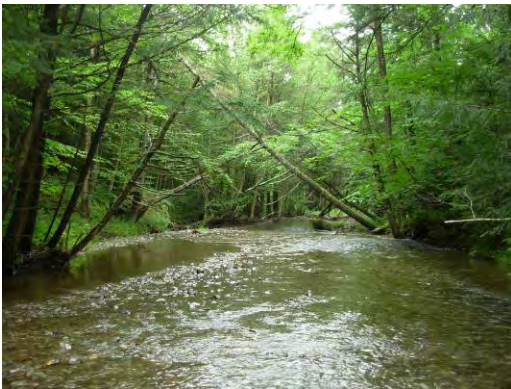
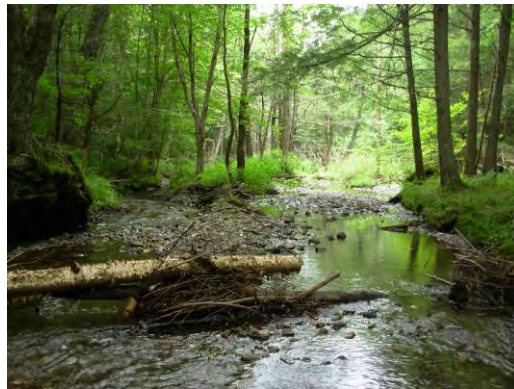
- Buffers on both sides are >100 ft.
- There is no development or encroachment on this segment.
- It appears that this stream channel has been used for skidding in the past. Although straightening was not mapped, the effect of skidding was to straighten and widen this stream channel.
- There is one ledge grade controls at the top of this segment. It measures 2 feet in height.
- Lateral movement seems to be common for this section of stream and there were 3 flood chutes and 3 recent channel avulsions mapped.
- The stream is in stage III, with major aggradation and planform changes occurring. Past skidding in the channel has caused widening.
- Substrate is gravel, sensitivity rating is Very High, and geomorphic rating is Fair.

Figure 65: Bogue Branch reach T2S1.02 segment B. Past skidding has significantly widened the stream channel (left) and channel avulsions are common in this segment (right).

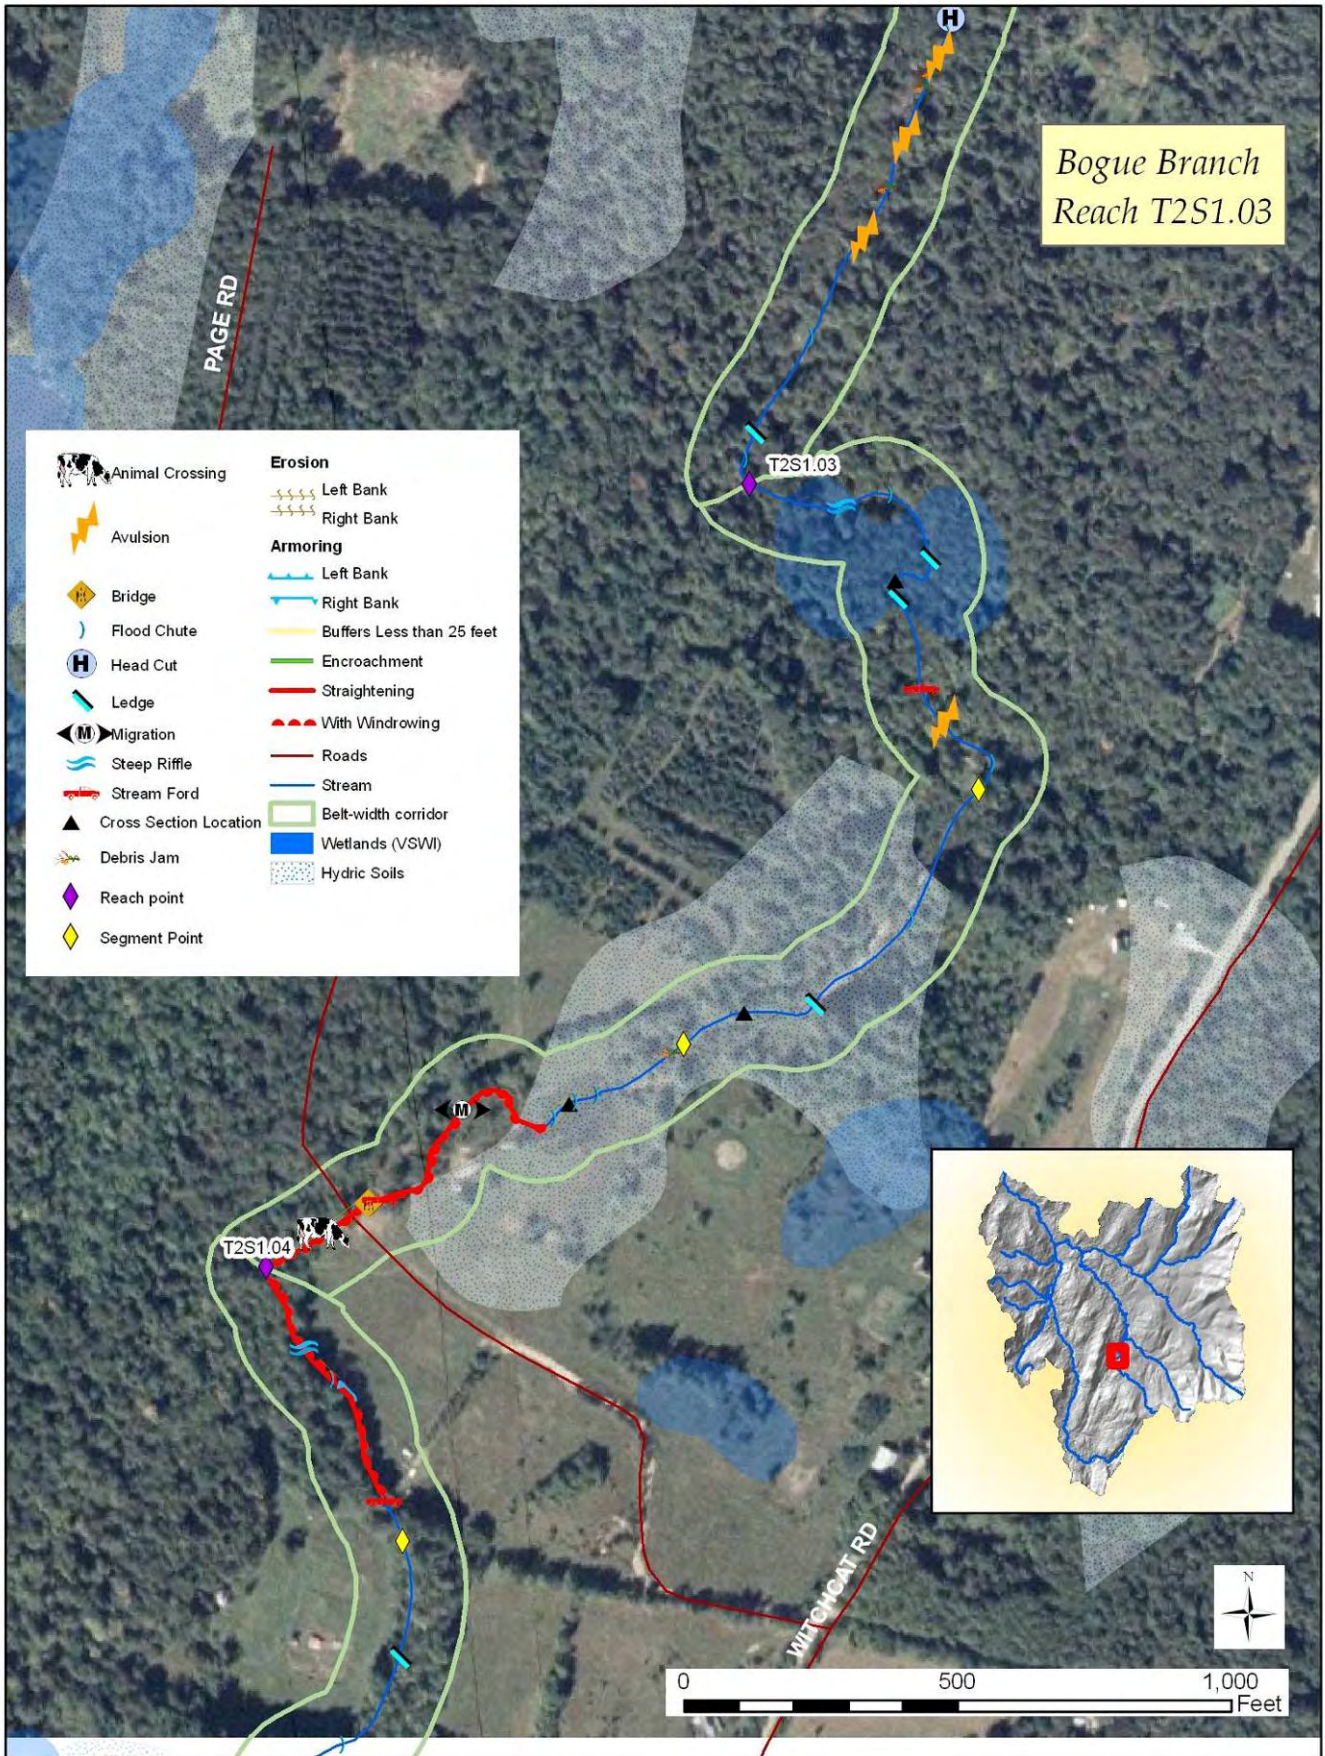
Figure 66: Reach map for Bogue Branch reach T2S1.03.

Soil maps show that both hydric soils and Vermont Significant Wetland Inventory mapped wetlands are a significant presence in this valley (Fig. 66).

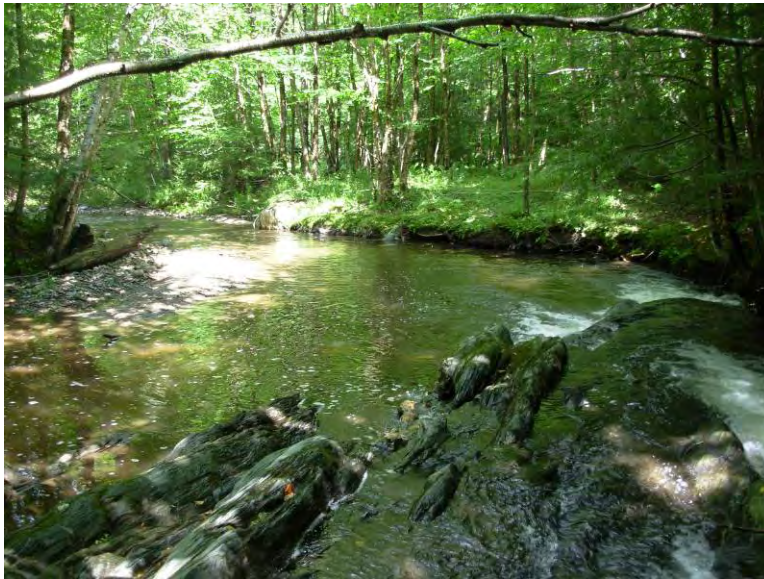
- Dominant buffer on both banks is >100 ft.
- There is no encroachment or development on this segment.
- Lateral movement is somewhat common and 3 flood chutes and one channel avulsion were mapped for the segment.
- Two ledge grade controls are found in mid-segment with one having a total height of 7 feet. There is a constriction also associated with this grade control.
- The stream is in stage I; bedrock serves to stabilize this segment.
- Substrate is gravel, sensitivity rating is Moderate, and geomorphic rating is Reference.

Figure 67: Bogue Branch reach T2S1.03 segment A is stabilized by bedrock features.

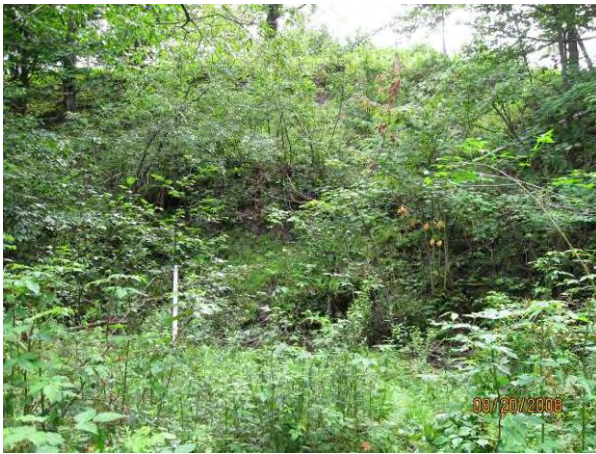
Segment T2S1.04C passes through a recently logged corridor that has a good bit of streamside cutting and several logging crossing points, some of which are used for cattle access to the woods across the stream. More open pasture is visible downstream of a squashed culvert at East Bakersfield Rd., and cattle have unrestricted access to most of the stream from this area extending to the upper portions of the segment. Rotational grazing paddocks appear to be fenced across the stream above East Bakersfield Rd. and extend west to the border of Peaked Hill Rd., and there are some steep erodible sideslopes in this area that have slid under impacts from grazing cattle (Fig. 71). The pasture along Peaked Hill Rd. includes a lot of alder wetland that has been heavily impacted by grazing, and a 200 foot long, 5-6 foot deep gully opened beneath a drainage coming down to segment T2S1.04C from the pasture during summer 2008 storms; this was not necessarily caused by the grazing.

Figure 71. Rotational grazing paddocks appear to be fenced across the stream in segment T2S1.04C, and steep erodible sideslopes have slid under impacts of grazing cattle in some areas.

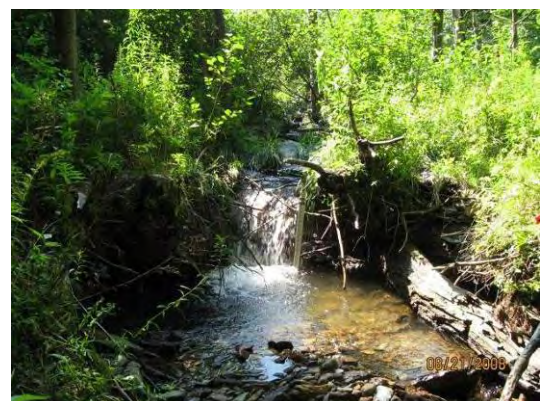
In the upstream portions of segment T2S1.04C, the Branon sugarhouse appears to be located on what may be an alluvial fan, underlain by hydric soils. Several culverts have been installed to channelize streams under the road system that was built to access the property, all of which are undersized to some degree and present both channel and floodprone constrictions. The main culvert that carries Ross Brook is a 7 foot smooth steel culvert that is sized at about 70% of the reference channel width for the stream at this point. Sediment deposition was evident upstream of all of these culverts, likely due to discharges in flash flooding that hit the area upstream of here hard during the summer of 2008. A beaver dam shortly downstream of the culverts was blown out during the storm that caused the flooding, and a significant headcut with potential for upstream migration was evident upstream of the former beaver pond (Fig. 72).

Figure 72. Headcut upstream of beaver pond blow-out in Ross Brook segment T2S1.04C from summer 2008.
