TYLER BRANCH WATERSHED

PHASE 2 STREAM GEOMORPHIC ASSESSMENT

June 2, 2009

Prepared by:
Daniel Ruddell, Elisabeth McLane,
Staff Scientists, and
Ben Machin, Principal
Redstart Consulting

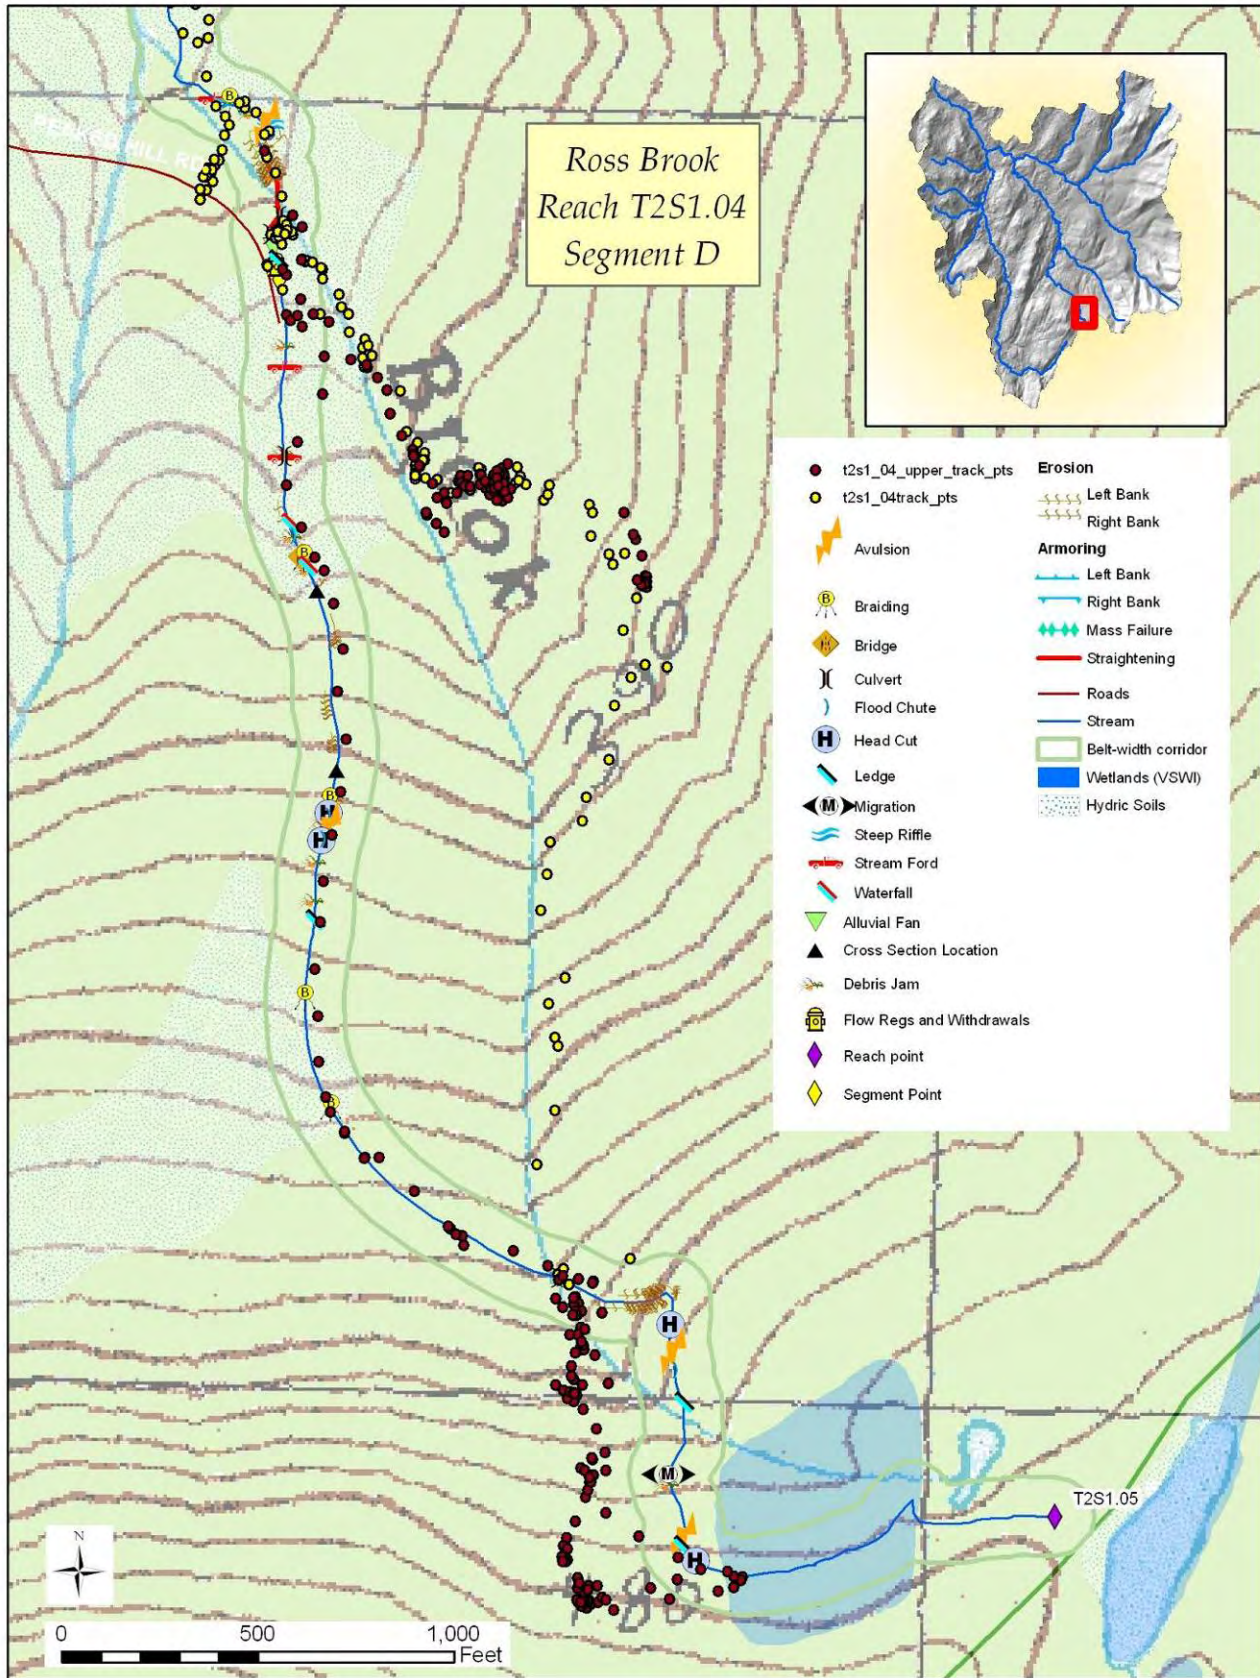
Figure 73. GPS tracks taken along Ross Brook segment T2S1.04 on two different days (yellow and red) indicate that the current stream location coincides better with the streamline indicated on 1986 USGS topographic maps than that indicated by the Vermont Hydrography Dataset (VHD) streamline on which stream impacts and features are mapped. The relatively evenly spaced red points along the VHD at left were collected while walking the main road in the Branon sugarbush.

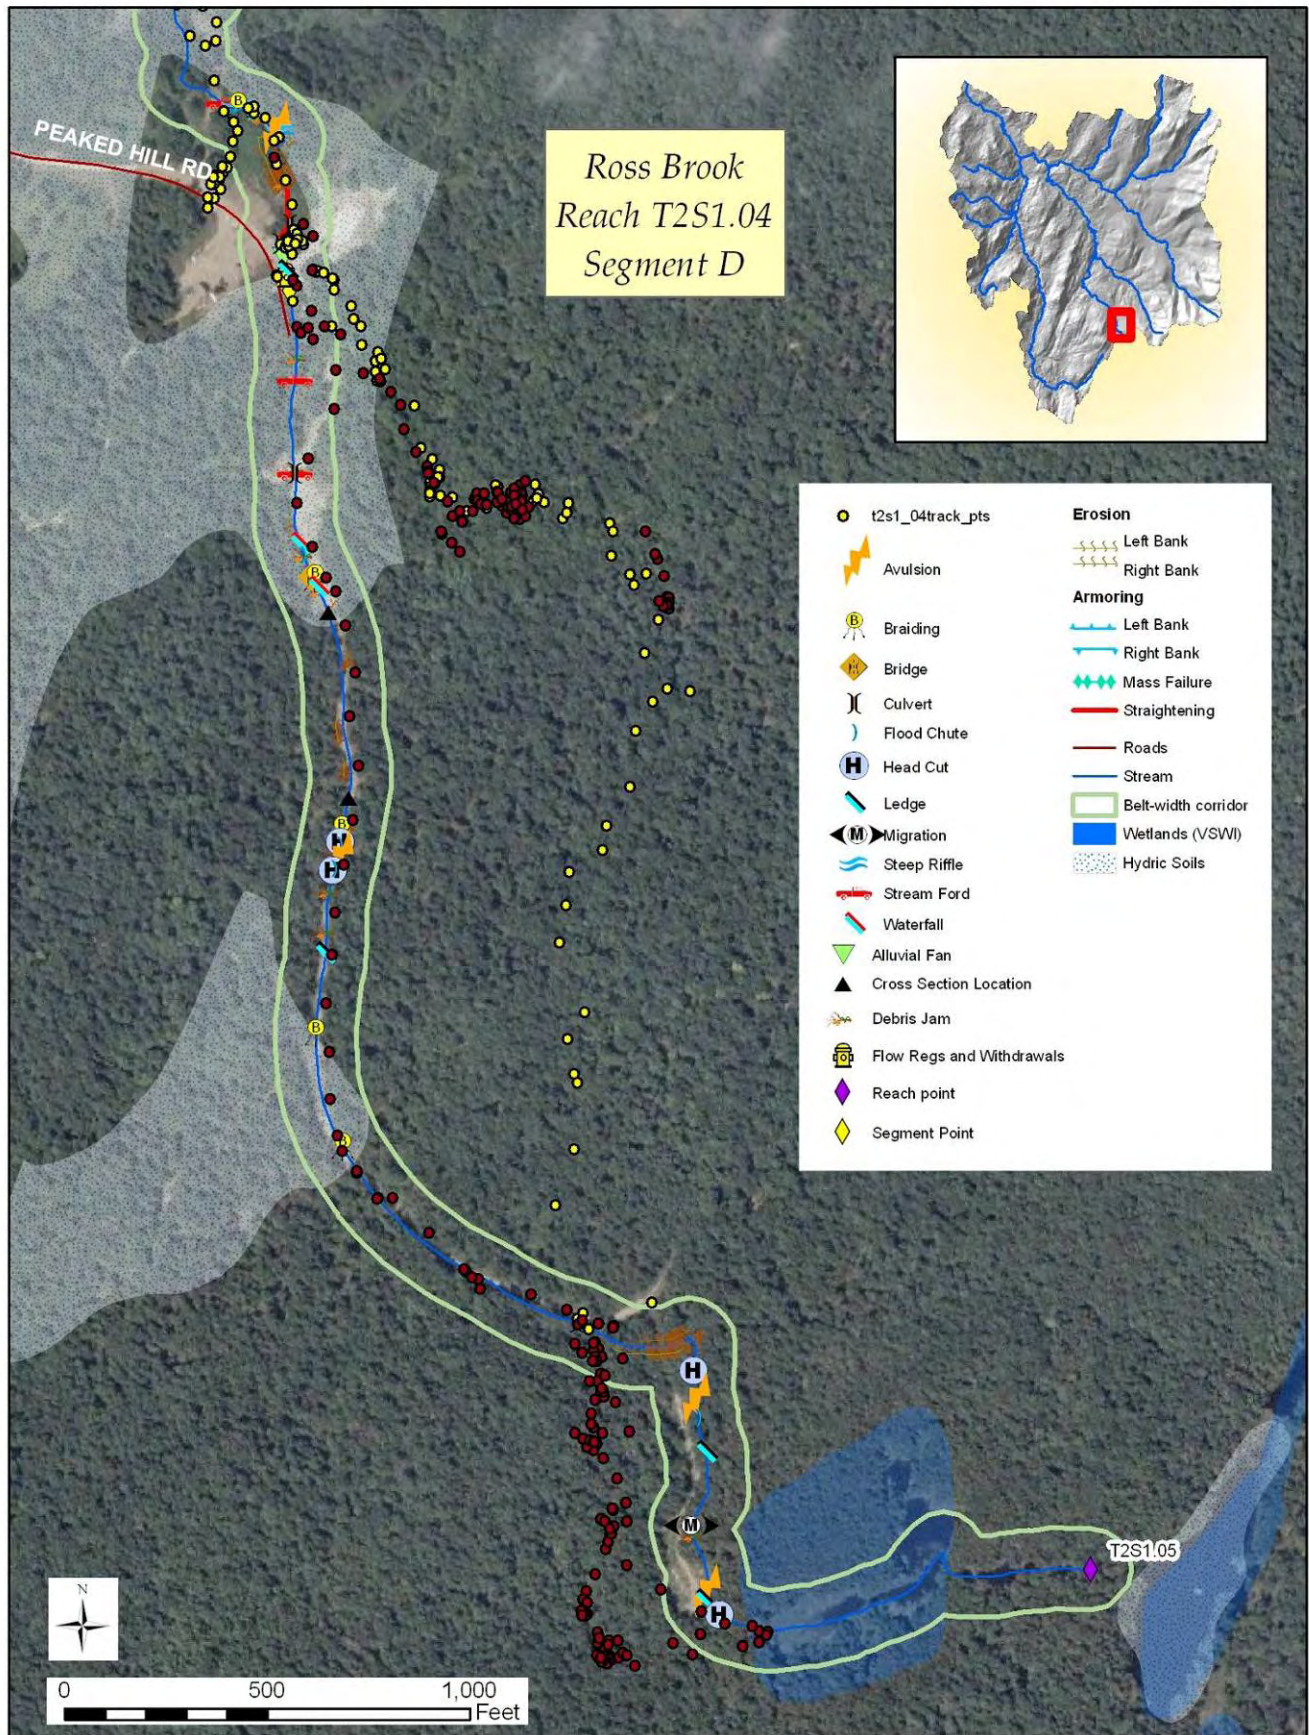
Figure 74. Map for Ross Brook segment T2S1.04D. Yellow GPS track points and clustered red points indicate current stream location.

Further discrepancies on the mapping of segment T2S1.04D occur on the 1986 USGS topos as well. The mid-segment “bulge” in the stream line (Fig. 74) indicates a recent channel avulsion (Fig. 75) that created a new meander in the stream with access to valuable assets for attenuating flow and sediment loads. Beaver ponds at the top of the reach do not drain to this segment as indicated on the USGS topo maps and VHD streamline, rather draining north (larger ponds just to the east drain NNE into another watershed); the closest pond to the head of the reach probably drains back to this segment further downslope in an intermittent tributary that was captured by the recent channel avulsion.

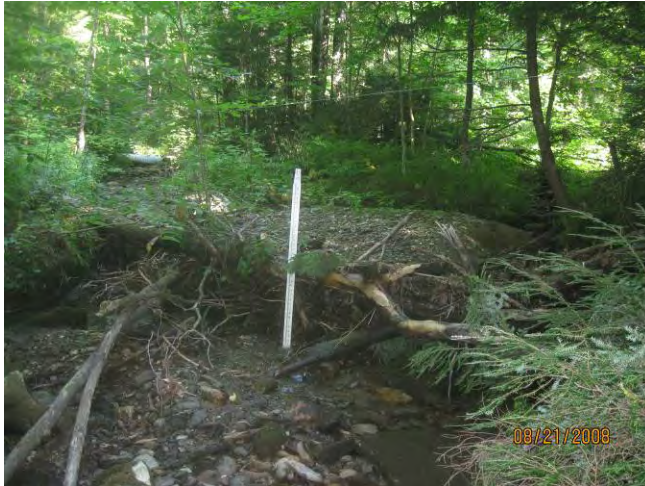
Figure 75. Recent channel avulsion in segment T2S1.04D helped create a new meander that offers opportunities for attenuation of flow and sediment loads. 18 in. culvert visible in background was one of three along this segment that got plugged and outflanked in recent flash flooding.

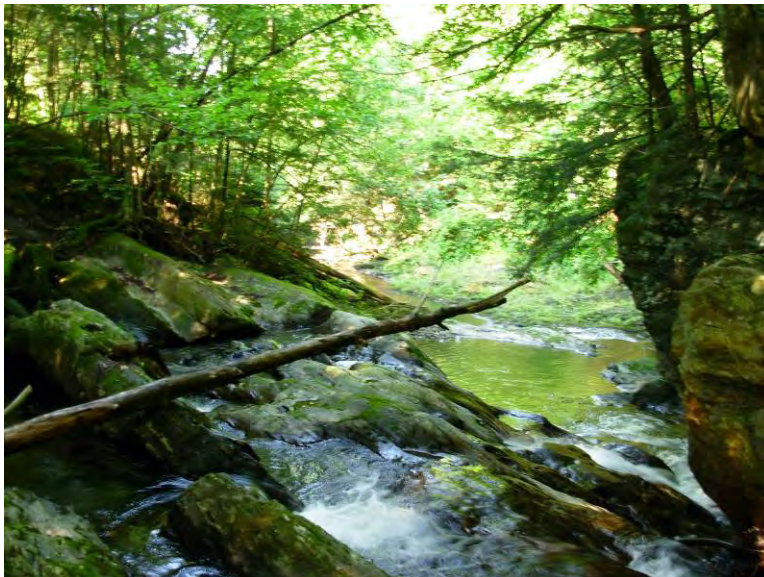
- There were 3 measured grade controls in the segment, one of which measured 27 feet in height.
- There are two mass failures in this segment.
- There is >20% road encroachment along one side of this segment.
- There is one bridge showing signs of deposition both above and below.
- There is a small amount of straightening and armoring associated with the bridge and house encroachment.
- The stream is in stage IIc (using D evolution model). Bedrock controls incision and widening occurs where bedrock allows.
- Substrate is cobble, sensitivity rating is High, and geomorphic rating is Good.

Figure 77: Beaver Meadow Brook (East Enosburgh), Reach T3.01, segment A, bedrock cascade.

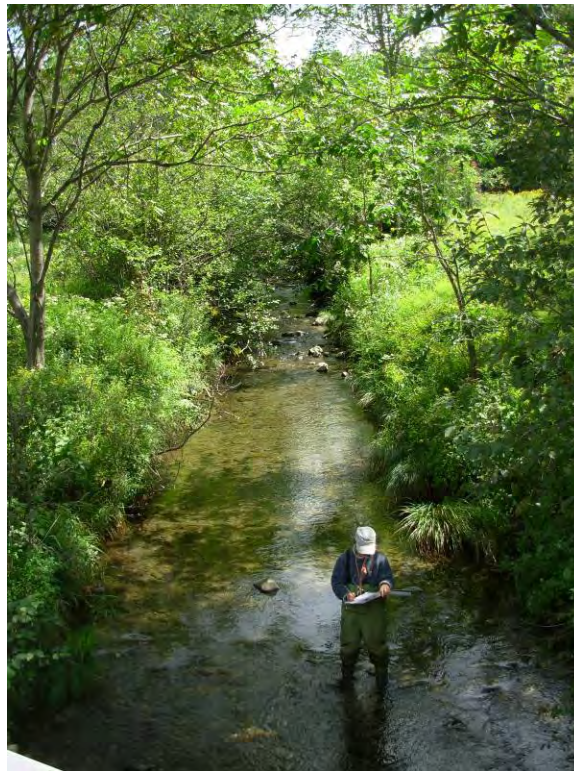
T3S1.01A (1,225 ft) is characterized by having been straightened, channelized and bermed along much of its left bank. The stream may have been dredged or bulldozed post flooding in 1997 or 1998 in an effort to clear sediments from the bridge at Longley Bridge Rd. Channel dimensions are narrower than would be expected for a C-type stream. Channelization may have both deepened the channel and lined the banks with material from the bed. There is some possibility that this section of stream could be an E-type by reference, but given the setting and slope, it seems more likely that it would naturally retain C-type channel dimensions similar to both upstream and downstream. Key features include:

- More than 50% of the segment appears to have been straightened and windrowed.
- There is a berm along the left bank for almost 40% of the segment (likely protecting downstream development).
- There is >20% armoring along the left bank of this segment.
- Buffer is <25 ft for almost 40% of the segment on the left bank.
- Longley Bridge Rd. bridge is sized at 108% of reference channel width but is showing signs of deposition upstream of the bridge.
- The stream is in stage II, with incision still the dominant process. Channel evolution maybe be somewhat inhibited by windrowing, armoring, and berming of the channel banks.
- Substrate is gravel, sensitivity rating is Very High, and geomorphic rating is Fair.

Figure 82: Reach T3S1.01, segment A shows significant historic straightening.

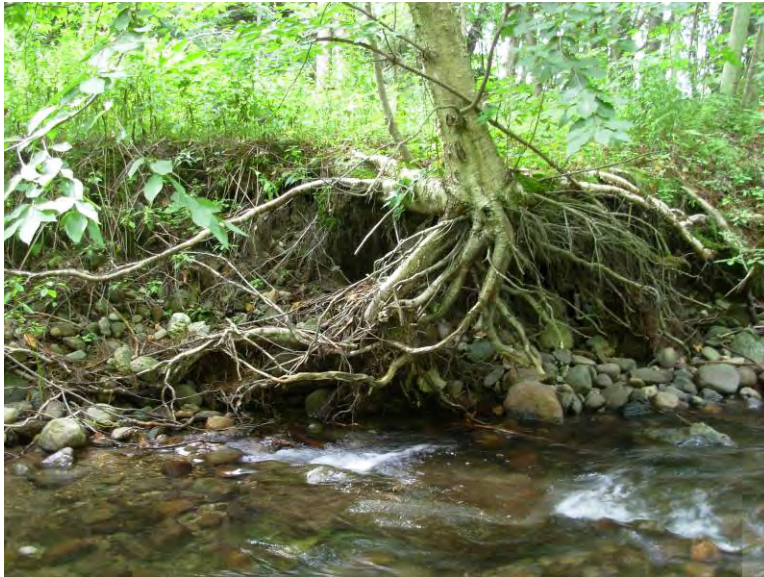
T3S.101B (1,523 ft) has been less manipulated and retains a more natural planform than segment A. Processes appear dynamic in this segment, as historic incision has led to widening and aggradation as the stream attempts to re-establish its equilibrium. Timber harvesting has taken place recently in the area, thinning the buffer, but not overly affecting the stream channel. There is one stream ford. Key features include:

- There are no corridor encroachments in this segment.
- Erosion is common with >20% effected on the left bank and >10% on the right bank.
- Debris jams are common, with 6 occurring in this segment.
- Buffers are >100 ft for the entire segment, on both sides.
- The stream is in stage III, historic incision having led to widening and aggradation. New floodplain benches are forming as the stream moves towards evolution stage IV (stabilizing).
- Substrate is gravel, sensitivity rating is High, and geomorphic rating is Fair.

Figure 83: Reach T3S1.01 segment B has a forested buffer. Widening following incision has led to a significant amount of bank erosion and tree-fall into the stream, causing debris jams.

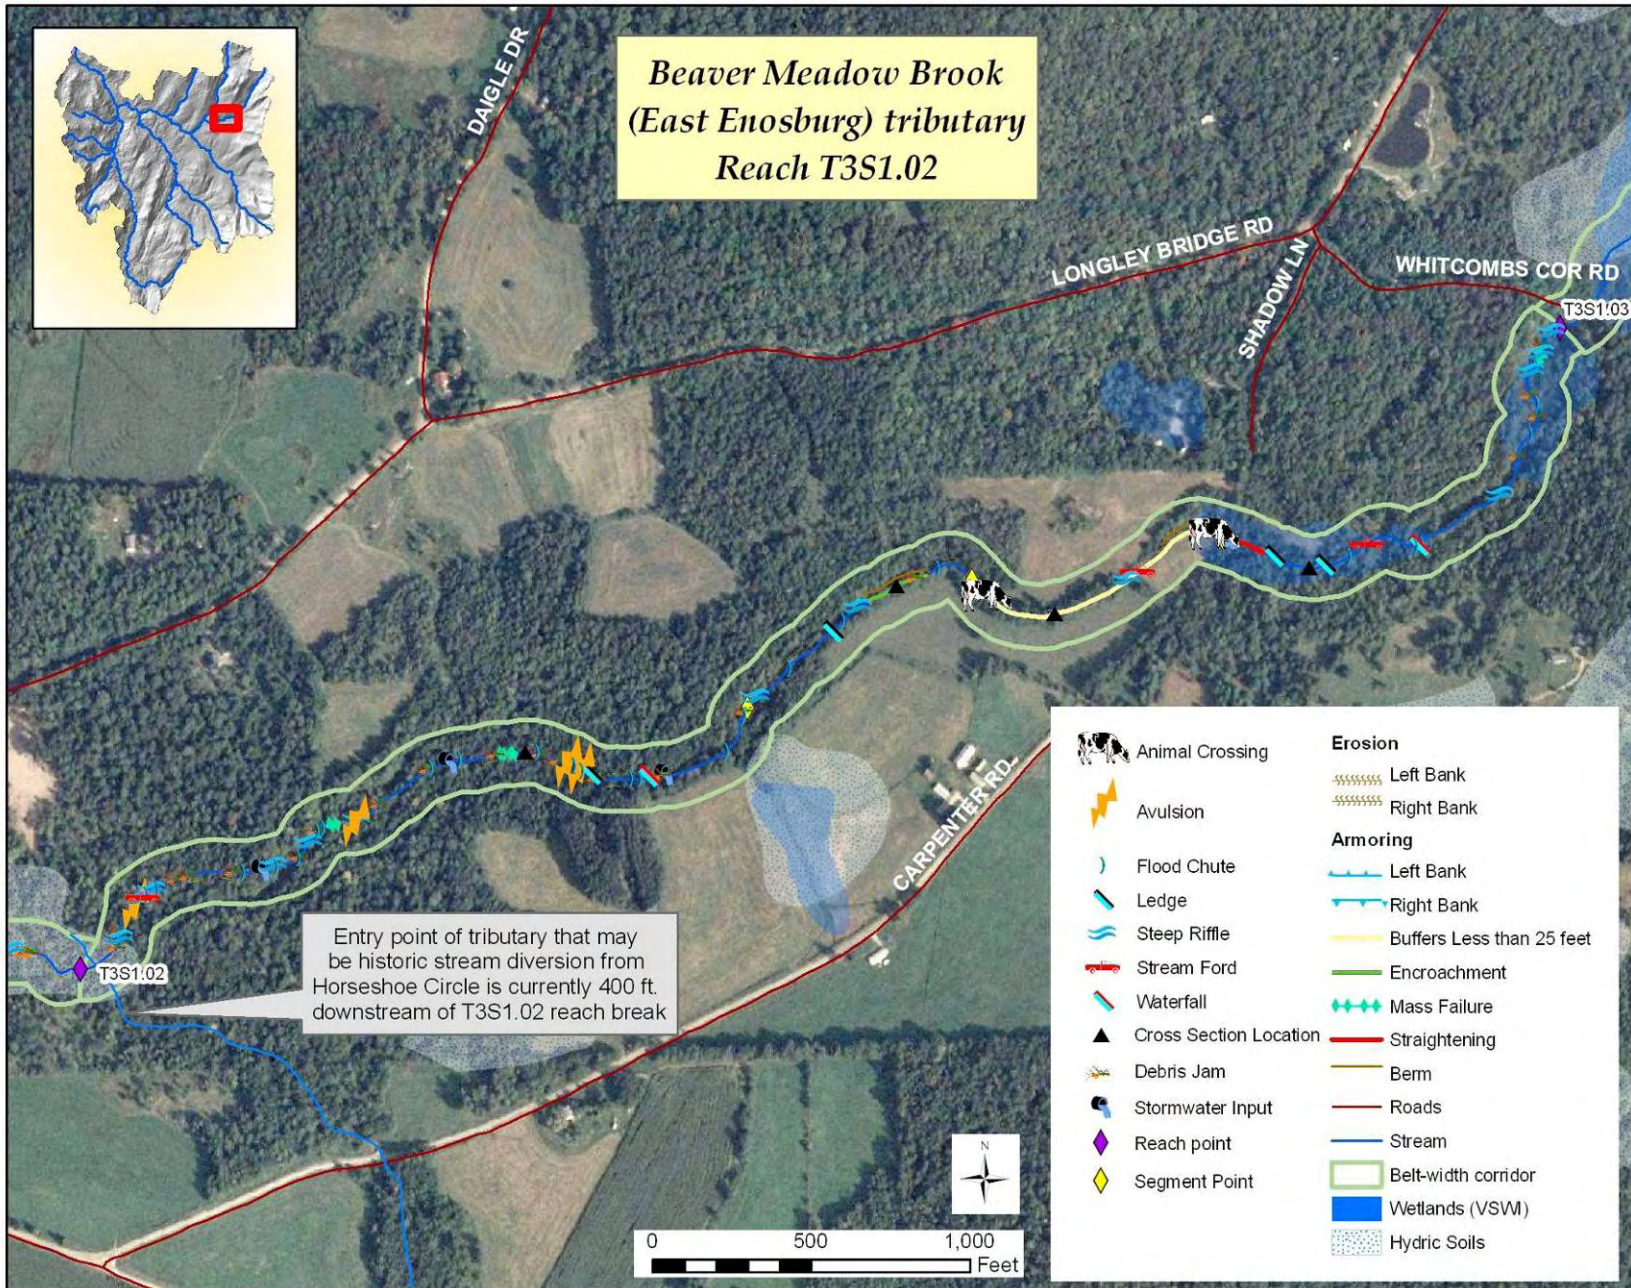
Figure 84: Un-named tributary to Beaver Meadow Brook (East Enosburgh), reach T3S1.02.

Reach T3S1.02 is 5,899 feet long (1.12 miles) and was segmented four times during the Phase 2 assessment process. Segments are 2,499, 890, 914, and 1,595 feet long. This reach is characterized by a Broad valley and only a small amount of hydric soils in the valley, at the top of the reach. The Phase 1 process classified this reach as a C-type stream with a b-subslope (2-4%), a riffle-pool bedform, and a cobble substrate. Three of the 4 segments retained this classification. Segment B has experienced a stream type departure from C to F due to extensive historic incision.

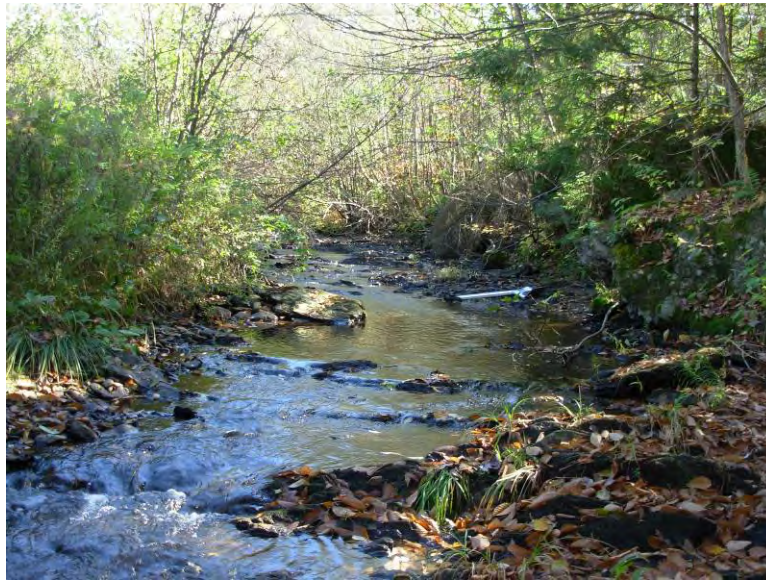
- Dominant buffer on both banks is >100 feet.
- There is no corridor development in this segment and only a tiny bit of road encroachment at the top of the reach
- Three bedrock grade controls were mapped in this segment. One of them had a height of 6 feet.

- Aggradation in T3S1.02D is moderate, with 1 mid-channel bar, 13 side bars, and 4 steep riffles being mapped.
- Flood chutes are common in the segment (7 were mapped).
- The stream is in stage III. Historic incision has lowered the stream bed to where it has encountered bedrock. Further incision is unlikely. Widening and planform changes are somewhat inhibited by bedrock in the stream banks.
- Substrate is cobble, sensitivity rating is High, and geomorphic rating is Fair.

Figure 87: Reach T3S1.02 segment D has frequent bedrock in the bed and on the banks that inhibits incision, widening, and planform changes.

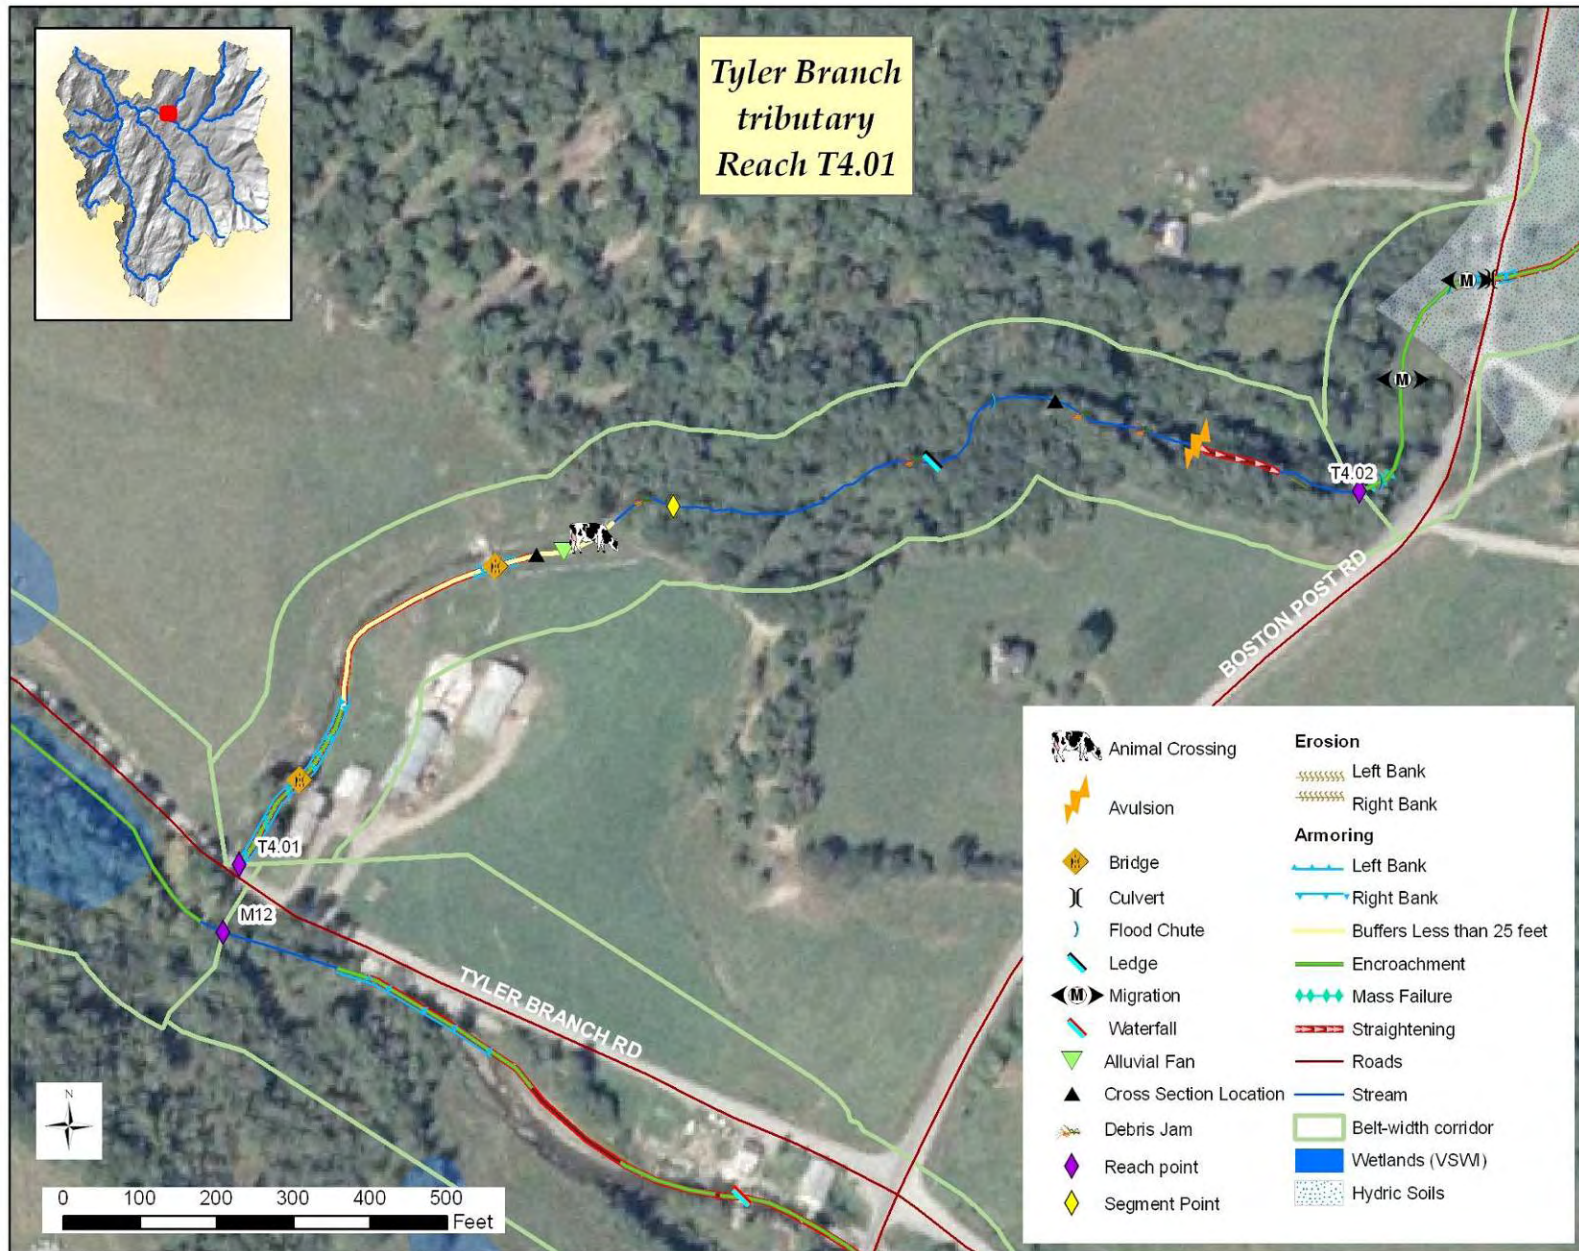
Figure 89: Un-named tributary to the Tyler Branch mainstem: Reach T4.01.

Reach T4.01 is 1,789 feet long (0.34 miles) and was segmented once during the Phase 2 assessment process. Segments are 805 and 984 feet long. This reach was characterized during the Phase 1 process as having a semi-confined valley. Phase 2 assessment found only the upper portion of the reach having a semi-confined valley, with the lower widening into a very broad valley. The stream was classified as a B-type stream with a step-pool bedform and a cobble substrate. Segment B retained this classification, but segment A, due to a much broader valley and extensive manipulation of the channel, was found to be a C-type stream with a b-subslope (2-4%), planebed bedform and a gravel substrate.

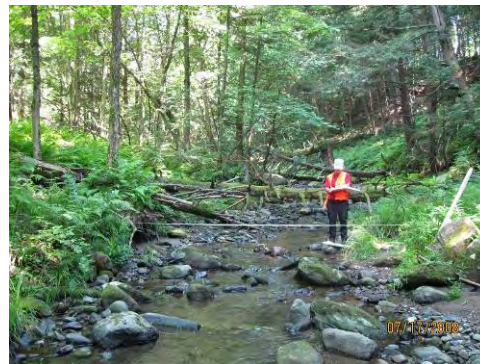
T4.01B (984 ft) has not been manipulated and is characterized by a forested buffer, a semi-confined valley, and a small amount of bedrock in the bed and banks. Key features include:

- Buffer vegetation is >100 feet on both banks.
- There is no development or encroachment on this segment.
- There is one bedrock grade control in mid-segment, with a total height of 4 ft.
- Aggradation is moderate, with 3 mid-channel bars and 7 side bars mapped.
- Moderate planform changes include an avulsion.
- The stream is in stage IV. Historic incision in the upper reach has led to widening and new flood plain development.
- Substrate is cobble, sensitivity rating is Moderate, and geomorphic rating is Good.

Figure 90: Reach T4.01 segment B is in relatively stable condition with coarse substrate and a forested buffer.
