# **Phase 2 Stream Geomorphic Assessment**

**Tyler Branch Watershed  
Towns of Sheldon, Enosburg, and Bakersfield  
Franklin County, Vermont**

**March 2006**

Re: Phase 2 Stream Geomorphic Assessment  
Tyler Branch Watershed  
Franklin County, Vermont  
JCO Project No. 3-1313-1

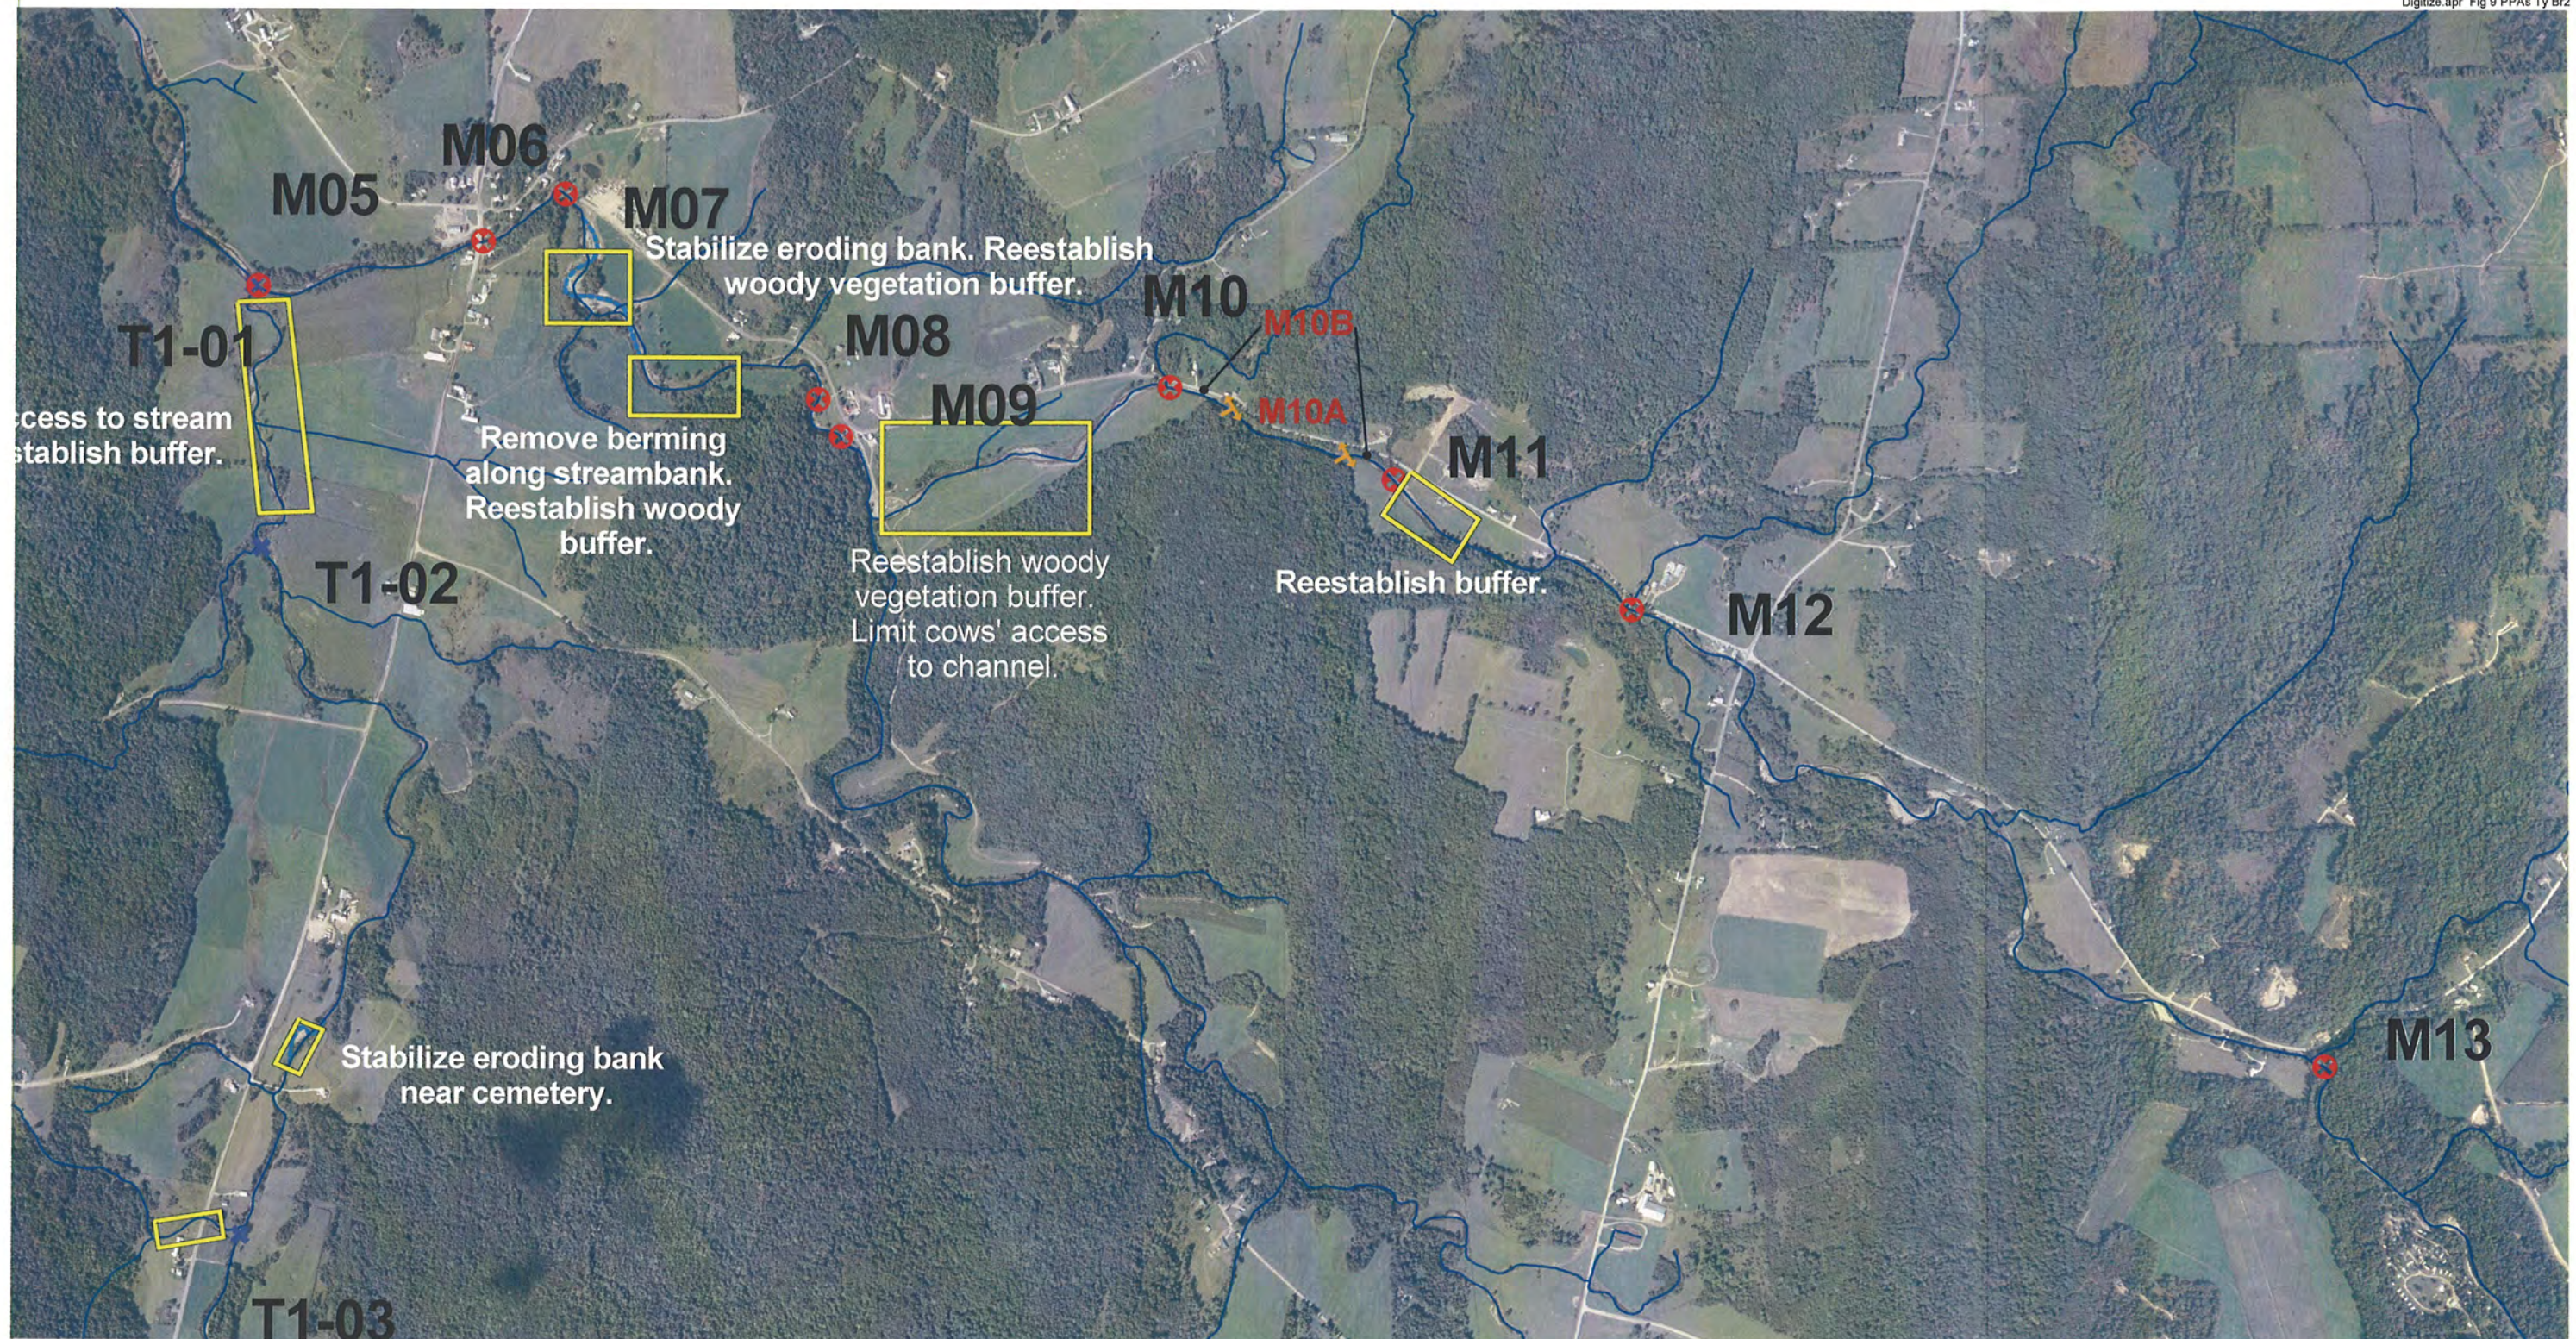
**Figure 9. Potential Project Areas- Tyler Branch Reach M05-M12 Phase 2 Geomorphic Assessment Enosburg-Bakersfield, Vermont**

- **Tyler Branch M09** (Photo Point 7) – Two major problems were noted in M09, virtually no riparian buffer, and cattle access to the streambed throughout the reach. The entire right riparian corridor, including the stream channel is utilized for pasture, and a travel corridor for cattle to access upstream grazing areas. It may be possible to work with the landowner to reestablish an adequate buffer, and limit the cows' access to the stream channel to reduce nutrient inputs.
- **Tyler Branch M11** – Like M09, M11 suffers from a lack of riparian buffer along the downstream end of the reach. While there is no major active erosion currently taking place, establishment of woody vegetation would stabilize the stream bank and help prevent erosion in the future.

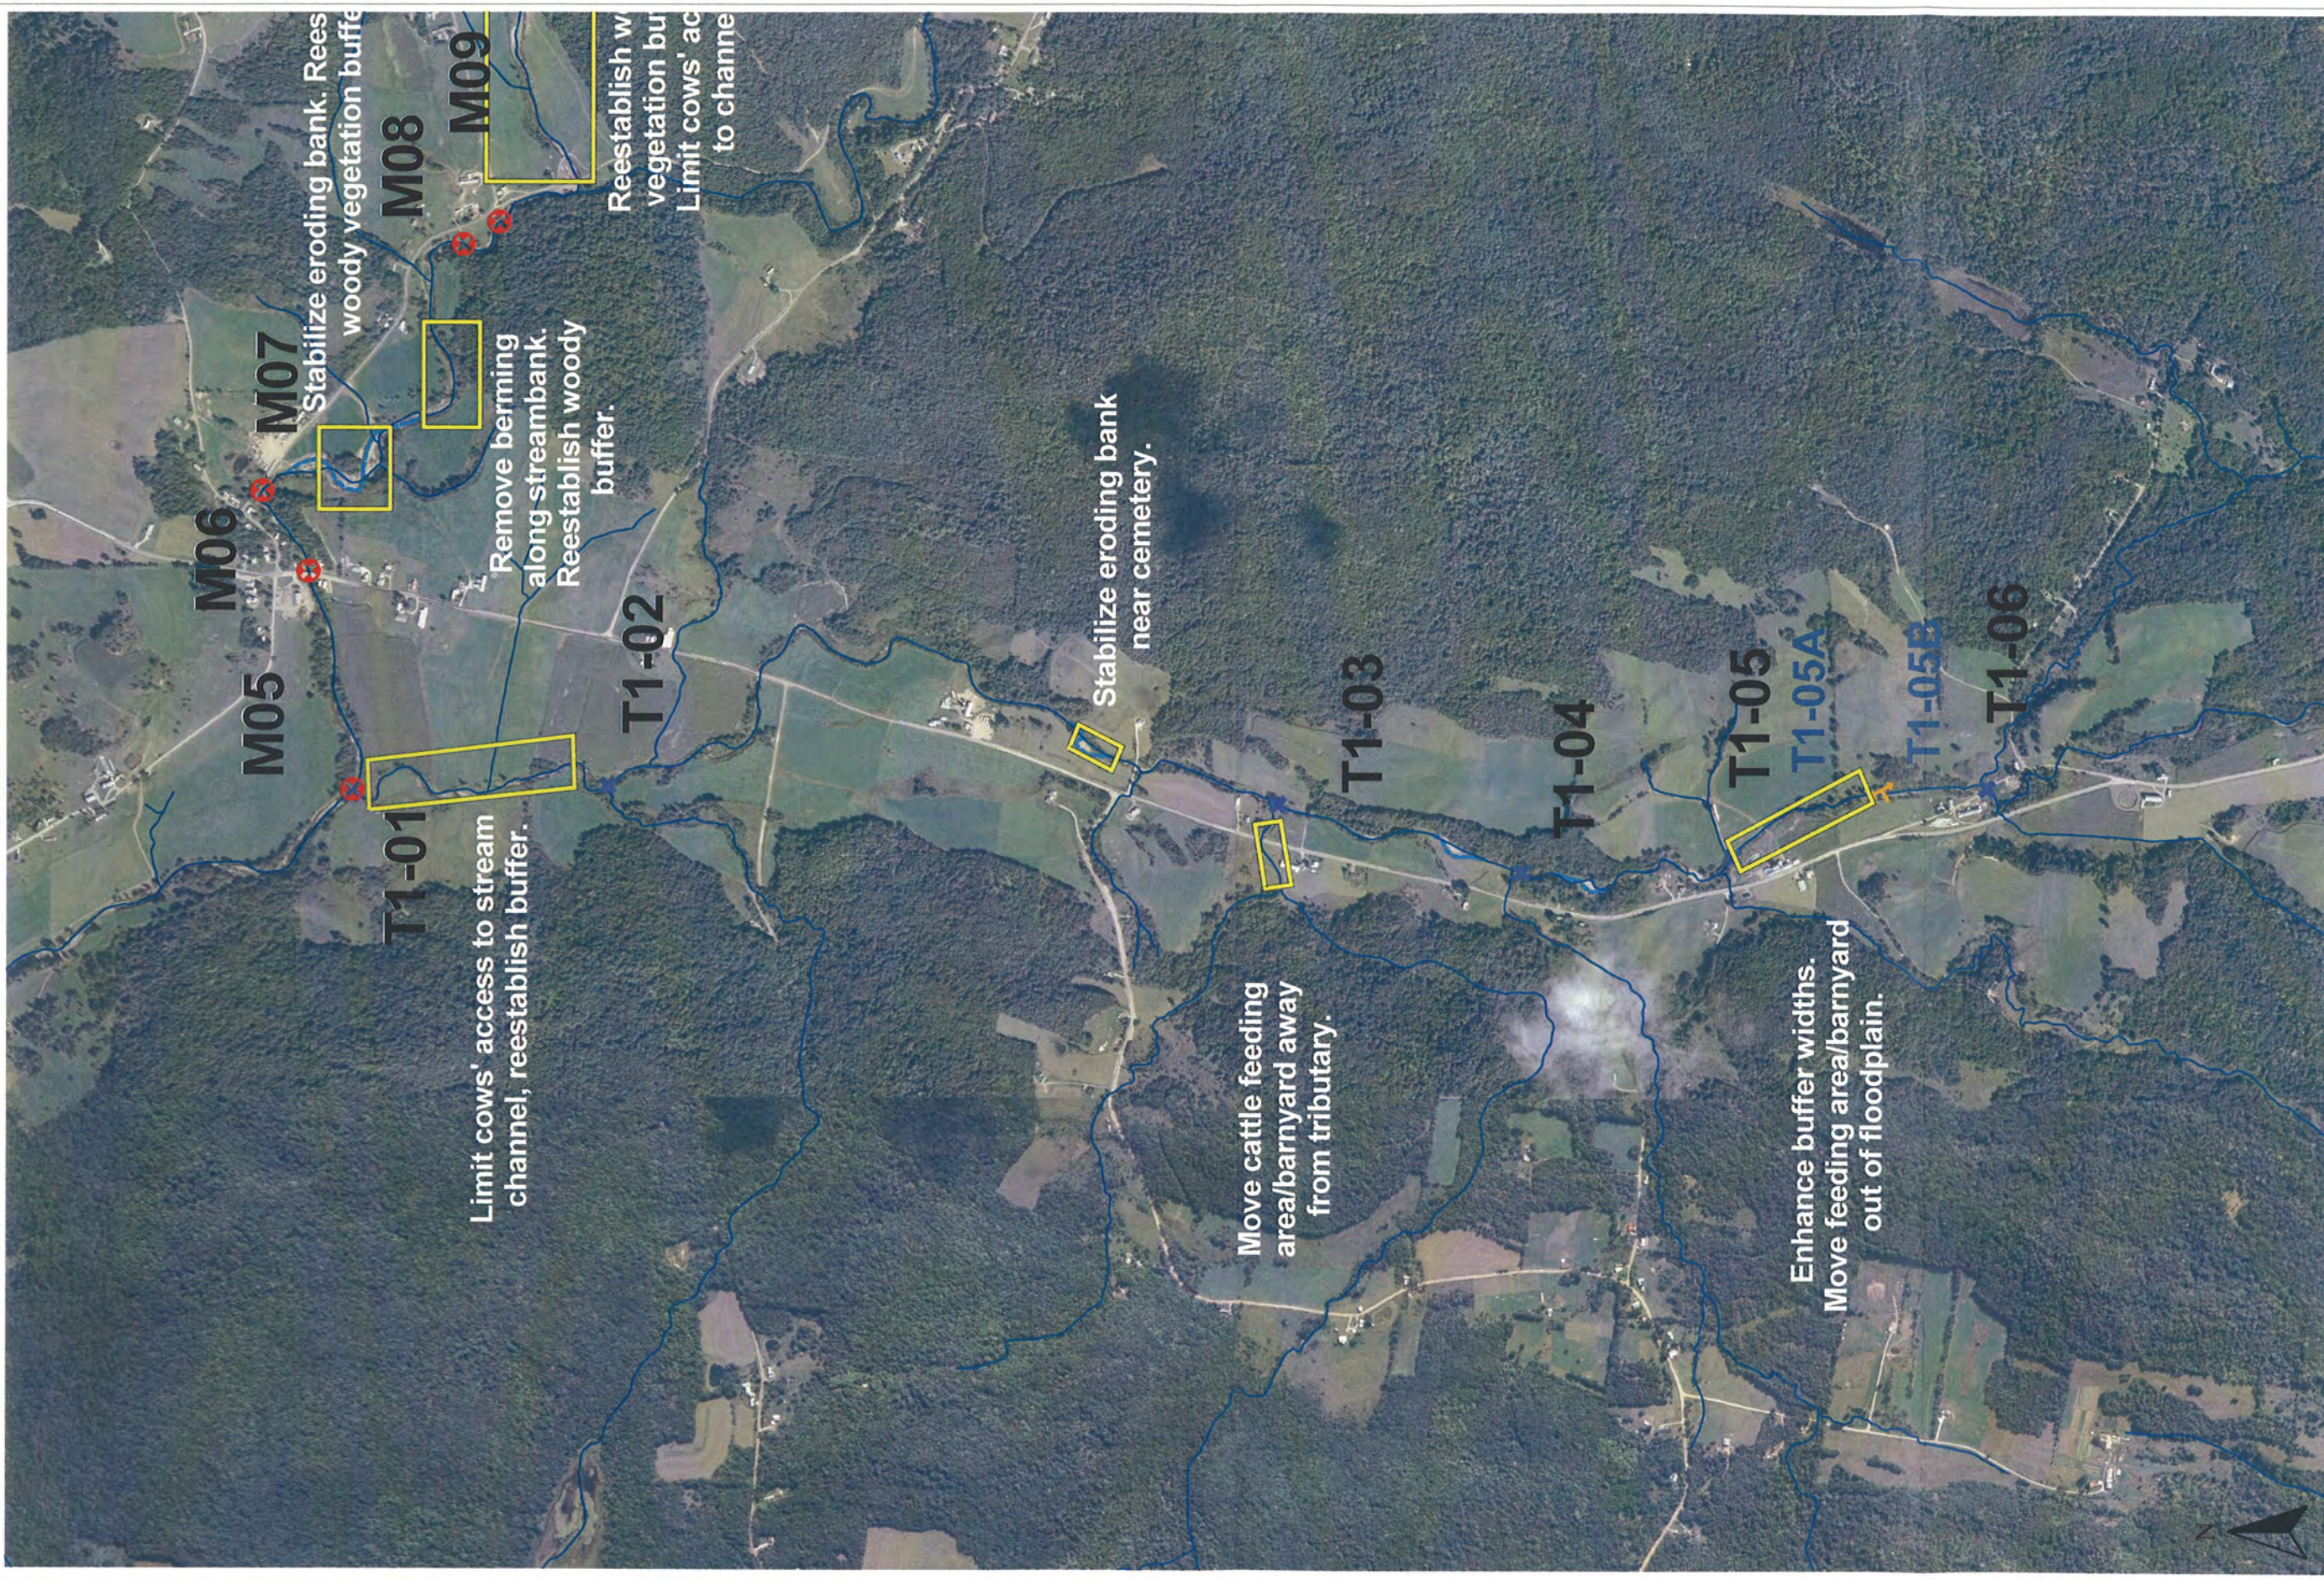
**Figure 10. Potential Project Areas- The Branch Reach T1-01-T1-05 Phase 2 Geomorphic Assessment Enosburg-Bakersfield, Vermont**

Stream type departures were observed in only three of the 20 reaches; T1-01, T1-03, and T1-05A which all have departed from their reference type (C) to a B type channel due to historic degradation. The other reaches have all experienced some degree of historic degradation, though not enough to totally eliminate floodplain access. The dominant sediment regime for the watershed is aggradation. A tremendous amount of excess sediment was observed throughout as seen by enlarged point, side, mid-channel, and diagonal bars. Multiple steep riffles were also observed. Some rather significant erosion was noted at various points, but not enough to account for all of the observed stored sediment. Two factors could explain this discrepancy: 1) The tributaries which were not assessed as part of this project are contributing a great deal of sediment to the system, and 2) The watershed is a naturally high bedload system, and historic
