Poultney River Geomorphic Assessment and Stream Corridor Plan

**Prepared by the Poultney-Mettowee
Natural Resources Conservation District**

December 2006

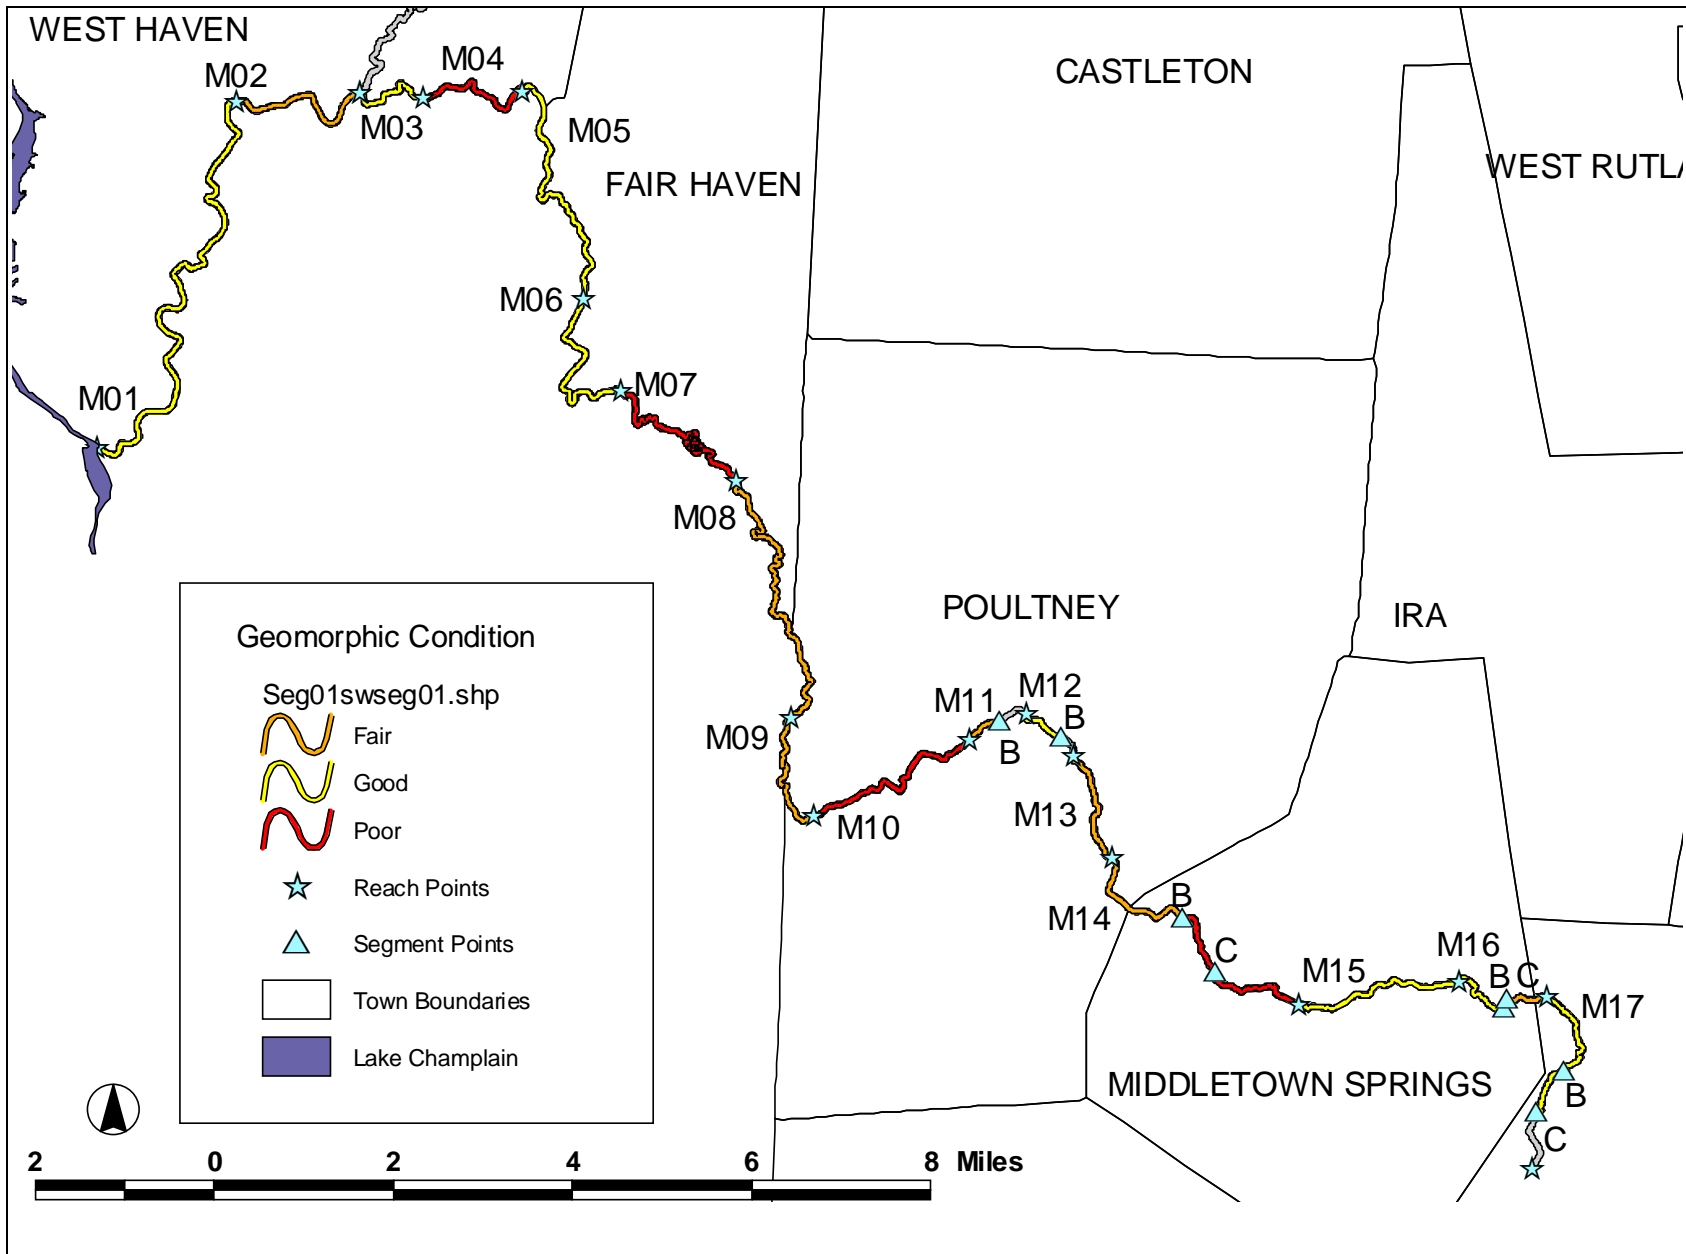
Figure 3 shows RGA Condition categories for each of the study reaches and segments. Main factors affecting RGA condition were historical channel straightening, aggradation, migration, and channel obstructions and constrictions, which are discussed in more detail below.

Reach M04 appeared in “Poor” condition, resulting from severe channel incision attributed to dam operations and reduction in sediment load downstream of the dam (Figure 4). Reach M07 also appeared in “Poor” condition. Factors affecting M07 were channel straightening for highway construction resulting in extreme channel planform adjustments, bank erosion, and pending neck cutoffs.

Figure 3. Rapid Geomorphic Assessment Condition category for study reaches.

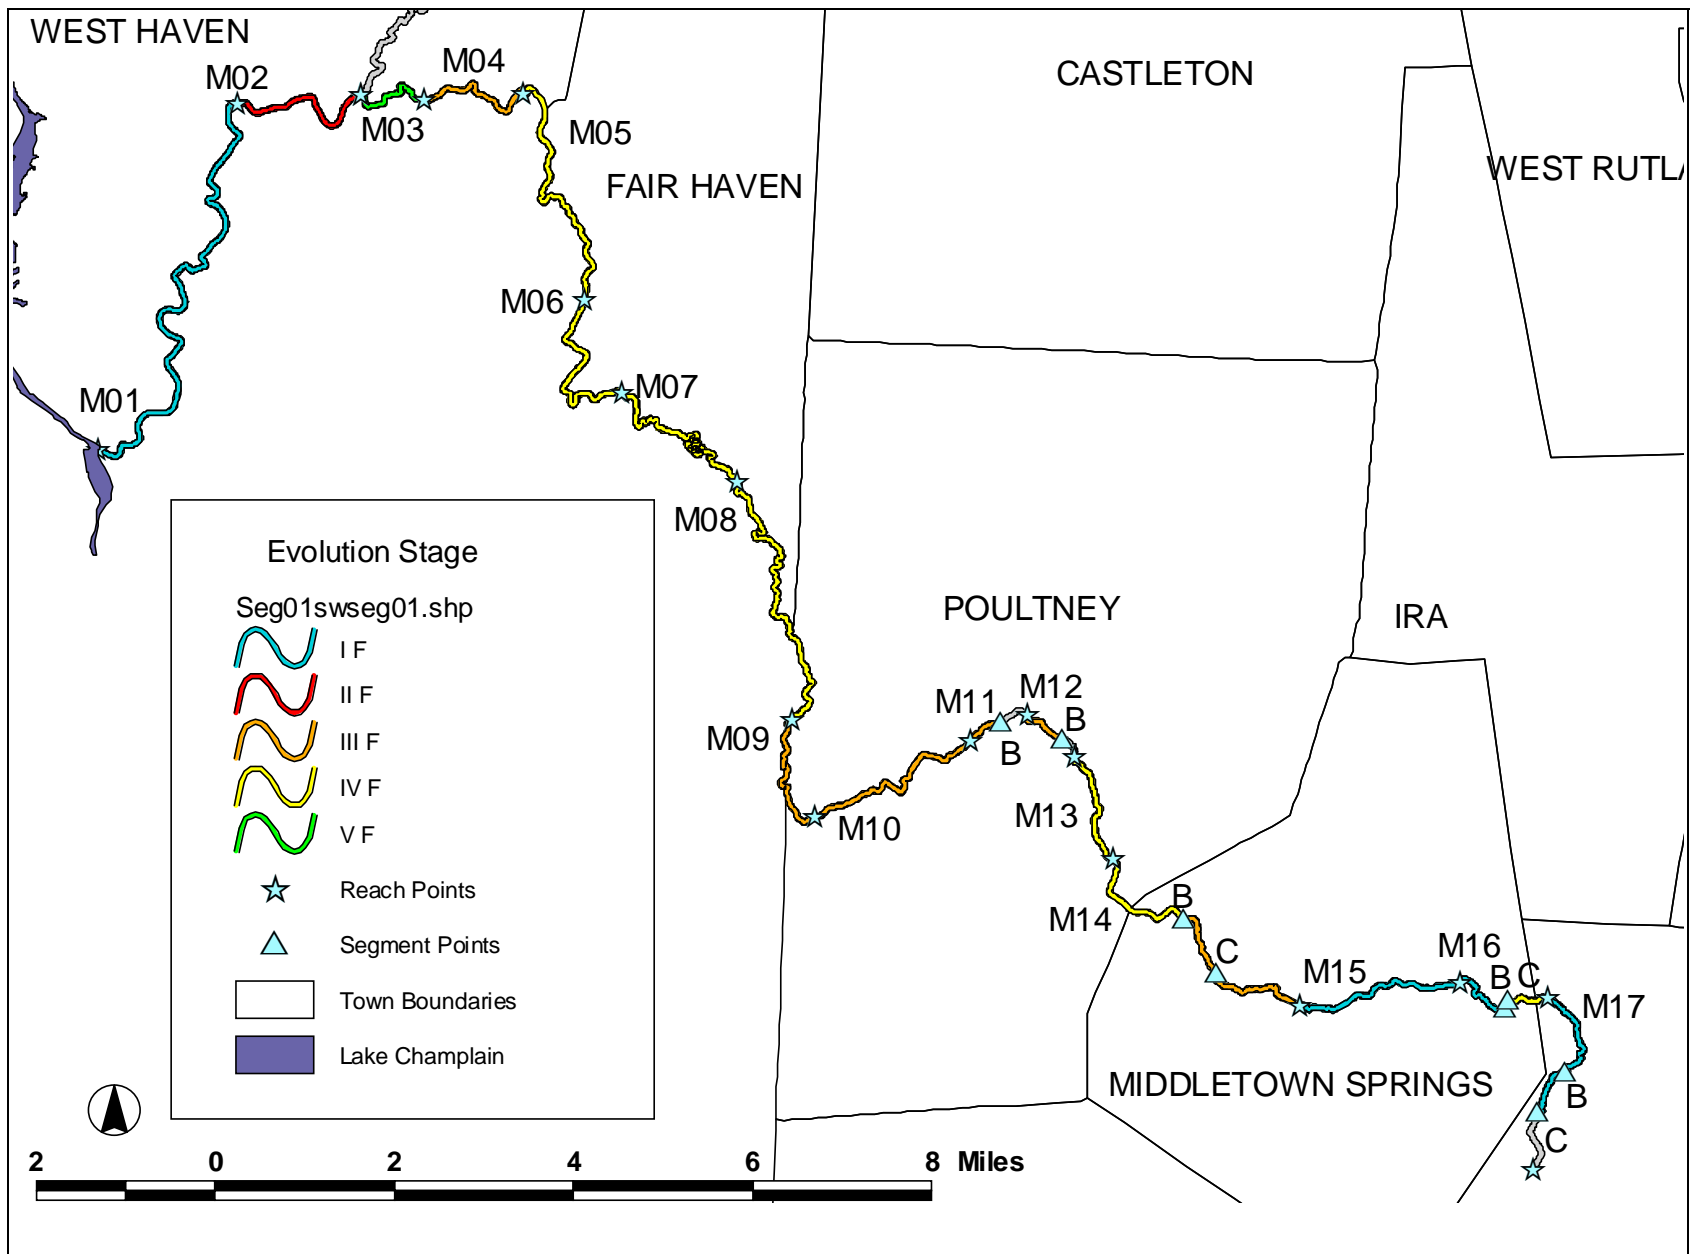
Figure 15 shows the stage of channel evolution for study reaches.

Reach M01 appeared to be “in regime” with only minor planform adjustments fitting for a low-gradient, meandering stream. Reach M15 and segments M16A, M17A, and M17B also appeared to be “in regime.” Many reaches appeared to have incised and widened and were now in stage IV, experiencing aggradation and planform adjustments. Continued bank armoring on some of these reaches was limiting their ability to complete the evolution process and regain equilibrium.

M08 appeared to be in stage IV with planform adjustments dominant. The channel was attempting to migrate (Figure 16), however continued straightening and bank armoring of this reach has inhibited the ability of the channel to regain equilibrium. Similarly, Reaches M07, M10, and segments M14A and C have experienced recent straightening and continue to attempt planform adjustments. Allowing these reaches to complete the current adjustment processes will increase overall stream stability and benefit upstream and downstream reaches by attenuating flow and sediment and improving water quality for downstream reaches, as well as reducing pressures.

Figure 15. Stage of channel evolution for study reaches.

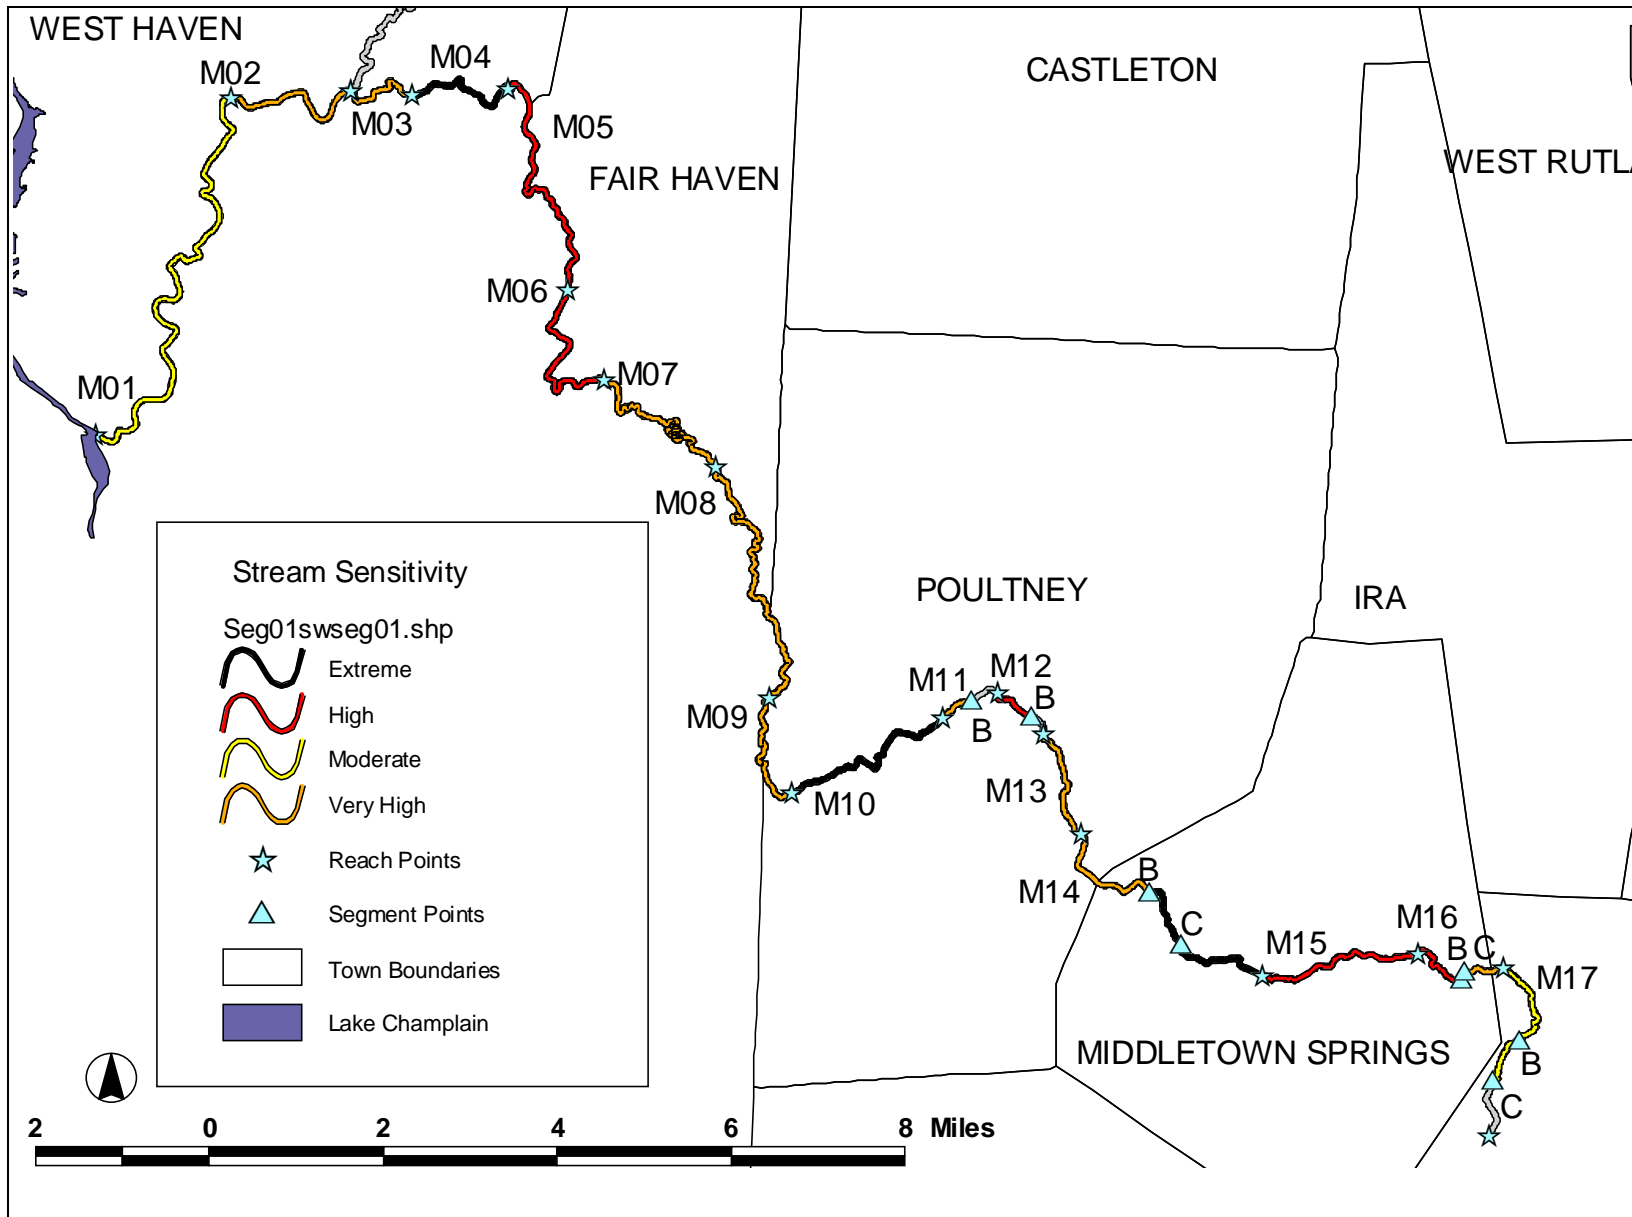
Figure 17 shows stream sensitivity ratings for study reaches and segments. Stream sensitivity ranged from high to extreme with only segments M01, M17A, and M17B having “moderate” sensitivity. This implies that continued or increased adjustments are likely with ongoing channel or watershed disturbance. Reaches M05 and M06, which were in “good” geomorphic condition and stage IV of the F-stage evolution process, were highly sensitive. Continued or increased stressors from upstream could push these lower reaches further into adjustment or departure. Addressing stressors such as stream alteration and channel constrictions could alleviate pressures and reduce potential for further departure or help reaches and segments achieve a dynamic equilibrium state.

The three segments with “moderate” sensitivity were located at the extreme ends of the watershed and were considered “in regime.”

Reaches M04 and M10 and segments M14B and M14C were “extremely” sensitive to disturbance. These segments had experienced stream type departures from their “reference” stream type. Reach M04 resulting from dam effects and reach M10 and segments M14B and C from channel straightening.

Figure 17. Stream Sensitivity Rating for study reaches. Note only segments M01, M17A, and M17B had “moderate” sensitivity.

Reach M07 was “Extremely” sensitive to disturbance. This reach was a highly meandering segment of stream with sand/silt/clay banks. Old abutments (Figures 18) constrict the channel and have been outlined as potential removal/replacement projects in Table 3: River Corridor Restoration and Protection Project Table. One abutment is just downstream of an actively migrating channel (Figure 19), some of which might be resulting from the channel being constricted at this point.

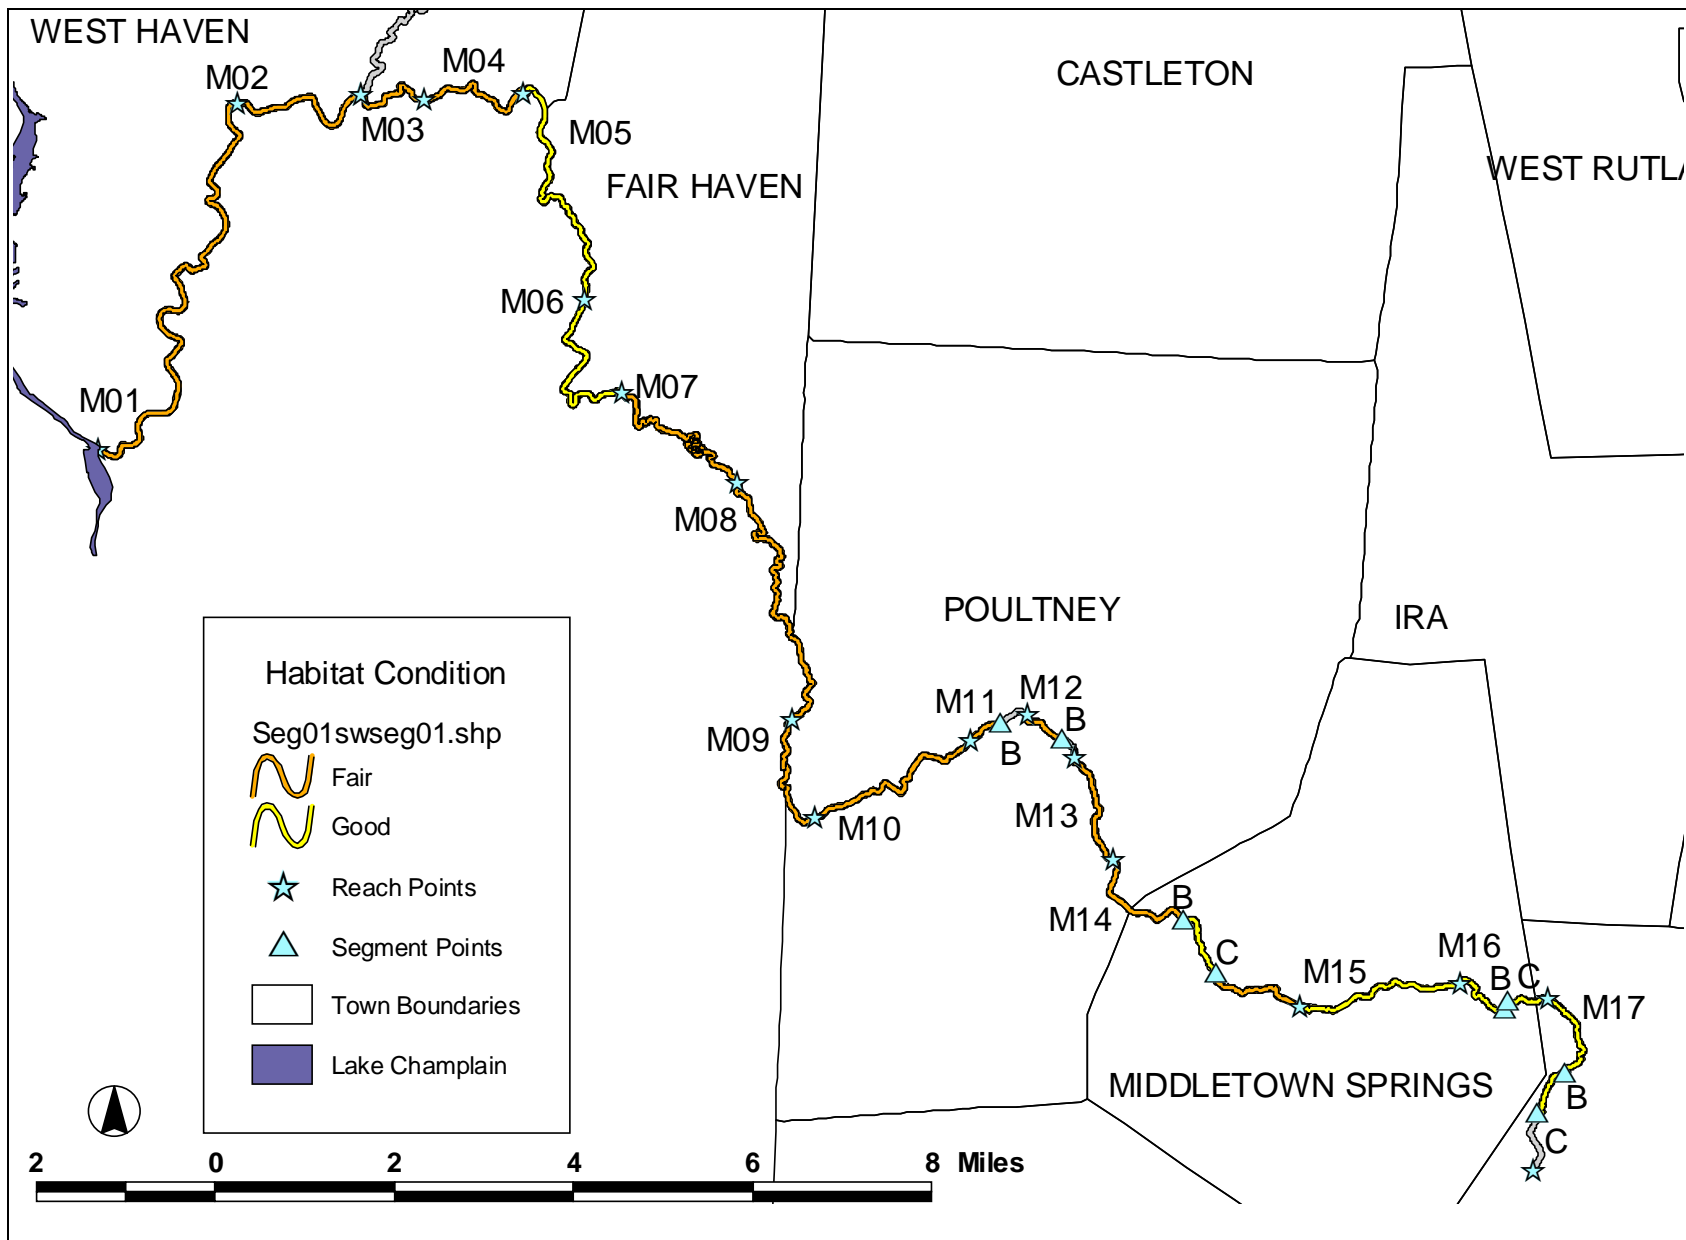
Figure 20 shows RHA condition categories for the study reaches. Habitat condition was rated as “Fair” for most segments, 17 out of 25 assessed segments. Typically, reduced riparian and bank vegetation, bank instability (Figure 21), increased sediment deposition and related embeddedness of bed substrates, reduced morphological diversity, and reduced epifaunal substrate and cover were the main contributors to the low habitat condition scores. Bank instability was less of a factor in segments M12A, M11A,

Channel alteration in the form of straightening and rip-rap on both banks affected habitat scores in reach M08. Channel alteration also affected habitat in M07, which was assessed as a Low-Gradient stream.

Segment M11A was rated “Poor” for epifaunal substrate and cover, embeddedness, sediment deposition and right bank riparian buffer width. M12A also had a “Poor” rating for sediment deposition.

Figure 20. Rapid Habitat Assessment Condition Category for study reaches.

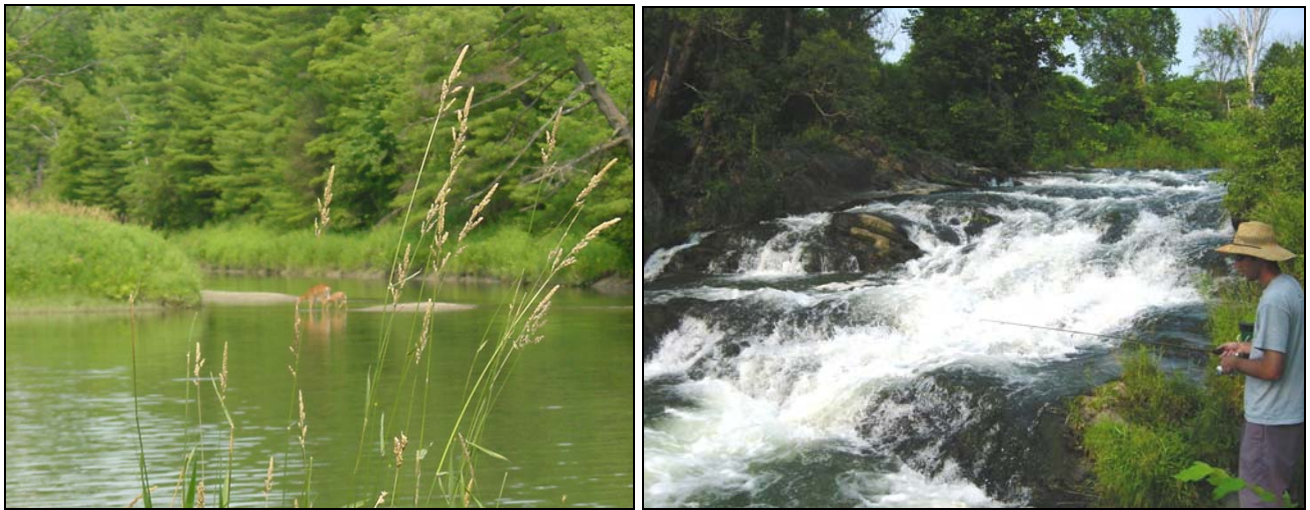
Figure 22. Deer and fishing in reach M06.

Reach M06 had “Poor” left bank riparian buffer width and “Fair” epifaunal substrate and cover. But overall the habitat quality appeared higher than most other reaches. Deer were seen and the fishing (catch and release) was good (Figure 22).

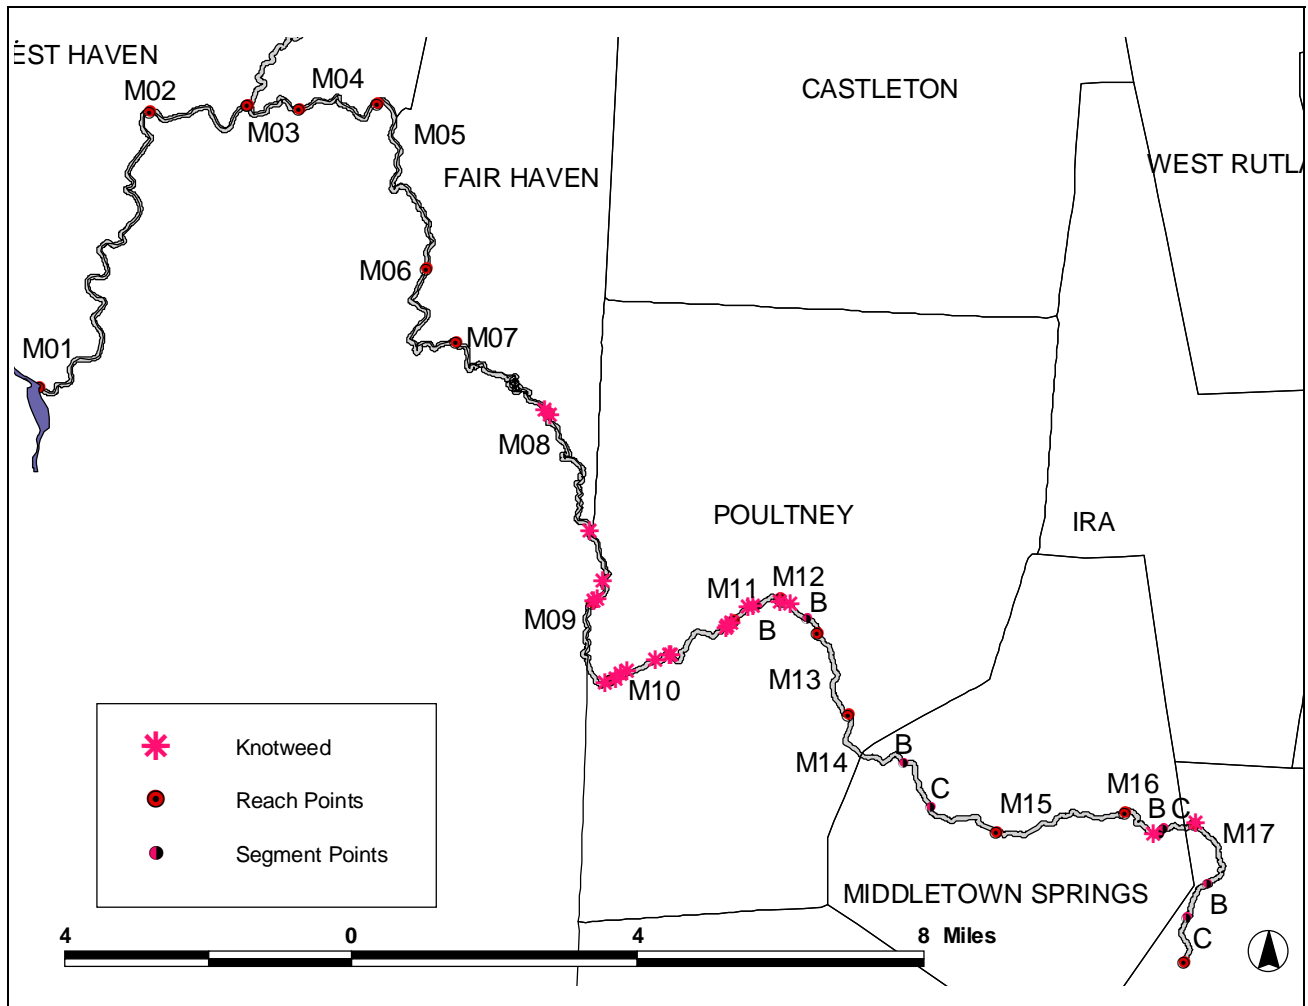
Sites where invasive Japanese Knotweed (Figure 26) was observed were marked with a GPS unit and are included in a shapefile. Sightings of Knotweed were concentrated near the town of Poultney in reaches M07, M08, M10, M11, M12, and M16. Reach M08 had knotweed all along the reach, ending in reach M07. Knotweed was not observed in reaches M02, M03, M04, M05, M06, M13, M14, and M17. Reaches M01, M03, M09, and M15 were not assessed for Knotweed.

Figure 26. Sites where Japanese Knotweed was observed. Note that reach M08 had knotweed along the entire reach and GPS points were not collected for that reach. Knotweed appeared concentrated in the area between the upper portion of M07 and M12 with some seen in M16 and lower M17A.

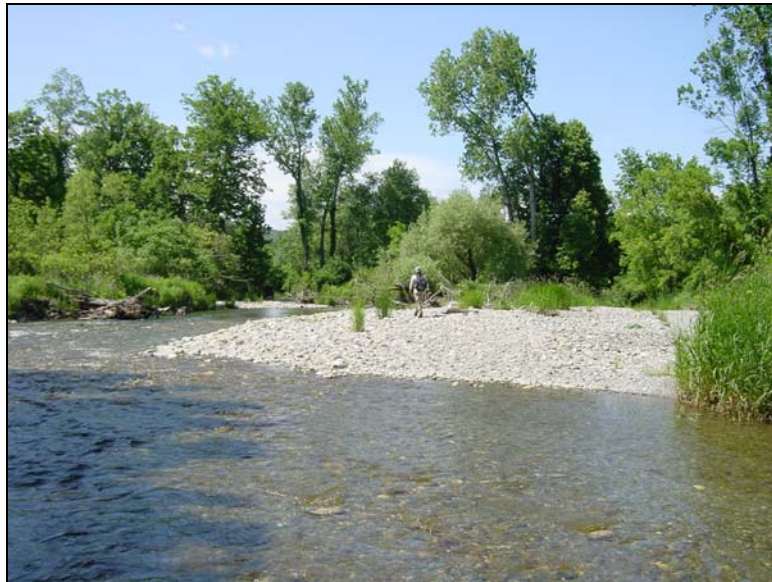
Background: This area appears to be actively migrating and has a wooded wetland adjacent to the channel. After traveling through multiple small gorges, the river enters this flat area, which is a good place for sediment attenuation. Active agriculture did not appear to be in the corridor here, possibly prohibited by the channel migration. Therefore conserving/protecting the corridor here could be relatively easy – very little current use here. A stream crossing for fields to the southwest was present. A bridge for that crossing would benefit the instream habitat and banks, however migration makes placement difficult. Preserving this crossing as an in-stream crossing might be the only option here. This area appears to be an attenuation zone for sediment, which would help alleviate pressures from upstream straightening.

- Replace Structures – Resize the bridge as it is up for replacement.
- Remove Berm – A small area of berm (145 feet) was present in the reach and did not appear to be protecting anything. It was a sediment source and could be removed to prevent that sediment from entering the system.
