Browns River Phase 2 Stream Geomorphic Assessment Summary Underhill, Jericho, and Westford Reaches

March 30, 2010

Fitzgerald Environmental Associates, LLC.
316 River Road
Colchester, VT 05446

Chittenden County Regional Planning Commission
110 West Canal Street, Suite 202
Winooski, VT 05404

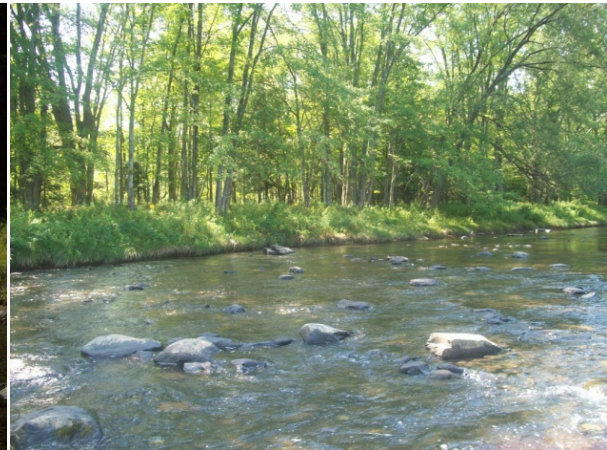
Figure 4.2 Area of cattle grazing along right bank mid-segment

With the exception of some minor impacts to the buffer conditions mid-segment, M03-A was relatively stable. Only one small section of the segment had ongoing impacts from cattle grazing in the buffer (Figure 4.2). The valley confinement naturally limits the development of meanders, and may explain the stable condition despite the high WDR. As plane bed rivers with greater sediment

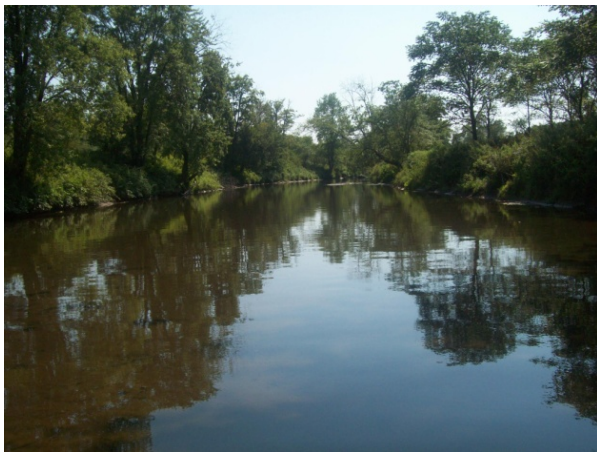
Figure 4.3 Plane bed morphology and degraded buffer

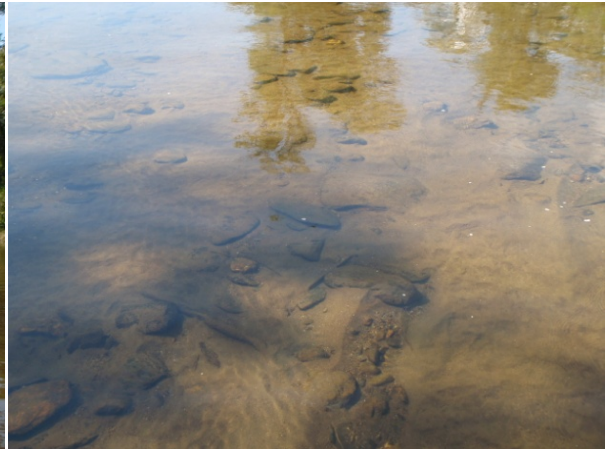
Figure 4.8 Sand-dominated bed substrate

Historical channel straightening has impacted the entire segment. As in M03-B, the channel has responded by incising its bed. Due to the moderate incision and aggradation, the CEM has been classified as stage II since there is no evidence of channel widening (RGA = “Fair”). The segment has a “very high” sensitivity to future human impacts, and is predicted to undergo lateral adjustments in the future. The habitat condition is “Fair” due to limited bed features, pools (Pools/Mile = 19), and the high degree of bed fining. Woody debris was common (LWD/Mile = 59), but dominated by smaller pieces found along the channel margins.

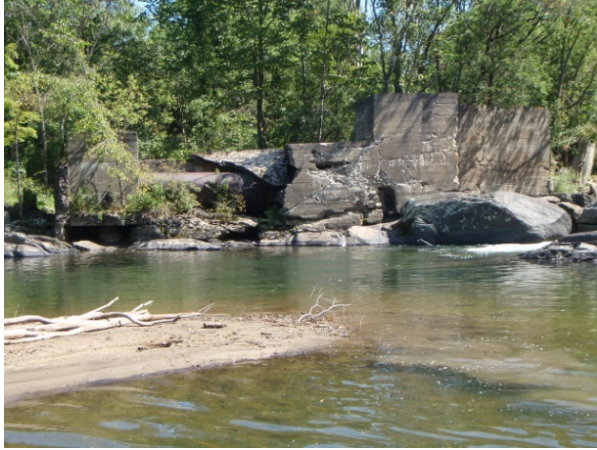
Figure 4.9 Remnants of dam/hydro-electric facility

A high degree of channel incision was noted in the cross-section in the upper segment ($IR = 1.8$). The lack of grade controls in the upper segment have allowed the channel to become disconnected from a small adjacent floodplain; however, channel incision was less severe in the lower segment. The scour pool below the defunct dam is very wide (over 150 feet) because of the increased stream power through this section of the segment. Due to the incision and early stages of widening ($RGA = \text{“Fair”}$), the channel has been classified as CEM stage III. Despite the good conditions for woody debris and pools noted in the habitat surveys ($LWD/\text{Mile} = 133$; $\text{Pools}/\text{Mile} = 29$), the habitat condition is “Fair” due to the frequency of riffles, channel alterations associated with the dam, and bank/buffer impacts from residential development.

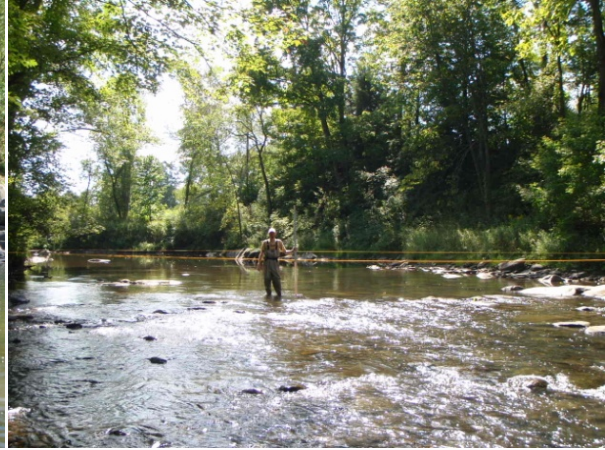
Figure 4.10 Riffle at cross-section location in upper segment

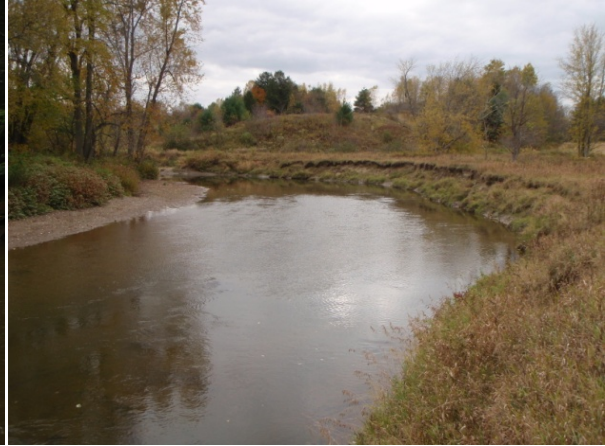
Figure 4.12. Severe erosion along left (west) bank in upper M05

A moderate degree of channel incision was noted in the cross-section in the upper reach ($IR = 1.5$). The absence of natural grade controls in the upper reach has allowed the channel to become disconnected from the adjacent floodplain on the west bank - incision increases in severity as you move upstream. In the upper reach, where the channel lacks buffers greater than 25 feet in many places, bank erosion is severe (Figure 4.12). Channel incision and bank erosion has likely been exacerbated by historical channel straightening where corn fields are found adjacent the channel. The bed substrate is assumed to be gravel by reference, and was noted beneath an aggraded sand layer above. The bank erosion in the upper reach, as well as in upstream Reach M06 and M07 are likely the sources of fine sediment in this reach. Due to the moderate channel incision ($RG\ A = \text{“Fair”}$) and lack of widening, the channel has been classified as CEM stage II. The habitat condition is “Fair” due to limited bed features, pools (Pools/Mile = 11), woody debris (LWD/Mile = 42), and the high degree of bed fining.

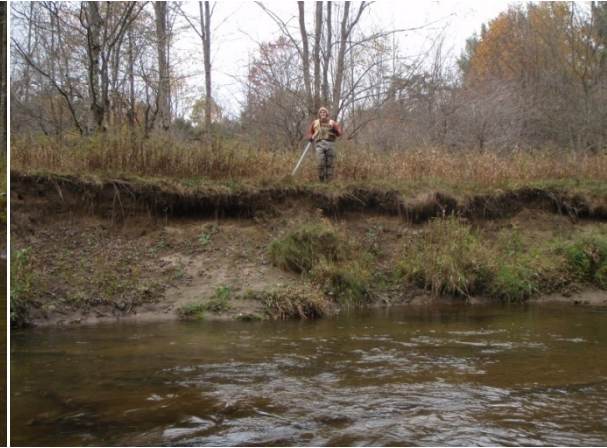
Figure 4.14 Severe erosion along left (west) bank in upper M06

A moderate to high degree of channel incision was noted in the cross-section in the upper reach (IR = 1.6). Historical channel straightening (86% of reach), in combination with lack of natural grade controls, have caused the channel to become disconnected from the adjacent floodplain throughout the entire reach. Bank erosion is severe throughout, especially along the left bank (47% of entire reach). Buffers along the right bank have been impacted by historical agricultural uses in the corridor, with 48% of the right bank lacking a healthy buffer greater than 25 feet in width. The bed substrate is assumed to be gravel by reference, and was noted beneath an aggraded sand layer above. The bank erosion in the upper reach (Figure 4.14) is probably one of the sources of fine sediment in this reach. Accounting for the channel incision (RGA = “Fair”) and lack of widening, the channel has been classified as CEM stage II. The habitat condition was assessed at the very low end of “Fair” due to lack of well formed bed features and high degree of bed fining. Pools (Pools/Mile = 29) and woody debris (LWD/Mile = 133) were very common; however the woody debris was often found along the channel margins, and the pools were homogeneous and lacked good cover.

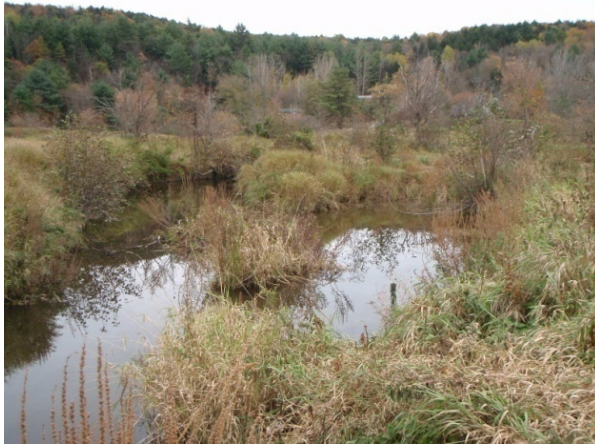
Segment T1.01-B was not assessed fully because of ponding associated with beaver activity. A total of 3 beaver dams were observed in this segment impounding approximately 1,175 feet (Figure 4.17). The segment begins at the first beaver dam west of the first house between Osgood Hill Road and Route 128 coming from downtown Westford and ends at the reach break at the second Osgood Hill Road crossing. The segment is 0.2 miles in length with a slope too low to measure using the available spatial data. Professional judgment was used to identify the stream type, bedform, and substrate (E-type; Dune-Ripple; Sand). Administrative judgment was also used to determine the RGA condition (RGA score = “Good”). Interestingly, the beavers used corn stalks from nearby cornfield to aid in their dam construction. These structures may not be as durable as dams constructed from alder or other woody plants, but appeared to be stable (Figure 4.18).

Figure 4.17 Impounded channel downstream of the reach break

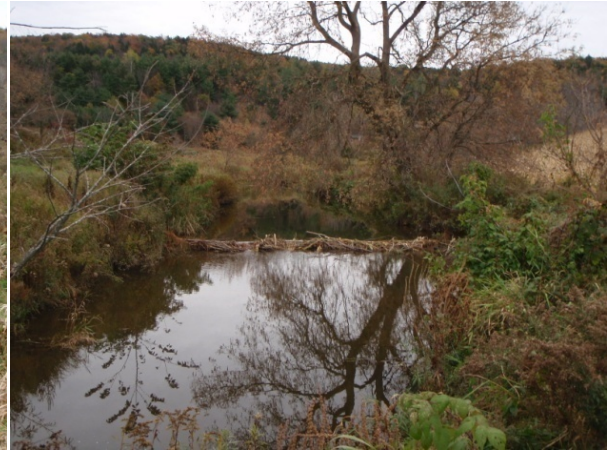
Figure 4.18. Beaver dam constructed largely of corn stalks

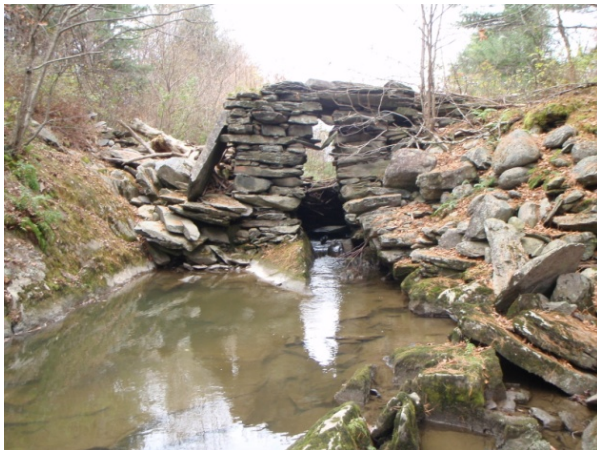
Figure 4.21 Looking upstream at the channel constriction

The habitat and geomorphic condition of this segment have been heavily impacted by the structure located at the segment break with T1.02-C, but impacts to the channel form and function have also been influenced by a very large beaver dam located mid-reach. The beaver dam was about 6 feet in height and caused water to pond up to the channel constriction. The structure was breached

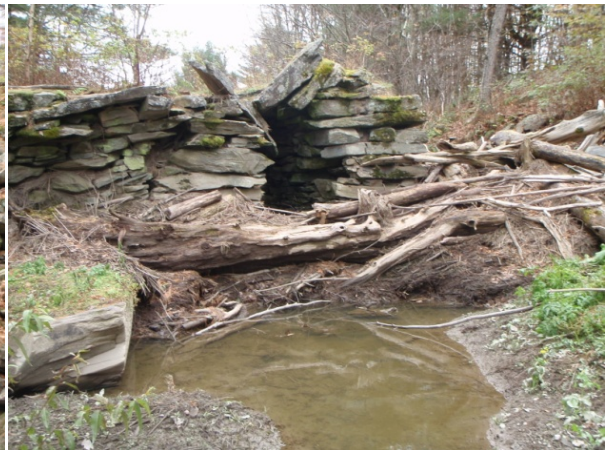
Segment T1.02-B begins at the southeast corner of the hay field and extends upstream 0.3 miles, ending at an old channel crossing. The channel is in a broad valley setting with no human caused change to the valley width. The C-type channel has a riffle-pool bedform with complete riffles. Channel geometry is consistent with the C-type designation (WDR = 13.3; ER = 5.7) and no incision was observed on this segment. Substrate is predominately cobble (53%) and silt (18%) with a median substrate size of 85.0 mm. The coarser substrate of this segment can be attributed to the greater slope and transport capacity compared with the segment downstream. Two grade controls were observed in this segment with approximately 6 feet of height above water. The old channel crossing located at the upstream segment break is a severe channel constriction. The width of this structure is only 11% of the bankfull channel width (Figure 4.21). In addition to the narrow span of the structure, the upstream end is blocked with debris, making it even more problematic to the dynamics of the channel (Figure 4.22). This structure should be removed to help reduce ponding upstream.

Figure 4.22 Looking downstream debris jam above the constriction

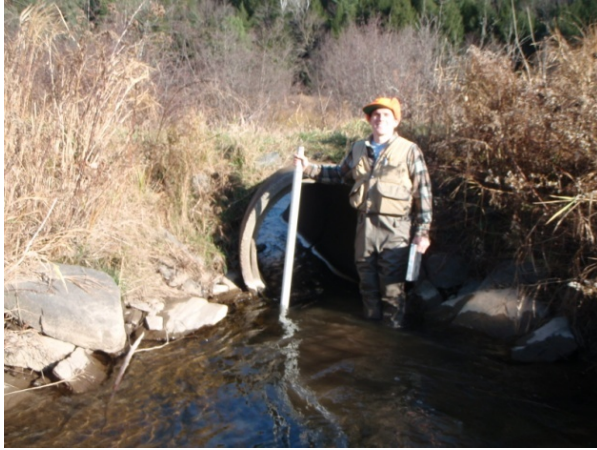
T2.01-C begins at the constricted culvert crossing and ends 0.5 miles upstream at the farm pasture where property access is restricted. The segmentation was made because of depositional features associated with the culvert constriction (Figure 4.34). Lots of fine sediment has backed up upstream of the culvert changing the channel dynamics. The slope in this segment is similar to that downstream, approximately 0.2%, and the valley is also very broad with no human-caused change in valley width. The channel exhibits E-type morphology and the dominant bedform is riffle-pool. The width-to-depth and entrenchment ratios are 12.0 and 7.6, respectfully. The substrate in this segment is predominately sand (54%) and silt (30%) with a median particle size between 0.06 and 2 mm (Sand). Aggradation upstream of the crossing has led to the formation of several mid-channel, point, and side bars. The channel may become bifurcated in the future if aggradation continues. Approximately 500 feet downstream of the segment break with T2.01-C a large beaver dam was observed (Figure 4.35). The dam is 5 feet in height and impounds water well into the next segment. No further segmentation was done on the beaver dam area because of its short length.

Figure 4.34 Culvert inlet looking downstream

Habitat in this segment was impacted by the aggradation of sediment and some bank stability issues (RHA score = “Fair”). The total woody debris density was very similar to the downstream segment (87 LWD/ Mile), but the pool density was much lower because of deposition of fines filling the pools (Pools/Mile = 42). Aggradation and planform shifts were the most significant impacts that decreased the geomorphic stability in this segment (RGA score = “Fair”). The channel is in stage IV of channel evolution like the downstream segment. If the culvert were to be replaced at the segment break, the segments would equilibrate and be very similar in stage IV of the CEM and start approaching dynamic equilibrium in stage V.

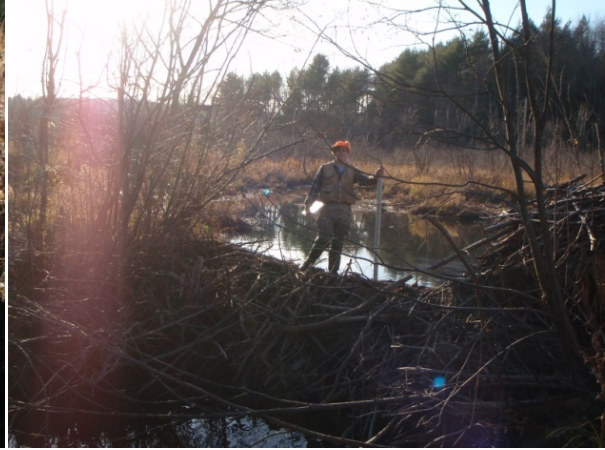
Figure 4.35 Large beaver dam in upper segment

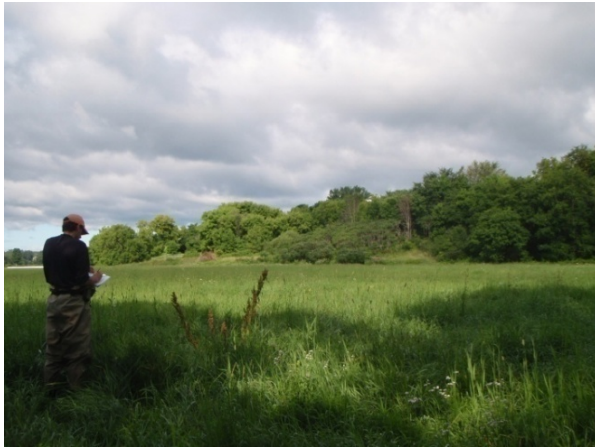
Figure 4.36 Right valley wall and floodprone area

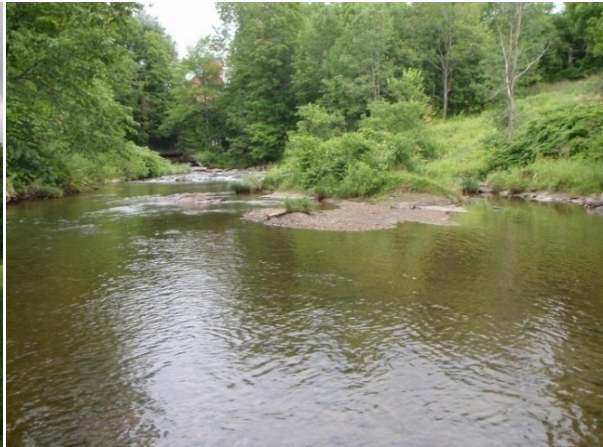
The sharp change in slope between the upstream segment and segment A has caused a large mid-channel bar to form at the top of this segment (Figure 4.37). The minor impacts to the degradation adjustments have lowered the geomorphic stability and put this segment in stage II of the CEM (RGA score = “Fair”). The change in slope responsible for the mid-channel bar also aided in the attenuation of large woody debris pieces (LWD/Mile = 156). The overall habitat condition of this reach was impacted by the limited depth-velocity patterns, and the number of pools (Pools/Mile = 28; RHA score = “Fair”).

Figure 4.37 Large MCB downstream of segment break

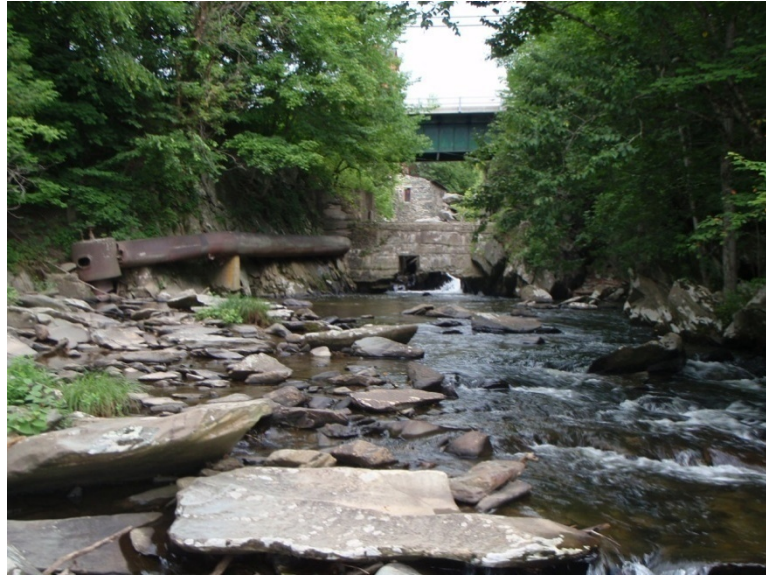
Beginning at the start of the bedrock gorge downstream of the Route 15 crossing, M13-B extends 0.9 miles to the reach break just upstream of the Old Pump Road crossing. This segment is considered to be a “gorge” and isn’t responding or adjusting to the stressors identified in the assessment protocol. This reach was assessed as normal, but professional judgment was used to estimate the substrate distribution and stream type. Channel dimensions of this reach were dependent on the positioning of the bedrock side walls, as opposed to the slope (2.6%) and substrate size, and therefore no cross-section was taken. Substrate was predominately bedrock (50%) and boulder (20%). The channel had geometry similar to a B-type channel with step-pool bedform. Downstream of Route 15 an old dam remains partially intact. Water is currently flowing under the structure and the old mill and the rusty penstock on the right bank (Figure 4.38).

Figure 4.38 Dam and penstock downstream of Rt. 15 crossing

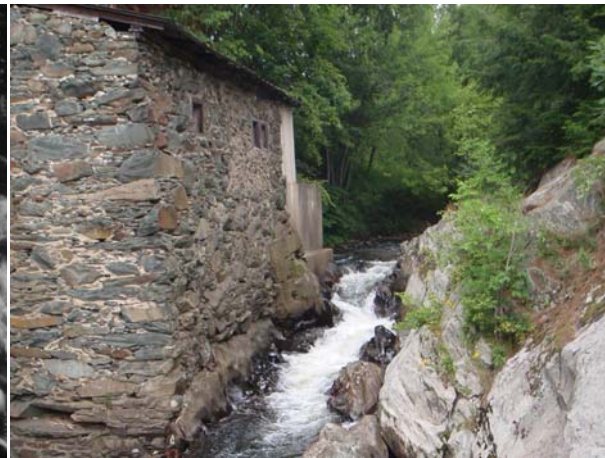
Upstream of Route 15 is the Red Mill, an iconic structure in downtown Jericho. There, another dam was located at the upstream end and water was drawn in to power a variety of milling machines (JHS, 2009; Figure 4.39). The dam that was once located on the upstream end of this structure has since been removed and water and sediment is free to flow downstream (Figure 3.40).

Figure 4.40 The Jericho Mill with the dam removed

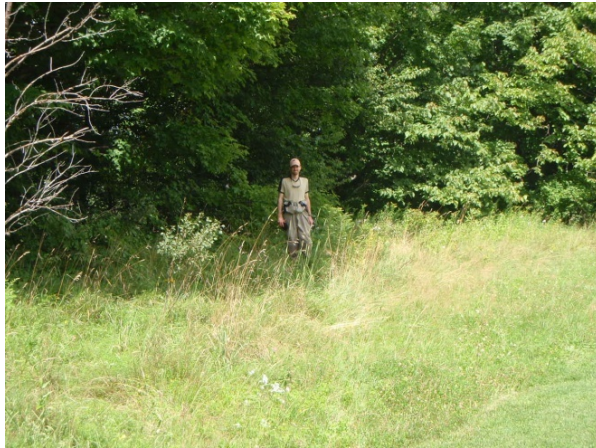
Upstream of the Route 15 crossing the channel's high incision ratio can be attributed to a human elevated floodplain in the form of a berm (Figure 4.42). From the covered bridge crossing downstream to Route 15 the left bank is bermed in the Mills Riverside Park area. This berm is typically 2.0 feet in height and greatly reduces floodplain connectivity. This feature was likely made to protect the hay fields downstream, and could be an opportunity for restoration. The bank and buffer conditions were substantially worse in the lower segment. Several hundred feet of the bank were almost entirely covered with Japanese knotweed that was growing on top of rip-rap (Figure 4.43). Geomorphically, this segment is fairly stable, because the channel has been severely manipulated. The armoring on the banks inhibits any future changes in planform and the segment will continue to carry sediment downstream. The aggradation and degradation adjustment processes reflect the historic incision and complete loss of any riffle-pool sequences from the filling of pools (RGA score "Poor"). The channel is in stage II of the CEM and will likely remain there because of the armoring. There is little to no habitat in this segment because of its human manipulated state. The limited woody debris and pools decreased the habitat further (RHA score "Poor").

Figure 4.42 Berm on the left bank in the Mills Riverside Park Area

<p>Browns River M16-A # 2</p> <p>Upstream of the Route 15 crossing on the left bank up to the covered bridge at Mills Riverside Park</p> <p><i>Jericho</i></p>	<p>Active Restoration</p> <p><i>Berm Removal</i></p>	<p>Left floodplain has been disconnected because of a berm that extends from the Route 15 crossing up to the covered bridge at Mills Riverside Park.</p>	<p>Excavation of the berm and buffer plantings would help restore this site to a natural state. However, the removal of the berm may create a flooding hazard and the channel could potentially cross over Route 15 downstream.</p>	Low	Low	Regain floodplain connectivity and allow for natural channel dynamics	High costs associated with berm removal and floodplain management	VTDEC; Town of Jericho
<p>Browns River M16-B # 1</p> <p>Approximately 500 feet upstream of the covered bridge crossing at Mills Riverside Park</p> <p><i>Jericho, Underhill</i></p>	<p>Passive Restoration</p> <p><i>Buffer Plantings; Corridor Conservation</i></p>	<p>There is no infrastructure in place in the corridor of this segment. Changes in planform and deposition are the dominant processes; it is a sediment attenuation site. Historical aerial imagery shows a very large neck-cutoff and bank erosion, possibly contributing sediment downstream.</p>	<p>Corridor protection will enable sediment that is transported from above reaches to settle out in developing meanders before it reaches the straightened transport reach. The area is also extremely active; easements and buffer plantings could stabilize banks and allow for more sediment attenuation.</p>	High	High	Allow an area where floodplain can redevelop with no human infrastructure	Low to moderate costs for buffer restoration; moderate to high cost for easements	WNRCD; VRC; VTDEC; LCBP; Town of Jericho; Town of Underhill

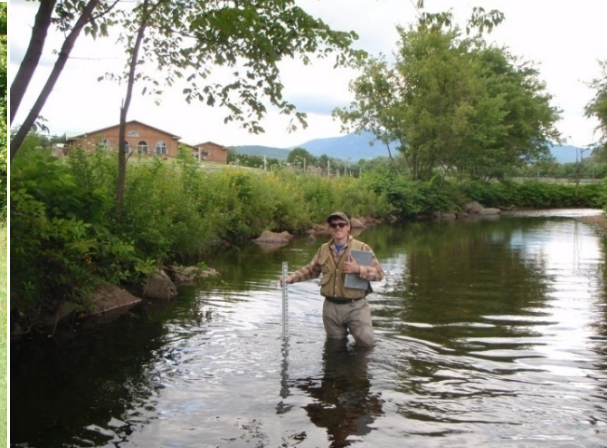
Figure 4.43 Buffer less than 25 feet, rip-rap, and invasive spp.

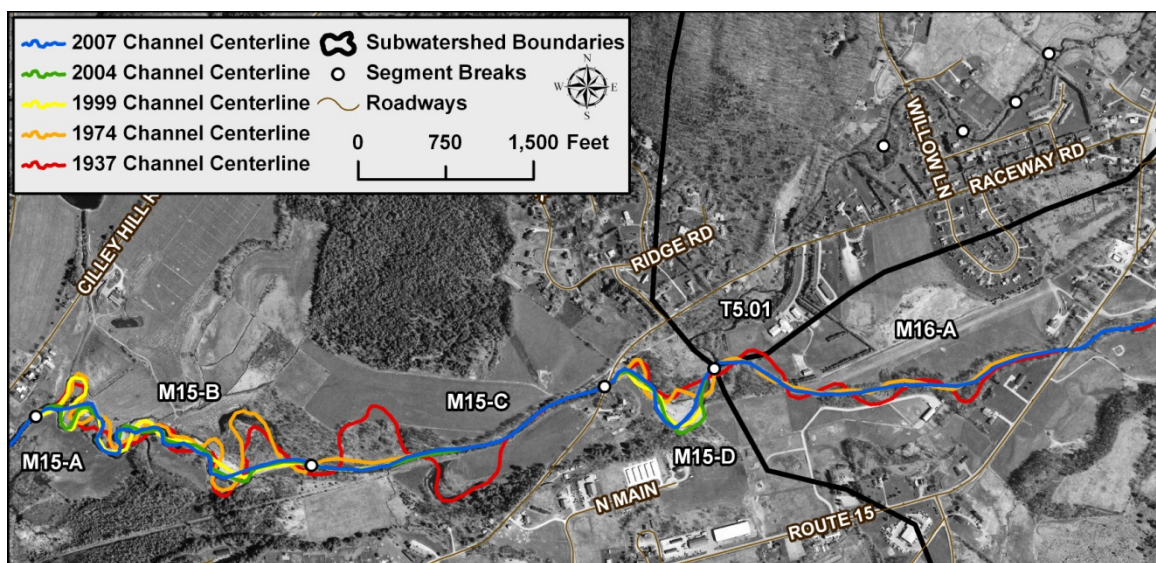
This segment and the downstream reach M15 have experienced significant channel migration and avulsions within the last 70 years. All of M16-A was straightened and is unable to regain any sinuosity because of the extensive bank armoring. Figure 4.44 shows the extent of channel migration at four unique time intervals in the last century. The channel centerline was derived from georeferenced historical aerial imagery.

Figure 4.44 The extent of channel migration in segment M16-A and reach M15 at four different time periods

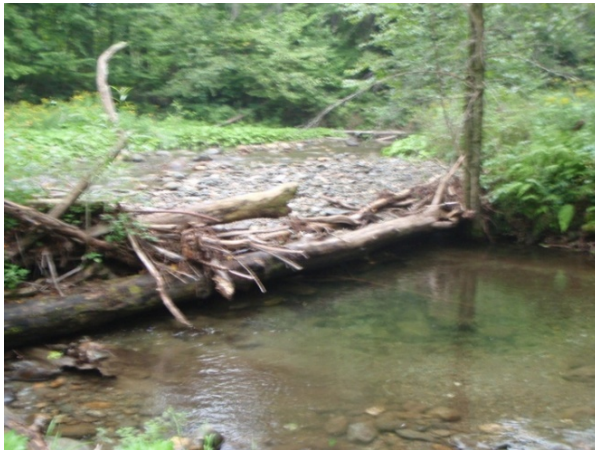
The lower portion of this reach has extensive aggradation. Steep riffles and large, well developed bars were common. Wood was prevalent in the channel and led to the formation of deep pools downstream of partial and full debris jams (LWD/Mile = 68). One full debris jam in the lower reach caused extensive aggradation above and a deep pool to form below (Figure 4.45). The downstream pool was in excess of four-feet deep and provided excellent habitat (Pools/Mile = 24). The upper section of this reach near the Maple Leaf Road Crossing has encroachments on both sides from a farm road on the east and from Mountain Road on the west (Figure 4.46). Development was also noted in the left corridor of the upper reach. This section is more confined and has a steeper slope, but it was not segmented because the extent of encroachment leading up to M21 is only about 400 feet. The high slope (8.7%) and confined setting of M21 facilitates sediment transport downstream and the lower part of this reach seems to be a prime area for aggradation. The habitat score in this reach was negatively impacted by the low buffer widths mid-reach and the lack of any woody debris and pools in the upper plane bed section (RHA score = "Fair"). Significant sediment deposition and many bar features caused aggradation and planform changes to be the most prominent adjustment processes in the reach (RGA score = "Fair"). Minor widening also suggests stage III of the CEM.

Figure 4.45 Deep pool downstream of a debris jam

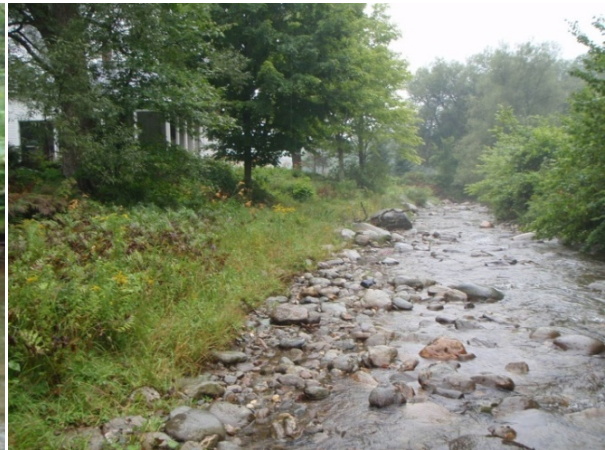
Figure 4.46 Low buffer width and encroachment mid-reach

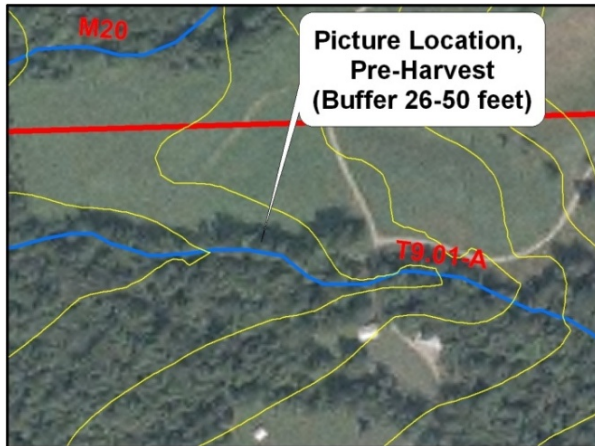
within the last 5 years. The 2003 NAIP imagery shows a buffer between 26 and 50 feet wide with large deciduous species (Figure 4.47). Now the area is planted for hay within 10 to 20 feet of the channel and only tree trunks and vegetation stubble remain (Figure 4.48). The left bank also had some buffer impacts upstream by the house. There, the buffer is mowed all the way up to the channel's edge. The habitat score was greatly reduced by the lack of buffer and subsequent reduction in LWD and pools (LWD/Mile = 114; Pools/Mile = 26; RHA score = "Fair"). The geomorphic condition of this segment was fair (RGA score = "Fair"). Degradation being the most prominent adjustment process lowering the overall score.

Figure 4.47 Location of Figure 4.48 pre-harvest

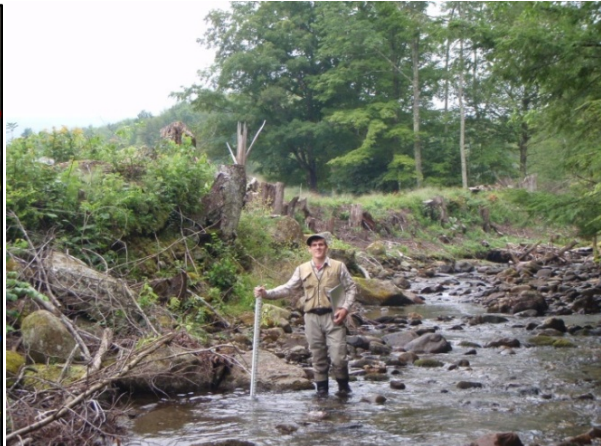
Figure 4.48 Post-harvest looking upstream from picture location

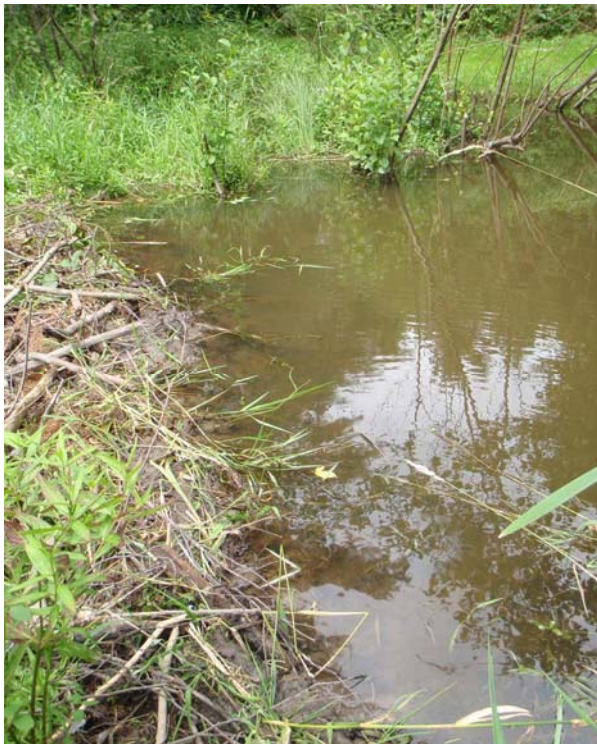
Reach M15.S2.01 is 0.7 miles long and has an average slope of 0.7%. The reach begins at the confluence with the main stem 620 feet upstream of the Cilley Hill Dam. This reach is largely impounded by beaver activity, but areas with channelized flow were assessed for geometry (Figure 4.50). The entrenchment and width-to-depth ratios are 11 and 6.4, respectively. The channel morphology is indicative of an E-type channel and the dominant bedform was dune-ripple. The substrate in this reach was almost entirely fines, with 45% silt and 40% sand.

Figure 4.50 Ponding upstream of the first beaver dam

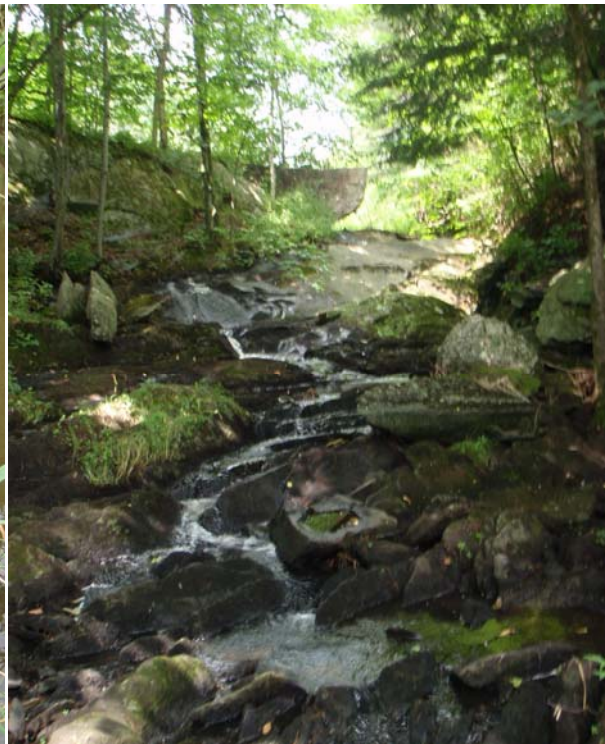
A waterfall, 15 feet in height is located just upstream of the Cilley Hill Road crossing (Figure 4.51). The culvert downstream of the waterfall poses an alignment issue and a large wing wall was constructed to divert water into the culvert. The top edge of the grade control is constricted by an old dam that has been blown out. Considering the height of the grade control the slope of the channel upstream is about 0.3%; less than the average Phase 1 channel slope. The habitat score was “Fair,” which reflects the limited large woody debris (LWD/Mile = 26) and pools (Pools/Mile = 27). The upper 1,200 feet of this reach was straightened like much of the upslope farm drainage ditches. The historic straightening reduced the geomorphic stability making the major adjustment processes in this reach to be degradation and shifts in planform. However, beaver activity in the segment has reduced the extent of the degradation adding localized stability upstream of the dams (RGA score “Fair”; CEM stage I).

Figure 4.51 Large waterfall upstream of the culvert crossing

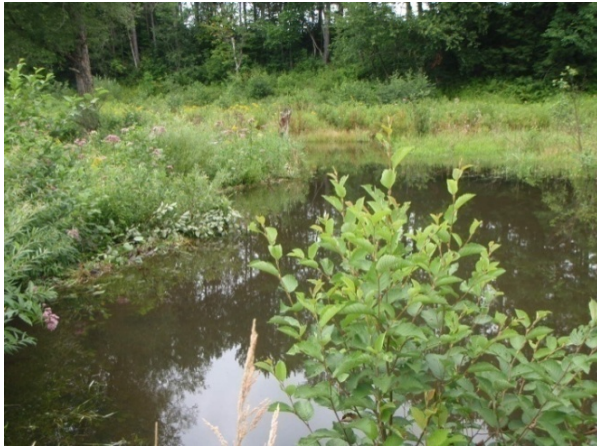
M19.S1.01-A is 0.2 miles in length. This segment was only assessed for bank, buffer and corridor conditions (Steps 1, 3, and 4), because of beaver dams that impounded the area (Figure 4.52). A total of 8 significant beaver dams were observed in the field and using aerial imagery (Figure 4.53).

Figure 4.52 Ponding behind one of the beaver dams

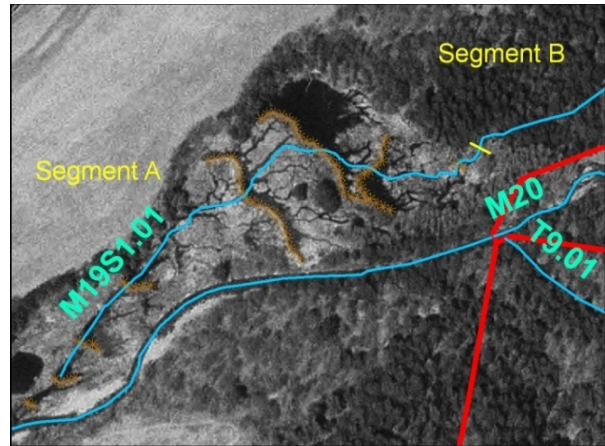
Figure 4.53 Aerial image showing locations of the 8 dams

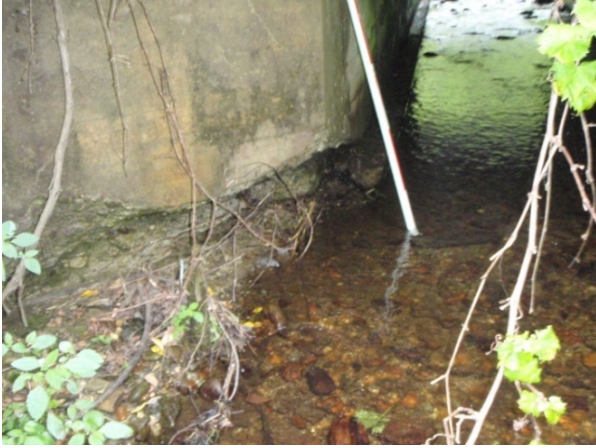
The segment was well buffered on the left side with a dense hemlock stand in the lower segment and a mixed hardwood forest in the upper. The right corridor was similarly buffered in the lower segment, but the adjacent side slope was logged in places limiting the buffer width from 26 to 50 feet. At the Mountain Road crossing near the segment break with M19.S1.01-C the bridge acted as a bankfull and floodprone channel constriction. This structure had some deterioration of the footer and the wing-walls on the up and downstream ends (Figure 4.54). Large woody debris (LWD = 200 LWD/Mile) was abundant and positively impacted the habitat score (Figure 4.55). Other habitat features such as debris jams, pools and undercuts were common, but not as abundant. The healthy bank and buffer condition along with LWD led to “Good” habitat rating for the RHA. The RGA condition was also “Good,” with similar scores with all of the adjustment processes and a CEM stage of I.

Figure 4.54 Mountain Rd crossing, with scour to the wing-walls

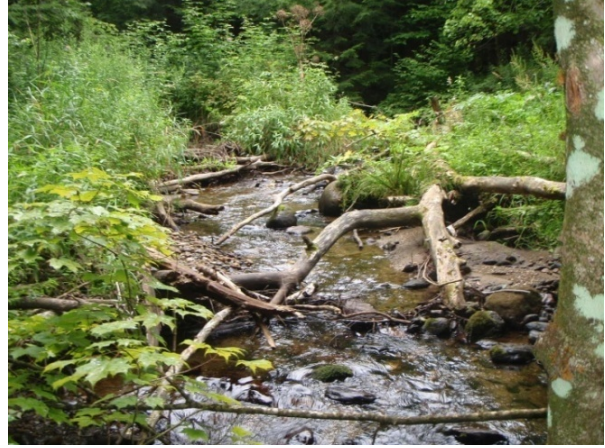
Figure 4.55 Great woody debris density in the lower segment

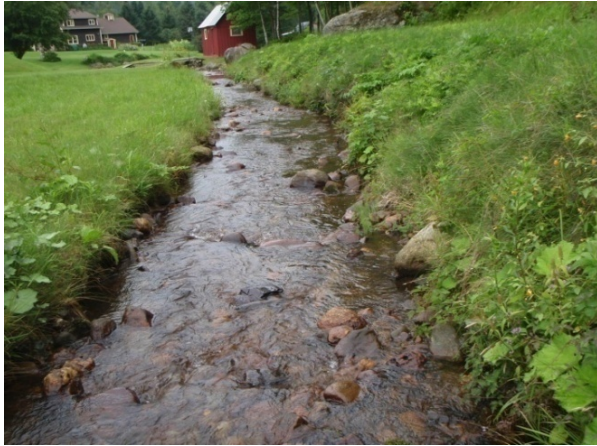
M19.S1.01-C was segmented to distinguish between the healthy bank and riparian conditions in segment B. The segment extends from the break point above Mountain Road to the reach break 0.4 miles upstream. The lower two-thirds of this segment are missing any natural buffer on the left bank, and the right bank only has some areas with buffers (Figure 4.56). The wide unconfined valley is mowed and used for hay production. The channel geometry reflects E-type morphology and with a subclass slope of b (Slope =3.6%). The entrenchment and width-to-depth ratios are 20.1 and 6.3, respectfully. The highly managed state of the channel and lack of woody debris has changed the bedform to plane bed. The substrate was predominately cobble (47%), but the median substrate was gravel (42%).

Figure 4.56 Plane bed channel mowed up to the edge

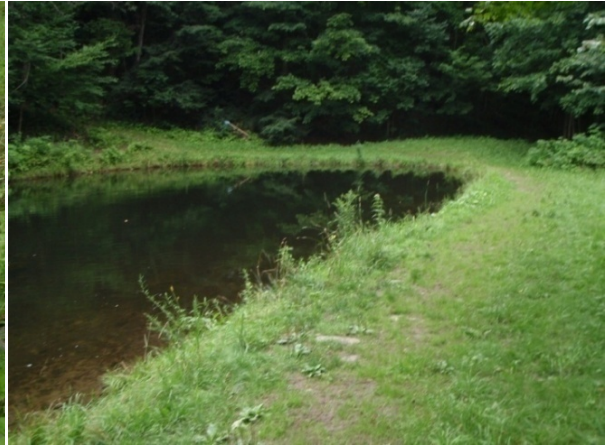
Two man-made ponds were observed to the left of the channel. Both of these features divert water from the channel upstream and have an outlet pipe that allows it to re-enter downstream. The ponds are raised slightly above the floodplain making an avulsion, if the pond blows out, unlikely. The outlet of the upstream pond (Figure 4.57) has caused a small channel to form. This channel resembles a rejuvenating tributary and is contributing sediment downstream. Degradation and planform changes are the two most notable adjustment processes. Straightening was observed for over 55% of the reach length. Changes in planform and incision (IR = 1.9) in the straightened areas suggests departure from a C-type to an E-type channel. Although the incision was not observed throughout the segment, the majority of the channel was impacted by land use changes. The poor scoring for degradation and planform in those areas lowered the geomorphic condition of this segment (RGA score “Fair”; CEM stage II). The lack of habitat features such as pools (Pools/Mile =2) and woody debris (LWD/Mile = 45) along with the poor riparian and bank condition was reflective of the “Poor” habitat rating. This is a prime site for riparian plantings and other restoration efforts described in greater detail in table 4.5.

Figure 4.57 Man-made pond located in the left floodplain.

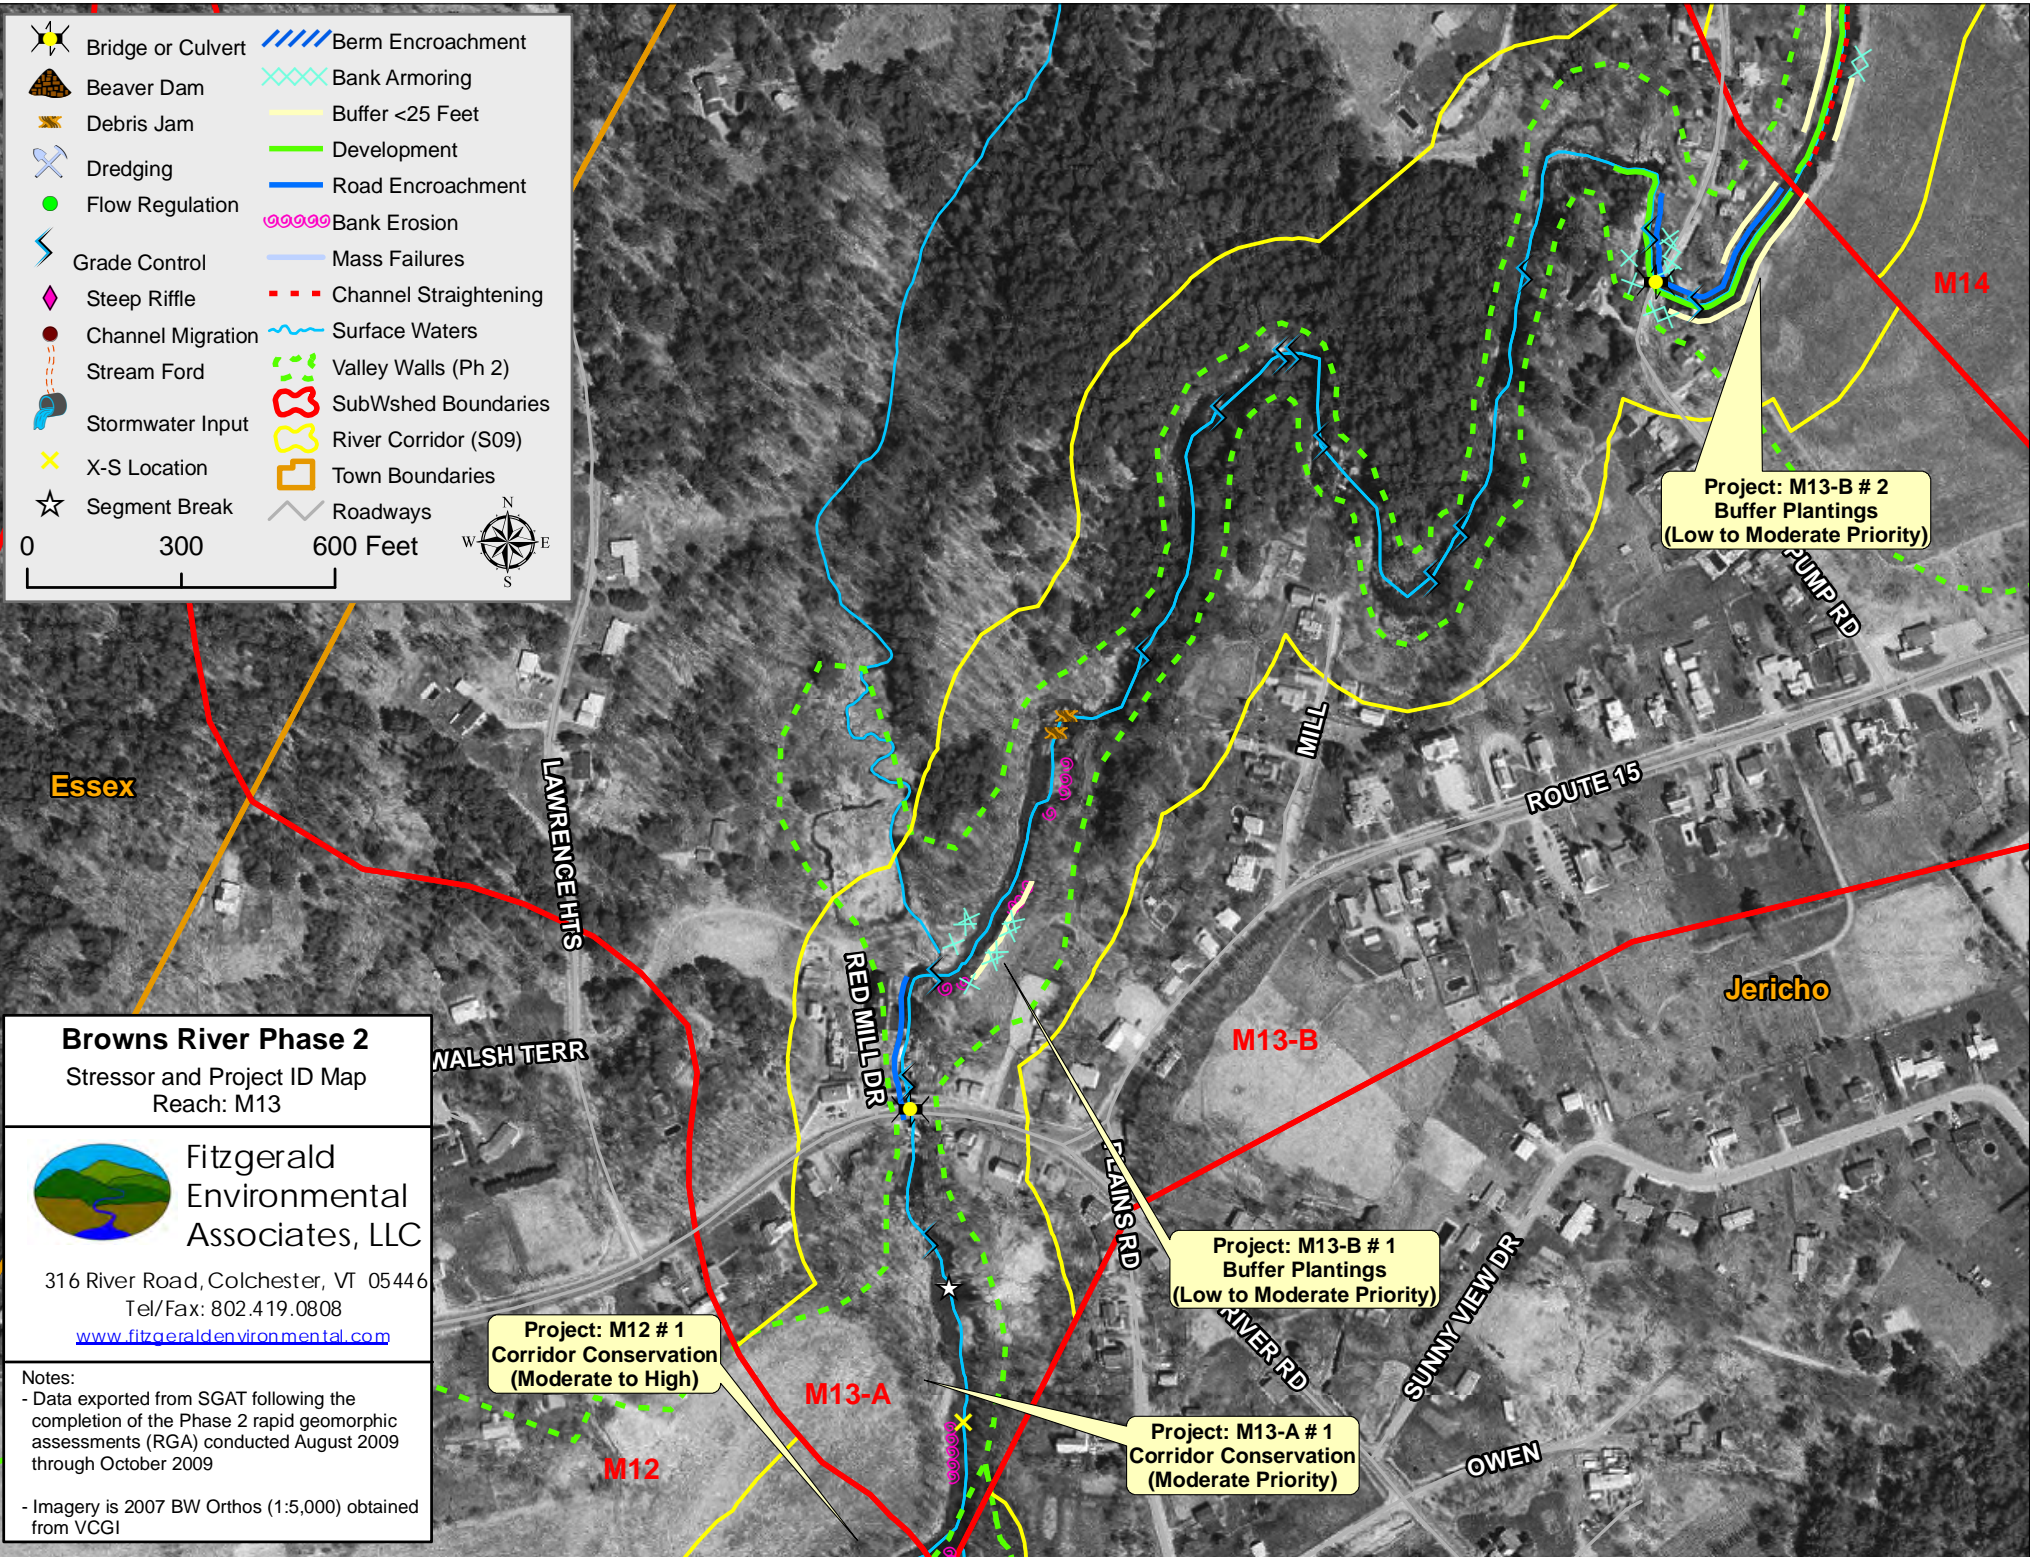
Browns River Phase 2
Stressor and Project ID Map
Reach: M13

- Step 2.8 Channel Width: The channel width is noted as 76 ft. Does this make sense given the bedrock gorge is the dominant condition? Is the channel width narrower in the gorge?

- Step 2.10 Valley type: Noted as “narrow”; Phase 2 dominant condition is “narrowly confined”. Please review and update as appropriate.
- **Changes have been made, valley width averaged from several field measurements and GIS measurements estimated to be 126 feet; M13 is narrowly confined.**

- Step 2.11 Reference stream type: Is noted as B step-pool. Dominant condition in Phase 2 is the gorge, and is noted as Ab cascade. Review and determine if the Phase 2 condition is accurate description of stream type and/or if the Phase 1 should be updated to show the dominant Phase 2 reference condition.
