Browns River Phase 2 Stream Geomorphic Assessment Summary Underhill, Jericho, and Westford Reaches

March 30, 2010

Fitzgerald Environmental Associates, LLC.
316 River Road
Colchester, VT 05446

Chittenden County Regional Planning Commission
110 West Canal Street, Suite 202
Winooski, VT 05404

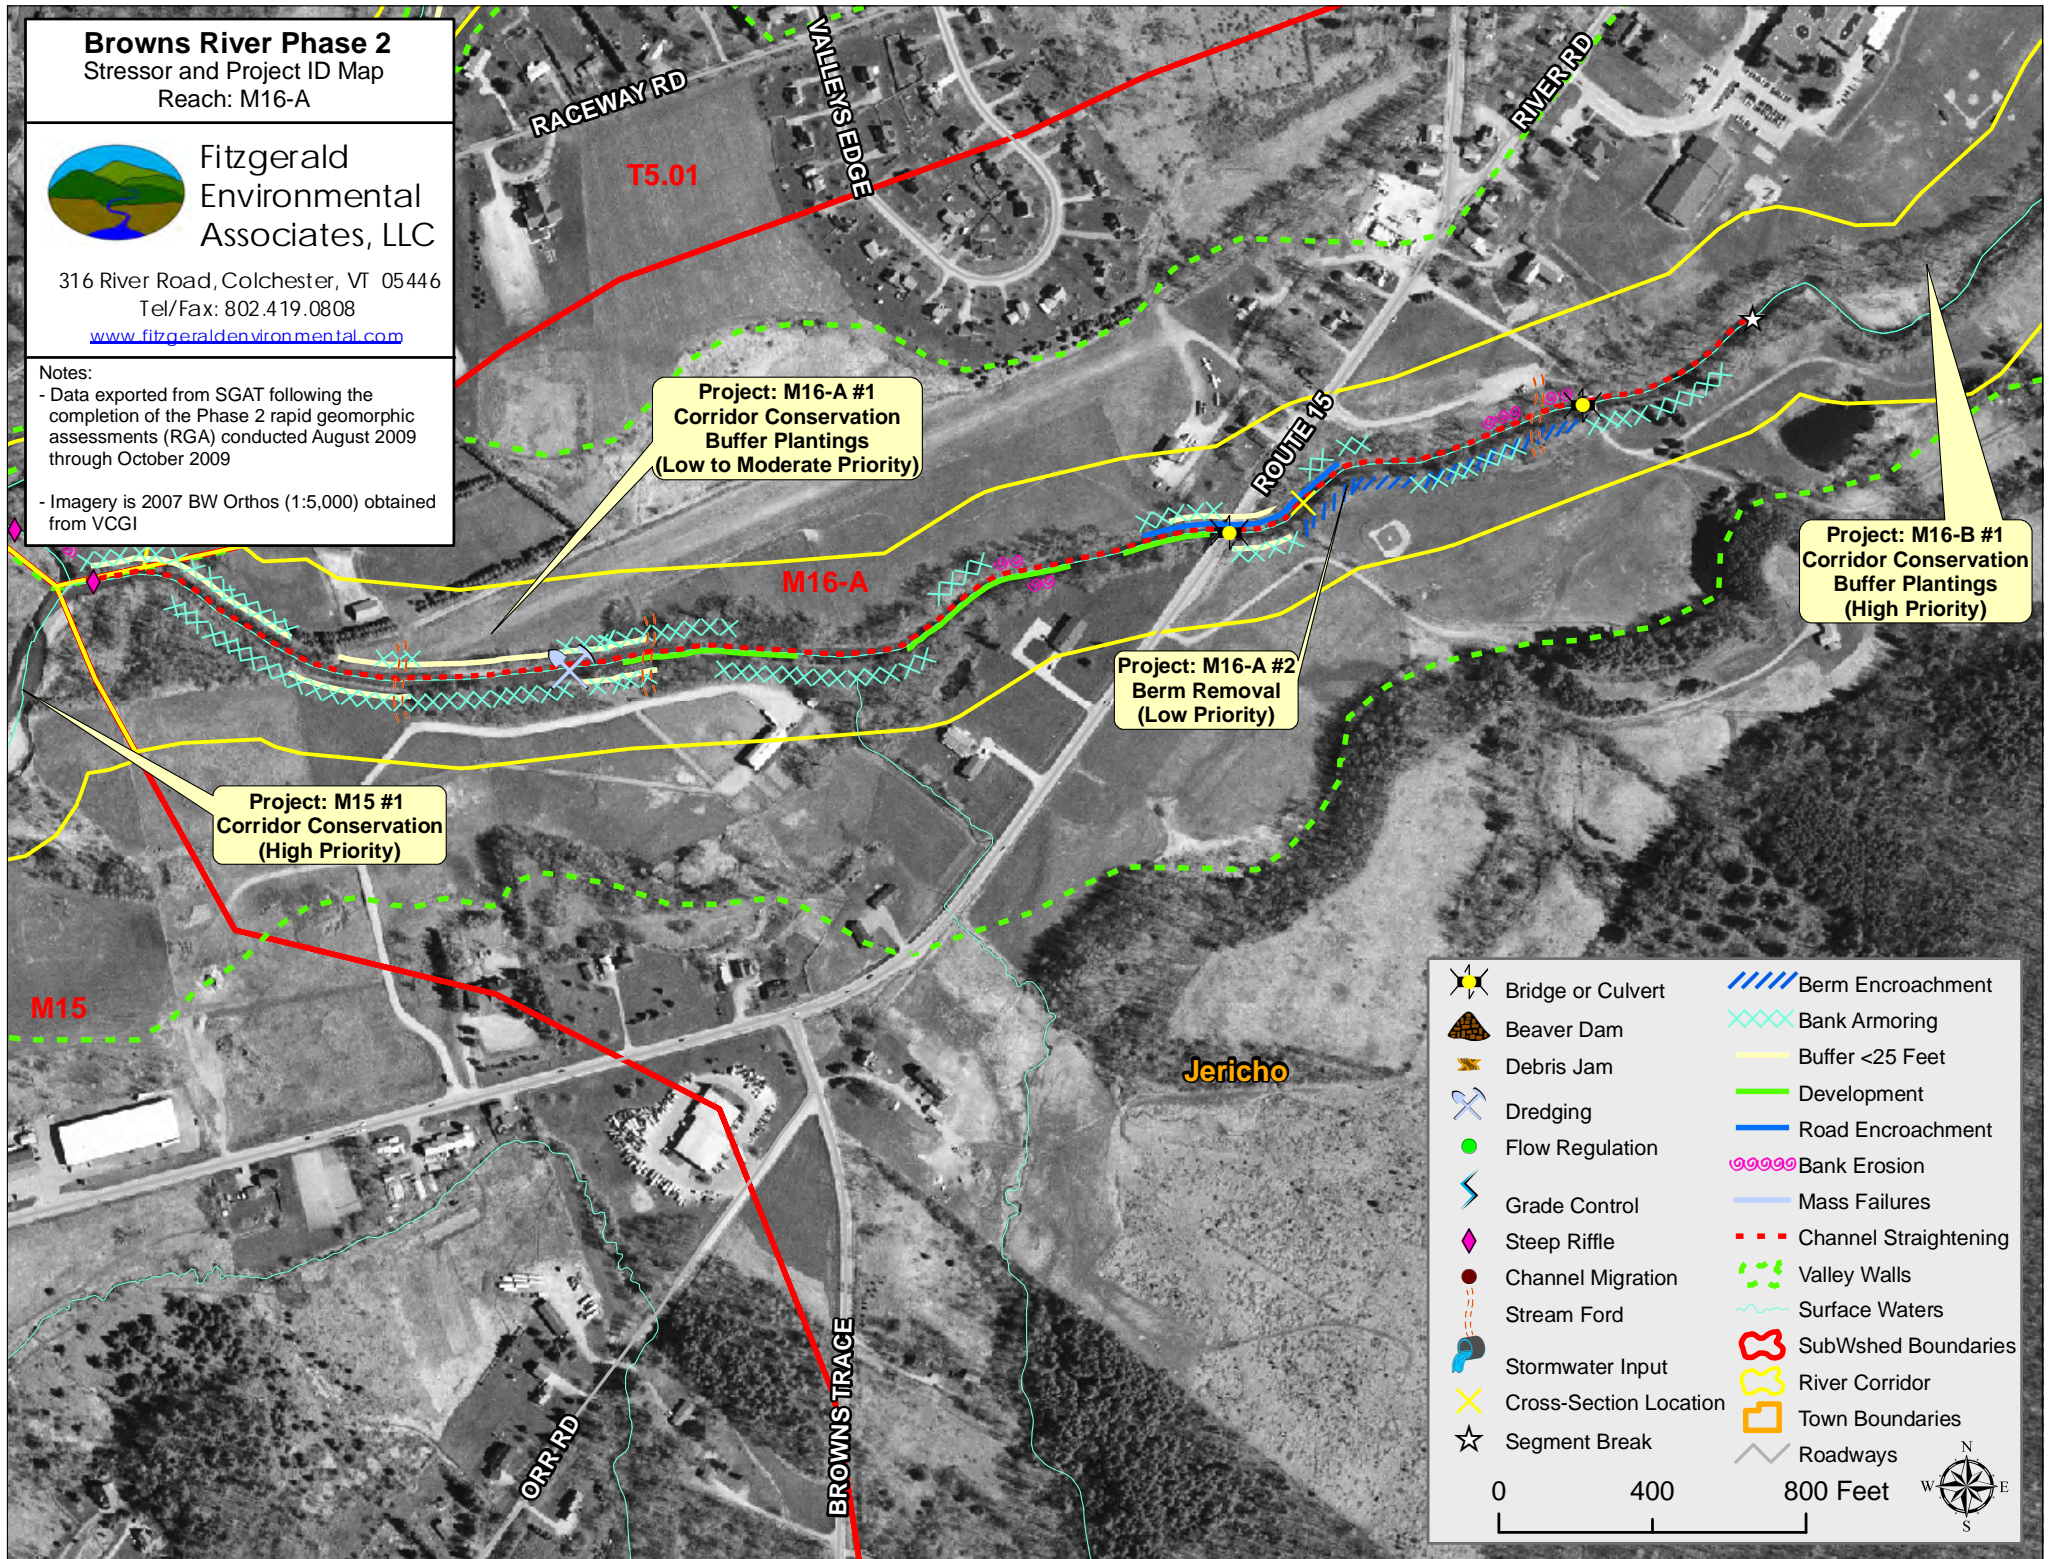
**Project: M16-A #1
Corridor Conservation
Buffer Plantings
(Low to Moderate Priority)**

**Project: M16-B #1
Corridor Conservation
Buffer Plantings
(High Priority)**

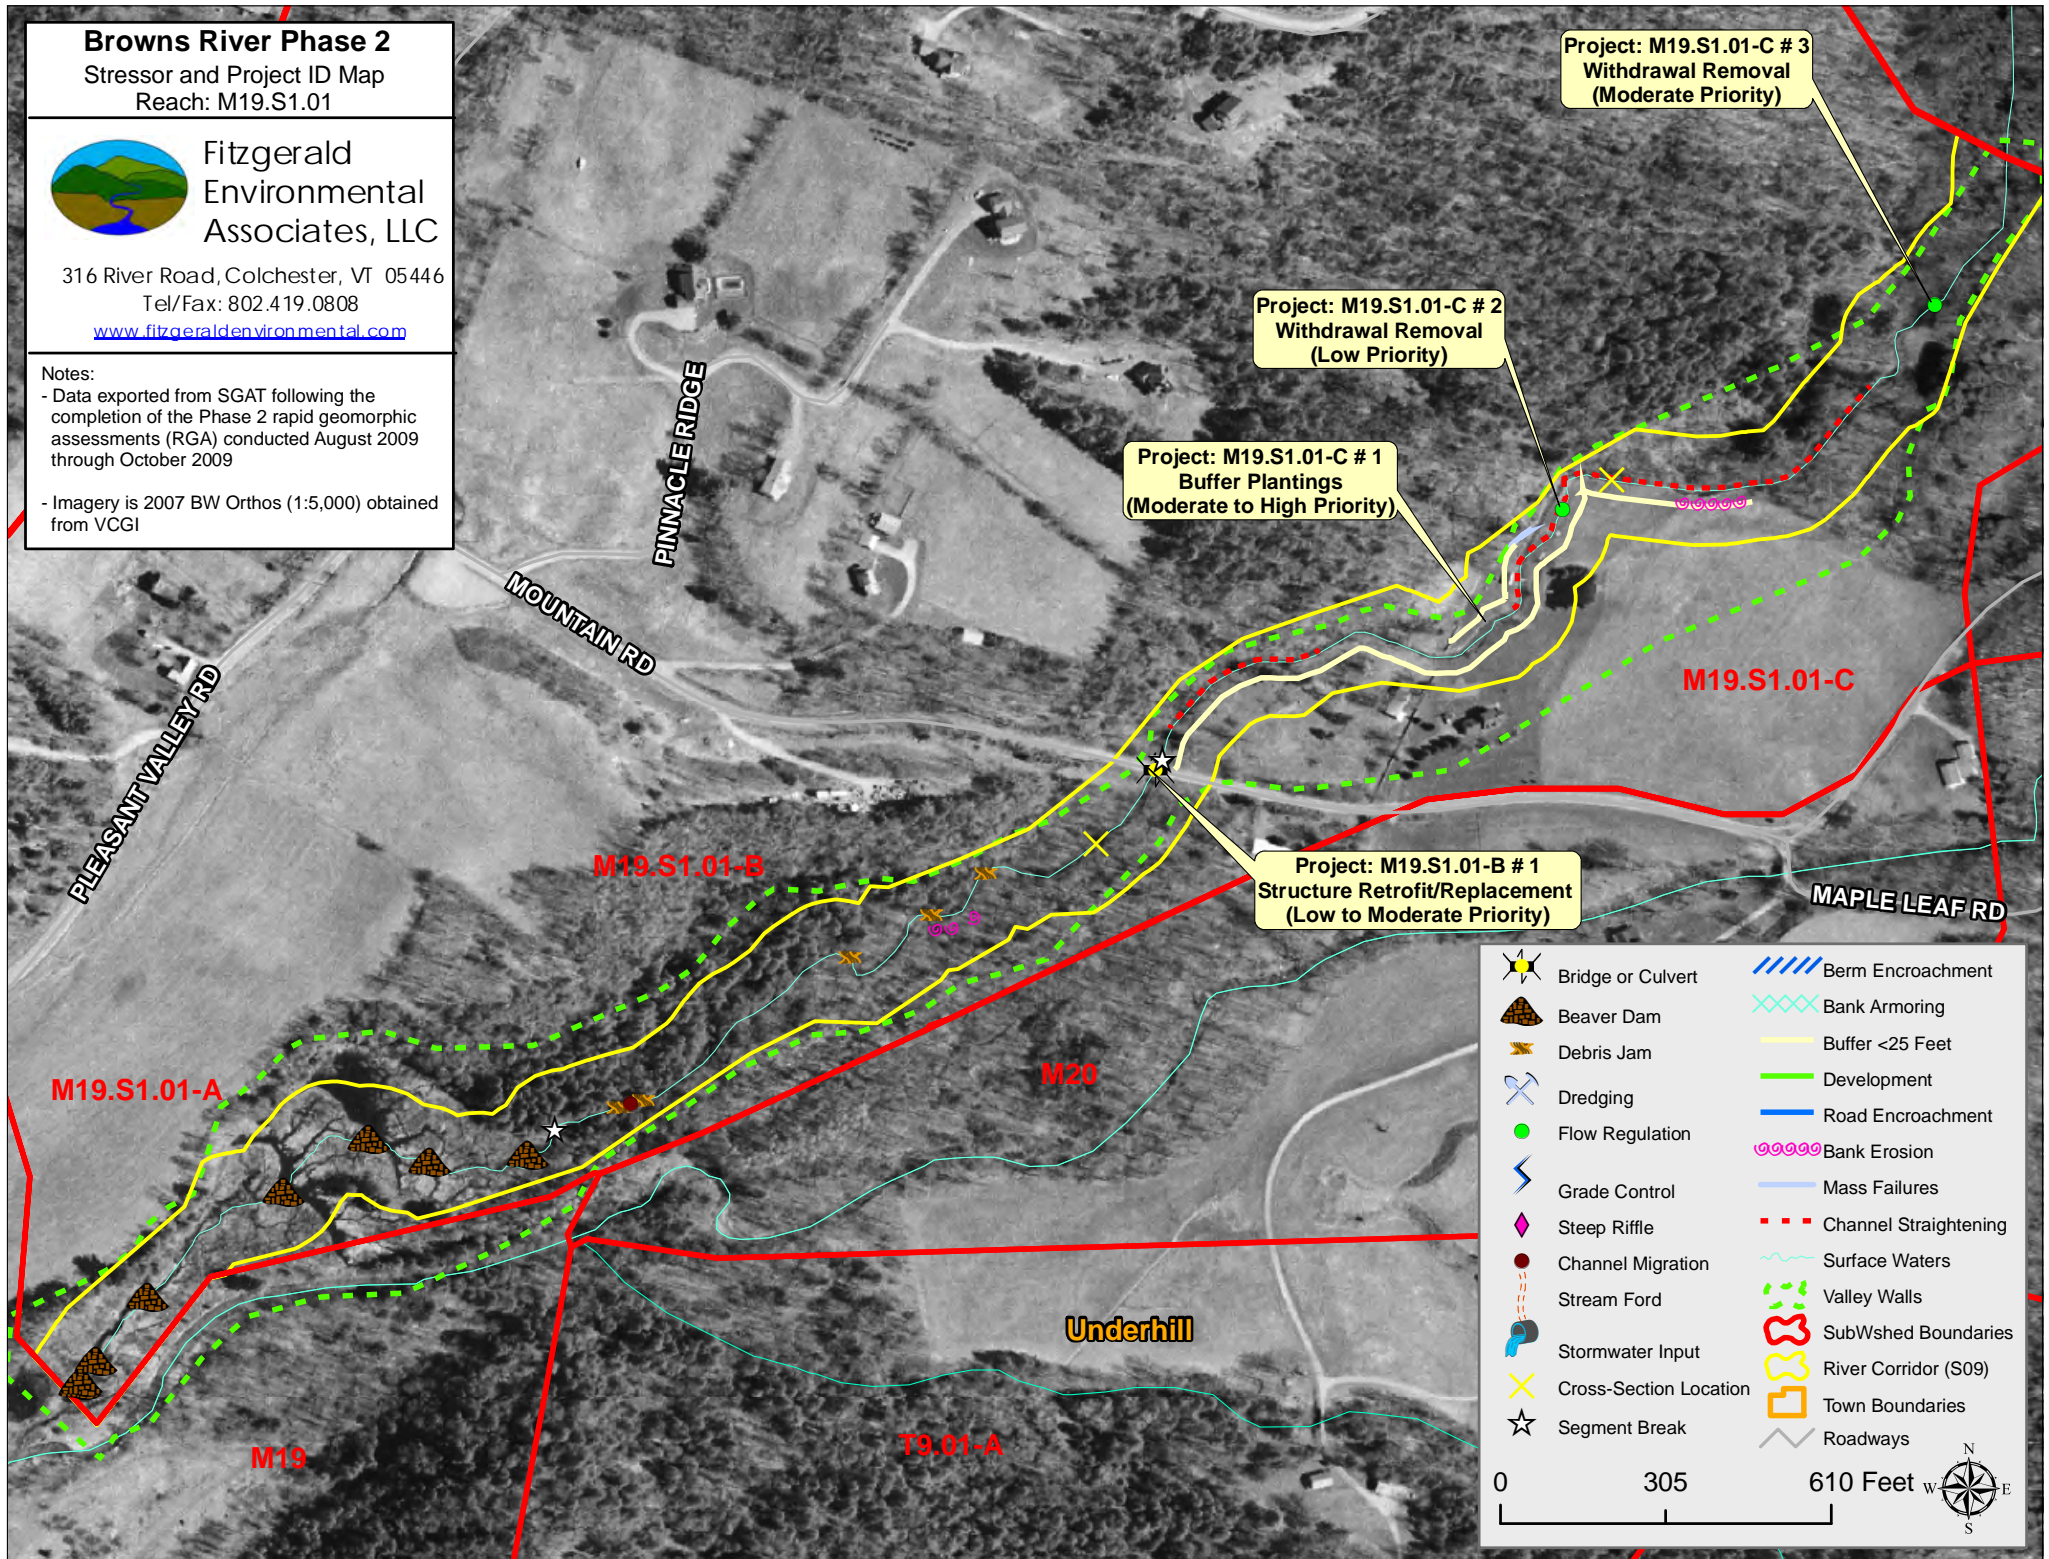
Stressor and Project ID Map
Reach: M19.S1.01

Project: M19.S1.01-C # 3
Withdrawal Removal
(Moderate Priority)

Project: M19.S1.01-C # 2
Withdrawal Removal
(Low Priority)

Project: M19.S1.01-B # 1
Structure Retrofit/Replacement
(Low to Moderate Priority)

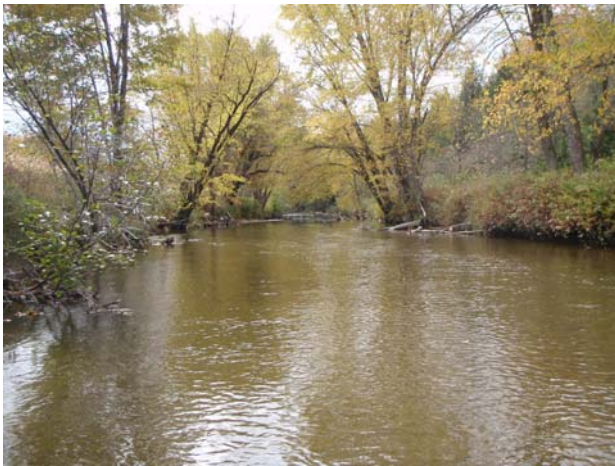
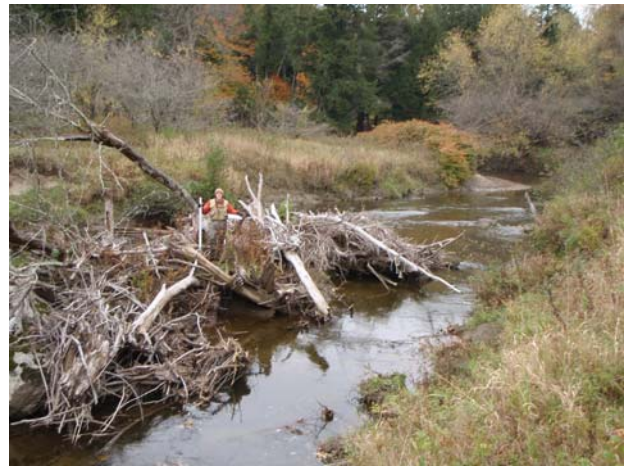
- Impressive how much wood was in this channel! Wow 104 LWD!!
- Yes, this channel had a lot of wood. Throughout the reach there was a good amount of wood near the channel banks, but what really increased the total count was a huge debris jam, with a lot of small pieces of wood and some larger pieces as well (See below). Wow that is a big jam.

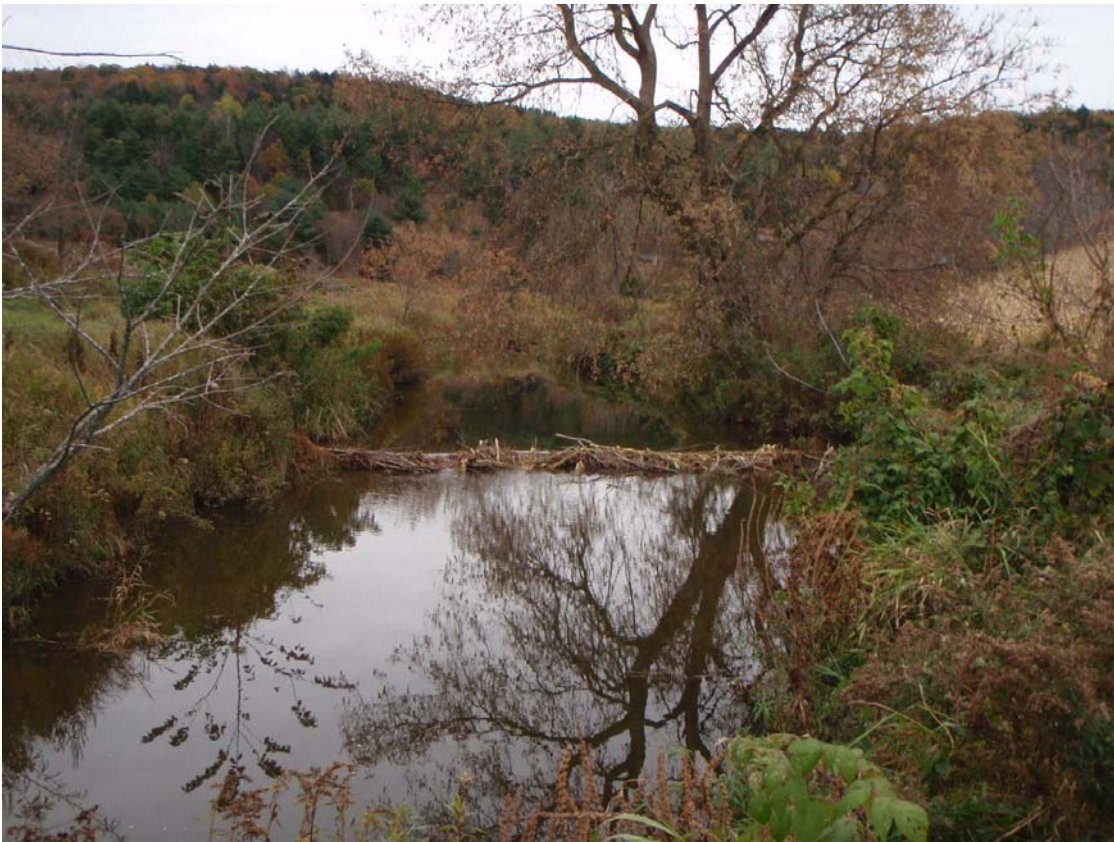
- Phase 1: Step. 5.1 and Step 6.4, please update data from “no data” to appropriate data type.
- Step 5.1 has been changed to “None” & step 6.4 has been changed to “Low” Thanks
- **Seg. A:** no comments
- **Seg. B:** Thank you for collecting as much data as possible for beaver impacted reach. Interesting about the corn stock use for beaver dams.
- See photo below – these beavers were quite crafty... I saw this on the Lewis Creek some years ago too. The famer indicated the corn field didn't look disturbed until he started to cut the corn and then came across a circle in the middle of the field where the beaver had come in through a small path and taken out of the center.. really sneaky ☺ no sign of activity from the edge of the field, but a big bare patch in the middle!

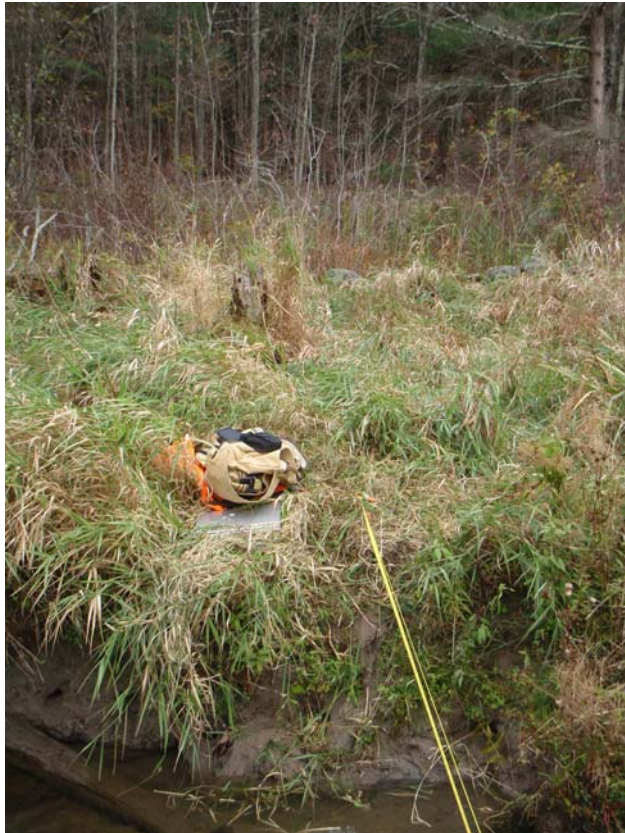
- **Seg. B:**
 - Step 2 cross-section: No incision was noted (bankfull and RAF noted as the same). In reviewing the cross-section there appears to be a floodplain on the right bank that is now accessed at the 2x bankfull. Should this floodplain be considered the RAF (at elevation 5.6 on the xs worksheet)? Or could this be a possible bankfull indicator? Please review.

- This segment/cross-section is a bit tricky because of the changes that have occurred in the last 10 years. The lower portion of the segment had a very large and robust beaver dam that has breached between the time of survey and the summer of 2008. The water was completely filling the current bankfull channel. At the time of survey, the best bankfull bench was the one used on the left bank (see photo below). There was a small, well-formed floodplain along the left bank that was well accessible. Since the bankfull width we chose was right on the HGC predicted for C-type streams, and we felt the channel was relatively stable, we feel we had decent indicators. Okay, good note, be sure to capture this in the narrative for the reach.

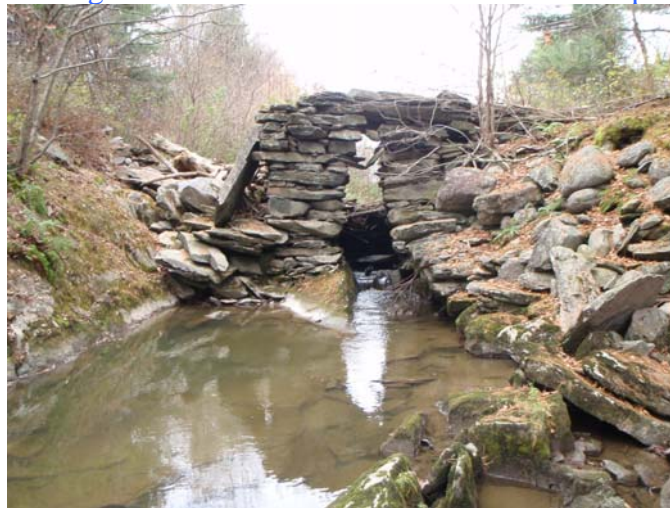
- Step 4.8 constrictions: Wow, a 3 ft old abutment(?) on a 28 ft wide stream. Is this something that might be a good project for removal? Please be sure to mark the location of this on the reach map, as it is not something that was FIT'd and would be good to know where it is in reviewing possible project and/or hazards.
- Yes, it would be a great project area. Sometimes it would be helpful to have a constriction point feature on FIT. I know that these things can't just be added in, but in terms of features that influence the channel it would be nice to have the spatial locations of constrictions on record. Perhaps it could be captured under the bridge/culvert point in FIT for helping track this "structure". Agree some additional FIT options would be helpful, something I will review with folks. Thanks for the picture.
