**STEVENS RIVER WATERSHED**  
**STREAM GEOMORPHIC ASSESSMENT**  
**and RIVER CORRIDOR PLAN**  
**2010-2011**

August 12, 2011

Prepared by:  
Daniel Ruddell, Courtney Haynes,  
and Elisabeth McLane,  
Staff Scientists, and  
Ben Machin, Principal  
Redstart Consulting

Prepared for:  
Caledonia County Natural Resources Conservation District and  
Vermont Agency of Natural Resources/  
Department of Environmental Conservation  
River Management Program

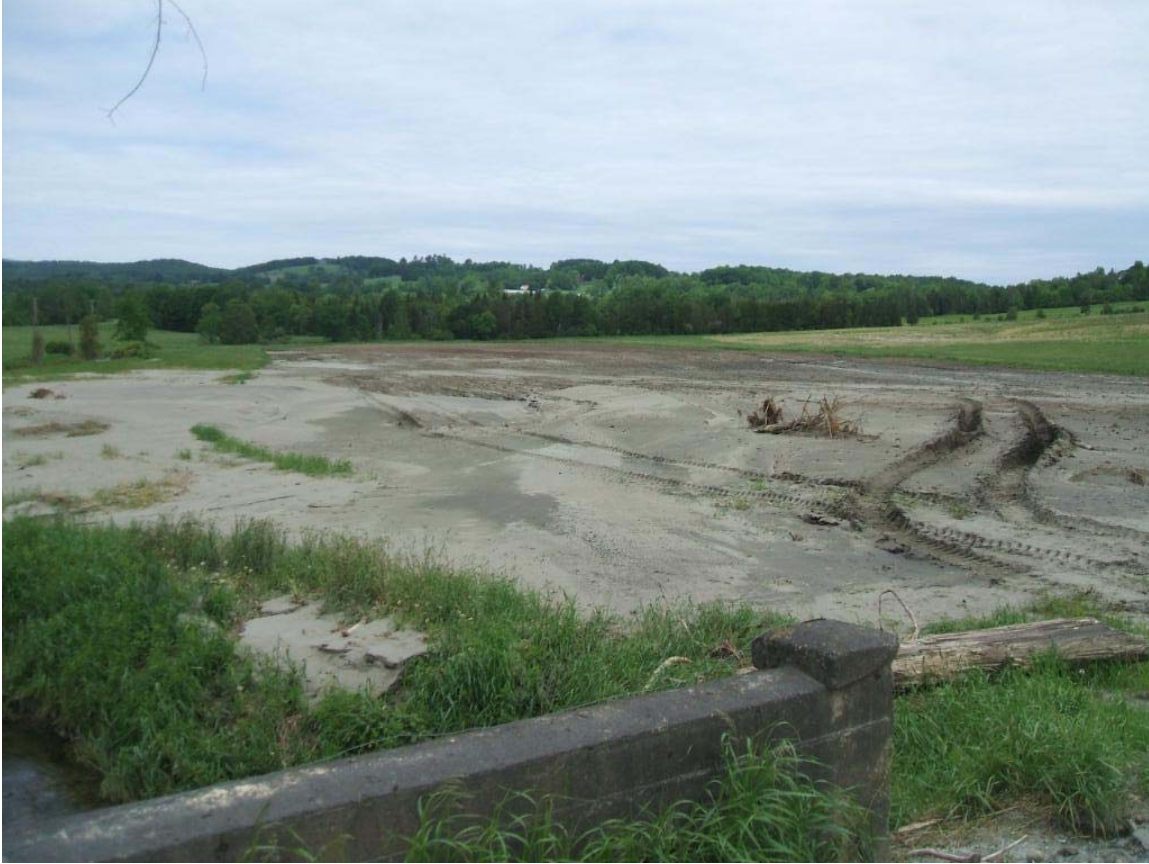
**Figure 6. Alluvial deposition: May 2011 flooding deposited large amounts of sediment at a likely alluvial fan on South Peacham Brook, at the Hollow Woods Road corner with the Peacham-Barnet Road.**

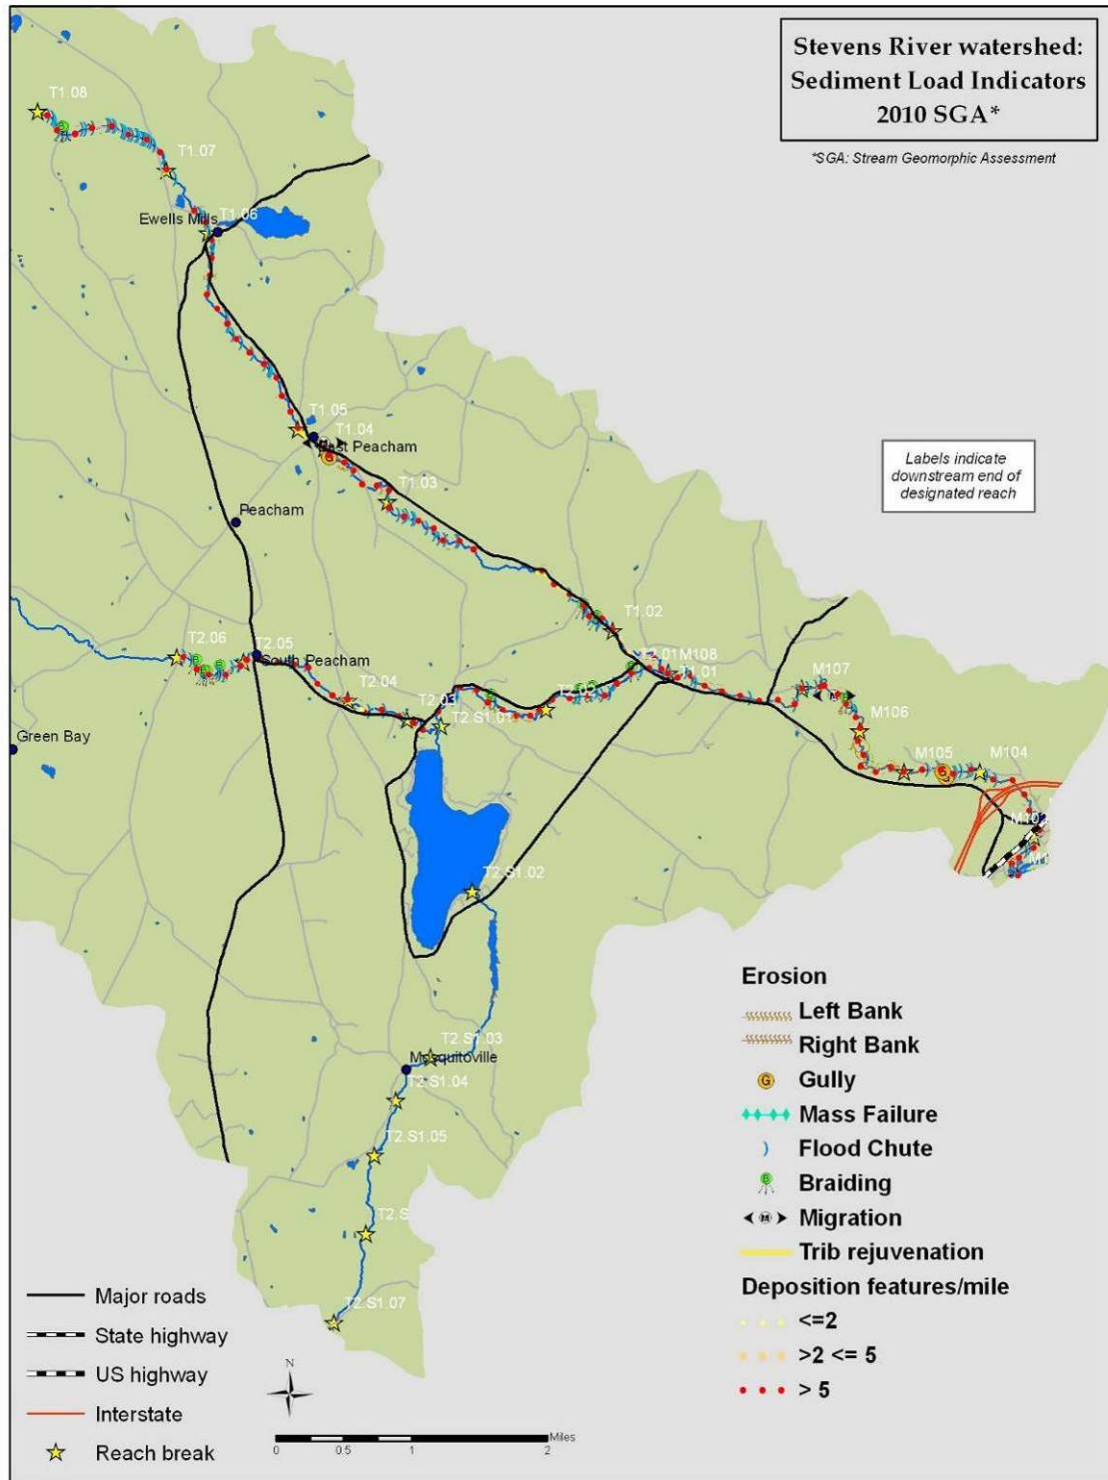
Mass failures and gullies, triggered primarily in flash flooding in the Stevens River basin, generate both wash-load and bed-load sediments and were generally not extensive. These occurred most prominently in reaches M1.04, T1.02, T2.04 and T2.05. A mass failure

that is healing over was noted on reach M1.07 at a distance of several hundred feet back from the current stream location, indicating the strength of stream impacts when the Ben's Mill dam breached.

Figure 17. Sediment load indicators map for the Stevens River watershed.

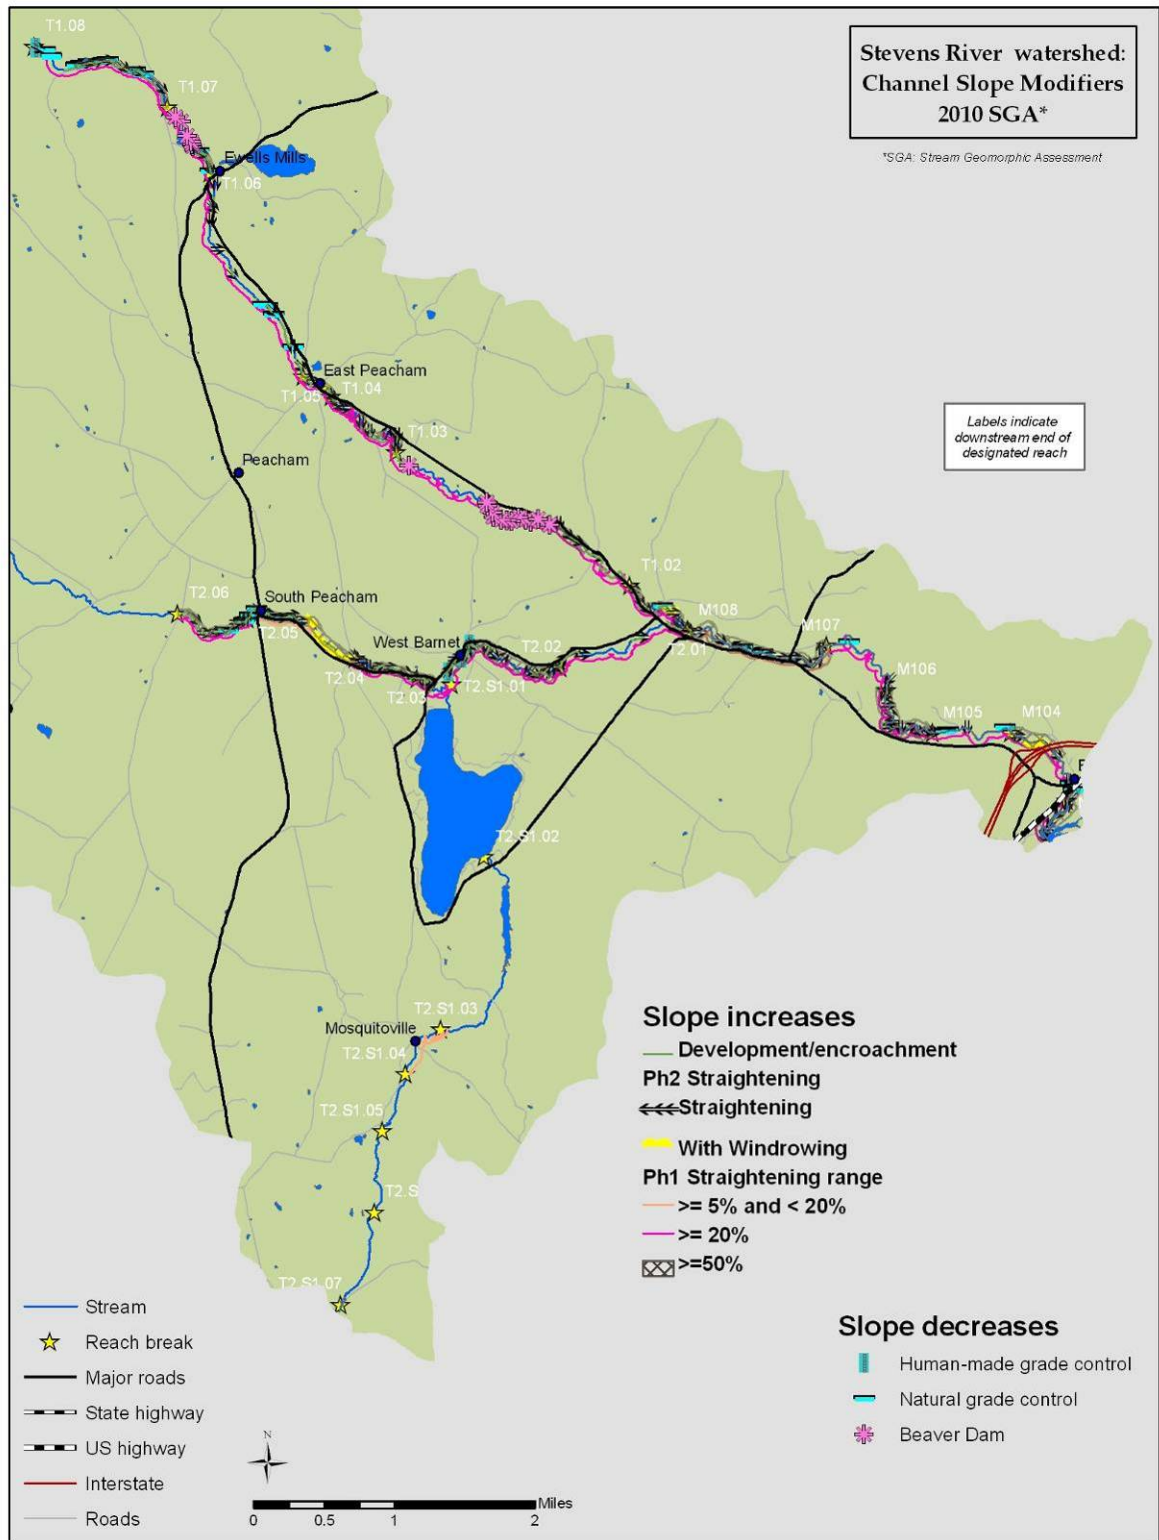
Analysis of channel slope modifiers in the Stevens River watershed indicates that channel straightening is the predominant stressor in the basin, with indications of straightening observed in at least some portion of every reach and segment assessed in Phase 2 (Fig. 18). Channel straightening occurred historically through direct channel manipulation to supply mills on each of the assessed streams and possibly some of the other smaller tributaries of the watershed as well. In addition, straightening has occurred through a

Figure 18. Channel slope modifiers map for the Stevens River watershed.

combination of incremental impacts including: road and development encroachments; structural measures such as riprap and bank toe stabilization; less direct maintenance of the channel “in its place” through field cultivation and ditching; and remediation of flood damage through windrowing of stream sediments, removal of debris jams, and channel “clean-outs” in the areas of bridges and culverts damaged in floods and subsequently repaired or replaced.

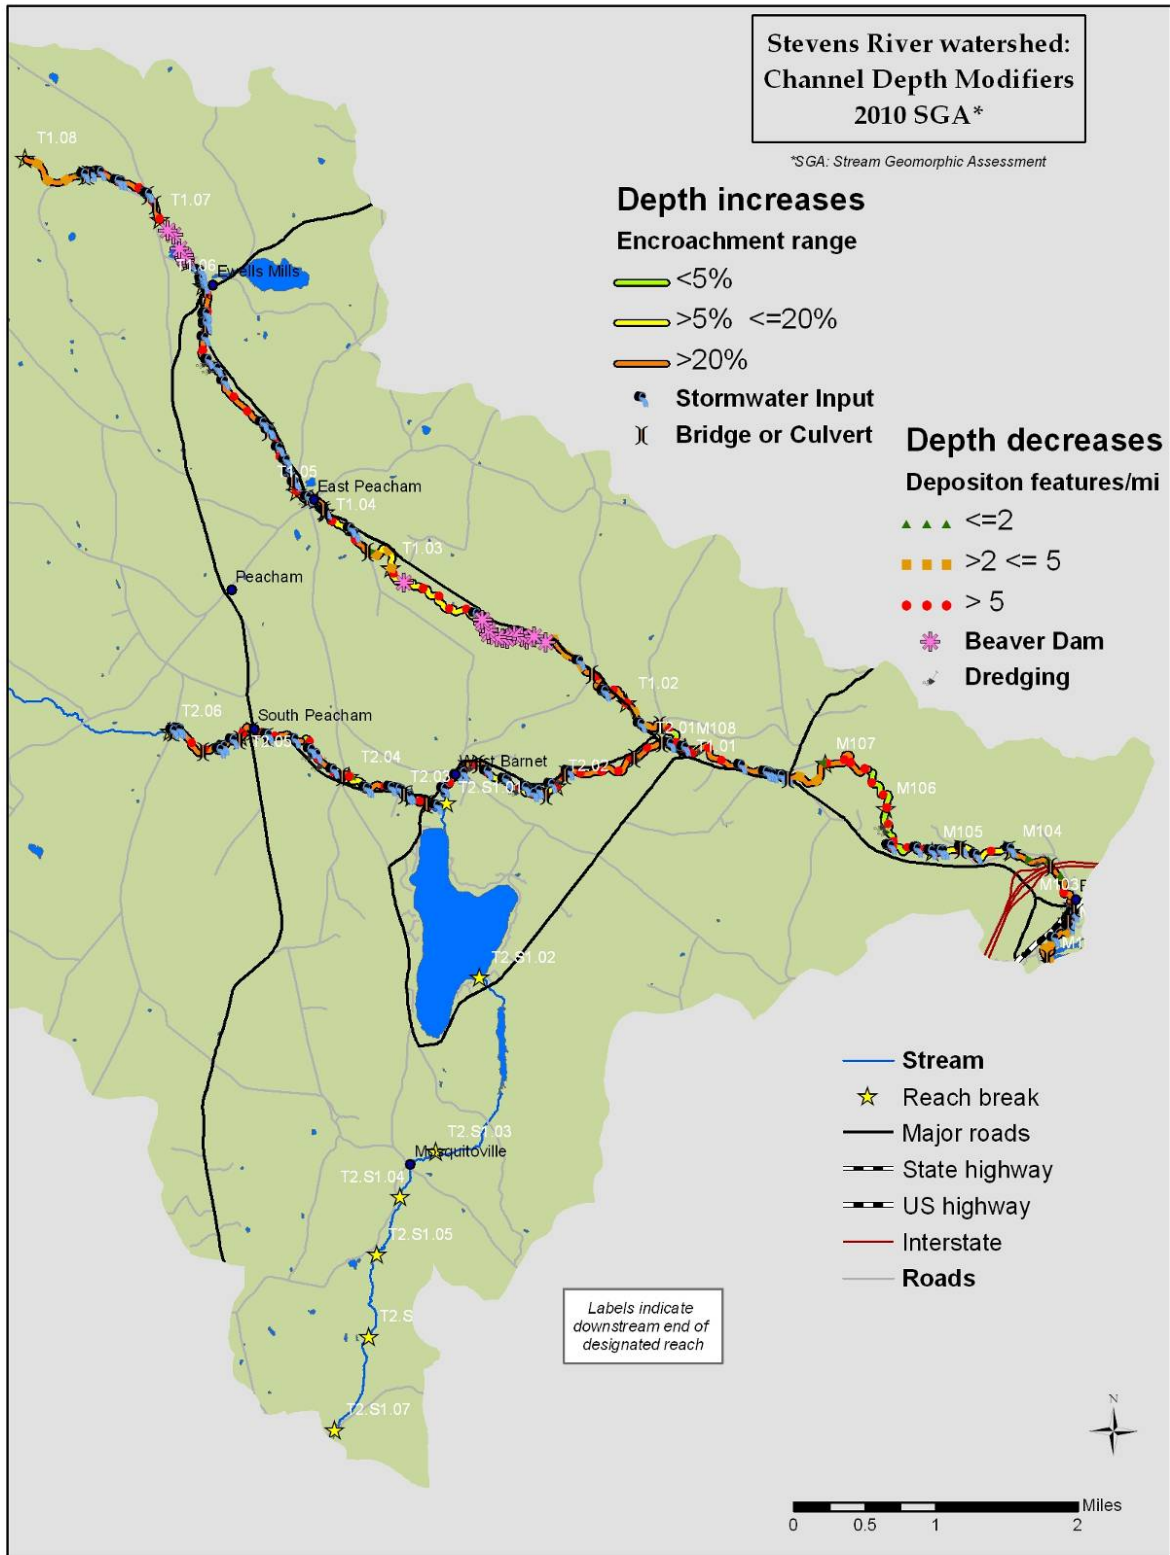
Phase 1 and 2 data collection indicate road encroachments exceeding 20% of the length of the stream segment on 26 of 36 segments (in 17 of 19 reaches assessed in Phase 2) in the Stevens basin. An additional 6 segments have encroachments along 5-20% of the segment length, leaving just 4 segments in 4 reaches without significant road encroachments in the stream corridor. Stormwater inputs such as road and field ditches can amplify these effects as well (Fig. 18). Flash flooding impacts in May 2011 clarified possible implications of this, as road gulying and erosion were prominent in numerous areas along streams (Fig. 15).

Figure 19. Channel depth modifiers map for the Stevens River watershed.

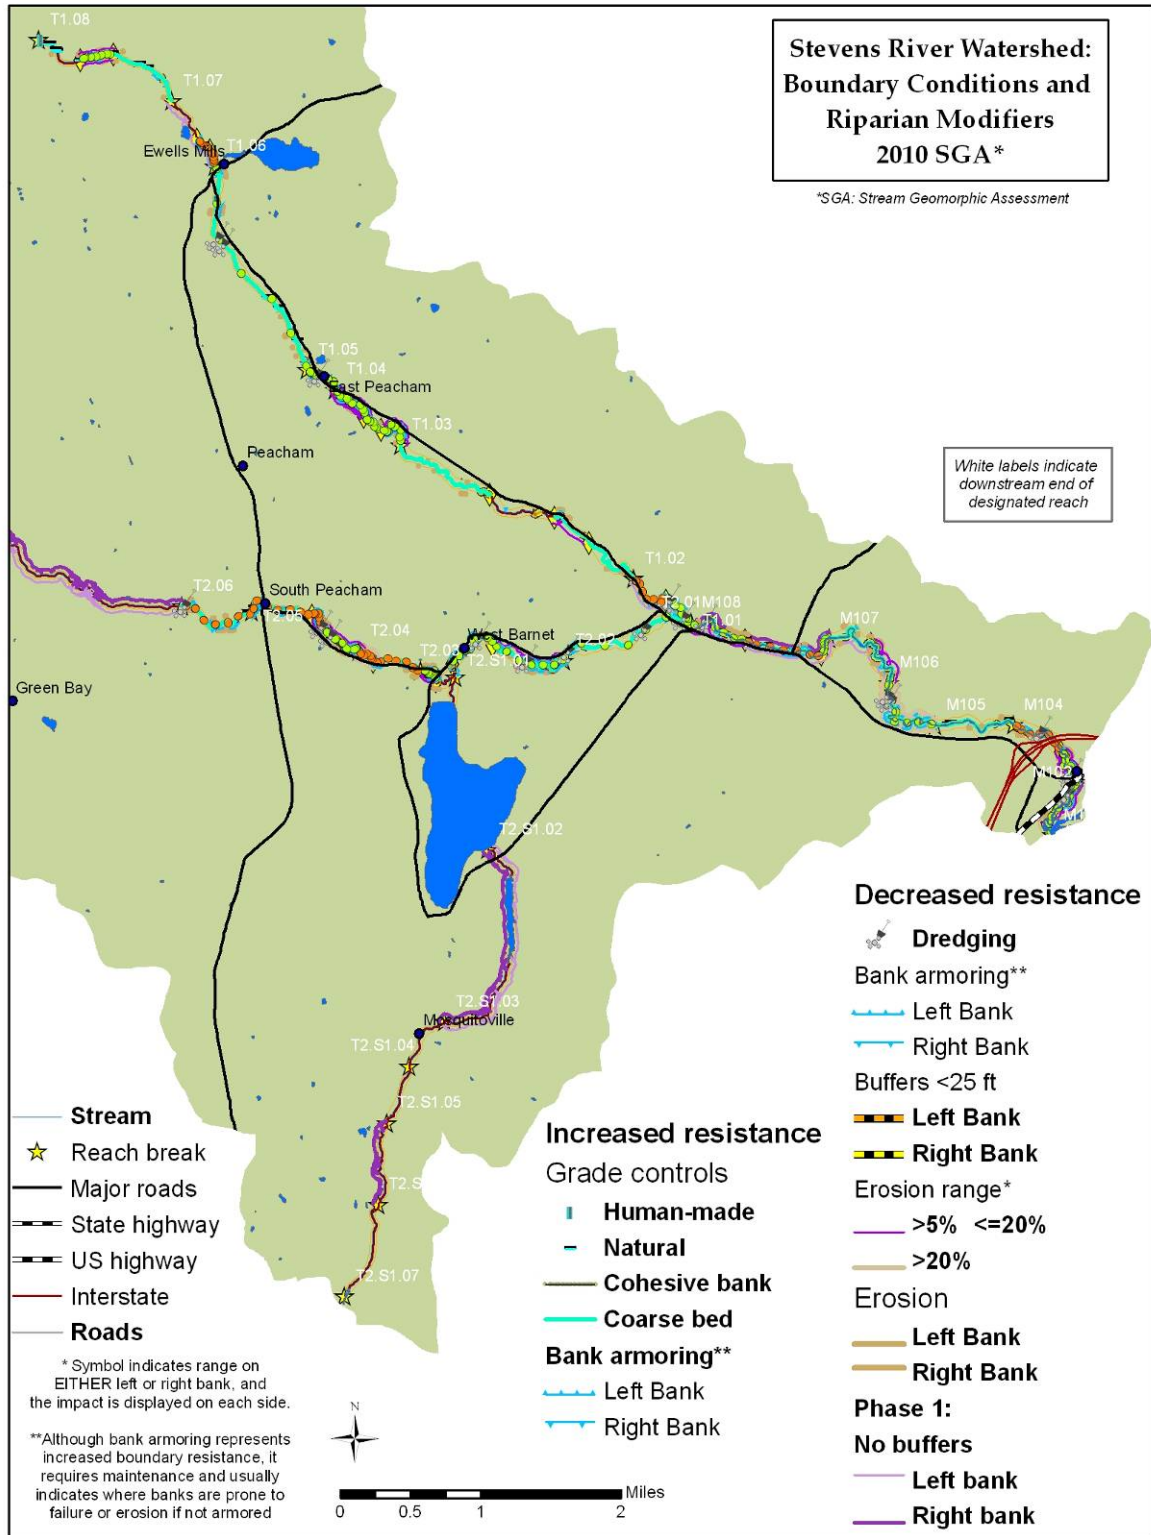
**Figure 21. Boundary Conditions and Riparian modifiers map for the Stevens River watershed.**

two segments with >20% of the segment length armored on both banks: T1.03B beneath the 30-ft embankments of Interstate-91, and T2.04B on the likely alluvial fan downstream of South Peacham village at the edge of the Roy fields (see discussion in sec. 5.1.3b). Fifteen additional segments had one bank or the other heavily armored (>20% of the segment length). This brings the total to 17 out of 36 – nearly half of the segments assessed in Phase 2 heavily armored. An additional 24 of 36 segments had moderate levels of bank armoring and revetments (5-20%) on at least one bank. These armored reaches are dispersed throughout the reaches assessed in 2010.

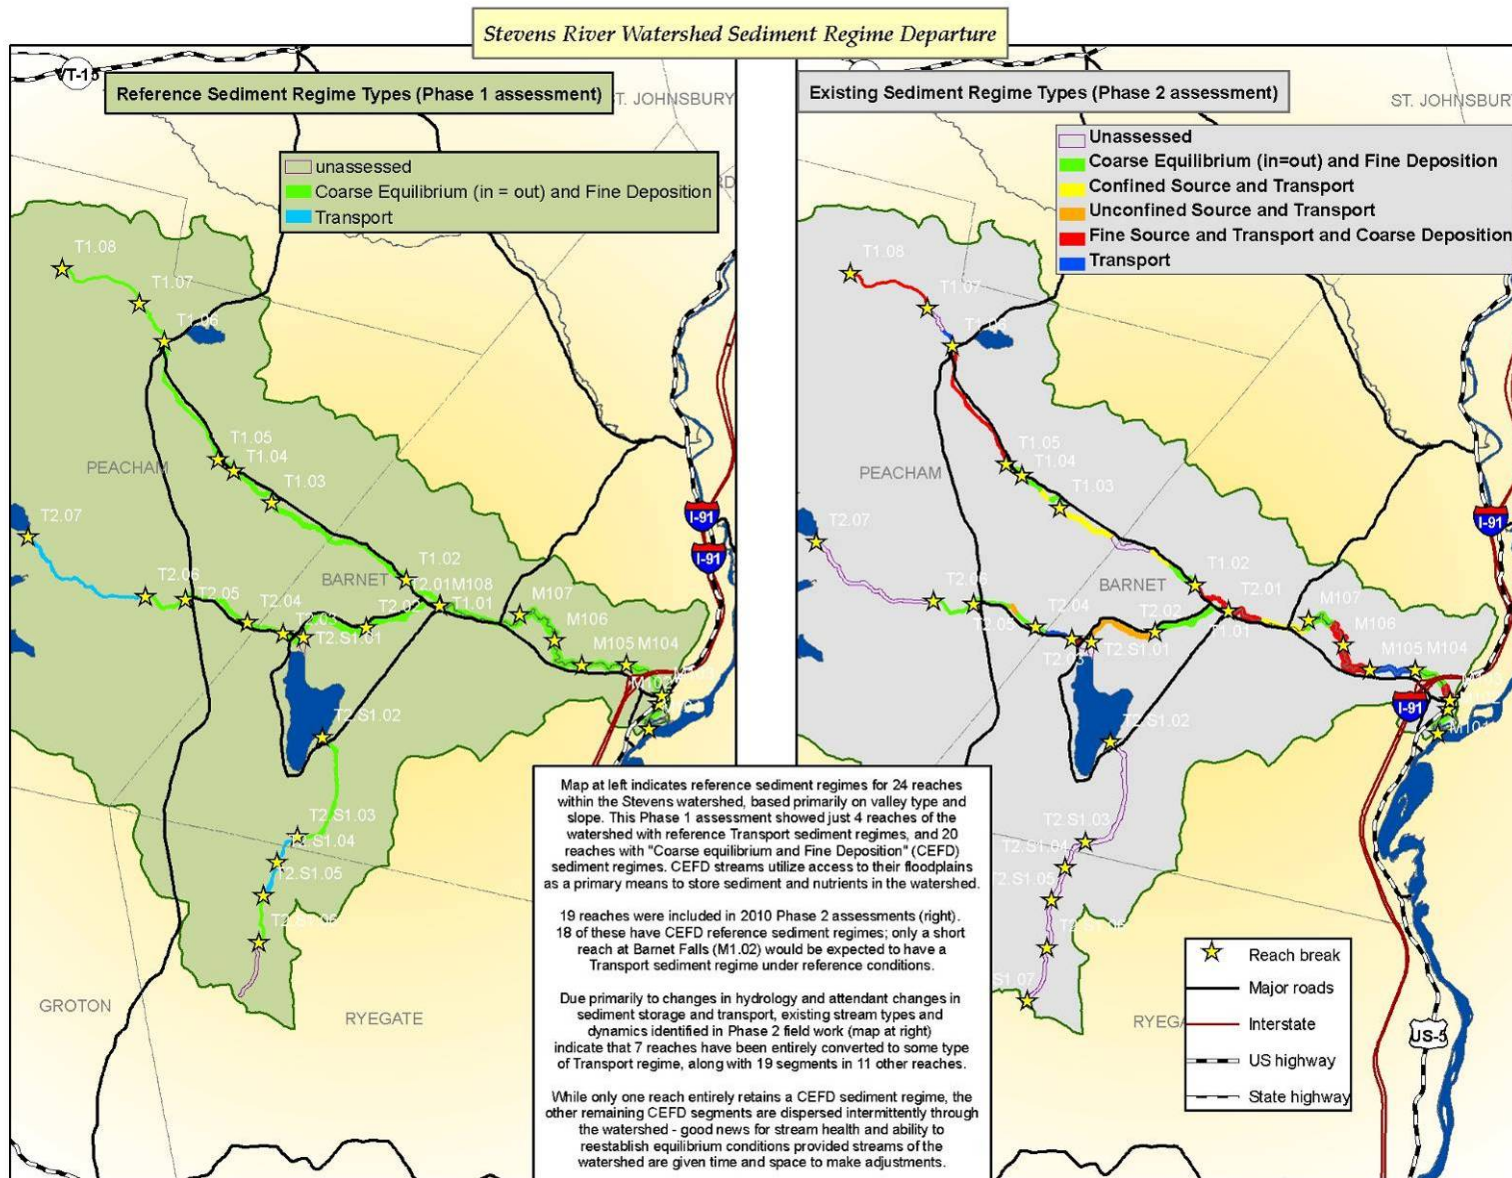
Figure 26. Sediment regime departure maps for the Stevens River watershed.

Phase 2 assessments in the Stevens River watershed indicated that, in contrast to eighteen Phase 1 reaches that would function as Coarse Equilibrium and Fine Deposition (CEFD) areas under reference conditions, only thirteen (of thirty-six total) segments in eleven Phase 2 reaches currently function with CEFD sediment regimes. While this indicates greatly diminished functions for sediment, nutrient and floodwater storage within the watershed, the fact that the thirteen segments are intermittently spaced through the watershed (Fig. 26) is helpful in terms of overall stream functions and health. Visual assessment indicates, however, that the current sediment regime is out of balance in terms of an even distribution of sediment loads and bed features.

Sediment regime departure in the Stevens watershed appears to currently be primarily related to alternation of levels in stream power. Due to the significant conversion of CEFD sediment regimes to various transport sediment regimes in Phase 2 reaches, fine grained “washload” materials are often being transported long distances through the watershed, dropping out primarily when low velocity conditions are encountered and frequently contributing to infilling of planebeds (sedimented areas of the stream with no major elevations or depressions) in downstream reaches. Coarser “bedload” sediments appear to be:

Fine Source and Transport and Coarse Deposition regimes (coded red in Fig. 26) now exist in eleven stream segments that lack extensive bank armoring and are characterized by channel widening, elevated levels of erosion and concentrated deposition at channel constrictions, tributary mouths, and overwidened sections of the stream. Backwater areas behind the Harvey’s Lake dam (T2.02C (excluded from full assessment) and T2.02D) and Barnet Falls dam (M1.03A) have significantly aggraded with fine sediments over time, and are accruing sediment “slugs” from upstream reaches as well as their own banks. The relatively recent (~1990) breach of the Ben’s Mill dam has contributed to deposition and widening in segments M1.05, M1.06A and M1.07C on the Stevens mainstem. Similar dynamics in segments T1.01A and B and T1.05, and T1.07 A, B and C on Peacham Hollow Brook appear related to flash flooding in the past decade or two, and this current sediment regime appears related to the movement of flood-related sediment discharges through this portion of the stream network. Widespread mill history

Unconfined Source and Transport sediment regimes (coded orange in Fig. 26) currently dominate three segments: T2.02A and B and T2.04B, all on South Peacham Brook. While these areas would have floodplain access and storage under reference conditions, historic and current channel management practices leave little ability to store sediments or high flows and thus transfer impacts to downstream reaches. Segment T2.02A along the Choate fields appears to have also had a dam at the upstream end of the segment (no longer present) and the primarily sand banks are extensively lined with large stone for bank toe stabilization; some of it has failed over time and clearly requires maintenance to remain intact. Segment T2.02B is located downstream of the Harvey’s Lake dam in West Barnet village and is essentially walled in along one bank for much of the segment; check dams are in place on this segment to prevent further incision of the bed and require maintenance to fulfill that function. T2.04A is located on a likely alluvial fan just downstream of a number of historic mill and stream-powered business locations (see description in sec. 5.1.3b).

Confined Source and Transport sediment regimes (coded yellow in Fig. 26) exist in the narrower valleys of the Stevens River watershed, which are relatively limited in extent but are prone to mass failures and erosion along the valley walls that contribute sediment discharges that quickly transfer to downstream reaches due to elevated stream power in these narrower valleys. Segment M1.07B from Ben’s Mill downstream to the Barnet Center Road bridge on the Stevens River mainstem is confined by the Peacham-Barnet Rd. on the right bank (looking downstream); the opposite side evidences the impacts of the breached Ben’s Mill dam via a large mass failure healing over on the left valley wall. The narrow valley portions of reach T1.02 lie alongside the Peacham-Barnet Rd. on either side of the Peacham-Barnet town line, but are separated by a broader, beaver-controlled valley in segment T1.02C that is able to store some of the sediment discharges from upstream. T1.03B is a confined portion of Peacham Hollow Brook running alongside Stevenson Rd., and it is likely that construction of the road has combined with the features of a “pinch point” in the valley, created by glacial streams, to leave relatively steep slopes with erodible soils along the valley walls.

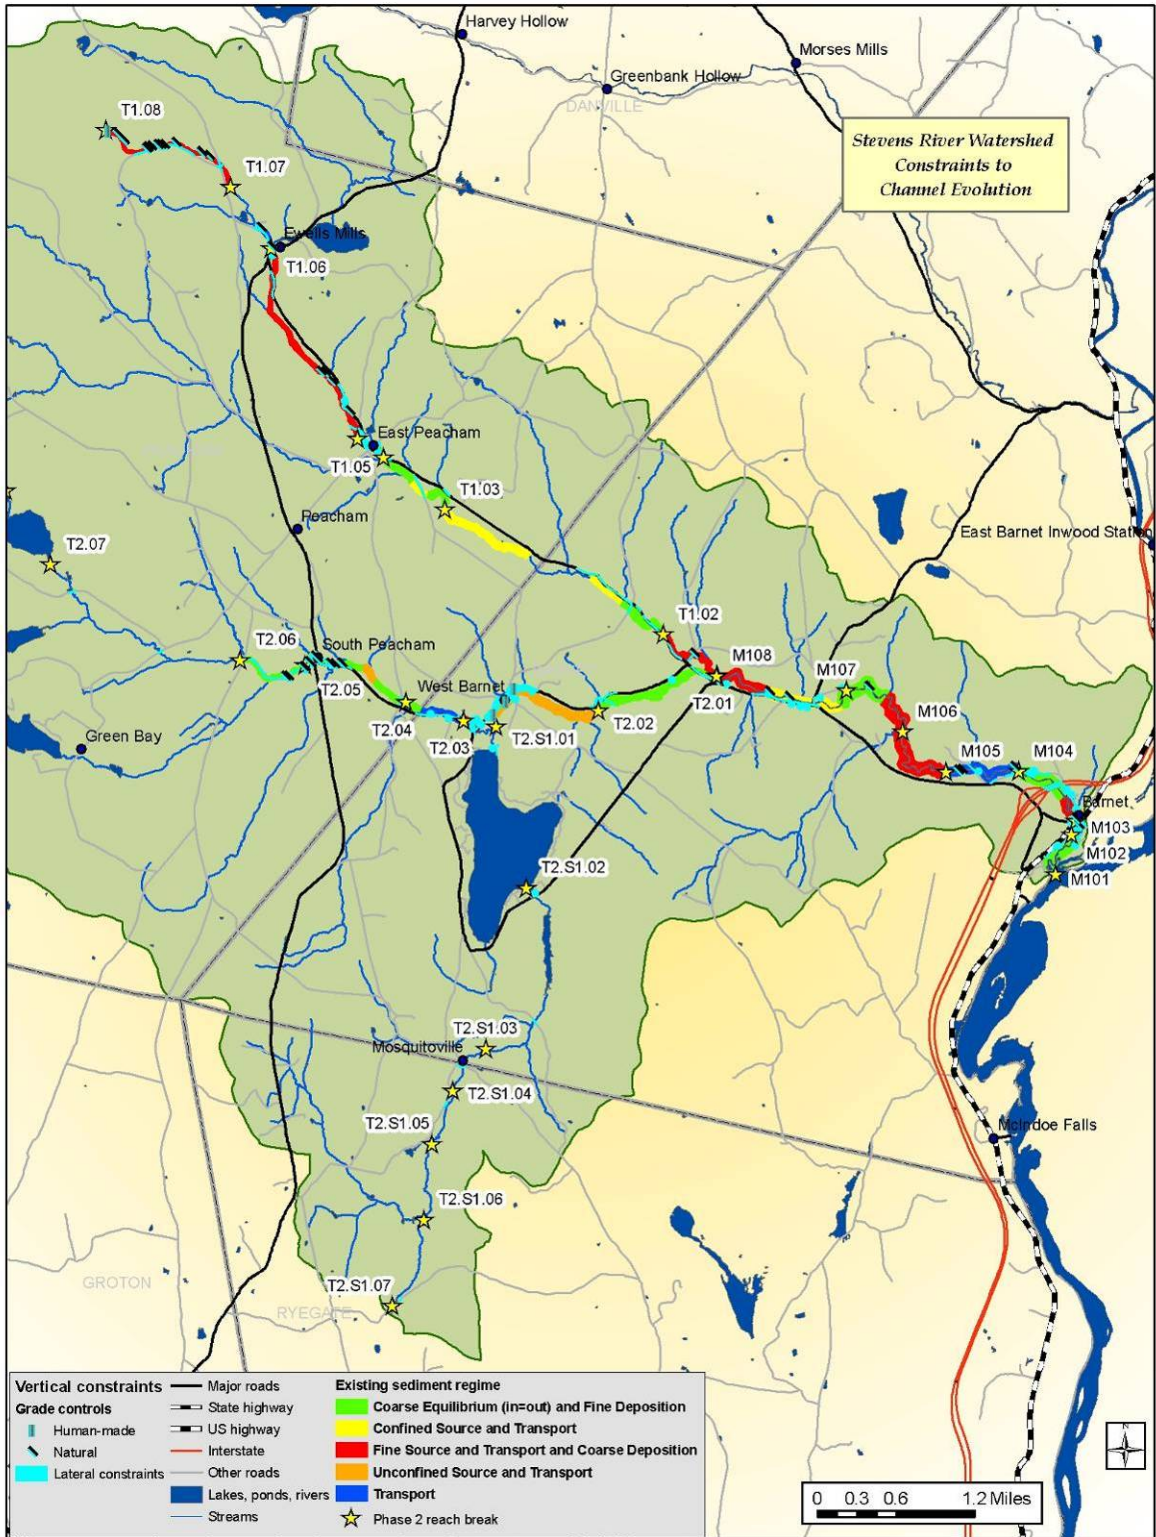
**Figure 28. Map of existing sediment regime in conjunction with vertical and lateral constraints to channel evolution in the Stevens River watershed 2010 Phase 2 assessment area.**

Lateral constraints to channel evolution are more common in the Stevens River watershed, but are not commonly found as bedrock outcrops in the reaches assessed in 2010. In fact, the relatively few narrow valleys in the assessed portions of the watershed often contain erodible materials in the valley sidewalls and can easily contribute sediments from mass failures and heightened erosion when subjected to elevated stream power.

With widening and planform adjustments the dominant phase of channel evolution in the watershed, human-constructed constraints to lateral channel evolution are thus primary stressors in the Stevens River basin. Settlement patterns in the watershed have featured extensive road encroachment, with concentrated development in a number of villages situated in close proximity to the stream (Fig. 28). With few natural constraints to widening and planform adjustments, the physical mandates of stream adjustments to flash floods and other events (and changes that have amplified the impacts of these types of events - particularly straightening, encroachments and increased stormwater inputs) are likely to impact human-constructed lateral constraints. This implies escalating costs and effort to remediate conflicts with human-constructed lateral constraints already placed in stream corridors within the basin, and emphasizes the value of minimizing future conflicts by limiting introduction of new lateral constraints. It also implies that minimizing these costs and efforts regarding existing encroachments will require careful attention to protecting existing floodplain access.

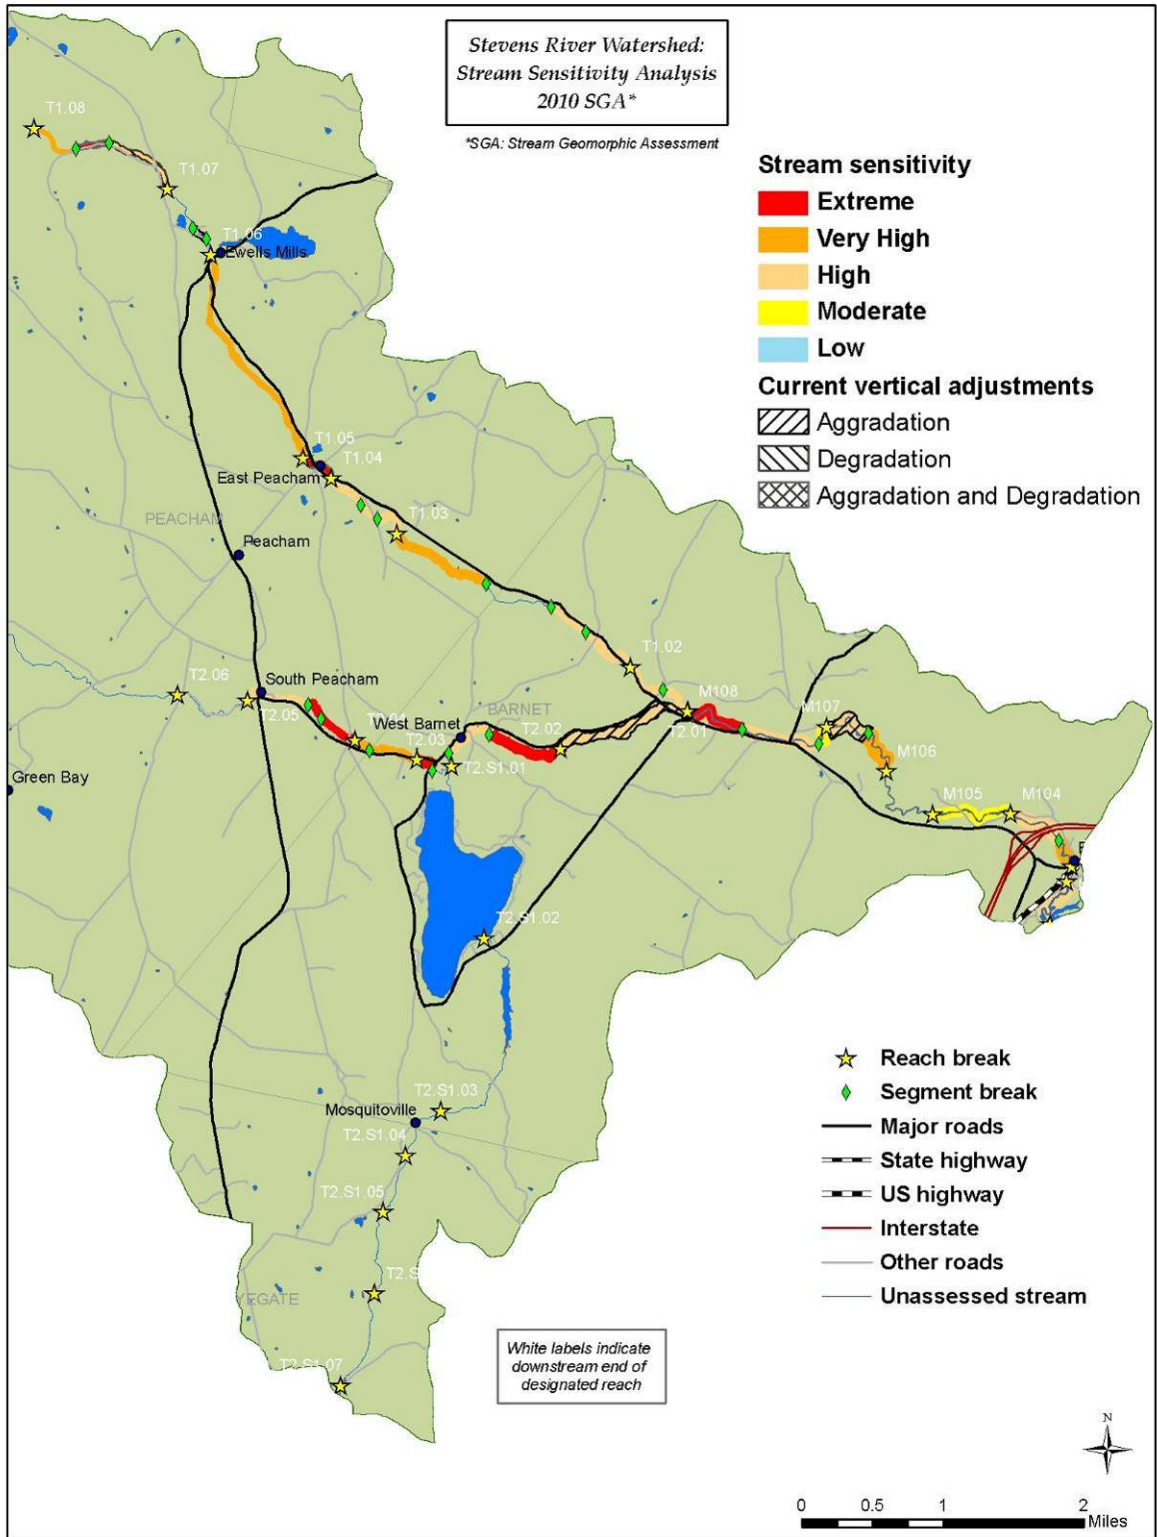
Figure 29. Stream sensitivity map for the Stevens River watershed.

Only two segments (M1.04 and T1.07A) assessed in Phase in the Stevens River watershed were rated with Moderate sensitivity. All other fully assessed stream segments are Highly to Extremely sensitive to disturbance and stressors, and thus also capable of a relatively rapid response (channel evolution to reestablish equilibrium conditions) if stressors are addressed (Fig. 29). This is in part due to the selection of mostly C- and E-type streams for Phase 2 assessment, which are by nature relatively sensitive and capable of recovery to equilibrium conditions in response to restoration efforts (Rosgen 1994).

Current major vertical adjustments in the Stevens River basin are limited in extent (Fig. 29), as many of the major vertical adjustments in the watershed have been primarily historical in nature, including aggradation behind the long-standing dams at Harvey's Lake (T2.02C) and Barnet Falls (M1.03A). Current aggradation was noted in M1.06 downstream of the former dam breached at Ben's Mill; T1.04 (likely in response to windrowing, as this reach in East Peacham village also showed signs of current degradation), T1.06B and T1.07B (in response to recent flash flooding) and T2.01 on South Peacham Brook. Mass failures and erosion in reach T.202 are likely contributing to the aggradation in T2.01, but it should be noted that this reach has High (rather than Very High or Extreme) sensitivity; while the reach is important as an attenuation asset, particularly in the lowest portion of the reach (a shared floodplain with reach T1.01), channel evolution responses are likely to be relatively slow (i.e., could be decades).

Recent incision or downcutting was noted in T1.04 and T1.07 on Peacham Hollow Brook; in T1.04 (East Peacham village) this appears related to extensive windrowing and armoring, likely due to bridge clean-outs following floods. Degradation in the headwaters of Peacham Hollow Brook (T1.07) appears related to a combination of recent land use changes (including encroachments, flow regulation, extensive forest cutting, and significant stream straightening) and recent impacts of microburst storms. No active headcuts were noted anywhere in the watershed.

That said, the check dams in place downstream of the Harvey's Lake dam, in segment T2.02B, indicate that this area is particularly sensitive to these processes and failure to maintain these structures could initiate changes quickly. This increases the importance of attenuation assets upstream of the dam area. With extensive encroachments present in West Barnet village and along the Peacham-Barnet Rd., the Extremely sensitive reaches in T2.04A and B (Roy fields near the Hollow Woods Rd. bridge) take on increased importance for possibilities of restoring and maintaining equilibrium conditions on South Peacham Brook. These segments also have increased value for storing sediments and floodwaters due to the unique set-up of the dam at Harvey's Lake, which allows floodwaters to back up into the lake from South Peacham Brook. In addition, recent flash flooding impacts indicate that these segments play an important role in attenuating floodwaters and sediment discharges from upstream portions of reaches T2.04 and T2.05 where these impacts are difficult to address due to extensive encroachments in South Peacham village and along Governor Mattocks Rd. (Fig. 6; Fig. 15).

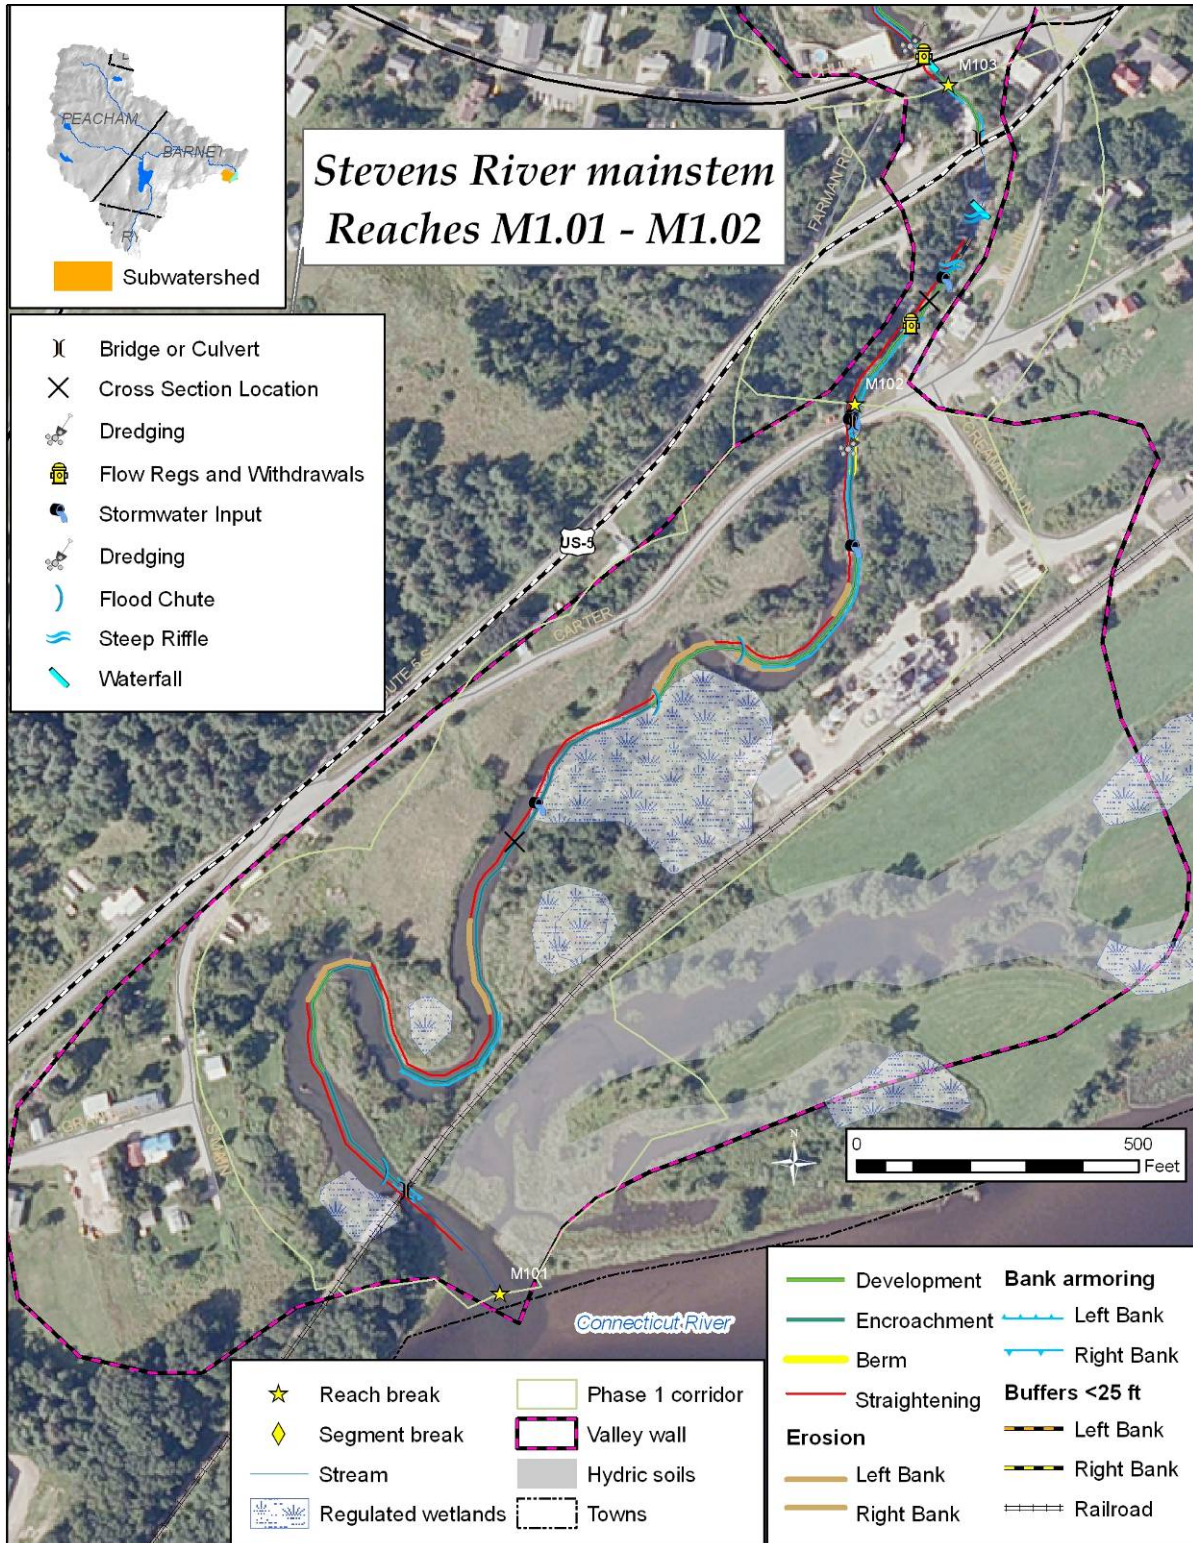
**Figure 30. Reach map for Stevens River mainstem reaches M1.01 and M1.02**

Reach M1.01 extends from the confluence of the Stevens River with the Connecticut River, just downstream of a trestle on the Washington County Railway, upstream to the Carter St. bridge (Fig. 30). The reach includes extensive wetlands and oxbows and represents high value wildlife habitat and important storage for floodwaters and sediment discharges; beavers are currently active in the downstream portions of the reach. Morrison Feeds dominates the left bank, and the elevated roadbed of the Canadian Pacific railway confines the reach at all but the highest flows; highest flows can access the shared floodplain with the Connecticut River near Creamery St. on the upstream end of the Morrison Feeds complex. The reach is heavily influenced by backwater influences created by impoundment of the Connecticut River at McIndoe Falls.

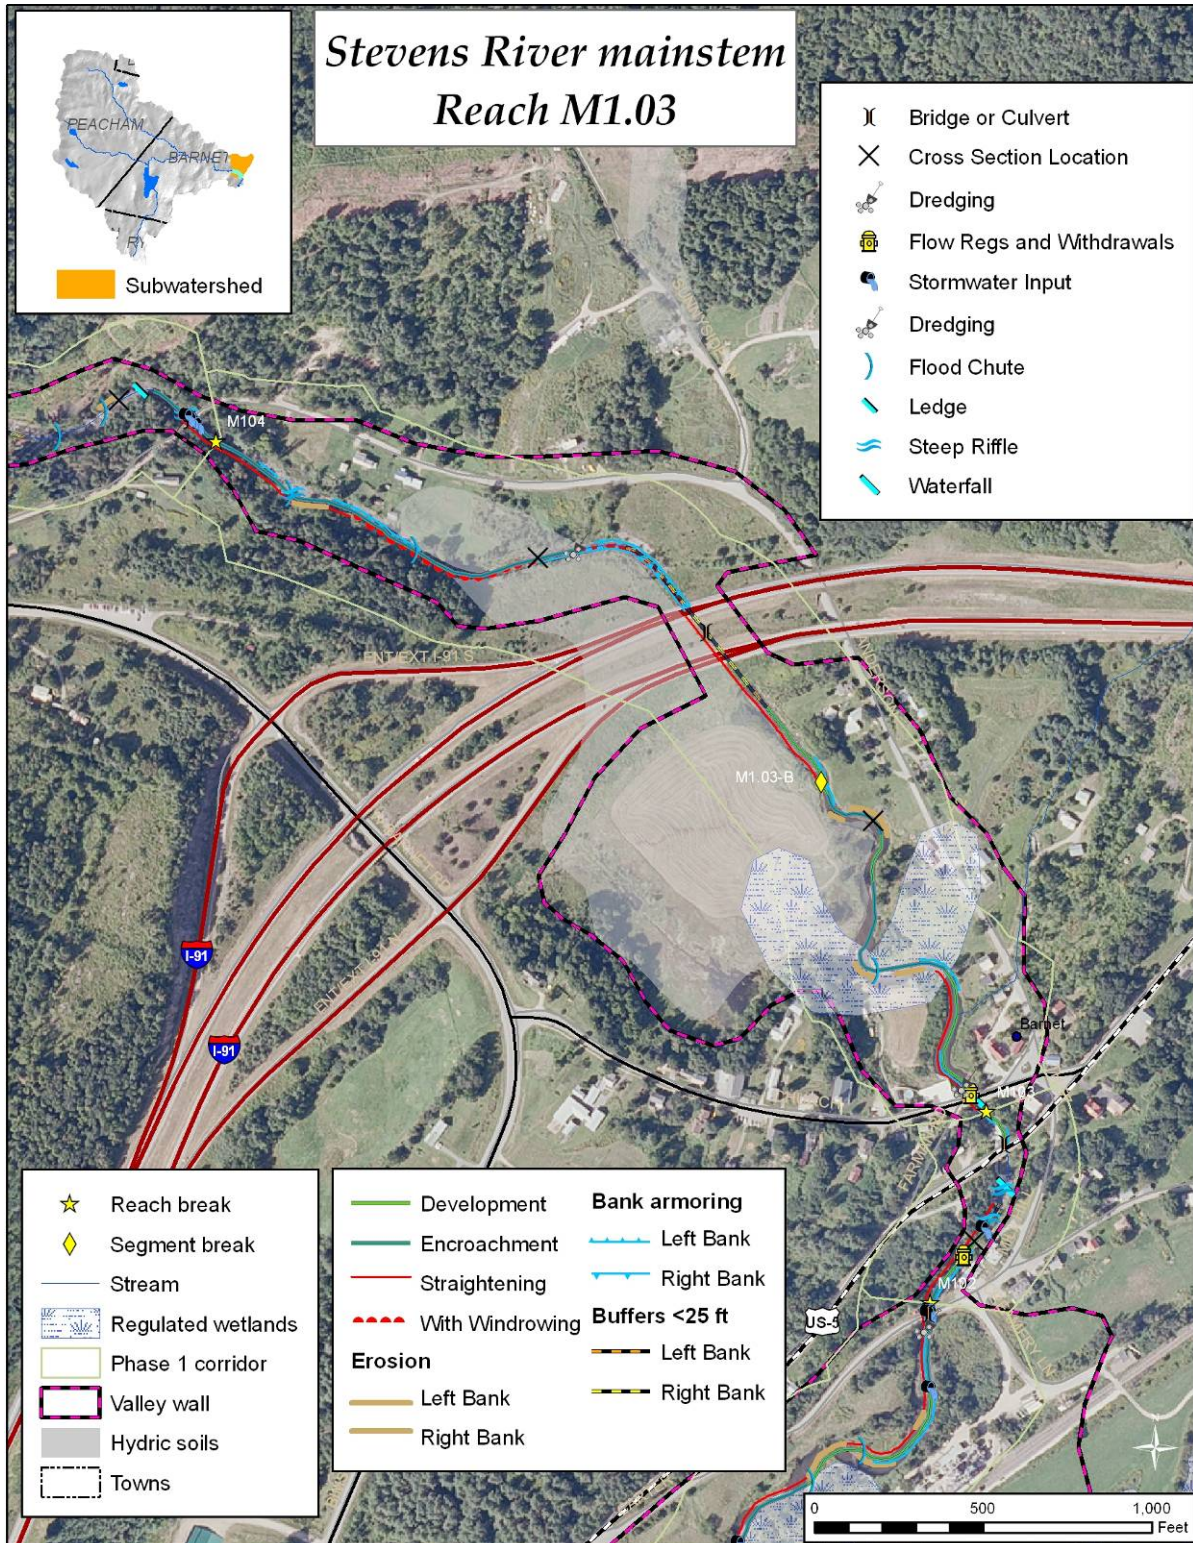
**Figure 31. Reach map for Stevens River mainstem reach M1.03**

Reach M1.03 was segmented during Phase 2 assessment due primarily to a human-caused change in valley width between the downstream segment M1.03A (Church St. bridge to ~350 ft. downstream of a pair of box culverts under Interstate-91) and upstream segment M1.03B (I-91 culverts to ~100 ft downstream of the Anderson St. bridge; Fig. 31). I-91 had significant blasting of ledges nearby during construction in the late 1970s and 1980s, and it appears that much of the stone was used to raise or augment the high embankments (~30 ft high) off the right bank of M1.03B and create the enormous amount of fill that supports the bridge above the box culverts that funnel the Stevens river under the interstate.
