**STEVENS RIVER WATERSHED**  
**STREAM GEOMORPHIC ASSESSMENT**  
**and RIVER CORRIDOR PLAN**  
**2010-2011**

August 12, 2011

Prepared by:  
Daniel Ruddell, Courtney Haynes,  
and Elisabeth McLane,  
Staff Scientists, and  
Ben Machin, Principal  
Redstart Consulting

Prepared for:  
Caledonia County Natural Resources Conservation District and  
Vermont Agency of Natural Resources/  
Department of Environmental Conservation  
River Management Program

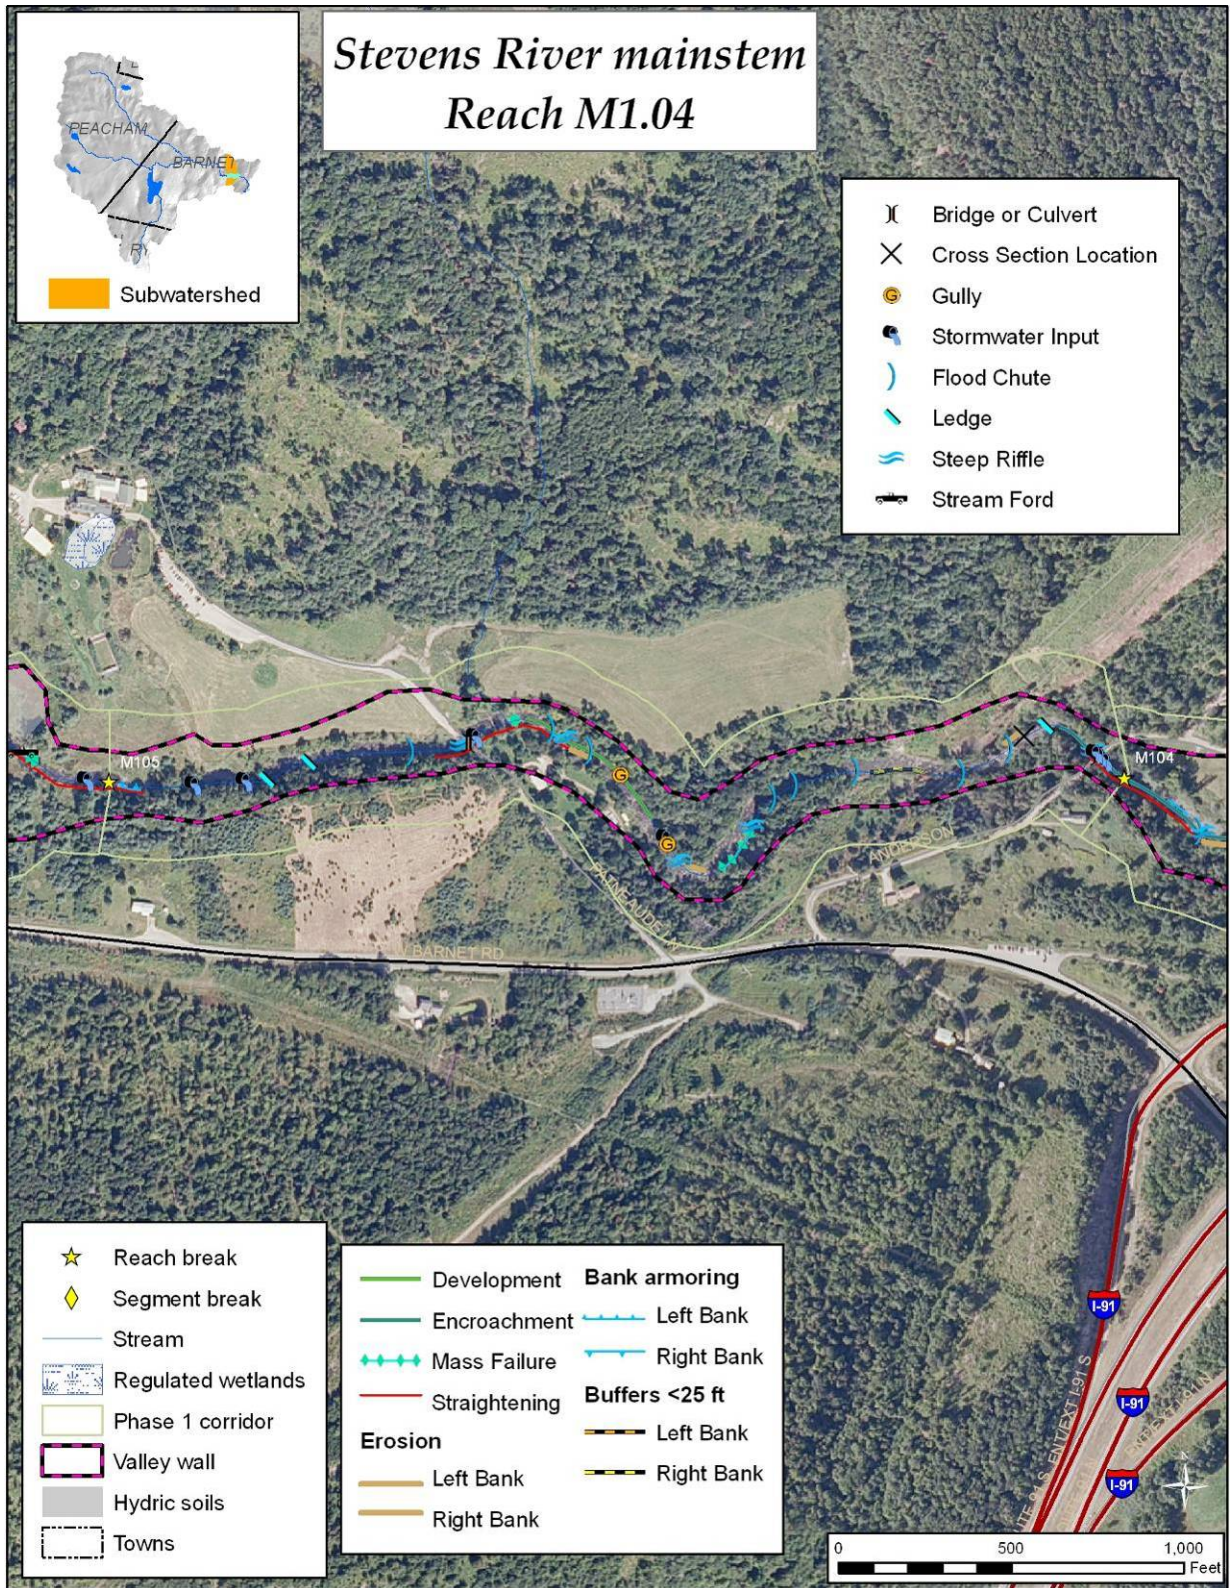
Figure 33. Reach map for Stevens River mainstem reach M1.04

Reach M1.04 extends from ~100 ft. downstream of the Anderson St. bridge to ~1000 ft. upstream of the Patenaude Rd. bridge that is the entrance to Karne Cho-ling (Fig. 32). The reach is bedrock-controlled, with ledge outcrops providing grade controls at the upstream and downstream ends of the reach. The valley width alternates between more and less constricted areas, leading to evidence of “pulse” flows and signs of episodic enlargement in response to high flows. The right valley wall appeared to have a number of groundwater seeps. One fairly recent mass failure was evident off the right valley wall, and an older mass failure was evident further back from the stream on the left bank that appeared to be in the correct time range to have been a response to the breach of the Ben’s Mill dam. Two gullies appeared to have initiated beneath drainage ditches off the side of Patenaude Road, in areas where seeps were present, in more recent microburst storms (during the weeks preceding the assessment). The gullies did not appear to be contributing a lot of sediment directly to the stream, as there were low gradient areas beneath that captured much of the sediment.

<i>River Segment</i>	<i>Project</i>	<i>Reach Priority</i>	<i>Watershed Priority</i>	<i>Completed Independent of Other Practices</i>	<i>Next Steps and Other Project Notes</i>
M1.04-0	Protect River Corridor	Medium	Low	Y	Right bank important for attenuation of ice jam flooding impacts
M1.04-0	Augment stream buffers	Low	Low	Y	Power line cut – need low-growing spp, but non-invasive; sumac?
M1.04-0	Stabilize undercutting at gully heads	Medium	Low	Y	Town of Barnet may want to assess risk to Patenaude Rd.; sediment was largely intercepted but might not be out of growing season

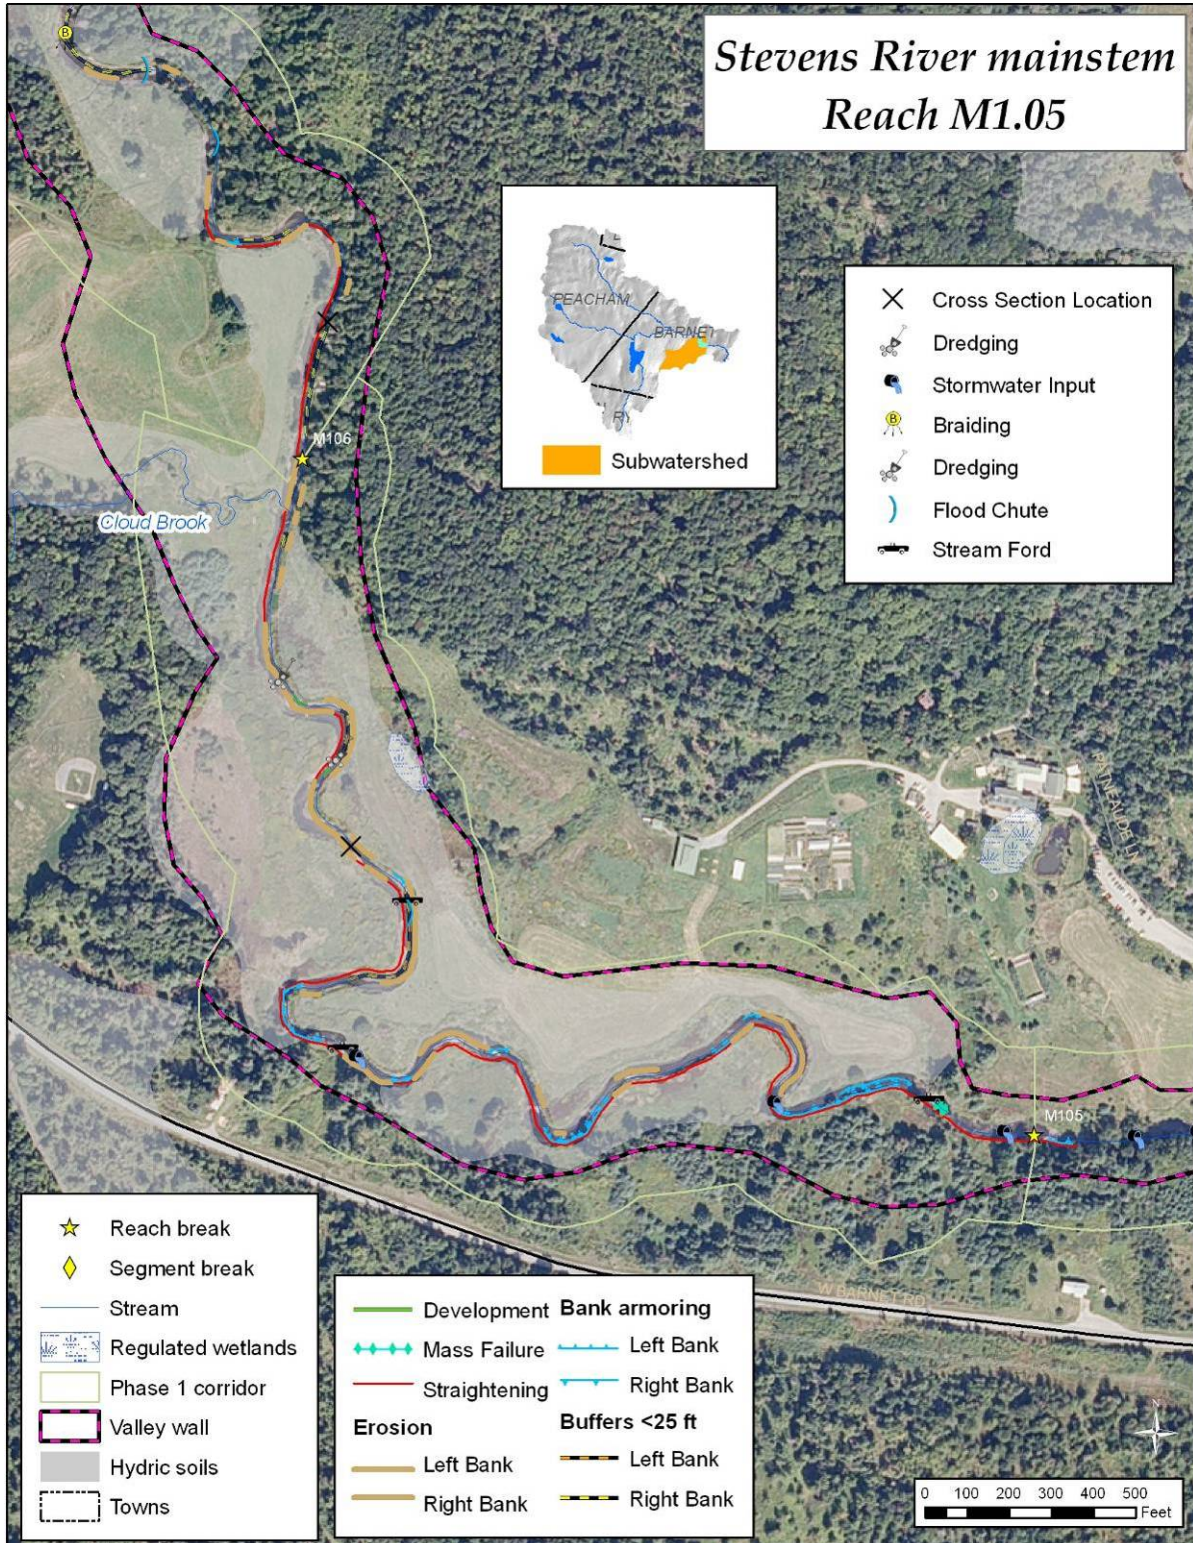
**Figure 34. Reach map for Stevens River mainstem reach M1.05**

Reach M1.05 extends from ~1000 ft. upstream of the Patenaude Rd. bridge that is the entrance to Karne Cho-ling to just upstream of the confluence of Cloud Brook and the Stevens River mainstem, where the Stevens River approaches the left valley wall and the left bank becomes steeper and wooded (Fig. 34). The reach is dominated by fine-grained glaciolacustrine, glaciofluvial and alluvial soils that are the legacy of its location near the upstream end of a “finger” of glacial Lake Hitchcock, and is currently dominated by active hayfields that have not been mowed as extensively in recent years, possibly due to reduced accessibility in a series of recent wet summers. Hydric soils are extensive in the reach (Fig. 34), indicating likely conversion of former wetlands to agricultural lands with attendant reduction of wetland functions including attenuation of high flows and retention of nutrients and sediments.

<i>River Segment</i>	<i>Project</i>	<i>Reach Priority</i>	<i>Watershed Priority</i>	<i>Completed Independent of Other Practices</i>	<i>Next Steps and Other Project Notes</i>
M1.05-0	Protect River Corridor	High	High	Y	Much of reach may be under limited number of landowners
M1.05-0	Augment stream buffers	High	High	Y	Monitor and augment plantings done by Barnet School and others

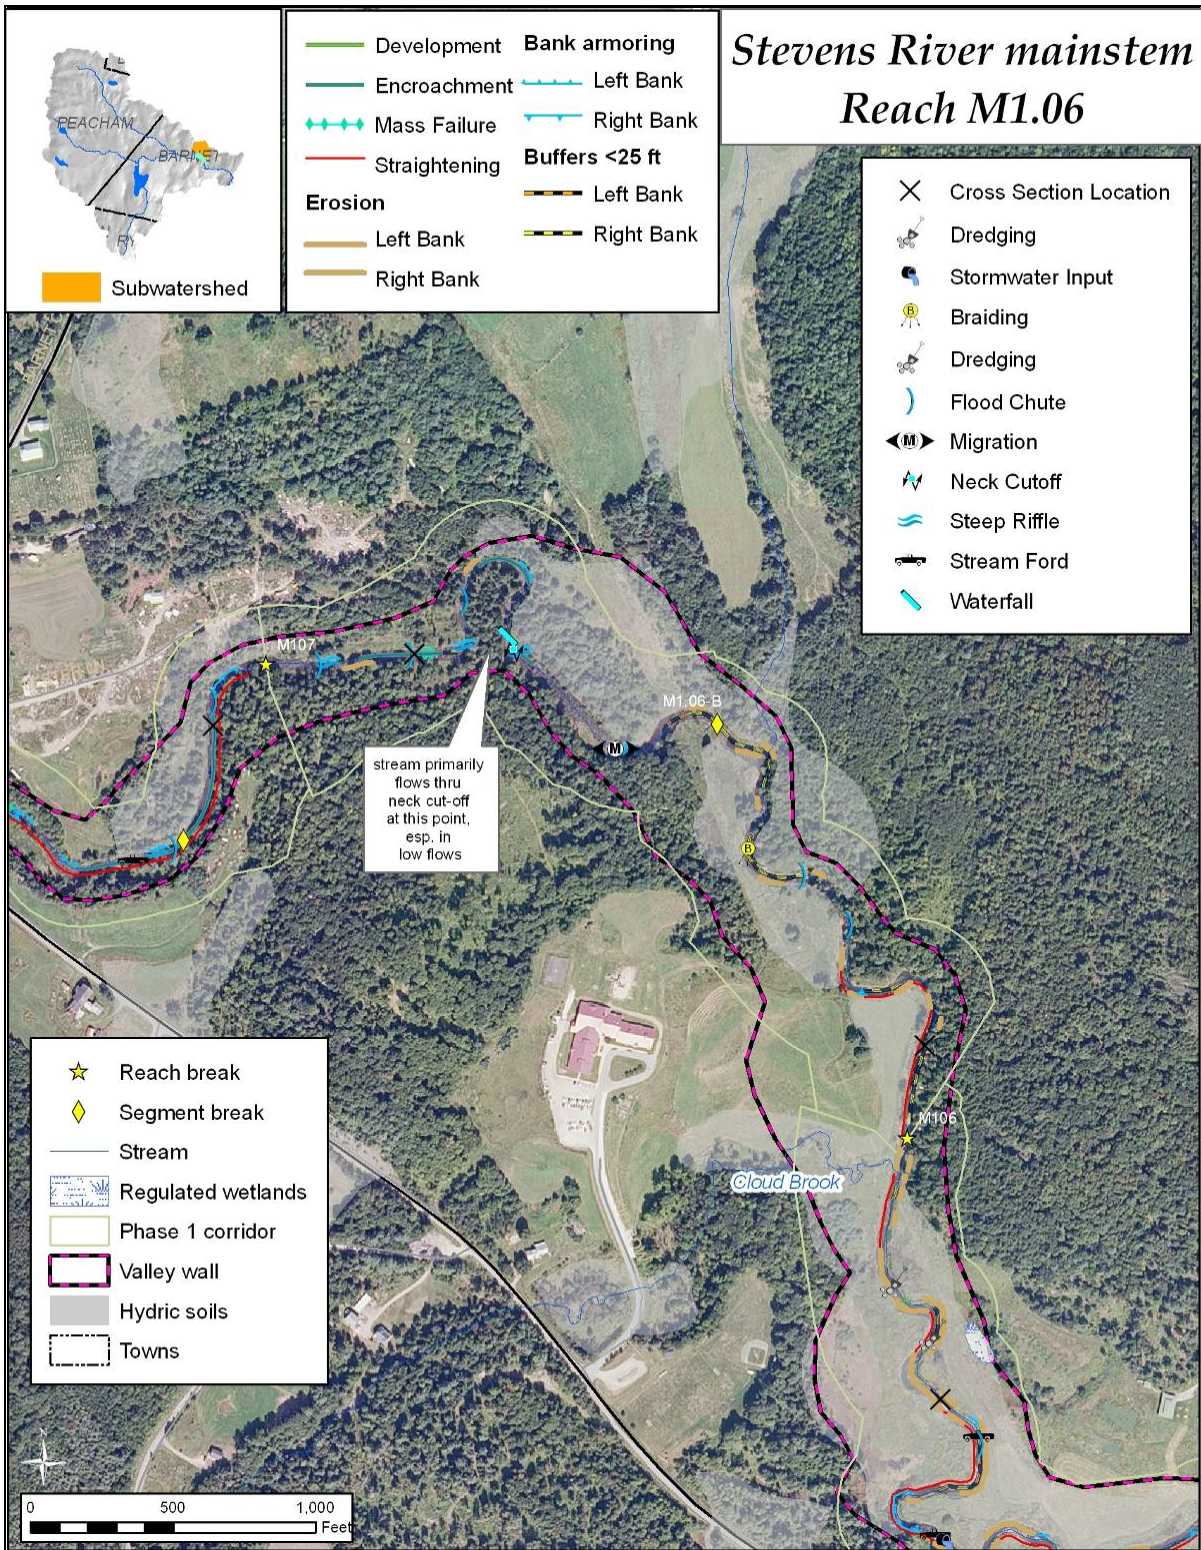
**Figure 36. Reach map for Stevens River mainstem reach M1.06**

Reach M1.06 was segmented during Phase 2 assessment due primarily to differences in the amount of channel evolution that has occurred since the breach of the Ben’s Mill dam, which appears to have had significant impacts on the entire reach. M1.06B, located closer to the old dam, has a neck cut-off in the middle of the segment (Fig. 36) that likely occurred at the time of the breach. A mass failure on the left valley wall upstream (well back from the current location of the stream) probably contributed sediments that helped push the stream in the direction of the neck cut-off. The stream now splits around an island created by the neck cut-off at higher flows, but at lower levels it flows over a 9-ft. waterfall that was scoured to bedrock.

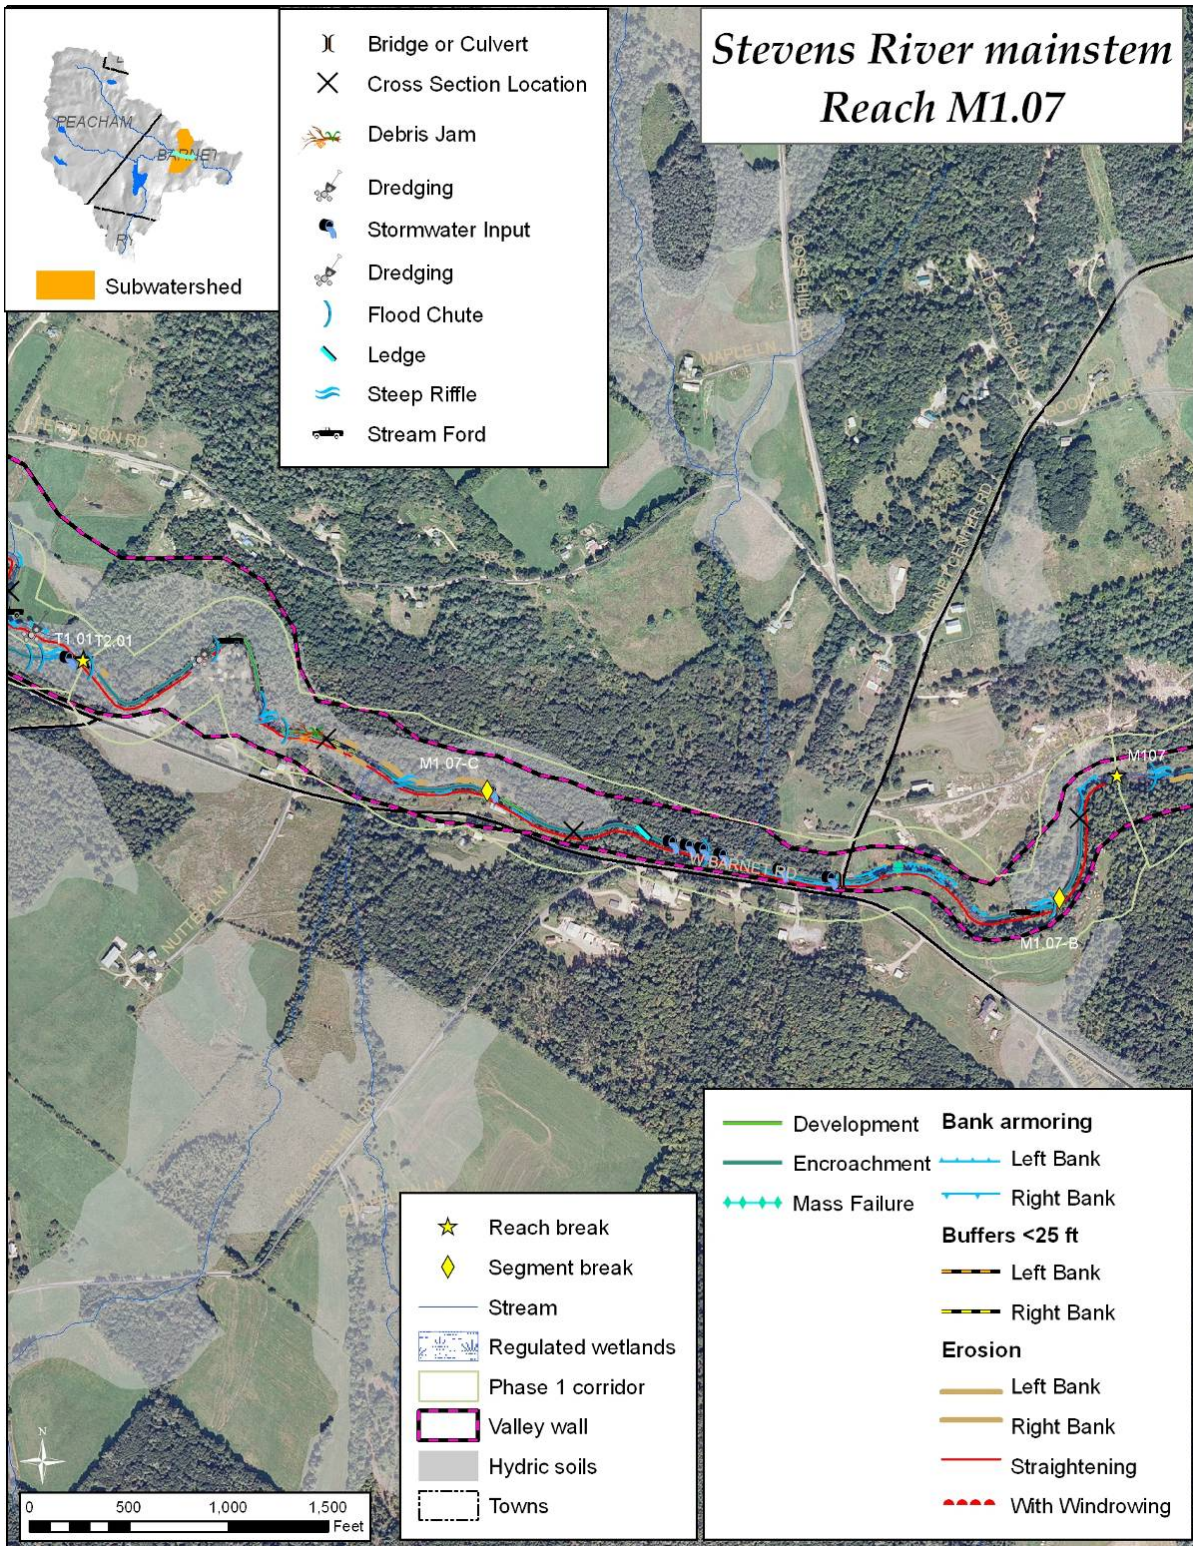
Figure 38. Reach map for Stevens River mainstem reach M1.07

Reach M1.07 was broken into three different segments during Phase 2 (Fig. 38).

M1.07C includes the head of the reach above the old dam, and is dominated by very high banks from years of aggraded sediments; rapid erosion when the dam breached has exposed distinctively banded layers of legacy sediments indicating cyclic deposition (Fig. 13). Although the high banks do not continue all the way to the head of the reach, the

valley walls increase in height and present similar dynamics; development and encroachment appear to be at risk in flood situations in this area, and maintenance of existing buffers will be important to minimizing erosion.

<i>River Segment</i>	<i>Project</i>	<i>Reach Priority</i>	<i>Watershed Priority</i>	<i>Completed Independent of Other Practices</i>	<i>Next Steps and Other Project Notes</i>
M1.07A	Protect River Corridor	Medium	Low	Y	Short segment has some value but should be treated with M1.06B
M1.07C (none ID'd in M1.07B)	Protect River Corridor	High	Low	Y	include encroachments in Pre-disaster Mitigation Planning (esp. campsites and truck shop on upstream end); address Japanese knotweed at Ben's Mill site (one of few invasives locations in watershed)
M1.07C	Plant stream buffers	Medium	Low	Y	Replace Japanese knotweed at Ben's Mill with trees or shrubs

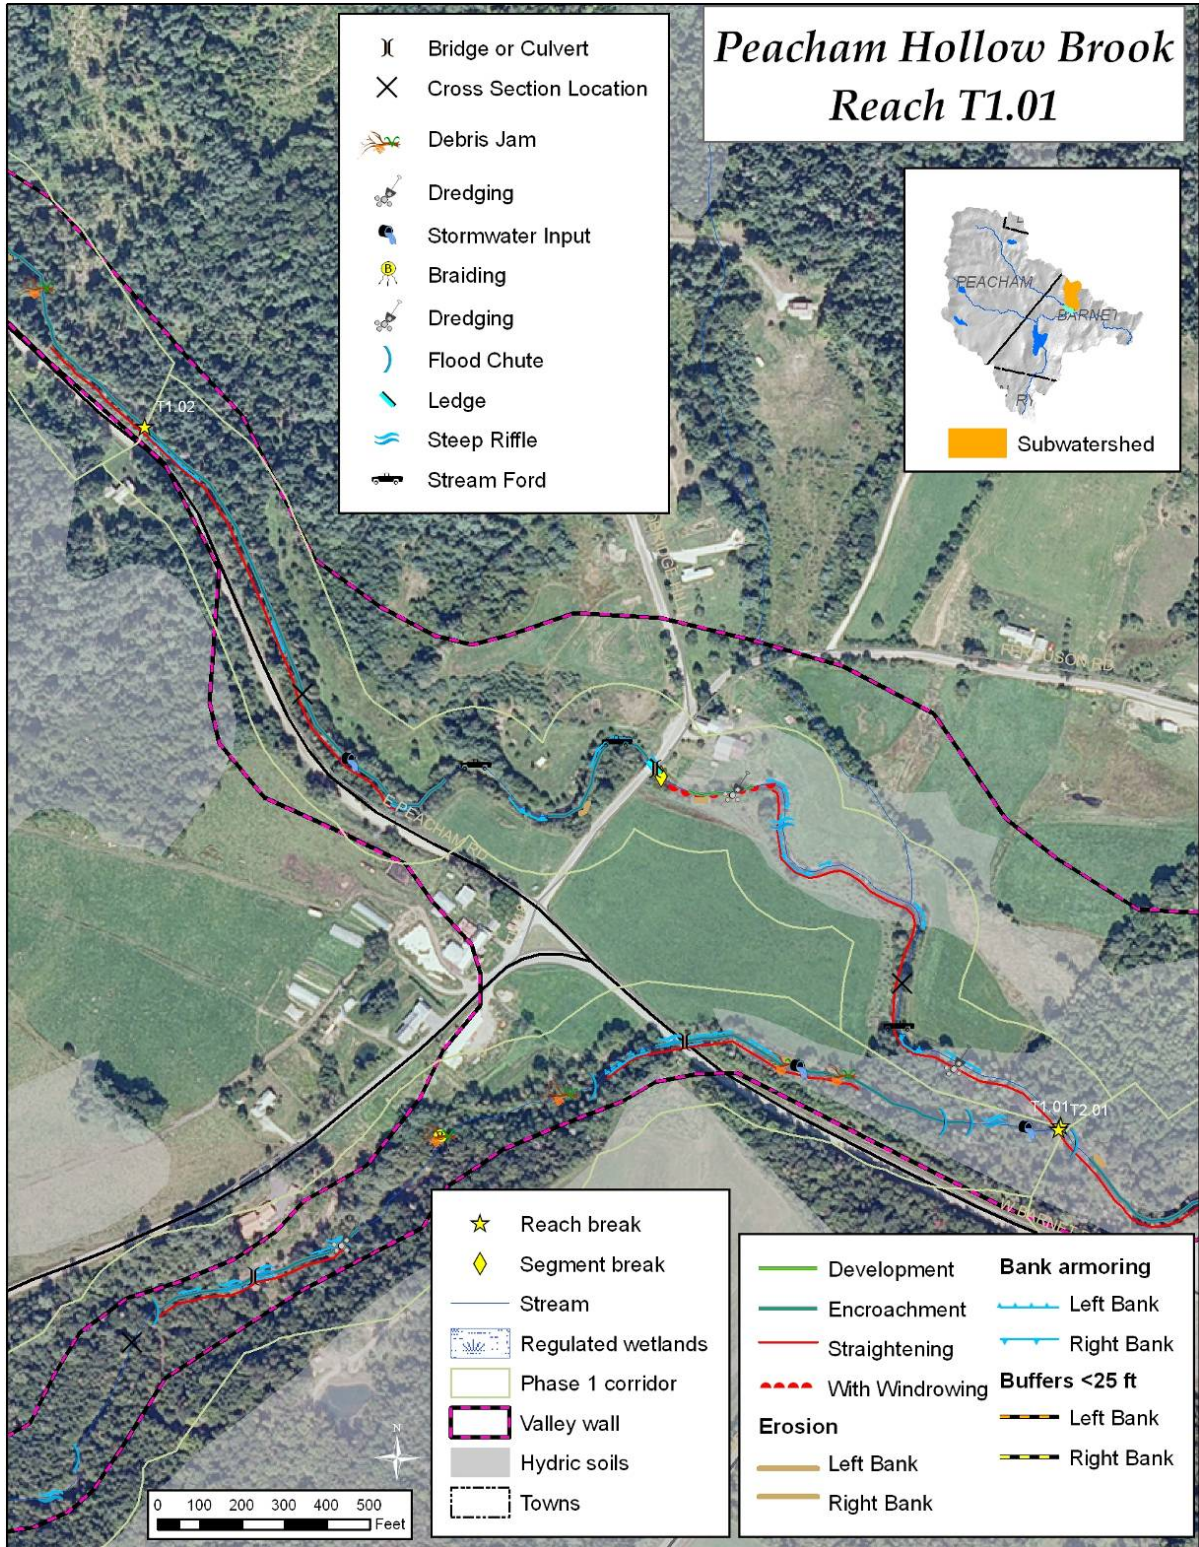
**Figure 39. Reach map for Peacham Hollow Brook reach T1.01**

Reach T1.01 was broken into two segments during Phase 2 assessments, with the segment break located at the Ferguson Rd. bridge (Fig. 39).

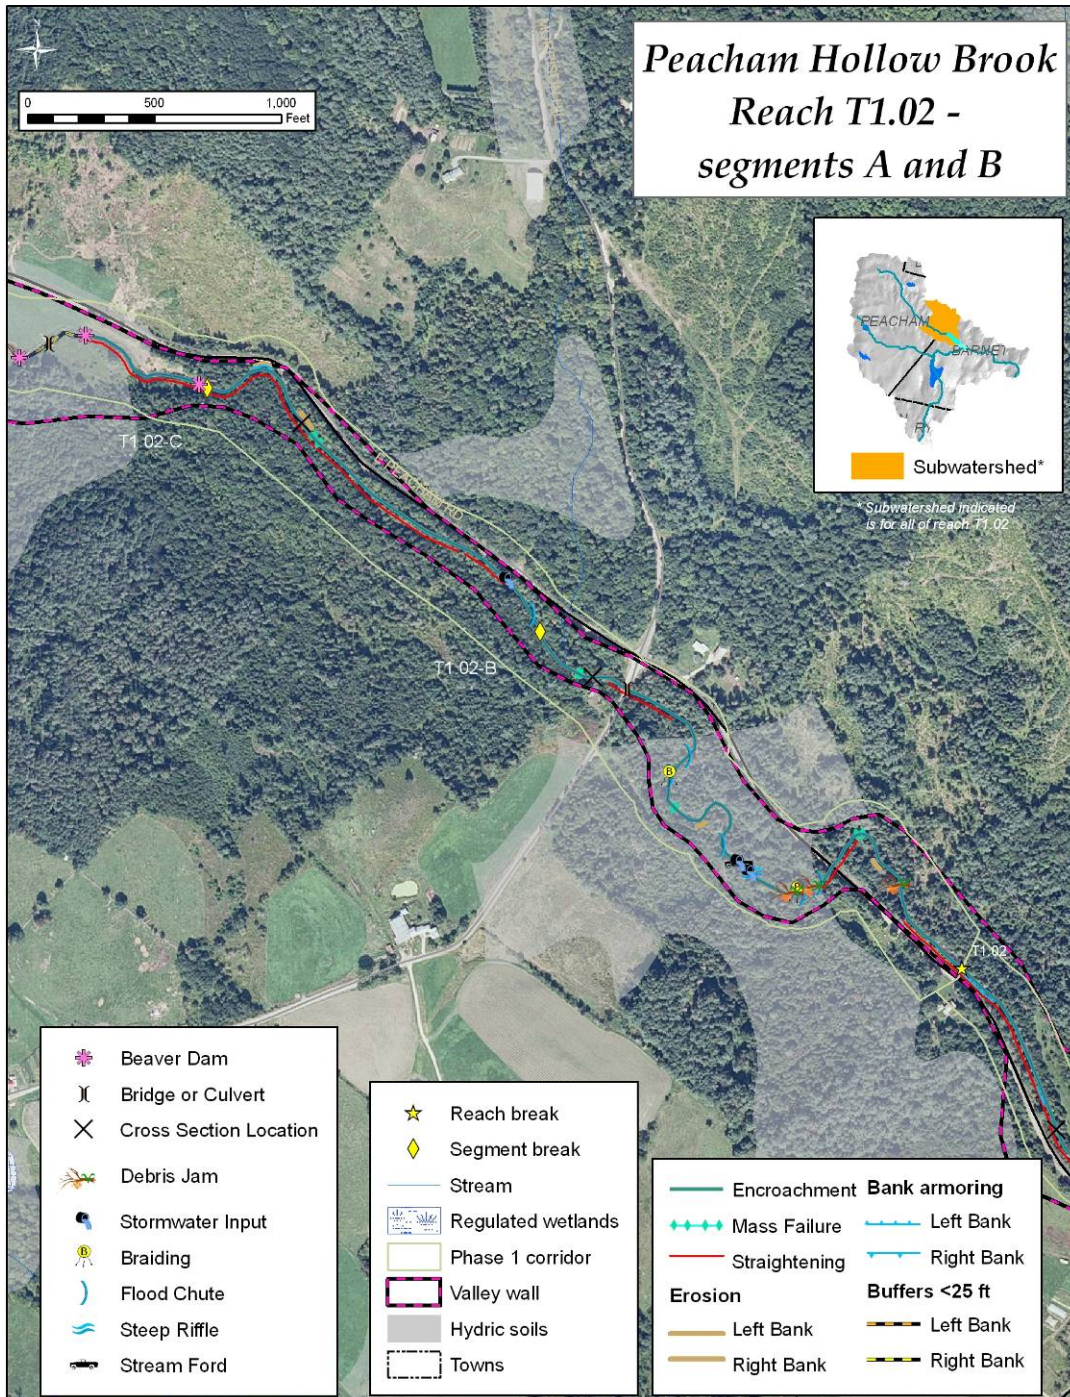
Figure 40. Reach map for Peacham Hollow Brook reach T1.02 segments A and B

T1.02A and B run alongside the East Peacham Road and were segmented primarily because the upstream segment B is more narrowly confined between the road and the valley wall opposite the road (Fig. 40).

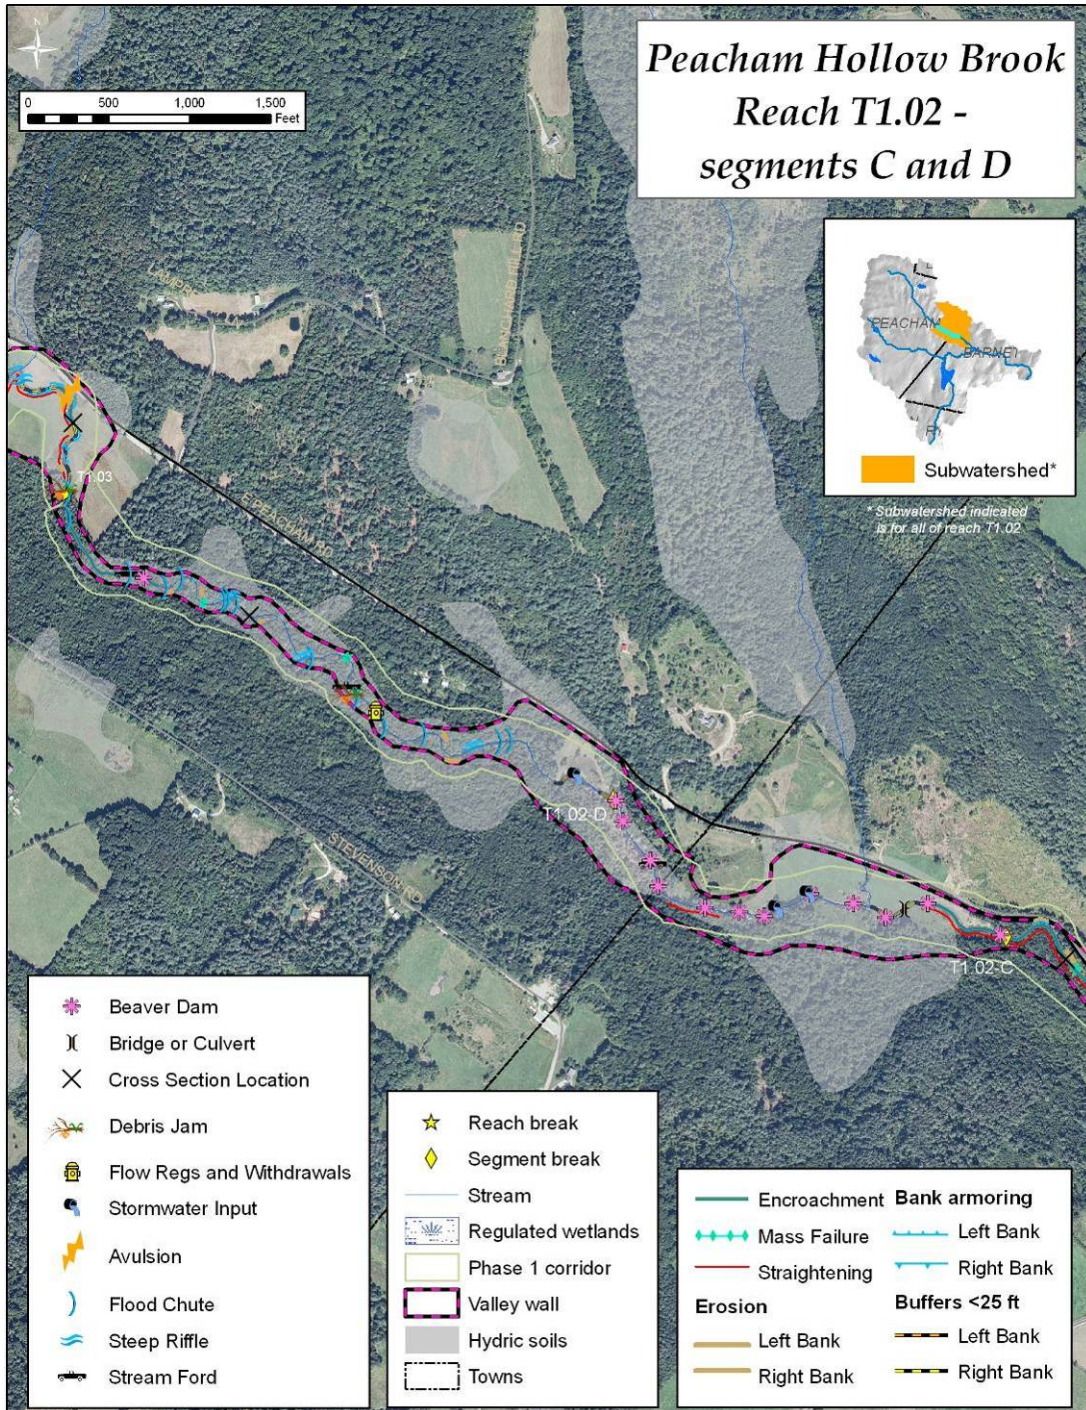
Figure 41. Reach map for Peacham Hollow Brook reach T1.02 segments C and D

T1.02C is in a Very Broad valley and is beaver-controlled, with multiple dams along the stream; this segment did not receive a full geomorphic assessment due to these influences, in accordance with the assessment protocols.

T1.02D becomes more narrowly confined again, and departs further from the side of the East Peacham Road than the downstream segments; the reach break is located along the open fields across from Blanchard Hill Rd. (Fig. 41).

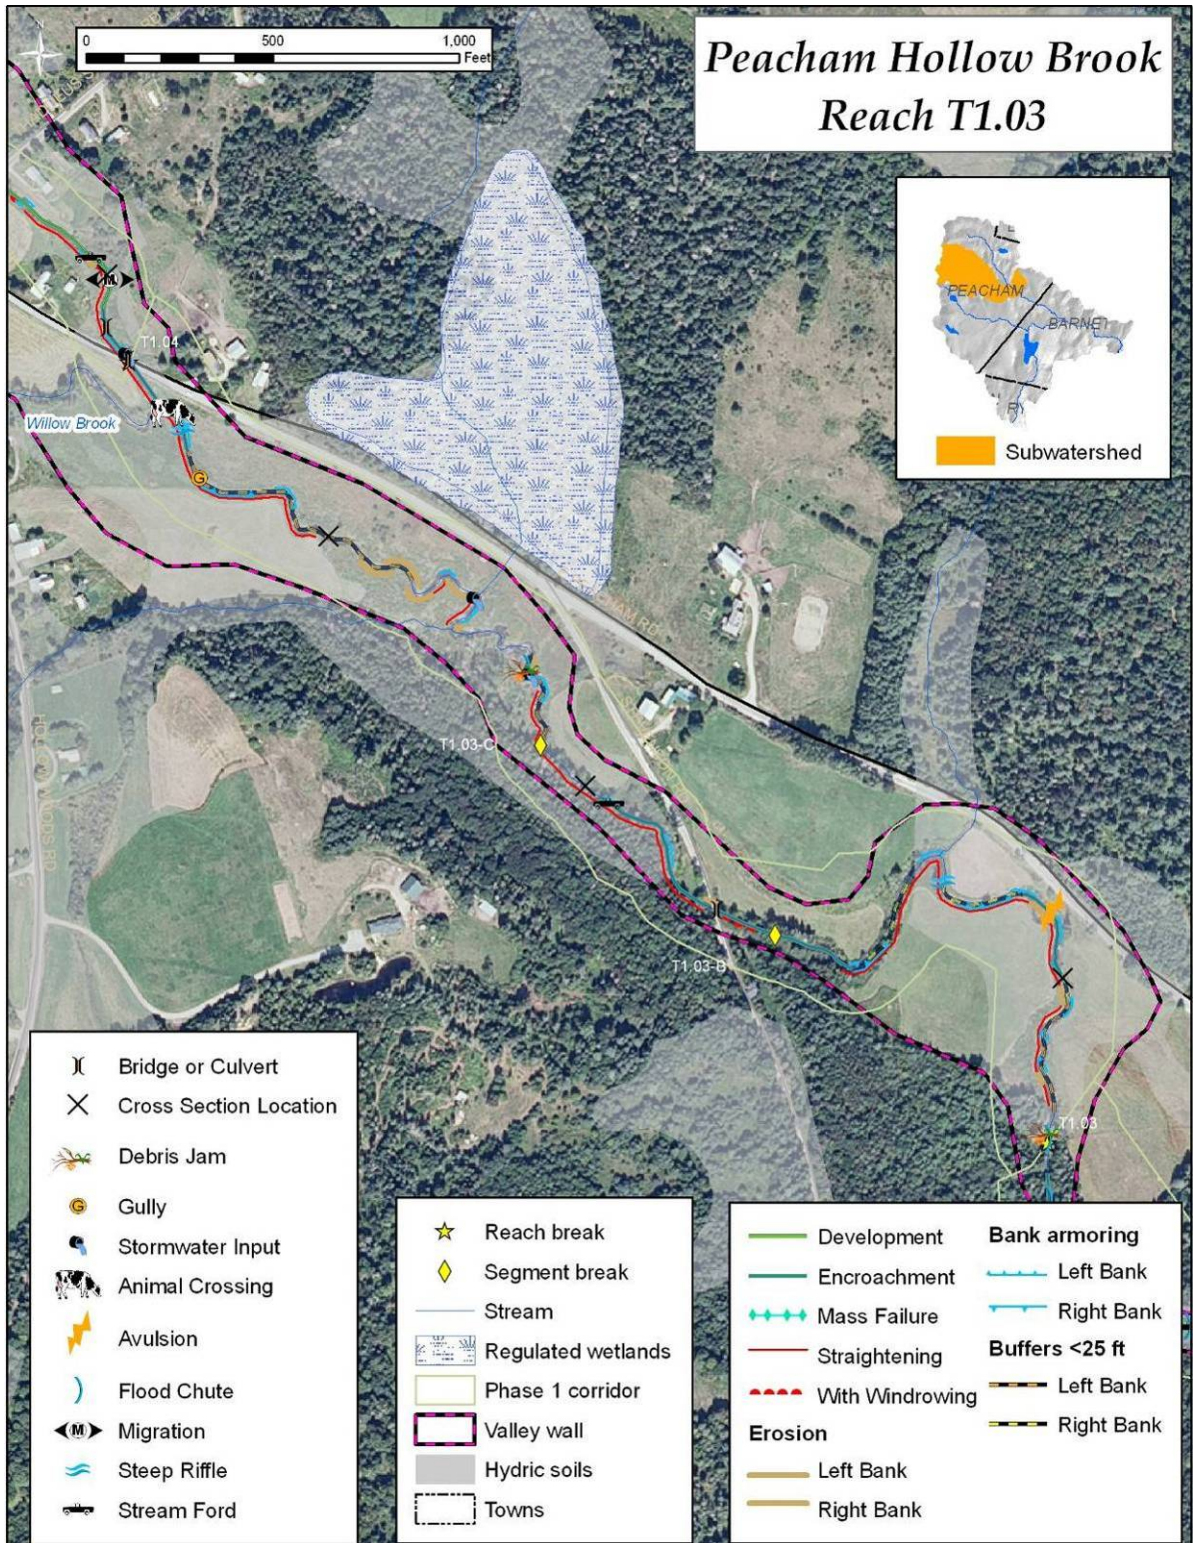
Figure 42. Reach map for Peacham Hollow Brook reach T1.03

Reach T1.03 was divided into three segments during Phase 2 assessments (Fig. 42).

T1.03B was broken out as a subreach due to its classification as a Cb stream type (b subslope is for 2-4 pct slope) in between two segments of E-type stream. T1.03B is situated in a peculiar geologic formation as the stream makes a bend downstream of Stevenson Rd.: terraces on both sides of the stream are very high, and the valley is a 'pinch point' naturally (further exacerbated by construction of Stevenson Rd. along the valley wall). This scenario raised speculation about a possible Lake Hitchcock/Quechee Gorge type scenario, where a glacial stream may have been impounded by sediments and

then created a massive headcut when the jam let loose; no records of mill dams in this area have been located that might suggest that as an alternative explanation.

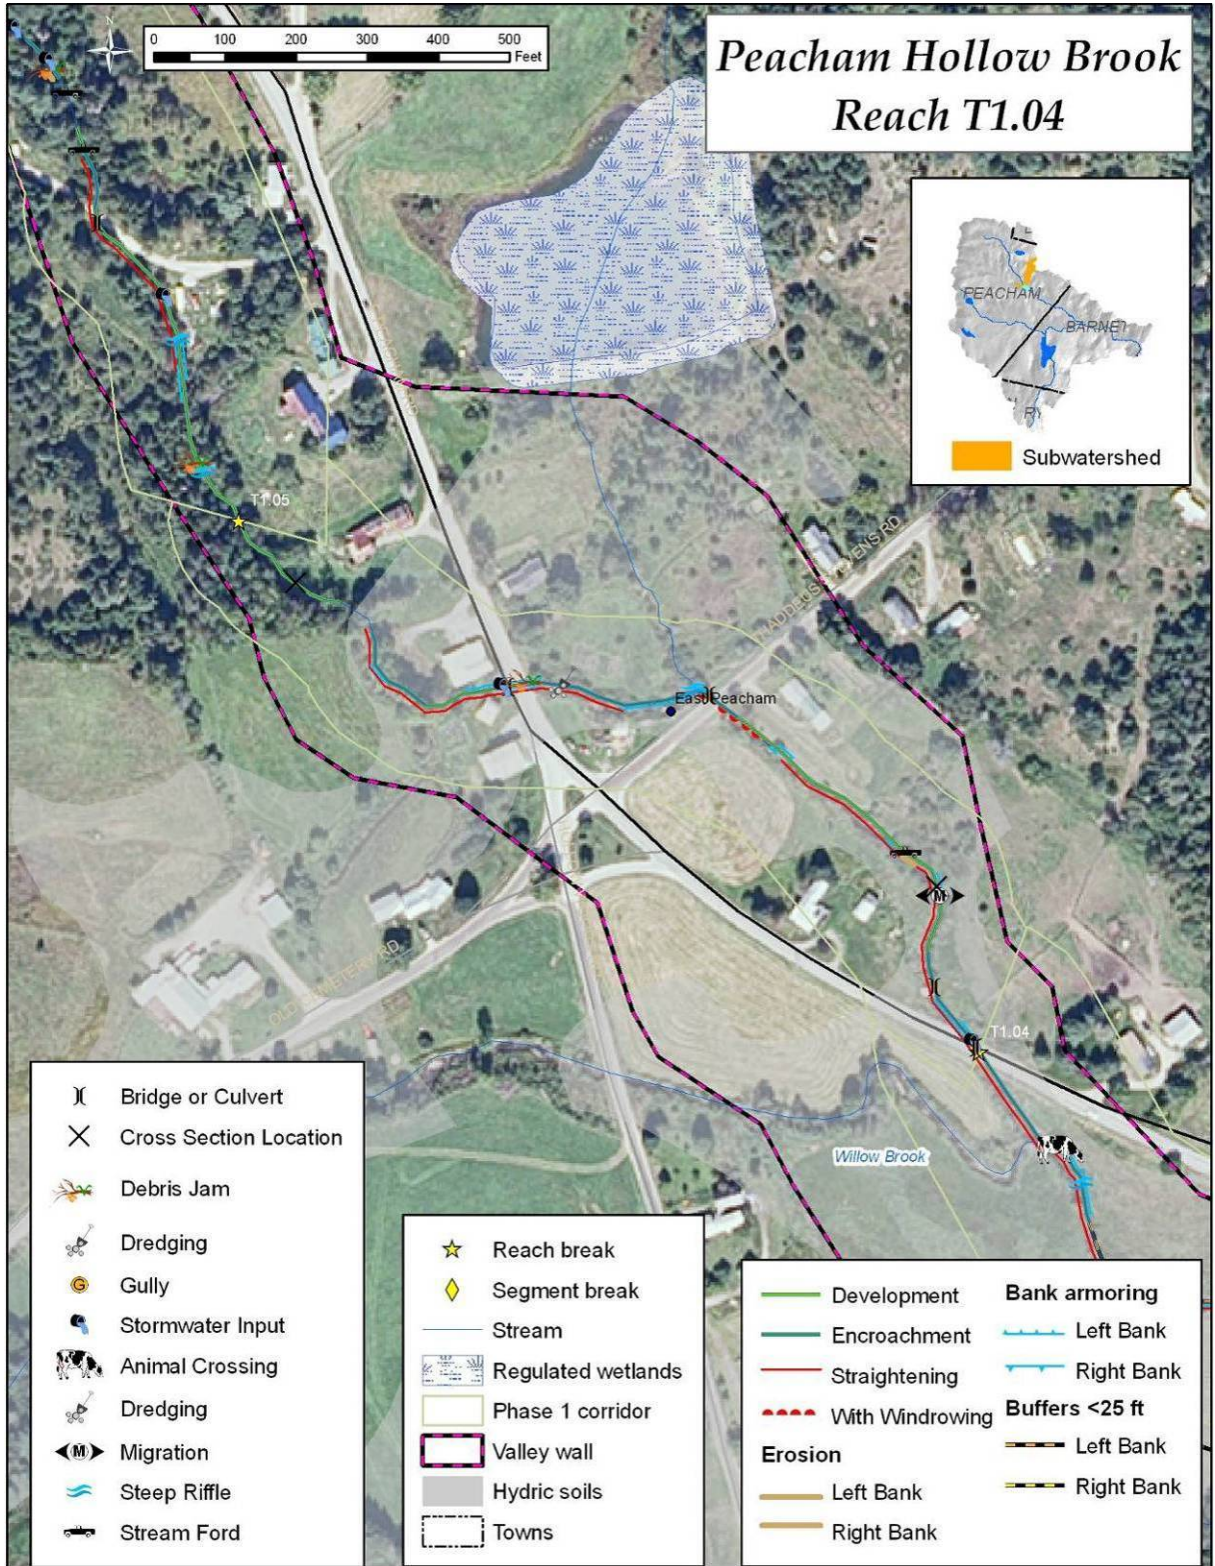
Figure 43. Reach map for Peacham Hollow Brook reach T1.04

As with segment T1.03C, T1.04 may be located on an alluvial fan historically related to the confluence of Peacham Hollow Brook, a small tributary (now dammed for two small ponds) and Willow Brook (and/or located on sediments backed up behind a glacial sediment dam; see discussion in sec. 6.1.10). Soil maps indicate both alluvial and glaciofluvial soils in the shared floodplain between this reach and Willow Brook (Fig. 43). Bank soil composition is obscured in the field by extensive armoring; the reach appears relatively stable at this time but may have been repeatedly windrowed.

There are two bridges and two culverts in the segment, and all are undersized, which probably has contributed to the stream being windrowed over time. No incision was noted in the cross-section measurements however, and the channel appears to be evolving with D-model characteristics (see sec. 5.1.3. for description of D-model evolution).

<i>River Segment</i>	<i>Project</i>	<i>Reach Priority</i>	<i>Watershed Priority</i>	<i>Completed Independent of Other Practices</i>	<i>Next Steps and Other Project Notes</i>
T1.04-0	Plant stream buffers	Medium	Low	Y	May be difficult to obtain CREP or other funding
T1.04-0	Replace existing bridges and culverts	High	Medium	Y	Assess risks to surrounding area for pre-disaster mitigation planning. None appear at risk of imminent failure, but plugging has likely contributed to repeated windrowing; farm bridge may float or plug, but outflanking for it or next bridge downstream would likely not cause a lot of damage

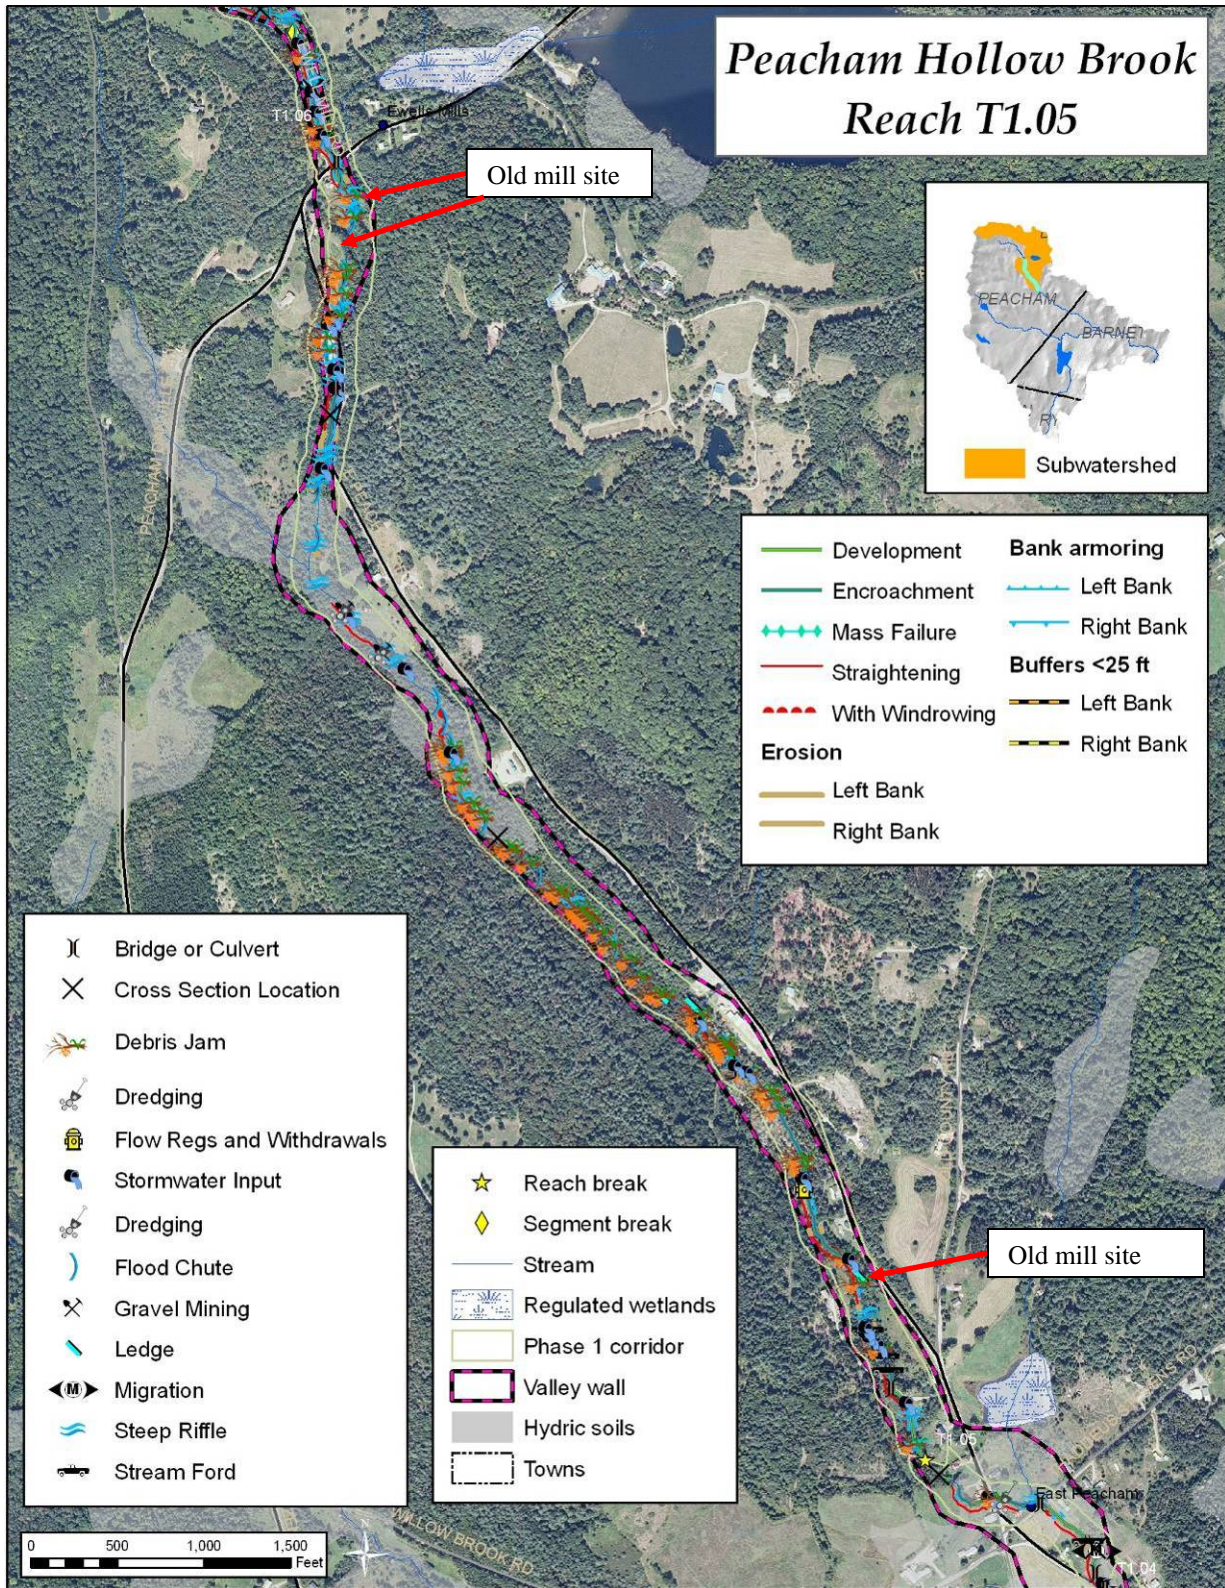
Figure 44. Reach map for Peacham Hollow Brook reach T1.05

Small-scale gravel removal is occurring in one of the broader sections of the T1.05 valley located downstream of a very confined upstream portion of the valley, and the widening at dredged areas appears to contribute to further subsequent aggradation due to the widened channel (Fig. 20). Flash flooding during 2010 may have been contributing to some of this deposition, as sediment discharge impacts from heavy rains were also evident at the Town of Peacham sandpiles located adjacent to reach T1.05. While silt fences might help retain some of the sand that made its way into Peacham Hollow Brook by the Town Garage, it appeared that large woody debris in the stream retained a large proportion of these sediments and dramatically slowed their movement downstream (and there is a beaver-controlled area a short distance downstream (no dam) that also traps many of these sediments). This appeared to be true throughout much of the reach, as buffers are in good shape and frequent debris jams were noted retaining sediment discharges and contributing to movement of the stream that helps diffuse stream power.

<i>River Segment</i>	<i>Project</i>	<i>Reach Priority</i>	<i>Watershed Priority</i>	<i>Completed Independent of Other Practices</i>	<i>Next Steps and Other Project Notes</i>
T1.05-0	Protect River Corridor	Medium	Medium	Y	Get more info from landowner on sediment loading history in dredging areas at upstream end of reach. Assess impacts downstream; evaluate channel management options
T1.05-0	Replace existing culverts	High	Medium	Y	<p>All three culverts are 6 ft; E. Peacham Rd. culvert by pond on upstream end may be top priority: perched and scouring, may trigger bank instability beneath pond. VHD MAPPING NOT ACCURATE FOR LOCATION OF THIS CULVERT (Fig. 46)</p> <p>Ewells Mills (concrete box culvert) is buried under a lot of fill and is a substantial investment to replace; concrete bottom and skirt hard for AOP passage. Assess risks to surrounding area for pre-disaster mitigation planning at Ewells Mills.</p> <p>Private culvert leading to 1558 E. Peacham Rd. may be lowest priority but does present full floodprone blockage; assess risks to E. Peacham village for pre-disaster mitigation planning</p>

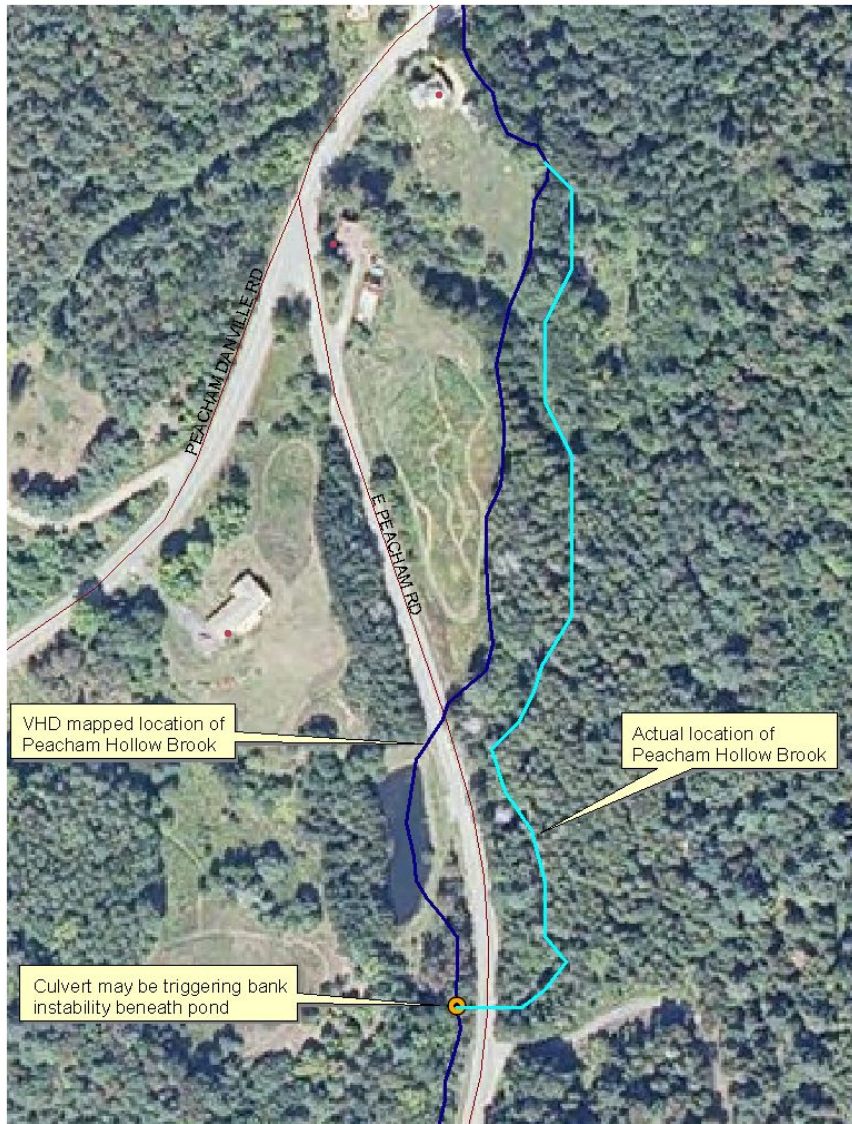
**Figure 46. Map of actual location of culvert in T1.05 that may be triggering bank instability beneath a perched pond, which differs from Vermont Hydrography Dataset (VHD) mapped location.**

T1.05-0	Replace existing culvert	High	Medium	Y	All three culverts are 6 ft; E. Peacham Rd. culvert by pond on upstream end may be top priority: perched and scouring, may trigger bank instability beneath pond. VHD MAPPING NOT ACCURATE FOR LOCATION OF THIS CULVERT (Fig. 45)
T1.05-0	Replace existing culvert	High	Medium	Y	Ewells Mills (concrete box culvert) is buried under a lot of fill and is a substantial investment to replace; concrete bottom and skirt hard for AOP passage. Assess risks to surrounding area for pre-disaster mitigation planning at Ewells Mills.
T1.06C	Protect River Corridor	High	Medium	Y	Incorporate FEH zones in local planning, consider road risk in Pre-disaster mitigation planning and capital budgeting
