**STEVENS RIVER WATERSHED**  
**STREAM GEOMORPHIC ASSESSMENT**  
**and RIVER CORRIDOR PLAN**  
**2010-2011**

August 12, 2011

Prepared by:  
Daniel Ruddell, Courtney Haynes,  
and Elisabeth McLane,  
Staff Scientists, and  
Ben Machin, Principal  
Redstart Consulting

Prepared for:  
Caledonia County Natural Resources Conservation District and  
Vermont Agency of Natural Resources/  
Department of Environmental Conservation  
River Management Program

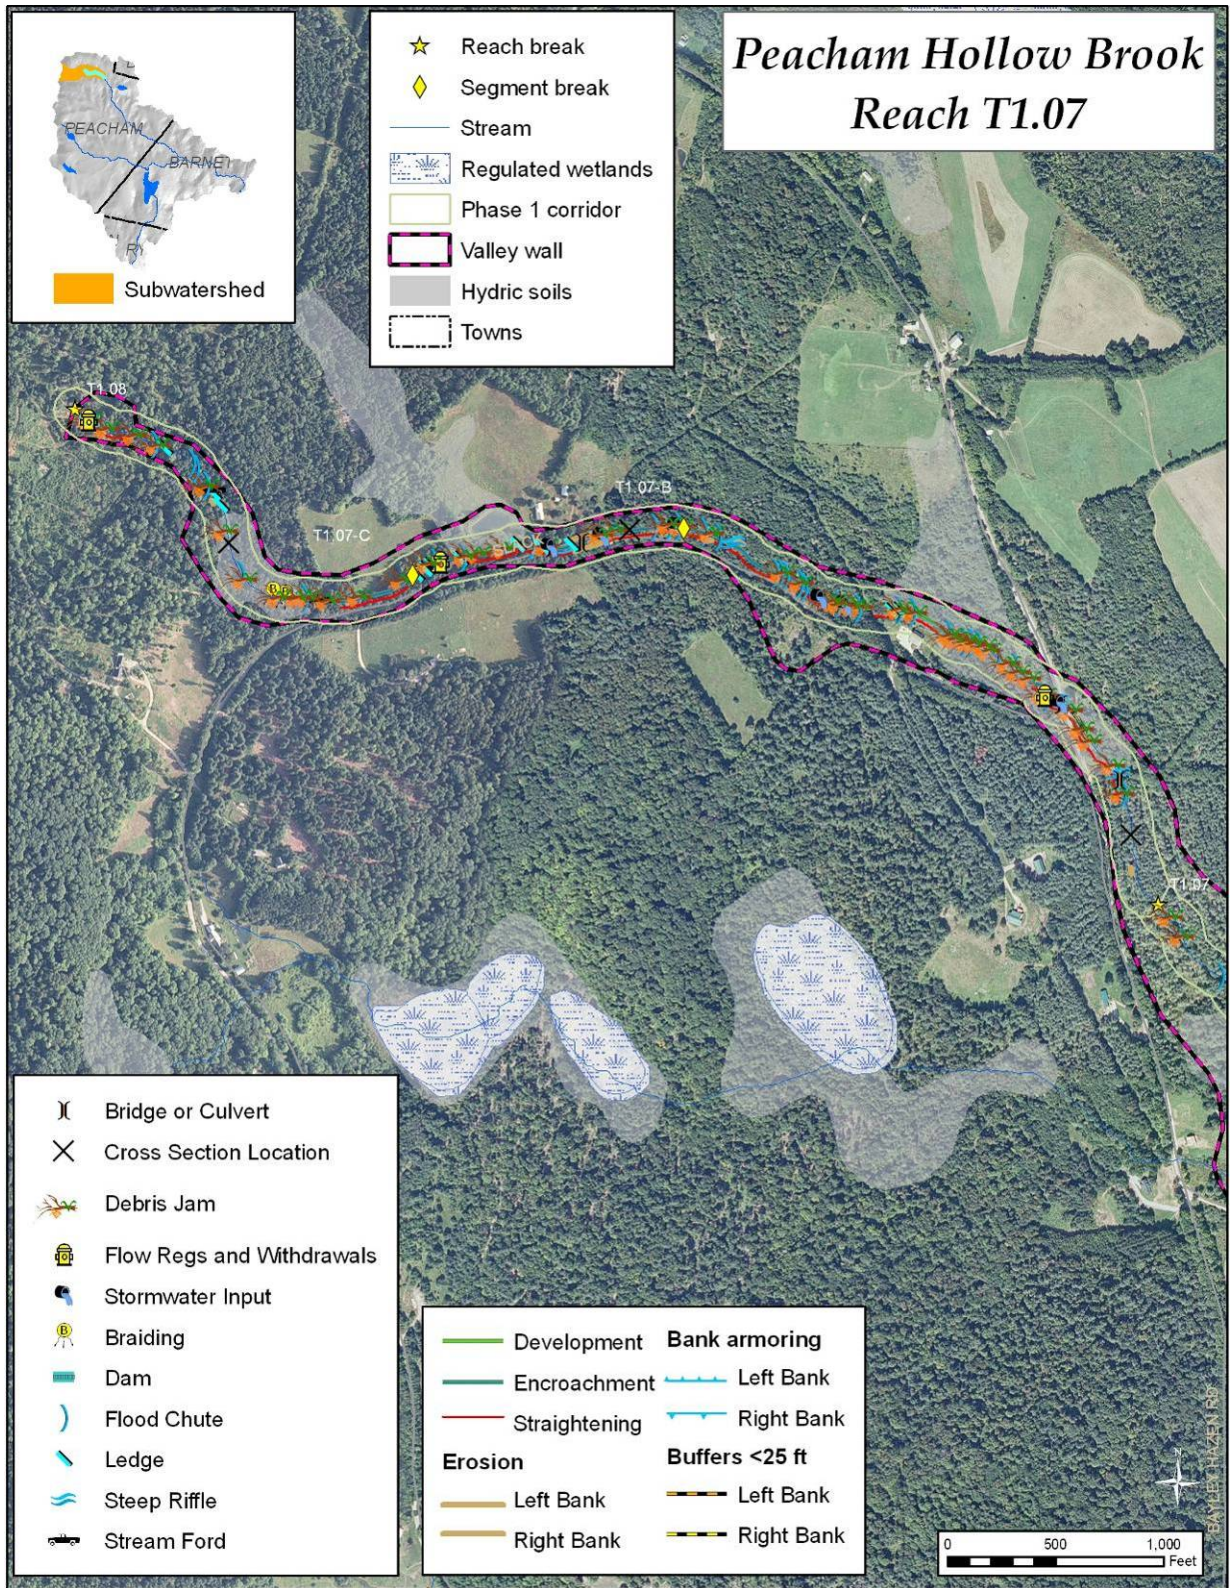
Figure 48. Reach map for Peacham Hollow Brook reach T1.07

Increasing development pressure along the reach includes: a clearcut for development being conducted along the left bank at the Bayley-Hazen Rd. junction with Slack St. during 2010 assessment; a recently built house, garage, and elevated parking areas that encroach on the right bank of the stream upstream; a for sale sign posted during 2010 assessments for a property that appears to be accessed along a logging road that runs over an undersized culvert a short distance downstream of the Bayley-Hazen Rd. junction with Slack St.; and a hilltop development with a heavy cut and new small pond installed at the head of the reach (heavy cut visible in comparison of 1998 black and white orthos and 2009 NAIP imagery).

Further heavy cutting occurred in T1.07C downslope at the corner of Slack St. where the road swings away from the stream (Fig. 48). A recent windstorm appeared to have blown a good deal of cedar down in this area, and a salvage log job was conducted. The stream area was corduroyed with some of the cedar for skidder passage, and the resulting numerous debris jams in this area has retained some of the sediment discharges from proceeding further downstream.

<i>River Segment</i>	<i>Project</i>	<i>Reach Priority</i>	<i>Watershed Priority</i>	<i>Completed Independent of Other Practices</i>	<i>Next Steps and Other Project Notes</i>
T1.07A	Protect River Corridor	High	High	Y	Incorporate FEH zones in local planning; consider road risk in Pre-disaster mitigation planning; gully repair US RB of Bayley-Hazen_Slack St.; knotweed control along Bayley-Hazen
T1.07A	Augment stream buffer	Medium	Low	Y	Replace clearcut buffer at new development clearing DS of Bayley-Hazen_Slack St.
T1.07B	Replace existing culvert and bridge	High	Medium	Y	Undersized culvert at Butternut Farm - scour below, and is slightly perched – reduced AOP; bridge new, no adjustments yet
T1.07C	Protect River Corridor	High	Medium	Y	Incorporate FEH zones in local planning, consider channel management easements if not

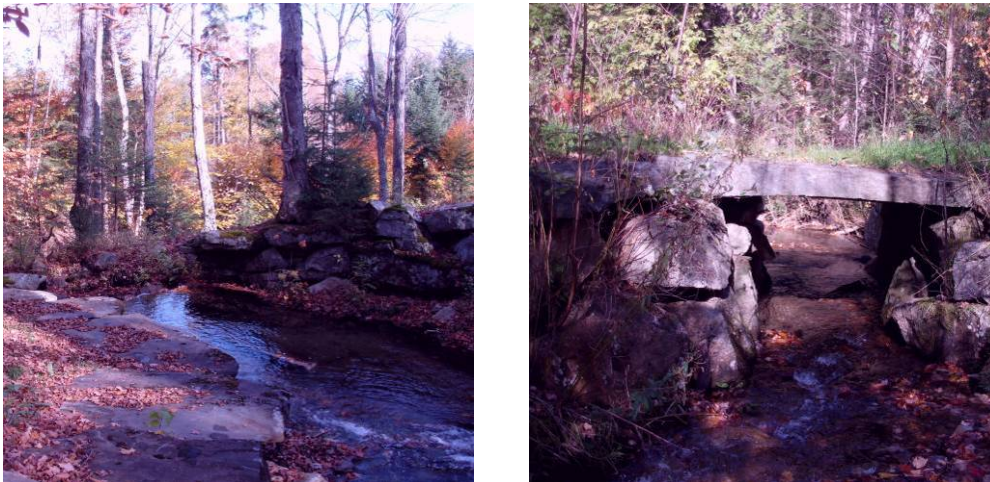
Fieldwork on T1.07C originally tracked up an unmapped tributary (on either USGS topos or the Vermont Hydrography dataset) in the area of the heavy cut at the top of the reach, and the tributary currently appears to be larger than the mapped T1.07C. This area has multiple ledge grade controls and has been significantly channelized (Fig. 49), and erosion in recent microburst activity appeared to be passing a significant amount of stream power and sediments to T1.07 further downstream. The relationship of the recent heavy cutting and the size of this tributary is unclear, but it does appear that water may reach the stream more quickly and intensely in storms than previous to the heavy cut, which resulted in a conversion of roughly 10 acres of continuous softwood cover to regenerating hardwoods.

**Figure 49. Fieldwork on T1.07C originally tracked up a small tributary that does not appear on maps; the stream has been significantly channelized and appeared to be passing heightened stream power and sediments in recent microburst activity.**

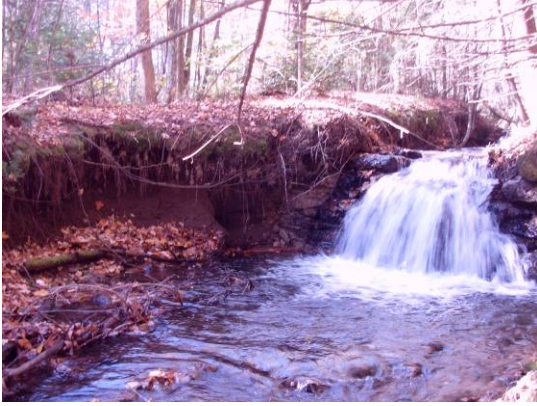
Straightening of the stream in T1.07B occurred with elimination of a former meander at the entrance drive to Butternut Hill Farm, and the portion of the stream that was channelized through a new culvert tore out both banks and scoured the bed to bedrock during recent microburst storm activity (Fig 50).

**Figure 50. A microburst storm in August 2010 tore out the banks and scoured the stream bed to bedrock in T1.07B just downstream of Butternut Hill farm. The impacts pictured here occurred after a former stream meander was eliminated by routing the stream through a new culvert installed at the drive entrance.**
