# **Upper West Branch Little River Corridor Plan**

**Stowe, Vermont  
October 12, 2010**

Prepared by:  
Bear Creek Environmental, LLC  
297 East Bear Swamp Road  
Middlesex, Vermont 05602

Prepared for:  
The Lamoille County Planning Commission  
632 LaPorte Road  
Morrisville, VT 05661

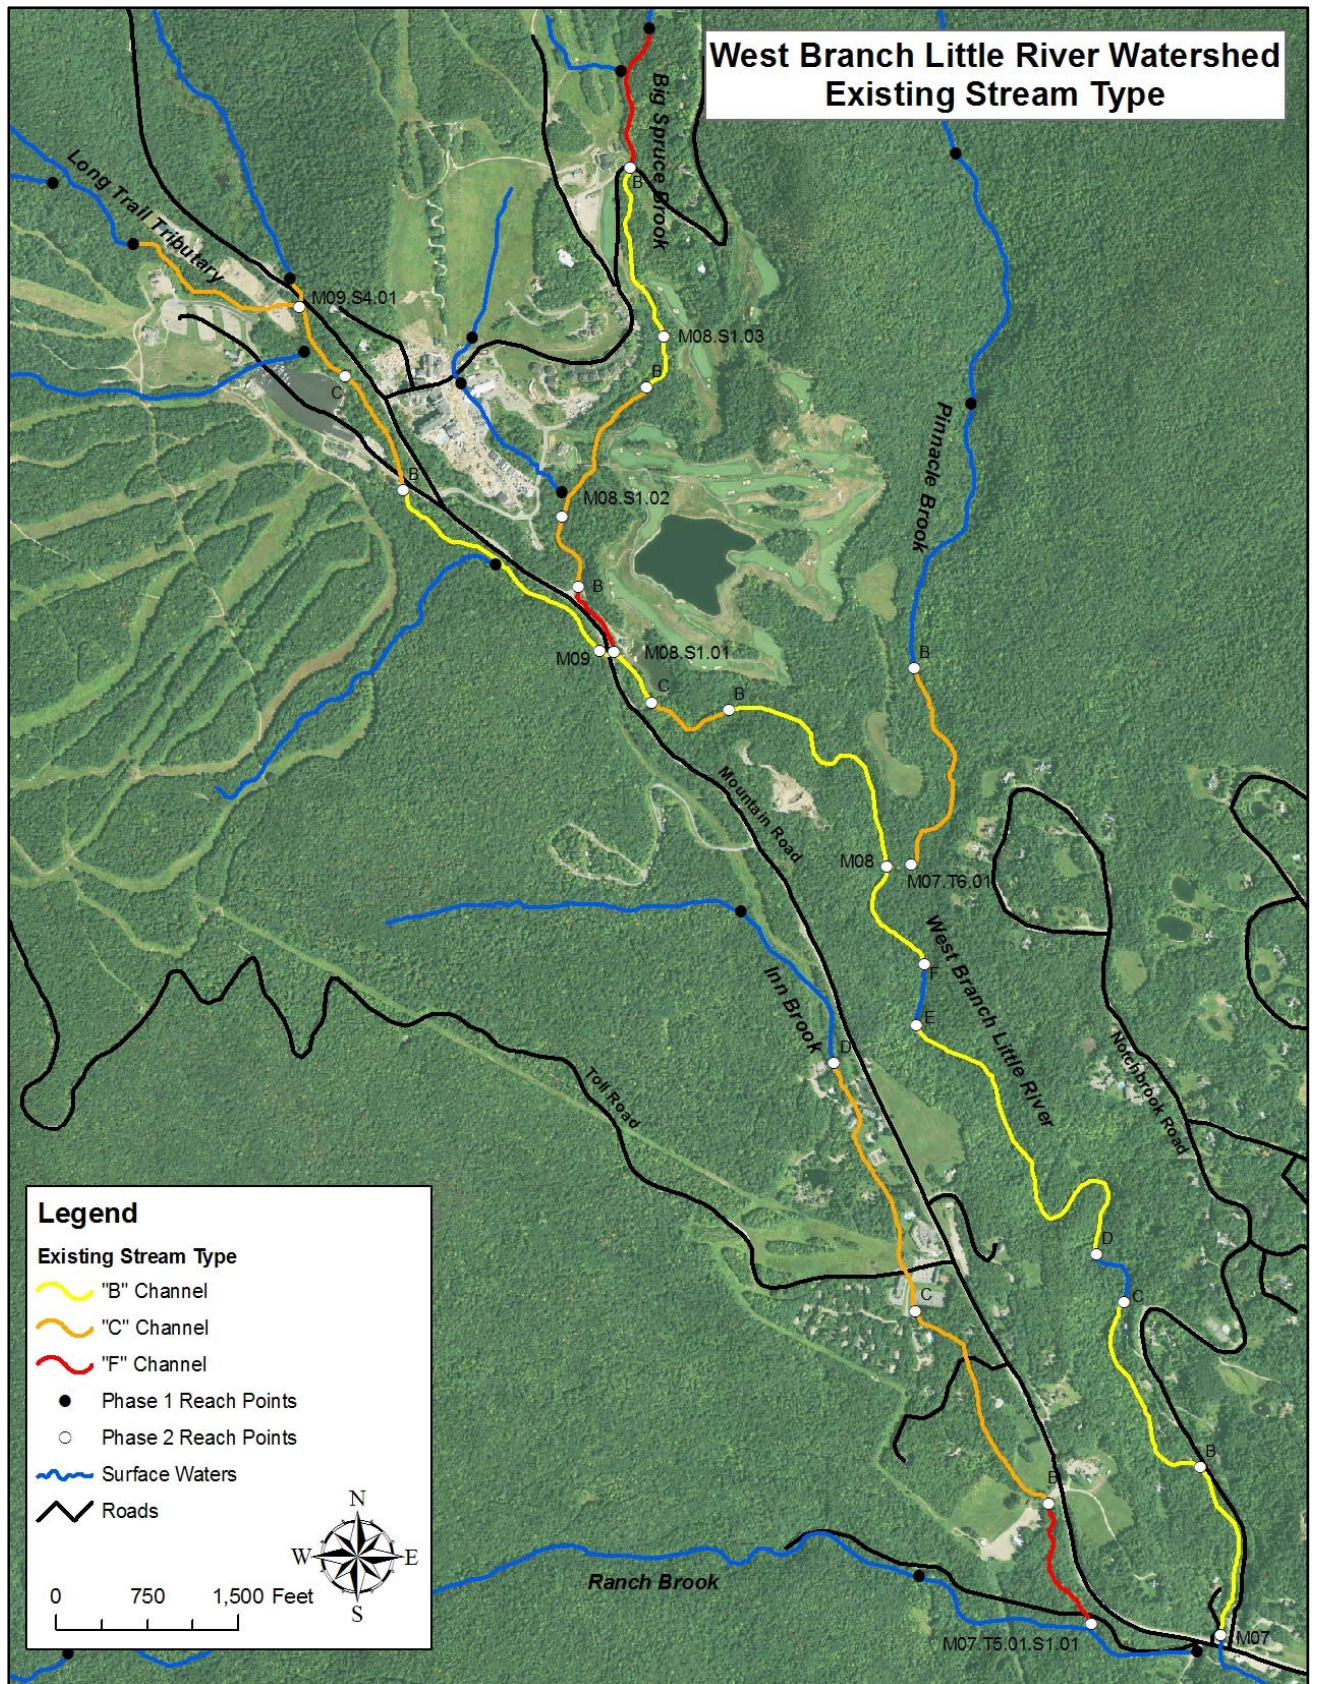
Figure 5.1 Existing stream types of the West Branch Watershed

During the Phase 2 assessment, nine reaches in the West Branch watershed were broken into 25 segments based on detailed field observations. The reference and existing stream type for each assessed reach/segment is included in Figure 3.7 and Figure 5.1, respectively. Detailed segment summary data are provided in Appendix A.

There are a few segments where the existing stream type differs from the reference stream type or a stream type departure has taken place. A stream type departure occurs when the channel dimensions deviate so far from the reference condition that the existing stream type is no longer the reference stream type. In reach M09-A, a stream type departure from a reference “Cb” channel with slight entrenchment to a “B” channel with moderate entrenchment has occurred due to the placement of the Mountain Road. A stream type departure occurred in the most downstream segment of Inn Brook (M07.T5.01.SI.01-A) where a moderately entrenched “B” channel has become a very entrenched “F” channel. A more extreme stream type departure from a reference “Cb” channel with slight entrenchment to an entrenched “F” channel has occurred on Big Spruce Brook in segments M08.SI.01-A and M08.SI.03-B. In segment M08.SI.01-A, the departure is due to historic rerouting and channelization of the stream so that it would not cross the Mountain Road. The incision that has occurred in segment M08.SI.03-B has resulted in a stream type departure from a “Cb” to an “F” channel. A localized stream type departure from a “Cb” to “B” has taken place in segment M08-C on the West Branch adjacent to the snowmaking pond. However, the overall segment is best classified as “Cb”.

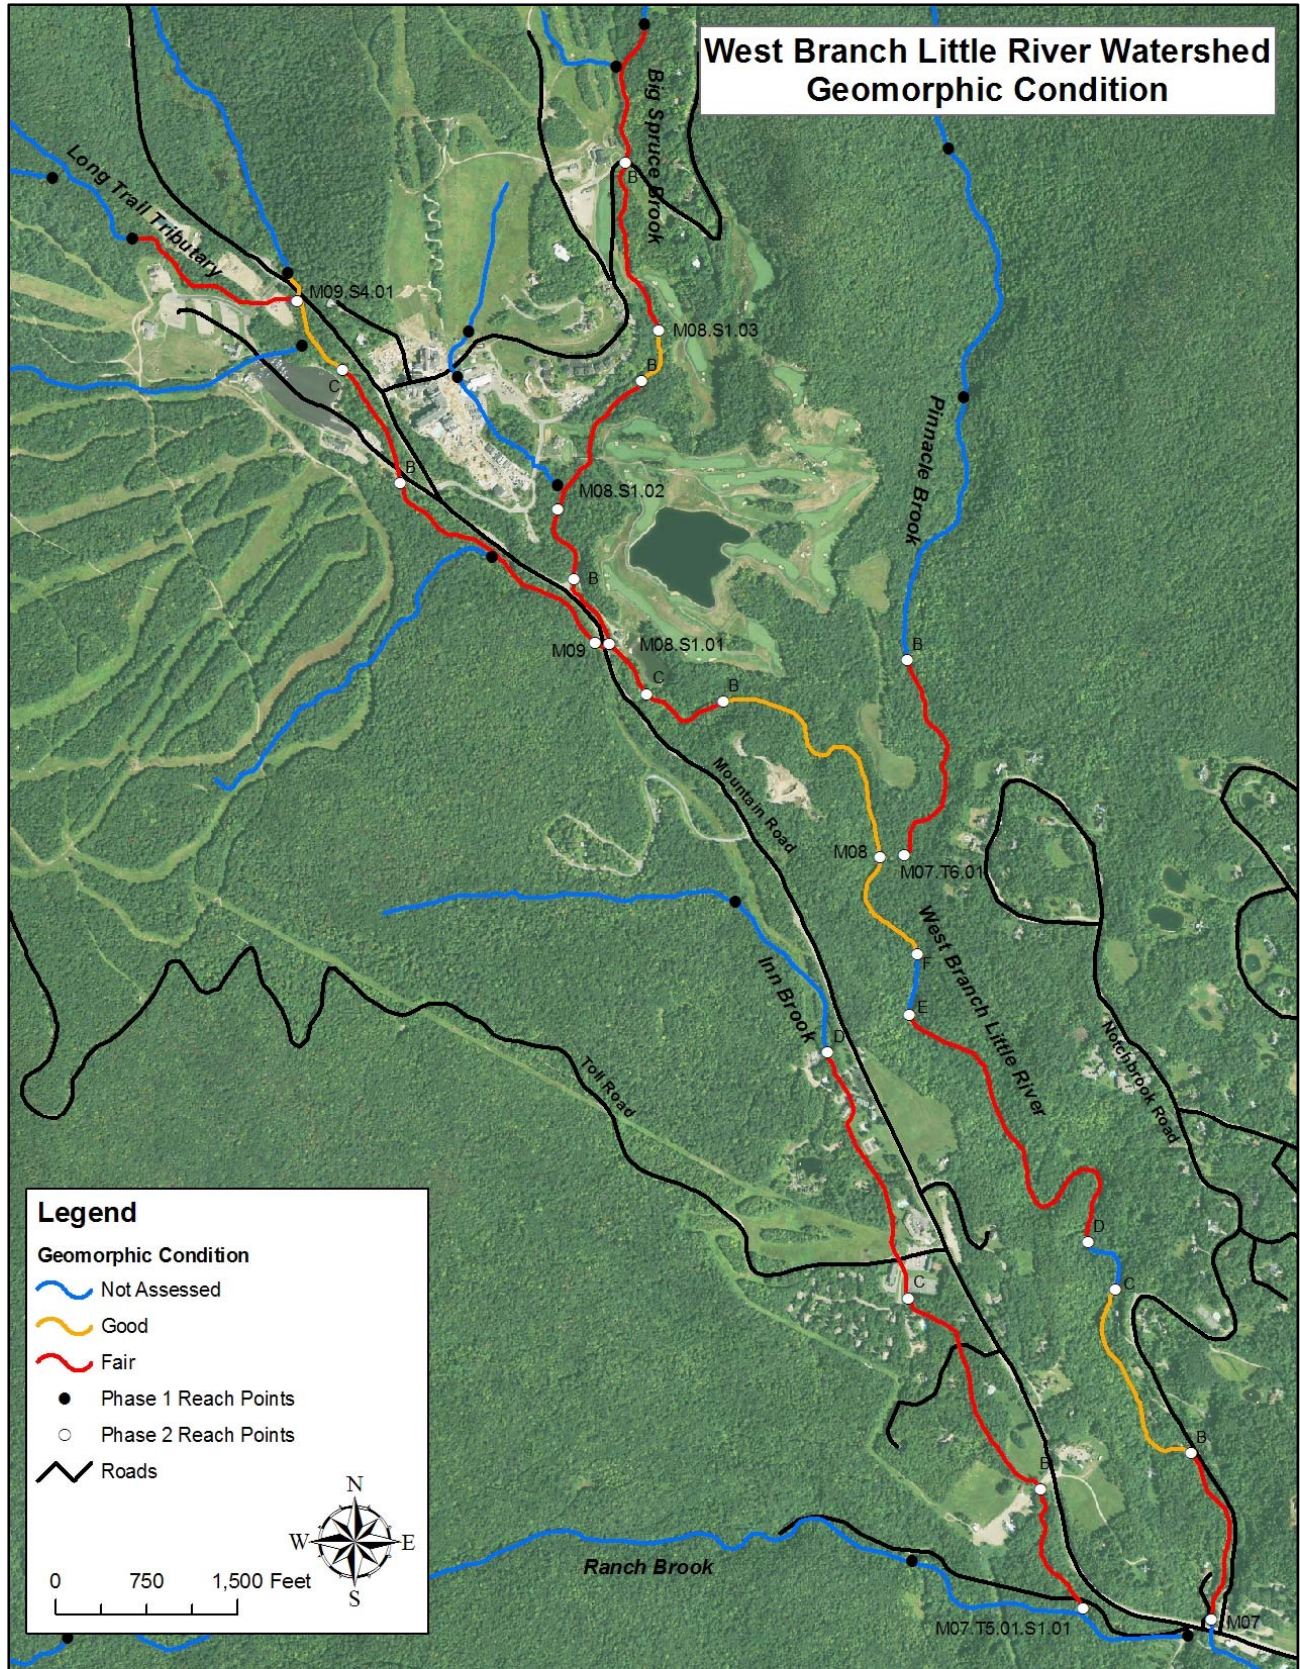
Figure 5.2. Phase 2 Geomorphic Condition of the West Branch Watershed

The existing geomorphic condition is depicted in Figure 5.2. Geomorphic condition is determined based on the degree (if any) of channel degradation, aggradation, widening and planform adjustment. Except for seven reaches/segments, the assessed segments and reaches in the upper West Branch watershed were found to be in “fair” geomorphic condition. The other five assessed reaches were in “good” geomorphic condition. Four segments did not receive a full Phase 2 assessment. Segment M07.T5.01.S1.01-D is a wetland and was not assessed. Segments M07-C and M07-E on the West Branch and M07.T6.01-B on Pinnacle Brook were not assessed because they are located in bedrock gorges.

The reach condition ratings of the West Branch indicate that most of the reaches/segments are actively or have historically, undergone a process of minor or major geomorphic adjustment. Many of the reaches studied in the West Branch watershed are undergoing a channel evolution process in response to large scale changes in its sediment, slope, and/or discharge associated with the human influences on the watershed. Table 3 below summarizes the channel evolution of each study reach and the primary adjustment processes that are occurring.

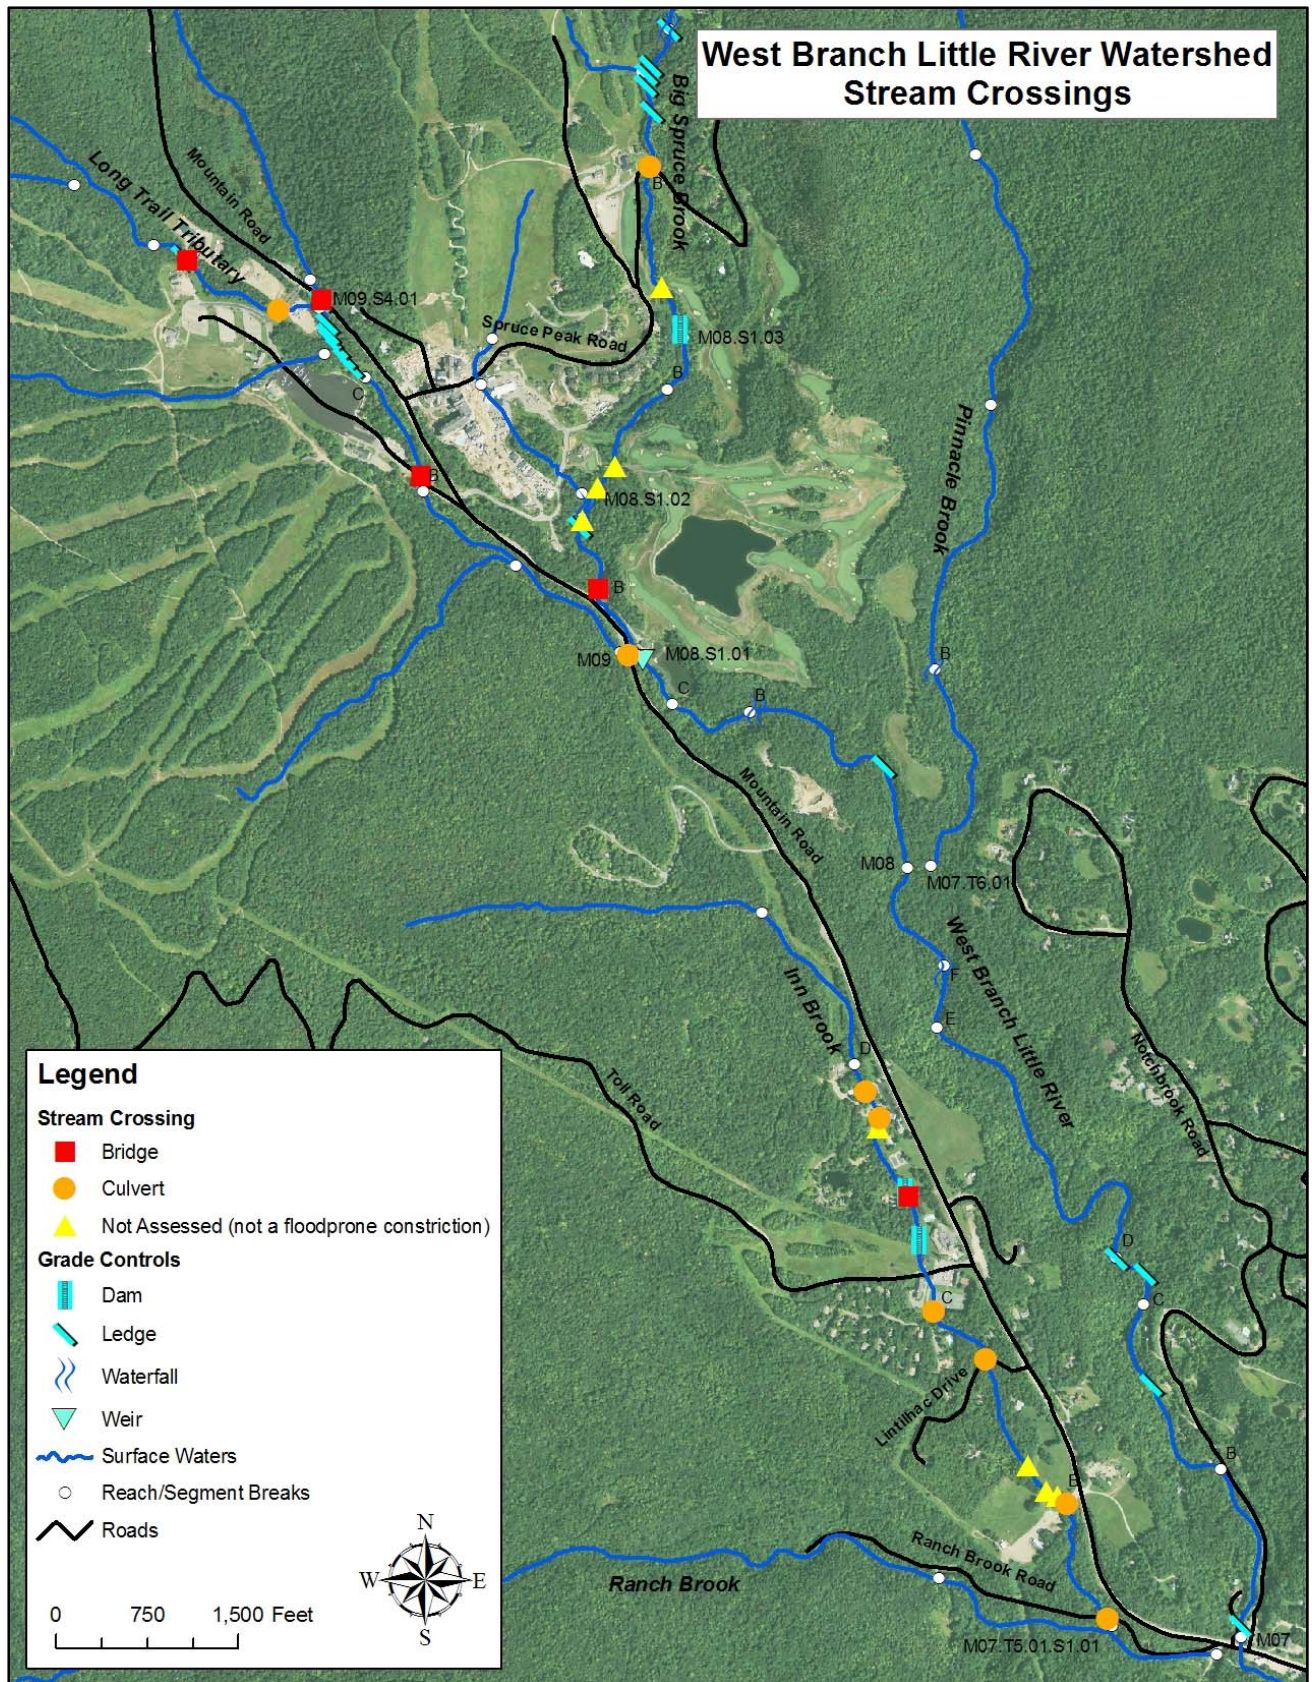
Figure 5.4. Stream Crossings within the West Branch Watershed

A total of 22 stream crossings (13 bridges and 9 culverts) are located within the Phase 2 West Branch study area (Figure 5.4). Eight bridges are not a floodprone constriction, and were not assessed. A bridge and culvert assessment using the VANR protocol was conducted on the remaining 14 structures by Bear Creek Environmental, LLC during the Phase 2 assessment. Seven of these stream crossings are on public roads. The geomorphic compatibility and AOP screening tools, photographs and Phase 2 constriction notes were used to prioritize structures for replacement/retrofit. A list of resources for towns regarding funding, planning and design for replacement and retrofit of stream crossings is available on the Vermont River Management and the Vermont Department of Fish and Wildlife’s web sites: [http://www.vtwaterquality.org/rivers/htm/rv\\_EducationalResources.htm](http://www.vtwaterquality.org/rivers/htm/rv_EducationalResources.htm) <http://www.vtfishandwildlife.com/library.cfm?libbase =Reports and Documents>).

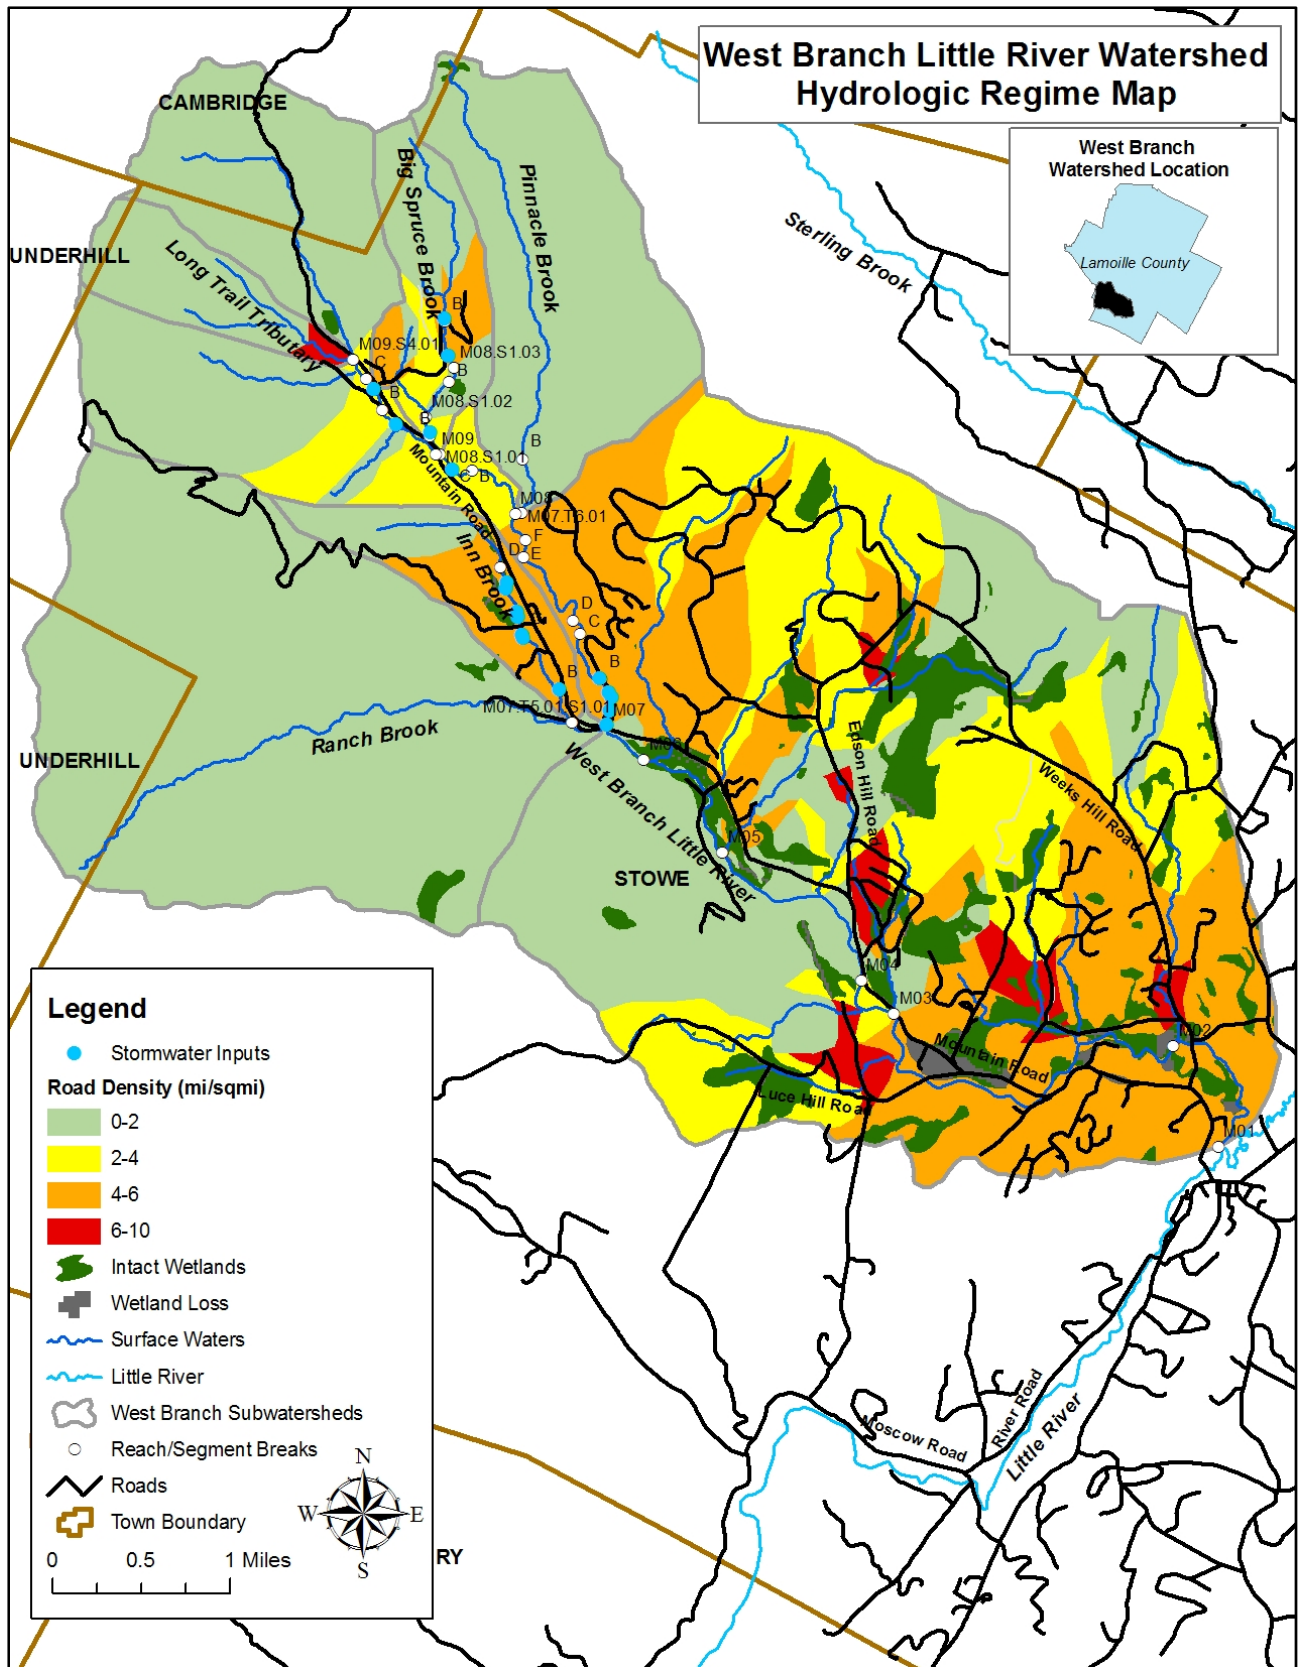
Figure 6.1 Hydrologic Regime Stressors in the West Branch Little River watershed

The West Branch watershed has a moderate network of roads as shown in Figure 6.1. Extensive road networks can contribute significantly to increased flows within a river resulting both from increased runoff and stormwater ditching. According to Foreman and Alexander (1998), increased peak flows in streams may be evident at road densities of 3.2 miles/ square mile. Subwatersheds with road densities of greater than 3.2 miles/ square mile account for about 26 percent of the West Branch watershed. The highest road densities within the watershed are along the tributaries to the West Branch in lower portion of the watershed and along Long Trail Tributary.

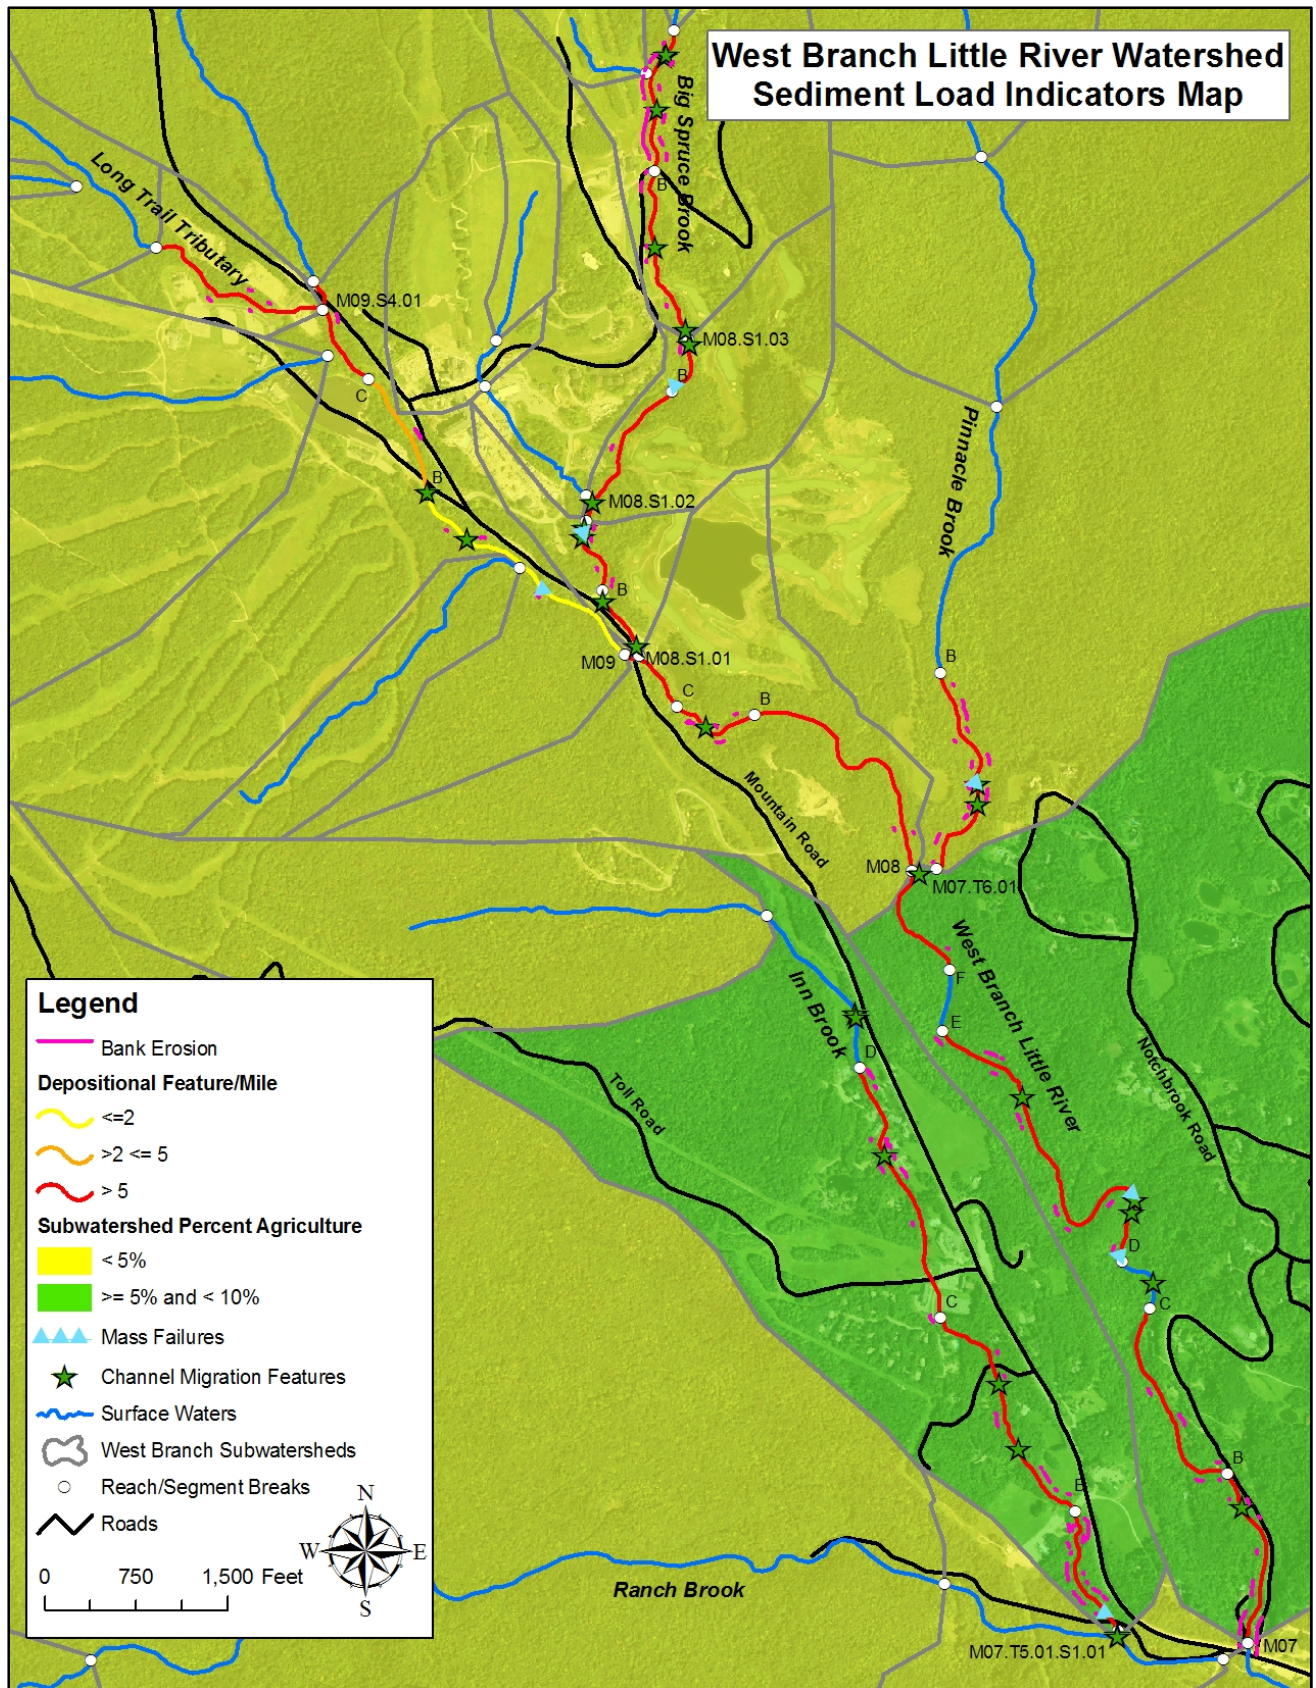
Figure 6.2. Sediment load indicators map for the West Branch

sources, the hydrologic regime, and the specific morphology of the valley, floodplain, and stream. The Sediment Load Indicators Map (Figure 6.2) shows the distribution of sediment load indicators in the study area. Figure 6.2 also shows the cumulative percentage of agricultural land (based on the percentage of cropland) for each subwatershed. As discussed in Section 3.1.3. Land Use, the West Branch watershed is 77 percent forest, 12 percent agriculture, 5 percent developed and urban land, 5 percent water and 1 percent wetland.

Depositional features per mile are mapped to show areas of deposition and planform adjustment. Steep riffles, mid-channel bars, delta bars, flood chutes, avulsions and braiding are parameters included in the depositional features’ map layer. This layer does not necessarily explain the sources of sediment, but these depositional and channel bifurcation features are common in areas where the sediment transport capacity of the channel has been exceeded (VANR, 2007a). Channel migration features (avulsions and flood chutes) are included on the map to show areas of significant planform adjustment. Over 80 percent of the Phase 2 segments assessed have a high number (greater than 5) of depositional features per mile. Two segments on the main stem of the West Branch assessed for Phase 2 (M07-A and M09-B) are the only segments with a moderate (between 2 and 5) number of depositional features per mile. Segment M09-A on the main stem of the West Branch was the only segment with a low (less than 2) number of depositional features per mile.

The bank erosion and the prevalence of mass failures illustrate the West Branch and its tributaries are providing a source of sediment input. This is resulting in the channel being overwhelmed by sediment and exceeding the sediment transport capability as observed by the numerous depositional features per mile.

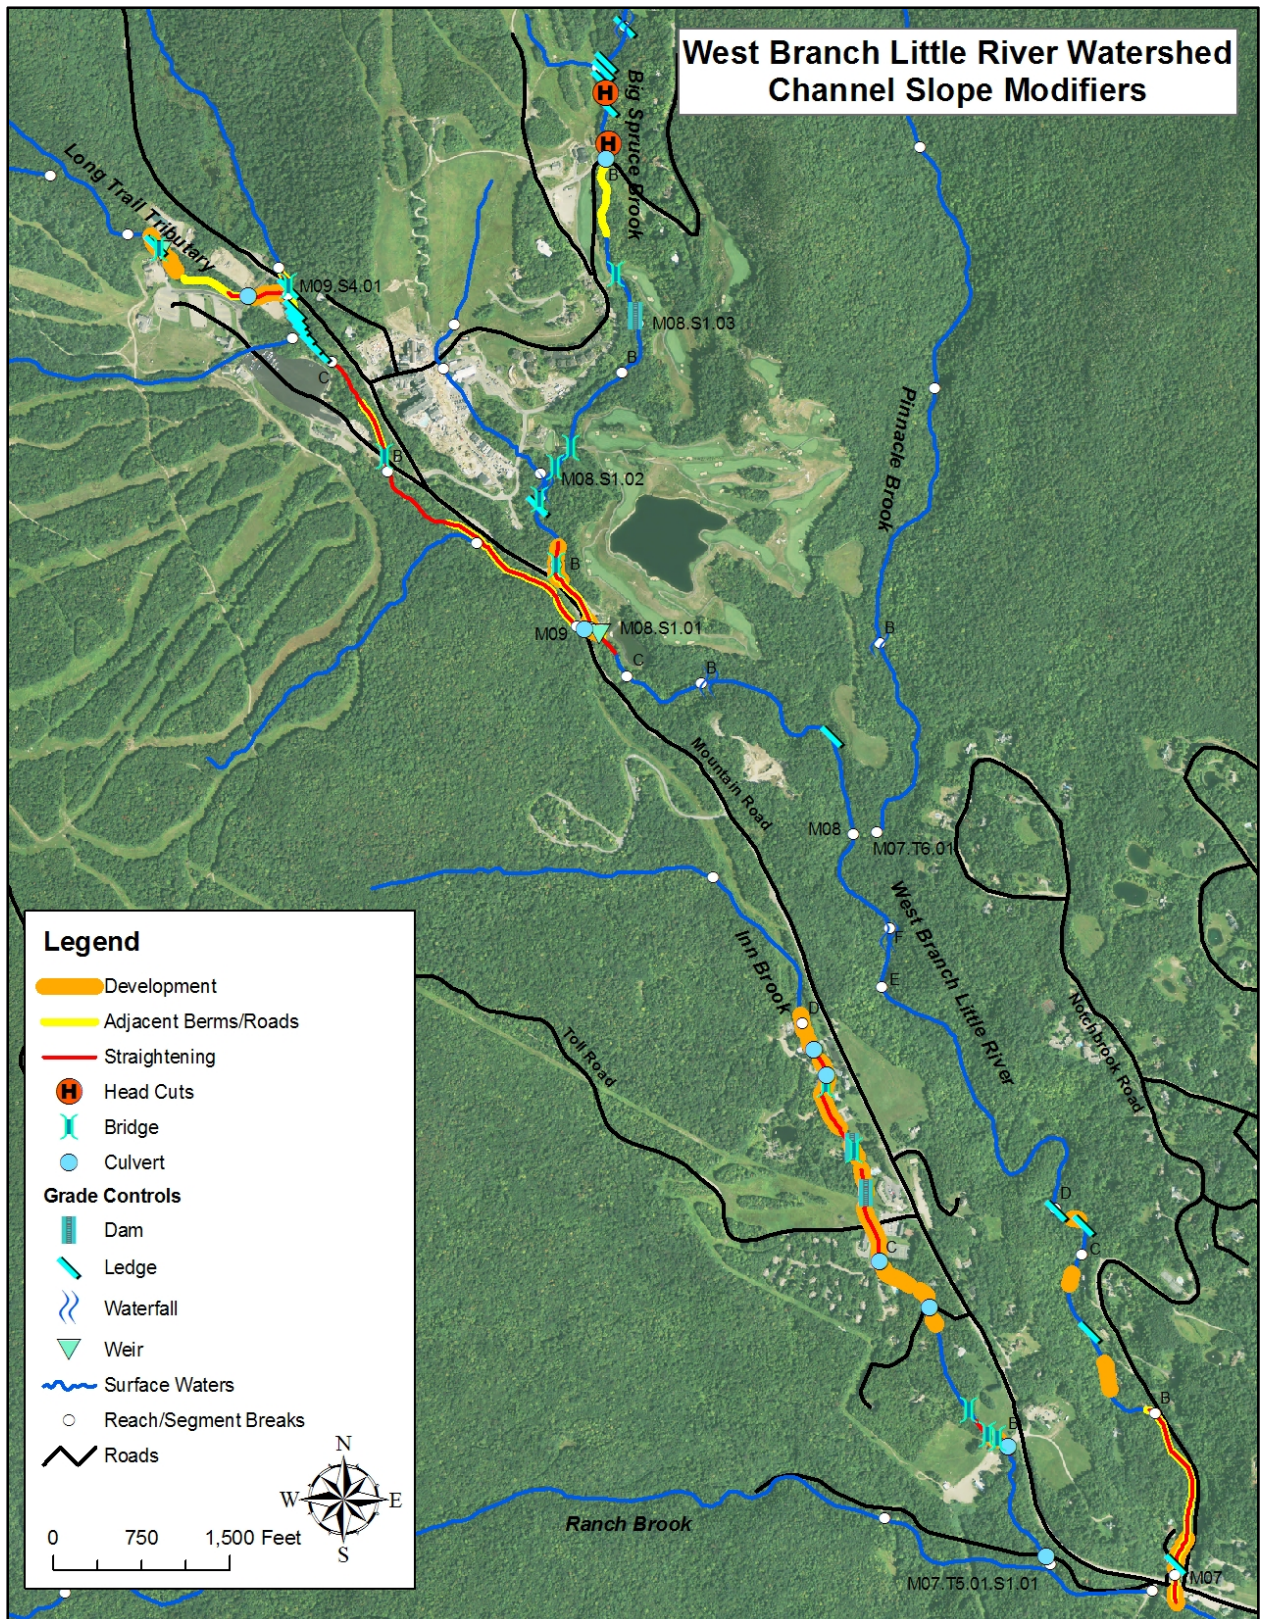
Figure 6.3. Channel slope modifiers map for the West Branch showing parameters contributing to increases (red and orange) or decreases (blue and green) in slope.

Channel straightening, floodplain encroachment, and berms and roads can increase the slope of a channel resulting in increased stream power. Increases in stream power (shown in red or orange in Figure 6.3) can initiate streambed erosion resulting in incision. The most extensive areas of channel straightening and floodplain encroachment (both development and adjacent berms and roads) are along central Inn Brook, the lower section of Big Spruce Brook, and the West Branch both in the most downstream segment (M07-A) and above the confluence of Big Spruce Brook (Figure 6.3). The streams within these segments run predominantly along the Mountain Road and Notchbrook Road and through the properties of The Inn at the Mountain and The Lodge. The majority of the channel straightening within the West Branch watershed is associated with roads that run parallel to the stream. Along Inn Brook, the channel straightening is related to channel rerouting through underground culverts. Another cause for slope increase is head cuts. There were two head cuts observed on Big Spruce Brook. The extensive areas with increases in stream power explain the channel adjustment that is occurring within the watershed.

Grade controls (waterfalls and ledge) and natural and manmade dams and constrictions (such bridges and culverts) constrict flows or raise the bed elevation. Backwater conditions and sediment deposition typically reduce channel slope and stream power (Vermont Agency of Natural Resources, 2007a). Localized areas where slope decreases are expected in the West Branch watershed are shown in blue and green in Figure 6.3.

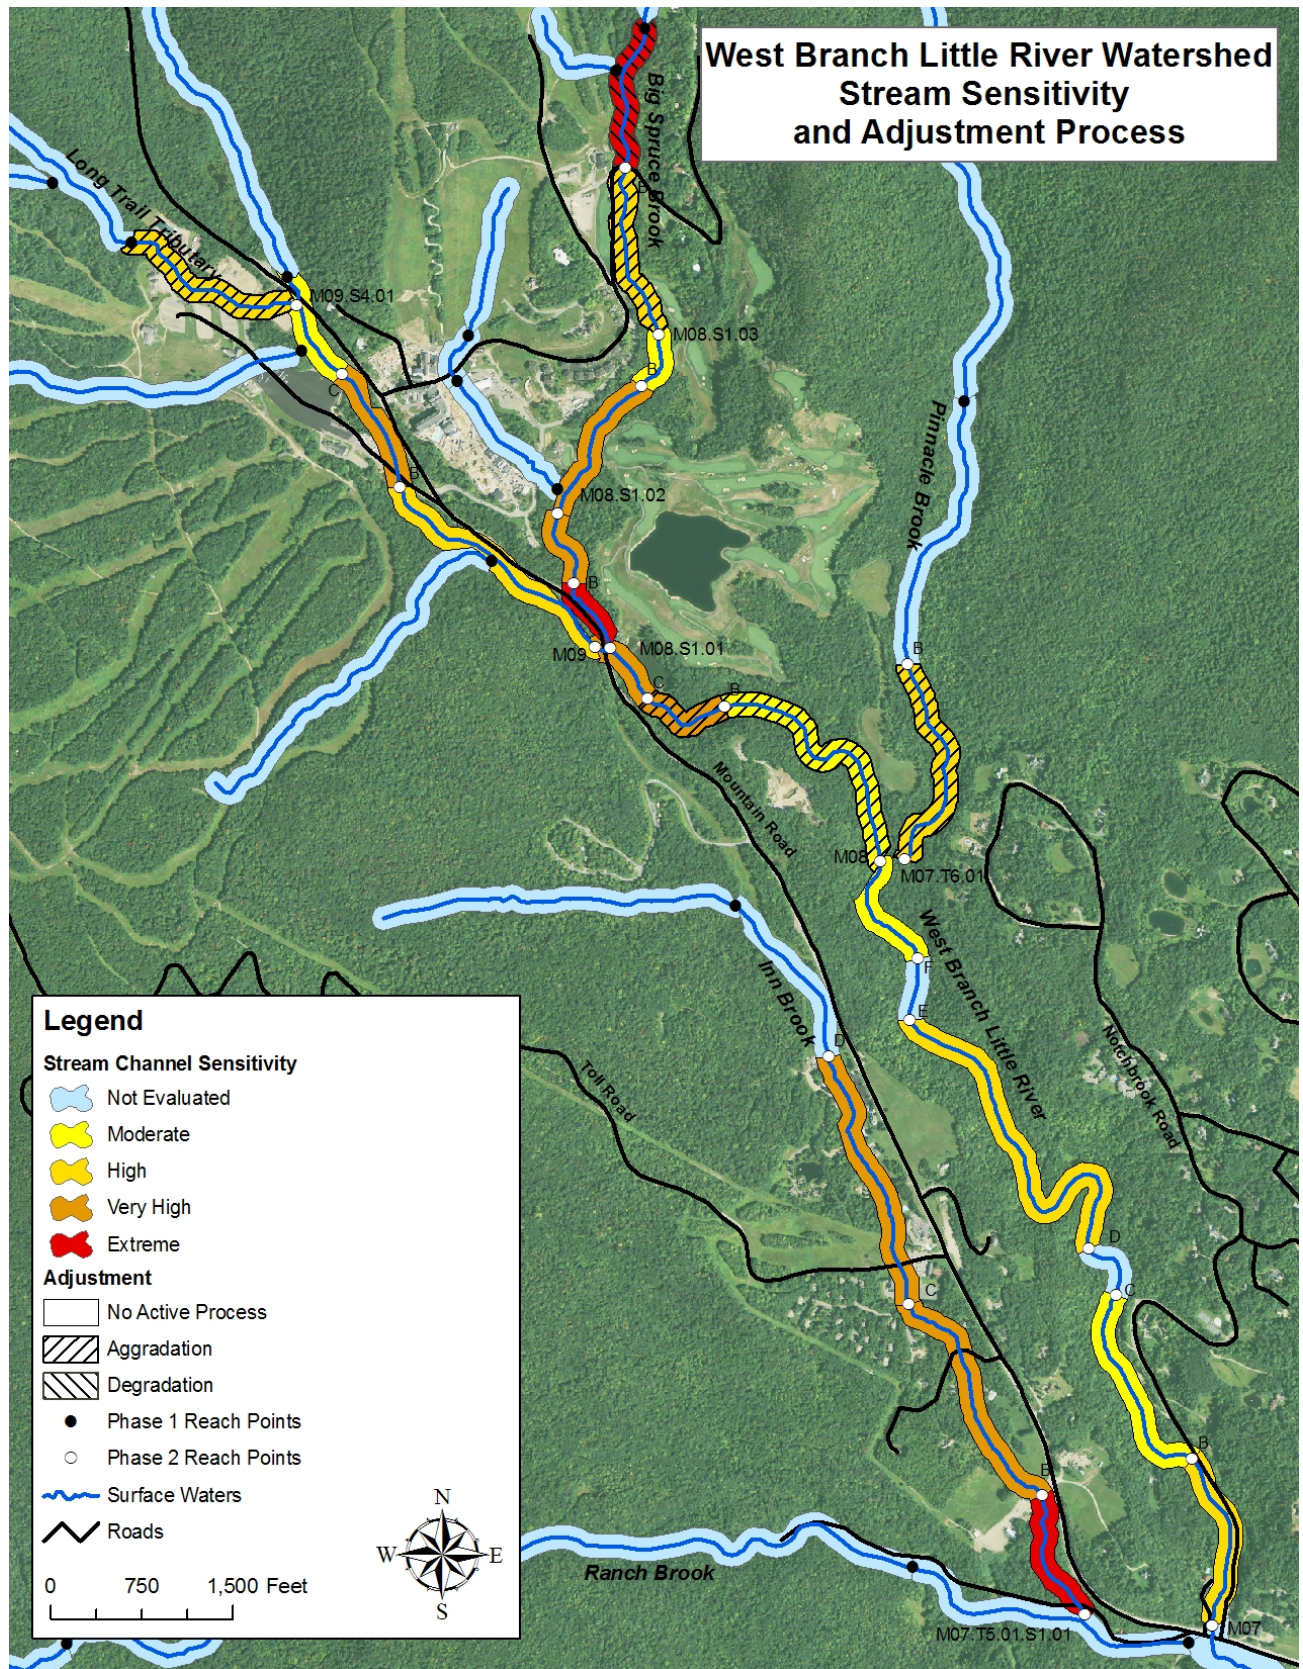
Figure 6.7 is a map presenting the stream sensitivity, generalized according to stream type and condition as per the VANR protocol, and current adjustments for each reach segment in the West Branch watershed. Sensitivity ratings have not been assigned for bedrock dominated segments and wetland segments that were not assessed. On Big Spruce Brook, segments M08.SI.01-A and M08.SI.03-B are gravel dominated segments that have undergone a stream type departure from a reference "C" channel to an "F" channel. This has resulted in a change in sensitivity from high to extreme (Figure 6.7). The channel sensitivity on segment M07.T5.01.SI.01-A on Inn Brook has gone from moderate to extreme due to a stream type departure from a "B" channel to an "F" channel. These stream type departures are attributed to historic incision. Major aggradation adjustment processes are displayed on the corridor where they were found to be actively occurring and not evaluated as historic. Aggradation is a current major active process for just four segments: M07.T6.01-A on Pinnacle Brook, M08-A and M08-B on the West Branch, M08SI.03-A on Big Spruce Brook, and M09.SI.04 on Long Trail Tributary. Degradation was found to be an active process in segment M08SI.03-B due to the presence of two headcuts.

Figure 6.7. Stream sensitivity and current adjustment of the West Branch

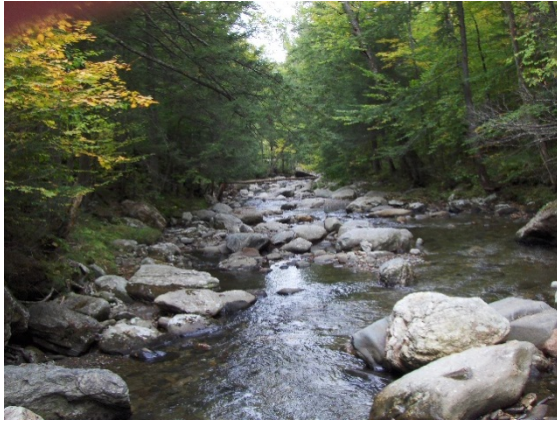
At the downstream end of segment M07-B the channel migrates away from Notchbrook Road and continues for 1,750 feet. Forest is the dominant land use within both corridors and the buffer is predominantly greater than 100 feet on both sides (Figure 7.3). On the eastern side, the subdominant buffer width is 26-50 feet due to development. No incision has occurred in segment M07-B. Therefore, the segment is in stage F-I of the channel evolution model. The presence of mid-channel bars, side bars and a delta bar indicate that M07-B is somewhat depositional. There are more large pools in segment M07-B than downstream in M07-A (Figure 7.4), but large woody debris is still limited.

**Figure 7.3. Typical channel of M07-B in well forested corridor**

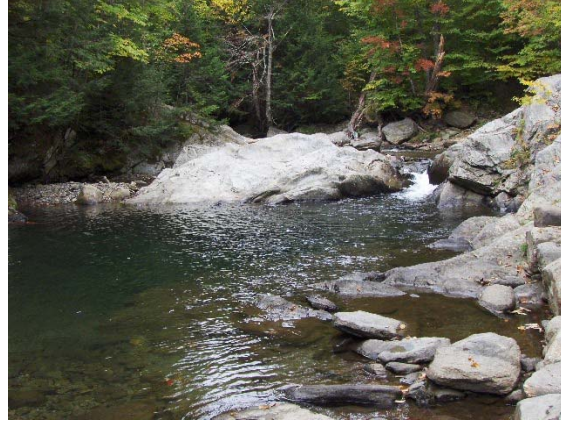
**Figure 7.4. Large pool and bedrock constriction in M07-B**

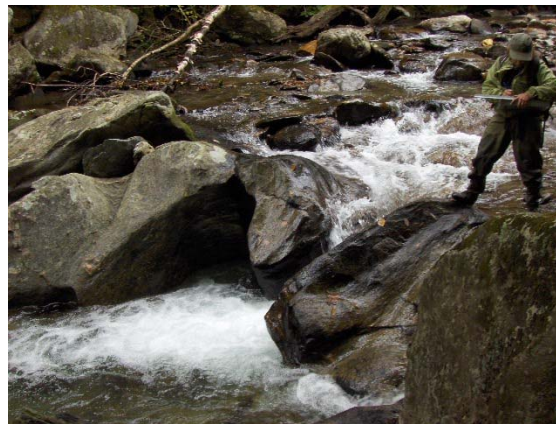
The next segment, M07-C, was not assessed since it is a 700 foot long bedrock gorge (Figure 7.5). It is located just downstream of the Bingham Falls parcel conserved by the Stowe Land Trust and owned by the State of Vermont (Stowe Land Trust, 2010a). To continue conservation efforts along the West Branch and to preserve the existing condition, segments M07-C and M07-B are being recommended for conservation.

**Figure 7.5. Bedrock grade control segment M07-C**

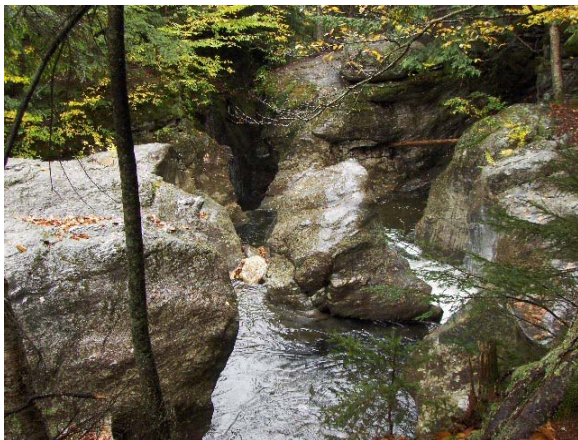
**Figure 7.8. Bedrock gorge of Bingham Falls in M07-E**

Another segment, M07-E, was created due to a second bedrock gorge, which is the location of Bingham Falls (Figure 7.8). The 520 foot long segment M07-E was therefore not assessed (Figure 7.5). The Bingham Falls parcel conserved by the Stowe Land Trust contains segment M07-E (Stowe Land Trust, 2010a).

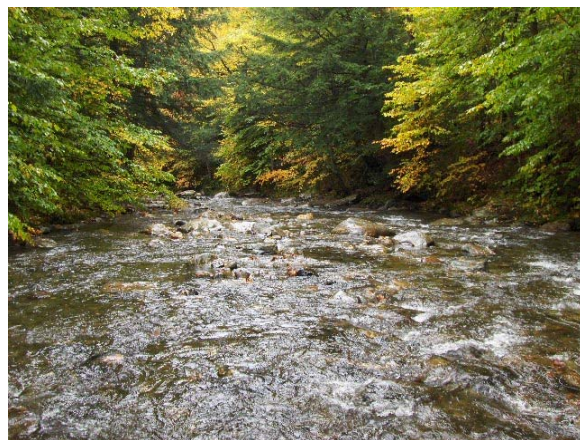
**Figure 7.9. Typical channel in M07-F**

Upstream of the bedrock gorge is M07-F, a cobble dominated “B” channel (Figure 7.9) that continues for 1,130 feet until the confluence with Pinnacle Brook. The stream remains in a well forested corridor with a wide buffer on both sides. Moderate incision has occurred in segment M07-F placing it in stage F-III of channel evolution. Similar to M07-D, the RAF in M07-F was difficult to determine. Since both upstream and downstream segments contain bedrock grade controls, it is possible that M07-F actually has not incised and the channel does not have a recently abandoned floodplain.

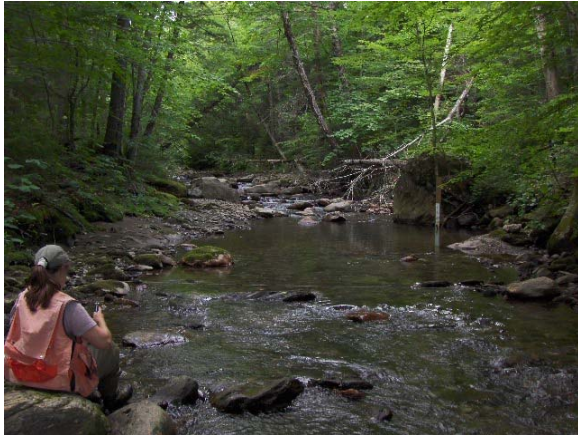
Segment M08-B begins where the valley width opens up and the channel is therefore less entrenched and continues until the confluence of Big Spruce Brook. The stream type is a gravel dominated “B” channel that has predominantly riffle-pool features with step-pool features subdominant. The segment is 720 feet long and continues until bank and buffer conditions change where the former snowmaking pond encroaches upon the eastern corridor. Both corridors within segment M08-B are well forested and the dominant buffer width is greater than 100 feet (Figure 7.10). There is a stormwater input from the

**Figure 7.10. Well forested corridor and buffer in M08-B**

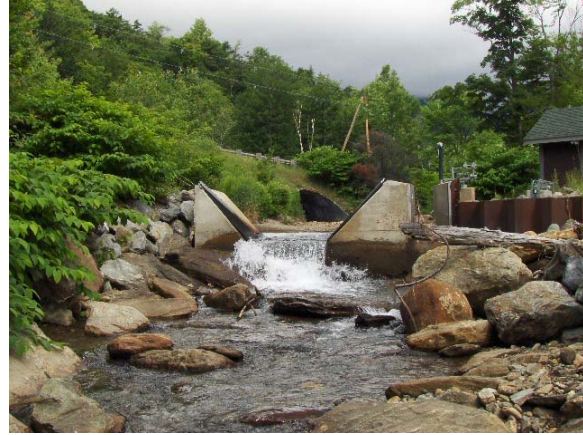
There is a weir grade control in segment M08-C where flow is diverted into a snowmaking pond during the winter. The weir is causing a channel constriction that is resulting in sediment deposition above and below the structure (Figure 7.12). There is a 2.2 foot drop on the downstream end of the weir, which may be impeding the passage of fish (Figure 7.13). A significantly undersized arch at Mountain Road is causing deposition and scour above and below the structure. There is sediment throughout the structure, and fish passage does not appear to be an issue. This structure has been given a high priority for replacement given the sediment transport issues.

**Figure 7.13. Downstream view of weir in M08-C**

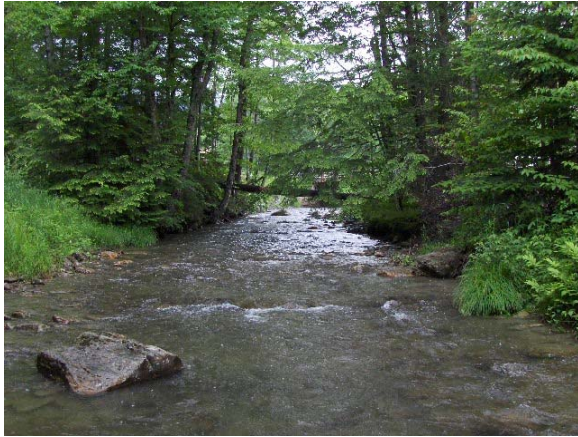
Three-quarters of segment M09-B is located within the Mount Mansfield State Forest. Segment M09-B begins just downstream of the entrance to the Mansfield Parking area and continues for one-quarter mile until the confluence with an unnamed tributary. The stream type is a gravel dominated “Cb” riffle-pool channel. The valley is more open in this segment than downstream and upstream segments. However, the valley width and type has changed due to the placement of the Mansfield Parking area on the western side and Route 108 on the eastern side. The majority of the segment has been straightened for Route 108 and the parking lot (Figure 7.16).

**Figure 7.16. Straightening along segment M09-B**

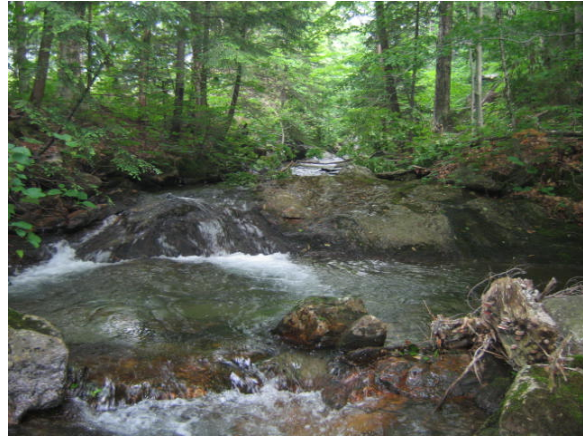
**Figure 7.17. Bedrock grade control in M09-C**

Segment M09-C begins at the confluence of an unnamed tributary and continues for 800 feet. The cobble dominated “Cb” channel has mostly step-pool features with numerous bedrock grade controls (Figure 7.17). The placement of Route 108 and the Mansfield Parking area has resulted in a human caused change in valley width, but not a change in valley type. Almost half the segment has been straightened, but the channel has not incised due to the abundant grade controls. A bridge that crosses the Mountain Road is significantly undersized and has been recommended for replacement. The scour associated with this undersized bridge is causing undermining of the wing walls at both the upstream and downstream ends of the structure.

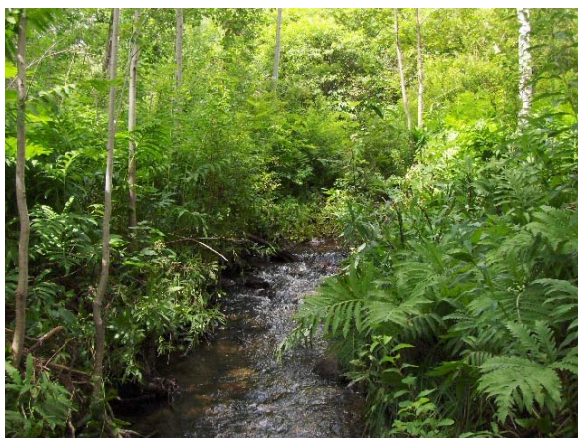
The slope decreases and the valley width increases where the road to the cross country ski center crosses Inn Brook. This is where segment M07.T5.01.S1.01-B begins and continues for 2,000 feet until the stream disappears into an underground culvert at the Inn at the Mountain. The entrenchment was variable within the segment, but the dominant stream type is a riffle-pool and gravel dominated “Cb” with some step-pool features. Buffers are wide and well forested predominantly, but there is some residential development in both sides of the corridor. The subdominant buffer width is 26 to 50 feet, especially at the downstream end within the cross-country ski center. Banks are well vegetated, which provides a good canopy for both sides (Figure 7.20).

**Figure 7.20. Well vegetated banks providing good canopy for segment M07.T5.01.S1.01-B**

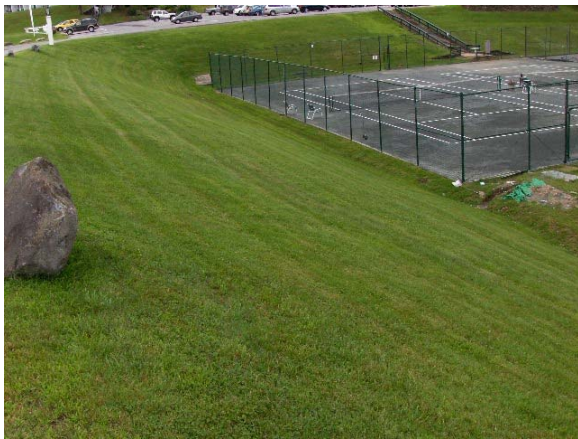
Segment M07.T5.01.S1.01-C begins where an underground culvert reroutes the stream for 600 feet at the Inn at the Mountain (Figure 7.22). The segment continues upstream of the culvert for another 1,500 feet until a wetland at the upstream end of the reach. The channel has been radically altered from extensive channel straightening (Figure 7.23), two dam grade controls (Figure 7.24), and the rerouting into two underground culverts. Buffer widths are predominantly less than 25 feet on both sides and due to the hotels (Figure 7.25), the dominant land use within the corridor is commercial on both sides.

**Figure 7.22. Location of underground culvert in M07.T5.01.S1.01-C**

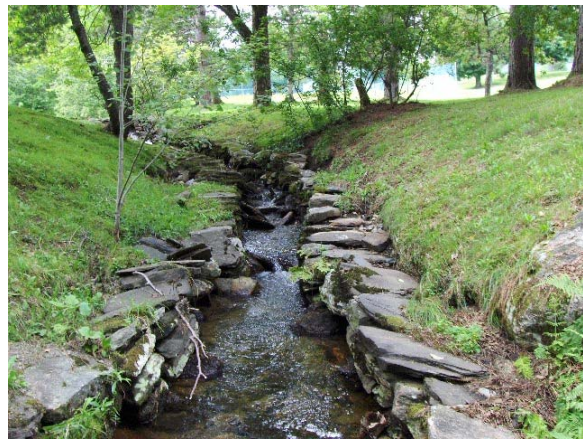
**Figure 7.23. Channel straightening and armoring in M07.T5.01.S1.01-C**
