# **Upper West Branch Little River Corridor Plan**

**Stowe, Vermont  
October 12, 2010**

Prepared by:  
Bear Creek Environmental, LLC  
297 East Bear Swamp Road  
Middlesex, Vermont 05602

Prepared for:  
The Lamoille County Planning Commission  
632 LaPorte Road  
Morrisville, VT 05661

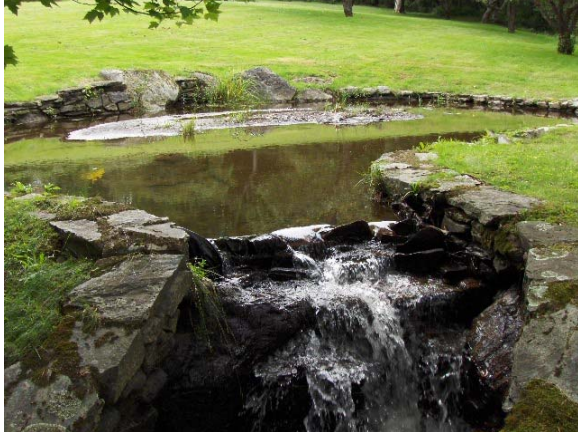
**Figure 7.24. Dam grade control creating small pond in M07.T5.01.S1.01-C**

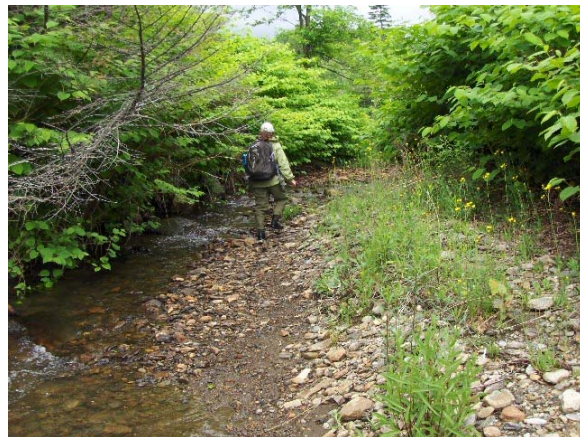
Reach M08.SI.01 was broken up into two segments due to differences in channel dimensions. The most downstream segment, M08.SI.01-A, starts at the confluence with the West Branch and continues 700 feet until just upstream of the bridge crossing at the ski hostel. The entire segment has been channelized and rerouted to enter the West Branch downstream from its original location on the other side of Route 108. There are roads along both banks causing entrenchment and a stream type departure from a “Cb” channel to an “Fb” channel. Most of the segment has a buffer width on both sides of less than 25 feet with a dominant corridor land use as residential due to the roads. Along Route 108, the stream bank is heavily armored with rip-rap (Figure 7.27). On the downstream end of the segment, Japanese knotweed is the dominant bank vegetation (Figure 7.28).

**Figure 7.28. Japanese knotweed on banks in M08.SI.01-A**

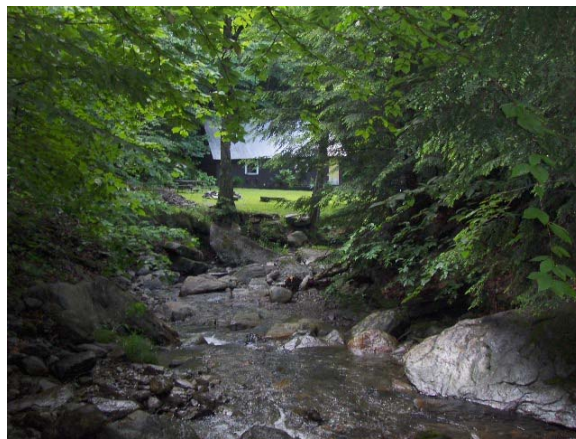
**Figure 7.29. Riparian buffers within the corridor of lower M08.SI.01-B**

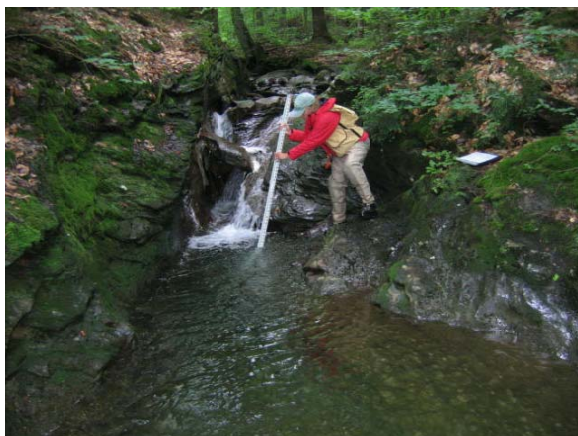
The second reach on Big Spruce Brook was segmented to account for differences in valley widths and channel dimension. Segment M08.SI.02-A begins just downstream of an unnamed tributary and continues for 1,255 feet. The stream type is a gravel and step-pool dominated “Cb” channel in stage F-III of channel evolution. There is a waterfall grade control causing a channel constriction and possibly preventing movement of aquatic organisms (Figure 7.30).

**Figure 7.30. Waterfall grade control in segment M08.S1.02-A**

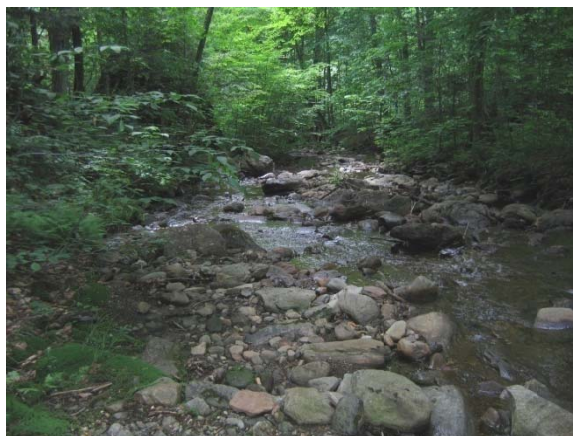
**Figure 7.31. Well forested riparian area in segment M08.S1.02-B**

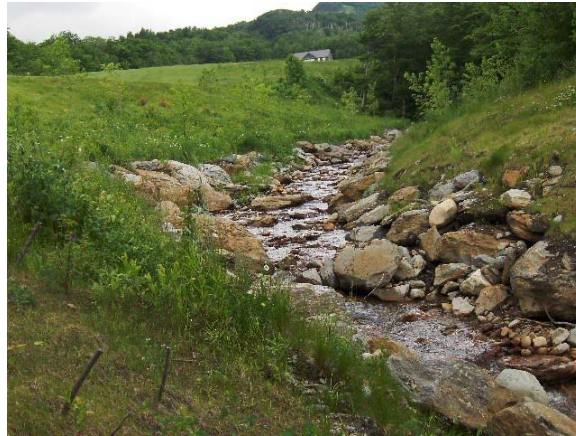
Reach M08.S1.03 was divided into two segments based on differences in valley widths and channel dimensions. The downstream segment, M08.S1.03-A, is similar to M08.S1.02-B in that it is a cobble dominated “B” channel which has historically incised and in stage F-III of channel evolution. The segment begins about 400 feet downstream of a golf course bridge crossing and continues about one-quarter mile until the crossing of Spruce Peak Road. In the vicinity of the golf course bridge, the channel has been reconstructed. Large boulders

line both banks in the reconstructed section and buffers at the time of the Phase 2 stream geomorphic assessment in 2008 were less than 25 feet (Figure 7.32). Shrub willow has subsequently grown in creating a vegetated buffer within this section.

**Figure 7.32. Reconstructed channel in segment M08.SI.03-A**

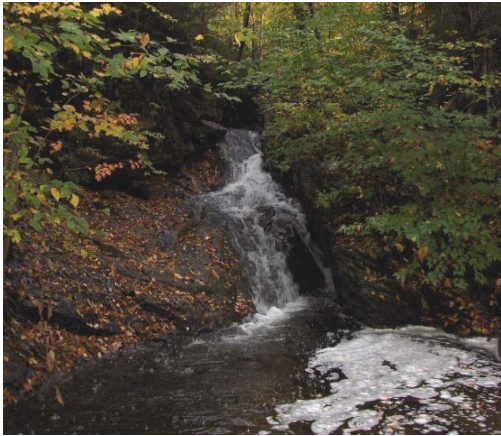
Segment M08.SI.03-B begins at the culvert crossing at Spruce Peak Road and continues for another quarter mile to a waterfall that is acting as a significant grade control (Figure 7.33). Except for the most downstream segment, segment M08.SI.03-B is the most impacted segment assessed on Big Spruce Brook. Channel incision is extreme (ratio of 4.48) and has resulted in a stream type departure from a “C” to an “F” channel. Two active head cuts were identified in this segment (see Figure 7.34). Arresting the active head cuts is a high priority restoration project that has been identified in this plan. A rejuvenating tributary was mapped about half way up segment M08.SI.03-B on the west side providing further evidence of the extreme incision. The RGA scored 0.35, and was the lowest RGA score of all the segments assessed within the upper West Branch watershed. Continuous and laterally extensive scour and erosion were noted at the base of both banks, providing evidence of major widening. Major planform adjustment was also noted in the form of multiple islands, mid-channel bars and flood chutes. Extensive bank erosion, lack of undercuts, a narrow riparian buffer on the west side, unstable steps, the high incision ratio, limited refuge habitat, lack of large woody debris and major system obstructions (such as the culvert crossing on Spruce Peak Road at the downstream end of the segment and the

**Figure 7.33. Waterfall grade control at upper end of segment M08.S1.03 of Big Spruce Brook**

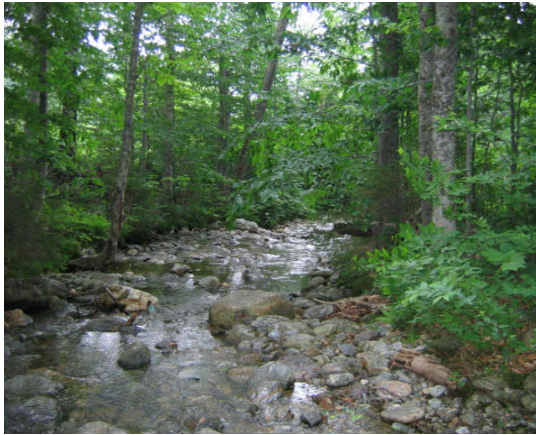
Figure 7.35. Upper end of Reach of M09.S4.01 (Longtrail Tributary)

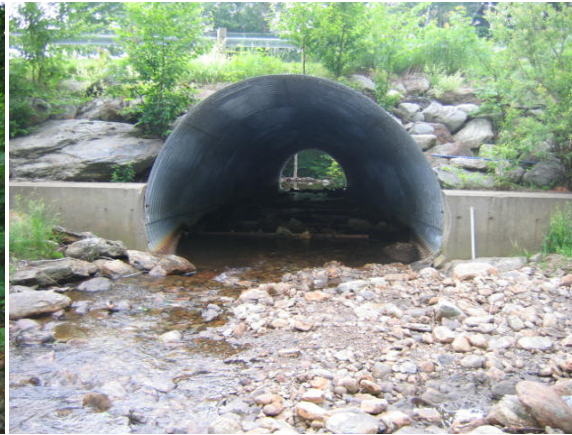
IV of the channel evolution model. The lower section where the channel had been altered was more incised and was likely in stage F-III. The RGA scored in the fair range, with major historic incision, major aggradation, minor widening and planform adjustment. Sediment build up, as shown in Figure 7.36, was evident at the inlet of the undersized culvert that crosses the access road to the Mansfield Parking. This structure has been identified as high priority for replacement. The RHA also scored in the “fair” range. Channel morphology, hydrologic characteristics, connectivity and the south riparian area are parameters that scored “fair”.

Figure 7.36. Significant sediment deposition above undersized culvert on Longtrail tributary

- Active Restoration by replacing undersized culvert on the access road to the Mount Mansfield parking lot (project #23).

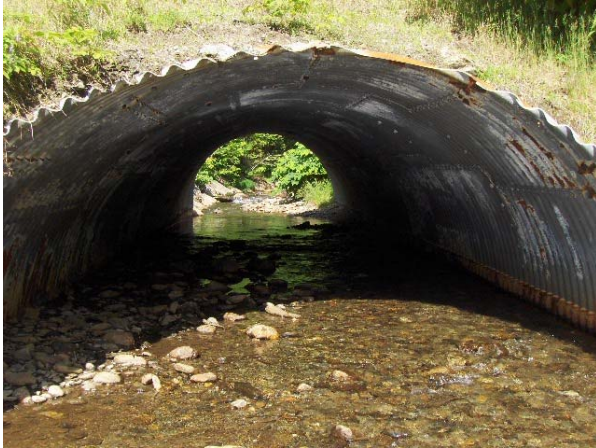
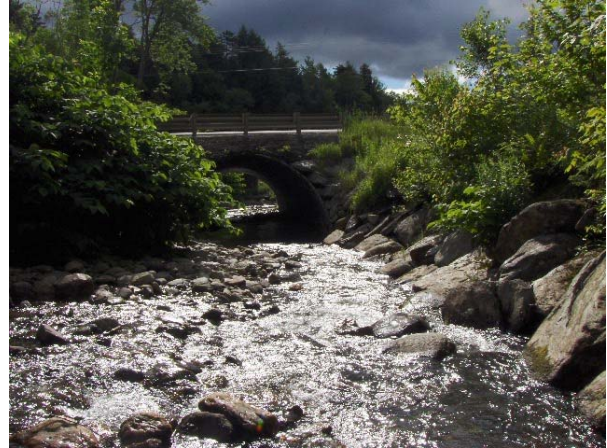
**West Branch Little River  
Mountain Road  
Segment M08-C**

#3 Mountain Road Arch M08-C West Branch	Active Restoration	The Mountain Road arch is significantly undersized and is causing deposition and scour above and below the structure. There is material throughout the structure; therefore, this structure does not appear to be an issue in terms of AOP	Replace structure with a structure that accommodates at least the bankfull channel width	High priority	Improved habitat and geomorphic stability	High cost of replacement	Unknown	Town of Stowe, VANR, LCPC

Arch Length: 73 feet  
Arch Height: 9.5 feet  
Arch Width: 16 feet

**Geomorphic Compatibility – Partially Compatible**

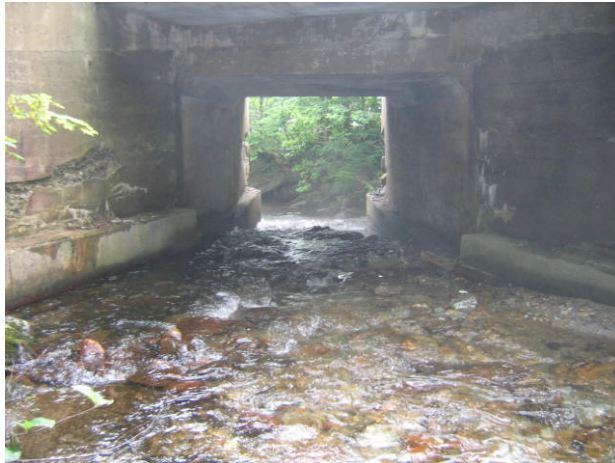
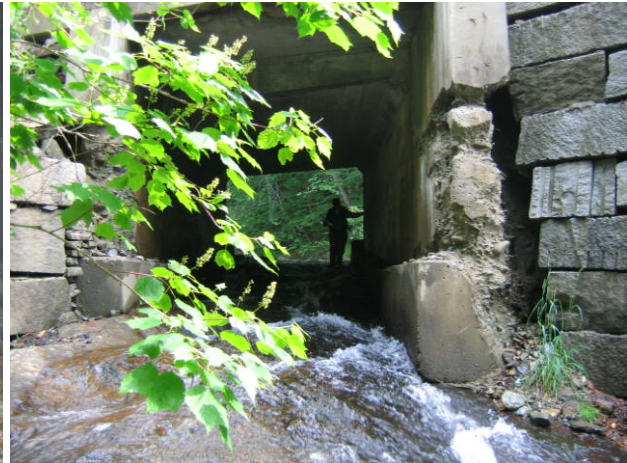
**West Branch Little River  
Mountain Road  
Segment M09-C**

#5 Mountain Road Bridge  M09-C West Branch	Active Restoration	The bridge crossing on the Mountain Road near the confluence of Long Trail Tributary is significantly undersized. The structure is causing scour below and has poor alignment	Replace with a structure that accommodates at least the bankfull channel width	High priority	Improved habitat and geomorphic stability	High cost of replacement	Unknown	Town of Stowe, VANR, LCPC

Road Width: 31 feet  
Bridge Clearance: 7 feet  
Bridge Span: 11 feet

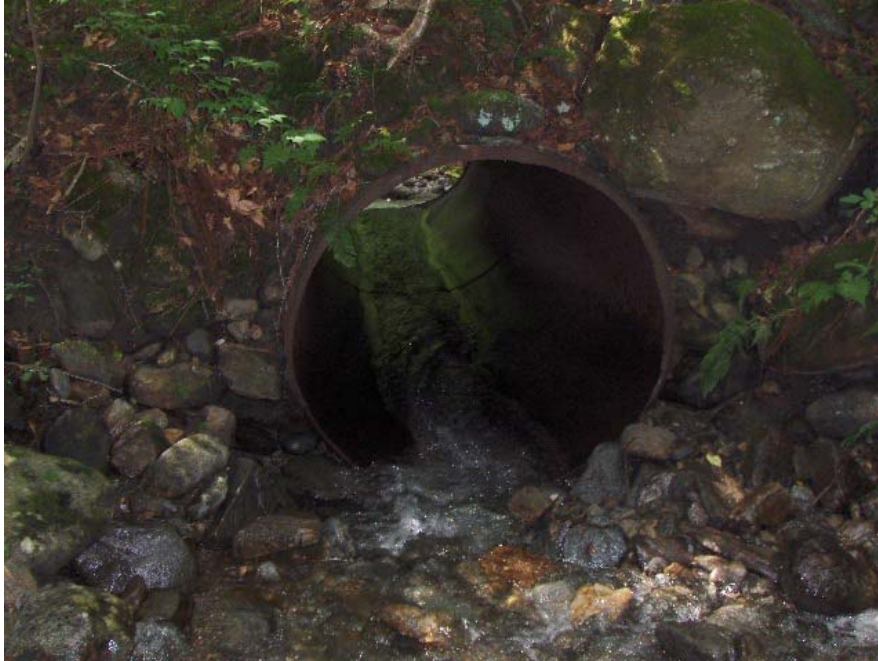
**Inn Brook**  
**Ranch Brook Road**  
**Segment M07.T5.01.SI.01-A**

#8 Ranch Brook Road Crossing  M07.T5.01.S1.01-A Inn Brook	Active Restoration	The culvert crossing on Ranch Brook Road is significantly undersized and is reducing AOP. The culvert was found to be partially compatible using the geomorphic screening tool. Deposition above and below and scour below the structure were noted.	Culvert replacement	High priority	Improved geomorphic stability and possibly AOP (if replaced with a bridge or arch)	High cost for replacement	Unknown	Town of Stowe, LCPC, ANR

Culvert Length: 20 feet  
Culvert Height: 4.7 feet  
Culvert Width: 5.3 feet

**Geomorphic Compatibility – Partially Compatible**

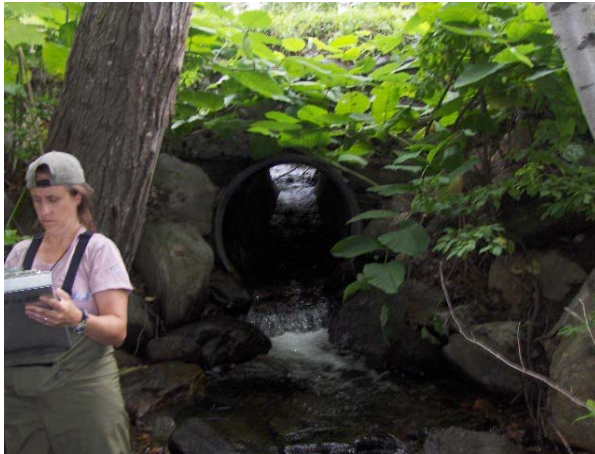
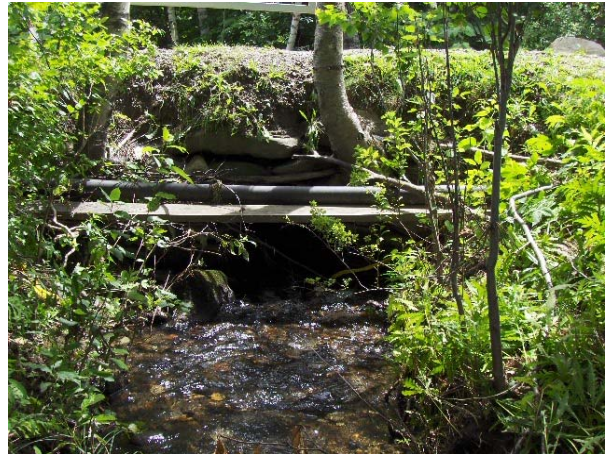
**Inn Brook**  
**Access Road to Cross Country Ski Center**  
**Segment M07.T5.01.SI.01-B**

#9 Culvert at Access Road to Nordic Ski Center  M07.T5.01.S1.01-A Inn Brook	Active Restoration	The culvert crossing the access road at the Nordic ski center is significantly undersized and is resulting in reduced AOP. The culvert was found to be mostly incompatible using the geomorphic screening tool. Deposition below and scour above the structure were noted.	Culvert replacement	High priority	Improved geomorphic stability and possibly AOP (if replaced with a bridge or arch)	High cost for replacement	Unknown	Nordic Ski Center, LCPC, ANR

Culvert Length: 20 feet  
Culvert Height: 3.5 feet  
Culvert Width: 3.5 feet

**Geomorphic Compatibility – Mostly Incompatible**

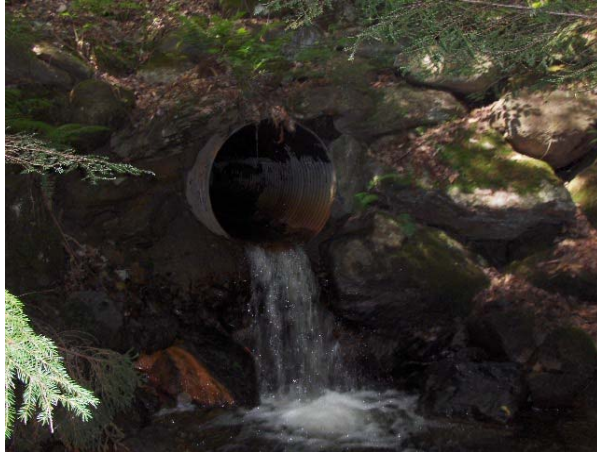
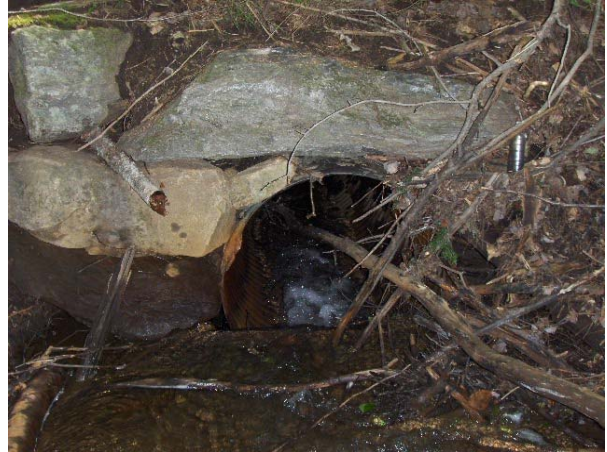
**Inn Brook  
Lintilhac Drive  
Segment M07.T5.01.SI.01-B**

#11 Lintilhac Drive Culvert  M07.T5.01.S1.01-B Inn Brook	Active Restoration	The culvert crossing at Lintilhac Drive is significantly undersized and is resulting in no AOP including adult salmonids. The culvert was found to be mostly compatible using the geomorphic screening tool. Deposition above and below and scour below the structure were identified as problems.	Culvert replacement	High priority	Improved geomorphic stability and AOP	High cost for replacement	Unknown	Town of Stowe, LCPC, ANR

Culvert Length: 35 feet  
Culvert Height: 3 feet  
Culvert Width: 3 feet

**Geomorphic Compatibility – Mostly Compatible**

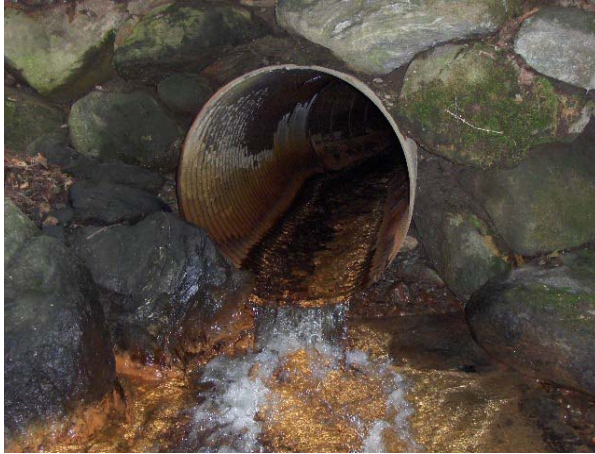
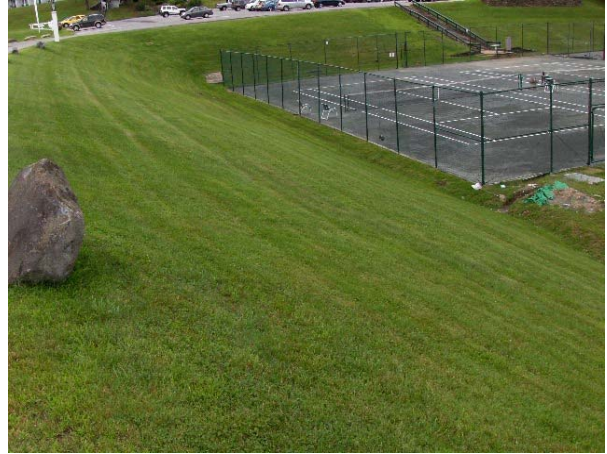
**Inn Brook**  
**Toll Road**  
**Segment M07.T5.01.SI.01-C**

#12 Underground culvert at Toll Road  M07.T5.01.S1.01-C Inn Brook	Active Restoration	The underground culvert at the Toll Road is undersized and is 600 feet in length. This culvert and is resulting in no AOP including adult salmonids. The culvert was found to be mostly incompatible using the geomorphic screening tool. Scour below and alignment were identified as possible problems.	Culvert replacement	High priority; the culvert replacement may not be practical due to the length of the culvert and landuse constraints.	Improved geomorphic stability and AOP; there may be opportunity for creating a stream channel to provide habitat, where there are not current landuse constraints	High cost for replacement	Unknown	LCPC, ANR, and private property owner

Culvert Length: 600 feet  
Culvert Height: 3 feet  
Culvert Width: 3 feet

**Geomorphic Compatibility – Mostly Incompatible**

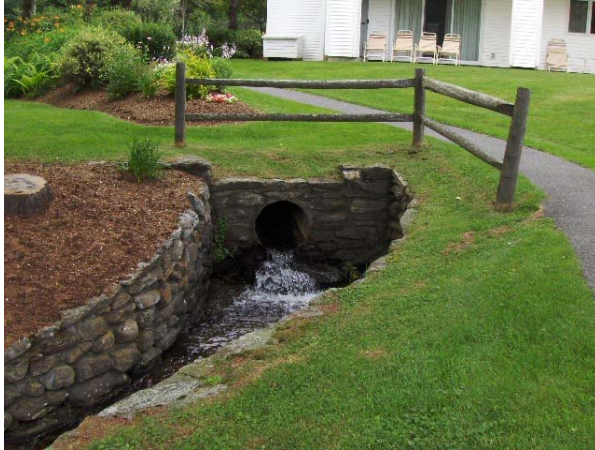
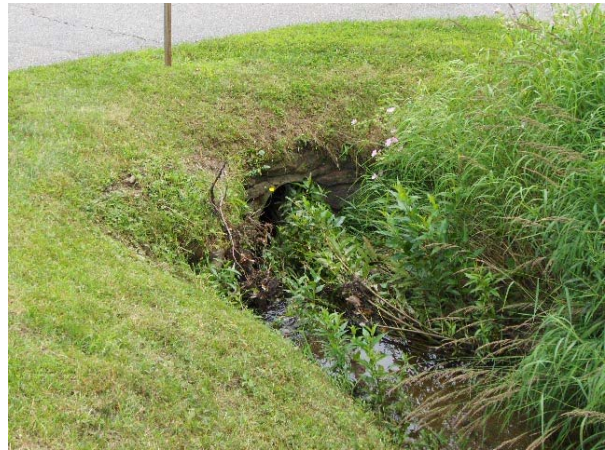
**Inn Brook**  
**The Lodge Parking Lot**  
**Segment M07.T5.01.SI.01-C**

#13 Underground culvert the Lodge Parking Lot  M07.T5.01.S1.01-C Inn Brook	Active Restoration	The underground culvert at the Lodge Parking Lot is undersized and is 120 feet in length. This culvert and is resulting in no AOP including adult salmonids. The culvert was found to be partially compatible using the geomorphic screening tool. Scour below and alignment were identified as possible problems.	Culvert replacement	High priority; the culvert replacement may not be practical due to the length of the culvert and landuse constraints.	Improved geomorphic stability and AOP	High cost for replacement	Unknown	LCPC, ANR, and private property owner

Culvert Length: 120 feet  
Culvert Height: 2 feet  
Culvert Width: 2 feet

**Geomorphic Compatibility – Partially Compatible**

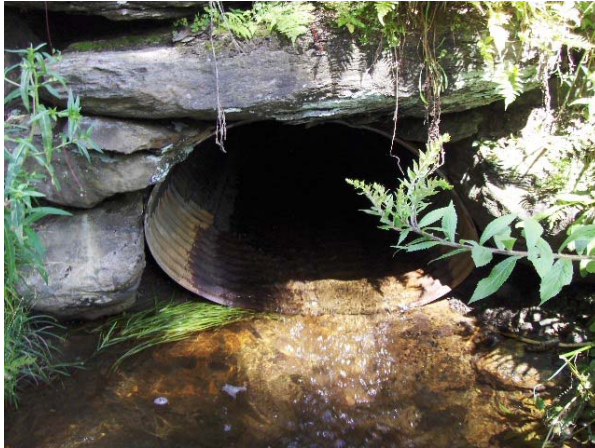
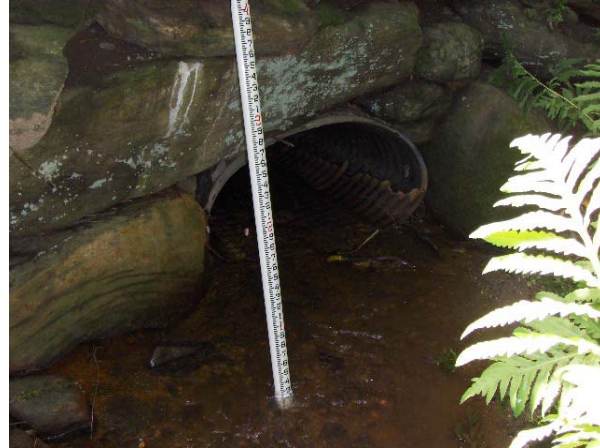
**Inn Brook**  
**The Lodge Driveway**  
**Segment M07.T5.01.SI.01-C**

#14 The Lodge Driveway  M07.T5.01.S1.01-C Inn Brook	Active Restoration	The culvert at the Lodge driveway is undersized and may be reducing AOP. The culvert was found to be partially compatible using the geomorphic screening tool. Deposition above, scour below, and alignment problems were noted.	Culvert replacement	High priority	Improved geomorphic stability and AOP	High cost for replacement	Unknown	LCPC, ANR, and private property owner

Culvert Length: 42 feet  
Culvert Height: 2.5 feet  
Culvert Width: 3.4 feet

**Geomorphic Compatibility – Partially Compatible**

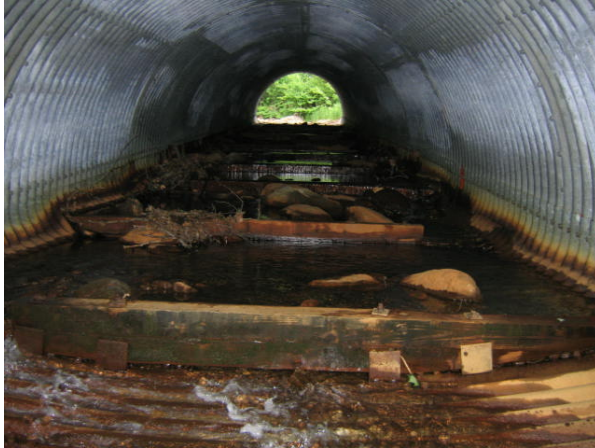
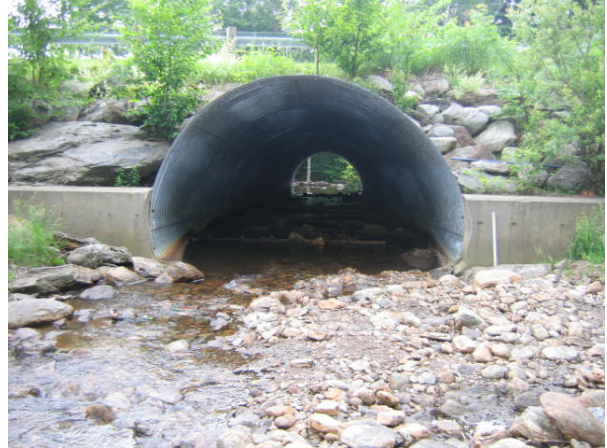
**Long Trail Tributary  
Mansfield Parking Lot  
Reach M09.S4.01**

Culvert Length: 84 feet  
Culvert Height: 8 feet  
Culvert Width: 12 feet

**Geomorphic Compatibility – Mostly Compatible**

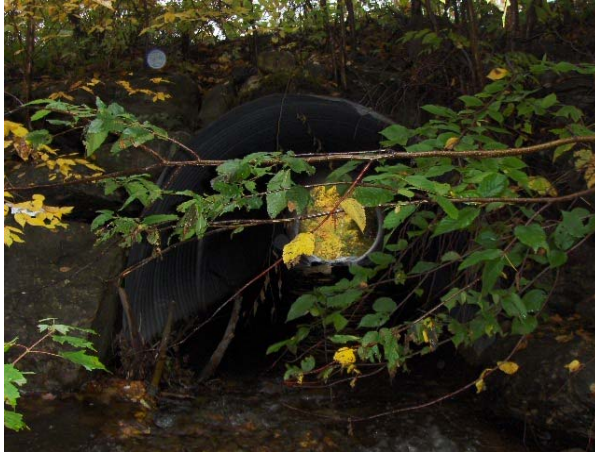
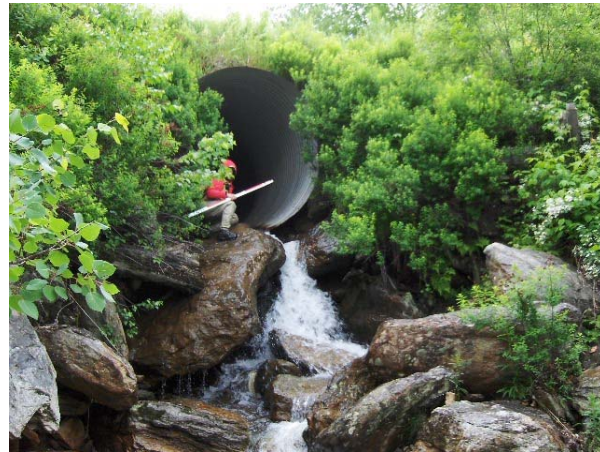
**Big Spruce Brook  
Spruce Peak Road  
Segment M08.S1.03-B**

Culvert Length: 60 feet  
Culvert Height: 8 feet  
Culvert Width: 8 feet

**Geomorphic Compatibility – Partially Compatible**
