**Stream Corridor Plan
LaPlatte River and Tributaries
Town of Hinesburg, Vermont**

Prepared by the LaPlatte Watershed Partnership
June 2007

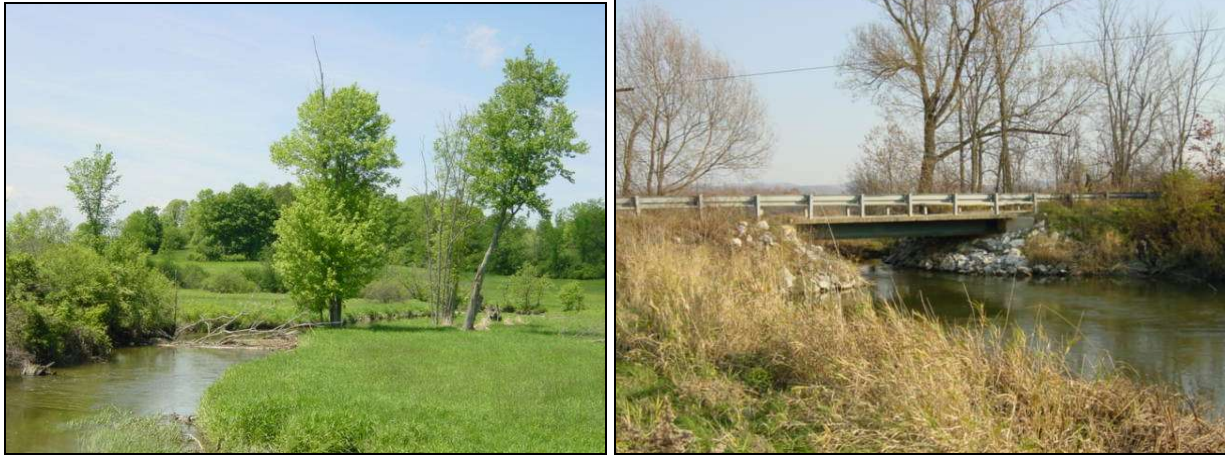
The river corridor was largely undeveloped and the channel appeared in regime, so protecting the corridor along the reach is recommended and a high priority to alleviate pressures from upstream. Also, perennial vegetation was lacking in some parts of the buffer, so planting the stream buffer with native woody vegetation is recommended. This can also act to stabilize the stream banks. Additional bank stabilization not recommended because bank erosion is minor and not endangering buildings.

An undersized bridge is in the reach at Leavensworth Rd. Flooding problems have been identified here by the landowner, who has noticed increased flooding of fields. The bridge and road were apparently designed to have flood flows run over the road, so even though the bridge constricts the bankfull width, pressure is low because of the opportunity for flood flows to access the floodplain and flow over the road. Development past the river on Leavensworth Road now makes road closure due to flooding inconvenient. A series of culverts under the road and adjacent to the bridge to pass flood flows has been proposed. If the culverts are put in and the road therefore raised, more pressure would likely be placed on the bridge (which brings problems there) because the floodplain would be constricted as well.

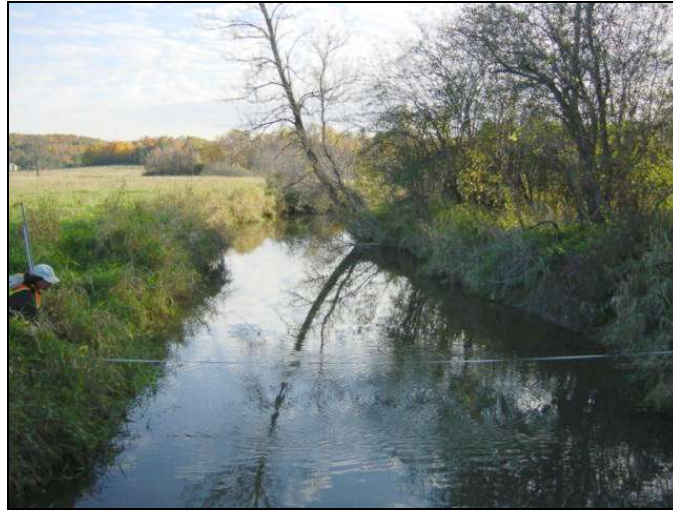
The river corridor was largely undeveloped and channel in regime, so protecting the corridor for the reach is recommended and a high priority to alleviate pressures from upstream. Perennial riparian vegetation was lacking in areas, especially on the left bank. Planting the stream buffer with native woody vegetation is recommended, some planting was observed at the time of assessment.

Bank erosion was observed with moderate changes in channel planform. Planting buffer vegetation can also act to stabilize the stream banks. Additional bank stabilization is not recommended because bank erosion is minor and not endangering buildings.

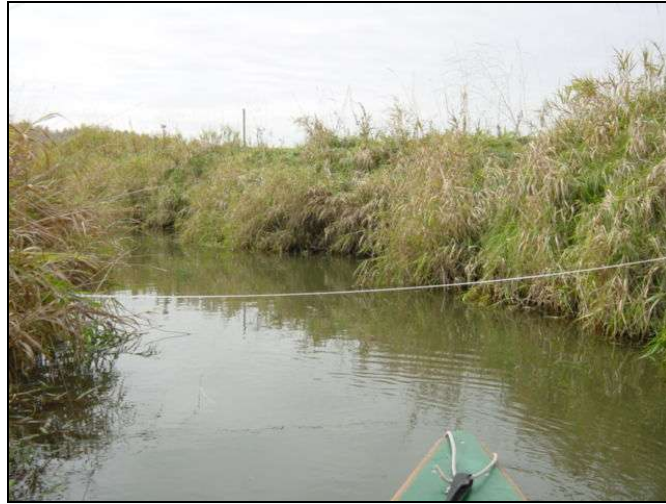
Reach: M14

The river corridor is undeveloped at this time. The channel appeared to be in stage III of the F-stage evolution process, with minor planform and aggradation observed and an incision ratio of 1.3. If the channel were not actively managed in the near term, it may adjust to equilibrium conditions, depending on ongoing channel management and adjustments upstream. So protecting the corridor along the reach is recommended to provide for passive geomorphic restoration of floodplain and meanders, although continued adjustment and/or changes in watershed stressors may require ongoing monitoring of conditions and adjustment here.

Perennial woody riparian vegetation was lacking, so planting the stream buffer with native woody vegetation is recommended, although planting away from actively migrating or unstable banks and toward the outer edges of the corridor is advised. This can also act to stabilize the stream banks. Additional bank stabilization not recommended because bank erosion is minor and not endangering buildings.

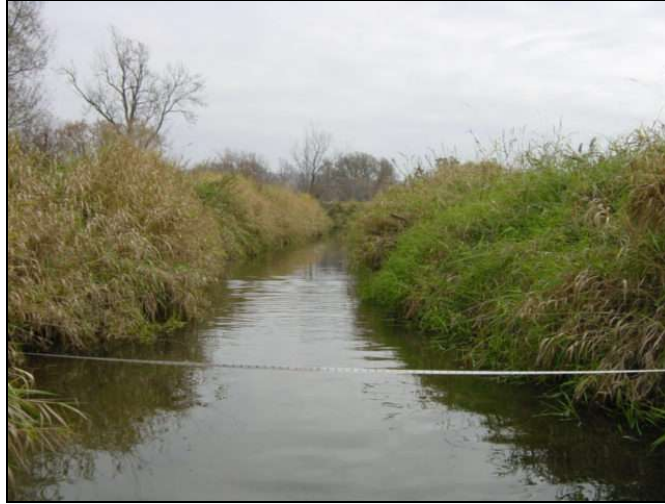
The channel appeared incised (incision ratio of 1.7), likely due to historical channel management activities and possibly some historical watershed deforestation (although the lesser of the stressors), resulting in greater stream power and sediment transport capacity (active bed degradation not observed). No recently abandoned channels were observed to capture as a restoration tool. No permanent constraints exist within the corridor of this segment, although the Hinesburg Sewage Treatment Plant is within the corridor of the upstream segment, M15B. Current corridor land use was pasture, although the landowner was working to fence the pasture and plant a small buffer (35 feet) In terms of flow and sediment load alterations, upstream reaches have been significantly straightened, so stream power would be higher, but no alterations appeared to inhibit active geomorphic restoration of floodplain or meanders here.

The stream is not likely to quickly equilibrate as significant clay in the bed and banks has limited channel movement. Therefore, if adjacent landowners are willing, an active restoration of floodplain with respect to the current channel bed elevation is recommended. Protect the river corridor and plant perennial native vegetation as part of the overall restoration plan to ensure long-term viability.

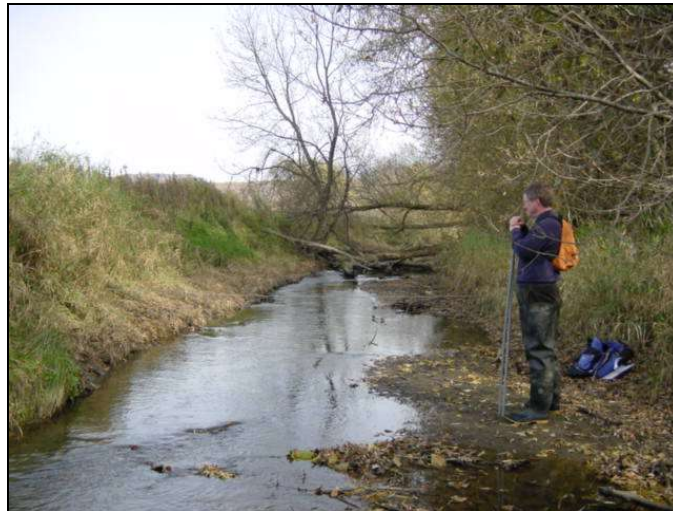
The river corridor is undeveloped except for the Hinesburg Sewage Treatment Plant (STP) on the left bank. If the channel were not actively managed, it may adjust to equilibrium conditions, although the 20-30 year “near-term” time line may not be realistic due to the clay present in the bed and banks, which has limited movement. Therefore, protecting the river corridor and planting stream buffers should be part of an overall restoration plan. Current beaver activity could help by trapping sediment.

The channel was straightened and incised, resulting in greater stream power and increased sediment transport capacity. No recently abandoned channels were observed to capture as a restoration tool. The Hinesburg Sewage Treatment Plant is a permanent constraint within the corridor on the left bank. The LWP has been working with the Town of Hinesburg to plan future Plant expansions out of the stream corridor. Other than that, adjacent land use appeared to be fallow field and flow and sediment load alterations do not appear to be significant enough to inhibit the active geomorphic restoration of floodplain and meanders.

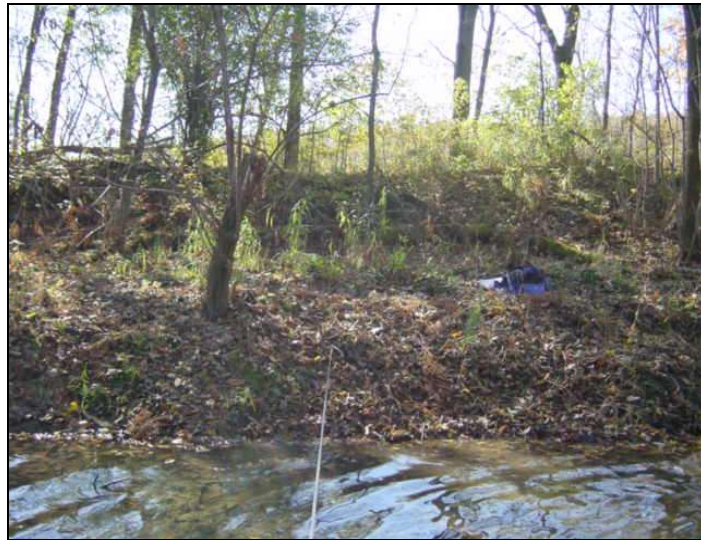
The river corridor is largely undeveloped, however the channel is not likely to adjust to equilibrium conditions in the near term due to the presence of berms and clay soils. Buffer width was 25-50 feet with some areas of about 5 feet or less. Bank erosion and lateral movement were observed. Since the channel was not at or near equilibrium conditions, it is recommended to protect the river corridor and plant perennial native vegetation as part of the overall restoration plan to ensure long-term viability.

Replace structures with appropriately sized structures as they come up for replacement. The culvert at Charlotte Road did not appear to have problems, but does back up water during high flows. The bridge at Silver Street constricted floodprone width, but not bankfull width. Reach is straightened (incision 1.17) resulting in an increase in stream power. No recently abandoned channels were observed to capture as a restoration tool. Very little development (300 feet) exists within the corridor. Current corridor land use was pasture and hay with some crop, although the area adjacent to the stream appears wet much of the year and might be of limited use for agriculture. The parking lot for the Hinesburg Community School, lagoons at the cheese factory, and one house encroached into the corridor. Berms were present in areas along both banks, limiting floodplain access.

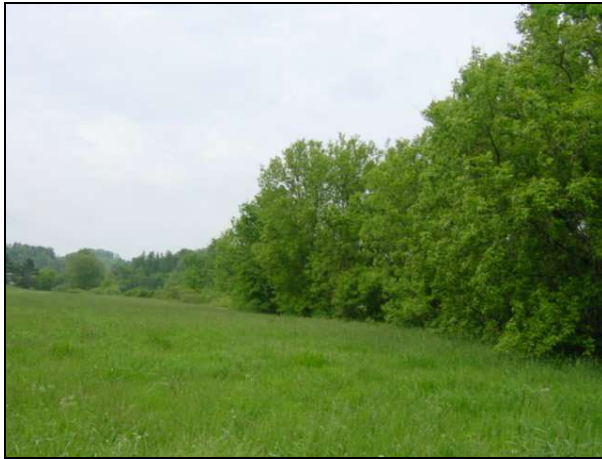
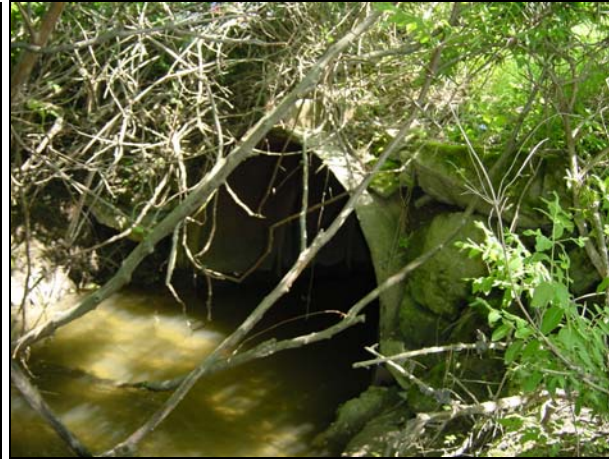
Reach M17 experienced a stream type departure (C to B) and currently appeared to be widening and aggrading, attempting to gain some floodplain and sinuosity in its incised and entrenched position.

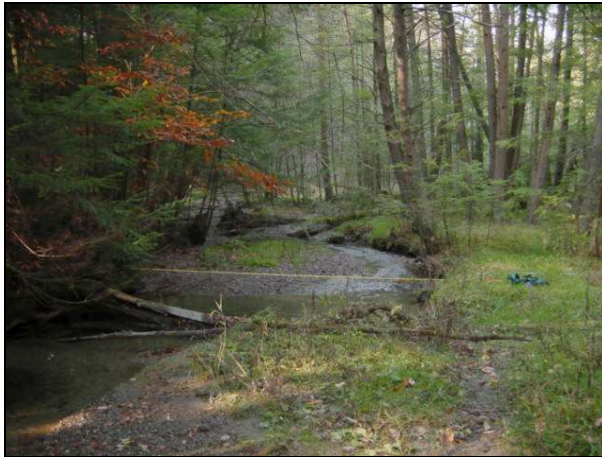
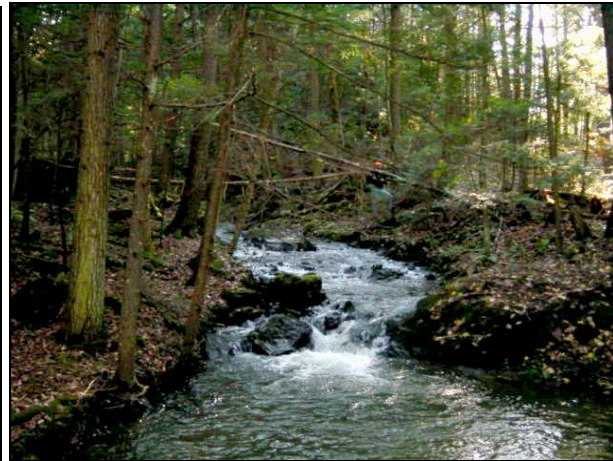
Reach: M18A

Ledge grade control toward downstream end

The river corridor is undeveloped and the channel is likely to adjust to equilibrium conditions in time. So protecting the river corridor is recommended. The segment appeared to be aggrading, but not due to significantly increased sediment supply or decreased peak flows. The stream has access to floodplain, but sediment is being generated in the upstream reach. Protecting the river corridor and addressing upstream issues is recommended.

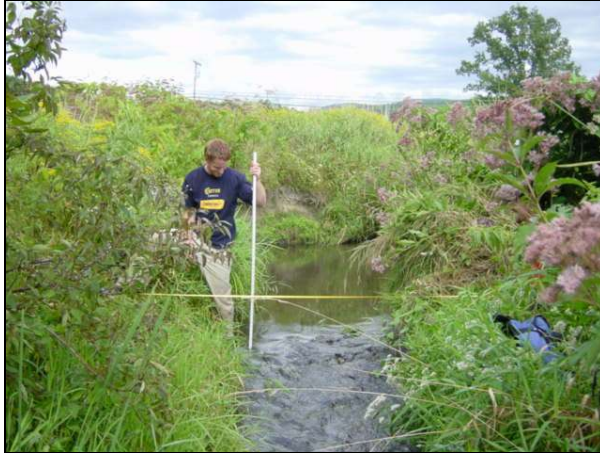
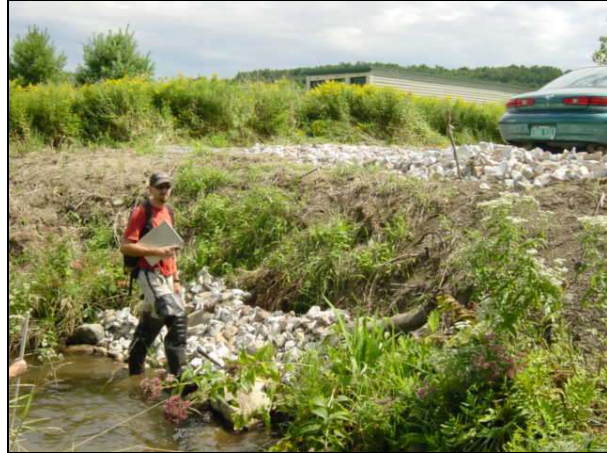
The river corridor is largely undeveloped except for the left bank along Commerce Park. Diversion of water from this reach into “The Canal” has altered flow historically. In recent years, a failing dam behind Nestech has allowed more water to return to this reach. It is likely that this reach would adjust to equilibrium conditions in the near term if conditions were constant. However with uncertainty in the stream flow and in how “The Canal” will be managed in the future, it is recommended that the stream corridor be protected to prevent further investments from encroaching on the area the stream needs to regain equilibrium. Additionally, restoring flow to this reach and finding alternative ways to fill “The Canal” (such as stormwater) are recommended further actions as Potential Restoration/Protection Projects (to also include planting a stream buffer).

A culvert constricts the channel at Route 116, with scour at the downstream end. No upstream sediment deposition was observed. Replacing the structure with one of appropriate size is recommended, especially if flow is restored to this reach from the Canal diversion.

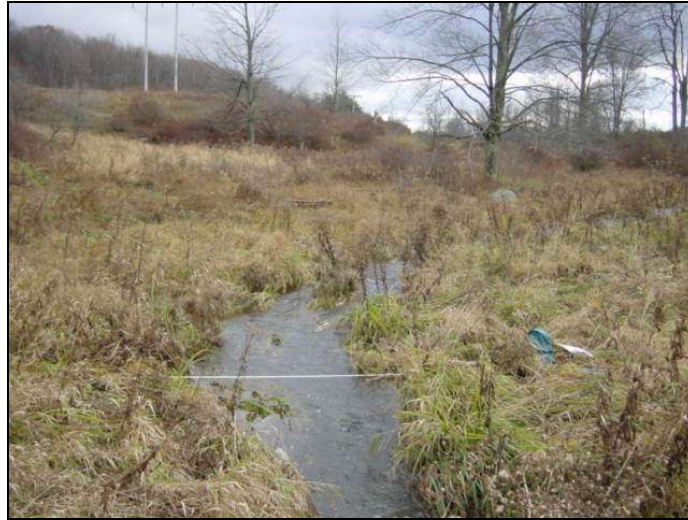
The river corridor is undeveloped and used for pasture. A large beaver dam and pond were located at the upstream end of the reach and beaver activity was observed in the reach. Bank vegetation consisted of herbaceous species with some shrub-saplings. Banks were moderately stable and assessed in “good” condition. Riparian buffer widths were 50-100 feet on each bank with some areas of 5-25 feet. Buffer vegetation was herbaceous with shrubs-saplings. Riparian corridor land use was pasture. Many wetland areas and seeps were noted along the reach. Historical straightening was noted along the reach. The channel is likely to adjust to equilibrium conditions if the corridor is protected and livestock fenced out of the channel. Plant stream buffers in areas where grazing and trampling have disturbed buffer, or allow vegetation to regenerate through corridor protection.

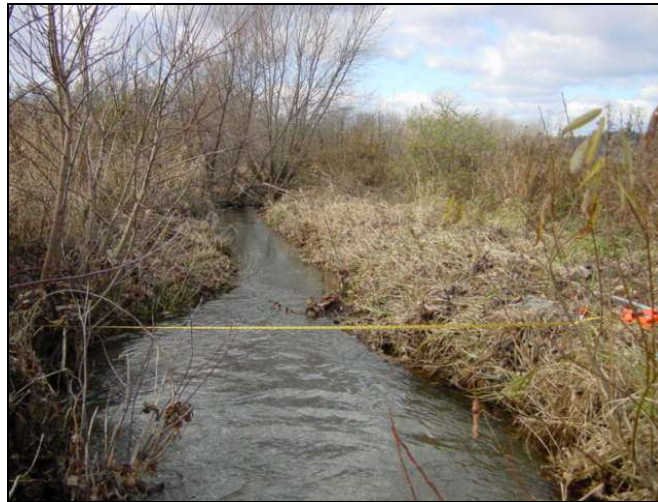
The river corridor is undeveloped, except for a house on the right bank near Route 116. Sediment supply is high and the channel is likely to adjust to equilibrium conditions, although it has been moved over to increase field area. Protecting the river corridor is recommended. The channel has been windrowed downstream of Route 116, with slight sediment buildup along the tops of the banks. This could be removed, or opened up in areas to allow more frequent floodplain access. Planting buffer vegetation away from where the channel is likely to actively migrate can help with long-term bank stability and habitat value.

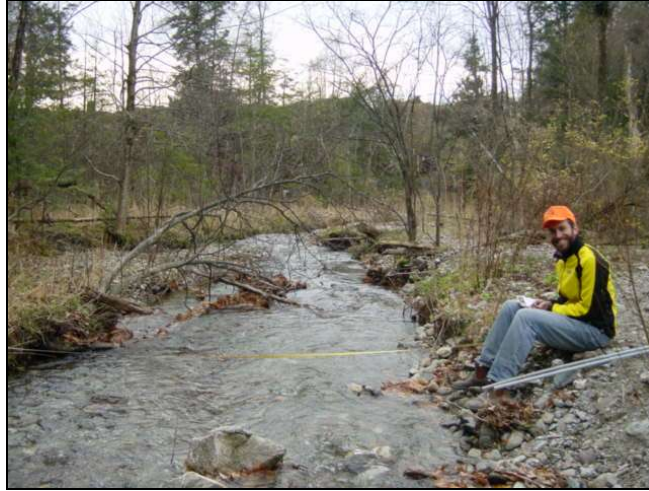
Reach: T5.01B

Attenuation area with floodplain connectivity.

The corridor is undeveloped and the channel is likely to adjust to equilibrium on its own, so protecting the stream corridor is recommended. This is also a valuable attenuation zone to buffer against upstream impacts. Planting stream buffer away from actively migrating banks is recommended.

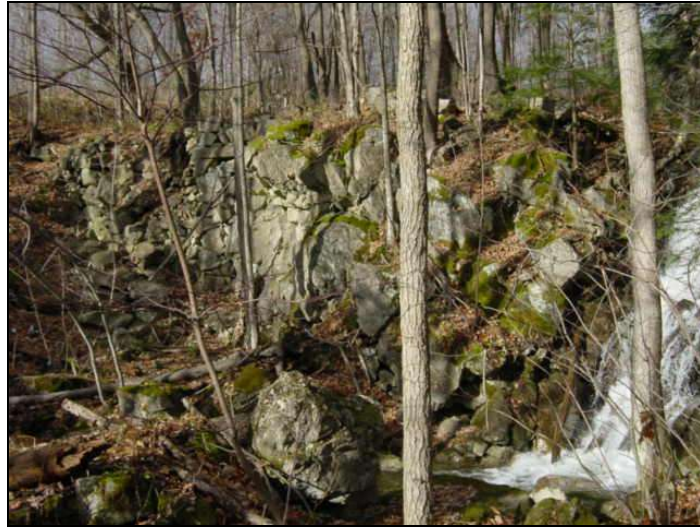
Reach: T5.01C

Milldam to left, falls to right.

This area had multiple ledges and a waterfall and a wooded corridor. Protect the corridor to avoid future encroachment.
