**LaPlatte River Phase 2 Stream Geomorphic Assessment:
Hinesburg Reaches**

**Prepared by the LaPlatte Watershed Partnership
February, 2006**

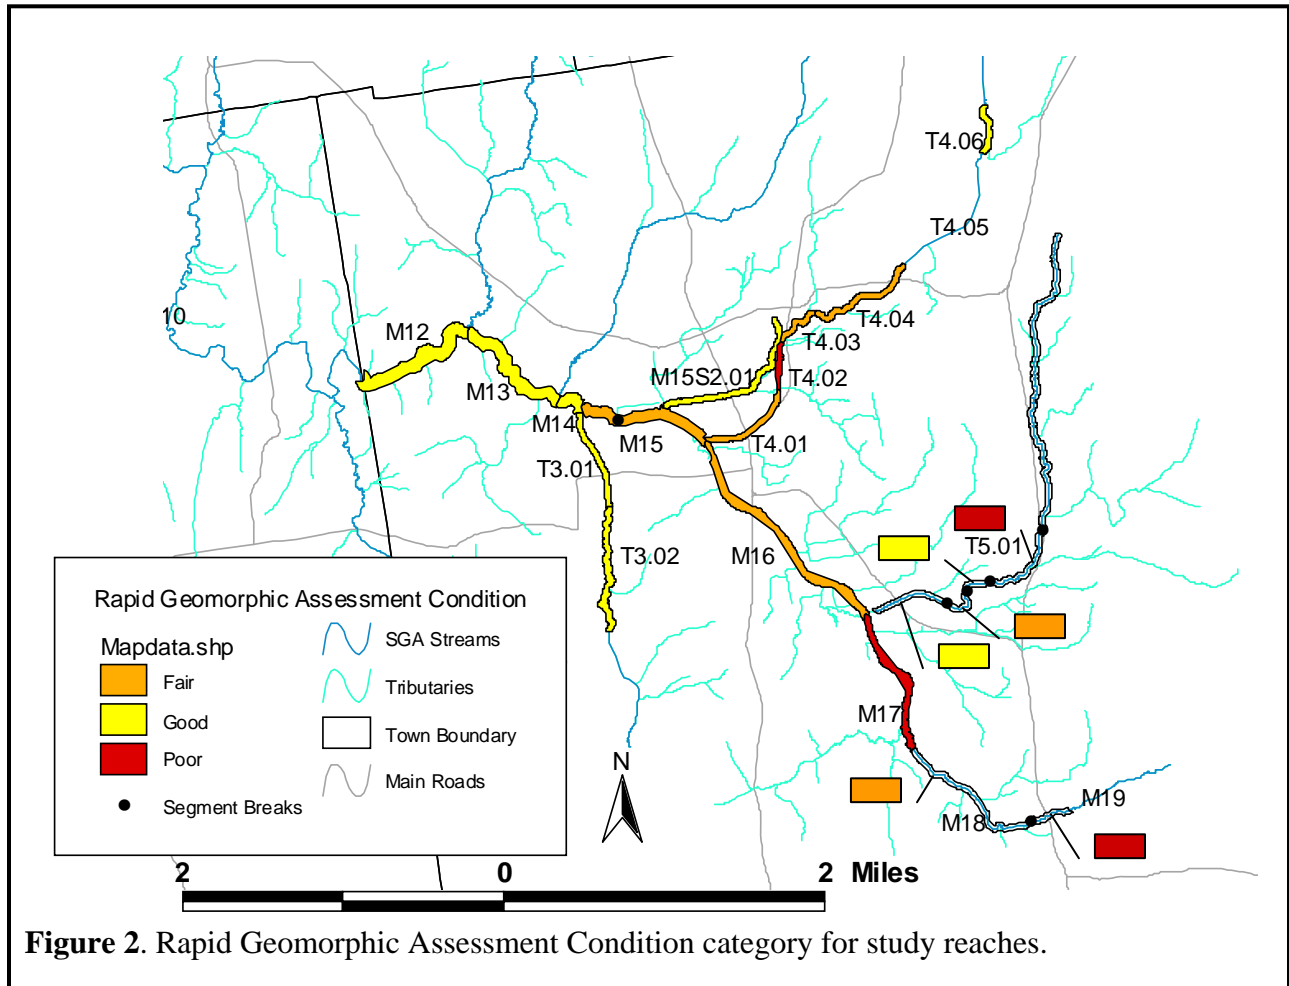
Figure 2. Rapid Geomorphic Assessment Condition category for study reaches.

Figure 2 shows RGA Condition categories for each of the study reaches and segments. Relatively little development has encroached into the stream corridor thus far in Hinesburg. Main factors affecting RGA condition were channel alteration and channel obstructions and constrictions, which are discussed in more detail below.

Straightening combined with berming on M17 and T5.01D resulted in severe channel departure from reference. Reach M17 experienced a stream type departure (C to B) and currently appeared to be widening and aggrading, attempting to gain some floodplain and sinuosity in its incised and entrenched position (Figure 4).

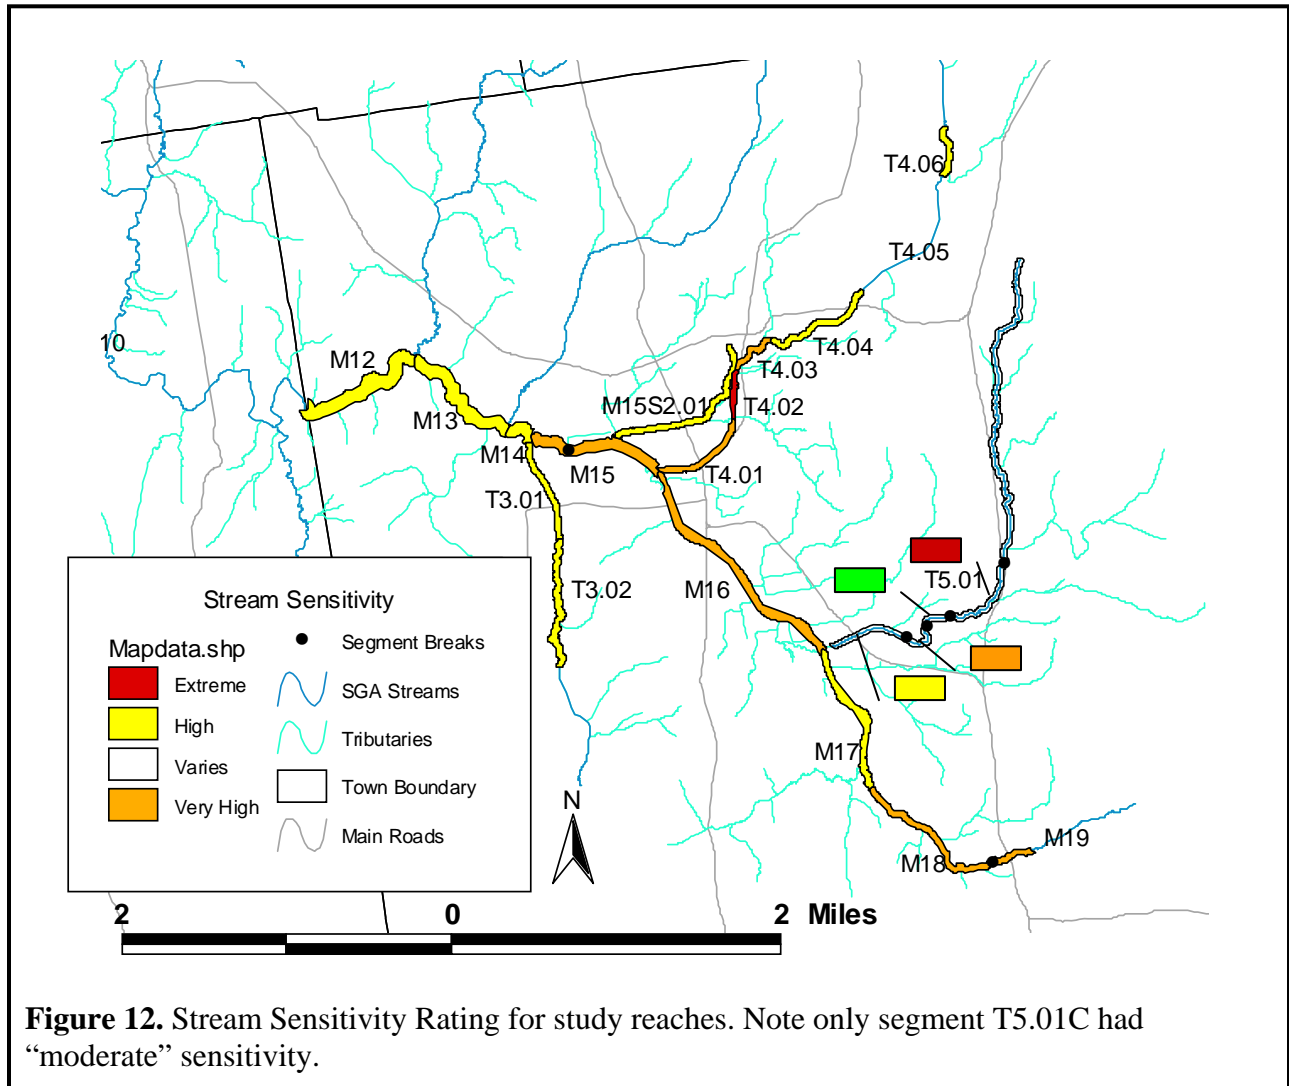
Figure 12 shows stream sensitivity ratings for study reaches and segments. Reaches were highly to extremely sensitive to ongoing or future disturbance except for T5.01C, in “moderate” condition, which was bedrock controlled and “in regime.”

Even the lower reaches (M12, M13, M14), which were in “good” geomorphic condition, were highly sensitive. Therefore continued or increased stressors from upstream could push these lower reaches into adjustment or departure. These lower reaches were acting to moderate upstream effects of channel adjustment to downstream reaches and protecting their geomorphic functions is important.

Addressing stressors such as stream alteration and channel constrictions could alleviate pressures and reduce potential for further departure or help streams achieve a dynamic equilibrium state.

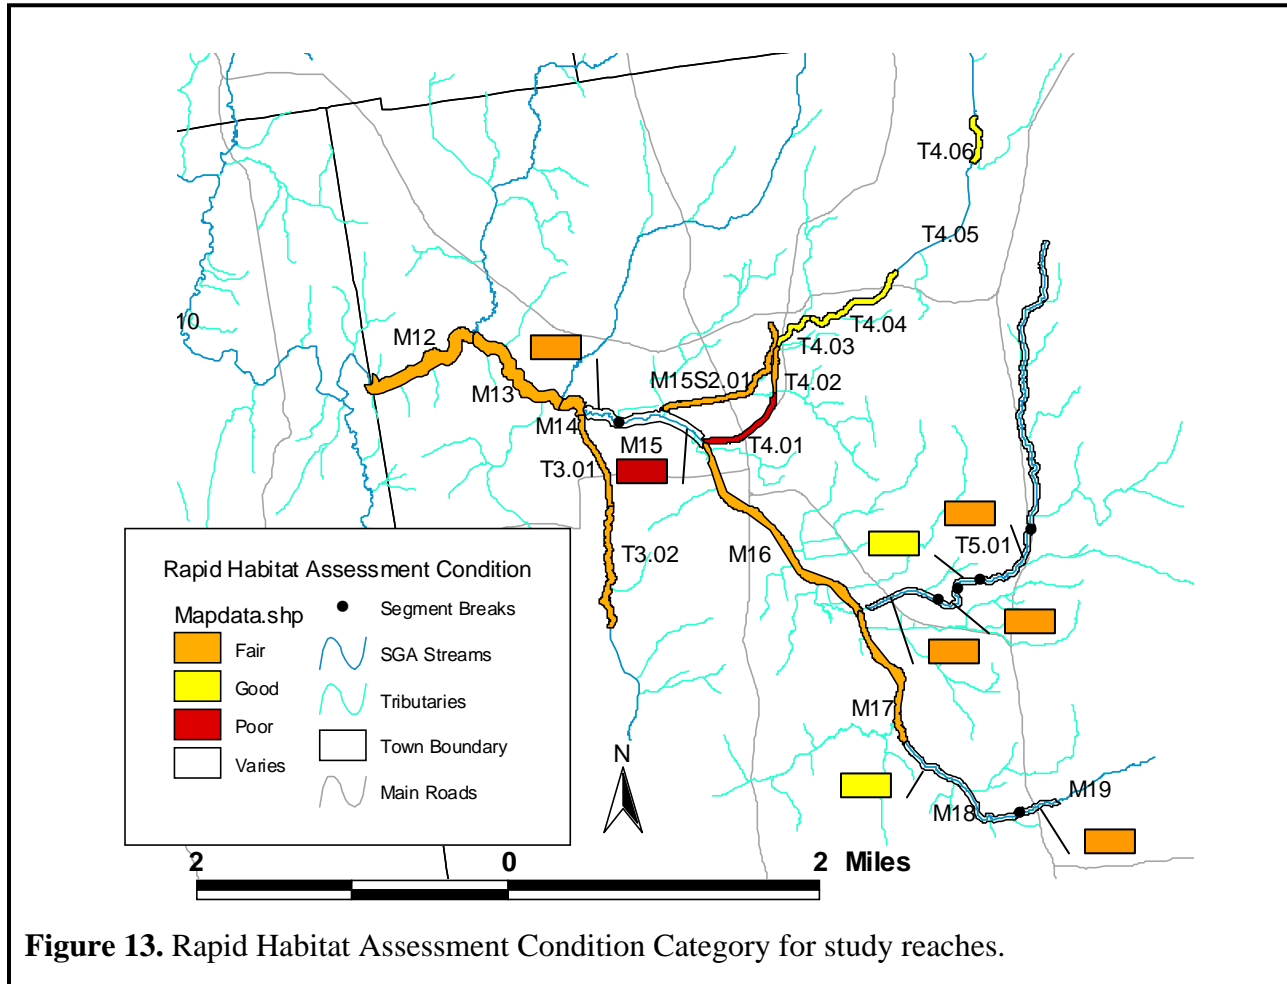
Figure 13. Rapid Habitat Assessment Condition Category for study reaches.

Figure 13 shows RHA condition categories for the study reaches. RHA conditions of the valley reaches were evaluated in “fair” condition except for segment M15B, which was in “poor” condition. Lack of diverse substrates for instream habitat, channel straightening, and lack of riparian buffer were the major factors contributing to these low scores. Segment M15B also suffered from exposed channel substrates, sediment deposition, and moderately unstable banks.
