LaPlatte Watershed Partnership

Phase 2 Stream Geomorphic Assessments  
Lower LaPlatte River & McCabe's Brook  
Shelburne and Charlotte, Vermont  
June 2007

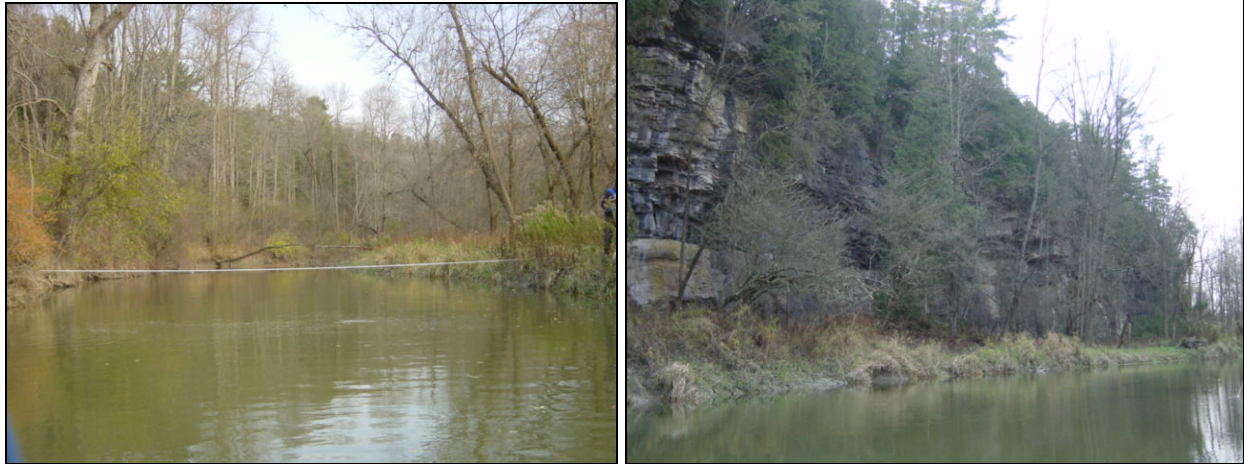
Reach M03 (L) and spectacular cliffs along the right bank between M03 and M04A (R).

Reach M03 began at the crossing of Route 7, just north of Shelburne Village. This reach was quite short, measuring 3060 feet long. Channel slope was shallow, with deep, slowly moving water (E Ripple-Dune stream type). The stream had floodplain access, but appeared to be slightly incised from its main terrace, possibly due to increased peak flows from stormwater runoff. The channel did not appear to have been altered or straightened and the minor erosion observed could be natural or from the possible increased peak flows. Stream banks were steep and composed of a cohesive sand/clay mix. An area of spectacular cliffs on the right bank was near the reach break between M03 and M04. Bank vegetation was deciduous trees with herbaceous under story. Buffer width was greater than 100 feet on each bank, with a forested riparian corridor and Route 7 encroaching into the corridor toward the downstream end. Beaver activity was evident with a dam and pond on the floodplain. RHA condition was “Good,” although epifaunal substrate and fish cover was only “Fair” due to lack of sufficient LWD, snags, and submerged vegetation. RGA condition was “Good” and the reach appeared to be “In Regime” (Stage I). Stream sensitivity was “High.” The downstream portion of reach M04 was similar, therefore M04 was segmented and M04A (downstream segment) was assessed with reach M03.

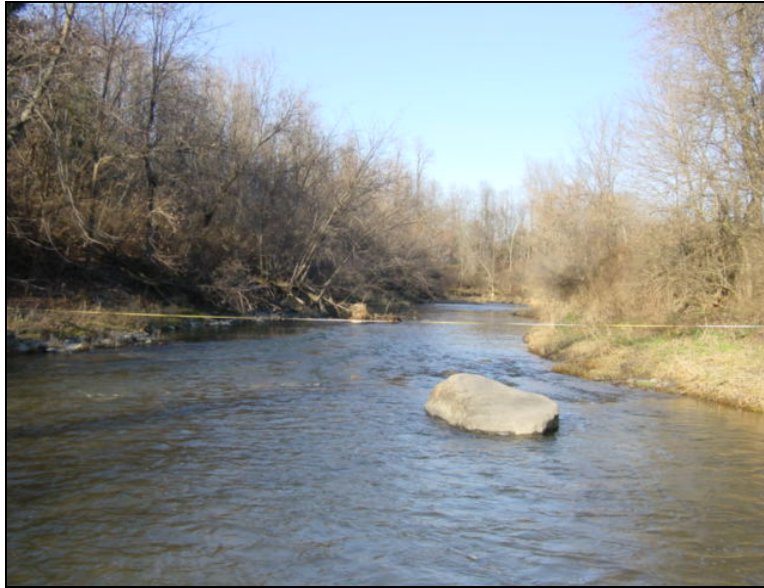
Reach M06 began just southwest of the intersection of Spear Street and Thomas Road and ended upstream of Shelburne Falls (12,025 feet long). The reference stream type for this reach appeared to be a C4 Riffle-Pool, but due to channel incision, the reach experienced a stream type departure to a B4c Plane Bed type. Floodplain access was limited, although old channels and/or flood chutes on the upper terrace could provide additional floodplain access and relief from high flows. Incision appeared to be historical, as did channel widening. Current channel adjustments appeared to be aggradation and major planform. Bank erosion, islands, and multiple mass failures were indicators of these adjustments with significant contributions to sediment loads. Also contributing sediment were rejuvenating tributaries in the reach and gullies from stormwater inputs. Shelburne Falls at the downstream end of the reach provided grade control.

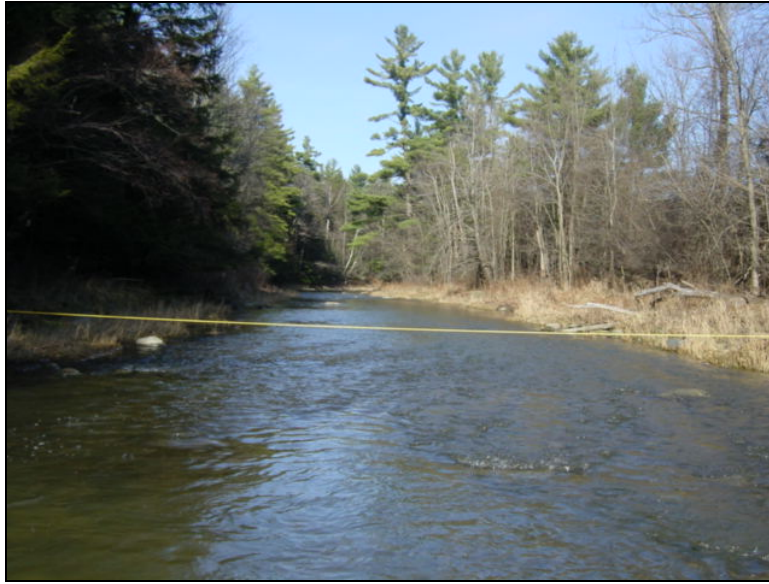
Reach M07 was fairly short, 2158 feet long, and appeared naturally straight in a narrowly confined valley setting with little floodplain. The “reference” stream type was B5 Step-Pool, however major aggradation filled pools, leaving the stream a Plane Bed type. Overall, geomorphic condition appeared “Good” with historical widening and the current aggradation adjustments. RHA condition was “Good” with low mix of substrate types, embedded particles, incomplete riffles, and sediment deposition affecting scores. Some hay fields on the right bank encroached into the otherwise forested corridor.

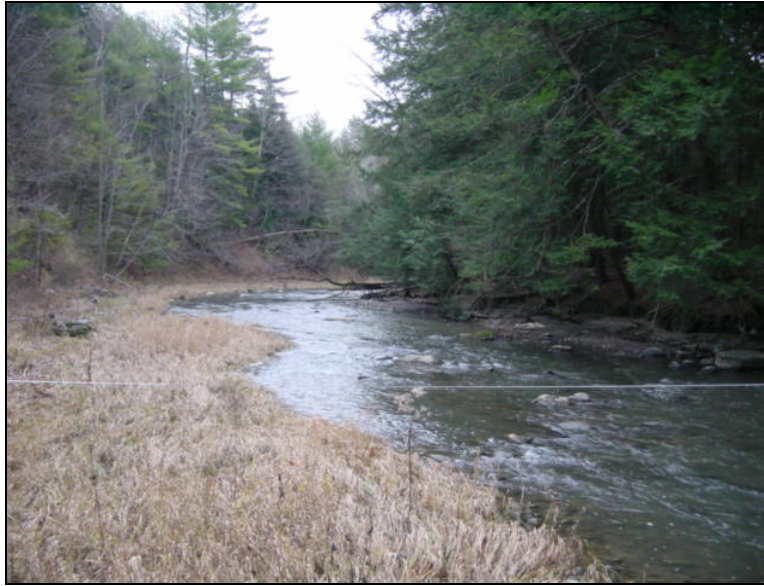
Reach M09 was segmented into two segments due to varying planform and slope characteristics. Segment M09A (downstream segment) had a steeper slope and appeared to be a B4 Plane Bed stream by reference. Adjacent side slopes in the narrow valley were steep to very steep. The channel appeared to have incised from an older terrace in the past, with current adjustment processes being minor aggradation, widening, and planform. Overall stream condition appeared “Fair” and the channel in stage IV of evolution. RHA condition appeared “Fair,” affected by bank instability, infrequent riffles, sediment deposition, and lack of cover. Some crop areas encroached into the corridor on both banks with forest in the majority of the corridor. Bank vegetation was dominated by herbaceous species. Multiple sediment deposits (bars) were present. A bridge at Spear Street constricted the bankfull width, with signs of deposition upstream.

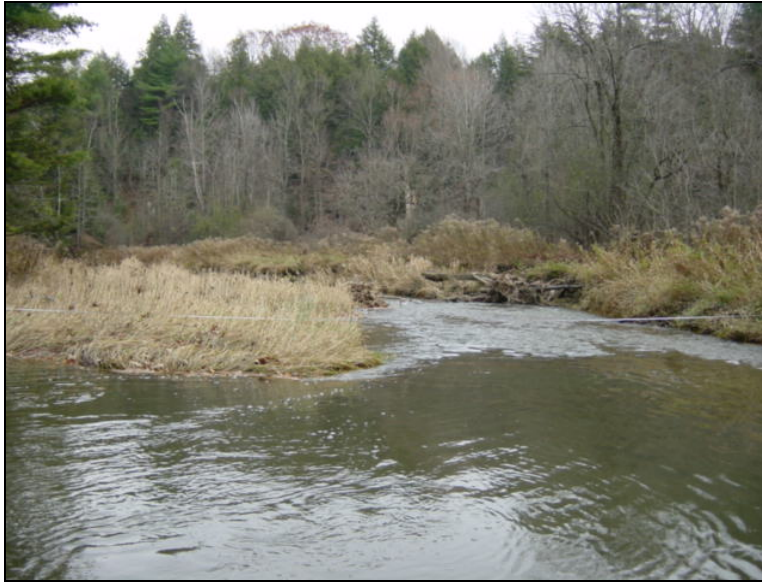
Segment M09B appeared to be in a slightly shallower valley, although also narrow, with a stream type of C5 Riffle-Pool. The riparian corridor was forested, with the same herbaceous bank vegetation as in M09A. This segment also appeared to have incised from an older terrace in the past, with current adjustment processes being planform with minor aggradation. Overall stream condition appeared “Fair” and the channel in stage IV of evolution. RHA condition appeared “Good” with bank instability and sediment deposition being the main factors affecting habitat. Some signs of beaver activity were observed in the segment.

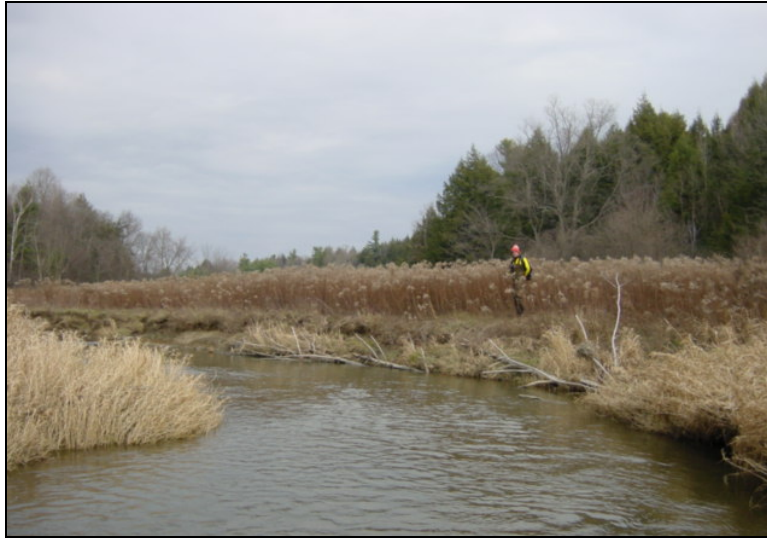
Tree Revetments

Reach M10 appeared to be a C5 Riffle-Pool stream type in a broad valley setting with steep adjacent hill slopes. Bank vegetation was herbaceous, as was the majority of the corridor vegetation with some saplings and forested areas. Many wetland areas were near the channel, which could account for some of the herbaceous vegetation. Many sediment deposition types (mid, point, side, diagonal bars) were noted in the reach along with two islands. Much bank erosion and several mass failures were present in the reach, contributing sediment. Current adjustments were major planform and minor aggradation and widening. The channel did not appear incised. Overall RGA condition was “Fair” and the channel appeared to be in stage IV of channel evolution. RHA condition appeared “Fair” with sediment deposition, embeddedness, and bank instability the main factors affecting habitat scores. Some ledges provide grade control in the reach, and one bridge constricts the flood prone width.

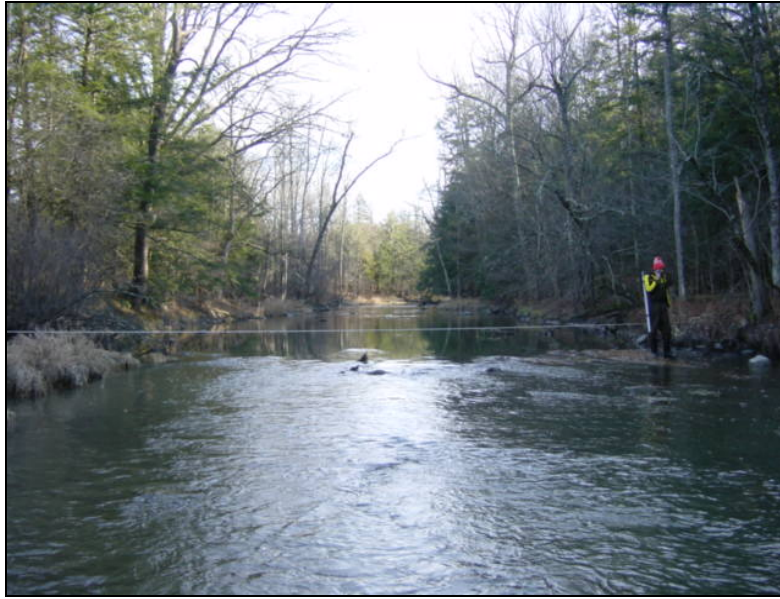
Reach M11 had a fairly shallow slope for its semi-confined valley setting. The stream type appeared to be B4c Riffle-Pool. Beaver activity increased toward the upstream end of the reach, with a large dam and pond on a tributary. The riparian corridor was forested, however downstream of the bridge, cows had free access to the channel and many crossing areas and areas where banks were trampled noted. The channel did not appear incised, however tributary rejuvenation was noted, possibly due to beaver activity in the upstream areas, and land use at the downstream end. One bridge constricted the floodprone width and had scour downstream. Trash and deer carcasses were seen dumped on the banks at the bridge. Trash and old farm equipment were dumped on the right bank roughly in the middle of the reach. RGA condition appeared “Good” with only minor aggradation observed. The reach was considered “in regime.” RHA condition was also “Good.” Few substrates for food and cover were present. Riffles and diversity of velocity/depth patterns were infrequent.

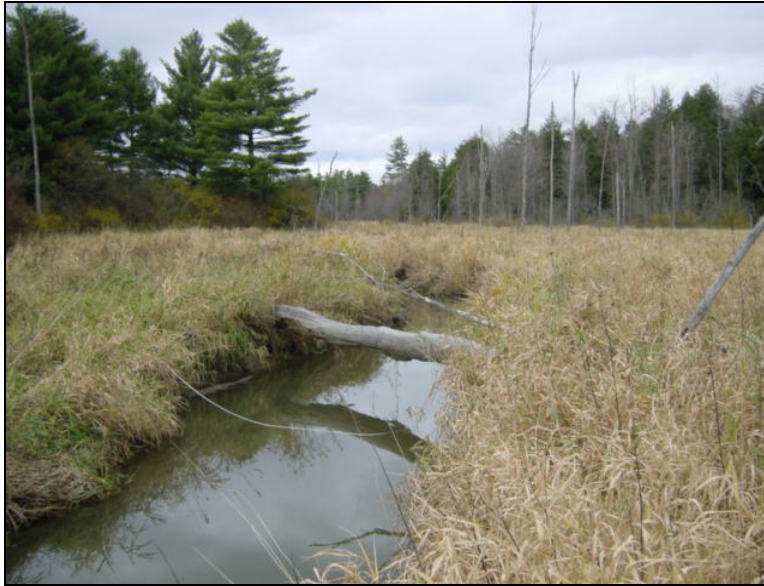
Reach T1.02 was a low gradient stream in a very broad valley setting. The stream had high sinuosity and appeared to be an E5 Ripple-Dune stream type. The riparian corridor had wetland areas and herbaceous and sapling vegetation. The outer corridor and adjacent lands were forested. Banks were fairly unstable with more slumping rather than erosion observed. Several debris jams and signs of beaver activity were seen in the reach. Two meander bend cutoffs were noted. At the downstream most end of the reach, water was backed up, likely from beaver activity in T1.01 and from lake effects. The reach appeared to have been straightened historically and the topographic map shows a significantly straighter stream line than the recent orthophotos. The reach did not appear incised, with current adjustments being planform with minor widening and aggradation. Overall, the reach appeared to be in stage IV of channel evolution and in “Good” condition. RHA condition appeared “Good.” Bank instability was the main factor affecting habitat with additional effects from sediment deposition in pools.

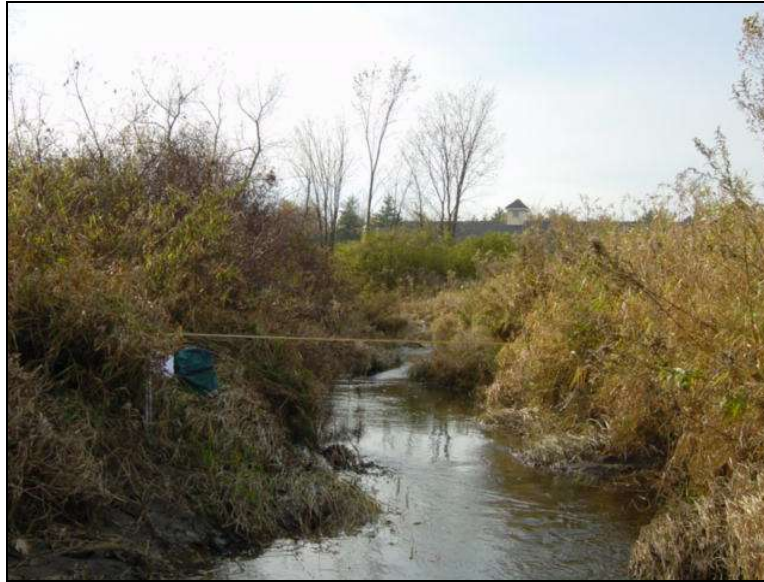
Reach T1.03 was also a low gradient stream in a very broad valley with an E5 Ripple-Dune stream type. Bank and buffer vegetation was herbaceous with some shrubs and saplings and deciduous trees. One bridge constricted the bankfull width with deposition upstream and scour downstream. Much bank slumping and erosion on outside bends was noted, signaling planform adjustments. The Town of Shelburne garage and sand pile encroached into the corridor at the downstream end of the reach. Evidence of beaver activity was also seen in the reach, especially toward the upstream end and into T1.04A. RGA condition appeared “Fair” with major planform and minor aggradation adjustments. The reach appeared to be in stage IV of channel adjustment. RHA condition appeared “Fair,” affected by bank instability, sediment deposition, and lack of substrates for food and cover.

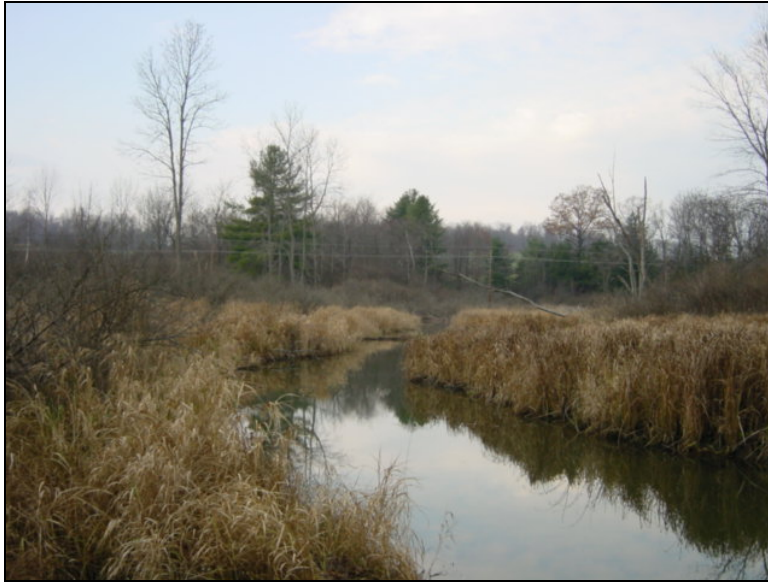
View of segment A with a beaver dam and lodge and backed up water.

Reach T1.04 was segmented due to beaver dams and flow back up at the downstream end. Segment T1.04A was in a very broad valley setting. The riparian corridor was forested with some shrub/sapling areas. Bank vegetation was herbaceous. No corridor encroachments were noted.

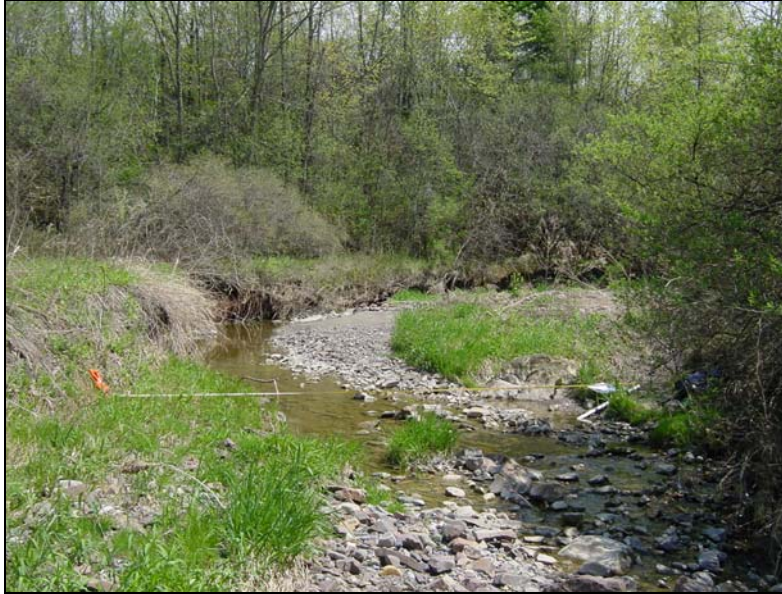
Segment T1.05A began at the T1.05 reach point (south of Bostwick Rd and the railroad crossing) and ended approximately 700 feet downstream of the Route 7 crossing. Segment T1.05A had several bedrock ledges acting as grade controls, providing bed stability. The segment appeared to have incised from a former terrace, resulting in a stream type departure (C to F). Bed substrate was gravel. Current adjustment processes appeared to be widening and planform. Multiple gravel bars signaled minor aggradation.

Close to the channel was open with herbaceous vegetation and invasive honeysuckle. Further out in the corridor was more forested with deciduous trees and shrubs/saplings. Overall habitat was “Fair,” affected by sediment deposition and bank instability. Many fish and frogs were seen in the channel however.

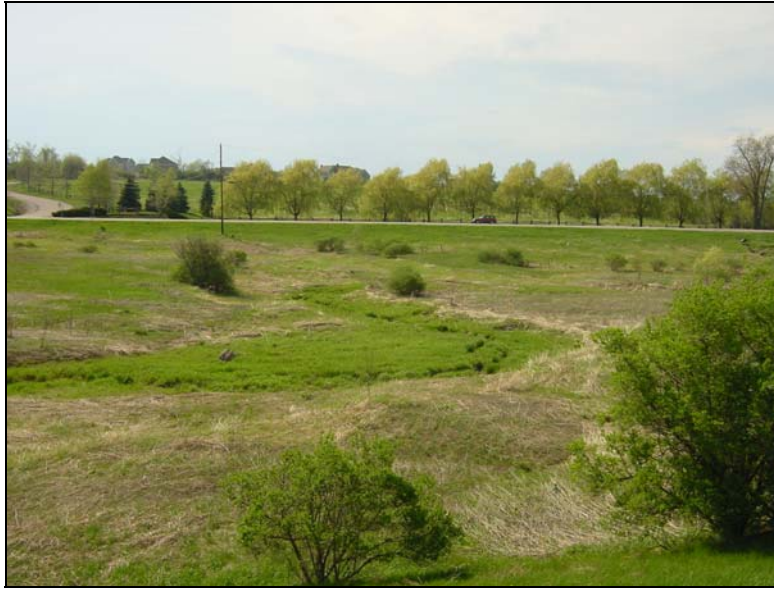
Segment T1.05B had a shallower slope, smaller substrate size and in a broad valley setting. The segment appeared to be “in regime,” remaining a C Riffle-Pool stream type and in “good” condition. Minor planform and widening processes were observed, and could be related to the lack of woody bank vegetation.

Bank and buffer vegetation was herbaceous with some shrubs/saplings. Some areas of forested corridor were present in the upstream portion of the segment. RHA condition was “good” but lacking sufficient mix of substrates and large pools. A cattle watering area had been fenced out in the channel and had turned into a large pool. For water quality purposes, cattle should be fenced out of the channel and alternative watering methods used.

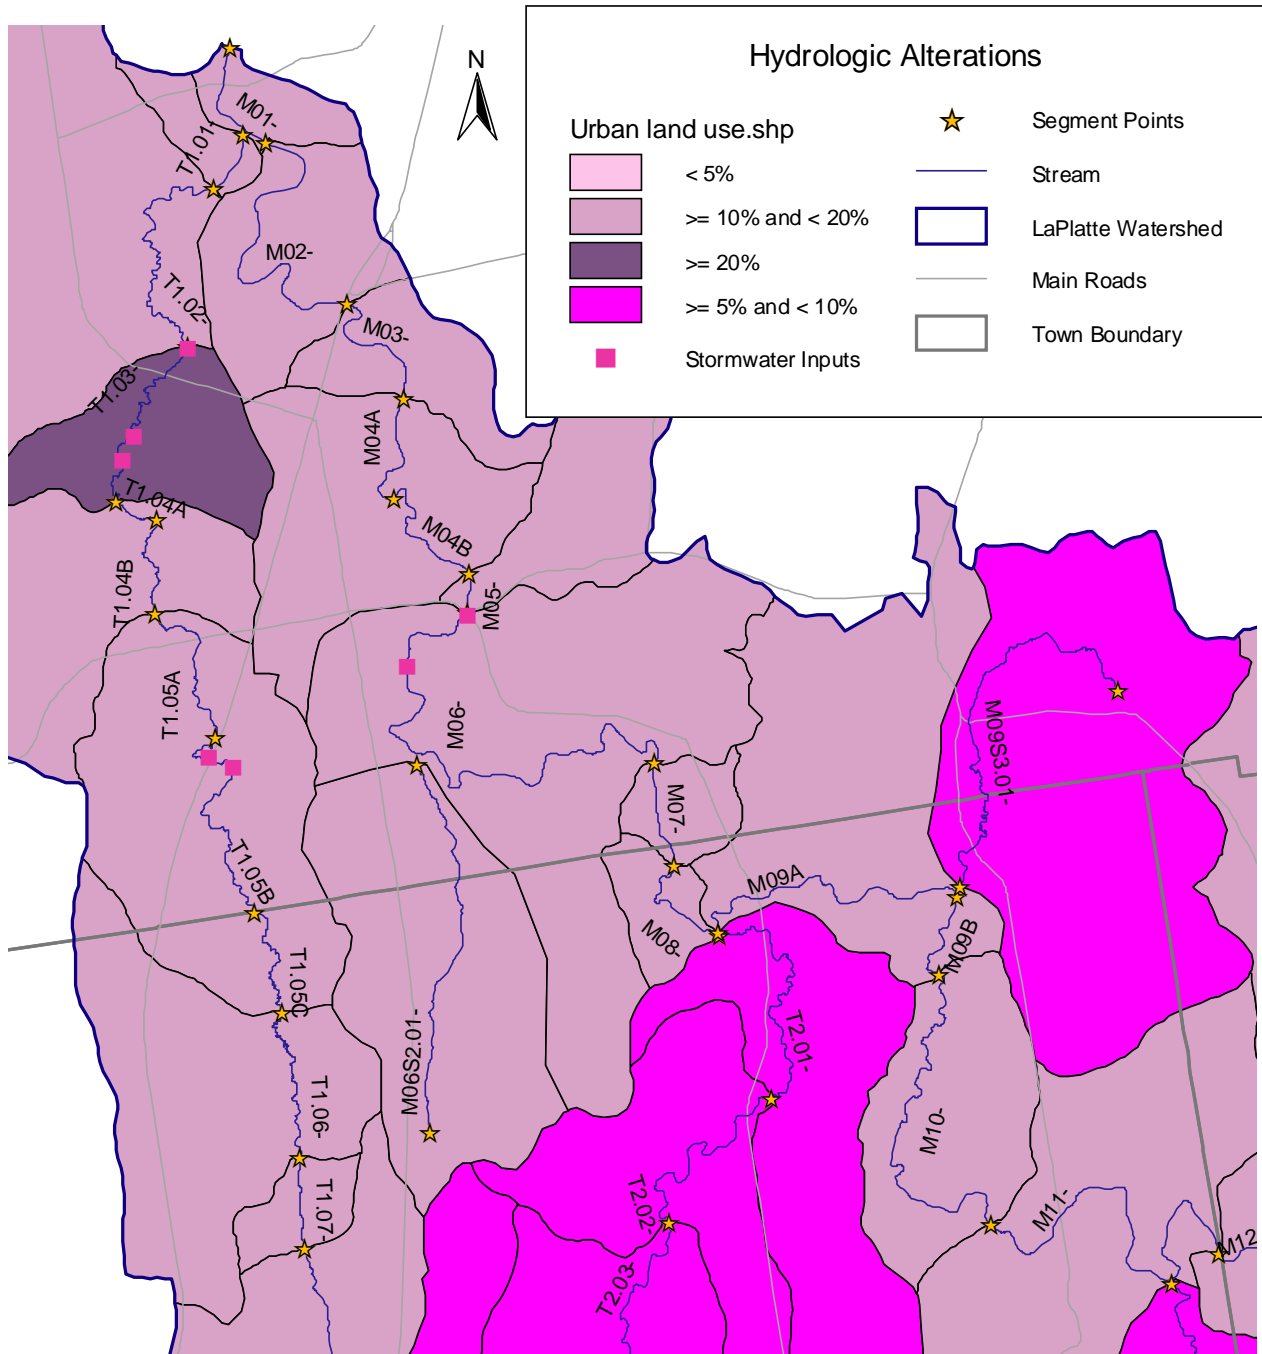
The variations in maroon shading of the sub watersheds indicate the percentage of the entire watershed to that point that is urban. Stormwater inputs identified in the assessments are indicated by the pink squares. Additional stormwater inputs may exist and enter small tributaries first.

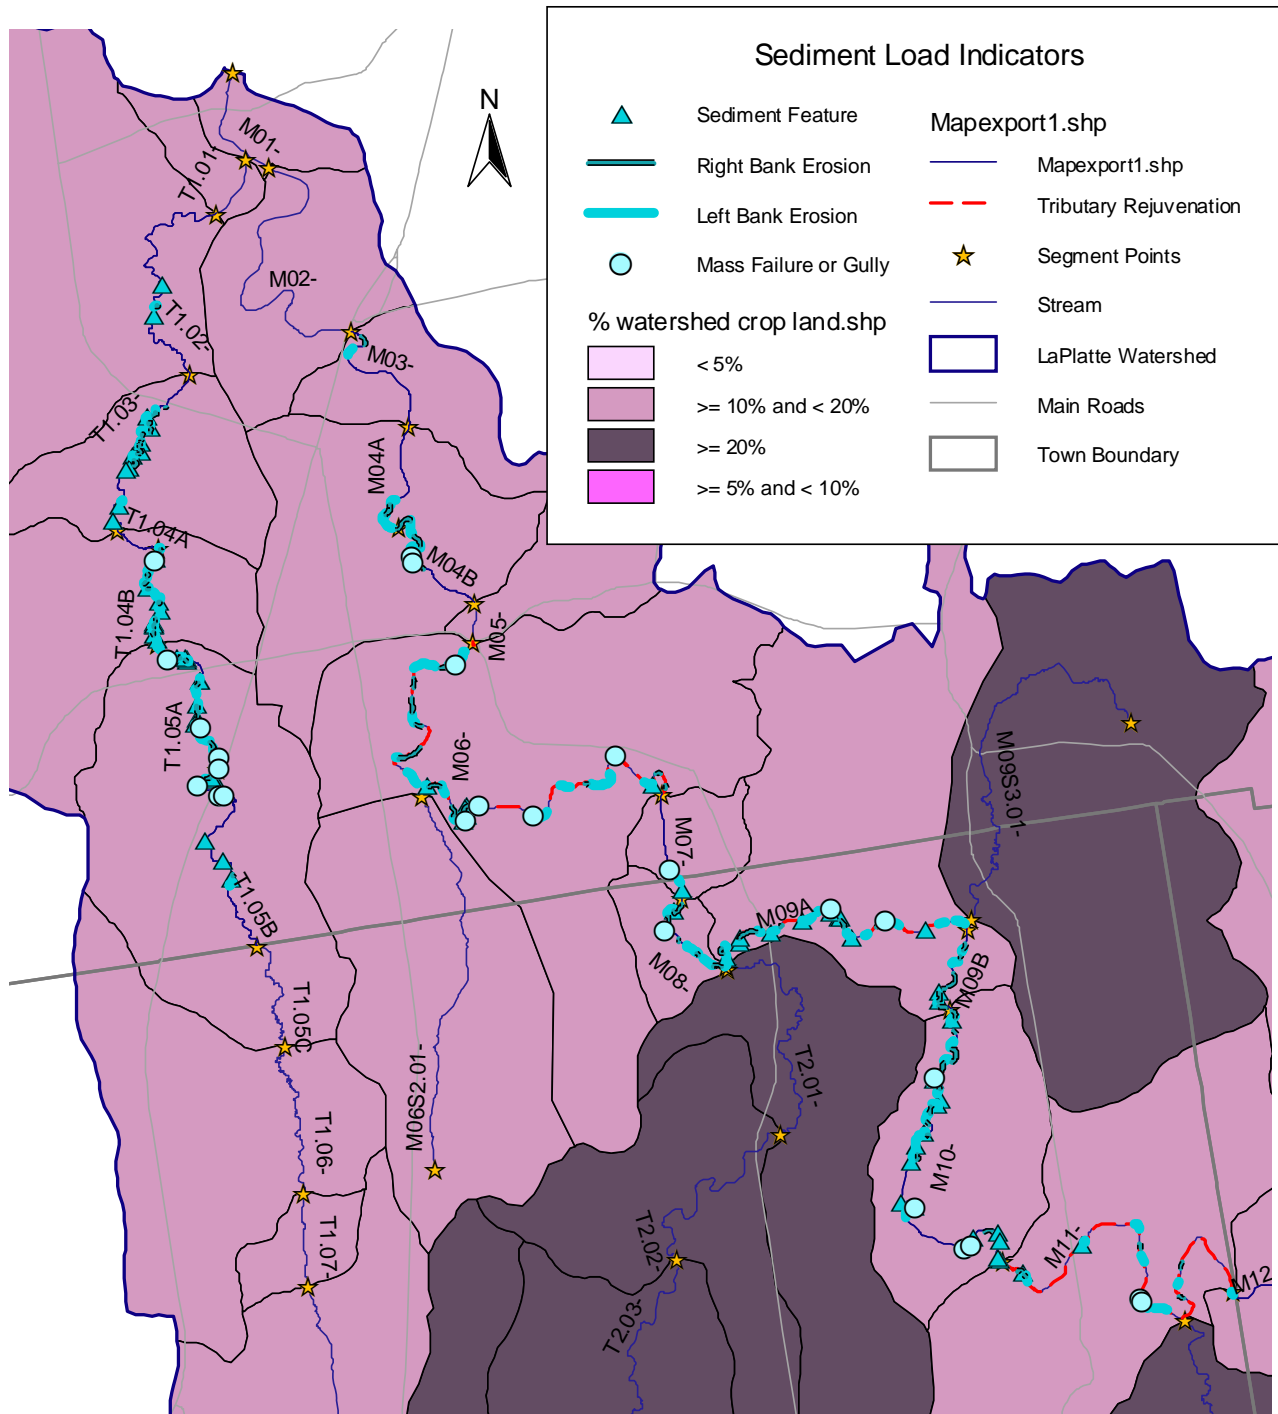
The variations in maroon shading of the sub watersheds indicate the percentage of the entire watershed to that point that is cropland. Sediment features indicated by the blue triangles include: steep riffles, flood chutes, avulsions and braiding. Streamlines with red dashes indicate segments where tributaries were rejuvenating, or incising to meet a new, lower bed elevation in the receiving stream. Rejuvenating tributaries can be significant sources of sediment.

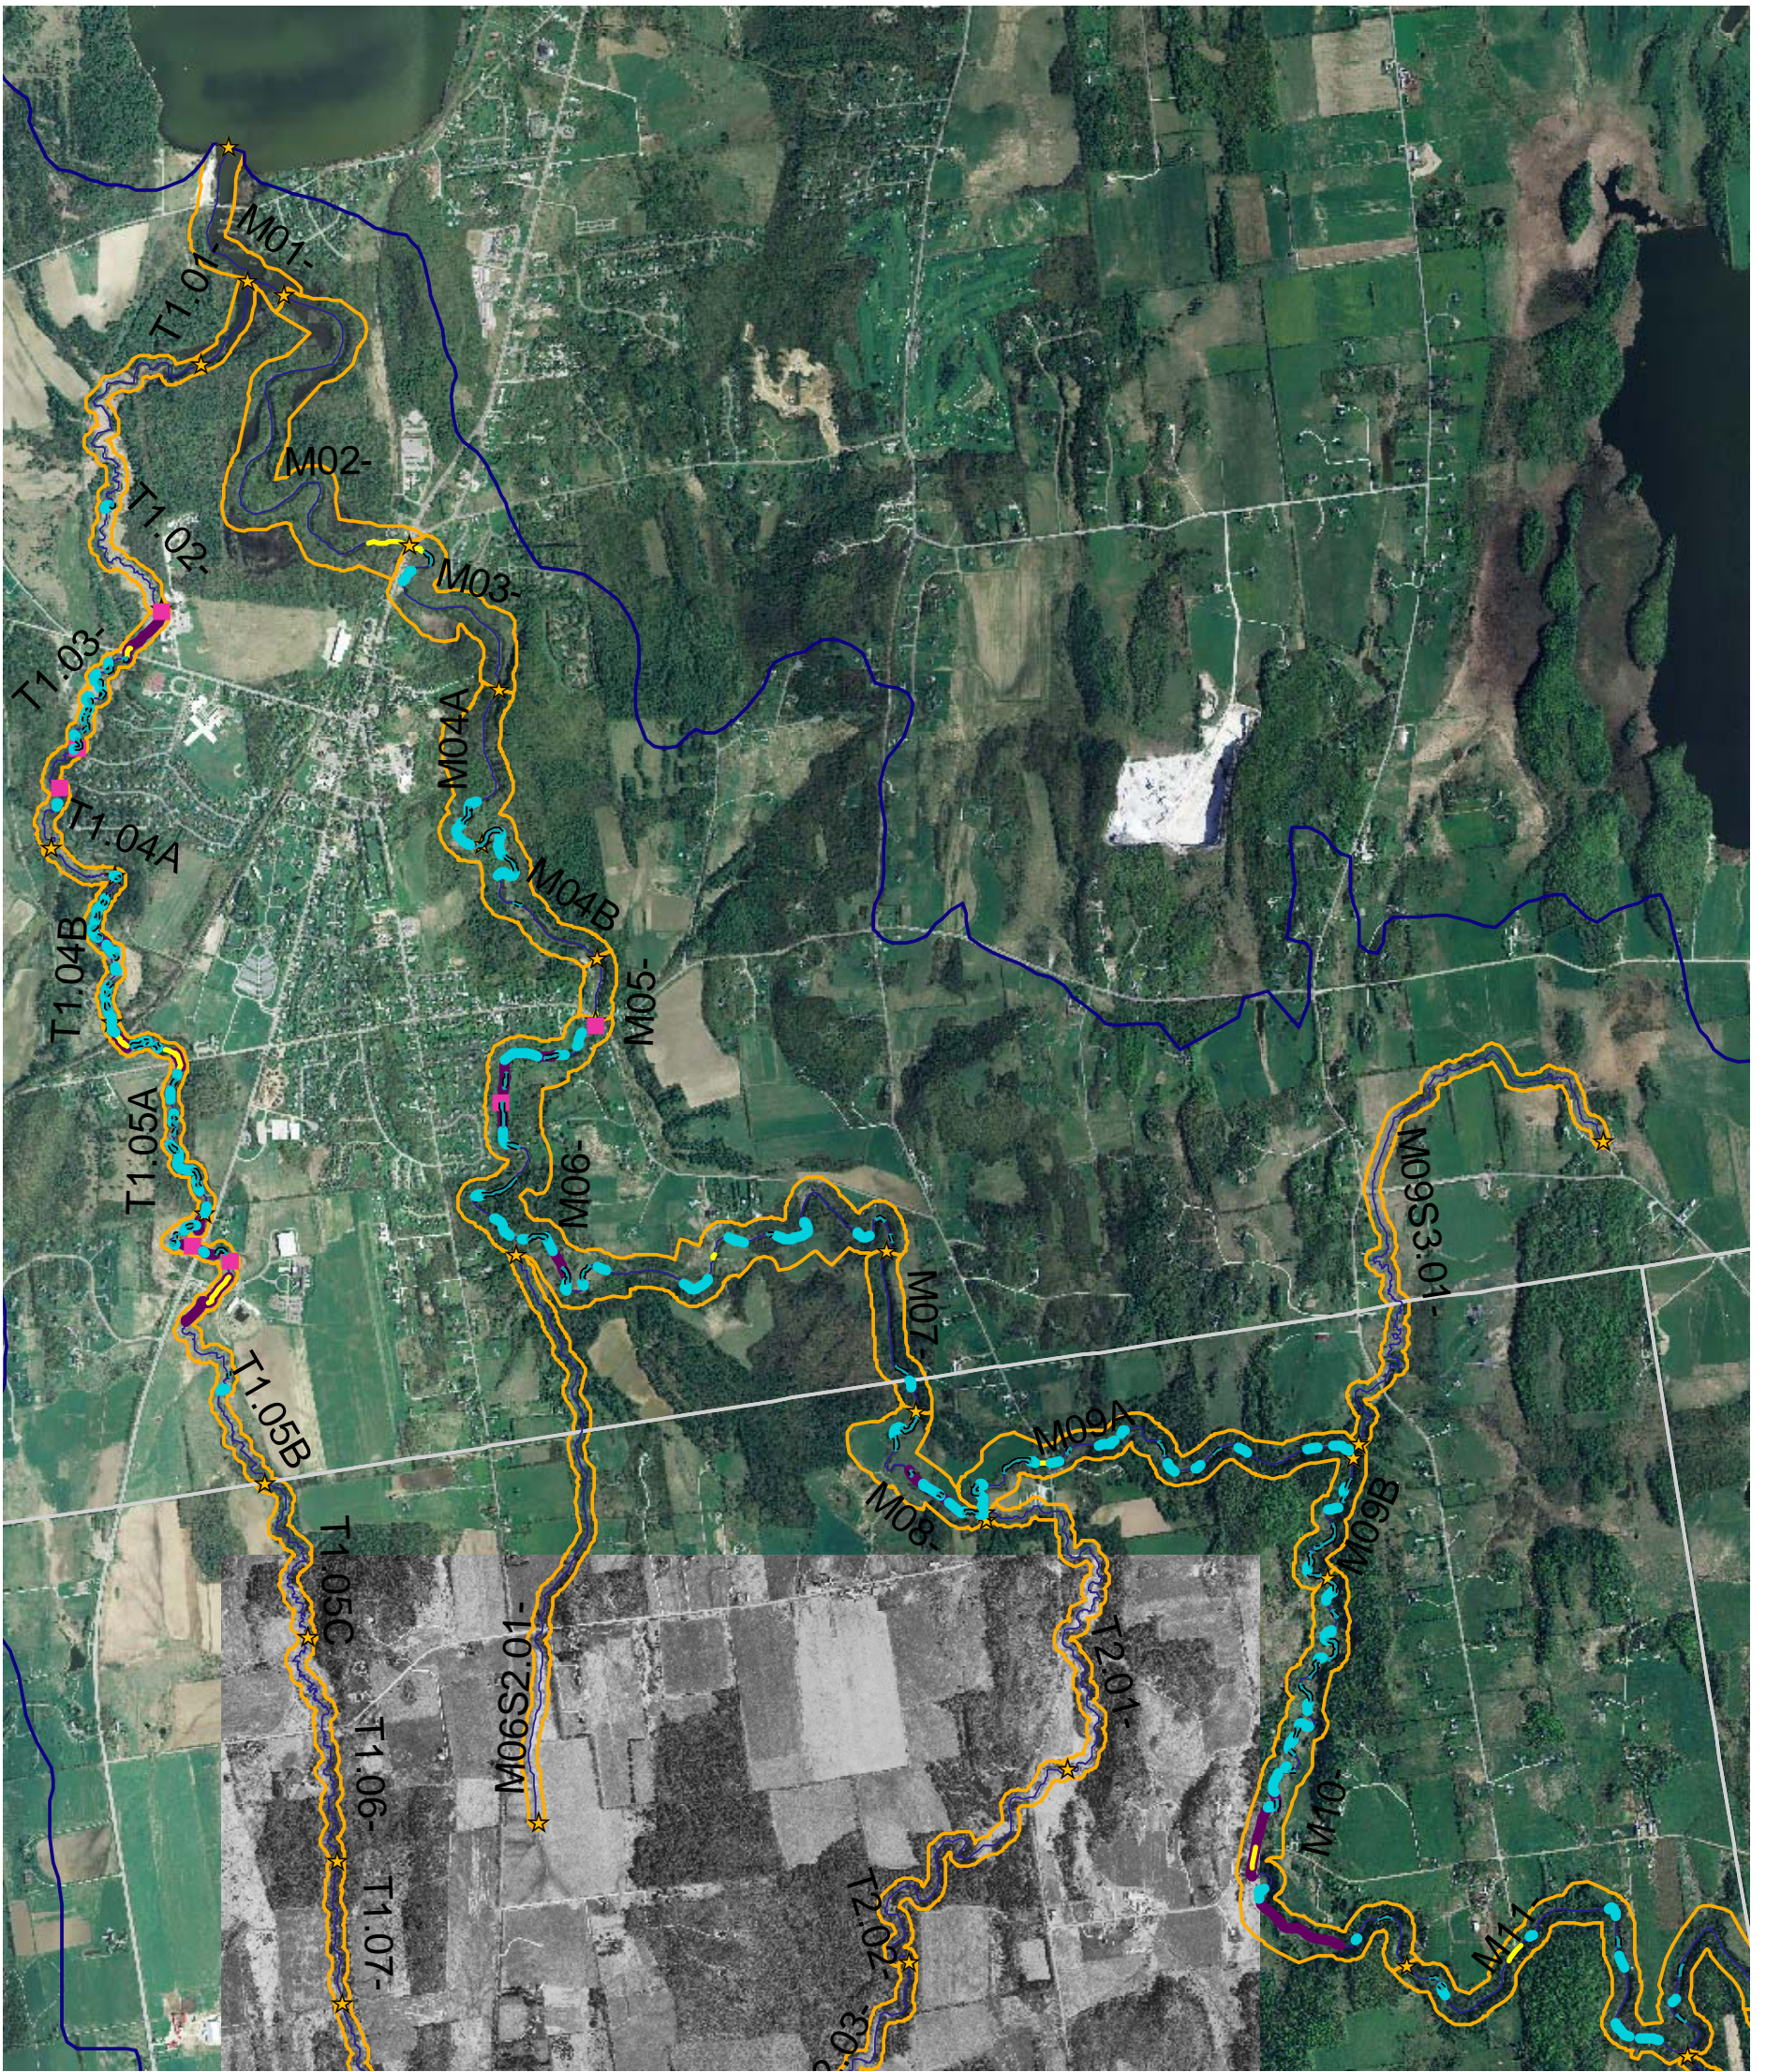
Stream Corridor and Select Impacts

- Stream Corridor
- Left Bank Erosion
