Lewis Brook & Finel Hollow Brook

Phase 2 Stream Geomorphic Assessment Report

Rutland Regional Planning Commission
August 20, 2006

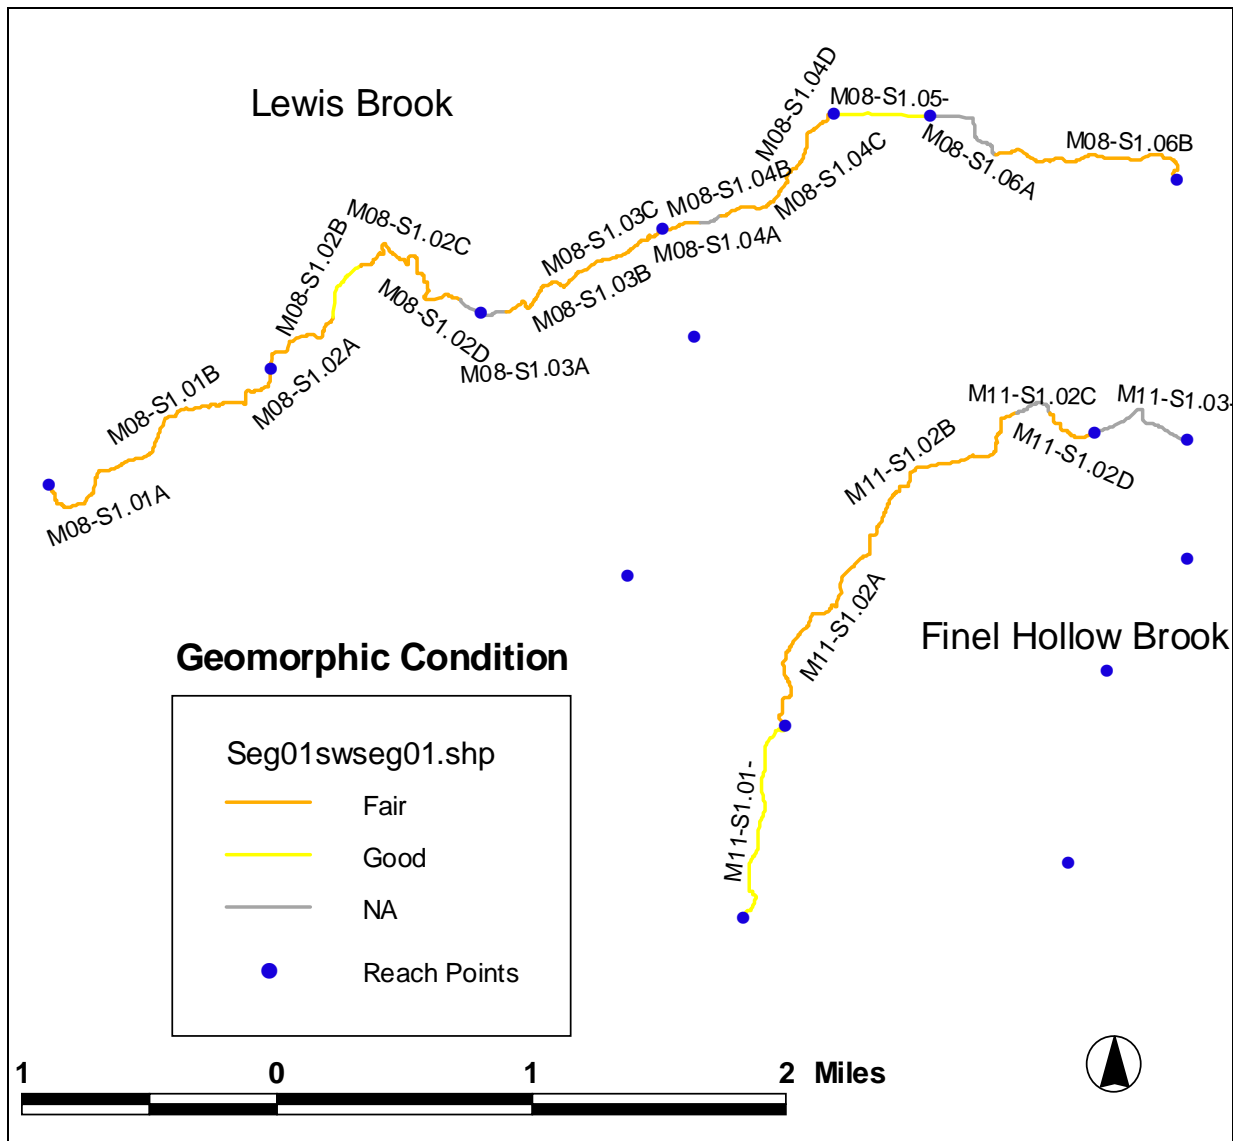
Figure 3 shows RGA condition categories for each of the study reaches and segments. Segments M08S1.02B, M08S1.05 and M11S1.01 appeared to be in “Good” condition. Segment M08S1.02B had berms on both banks (Figure 4) and appeared to be transporting all sediment. Incision due to berms, straightening and lack of riffles affected the geomorphic condition. Reaches M08S1.05 and M1S1.01 appeared fairly stable due to resistant boundary conditions and the presence of bedrock. Straightening also appeared to be a factor affecting geomorphic condition in M08S1.05.

Figure 3. RGA condition scores for Lewis Brook and Finel Hollow Brook.

The remainder of the study reaches assessed under the RGA appeared to be in “Fair” condition. Overall, the main factors that appeared to affect geomorphic condition on Lewis Brook were heavy sediment loads and planform adjustments. For many reaches, past channel straightening also contributed to lower scores.

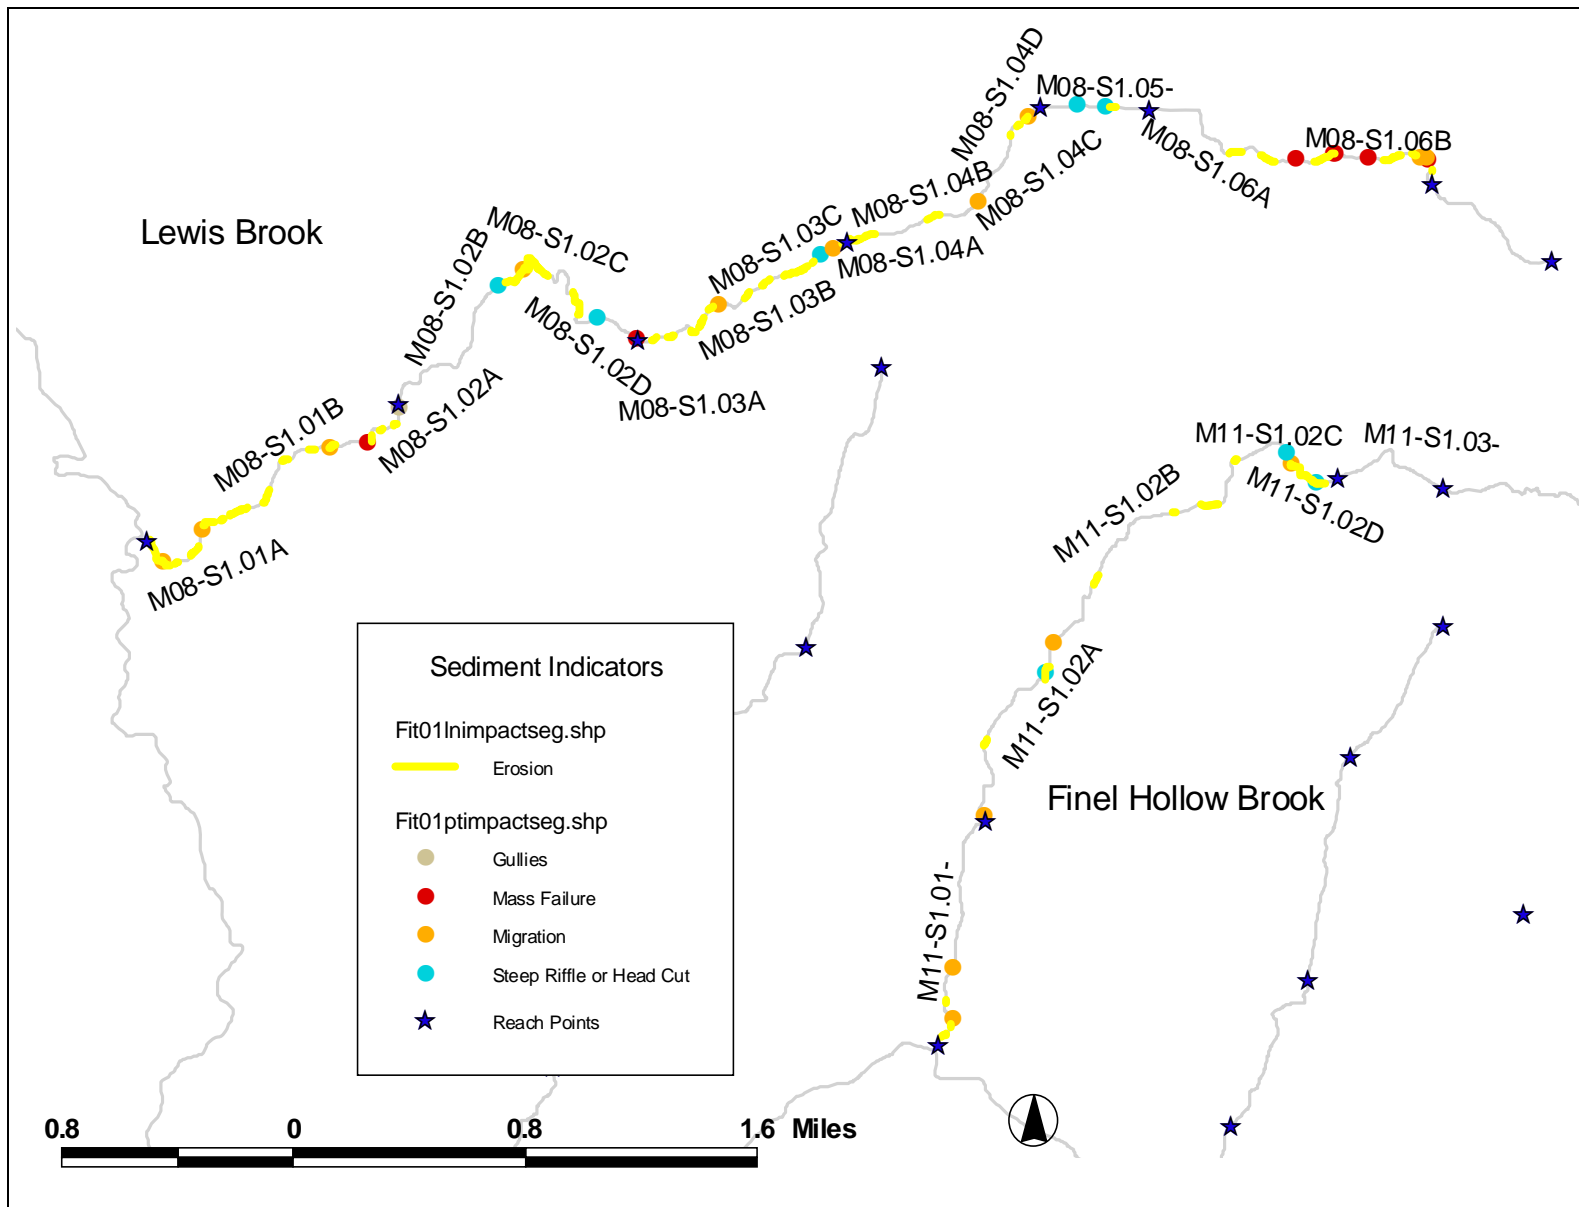
Figure 6 shows sediment load alteration indicators identified in Phase 2 for Lewis Brook and Finel Hollow Brook.

In Lewis Brook, many sediment sources along the length of the stream added to the high sediment load. Erosion and channel migration appeared to be the main factors, in part stemming from past channel straightening, highlighted in Appendix A. Gullies and bare pastureland were seen in the upper watershed and were also contributors to the high sediment load in Lewis Brook (Figure 5).

Less sediment production was observed in Finel Hollow Brook. The lower reach of Finel Hollow Brook had many grade controls, highlighted in Figure 7, providing resistance to erosion and further channel incision. A dam on M11S1.02A had trapped a very large amount of sediment upstream, which would be a large sediment source if the dam walls failed.

Figure 6. Sediment Load Indicators for Lewis Brook and Finel Hollow Brook.

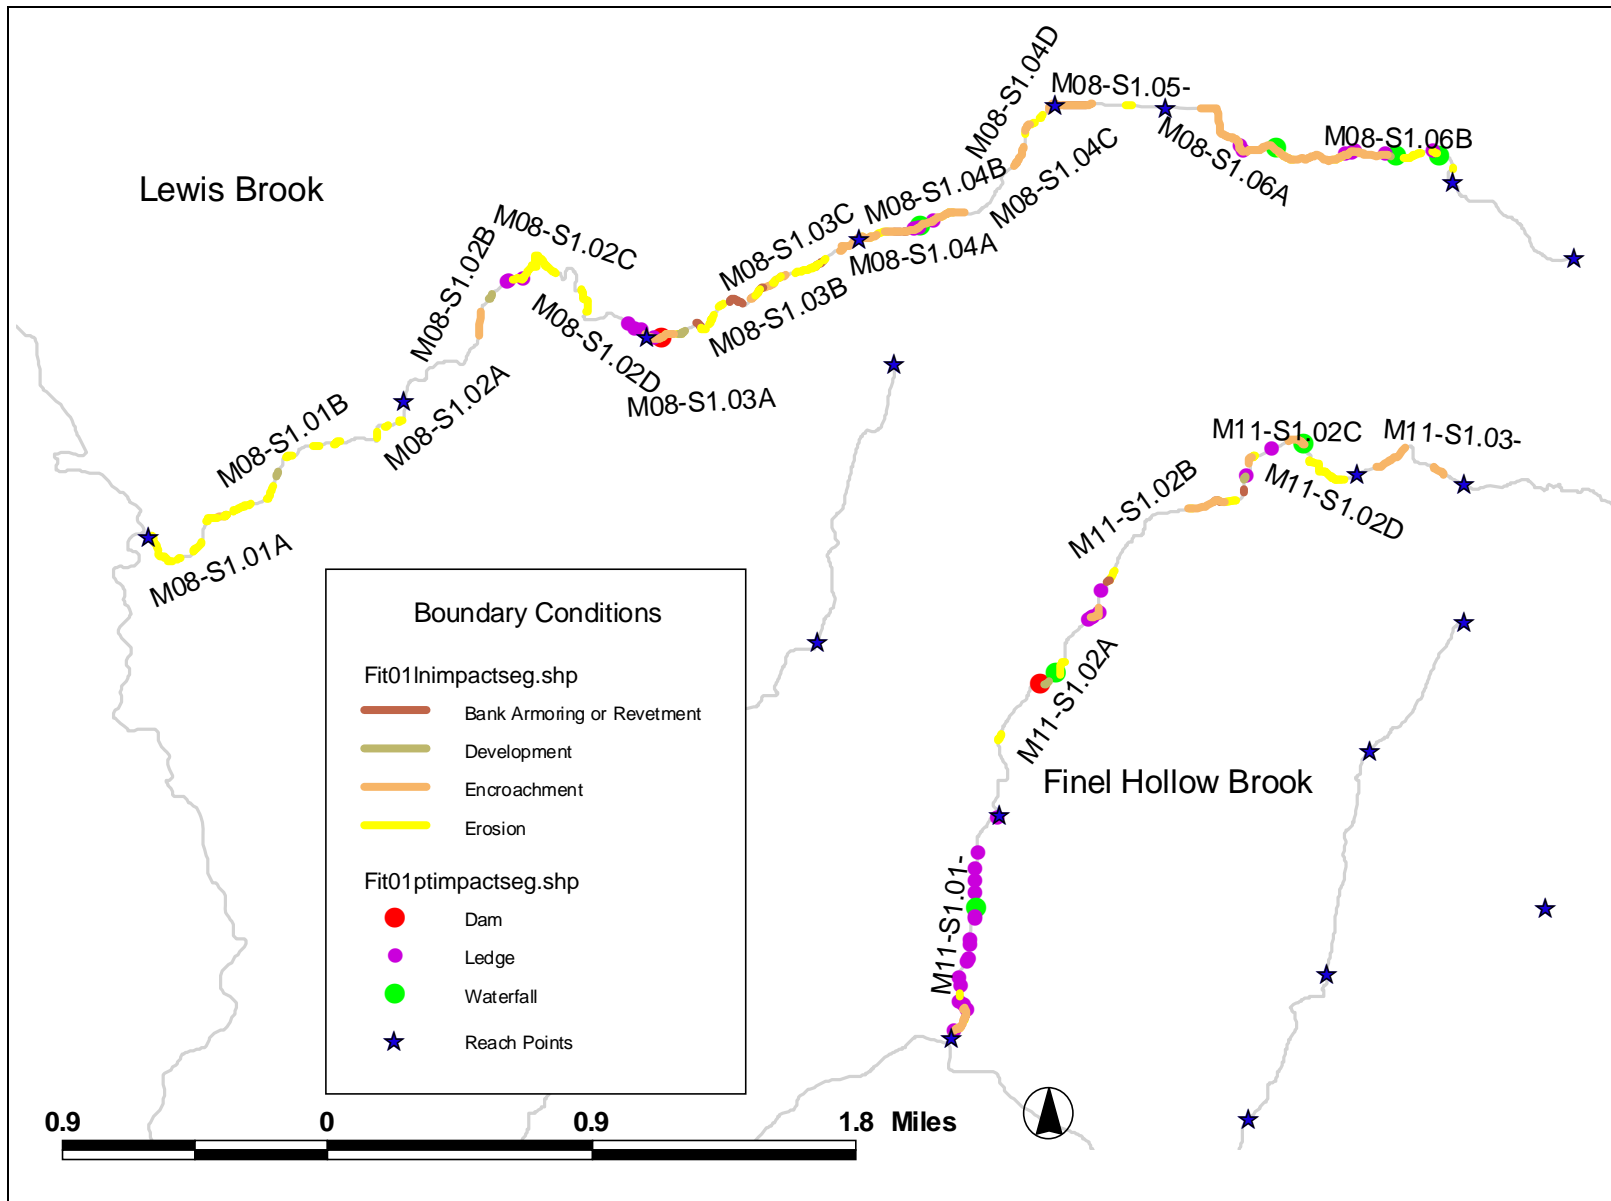
Both Lewis Brook and Finel Hollow Brook had many areas where roads encroached into their corridors (Figure 7), mainly in the upper reaches where valleys were narrower. This leaves very little room for the stream and any floodplain.

Figure 7. Boundary Conditions for Lewis Brook and Finel Hollow Brook.

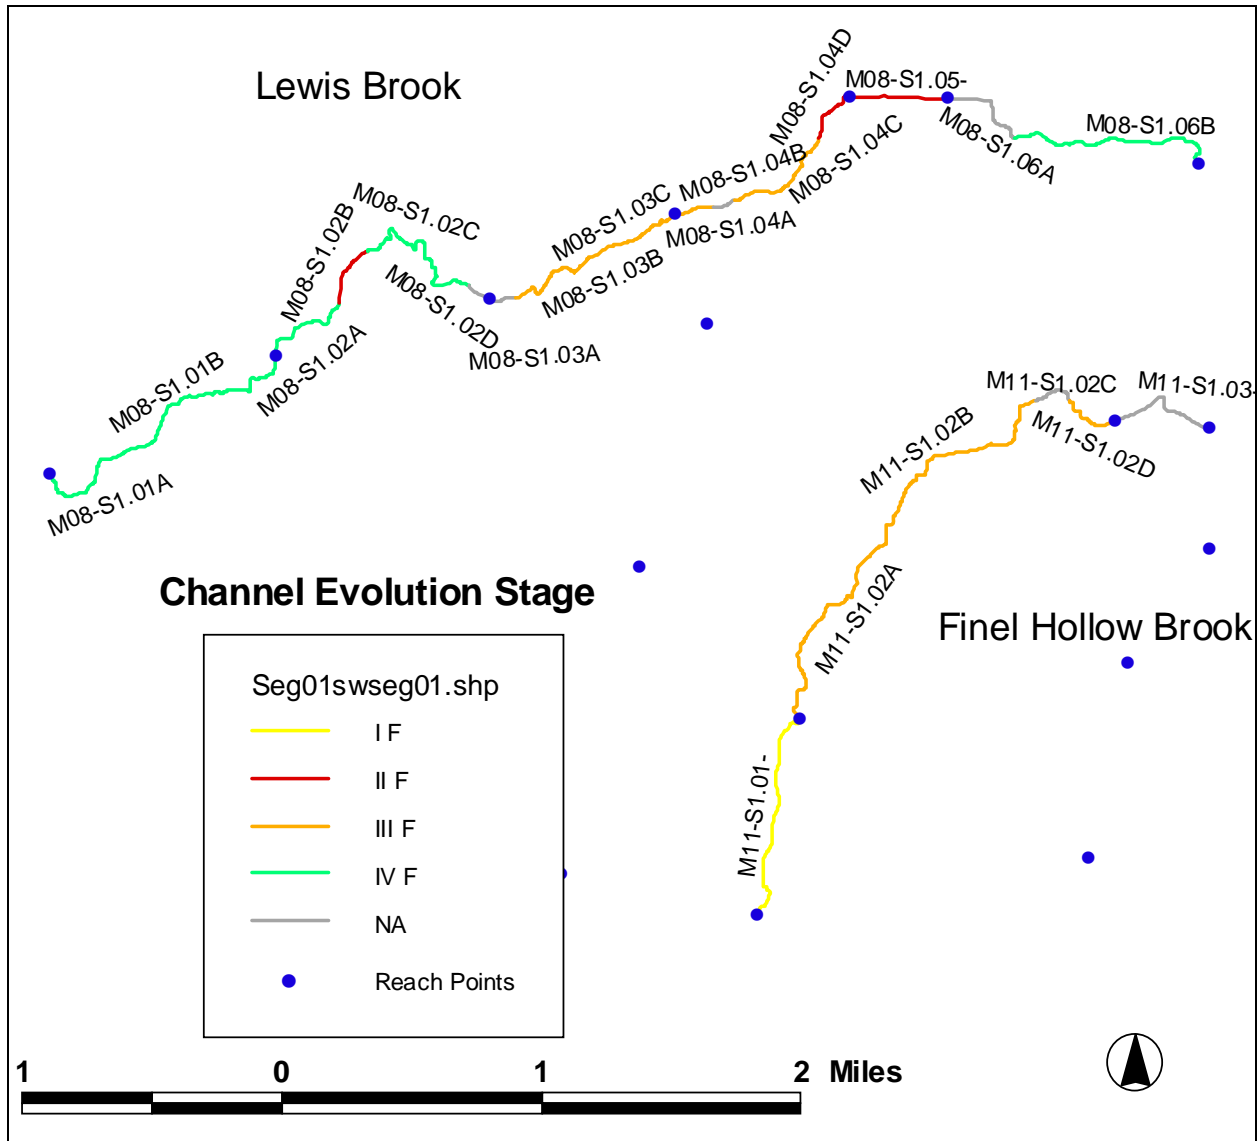
Figure 9. Stage of channel evolution for Lewis Brook and Finel Hollow Brook segments.

Segments M08S1.02B, M08S1.04D, and reach M08S1.05 appeared to be in stage II of the F-stage channel evolution process. M08S1.02B was confined by berms on both banks and appeared straightened and incised due to the presence of the berms. Reach M08S1.05 was in a narrow valley and was further confined by a road and likely straightened as well.

Reach M11S1.01 appeared to be “in regime” and not undergoing channel adjustments. This was likely due to the numerous grade controls providing resistance.

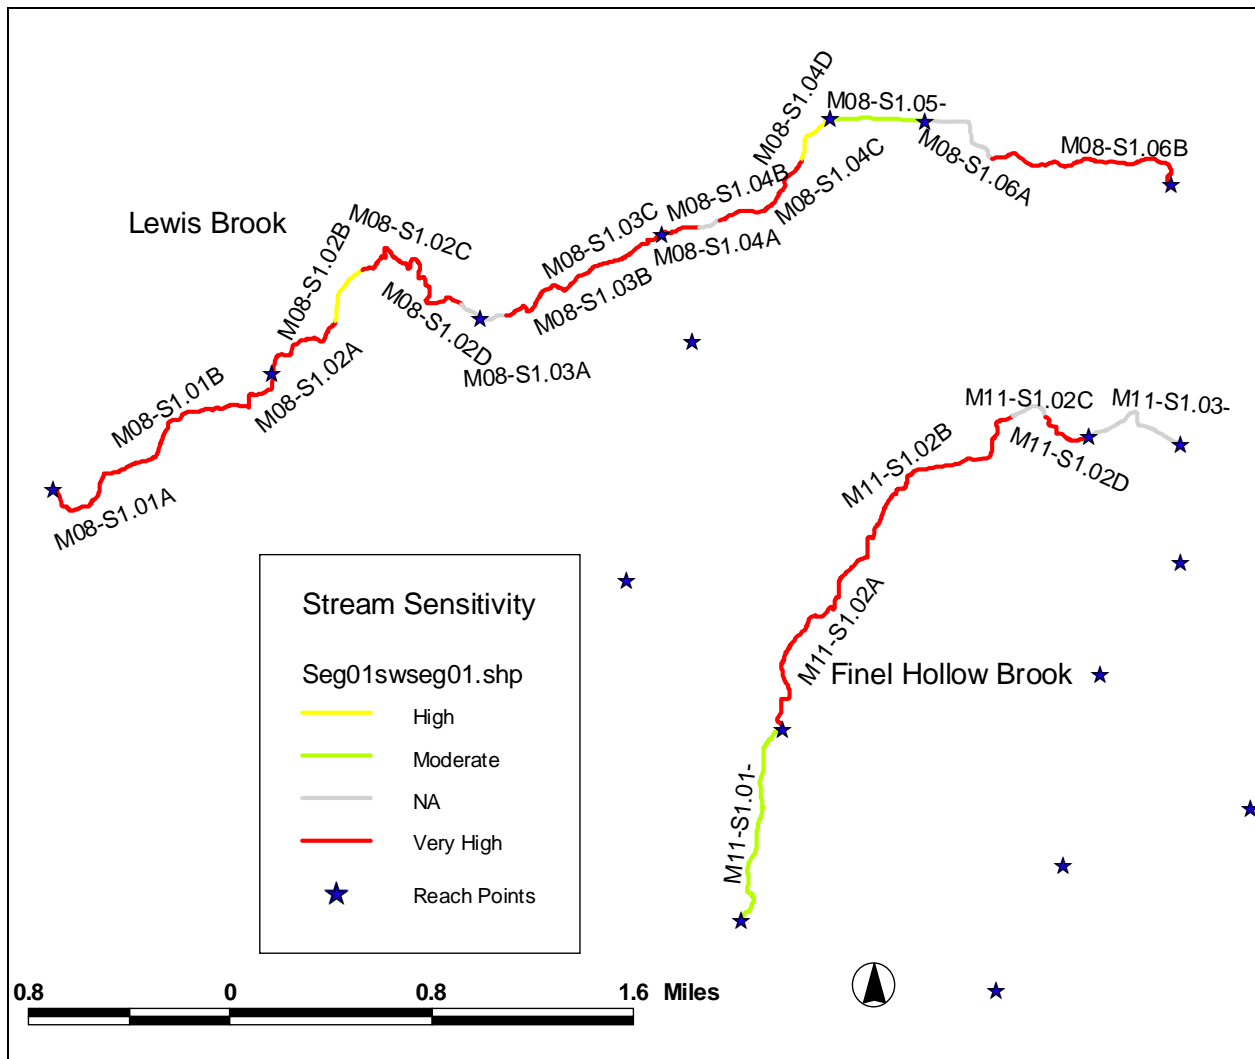
Figure 10. Stream Sensitivity ratings for Lewis Brook and Finel Hollow Brook.

Although many bedrock grade controls are present in Finel Hollow Brook and the upper area of Lewis Brook, most of the stream segments remain very highly sensitive to disturbance. These segments were undergoing adjustment and left with increased sensitivity to further disturbance. Reaches M08S1.05 and M11S1.01 had “moderate” sensitivity due to their “B” stream types and an RGA condition scores of “Good.”

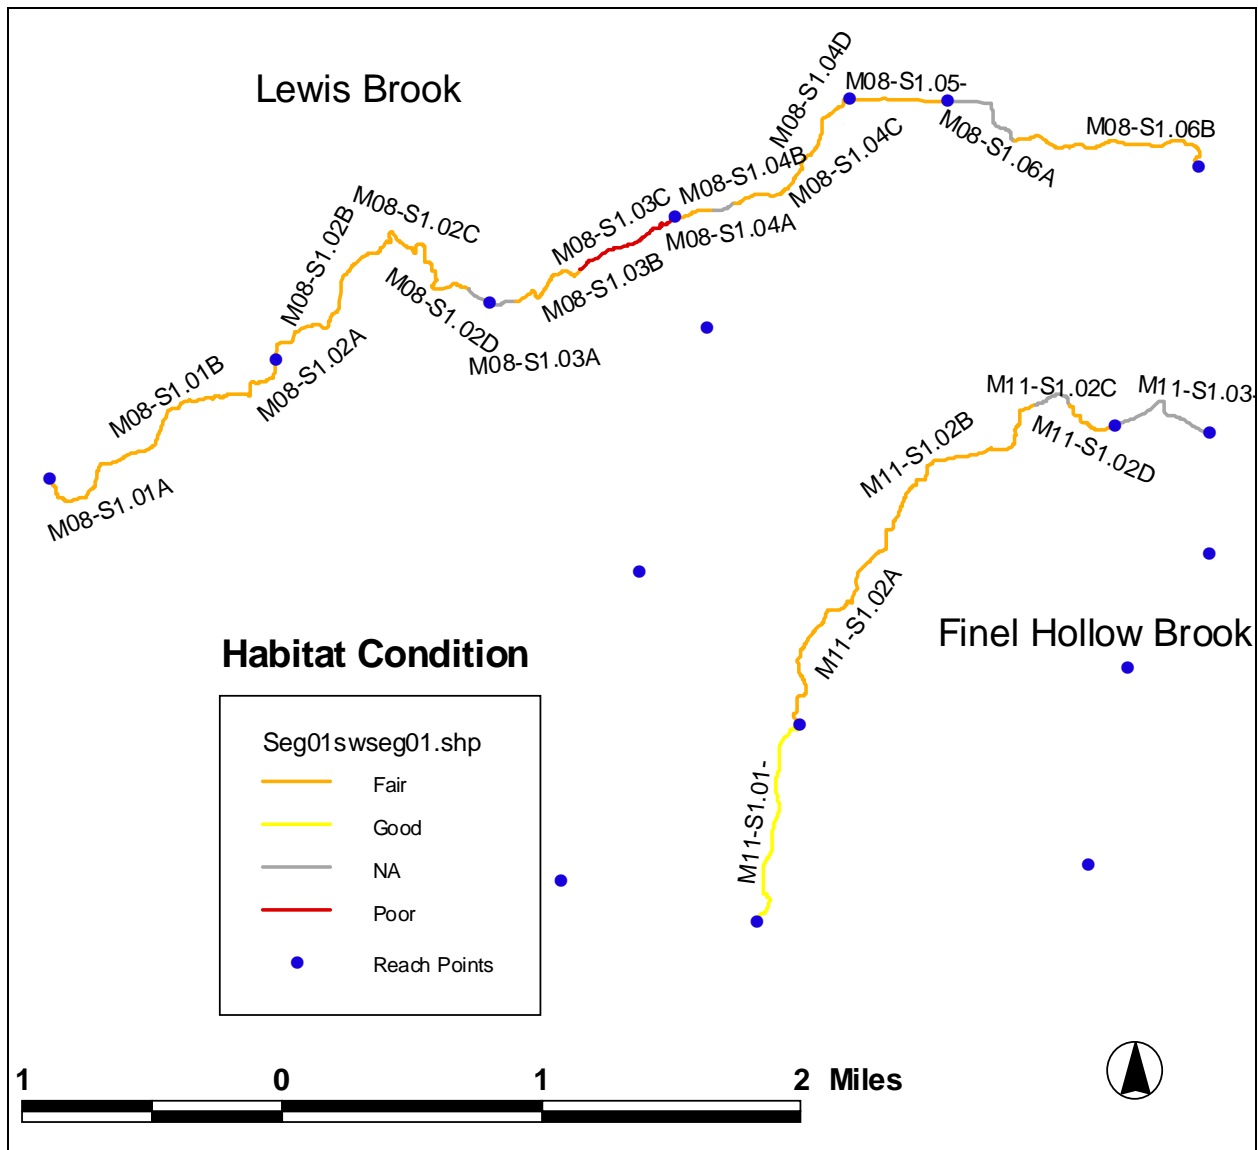
Figure 11. RHA condition scores for Lewis Brook and Finel Hollow Brook.

Habitat condition along Lewis Brook appeared to be “Fair” for most segments. The main factors that appeared to affect habitat in this area were lack of epifaunal substrate and cover, embedded gravel, cobble and boulder particles, increased sediment deposition, channel alteration, bank instability and reduced riparian buffers.
