**New Haven Tributaries  
Stream Geomorphic Assessment  
Phase 2 Report  
June, 2007**

**Landslide Natural Resource Planning**  
P O Box 311  
East Middlebury, VT 05740

Addison County Regional Planning Commission  
79 Court Street  
Middlebury, VT 05753

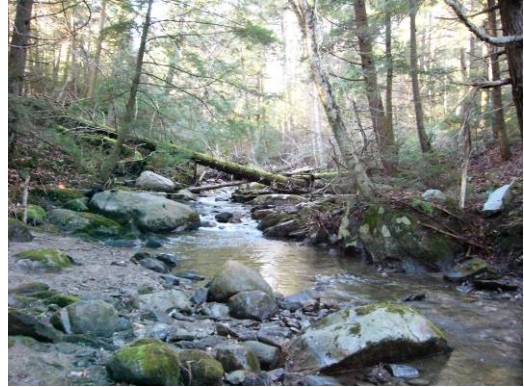
Segment A

**M17-S1.02** – This reach is located in a broad valley and the last 813’ were segmented due to a large beaver dam. It is a B stream type by reference and currently. It is in good geomorphic condition and is in stage IIb of the D stage channel evolution model with widening as the dominant adjustment. It is a reference Transport type sediment regime but is currently Confined Source and Transport due to widening. It has six flood chutes, two steep riffles, and greater than 5 depositional features/mile. Cropland use in the sub-watershed is high, but the riparian buffer within the corridor is greater than 100’ on both the right and left banks. There is a debris jam at the down stream end of the reach. In other places, someone is cutting fallen trees, presumably to prevent jamming. Urban land use within the corridor is not significant and is less than 5% in the sub-watershed. There are five channel spanning grade controls – two at the down stream end and three near the upstream end. There is a significant beaver pond at the upstream end. There are no encroachments into the corridor. The sensitivity is rated as moderate. It has one undersized bridge with deposition and scour above and below it.

This reach is a great candidate for corridor conservation due to the lack of encroachments and great riparian buffer and new housing being built in the area.

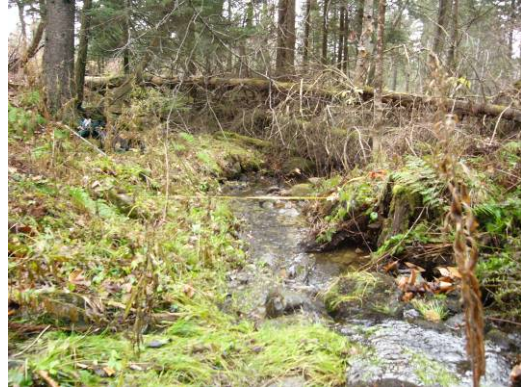
Segment B

**M17-S1.03** – This reach was segmented due to beaver activity. Segment A is a large beaver pond and segment B is the final 883’ of the reach before the stream turns into a wetland. It is located in a very broad valley and is a C stream type currently and by reference and is in reference geomorphic condition. Stream sensitivity is high. There is low cropland use within the watershed and few depositional features. Urban development within the corridor is not significant and it is less than 5% in the watershed. There is one channel spanning grade control. Riparian buffers are greater than 100’ on both the right and left banks.

This reach is a good candidate for corridor conservation as new development is beginning to encroach into the area adjacent to the corridor.

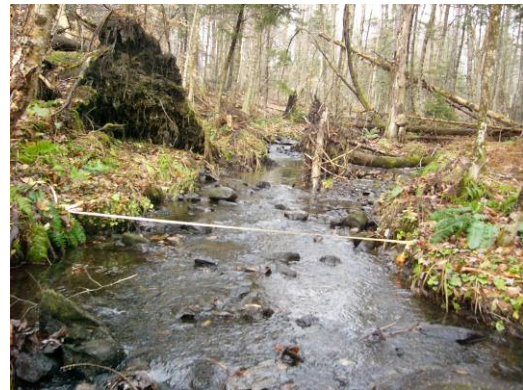
**M17-S1-t1.02** – This reach is located in a very broad valley and was segmented due to a beaver pond in the middle of it. It is a C stream type by reference and currently and is in Coarse Equilibrium/Fine Deposition sediment regime. It is in reference geomorphic condition. The sub-watershed is rated high from crop land use. Segment A has greater than 5 depositional features/mile, two flood chutes and two mass failures. Segment C has between 2 and 5 depositional features/mile. Segment C has 196' of berm set back from the bank on one side and the riparian buffer is greater than 100' on both banks.

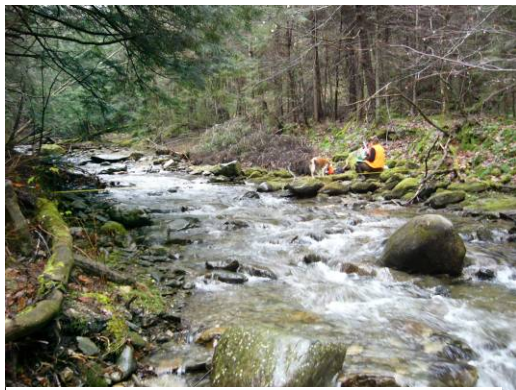
**T5.02** – This reach was segmented due to slope and valley confinement. Segment A is located in a very broad valley while segment B is in a narrowly confined valley. Segment A is a C stream type currently and by reference and is in reference geomorphic condition, making it a Coarse Equilibrium/Fine Deposition sediment regime type. Segment B is a B stream type currently and by reference is also in reference geomorphic condition making it a Transport sediment regime type.

is not a channel constriction. Depositional features are greater than five/mile on both segments. Segment A has one flood chute but segment B has 8 flood chutes. The left bank of segment A has greater than 20% erosion but the remainder of the banks are all between 5 and 20% eroding. There are three mass failures in Segment B. Corridor development is rated high in T5-S4.01, immediately upstream of Segment B and one of the sub-watersheds and corridors at the edge of the watershed has almost 8% urban development and the corridor development impact is rated low. On T5-S2.01, also upstream of Segment B, both banks have greater than 20% with no riparian buffer. These factors may account for the sediment and planform adjustment occurring on Segment B.

This reach is a good candidate for corridor conservation, particularly given the new camps that are being built within the corridor. However, upstream impacts should be explored further and with remediation pursued where necessary.
