# Centerville Brook Corridor Plan

Hyde Park, Vermont

February 10, 2010

# Centerville Brook Corridor Plan Hyde Park, Vermont

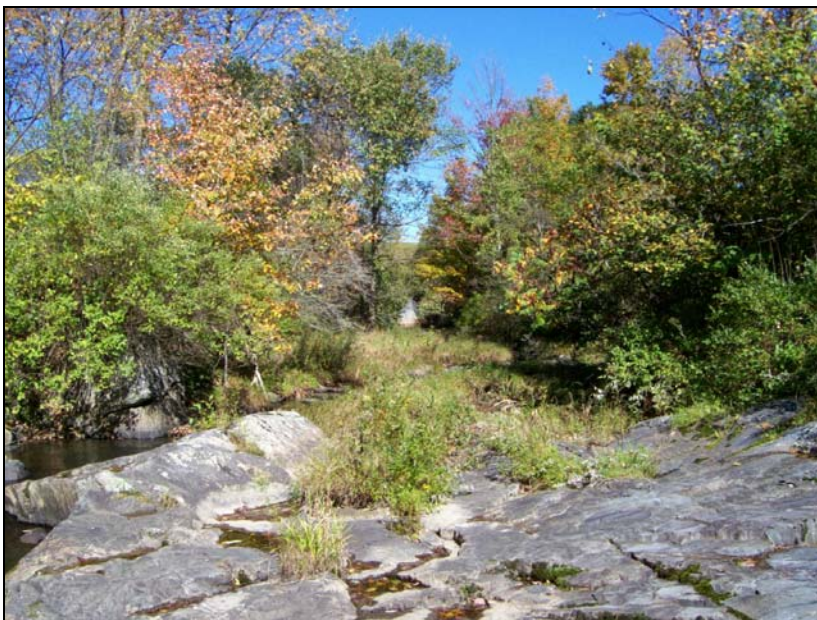
Centerville Brook segment R15.03 is a bedrock gorge between the Route 15 and Main Street crossings east of Hyde Park village. In accordance with ANR protocol, only a partial assessment was conducted on this reach.

**Centerville Brook segment R15.03 is a bedrock dominated channel.**

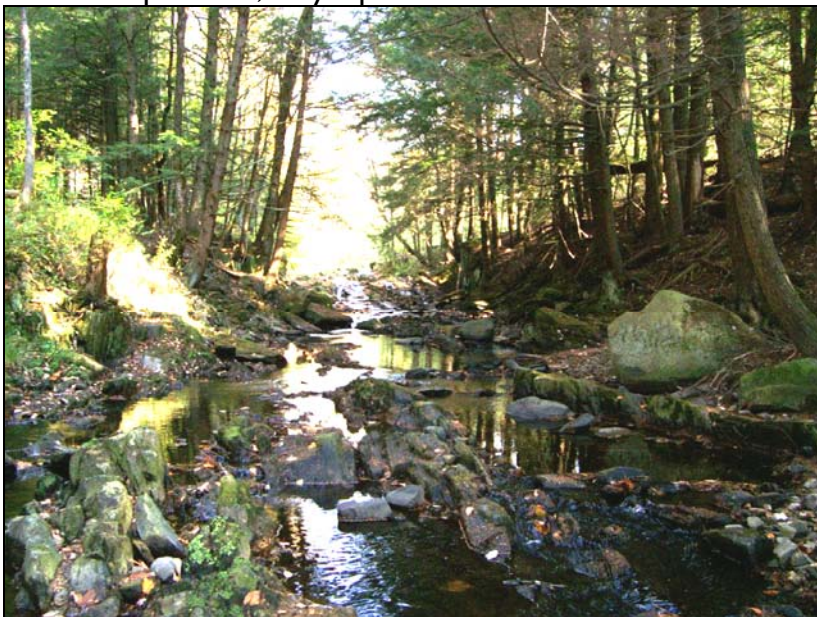
Centerville Brook segment R15.04-A is a bedrock dominated channel. In accordance with ANR protocol, only a partial assessment was conducted on this reach.

**Centerville Brook segment R15.04-A is a bedrock gorge.**

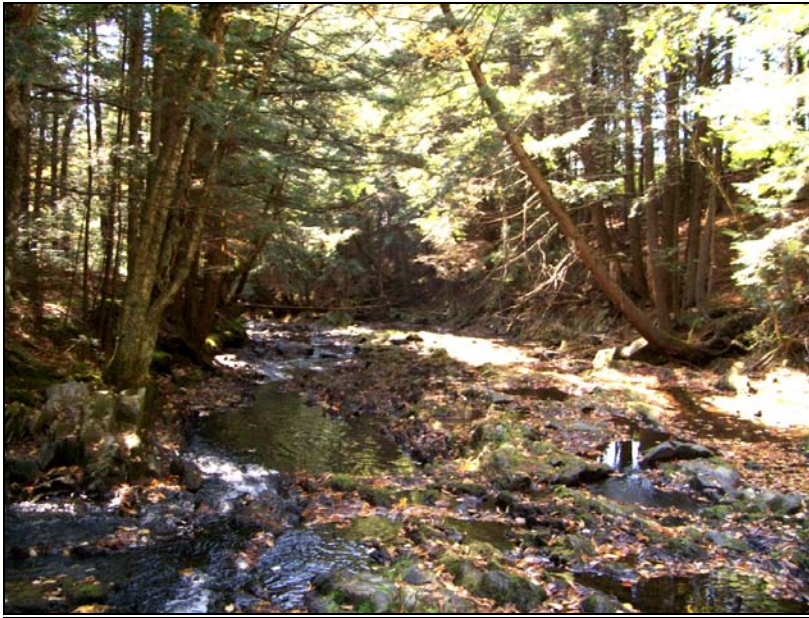
**Centerville Brook segment R15.04-C is a bedrock gorge.**

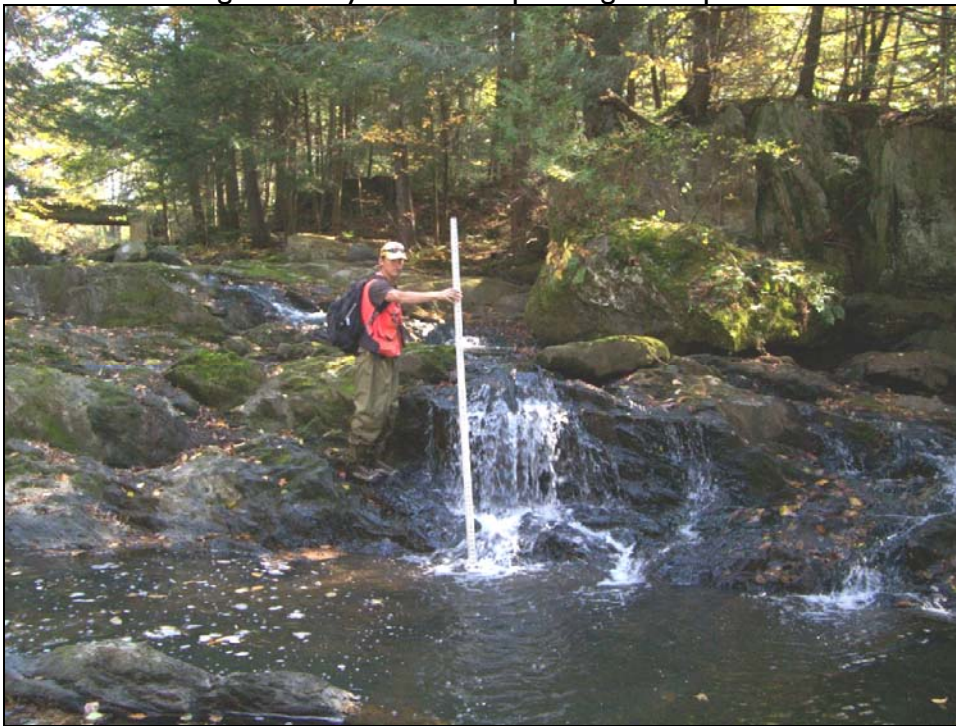
Centerville Brook R15.05-A begins just upstream from the private Pair Farm Road bridge where a very broad valley becomes confined and where the Centerville Brook encounters a bedrock dominated channel and a series of small waterfalls. Due to these waterfalls this segment only received a partial geomorphic assessment.

**Segment R15.05-A is a bedrock dominated channel with several small waterfalls.**

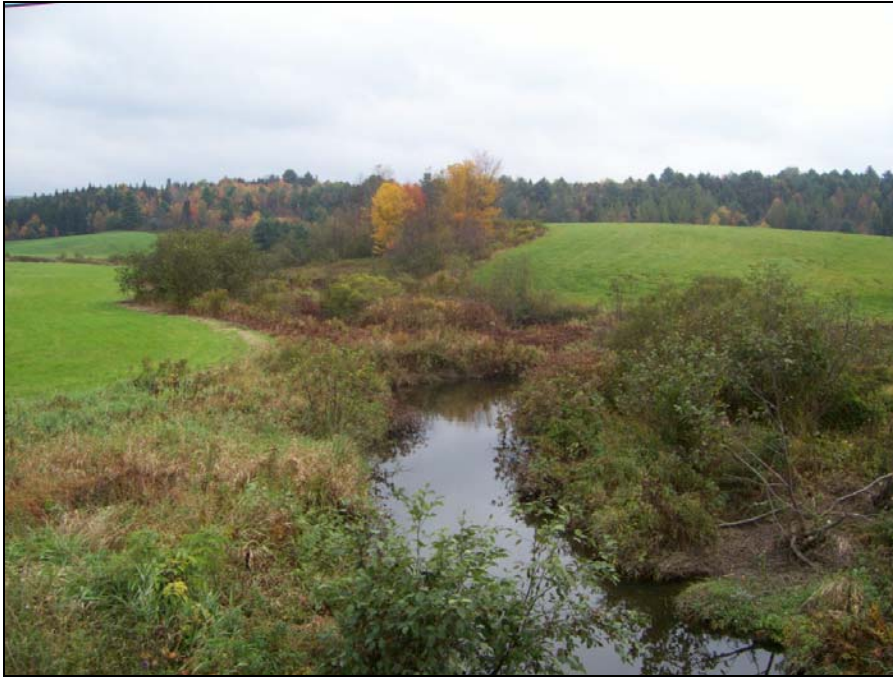
Centerville Brook segment R15.05-B begins above Slobada Road and continues downstream for over a mile crossing under Cleveland Corners and Silver Ridge roads. The stream corridor through this long reach is surrounded by hay fields; however, due to the wetland-type nature of the stream channel, agriculture has generally remained out of the immediate floodplain. Instead, a healthy riparian corridor lines both banks through almost the entire segment. This riparian vegetation is providing food and habitat for beavers that are actively damming the channel throughout this segment.

Centerville Brook segment R15.05-B has good floodplain access and numerous active beaver dams.

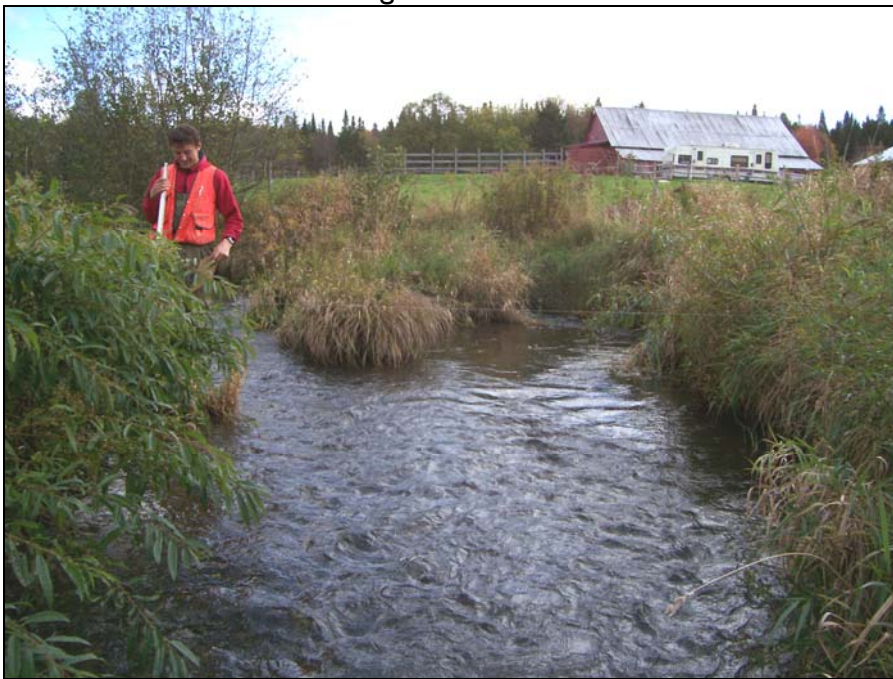
Centerville Brook segment R15.05-C begins at the Frost Road culvert off of Brook Road and continues downstream for 2200 feet to where the slope, sinuosity and influence of beavers were reason for a segment break.

The channel in Segment R15.05-C is narrow and deep.

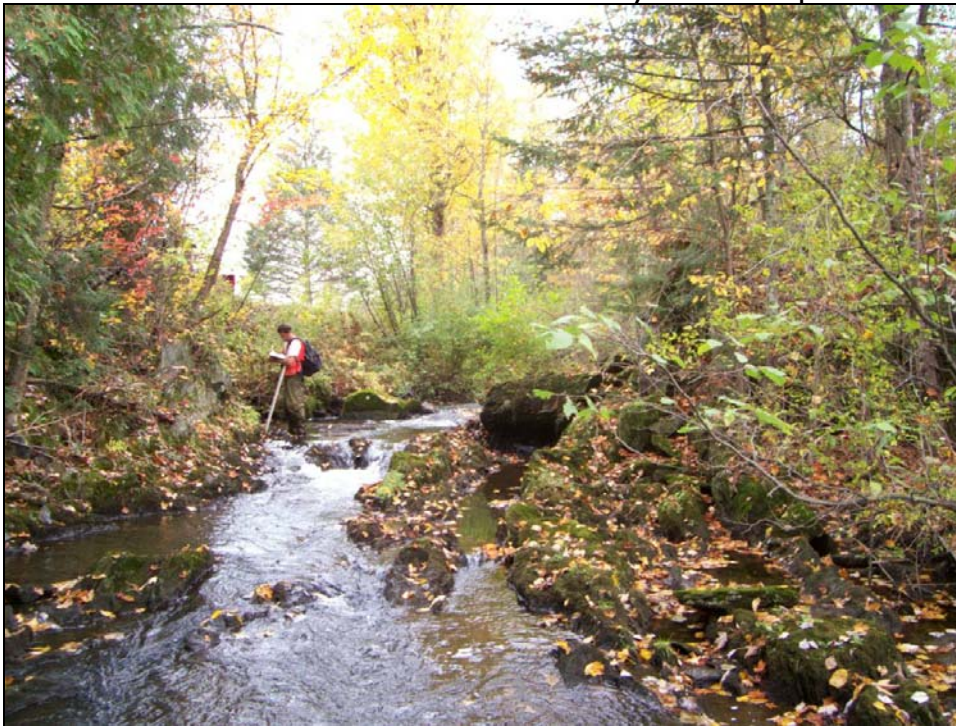
Centerville segment R15.05-D is a short (600 ft.) section of channel that begins where bedrock grade controls appear in the channel near the upper pastures of a dairy farm and ends at the culvert under Frost Road. The stream in this segment is controlled by bedrock on the bed and banks and therefore only received a partial Phase 2 assessment.

**Centerville Brook segment R15.05-D is controlled by bedrock on the bed and banks.**

#### **Replace bridge**

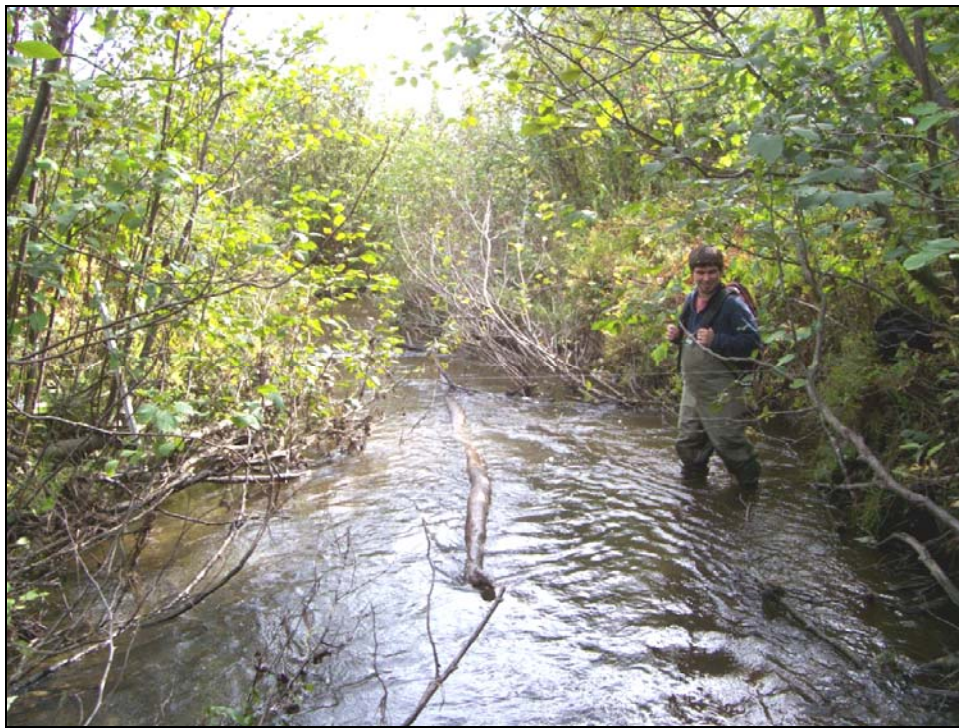
Centerville Brook segment R15.05-E begins at the confluence with a major tributary. The segment flows through a predominately undisturbed wetland area that is heavily vegetated with alder, willow, spruce, and fir. The channel through this segment is highly sinuous and has good floodplain access with abundant floodplain wetland noted. The stream is an “E” type channel that has been historically influenced by beavers (currently only the very upper portion of the segment is impounded). The channel did have evidence of some minor channel adjustment such as widening, aggradation, and planform. These observed adjustments are likely attributed to the highly dynamic nature (dam and avulsion, store and release) of beaver influenced channels.

Segment R15.05-E is a heavily vegetated “E” type channel.

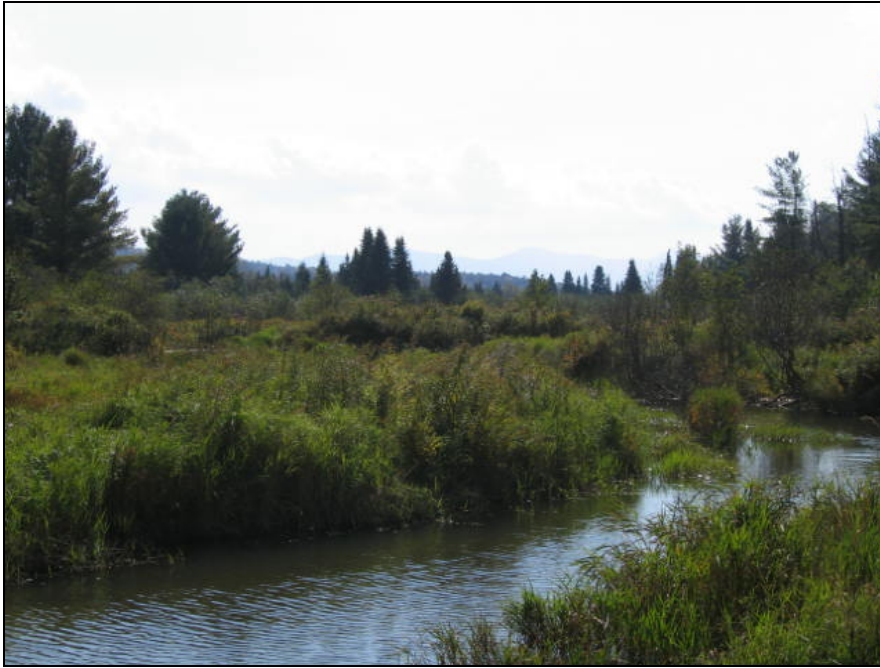
Centerville Brook segment R15.06-B has been impounded by a large beaver dam. Due to this impoundment this segment did not receive a full geomorphic and habitat assessment.

**Segment R15.06-A is a wetland system due to a beaver dam.**

**Segment R15.06-B**  
**Improve Riparian Buffer (CREP)**  
**Protect River Corridor**

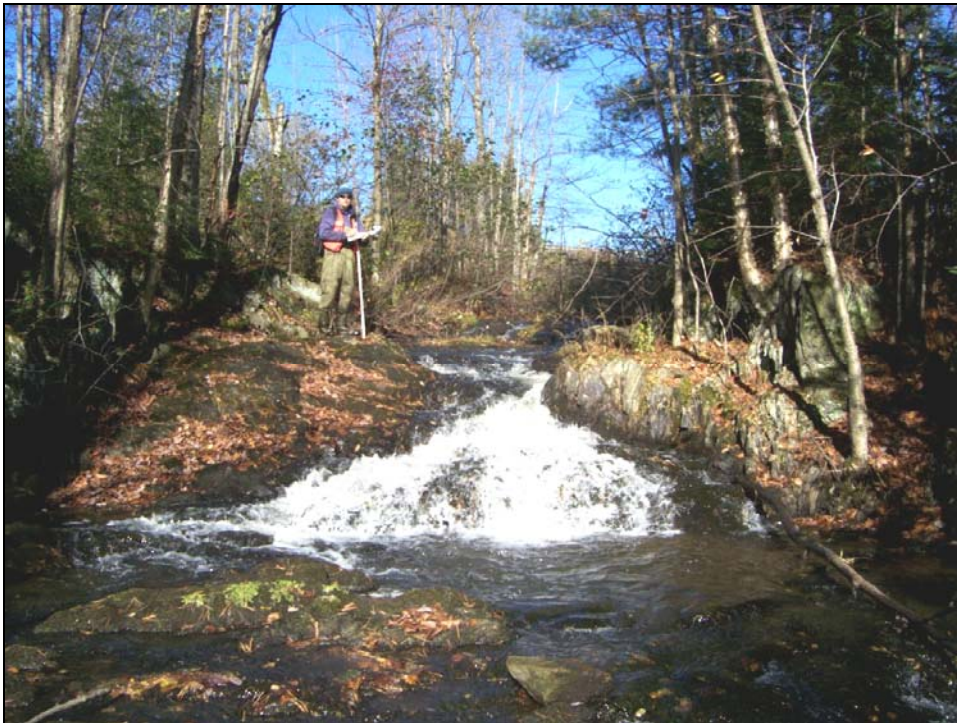
Centerville Brook segment R15.07-B is a short section of channel that begins at the Centerville Road crossing and continues downstream through a series of bedrock waterfalls. Due to the extensive bedrock in the stream channel only a partial stream geomorphic assessment was conducted.

**Centerville Brook segment R15.07-B is dominated by bedrock grade controls.**

#### **Replace freefall culvert**

#14 Centerville Road Crossing R1507-B	Active Restoration	Bedrock gorge	Replace undersized, freefall culvert at Centerville Road	Moderate to high	Improve sediment transport, reduce debris jam potential	High cost to replace structures	None	ANR, Town of Hyde Park, VTRANS

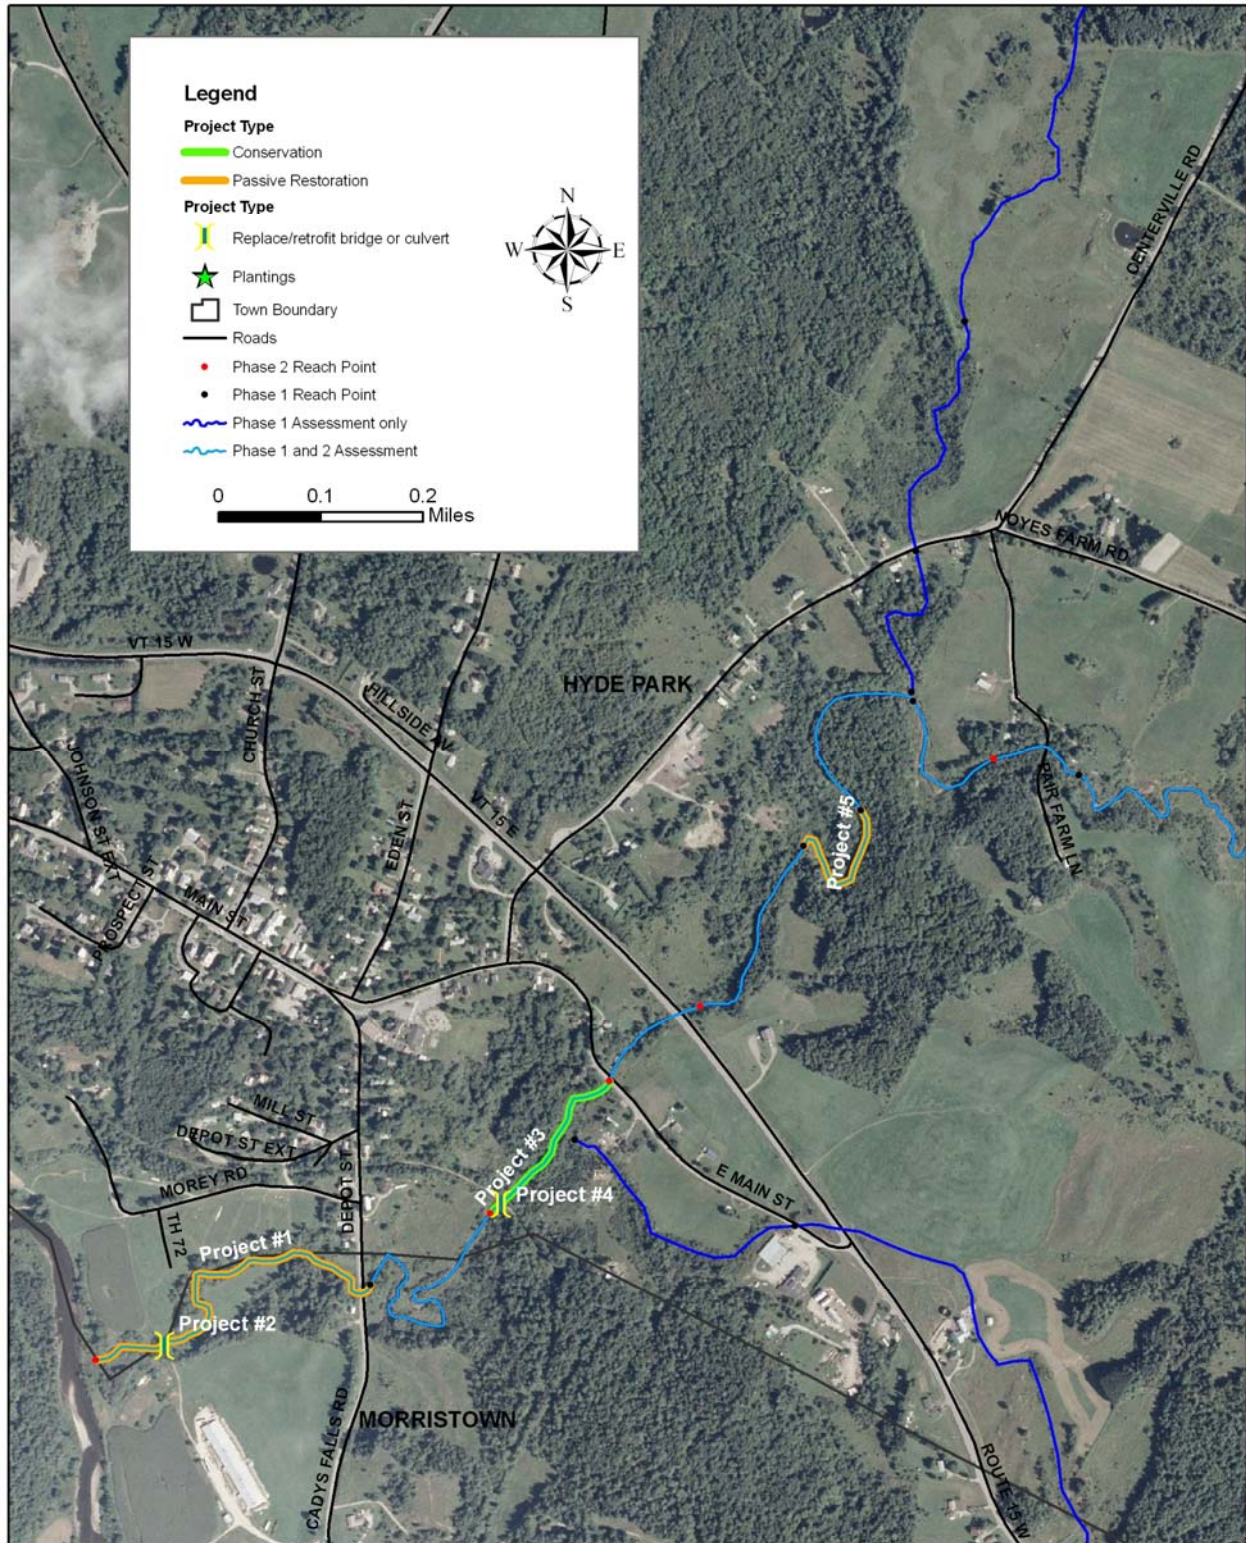
Figure 21. Proposed restoration and protection projects for the lower Centerville Brook mainstem.

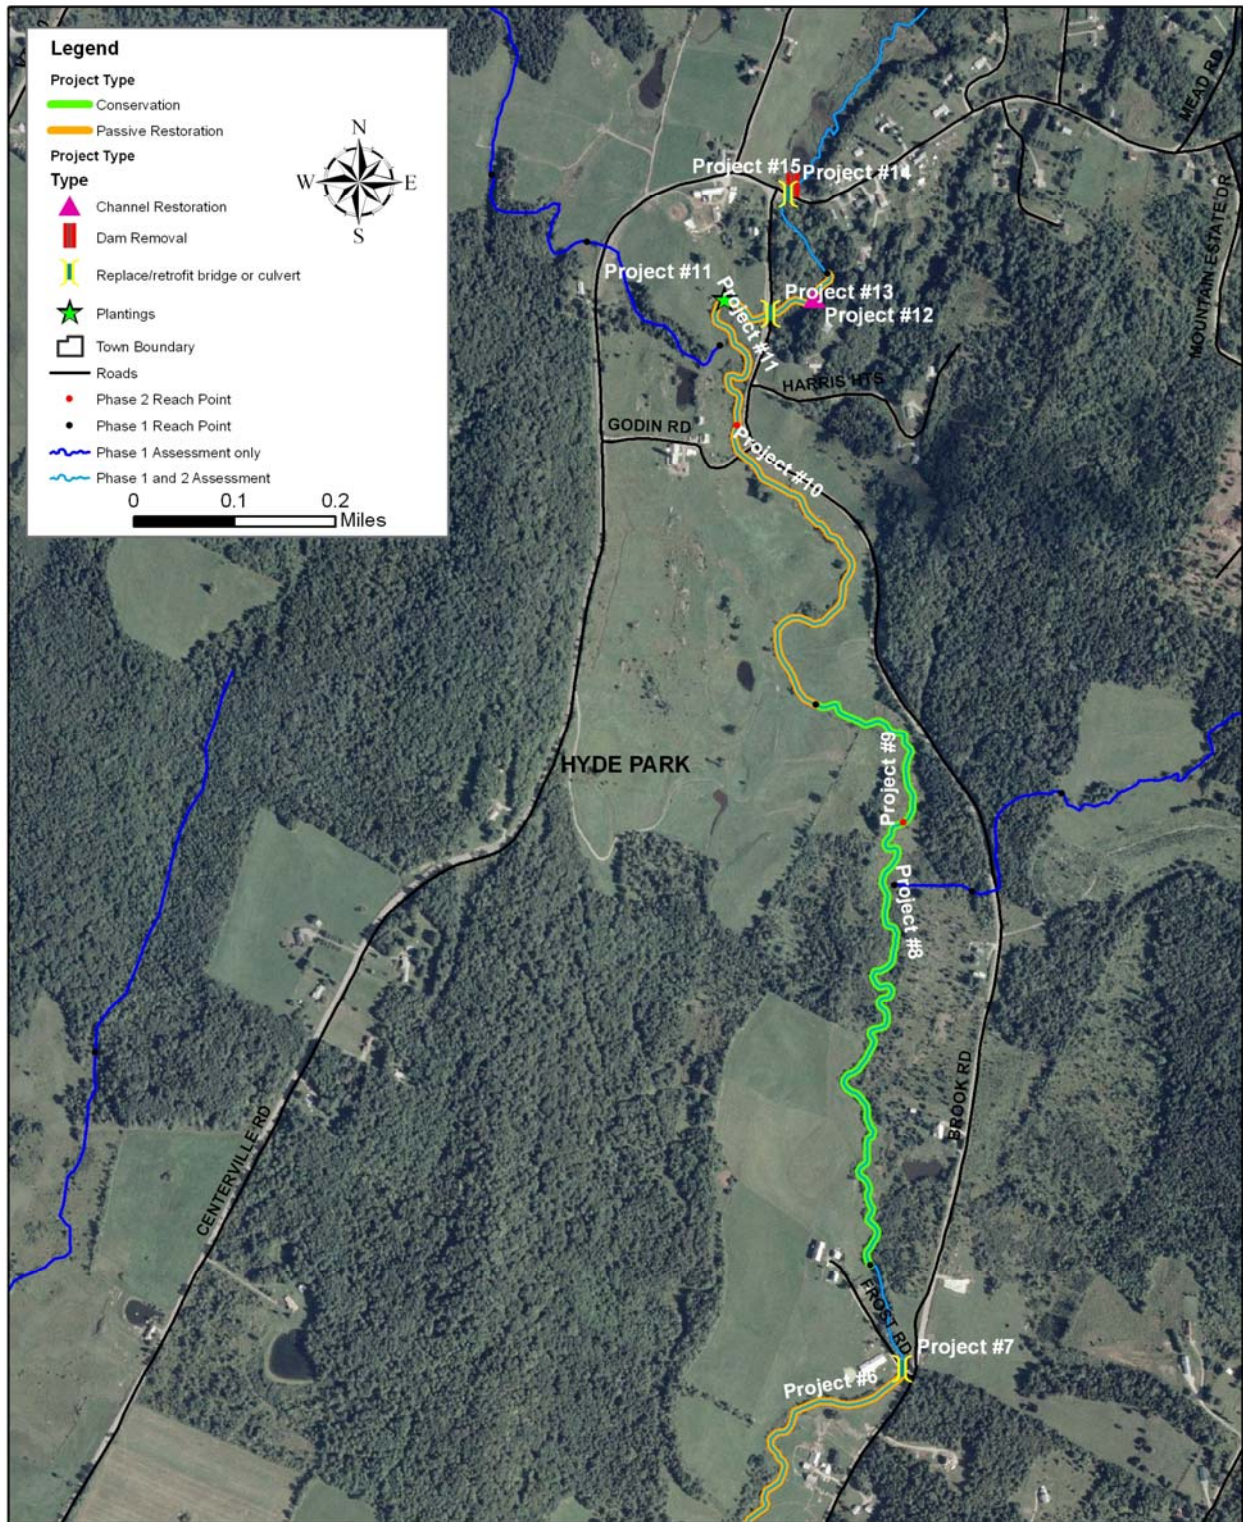
Figure 22. Proposed restoration and protection projects for the upper Centerville Brook mainstem.
