PHASE 1 STREAM GEOMORPHIC ASSESSMENT

GREEN RIVER WATERSHED

LAMOILLE COUNTY, VERMONT

Prepared by the Lamoille County Planning Commission
September 2012

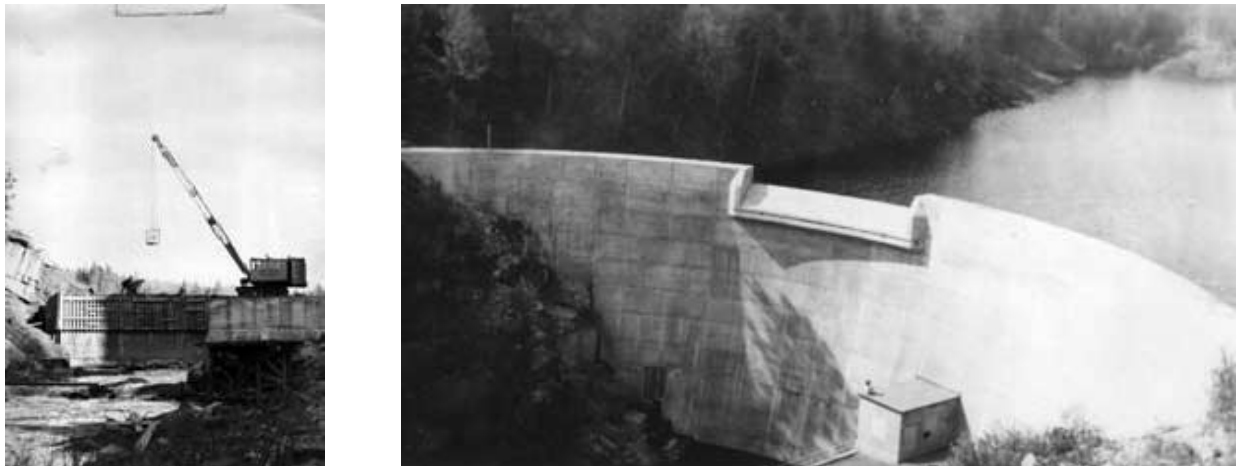
Figure 9: Historic images of the Green River Dam, from *A Brief History of the Green River Project and the area covered by it*, Willard K. Sanders, 1951.

The Green River is dammed at the upstream end of the twelfth reach which forms the Green River Reservoir. The dam on the Green River Reservoir (constructed in 1946 and owned by Morrisville Water and Light) makes the Green River unique among the rivers that have been assessed in Lamoille County. Because the dam is technically within the M13 reach, which was not assessed, the Stream Geomorphic Assessment Tool (SGAT) does not show it as significantly impacting flow regulation in reach M12 (see Appendix 9). This is somewhat misleading, as the

dam essentially cuts off the supply of sediment to the river; potentially causing erosion of the channel bed, and reducing depositional features. Fewer depositional features were noted here as on many other rivers in similar settings. Because the Green River is largely a bedrock controlled stream with adequate riparian buffer and little development along much of its length, the dam seems not to have caused significant erosion or channel incision/widening downstream.

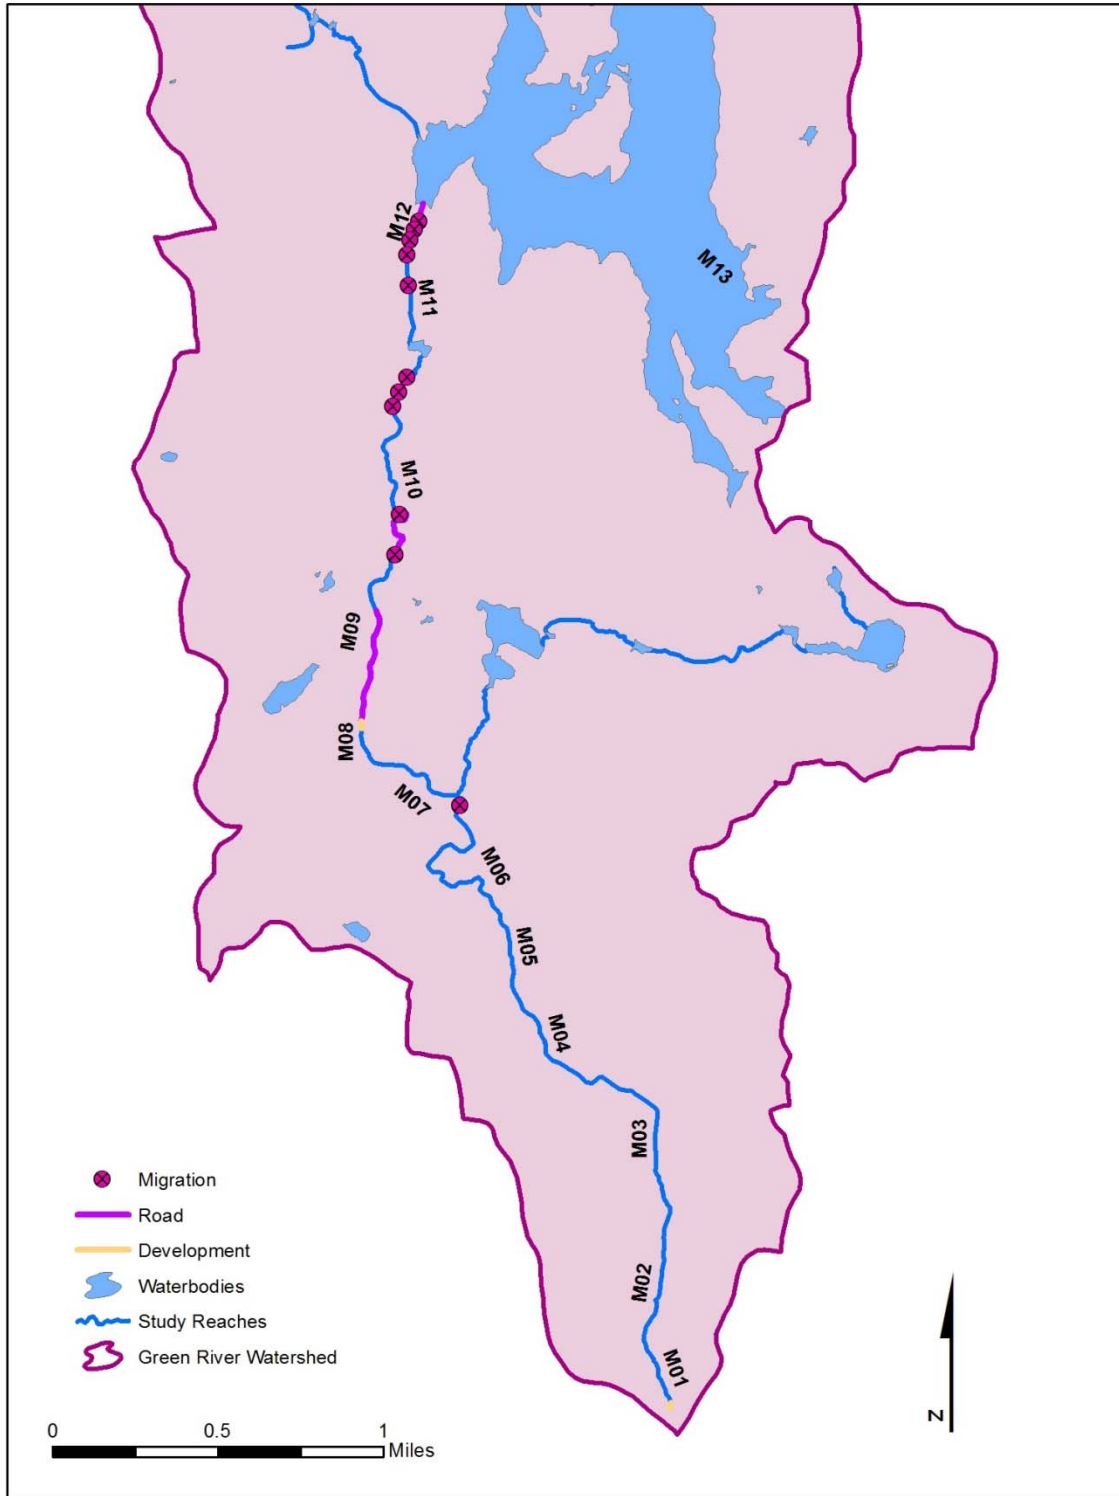
Results are presented in Appendices J and K. High impact rating scores indicate the meander width ratio is less than 3 or greater than 10, well outside the 5-8 range of reaches within regime. Many of the mainstem are in narrow or confined valleys, so were less likely to have full meander development; those reaches in wider valleys had no significant impact for changes in the expected meander geometry.

Figure 12: Floodplain and Planform Changes in the Green River watershed.
