West Branch Passumpsic River & Sutton River Corridor Plan Addendum Caledonia County, Vermont February 12, 2014

West Branch Passumpsic River & Sutton River Corridor Plan Addendum Caledonia County, Vermont

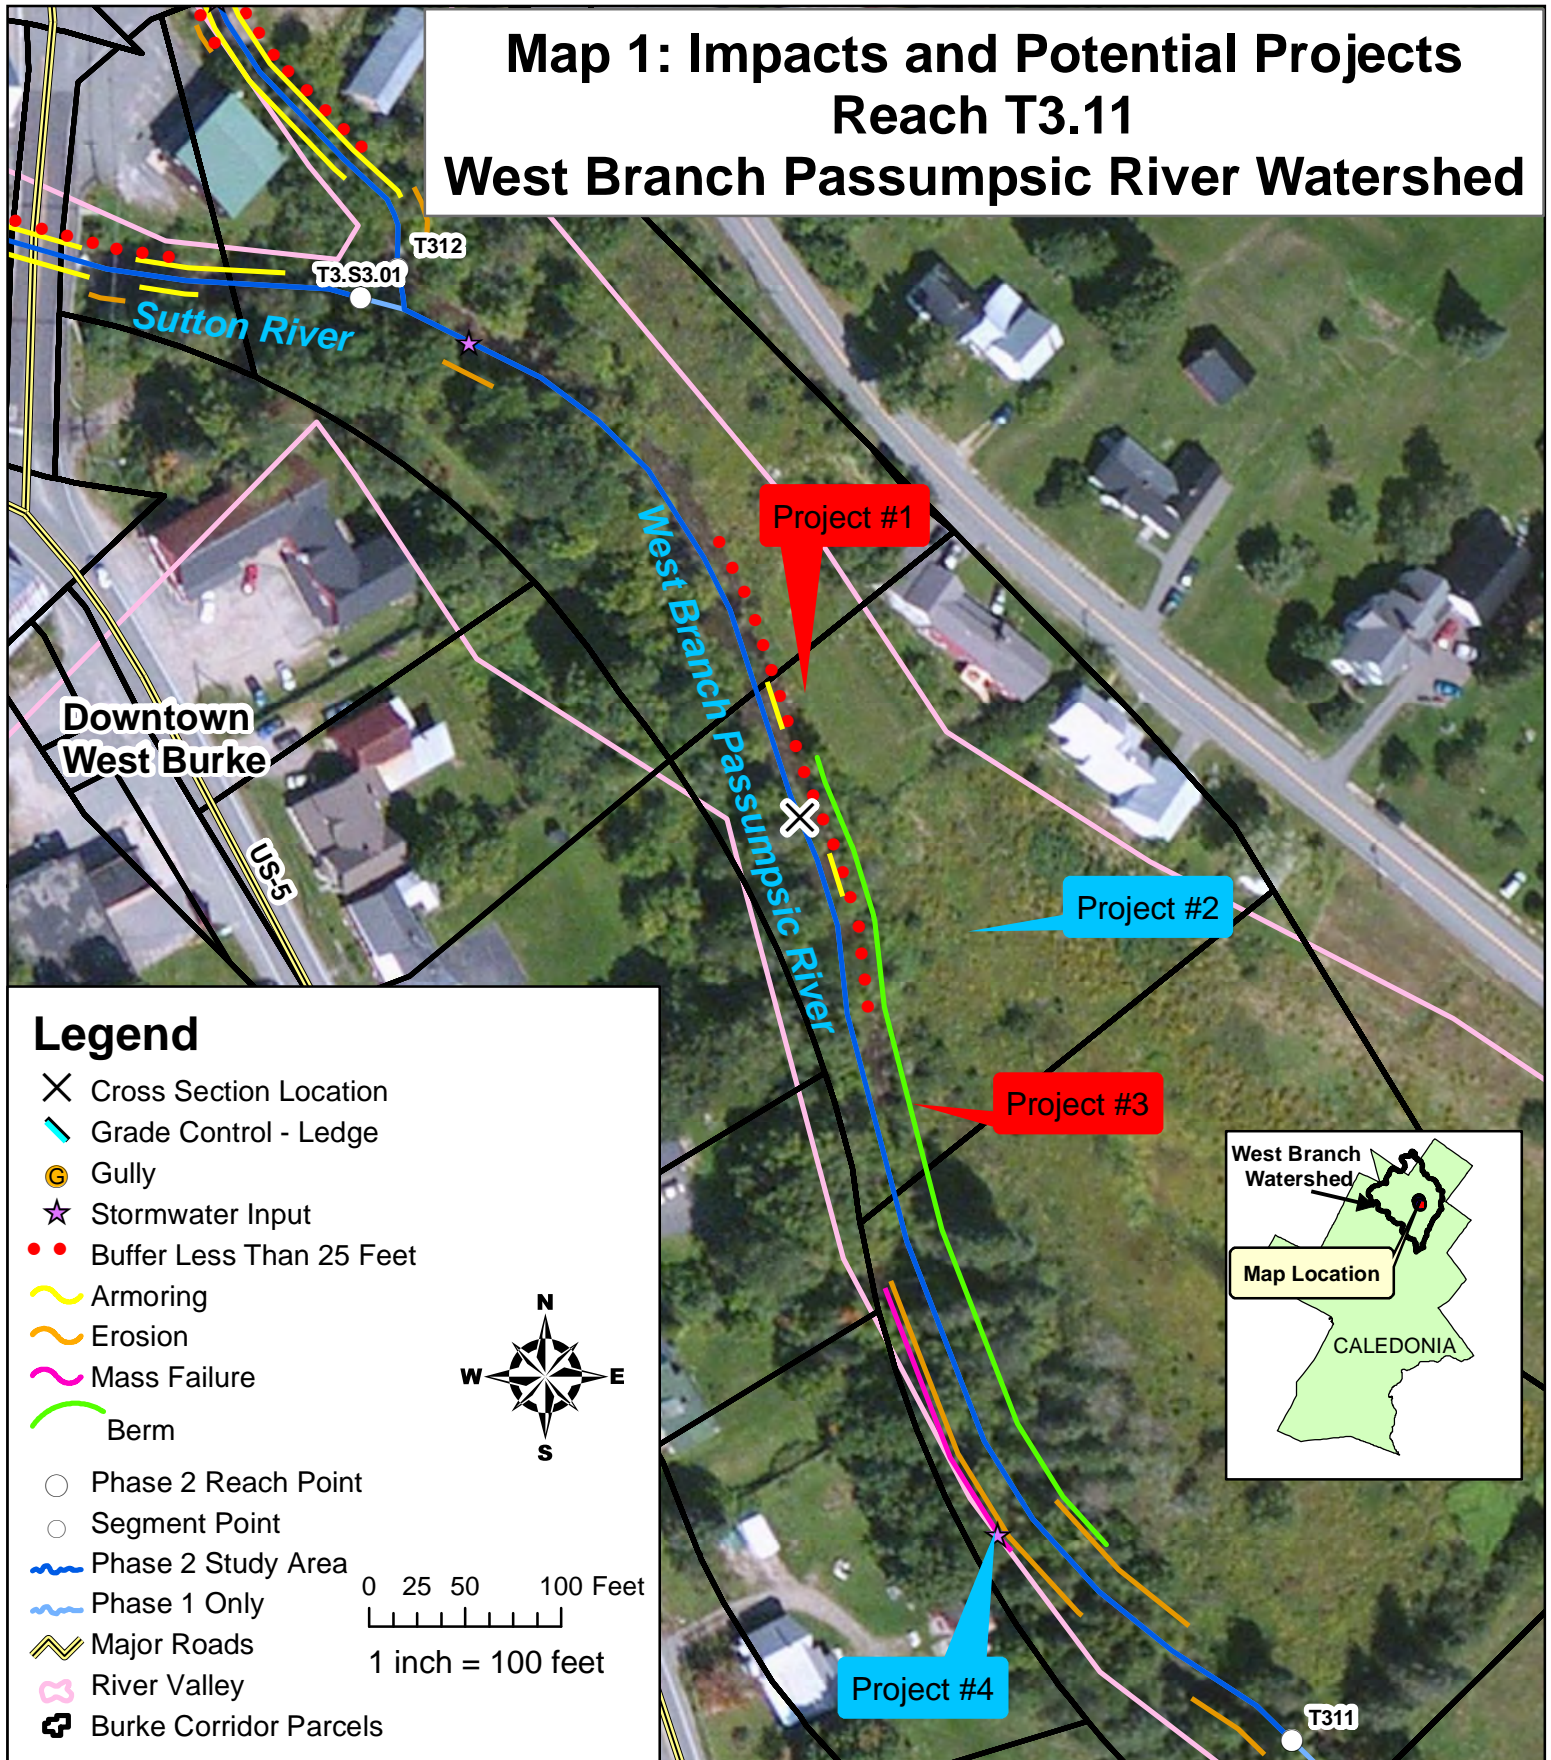
Map 1: Impacts and Potential Projects Reach T3.11 West Branch Passumpsic River Watershed

1. Streamside Plantings
2. Allow Natural Regeneration of Buffer
3. Alternatives Analysis for Berm Removal
4. Stormwater Management and Bank Stabilization

- **Passive Restoration** by planting trees within the riparian corridor in areas where buffers are less than 25 feet wide to reduce property loss from further bank erosion and enhance bank and buffer conditions. (Map 1: Project #1)
- **Passive Restoration** by allowing natural regeneration of buffer to improve buffer habitat and stream channel protection. (Map 1: Project #2)
- **Active Restoration** by conducting alternatives analysis for berm removal to open up more floodplain access for overbank streamflows and sediment storage. (Map 1: Project #3)
- **Stormwater Management** by evaluating stormwater input around old sewage pipe no longer in use and stabilizing stream bank around the pipe.(Map 1:Project #4)

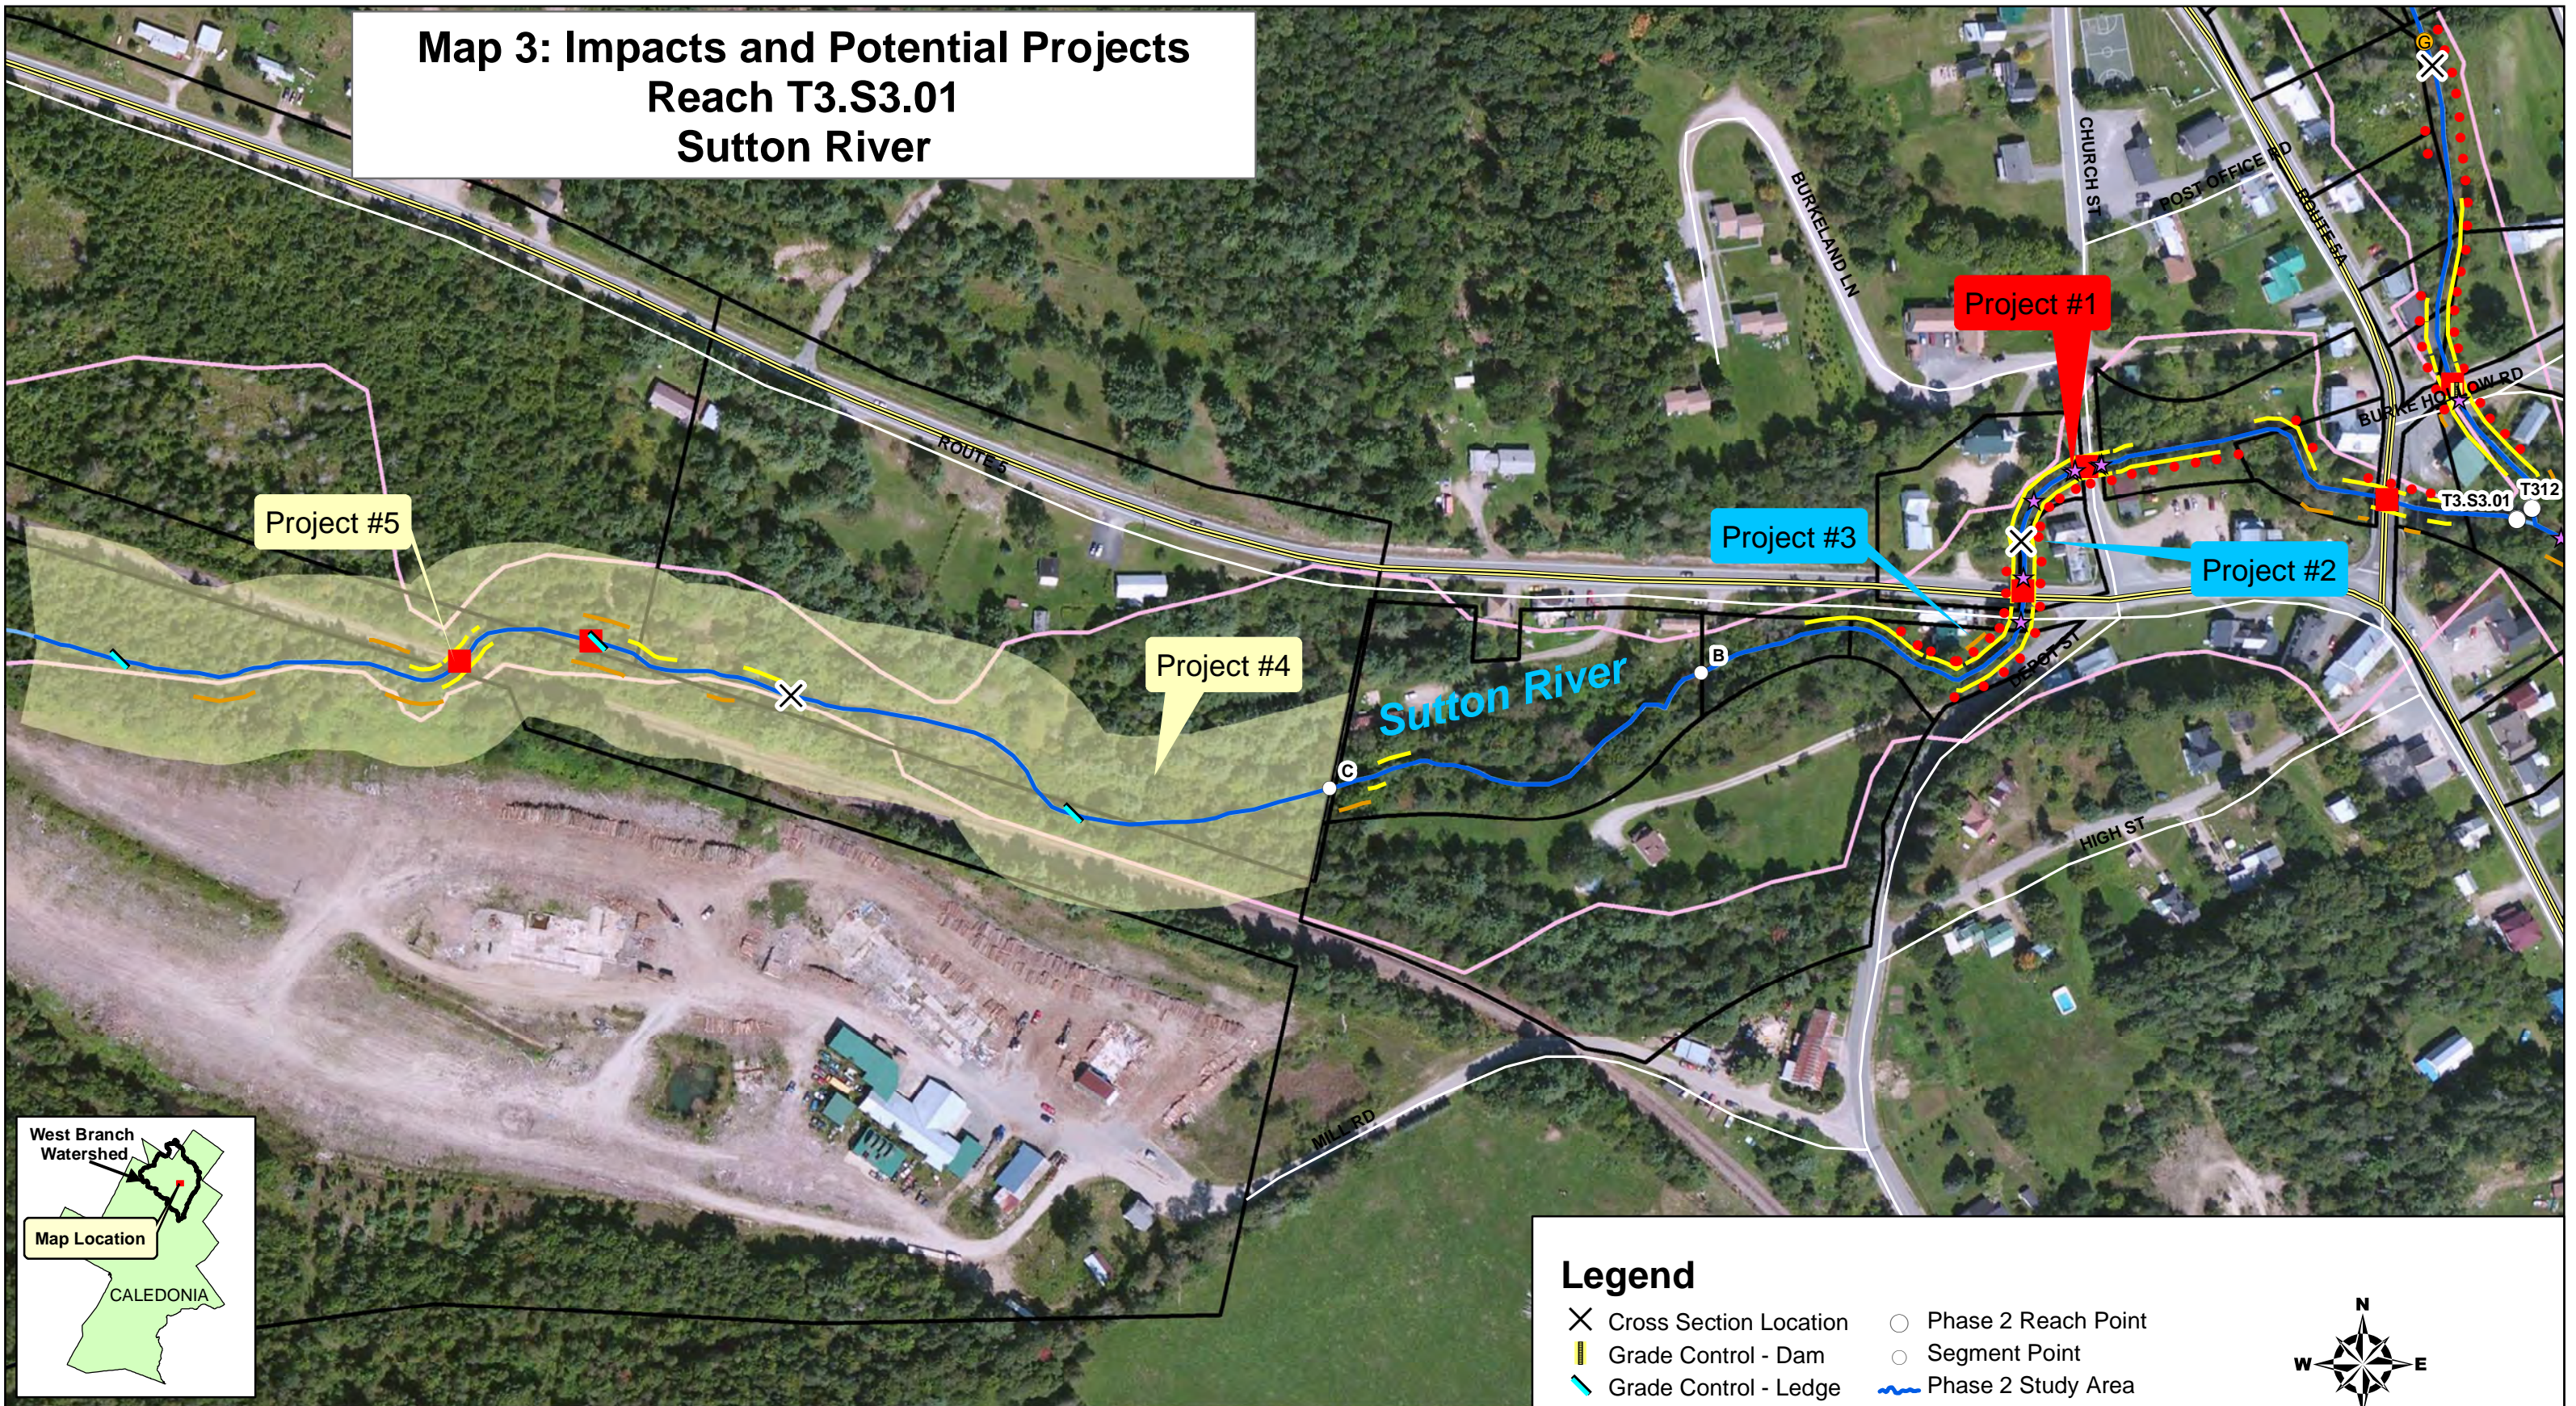
Map 3: Impacts and Potential Projects Reach T3.S3.01 Sutton River

- Projects:**
1. Stormwater Management
 2. Streamside Plantings
 3. Streamside Plantings
 4. River Corridor Easement
 5. Investigation of removal of piers and sheet metal

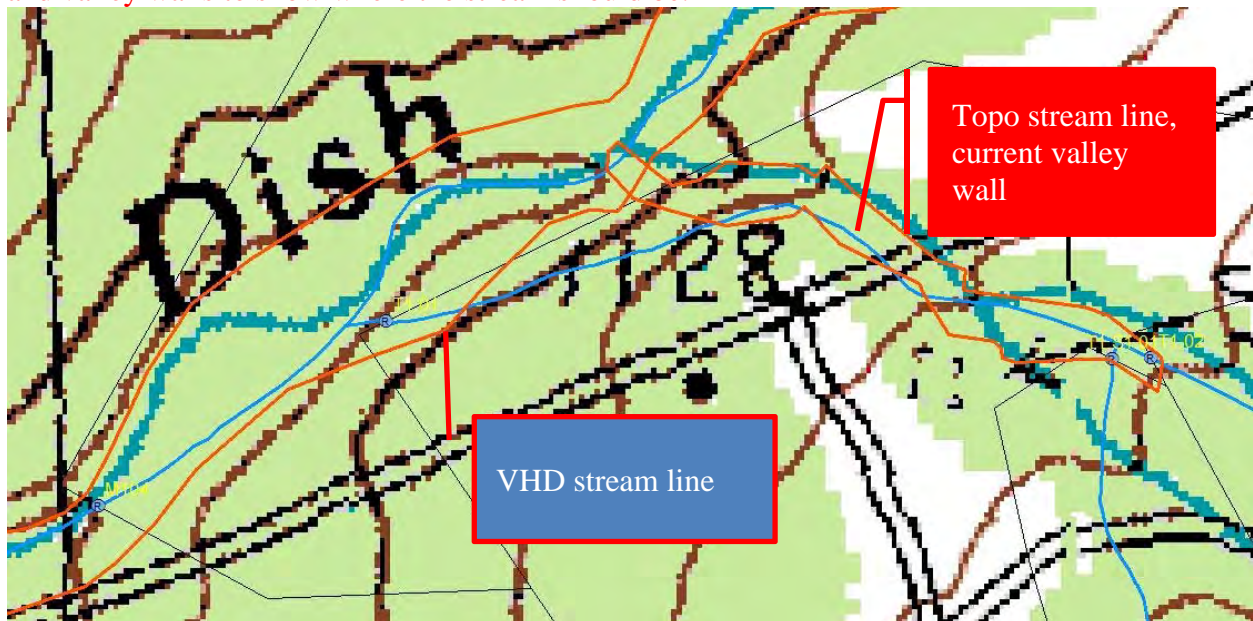
T1.01 –

- Discussion note – question on the Phase 2 valley wall. It does not line up with the current VHD stream line; it looks like it lines up with the topo stream line, which enters further upstream. Is the stream located as the VHD has it or as the topo has it?

The VHD is off. I can provide you with the GPS points we took in the field for line and point impacts and valley walls to show where the stream should be.

This could represent a difference in stream and valley length –changes in slope as well. As we are tied to the VHD at the moment and SGAT has been run with this configuration; this will need to be documented in the Phase 1 notes if the VHD stream line is not correct. Corrections in stream and valley length may be able to manually corrected in the DMS or updated in the notes for correct length/slopes.

There is a change in stream length as a result. The stream length should be about 940 feet and the valley length about 920 feet. I added a note in the phase 1 data and I updated the stream and valley lengths in the Phase 1 and 2 DMS. – ok, thank you

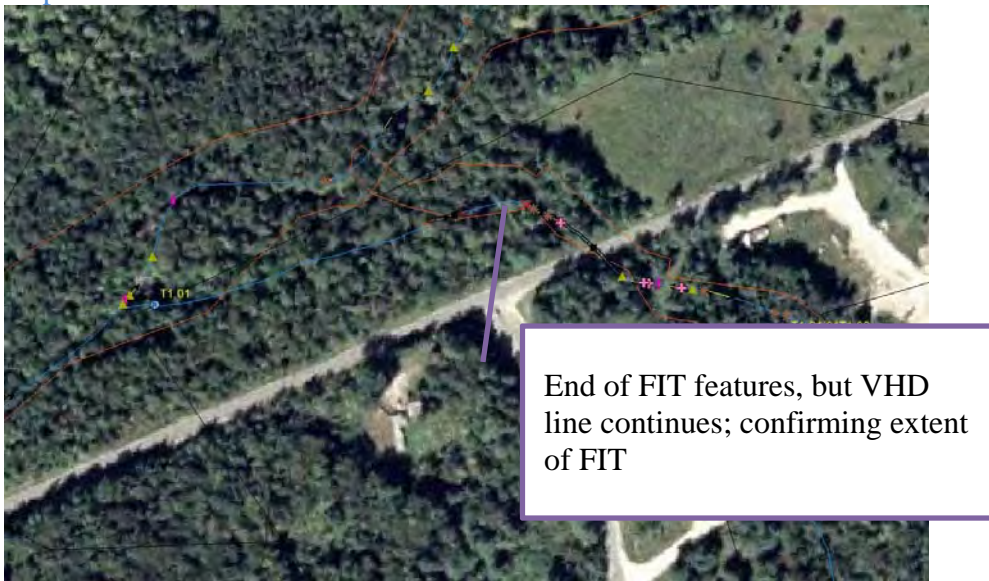
sure if FIT location indicates end of reach and/or information not in correct location spatially due to VHD off we can track it.

I used the current line to index the impacts so it would generate the lengths, but luckily I did not have any impacts in the downstream end. Again I can send you our points from the field so you can see where the impacts ended. – ok, just good to know that current features are in correct location and ended as noted on the map.

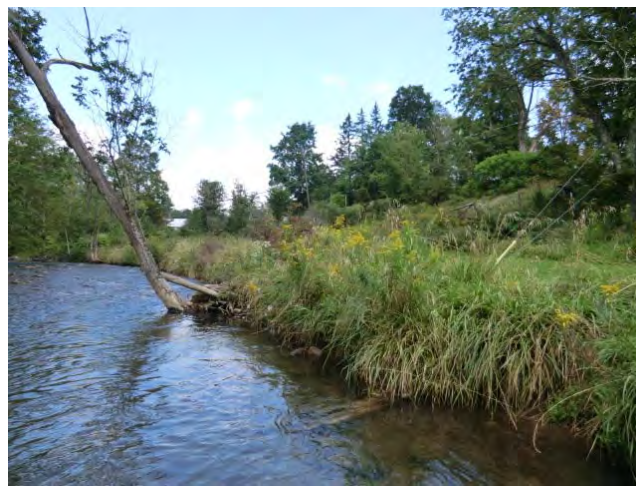
that the channel has widened. The tree in the following photograph used to be on the bank according to him. I changed the reference width to 30 feet to reflect this information considering that the channel is now about 40 feet wide. The channel was not straightened in the upstream reach and the channel width was also narrower than reference, so I don't think straightening had to do with the narrower actual channel width. While the curves do not always predict exact measures; a difference of ~23' in expected width raises questions. Given that this is a C stream type the width would be expected to be reasonably close to the expected curve estimate. Were there soils, slopes, valley constraints, etc. that would have caused the widths to be that much narrower than expected? What clues did you see that led you to 30'f or a reference width, was it only based on the landowner's comments?

Both T3.11 (613' out of 939') and T3.12A (1,013' out of 1,400') were identified as straightened segments. Perhaps when it was straightened it may have been narrowed? There were dams noted in the T3.12 reach, perhaps this has also influenced the widths in these reaches? It is likely the landowner is seeing the channel become wider if given the watershed size and other factors; the expected width would be wider. Given all factors, would we expect to be trying to manage this channel back to a width of 30ft?
