Green River Corridor Plan

Guilford and Halifax, VT

November 1, 2014

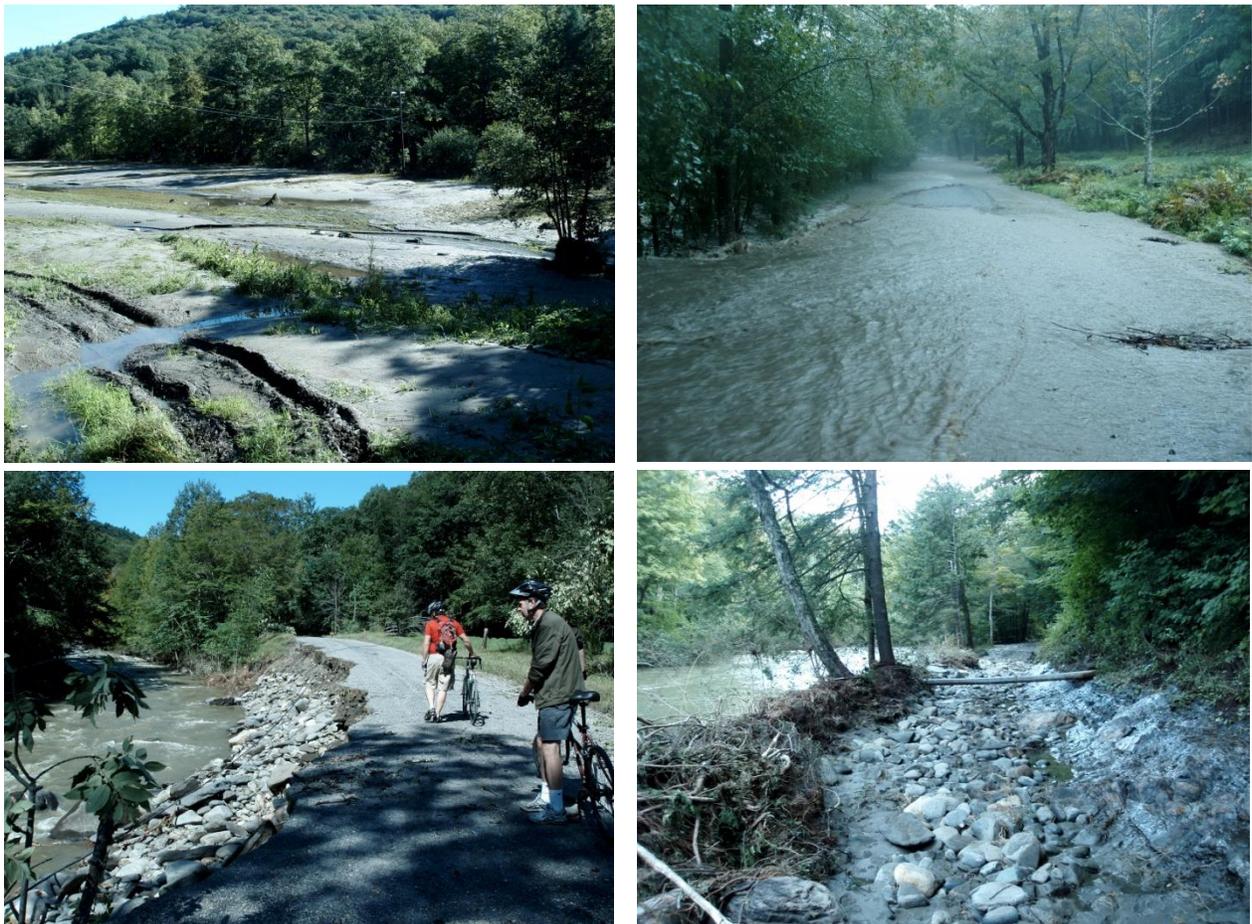
The Green River watershed was one of the hardest hit areas in Vermont during TSI. Area rainfall totals from August 28, 2011 recorded approximately 8" of rain and it is likely that higher amounts actually fell within the upper watershed. Huge volumes of water washed off of the steep headwaters and through the tight valleys of the upper mainstem. As the channel slope decreased the river began to spill over its banks and fill the valley. Major sand and silt deposits were left on accessible floodplains (Figure 1.5). Roads were damaged or destroyed throughout the study area as they were undermined or overtopped by floodwaters (Figures 1.6 - 1.8). The flood also caused major erosion and mass failures along the forested banks and valley walls generated huge volumes of fine sediment, filling in many of the deeper pools and the popular swimming area above the timber crib dam (Riggs, 1995).

Figures 1.5-1.8: Clockwise from top left: deep sand and silt deposition on floodplain in reach M05; floodwaters overtopping River Road near the Massachusetts border; Green River Road in Colrain MA destroyed after the waters receded; cyclists surveying damage to Hinesburg Road near the Deer Park Bridge on reach M08B. (All TSI photographs courtesy of Linda Lembke)

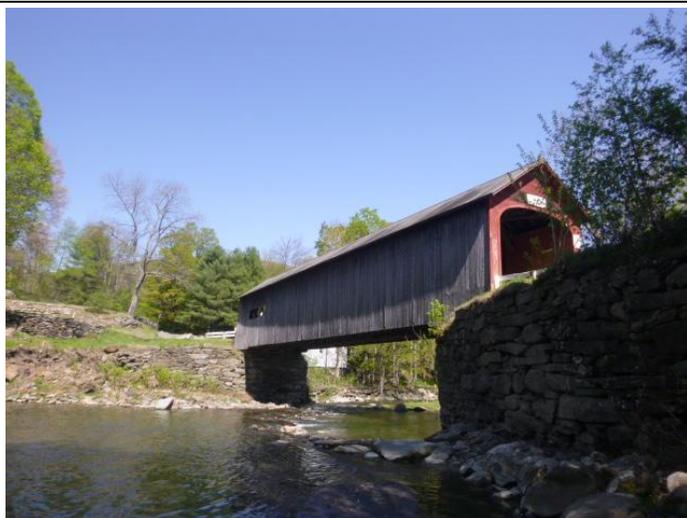
Historic Green River covered bridge

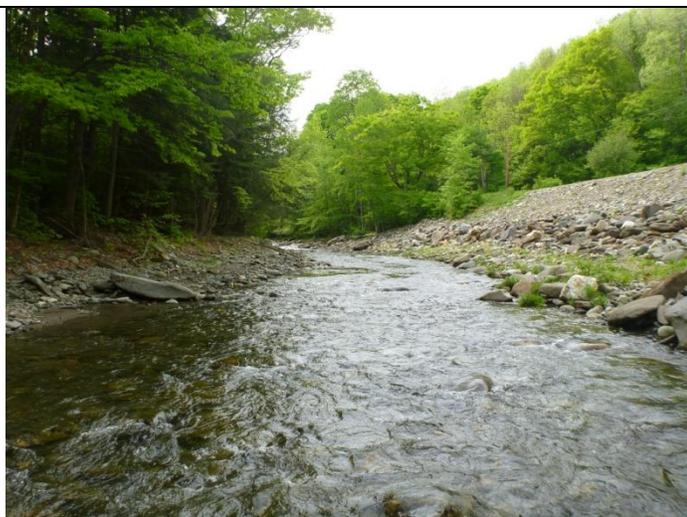
Reach Highlights: This segment is highly encroached and armored along Hinesburg Rd with development throughout. The extensive armoring pinned the channel against the right valley wall leading to large mass failures and incision as the bed degrades (CEM stage II). Somewhat accessible floodplain benches remain throughout the segment causing the stream type departure from C to B.

Narrow and somewhat accessible floodplain benches consistent throughout reach

- #14 - Add topsoil and plant upper armor slope along Green River Road

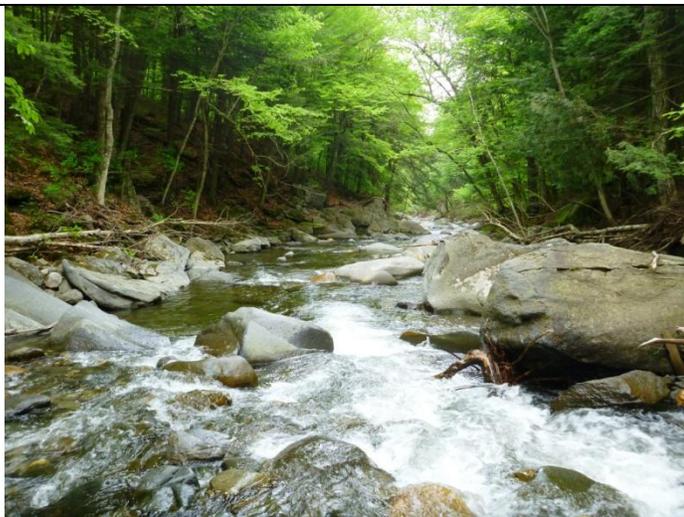
Reach Highlights: This segment was in near reference condition as an A2 step-pool. The channel was stable, resulting in a CEM stage I designation. Some increased gravel deposition was observed in pools as flood sediments work through the segment. A large mass failure occurred on the right bank at the bottom of the segment and is likely a contributing sediment source for lower reaches.

Well defined step pool sequence through boulders

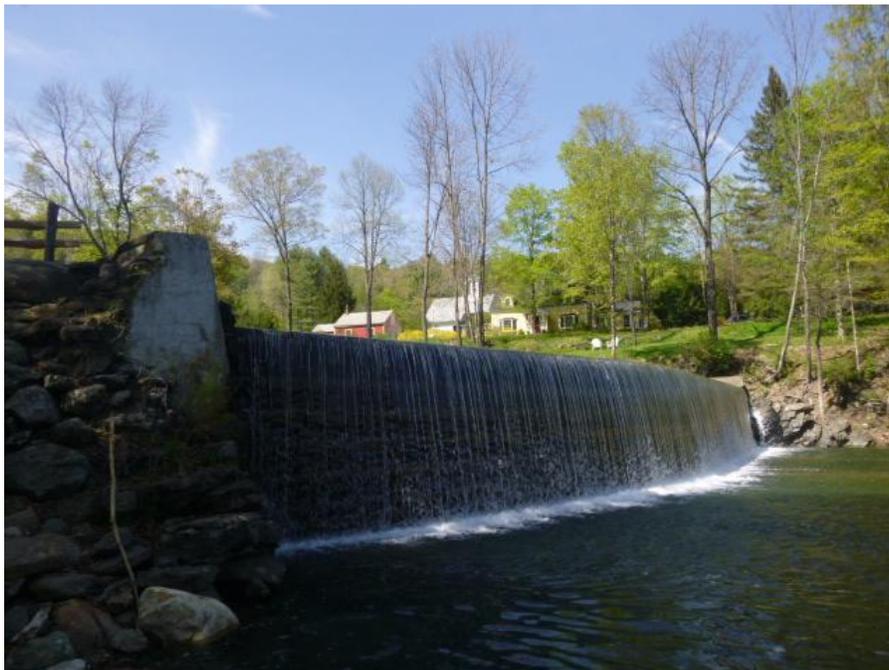
Figure 4.2: Historic timber crib dam on segment M05A.

Reach Highlights: This reach was segmented out and only partially assessed due to extreme sedimentation and ponding above the timber crib dam. The 13 foot tall dam has completely filled in with sand and gravel burying the natural stream bottom for approximately 1,100 feet to the start of M05-B. The dam is built on a bedrock grade control which continues downstream to the stacked stone abutments for the historic Green River covered bridge. A fish ladder was constructed around the dam, however the sediment deposits above the dam limit fish movement at low flows.

- Some dense areas of natural grade control on segments: M04, M09C, M12, and M13
- An on-stream dam is located on segment M05A (Figure 4.2)
- Extensive bank armoring on segments: M09A (Figure 4.3), M11, and M13

- #6 - Timber crib dam sediment management and/or long term planning for dam removal.

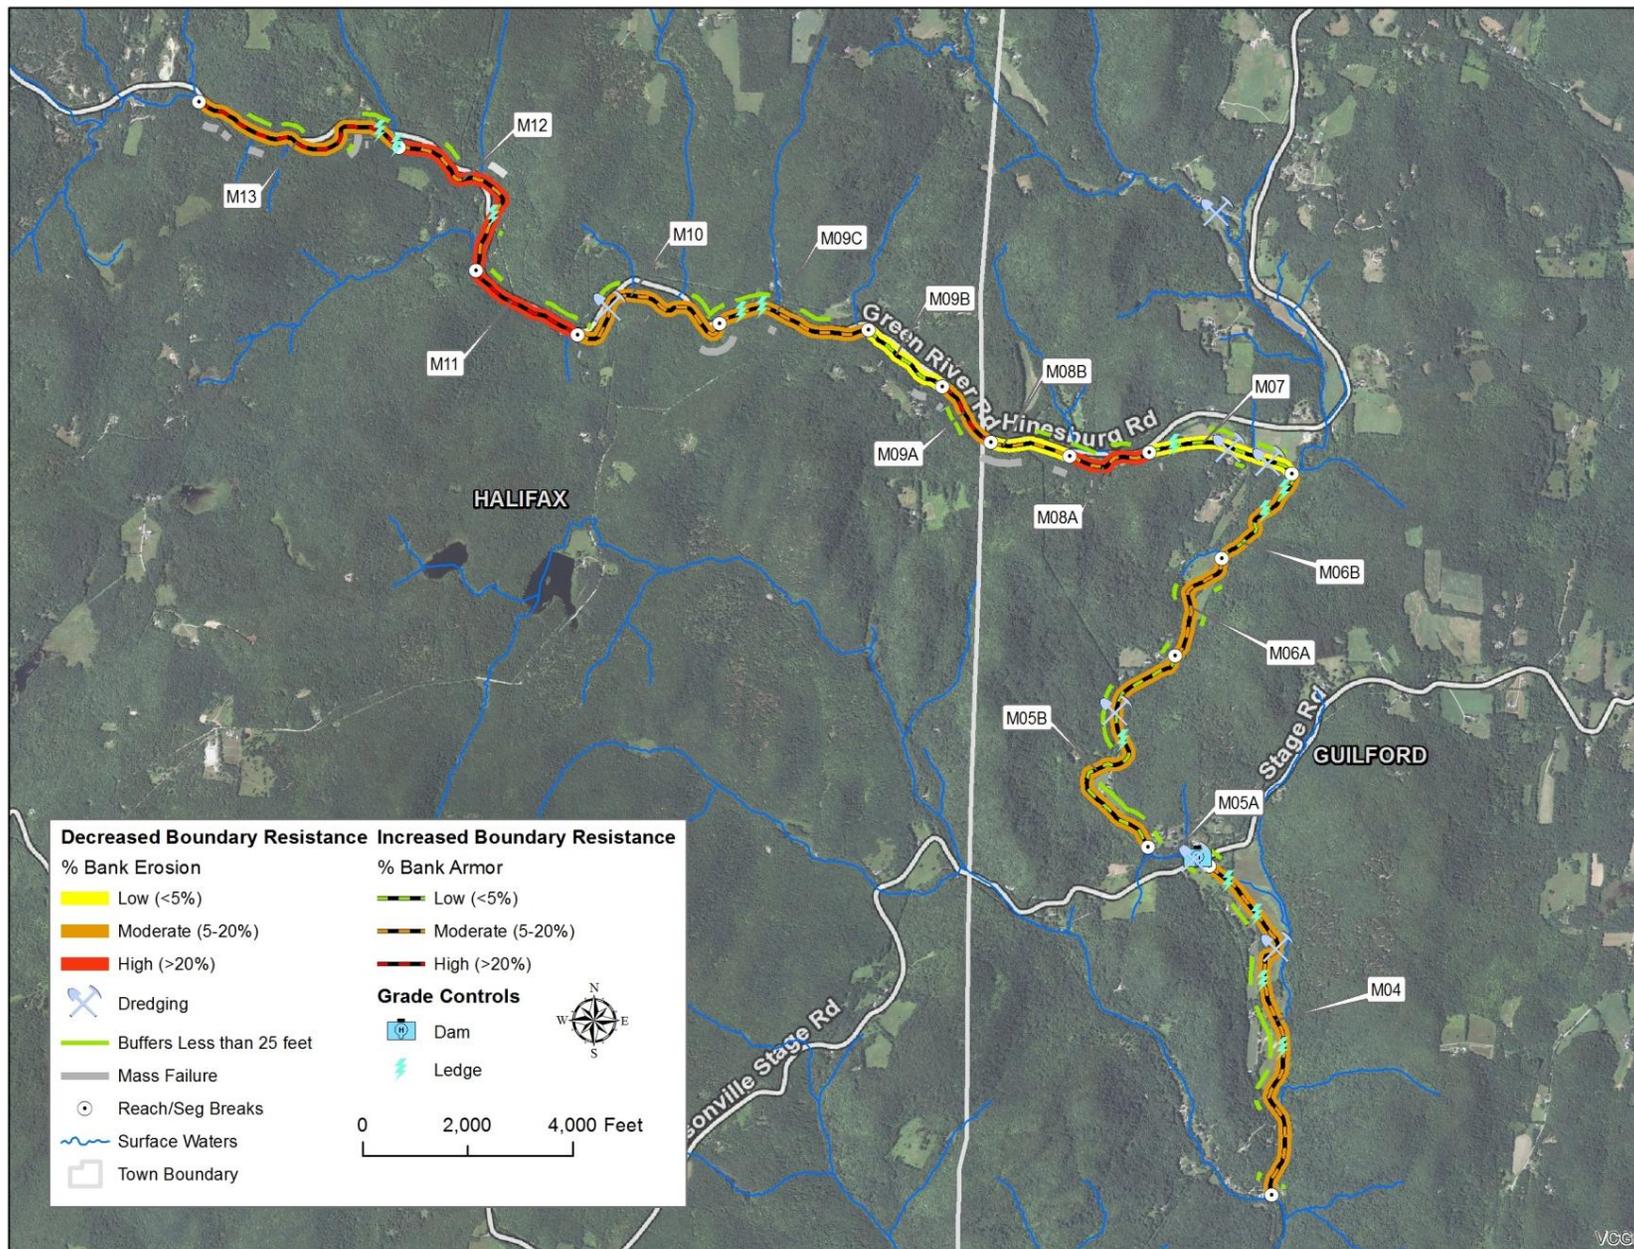
Figure 4.6: Riparian and boundary condition modifiers for the Green River watershed.

Alterations to the channel boundary conditions and riparian areas in the Green River study area have been mapped using the variables extracted from the Phase 2 field dataset (Figure 4.6). Bank armoring (e.g., rip-rap) highlights areas of increased resistance to lateral migration, whereas bank erosion highlights reaches where significant lateral adjustments are found. Additional data showing the location of natural and man-made channel features (e.g., ledges and dam) depict areas that have a resistance to channel change.

- High bank erosion in segments: M08A, M11, and M12 (Figure 4.4)
- Large mass failures in segments: M08B (Figure 4.5), M10, M12, and M13
- Dredging in segments: M04, M05A, M05B, M07, and M10
- High density of riparian buffer width impacts in segments M04, M05B, M07, M08A, M09A, M09C, and M13

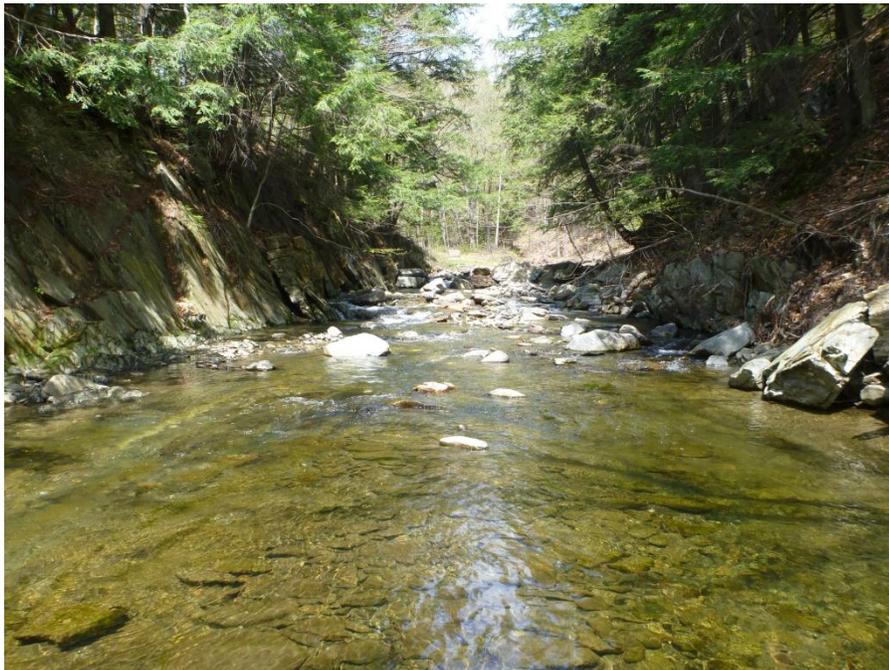
Figure 4.10: Bedrock gorge with grade control in reach M12.

- Segments with numerous or large natural grade controls: M04, M09C, M12, and M13 (Figure 4.10)
- Segments with man-made grade control (dam): M05A

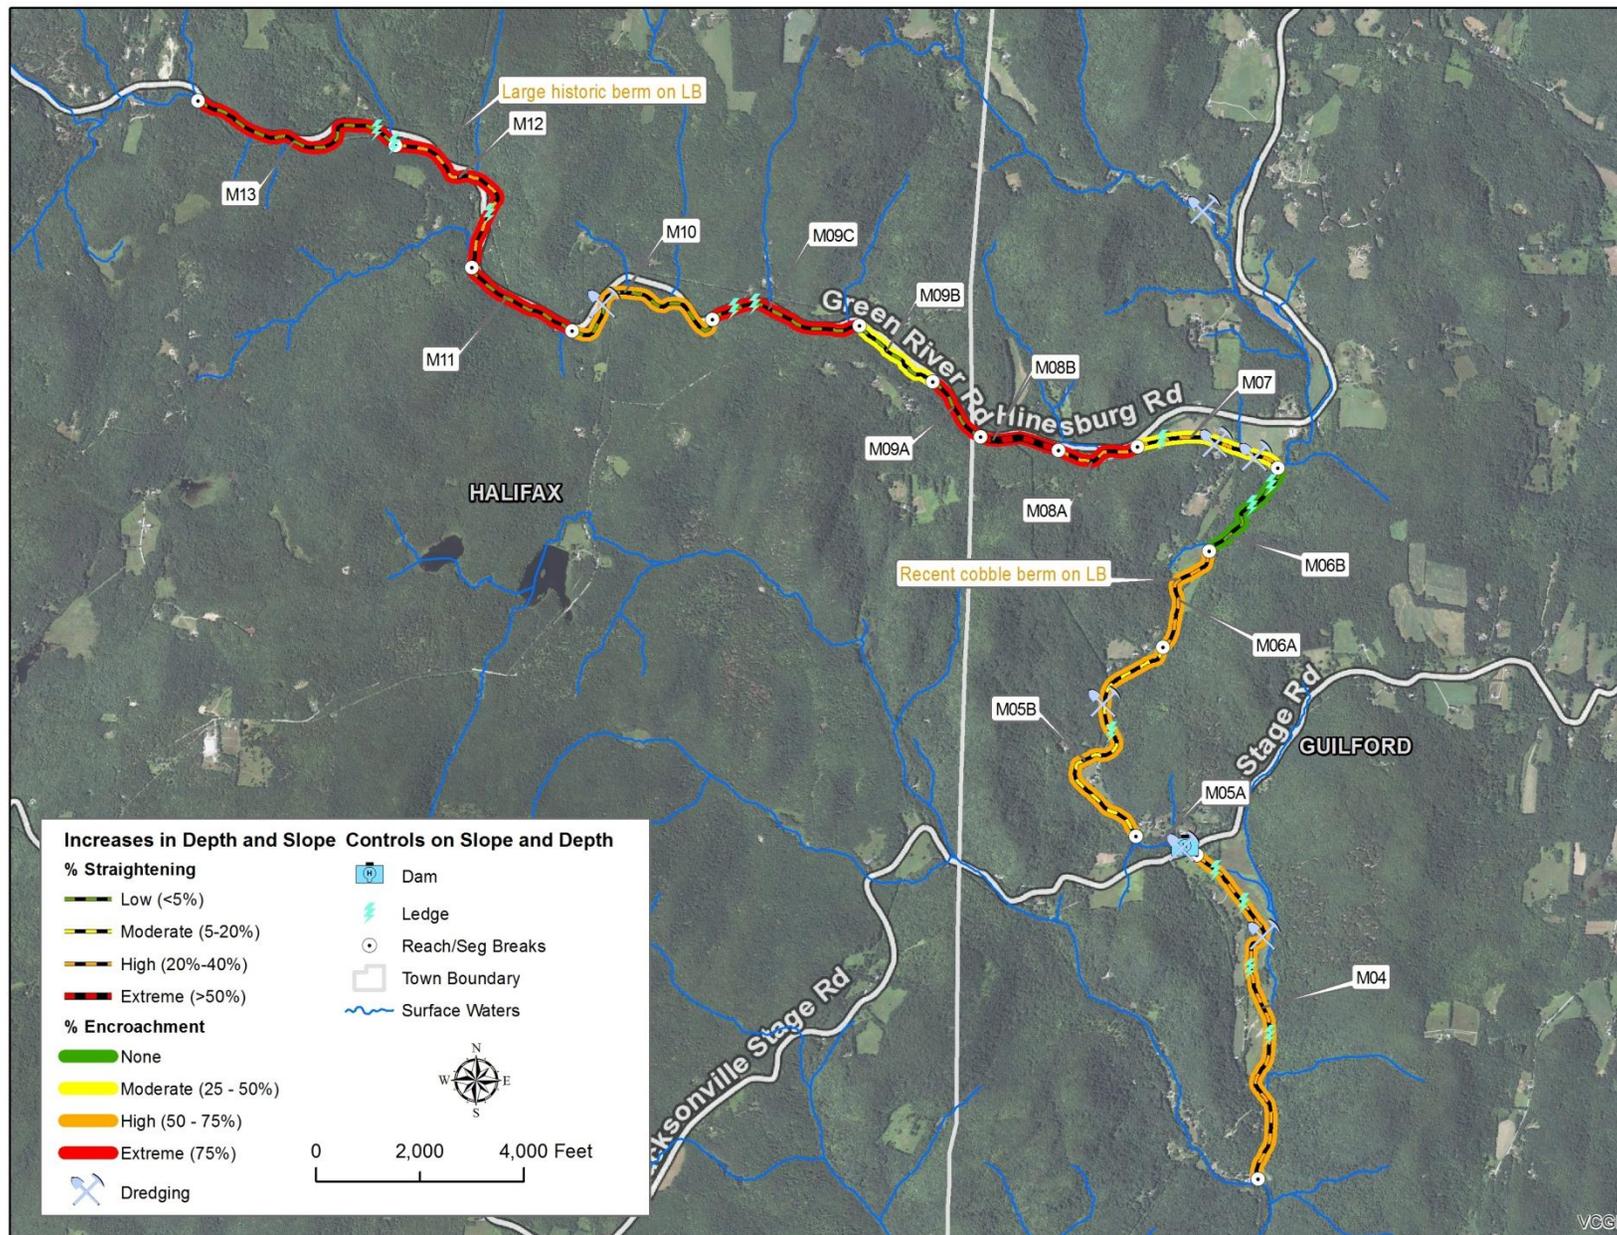
Figure 4.11: Controls on slope and depth for the Green River Watershed.

Alterations to channel slope and depth in the Green River study area have been mapped using the variables extracted from the Phase 2 field dataset (Figure 4.11). Channel straightening mapped during the Phase 1 and 2 assessments are included to depict areas of increased channel slope. Corridor encroachment data highlights where roads, development, and berms have reduced the floodplain area, typically resulting in increased stream power and channel deepening. Additional data shows the location of natural channel features (ledges) and a man-made dam, which depict areas that have a resistance to vertical channel change.

- Extreme channel straightening in segment : M08B (Figure 4.7)
- High straightening in segments: M04, M06A, M07, and M12
- Extreme corridor encroachments in segments: M08, M09A, M09C, M11, M12, and M13 (Figure 4.8)
- High corridor encroachments in segments: M04, M05B, M06A, and M10 (Figure 4.9)
- Dredging in segments: M04, M05A, M05B, M07, and M10

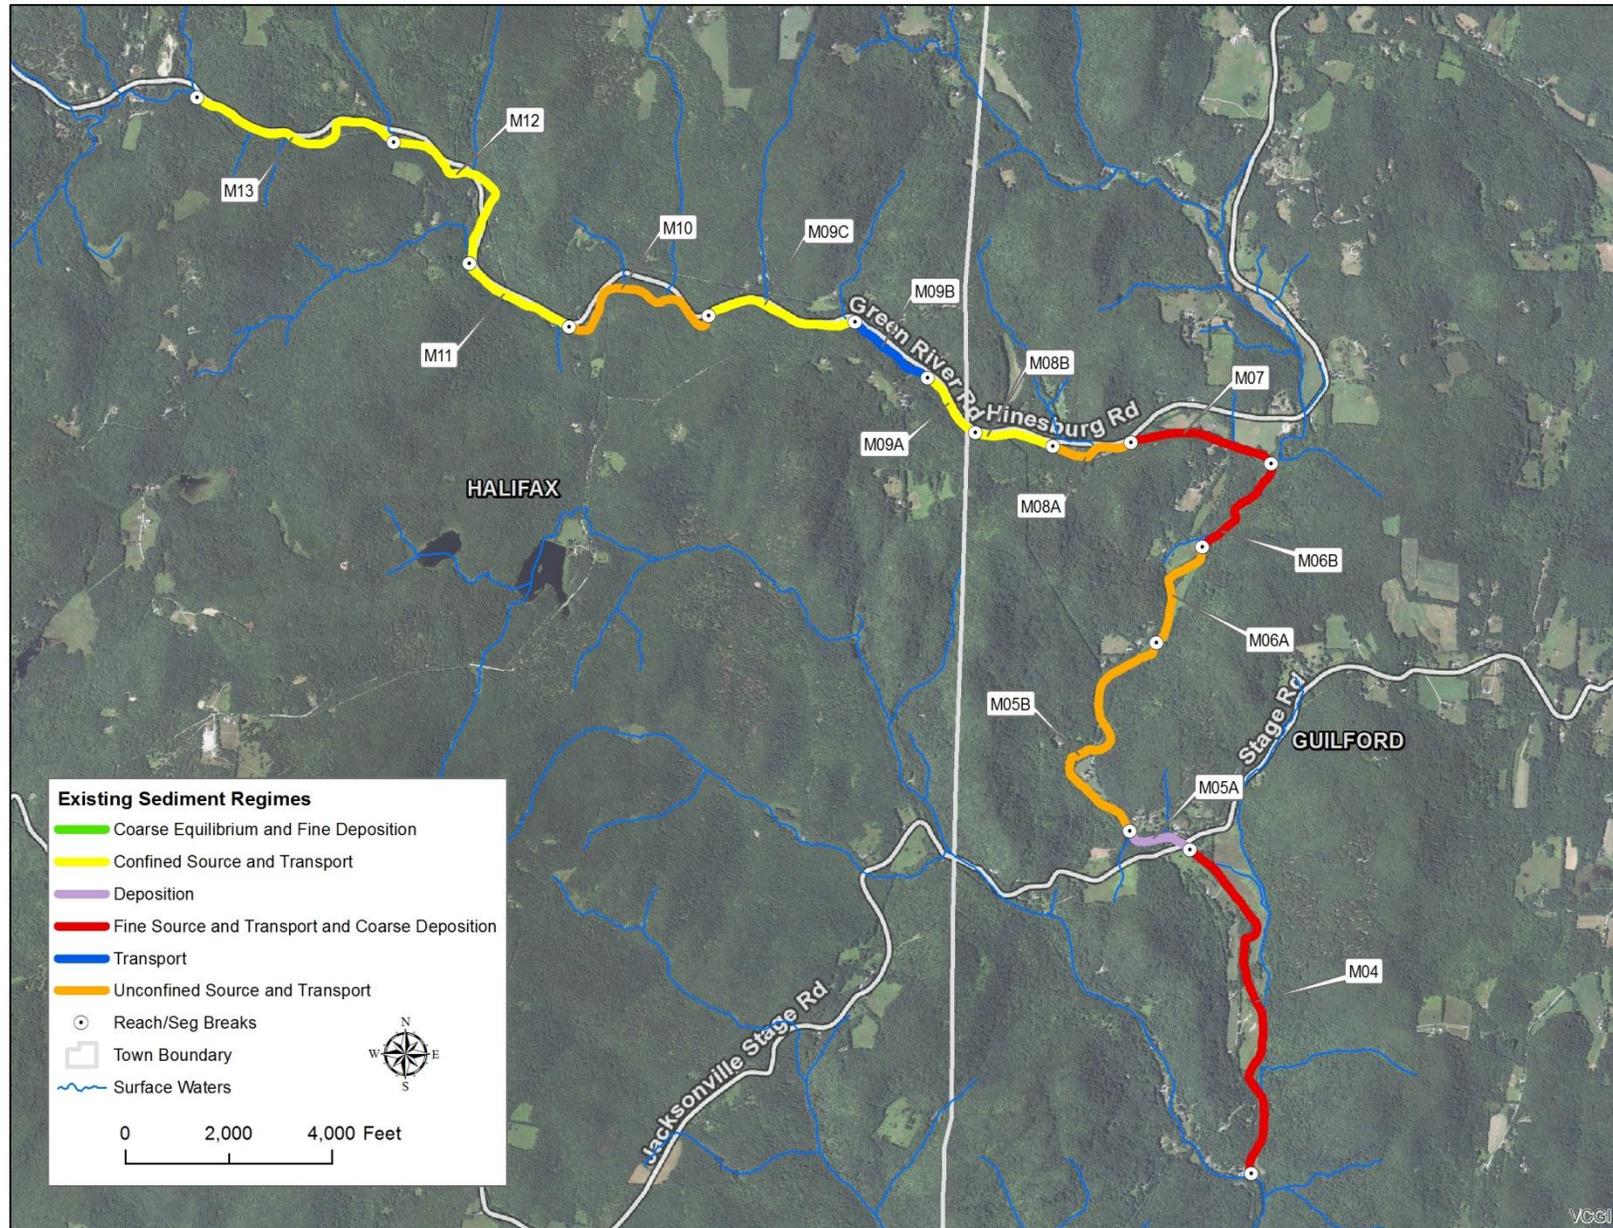
Figure 4.13: Existing Sediment Regime for the Green River watershed.

The reference and existing sediment regime types have been mapped using data from the Phase 1 and 2 assessments (Figures 4.12 and 4.13). Several segments in the Green River study area have undergone a departure in both sediment regime and stream type due to channel incision and/or widening as a result of: 1) historical land uses, 2) encroachments or development in the river corridor, or 3) extensive straightening and bank armoring. Many of the channel adjustments caused by these historic stressors were exacerbated by the extreme flood of 2011, leading to further stream type departures. Segment M09B was the only Phase 2 study segment that was assessed as stable and did not contain a stream type departure and/or a sediment regime departure.

Phase 2 Segment ID	Reference Sediment Regime	Existing Sediment Regime	Cause of Departure
M04	Coarse Equilibrium and Fine Deposition	Fine Source Transport and Coarse Deposition	Recent incision and active widening
M05A	Coarse Equilibrium and Fine Deposition	Deposition	Large historic impoundment
M05B	Coarse Equilibrium and Fine Deposition	Unconfined Source and Transport	Major incision from historic encroachment and recent flooding
M06A	Coarse Equilibrium and Fine Deposition	Unconfined Source and Transport	Moderate incision from historic and recent encroachment
M06B	Coarse Equilibrium and Fine Deposition	Fine Source Transport and Coarse Deposition	Major recent deposition and active widening
M07	Coarse Equilibrium and Fine Deposition	Fine Source Transport and Coarse Deposition	Historic and active widening, deposition
M08A	Coarse Equilibrium and Fine Deposition	Unconfined Source and Transport	Recent avulsion and widening, active incision

M08B	Transport	Confined Source and Transport	Incision from armoring and encroachment
M09A	Transport	Confined Source and Transport	Incision from armoring and encroachment
M09C	Transport	Confined Source and Transport	Incision from armoring and encroachment
M10	Coarse Equilibrium and Fine Deposition	Unconfined Source and Transport	Recent widening and historic incision
M11	Transport	Confined Source and Transport	Incision from armoring and encroachment
M12	Coarse Equilibrium and Fine Deposition	Confined Source and Transport	Incision from armoring and encroachment
M13	Transport	Confined Source and Transport	Incision from armoring and encroachment

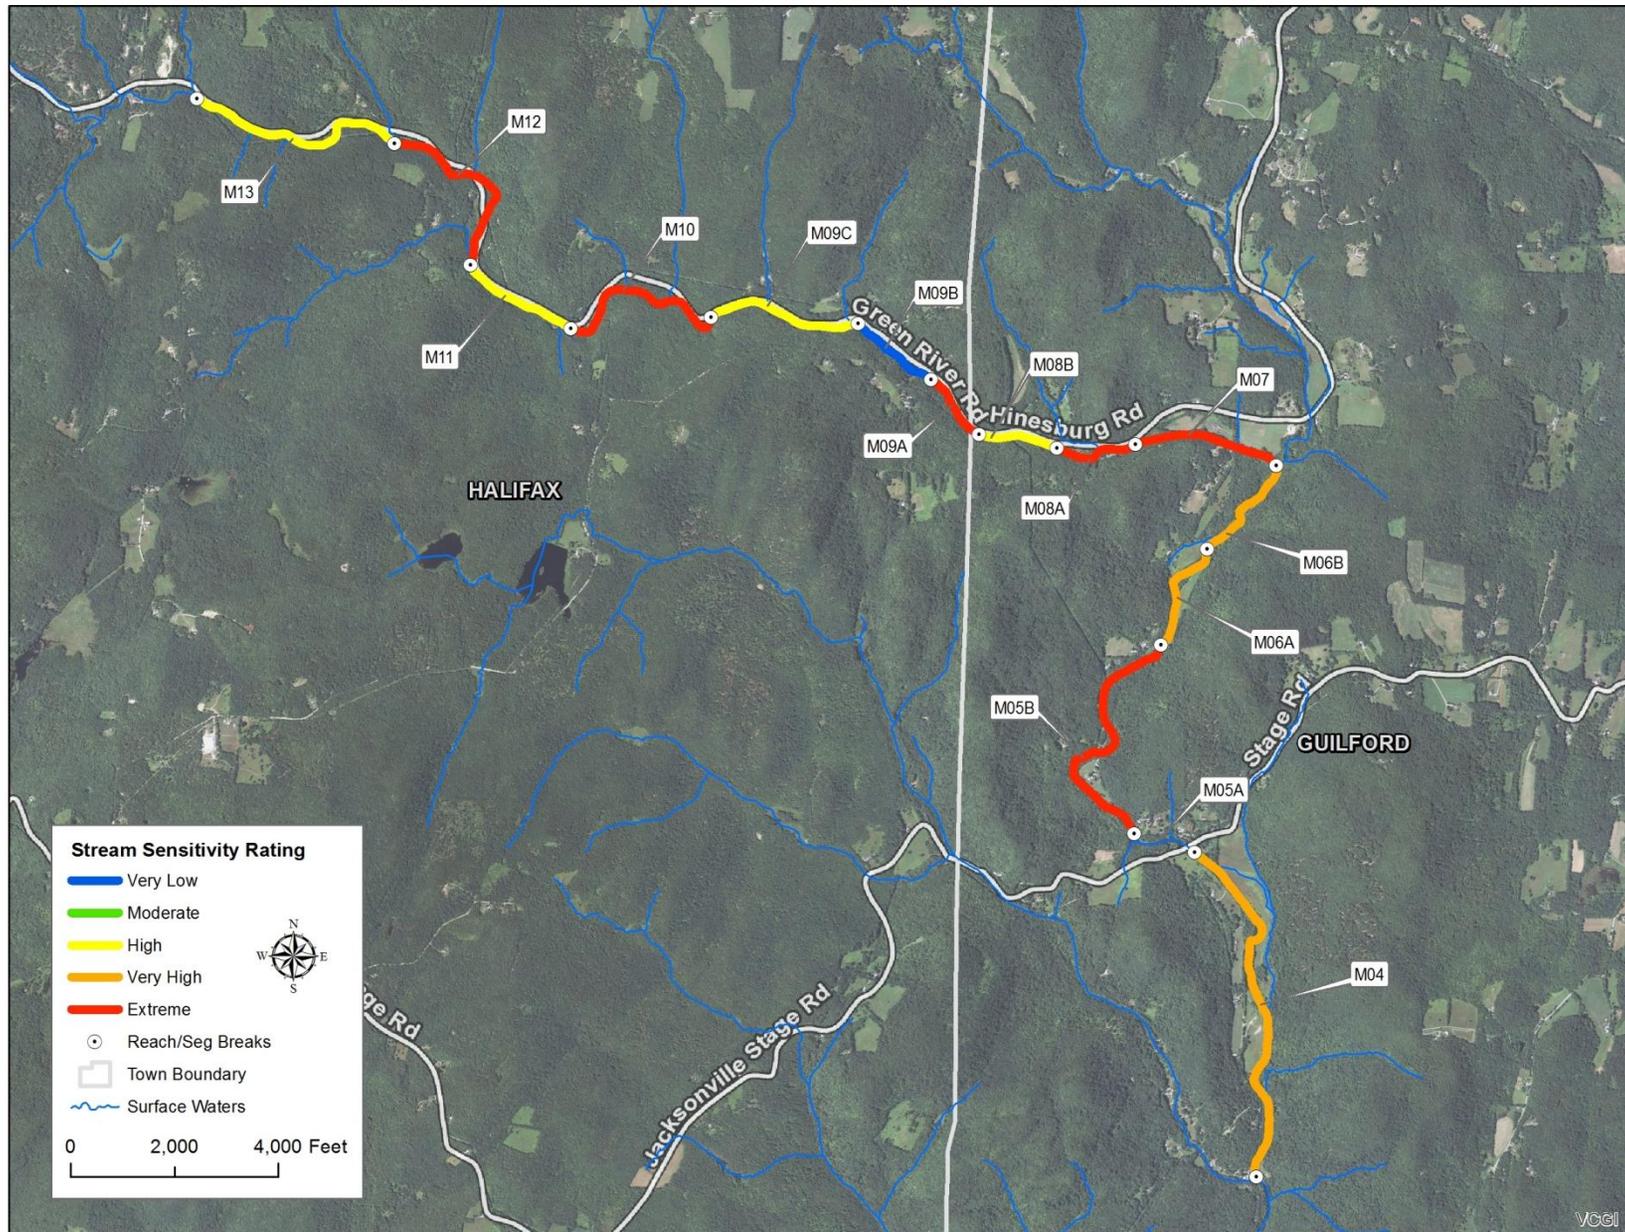
Figure 4.15: Stream Sensitivity Ratings for the Green River study area.

Phase 2 Segment ID	Stream Sensitivity	Description of Impacts
M04	Very High	Widening, Incision
M05B	Extreme	STD, Incision, Encroachment, Armoring
M06A	Very High	STD, Incision, Encroachment
M06B	Very High	Widening, Deposition
M07	Extreme	STD, Historic Straightening and Berming, Widening
M08A	Extreme	STD, Avulsion, Incision, Deposition
M09A	Extreme	STD, Encroachment, Armoring, Constriction, Incision
M10	Extreme	STD, Widening, Armoring, Encroachment
M12	Extreme	STD, Incision, Widening, Encroachment
