**Phase 2 Stream Geomorphic Assessment  
Huntington River Watershed  
Town of Huntington  
Chittenden County, Vermont**

January 17, 2006

Dori Barton  
Principal/Wetlands Ecologist  
Arrowwood Environmental

Town of Huntington, and  
Vermont Agency of Natural Resources

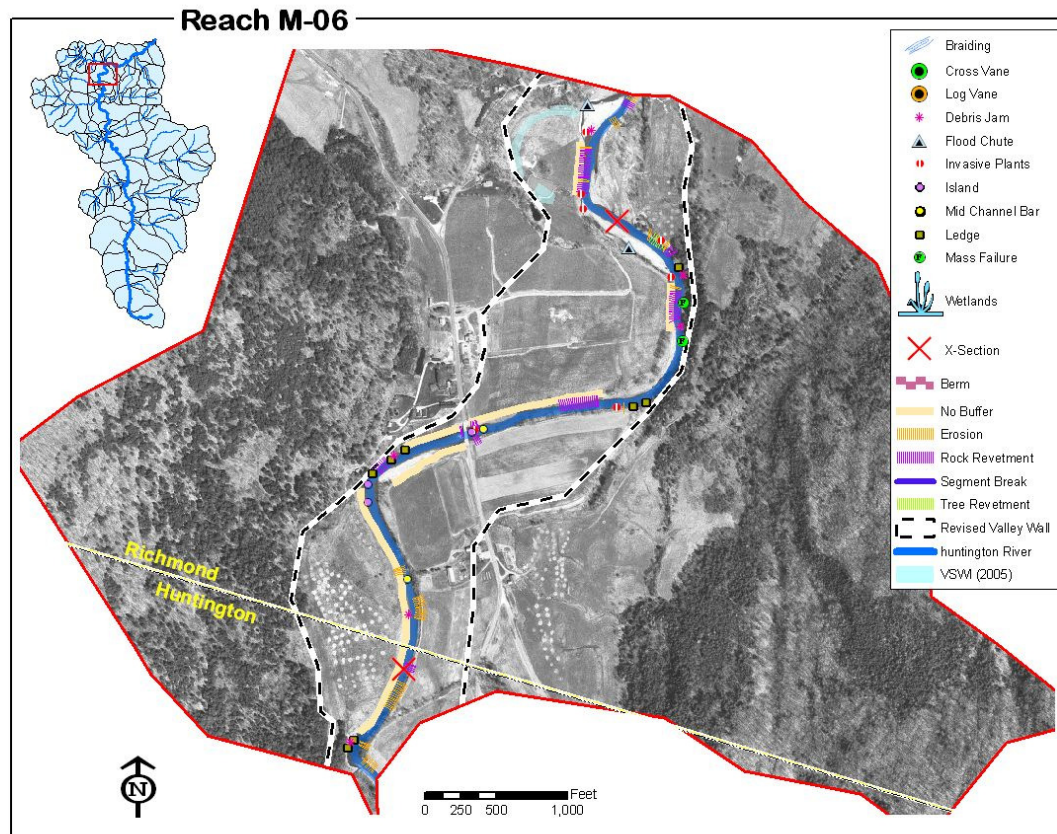
Figure 4. Reach M06 Inventory Map

Evidence of a stabilization project was found on the lower section of the reach. A tree revetment was located on the right bank, a rock revetment on the left bank, log weirs, also on the left bank, and livestock fencing. It did not appear that the log vanes were functioning as designed, partly due to the angle of the weir, its angle of departure from the bank, and placement in relation to planform. The stream could also have migrated, since the left bank is unstable.

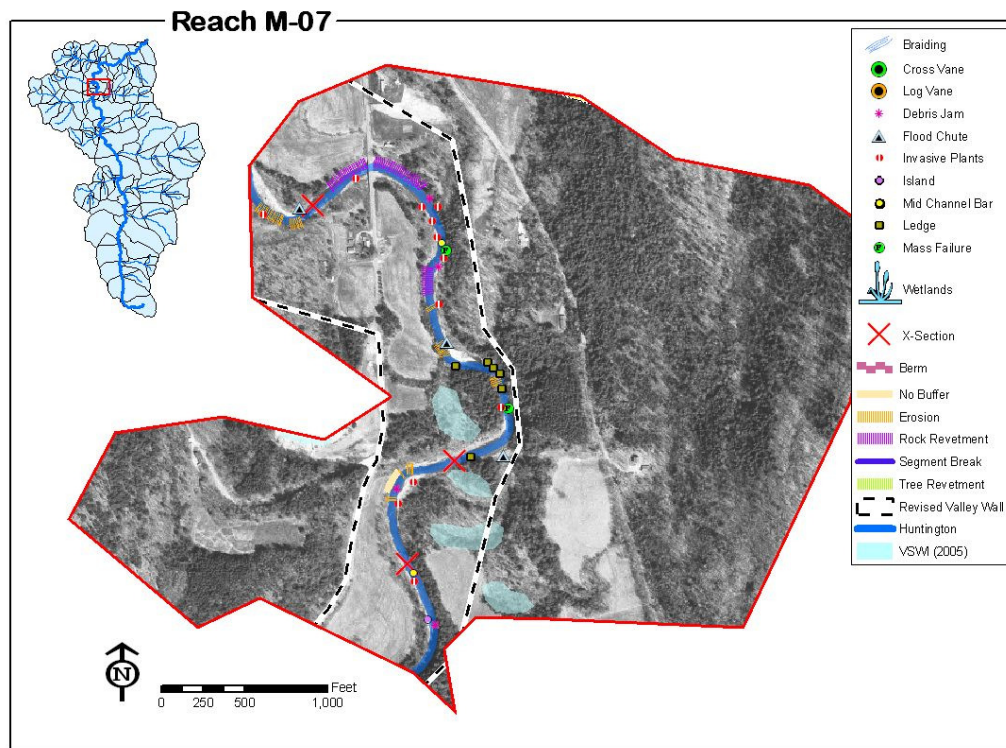
Figure 5. Reach M07 Inventory Map

Segment M07 has some erosion on both banks. Forest and hay fields were observed as the primary land uses within the riparian corridor. The buffer width is fair (greater than 26 feet) and consists of mixed trees. Invasives, particularly honey suckle, are extensive. Sediment storage bars include mid, point, side, diagonal, and delta bars and an island. The river in this reach also appears to have been relocated against the right valley wall and straightened in some locations.

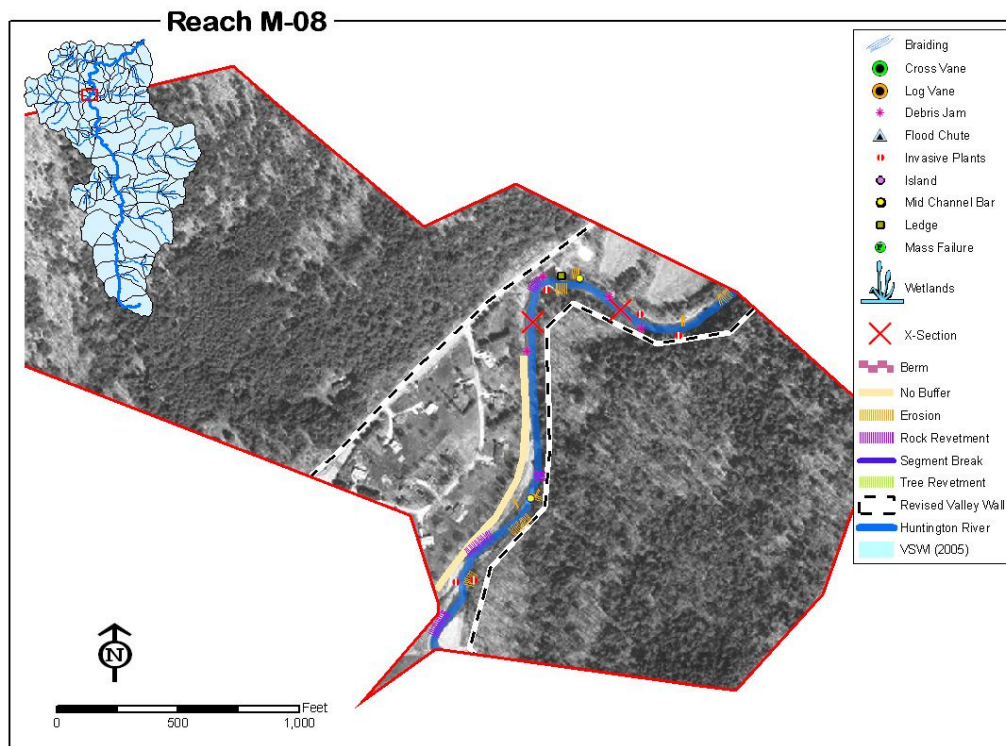
Figure 6. Reach M08 Inventory Map

This reach has also experienced significant historic channel straightening, with the stream relocated close to the valley wall. Bank erosion is found on both banks. The buffer width is less than 25 feet on the left bank, made up of primarily of mixed tree and herbaceous species. Invasive plants were found on both banks. Hay fields and residential development are the primary landuses in the riparian corridor. Sediment storage bars include mid, point, side, diagonal, and delta bars.

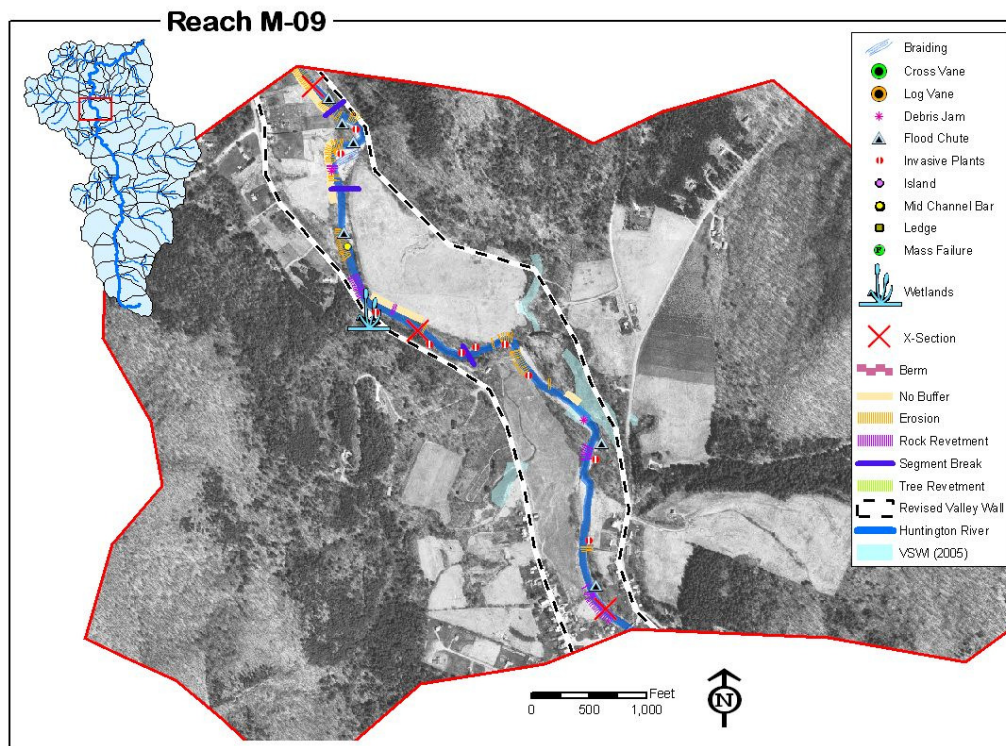
Figure 8. Reach M09 Inventory Map

Segment M09-D's confinement is classified as broad due to the road's encroachment on the river corridor. This segment is only slightly entrenched, with an entrenchment ratio of almost 4.0. However, its incision ratio, measured at 1.2, implies some reduction in floodplain access. The sinuosity of this segment is low, showing evidence of historic straightening.

A hay field dominates the left riparian corridor, while forest and residential housing are present on the right corridor. The buffer is narrow on both banks (<25 feet in width) and has herbaceous vegetation as the dominant vegetation type. Sediment storage bars include point, side, diagonal, and delta bars. Multiple flood chutes and a steep riffle were noted.

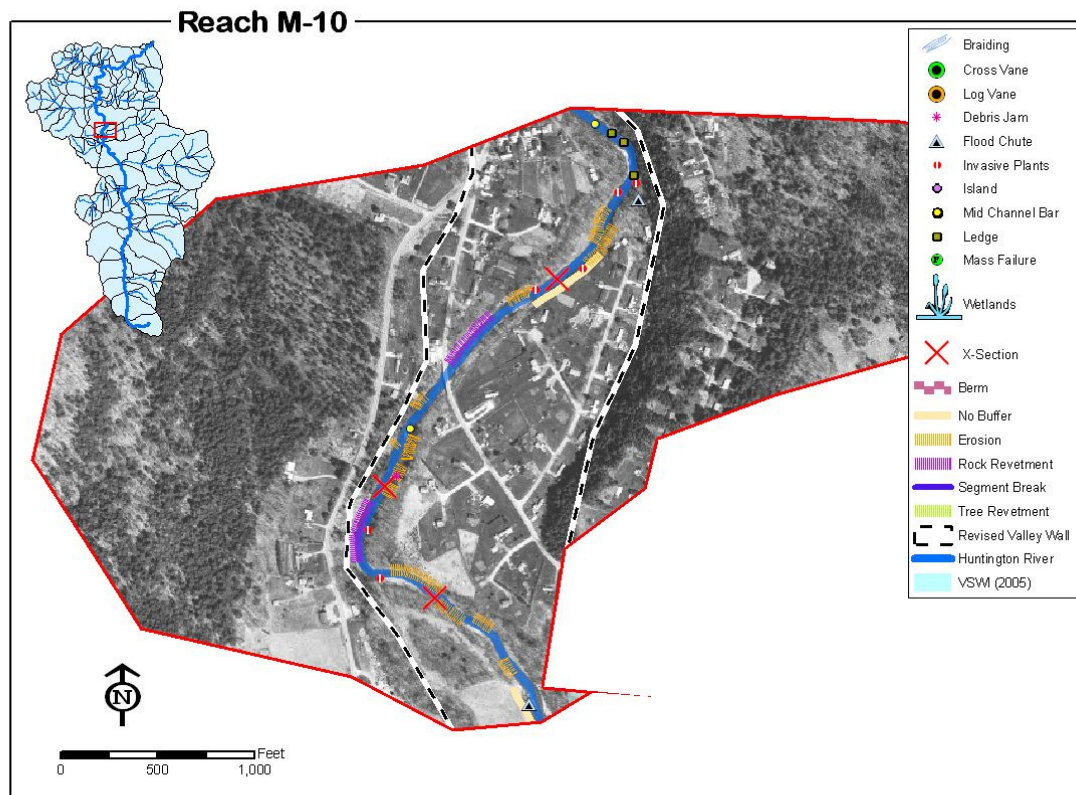
Figure 9. Reach M10 Inventory Map

Reach M10 is adjacent to Huntington Village and flows under the East Street Bridge. The upstream end of the reach is behind Liberty Head Post and Beam. Reach M10 is another riffle-pool system with gravel substrate and a very broad valley. The incision ratio is 1.5, showing limited access to floodplain. Sediment storage consists of multiple side bars, with a mid, point, delta bar and an island. Hay field and residential development are the primary land use on the right riparian corridor and forest was found on the left. The buffer is narrow on the right bank (<25 feet in width) with deciduous and herbaceous species as the major vegetation type. Invasive plant species are present on both banks. The segment's planform indicates historic channel straightening. The width/depth ratio is high, and erosion was present on both banks, indicating that some widening is taking place.

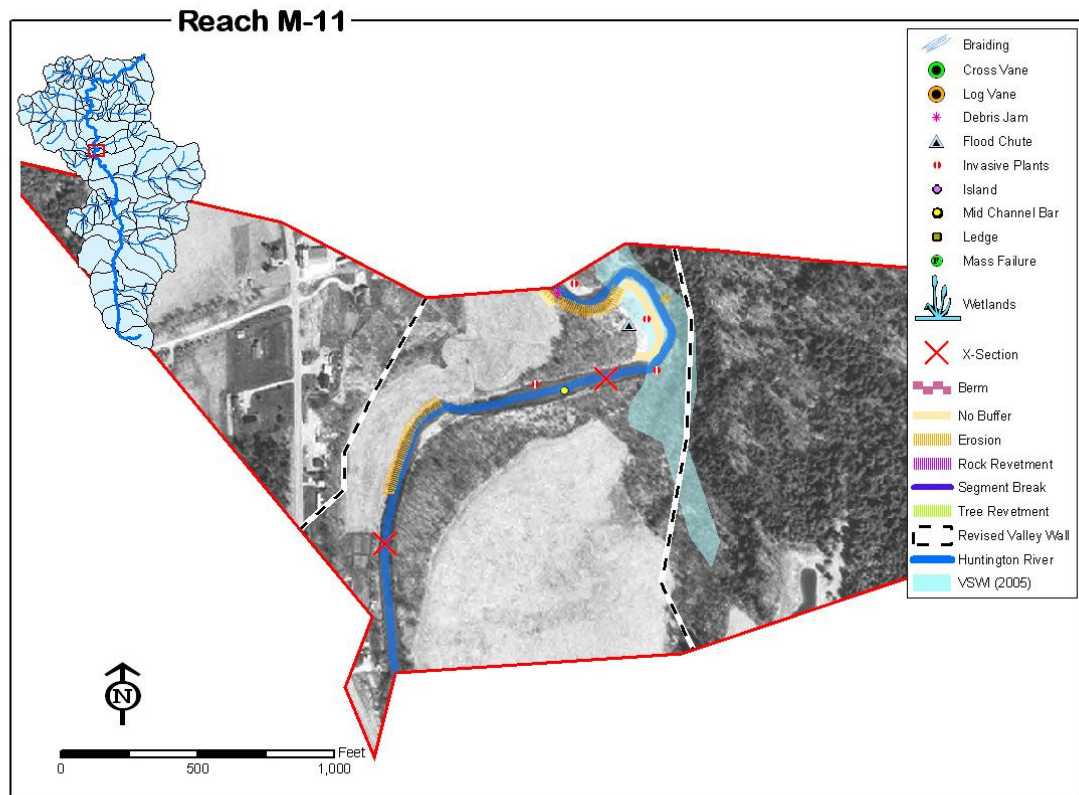
Figure 10. Reach M11 Inventory Map

Reach M11 is upstream (or south) of Huntington Village (upstream of Liberty Head Post and Beam), and downstream of the Spence Bridge. Reach M11 is a riffle-pool, gravel-dominated segment. Confinement was determined to be very broad. Sediment storage consists of mid, point, and side bars. A hay field is the dominate land use on the left corridor. The buffer is poor (<5 feet in width on the left bank and <25 feet on the right bank) with herbaceous species as the dominant vegetation type on both banks. Invasive plant species are present on both banks. Lack of vegetation is the likely cause of significant bank erosion on the left bank. The segment's planform indicates some historic channel straightening. The segment is experiencing aggradation.

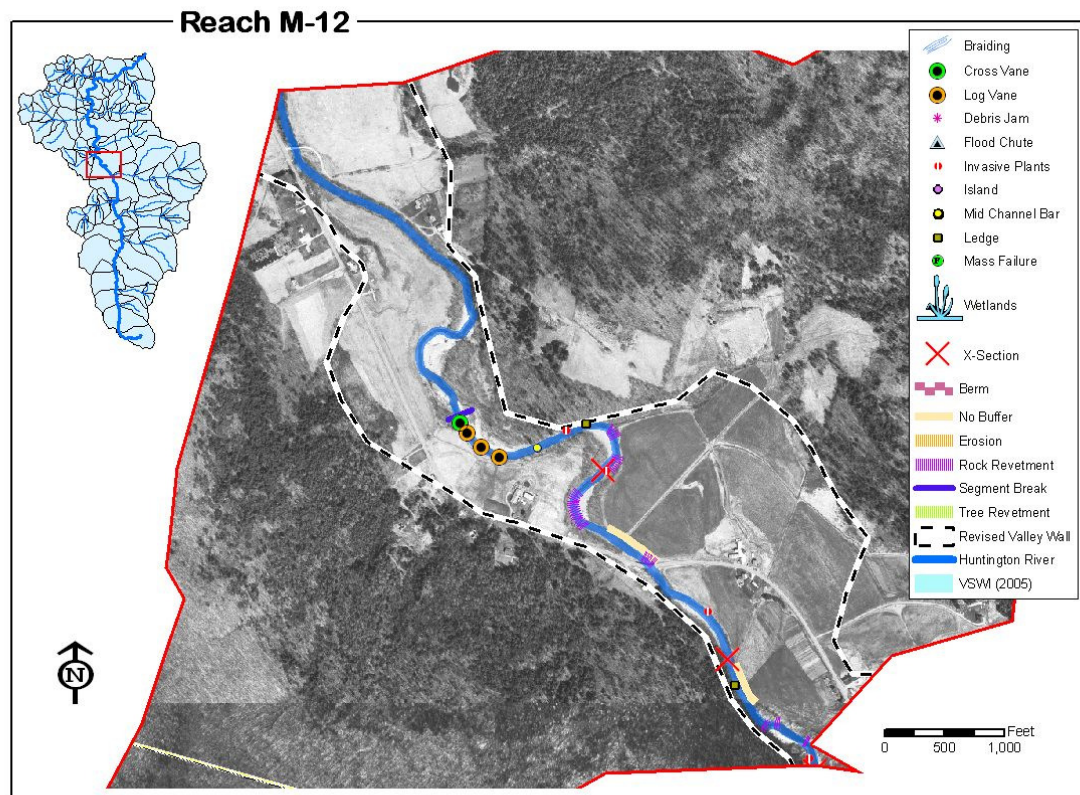
Figure 11. Reach M12 Inventory Map

Segment M12-B is a Rosgen C-4 stream, denoted by a riffle-pool system with gravel substrate. The segment's confinement is broad, due to the influence of Main Road. This location of the stream in relation to the valley wall, its straightened condition, as described by its sinuosity, and history of gravel extraction provide evidence that the channel had been altered. A natural channel design restoration project was recently implemented in the downstream portion of this segment, which is intact.

Hay fields were observed on both banks, and the right bank also contains crop field. The buffer width is poor to fair, noting that the right bank has less than 25 feet of buffer. The buffer on both banks consists of deciduous and herbaceous species. Invasives are present on both banks. Sediment storage bars include multiple side bars, some point bars, and a mid channel bar.

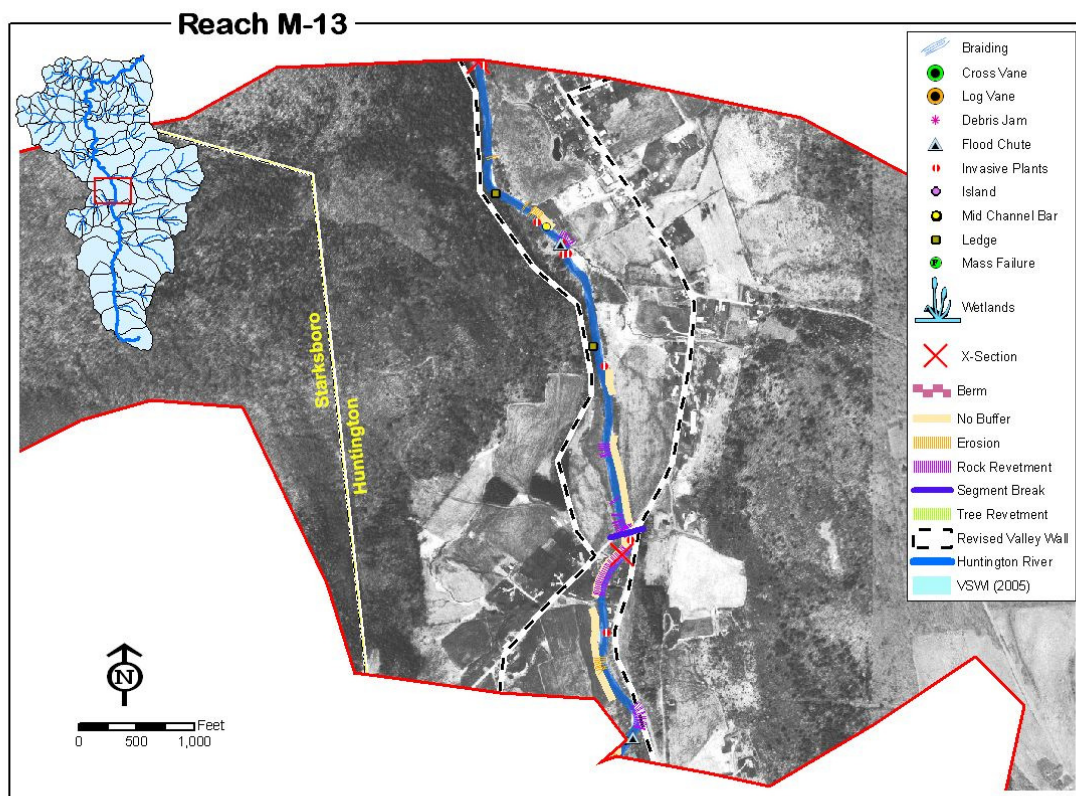
Figure 13. Reach M13 Inventory Map

This segment is downstream of the Shaker Mountain Road bridge crossing and flows through Huntington Center. The incision ratio for this segment was calculated to be 1.4, suggesting the river has only fair access to the floodplain within this segment. Bank erosion is present on the right bank. Hay fields dominate the riparian corridor. The buffer contains a mix of trees and herbaceous species. The width of the buffer on the left bank – the valley wall – is in reference condition, however, the buffer width on the right bank is fair (<50 ft). Invasive plant species are present on both banks. Sediment storage bars include multiple mid, side and diagonal bars with steep riffles. The river segment is pushed against the left valley wall and straightened.

The riparian corridor is dominated by crop and hay on the left bank and residential development on the right. The buffer is poor (<25 feet), made up of predominately deciduous and herbaceous plant species. Sediment storage bars include multiple side bars and a delta bar.

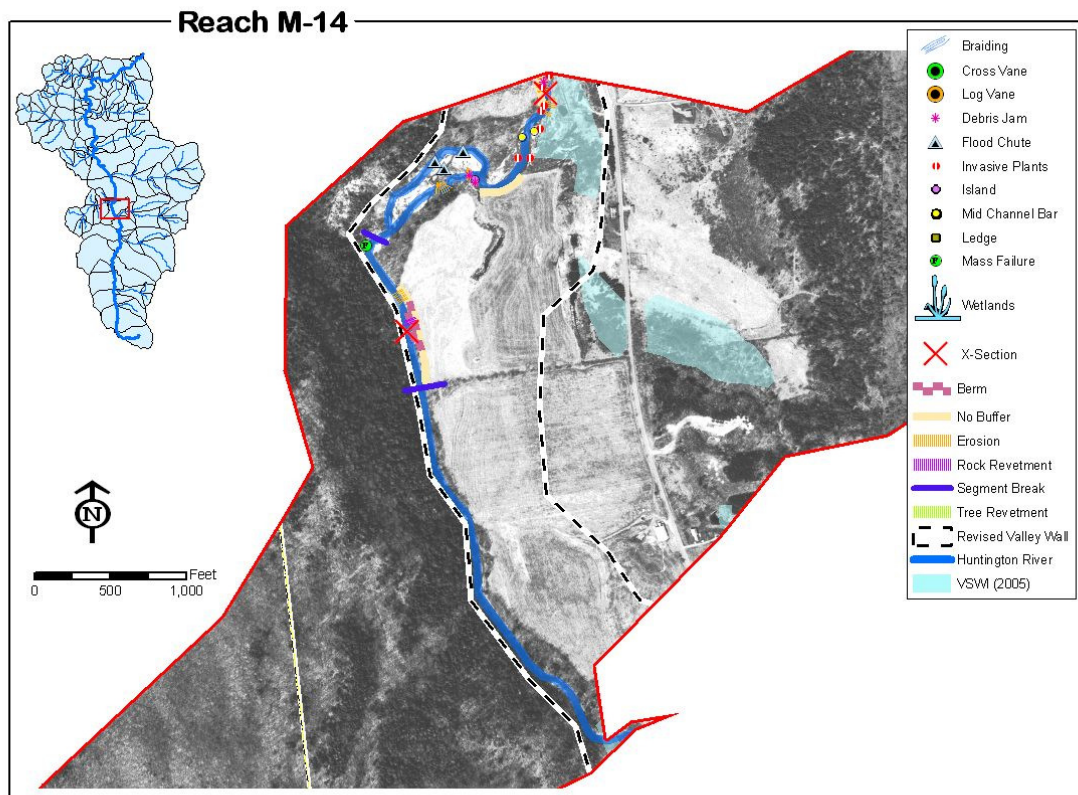
Figure 15. Reach M14 Inventory Map

Segment M14-B's valley confinement is very broad. This segment is a Rosgen C-4 stream, denoted by a riffle-pool system with gravel substrate. The riparian corridor is dominated by crop on the right bank and forest on the left bank. The right bank buffer is poor (<25 feet), made up of predominately herbaceous plant species. A berm follows the right bank. Sediment storage bars include multiple point and side bars. The segment contains a large mass failure with an average height of 25 feet, located at a 90 degree bend of the river. It is apparent that the mass failure is caused by a combination of a berm, which forces flood flows to remain in the channel, and the highly straightened condition of M14-B and M14-C, just upstream.

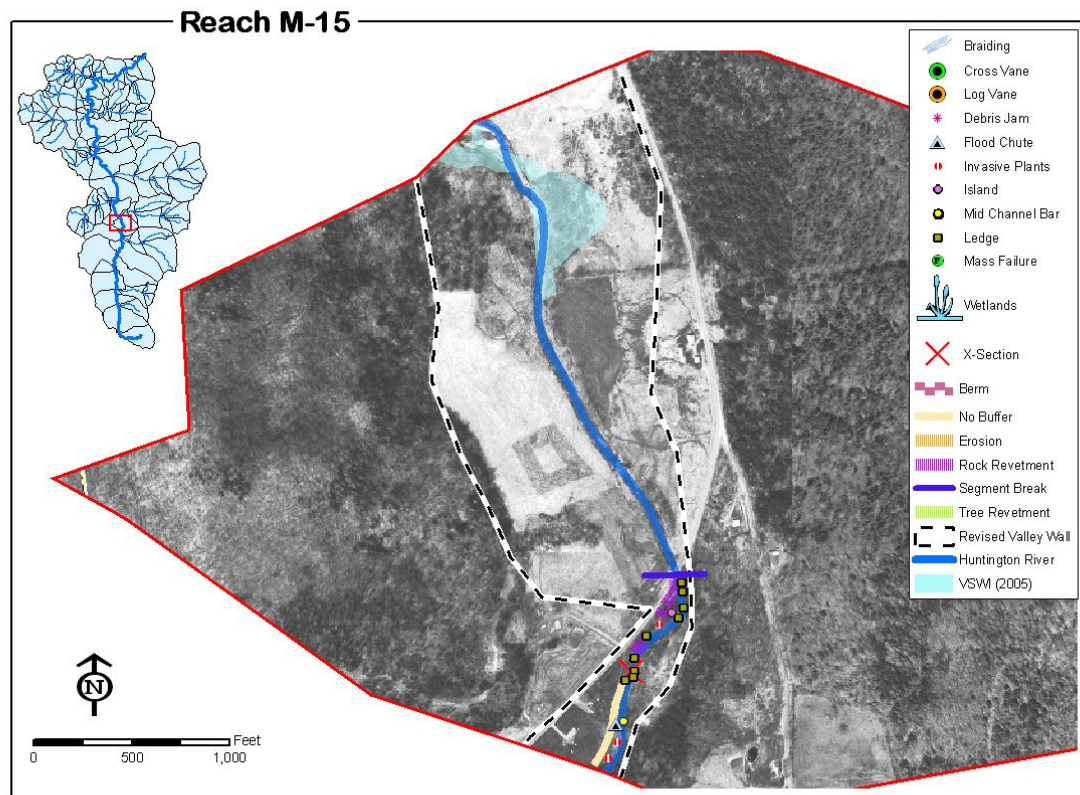
Figure 16. Reach M15 Inventory Map

Segment M15-B is a narrowly confined segment. Development also evident on the left side of the river corridor. The incision ratio of 1.6 and entrenchment ratio of 1.7 indicate that there is limited access to flood plain. The cross-section and pebble count information indicates that this reach is a B3 stream type, a riffle and pool stream with cobble bed material.

Rock revetments are found on both banks. The left bank's buffer width is poor (less than 25 feet), made up of primarily herbaceous and deciduous plant species. Invasive plants were found on the left bank. The left bank's riparian corridor consists primarily of forest and residential development; the right bank's corridor consists of pasture and forest. Sediment storage bars include a single mid, point, side, and delta bar and an island. There are also multiple flood chutes present.
