East Branch Passumpsic River Corridor Plan

Burke and Lyndon, Vermont January 2009

Prepared By: Kerry O'Brien, District Manager

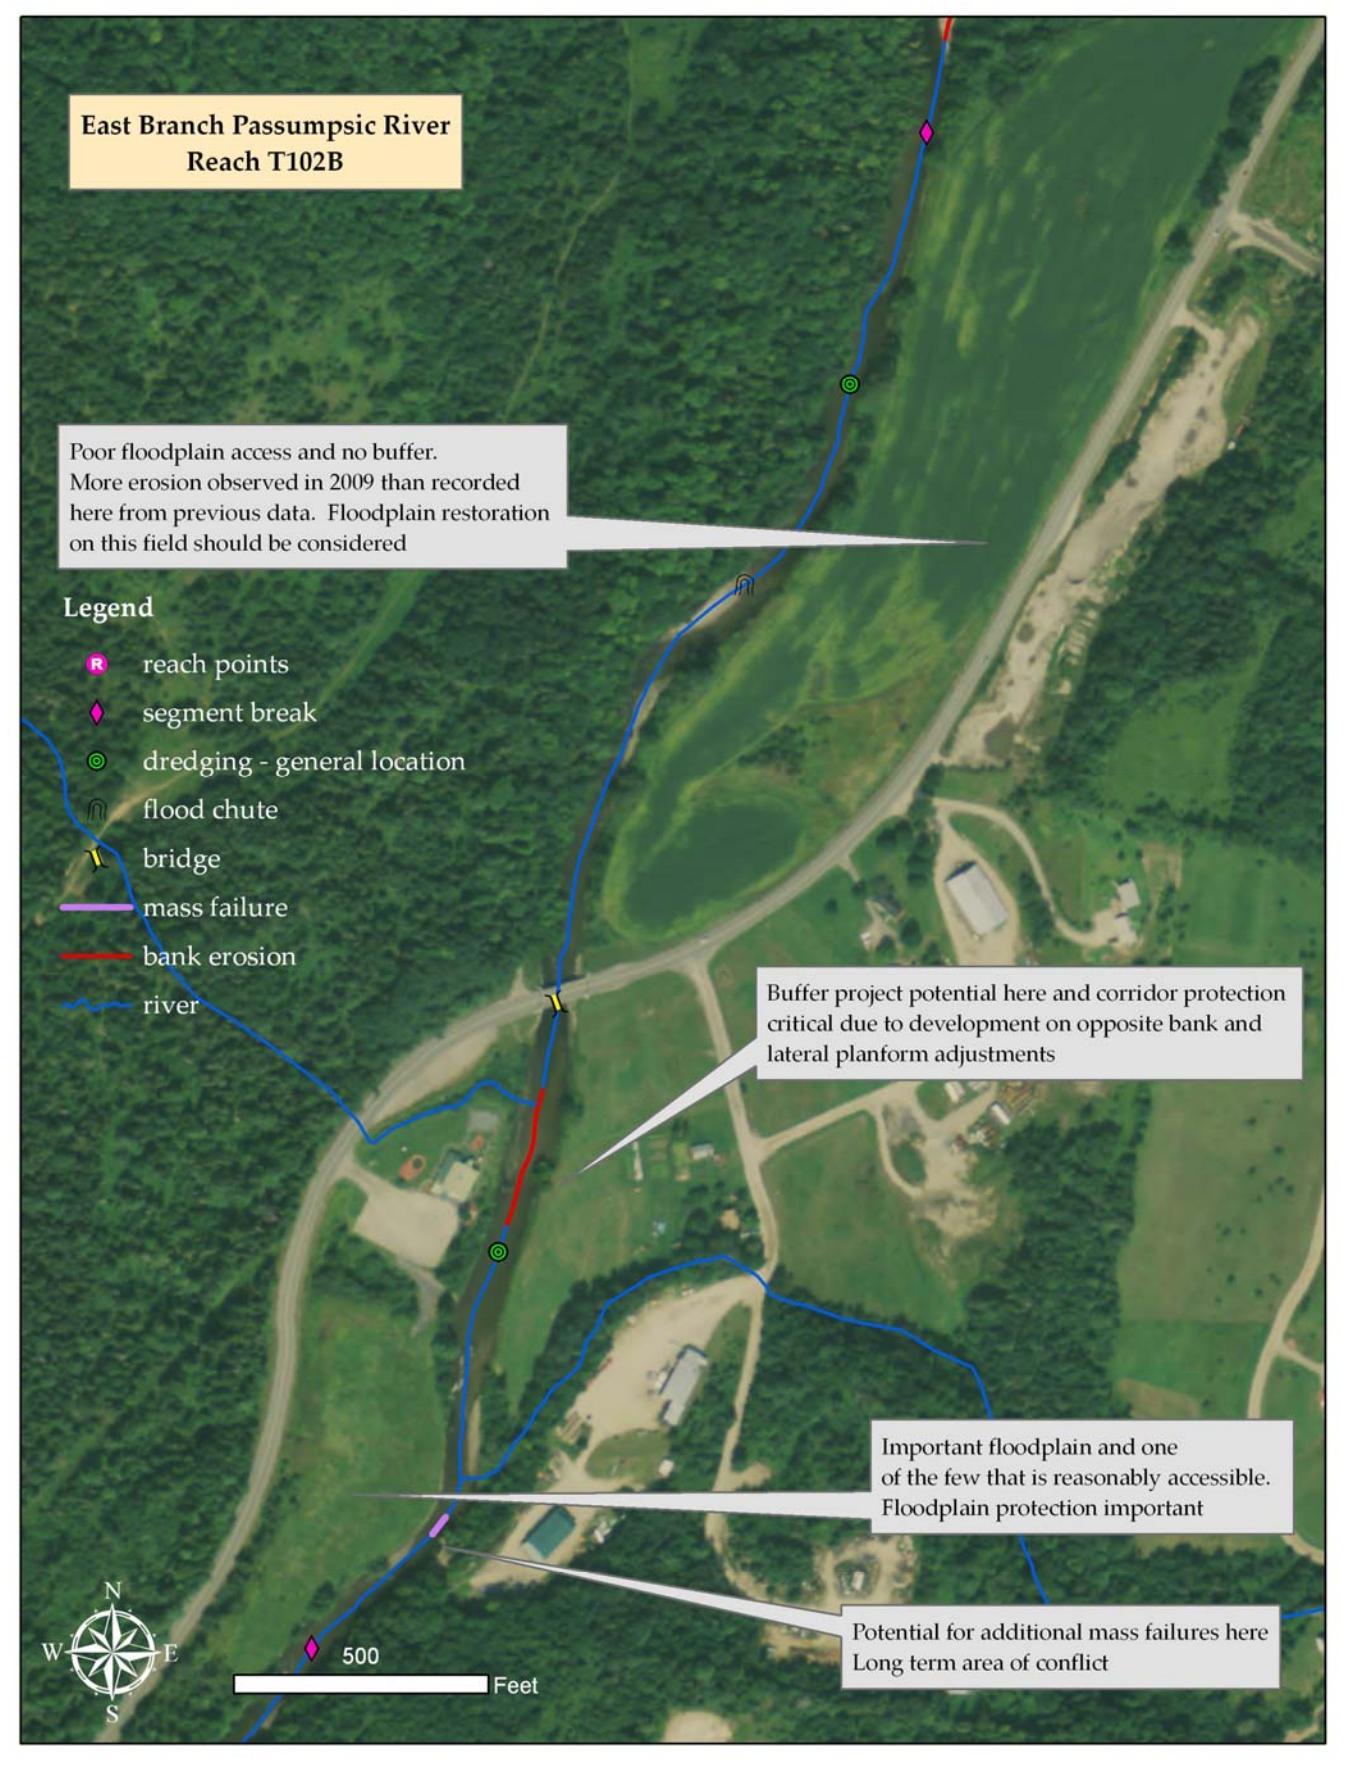
Figure 22: Preliminary Project Details Reach T102B

Reach T102B extends for 3343' from the downstream end of Riverside Life Enrichment Center's fields to the upstream end of a 12' acre cornfield. This segment keyed out to a C-type stream with gravel dominated substrate. The entrenchment ratio is 2.4 and the incision ratio is 1.2 though there were sections noted with very high eroding banks and pockets of greater incision and B-type stream features. The segment shows evidence of widening, bar development and planform change. Dredging and straightening are noted on this segment as well. Land use features a large 12-acre cornfield on the upstream end of the segment along the left bank, with the valley wall on the right. The stream passes under Rte 114 and then between a sparsely populated residential area on the left bank and the Riverside Center (a facility for the elderly) on the right. There are no buffers along the cornfield or the residential area and facility. The valley wall is the only vegetated area. The Center facility is in an area of conflict, as there is little space for the river to adjust. Evidence of dredging and straightening is noted. This segment is in stage III of channel evolution, aggrading and widening to build new floodplain.

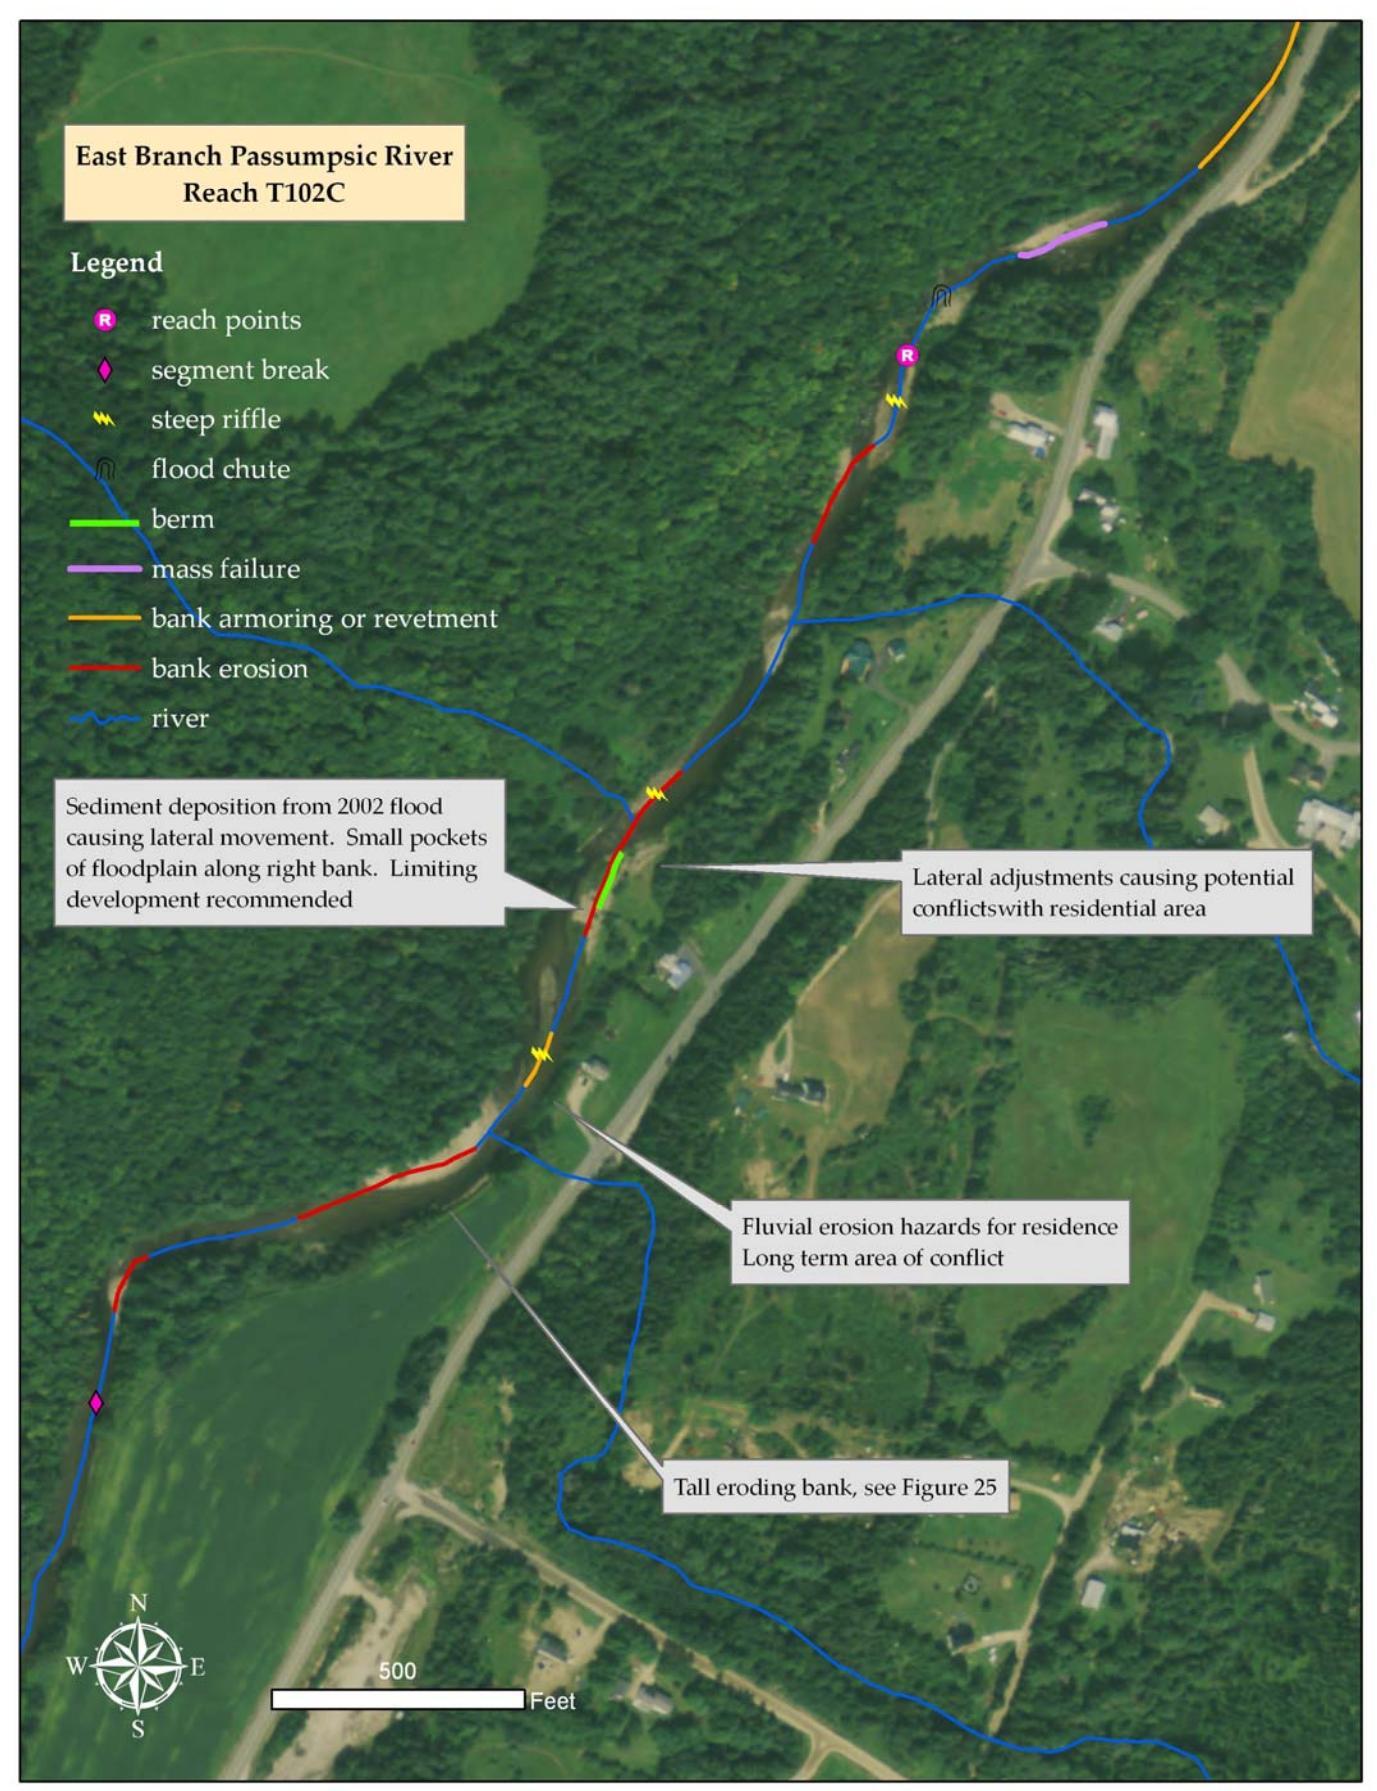
Figure 26: Preliminary Project Details Reach T102C

Reach T102C is 2843' long and begins at the upstream end of the 12-acre cornfield and extends to the reach break near the junction of Mount Hunger Road and Route 114. This reach was segmented due to having a greater level of depositional features and residential land use. The segment is flanked by the valley wall on the right bank, and the left corridor is occupied by 4-5 residences that sit between the river and Route 114. The river frontage is an integral part of the residential properties. A large amount of coarse sediment was deposited here during the 2002 flood and the river has been adjusting. Planform changes have been active historically in the segment as observed from historic photos where old channel and flood chutes are observed. Landowner interviews conducted on this segment also concur that the river has made planform changes since 2002 and some properties are experiencing enlargement of point bars, while others are experiencing more erosion. The segment keyed out to a C-type stream with gravel dominated substrate and a bed form of planed bed. The incision ratio on the segment is recorded at 1.3 and the entrenchment ratio is 2.2. The segment had some areas with entrenchment ratios similar to a Btype stream, however there are small but consistent pockets of floodplain along the valley wall. One of the landowners along the left bank built a berm after the 2002 flood with the available coarse materials deposited there. There is still potential for erosion hazards in the event of high water. The stream is in stage III channel evolution, with aggradation and widening noted as the current adjustments. The river will continue to make adjustments as it works through the excess sediment and tries to recapture floodplain. The cornfield at the downstream end of the segment has no buffer and is a high bank with erosion occurring.

Project	Reach	Watershed	Completed	Next Steps and
River		Priority	Priority	Independen	other project notes
Segment				t of Other	
				Practices	
T102C	Protect River	High	Moderate	Yes	Residences along left bank corridor
	Corridor				are dependent on small pockets of
					floodplain along right bank and
					valley wall. Segment is undergoing a
					great deal of adjustment. Erosion
					and trees/debris adding to
					adjustment. Further development
					should be prohibited.
T102C	Landowner	High	Moderate	Yes	Recommend continued outreach to
	Outreach				landowners so they're made aware
					of potential conflicts.
T102C	Install buffers	Moderate	Moderate	Yes	Opportunity for buffer on 12-acre
					corn field.
T102C	Examine areas	Moderate	Moderate	Yes	Fluvial erosion hazards are evident
	of conflict				at lower residence. House was built
					on same location where former
					house fell into stream. Area should
					be monitored very closely.

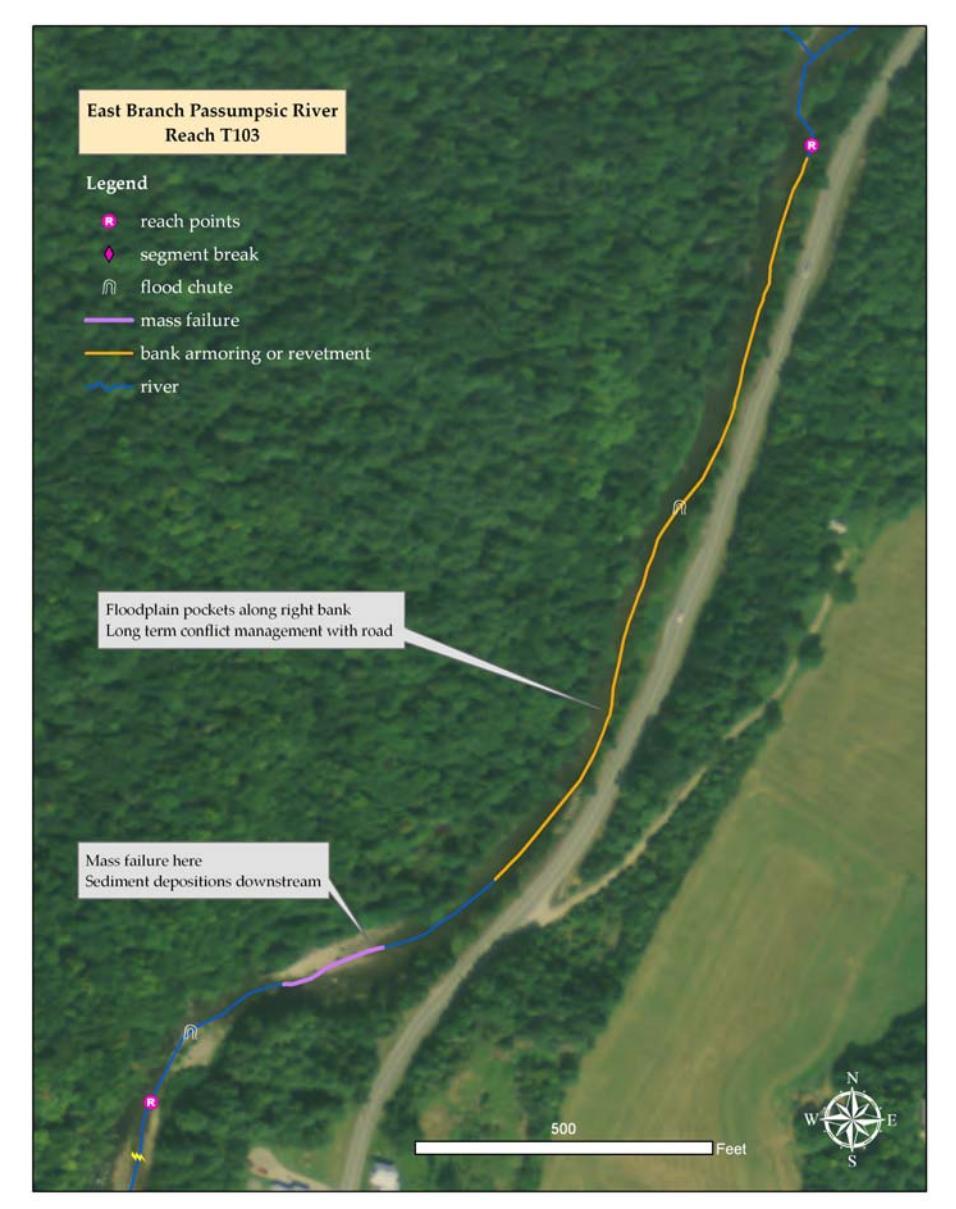
Figure 28: Preliminary Project Details Reach T103

Reach T103 extends for 2086' and is flanked on its entire left bank corridor by Route 114. It pulls away from the road slightly towards the downstream end of the segment, where there is a mass failure and an old vehicle within the bank. The right bank is flanked by the valley wall with small pockets of floodplain at its base. There is evidence of straightening and dredging on this reach. The reach keys out to a C subclass b type stream with gravel dominated substrate and riffle pool bed form. While the reach seems confined and locked against the valley wall by the road, there is enough room largely due to the small floodplain pockets along the right bank for planform movement to occur. There are some recent deposits along the reach, likely from the 2002 flood, but it was determined that the reach is in an early stage II of channel evolution with an incision ratio of 1.1 and an entrenchment ratio of 2.7. Channel degradation that was observed was historic.

Project	Reach	Watershed	Completed	Next Steps and
River		Priority	Priority	Independen	other project notes
Segment				t of Other	
				Practices	
T103	Protect River	Moderate	Moderate	Yes	Floodplains along right bank should
	Corridor				be protected to provide flood and
					sediment attenuation assets,
					particularly since this reach is
					upstream from a residential area
T103	Long term	Moderate	Low	Yes	Long term road conflict
	road				management will be necessary
	management

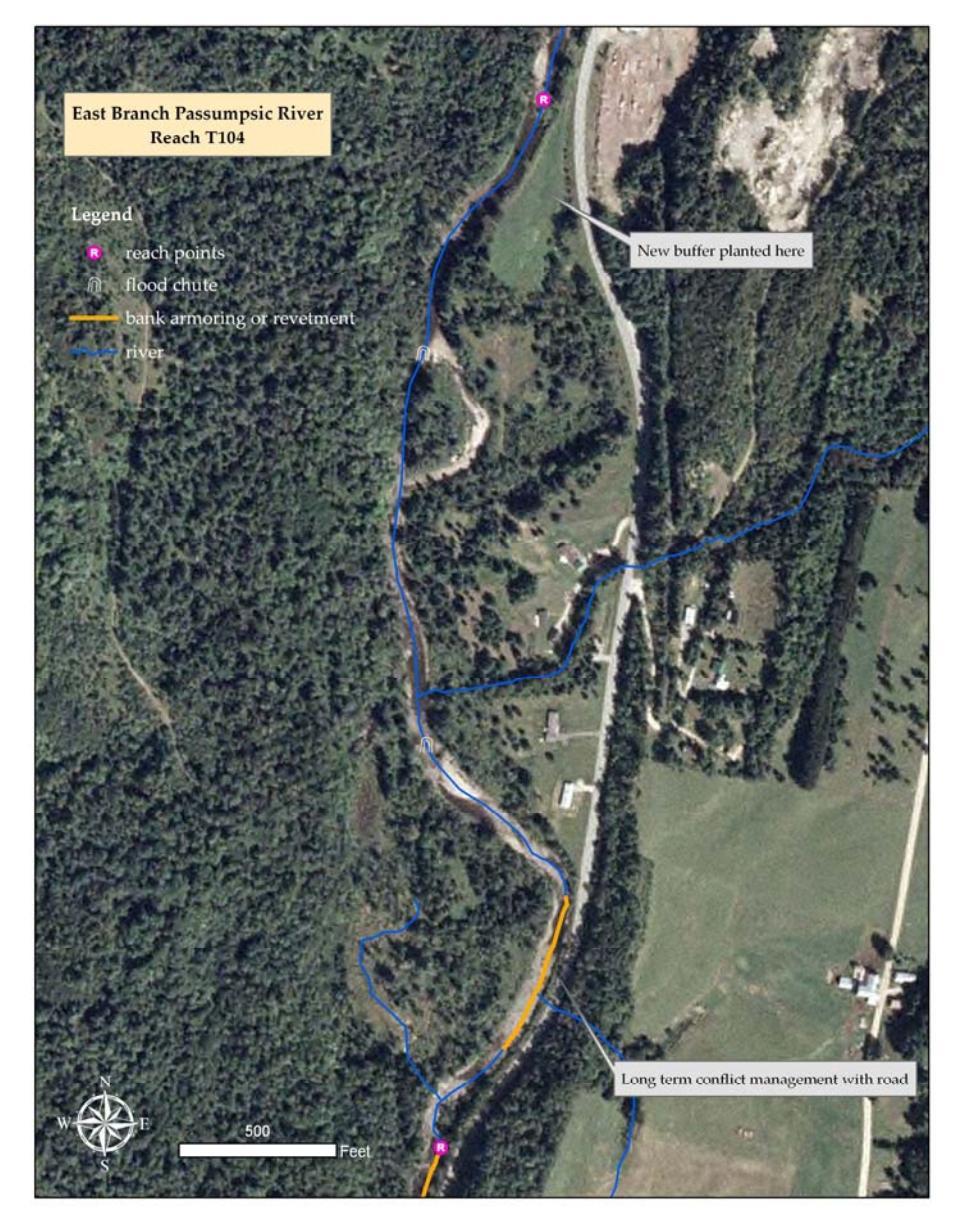
Figure 30: Preliminary Project Identification Reach T104

- Channel width of 105'
- Road encroachment in left corridor for 1393'
- Non-cohesive bank materials
- Geomorphic condition is Good
- Stream sensitivity is High
- Habitat Condition is Good

Project	Reach	Watershed	Completed	Next Steps and
River		Priority	Priority	Independen	other project notes
Segment				t of Other	
				Practices	
T104	Protect River	High	Moderate	Yes	Long term potential of development
	Corridor				pressures which could compromise
					the ability of the river to adjust
					along the left bank. Sediment
					attenuation assets on this reach.
T104	Long term	Moderate	Low	Yes	Long term road conflict
	road				management will be necessary
	management

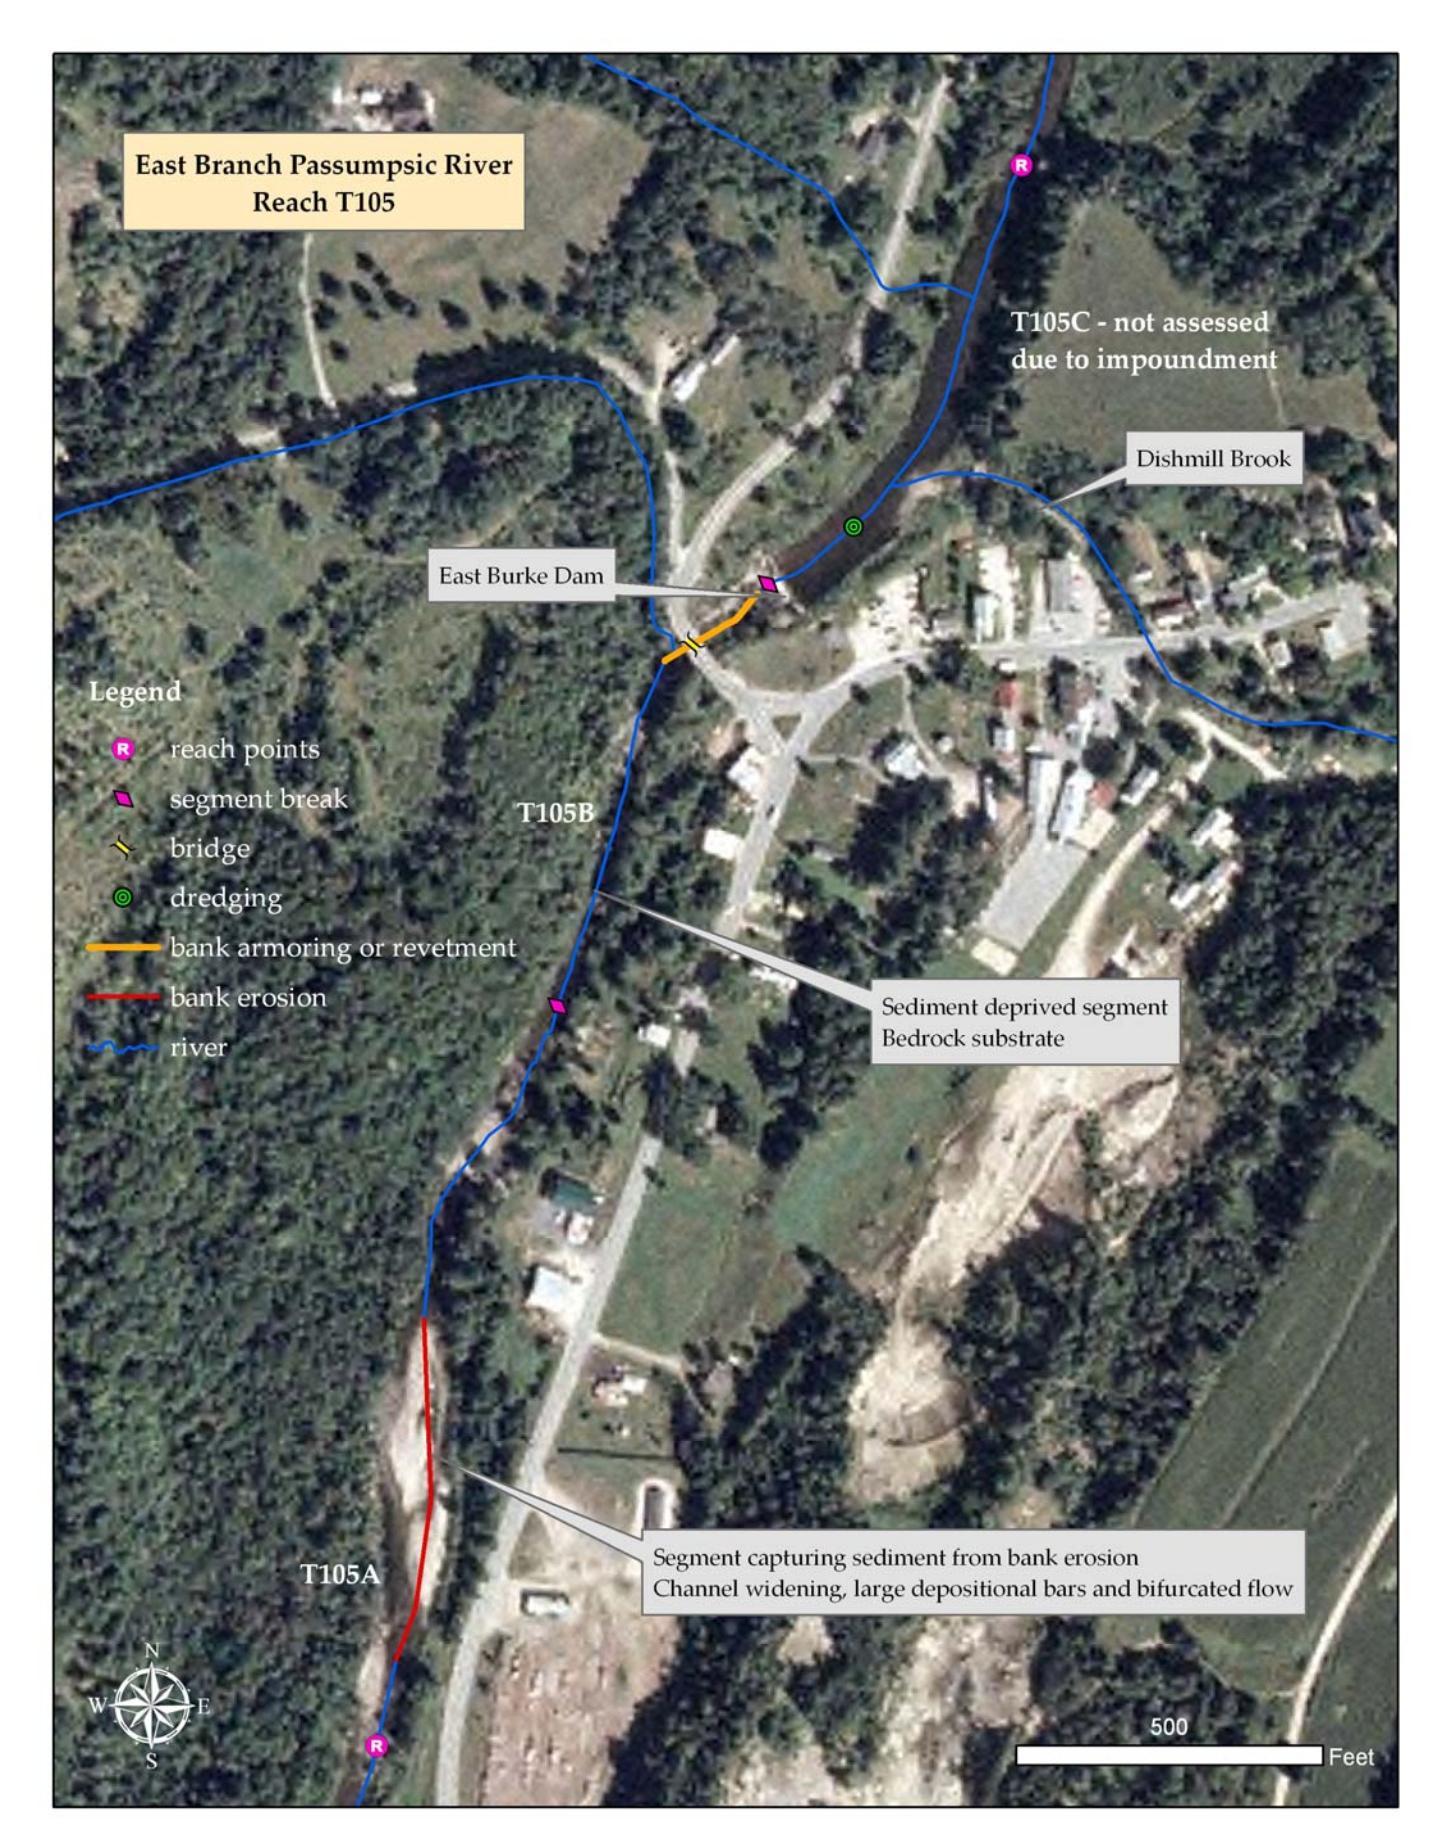
Figure 34: Preliminary Project Details Reach T105A and T105B:

- Road encroachment for 1248'
- Bankfull width of 90'
- Sedimented riffles
- Geomorphic condition of Fair
- Stream Sensitivity is High
- Habitat Condition is Good

River Segment	Project	Reach Priority	Watershed Priority	Completed Independen t of Other Practices	Next Steps and other project notes
T105 A & B	Dam removal	High	Moderate	Yes	Dam removal would restore sediment continuity downstream and reduce reliance on bank erosion to capture material. Dam removal would also provide habitat connectivity.
T105 A & B	Protect River Corridor	High	Moderate	Yes	Development pressures along left bank could reduce river's ability to adjust away from valley wall and access floodplain. Corridor protection should be considered to allow stream to recapture equilibrium.
T105B	Replace Bridge	Moderate	Moderate	Yes	Bridge structure is undersized and a channel constriction. Replacement should be considered.
T105 A&B	Address Invasive Species	Moderate	Moderate	Yes	Three separate invasive plants are noted in this area with high concentrations of honeysuckle and knotweed. Invasive plant removal should be considered as the plants will continue to spread downstream.

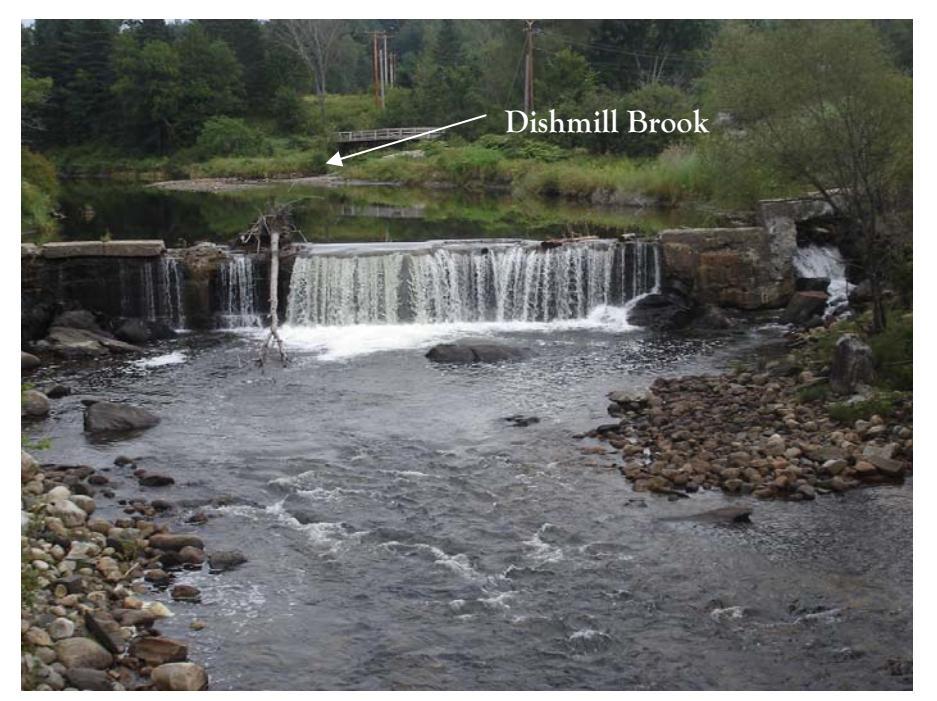
Figure 35: Reach T105 East Burke Dam and mouth of Dishmill Brook

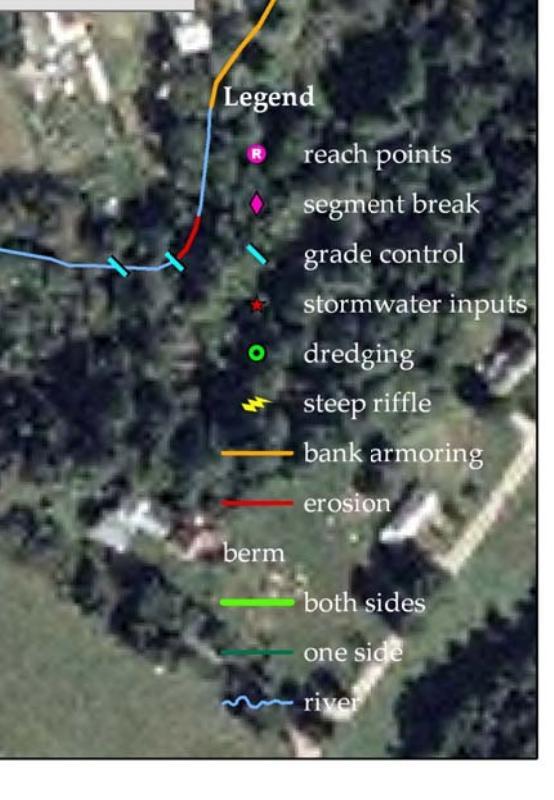
Figure 36: Preliminary Project Details Reach M101 Dishmill Brook

Debris jam in 2008 caused flood in East Burke village

Project	Reach	Watershed	Completed	Next Steps and
River		Priority	Priority	Independen	other project notes
Segment				t of Other	
				Practices	
M101A	Address	Moderate	Moderate	Yes	Three invasive plants are noted in
	Invasive				the area with high concentrations of
	Species				honeysuckle and Japanese
					knotweed. Invasive plant removal
					should be considered as the plants
					will continue to spread downstream.

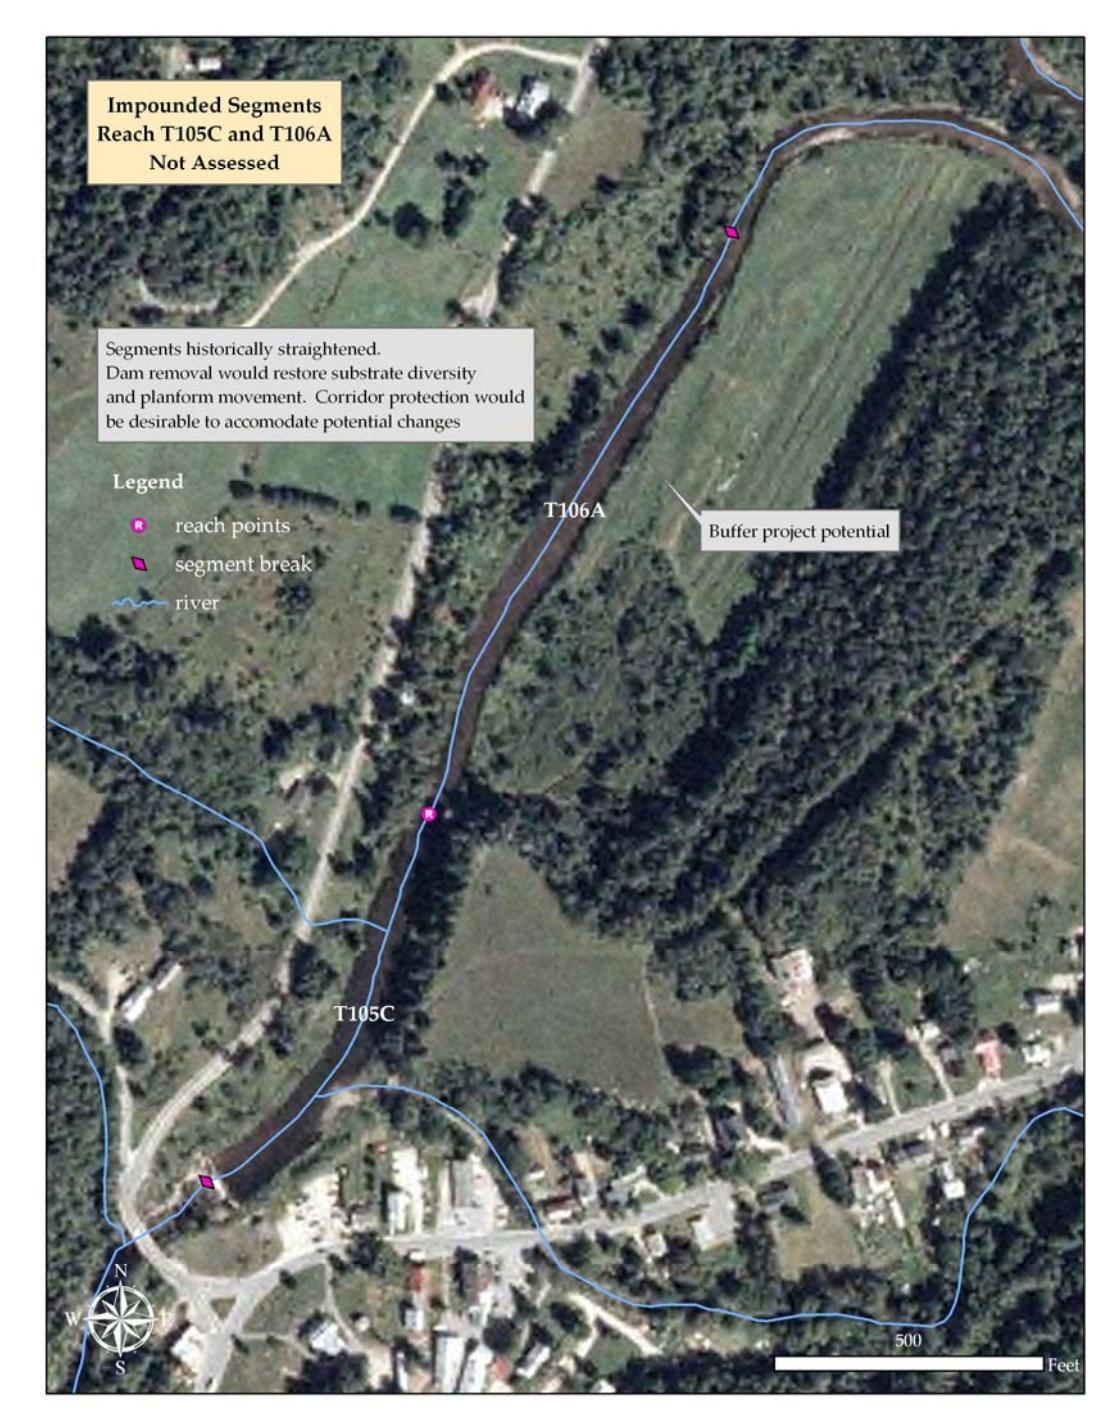
Reach T105C extends for 823' and T106 for 1428'. Their combined length of 2051' represents the approximate length of stream that is impounded by the East Burke Dam, though the length will vary from year to year. Both of these segments were not assessed in Phase 2 due to the impacts of the impoundment. A map is provided of both segments to provide a context for geomorphic conditions upstream and downstream of the dam. Dam removal would help restore these two segments to equilibrium by allowing sediment transport to restore sediment continuity and diversity, as well as allow for planform movement. Corridor protection and buffer plantings are recommended.

Figure 37: Impounded segments upstream of East Burke Dam

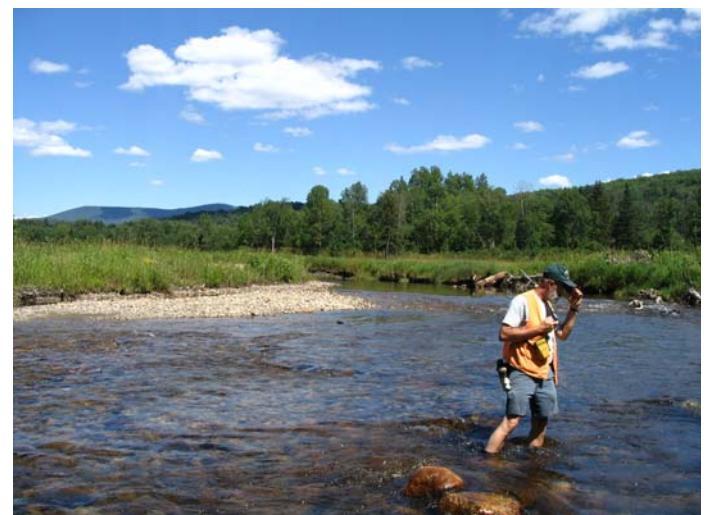
Figure 38: Reach T106B near agricultural fields

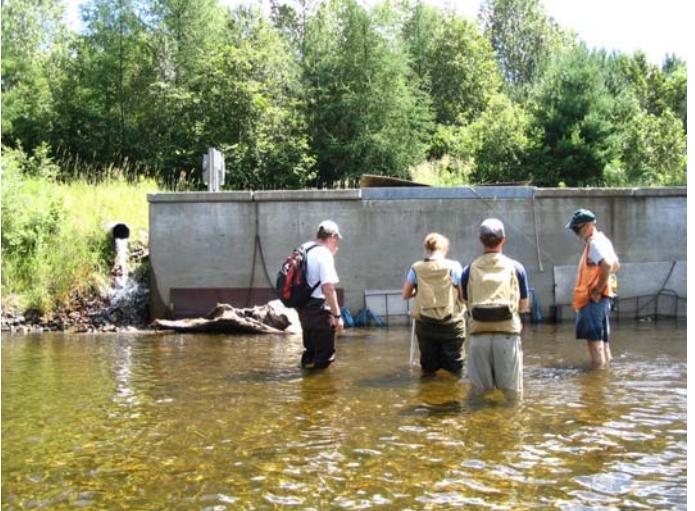
Figure 39: Reach T106B at water intake for Burke Mountain

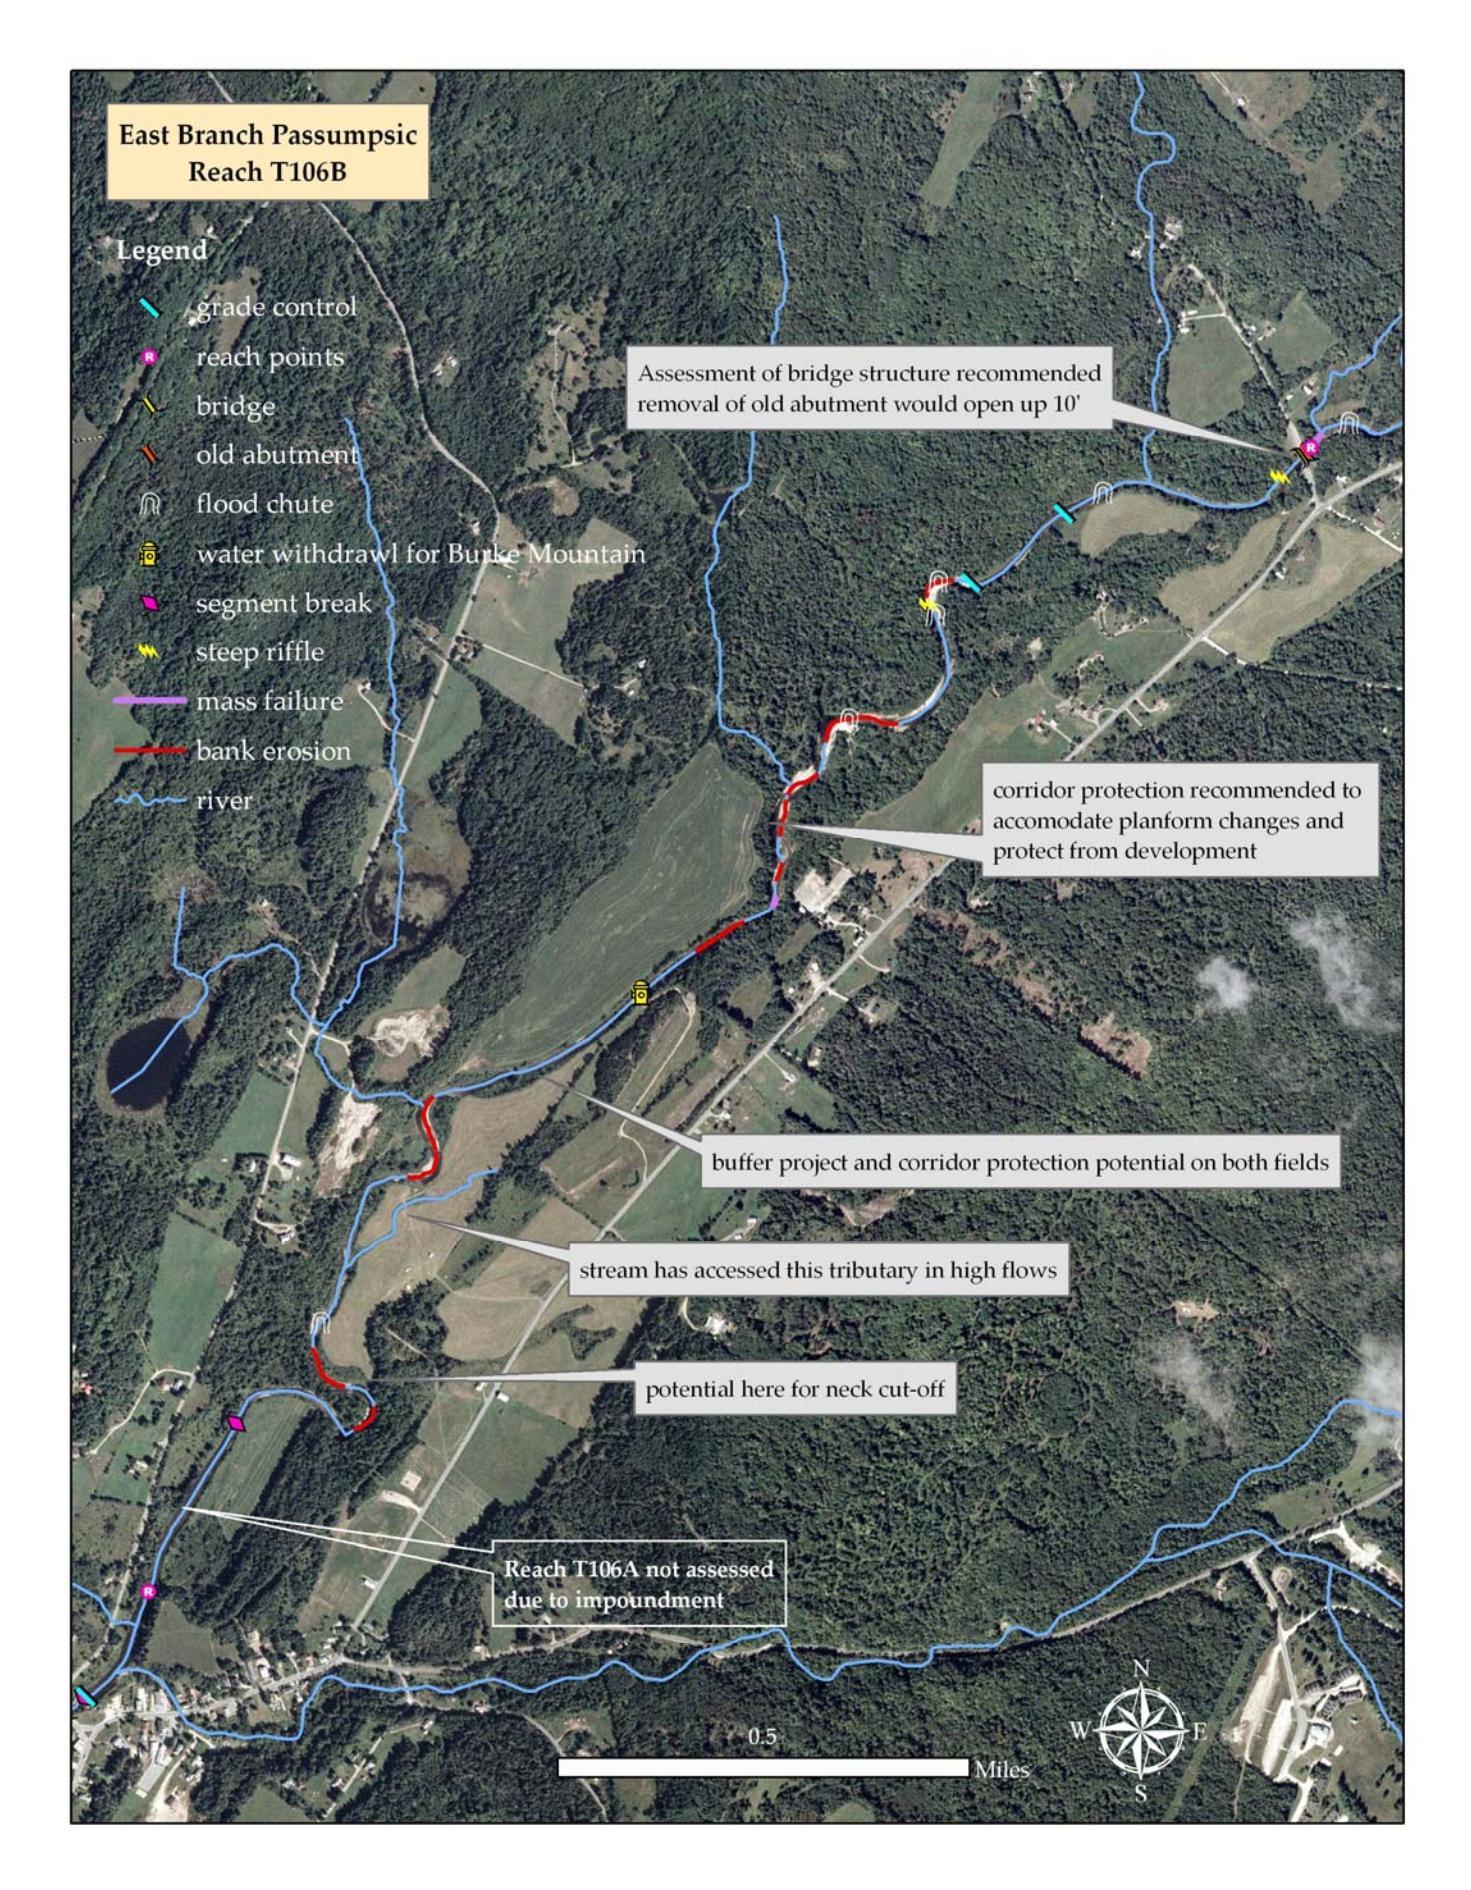
Figure 40: Preliminary Project Details Reach T106B

- Entrenchment ratio of 13
- Historic agricultural straightening evident, limited habitat on these sections
- Invasive plants present
- Geomorphic condition is Good
- Habitat condition is Good
- Natural grade controls present in two locations
- Two debris jams noted during 2006 assessment

River	Project	Reach Priority	Watershed Priority	Completed Independen t of Other	Next Steps and other project notes
oeginent				Practices	
T106B	Protect River Corridor	Moderate	Moderate	Yes	Explore potential of protecting river corridor to help accommodate channel adjustments and protect from development pressure. Dam removal would increase priority for this
T106B	Install Buffers	Moderate	Moderate	Yes	Agricultural fields would benefits from the installation of a vegetative buffer. Reducing sediment into East Burke village would also provide a benefit
T106B	Remove old abutment, assess bridge structure	Moderate	Low	Yes	Old abutment is channel constriction and does not have a purpose. Removal would open up 10' to accommodate channel.
T106B	Address Invasive Species	Moderate	Low	Yes	Invasive plants should be addressed as they will continue to spread downstream

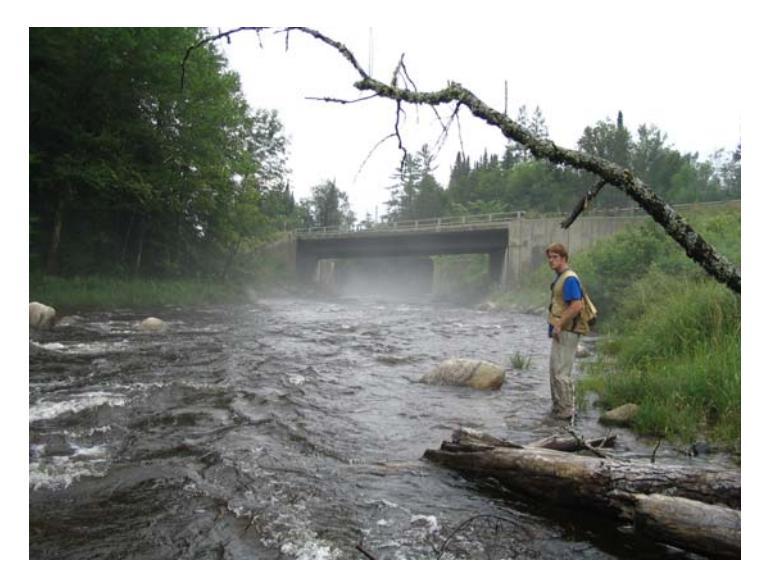
immediately downstream is 35'. The bankfull width is 87'. The bridge has alignment problems and together with the abutment the structures are acting as a channel constriction. The upstream bridge on Worden Road is 40' wide. The bank armoring recorded near the Worden Road bridge was noted as riprap but it is likely the result of windrowing after a flood event, with dredging also evident. And additional old abutment upstream measures 33' wide. There is just over 2000' of bank armoring which is located primarily where the stream abuts Route 114 or surrounding bridge structures. A natural gas pipeline crosses under the East Branch and a small rise in bed elevation is evident there.

Figure 42: Reach T107B Route 114 90' wide bridge with 35' old abutment immediately downstream

River	Project	Reach Priority	Watershed Priority	Completed Independen	Next Steps and other project notes		
Segment				t of Other			
				Practices			
T107B	Remove old abutments	High	Moderate	Yes	Removal of old abutments highly recommended as they are less than half bankfull width and constricting the channel.		
T107B	Assess Bridge Structure	Moderate	Moderate	Yes	Worden Road bridge undersized and acting as a channel constriction		
T107B	Monitor long term areas of conflict	Moderate	Low	Yes	Stream abuts road several times through reach and will need to be monitored/maintained in the long term		
T107A	Protect River	Moderate	Low	Yes	Good opportunity here to maintain

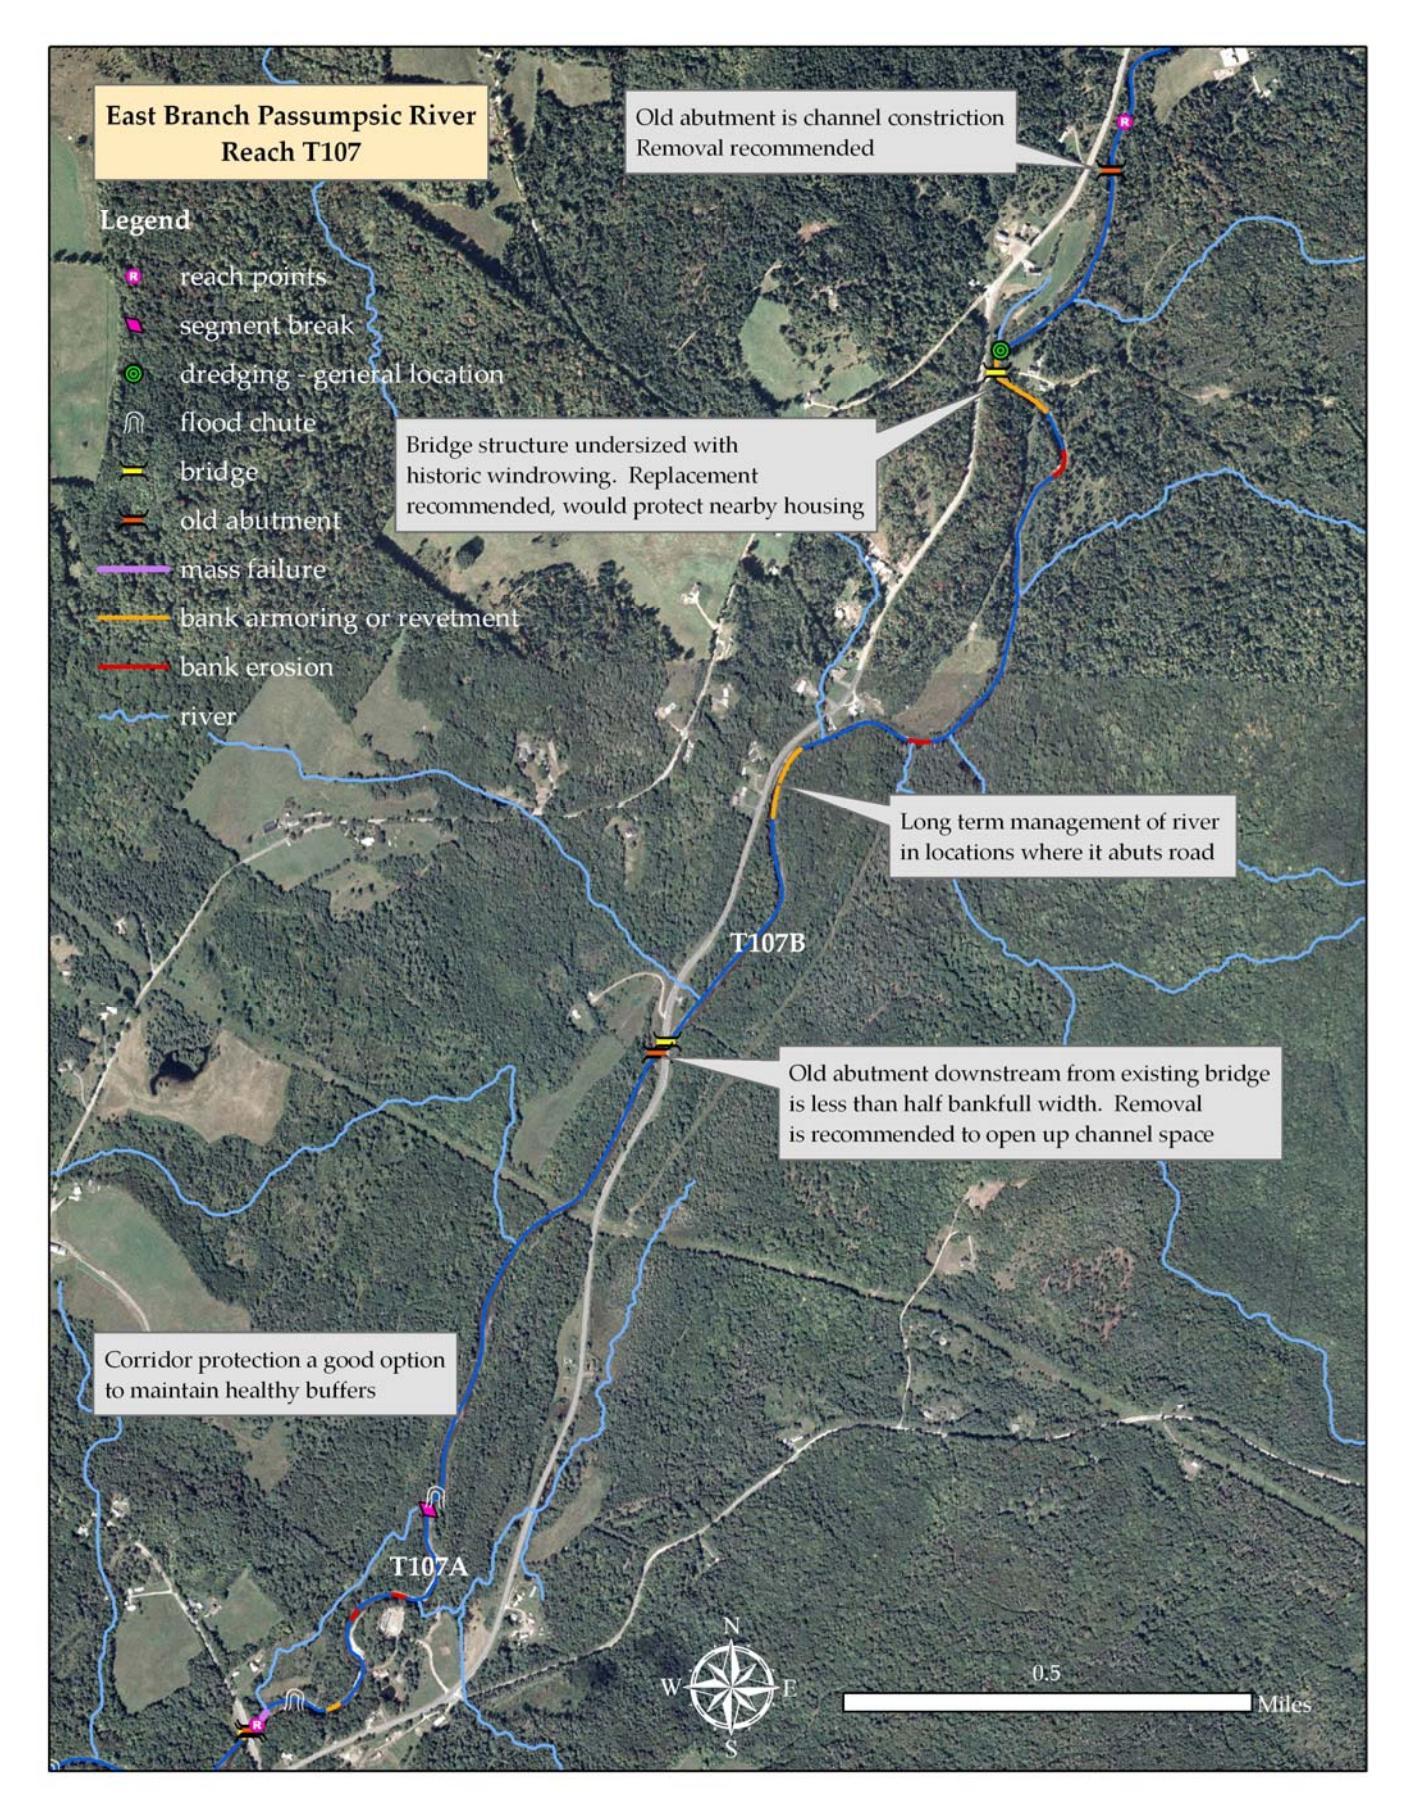
Figure 42: Preliminary Project Details Reach T107

- Incision ratio of 1.37
- Entrenchment ratio of 4.66
- Geomorphic condition is Good
- Habitat condition is Good
- 9 Depositional features
- Road encroachment for 4123'
