**Mad River Headwaters
Phase 2 Stream Geomorphic Assessments**

January 31, 2008

Samuel P. Parker, Staff Scientist, and Evan P. Fitzgerald, Principal
Fitzgerald Environmental Associates, LLC.

Friends of the Mad River
Waitsfield, Vermont

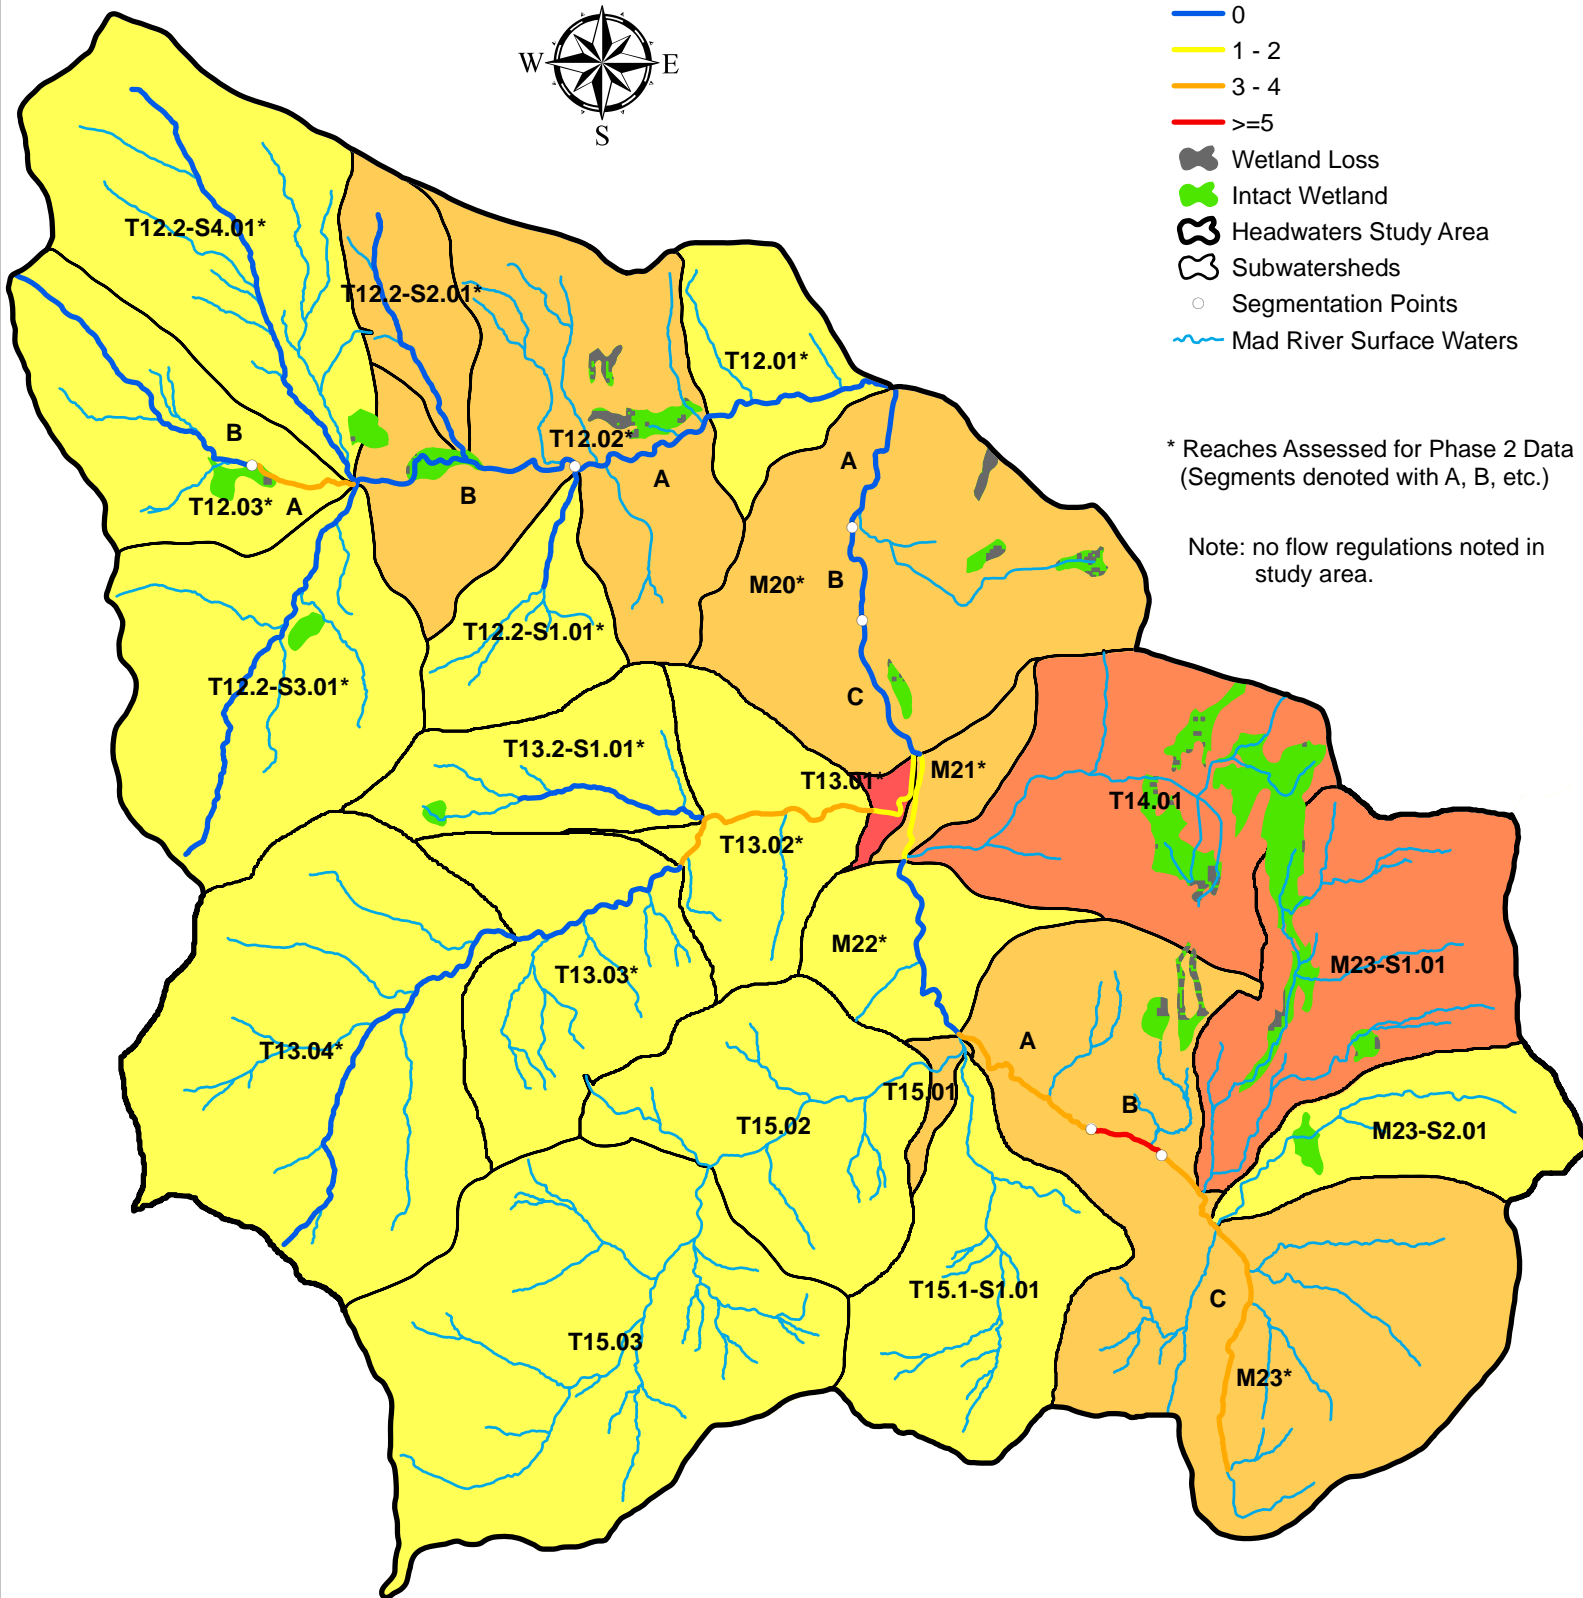
Figure 5.42 Hydrologic Alterations

The current day stressors to the hydrologic regime have been mapped using the variables extracted from the Phase 2 field assessments (indexed using FIT), watershed-scale loss of wetlands, and the road density at the subwatershed scale (Figure 5.42). An analysis of the percent impervious cover of the Mad River watershed was completed using methods specific to Vermont from Fitzgerald (2007). Percent impervious cover and road density

at the subwatershed scale in the Mad River watershed was analyzed for strength of correlation. This analysis revealed that in the Mad River watershed road density is positively correlated with percent impervious cover (Figure 5.43), and that a road density of approximately 4 miles per square mile corresponds to 5 percent impervious cover. This level of impervious cover is associated with decline of channel stability and biotic integrity in watersheds in Chittenden County (Fitzgerald, 2007). A total of 4 classes of road density were mapped in Figure 5.1 to depict the relative impact of the road network and impervious cover on the hydrologic regime. Wetland loss was mapped as the area where hydric soils intersect with urban or agricultural land uses in the watershed, with the remaining areas assumed to be intact wetland (the majority found in forested conditions). This approach allows for the interpretation of loss of hydrologic attenuation of surface runoff at the reach and watershed scale. In addition, stormwater outfall densities mapped during the Phase 2 assessments are included to depict areas of increased stormflows and decreased baseflows. No dams or diversions were observed in the study area. A summary of the local (reach-scale) and upslope impacts to the hydrologic regime for each mainstem reach based on Figure 5.43 is provided in Table 5.3.

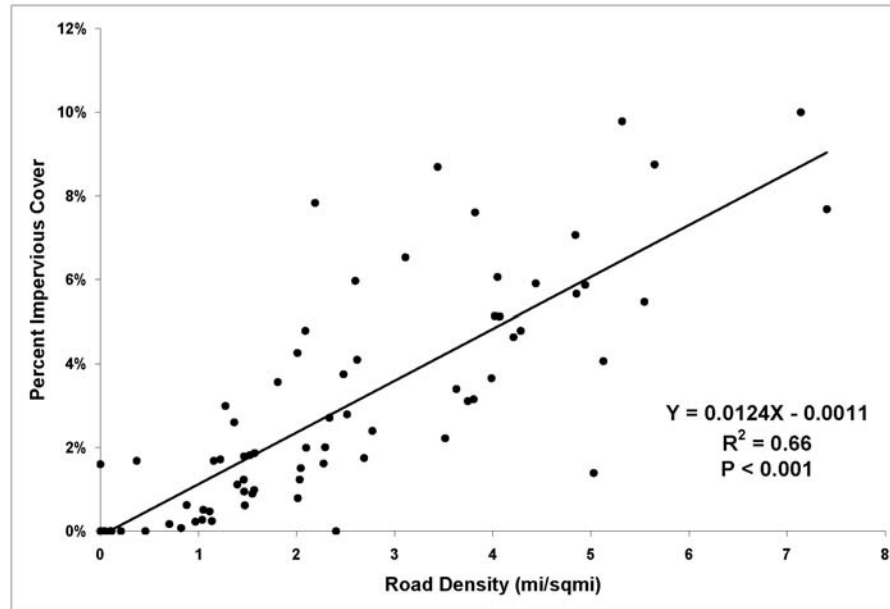
Figure 5.43 Correlation between road density and percent impervious cover for the Upper Mad River Watershed

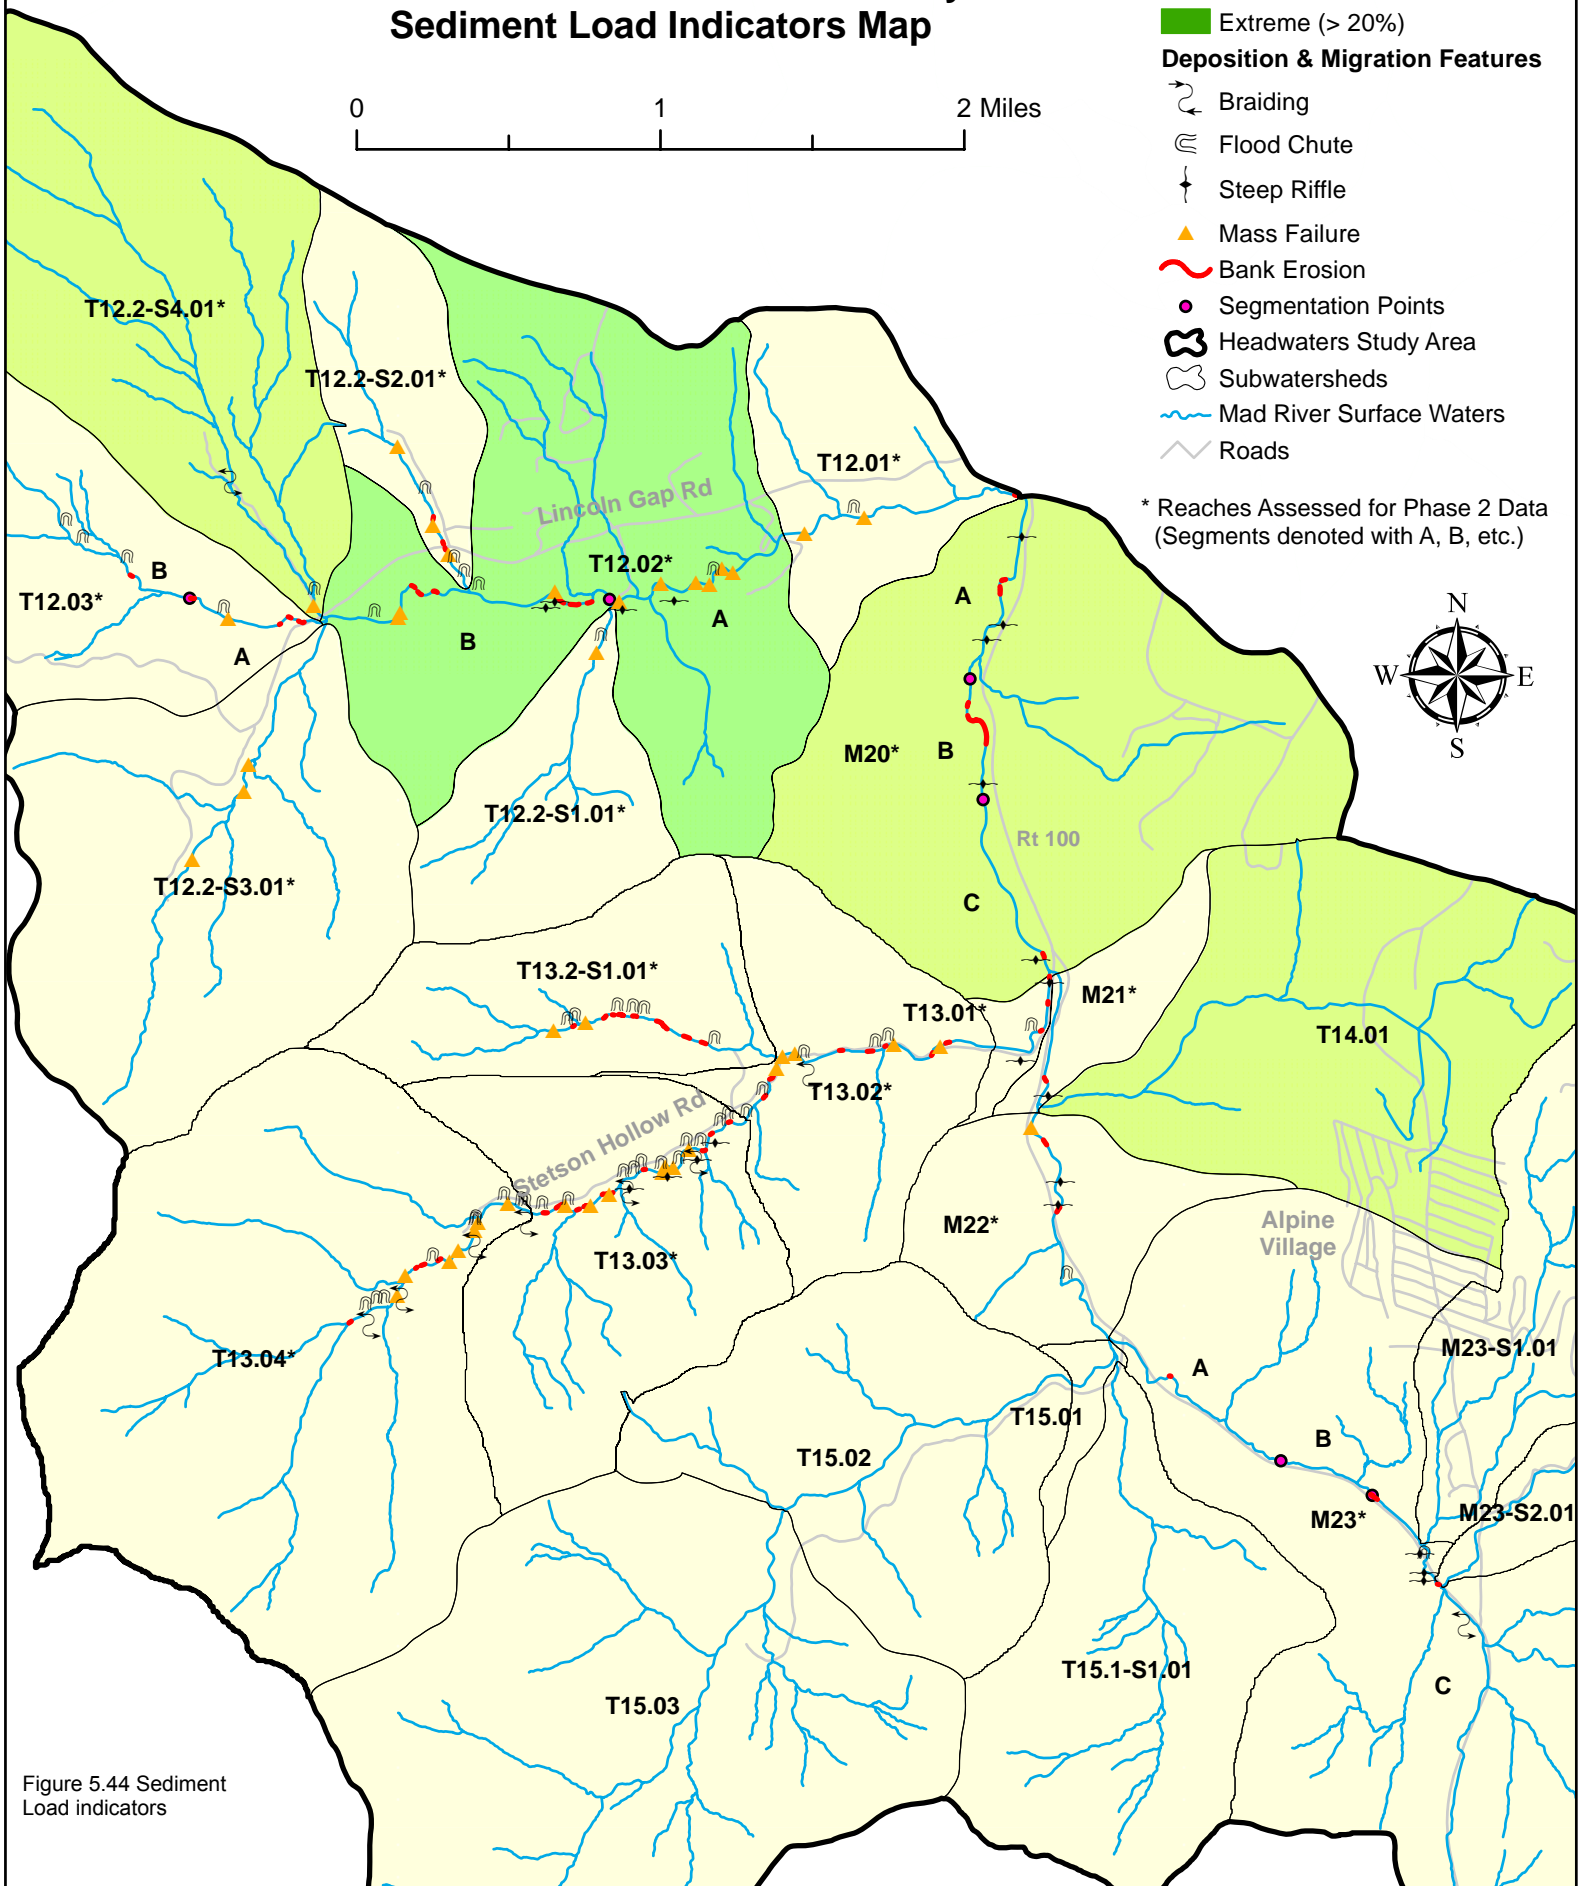
Figure 5.44 Sediment Load indicators

The current day stressors to the sediment regime have been mapped using the variables extracted from the Phase 2 field assessments, and the percent of agriculture within each subwatershed (Figure 5.44). Four classes of percent agriculture were mapped to depict the relative impact of sediment delivery from agricultural lands at the reach and watershed scales. In addition, depositional and migration features mapped during the Phase 2 assessments are included to depict areas of increased vertical and lateral channel adjustments due to aggradation. Mass failures and bank erosion depict where sediment delivery from the channel boundaries is occurring. A summary of the local and upslope impacts to sediment loading for each mainstem reach based on Figure 5.44 is provided in Table 5.3 at the end of this section.

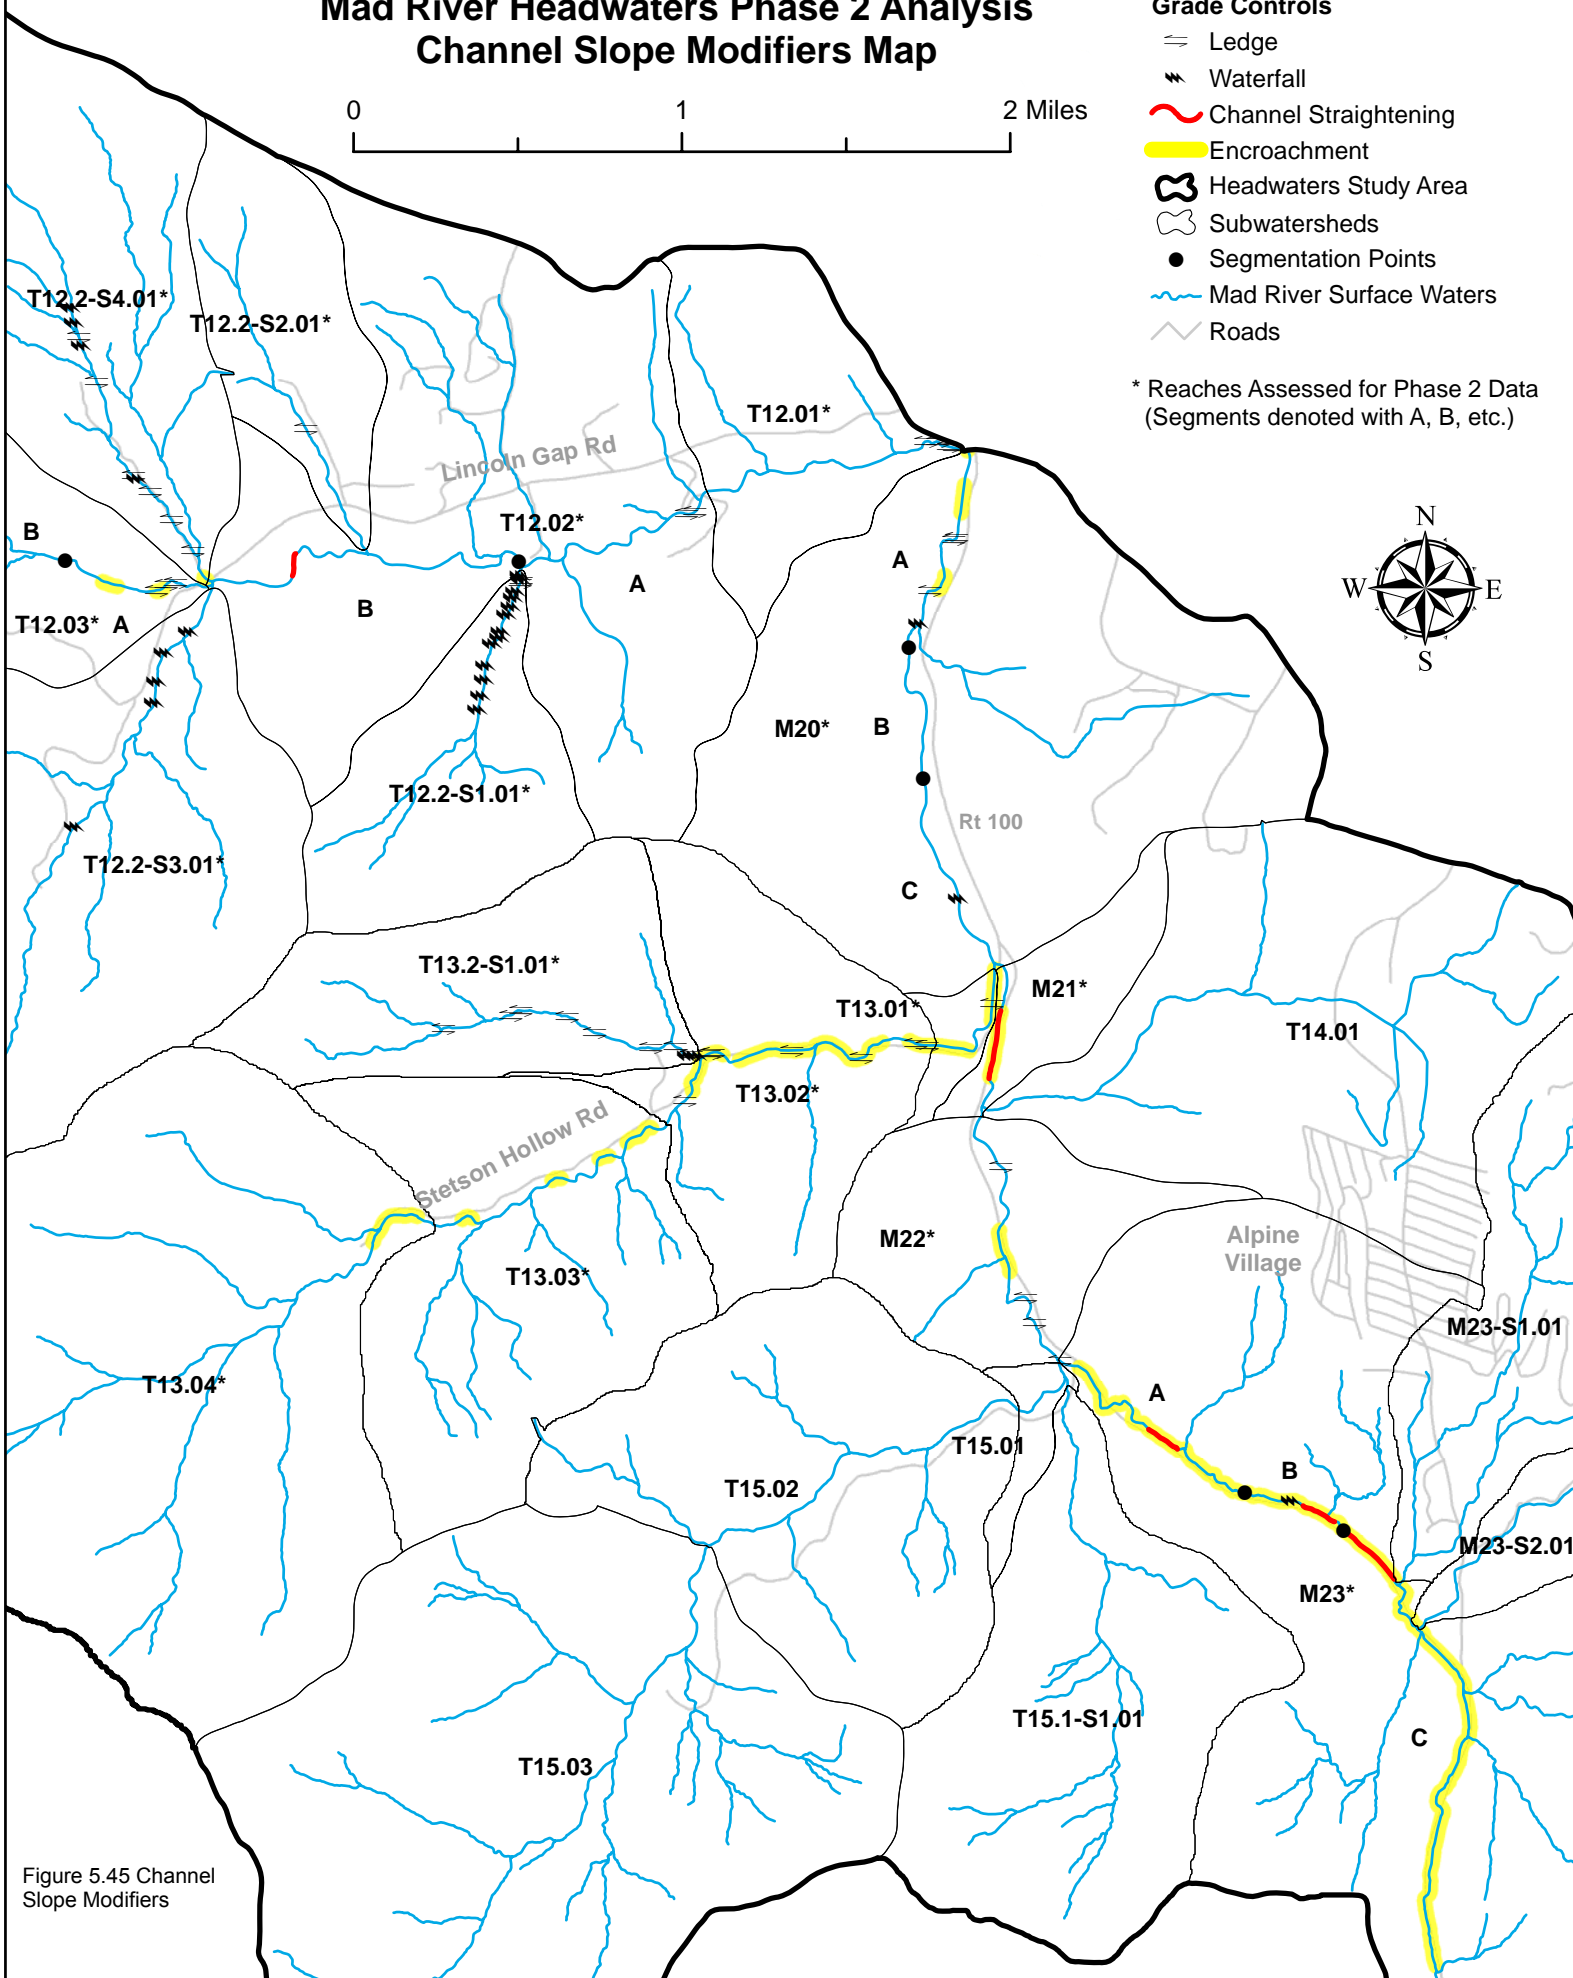
Figure 5.45 Channel
Slope Modifiers

Alterations to channel slope and depth in the Mad River headwaters have been mapped using the variables extracted from the Phase 2 field assessments (Figures 5.45 and 5.46). Channel straightening, found mainly along the upper Route 100 corridor, was mapped during the Phase 2 assessments and is included to depict areas of increased channel slope. Corridor encroachment data highlights where roads and development have reduced the floodplain area, typically resulting in increased stream power and channel deepening. Additional data showing the location of natural channel features (e.g., ledges) depict areas that have a resistance to vertical channel change. A summary of the local and upslope impacts to channel slope and depth for each mainstem reach based on Figures 5.45 and 5.46 is provided in Table 5.3 at the end of section 5.0.

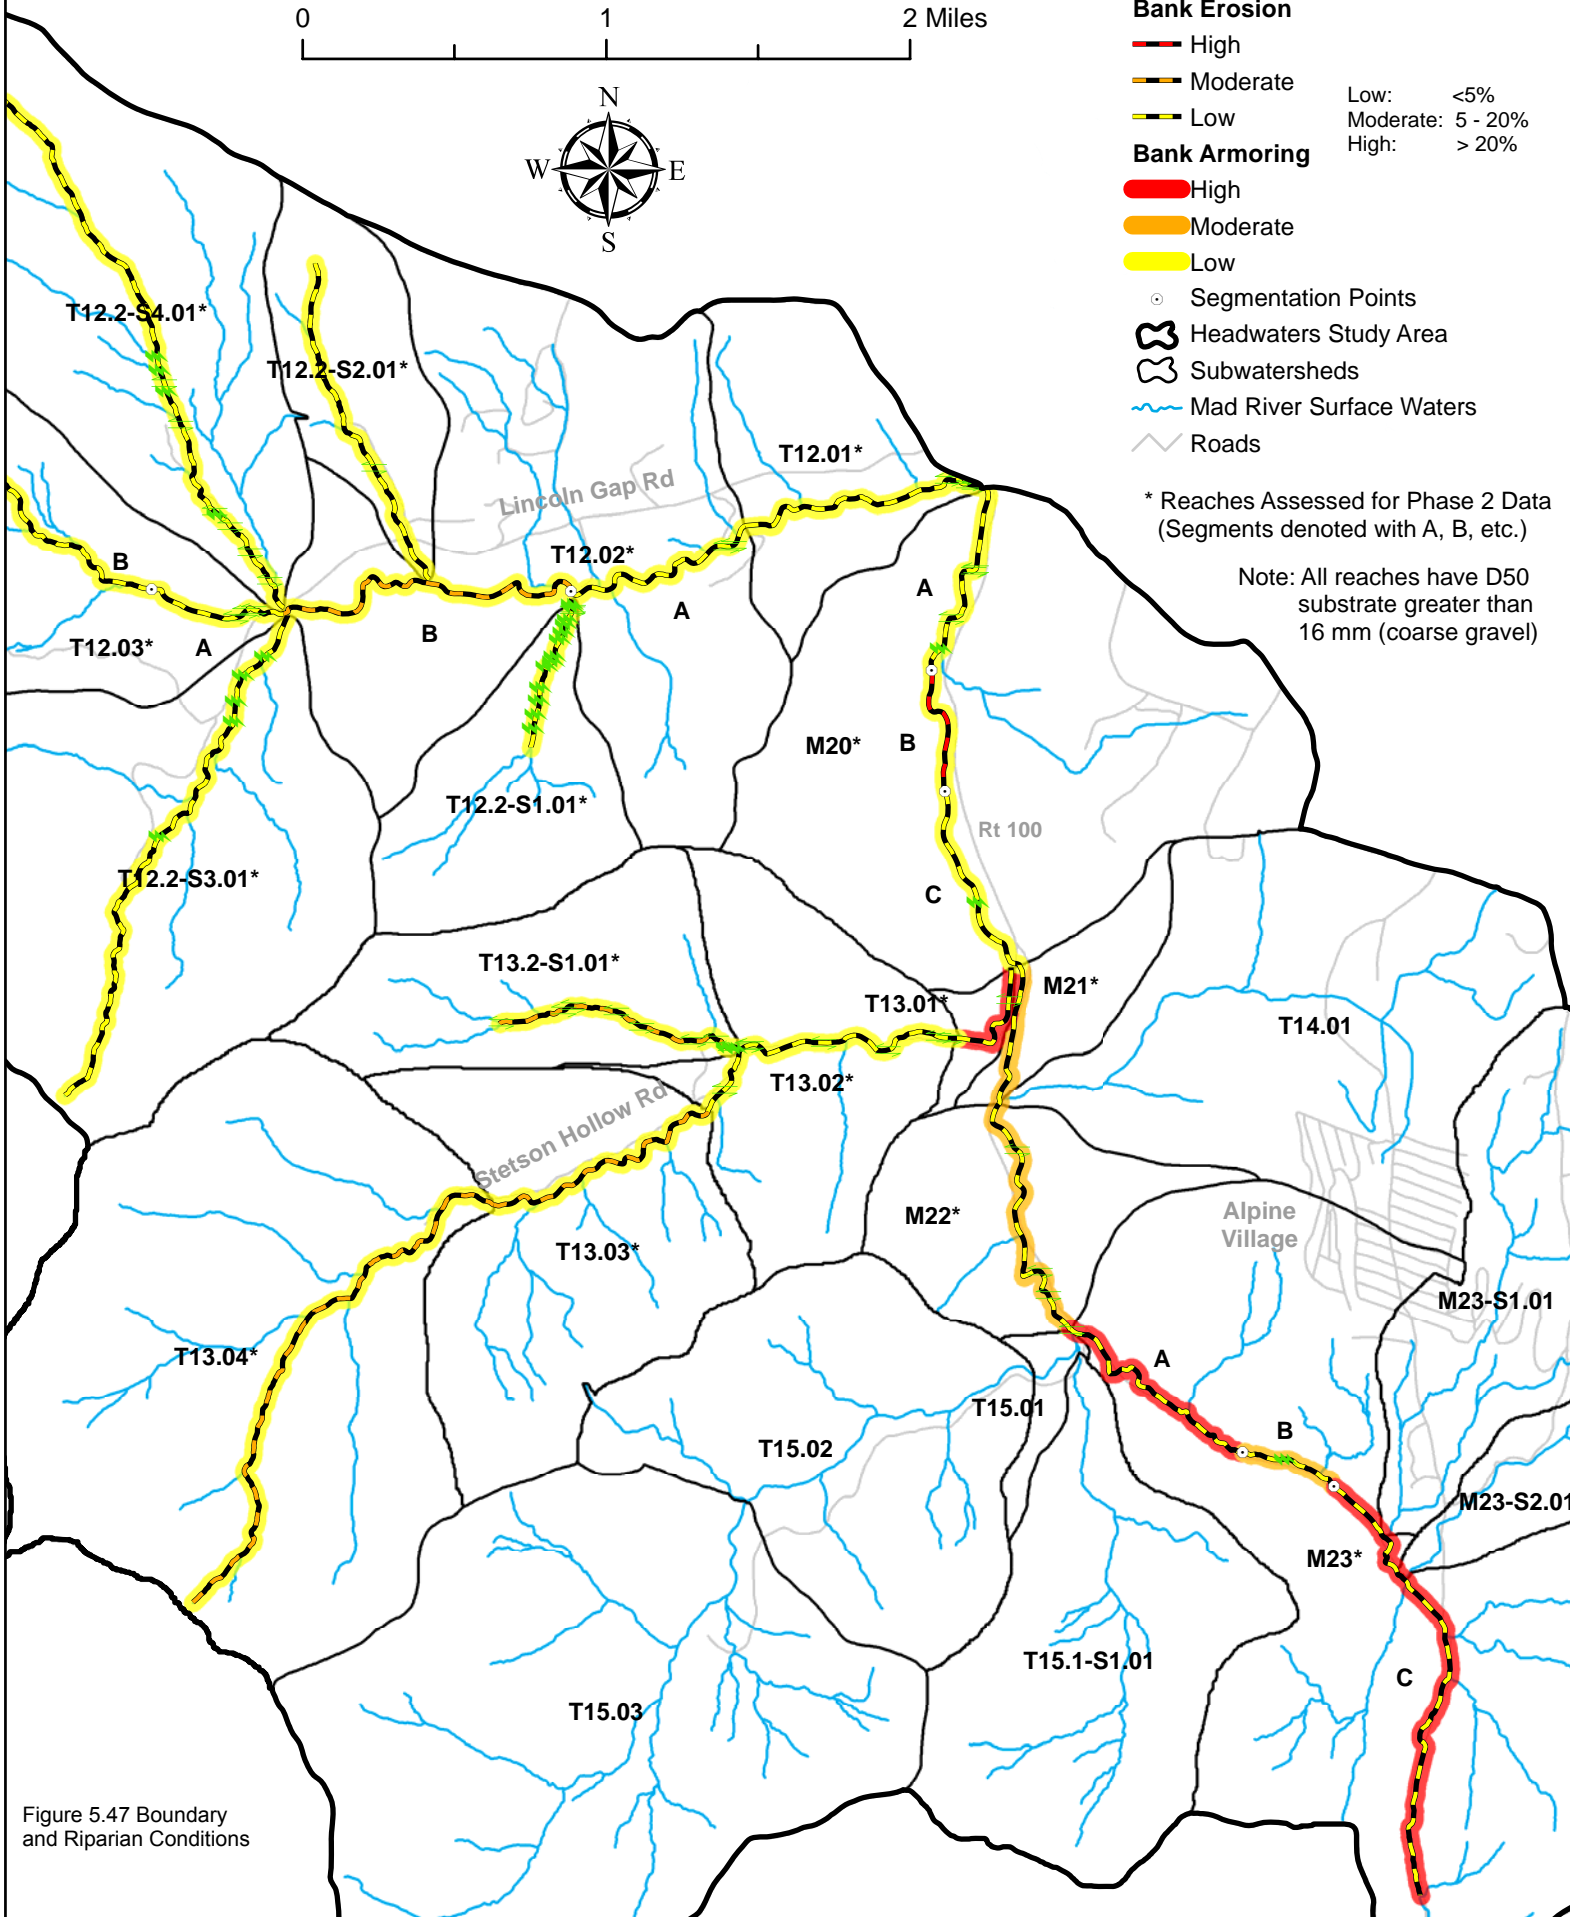
Figure 5.47 Boundary
and Riparian Conditions

Alterations to the channel boundary conditions and riparian areas in the Mad River headwaters have been mapped using the variables extracted from the Phase 2 field assessments (Figure 5.47). Relative bank armoring (e.g., riprap) highlights areas of increased resistance to lateral migration, whereas relative bank erosion highlights reaches where significant lateral adjustments are found. Additional data showing the location of natural channel features (e.g., ledges) depict areas that have a resistance to channel change. Five segments had areas of reduced riparian vegetation (at least 10% of channel length for one bank), including: M23-A, M23-C, T12.02-B, T13.01, and T13.02. However, even in segments where reduced riparian vegetation is high (as in M23-A, M23-C, and T13.02) any decreases in boundary resistance from this impact are offset by increases in boundary resistance from bank armoring, as depicted in Figure 5.47. A summary of the local impacts to channel boundary conditions for each mainstem reach based on Figure 5.47 is provided in Table 5.3 at the end of this section.

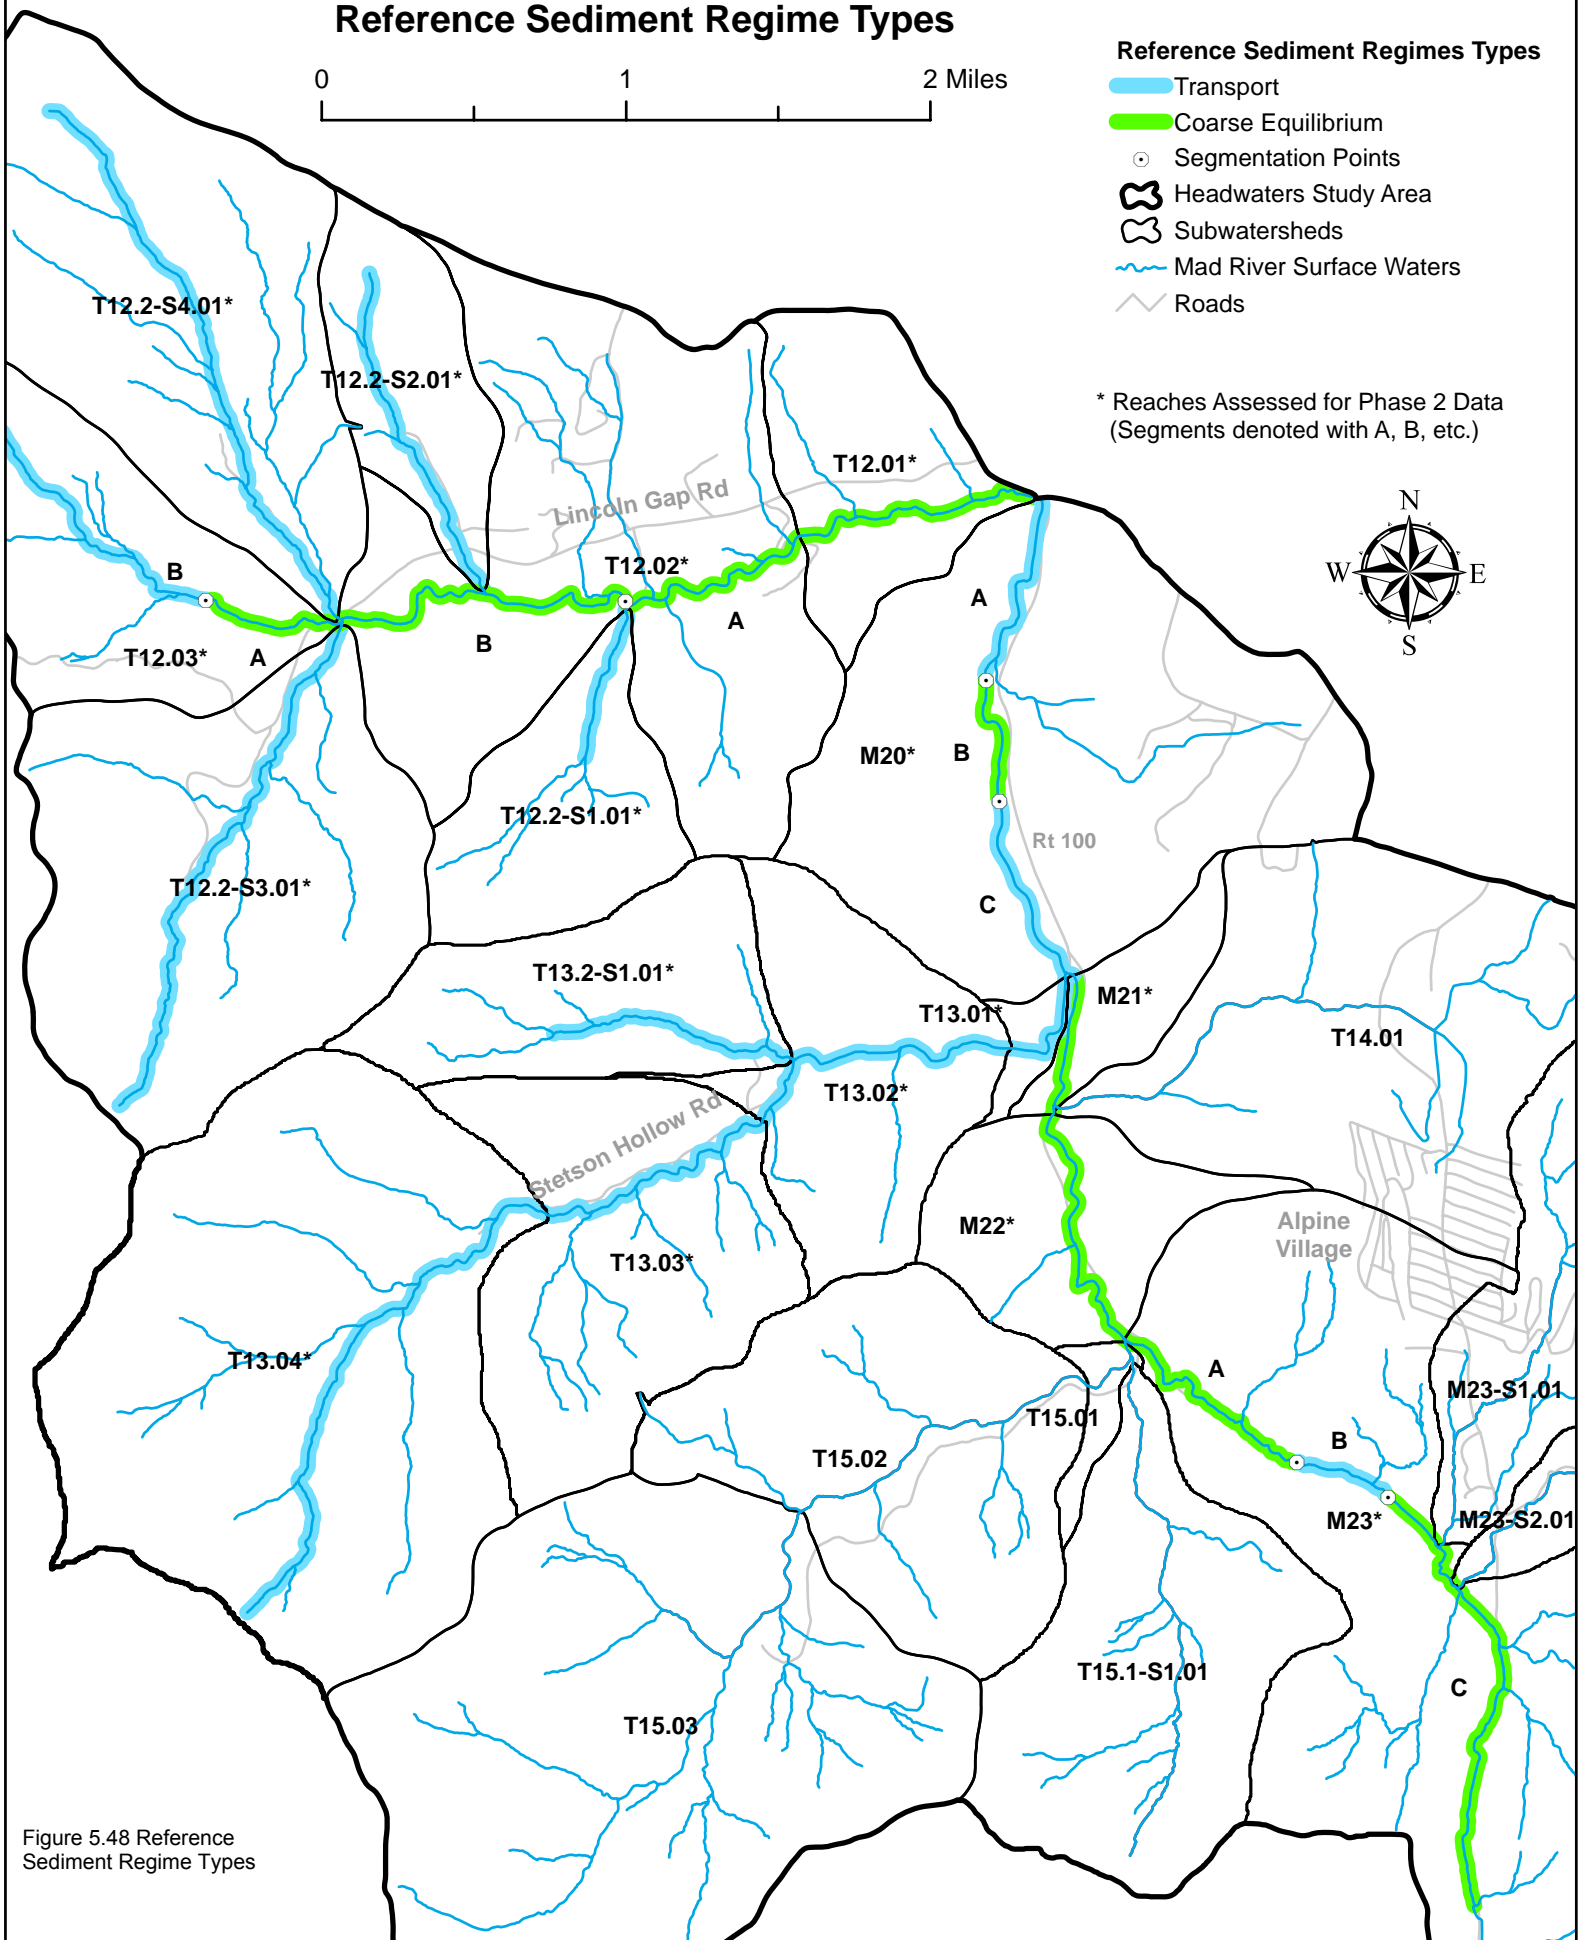
Figure 5.48 Reference
Sediment Regime Types

Figures 5.48 and 5.49 summarize the sediment regime types for reference and existing conditions for the headwaters reaches. The analysis of sediment regime types indicates that the headwaters of the Mad River have experienced many areas of departure from the reference regime conditions. Approximately half of the headwaters channels had background valley and slope conditions that supported coarse-bottomed streams in

equilibrium; there was a balance between sediment transport and supply. Segments M20-B, M21, M22, M23-A, M23-C, T12.01, T12.02-A, T12.02-B, and T12.03-A are characterized by this regime under reference conditions. However, with the exception of a single reach (T12.01), all experienced a departure to source and transport regimes due mainly to incision and other channel evolution processes brought on by human impacts. Along the mainstem, segments M20-A, M20-C, and M23-B have confinement and channel slope characteristics that support sediment transport channels. Only segment M20-C has experienced a sediment regime departure from reference conditions due to channel incision. Within the Lincoln and Stetson Brook watersheds, many transport reaches have become significant sources of sediment due mainly to historic impacts to the channel boundary conditions (e.g., straightening, encroachment and armoring). Table 5.3 summarizes both the departure of sediment regime conditions based on the transport and storage capacity, as well as the constraints to 1) the connectivity of the adjustment processes along the channel network, and 2) the redevelopment equilibrium conditions in the reach.

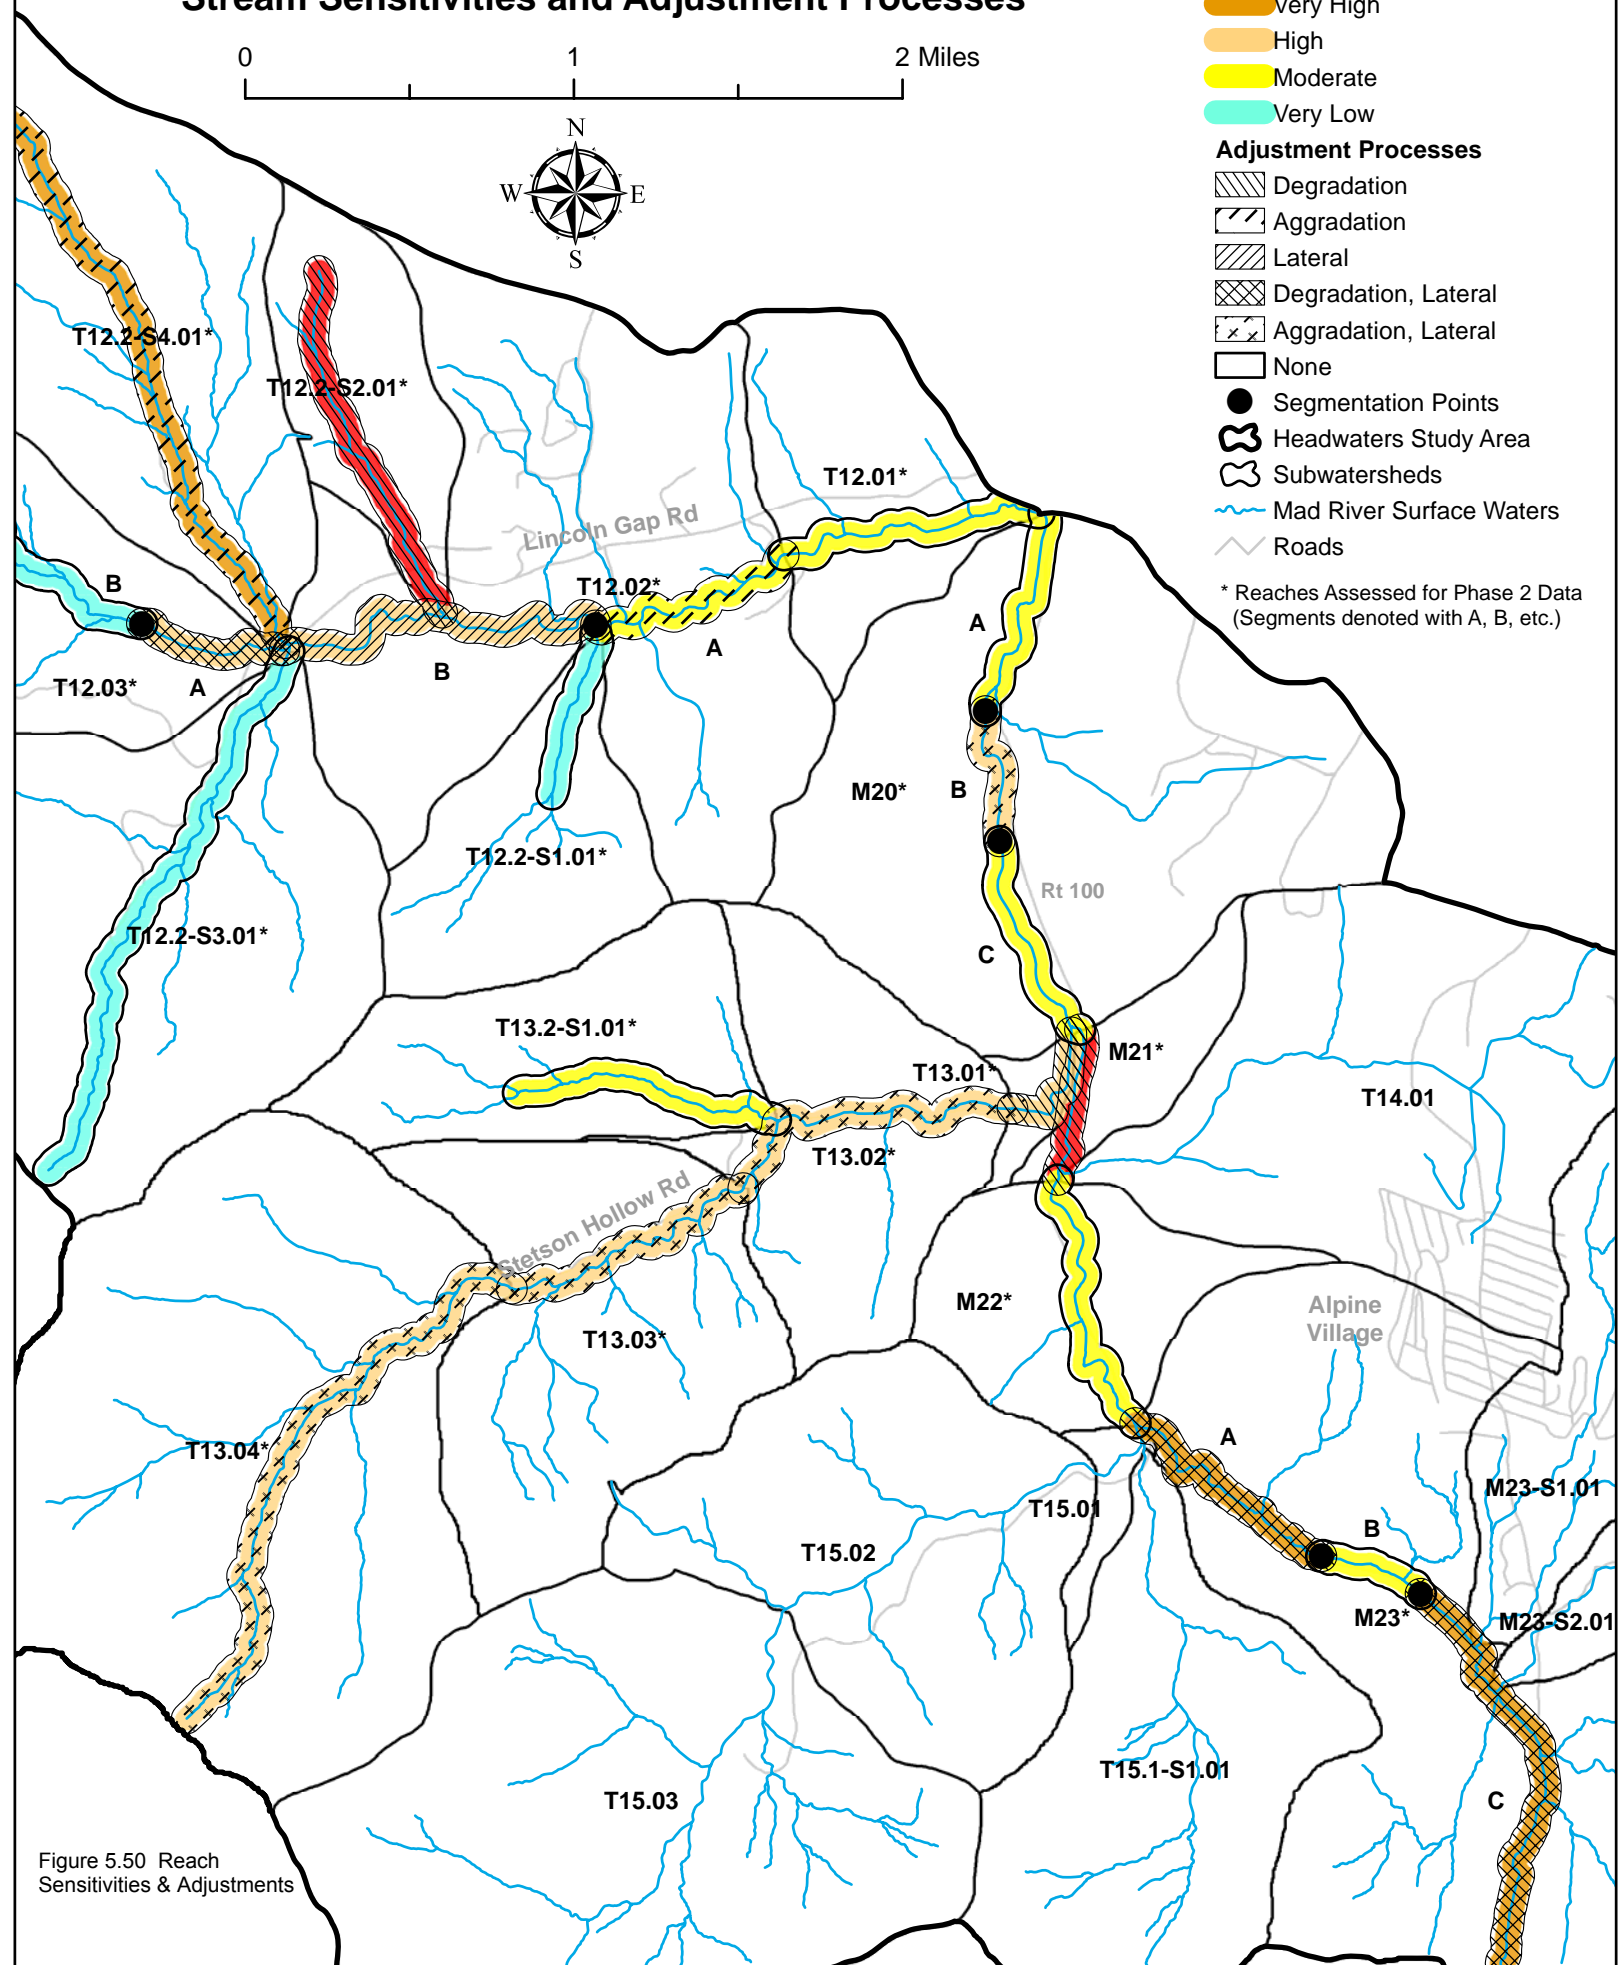
Figure 5.50 Reach
Sensitivities & Adjustments

The methods outlined in the Corridor Planning Guide have been used to describe the stream sensitivities of the headwaters reaches of the Mad River. Using the stream geometry and substrate data (Rosgen, 1994) collected during the 2007 field season, as well as the overall geomorphic stability of the reach (RGA score), stream sensitivity ratings have been assigned. In addition, the active adjustment processes described during the field effort have been summarized. An adjustment process was considered “active” if it received a score in the fair to poor range during the RGA scoring process. Figure 5.50 summarizes the current stream sensitivities and adjustment processes for the Mad River headwaters.

are being held in check by extensive bank armoring. The three headwaters segments on the Mad River mainstem having sensitivities of “very high” or “extreme” are summarized below.
