**Bridge and Culvert Assessment  
Using Agency of Natural Resources' Protocol  
Strafford Conservation Commission  
Town of Strafford, Vermont  
West Branch of Ompompanoosuc River Watershed**

April 25, 2005

Mary Nealon  
Principal/Aquatic Biologist

Strafford Conservation Commission

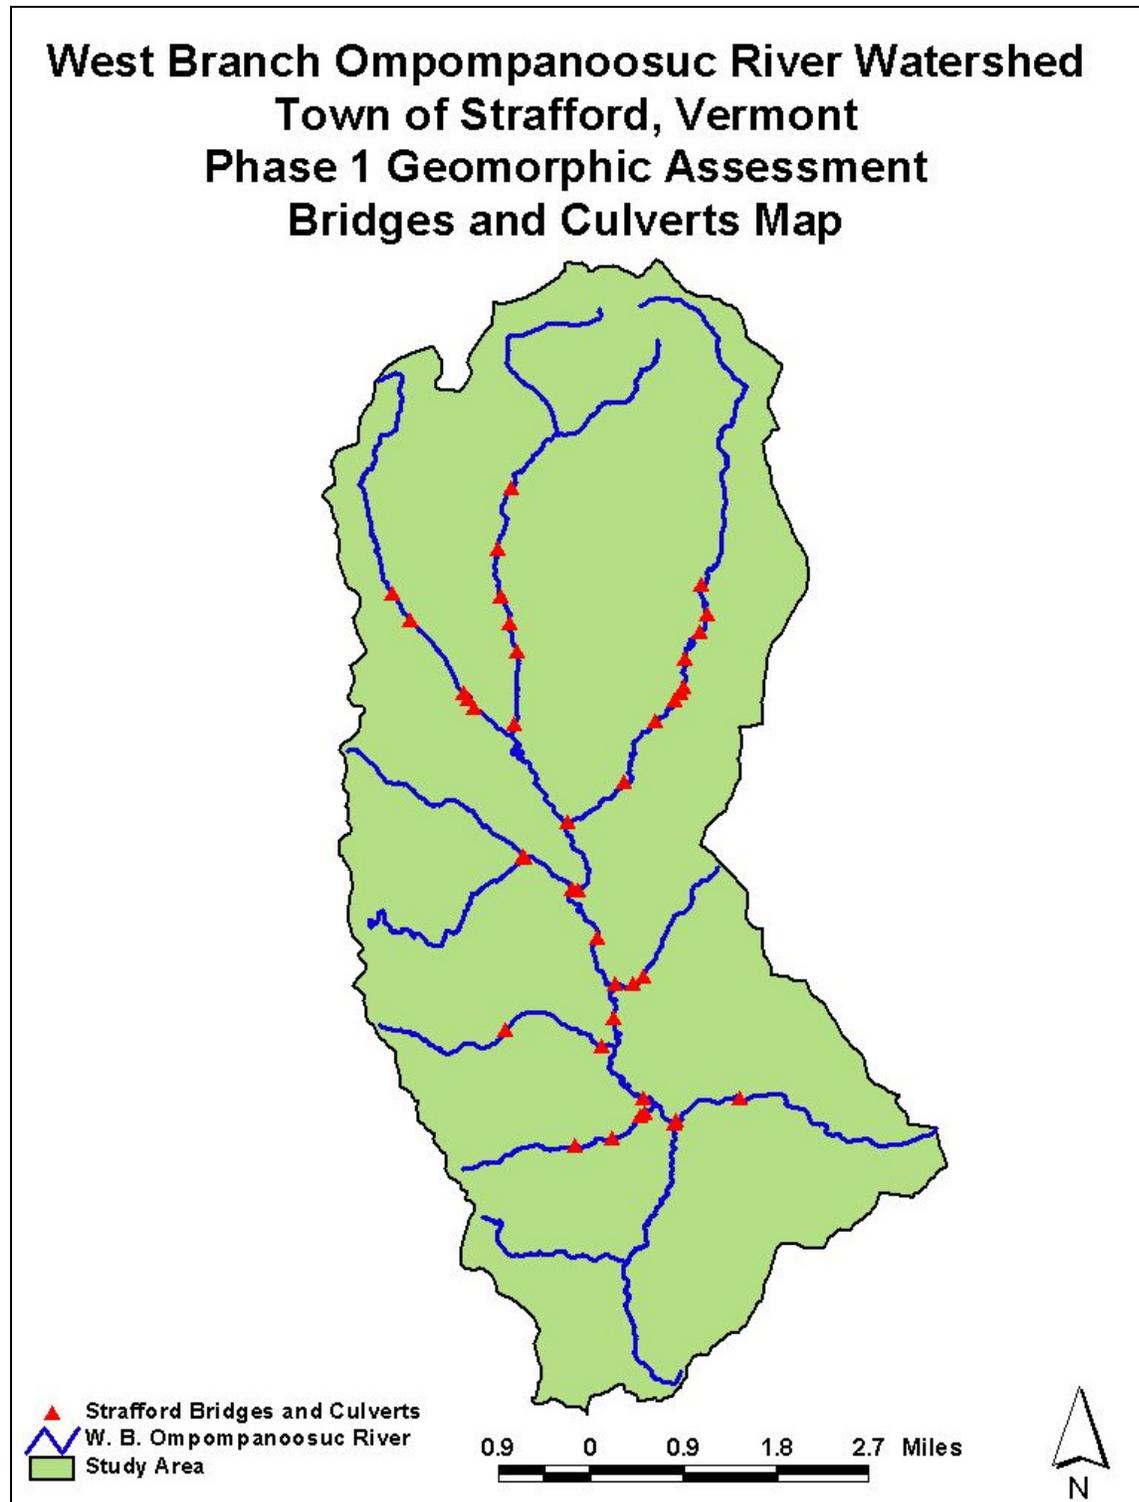
Figure 1. Bridges and culverts assessed during summer 2004 by the Strafford Conservation Commission using the ANR protocol

Twenty-nine bridges and ten culverts were included in the bridge and culvert assessment (see Figure 1). The geomorphic and habitat data for the ANR bridge and culvert assessment are provided on pages 1 through 78 of Appendix 1. As shown on the reports on pages 1 and 2 of Appendix 2, all 39 structures were flagged on the ANR's culvert failure mode report for geomorphic incompatibility.

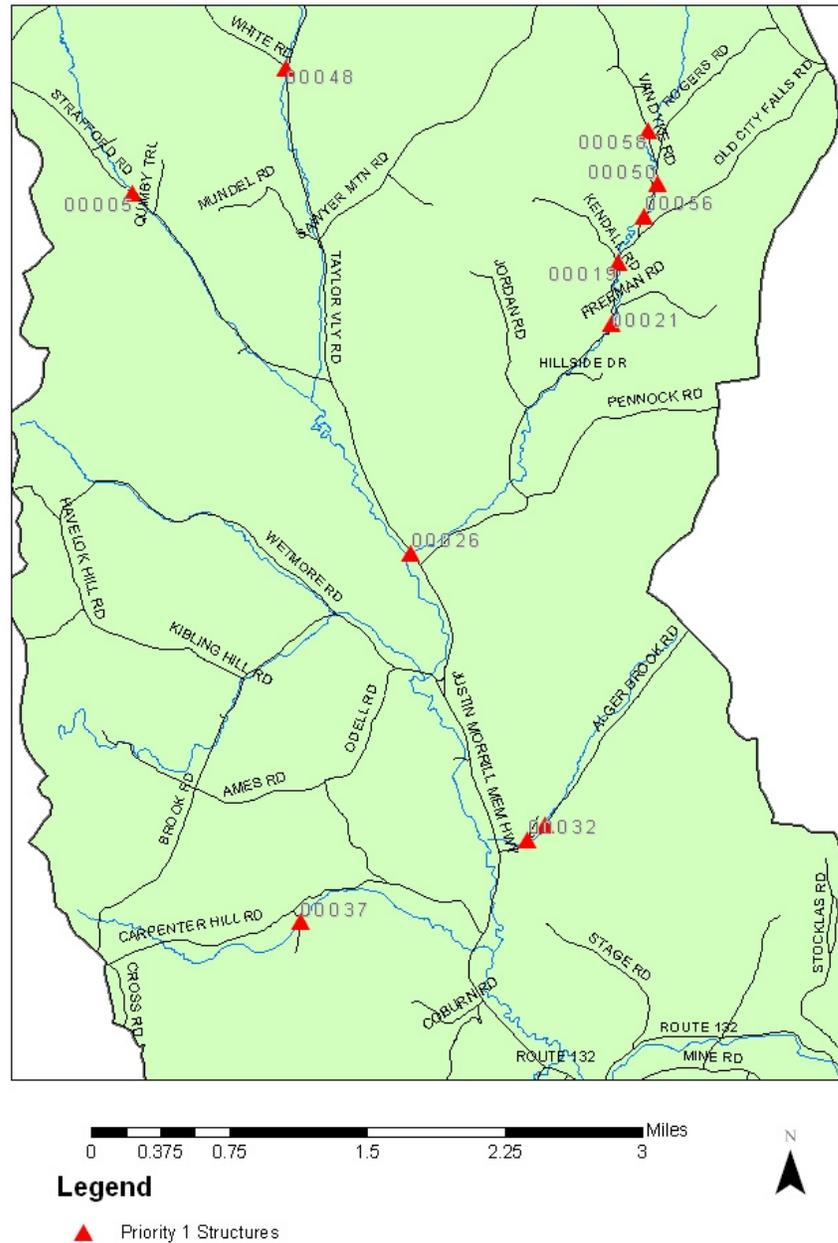
Figure 2. Stream crossings in Strafford, Vermont within the Ompompanoosuc River watershed considered to be high priority in terms of replacement due to geomorphic incompatibility, fish passage concerns, and condition.

The category 1 structures are summarized below in Table 1, and are identified on the map in Figure 2.
