# <u>Fluvial Geomorphology Assessment of the</u> <u>Poultney River and Hubbardton River,</u> <u>Vermont</u>

## The Nature Conservancy Southern Lake Champlain Valley Program West Haven, VT

Field Geology Services Farmington, ME

March 2006

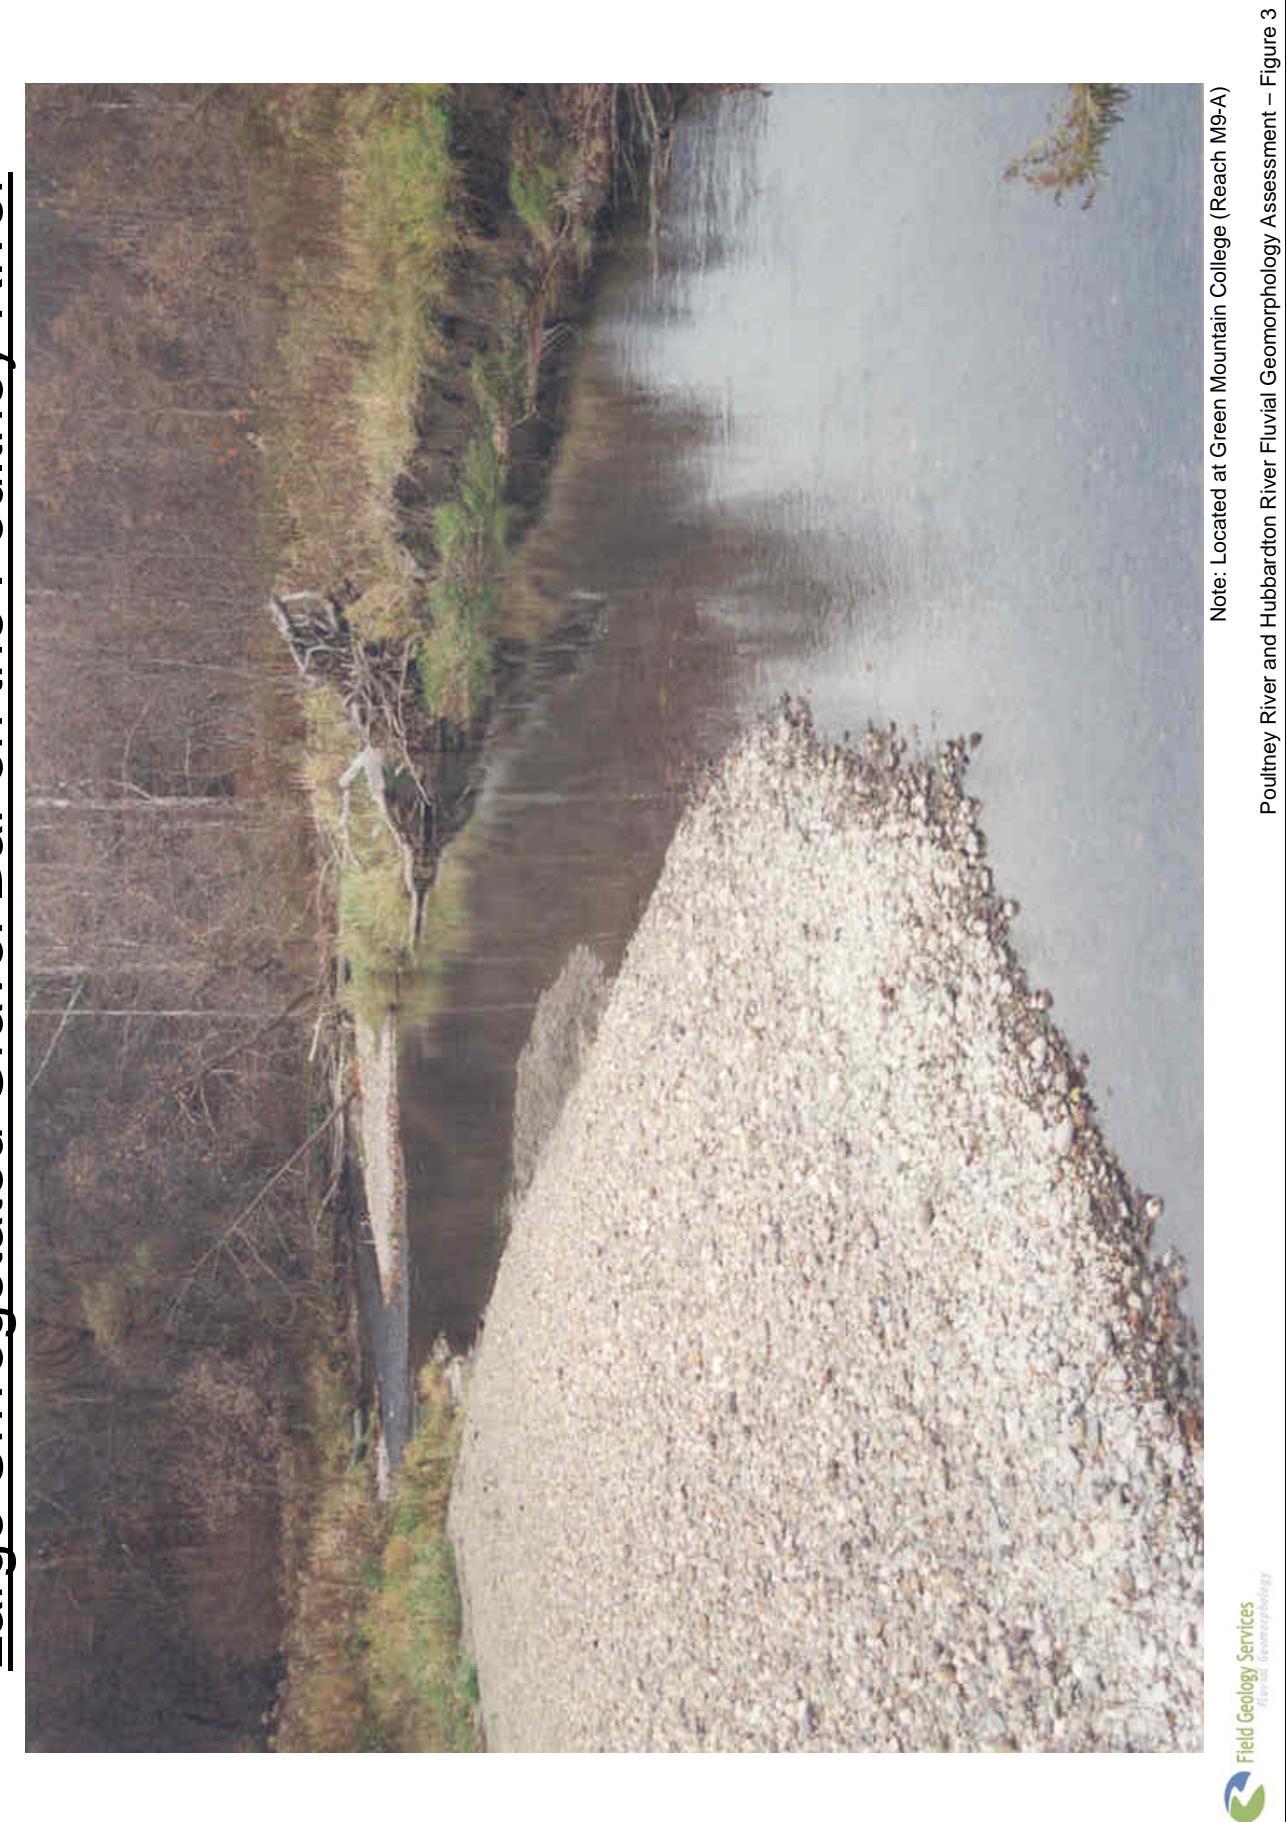
Poultney River and Hubbardton River Fluvial Geomorphology Assessment – Figure 4

- Figure 2: Eroding bank of glacial deposits on the upper Poultney River
- Figure 3: Large unvegetated gravel bar on the Poultney River
- Figure 4: High eroding bank of glacial lake deposits on the Hubbardton River

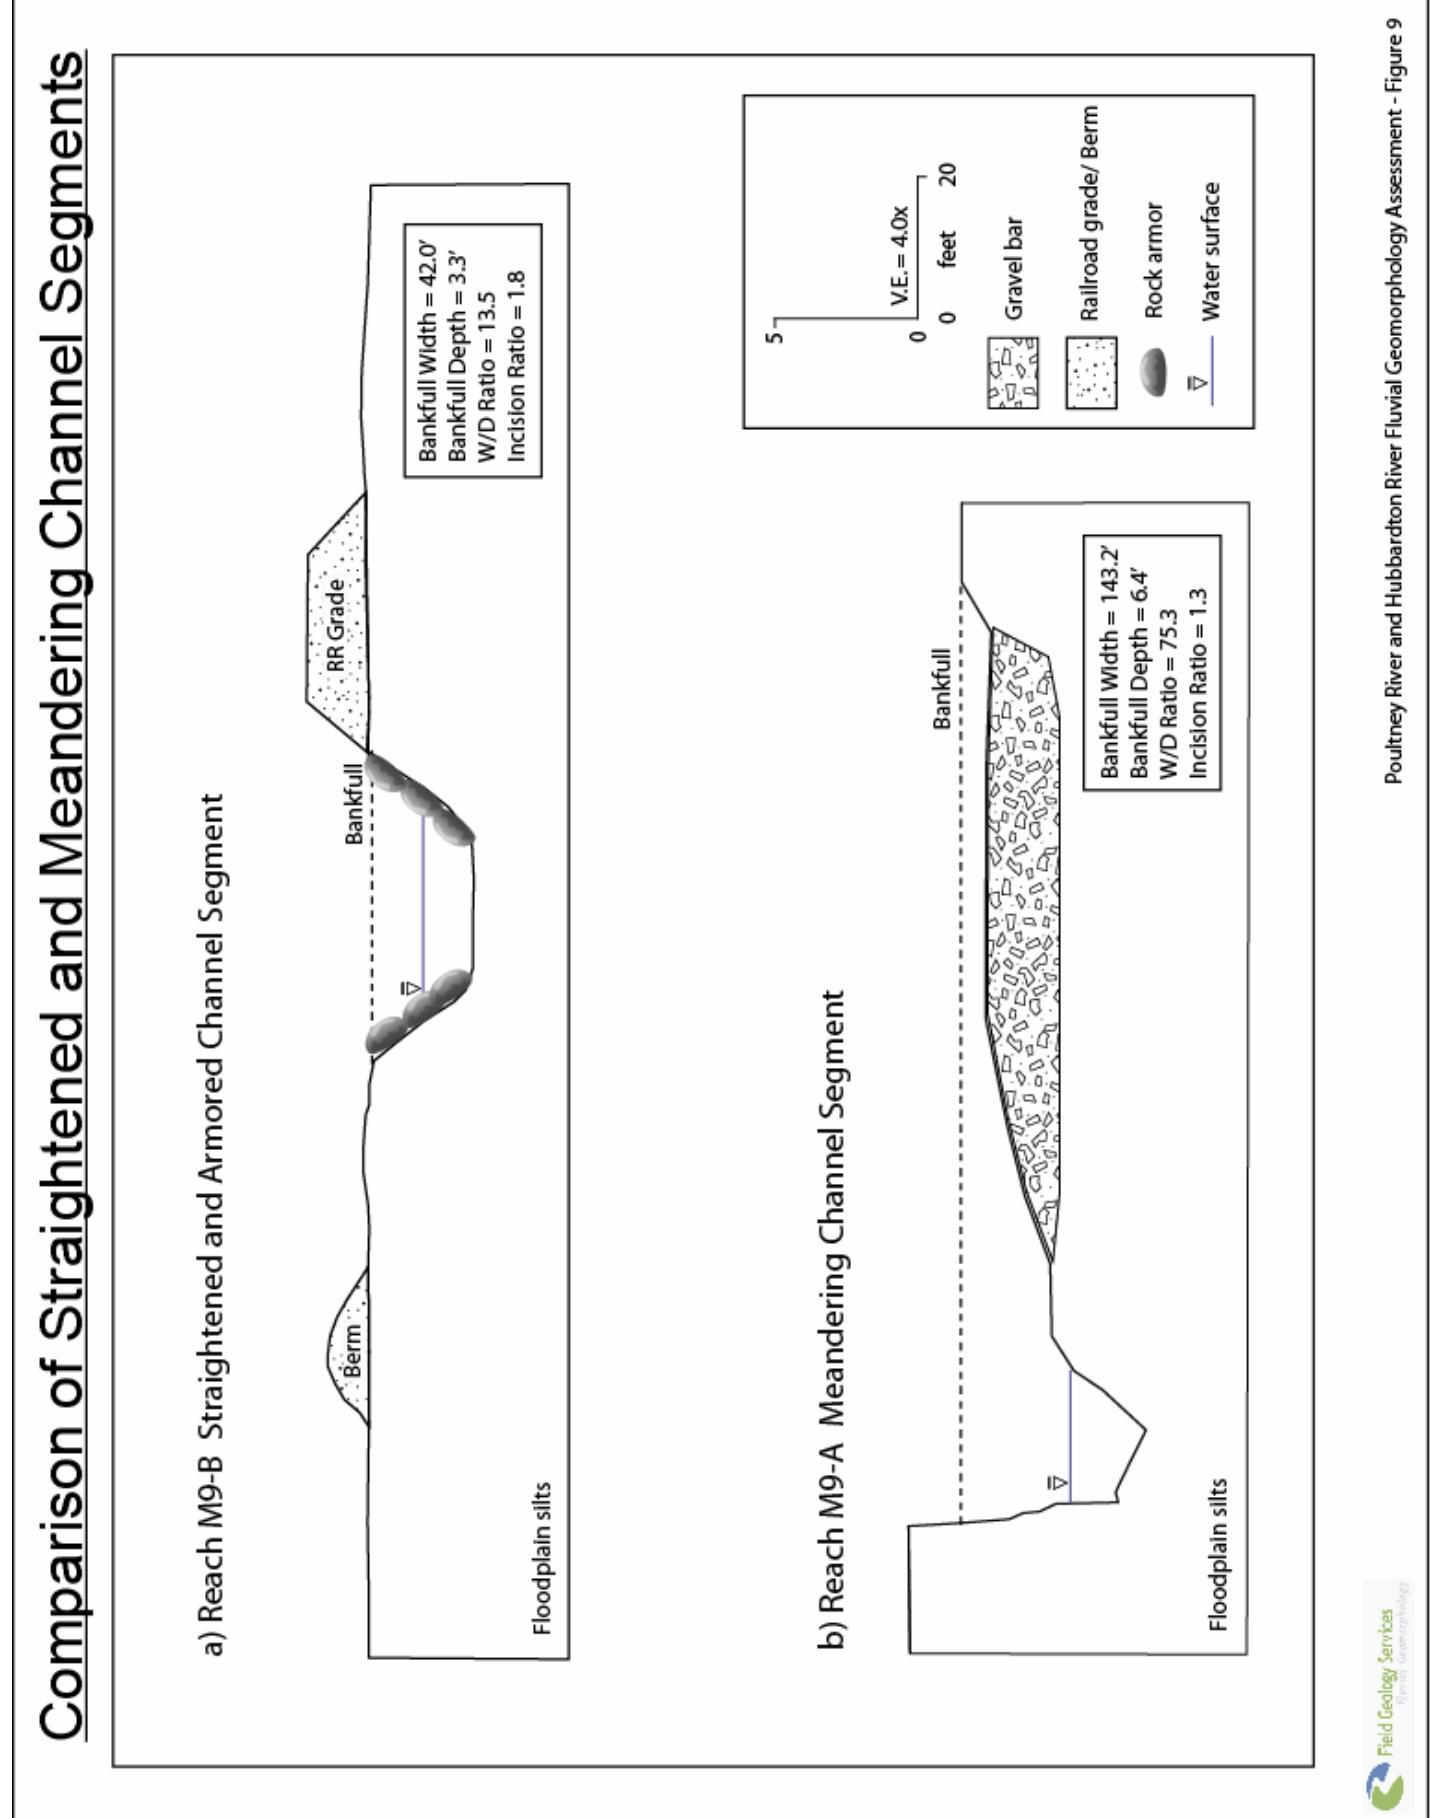
Poultney River and Hubbardton River Geomorphology Assessment - Hgure 10

- Figure 9: Comparison of cross sections along a) straightened and b) meandering channel segment on the Poultney River
- Figure 10: Cross section of lower Poultney River showing newly developed floodplain lower than older abandoned floodplain surface

A fluvial geomorphic assessment of the Poultney and Hubbardton Rivers has identified river reaches continuing to respond to past land use and river management practices. The Poultney River is characterized by alternating confined source reaches and unconfined response reaches. In the Town of Poultney (Reach M9-B), where the river emerges from mountainous areas onto a broad flat valley, channel straightening and bank armoring was used in the past to alleviate flooding and bank erosion by altering the river's natural tendency for sediment deposition. Downstream the channel continues to build large gravel bars (Figure 3), shift channel positions, and attack the river's banks in response to the human manipulations and natural loss of sediment transport efficiency (Reach M9-A). On the lower Poultney River (Reach M3), where the channel emerges from a narrow valley around Fair Haven, the channel experienced 14 feet of aggradation as a result of deforestation by early European settlers that increased sediment production from the surrounding sandy glacial lake terraces (Figure 11). Reforestation of the watershed in the past century has decreased sediment delivery to the river and has caused 14 feet of incision through the European settlement deposits. The river continues to erode the resulting high river banks (Figure 11) as a new floodplain level and equilibrium condition is achieved (Figure 10).

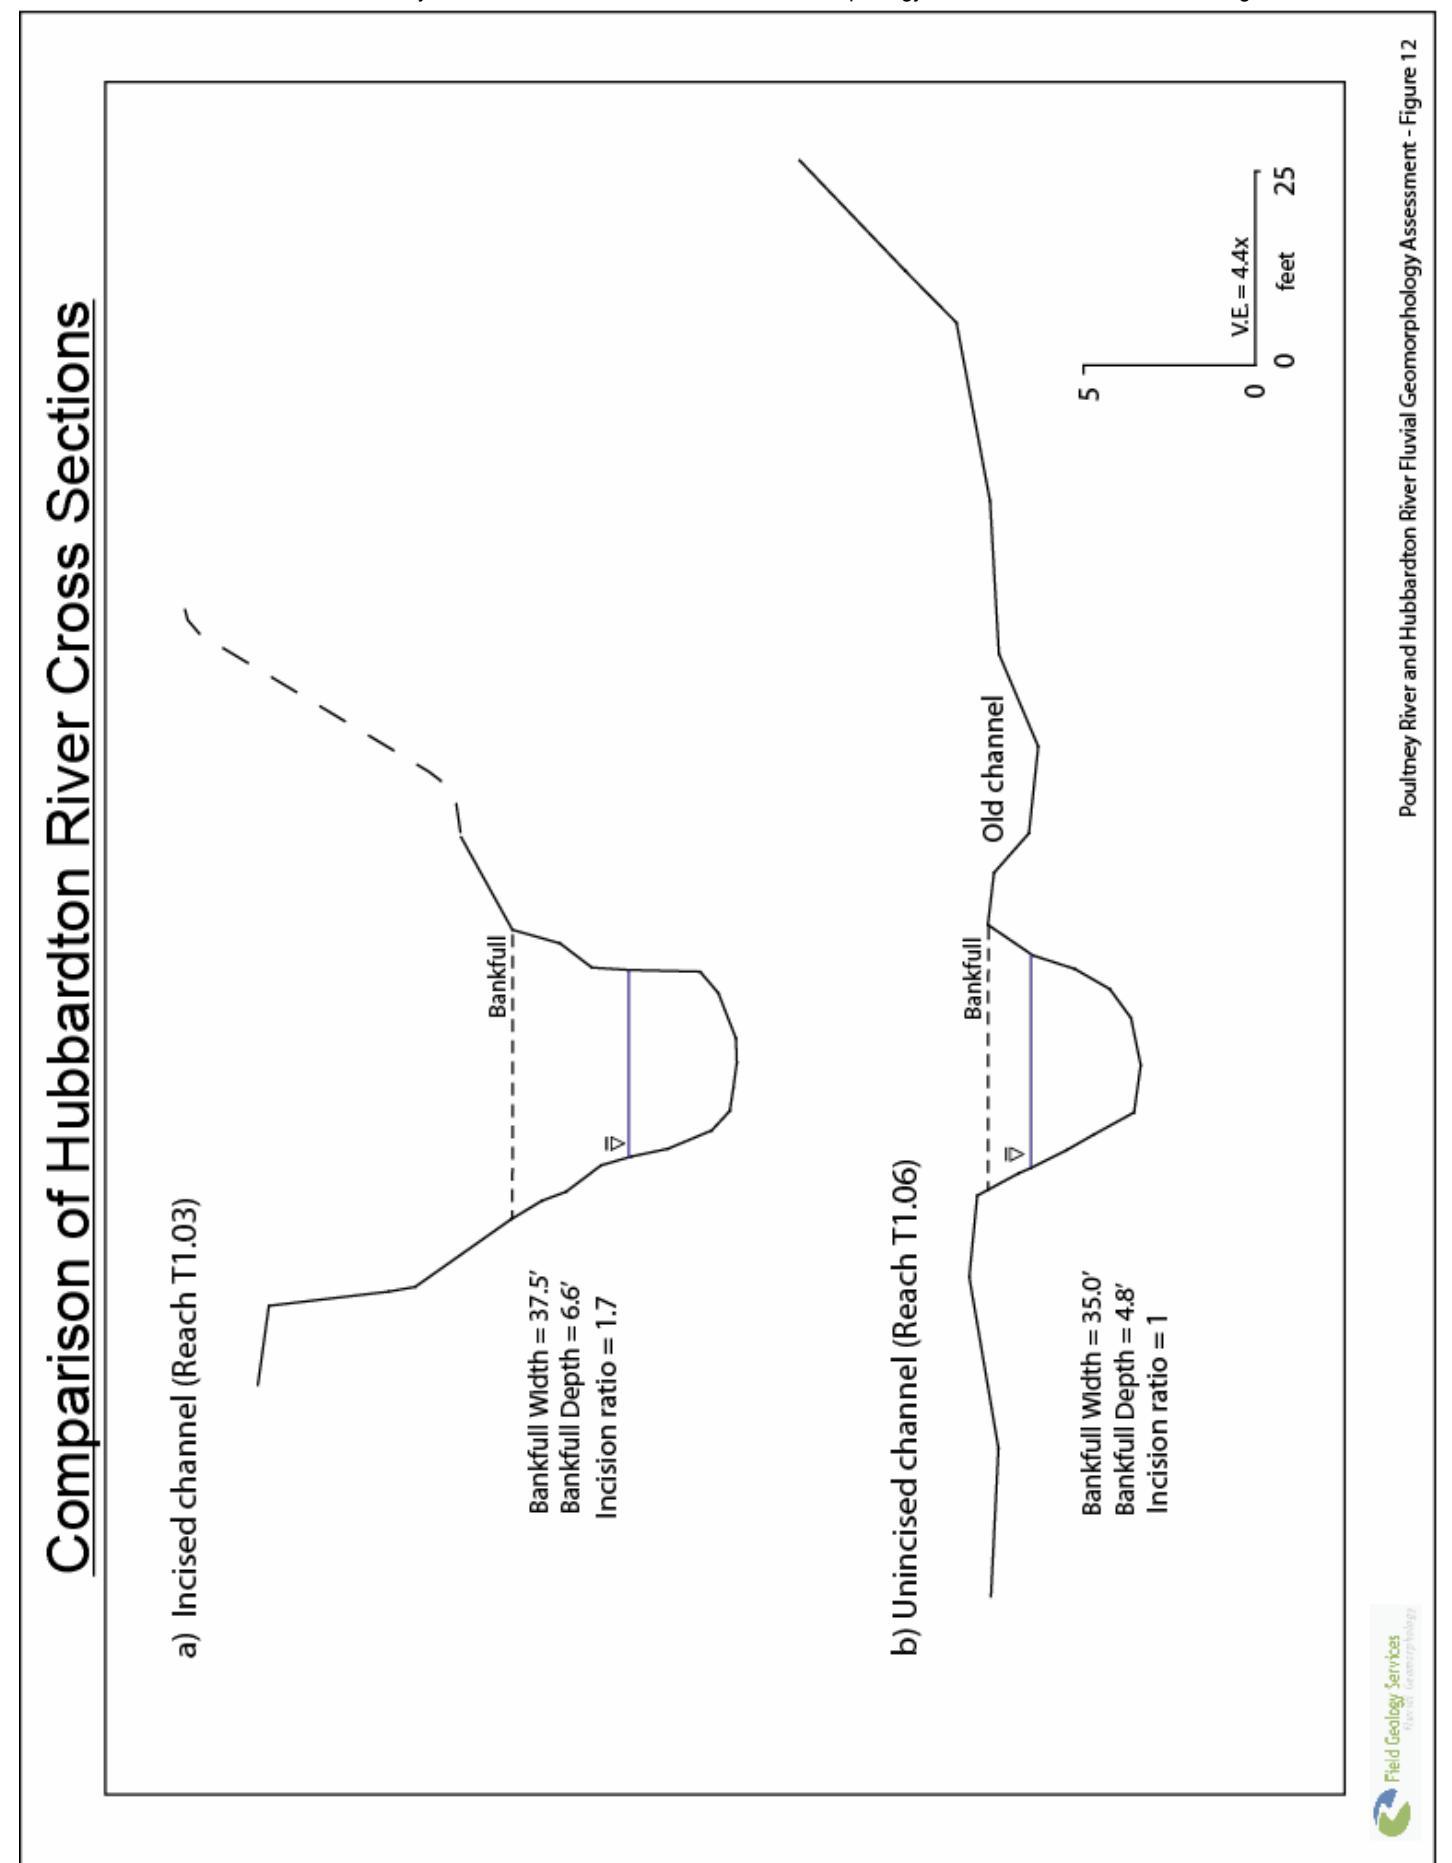
Poultney River and Hubbardton River Fluvial Geomorphology Assessment – Figure 11

- Figure 11: Photo of eroding bank on lower Poultney River exposing post-European settlement deposits
- Figure 12: Comparison of cross sections along an a) incised reach and b) unincised reach of the Hubbardton River
