Phase I and 2 Stream Geomorphic Assessments North Branch of Deerfield River Watershed Windham County, Vermont

Final Report
January 30, 2006

Vermont Department of Environmental Conservation
Water Quality Division
103 South Main Street
Building 10 North
Waterbury, VT 05671-0408

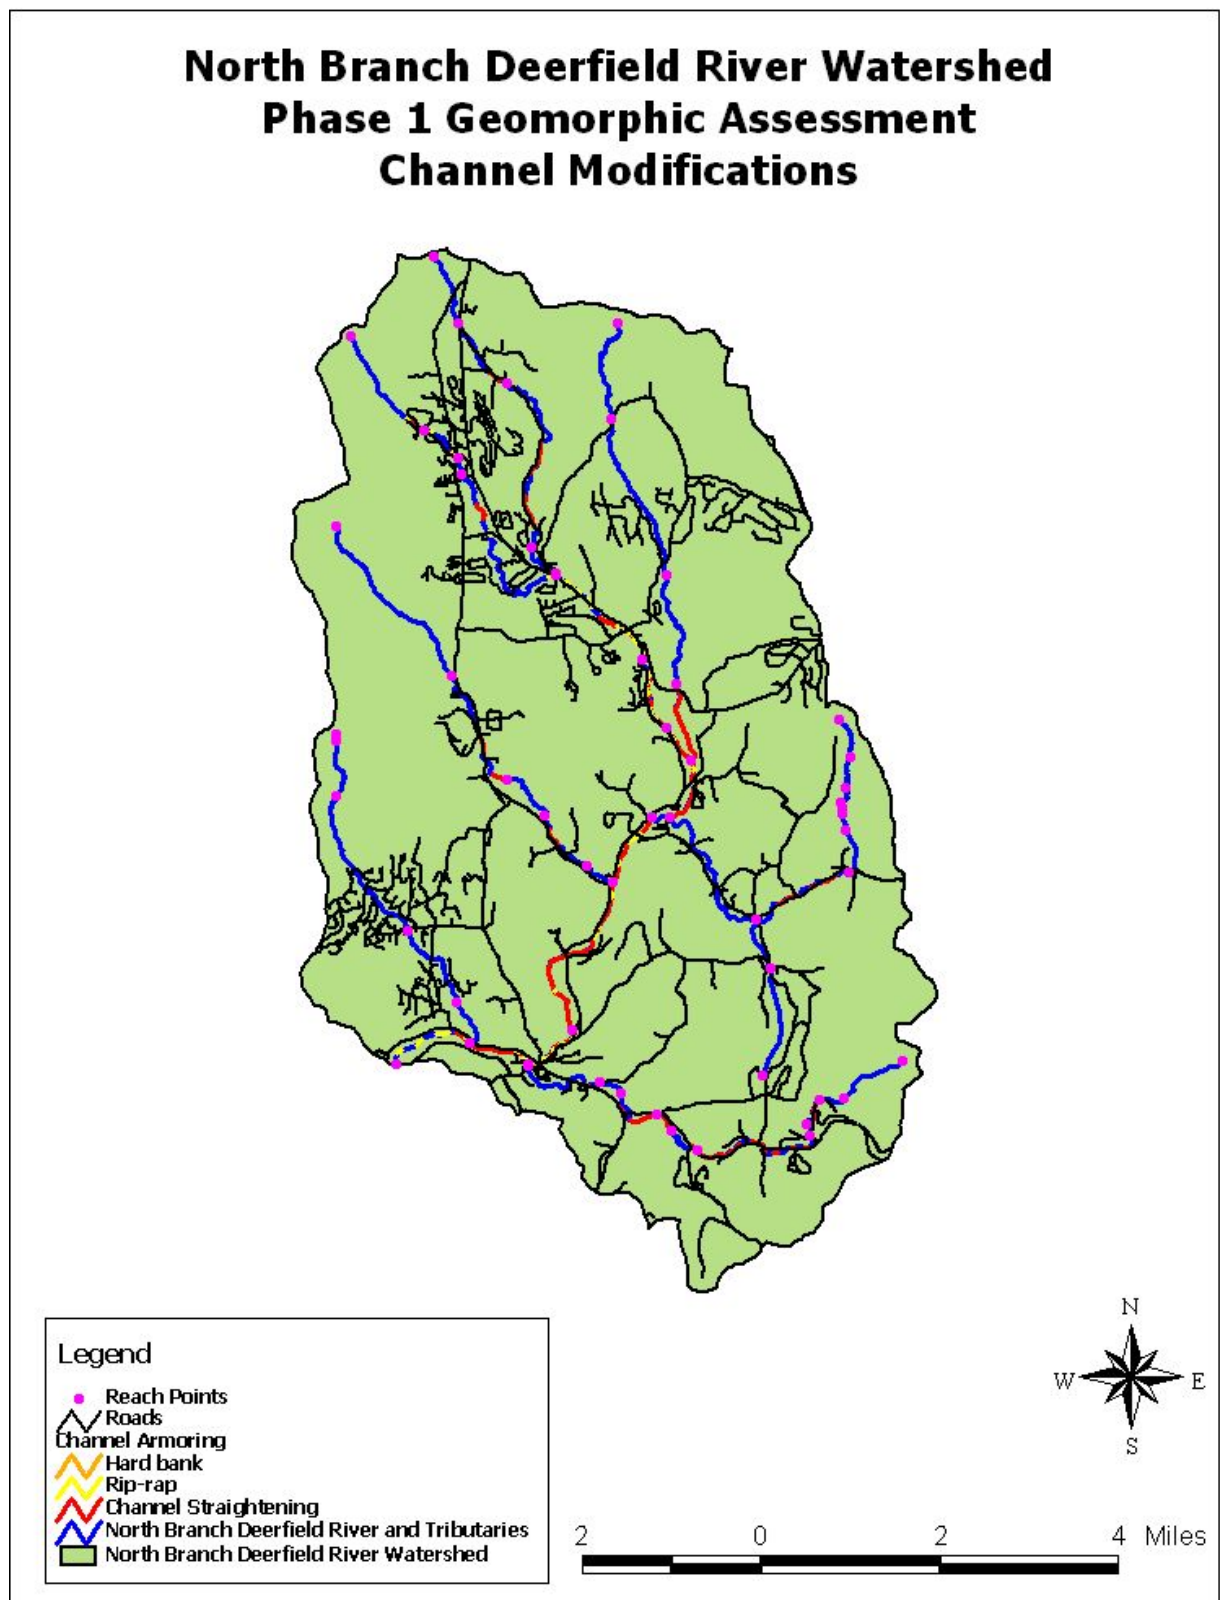
Figure 6. Instream Channel Modifications Identified for Phase I Reaches

The only channel modification noted within the North Branch watershed was straightening. Portions of stream reaches that have been historically channelized or straightened are identified below in Figure 6. Channel straightening was identified in 25 of the 48 reaches. Twenty of these reaches were given an impact rating of high for channel straightening, while 5 had an impact rating of low.

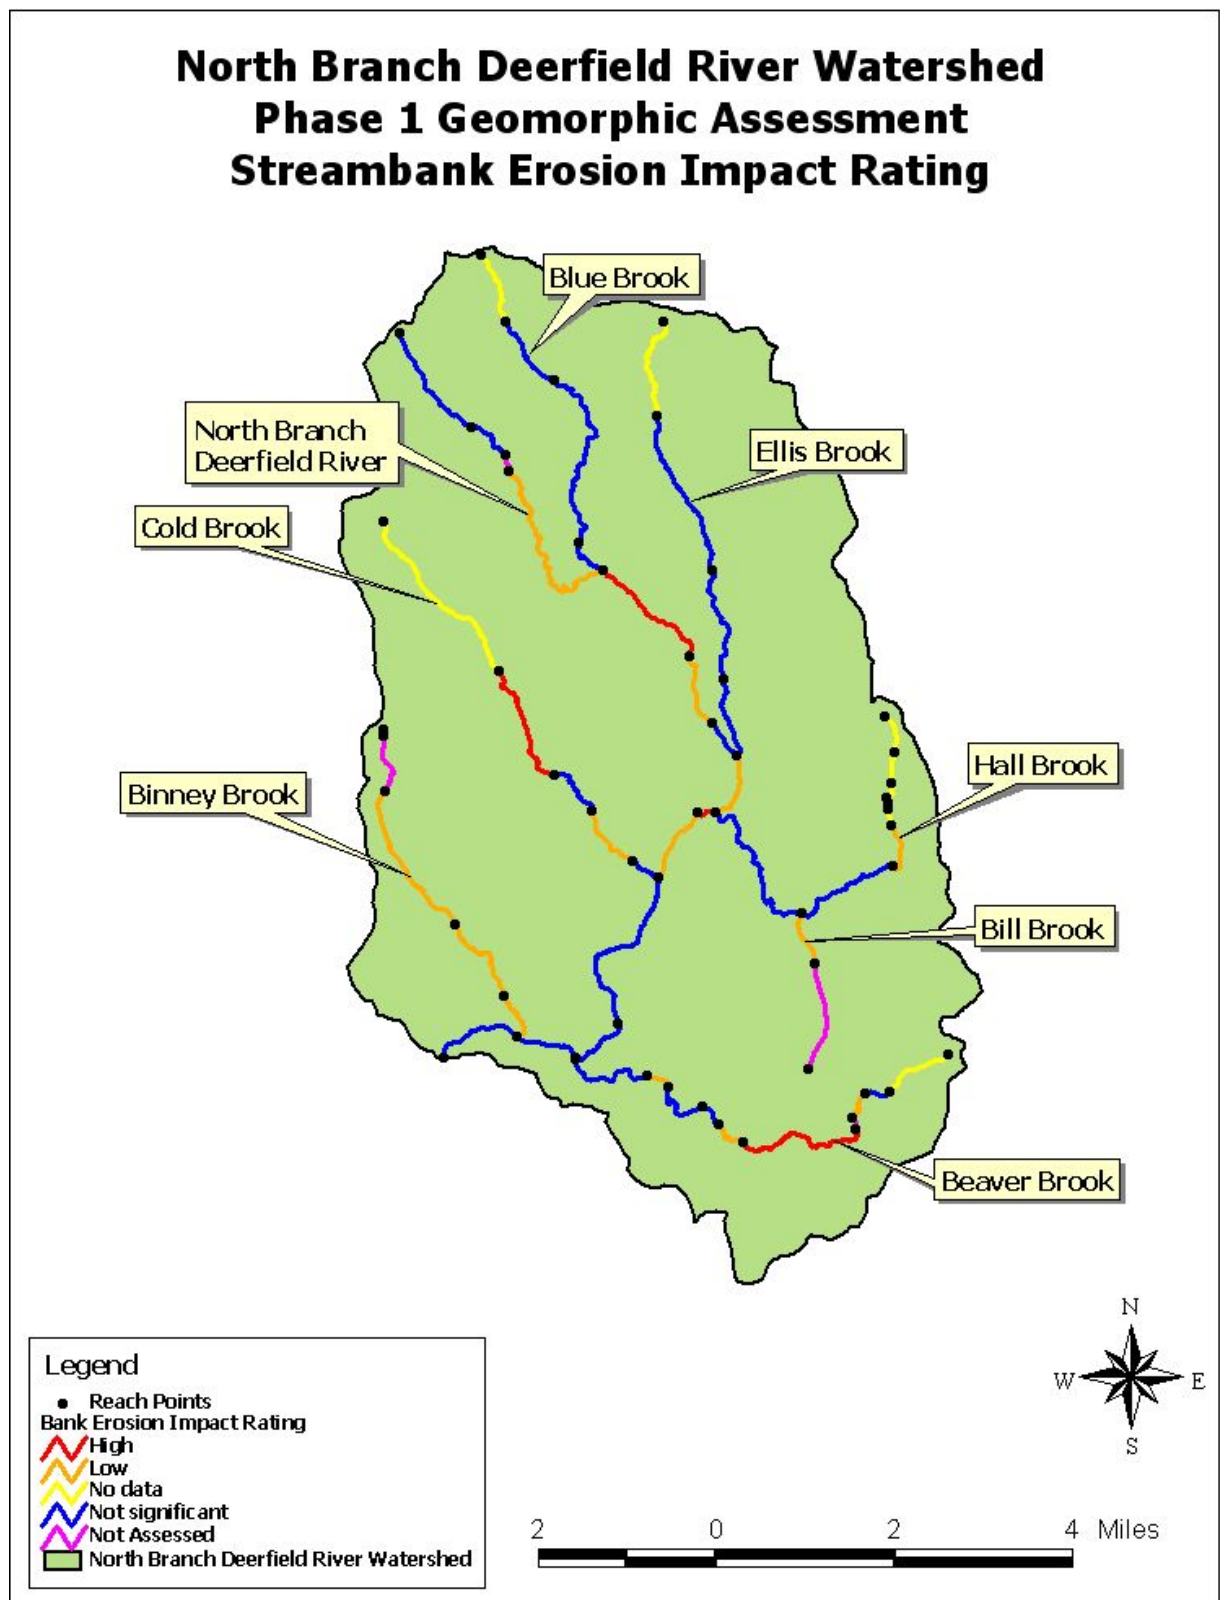
Figure 7. Streambank Erosion Impact Rating for North Branch River Watershed

bank material were previously discussed under Section 4.2, Stream Typing. The amount of bank erosion observed along a reach and the bank height were evaluated in conjunction with each other to provide a bank erosion impact rating. Bank erosion was rated as high for two reaches and low or not significant for the rest of the reaches. The bank erosion impact ratings are mapped in Figure 7.

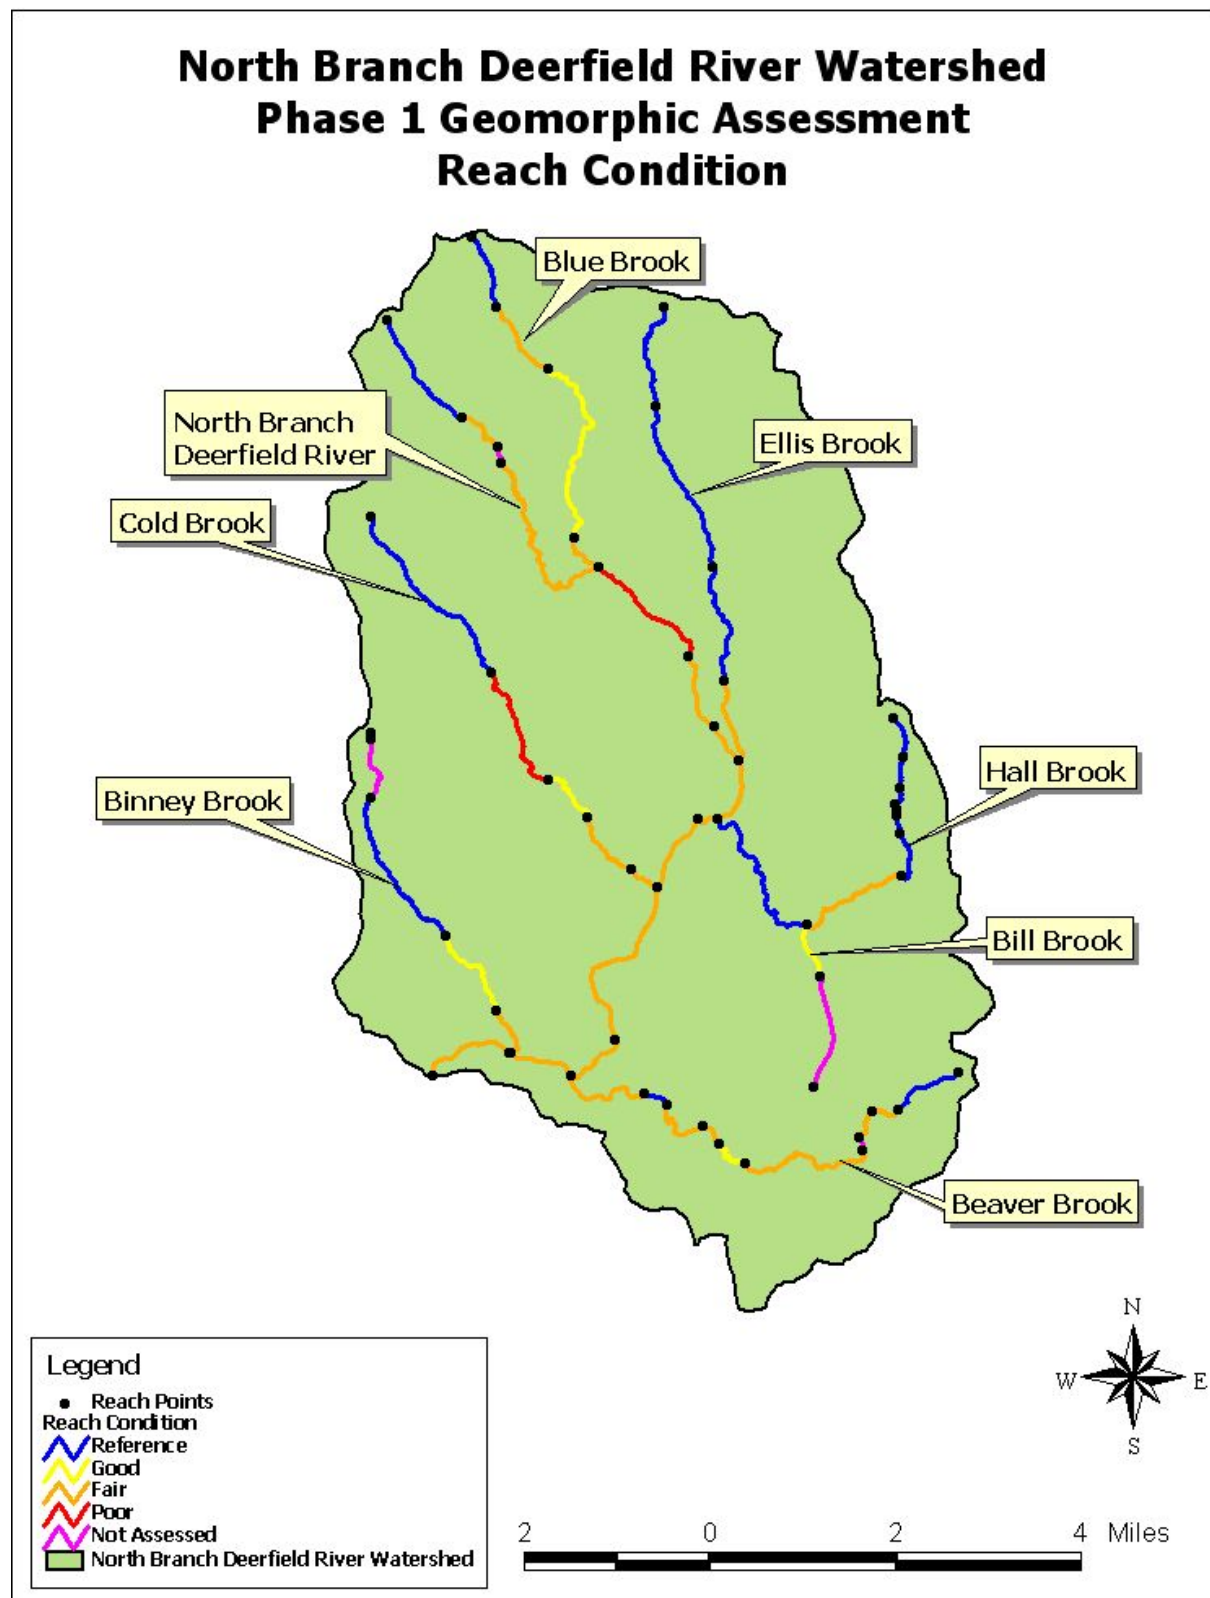
Figure 9. North Branch River Watershed Phase I Reach Condition

Based on impact ratings, there were two reaches in poor condition: T2.04-S1.04 (Cold Brook) and T2.10 (main stem of North Branch). T2.10 has undergone significant channel and floodplain modifications which may have resulted in a change in planform, profile, and dimension such that the stream is no longer in balance with the flow and sediment regime of its watershed. Reach T2.04-S1.04 has undergone significant floodplain modifications and some channel modifications. It may also be impacted by the snowmaking water withdrawals.

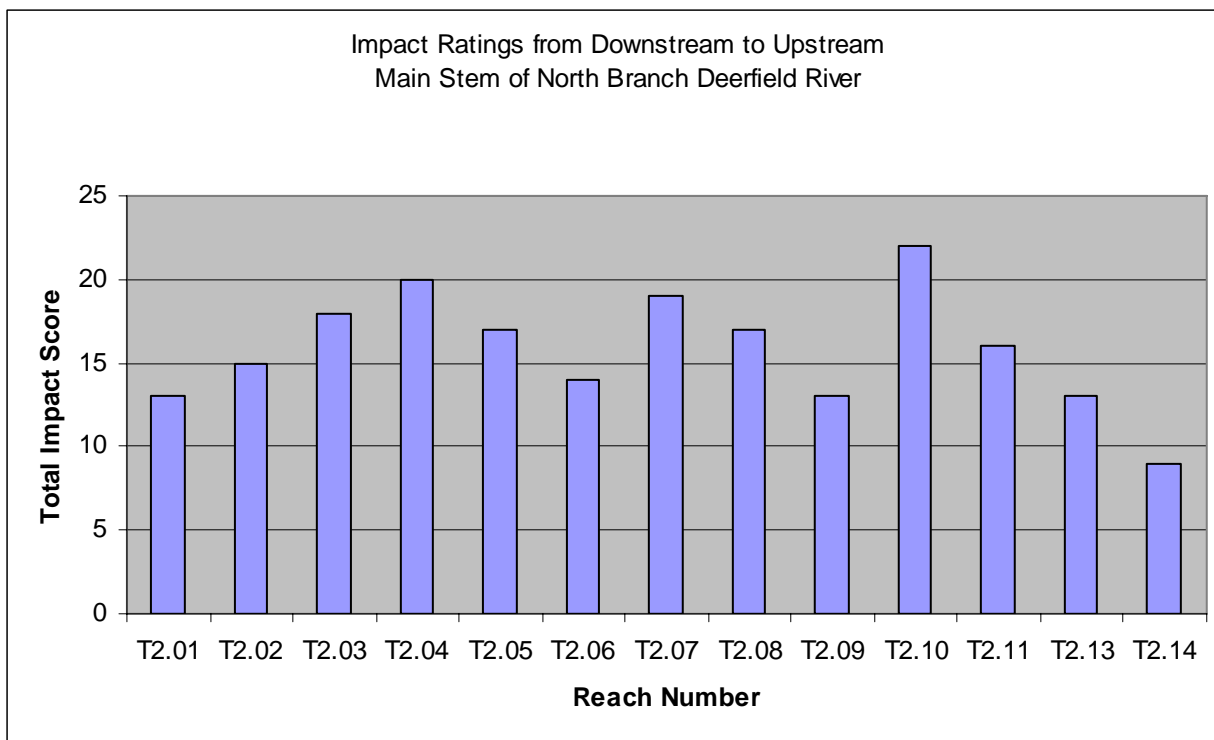
Figure 10. Impact Ratings from downstream to upstream on the main stem of North Branch

Total Impact scores on the main stem of the North Branch ranged from 9 to 22 as illustrated in Figure 10. The highest impacts were found on reaches T2.03 and T2.10 which run through the villages of Wilmington and West Dover. High impacts scores were also recorded on reach T2.04 and T2.07 which have both been extensively straightened and impacted by Route 100. BCE found no apparent trend in impact scores from upstream to downstream.

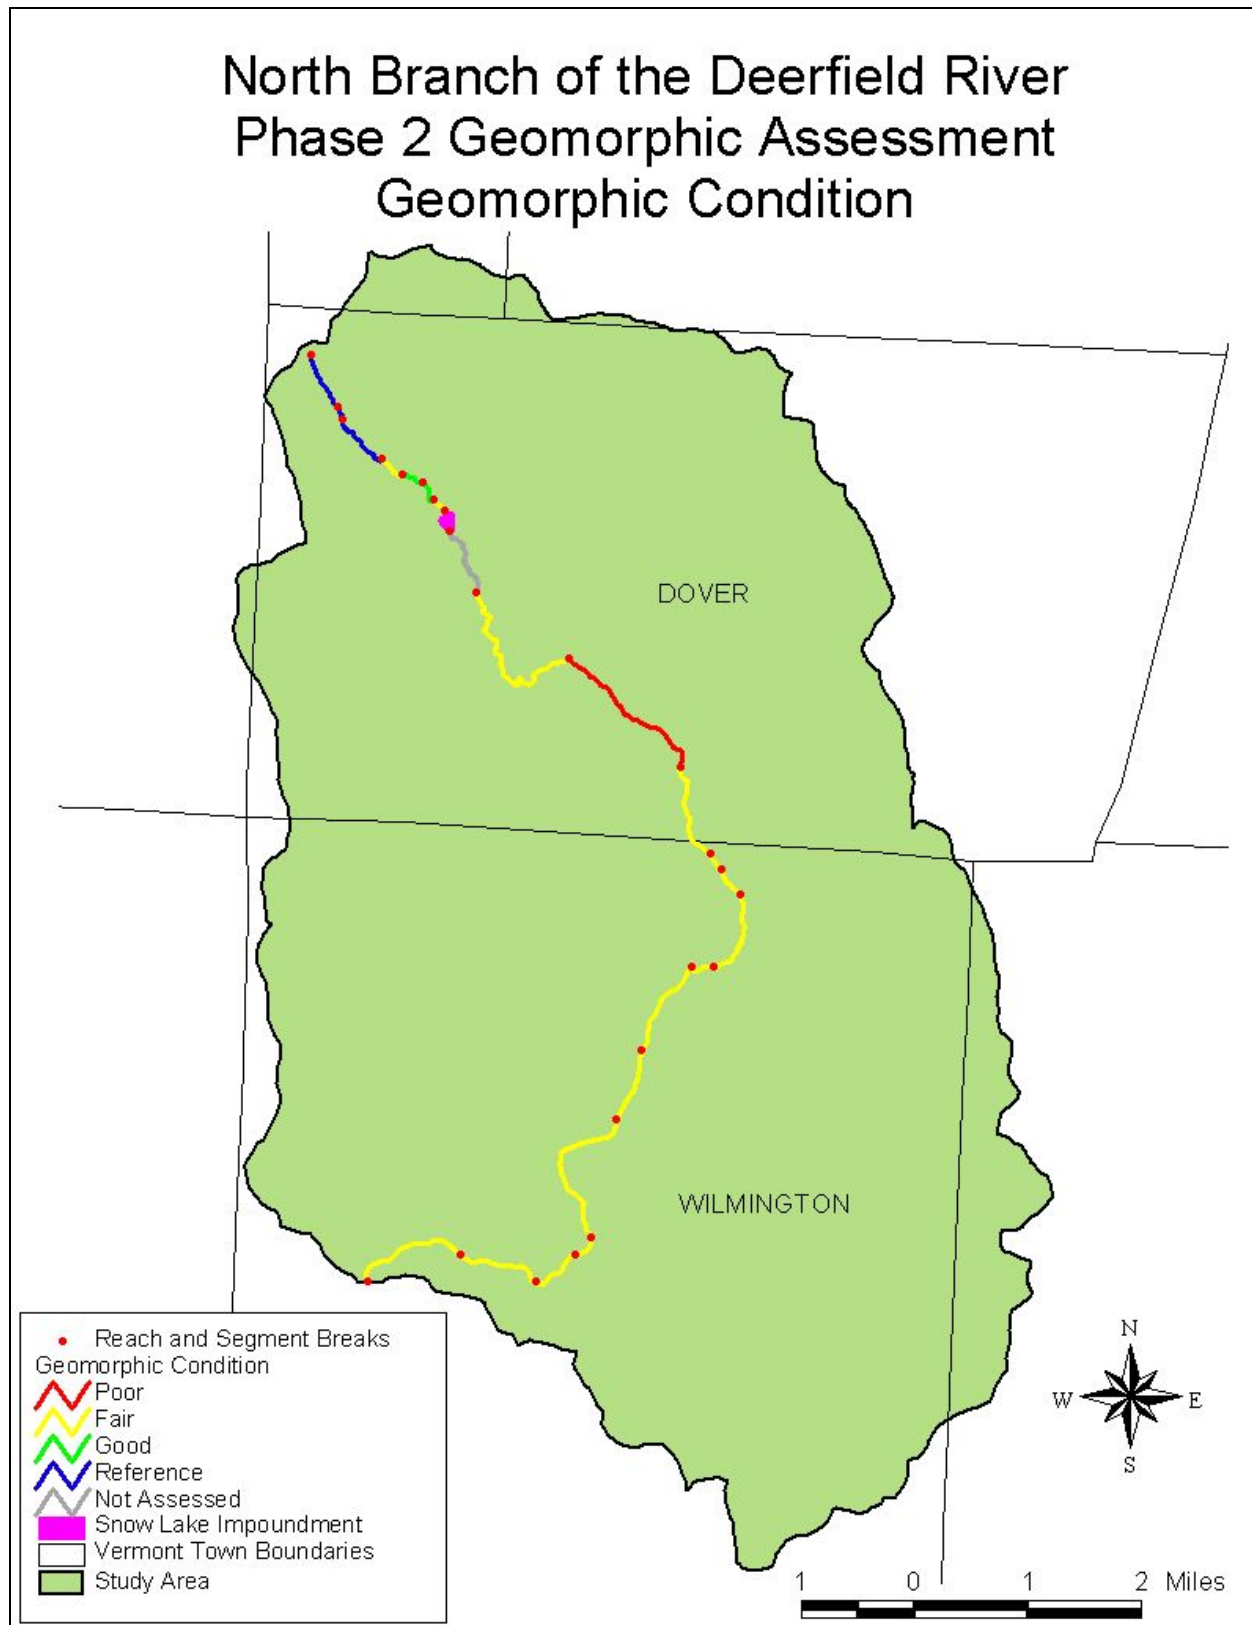
Figure 35: Phase 2 Geomorphic Condition of the North Branch of the Deerfield River

The reach condition is determined using the Rapid Geomorphic Assessment protocol, and is based on the degree of departure of the channel from its reference stream type (VANR 2005b). Of the 19 assessed segments, only two (T2.14-B and T2.14-C) were found to be in reference geomorphic condition. Both of these reaches are located at the top of the study area in the forested headwaters of the North Branch. Only two reaches (T2.13-B and T2.13-C) were found to be in good geomorphic condition, exhibiting only minor adjustment processes. Fourteen of the 19 sections were only in fair condition. These segments were currently undergoing major adjustments through aggradation, widening, and/or a change in their planform. Only one segment, T2.10, a highly altered reach which flows through the Village of West Dover, was found to be in poor geomorphic condition. Table 4 and Figure 35 present the geomorphic condition of the streams within the study area.

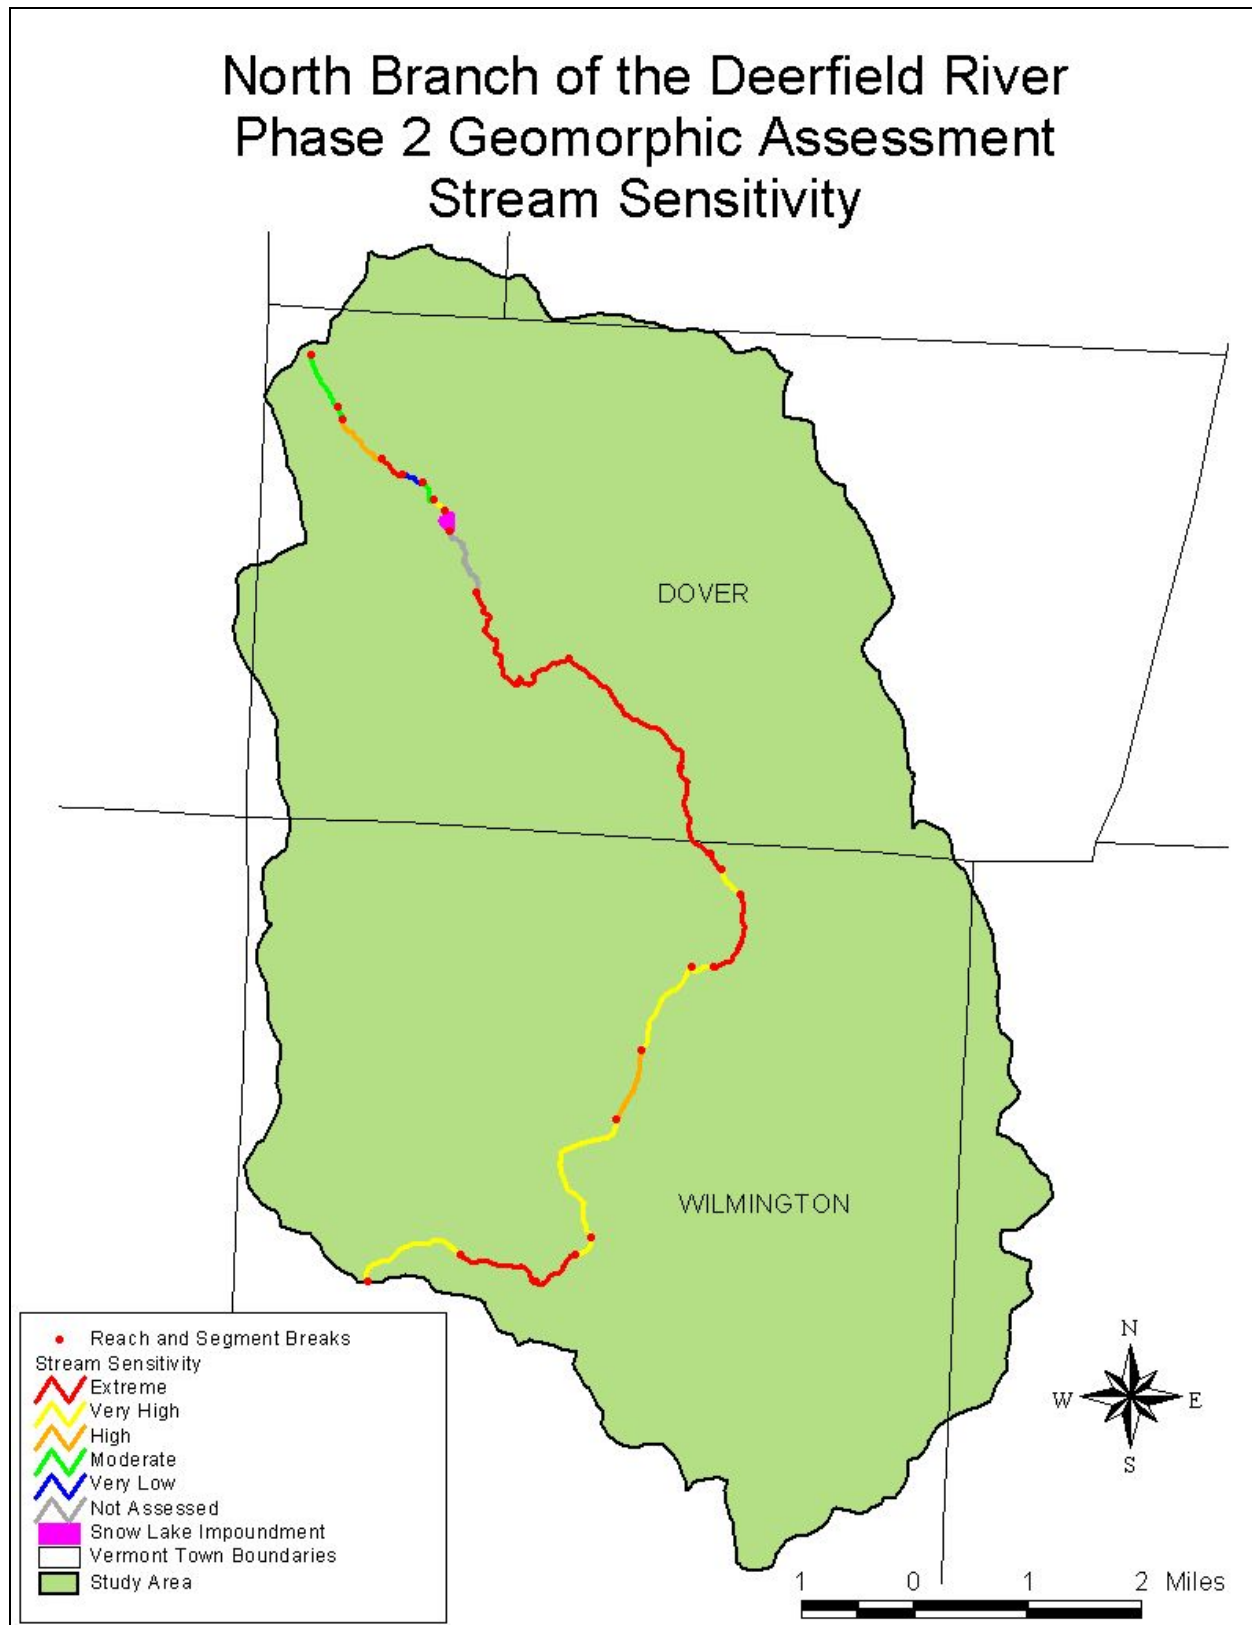
Figure 36: Phase 2 Stream Sensitivity Map for the North Branch of the Deerfield River

Figure 35 is a map presenting the existing stream types found in the North Branch watershed. The stream sensitivity of these reaches, generalized according to stream type as per the ANR protocol, is depicted in Table 6 and in Figure 36. In general the North Branch has many reaches that are very high to extremely sensitivity. The historic degradation and reduction of floodplain access in these reaches increases stream power in the channel making catastrophic geomorphic adjustment more likely.
