NORTHWOODS STEWARDSHIP CENTER

Leach Stream Phase 1 Geomorphic Assessment

Essex County Natural Resources Conservation District

September 2013

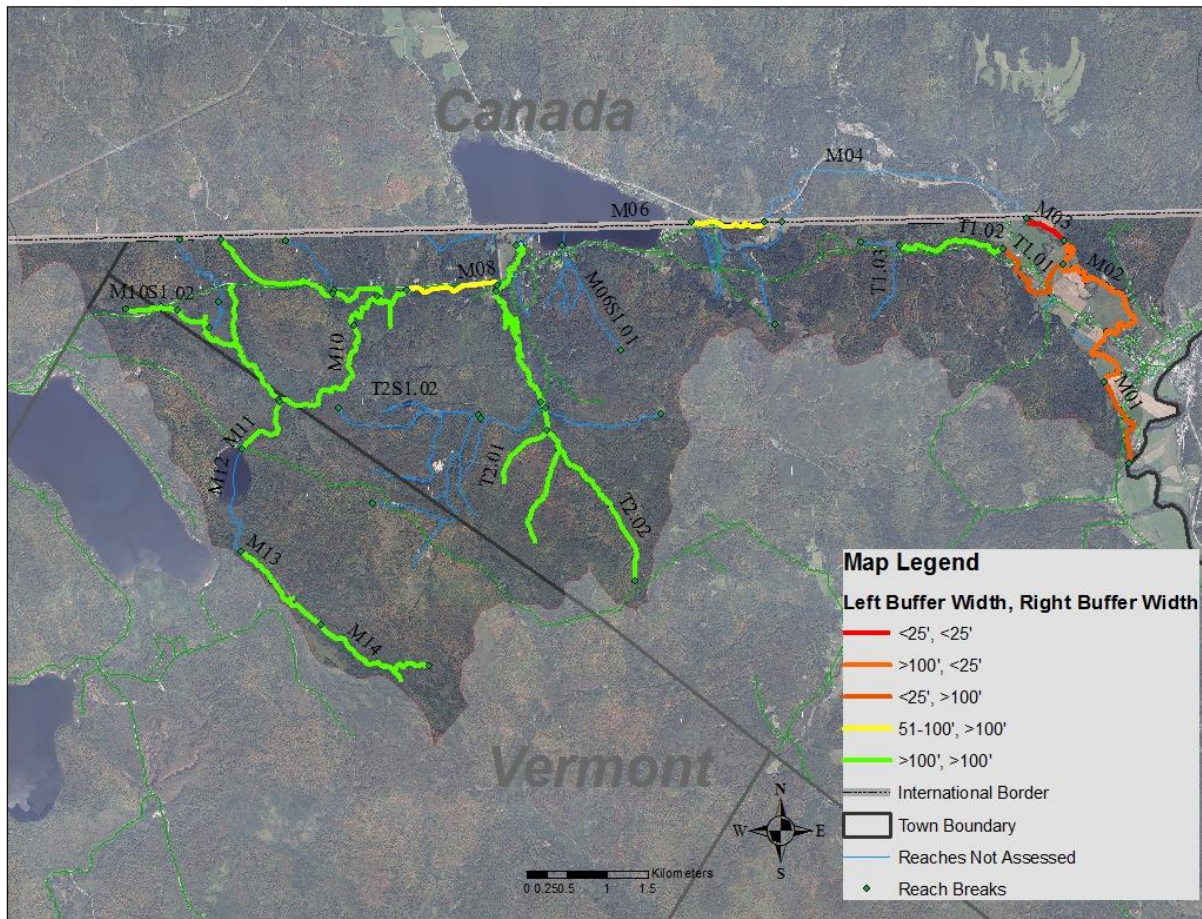
Figure 6 Map of dominant buffer widths for assessed Leach Stream reaches.

Approximately 68% of Phase 1 reaches were well-buffered, with dominant buffer widths of at least 100 feet along both banks. Two reaches, M05 and M08, were well-buffered along their right banks, but suffered reduced buffers of 51-100 feet along their left banks due to their close proximity to roads (Figure 6). The remaining four reaches, all located in the lower portion of the watershed near the confluence with the Connecticut River, had severely reduced buffers of less than 25 feet along one or both banks (Figure 6).

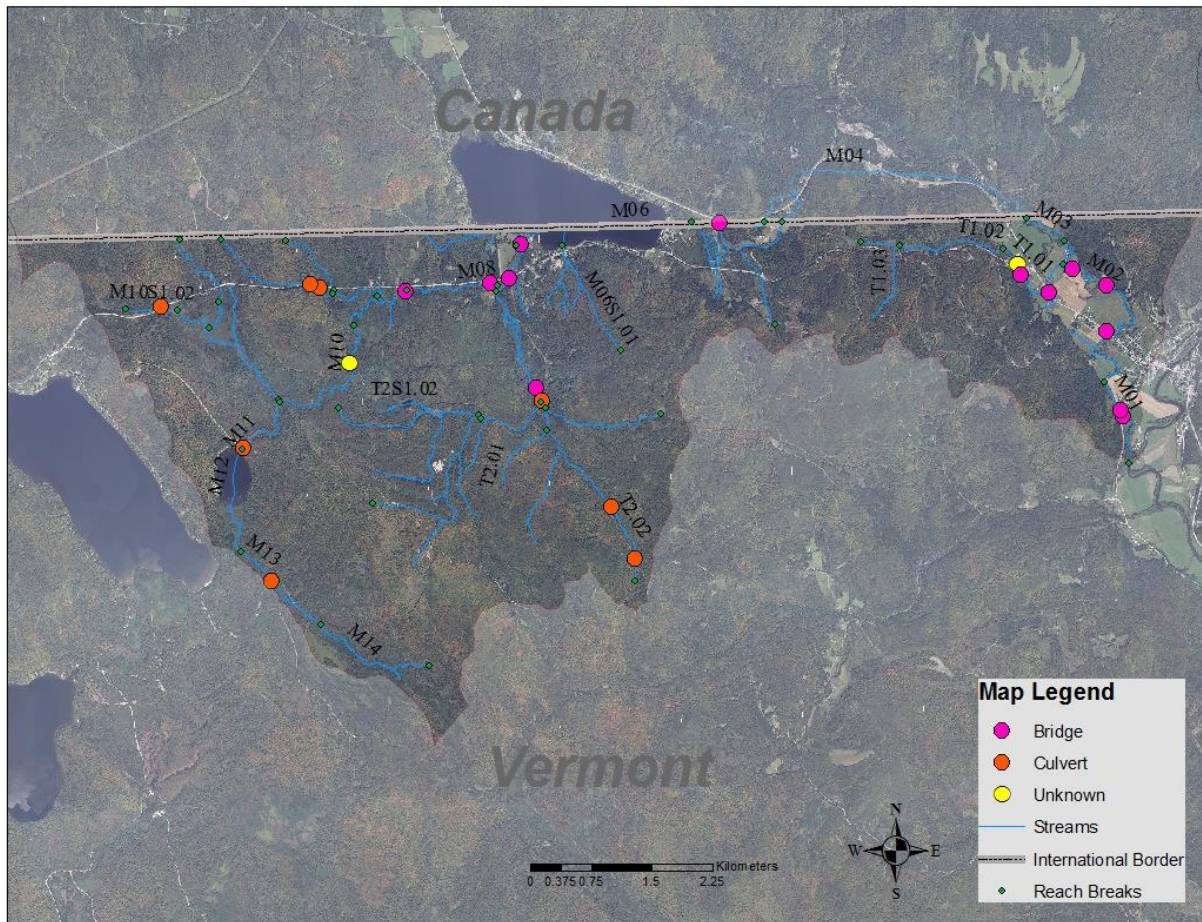
Figure 8 Map of bridge and culvert locations in the Leach Stream watershed.

A total of thirteen bridges, eight culverts, and two unknown structures with negative impacts were found on Phase 1 assessed reaches in the Leach Stream watershed (Figures 7 and 8). Together these stream crossings appear to affect about 0.4 river miles, or approximately 2% of the total length of assessed reaches. Several new culverts in the upper headwater tributaries were notably undersized, and will likely be undermined and result in flooding, sediment deposition, and channel migration in the future. In addition, the majority of the culverts observed were already perched, disrupting the upstream migration of fish and causing pooling downstream. Similarly, bridges in reaches M02, M08, M09, and T2.01 are currently constricting their floodplains. Upstream and/or downstream scour pools and sediment deposition are currently found at many of these sites, indicating the impacts of the structures on the stream condition.

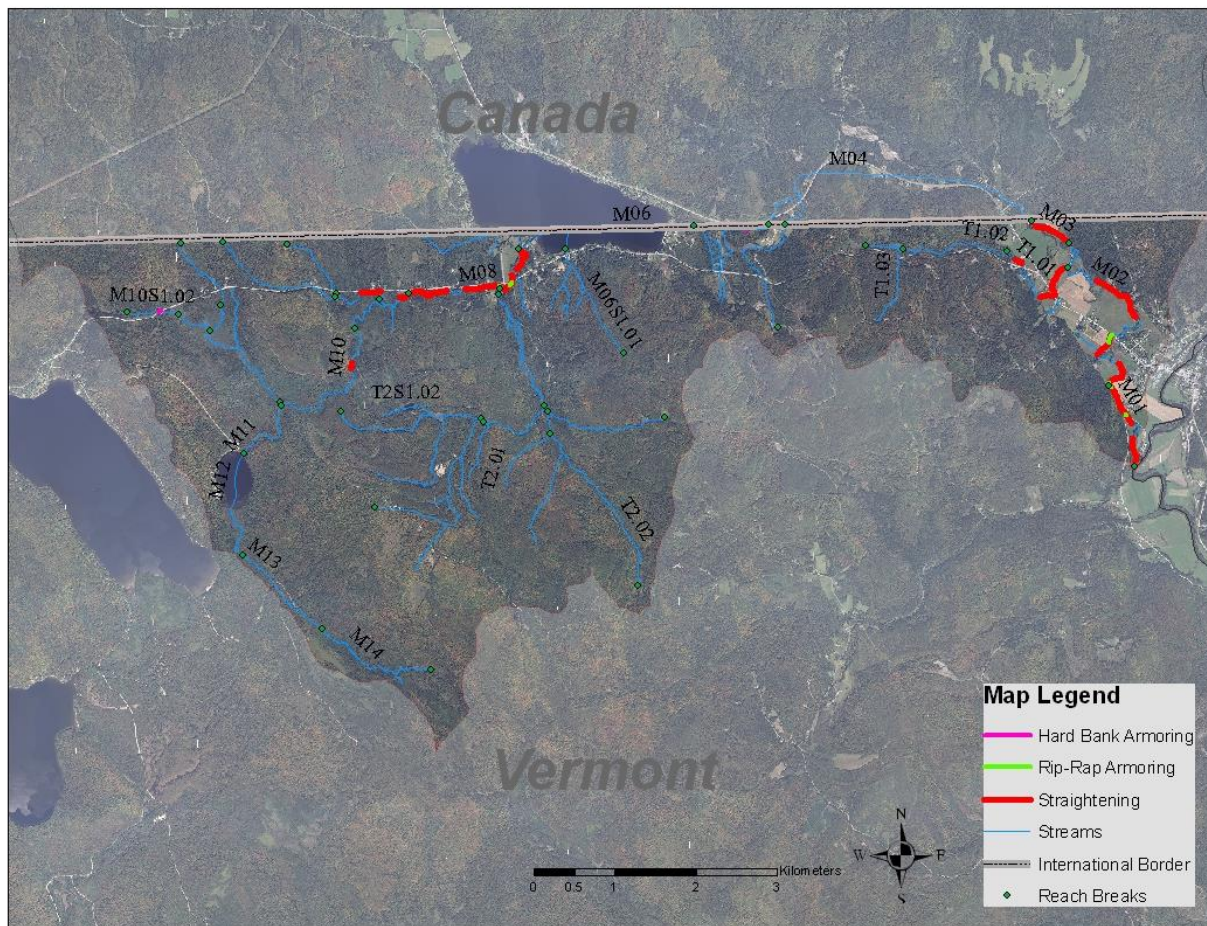
Figure 10. Bank armoring and channel straightening locations in Leach Stream Phase 1 reaches.

Similar to (and often in conjunction with) bank armoring; stream channels have frequently been straightened in the past to make more land along a river corridor accessible for agriculture, development, transportation, or other purposes. Channel straightening however often also increases water velocity, leading to major adjustments downstream as this increased energy is dissipated and equilibrium with the slope and substrate is re-established. In the Leach Stream watershed, approximately 3.7 river-miles of Phase 1 assessed reaches have been straightened, most notably in sections near Vermont Route 114 southwest of Wallace Pond and in agricultural areas in the lower portions of the watershed (Figure 10).

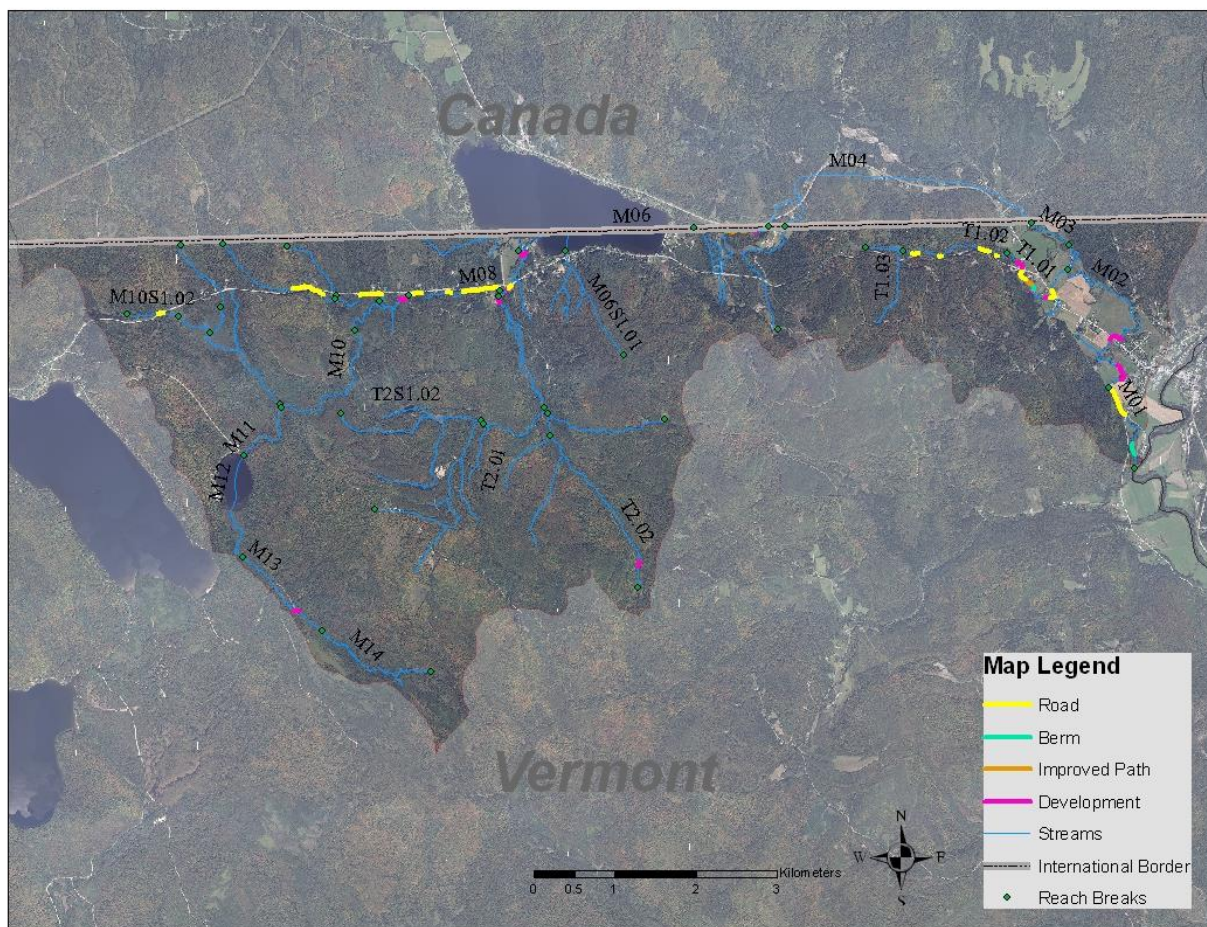
Figure 11. Location of encroachments and development on Phase 1 assessed reaches.

1 river-mile of Phase 1 assessed reaches. In the Vermont portion of the watershed, encroachments and development are concentrated along Vermont Route 114 southwest of Wallace Pond, and in the lower portion of the watershed, near Leach Stream's confluence with the Connecticut River (Figure 11).

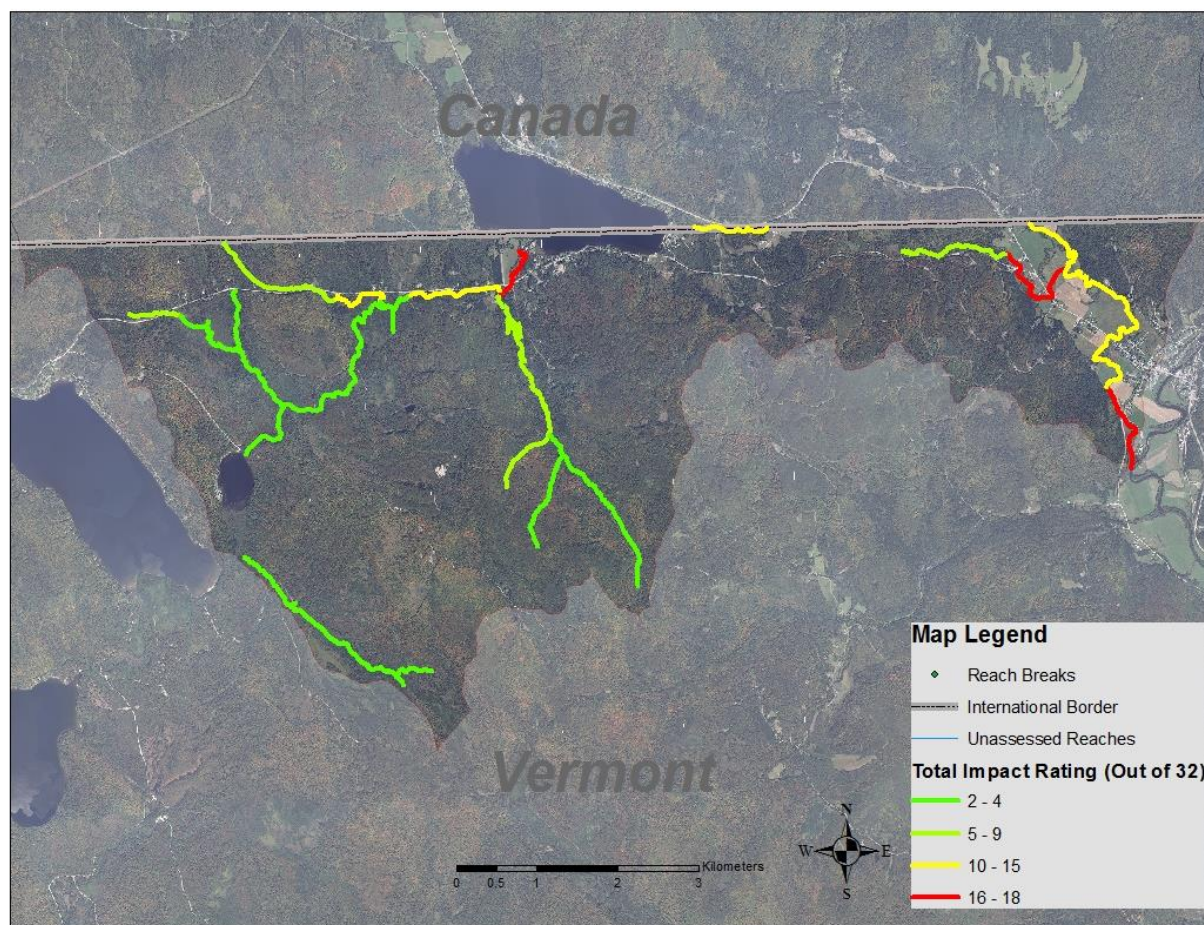
Figure 14. Total impact ratings for assessed reaches in the Leach Stream watershed.

This score provides an objective overall measure of stream health and is useful in determining which reaches have been most heavily impacted by human activity. Total impact scores have a potential range from 0-32, with 0 being least impacted and 32 being the most heavily impacted. In the Leach Stream watershed, total impact scores ranged from 2 to 18 (Table 3). In general, headwater reaches tended to be the least impacted reaches, while the lowest reaches in the watershed and those in close contact with Route 114 were the more heavily impacted (Figure 14).

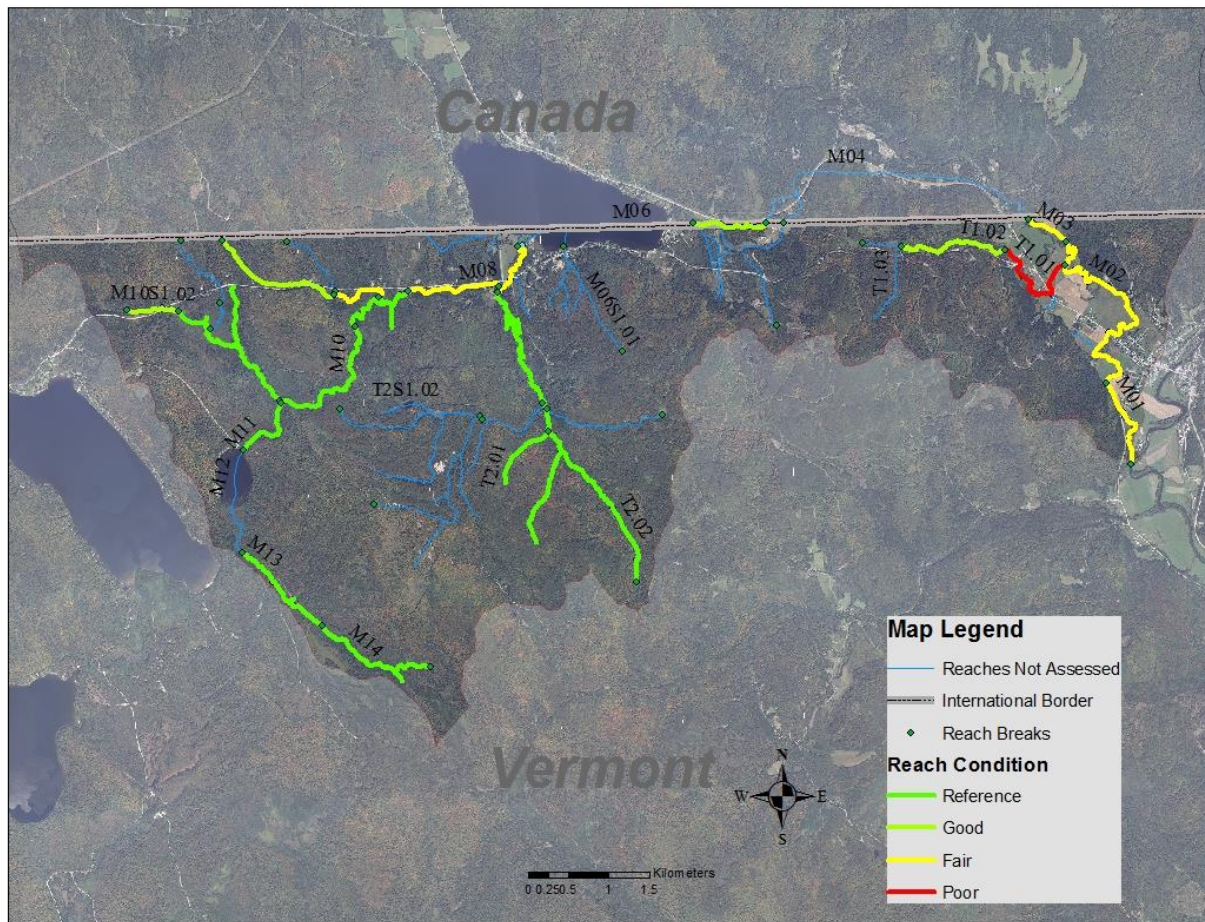
Figure 15. Geomorphic conditions of assessed reaches in the Leach Stream watershed.

Figure 15 depicts the geomorphic conditions found along the Leach Stream and its tributaries, as determined in the Phase 1 Stream Geomorphic Assessments. These condition rankings are based on the intensity of channel and floodplain modifications, as well as the overall stream condition observed during the field assessments, and include reference, good, fair, or poor. The Vermont Agency of Natural Resources Stream Geomorphic Assessment Protocol describes these conditions as follows (State of Vermont 2007):

Reach conditions of all assessed Phase 1 reaches are reported in Table 3. The majority (42%) of Phase 1 assessed reaches in the Leach Stream watershed were in reference condition, covering a total of approximately 11.58 river-miles. In general, these reaches were stable, low order streams, located in forested headwater areas removed from significant human development. Four reaches totaling 4.87 river-miles were in good condition. These reaches were also located within forested areas, but lay adjacent to roadways, which contributed some impact. Six reaches, totaling 5.98 river-miles, were in fair condition. These reaches flow through corridors with moderate levels of agriculture and development. Finally, one reach measuring 1.15 river-miles was in poor geomorphic condition. This reach was located just above the lowermost portion of the watershed near the confluence with the Connecticut River. This portion of the watershed is the most heavily impacted by agricultural use and development, vegetated buffers are limited along one or both banks in many areas, and there are multiple signs of active channel adjustment.
